United States Department of Agriculture Animal and Plant Health Inspection Service

Teachable Moments

Legal Name:	SINGLE VISION INC					
Customer Number:	331487	Certificate Number:	58-C-1117			
Inspection Date:	17-Mar-2020	Site Number:	001			
Inspector:	KRISTIN NAPOLI

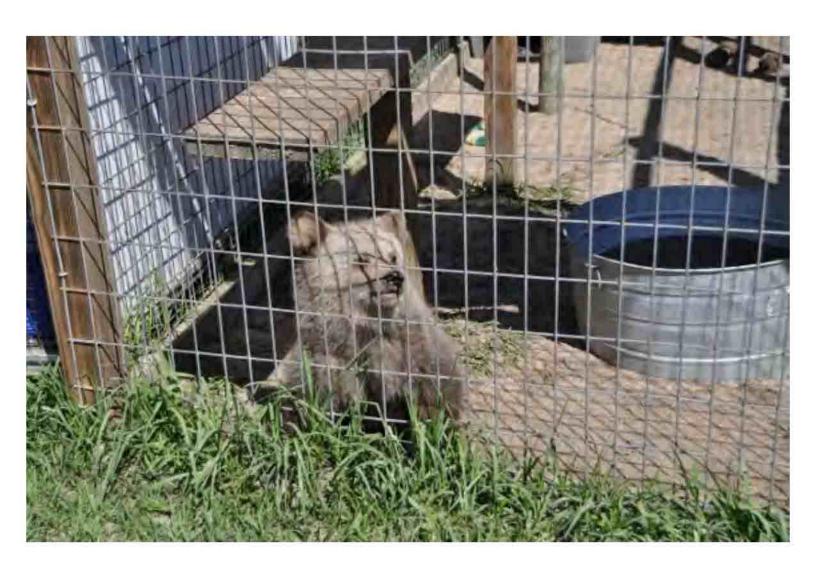
Description: Syrian Brown Bear Cub approximately 14-15 wks old, weighing 22 lbs, per licensee.

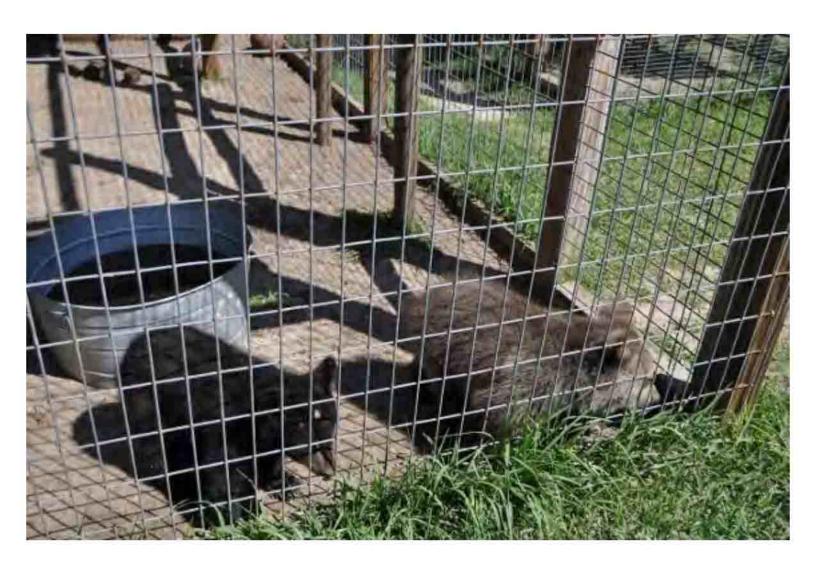
Description: Both North American Black Bear Cub and Syrian Brown Bear Cub

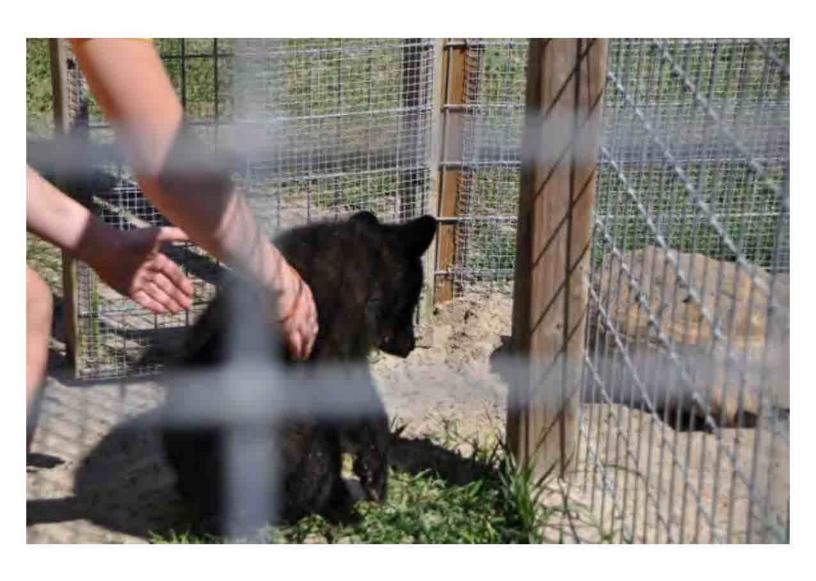
Description: North American Black Bear Cub approximately 14-15 wks old, weighing 18 lbs, per licensee
