CFR : 3.75(c)(1)(i)

Inspection No: 2016082569696178

Certificate: 65-C-0519

TIM LEPARD

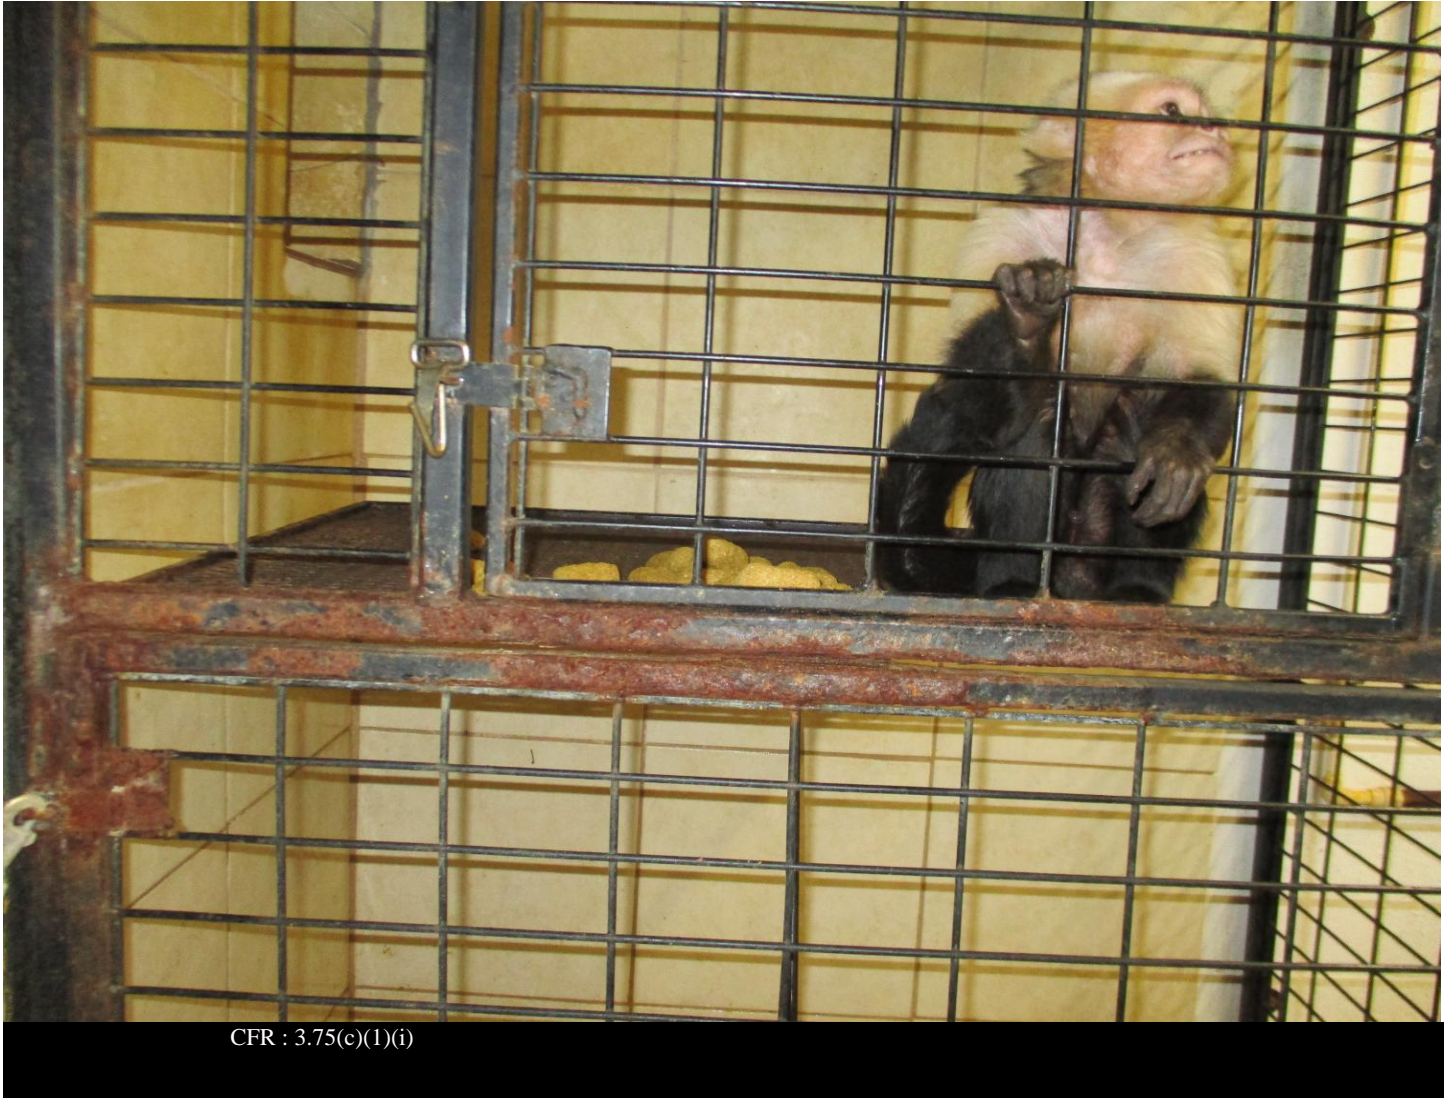
Up close - right side enclosure showing rust

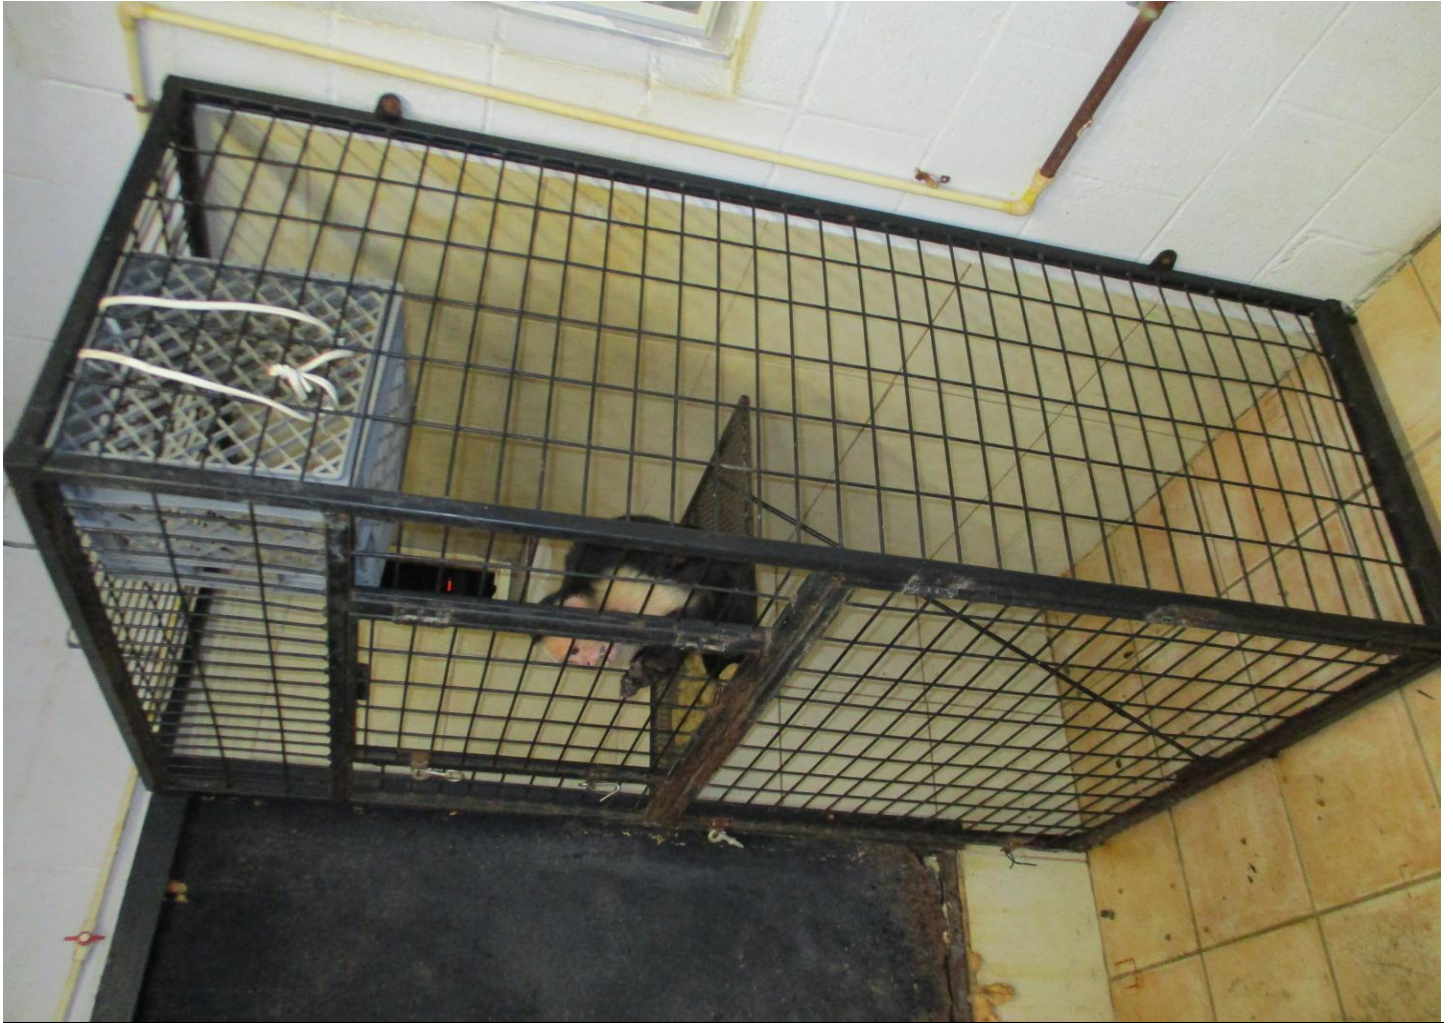
CFR : 3.75(c)(1)(i)

Enclosure on right side, showing rust on bar adjacent to platform.

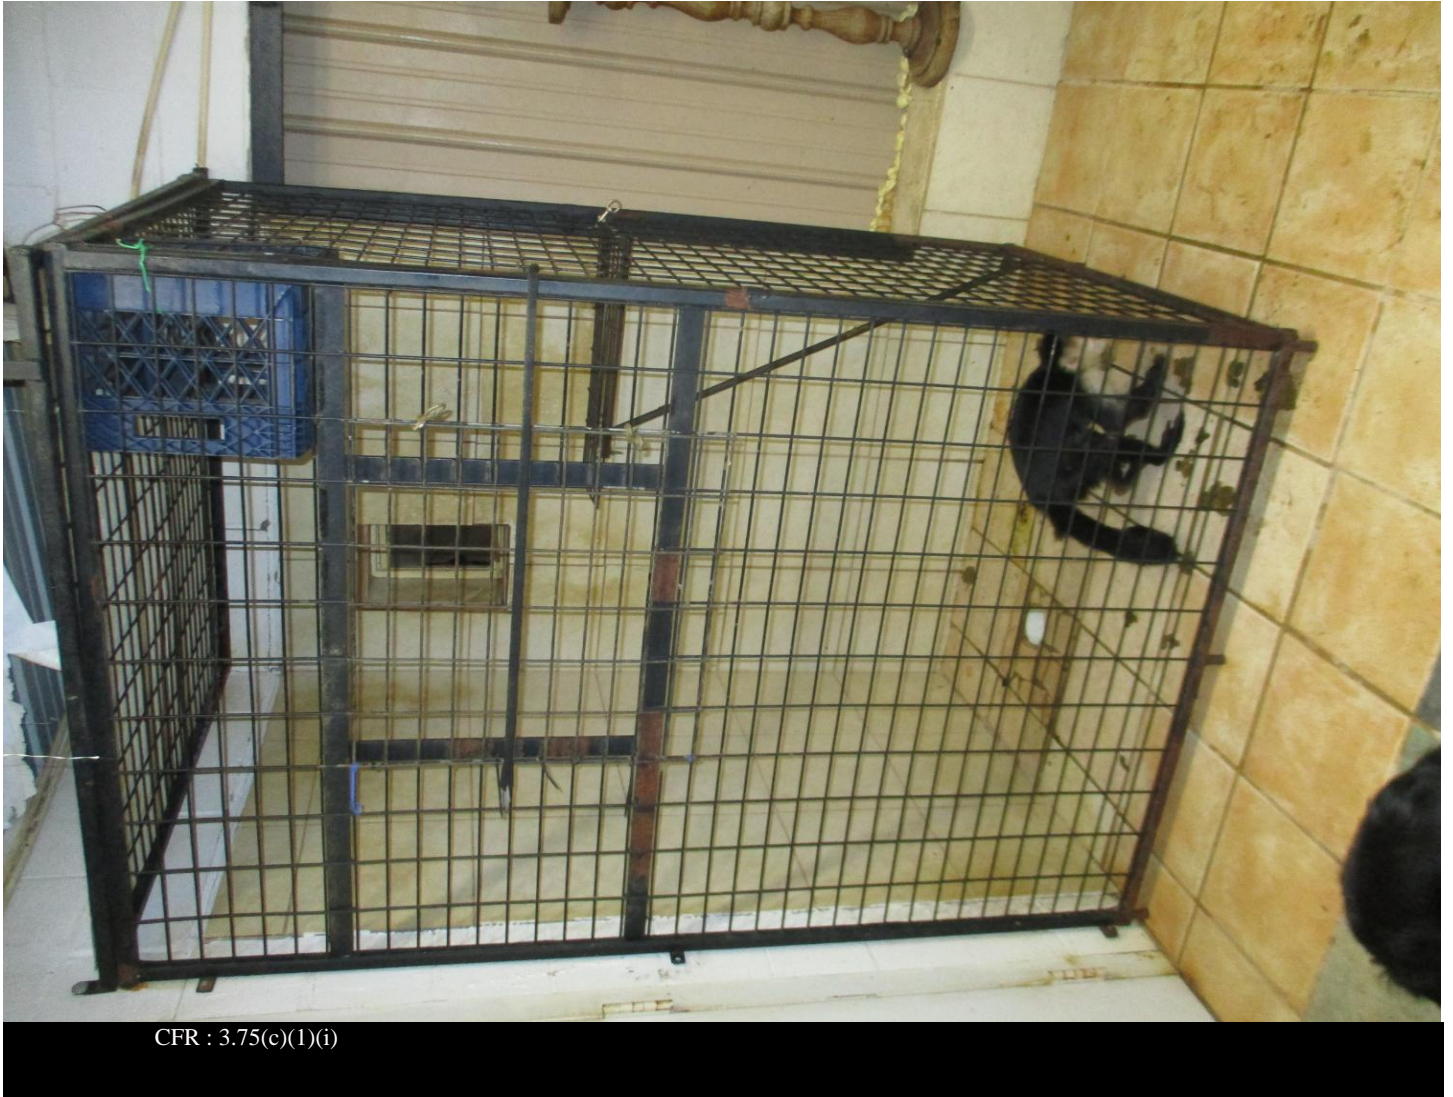
CFR : 3.75(c)(1)(i)

Enclosure on left side showing rust on lower and middle bars of front panel

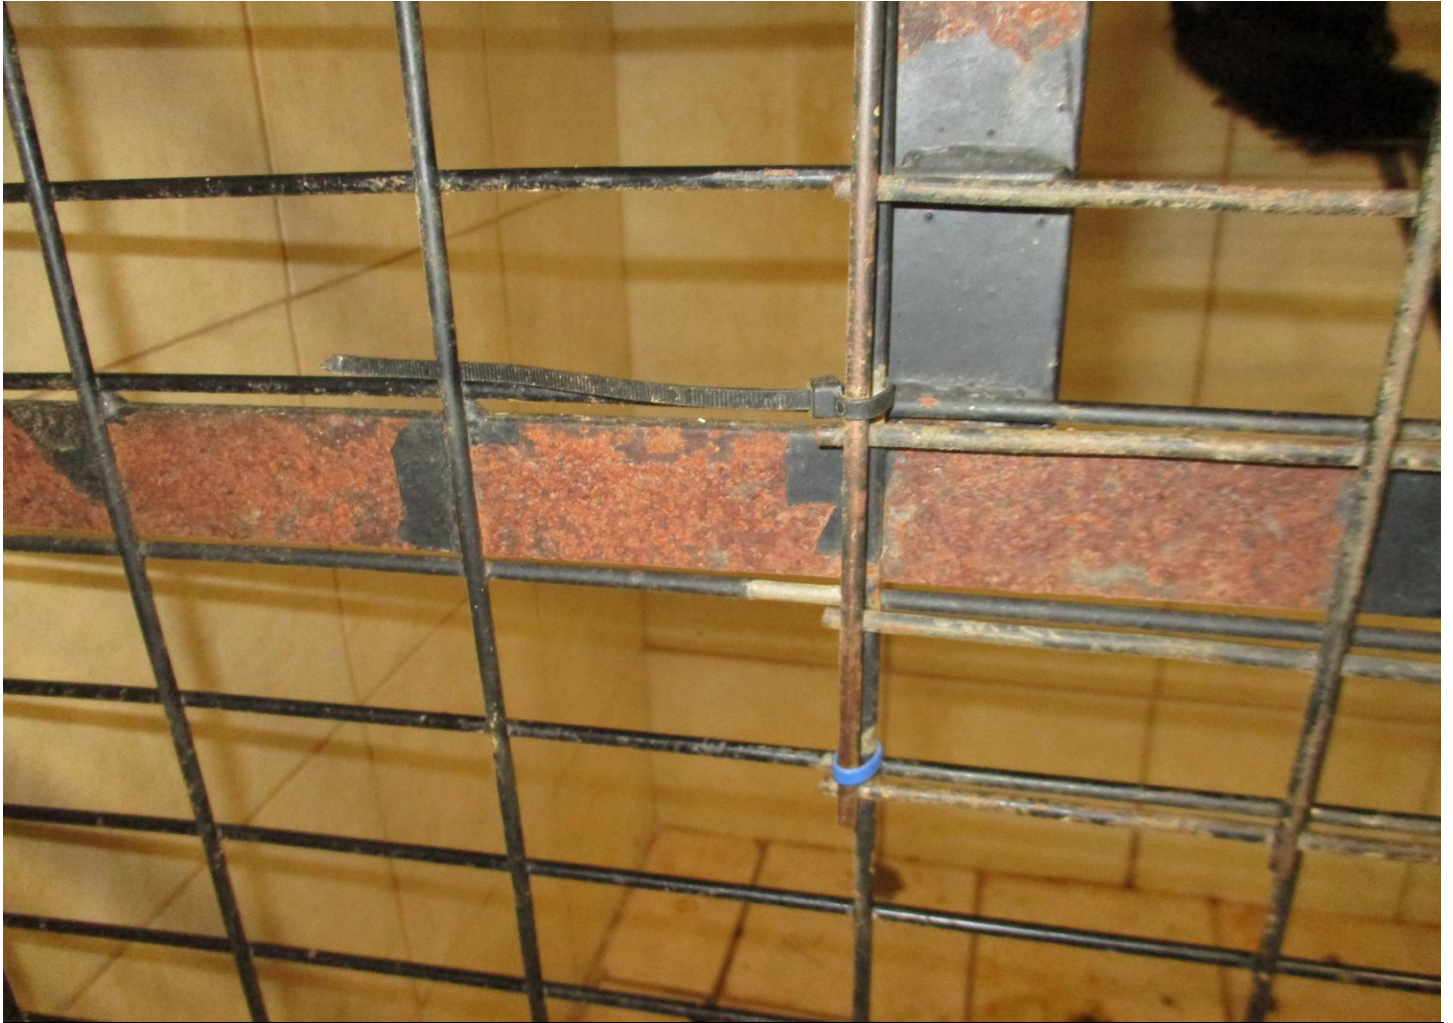
CFR : 3.75(c)(1)(i)

Up close enclosure on left side showing rust on bar
