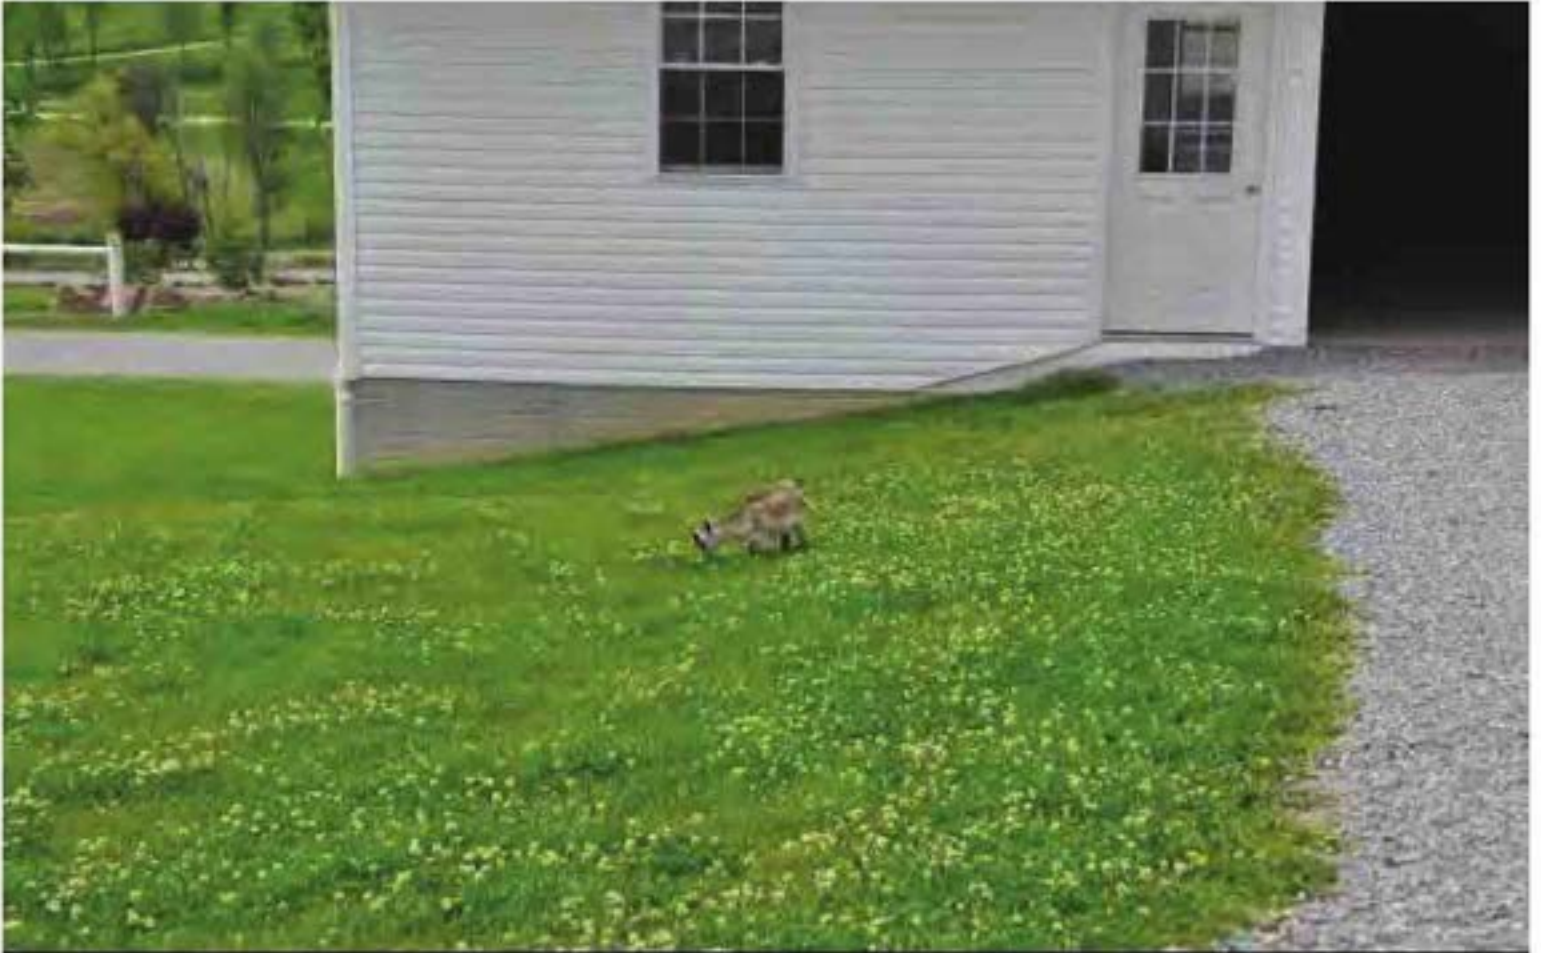
CFR: 3.125 (a)

Photographer:	R. Coleman, ACI	Legal Name:	55-B-0069
Photo Taken:	Wed, Jun 4, '14 1030	HENRY HAMPTON	
Inspection:	224140937090445		
Description:	Pygmy goat roaming freely

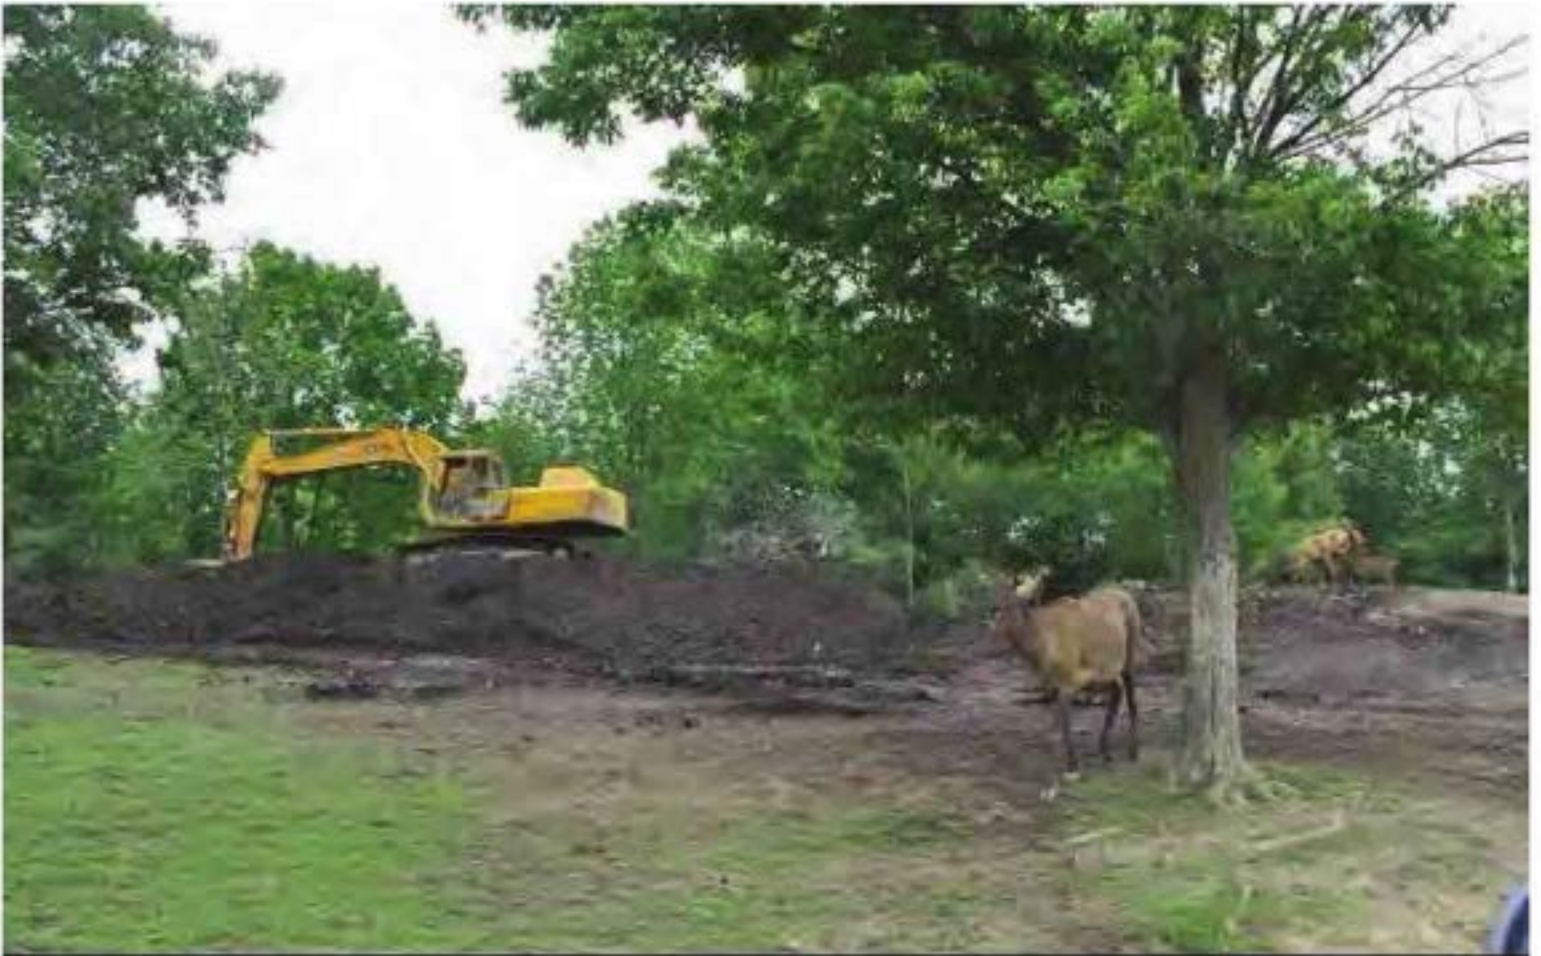
CFR: 3.125 (d)

Photographer:	R. Coleman, ACI	Legal Name:	55-B-0069
Photo Taken:	Wed, Jun 4, '14 1030	HENRY HAMPTON	
Inspection:	224140937090445		
Description:	Mound of animal waste in drive through

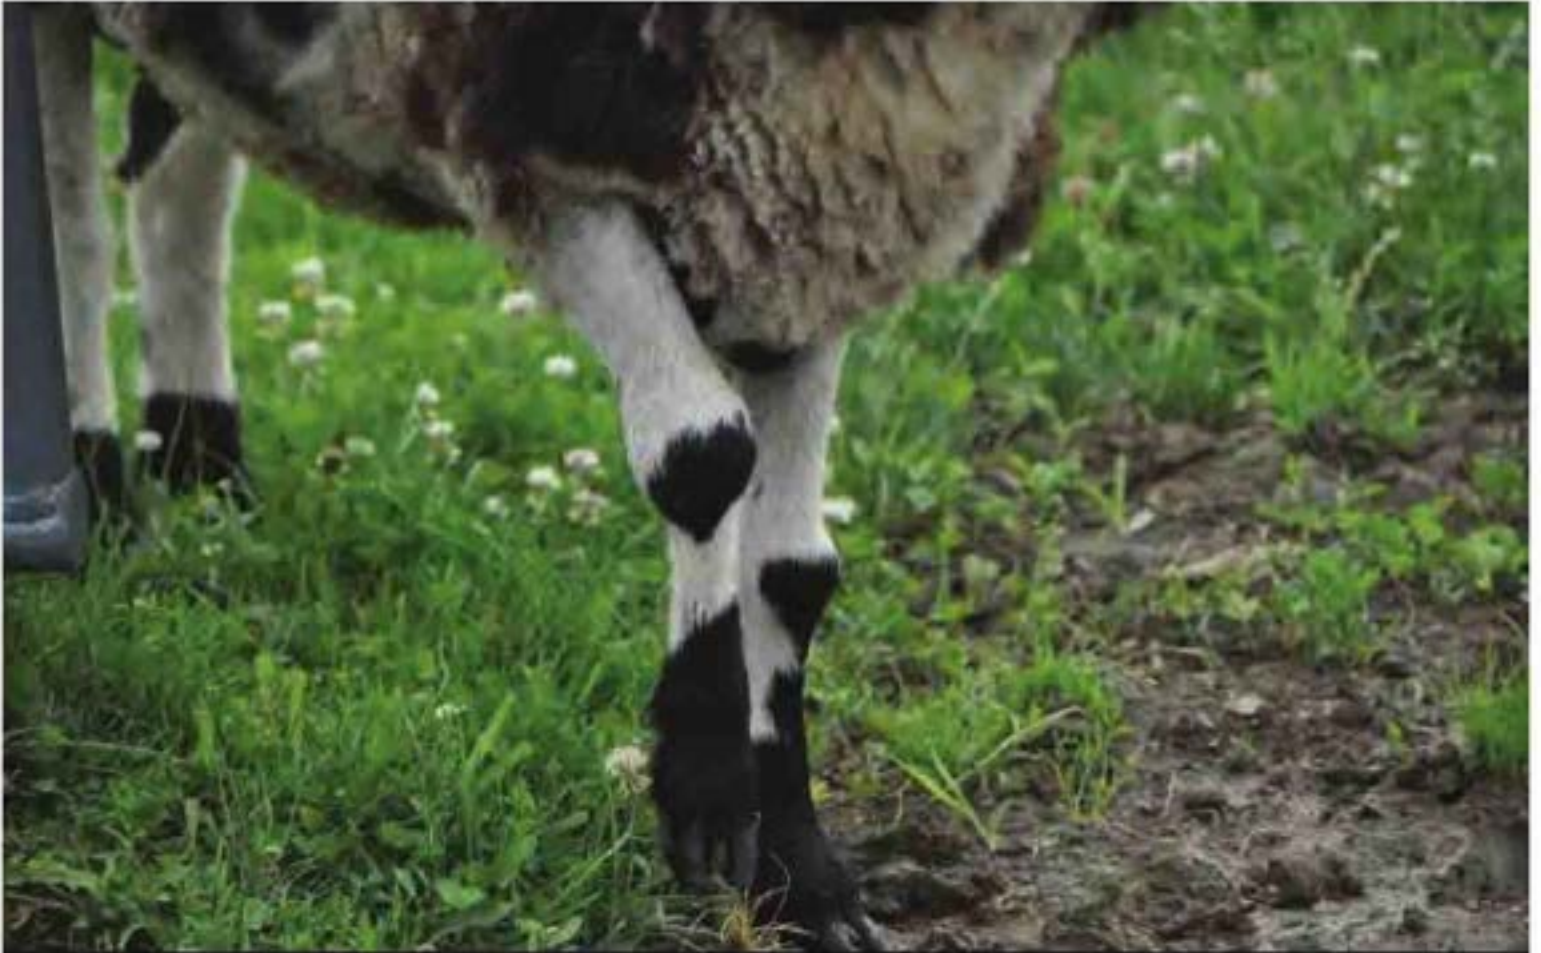
CFR: 2.40 (b) (2)

Photographer:	R. Coleman, ACI	Legal Name:	55-B-0069
Photo Taken:	Mon, Jun 30, '14 1030	HENRY HAMPTON	
Inspection:	181141516260708		
Description:	Black and white ewe found to be lame on right front, holding right foot off of ground.

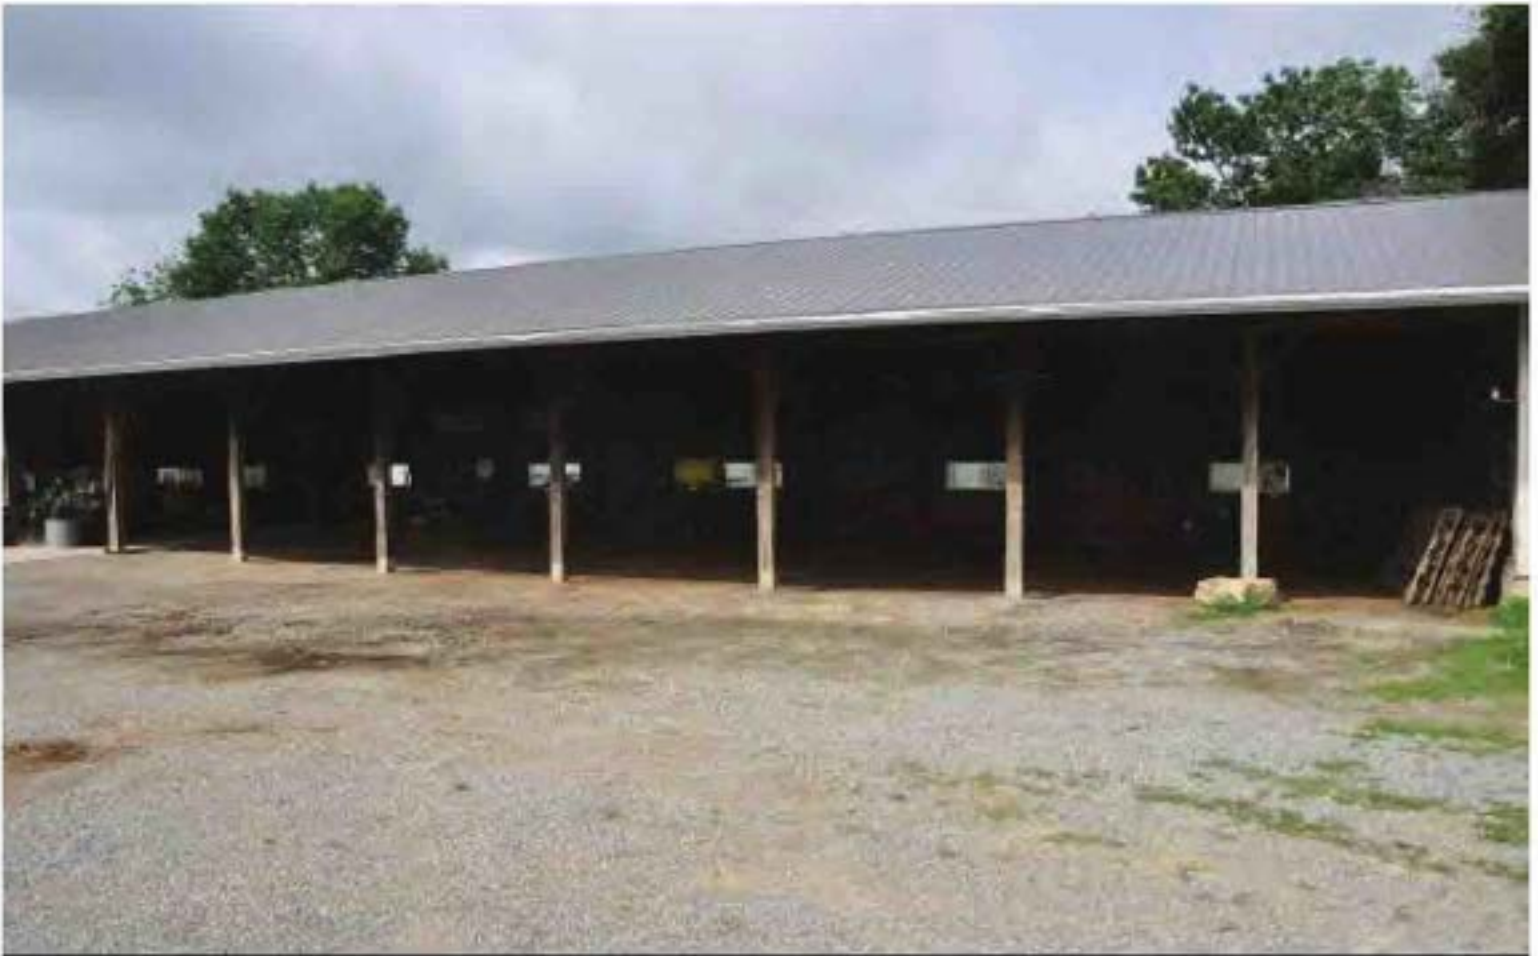
CFR: 2.75 (b) (2)

Photographer:	R. Coleman, ACI	Legal Name:	55-B-0069
Photo Taken:	Mon, Jun 30, '14 1030	HENRY HAMPTON	
Inspection:	181141516260708		
Description:	Production barn where Suffolk sheep previously housed. Sheep #160, 305, and 310 no longer on premises.

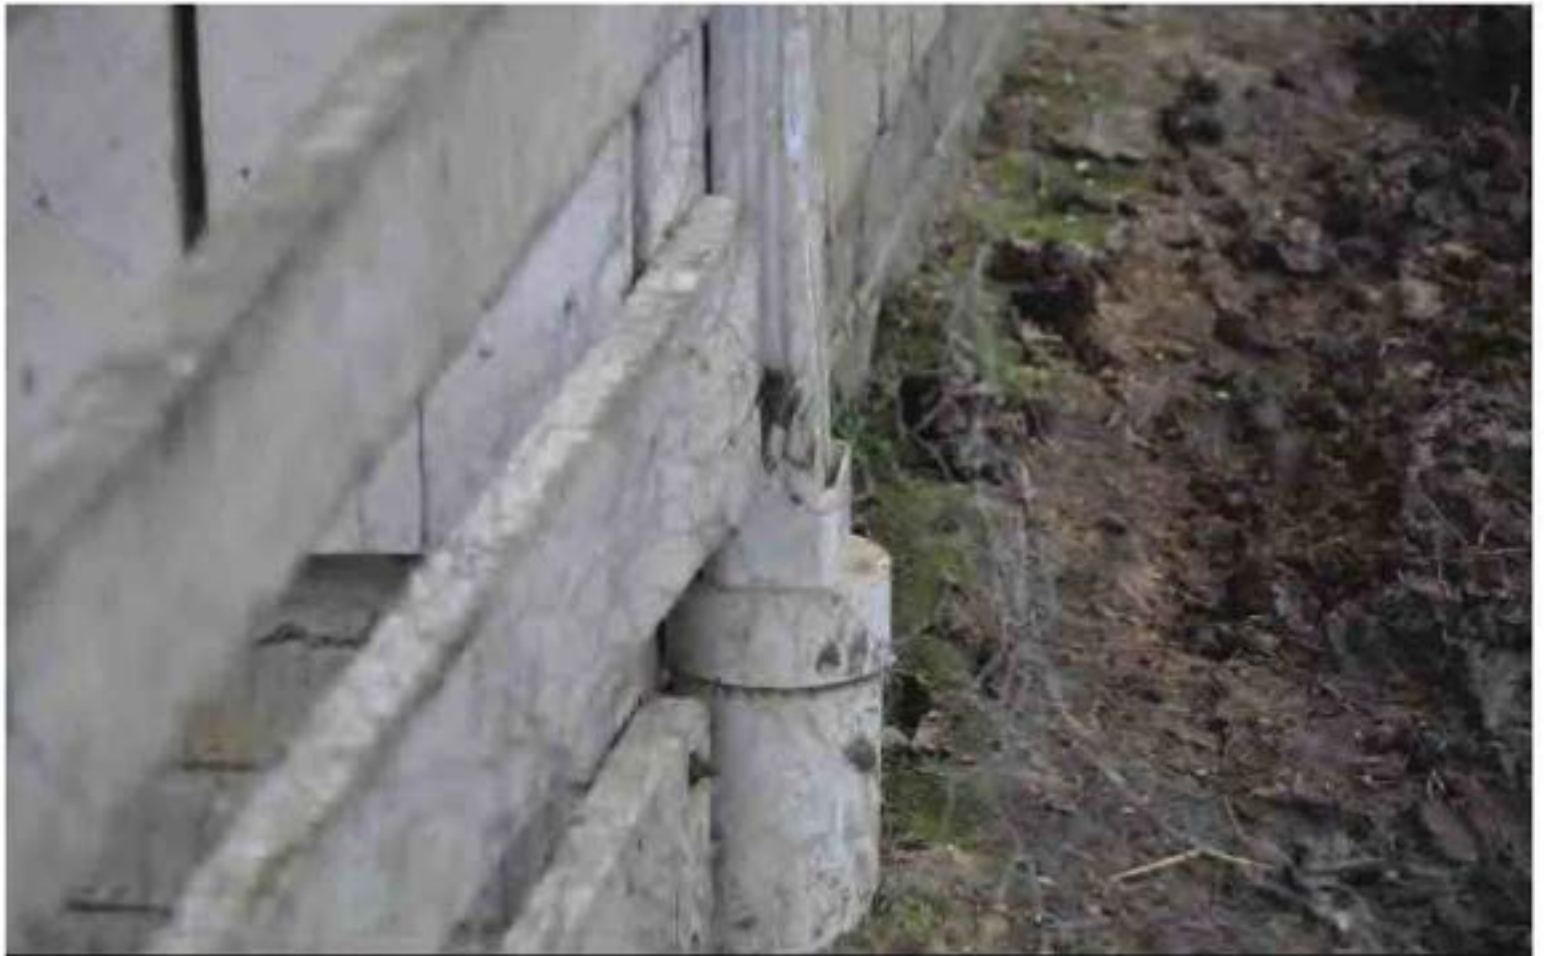
CFR: 3.125 (a)

Photographer:	R. Coleman, ACI	Legal Name:	55-B-0069
Photo Taken:	Wed, Nov 12, '14 12-4 pm	HENRY HAMPTON	
Inspection:	321140657190604		
Description:	Loose chicken wire fencing in enclosure housing zebu cattle and sheep near production sheep barn.

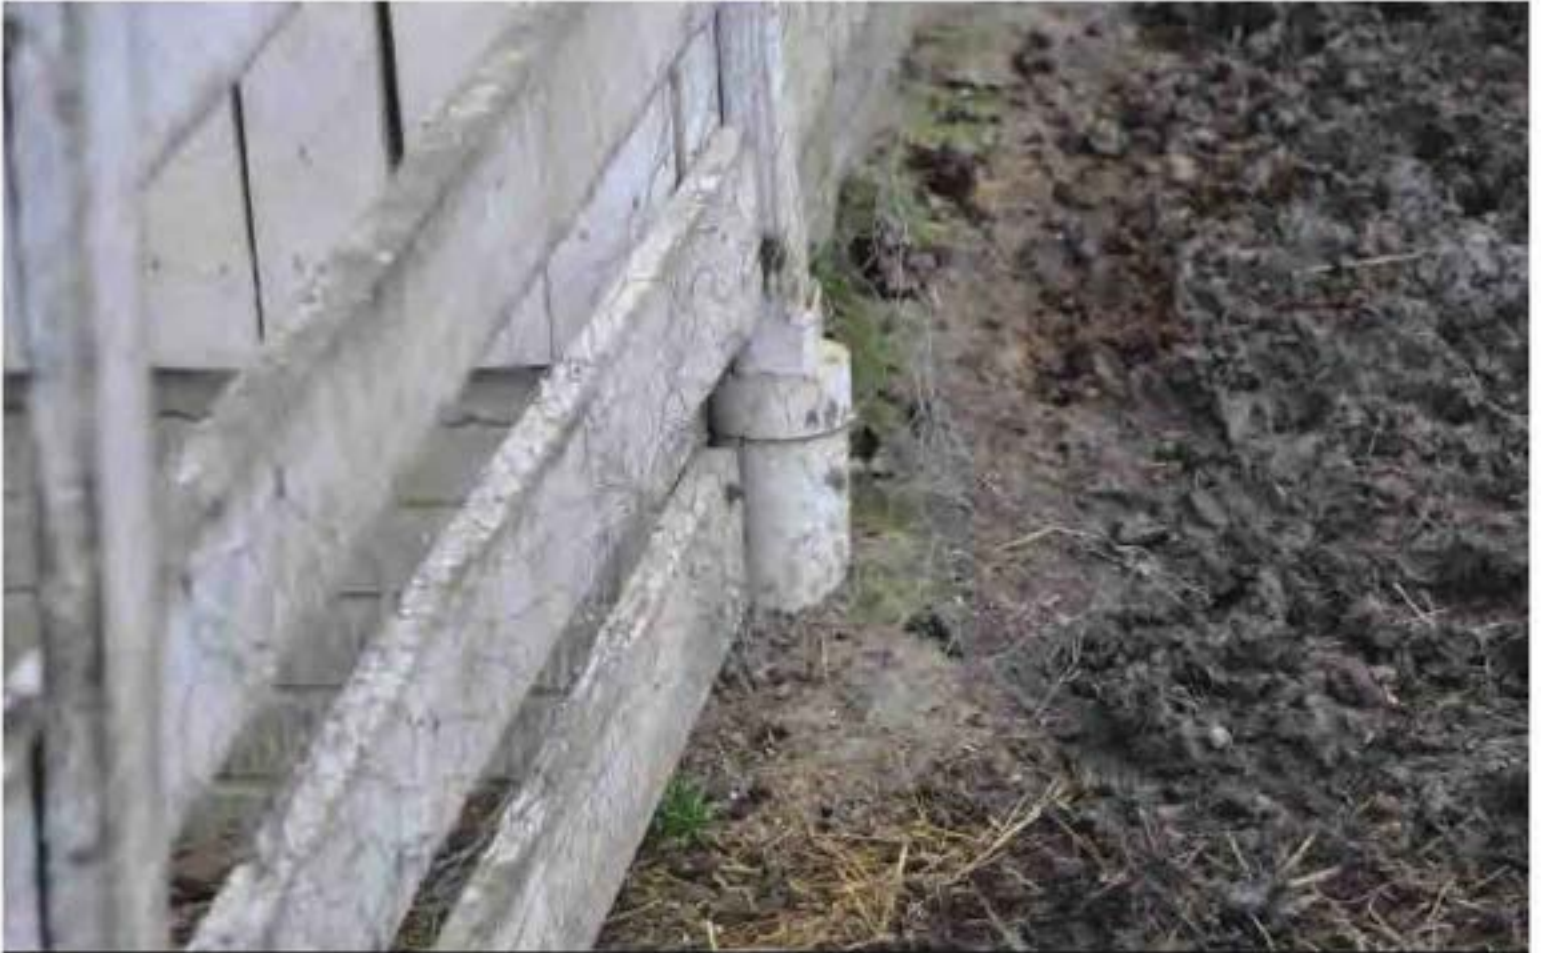
CFR: 3.125 (a)

Photographer:	R. Coleman, ACI	Legal Name:	55-B-0069
Photo Taken:	Wed, Nov 12, '14 12-4 pm	HENRY HAMPTON	
Inspection:	321140657190604		
Description:	Loose chicken wire fencing in enclosure housing zebu cattle and sheep near production sheep barn.

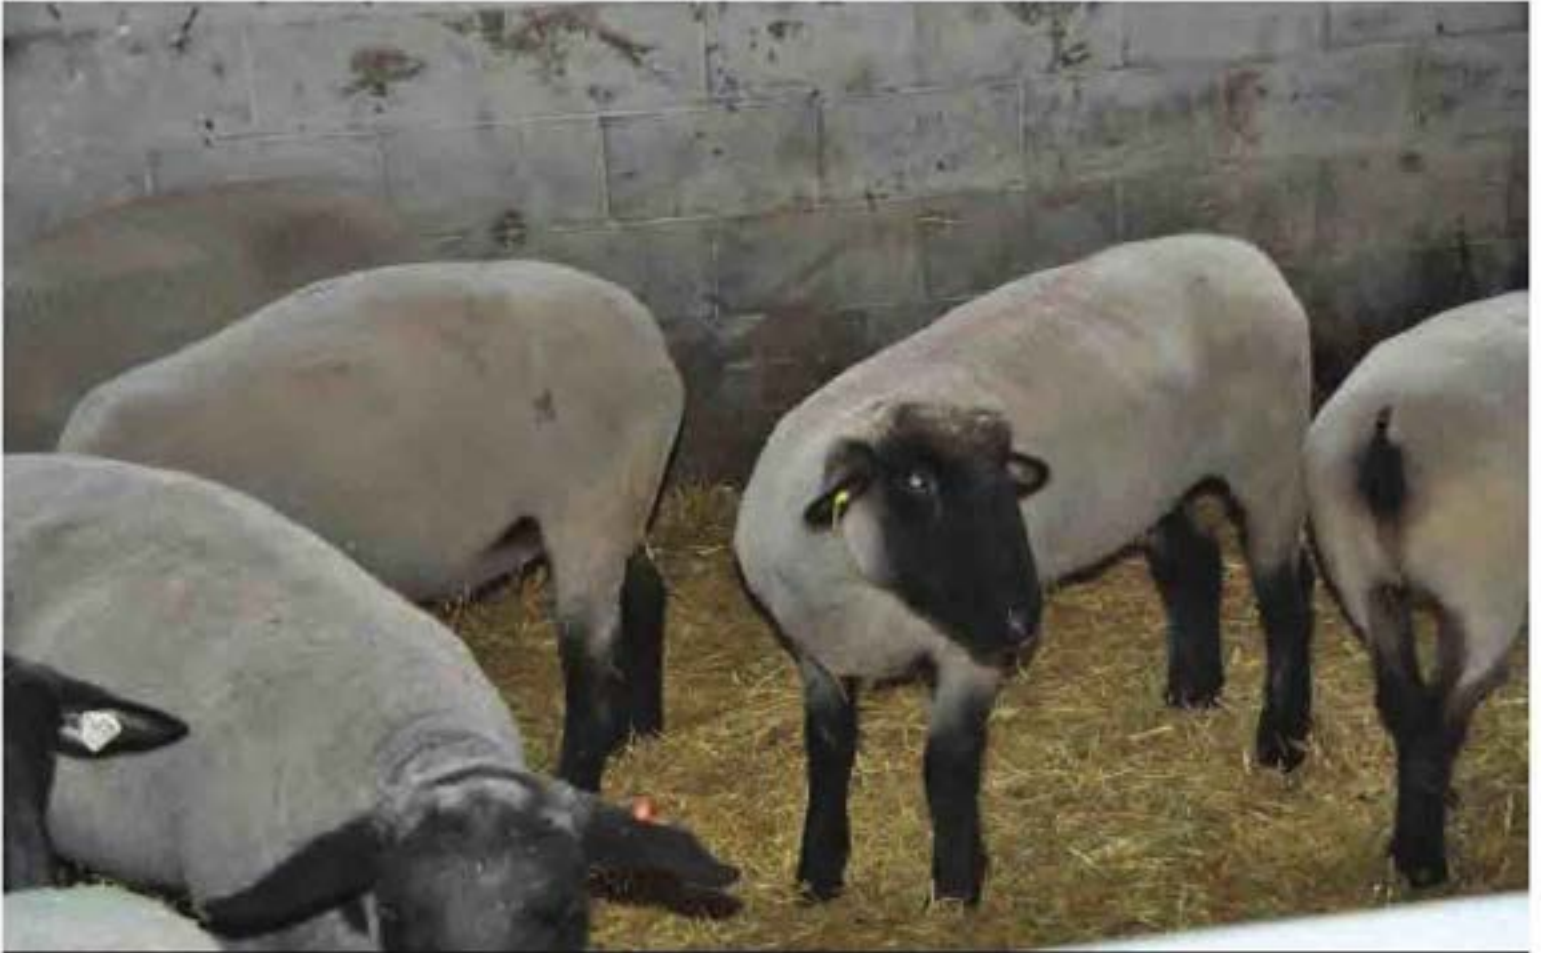
CFR: 2.40 (b) (2), 2.40 (b) (3)

Photographer:	R. Coleman, ACI	Legal Name:	55-B-0069
Photo Taken:	Wed, Nov 12, '14 12-4 pm	HENRY HAMPTON	
Inspection:	321140657190604		
Description:	Sheep #326 found limping.

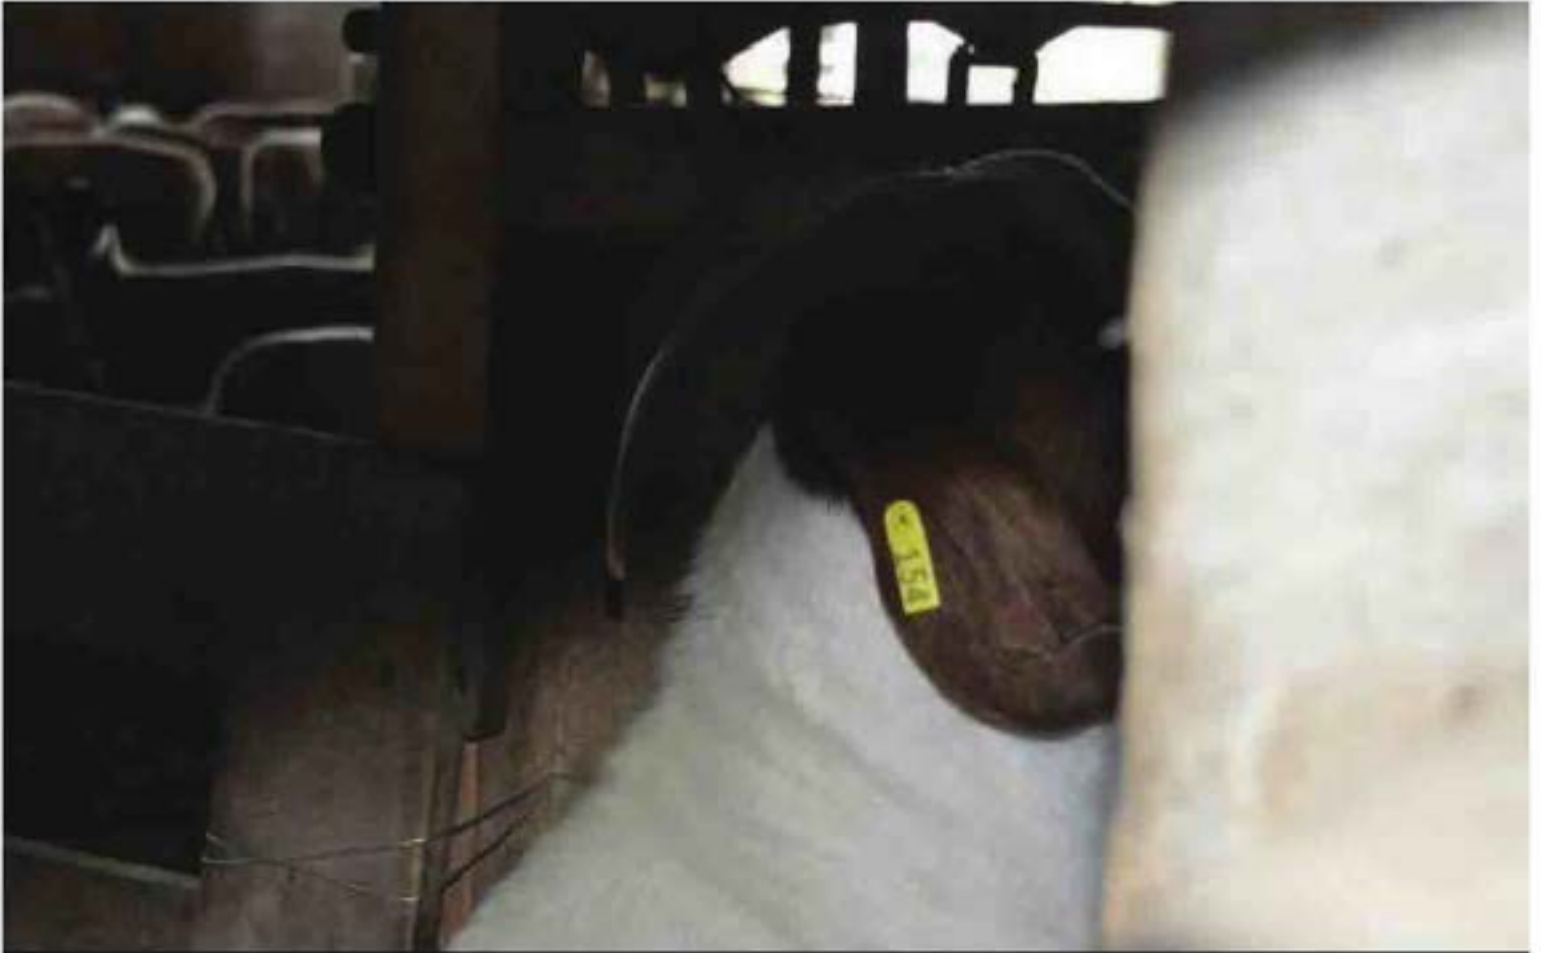
CFR: 2.40 (b) (2), 2.40 (b) (3)

Photographer:	R. Coleman, ACI	Legal Name:	55-B-0069
Photo Taken:	Wed, Nov 12, '14 12-4 pm	HENRY HAMPTON	
Inspection:	321140657190604		
Description:	Bohr goat #154 found coughing.

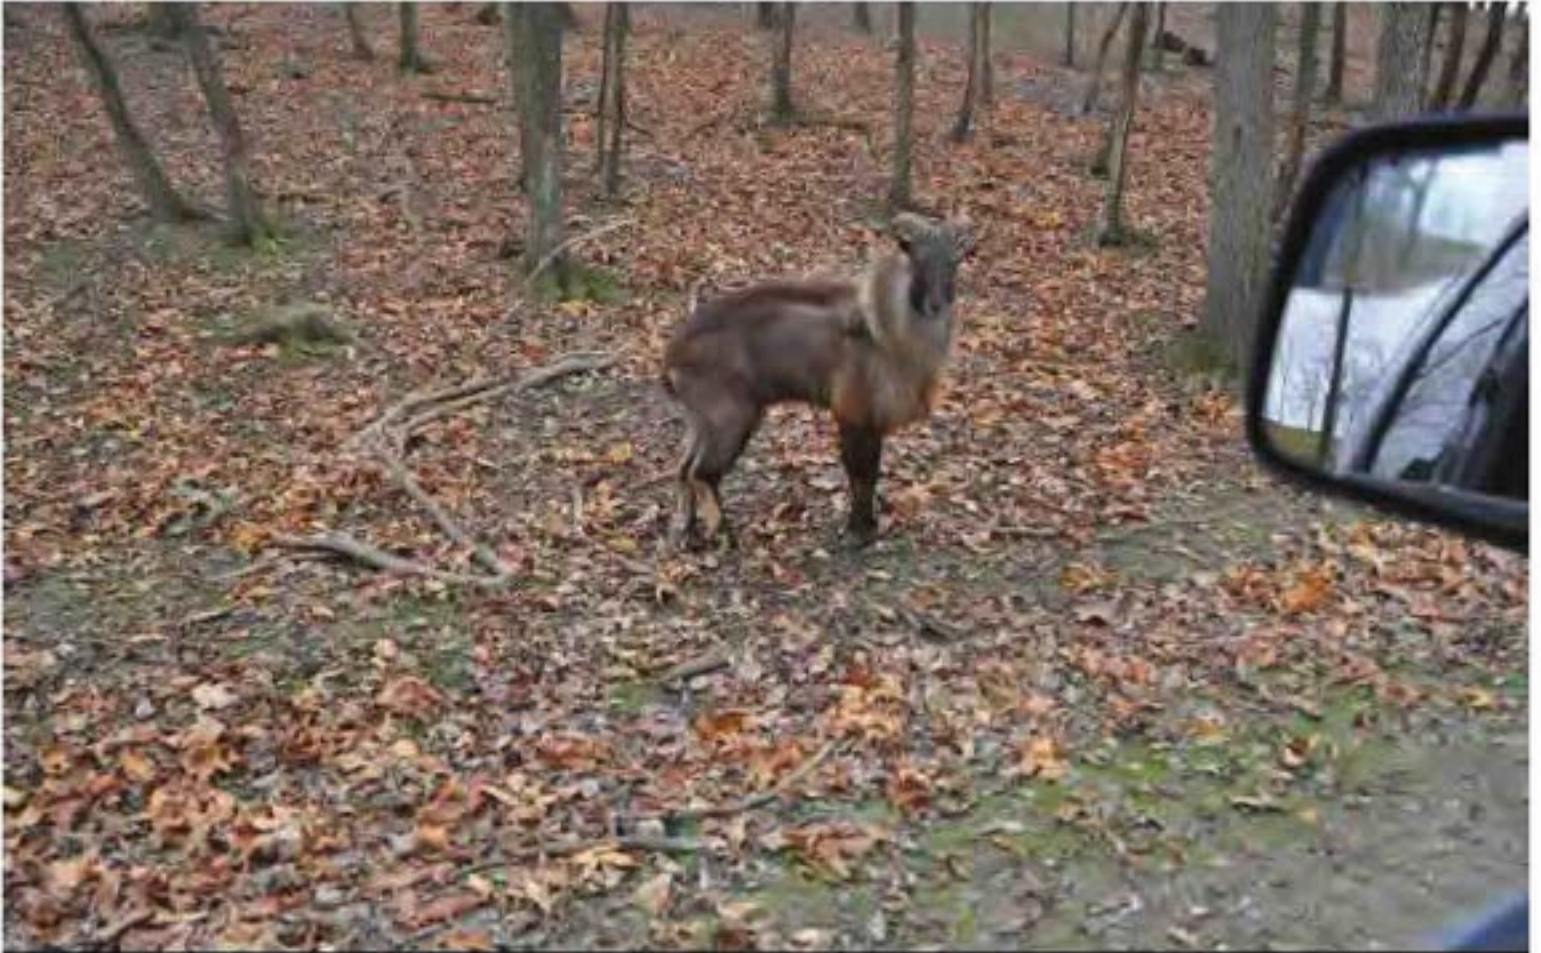
CFR: 2.40 (b) (2), 2.40 (b) (3)

Photographer:	R. Coleman, ACI	Legal Name:	55-B-0069
Photo Taken:	Wed, Nov 12, '14 12-4 pm	HENRY HAMPTON	
Inspection:	321140657190604		
Description:	Tahr goat found limping in drive thru area.

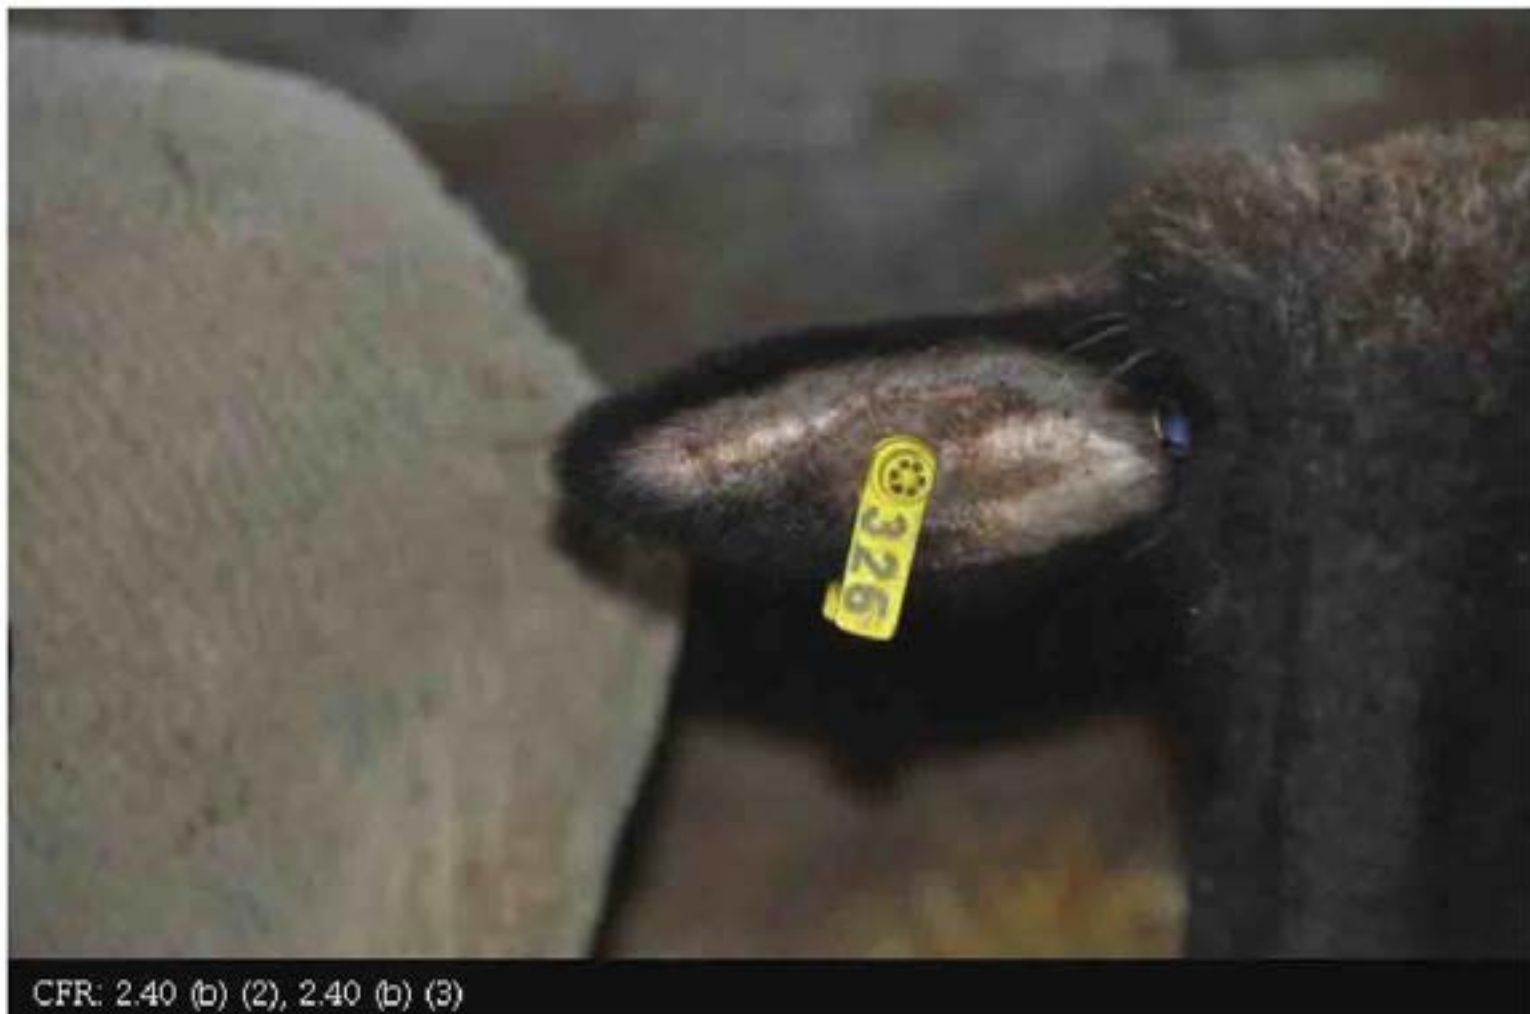
CFR: 2.40 (b) (2), 2.40 (b) (3)

Photographer:	R. Coleman, ACI	Legal Name:	55-B-0069
Photo Taken:	Wed, Nov 12, '14 12-4 pm	HENRY HAMPTON	
Inspection:	321140657190604		
Description:	Sheep #326 found limping.

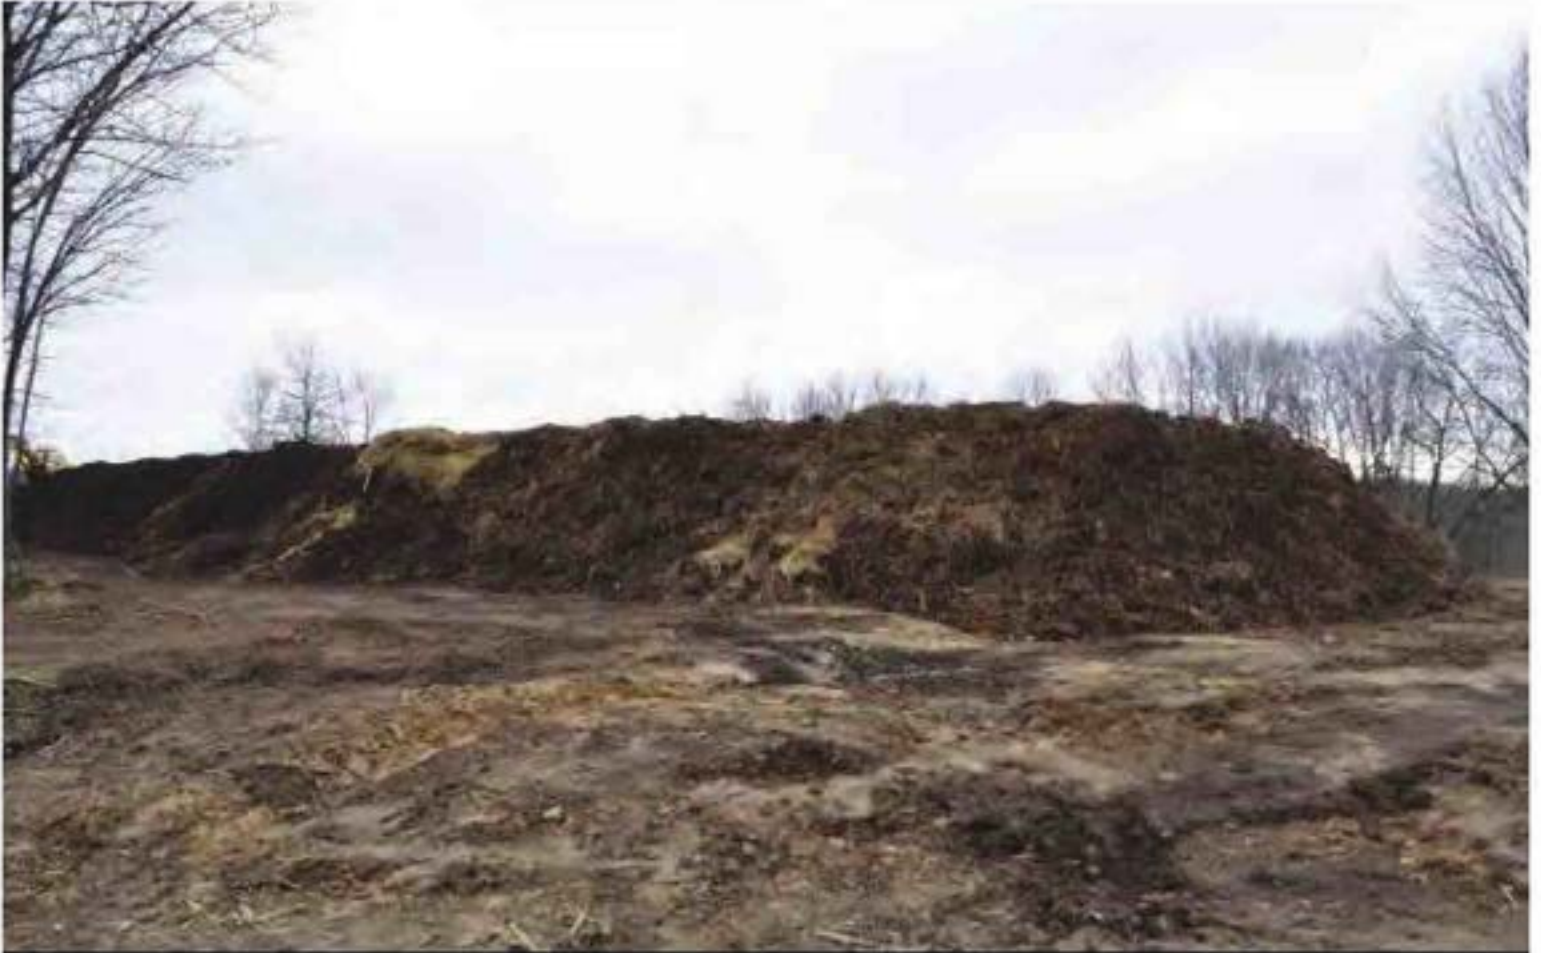
CFR: 3.125 (d)

Photographer:	R. Coleman, ACI	Legal Name:	55-B-0069
Photo Taken:	Wed, Nov 12, '14 12-4 pm	HENRY HAMPTON	
Inspection:	321140657190604		
Description:	Waste pile in drive thru area.

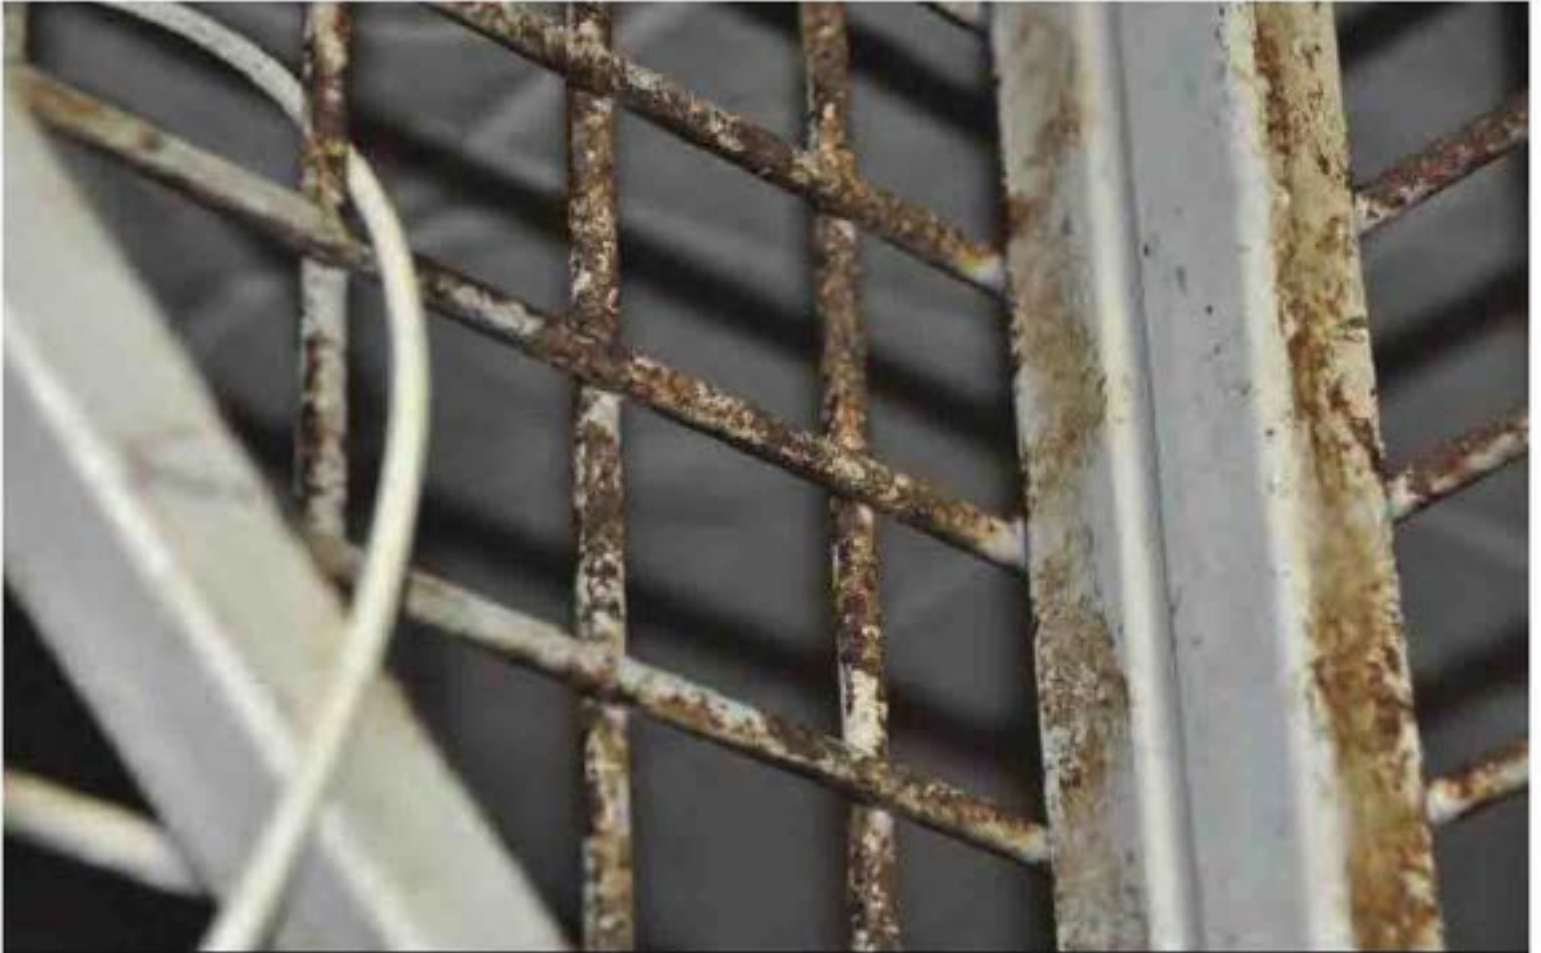
CFR: 3.75 (c) (2)

Photographer:	Randy Coleman, ACI	Legal Name:	55-B-0069
Photo Taken:	Mon, Mar 2, '15	HENRY HAMPTON	
Inspection:	64151500440984		
Description:	Section 3.75(c)(2): Section 3.75(c)(2): Metal bars for the lemur enclosure with worn and chipped paint.

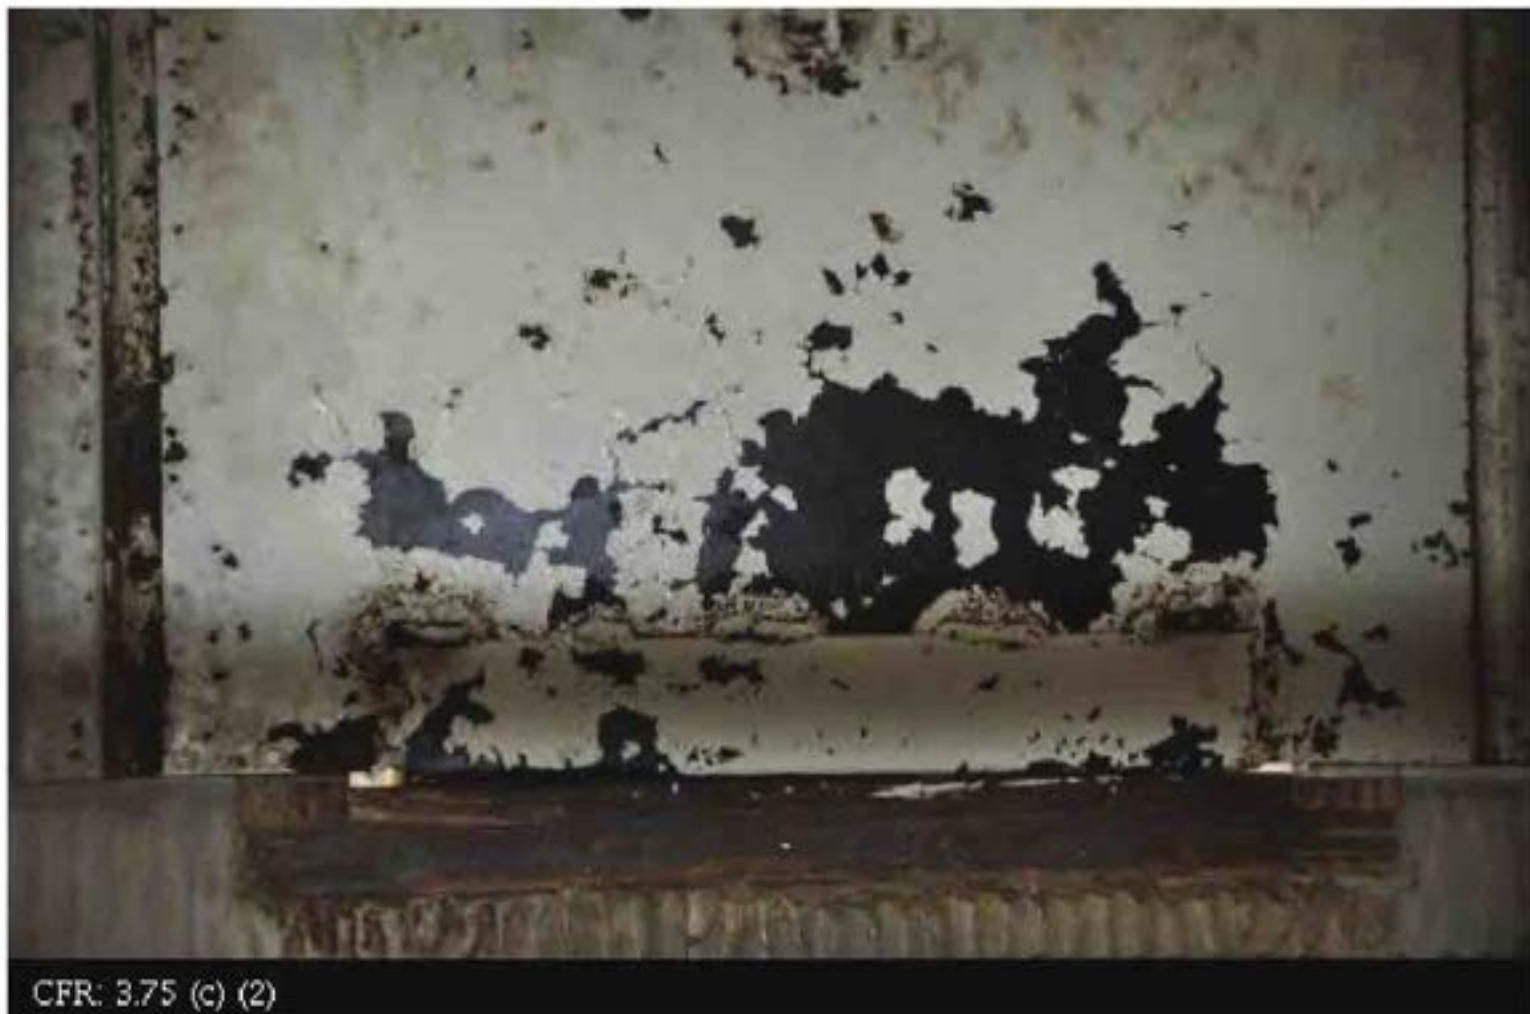
CFR: 3.75 (c) (2)

Photographer:	Randy Coleman, ACI	Legal Name:	55-B-0069
Photo Taken:	Mon, Mar 2, '15	HENRY HAMPTON	
Inspection:	64151500440984		
Description:	Section 3.75(c)(2): Guillotine door for lemur enclosure with peeled and chipped paint.

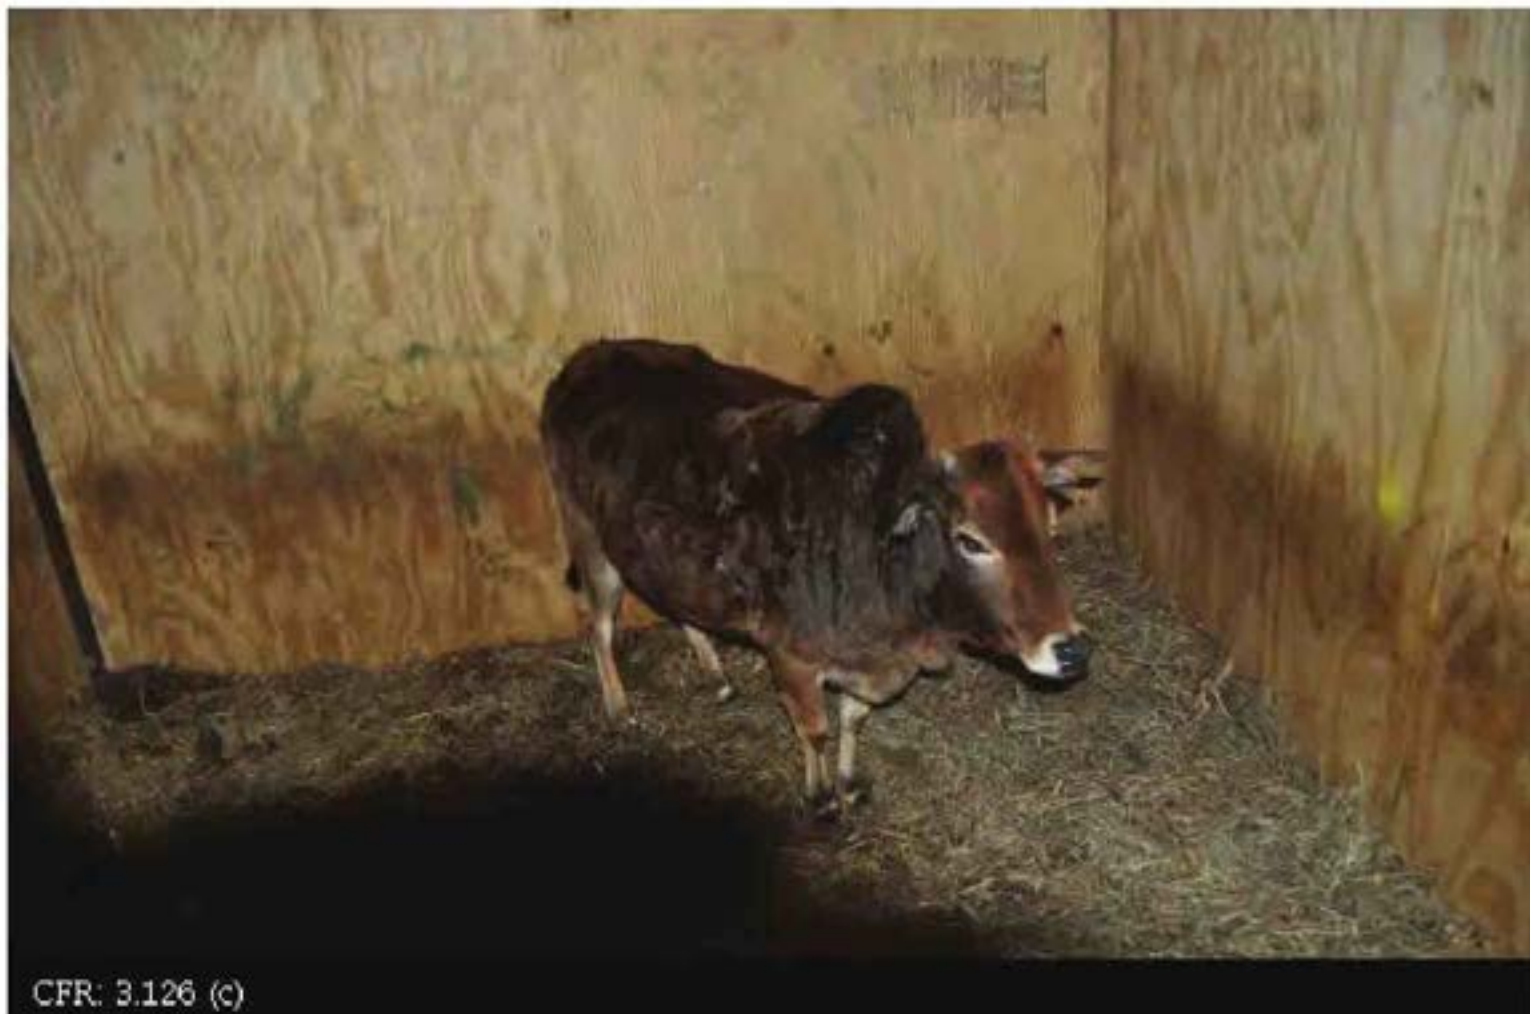
CFR: 3.126 (c)

Photographer:	Randy Coleman, ACI	Legal Name:	55-B-0069
Photo Taken:	Tue, Mar 3, '15 11:25 am	HENRY HAMPTON	
Inspection:	64151500440984		
Description:	Section 3.126(c): DIRECT: Enclosure previously used to house Tahr goat in complete darkness not houses Zebu found in need of vet care. Enclosure now has additional light.

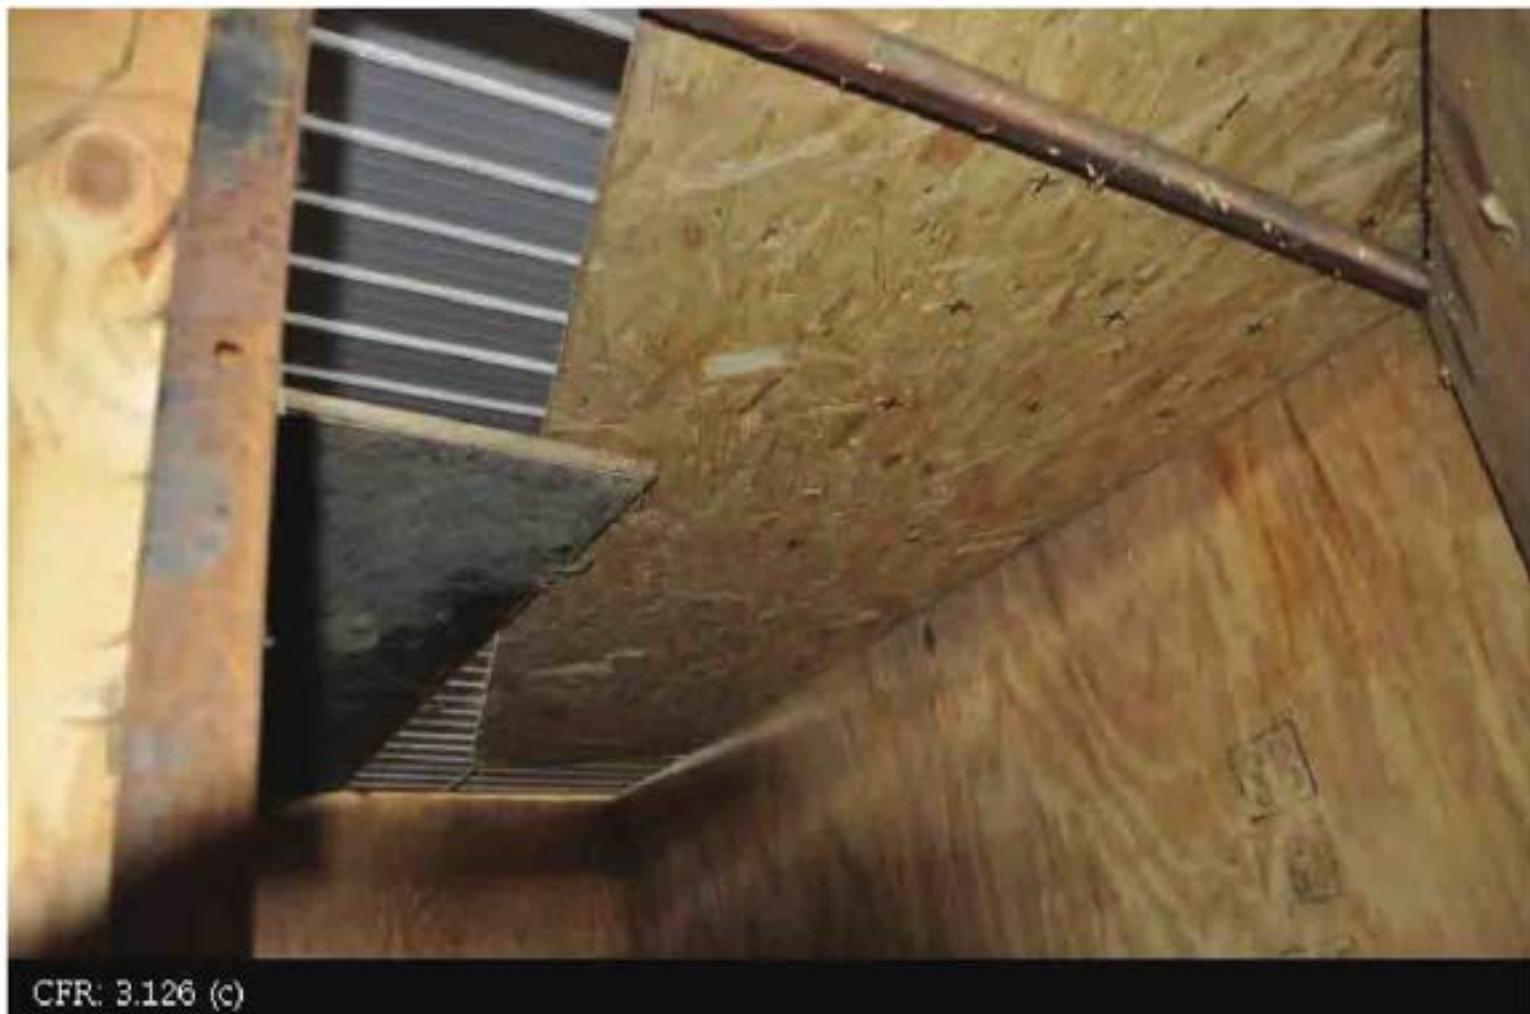
CFR: 3.126 (c)

Photographer:	Randy Coleman, ACI	Legal Name:	55-B-0069
Photo Taken:	Tue, Mar 3, '15 1125 am	HENRY HAMPTON	
Inspection:	64151500440984		
Description:	Section 3.126(c): DIRECT Roof of enclosure housing Tahr goat in complete darkness.
