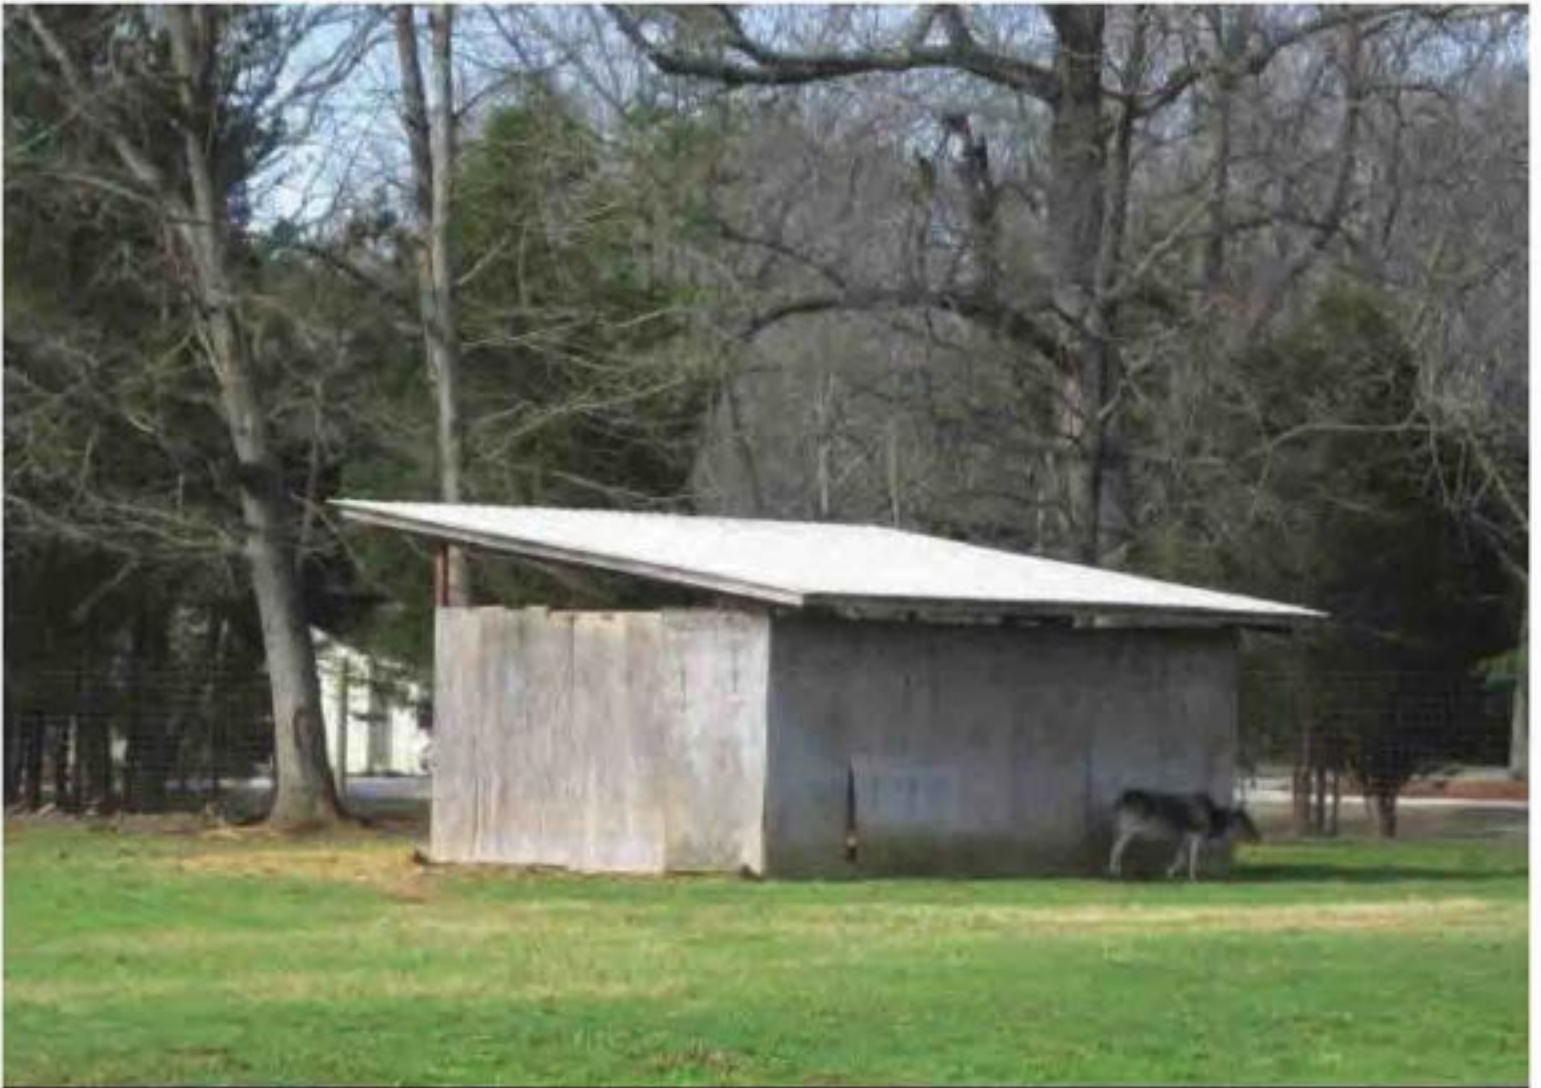
CFR: 3.125 (a)

Photographer:	S. Brunkhorst	Legal Name:	55-B-0069
Photo Taken:	Tue, Mar 17, '15	HENRY HAMPTON	
Inspection:	76151915490483		
Description:	Shelter structure in front pasture with loose panel back wall with opening.

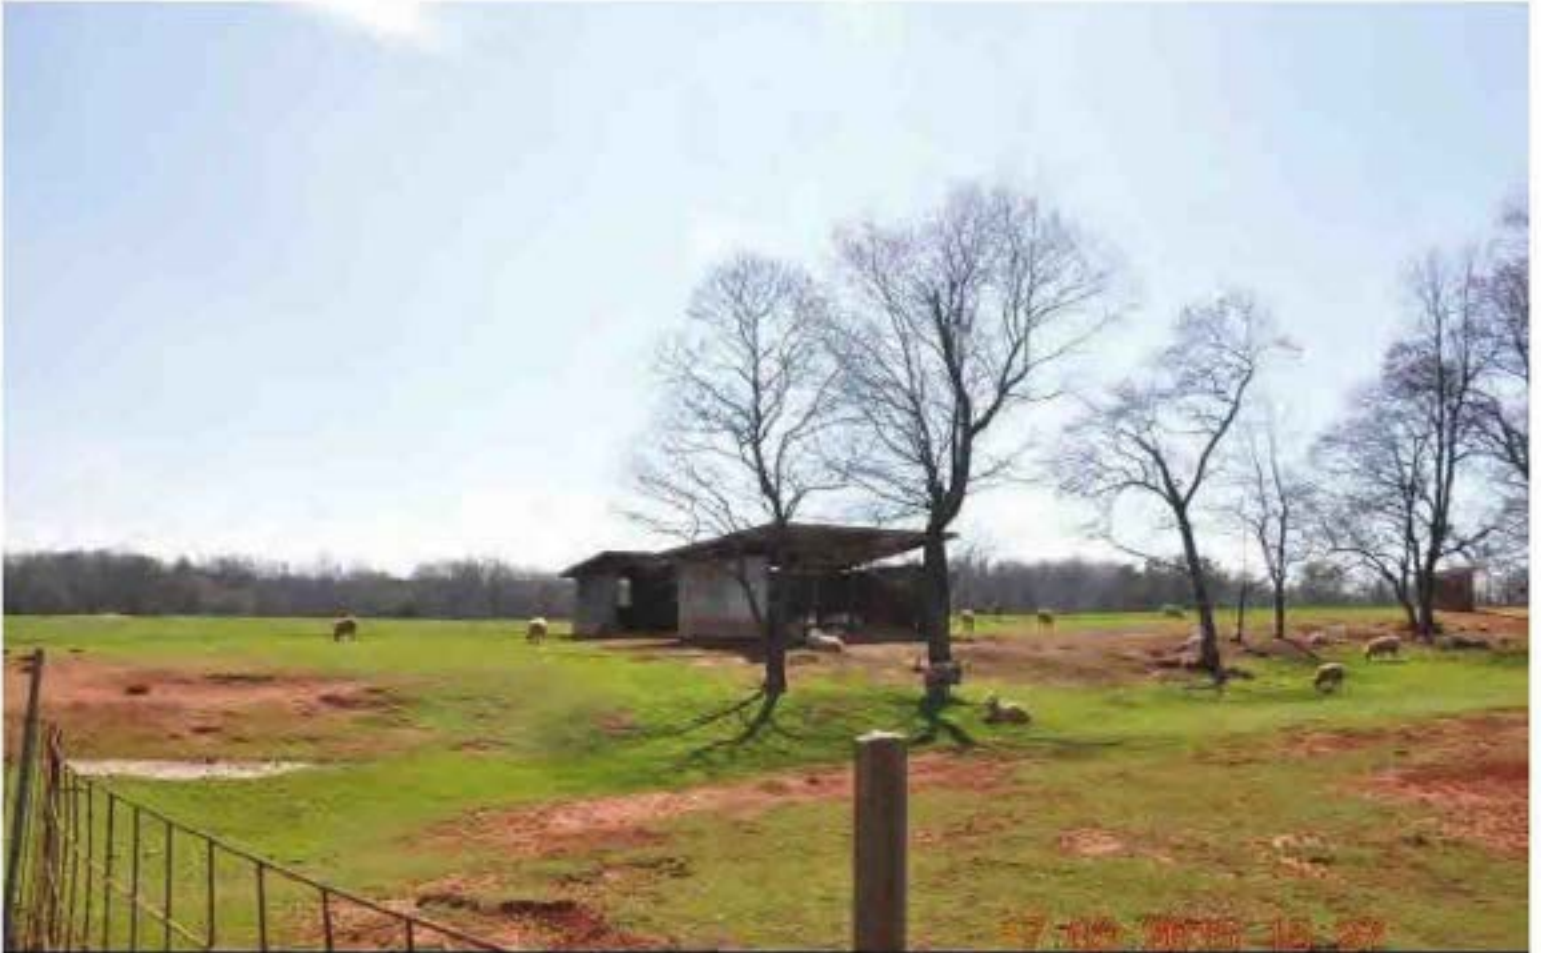
CFR: 3.125 (a)

Photographer:	G. McFadden	Legal Name:	55-B-0069
Photo Taken:	Tue, Mar 17, '15	HENRY HAMPTON	
Inspection:	76151915490483		
Description:	Two shelters in sheep/goat pen front view. See sunlight coming through openings.

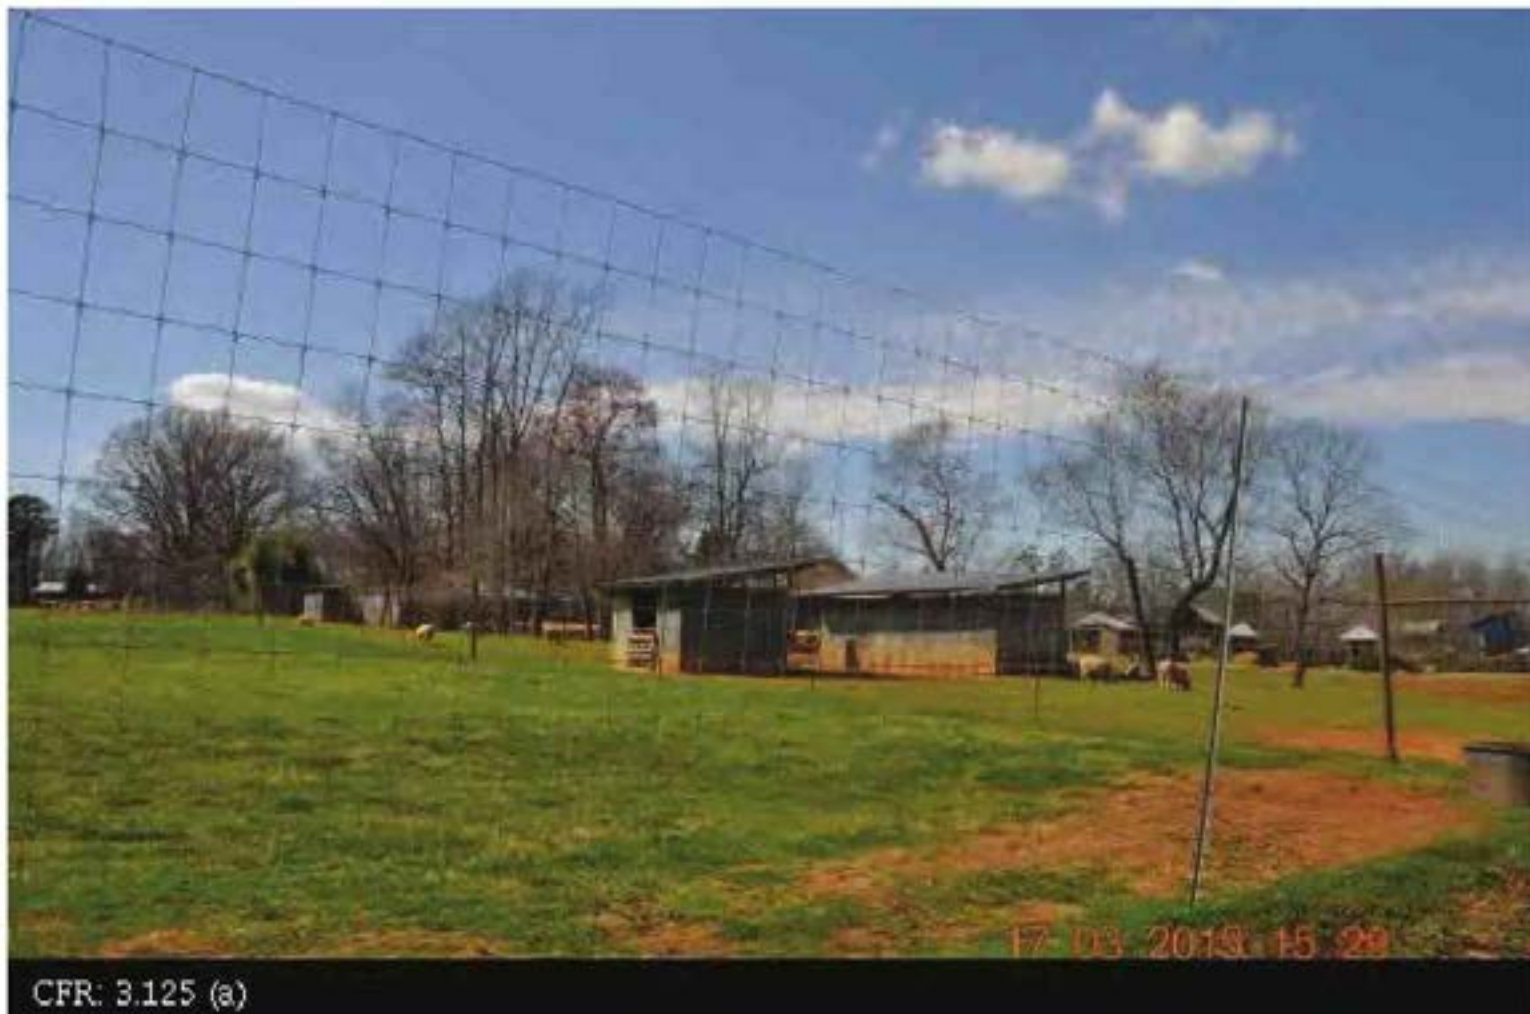
Photographer:	G. McFadden	Legal Name:	55-B-0069
Photo Taken:	Tue, Mar 17, '15	HENRY HAMPTON	
Inspection:	76151915490483		
Description:	View of back of two shelters in sheep/goat pen with damage leading to openings.

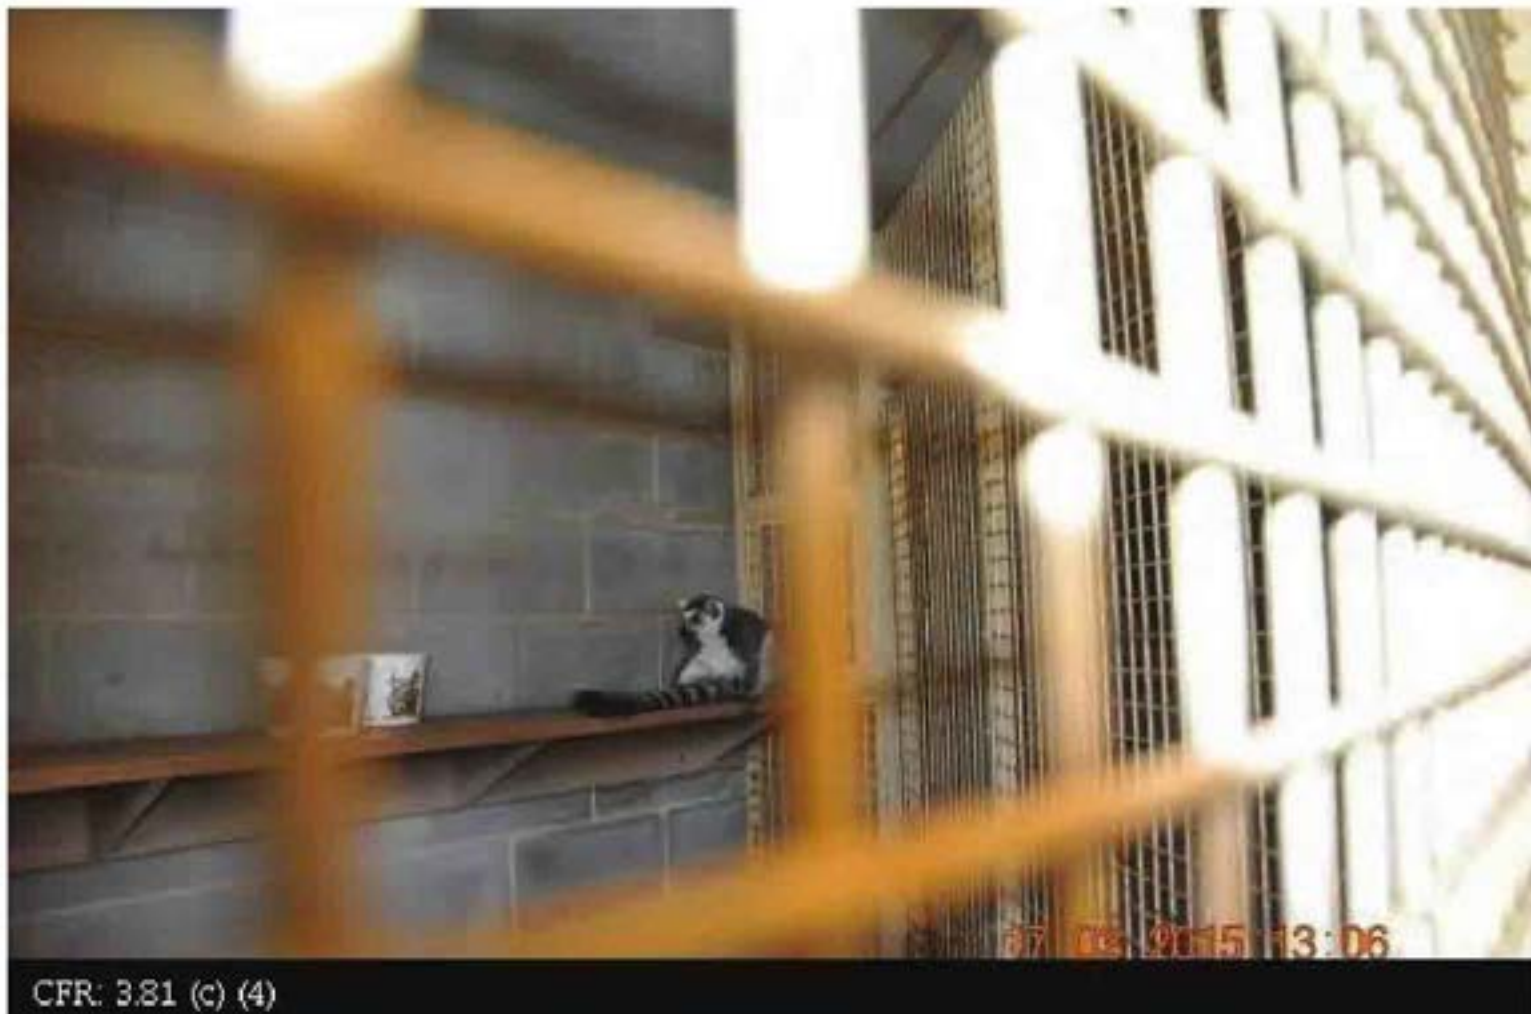
Photographer:	G. McFadden	Legal Name:	55-B-0069
Photo Taken:	Tue, Mar 17, '15	HENRY HAMPTON	
Inspection:	76151915490483		
Description:	Singly housed, isolated ringtail lemur with no enrichment.

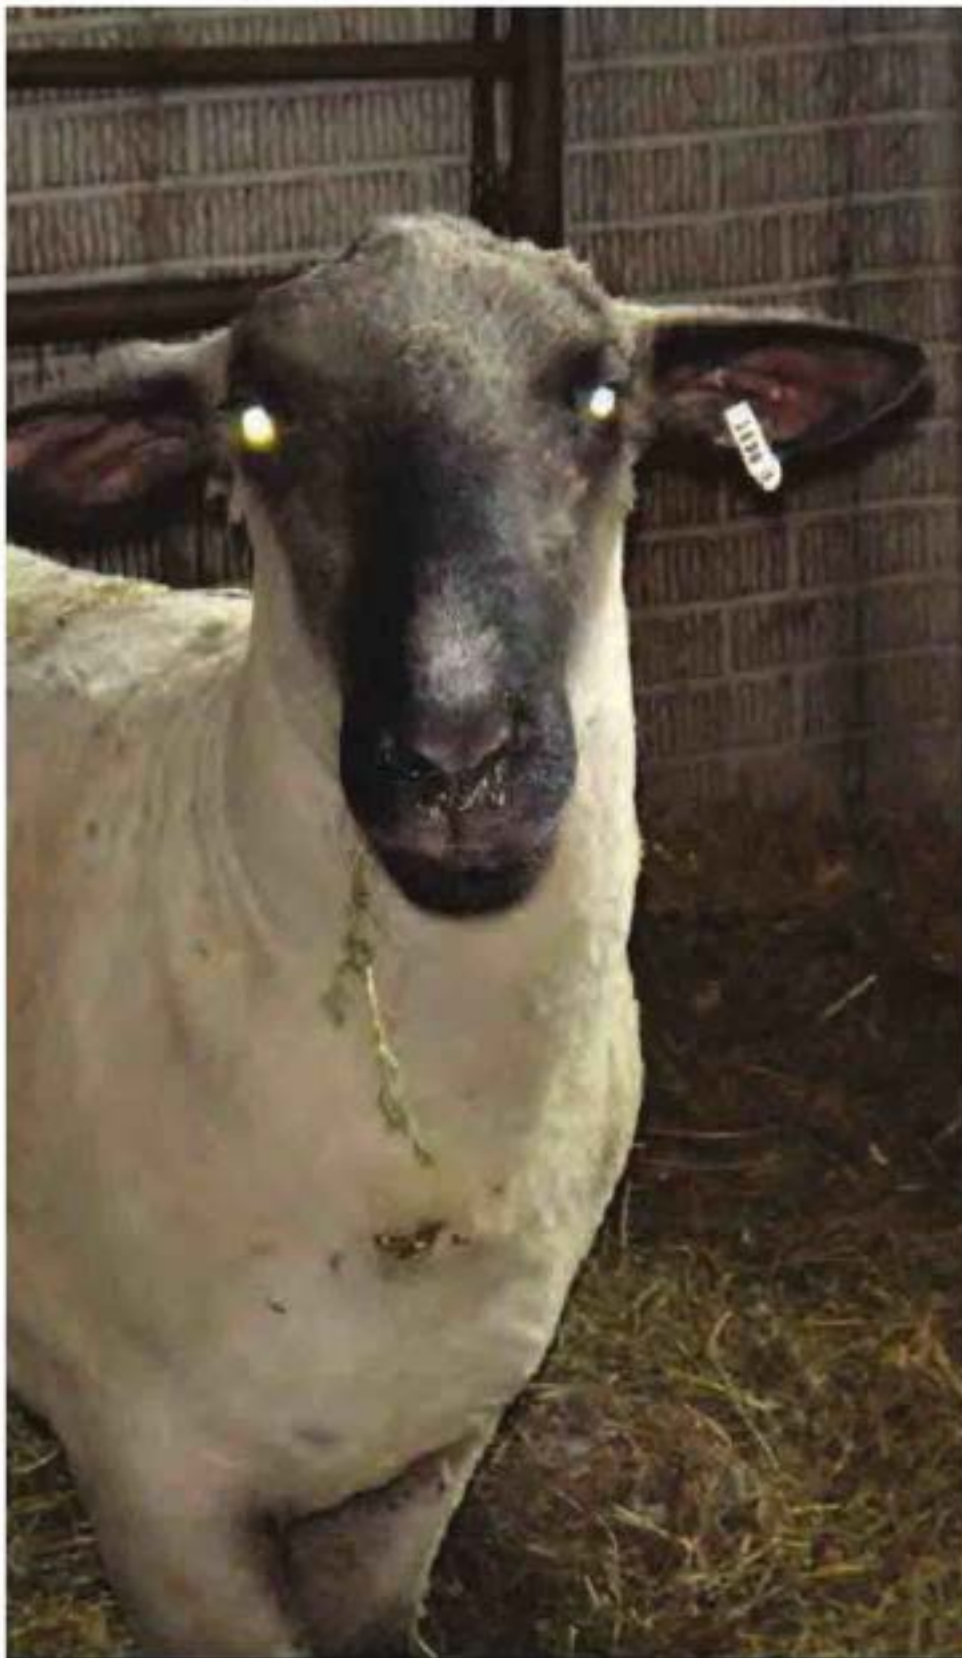
CFR: 2.40 (b) (2), 2.40 (b) (3)

Photographer:	Dana Miller, SACS	Legal Name:	HENRY HAMPTON	55-B-0069
Photo Taken:	Mon, Apr 20, '15 1146 am			
Inspection:	194151734120886			
Description:	Section 2.40(b)(2) and 2.40(b)(3): Suffolk ram #1636 found with mass on chest.

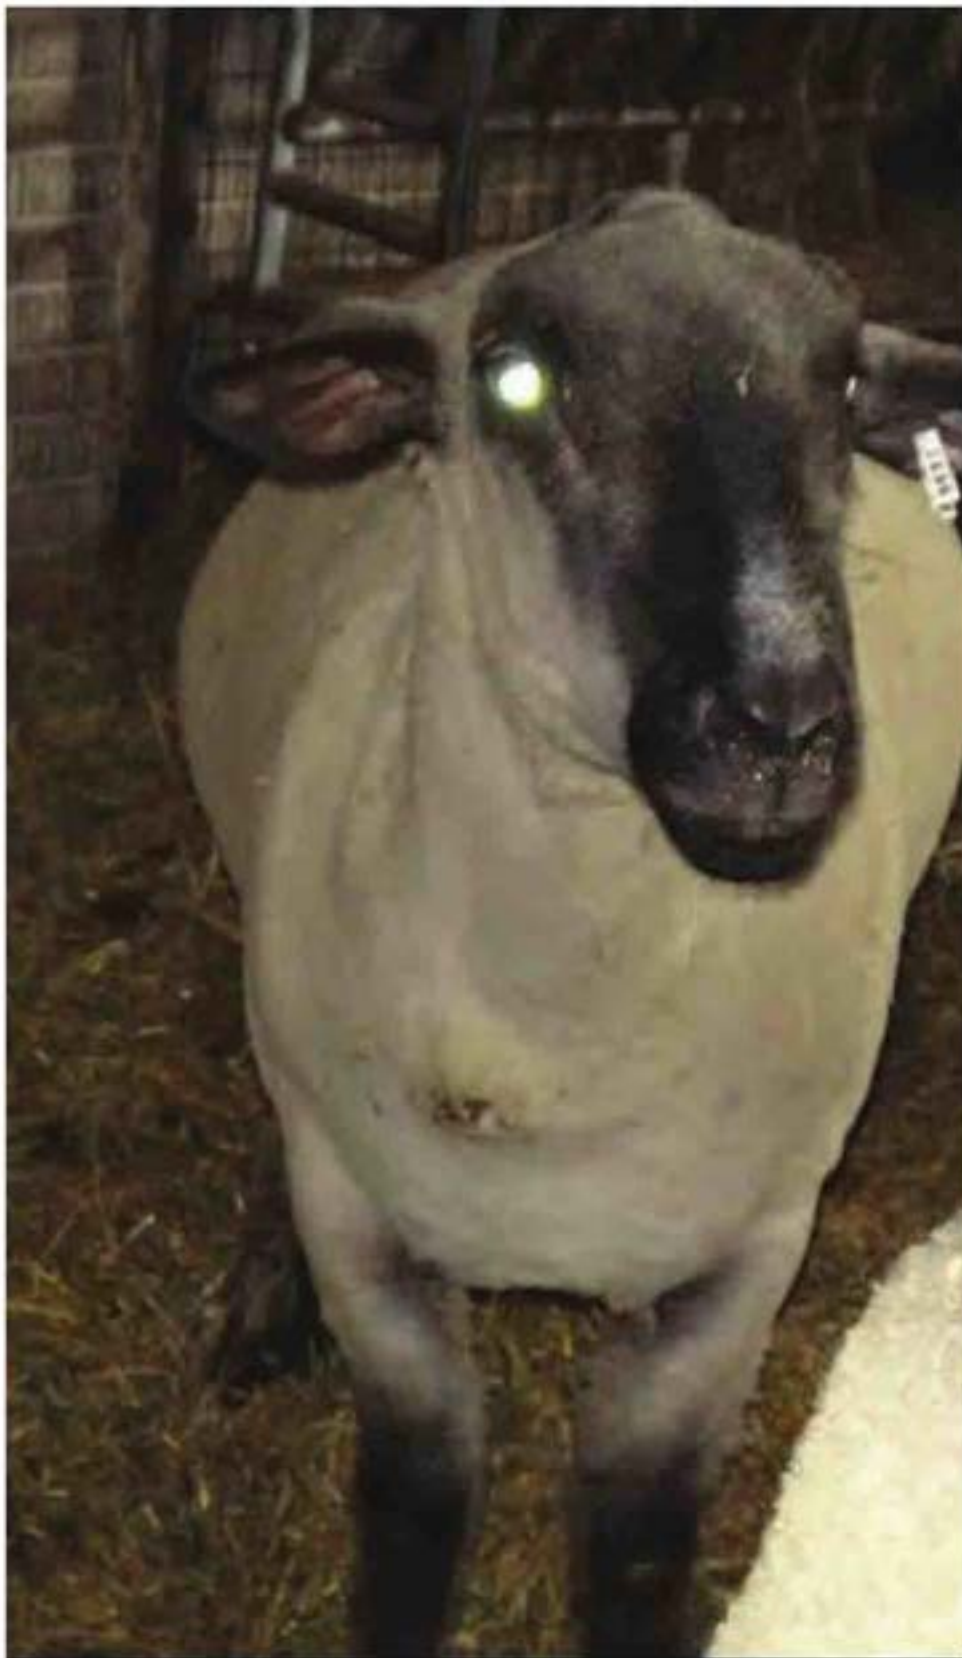
CFR: 2.40 (b) (3), 2.40 (b) (2)

Photographer:	Dana Miller, SACS	Legal Name:	HENRY HAMPTON	55-B-0069
Photo Taken:	Mon, Apr 20, '15 1146 am			
Inspection:	194151734120886			
Description:	Section 2.40(b)(2) and 2.40(b)(3): Suffolk ram #1636 found with mass on chest.

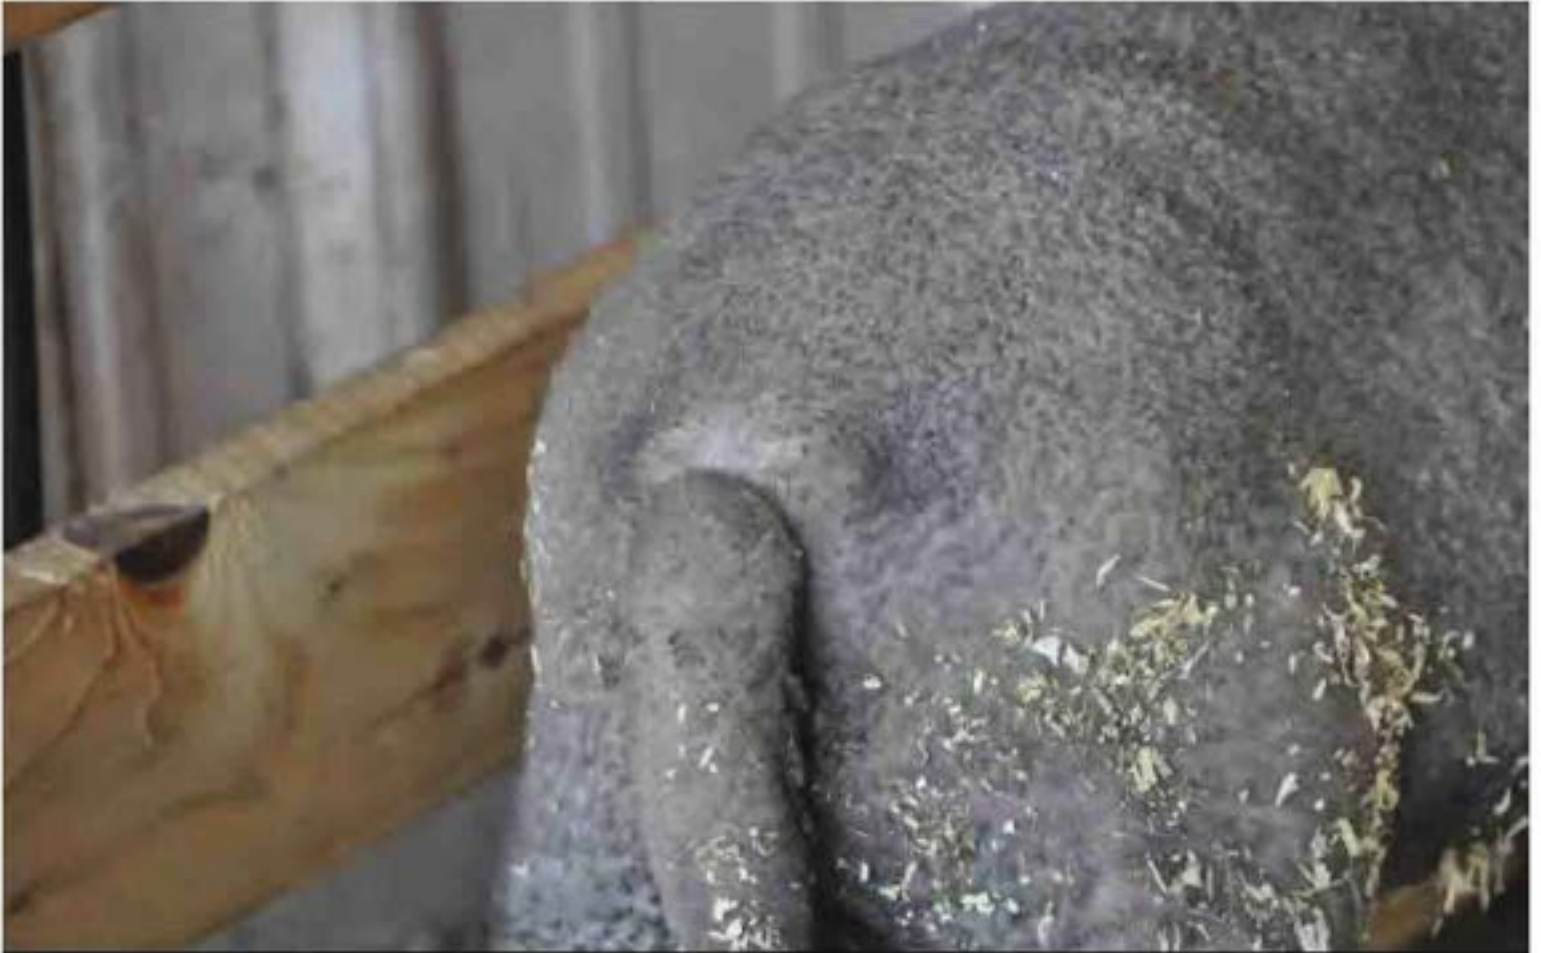
CFR: 2.40 (a) (1)

Photographer:	Randy Coleman, ACI	Legal Name:	55-B-0069
Photo Taken:	Mon, Apr 20, '15 108 pm	HENRY HAMPTON	
Inspection:	194151734120886		
Description:	Section 2.40(a)(1): Lambs found with tail bands in place. No guidance for this procedure in PVC.

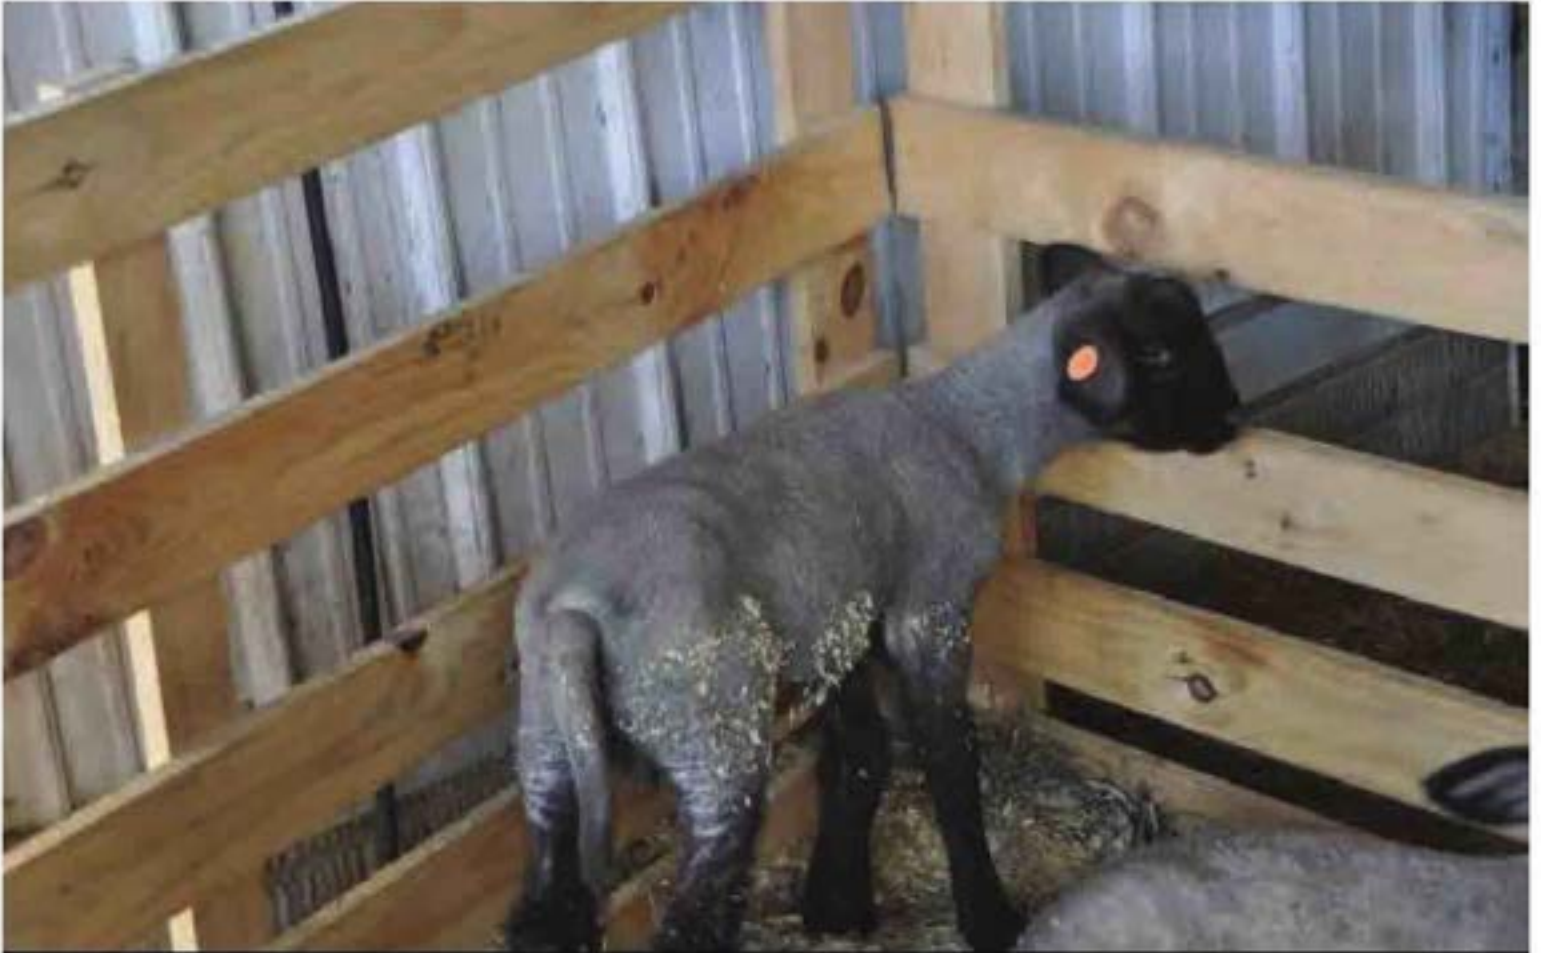
CFR: 2.40 (a) (1)

Photographer:	Randy Coleman, ACI	Legal Name:	55-B-0069
Photo Taken:	Mon, Apr 20, '15 108 pm	HENRY HAMPTON	
Inspection:	194151734120886		
Description:	Section 2.40(a)(1): Lambs found with tail bands in place. No guidance for this procedure in PVC.

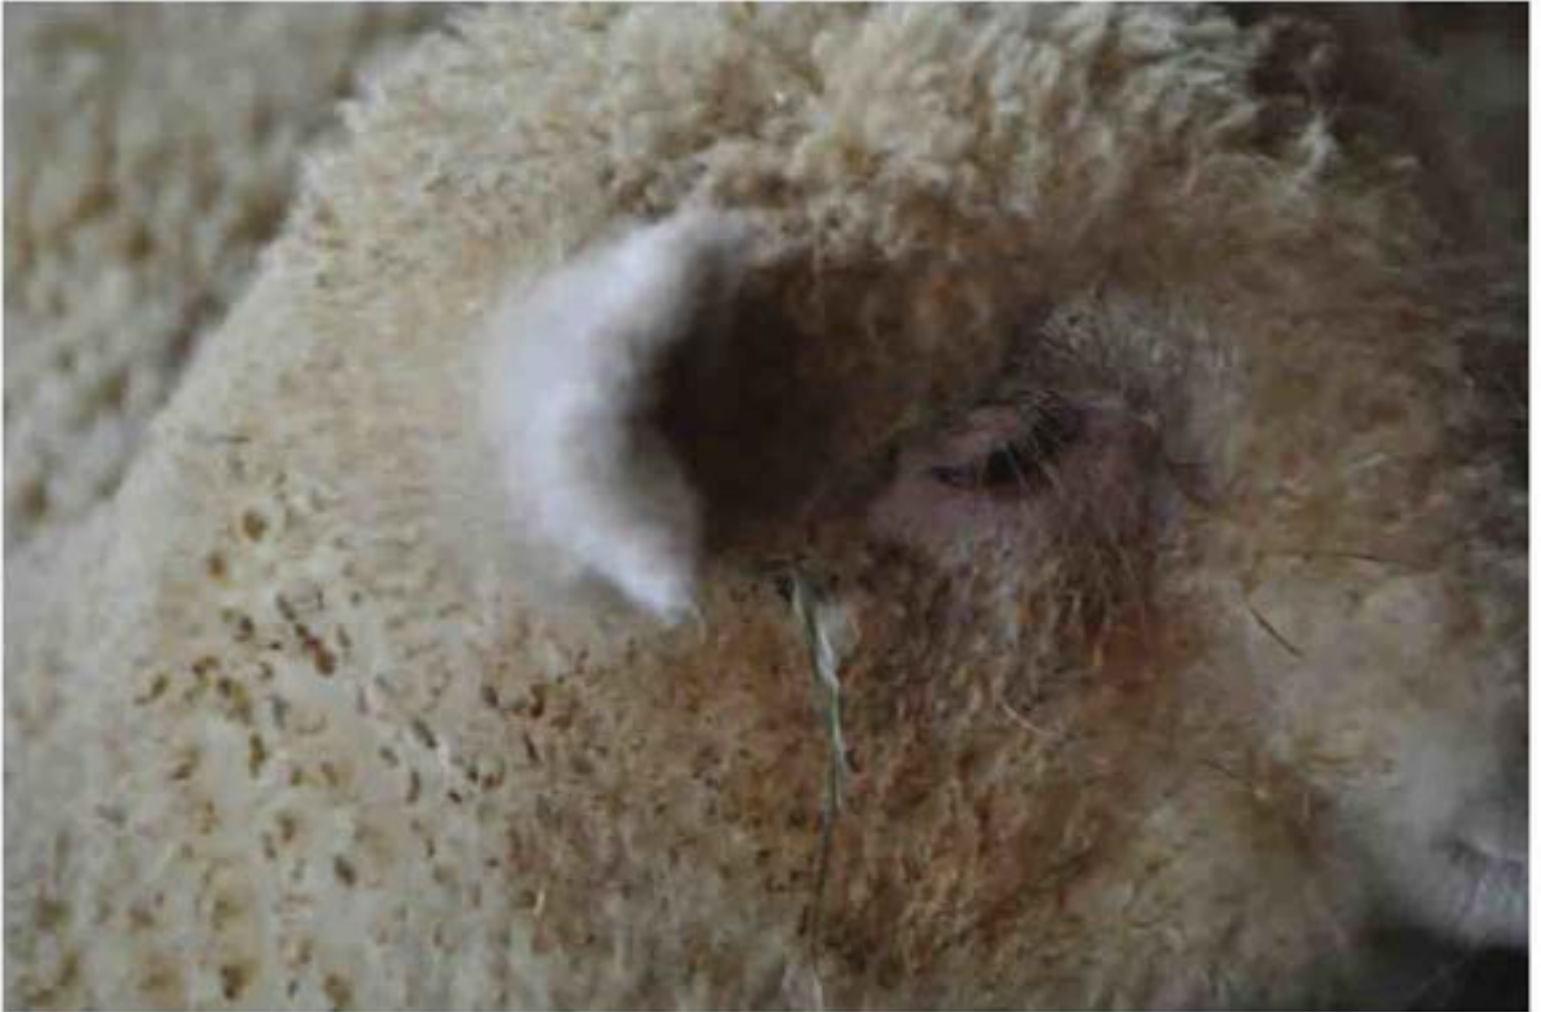
Photographer:	Randy Coleman, ACI	Legal Name:	55-B-0069
Photo Taken:	Mon, Apr 20, '15 115 pm	HENRY HAMPTON	
Inspection:	194151734120886		
Description:	Section 2.40(b)(2) and Section 2.40 (b)(3): Lambs found in machine shop area with excessive crust around eyes and/or noses.

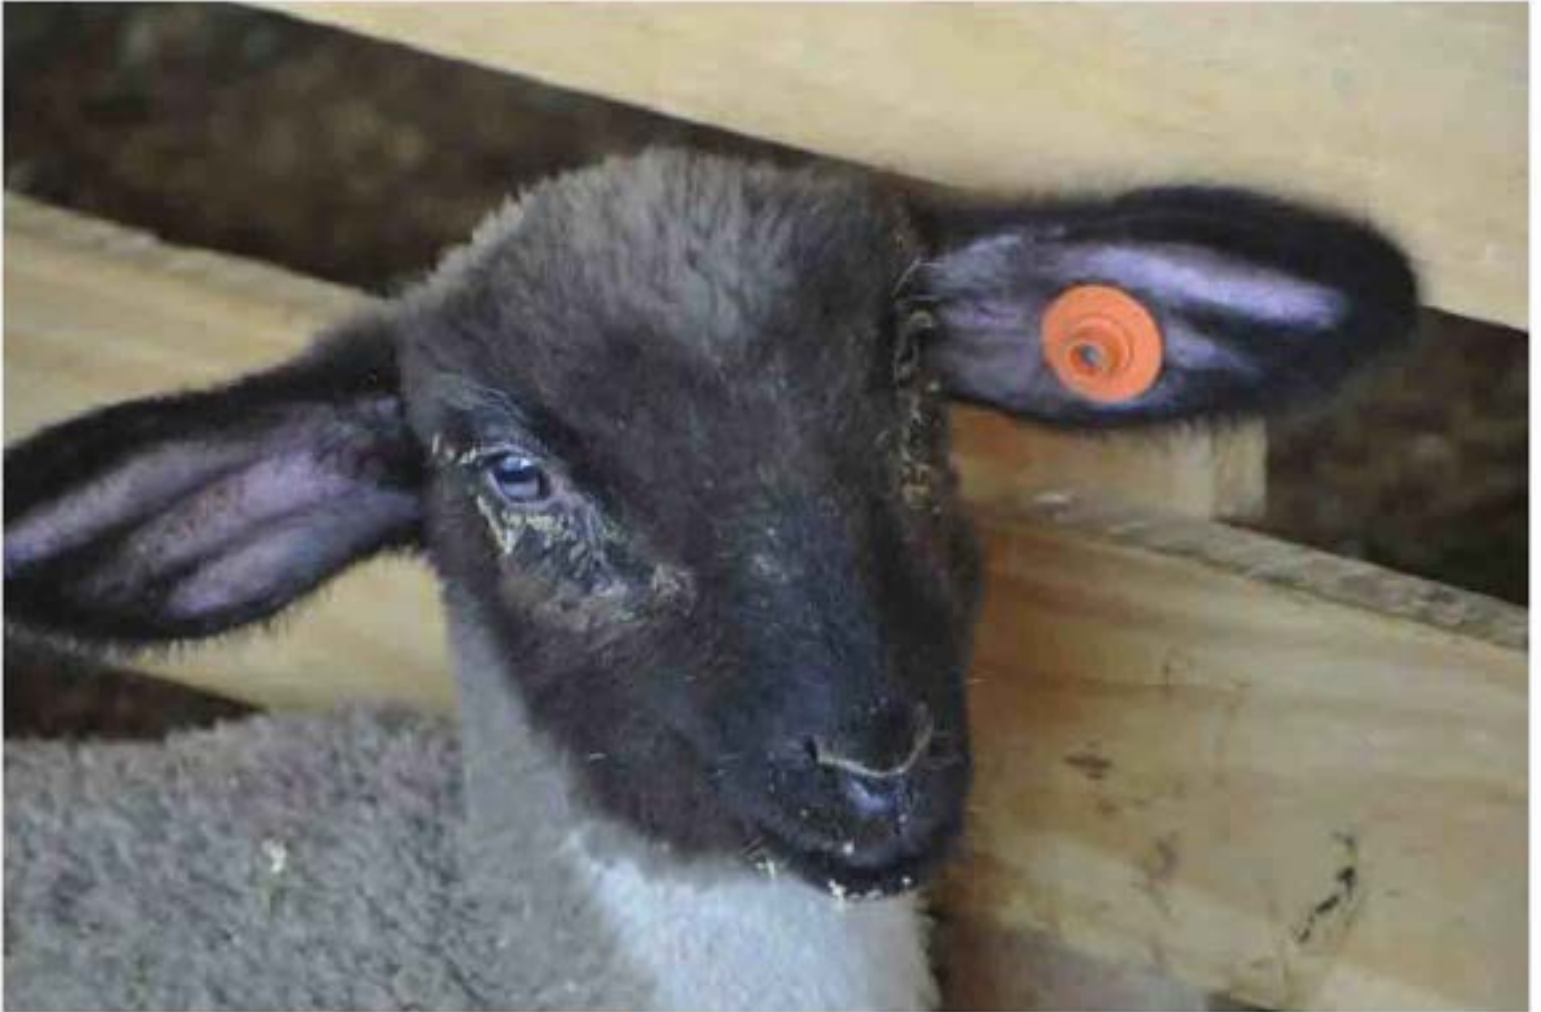
Photographer:	Randy Coleman, ACI	Legal Name:	55-B-0069
Photo Taken:	Mon, Apr 20, '15 115 pm	HENRY HAMPTON	
Inspection:	194151734120886		
Description:	Section 2.40(b)(2) and Section 2.40 (b)(3): Lambs found in machine shop area with excessive crust around eyes and/or noses.

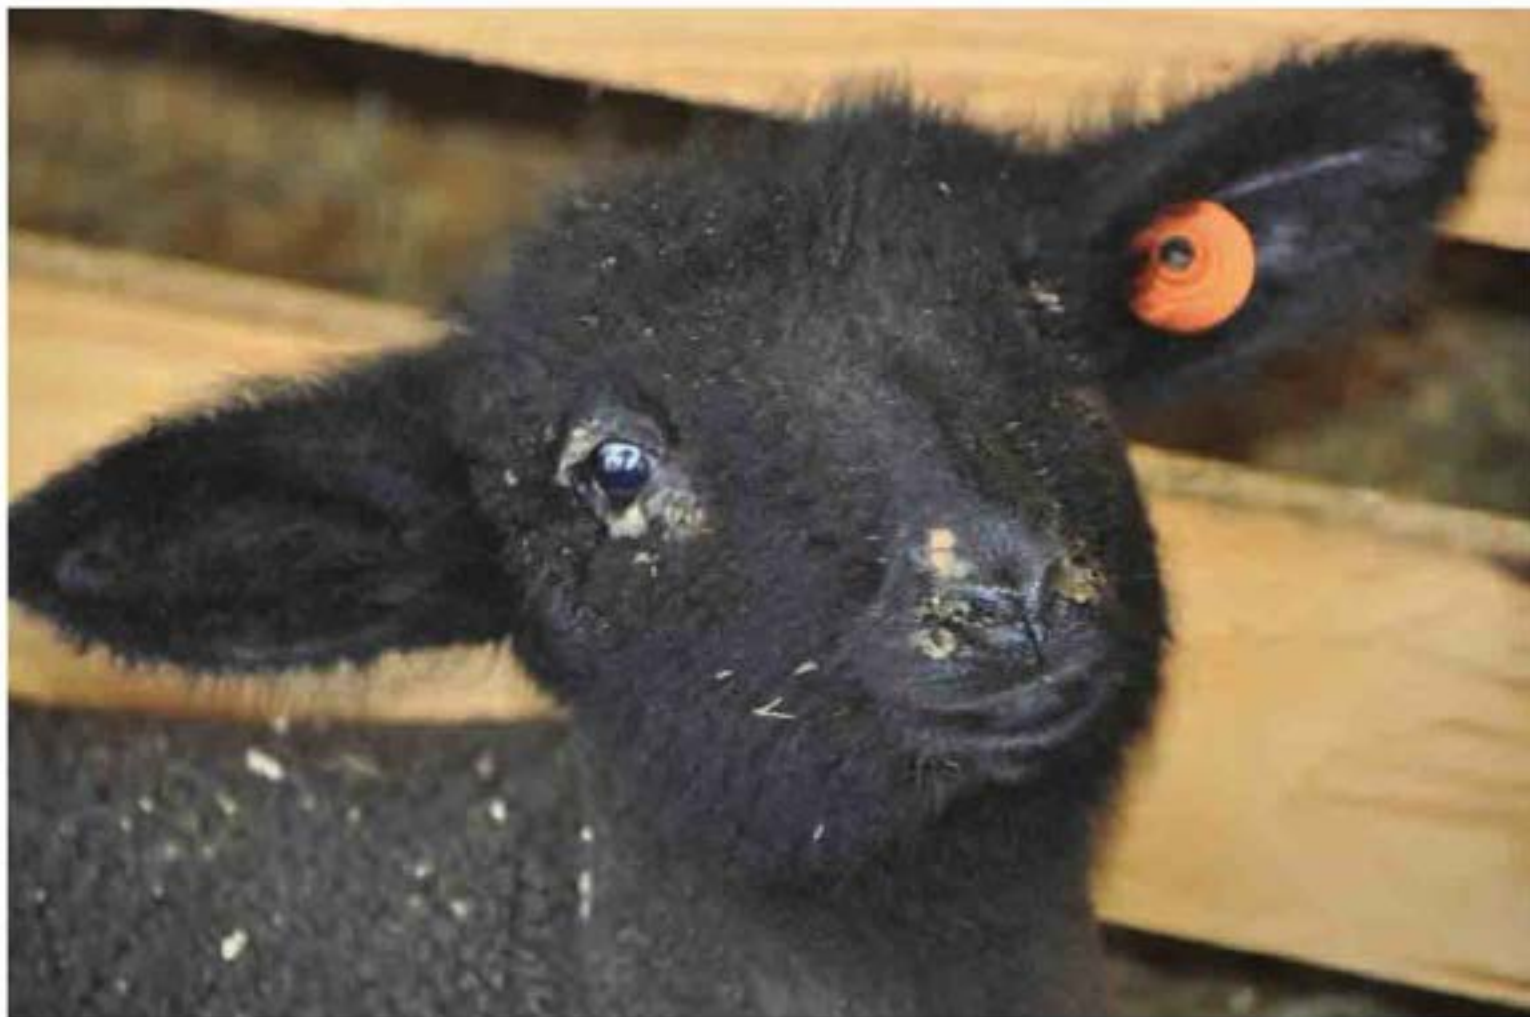
Photographer:	Randy Coleman, ACI	Legal Name:	55-B-0069
Photo Taken:	Mon, Apr 20, '15 115 pm	HENRY HAMPTON	
Inspection:	194151734120886		
Description:	Section 2.40(b)(2) and Section 2.40 (b)(3): Lambs found in machine shop area with excessive crust around eyes and/or noses.

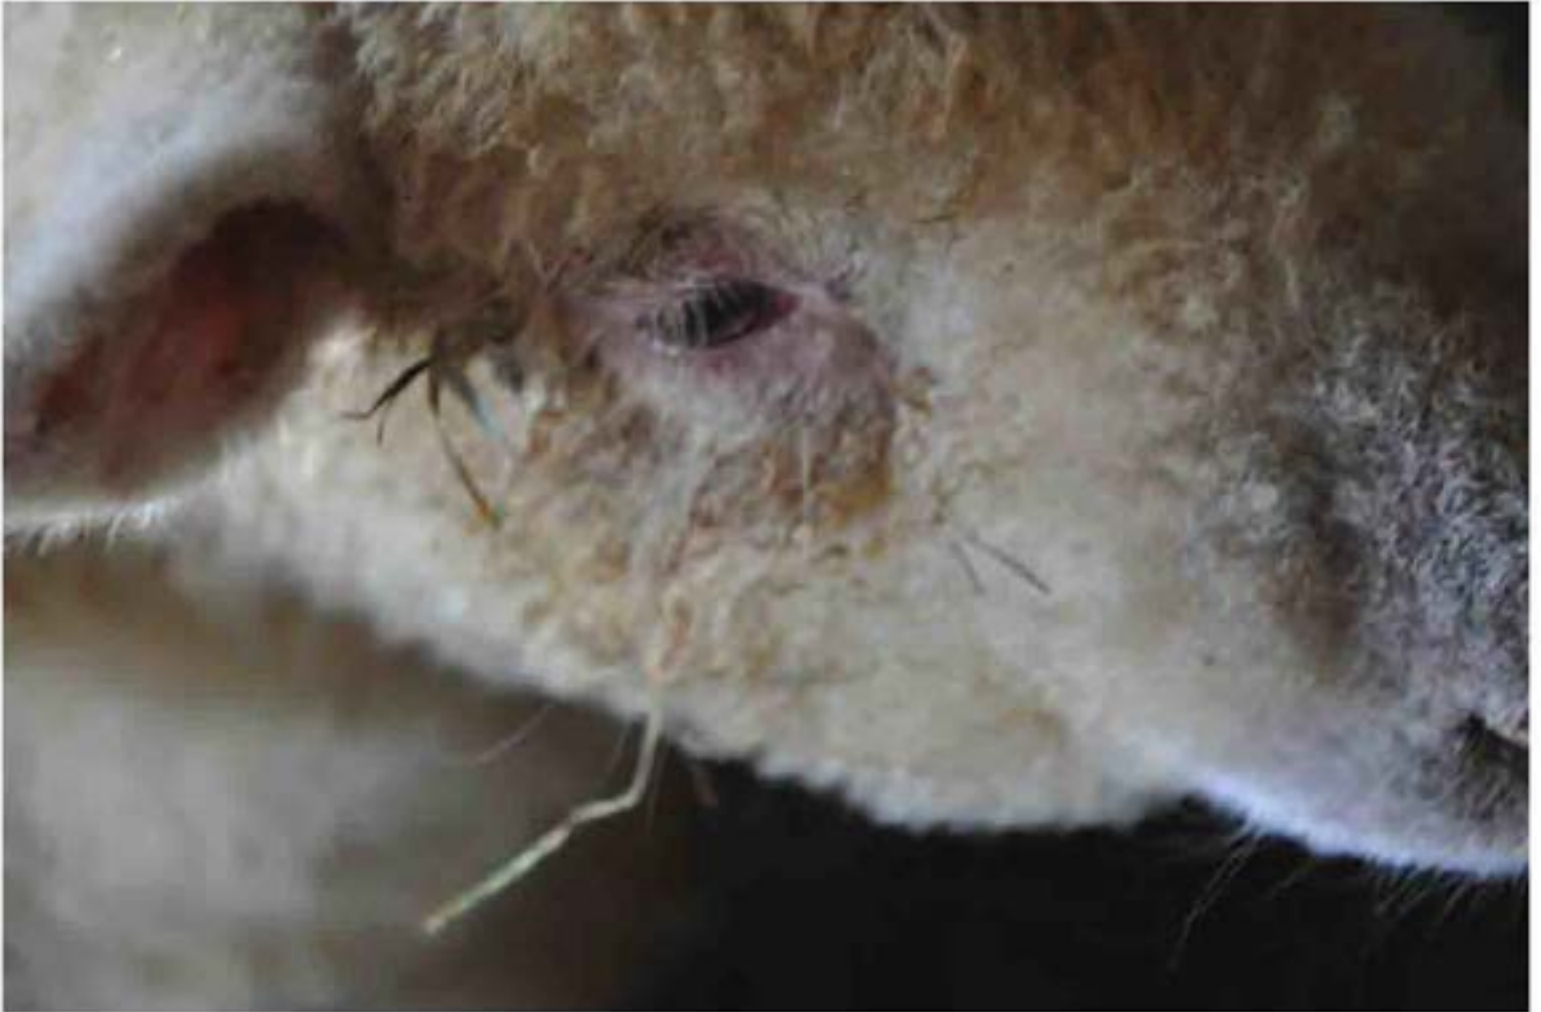
Photographer:	Randy Coleman, ACI	Legal Name:	55-B-0069
Photo Taken:	Mon, Apr 20, '15 115 pm	HENRY HAMPTON	
Inspection:	194151734120886		
Description:	Section 2.40(b)(2) and Section 2.40 (b)(3): Lambs found in machine shop area with excessive crust around eyes and/or noses.

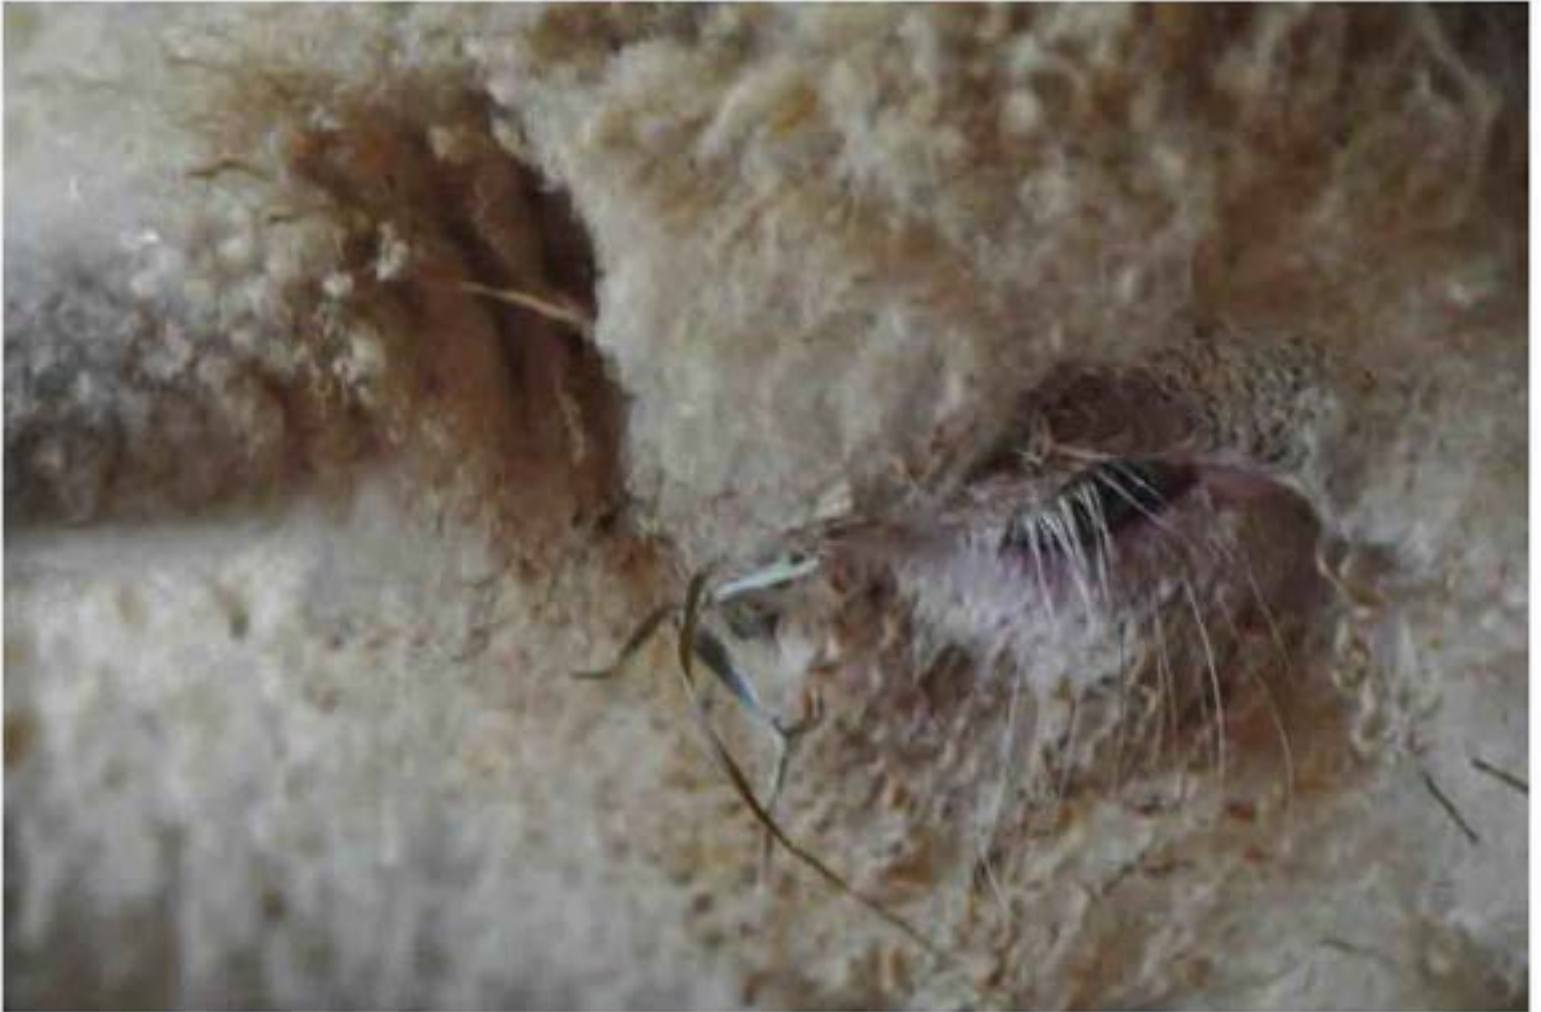
Photographer:	Randy Coleman, ACI	Legal Name:	55-B-0069
Photo Taken:	Mon, Apr 20, '15 115 pm	HENRY HAMPTON	
Inspection:	194151734120886		
Description:	Section 2.40(b)(2) and Section 2.40 (b)(3): Lambs found in machine shop area with excessive crust around eyes and/or noses.

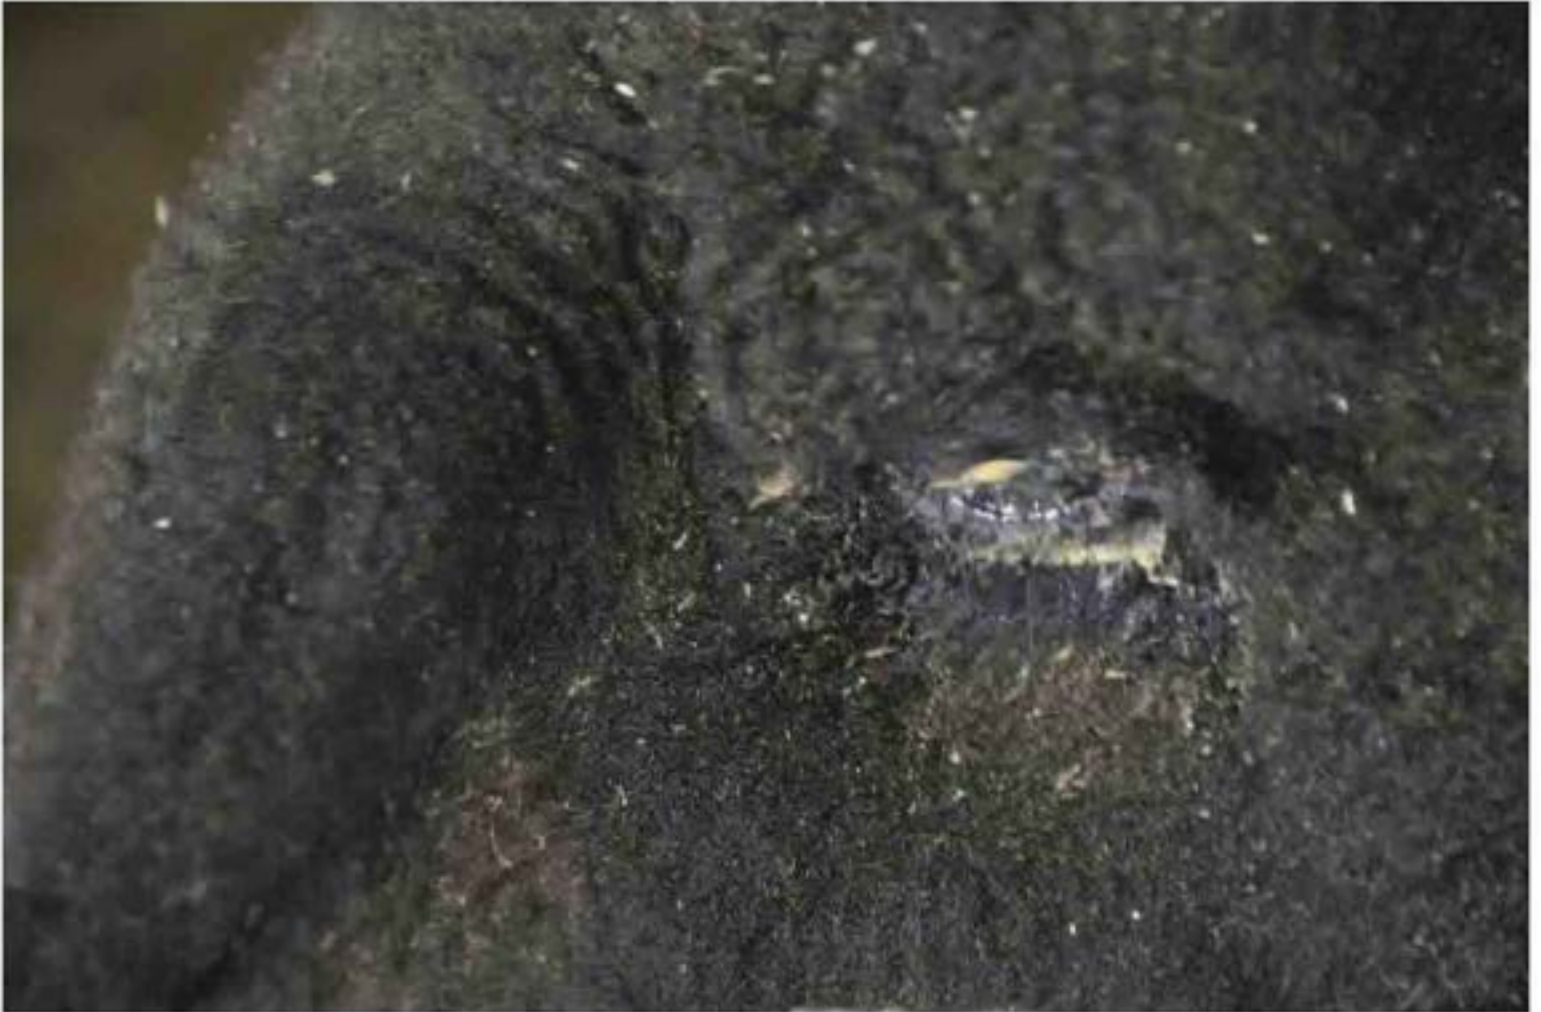
Photographer:	Randy Coleman, ACI	Legal Name:	55-B-0069
Photo Taken:	Mon, Apr 20, '15 115 pm	HENRY HAMPTON	
Inspection:	194151734120886		
Description:	Section 2.40(b)(2) and Section 2.40 (b)(3): Lambs found in machine shop area with excessive crust around eyes and/or noses.
