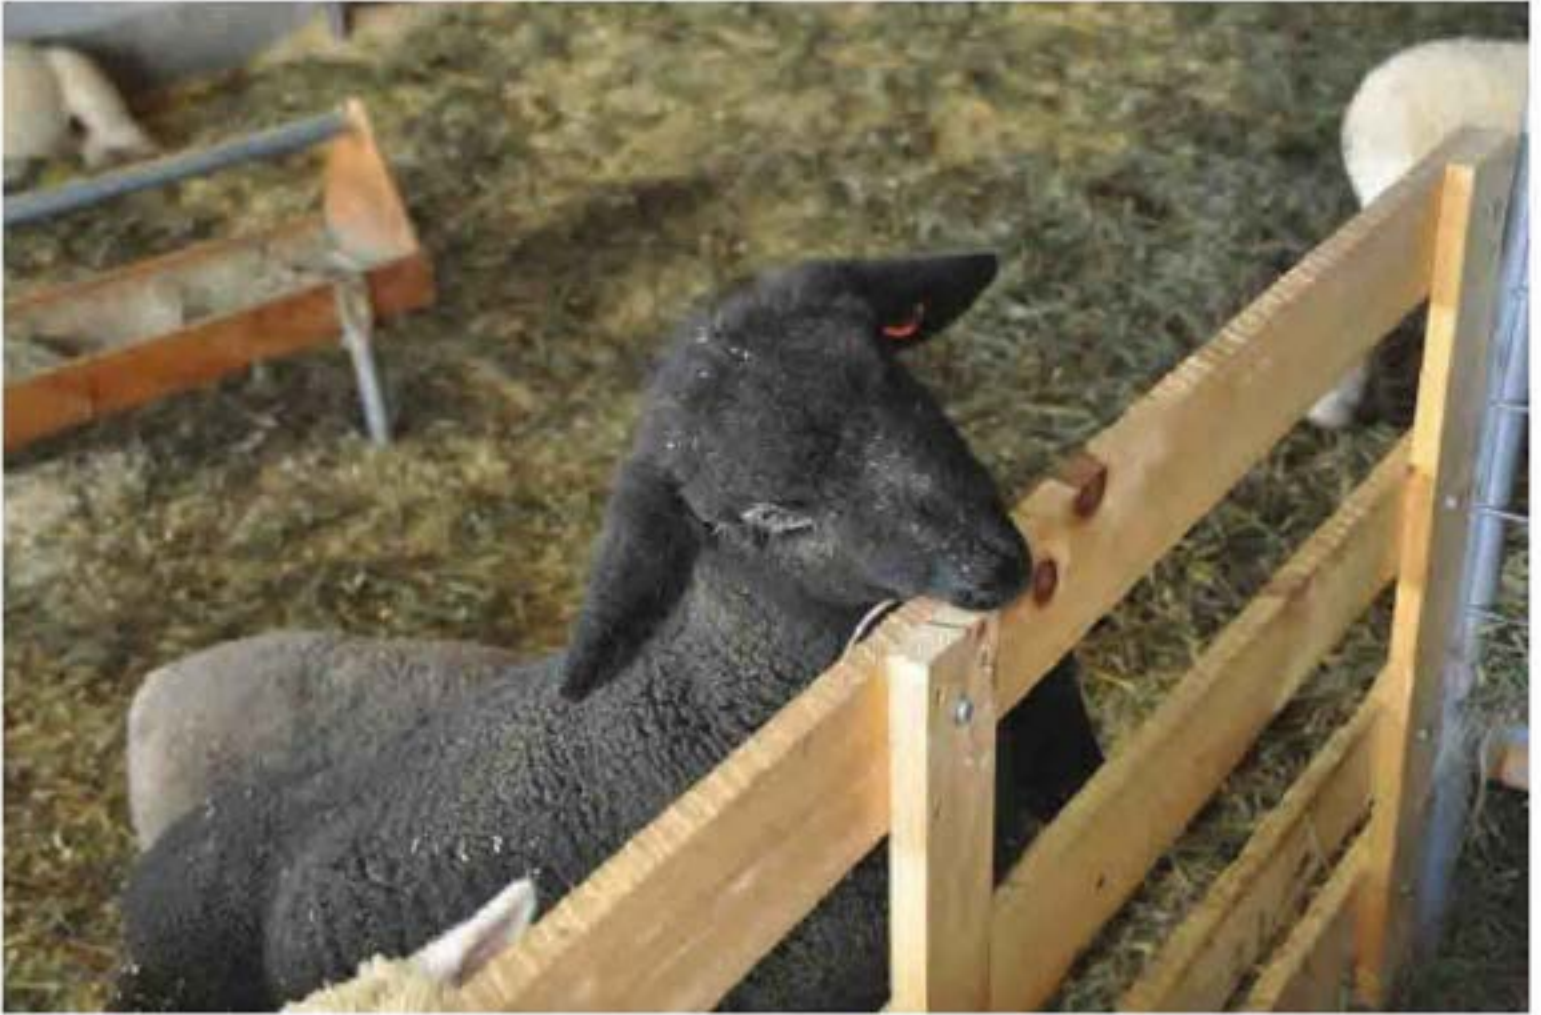
Photographer:	Randy Coleman, ACI	Legal Name:	55-B-0069
Photo Taken:	Mon, Apr 20, '15 115 pm	HENRY HAMPTON	
Inspection:	194151734120886		
Description:	Section 2.40(b)(2) and Section 2.40 (b)(3): Lambs found in machine shop area with excessive crust around eyes and/or noses.

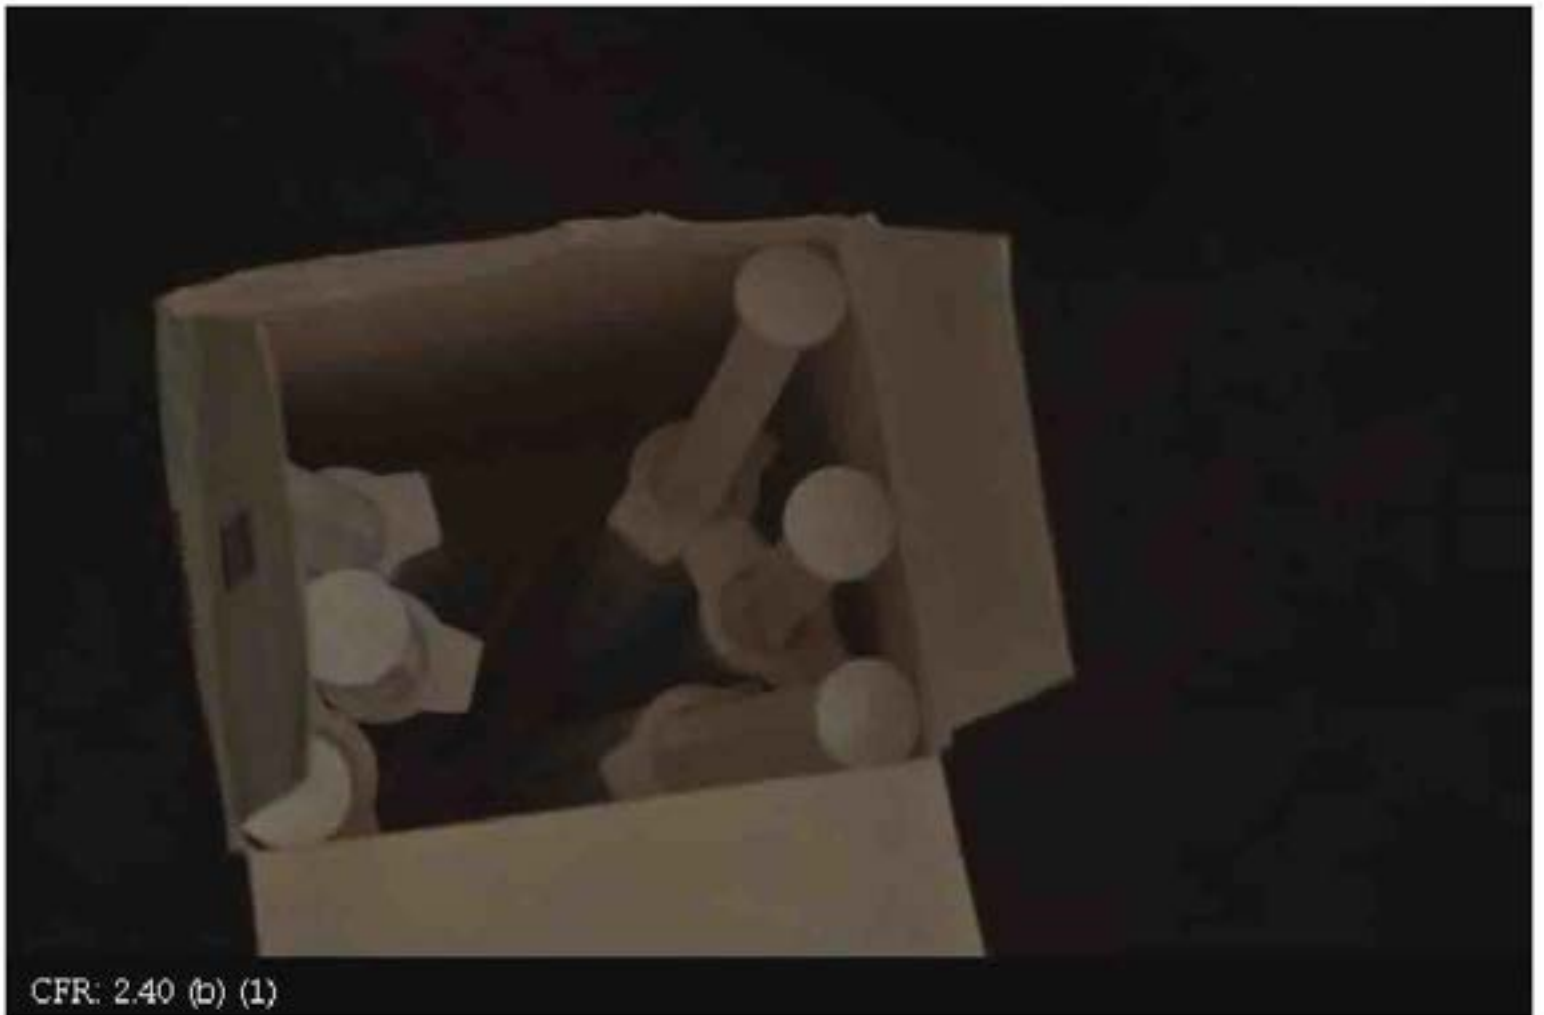
Photographer:	Randy Coleman	Legal Name:	55-B-0069
Photo Taken:	Tue, Aug 25, '15 2:12 pm	HENRY HAMPTON	
Inspection:	240150633510674		
Description:	Section 2.40(b)(1): Expired drug found at facility.

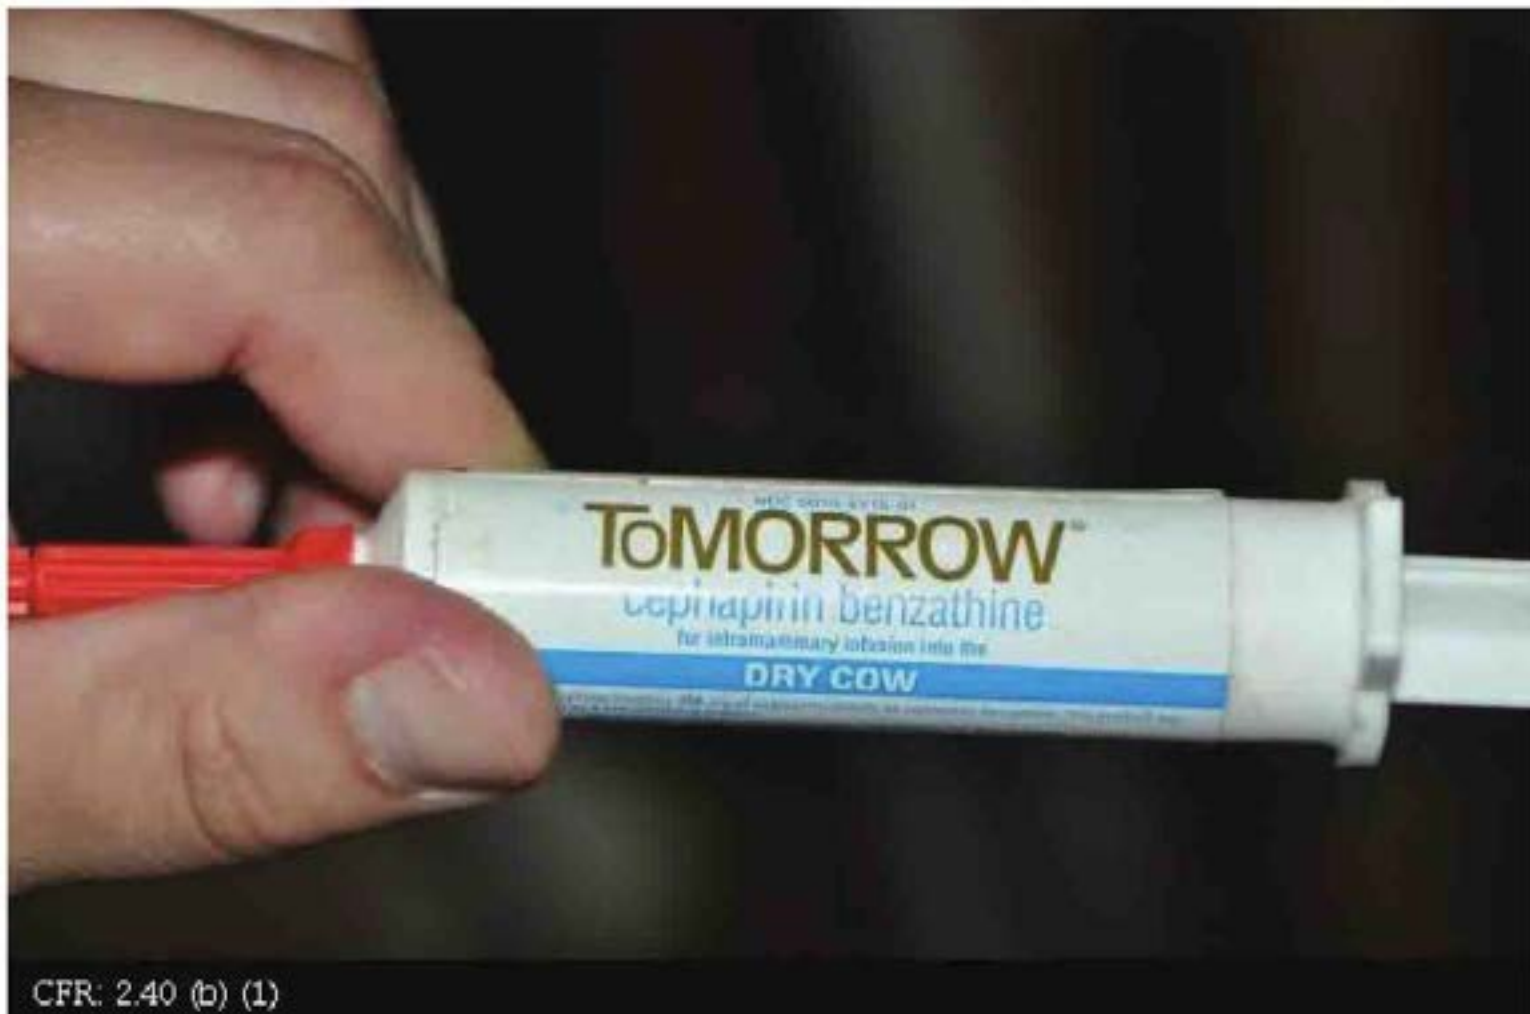
Photographer:	Randy Coleman	Legal Name:	55-B-0069
Photo Taken:	Tue, Aug 25, '15 212 pm	HENRY HAMPTON	
Inspection:	240150633510674		
Description:	Section 2.40(b)(1): Expired drug found at facility.

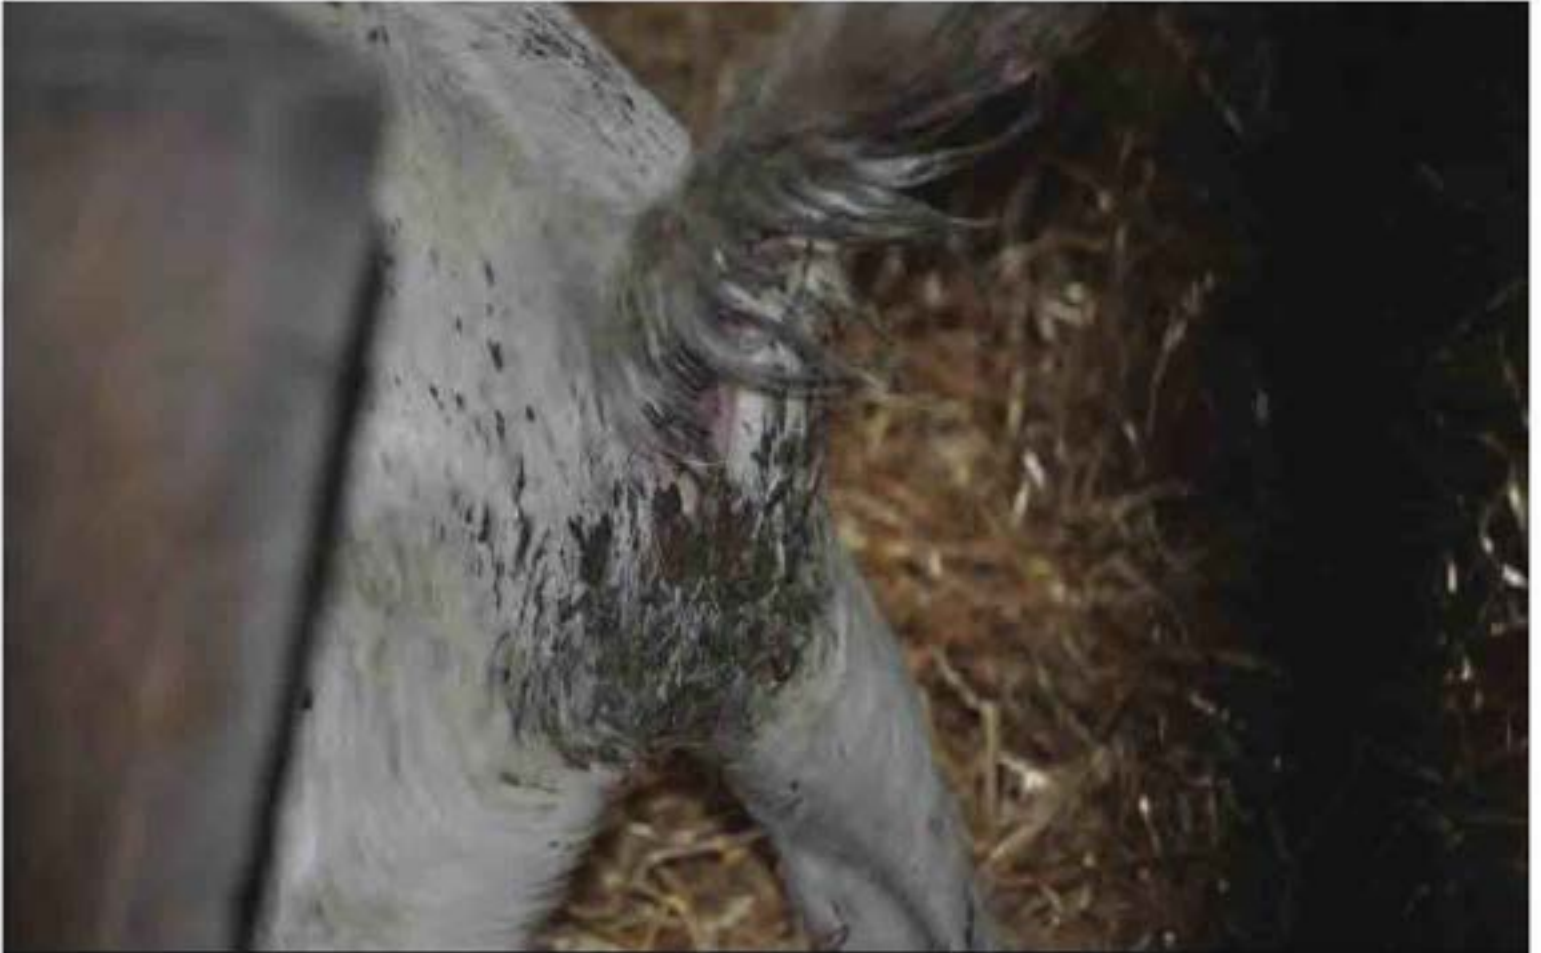
CFR: 2.40 (b) (3), 2.40 (b) (2)

Photographer:	Randy Coleman	Legal Name:	55-B-0069
Photo Taken:	Tue, Aug 25, '15 103 pm	HENRY HAMPTON	
Inspection:	240150633510674		
Description:	Section 2.40(b)(2): Brown and white Boer-type goat with loose stool.

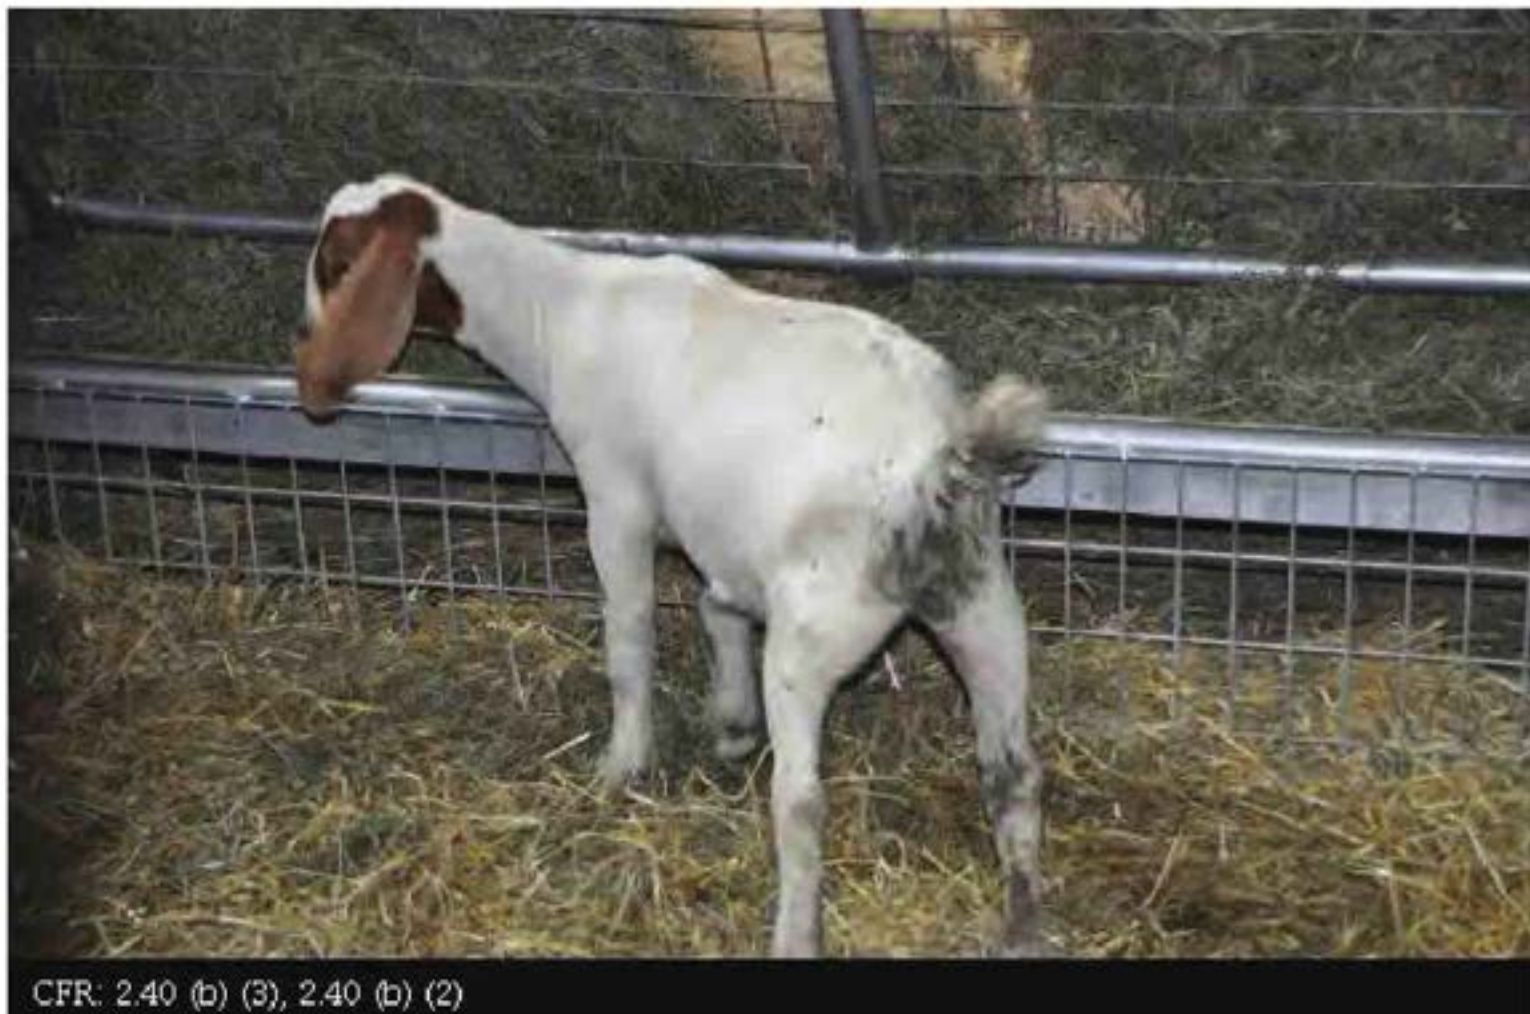
CFR: 2.40 (b) (3), 2.40 (b) (2)

Photographer:	Randy Coleman	Legal Name:	55-B-0069
Photo Taken:	Tue, Aug 25, '15 103 pm	HENRY HAMPTON	
Inspection:	240150633510674		
Description:	Section 2.40(b)(2): Brown and white Boer-type goat with loose stool.

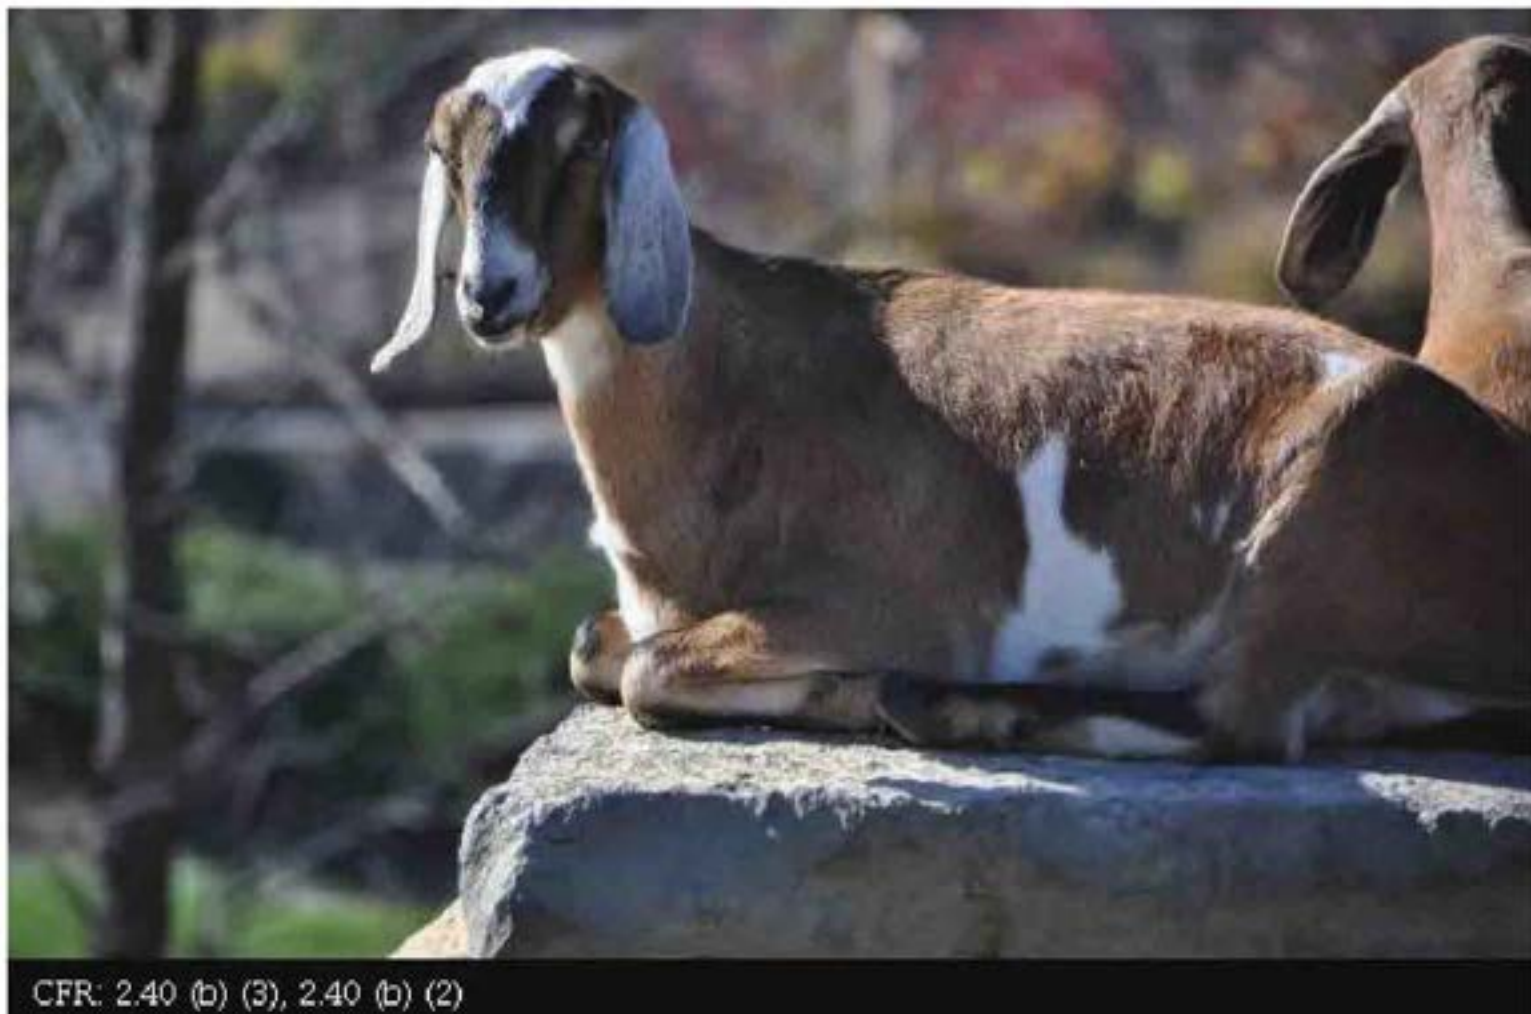
CFR: 2.40 (b) (3), 2.40 (b) (2)

Photographer:	Randy Coleman	Legal Name:	55-B-0069
Photo Taken:	Mon, Nov 9, '15 1130 am	HENRY HAMPTON	
Inspection:	314151637070903		
Description:	Section 2.40(b)(2) and 2.40(b)(3): Female goat found with discolored area on left side of neck.

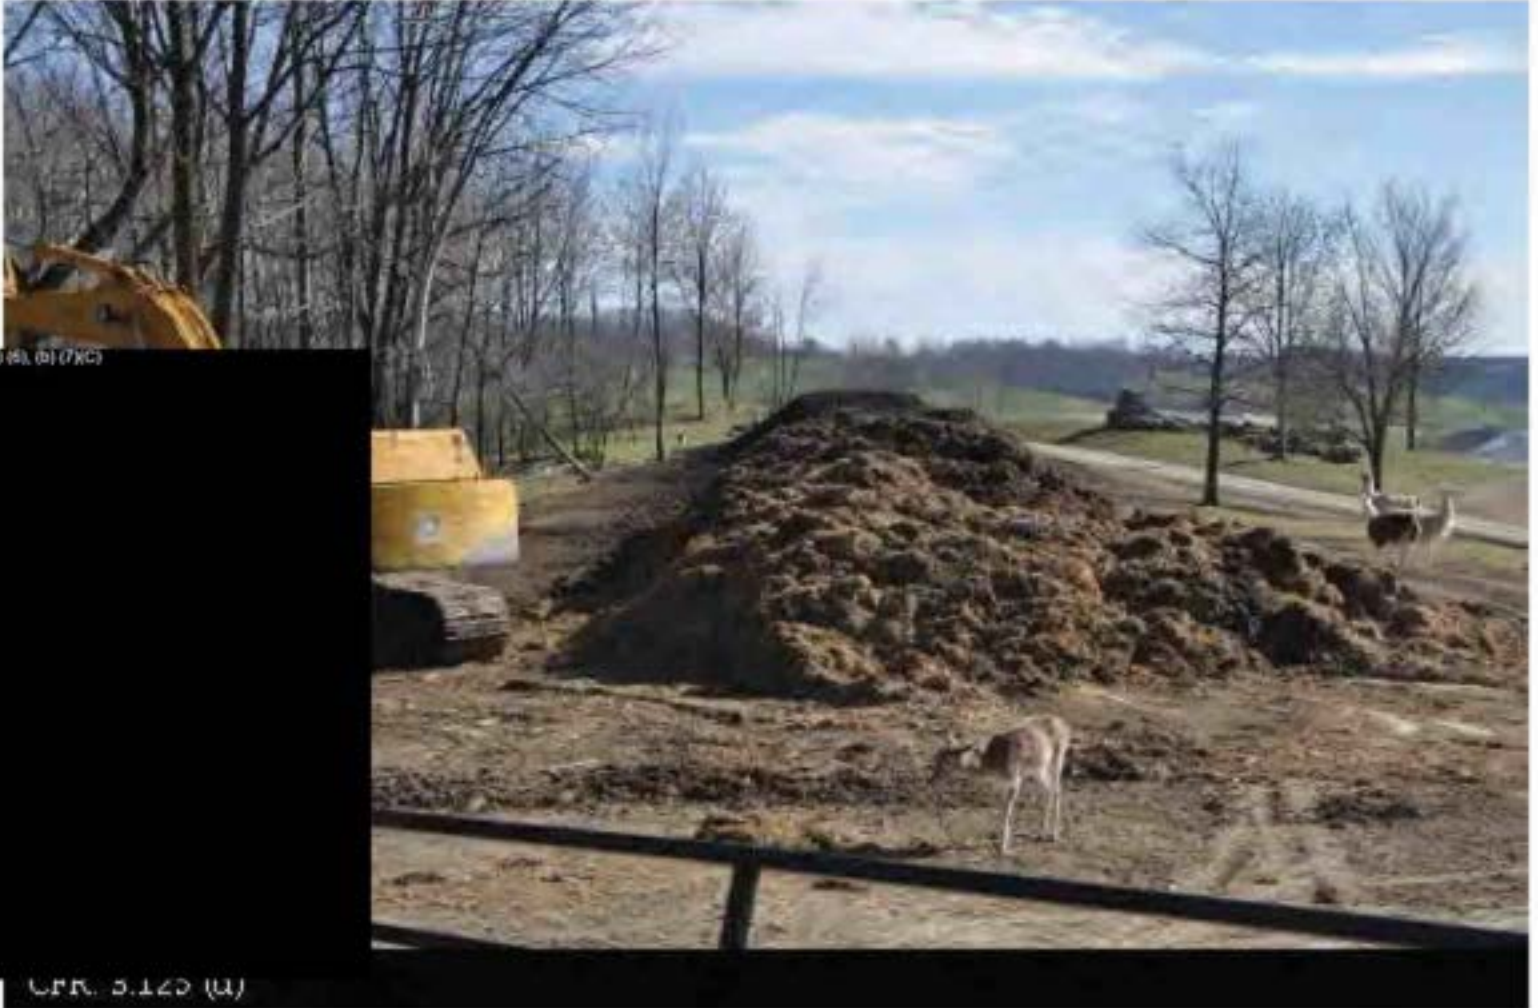
Photographer:	Randy Coleman	Legal Name:	55-B-0069
Photo Taken:	Mon, Nov 9, '15 132 pm	HENRY HAMPTON	
Inspection:	314151637070903		
Description:	Section 3.125(d): Large mound of animal waste and bedding remains in drive thru area.

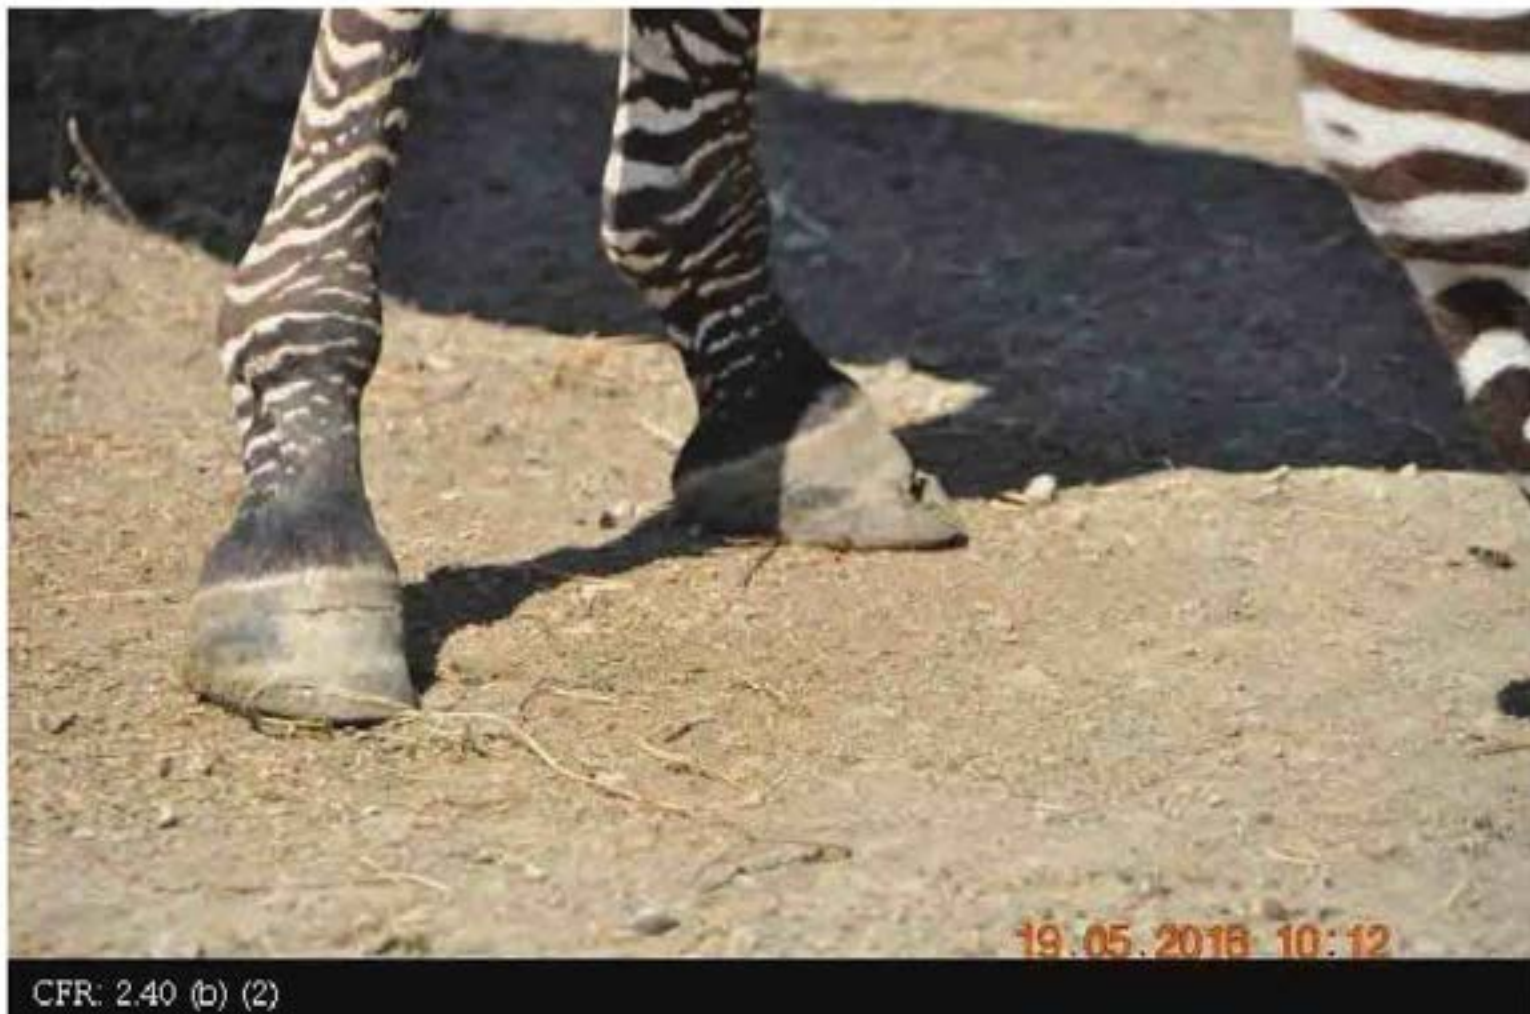
Photographer:	K. Campitelli	Legal Name:	55-B-0069
Photo Taken:	Thu, May 19, '16 10:30	HENRY HAMPTON	
Inspection:	141161055040796		
Description:	Close-up of crack on left front hoof of zebra in drive-thru

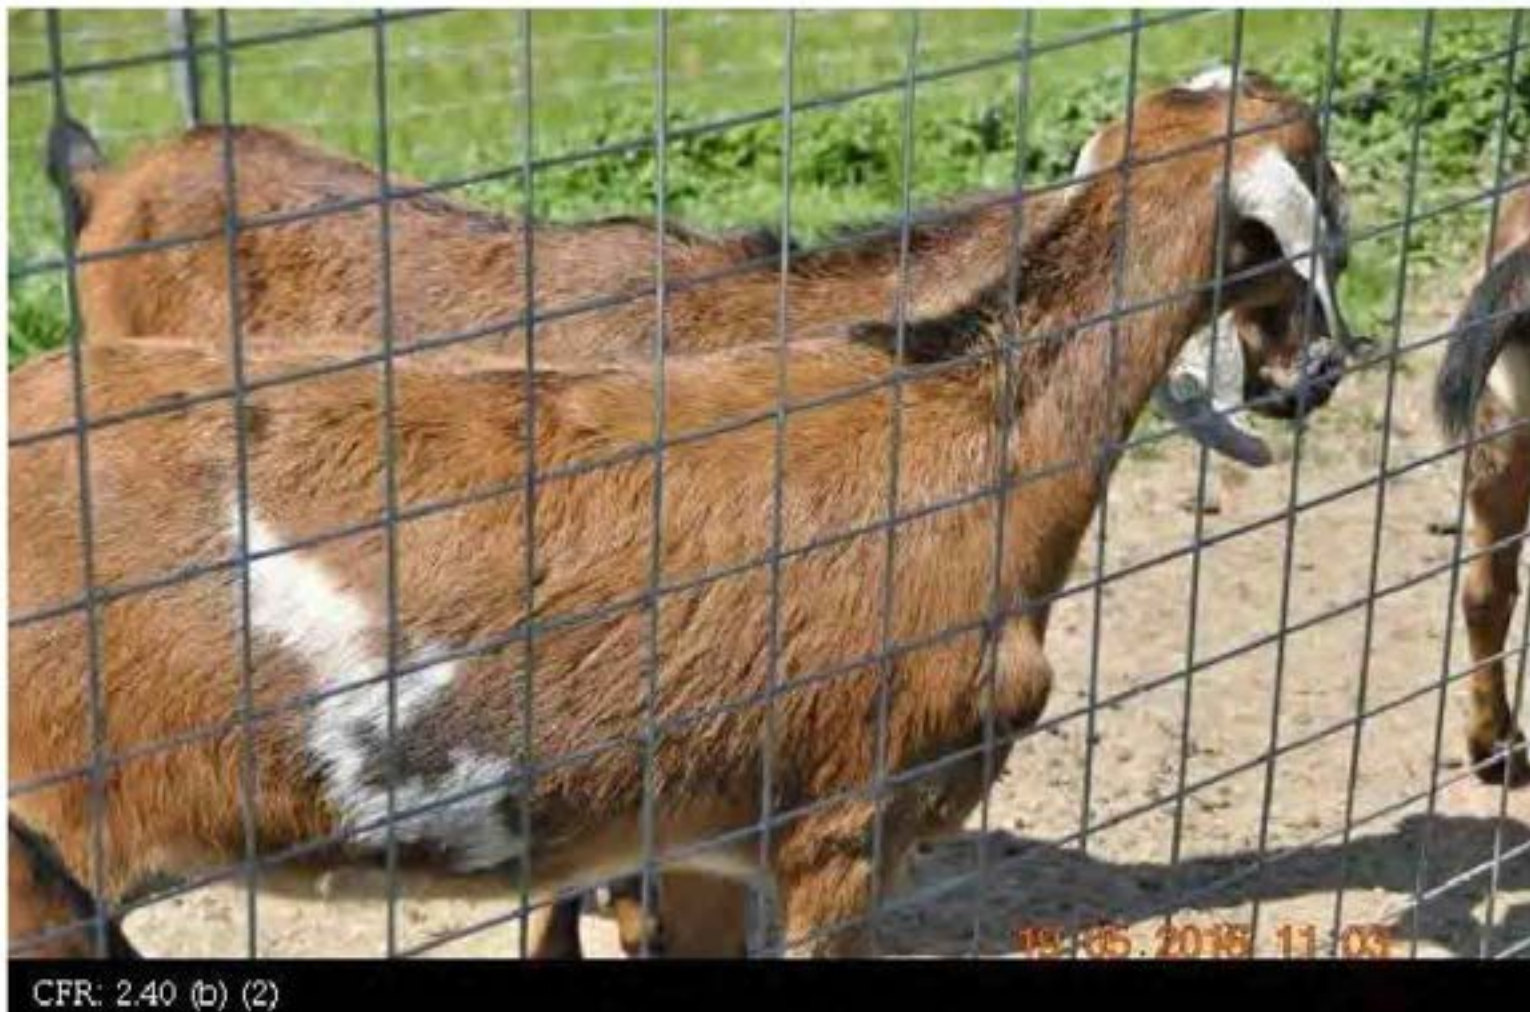
Photographer:	K. Campitelli	Legal Name:	55-B-0069
Photo Taken:	Thu, May 19, '16 10:30	HENRY HAMPTON	
Inspection:	141161055040796		
Description:	Overview of goat with lump on right shoulder

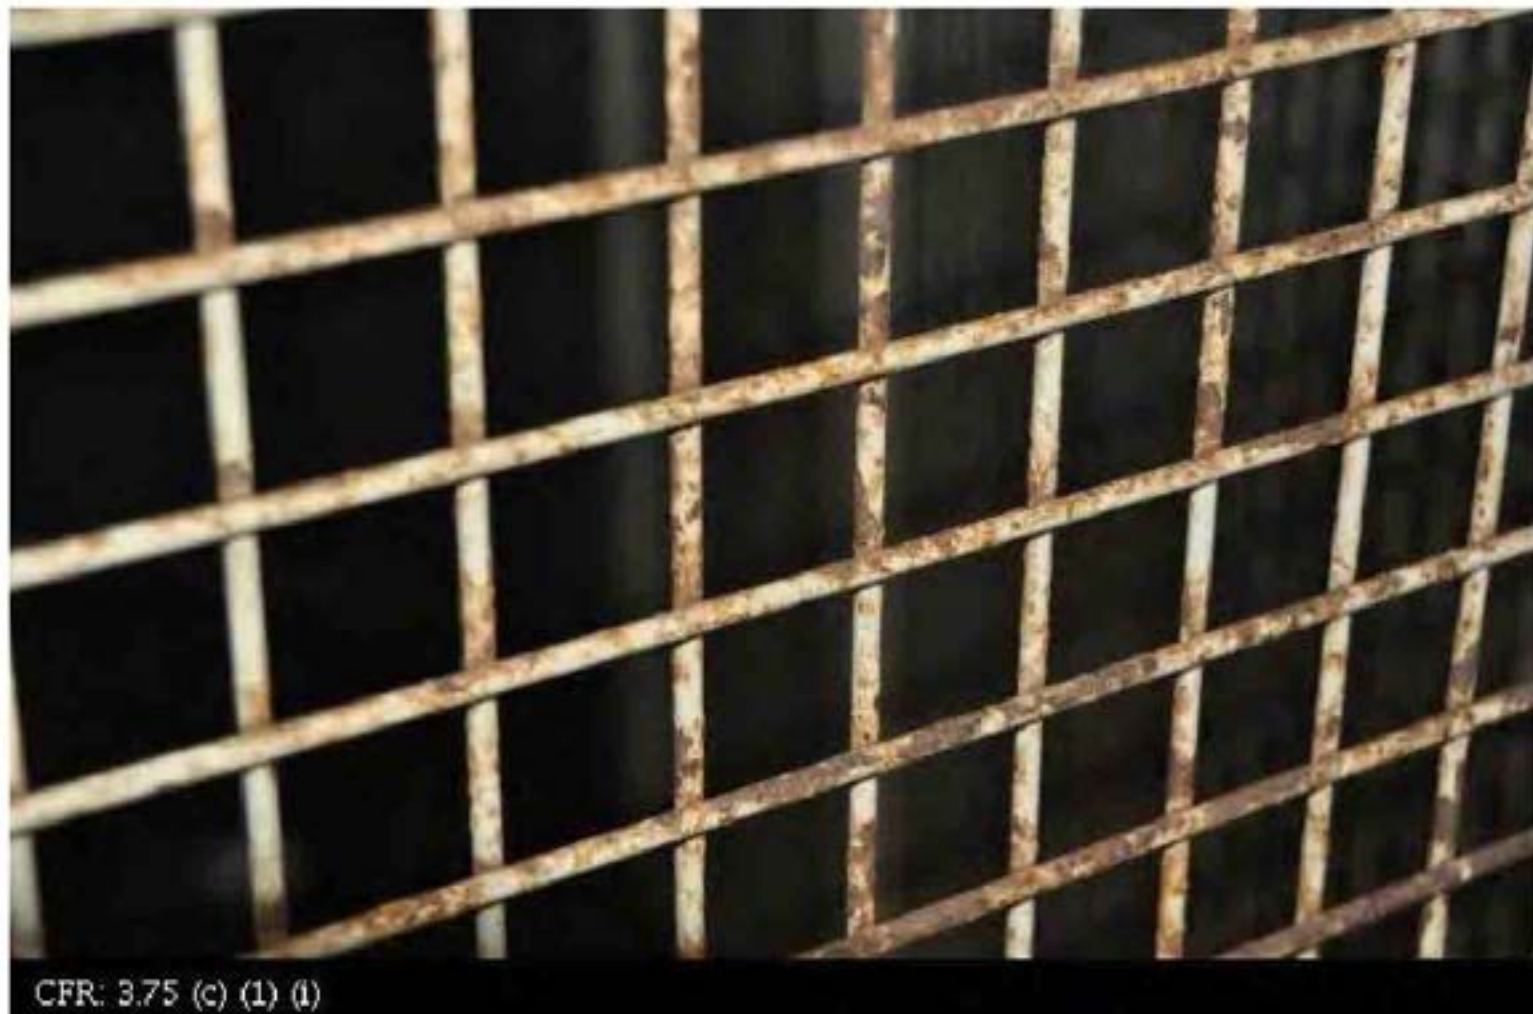
Photographer:	Randy Coleman	Legal Name:	55-B-0069
Photo Taken:	Wed, May 25, '16	HENRY HAMPTON	
Inspection:	147160841480226		
Description:	Section 3.75(c)(1): Rusty bars of indoor lemur enclosure on lower lemur island.

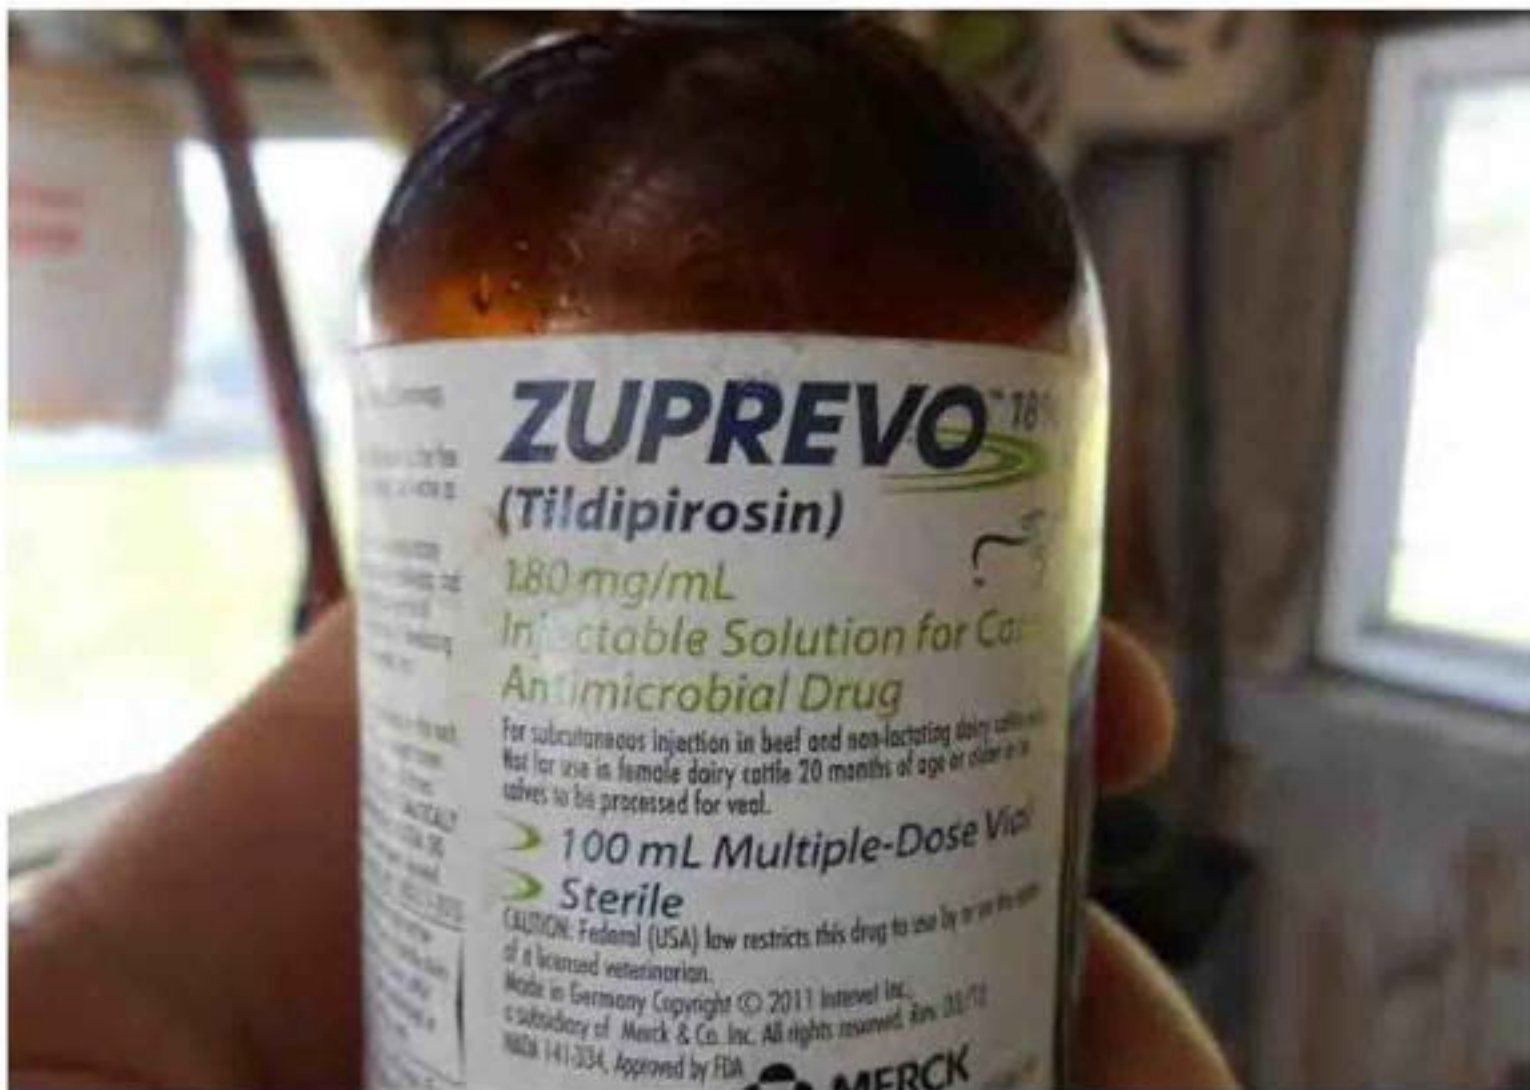
CFR: 2.40 (b) (1)

Photographer:	Randy Coleman	Legal Name:	55-B-0069
Photo Taken:	Wed, Aug 3, '16 1100 am	HENRY HAMPTON	
Inspection:	217160732290590		
Description:	2.40(b)(2): expired drugs found at facility.

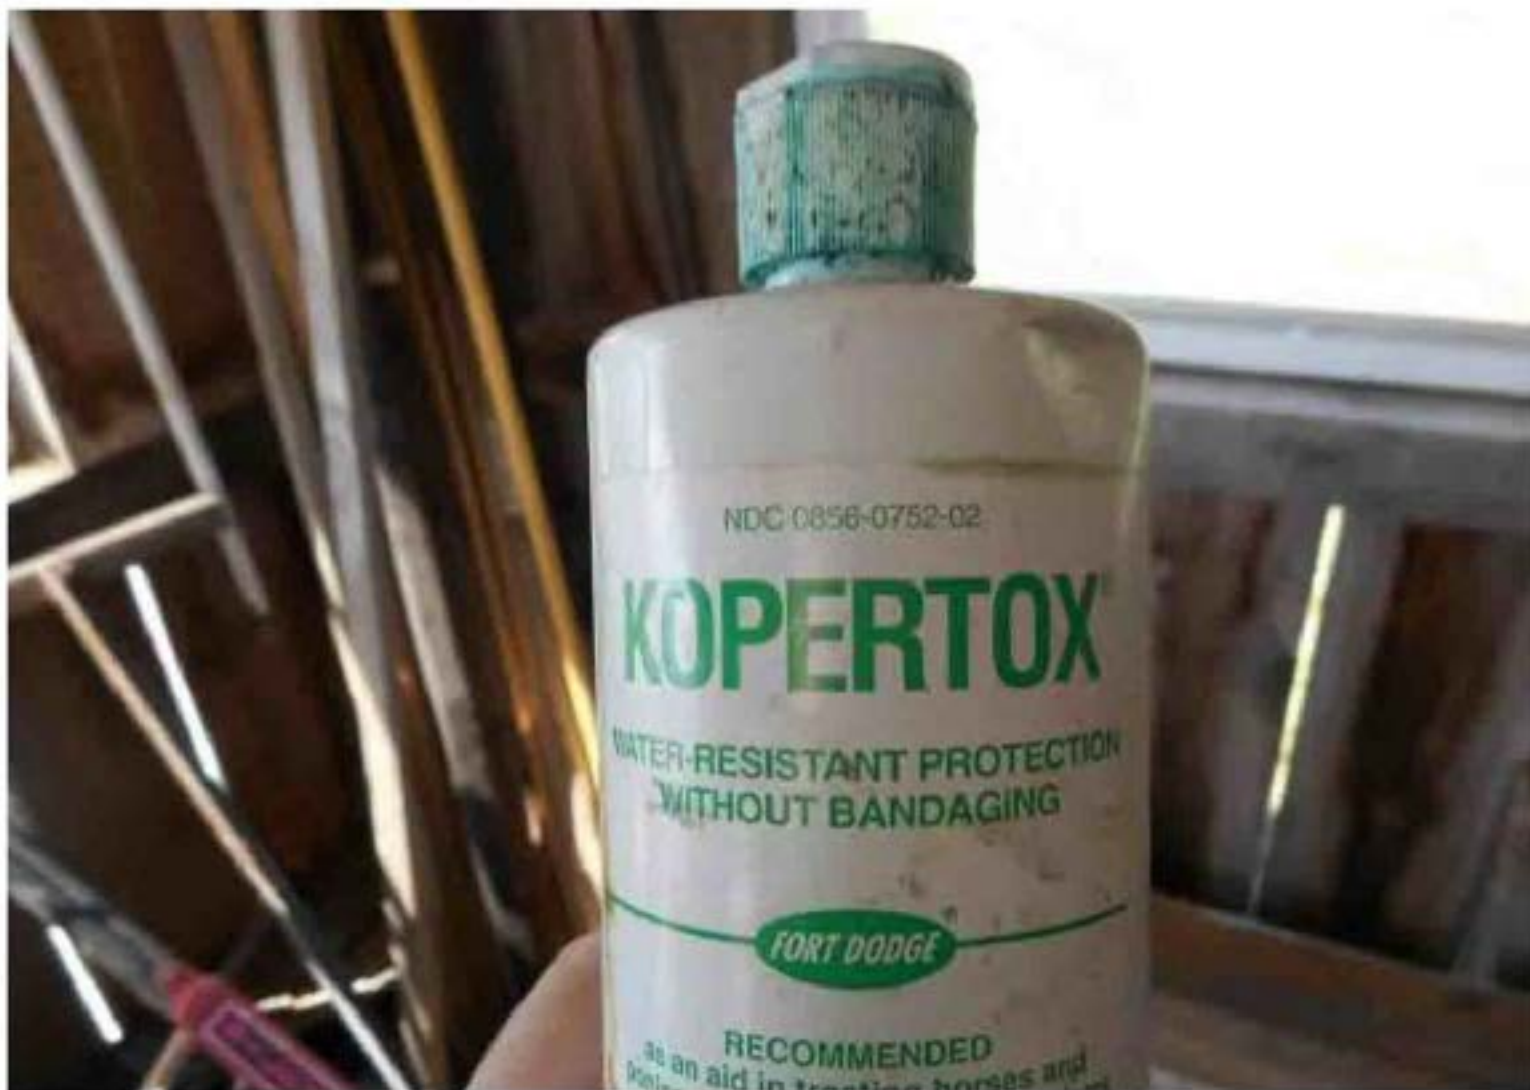
CFR: 2.40 (b) (1)

Photographer:	Randy Coleman	Legal Name:	55-B-0069
Photo Taken:	Wed, Aug 3, '16 1100 am	HENRY HAMPTON	
Inspection:	217160732290590		
Description:	2.40(b)(2): expired drugs found at facility.

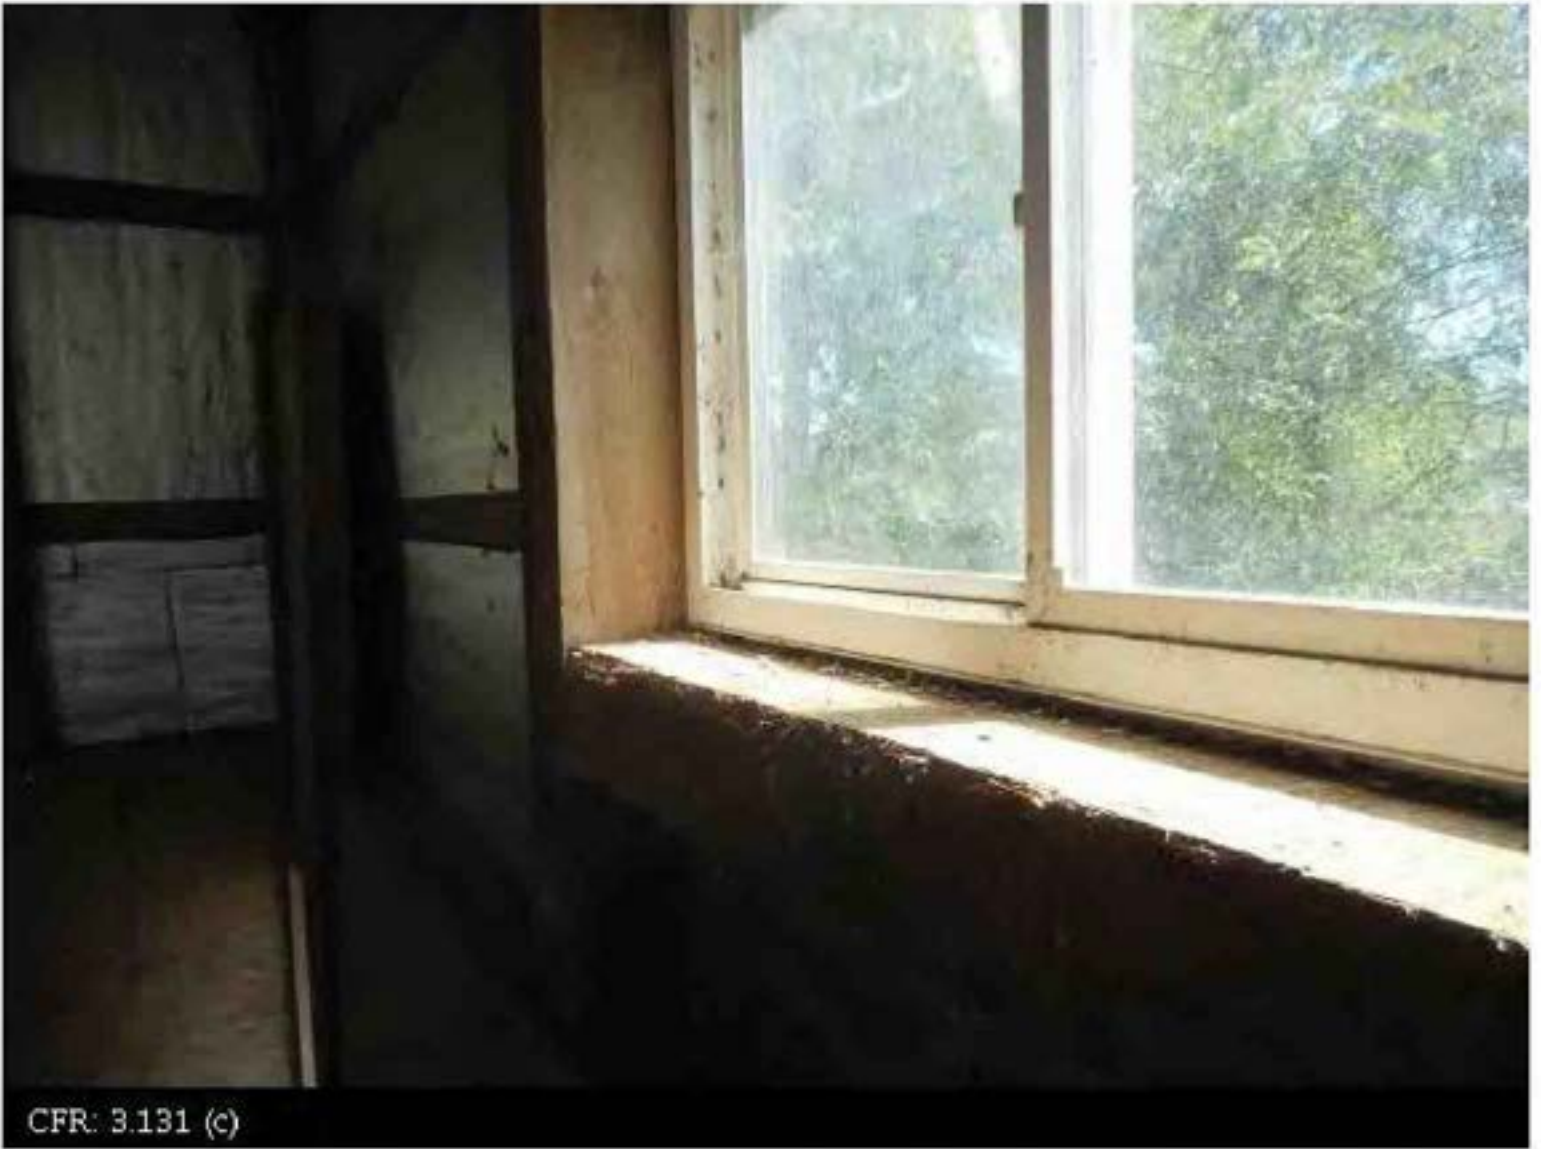
Photographer:	Randy Coleman	Legal Name:	55-B-0069
Photo Taken:	Wed, Aug 3, '16 1100 am	HENRY HAMPTON	
Inspection:	217160732290590		
Description:	3.131(c): Kangaroo indoor area in need of cleaning.

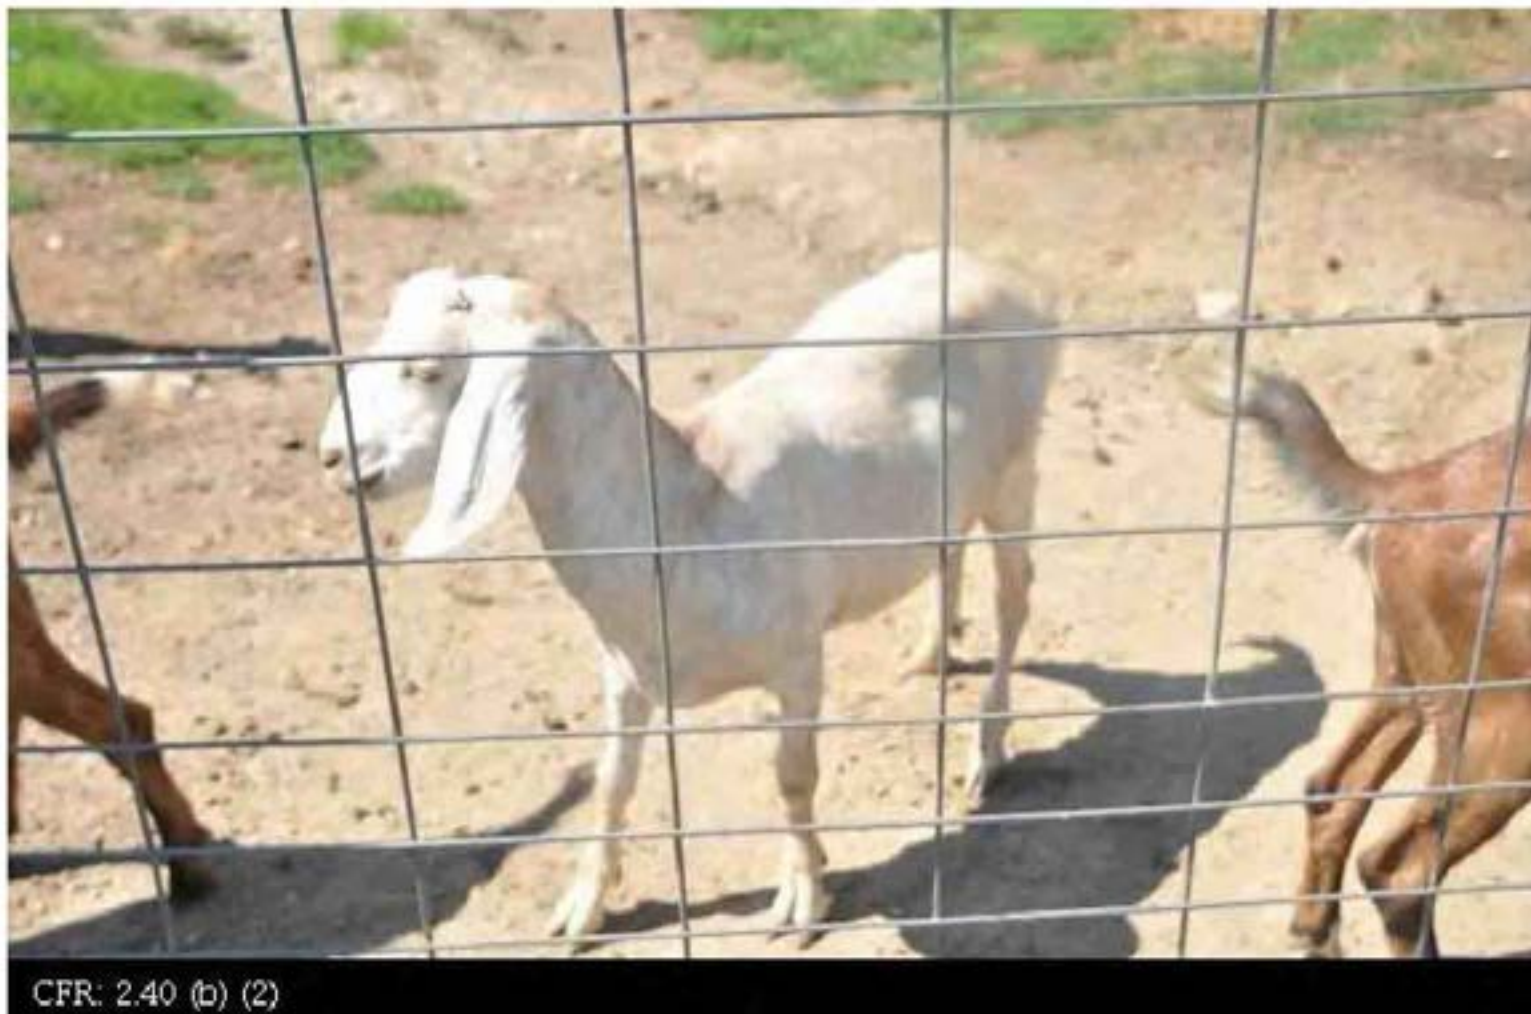
Photographer:	Kathy Campitelli	Legal Name:	55-B-0069
Photo Taken:	Wed, Aug 3, '16 1100 am	HENRY HAMPTON	
Inspection:	217160732290590		
Description:	2.40(b)(2): white Nubian with no ID found with long feet.
