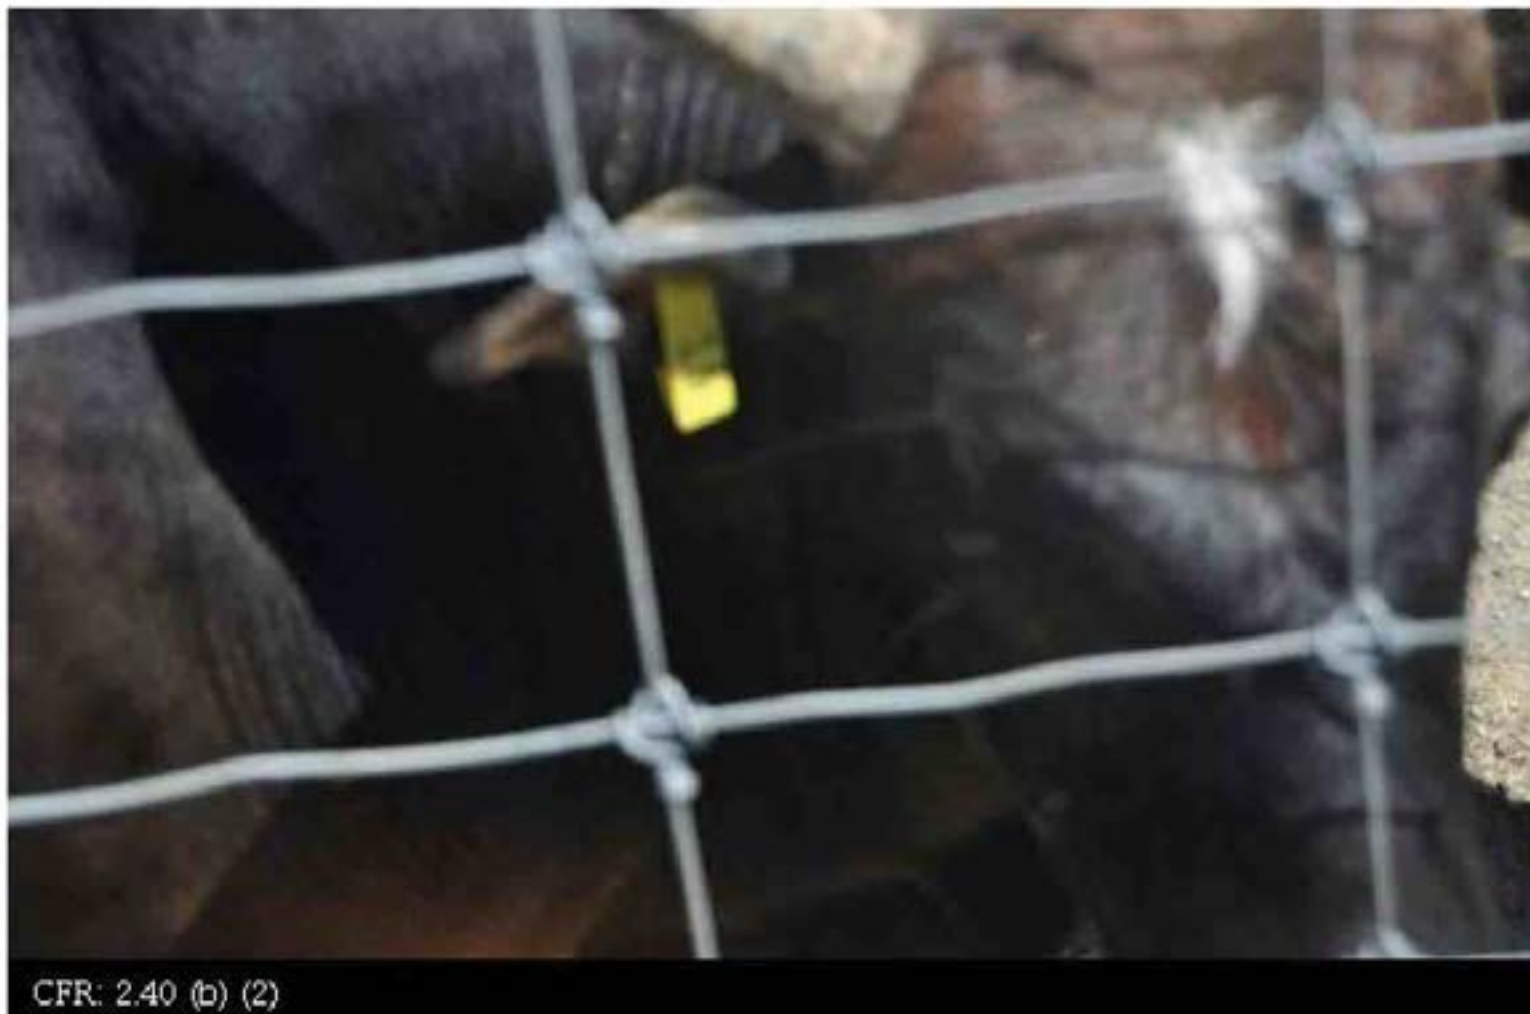
Photographer:	Kathy Campitelli	Legal Name:	55-B-0069
Photo Taken:	Wed, Aug 3, '16 1100 am	HENRY HAMPTON	
Inspection:	217160732290590		
Description:	2.40(b)(2): Pygmy zebu found with long feet.
