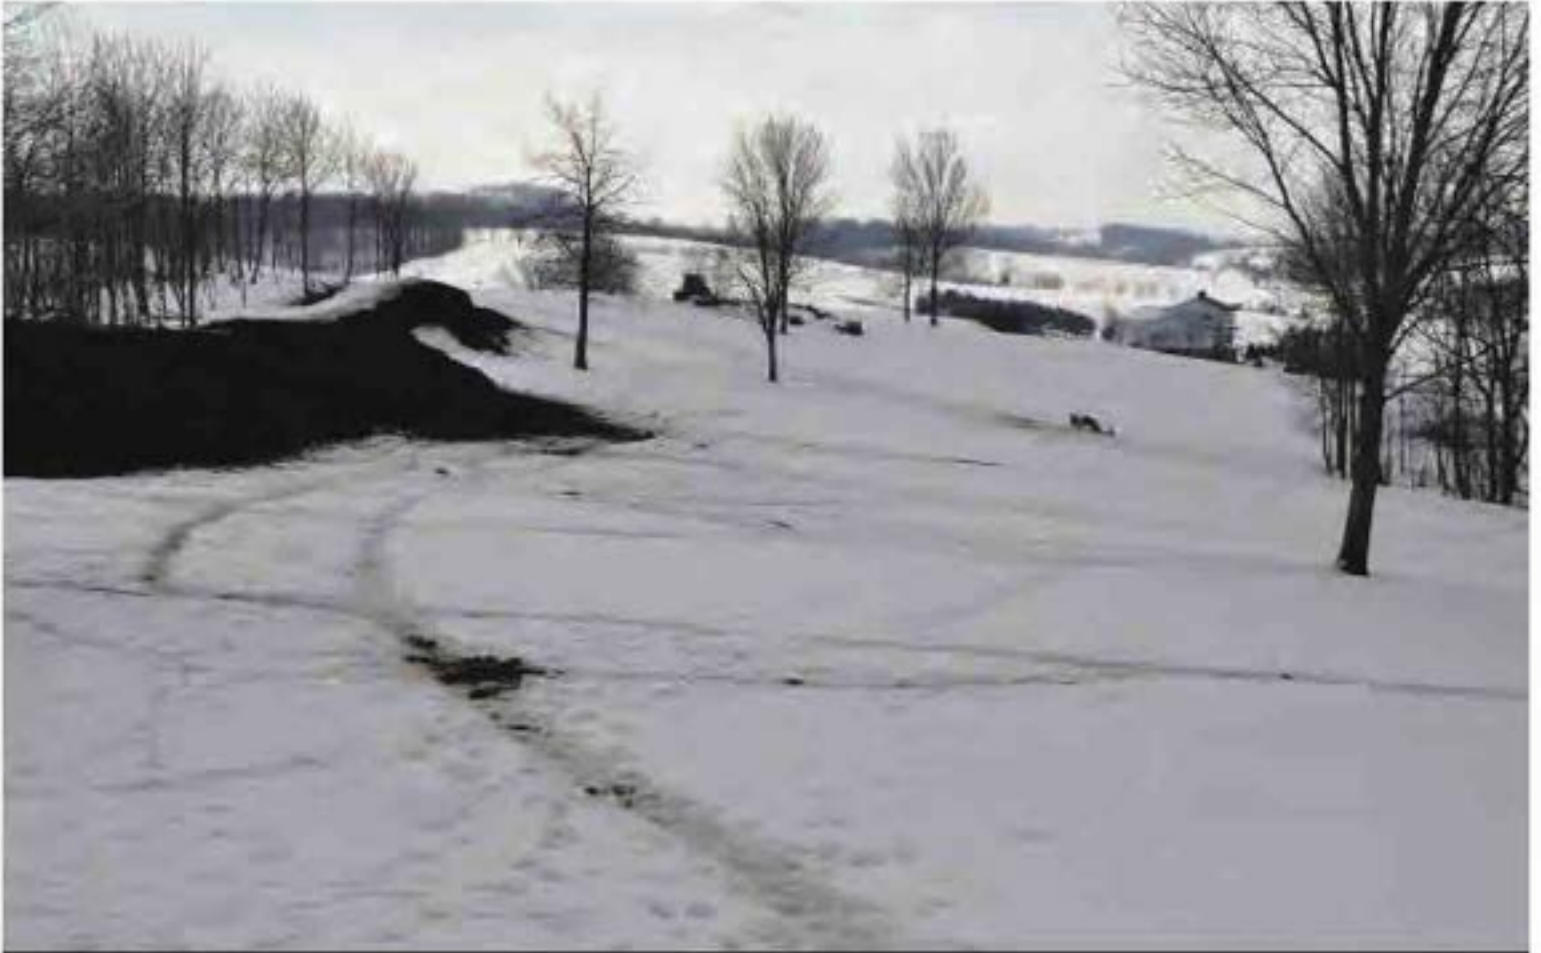
000020

CFR: 3.125 (d)

Photographer:	K. McHenry VMO	Legal Name:	55-B-0069
Photo Taken:	Wed, Feb 19, '14 10:40am	HENRY HAMPTON	
Inspection:	30140840096977		
Description:	Animals in the drive through area have free access to a large heap of animal waste, bedding, and other material

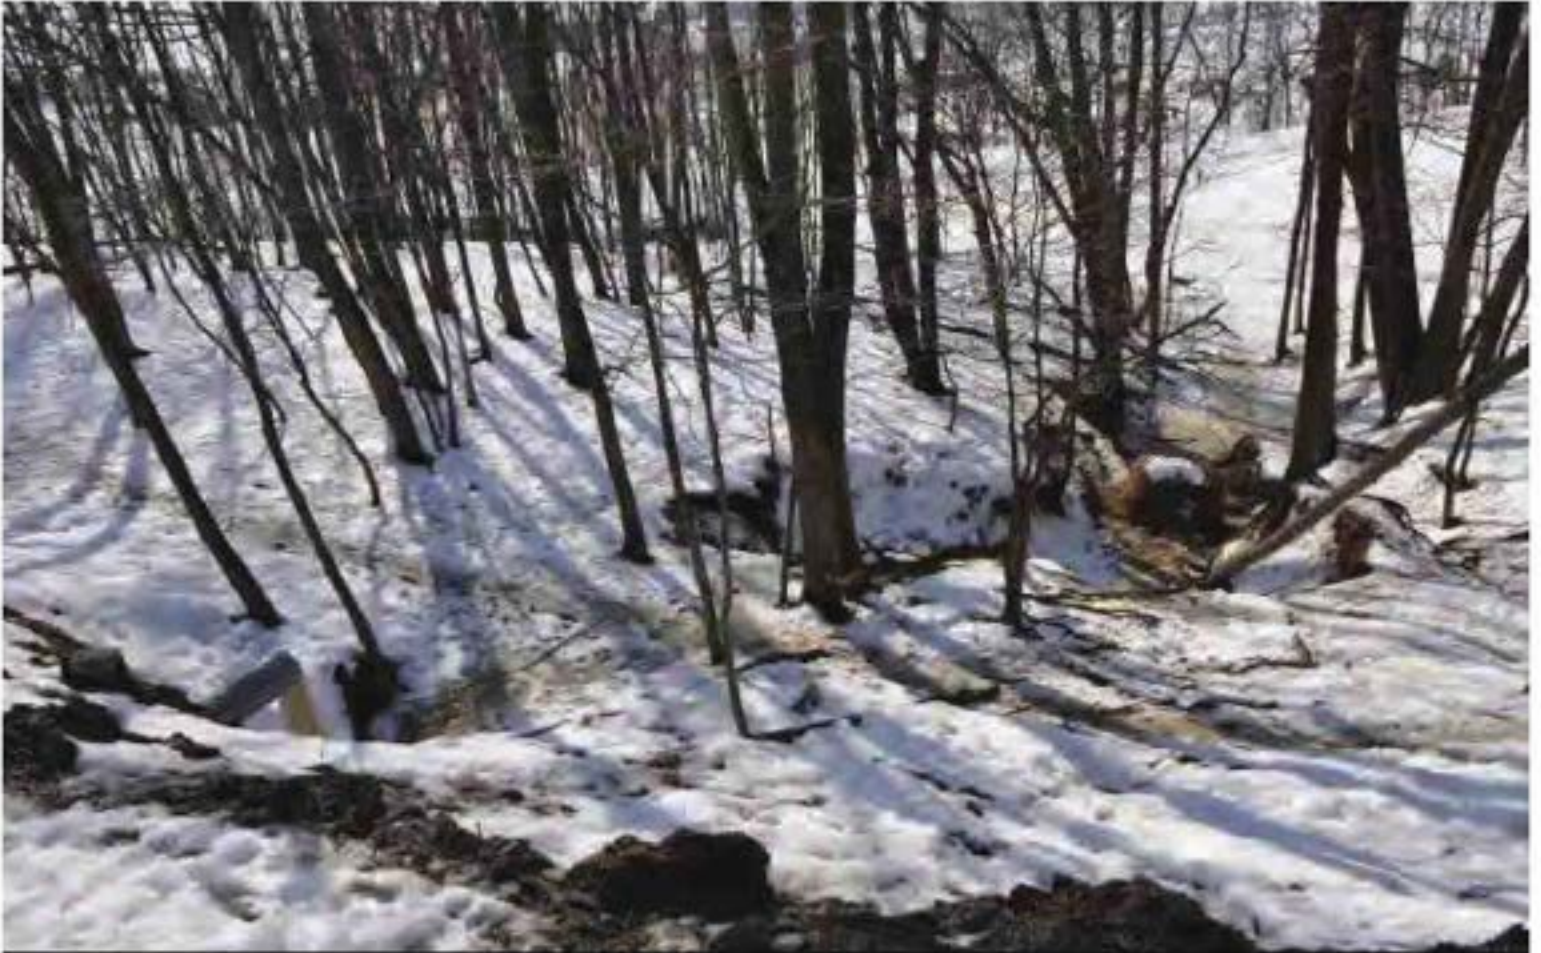
000021

CFR: 3.130

Photographer:	K. McHenry VMO	Legal Name:	55-B-0069
Photo Taken:	Wed, Feb 19, '14 11:13am	HENRY HAMPTON	
Inspection:	30140840096977		
Description:	Overview of drain pipe and frozen pond in the drive through area

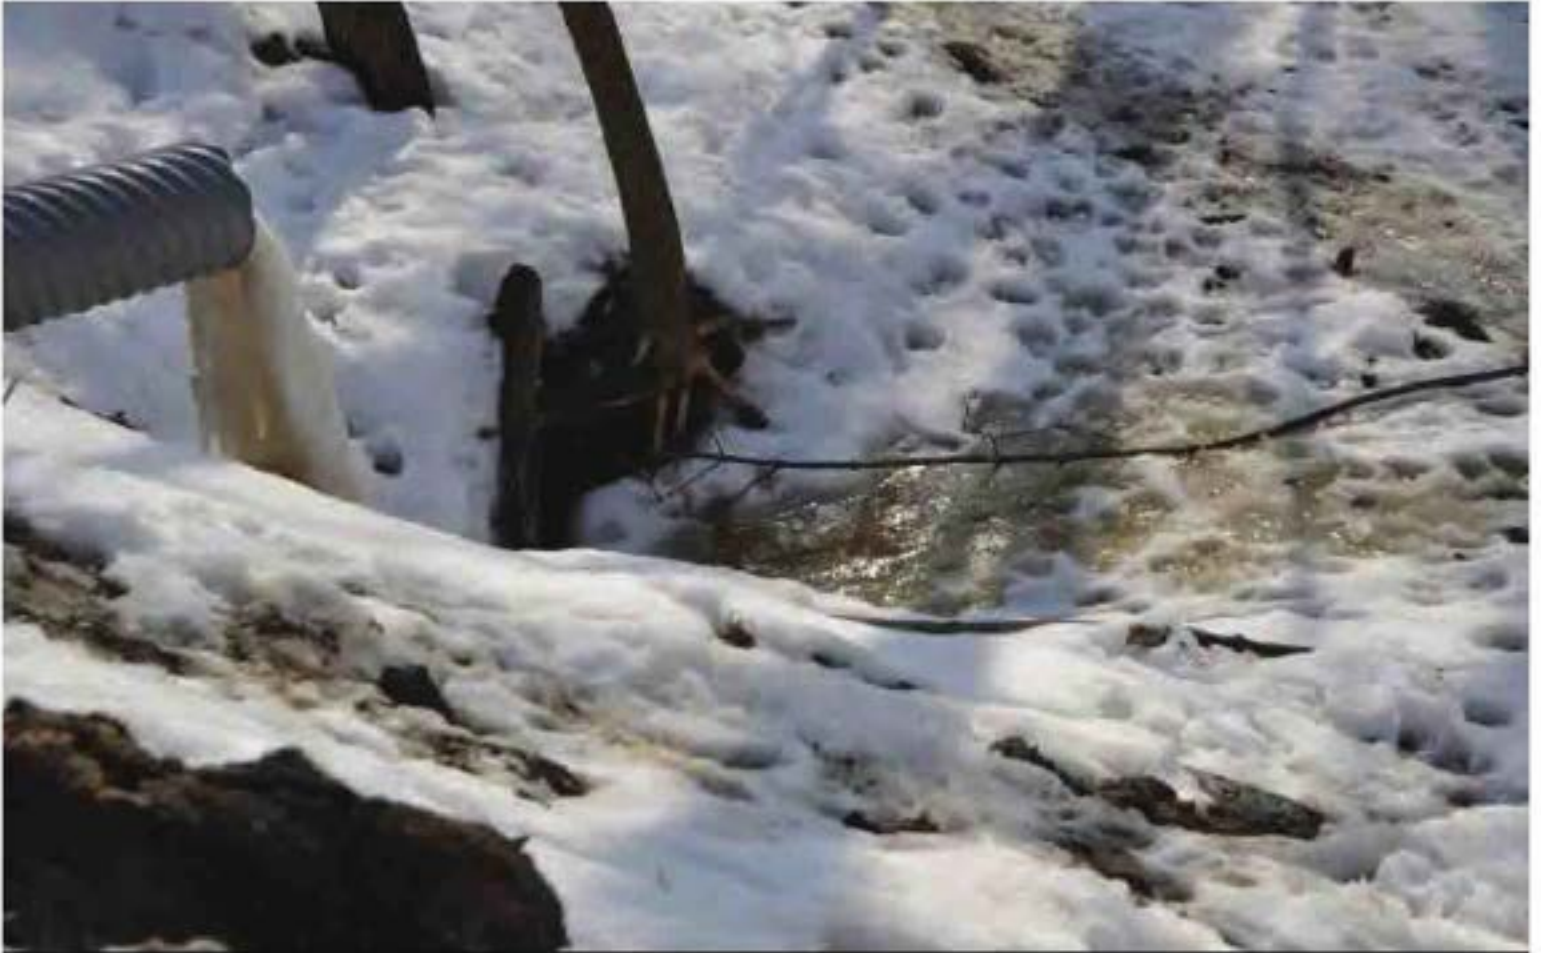
000022

CFR: 3.130

Photographer:	K. McHenry VMO	Legal Name:	55-B-0069
Photo Taken:	Wed, Feb 19, '14 11:12am	HENRY HAMPTON	
Inspection:	30140840096977		
Description:	A small amount of water is running from the drain pipe

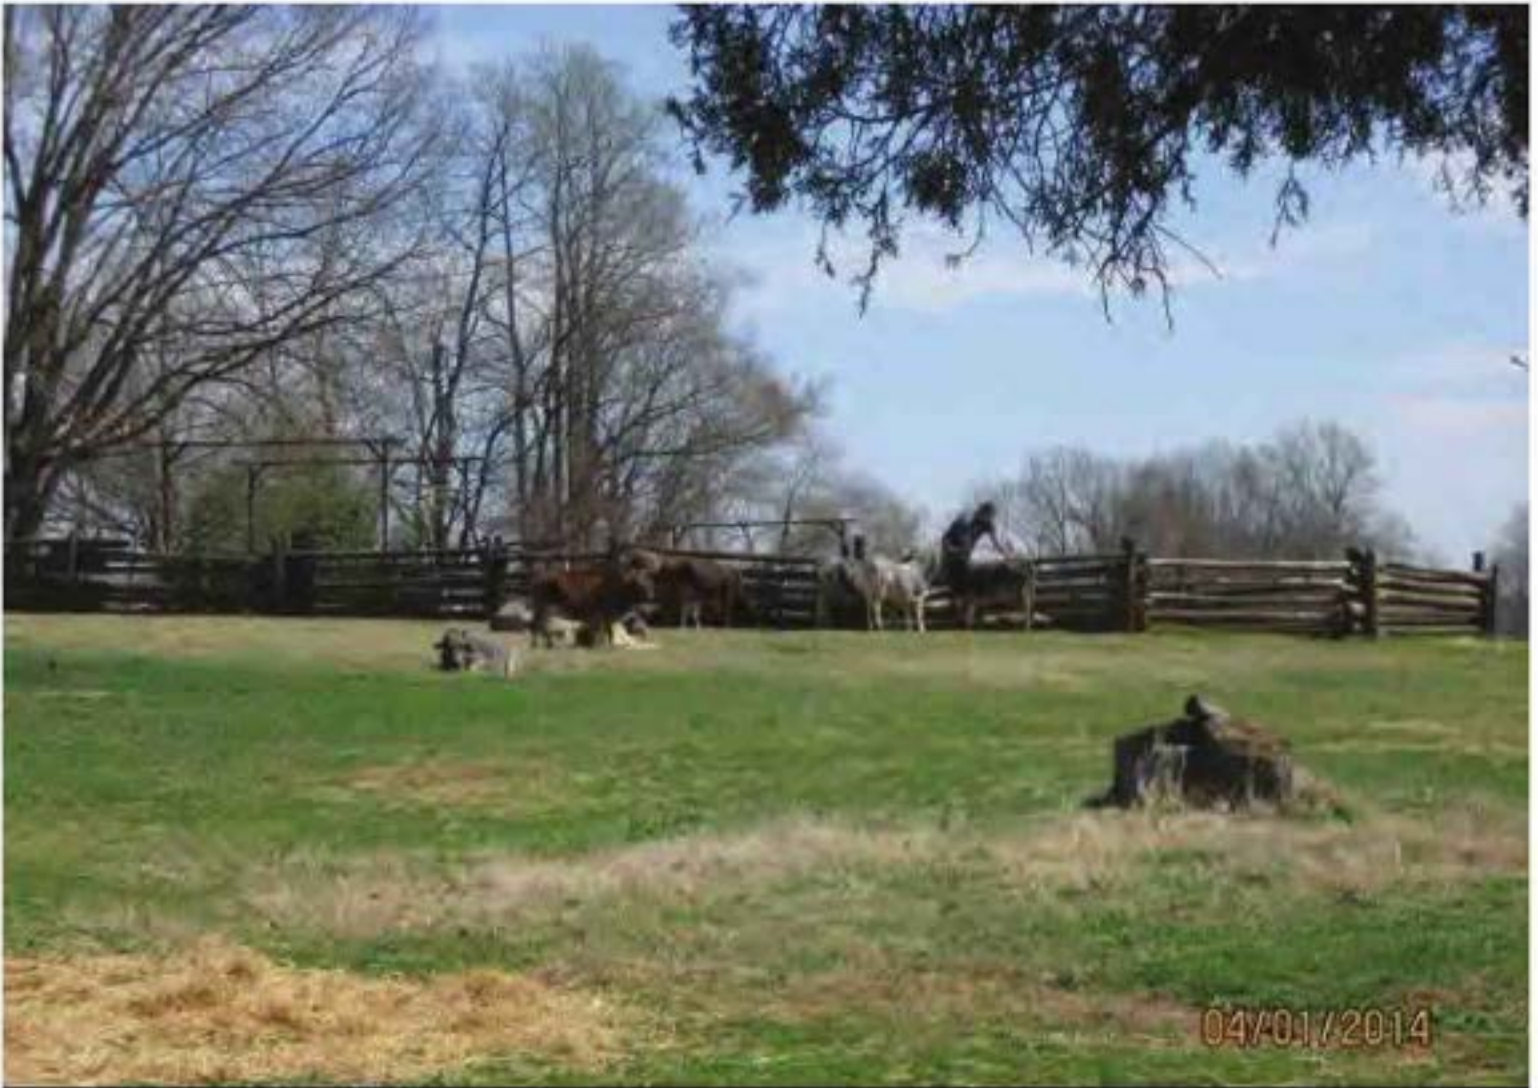
000023

CFR: 2.131 (d) (2)

Photographer:	M. Binkley, VMO	Legal Name:	55-B-0069
Photo Taken:	Tue, Apr 1, '14 12:54pm	HENRY HAMPTON	
Inspection:	91140803324573		
Description:	Public contact with animals without attendant present.

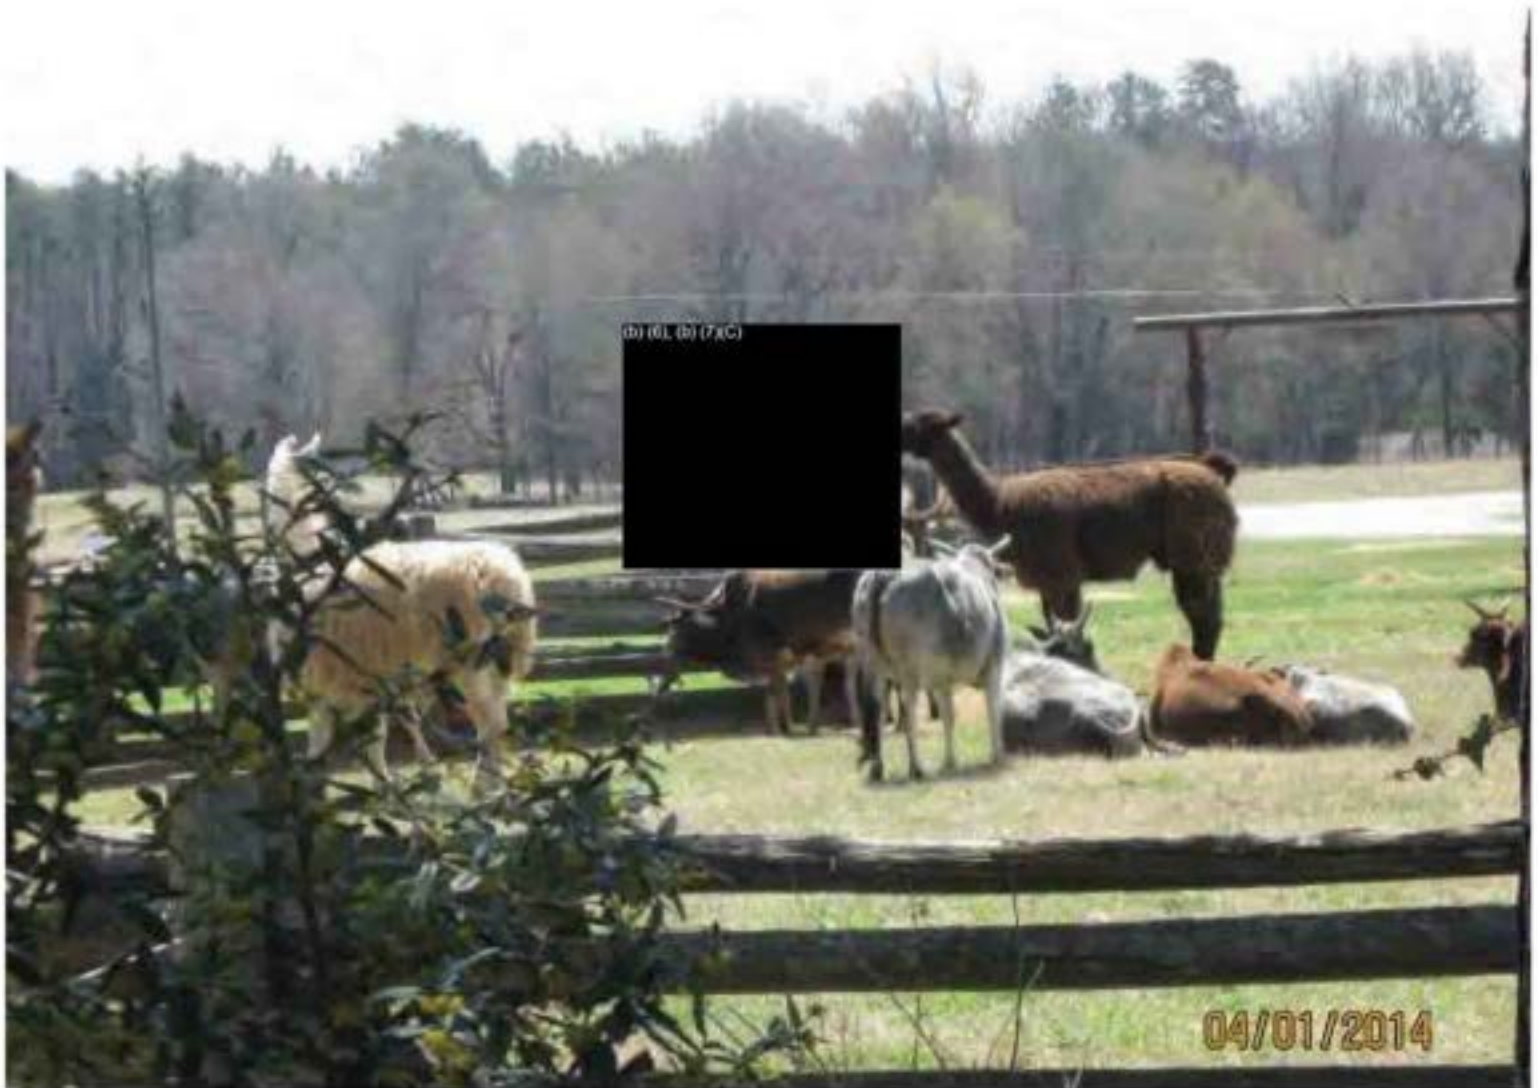
000024

CFR: 2.131 (d) (2)

Photographer:	M. Binkley, VMO	Legal Name:	55-B-0069
Photo Taken:	Tue, Apr 1, '14 1:01pm	HENRY HAMPTON	
Inspection:	91140803324573		
Description:	Public contact with animals without attendant present.

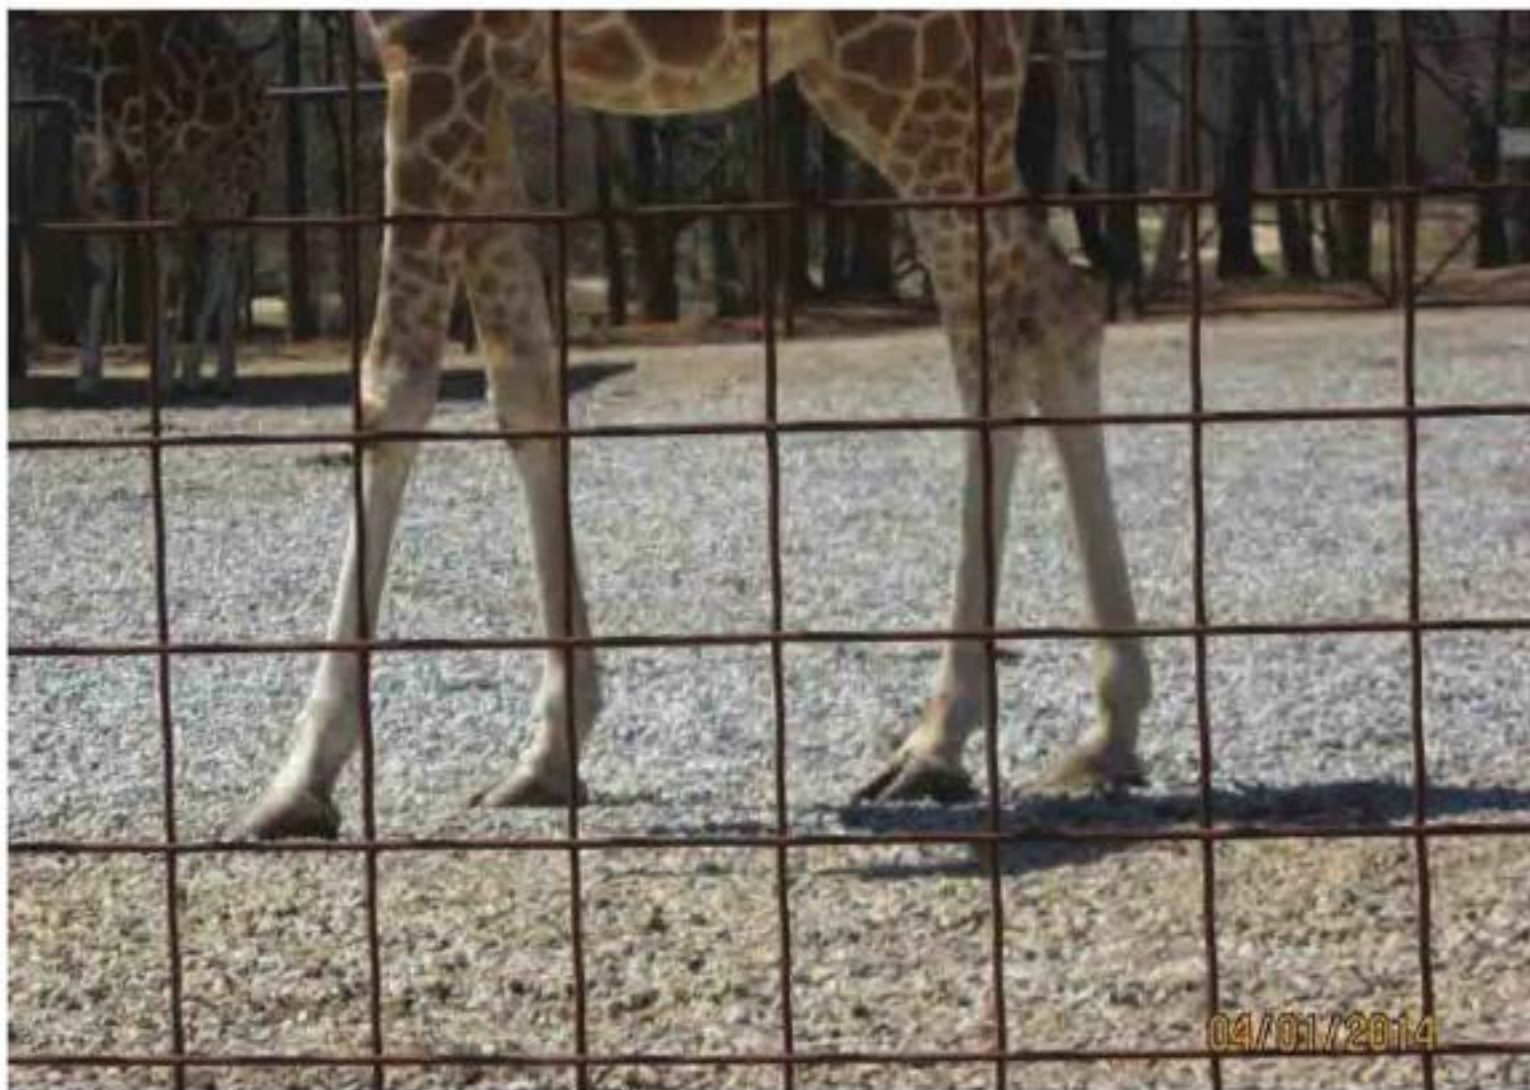
000025

CFR: 2.40 (b) (2)

Photographer:	M. Binkley, VMO	Legal Name:	55-B-0069
Photo Taken:	Tue, Apr 1, '14 1:01pm	HENRY HAMPTON	
Inspection:	91140803324573		
Description:	Overgrown giraffe feet

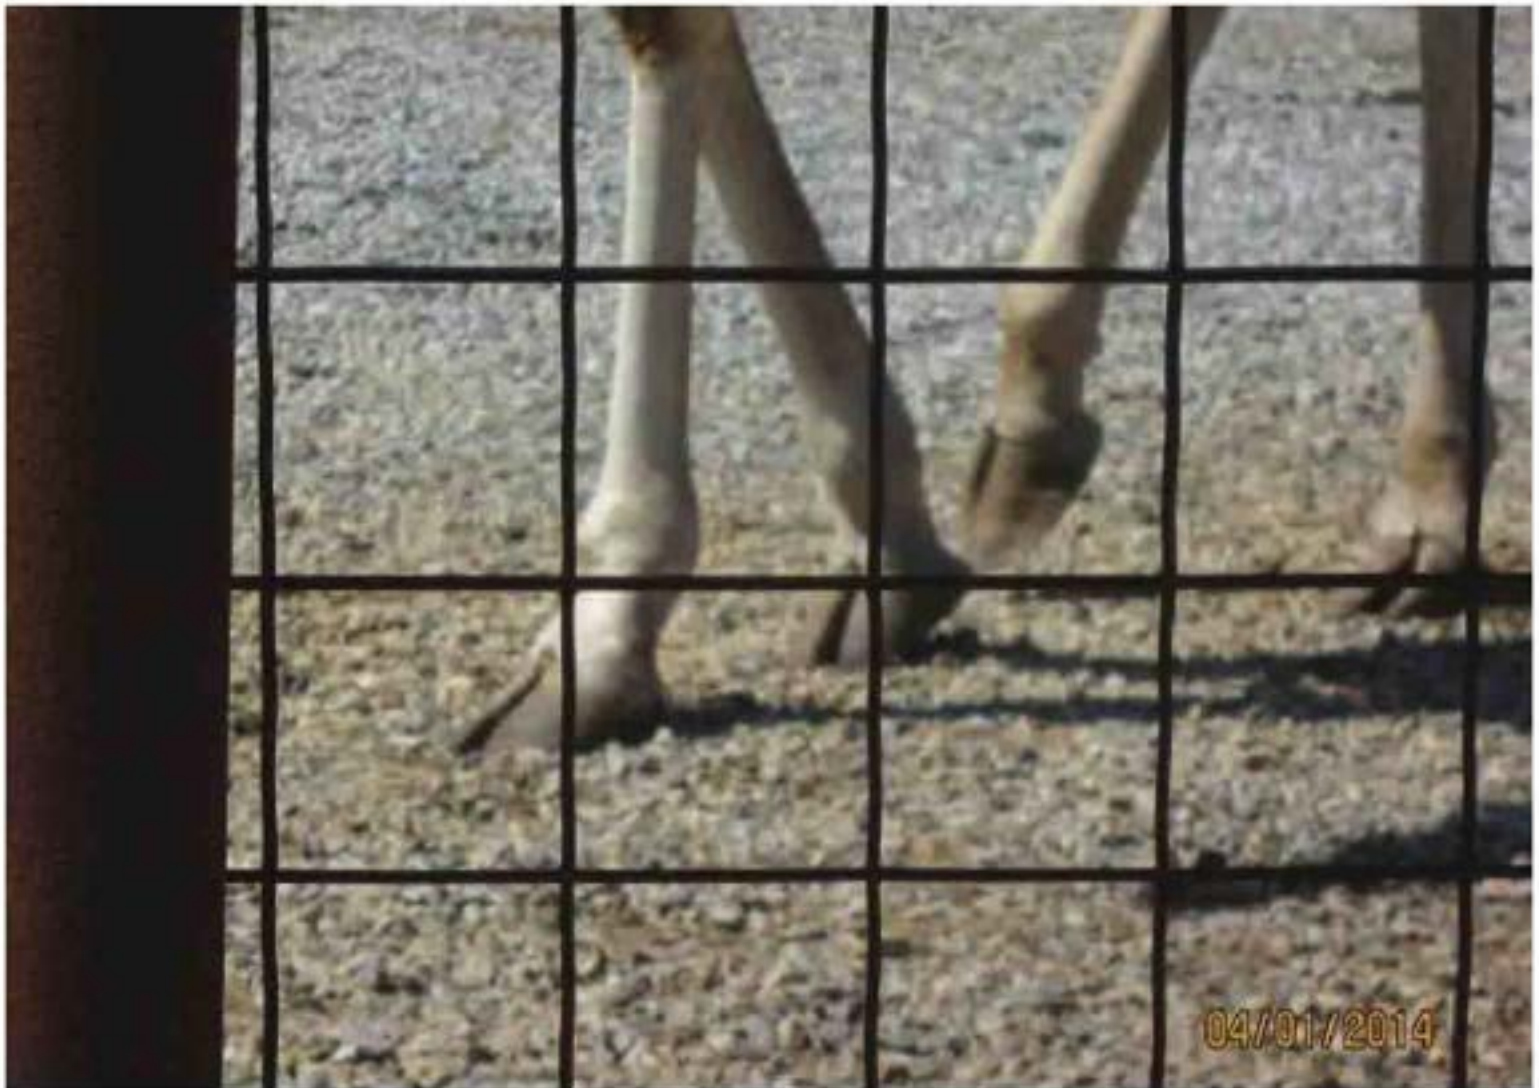
000026

CFR: 2.40 (b) (2)

Photographer:	M. Binkley, VMO	Legal Name:	55-B-0069
Photo Taken:	Tue, Apr 1, '14 2:35pm	HENRY HAMPTON	
Inspection:	91140803324573		
Description:	Overgrown giraffe feet

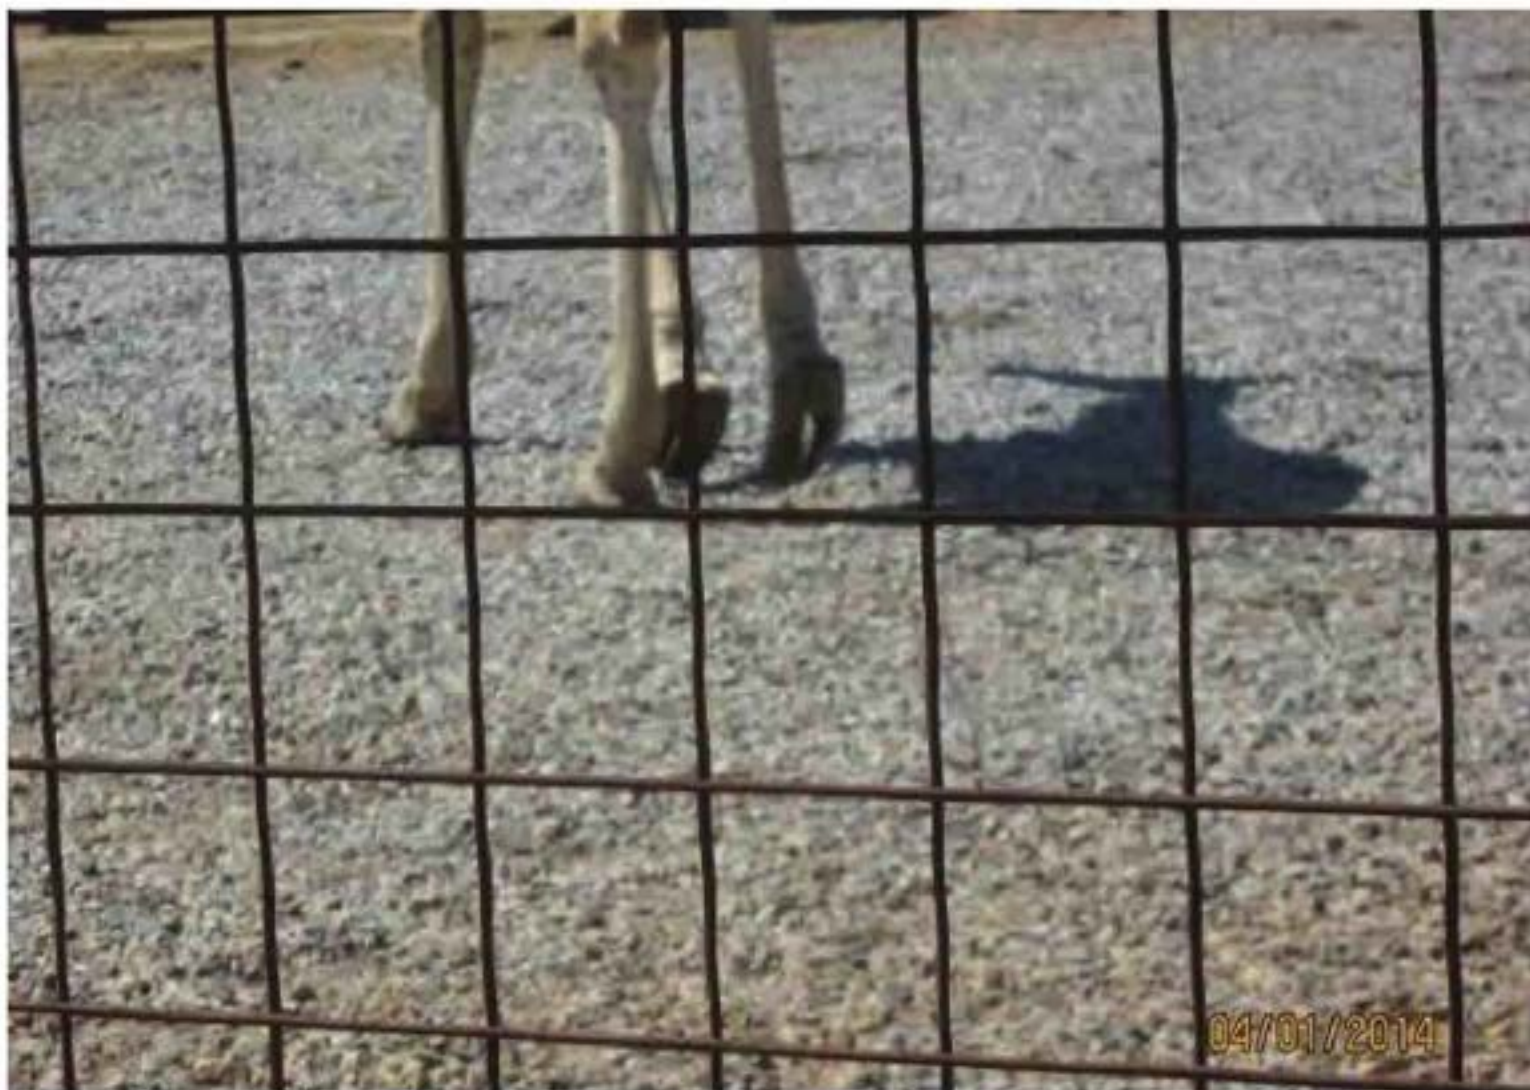
000027

CFR: 2.40 (b) (2)

Photographer:	M. Binkley, VMO	Legal Name:	55-B-0069
Photo Taken:	Tue, Apr 1, '14 2:35pm	HENRY HAMPTON	
Inspection:	91140803324573		
Description:	Overgrown giraffe feet

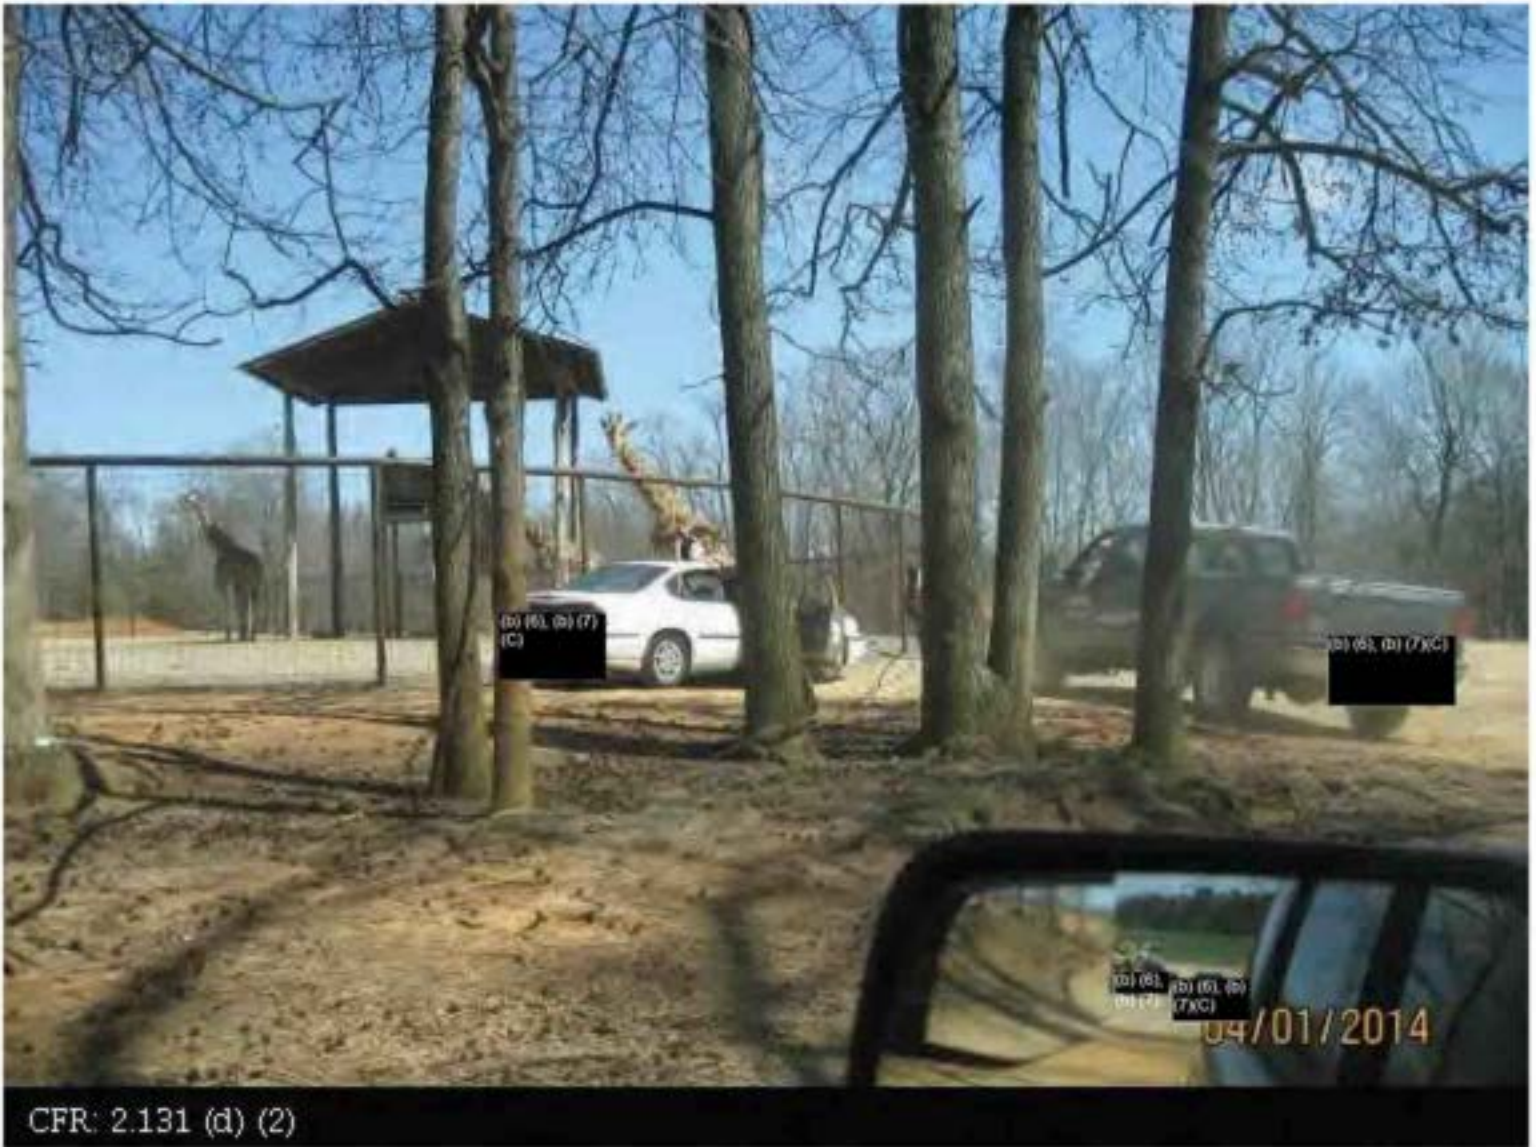
Photographer:	M. Binkley, VMO	Legal Name:	55-B-0069
Photo Taken:	Tue, Apr 1, '14 2:55pm	HENRY HAMPTON	
Inspection:	91140803324573		
Description:	Child on roof of car next to giraffe pen. Father out of car.

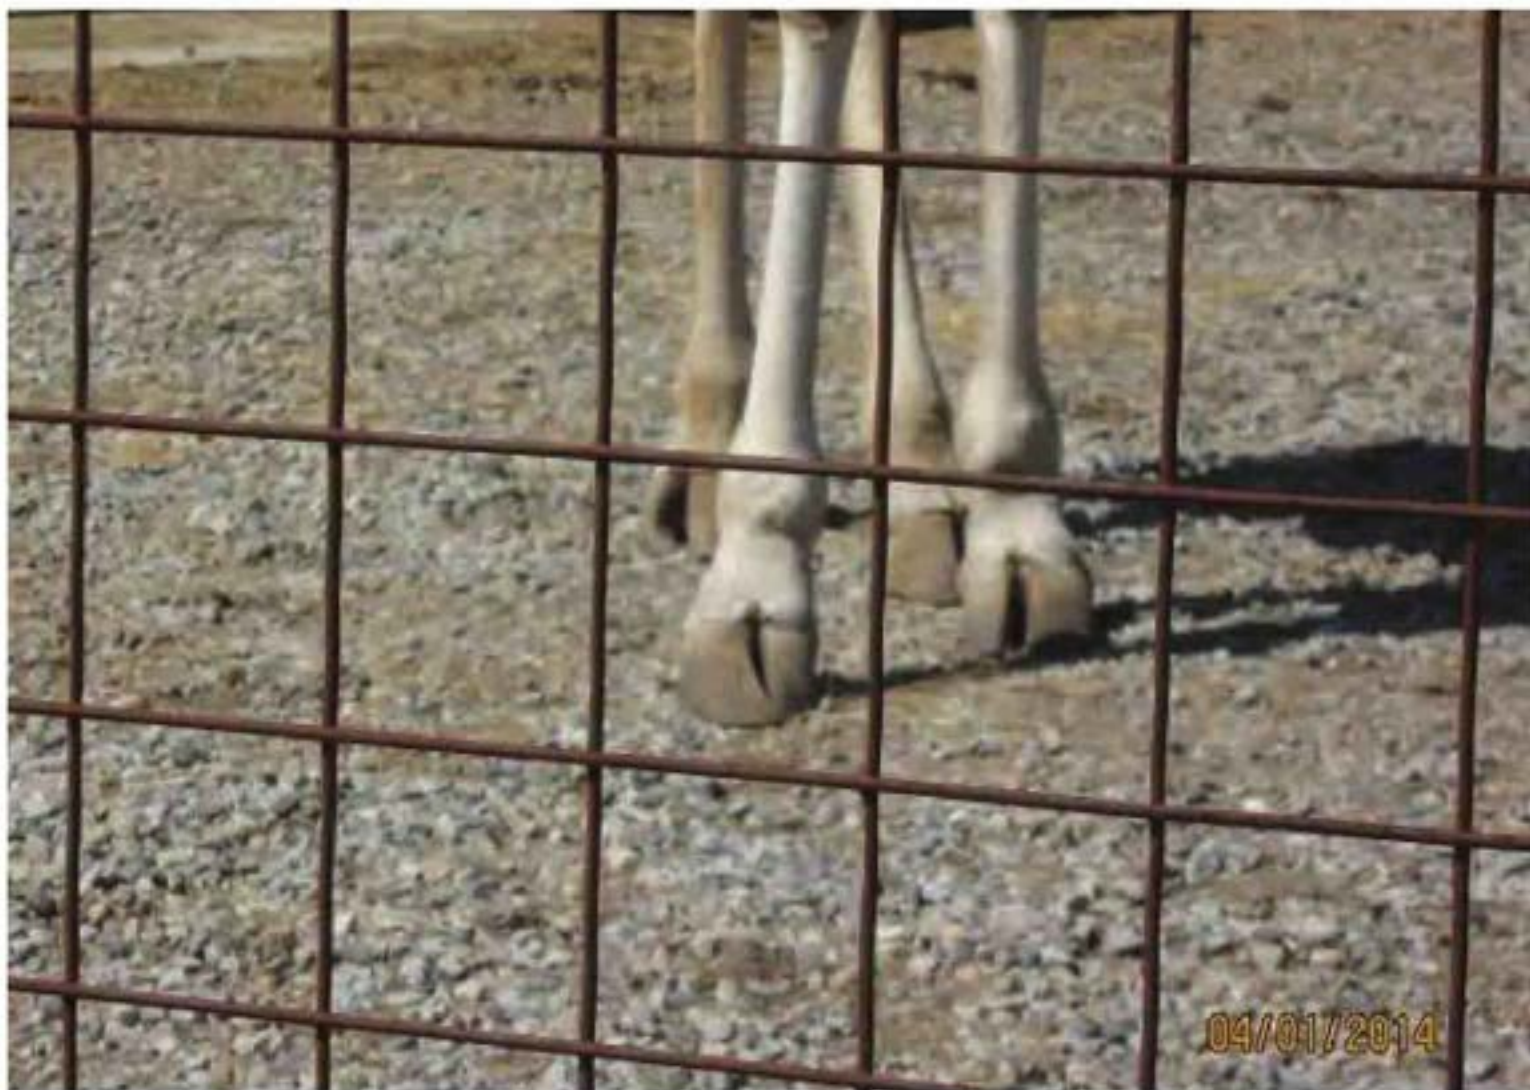
000029

CFR: 2.40 (b) (2)

Photographer:	M. Binkley, VMO	Legal Name:	55-B-0069
Photo Taken:	Tue, Apr 1, '14 2:36pm	HENRY HAMPTON	
Inspection:	91140803324573		
Description:	Overgrown giraffe feet.

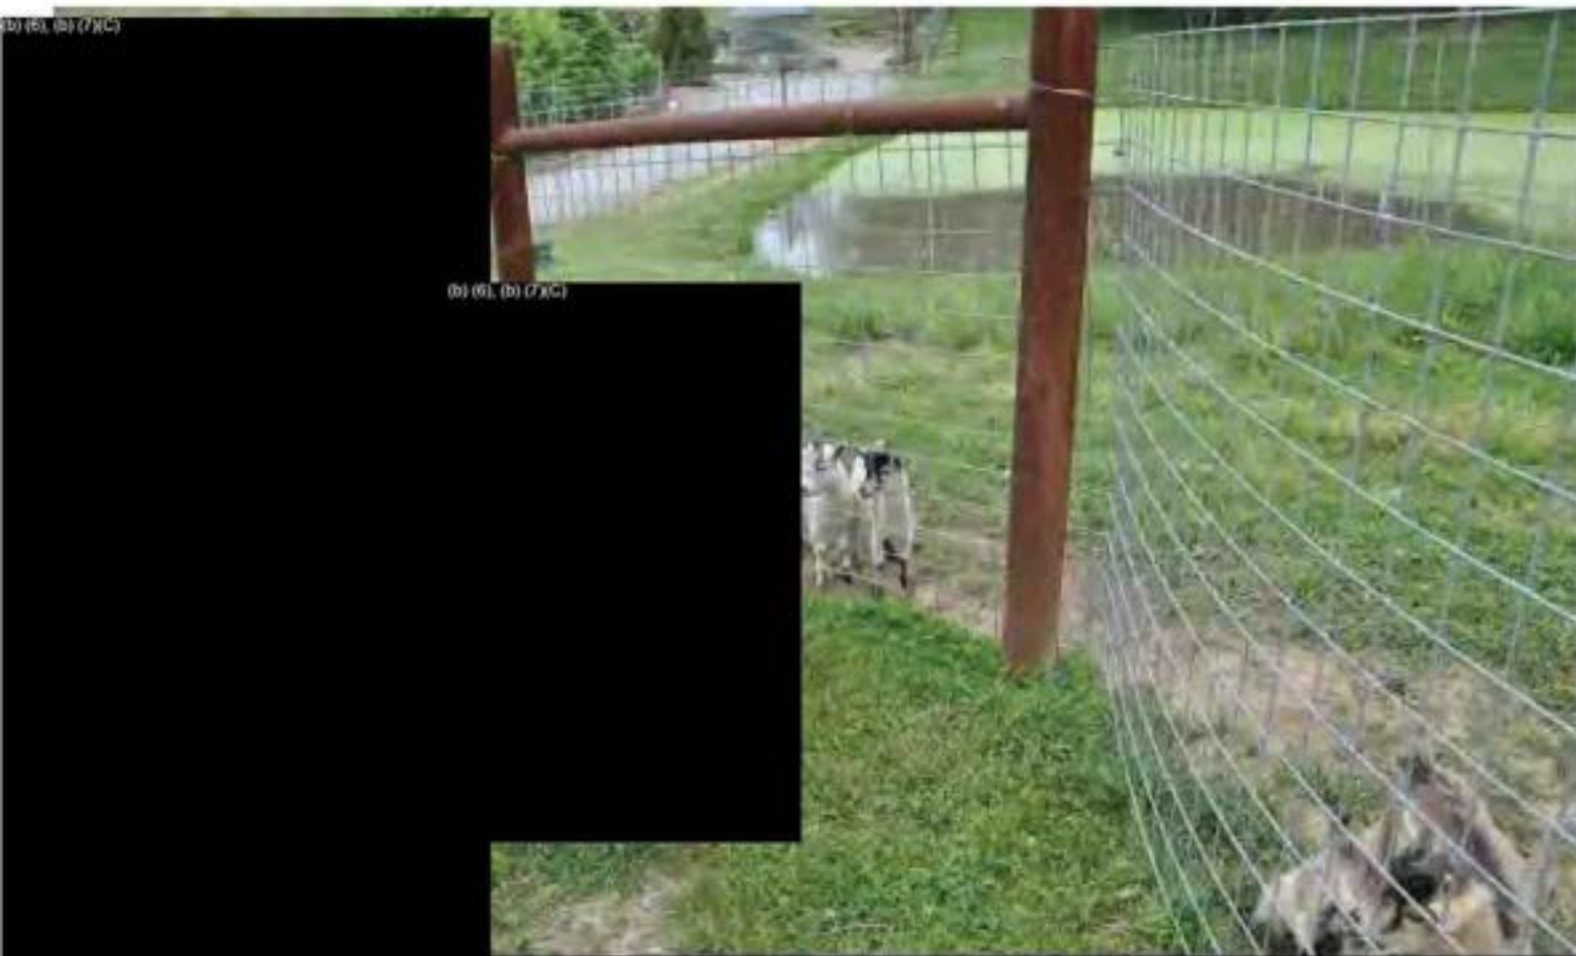
000030

CFR 2.131 (c) (1)

Photographer:	R. Coleman, ACI	Legal Name:	55-B-0069
Photo Taken:	Wed, Jun 4, '14 1030	HENRY HAMPTON	
Inspection:	224140937090445		
Description:	No barriers for goat enclosure

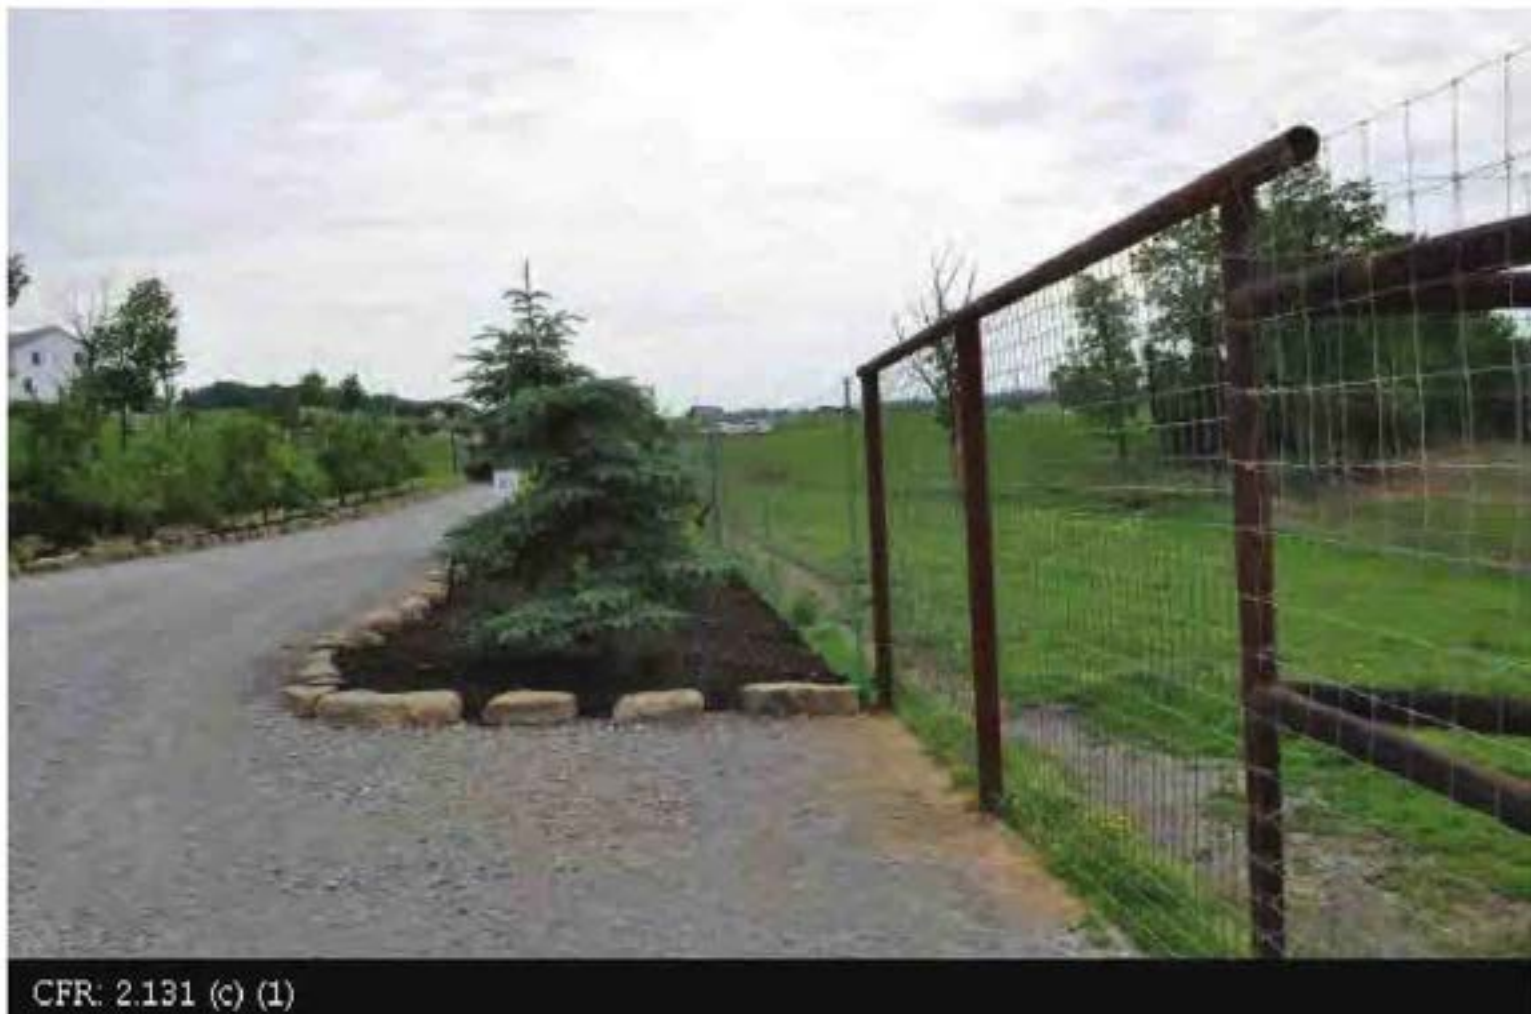
000031

CFR: 2.131 (c) (1)

Photographer:	R. Coleman, ACI	Legal Name:	55-B-0069
Photo Taken:	Wed, Jun 4, '14 1030	HENRY HAMPTON	
Inspection:	224140937090445		
Description:	No barrier for camel enclosure

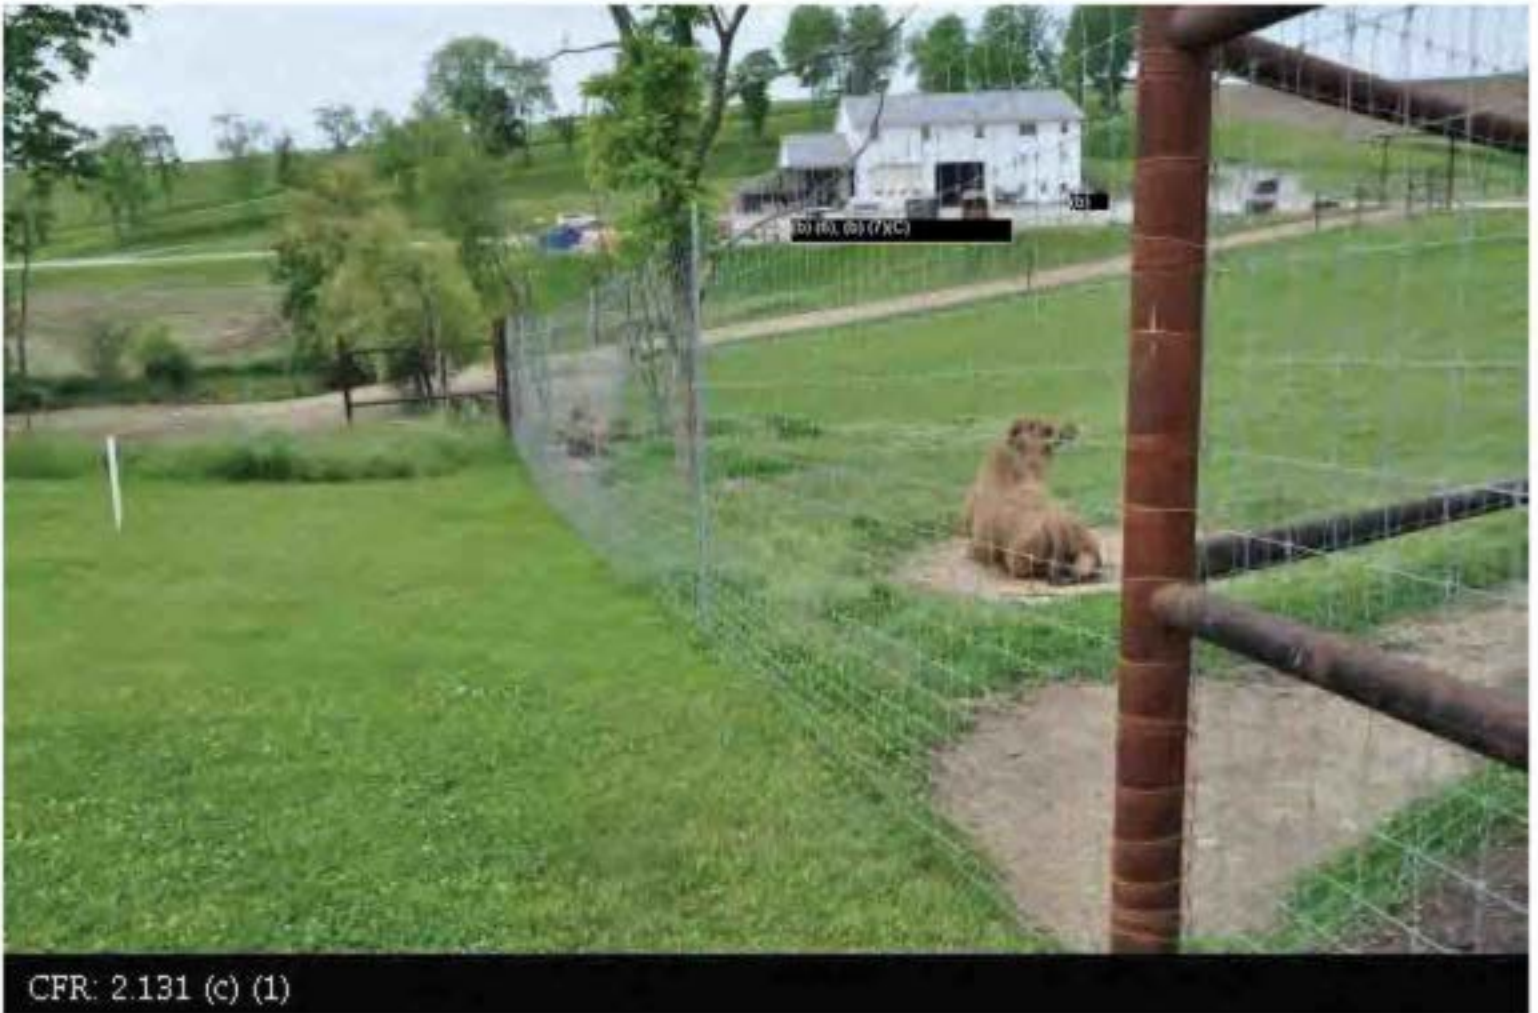
Photographer:	R. Coleman, ACI	Legal Name:	55-B-0069
Photo Taken:	Wed, Jun 4, '14 1030	HENRY HAMPTON	
Inspection:	224140937090445		
Description:	No barrier for camel enclosure

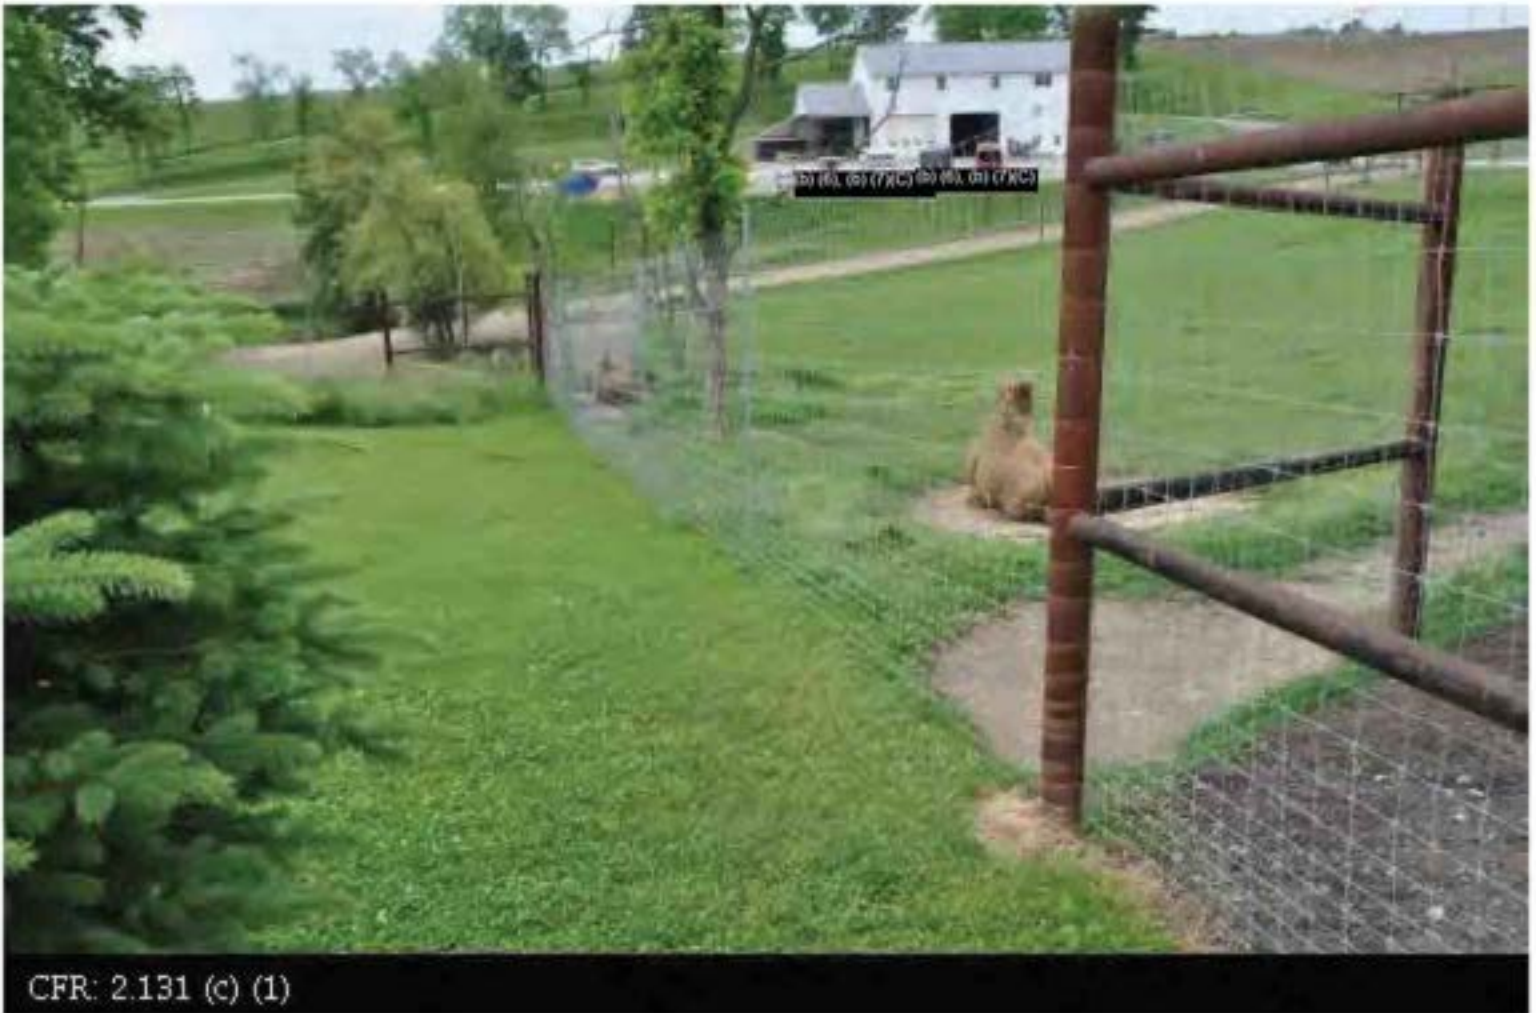
Photographer:	R. Coleman, ACI	Legal Name:	55-B-0069
Photo Taken:	Wed, Jun 4, '14 1030	HENRY HAMPTON	
Inspection:	224140937090445		
Description:	No barrier for camel enclosure
