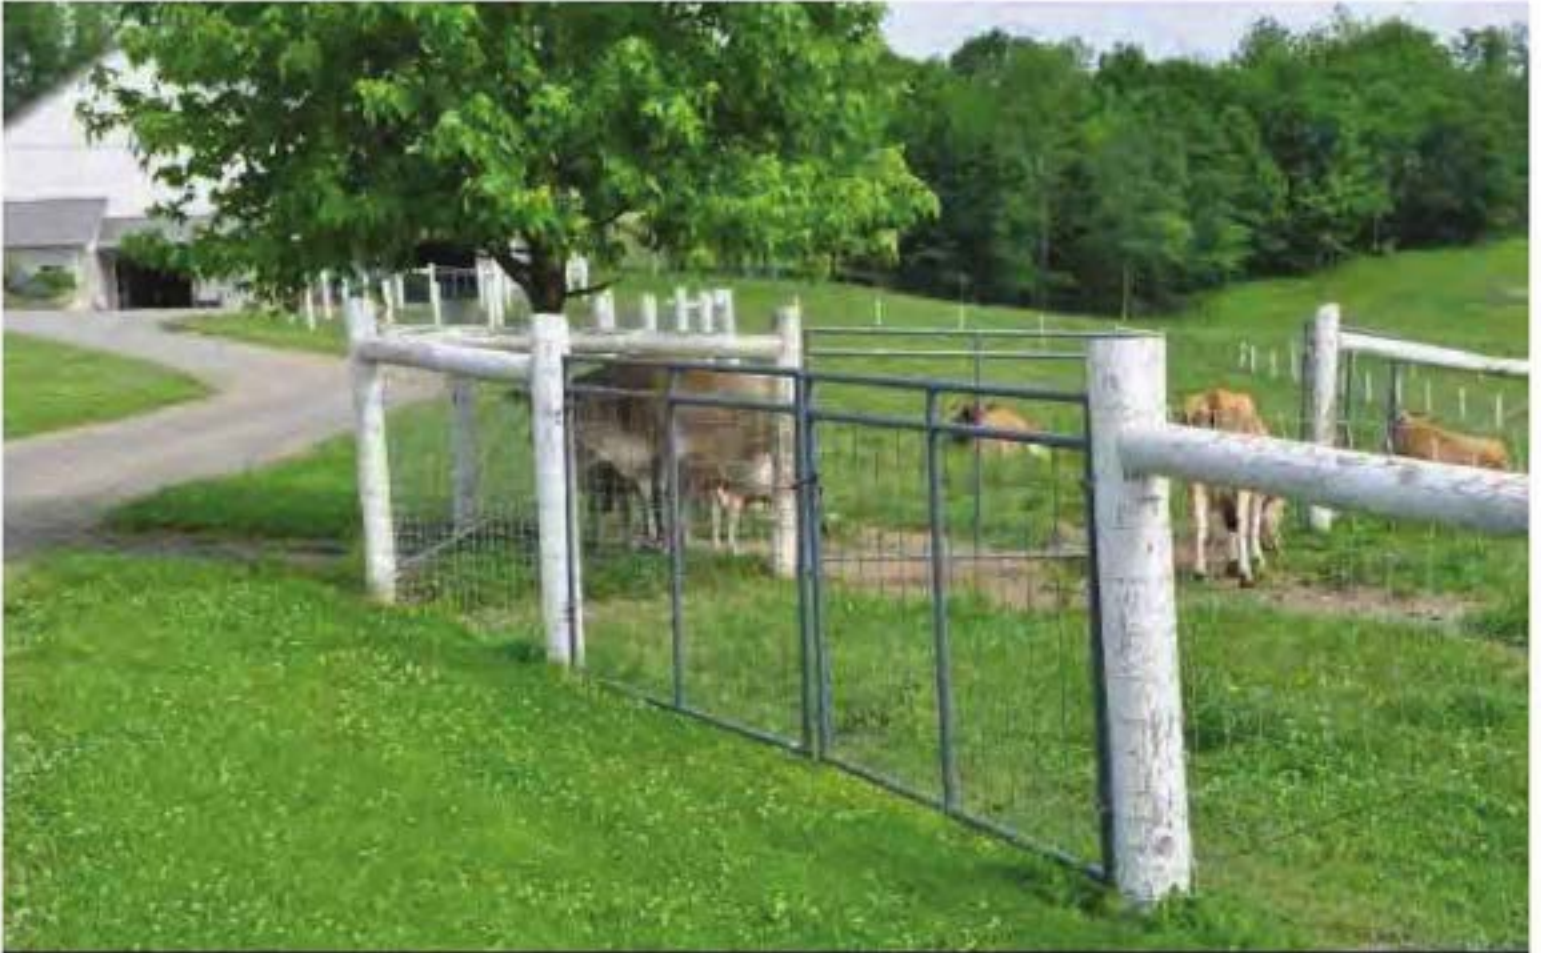
000034

CFR: 2.131 (c) (1)

Photographer:	R. Coleman, ACI	Legal Name:	55-B-0069
Photo Taken:	Wed, Jun 4, '14 1030	HENRY HAMPTON	
Inspection:	224140937090445		
Description:	No barrier for cow enclosure.

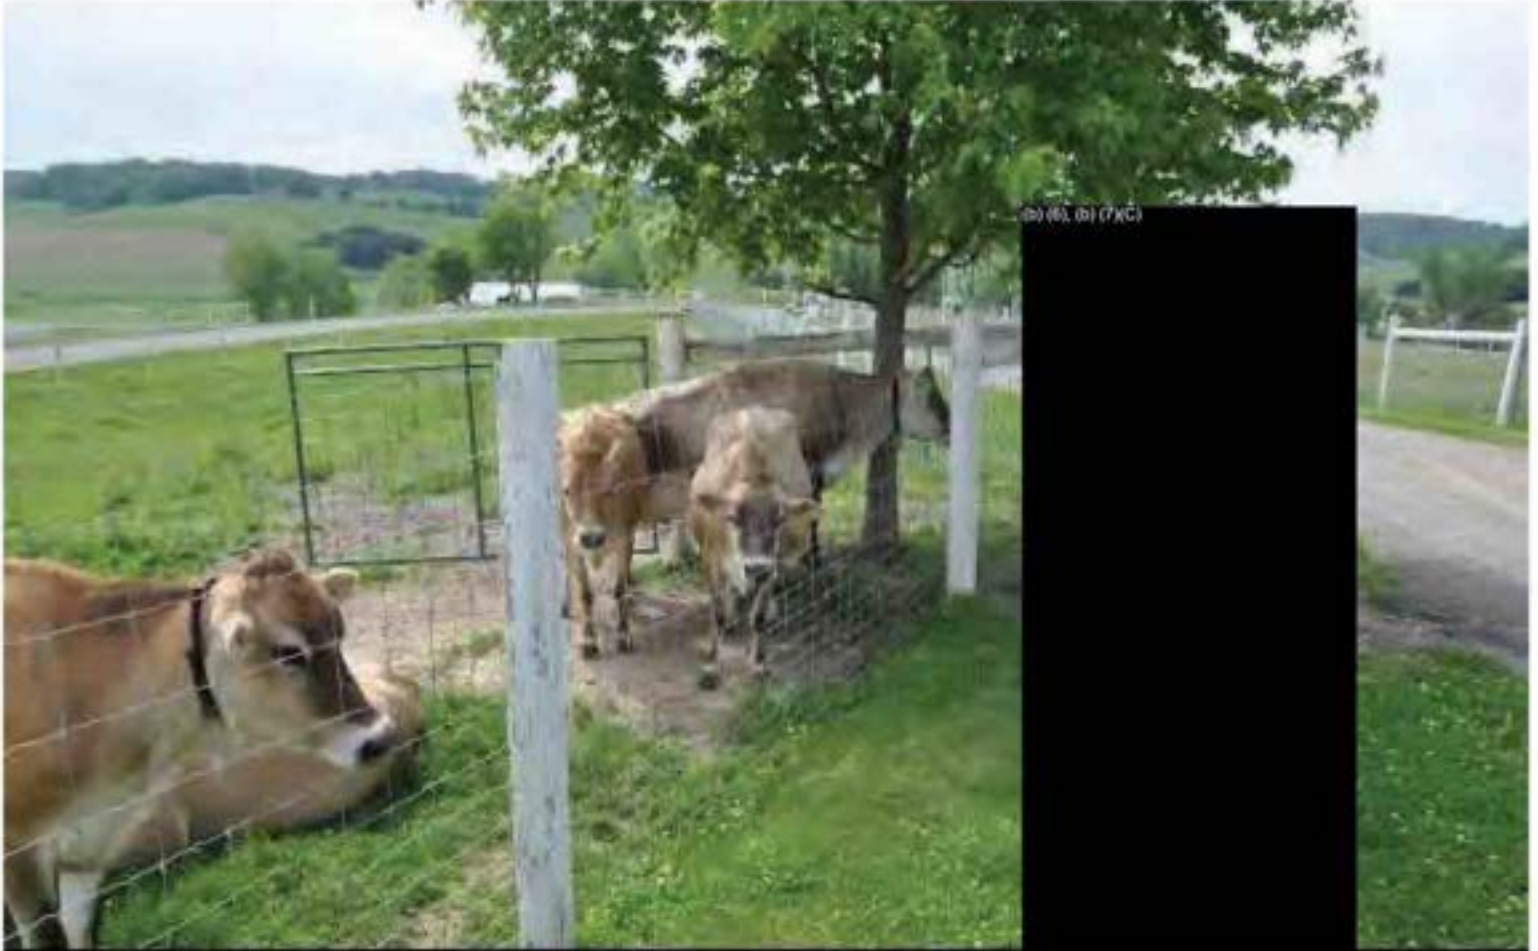
000035

CFR: 2.131 (c) (1)

Photographer:	R. Coleman, ACI	Legal Name:	55-B-0069
Photo Taken:	Wed, Jun 4, '14 1030	HENRY HAMPTON	
Inspection:	224140937090445		
Description:	No barrier for cow enclosure

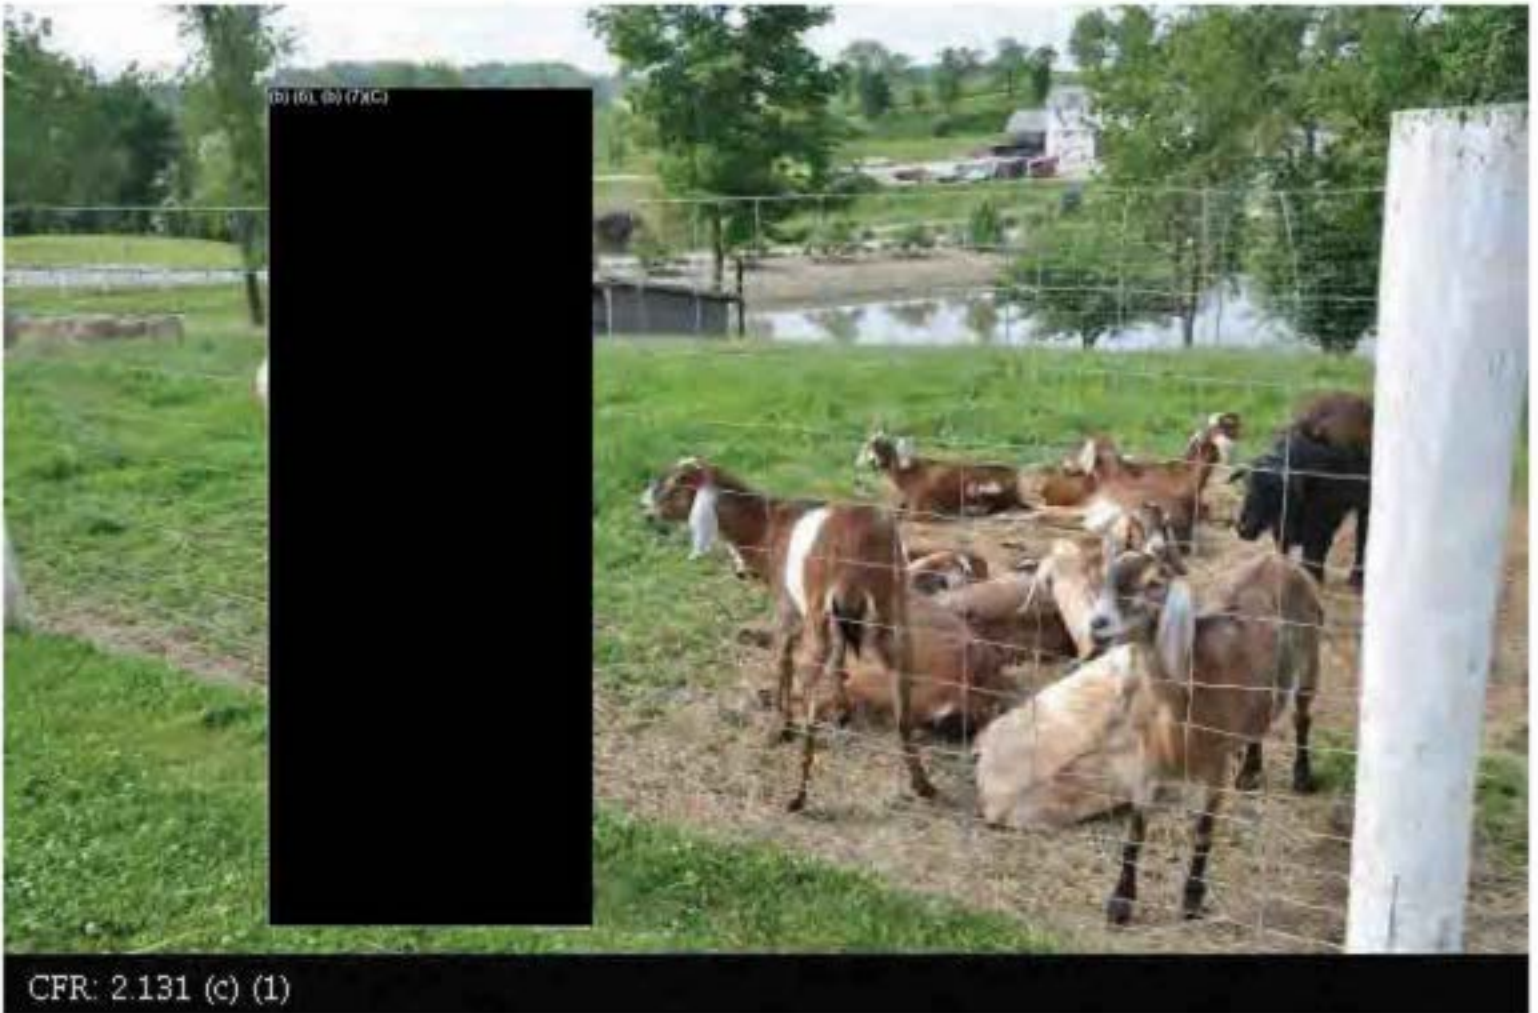
000036

CFR: 2.131 (c) (1)

Photographer:	R. Coleman, ACI	Legal Name:	55-B-0069
Photo Taken:	Wed, Jun 4, '14 1030	HENRY HAMPTON	
Inspection:	224140937090445		
Description:	No barreir for goat enclosure.

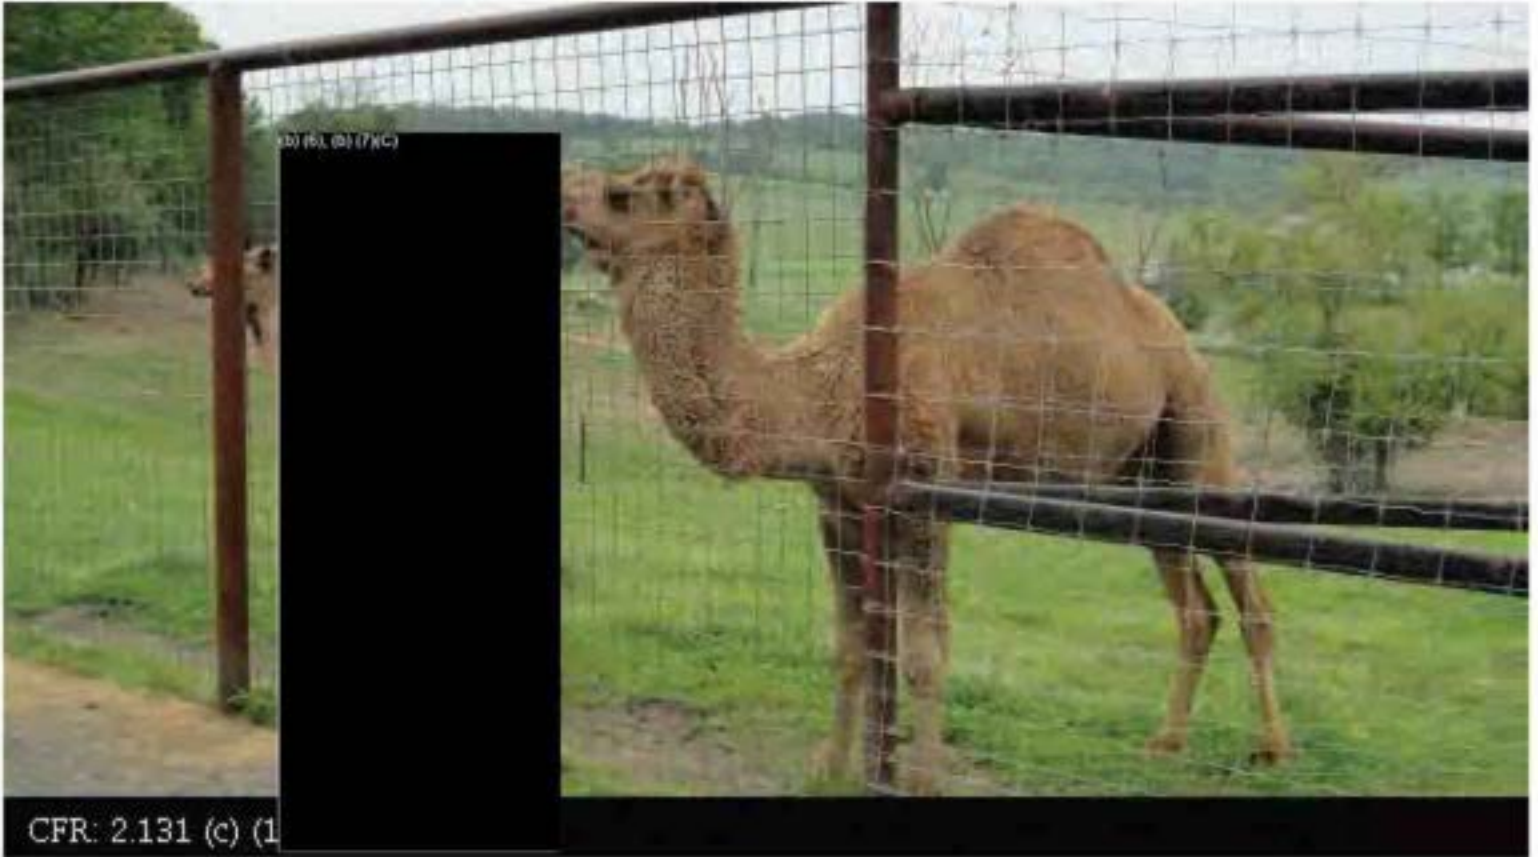
Photographer:	D. Miller, SACS	Legal Name:	55-B-0069
Photo Taken:	Wed, Jun 4, '14 1030	HENRY HAMPTON	
Inspection:	224140937090445		
Description:	No barrier for camel enclosure

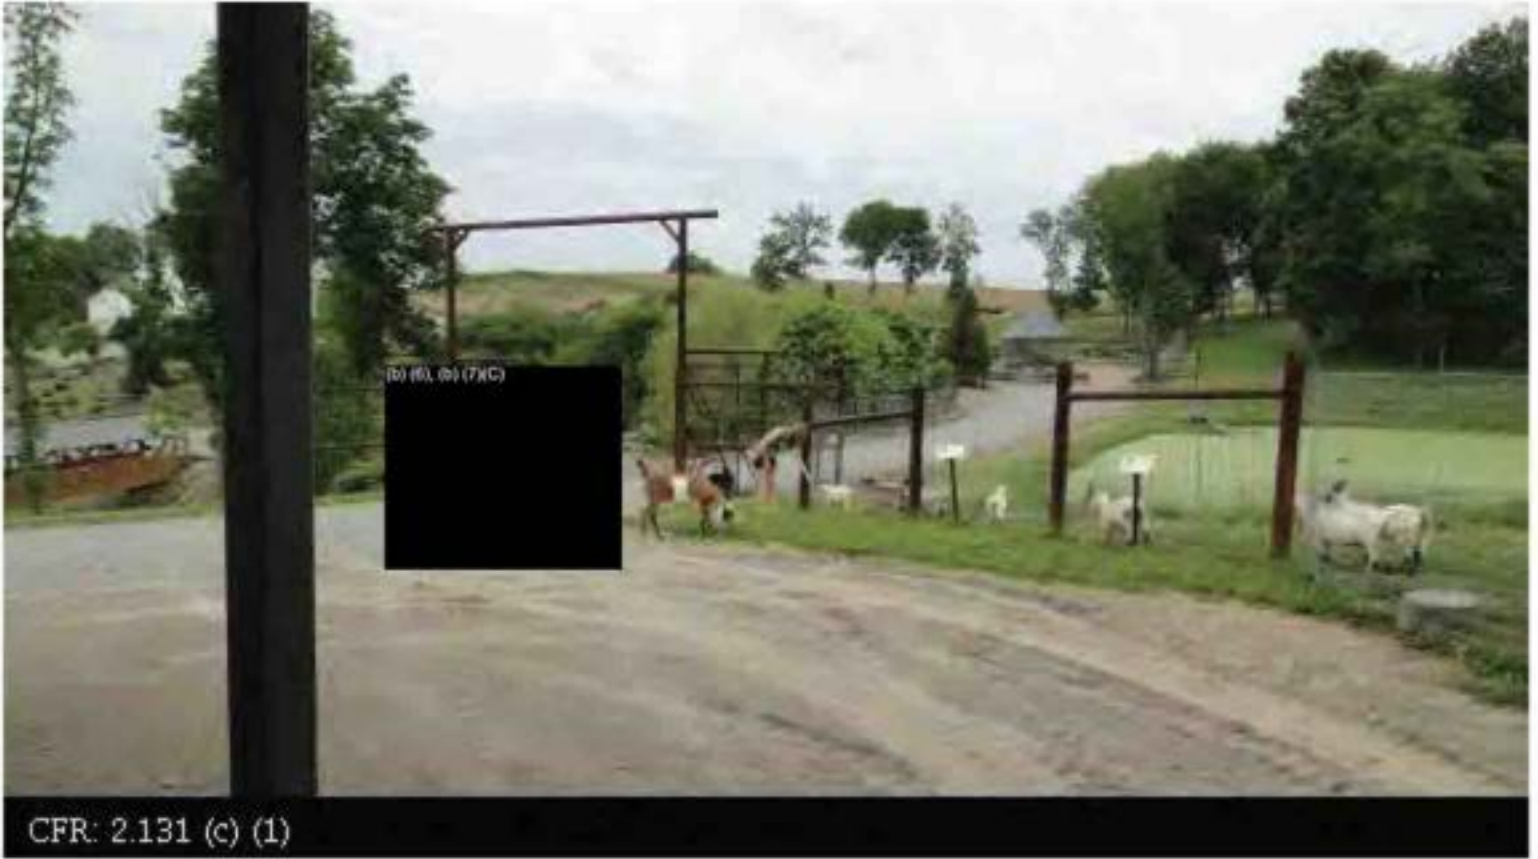
Photographer:	D. Miller, SACS	Legal Name:	55-B-0069
Photo Taken:	Wed, Jun 4, '14 1030	HENRY HAMPTON	
Inspection:	224140937090445		
Description:	No public barrier for goat enclosure

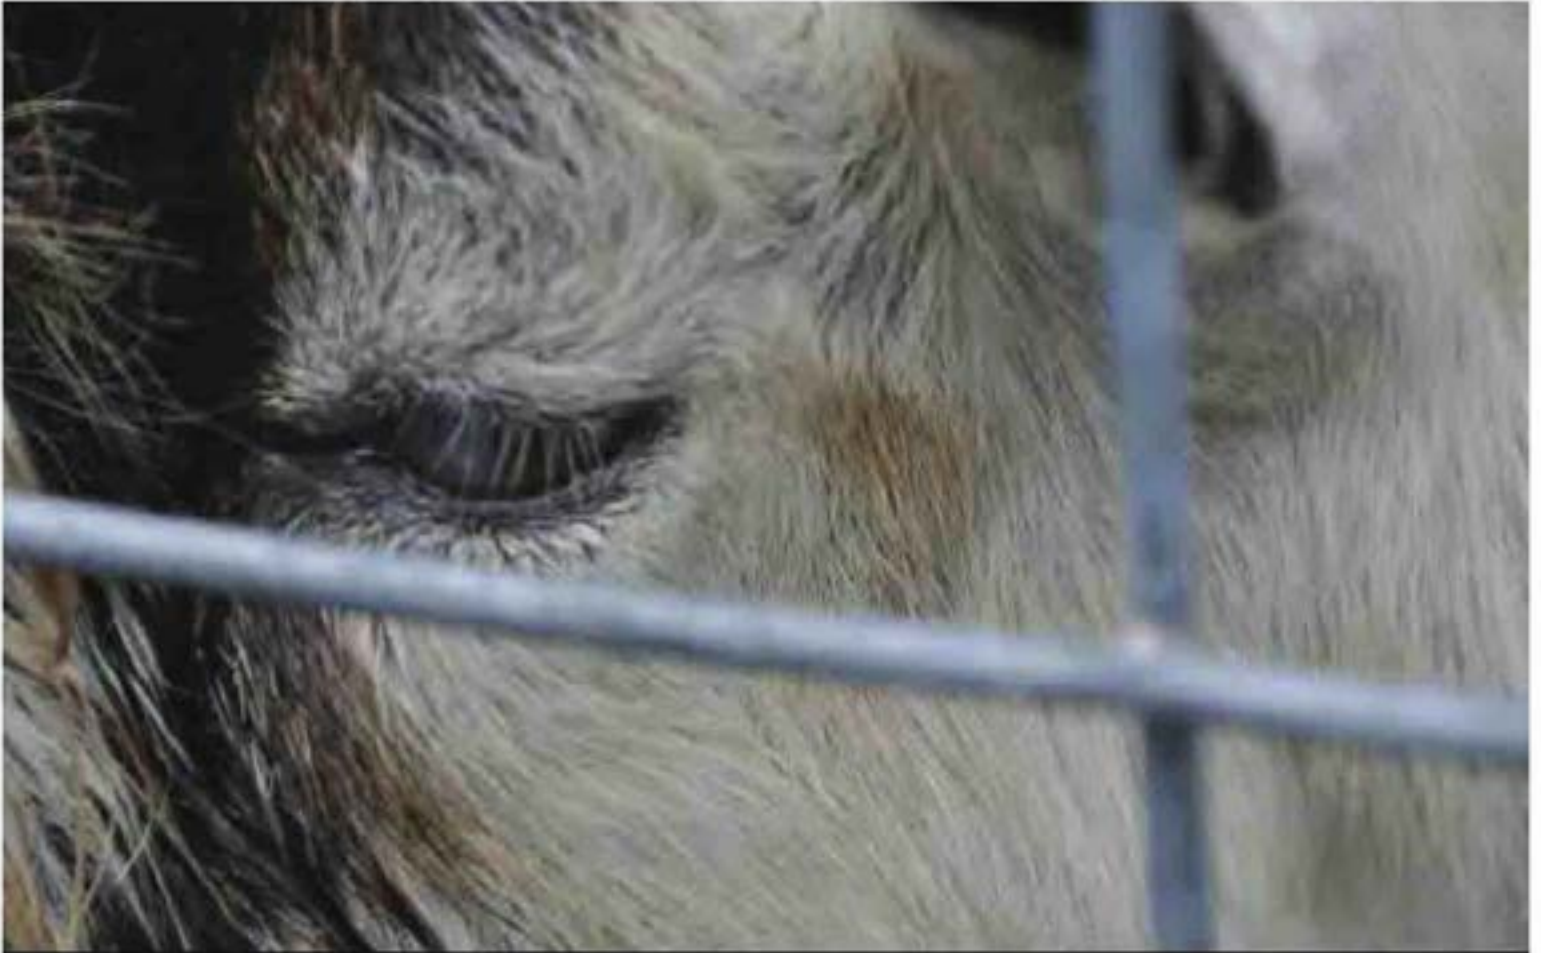
000039

CFR: 2.40 (b) (2)

Photographer:	R. Coleman, ACI	Legal Name:	55-B-0069
Photo Taken:	Wed, Jun 4, '14 1030	HENRY HAMPTON	
Inspection:	224140937090445		
Description:	Left eye of younger pygmy goat with opacity.

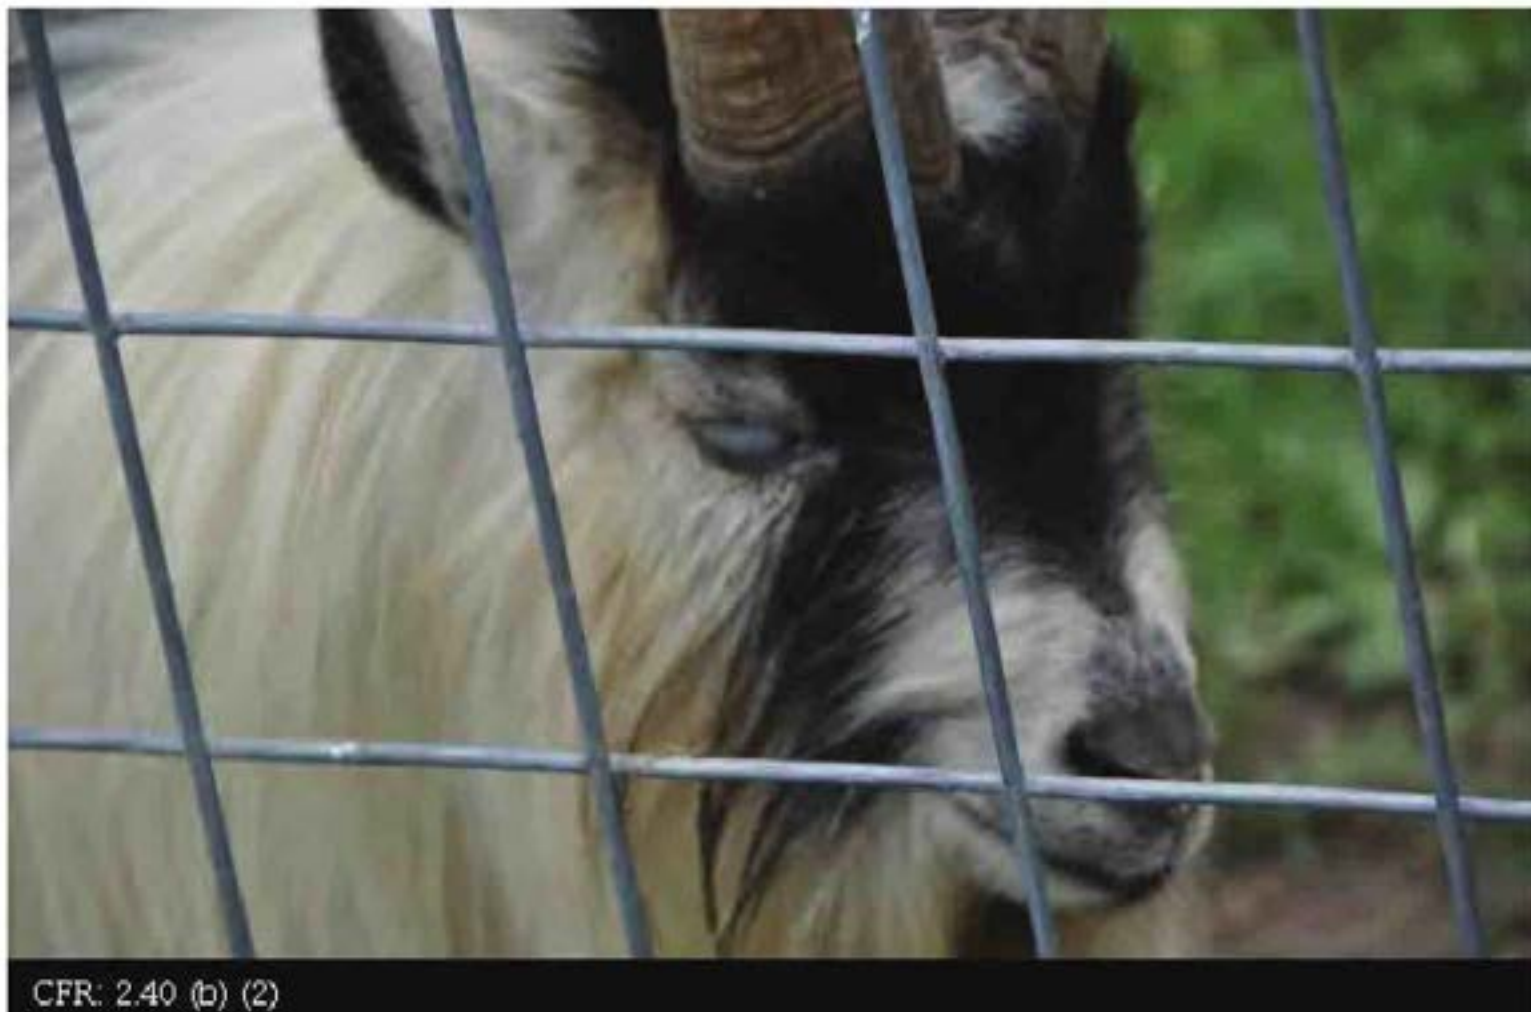
CFR: 2.40 (b) (2)

Photographer:	R. Coleman, ACI	Legal Name:	55-B-0069
Photo Taken:	Wed, Jun 4, '14 1030	HENRY HAMPTON	
Inspection:	224140937090445		
Description:	Older pygmy goat with right eye opacity.

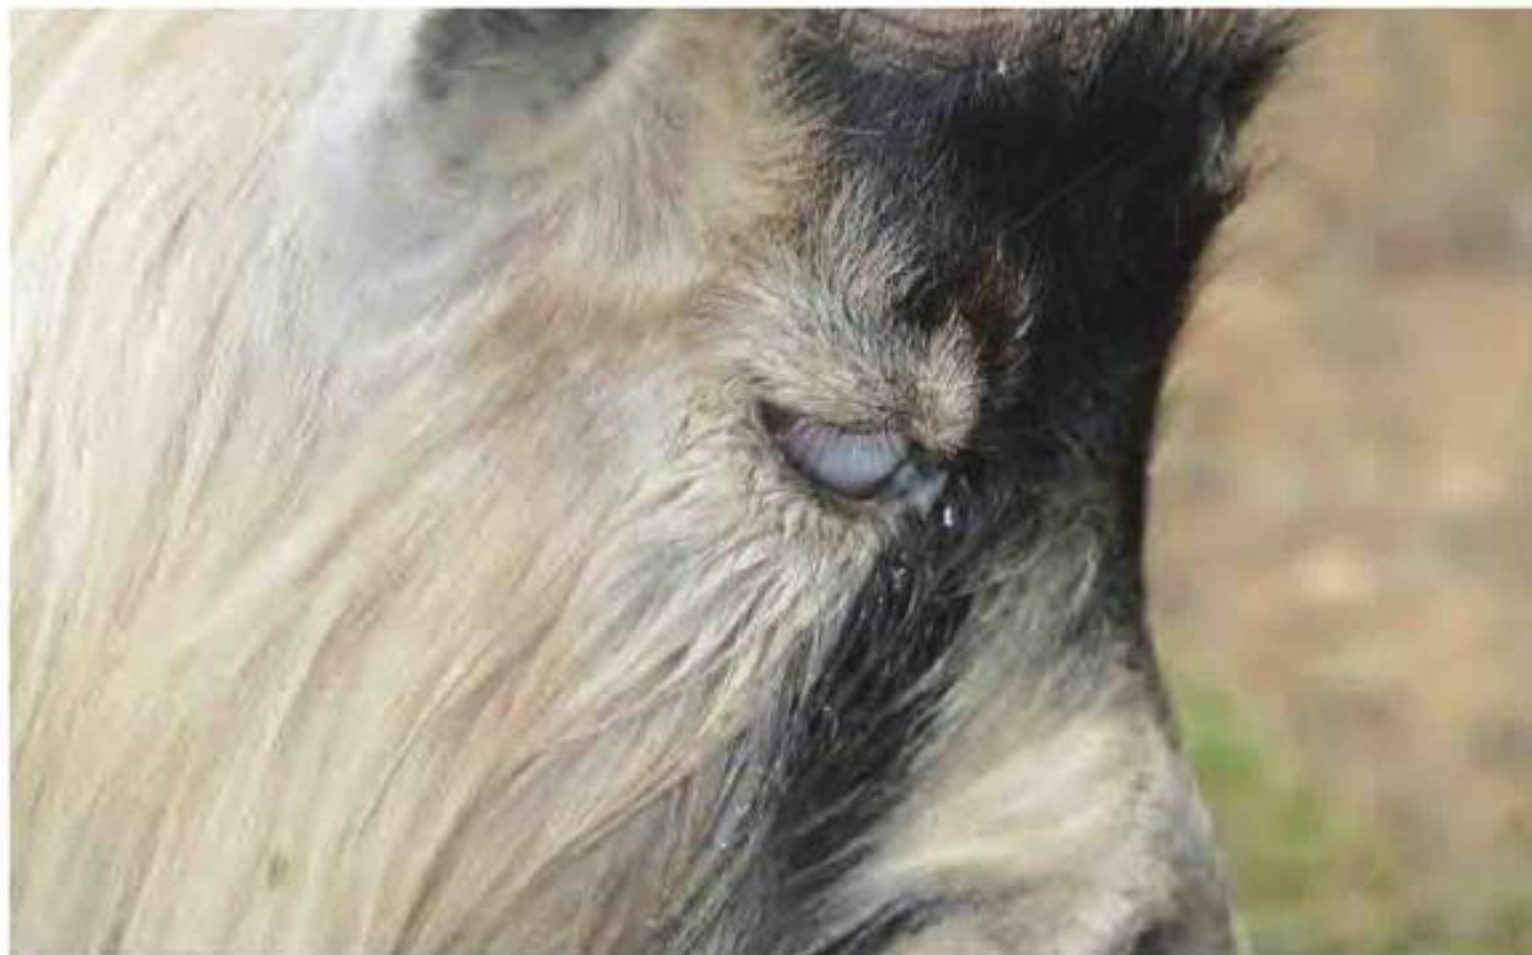
000041

CFR: 2.40 (b) (2)

Photographer:	R. Coleman, ACI	Legal Name:	55-B-0069
Photo Taken:	Wed, Jun 4, '14 1030	HENRY HAMPTON	
Inspection:	224140937090445		
Description:	Older pygmy goat with right eye opacity.

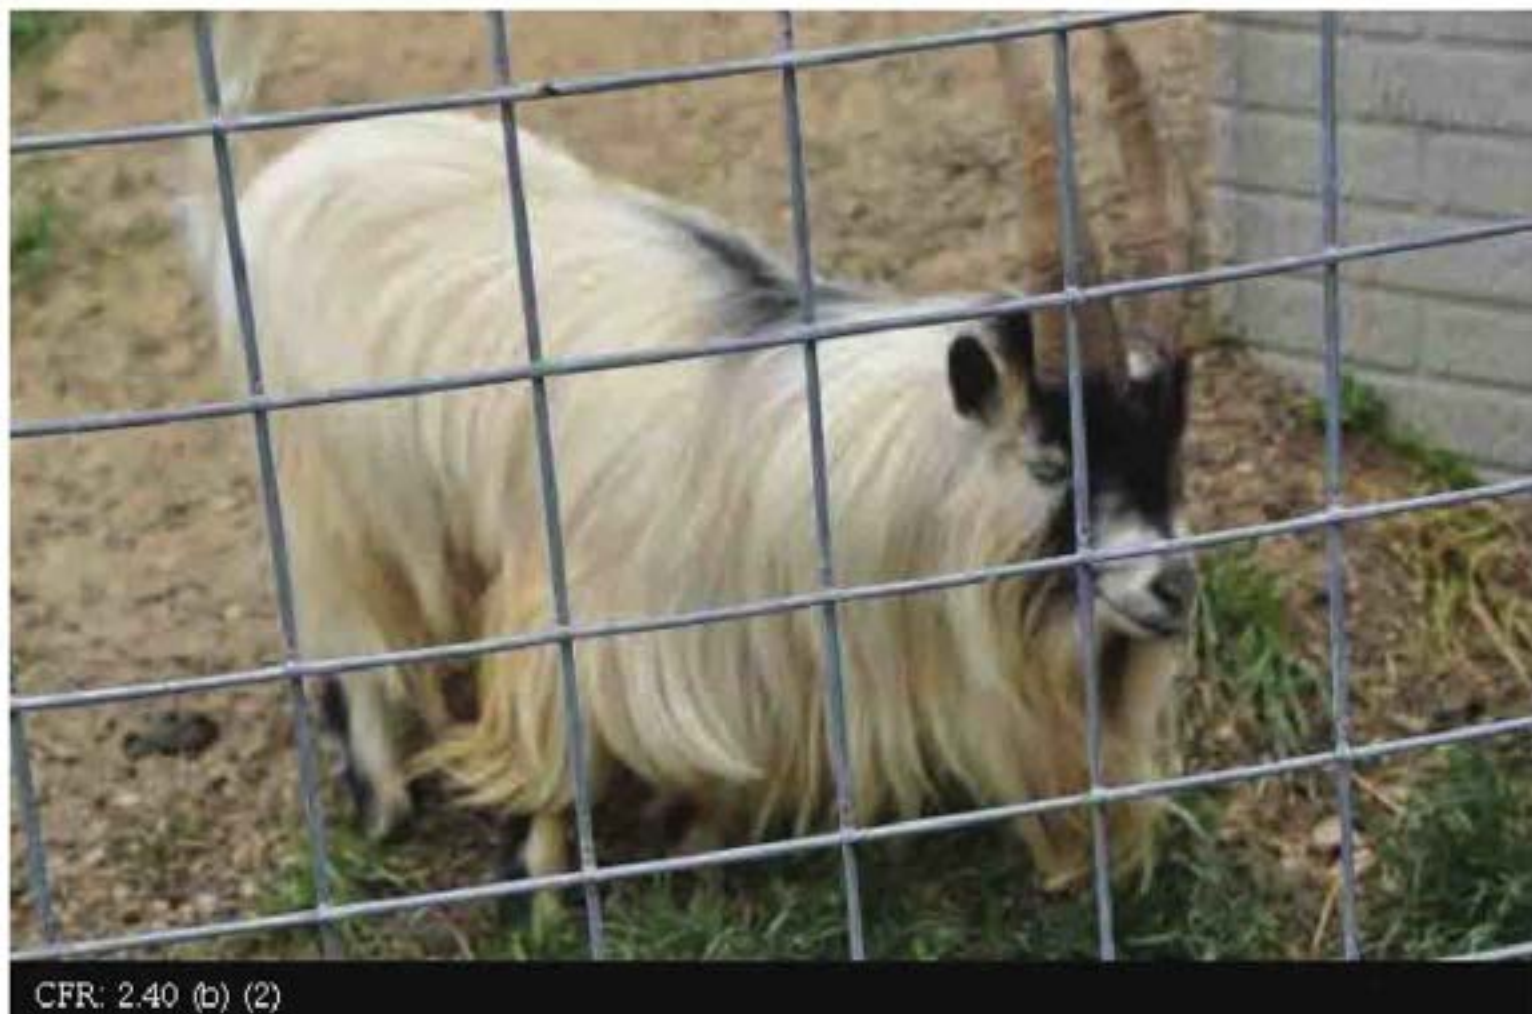
000042

Photographer:	R. Coleman, ACI	Legal Name:	55-B-0069
Photo Taken:	Wed, Jun 4, '14 1030	HENRY HAMPTON	
Inspection:	224140937090445		
Description:	Older pygmy goat with right eye opacity.

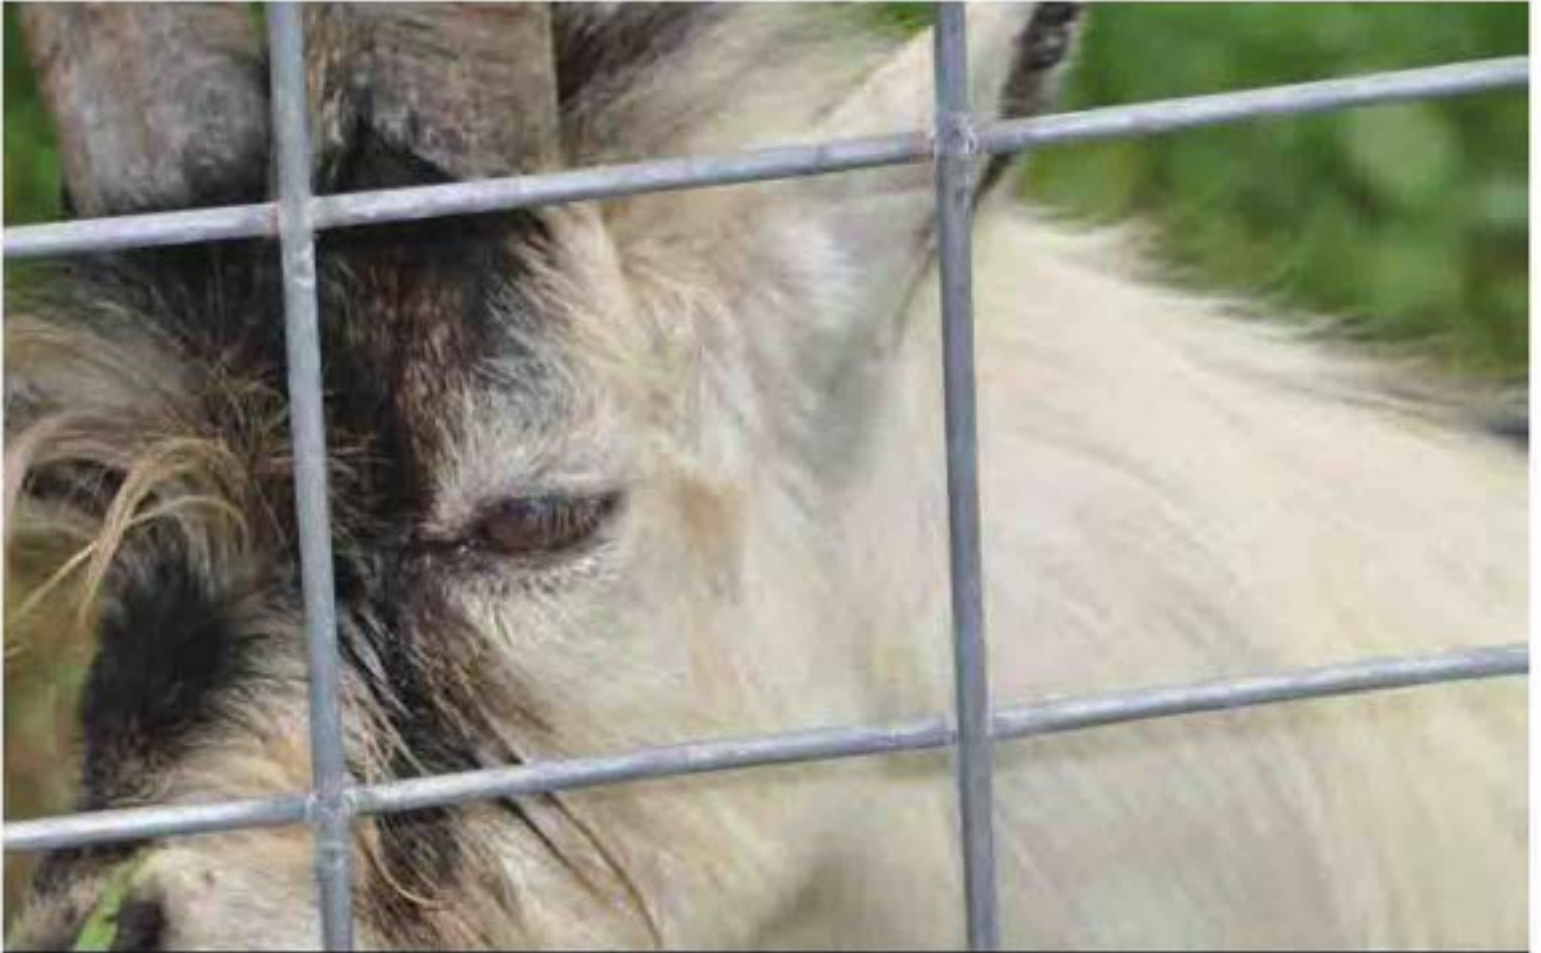
000043

CFR: 2.40 (b) (2)

Photographer:	D. Theodorson, VMO	Legal Name:	55-B-0069
Photo Taken:	Wed, Jun 4, '14 1030	HENRY HAMPTON	
Inspection:	224140937090445		
Description:	Left eye of younger pygmy goat.

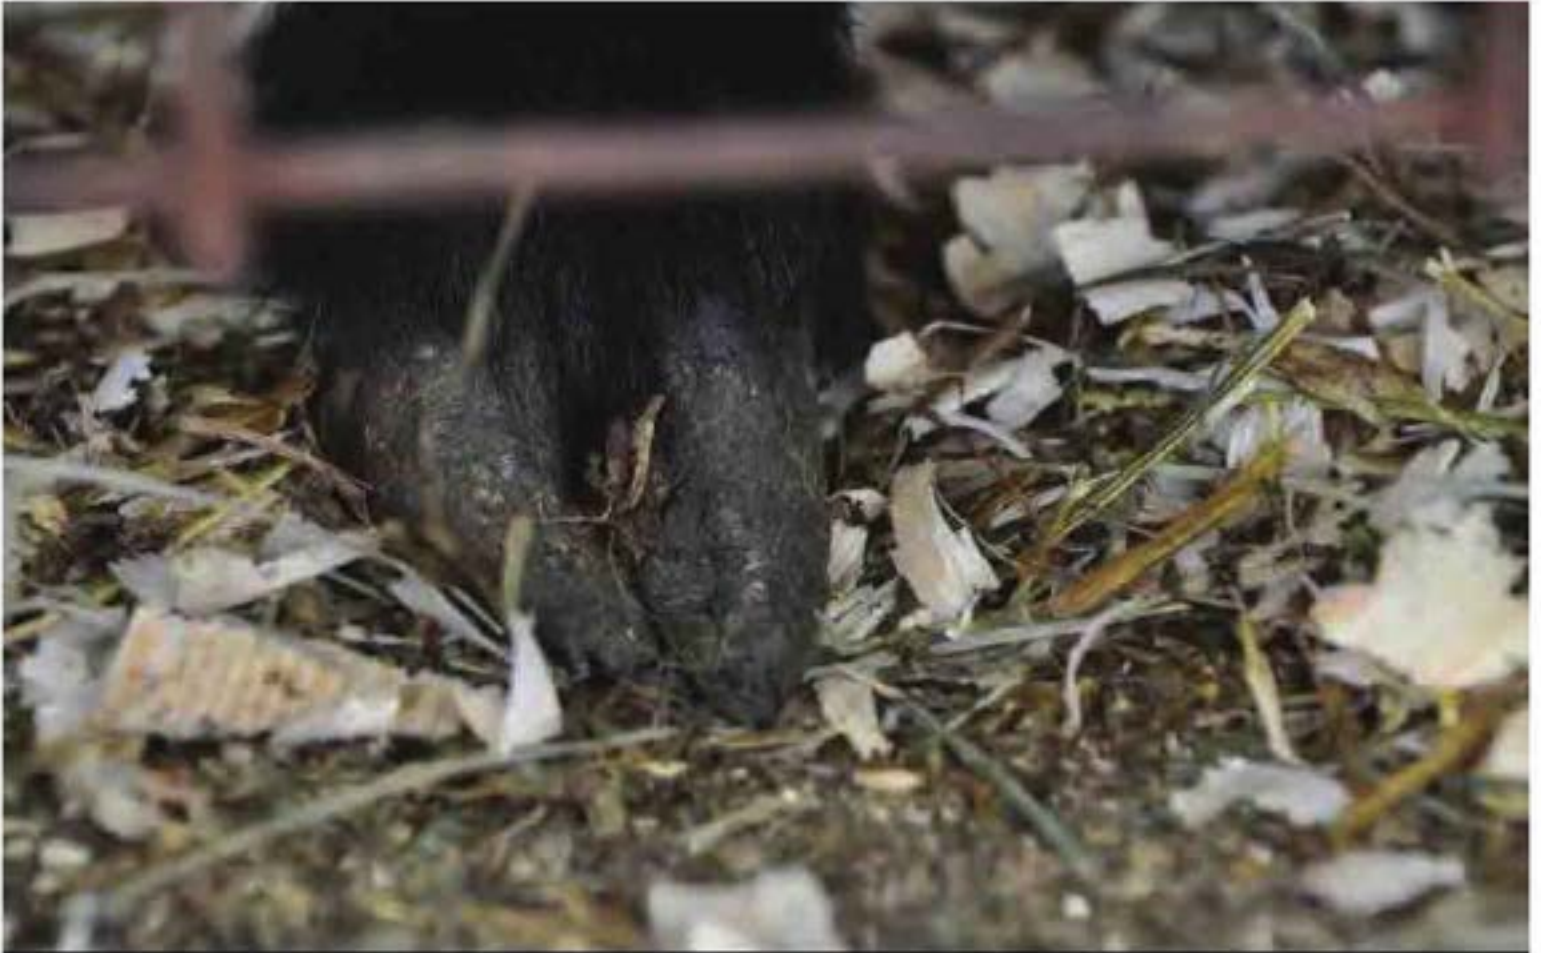
000044

CFR: 2.40 (b) (2)

Photographer:	R. Coleman, ACI	Legal Name:	55-B-0069
Photo Taken:	Wed, Jun 4, '14 1030	HENRY HAMPTON	
Inspection:	224140937090445		
Description:	Foot of sheep #310

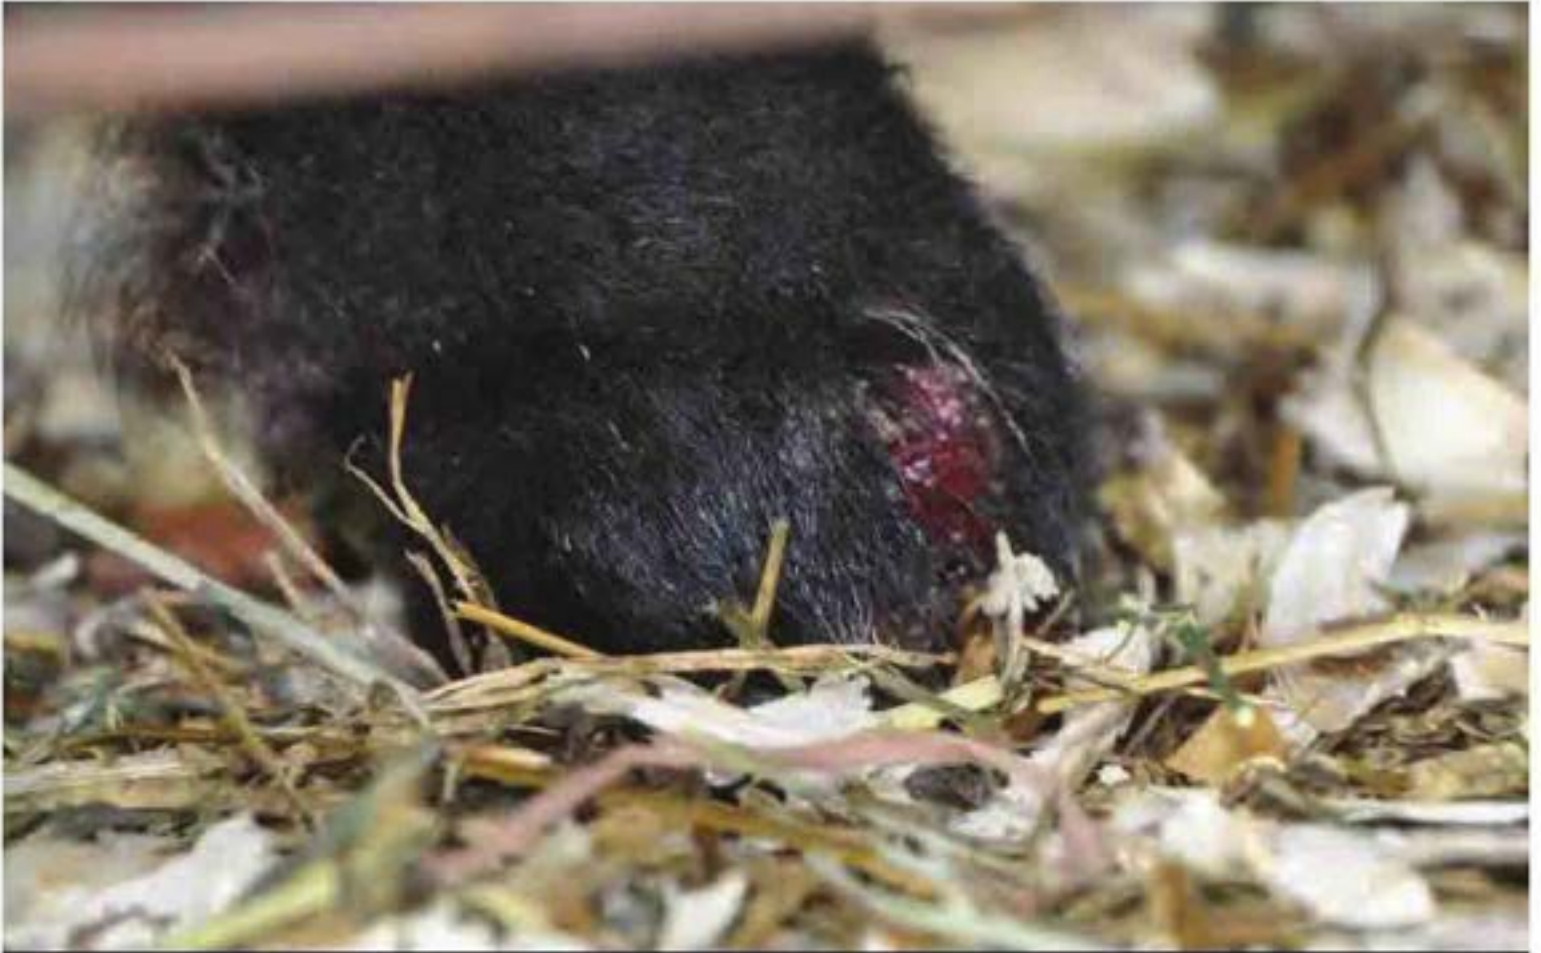
000045

CFR: 2.40 (b) (2)

Photographer:	R. Coleman, ACI	Legal Name:	55-B-0069
Photo Taken:	Wed, Jun 4, '14 1030	HENRY HAMPTON	
Inspection:	224140937090445		
Description:	Left front foot of sheep #160

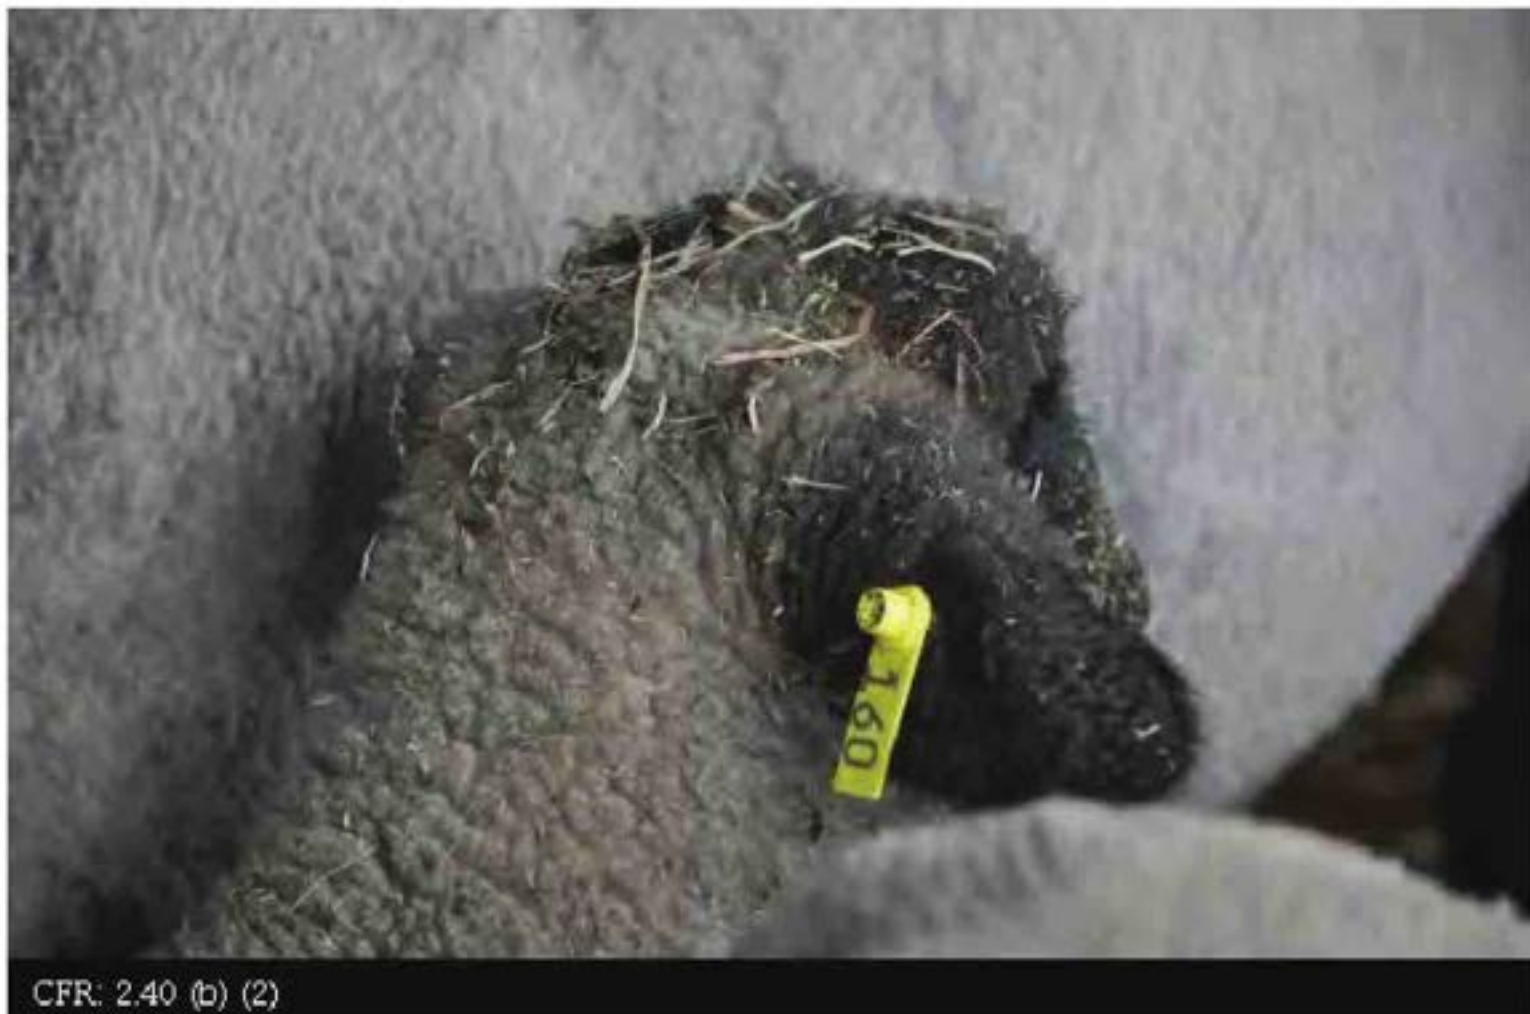
000046

CFR: 2.40 (b) (2)

Photographer:	R. Coleman, ACI	Legal Name:	55-B-0069
Photo Taken:	Wed, Jun 4, '14 1030	HENRY HAMPTON	
Inspection:	224140937090445		
Description:	Photo of ear tag for sheep #160

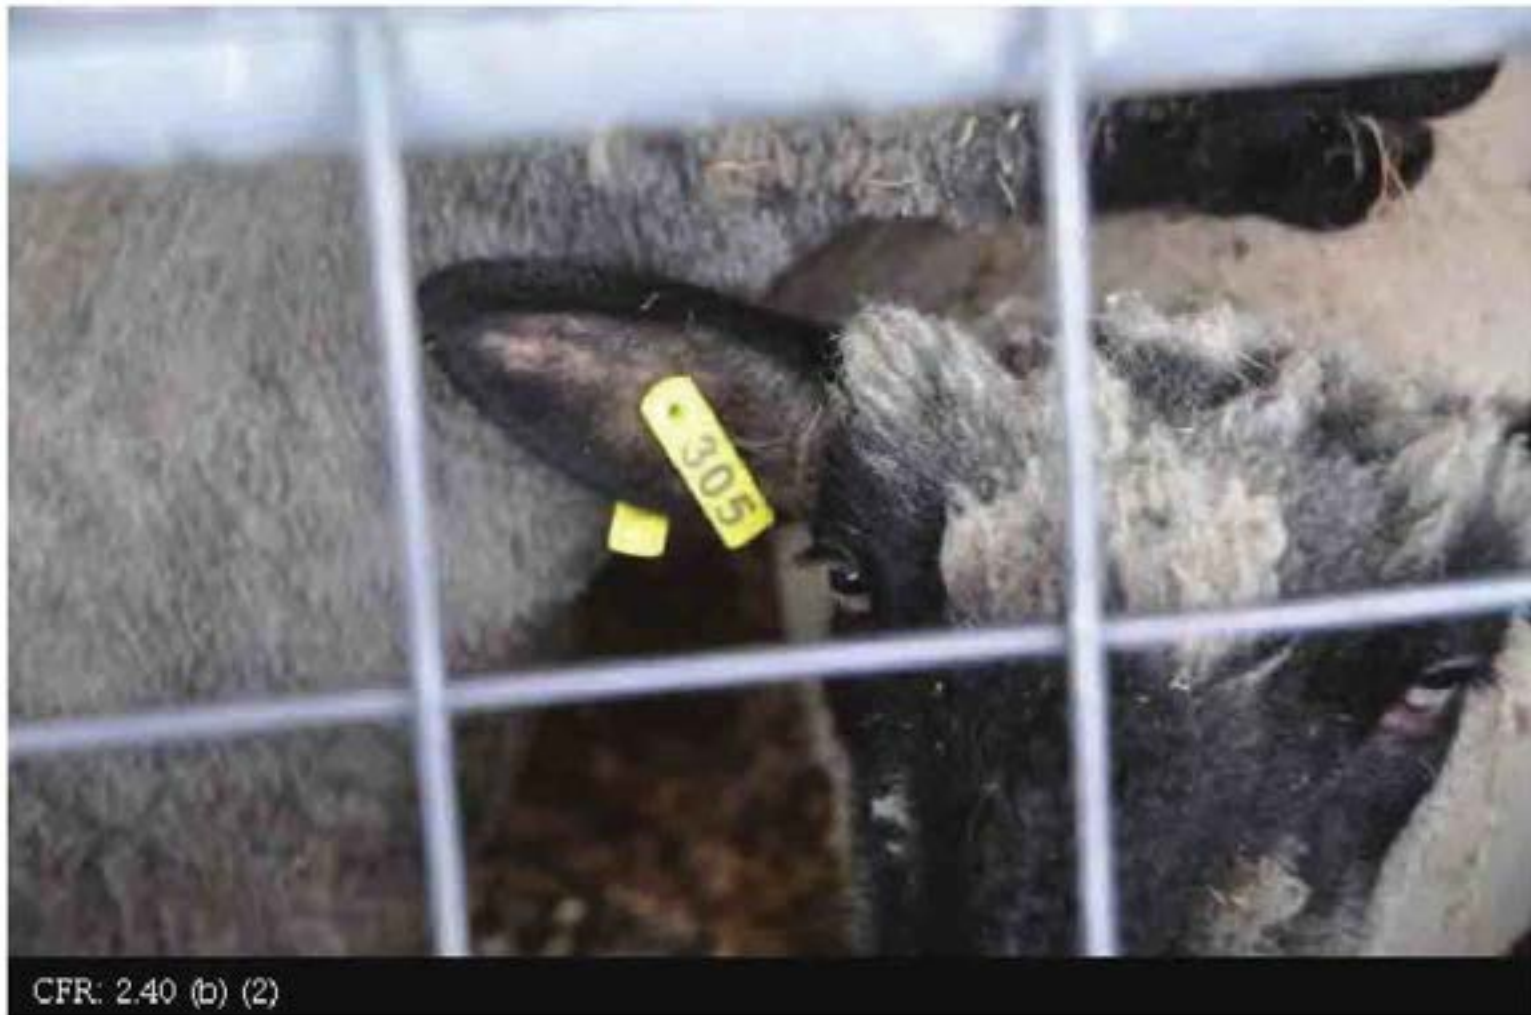
000047

CFR: 2.40 (b) (2)

Photographer:	R. Coleman, ACI	Legal Name:	55-B-0069
Photo Taken:	Wed, Jun 4, '14 1030	HENRY HAMPTON	
Inspection:	224140937090445		
Description:	Ear tag of sheep #305

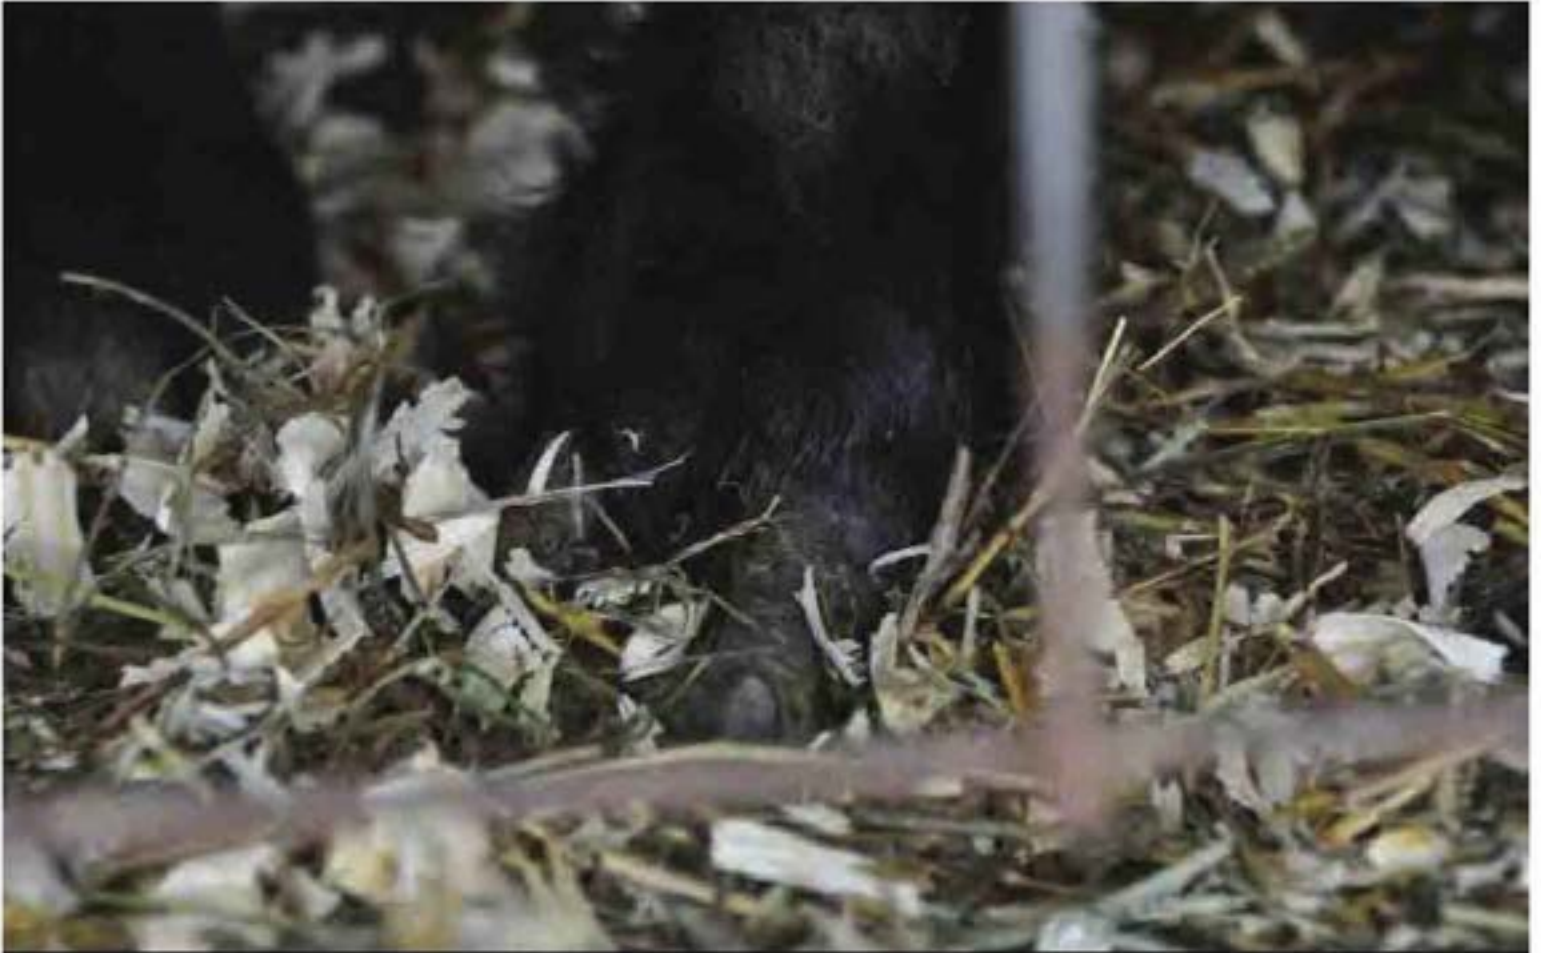
000048

CFR: 2.40 (b) (2)

Photographer:	R. Coleman, ACI	Legal Name:	55-B-0069
Photo Taken:	Wed, Jun 4, '14 1030	HENRY HAMPTON	
Inspection:	224140937090445		
Description:	Foot of sheep #305
