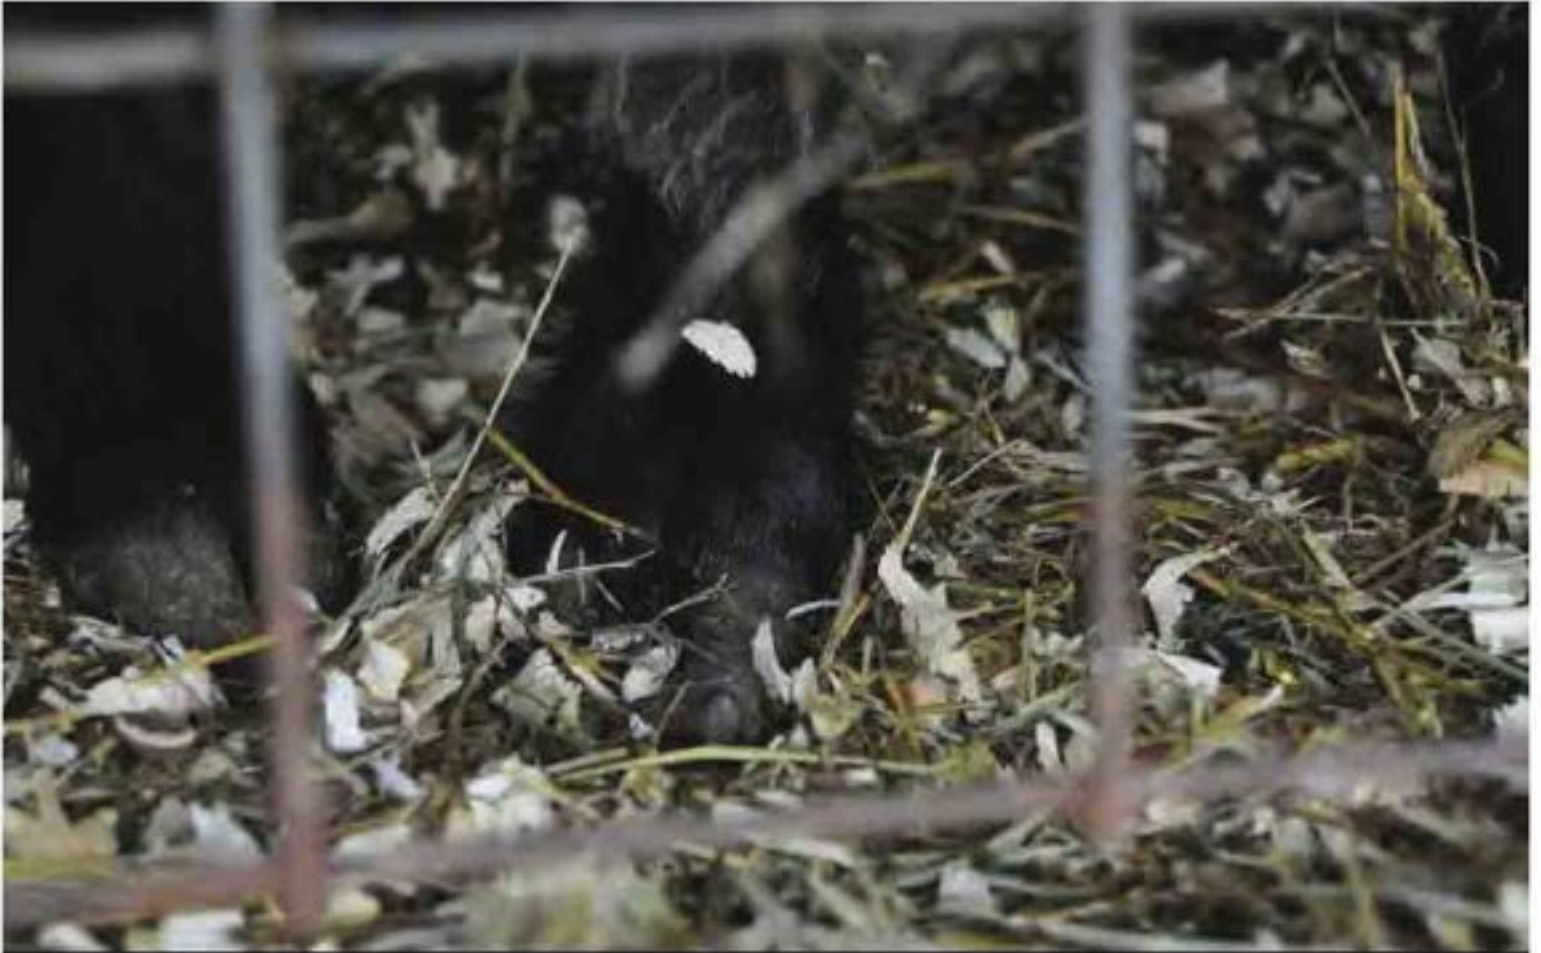
000049

CFR: 2.40 (b) (2)

Photographer:	R. Coleman, ACI	Legal Name:	55-B-0069
Photo Taken:	Wed, Jun 4, '14 1030	HENRY HAMPTON	
Inspection:	224140937090445		
Description:	Foot of sheep #305

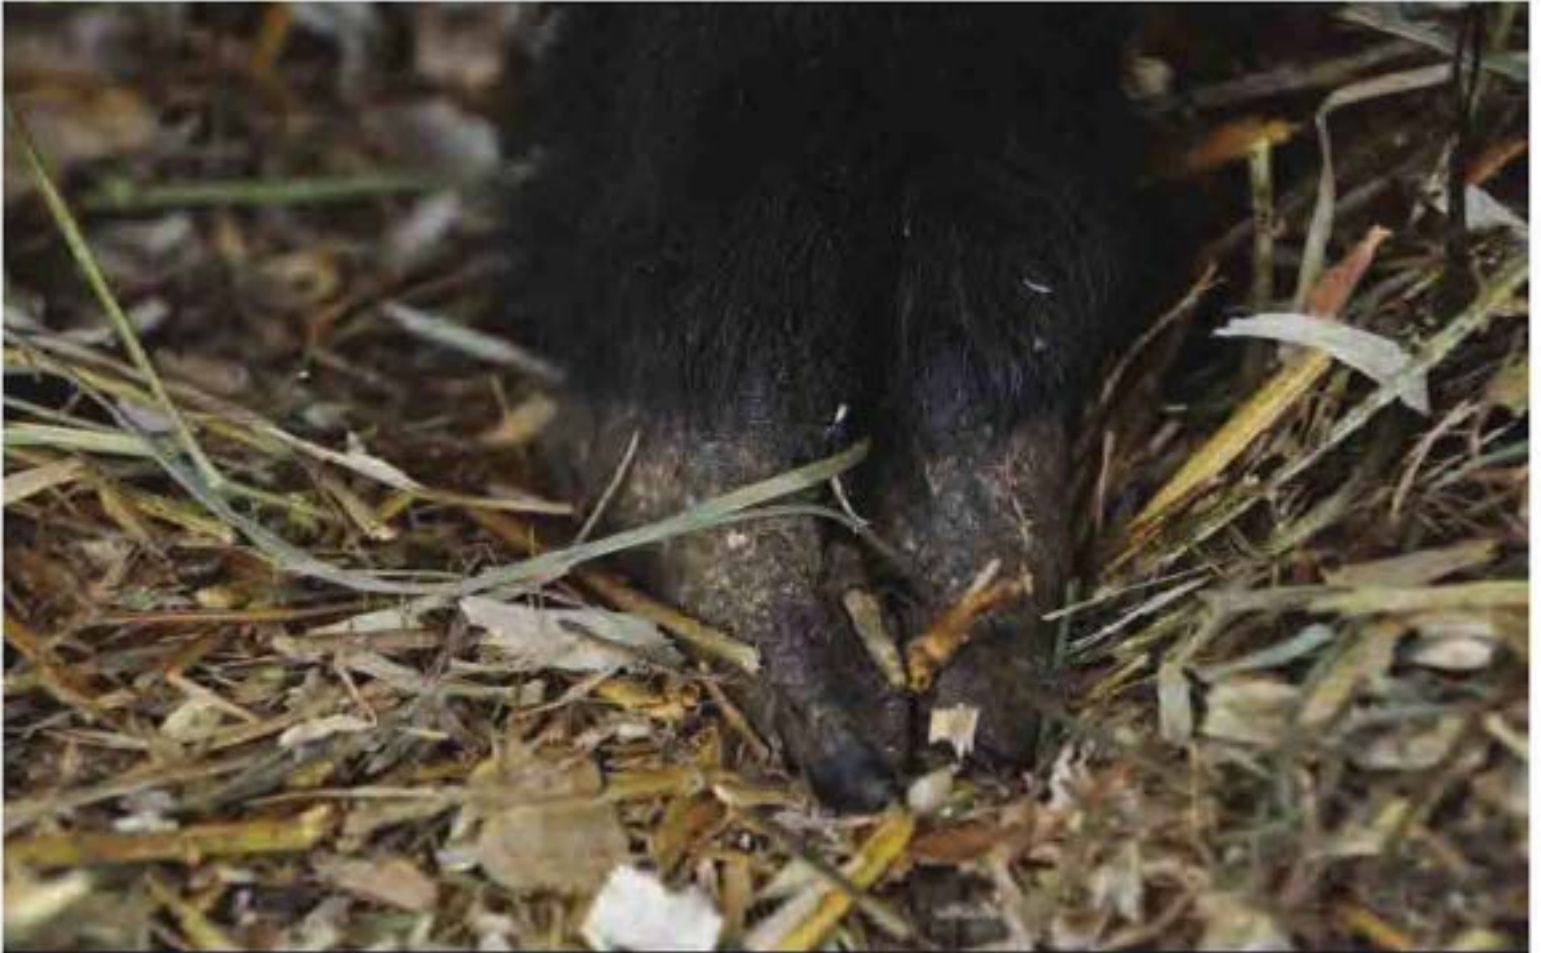
000050

CFR: 2.40 (b) (2)

Photographer:	R. Coleman, ACI	Legal Name:	55-B-0069
Photo Taken:	Wed, Jun 4, '14 1030	HENRY HAMPTON	
Inspection:	224140937090445		
Description:	Foot of sheep #310

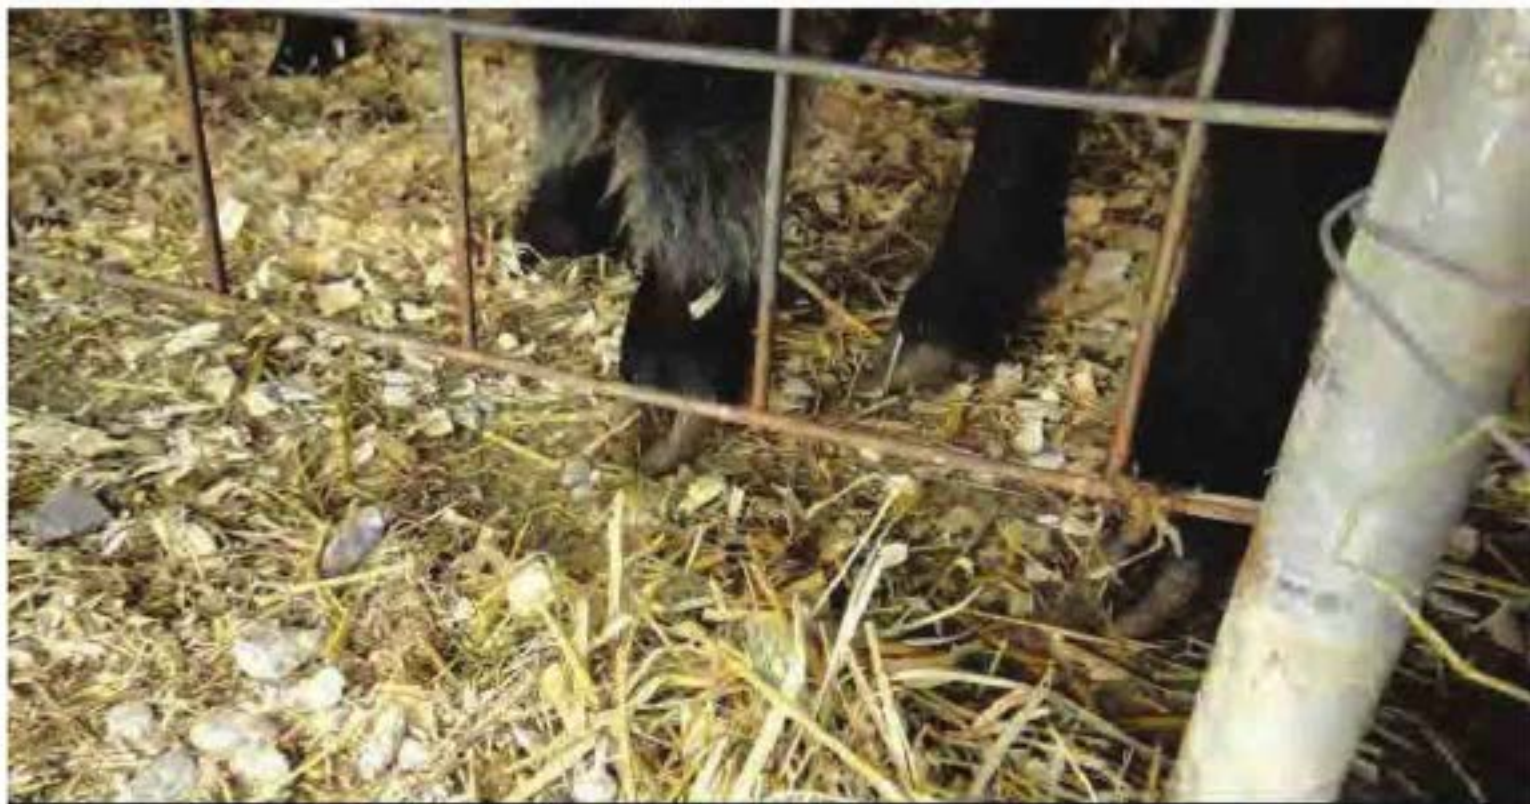
000051

CFR: 2.40 (b) (2)

Photographer:	D. Miller, SACS	Legal Name:	55-B-0069
Photo Taken:	Wed, Jun 4, '14 1030	HENRY HAMPTON	
Inspection:	224140937090445		
Description:	Feet of sheep in production barn

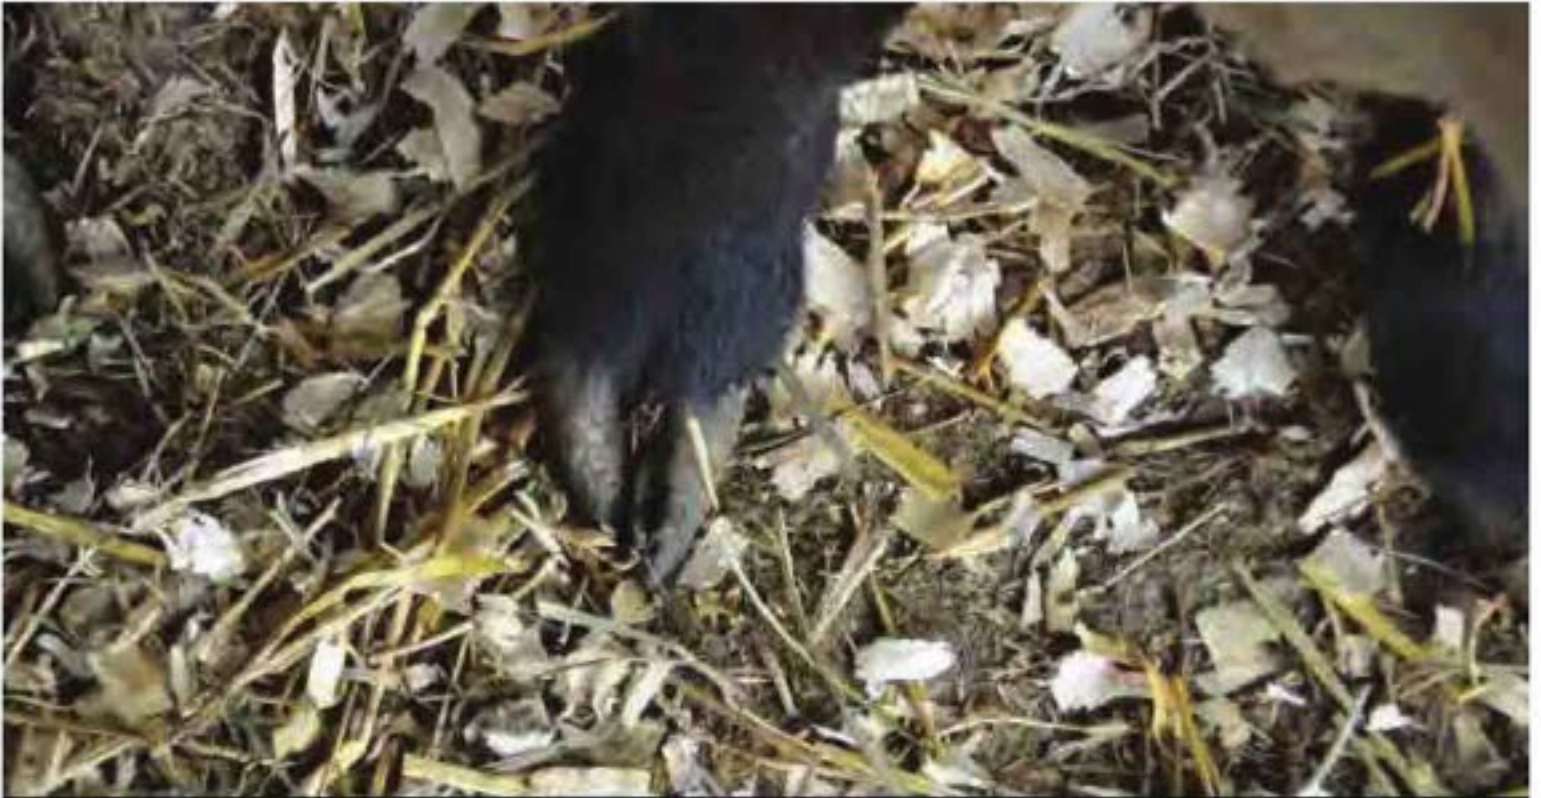
000052

CFR: 2.40 (b) (2)

Photographer:	D. Miller, SACS	Legal Name:	55-B-0069
Photo Taken:	Wed, Jun 4, '14 1030	HENRY HAMPTON	
Inspection:	224140937090445		
Description:	Feet of sheep in production barn

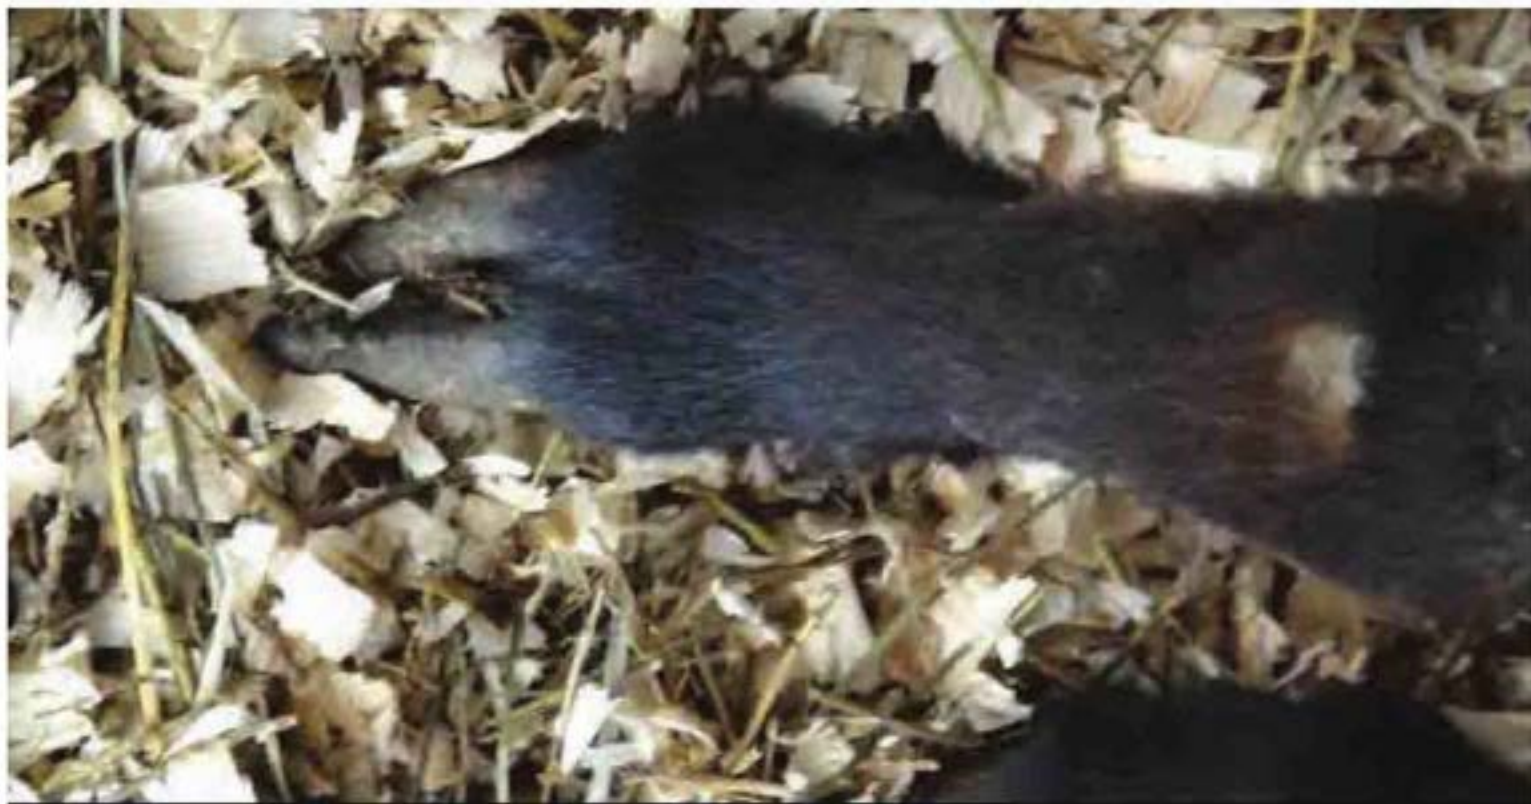
000053

CFR: 2.40 (b) (2)

Photographer:	D. Miller, SACS	Legal Name:	55-B-0069
Photo Taken:	Wed, Jun 4, '14 1030	HENRY HAMPTON	
Inspection:	224140937090445		
Description:	Feet of sheep in production barn

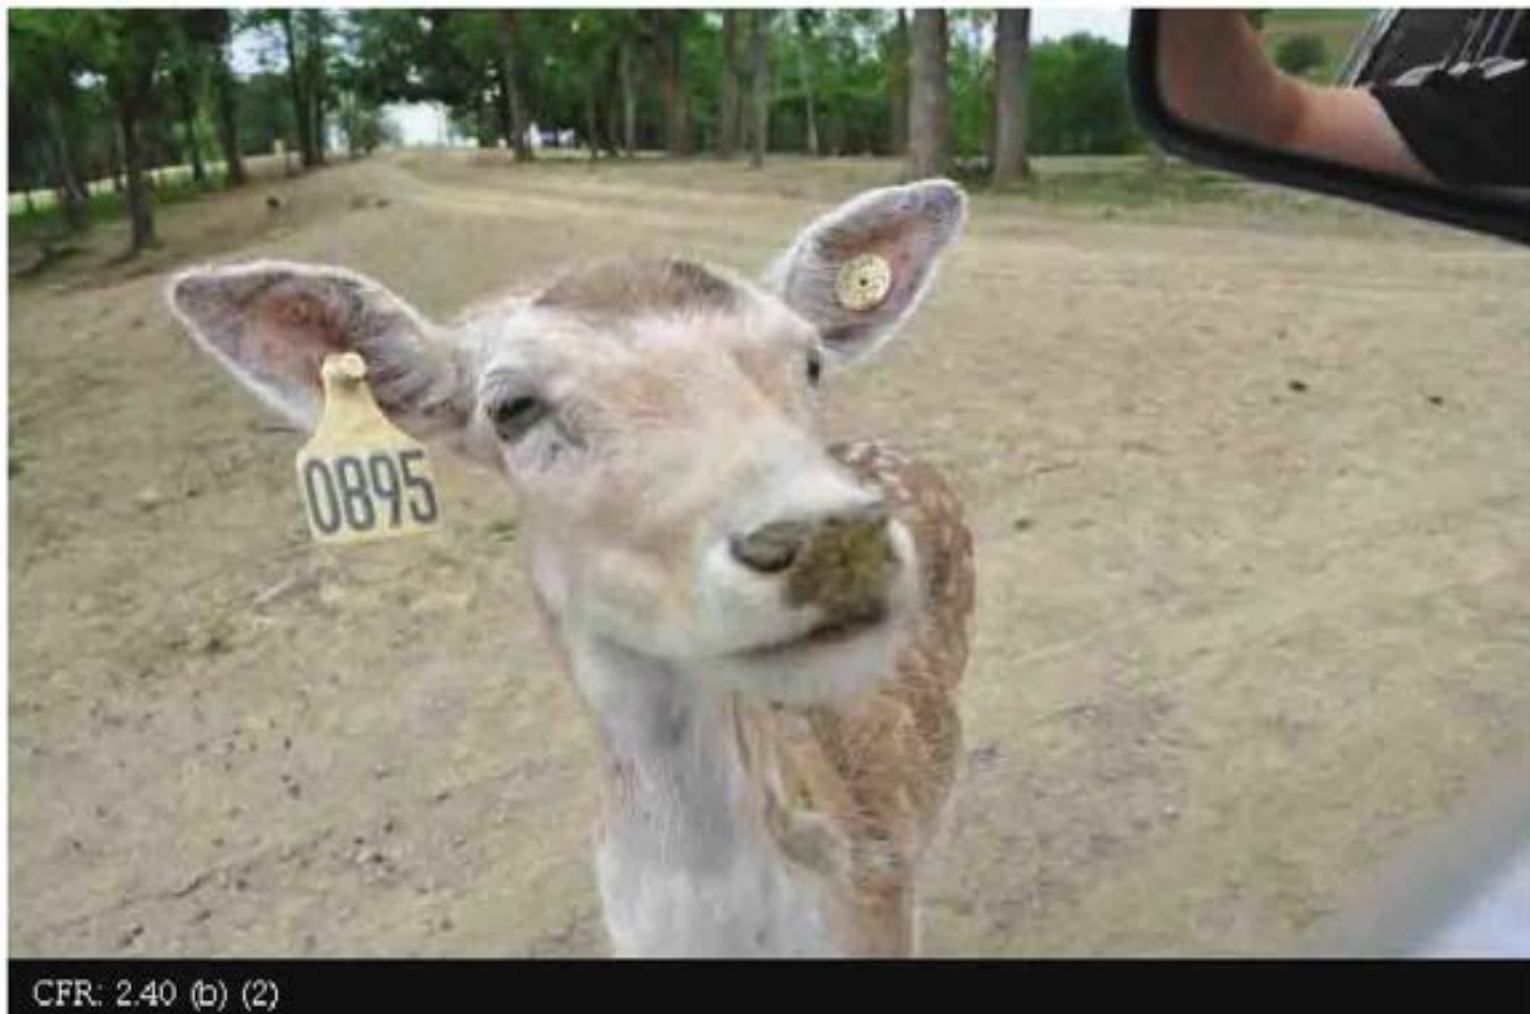
000054

CFR: 2.40 (b) (2)

Photographer:	R. Coleman, ACI	Legal Name:	55-B-0069
Photo Taken:	Wed, Jun 4, '14 1030	HENRY HAMPTON	
Inspection:	224140937090445		
Description:	Photo of Fallow deer #0895

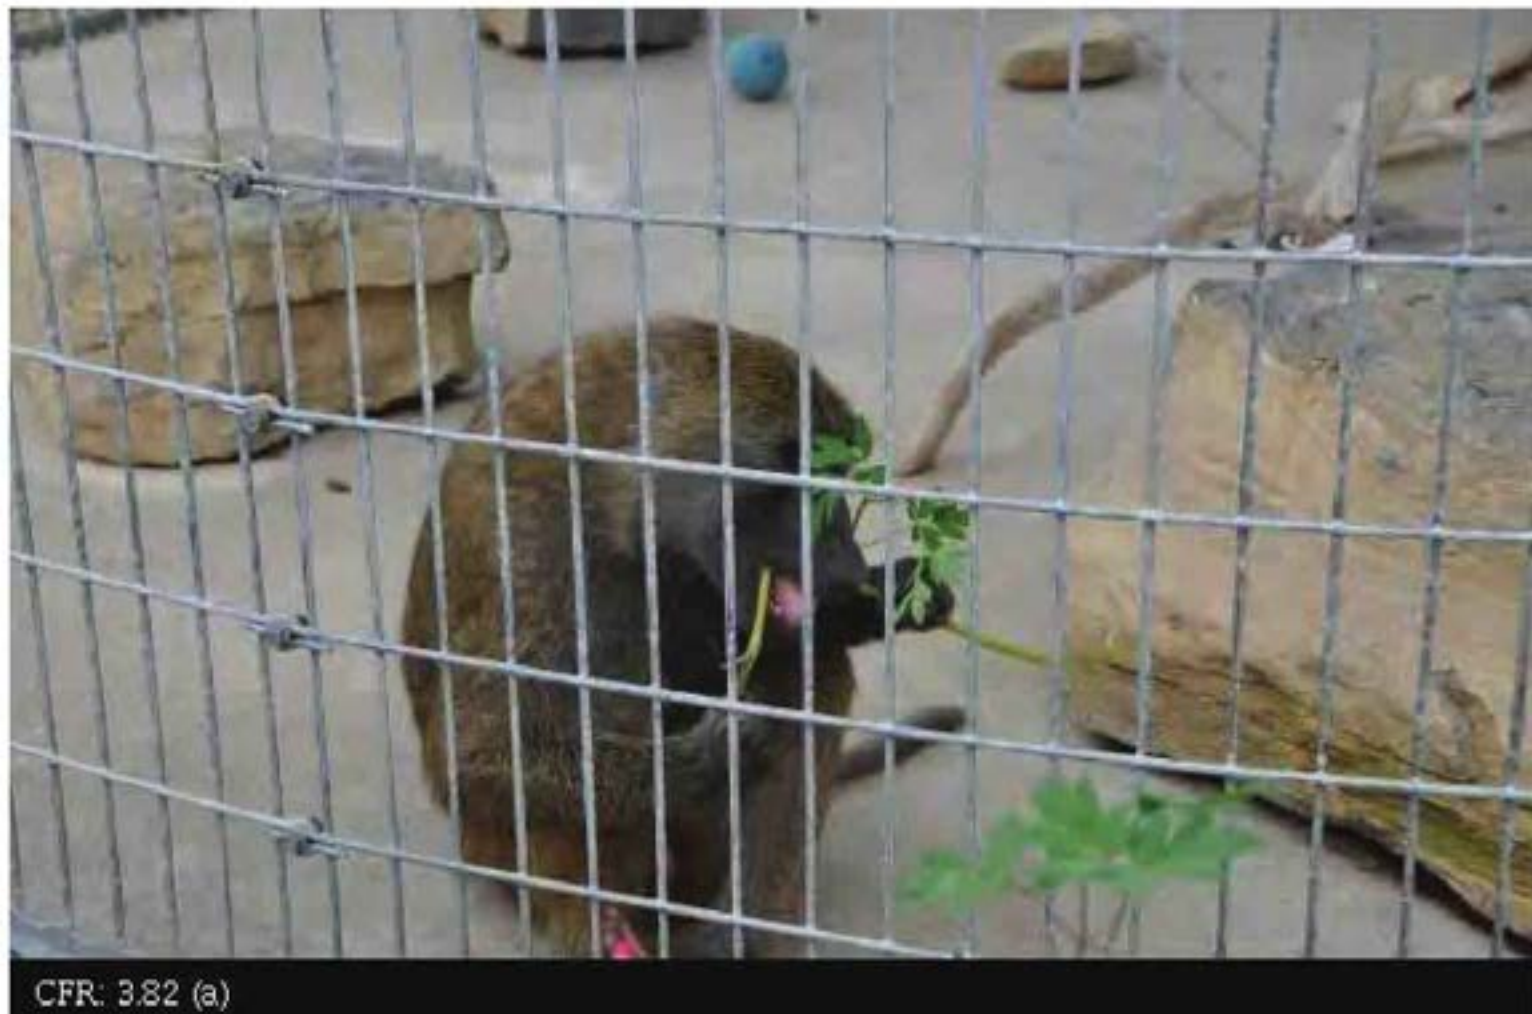
000055

CFR: 3.82 (a)

Photographer:	R. Coleman, ACI	Legal Name:	55-B-0069
Photo Taken:	Wed, Jun 4, '14 1030	HENRY HAMPTON	
Inspection:	224140937090445		
Description:	Baboon eating Bleeding Heart plant

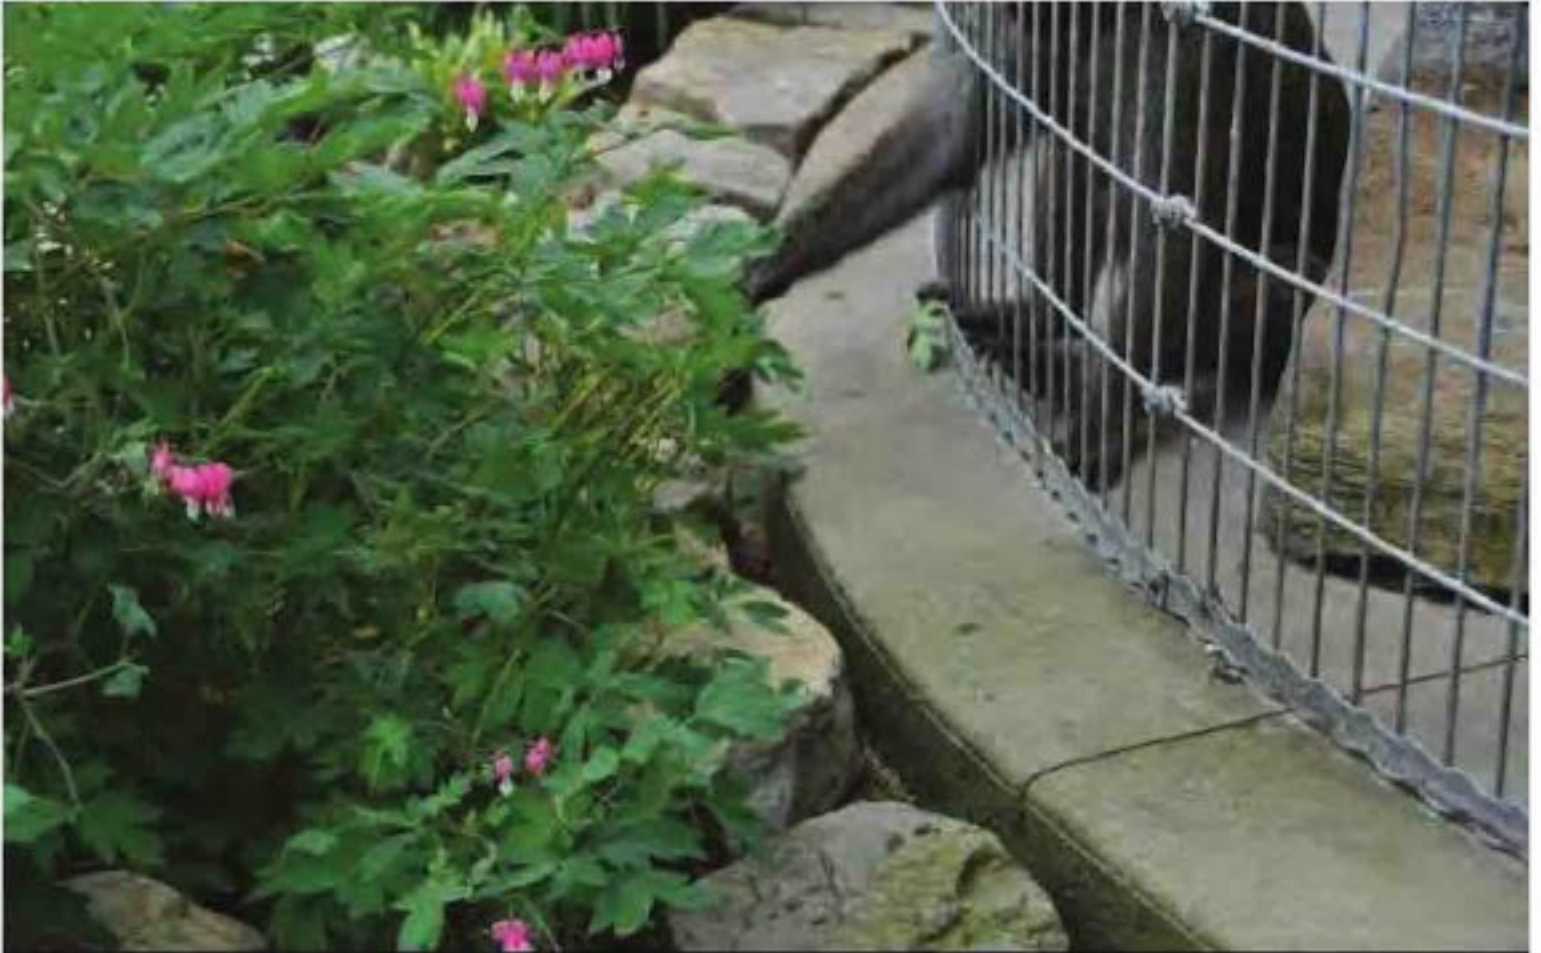
000056

CFR: 3.82 (a)

Photographer:	D. Theodorson, VMO	Legal Name:	55-B-0069
Photo Taken:	Wed, Jun 4, '14 1030	HENRY HAMPTON	
Inspection:	224140937090445		
Description:	Baboon reaching out of enclosure for Bleeding Heart plant

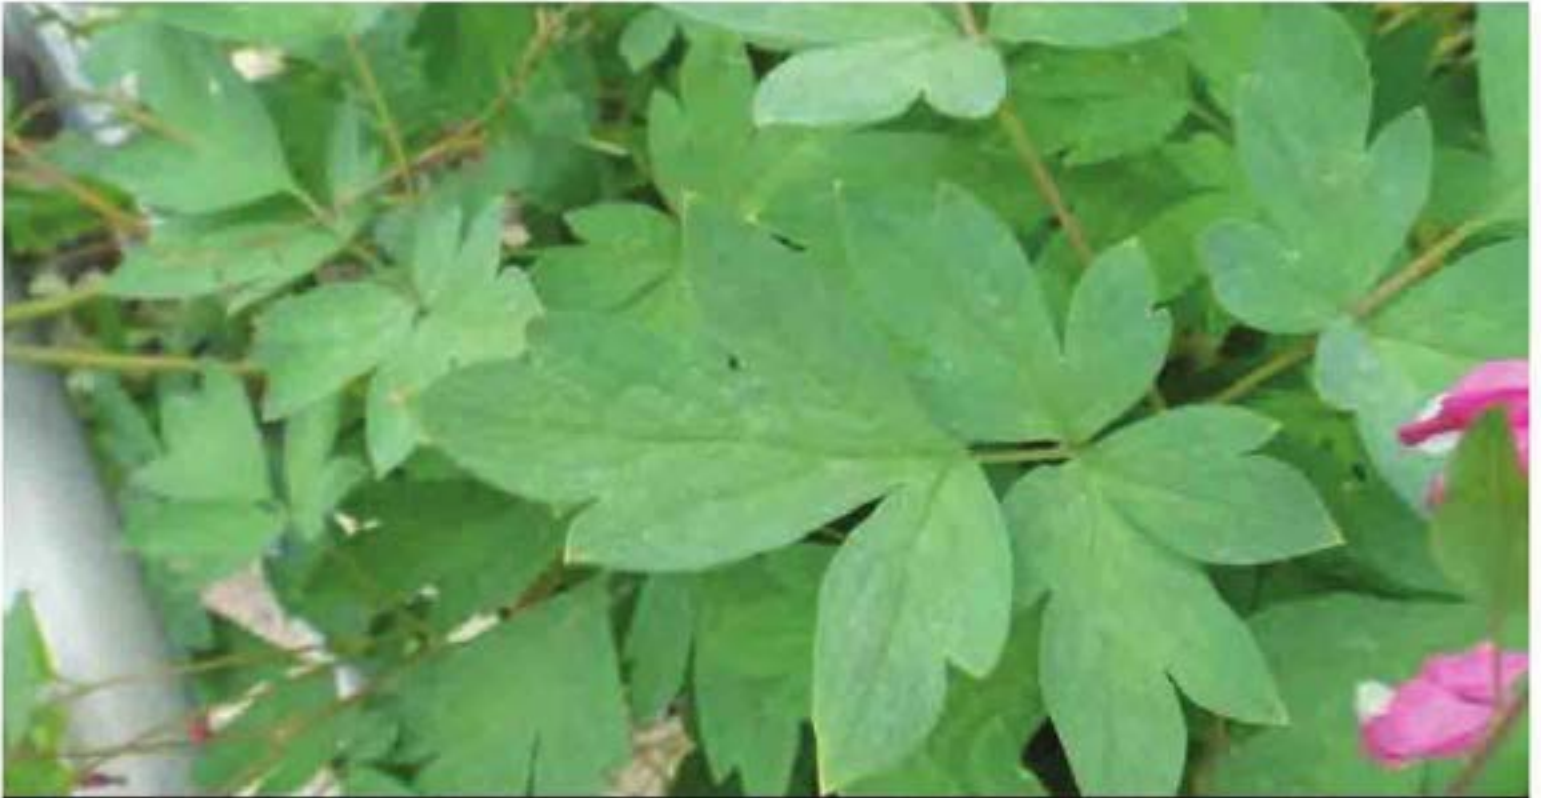
000057

CFR: 3.82 (a)

Photographer:	D. Miller, SACS	Legal Name:	55-B-0069
Photo Taken:	Wed, Jun 4, '14 1030	HENRY HAMPTON	
Inspection:	224140937090445		
Description:	Close up of plants being eaten by baboon

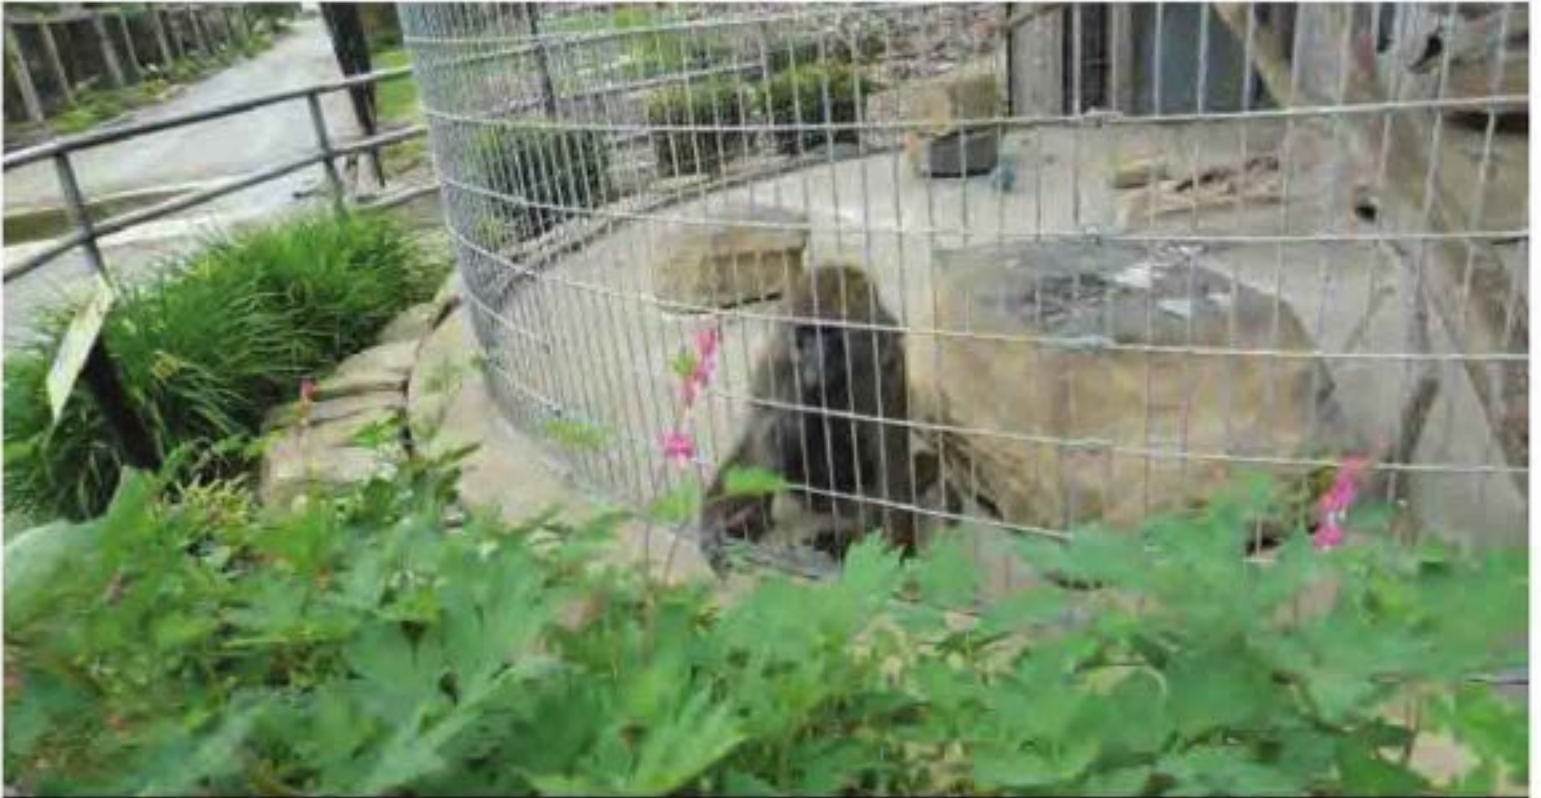
000058

CFR: 3.82 (a)

Photographer:	D. Miller, SACS	Legal Name:	55-B-0069
Photo Taken:	Wed, Jun 4, '14 1030	HENRY HAMPTON	
Inspection:	224140937090445		
Description:	Baboon reaching for Bleeding Heart plant

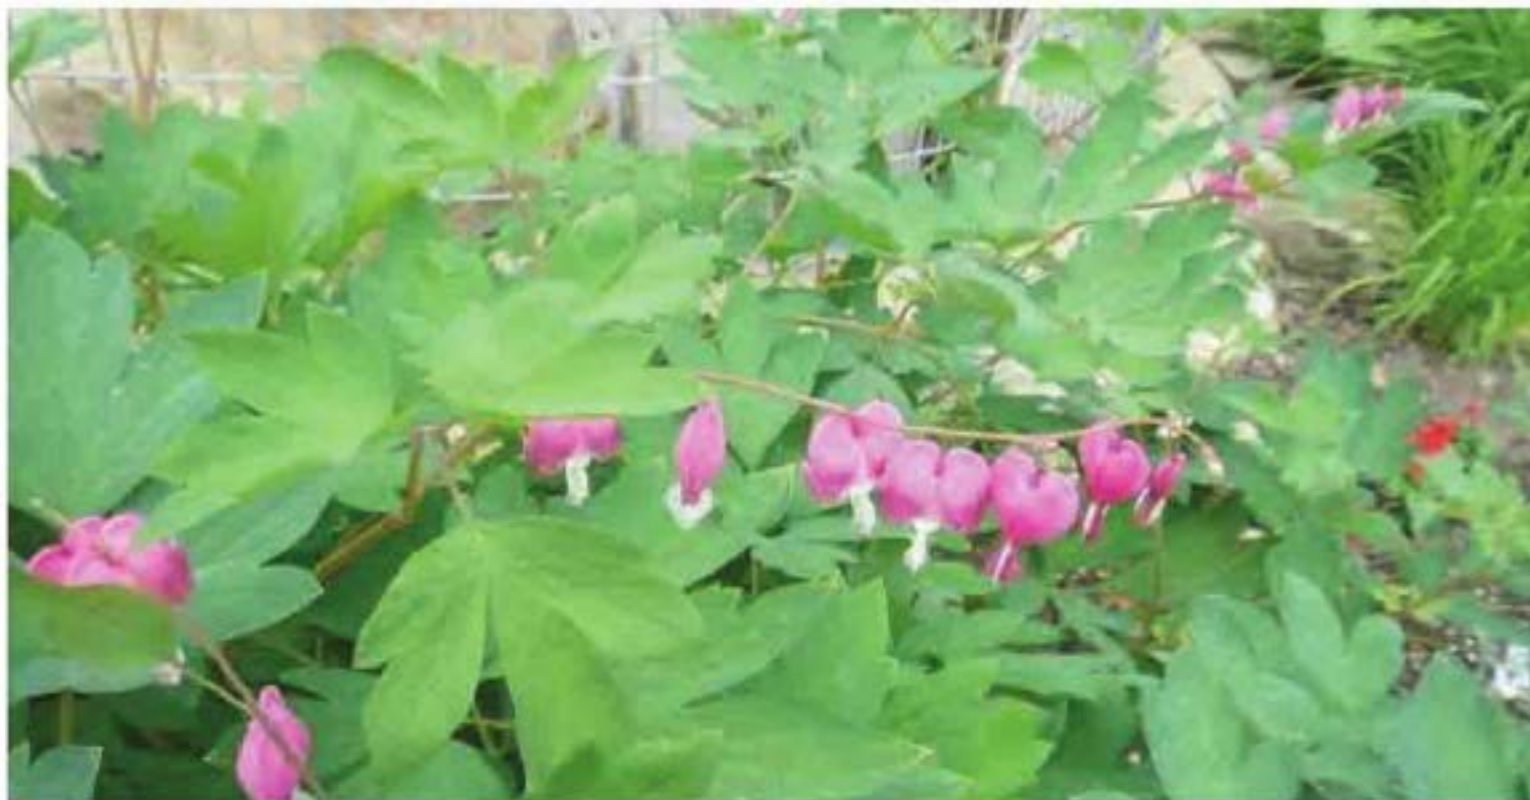
000059

CFR: 3.82 (a)

Photographer:	D. Miller, SACS	Legal Name:	55-B-0069
Photo Taken:	Wed, Jun 4, '14 1030	HENRY HAMPTON	
Inspection:	224140937090445		
Description:	Plant being eaten by baboon

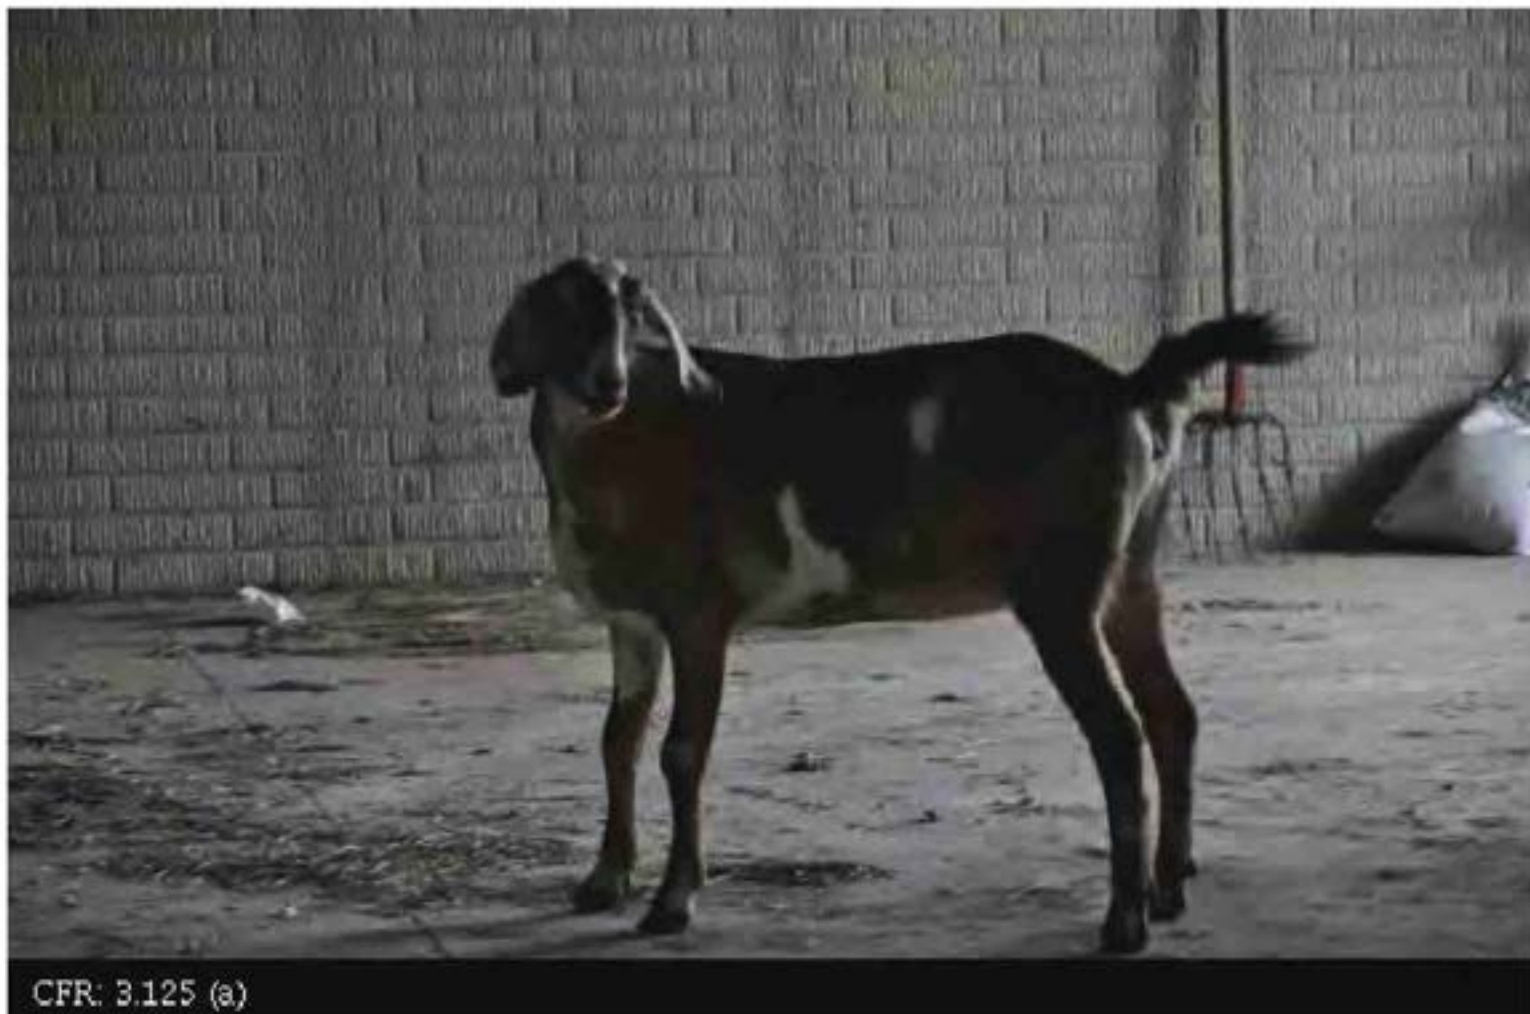
CFR: 3.125 (a)

Photographer:	R. Coleman, ACI	Legal Name:	55-B-0069
Photo Taken:	Wed, Jun 4, '14 1030	HENRY HAMPTON	
Inspection:	224140937090445		
Description:	Boer goat loose from enclosure

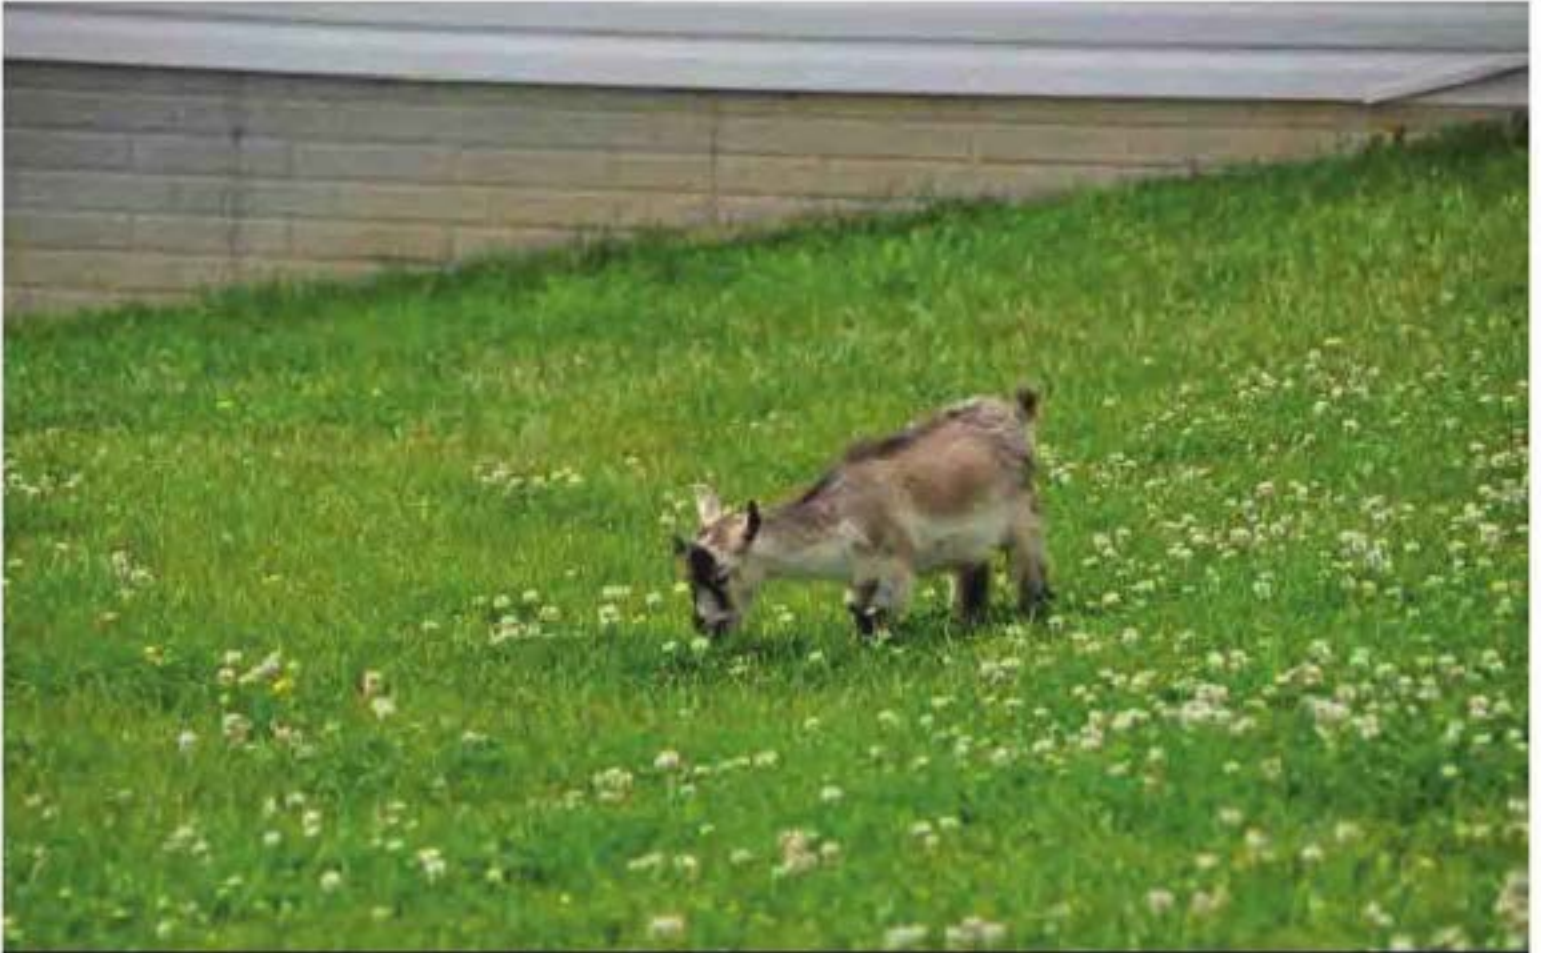
000062

CFR: 3.125 (a)

Photographer:	R. Coleman, ACI	Legal Name:	55-B-0069
Photo Taken:	Wed, Jun 4, '14 1030	HENRY HAMPTON	
Inspection:	224140937090445		
Description:	Pygmy goat roaming freely

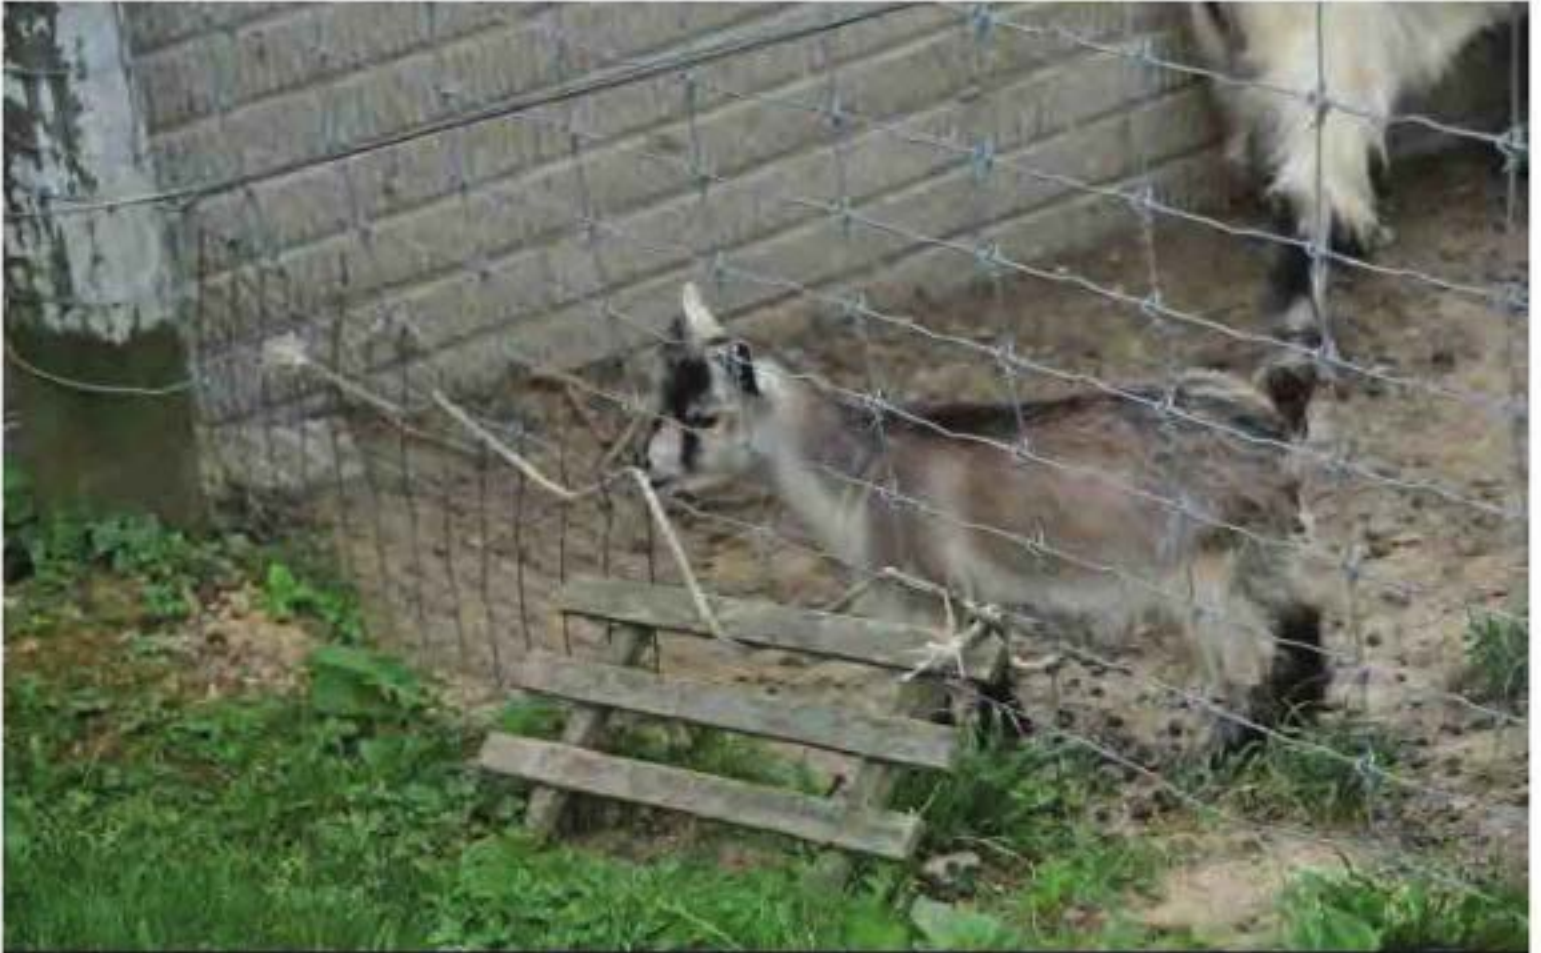
000063

CFR: 3.125 (a)

Photographer:	R. Coleman, ACI	Legal Name:	55-B-0069
Photo Taken:	Wed, Jun 4, '14 1030	HENRY HAMPTON	
Inspection:	224140937090445		
Description:	Pygmy goat returned to enclosure, note gate on primary enclosure fence

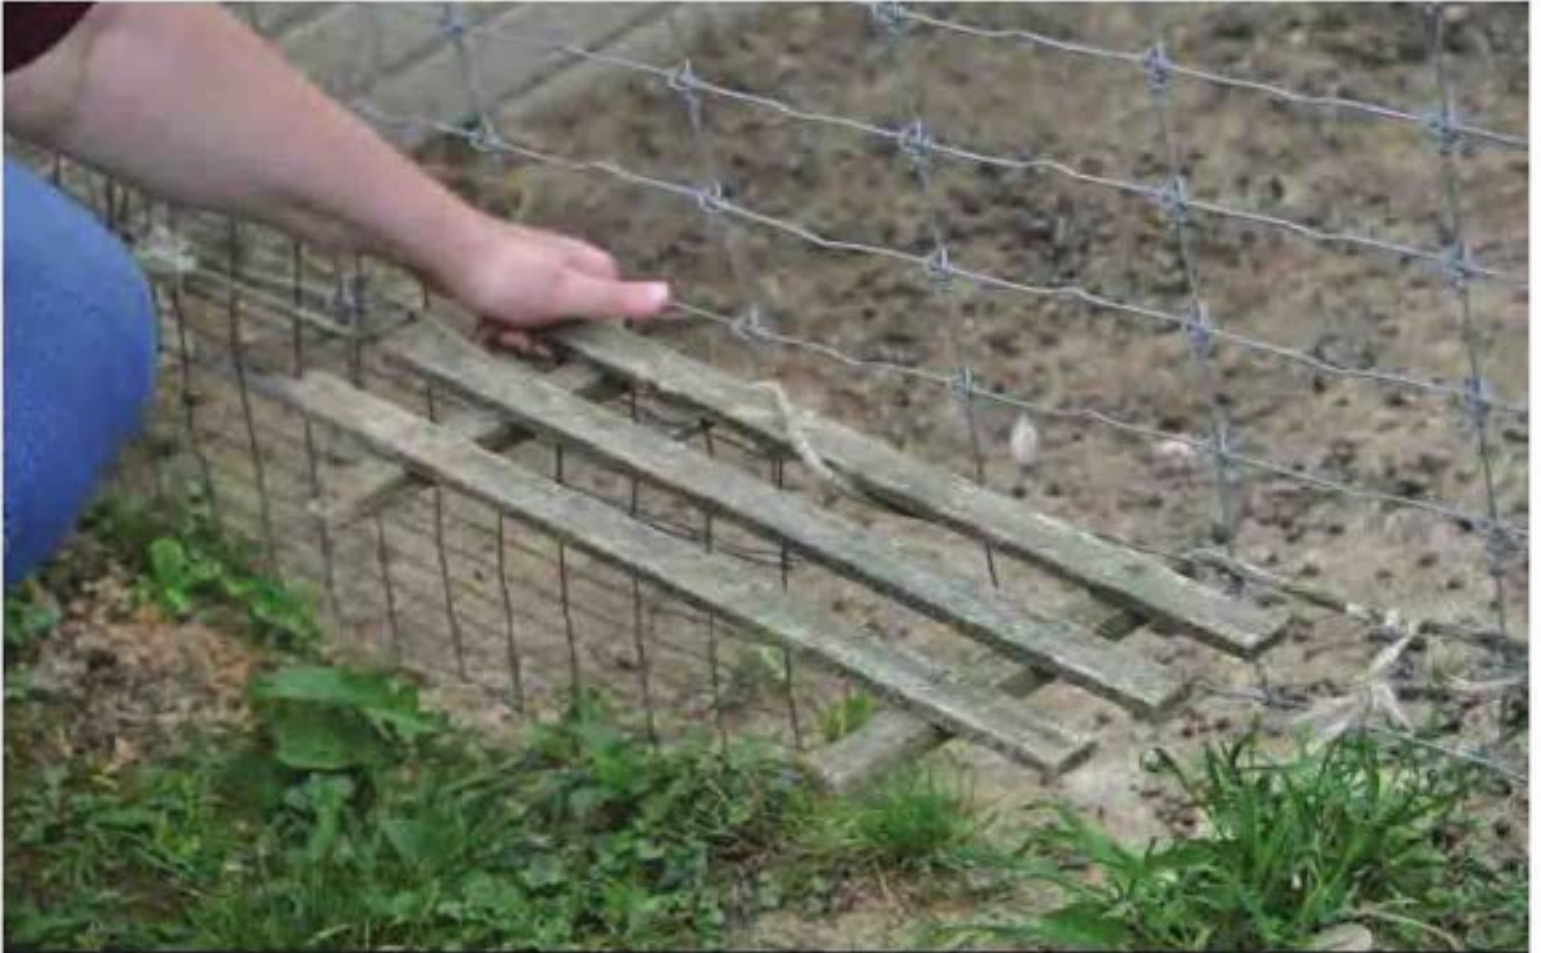
000064

CFR: 3.125 (a)

Photographer:	R. Coleman, ACI	Legal Name:	55-B-0069
Photo Taken:	Wed, Jun 4, '14 1030	HENRY HAMPTON	
Inspection:	224140937090445		
Description:	Gate loose for pygmy goat enclosure fence.

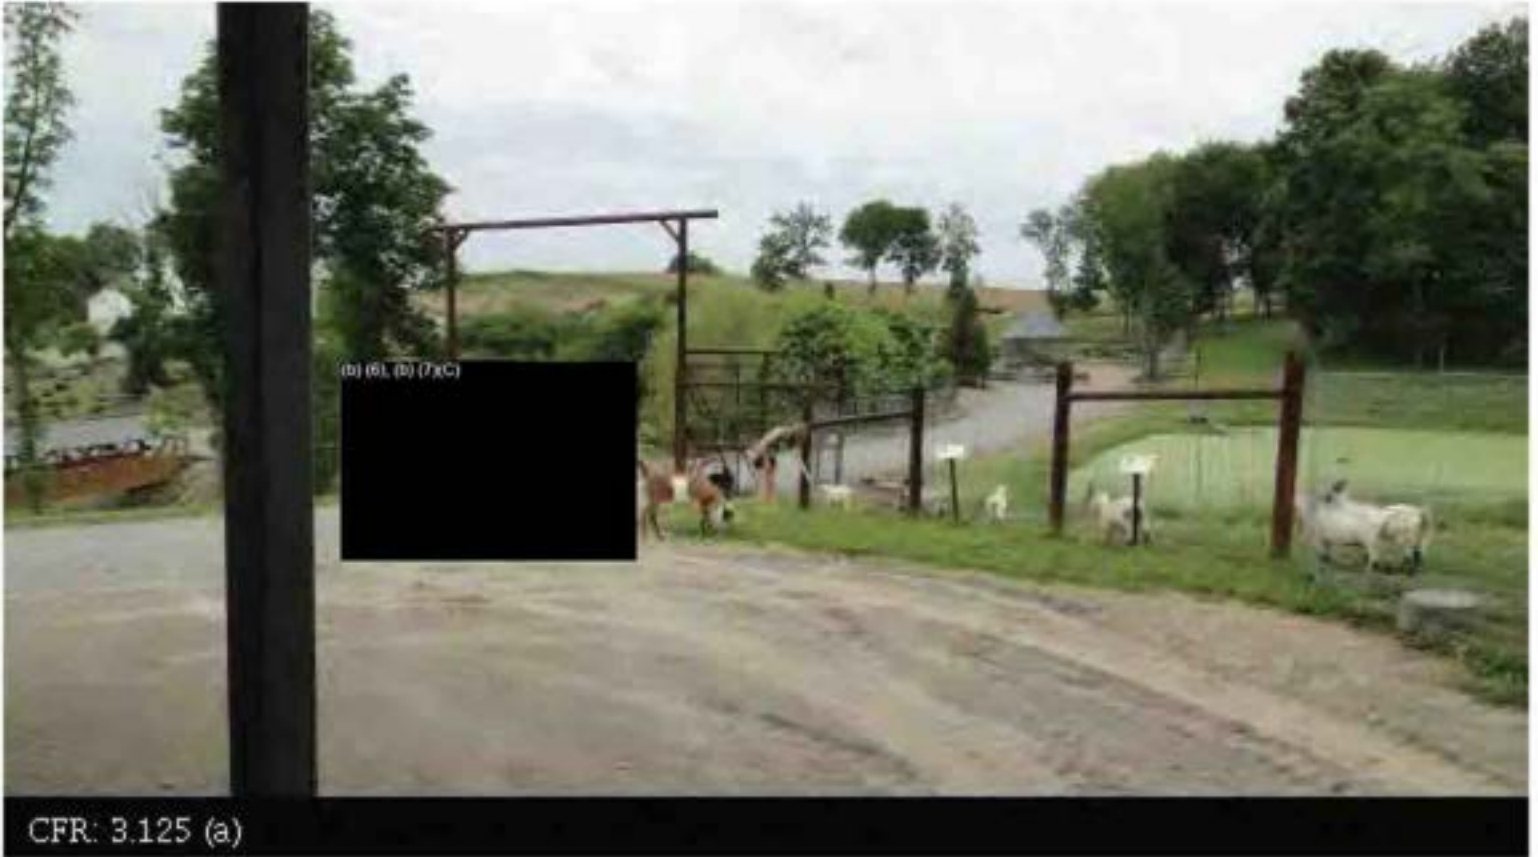
Photographer:	D. Miller, SACS	Legal Name:	55-B-0069
Photo Taken:	Wed, Jun 4, '14 1030	HENRY HAMPTON	
Inspection:	224140937090445		
Description:	Boer goat loose from primary enclosure
