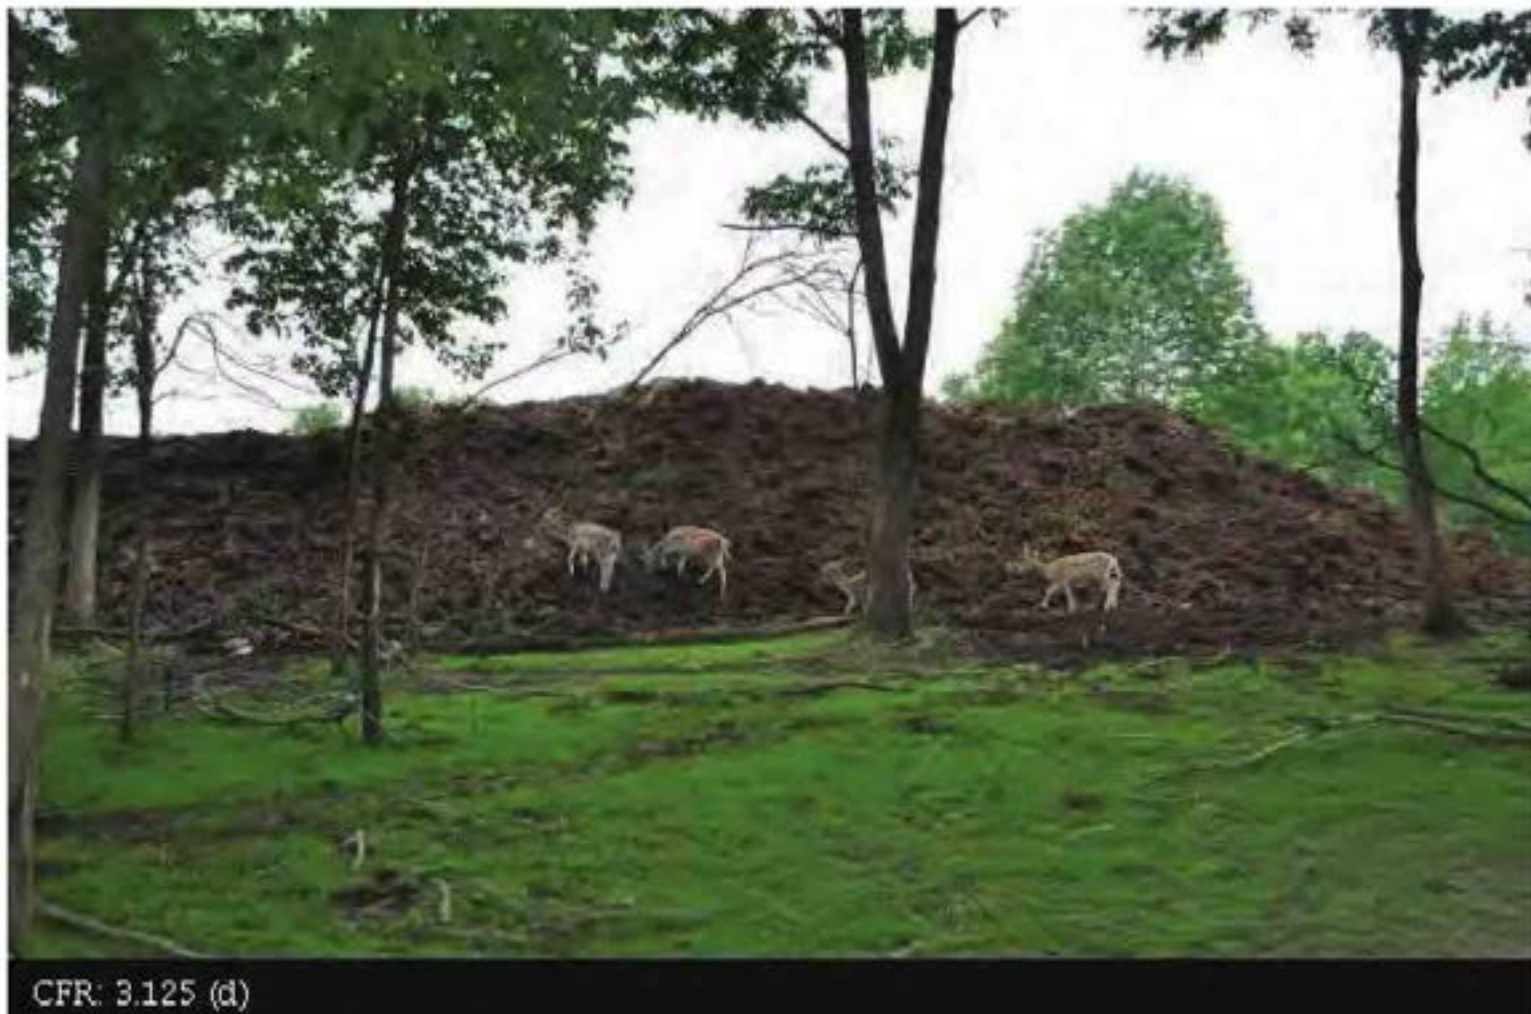
000067

CFR: 3.125 (d)

Photographer:	R. Coleman, ACI	Legal Name:	55-B-0069
Photo Taken:	Wed, Jun 4, '14 1030	HENRY HAMPTON	
Inspection:	224140937090445		
Description:	Deer walking through waste mound

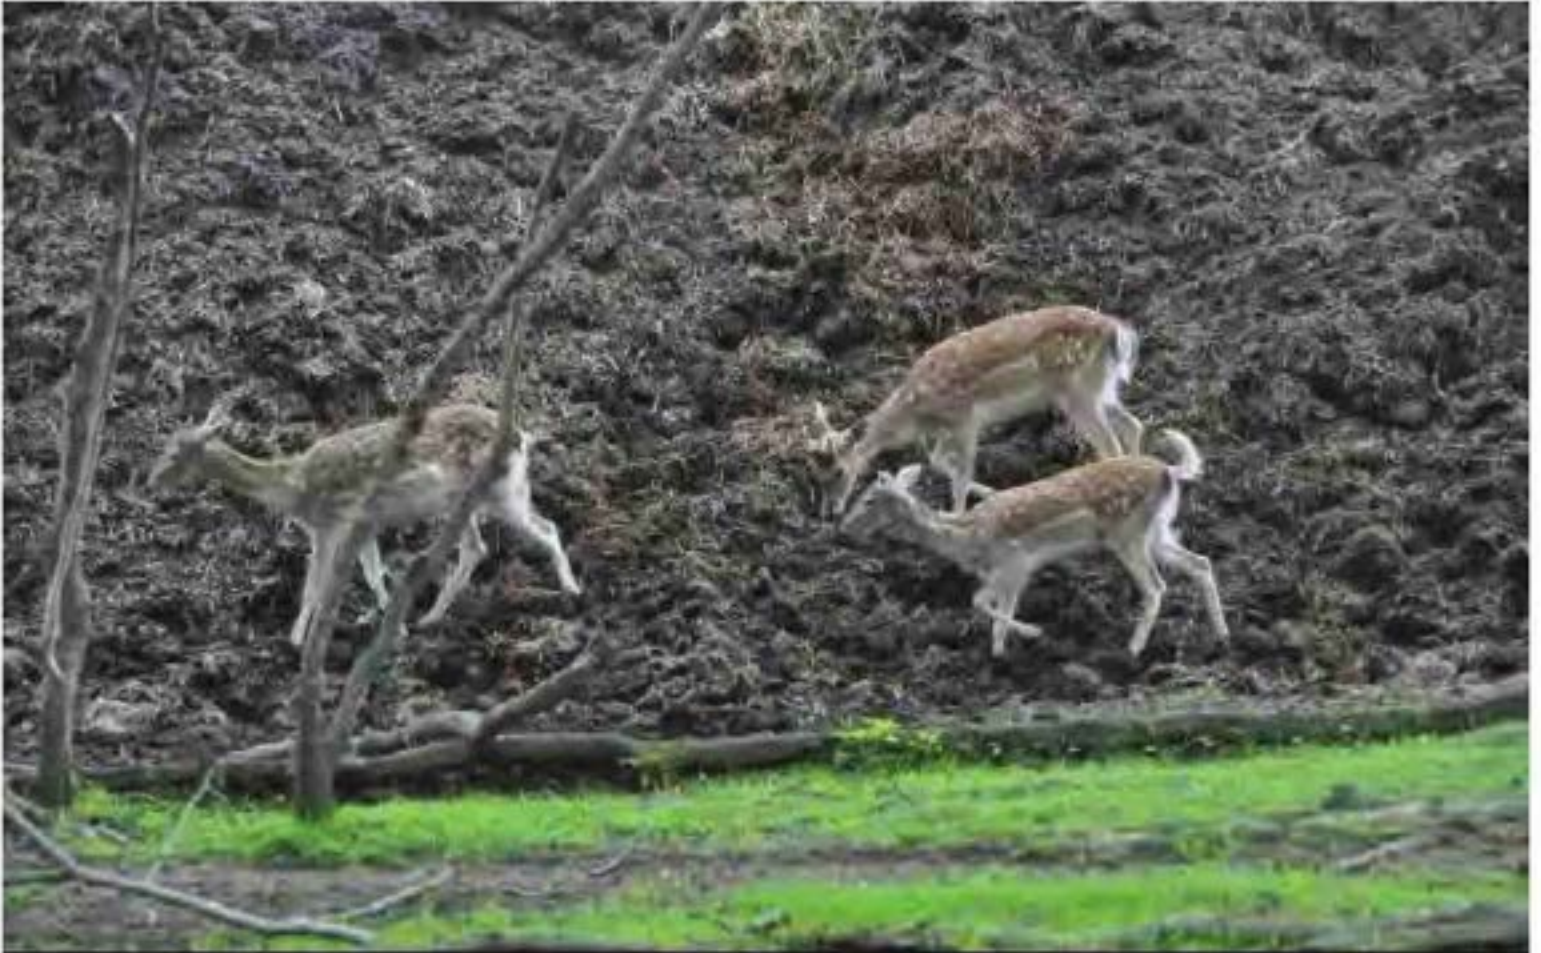
000068

CFR: 3.125 (d)

Photographer:	R. Coleman, ACI	Legal Name:	55-B-0069
Photo Taken:	Wed, Jun 4, '14 1030	HENRY HAMPTON	
Inspection:	224140937090445		
Description:	Deer grazing in waste mound

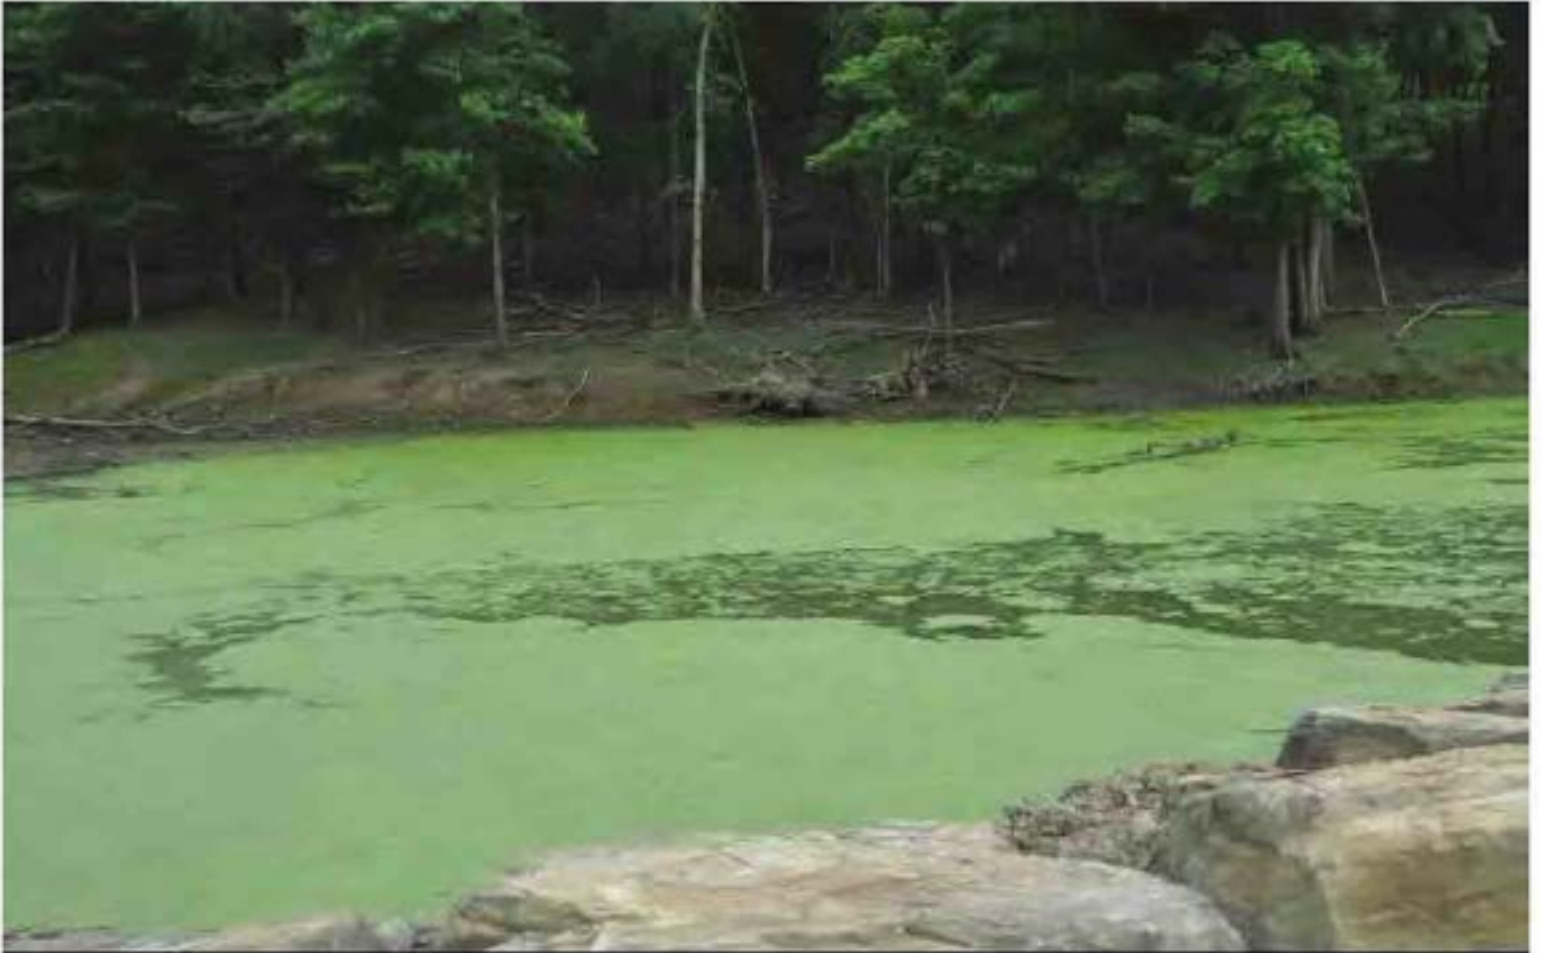
000069

CFR: 3.130

Photographer:	R. Coleman, ACI	Legal Name:	55-B-0069
Photo Taken:	Wed, Jun 4, '14 1030	HENRY HAMPTON	
Inspection:	224140937090445		
Description:	Pond in drive through section of facility.

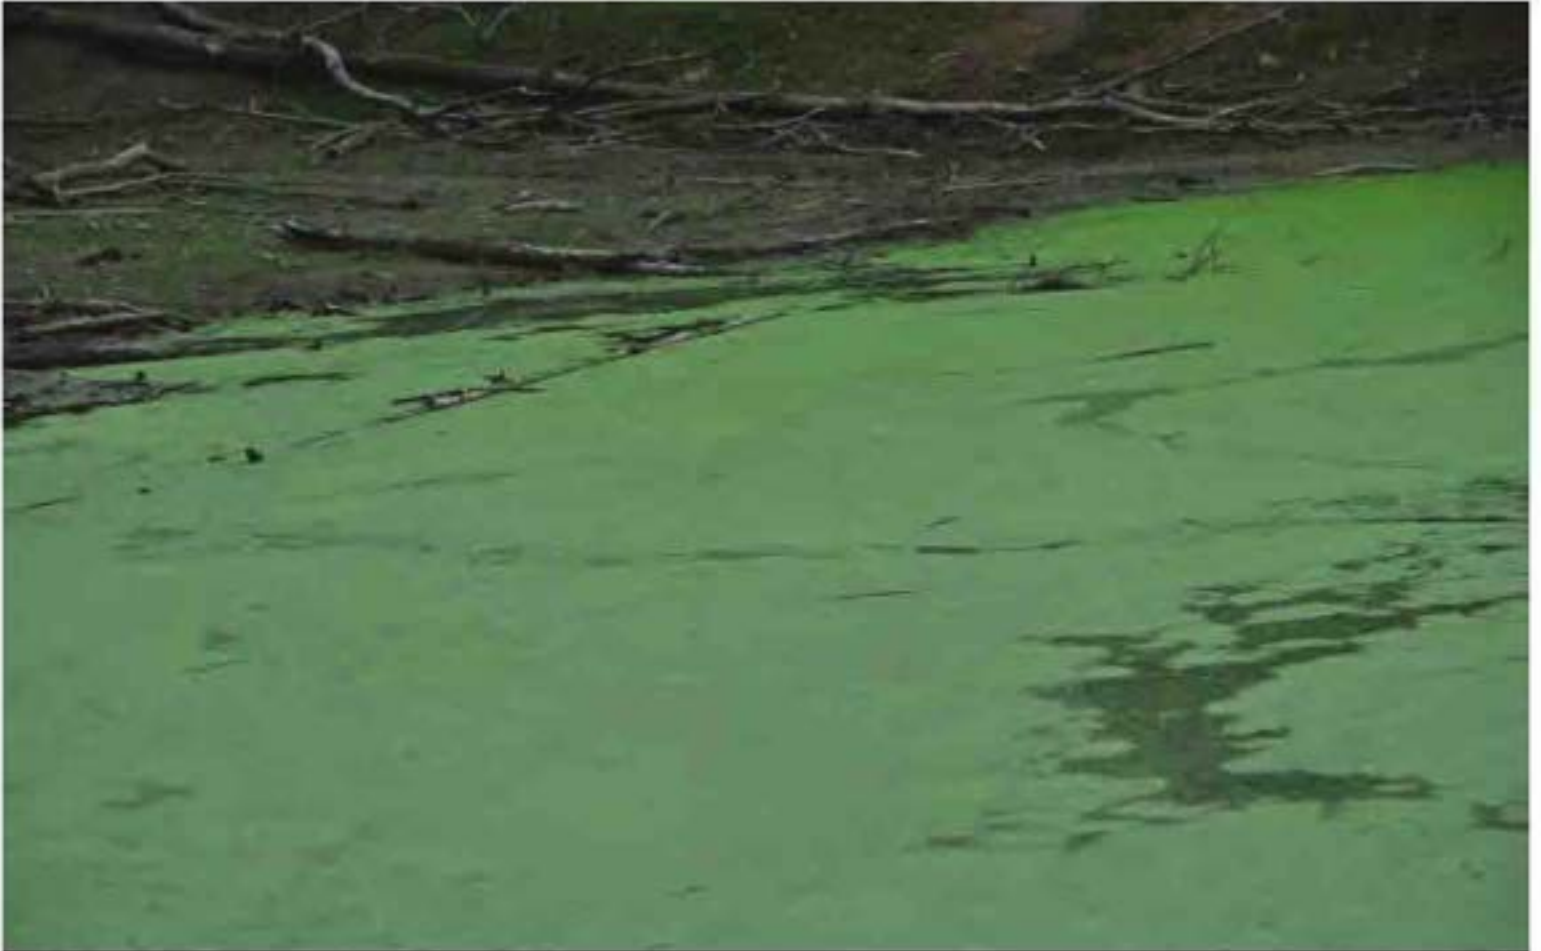
000070

CFR: 3.130

Photographer:	R. Coleman, ACI	Legal Name:	55-B-0069
Photo Taken:	Wed, Jun 4, '14 1030	HENRY HAMPTON	
Inspection:	224140937090445		
Description:	Pond in drive through section of facility.

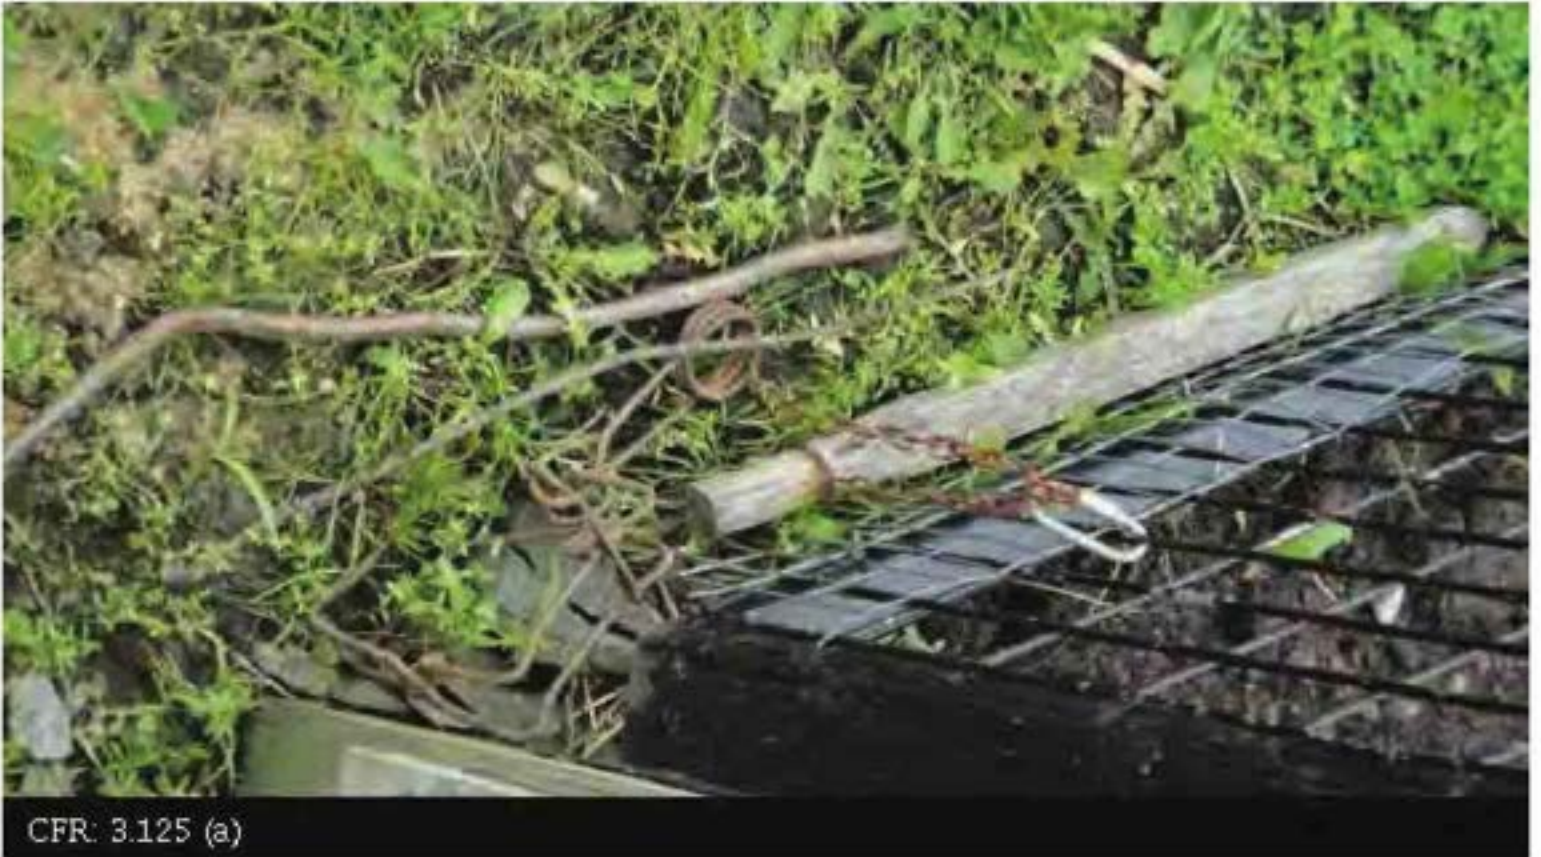
Photographer:	D. Miller, SACS	Legal Name:	55-B-0069
Photo Taken:	Wed, Jun 4, '14 1030	HENRY HAMPTON	
Inspection:	224140937090445		
Description:	Spring leg hold trap in kangaroo enclosure.

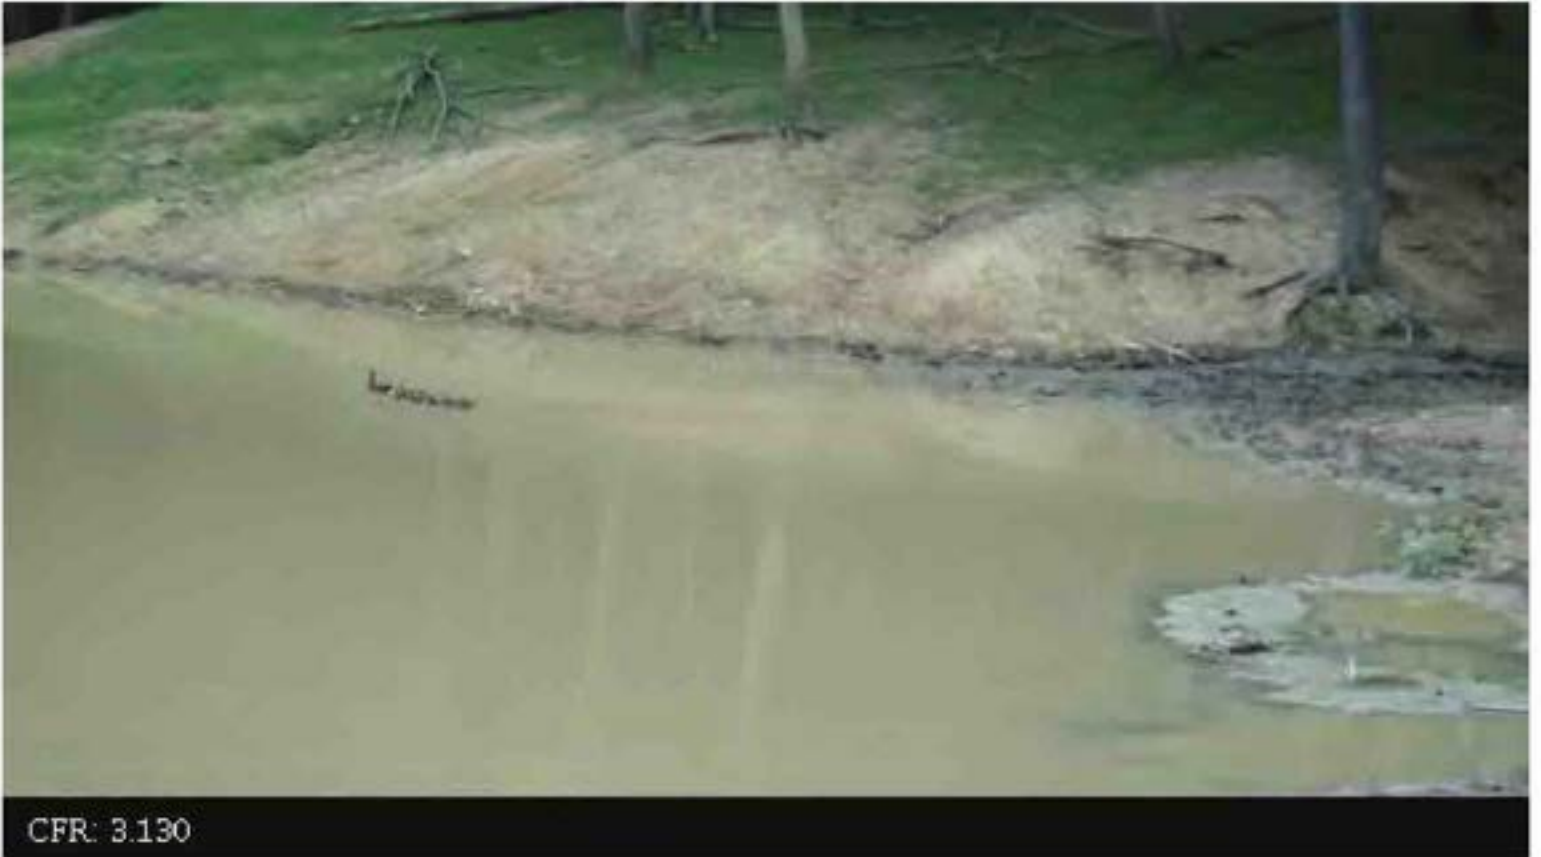
000072

CFR: 3.130

Photographer:	D. Miller, SACS	Legal Name:	55-B-0069
Photo Taken:	Wed, Jun 4, '14 1030	HENRY HAMPTON	
Inspection:	224140937090445		
Description:	Pond in drive through section of facility

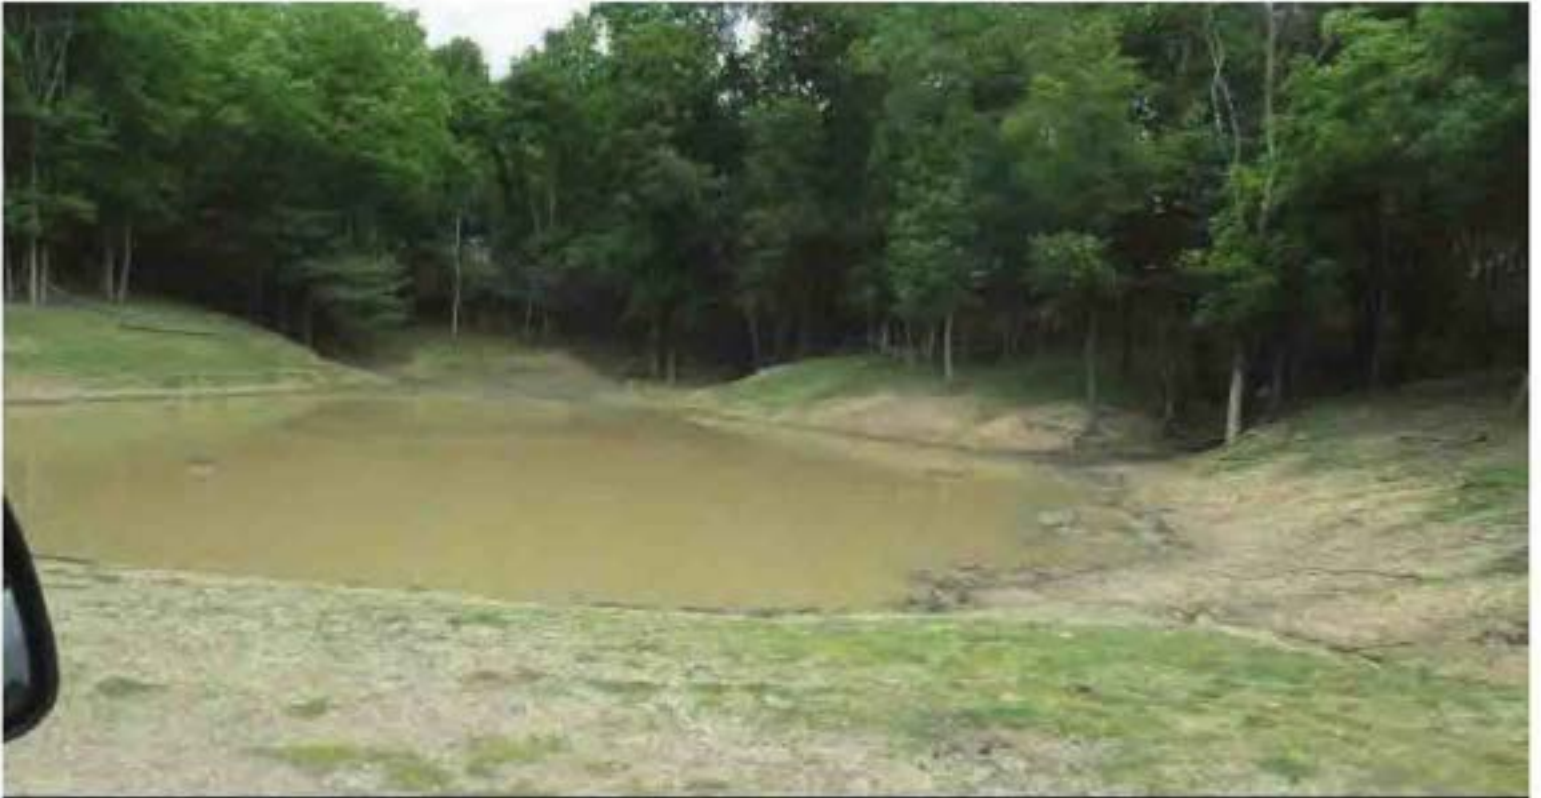
000073

CFR: 3.130

Photographer:	D. Miller, SACS	Legal Name:	55-B-0069
Photo Taken:	Wed, Jun 4, '14 1030	HENRY HAMPTON	
Inspection:	224140937090445		
Description:	Pond in drive through section of facility

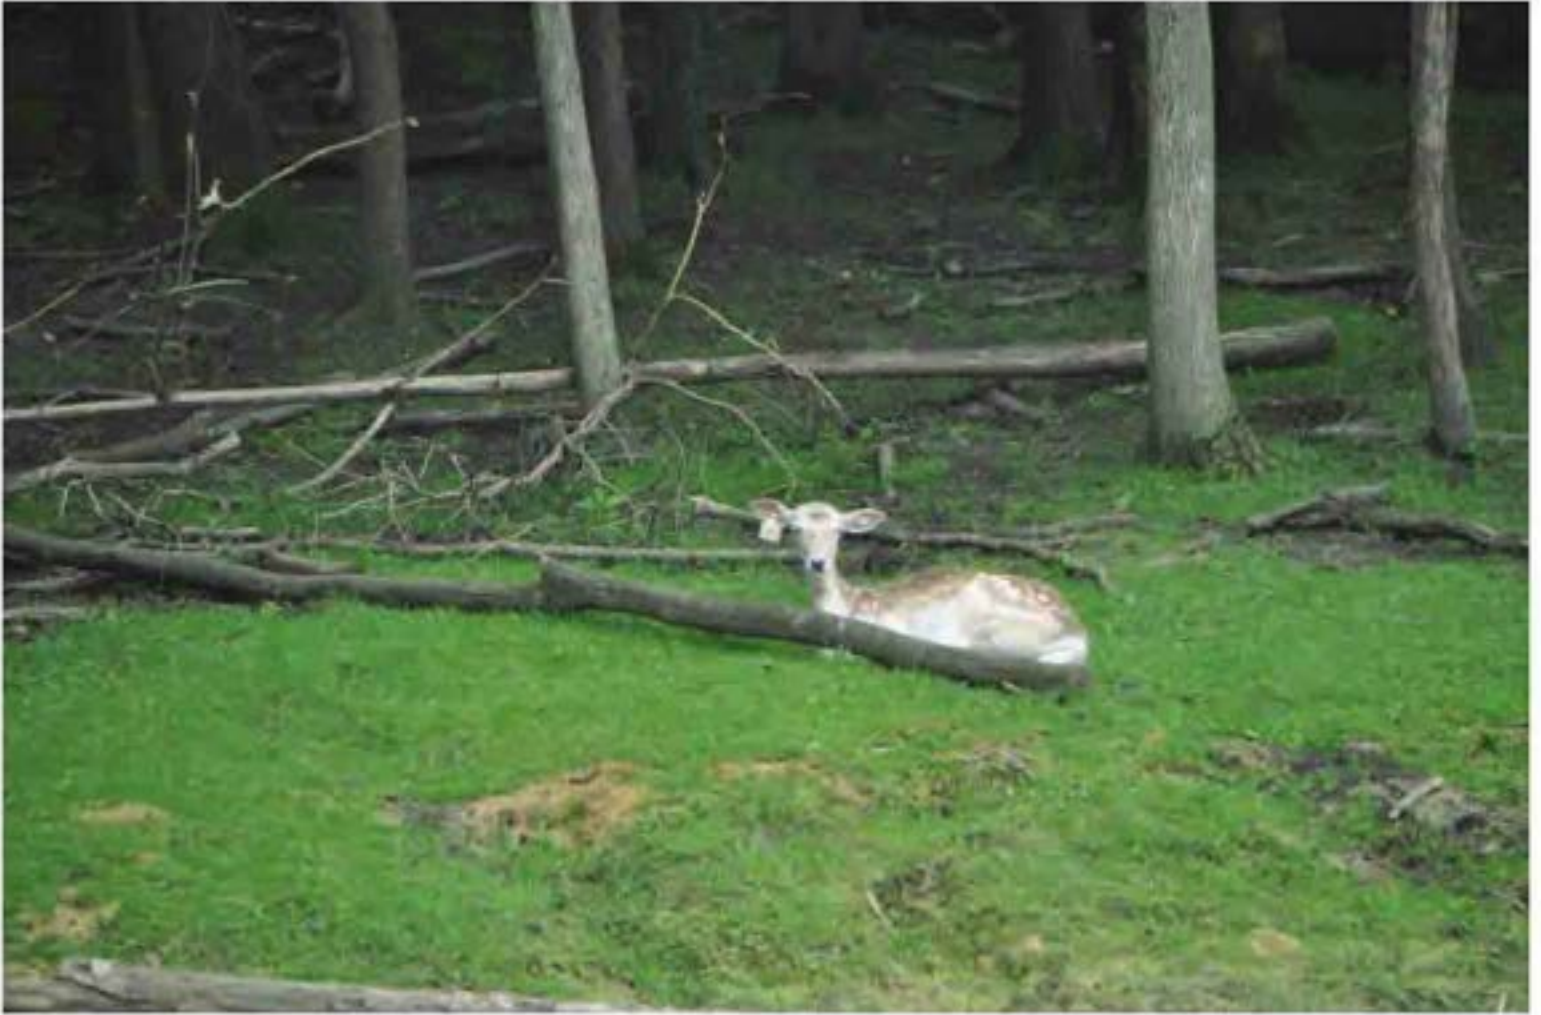
Photographer:	R. Coleman, ACI	Legal Name:	55-B-0069
Photo Taken:	Mon, Jun 30, '14 1030	HENRY HAMPTON	
Inspection:	181141516260708		
Description:	Follow-up photo of fallow deer #0895

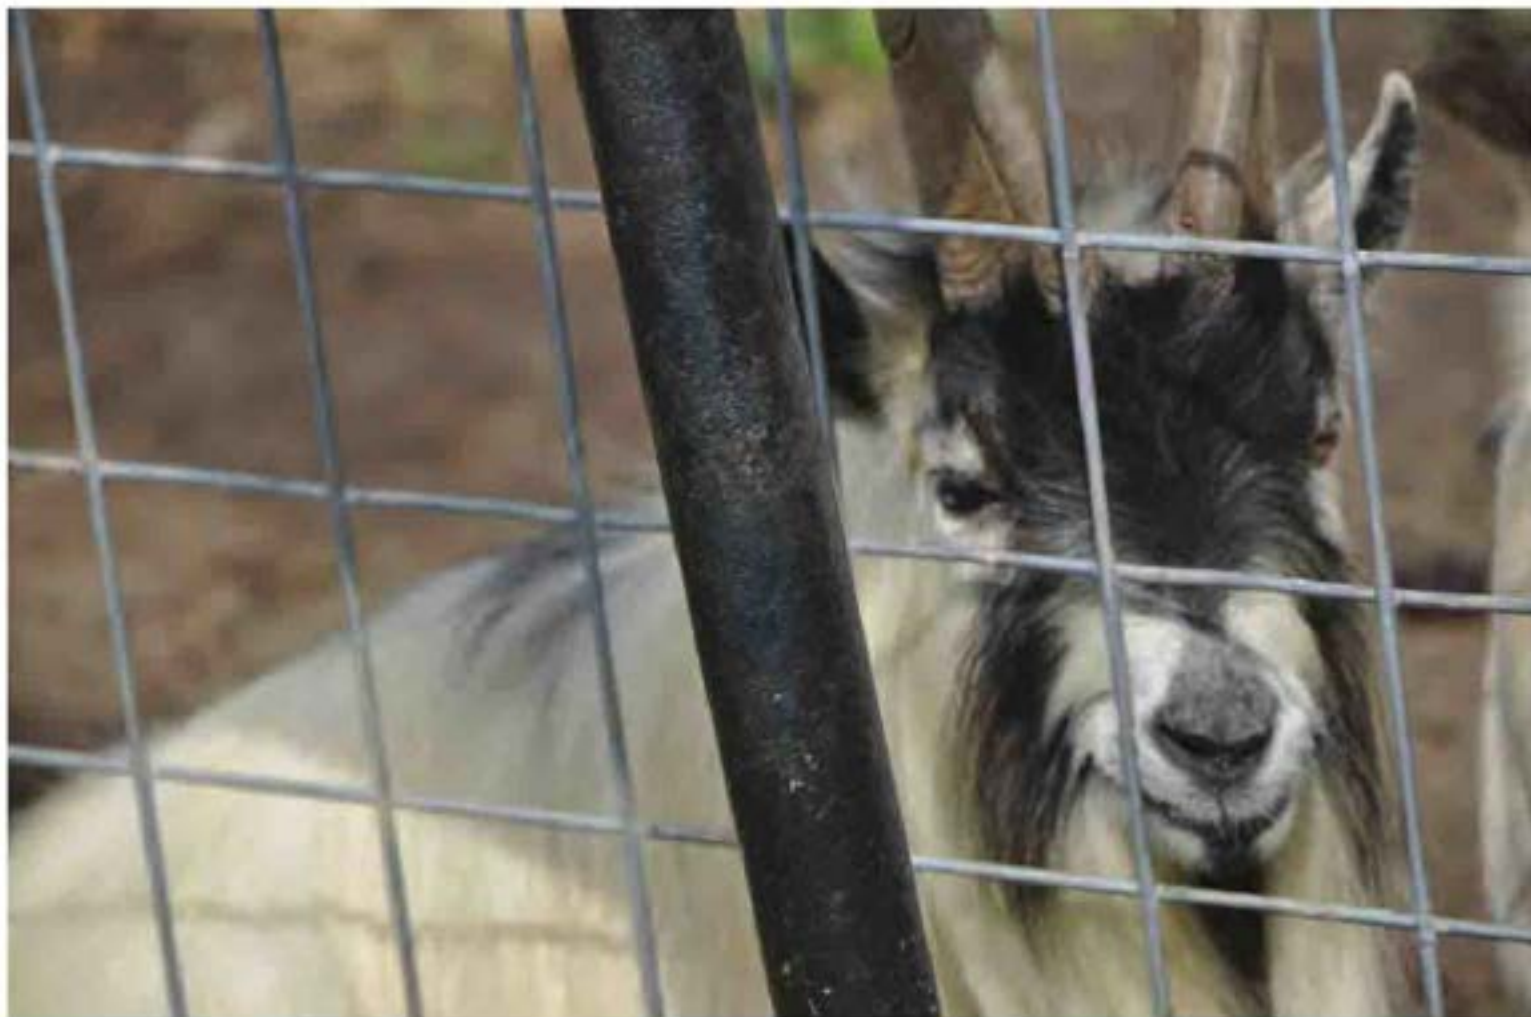
000078

Photographer:	R. Coleman, ACI	Legal Name:	55-B-0069
Photo Taken:	Mon, Jun 30, '14 1030	HENRY HAMPTON	
Inspection:	181141516260708		
Description:	Follow-photo of male Pygmy goat with right eye problem.

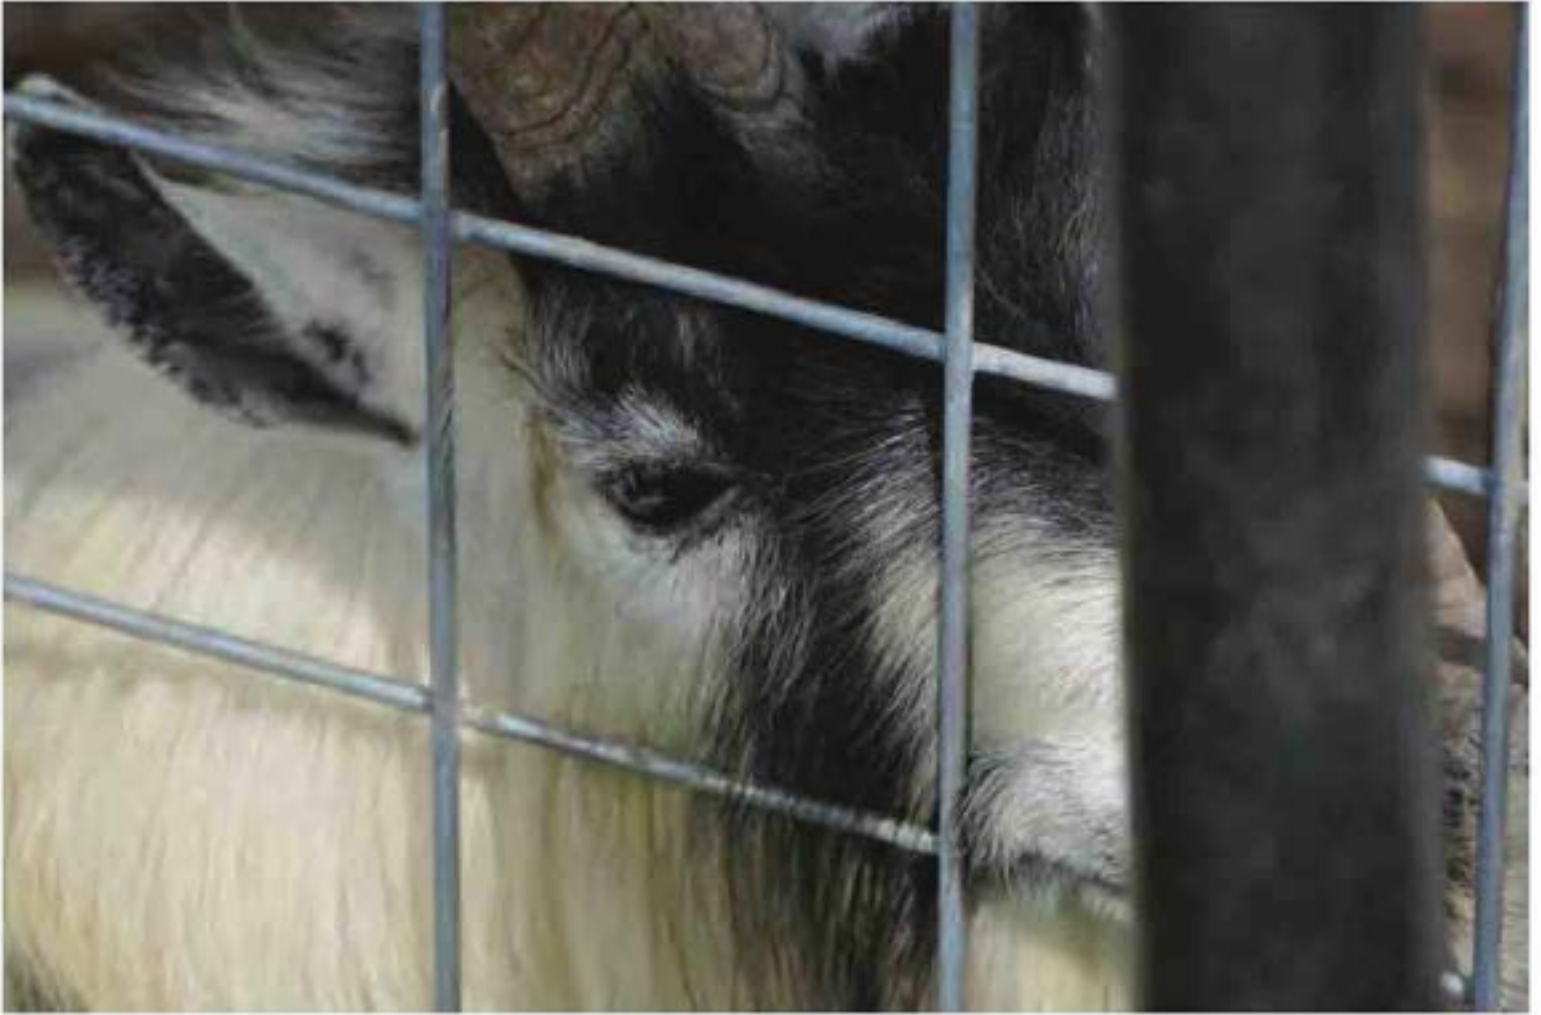
Photographer:	R. Coleman, ACI	Legal Name:	55-B-0069
Photo Taken:	Mon, Jun 30, '14 1030	HENRY HAMPTON	
Inspection:	181141516260708		
Description:	Follow-photo of male Pygmy goat with right eye problem.

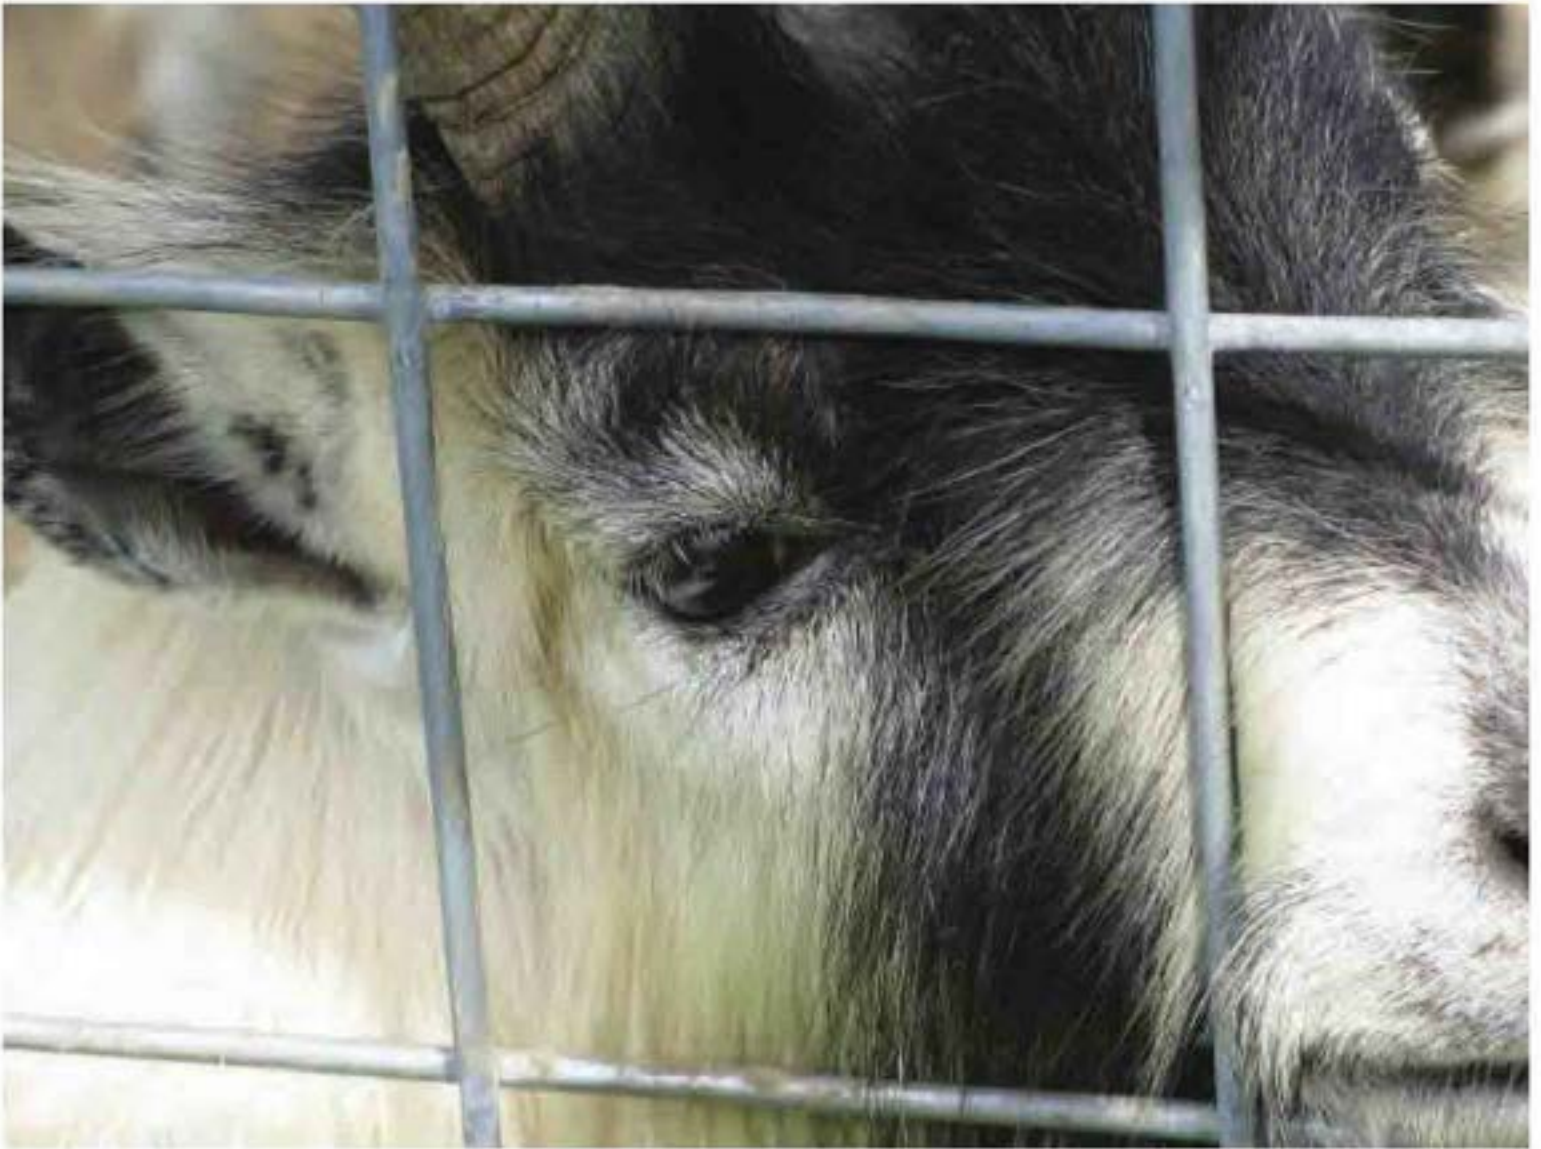
Photographer:	D. Theodorson, VMO	Legal Name:	55-B-0069
Photo Taken:	Mon, Jun 30, '14 1030	HENRY HAMPTON	
Inspection:	181141516260708		
Description:	Follow-photo of male Pygmy goat with right eye problem.

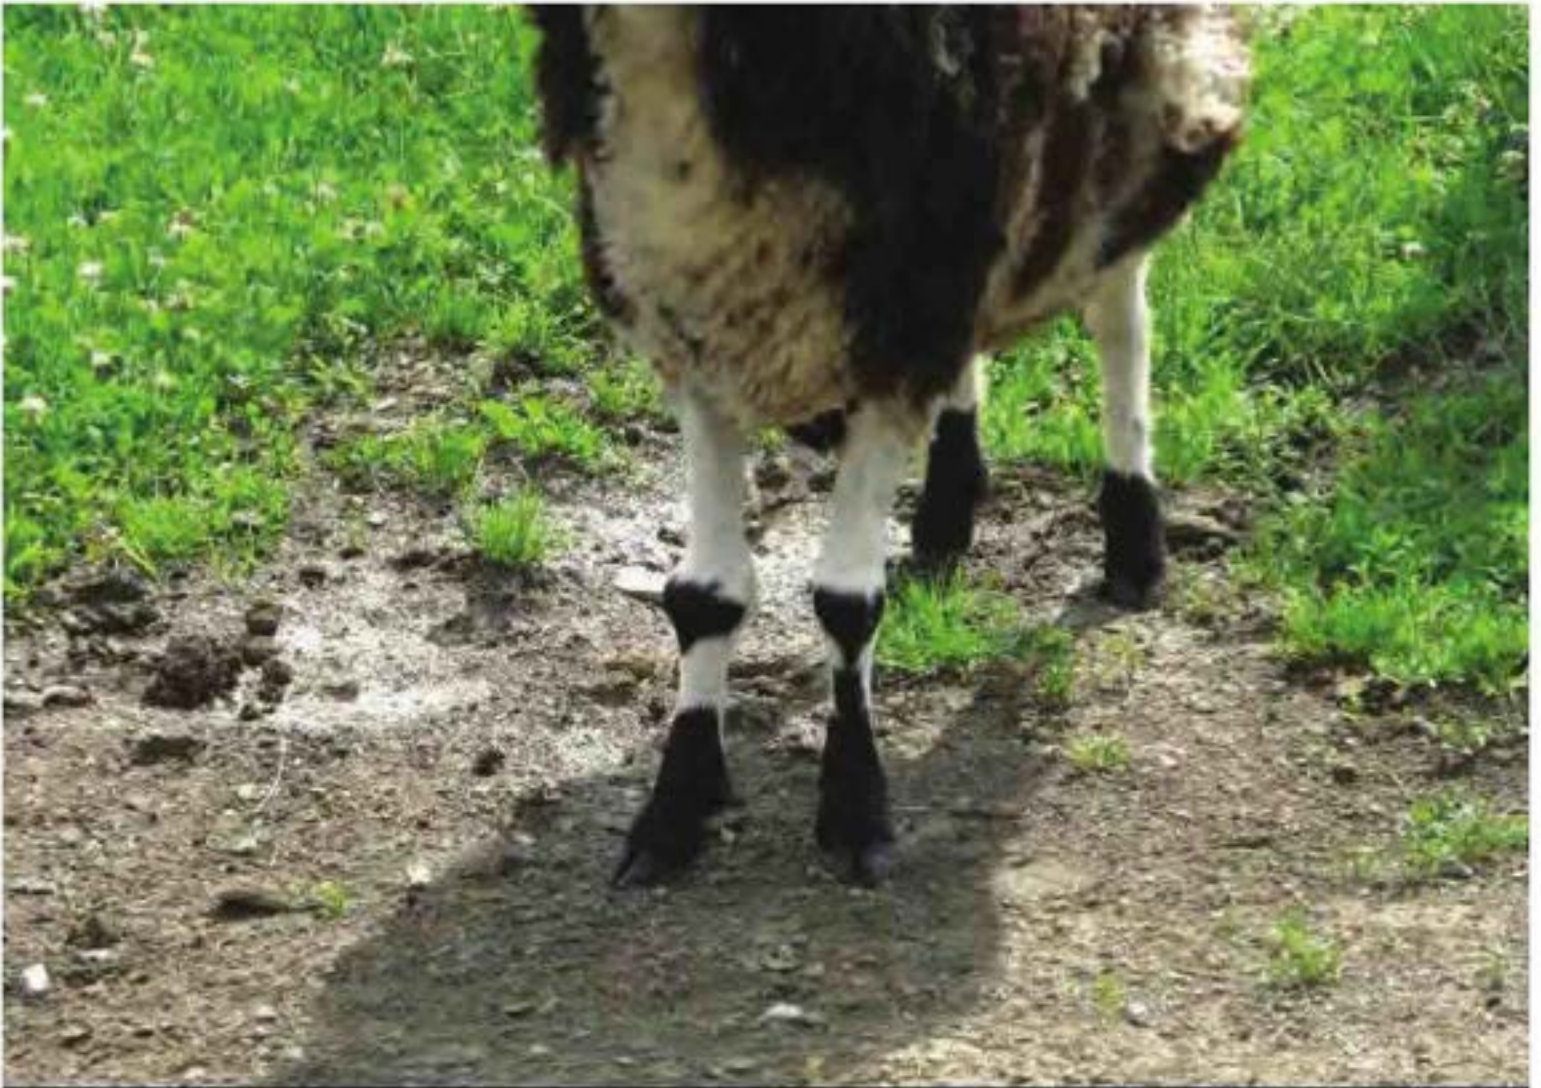
000081

CFR: 2.40 (b) (2)

Photographer:	D. Theodorson, VMO	Legal Name:	55-B-0069
Photo Taken:	Mon, Jun 30, '14 1030	HENRY HAMPTON	
Inspection:	181141516260708		
Description:	Swollen right front carpus on black and white ewe.

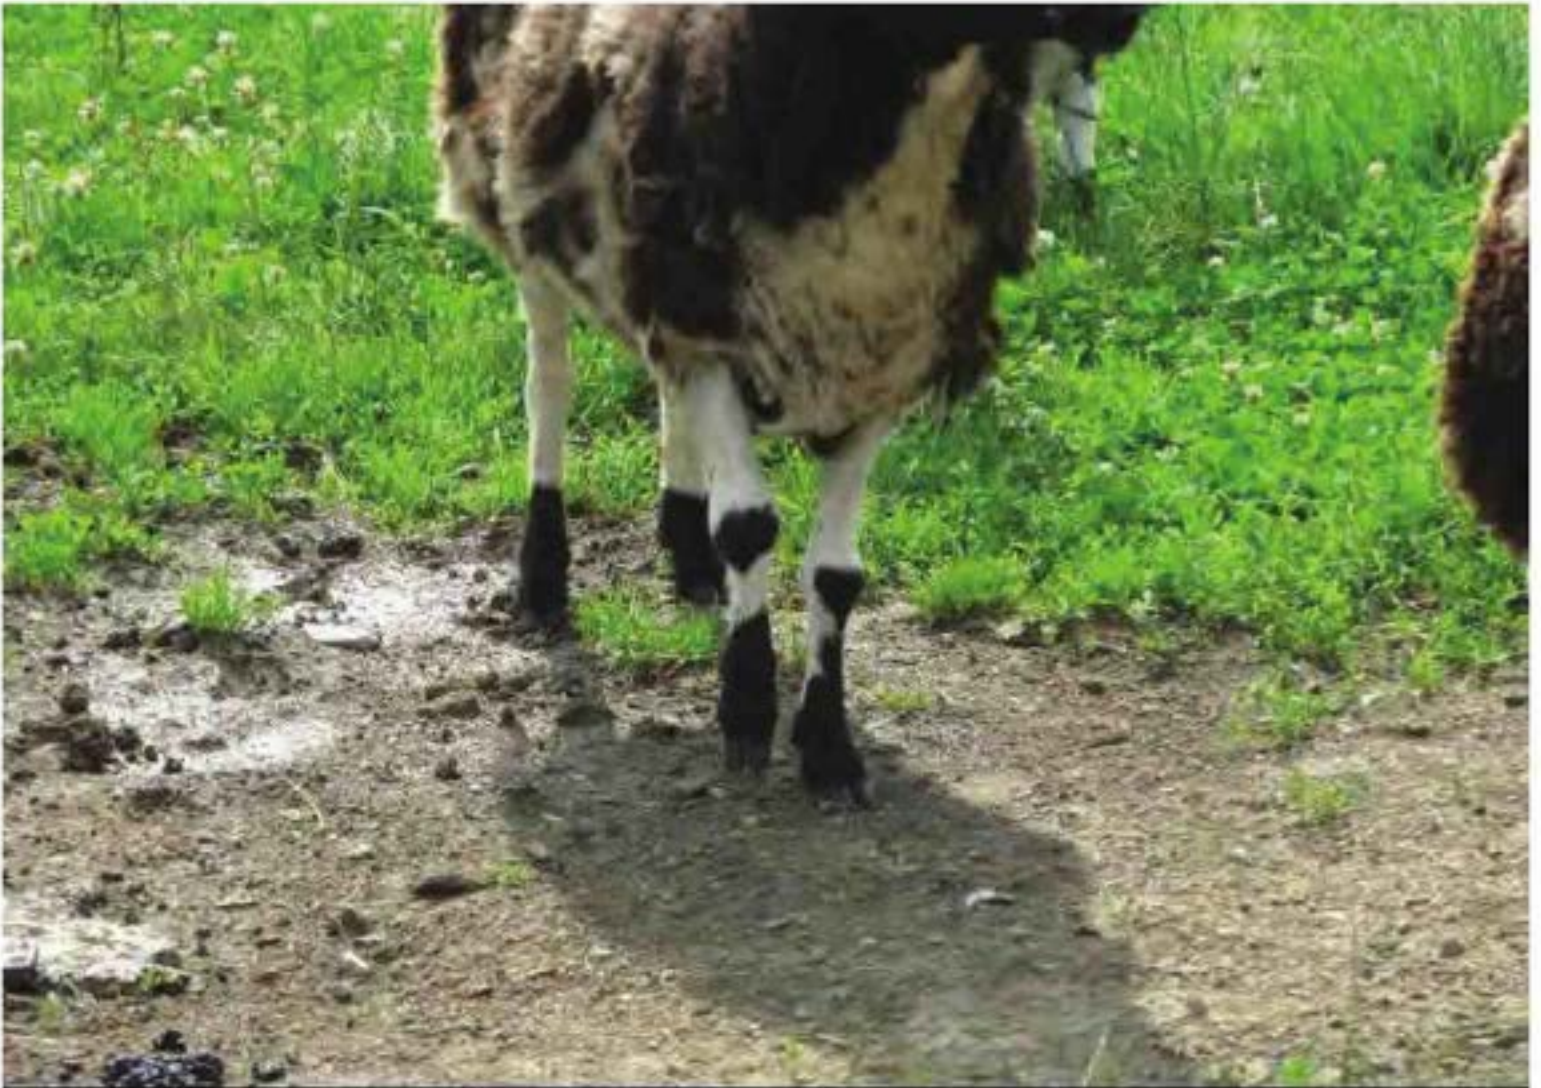
000082

CFR: 2.40 (b) (2)

Photographer:	D. Theodorson, VMO	Legal Name:	55-B-0069
Photo Taken:	Mon, Jun 30, '14 1030	HENRY HAMPTON	
Inspection:	181141516260708		
Description:	Black and white ewe lame.

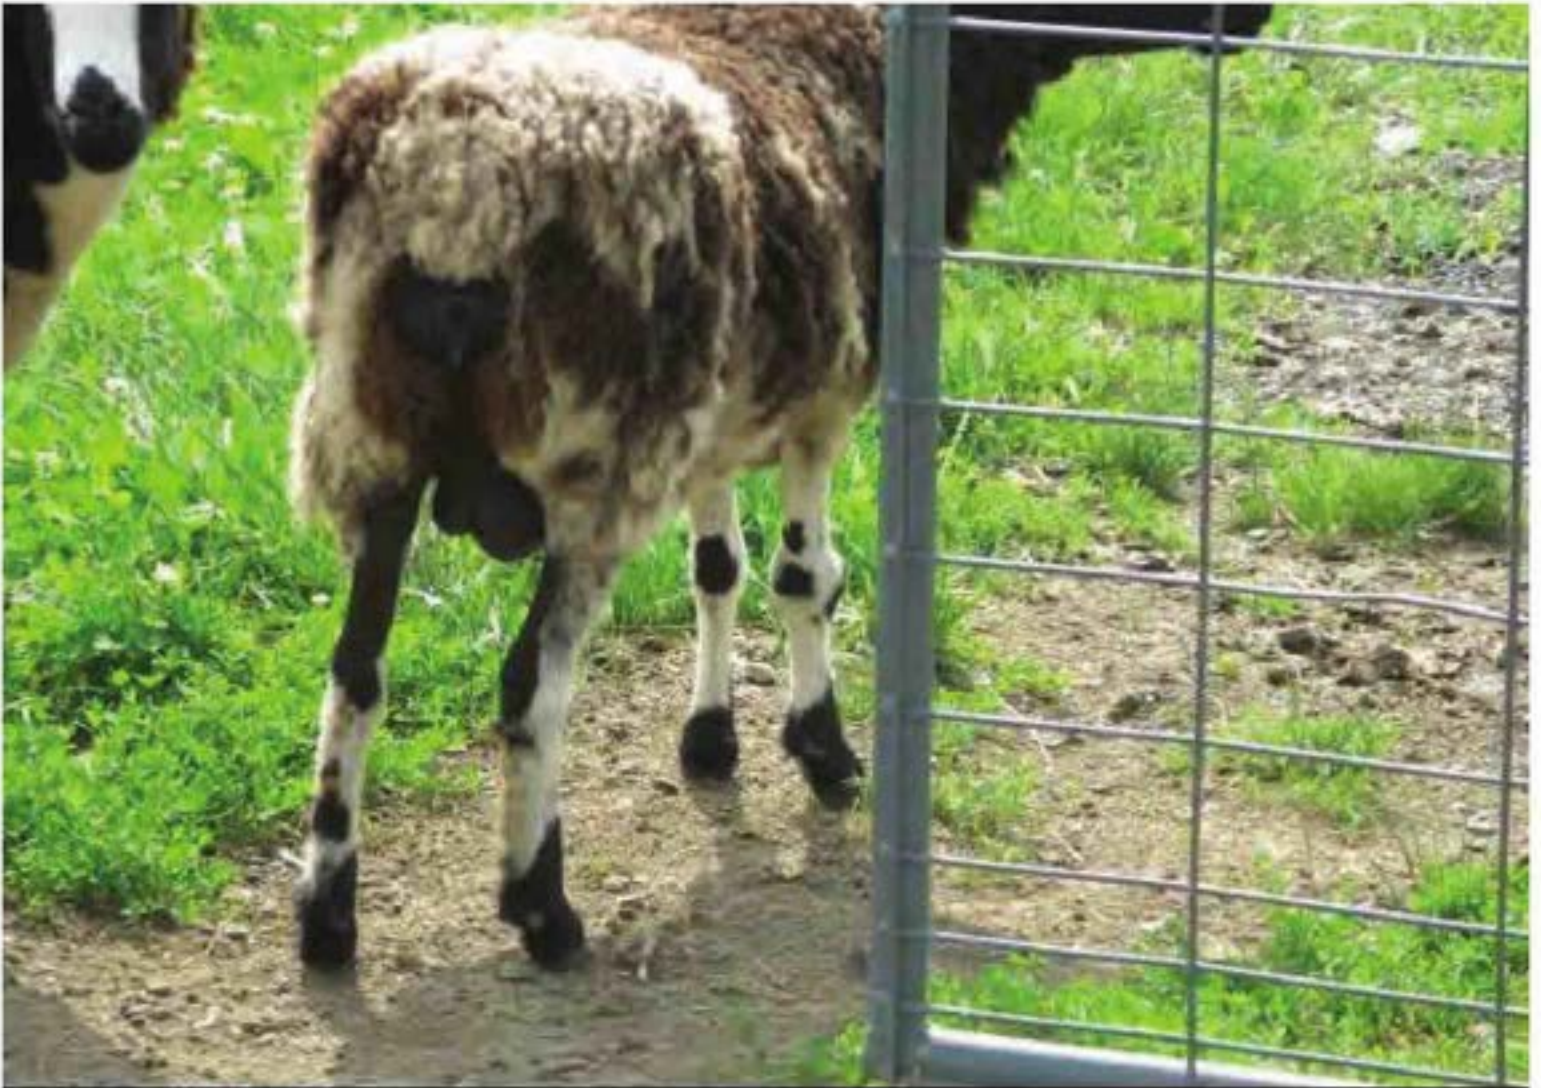
000083

CFR: 2.40 (b) (2)

Photographer:	D. Theodorson, VMO	Legal Name:	55-B-0069
Photo Taken:	Mon, Jun 30, '14 1030	HENRY HAMPTON	
Inspection:	181141516260708		
Description:	Swollen right front carpus of black and white ewe.
