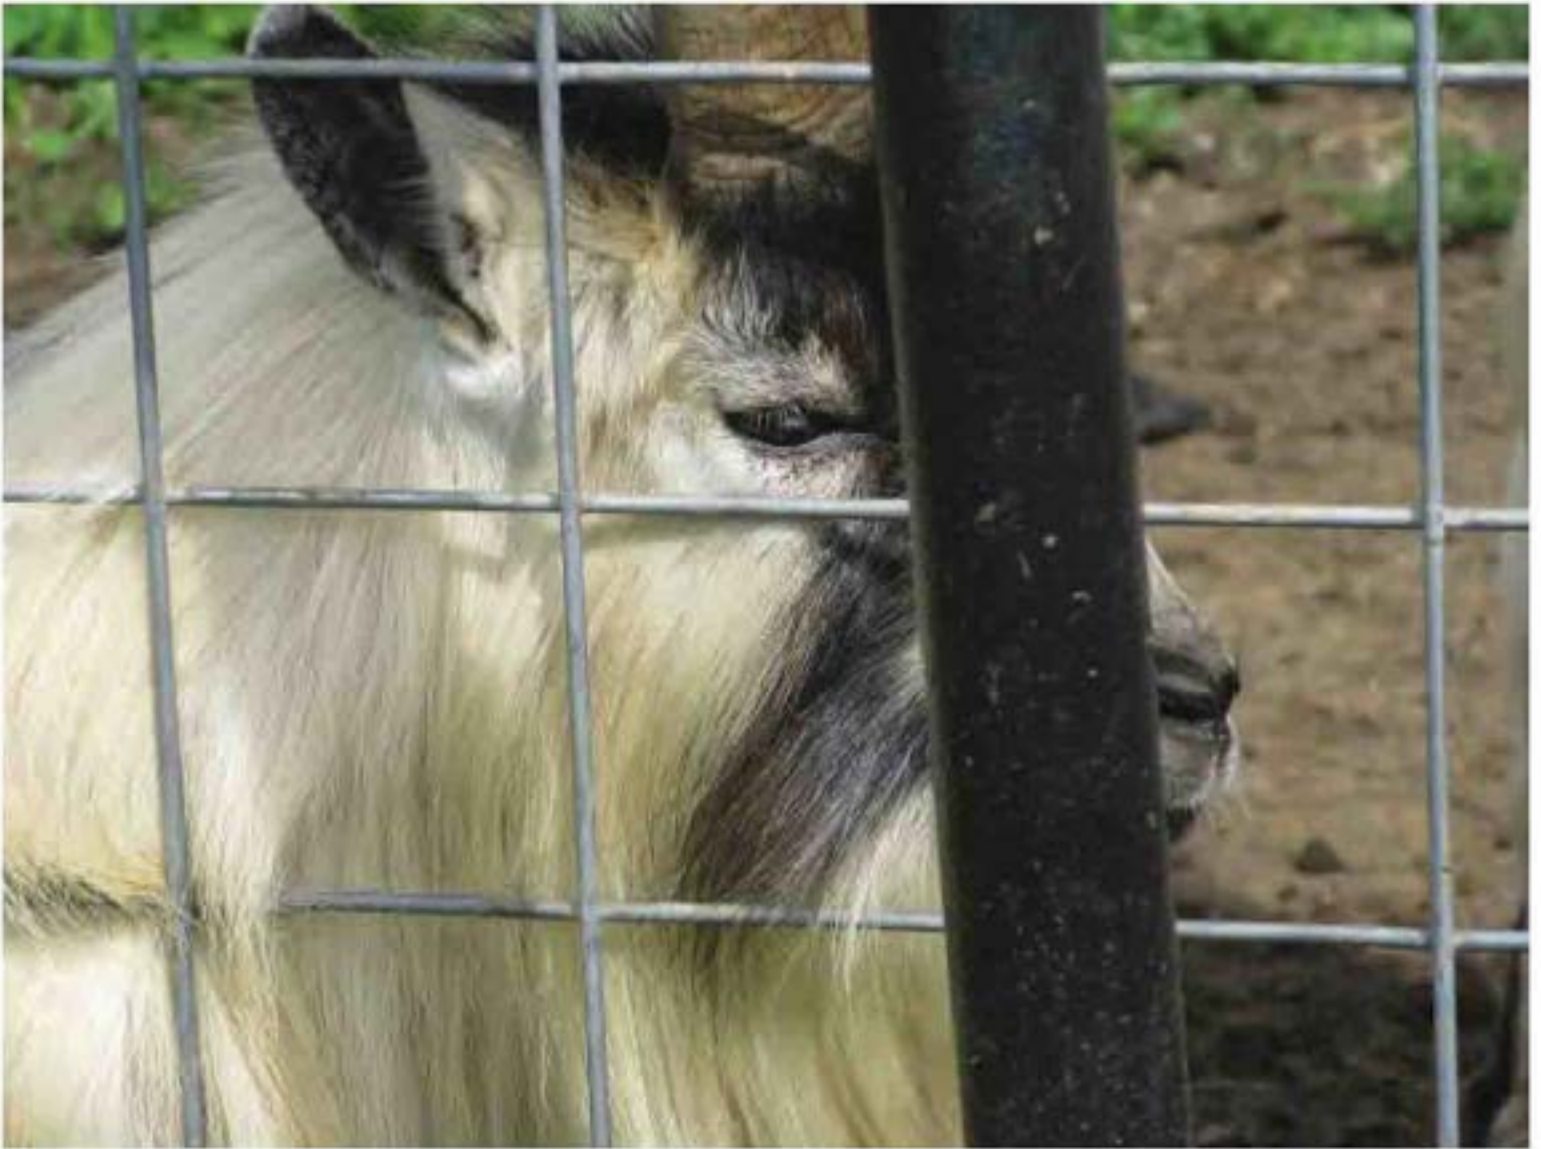
000084

Photographer:	D. Theodorson, VMO	Legal Name:	55-B-0069
Photo Taken:	Mon, Jun 30, '14 1030	HENRY HAMPTON	
Inspection:	181141516260708		
Description:	Follow-photo of male Pygmy goat with right eye problem.

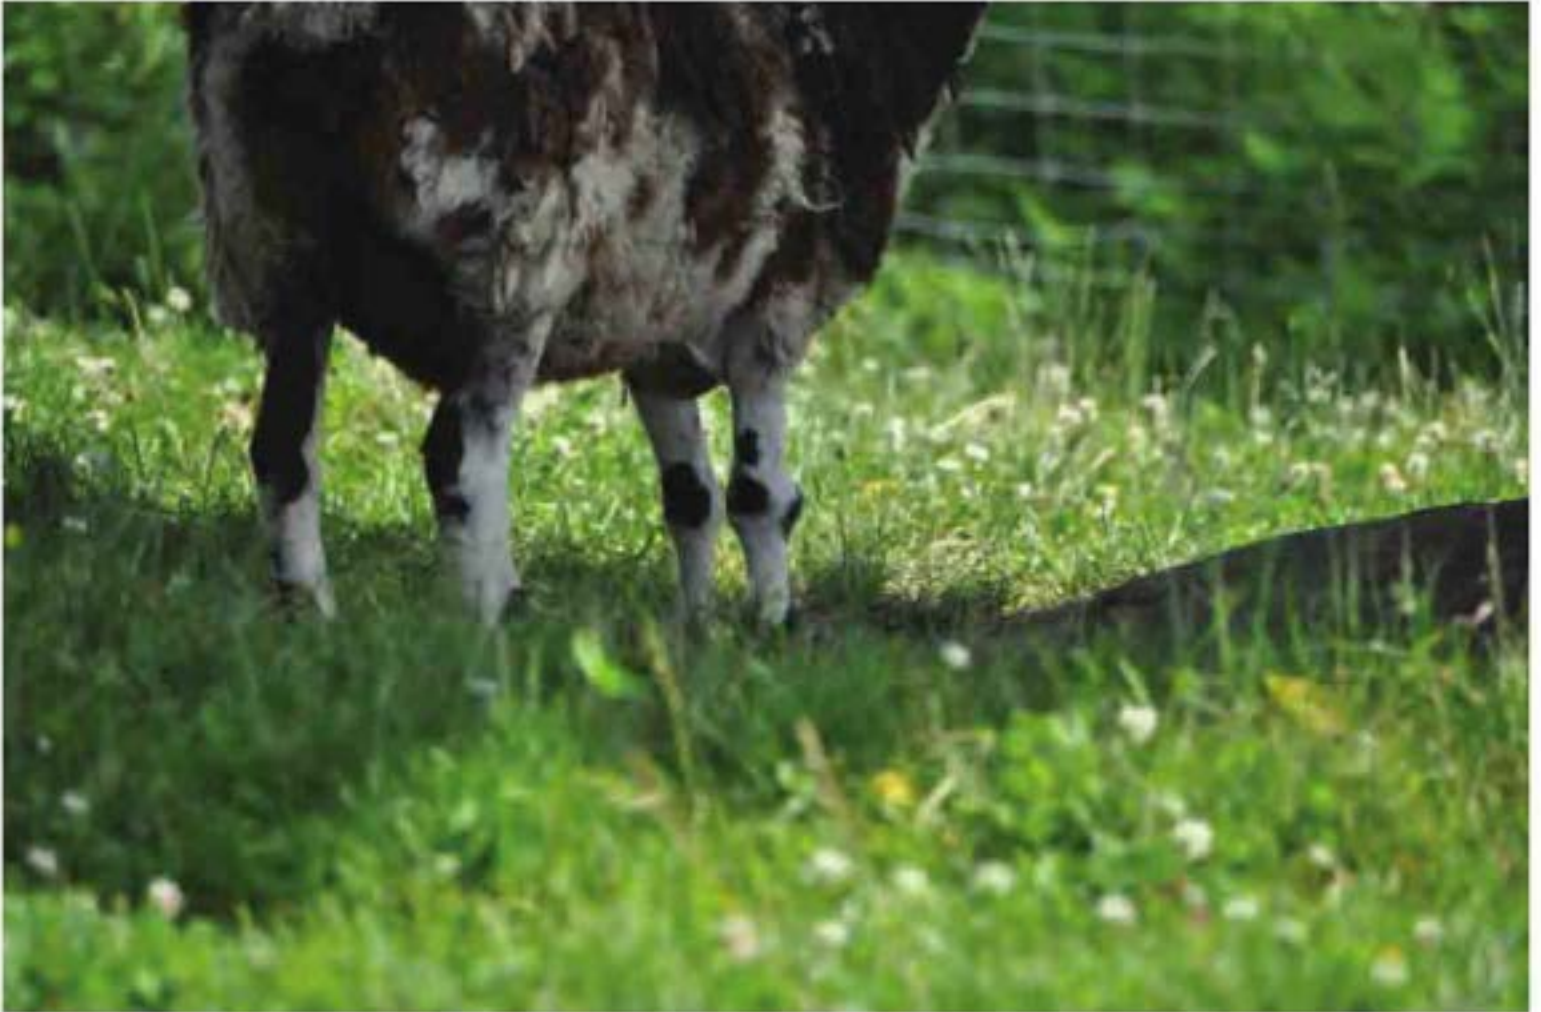
Photographer:	R. Coleman, ACI	Legal Name:	55-B-0069
Photo Taken:	Wed, Jul 16, '14 1000	HENRY HAMPTON	
Inspection:	203141146410962		
Description:	Closer up photo of carpus joints.

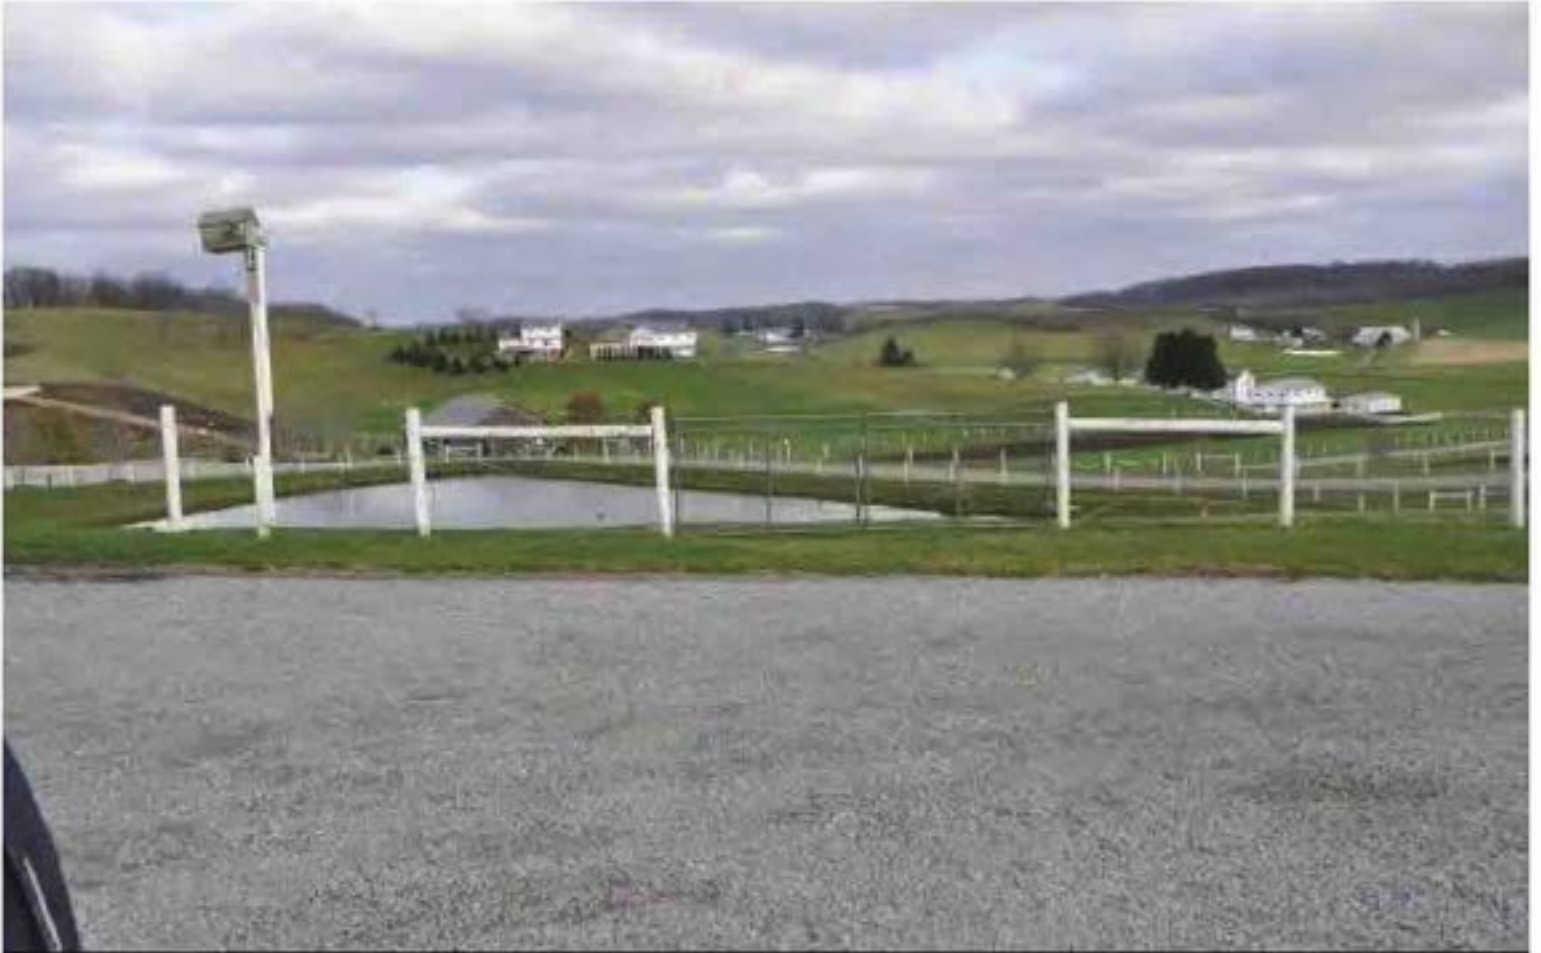
Photographer:	R. Coleman, ACI	Legal Name:	55-B-0069
Photo Taken:	Wed, Jul 16, '14 1000	HENRY HAMPTON	
Inspection:	203141146410962		
Description:	Overivew of black and white ewe.

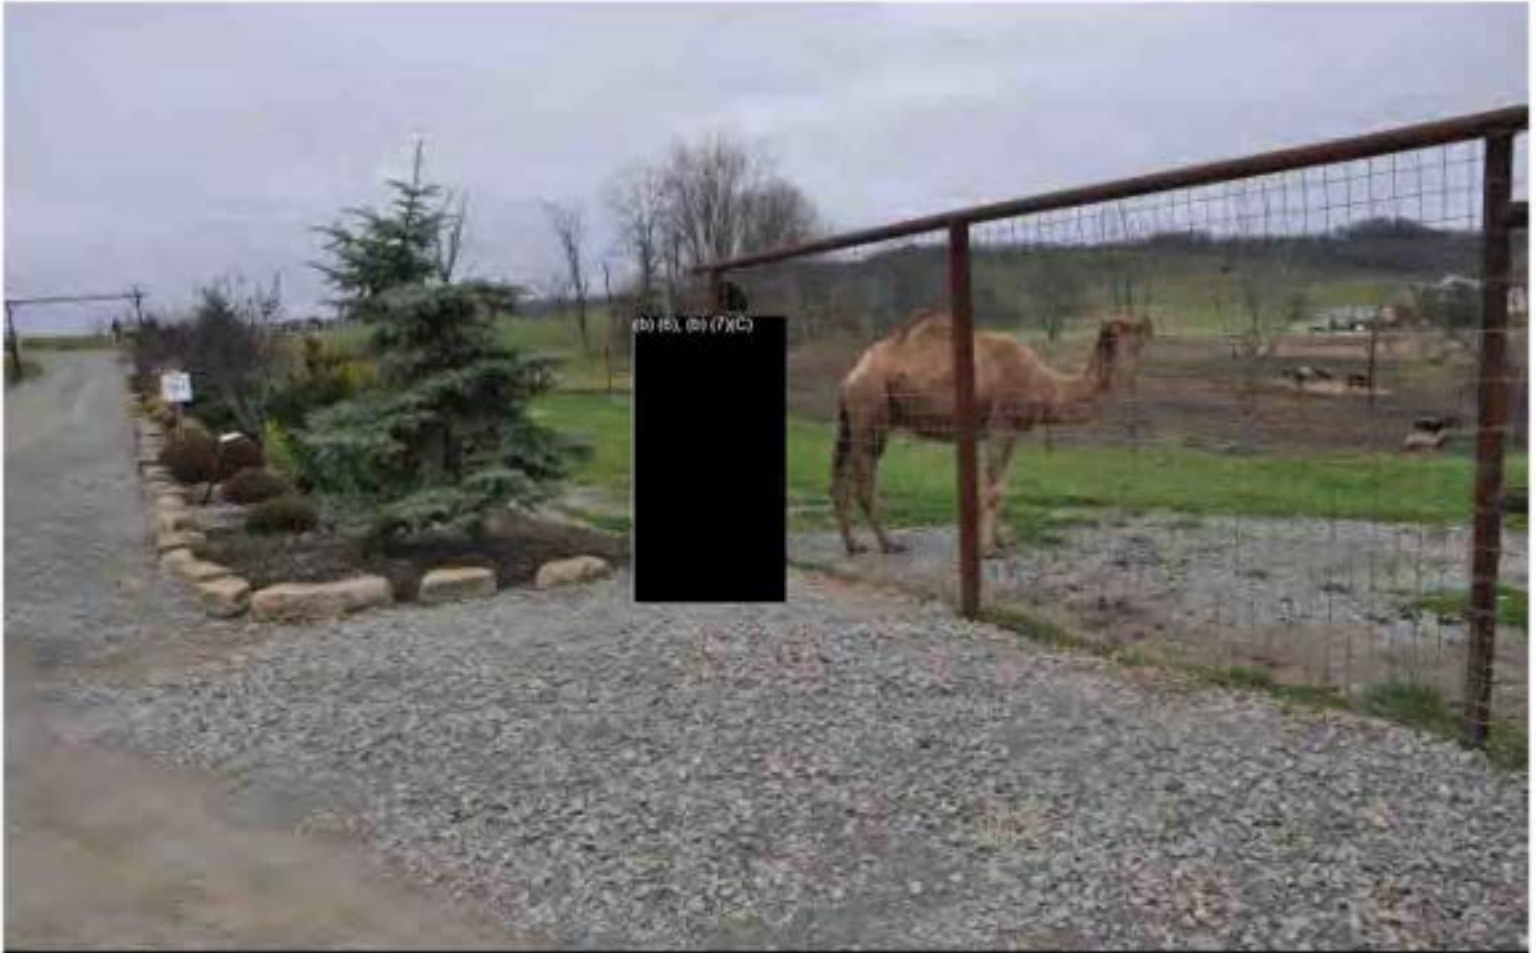
000088

CFR: 2.131 (c) (1)

Photographer:	R. Coleman	Legal Name:	55-B-0069
Photo Taken:	Wed, Nov 12, '14 12-4 pm	HENRY HAMPTON	
Inspection:	321140657190604		
Description:	No barrier or attendant for pasture containing goats.

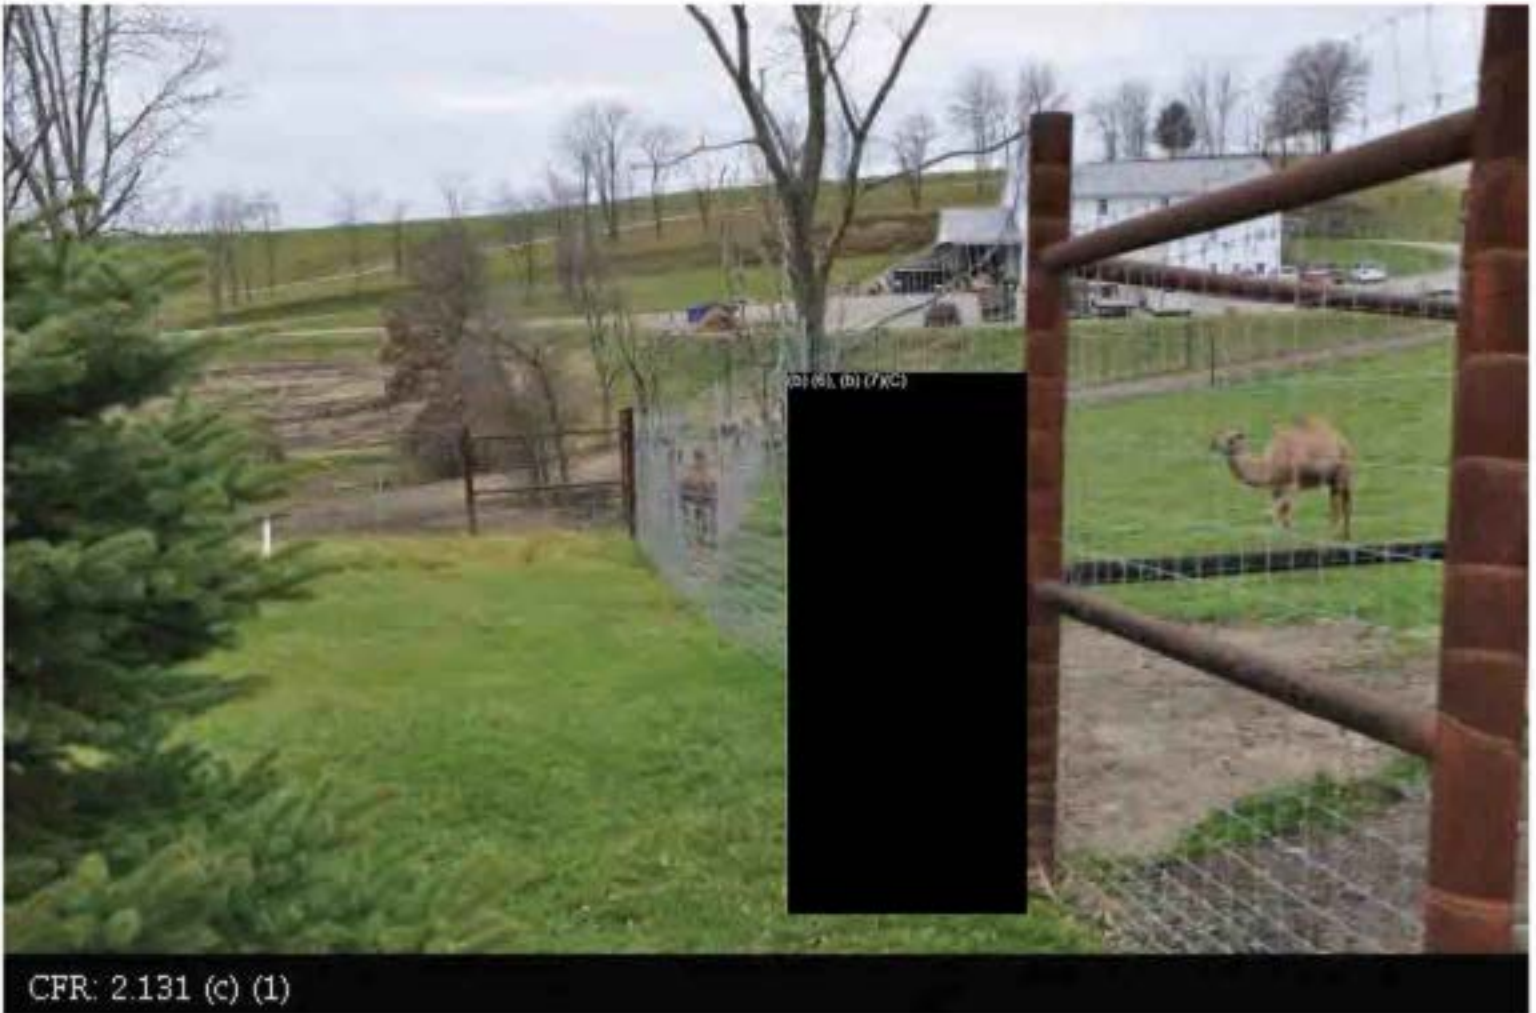
000089

CFR: 2.131 (c) (1)

Photographer:	R. Coleman	Legal Name:	55-B-0069
Photo Taken:	Wed, Nov 12, '14 12-4 pm	HENRY HAMPTON	
Inspection:	321140657190604		
Description:	No barrier or attendant for camel enclosure.

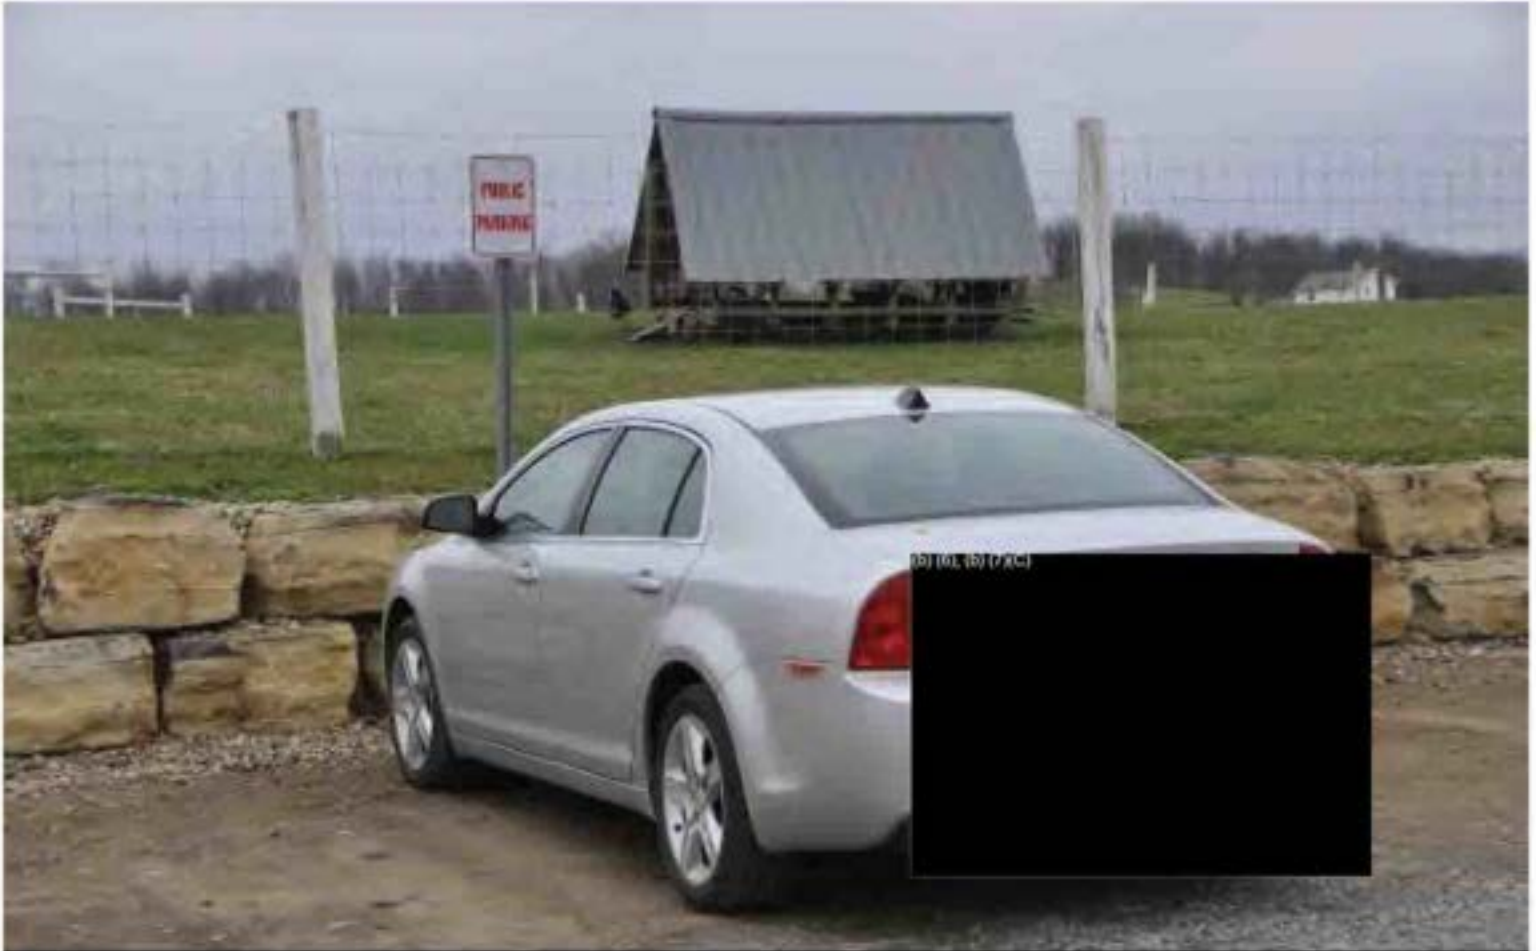
Photographer:	R. Coleman	Legal Name:	55-B-0069
Photo Taken:	Wed, Nov 12, '14 12-4 pm	HENRY HAMPTON	
Inspection:	321140657190604		
Description:	No barrier or attendant for camel enclosure.

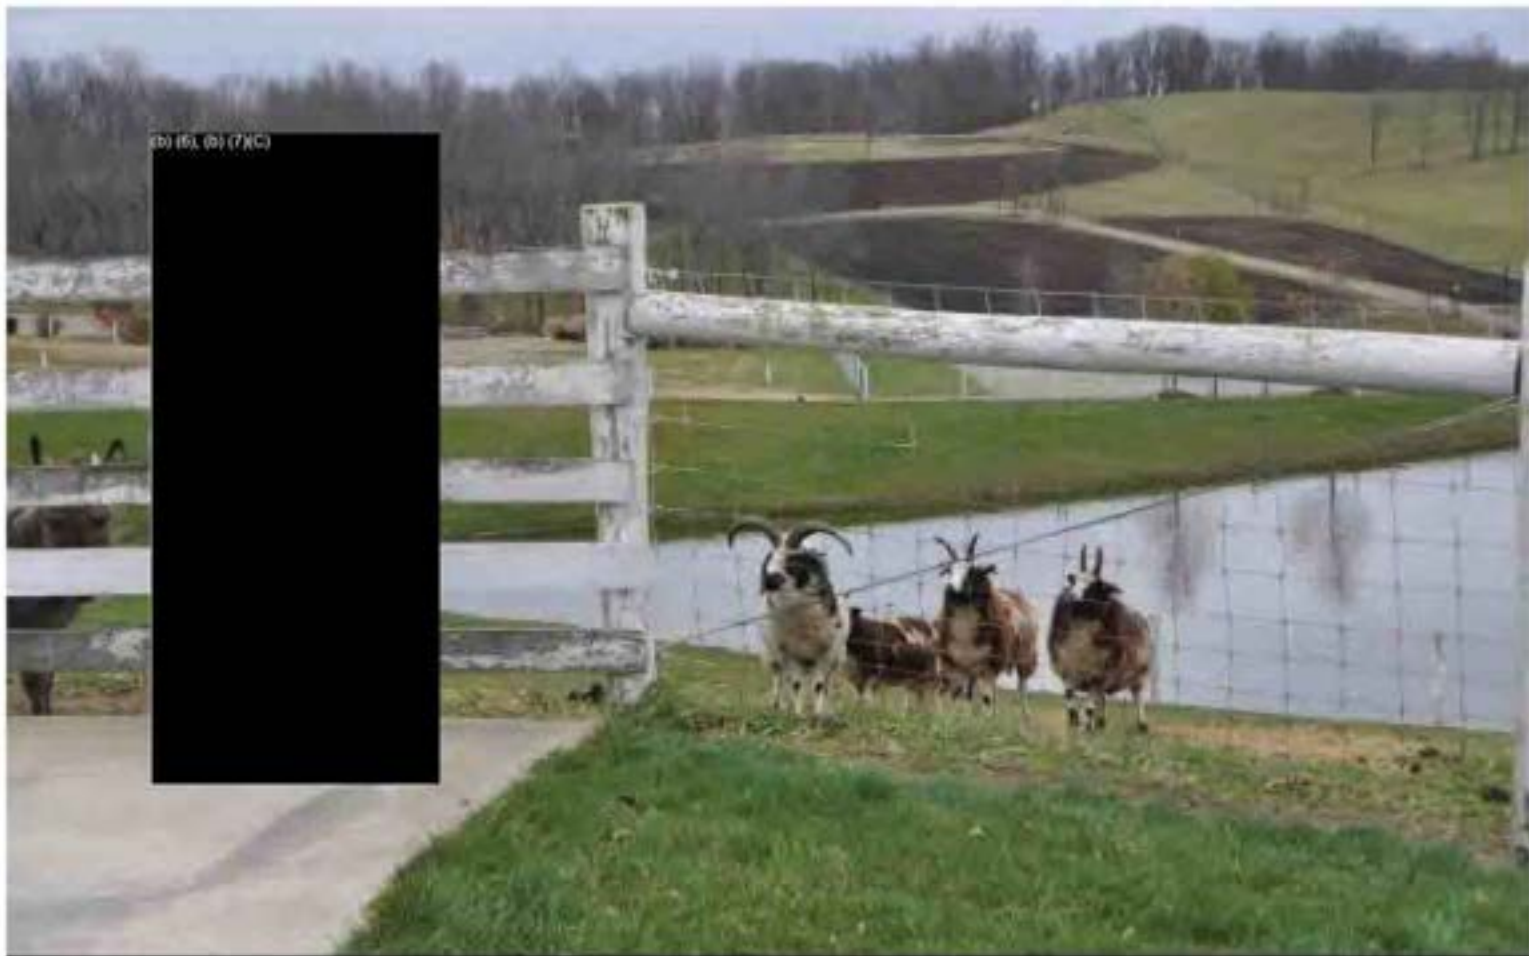
000091

CFR: 2.131 (c) (1)

Photographer:	R. Coleman	Legal Name:	55-B-0069
Photo Taken:	Wed, Nov 12, '14 12-4 pm	HENRY HAMPTON	
Inspection:	321140657190604		
Description:	Public parking showing vehicle present.

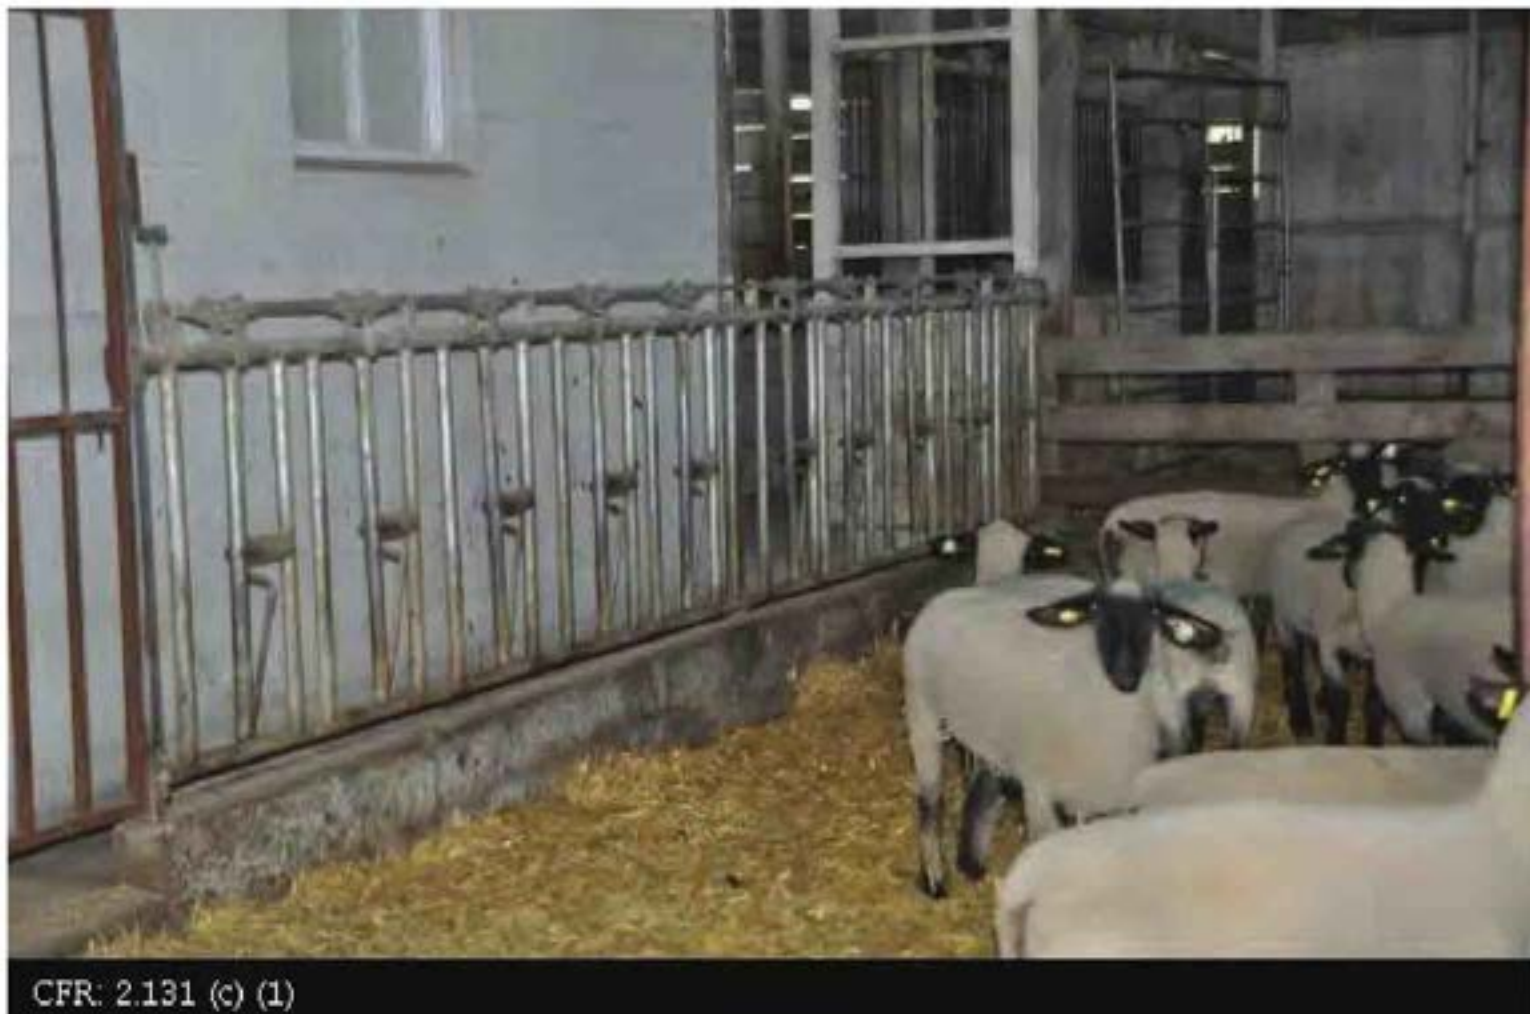
000092

CFR: 2.131 (c) (1)

Photographer:	R. Coleman	Legal Name:	55-B-0069
Photo Taken:	Wed, Nov 12, '14 12-4 pm	HENRY HAMPTON	
Inspection:	321140657190604		
Description:	No barrier or attendant for pasture containing goats.

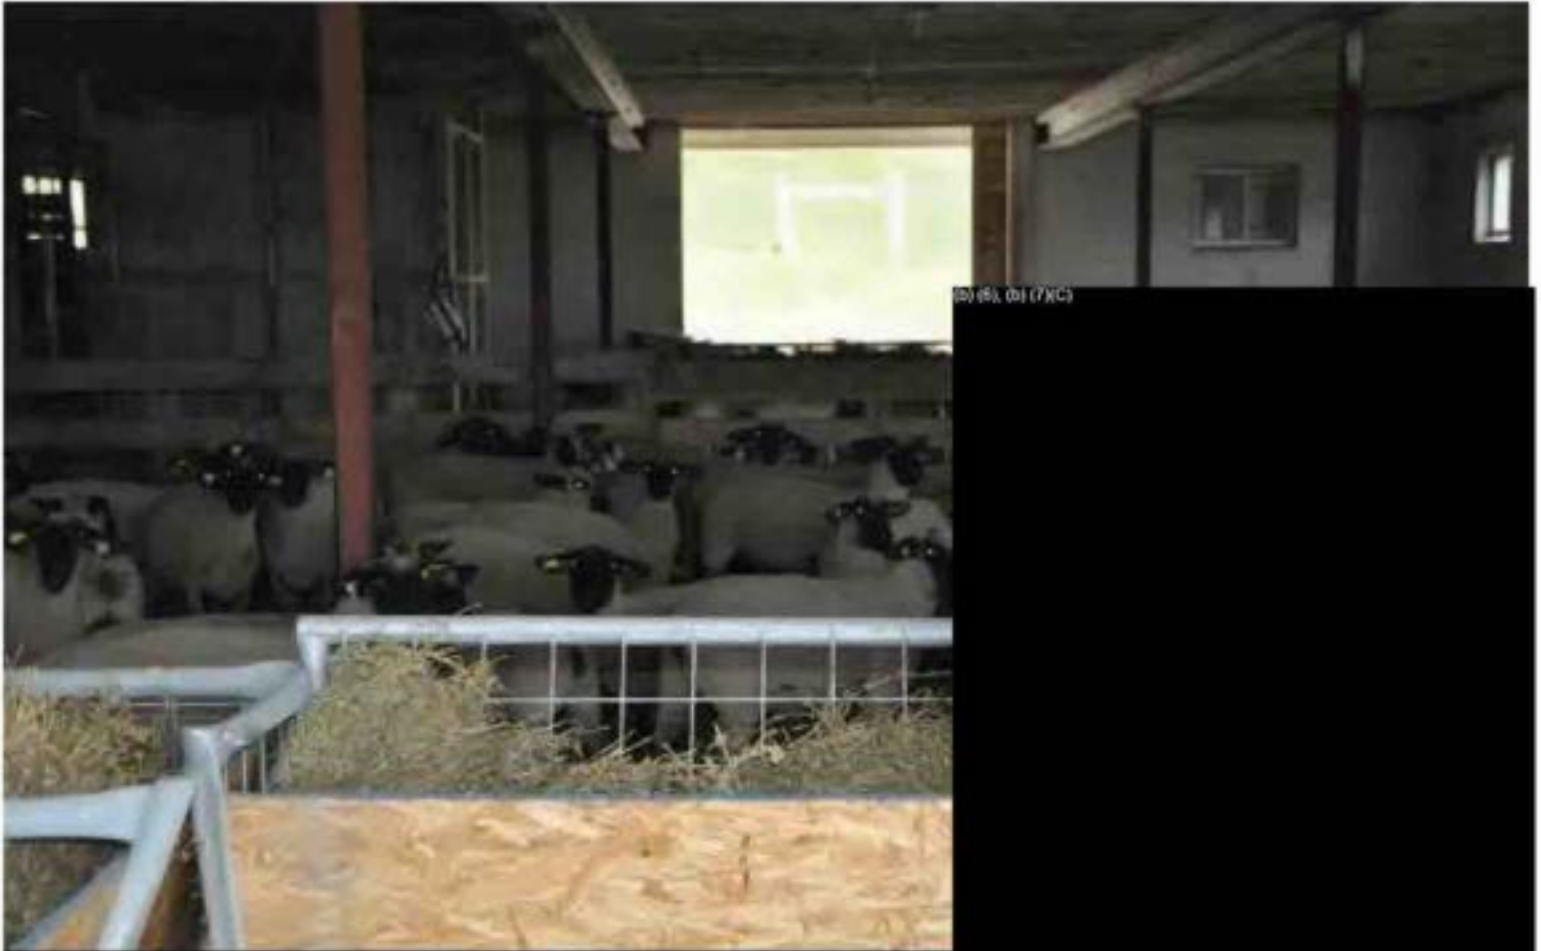
000093

CFR: 2.131 (c) (1)

Photographer:	R. Coleman	Legal Name:	55-B-0069
Photo Taken:	Wed, Nov 12, '14 12-4 pm	HENRY HAMPTON	
Inspection:	321140657190604		
Description:	No barrier or attendant for dairy barn containing sheep and goats.

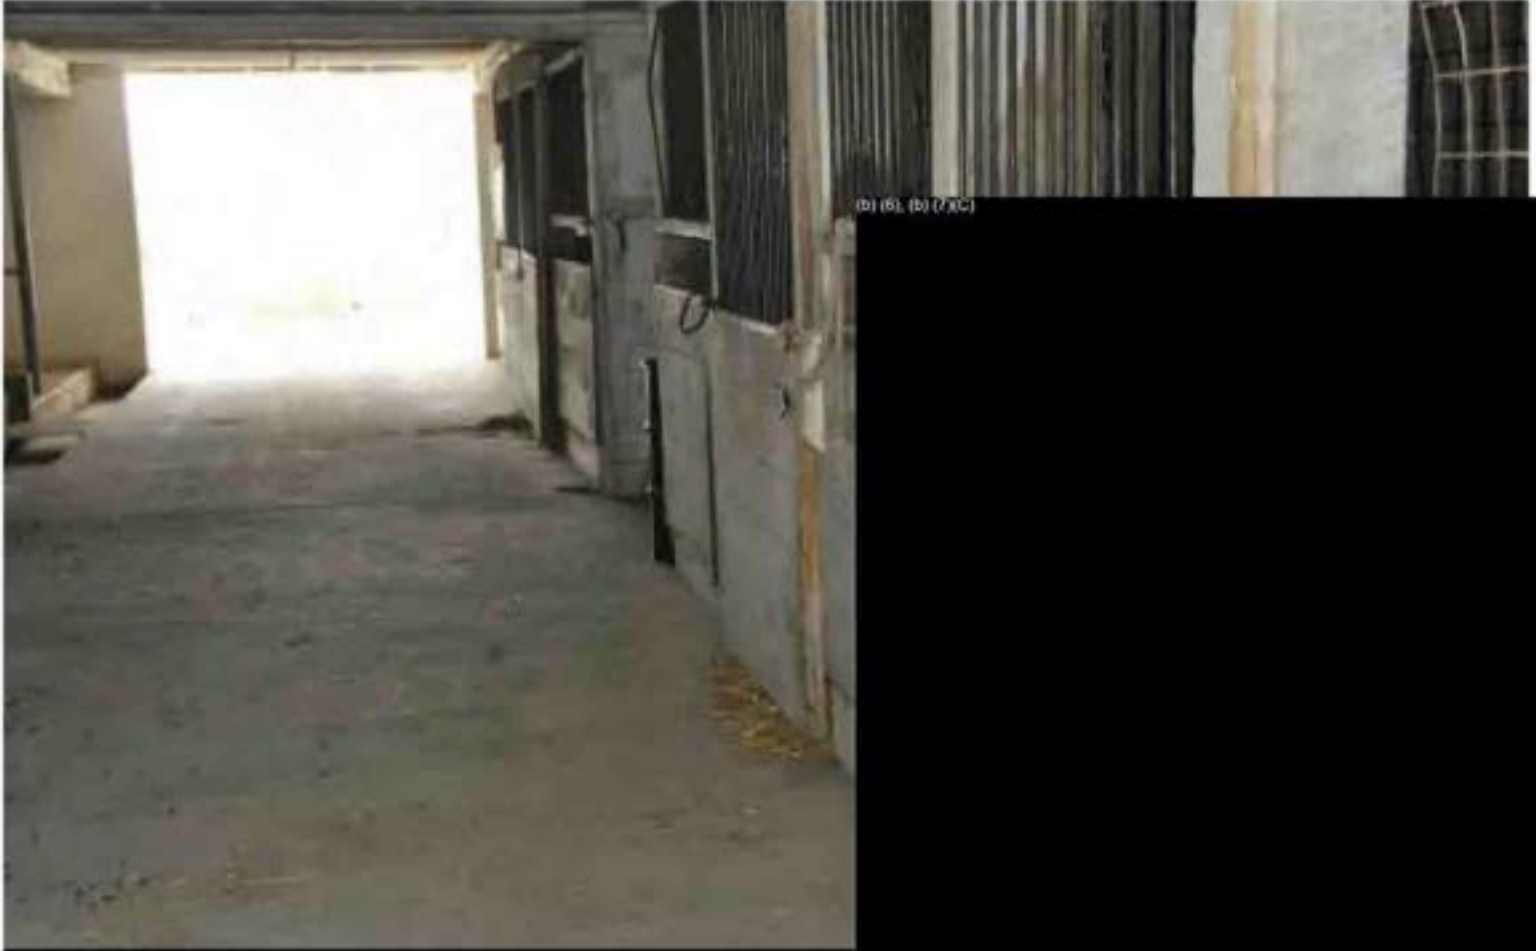
CFR: 2.131 (c) (1)

Photographer:	R. Coleman	Legal Name:	55-B-0069
Photo Taken:	Wed, Nov 12, '14 12-4 pm	HENRY HAMPTON	
Inspection:	321140657190604		
Description:	No barrier or attendant for dairy barn containing sheep and goats.

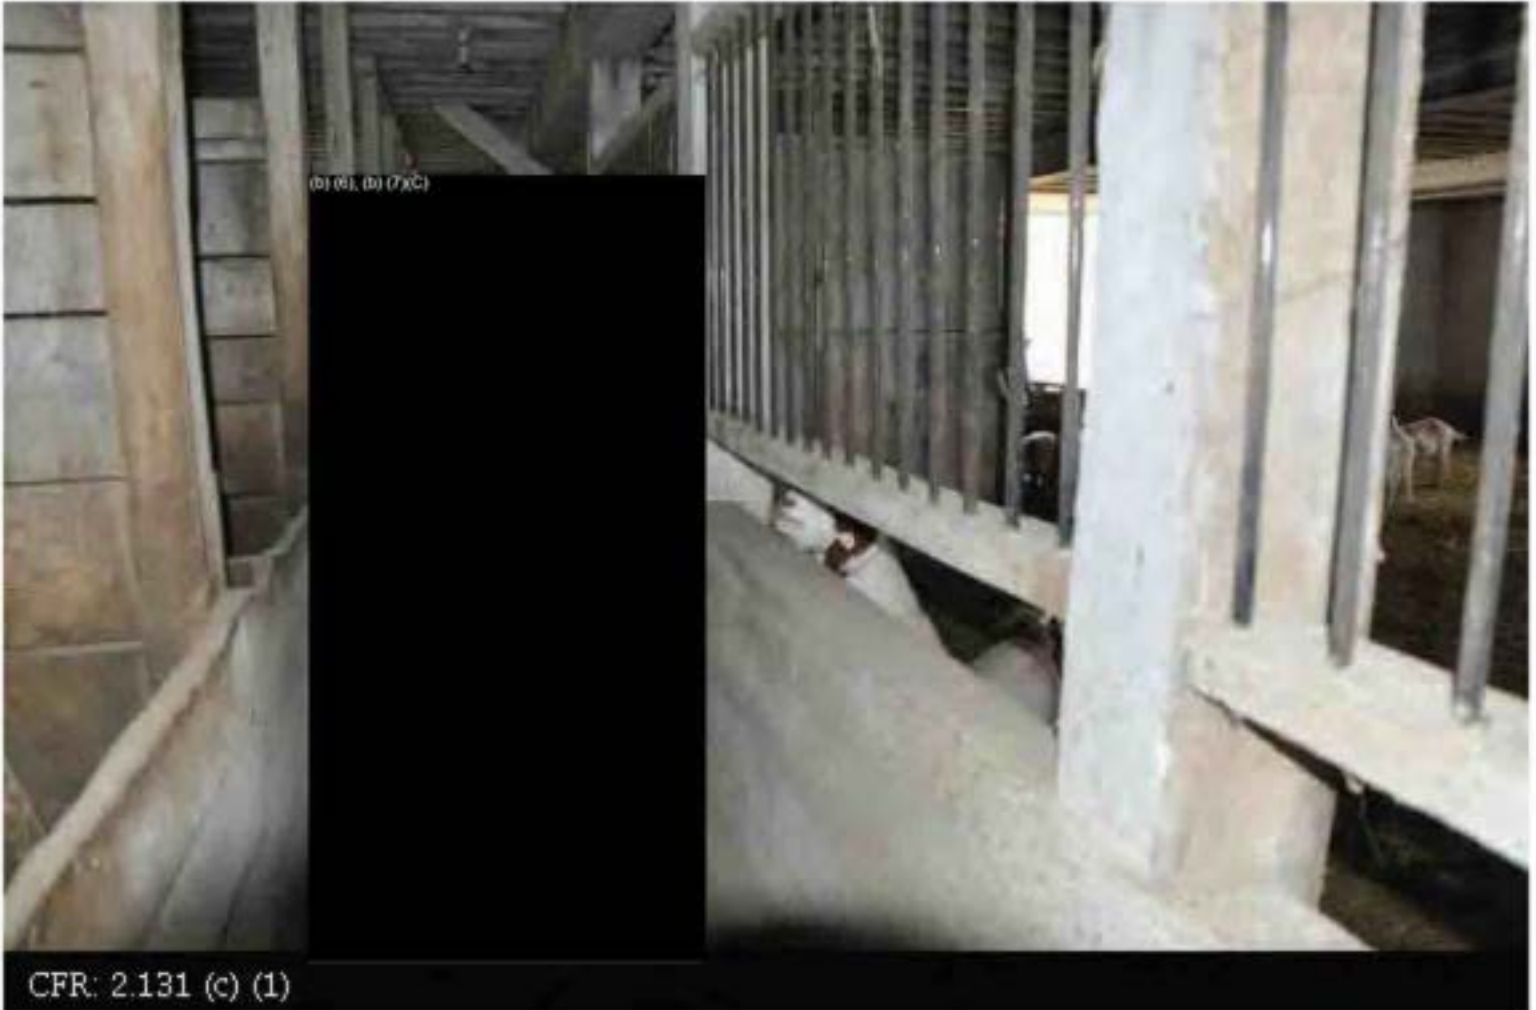
000095

CFR: 2.131 (c) (1)

Photographer:	R. Coleman	Legal Name:	55-B-0069
Photo Taken:	Wed, Nov 12, '14 12-4 pm	HENRY HAMPTON	
Inspection:	321140657190604		
Description:	No barrier or attendant for dairy barn containing sheep and goats.

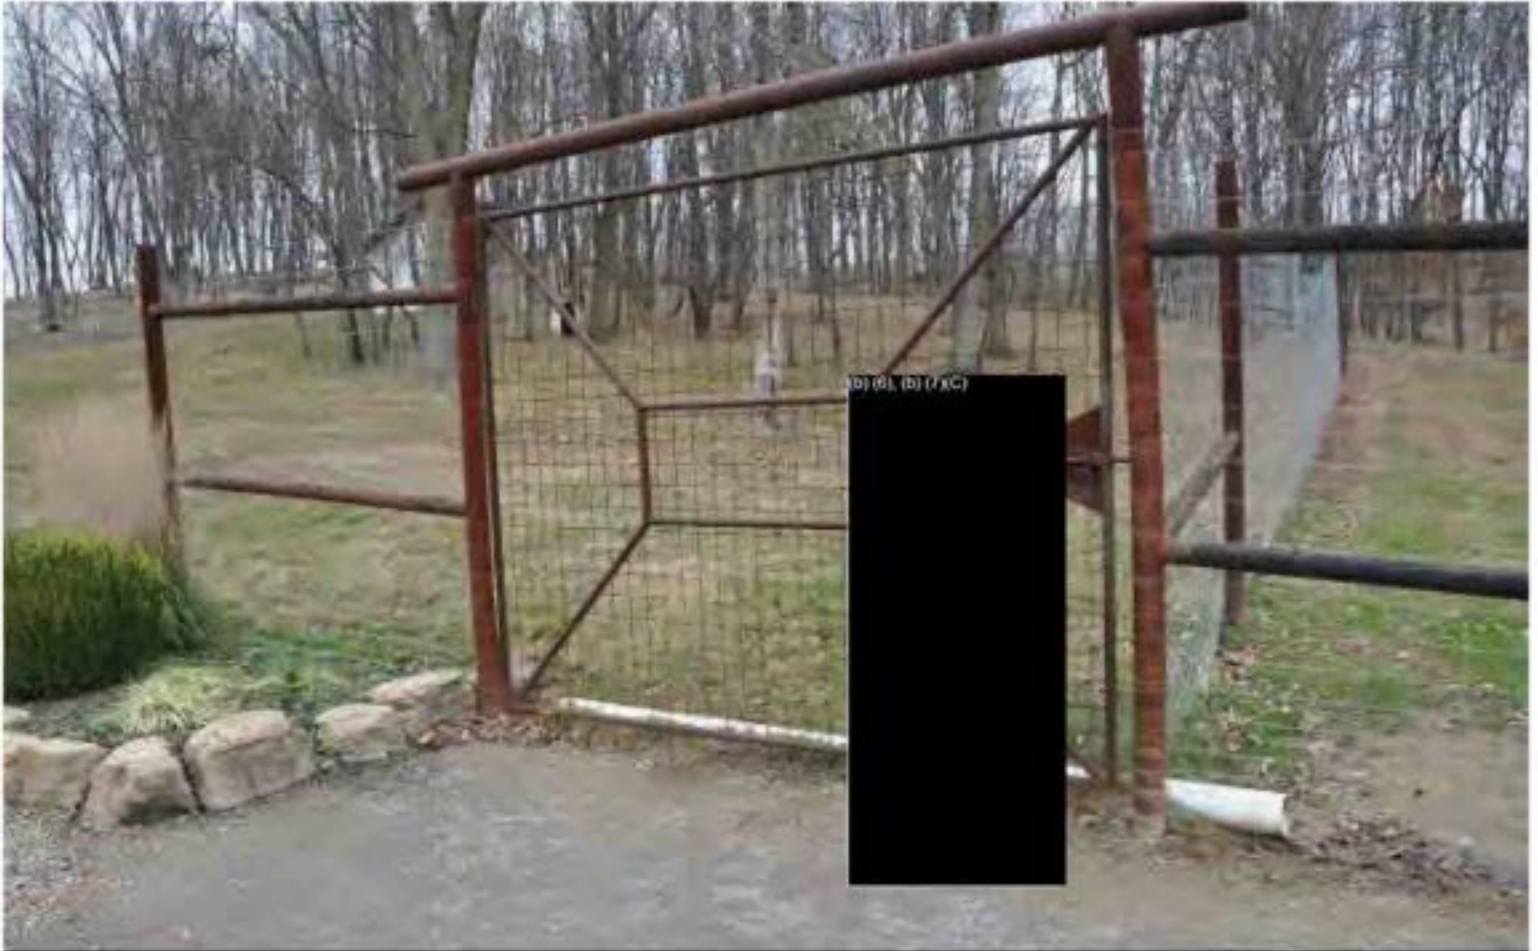
000097

CFR: 2.131 (c) (1)

Photographer:	R. Coleman	Legal Name:	55-B-0069
Photo Taken:	Wed, Nov 12, '14 12-4 pm	HENRY HAMPTON	
Inspection:	321140657190604		
Description:	No barrier or attendant for enclosure containing muntjac deer.

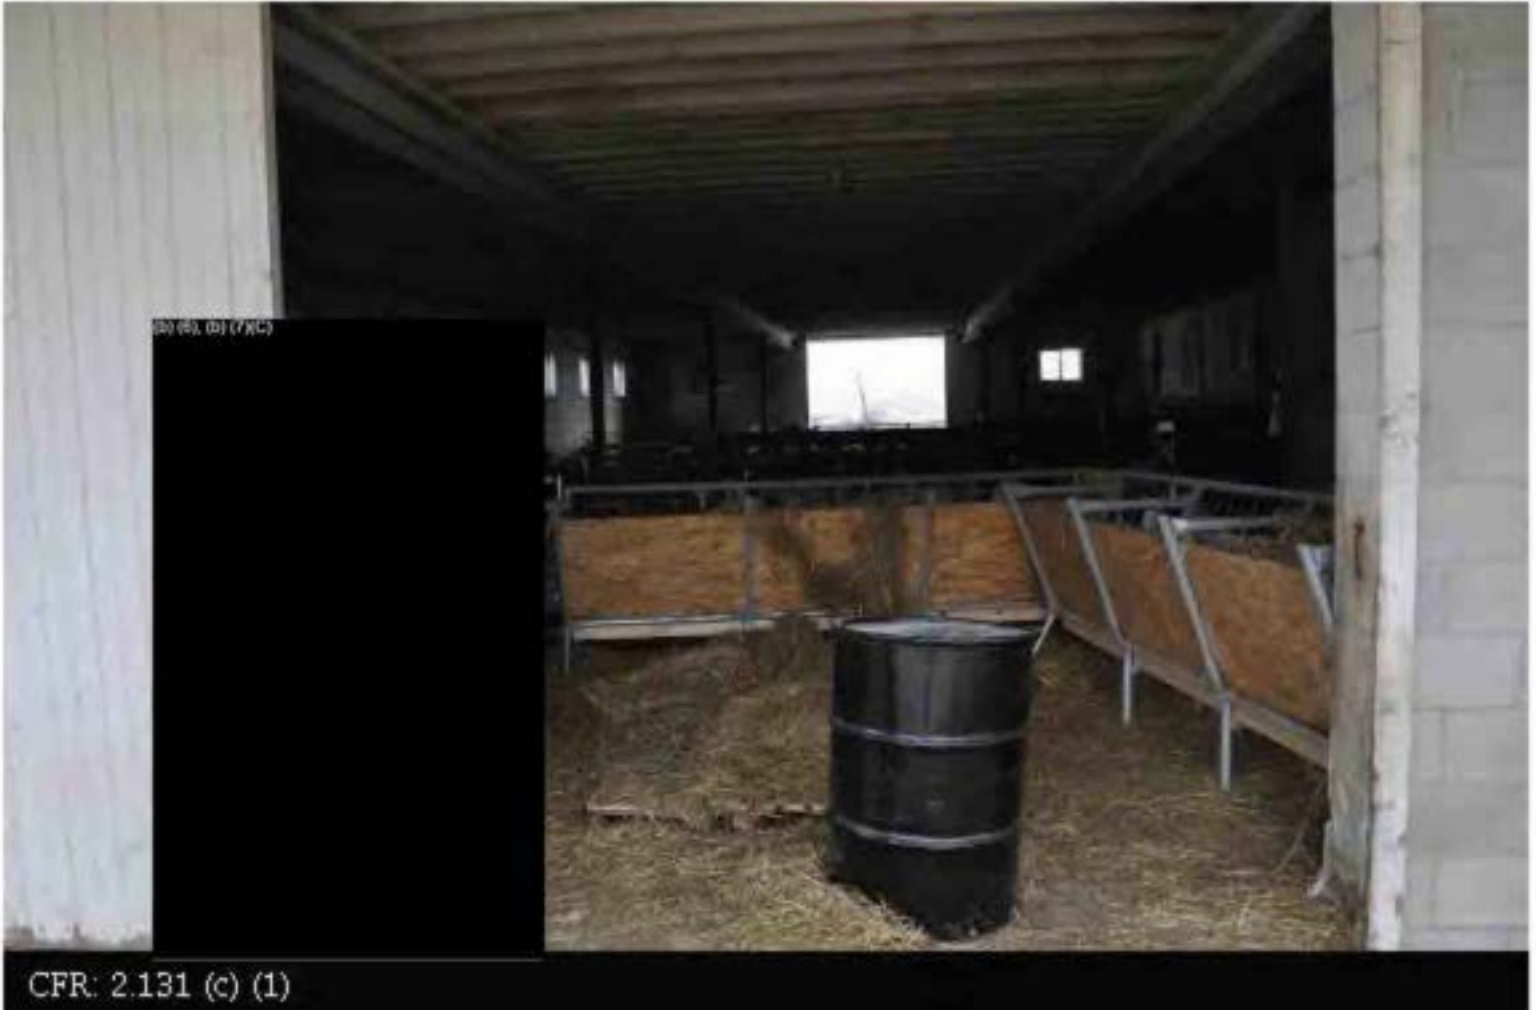
000098

CFR: 2.131 (c) (1)

Photographer:	R. Coleman	Legal Name:	55-B-0069
Photo Taken:	Wed, Nov 12, '14 12-4 pm	HENRY HAMPTON	
Inspection:	321140657190604		
Description:	No barrier or attendant for enclosure containing muntjac deer.

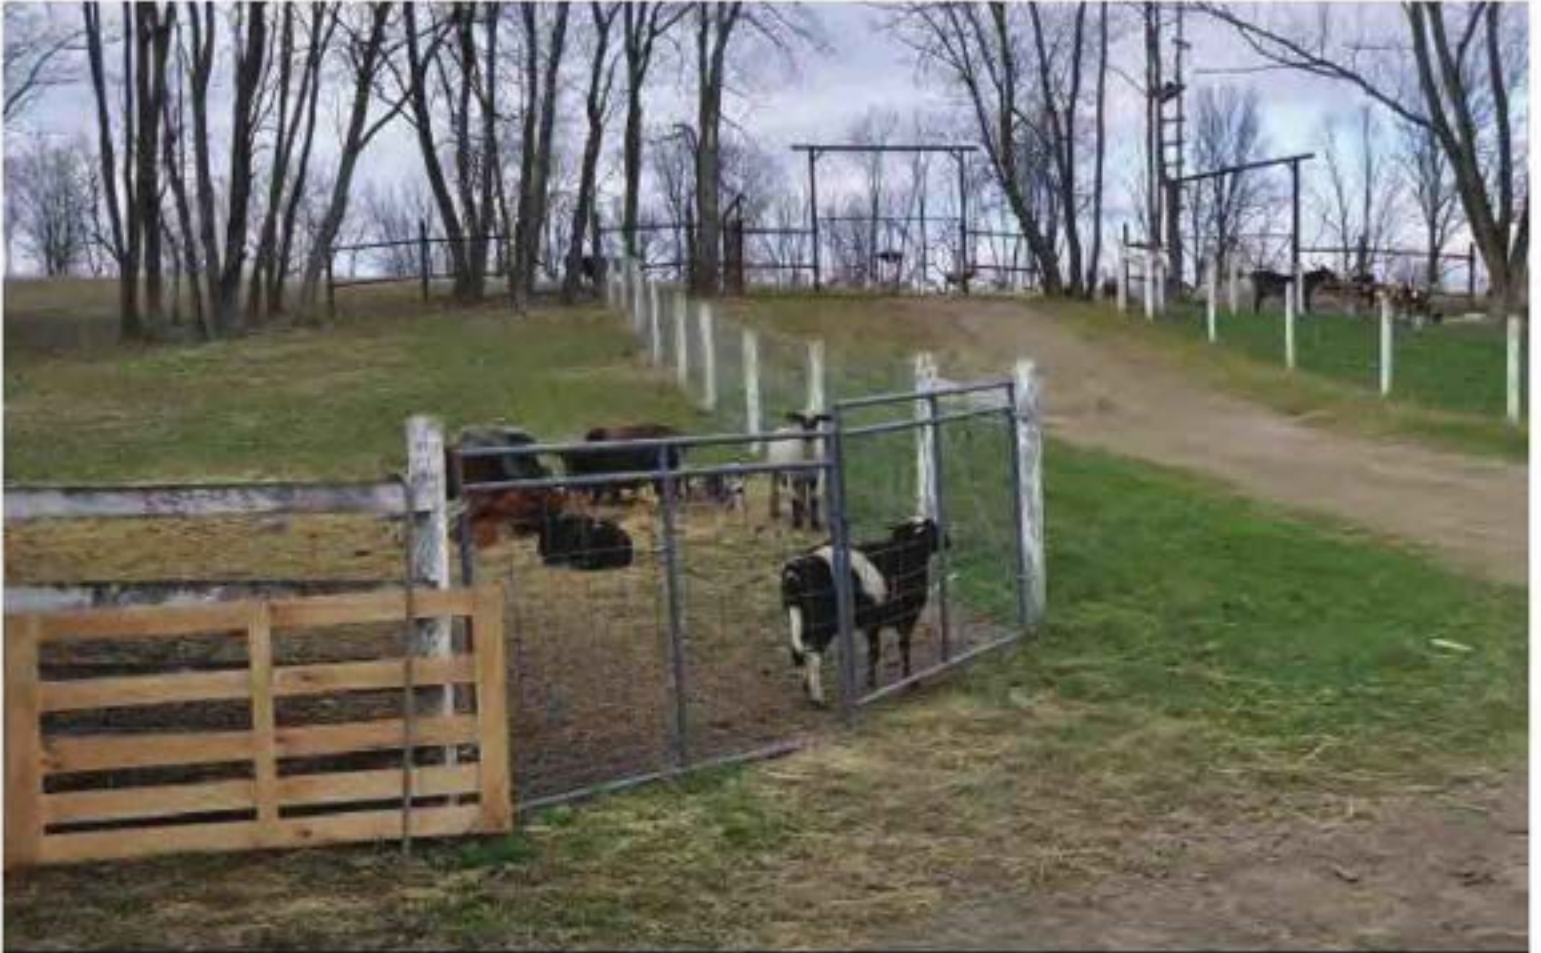
000100

CFR: 2.131 (c) (1)

Photographer:	R. Coleman	Legal Name:	55-B-0069
Photo Taken:	Wed, Nov 12, '14 12-4 pm	HENRY HAMPTON	
Inspection:	321140657190604		
Description:	No barrier or attendant for pasture containing goats.
