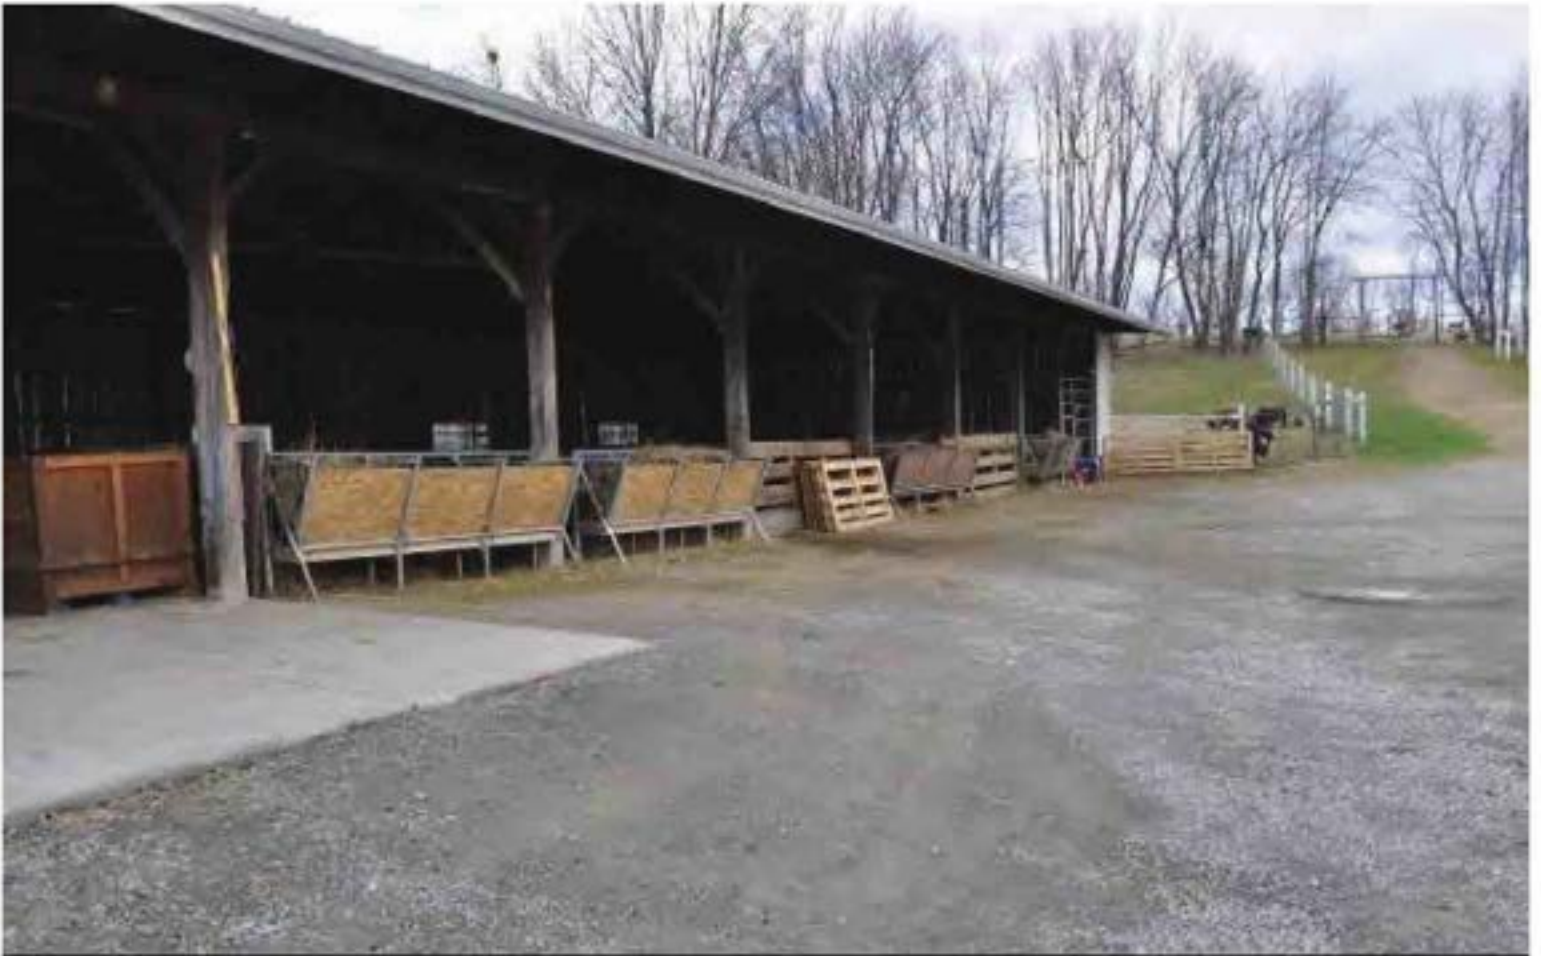
000101

CFR: 2.131 (c) (1)

Photographer:	R. Coleman, ACI	Legal Name:	55-B-0069
Photo Taken:	Wed, Nov 12, '14 12-4 pm	HENRY HAMPTON	
Inspection:	321140657190604		
Description:	No barrier or attendant for pasture containing zebu cattle and sheep.

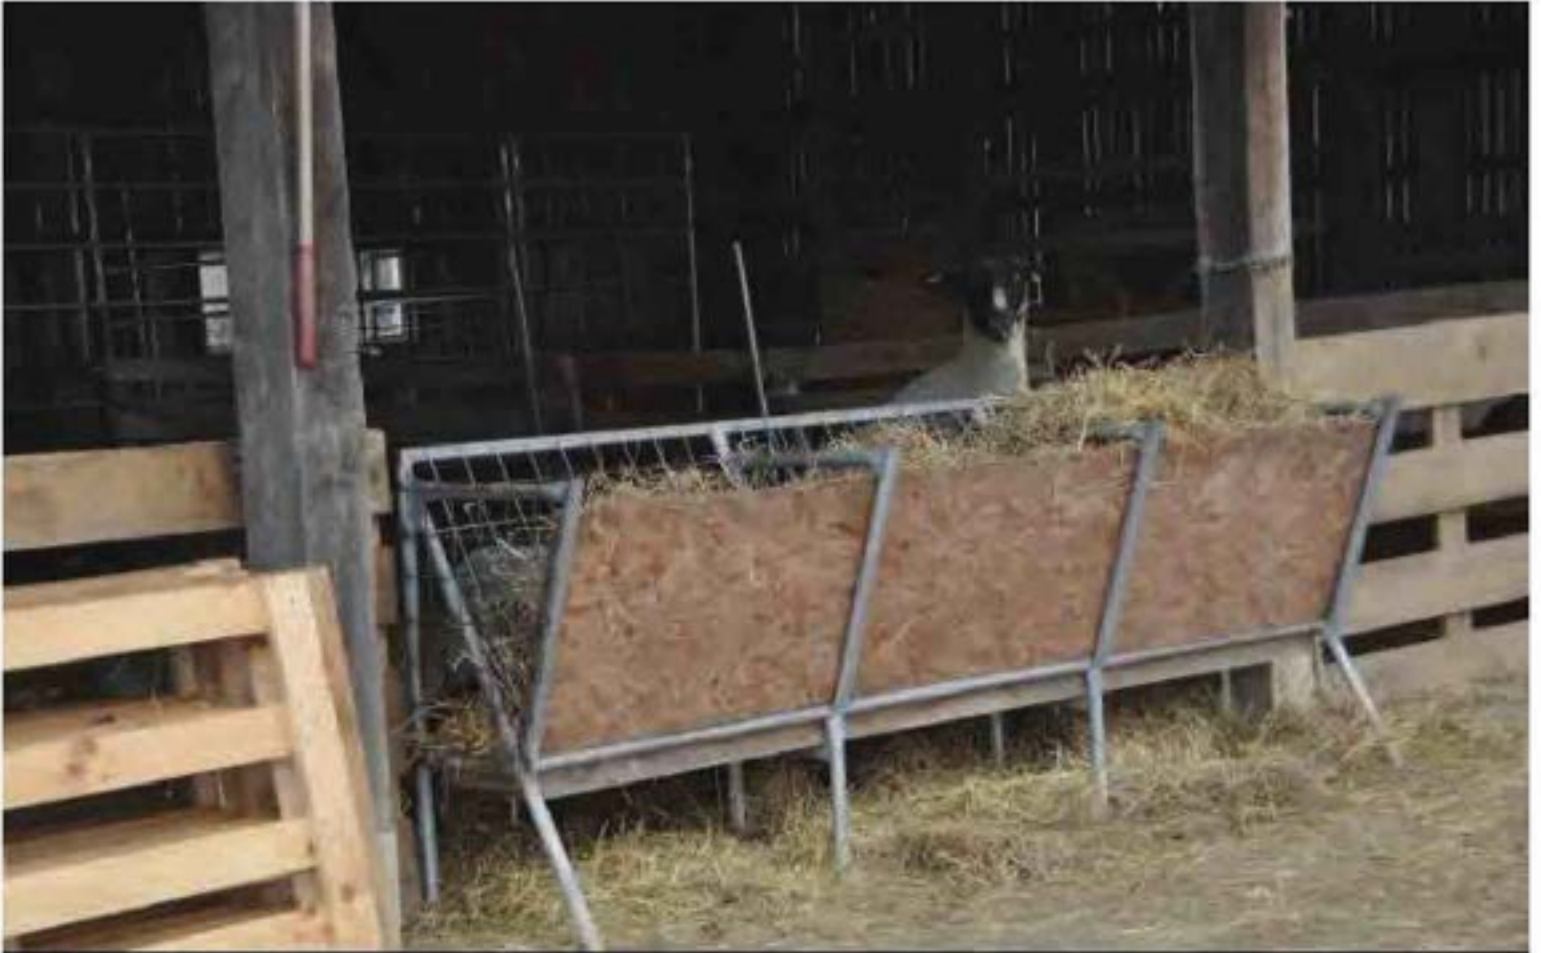
000102

CFR: 2.131 (c) (1)

Photographer:	R. Coleman, ACI	Legal Name:	55-B-0069
Photo Taken:	Wed, Nov 12, '14 12-4 pm	HENRY HAMPTON	
Inspection:	321140657190604		
Description:	No barrier or attendant for sheep in production barn.

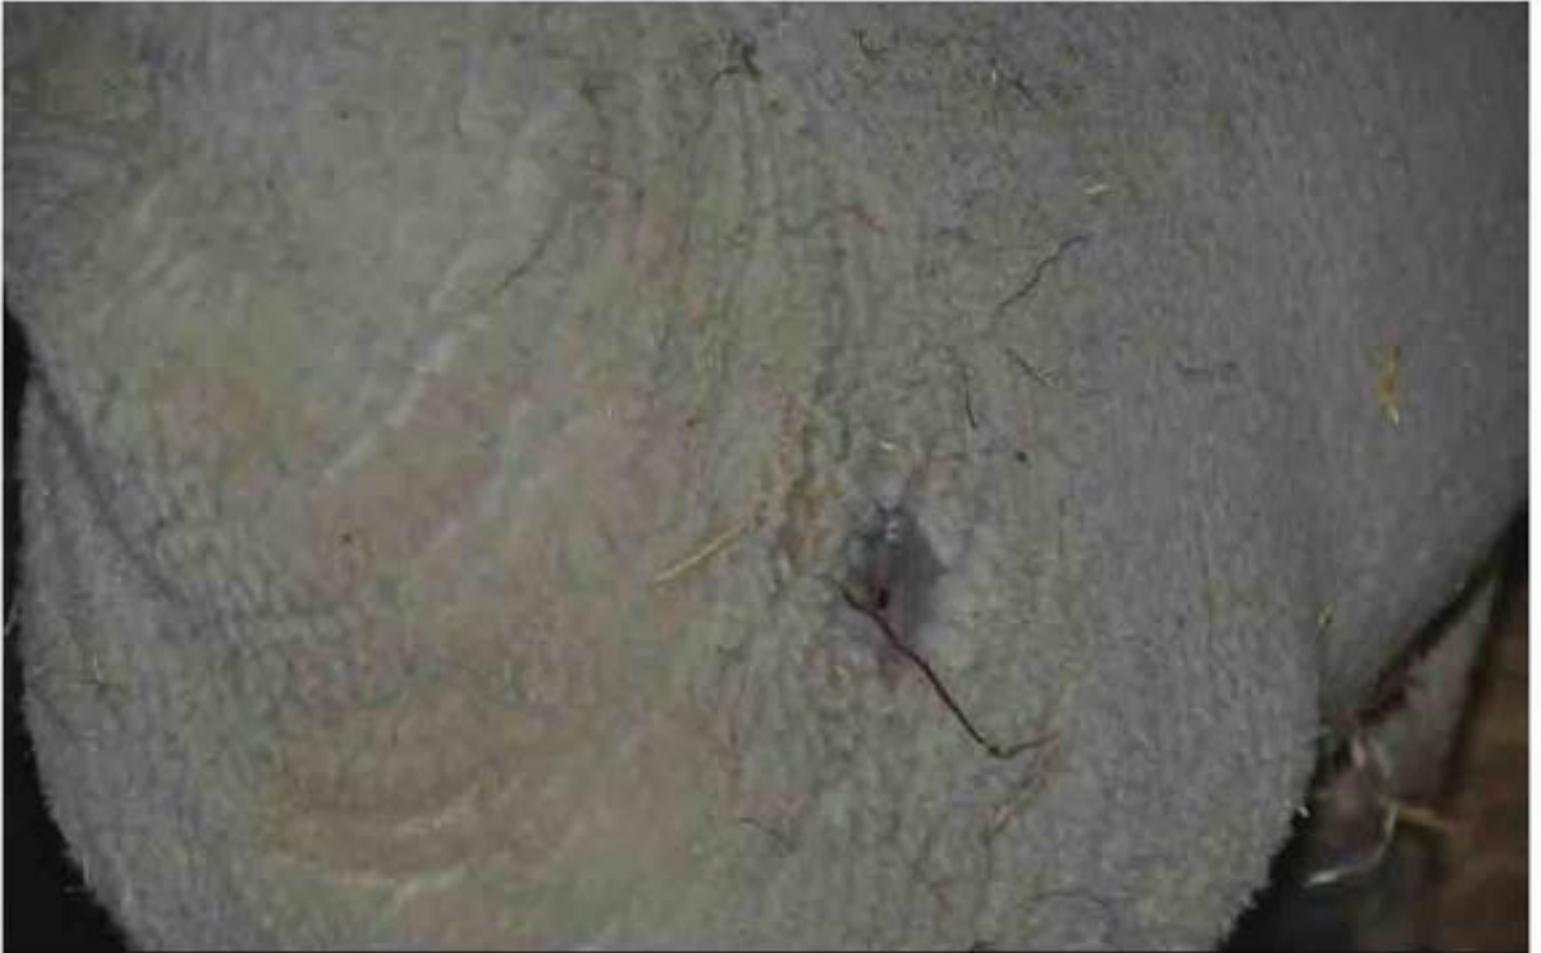
Photographer:	R. Coleman, ACI	Legal Name:	55-B-0069
Photo Taken:	Wed, Nov 12, '14 12-4 pm	HENRY HAMPTON	
Inspection:	321140657190604		
Description:	Sheep #596 in 1st stall of dairy barn with hairloss on left shoulder and left flank.

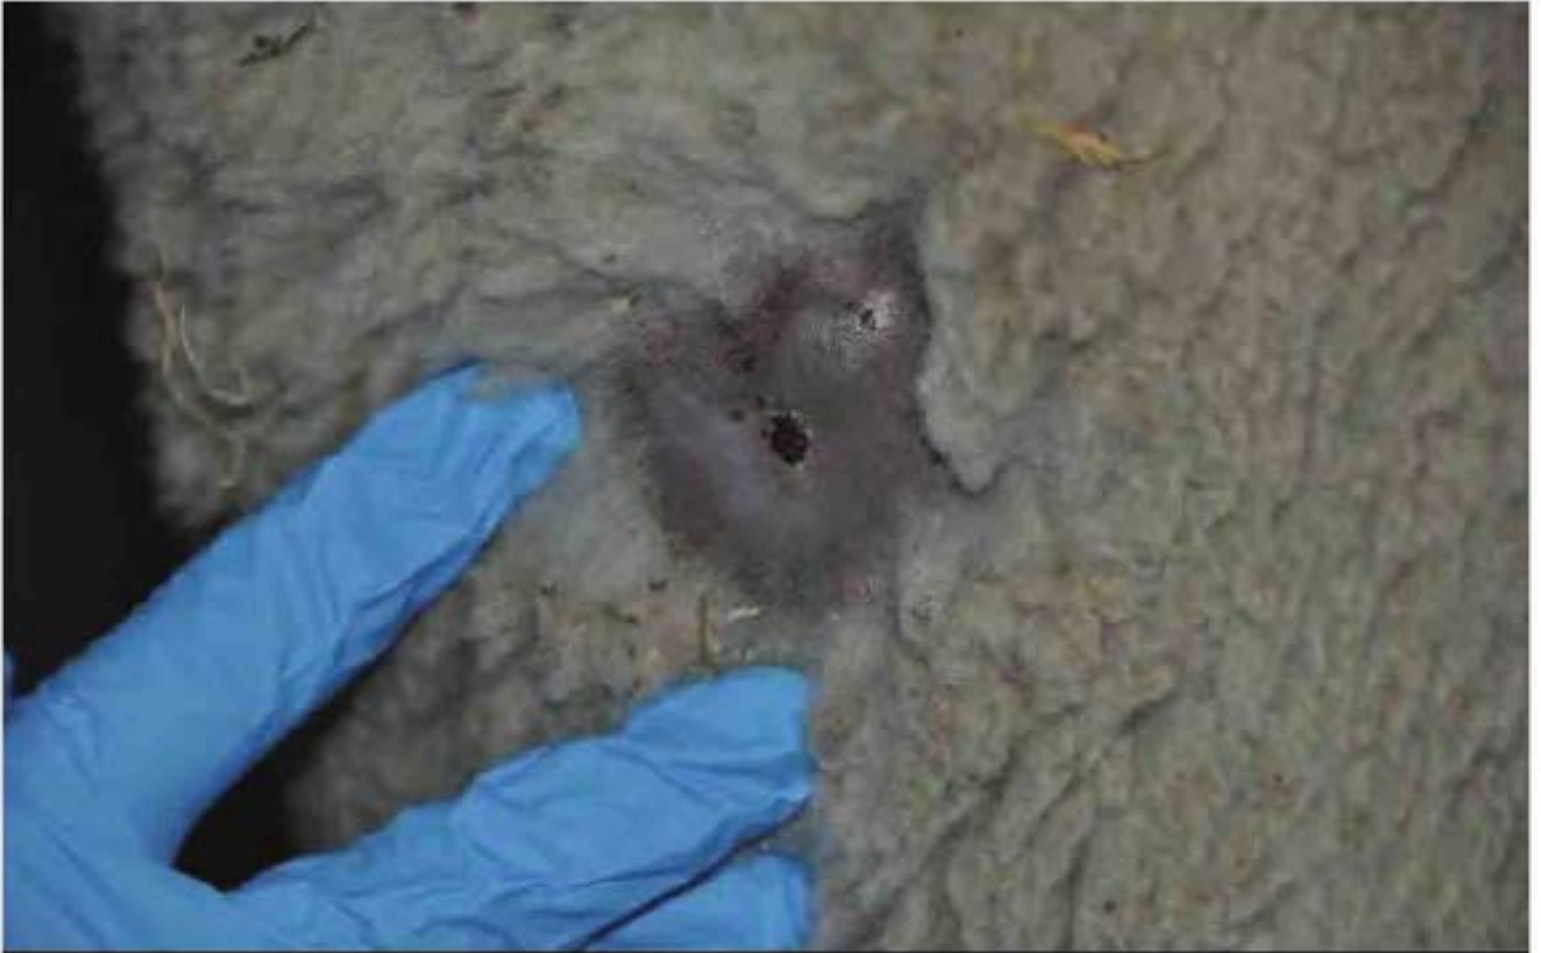
000105

CFR: 2.40 (b) (3), 2.40 (b) (2)

Photographer:	R. Coleman, ACI	Legal Name:	55-B-0069
Photo Taken:	Wed, Nov 12, '14 12-4 pm	HENRY HAMPTON	
Inspection:	321140657190604		
Description:	Sheep #596 in 1st stall of dairy barn with hairloss on left shoulder and left flank.

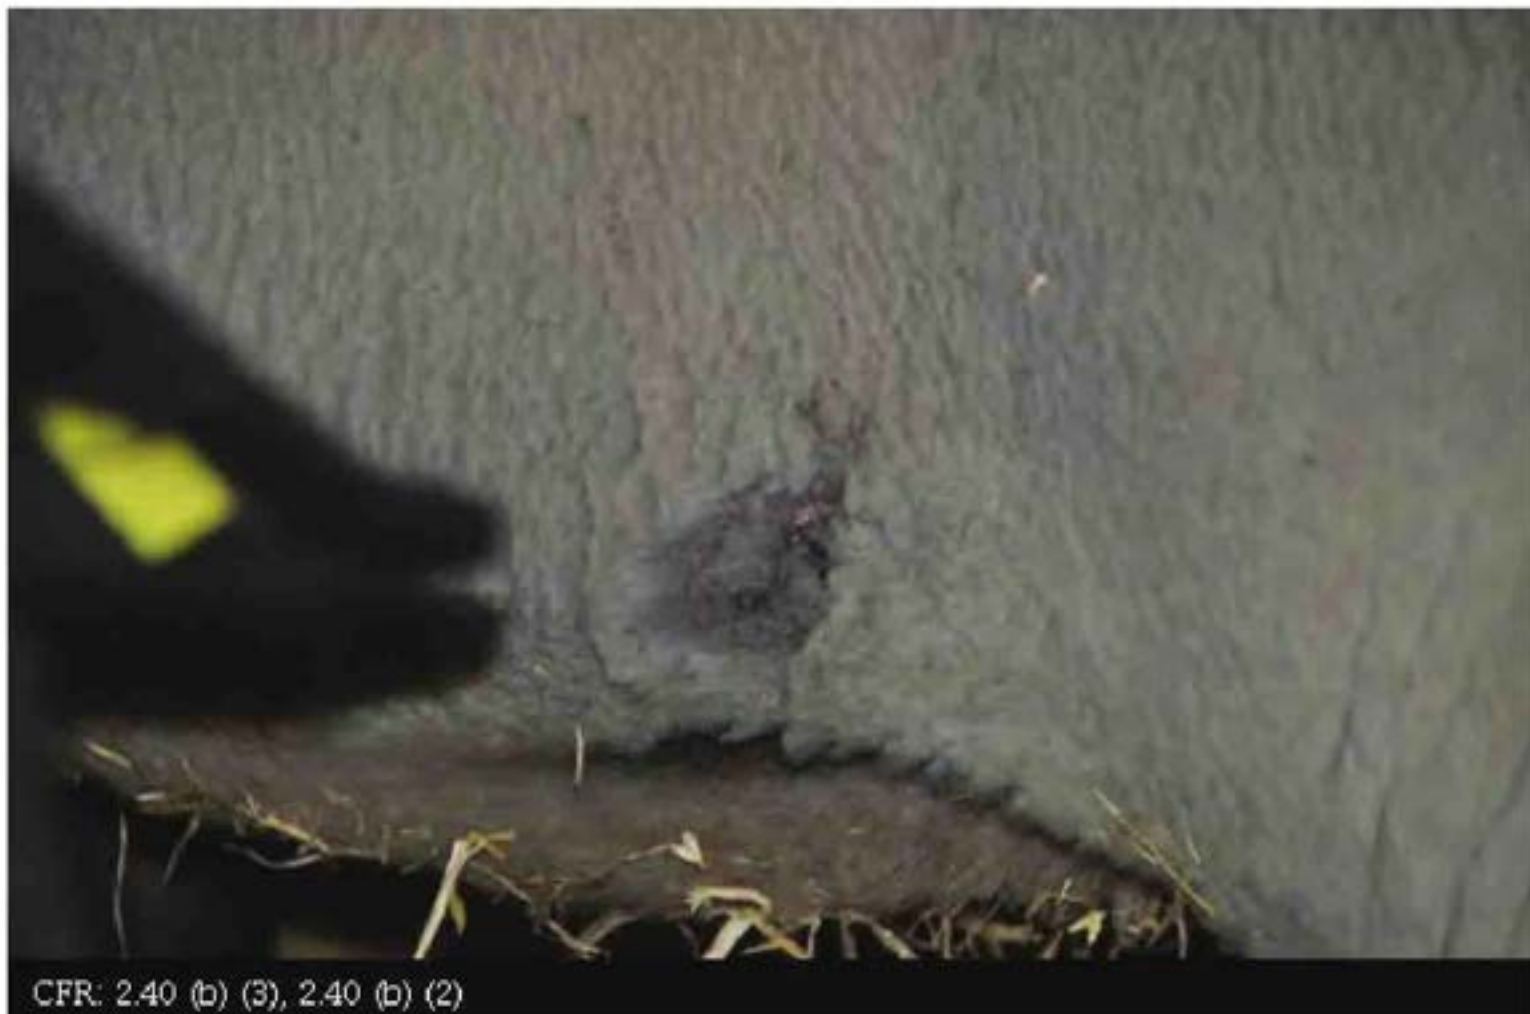
CFR: 2.40 (b) (2), 2.40 (b) (3)

Photographer:	R. Coleman, ACI	Legal Name:	55-B-0069
Photo Taken:	Wed, Nov 12, '14 12-4 pm	HENRY HAMPTON	
Inspection:	321140657190604		
Description:	Sheep #596 in 1st stall of dairy barn with hairloss on left shoulder and left flank.

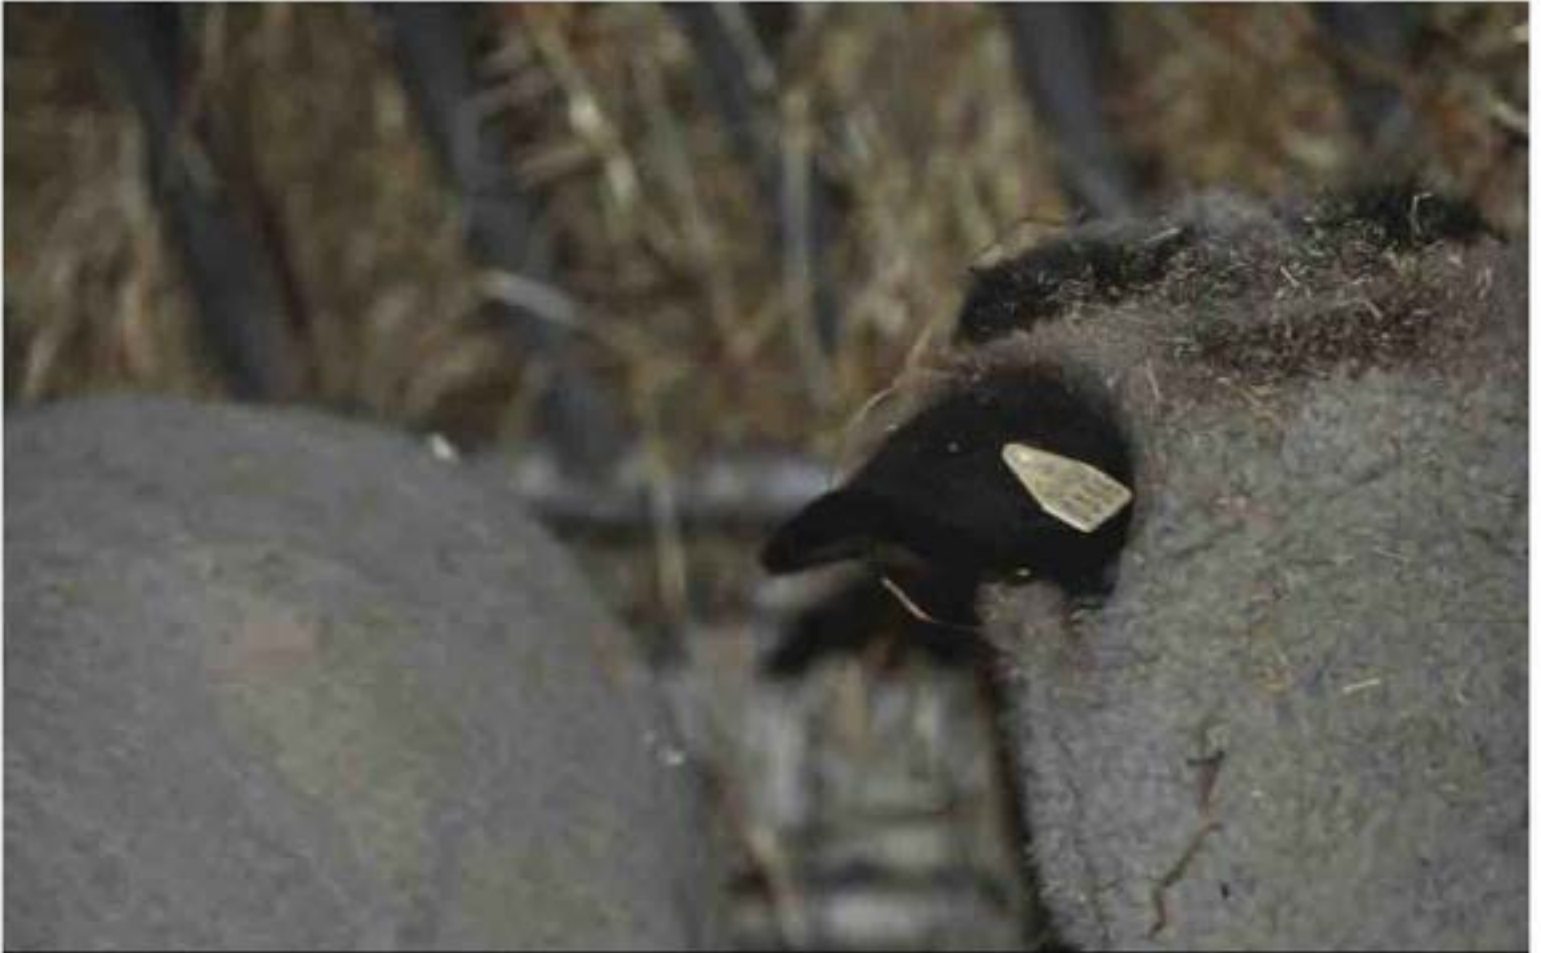
000107

CFR: 2.40 (b) (3), 2.40 (b) (2)

Photographer:	R. Coleman, ACI	Legal Name:	55-B-0069
Photo Taken:	Wed, Nov 12, '14 12-4 pm	HENRY HAMPTON	
Inspection:	321140657190604		
Description:	Sheep #596 in 1st stall of dairy barn with hairloss on left shoulder and left flank.

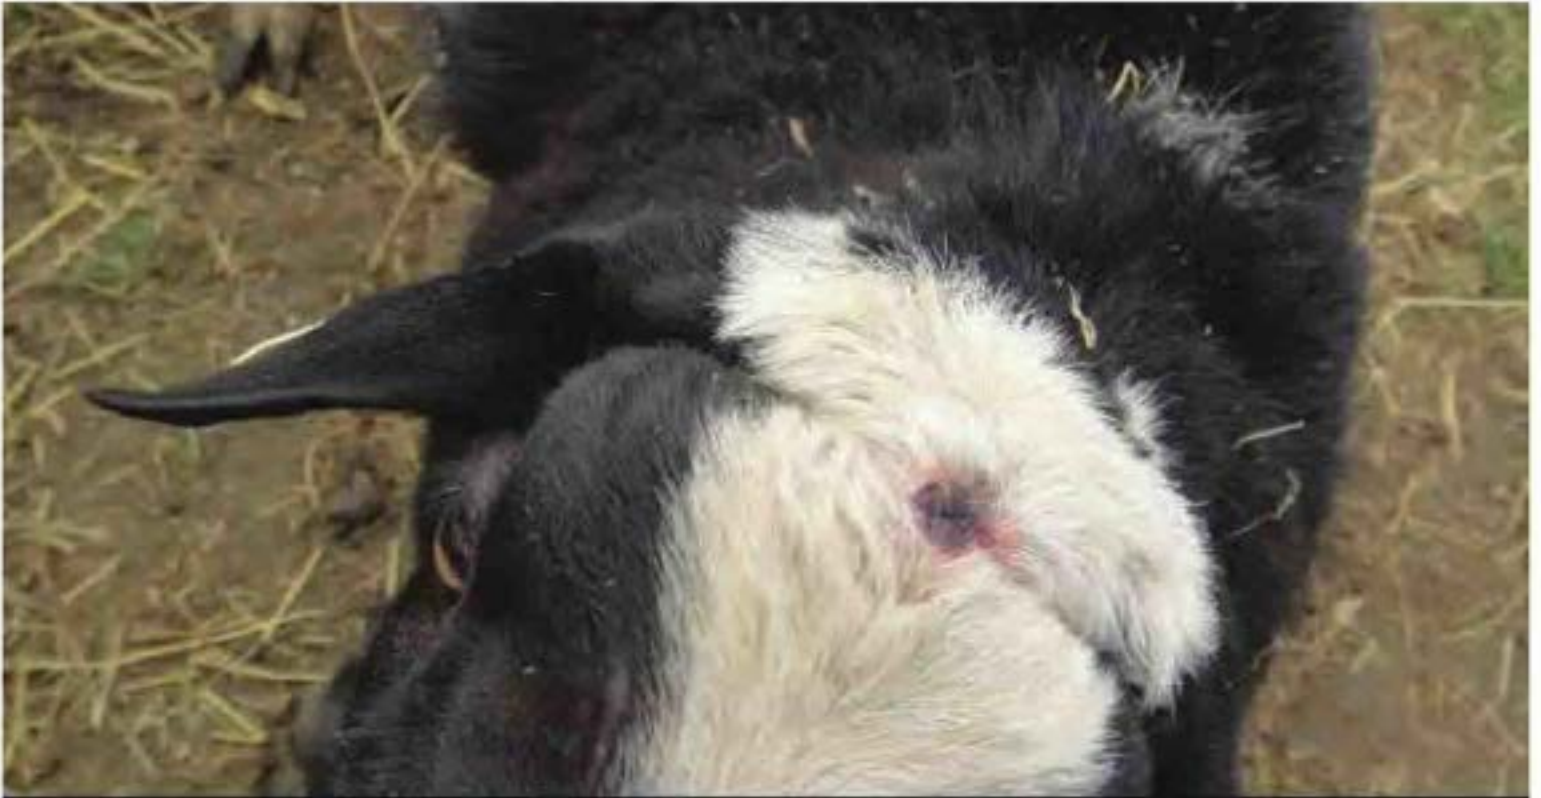
000110

CFR: 2.40 (b) (3), 2.40 (b) (2)

Photographer:	D. Miller, SACS	Legal Name:	55-B-0069
Photo Taken:	Wed, Nov 12, '14 12-4 pm	HENRY HAMPTON	
Inspection:	321140657190604		
Description:	**ORIGINAL PHOTO**Overview of sheep #35

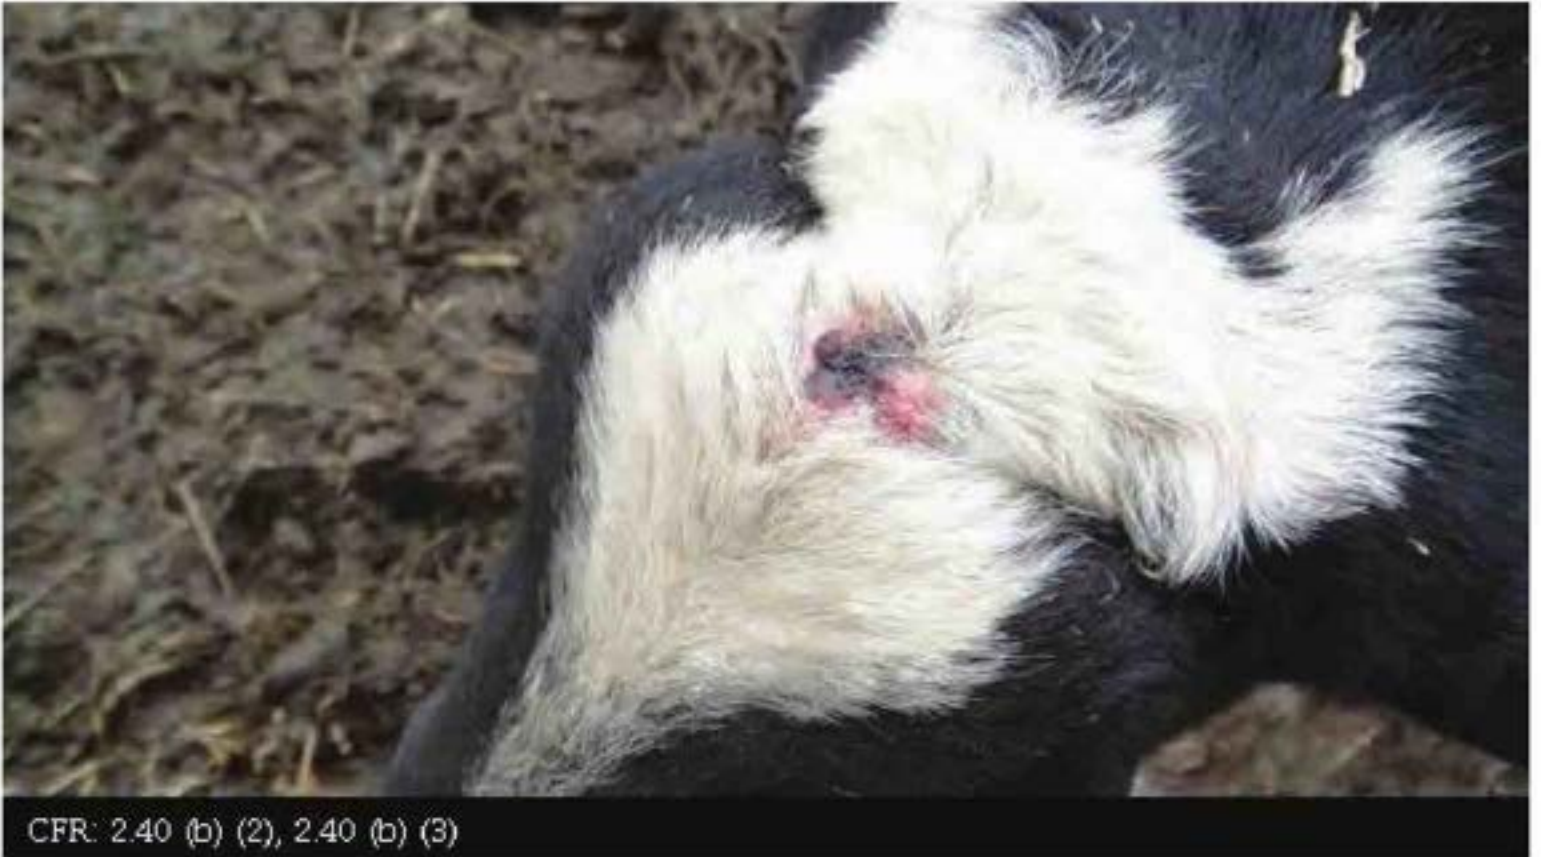
000111

CFR: 2.40 (b) (3), 2.40 (b) (2)

Photographer:	D. Miller, SACS	Legal Name:	55-B-0069
Photo Taken:	Wed, Nov 12, '14 12-4 pm	HENRY HAMPTON	
Inspection:	321140657190604		
Description:	Sheep #35 with hairloss and abrasion on poll of head.

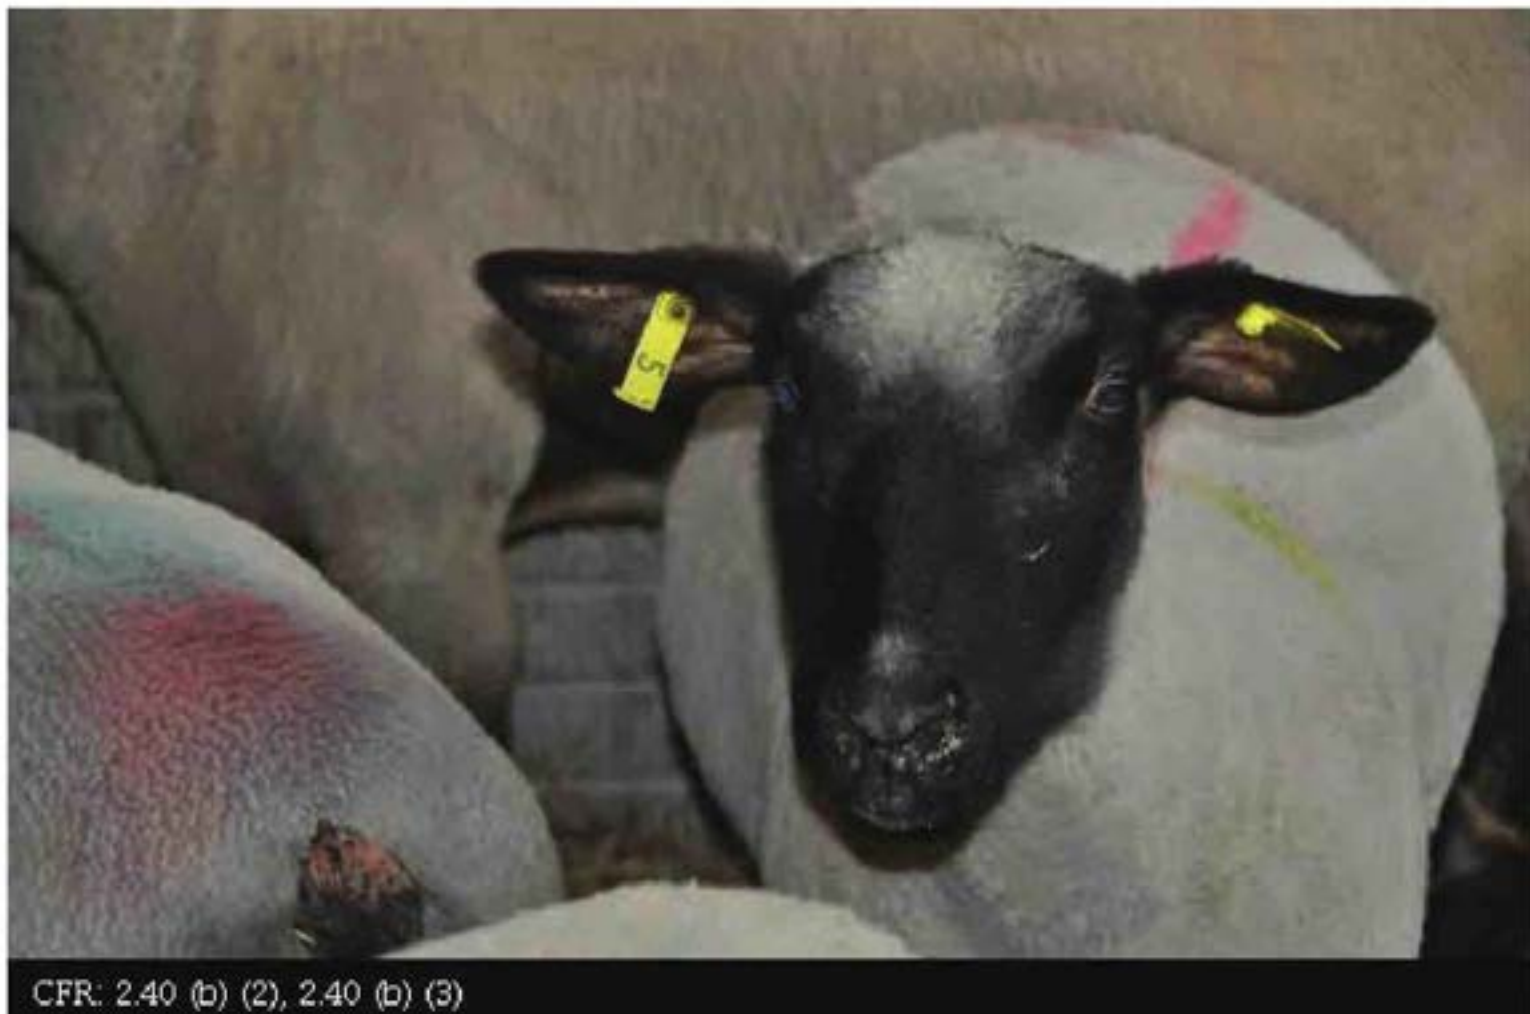
000113

CFR: 2.40 (b) (2), 2.40 (b) (3)

Photographer:	R. Coleman, ACI	Legal Name:	55-B-0069
Photo Taken:	Wed, Nov 12, '14 12-4 pm	HENRY HAMPTON	
Inspection:	321140657190604		
Description:	Black faced Suffolk-type sheep (ear tag #5 in the right ear and tag #6 in the left ear) in first stall of the Dawdy Barn had nasal discharge.

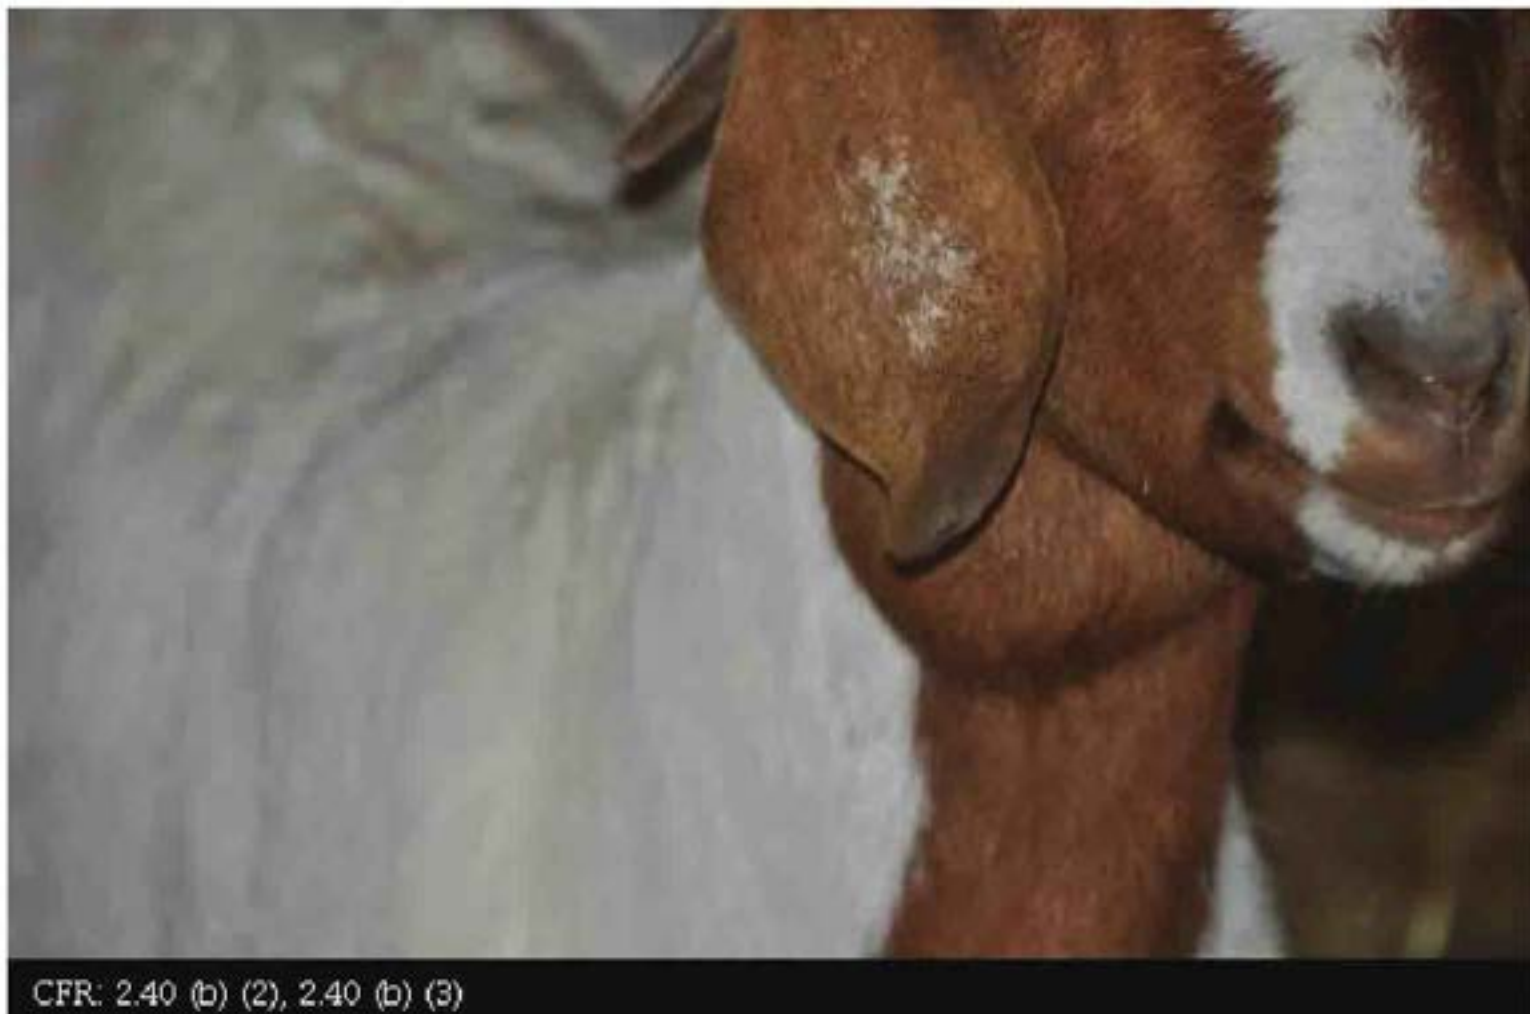
Photographer:	R. Coleman, ACI	Legal Name:	55-B-0069
Photo Taken:	Wed, Nov 12, '14 12-4 pm	HENRY HAMPTON	
Inspection:	321140657190604		
Description:	Red and white bohr goat #1120 with mass in R upper neck area.

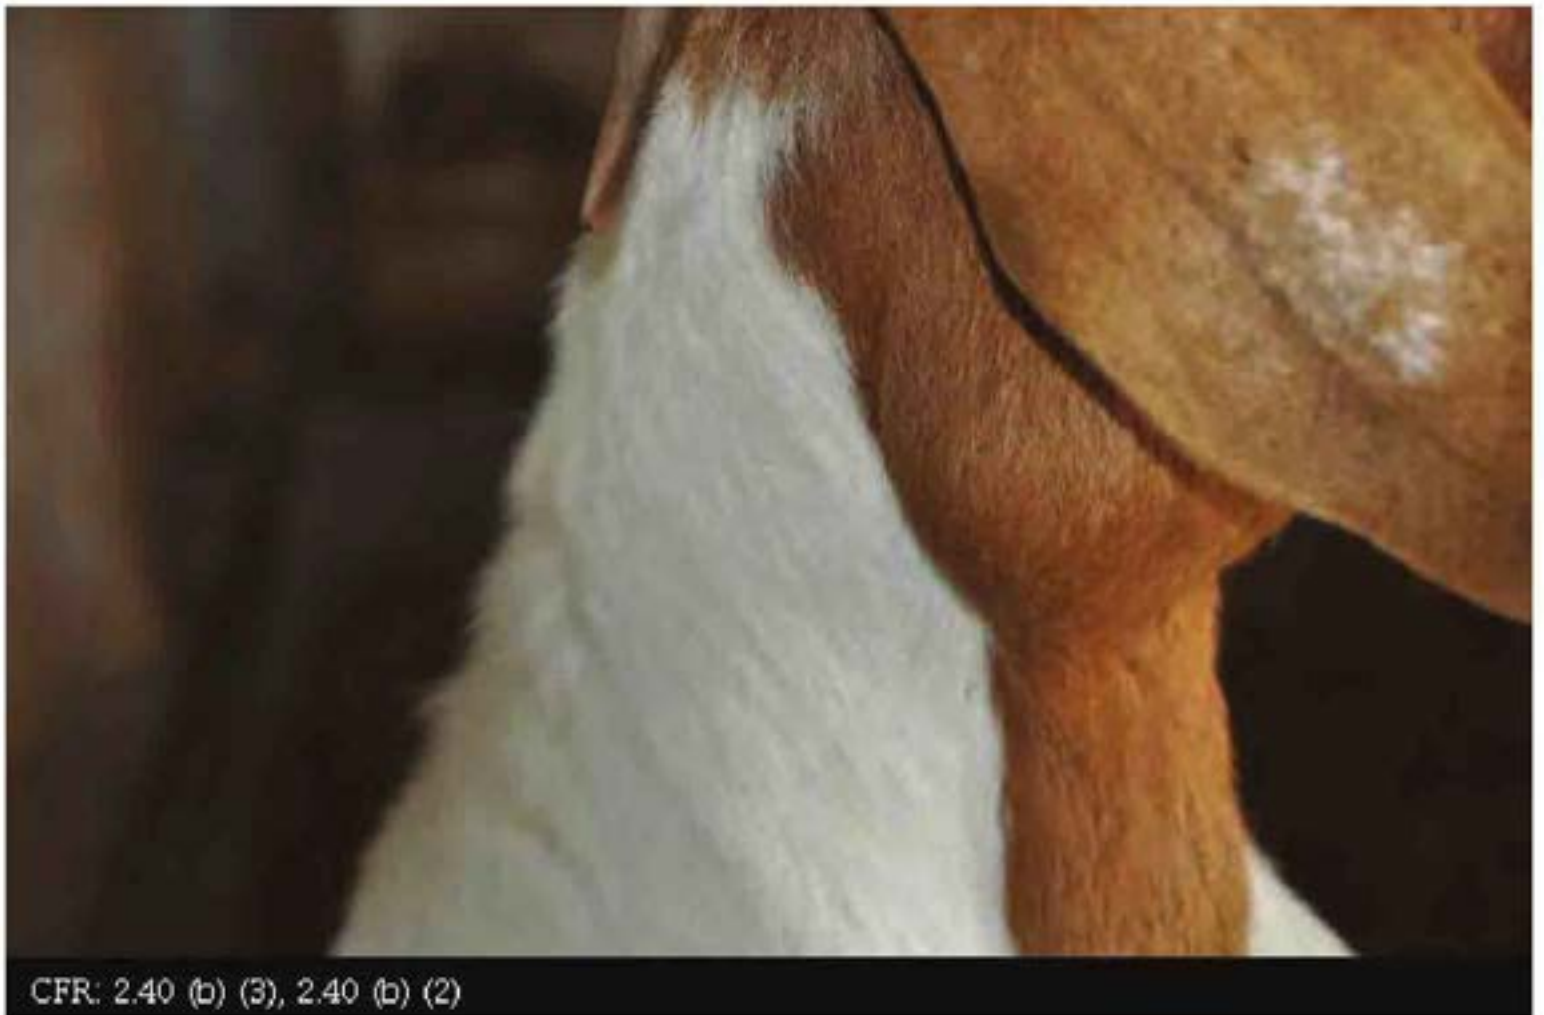
000116

CFR: 2.40 (b) (2), 2.40 (b) (3)

Photographer:	R. Coleman, ACI	Legal Name:	55-B-0069
Photo Taken:	Wed, Nov 12, '14 12-4 pm	HENRY HAMPTON	
Inspection:	321140657190604		
Description:	Red and white bohr goat #1120 with mass in R upper neck area.

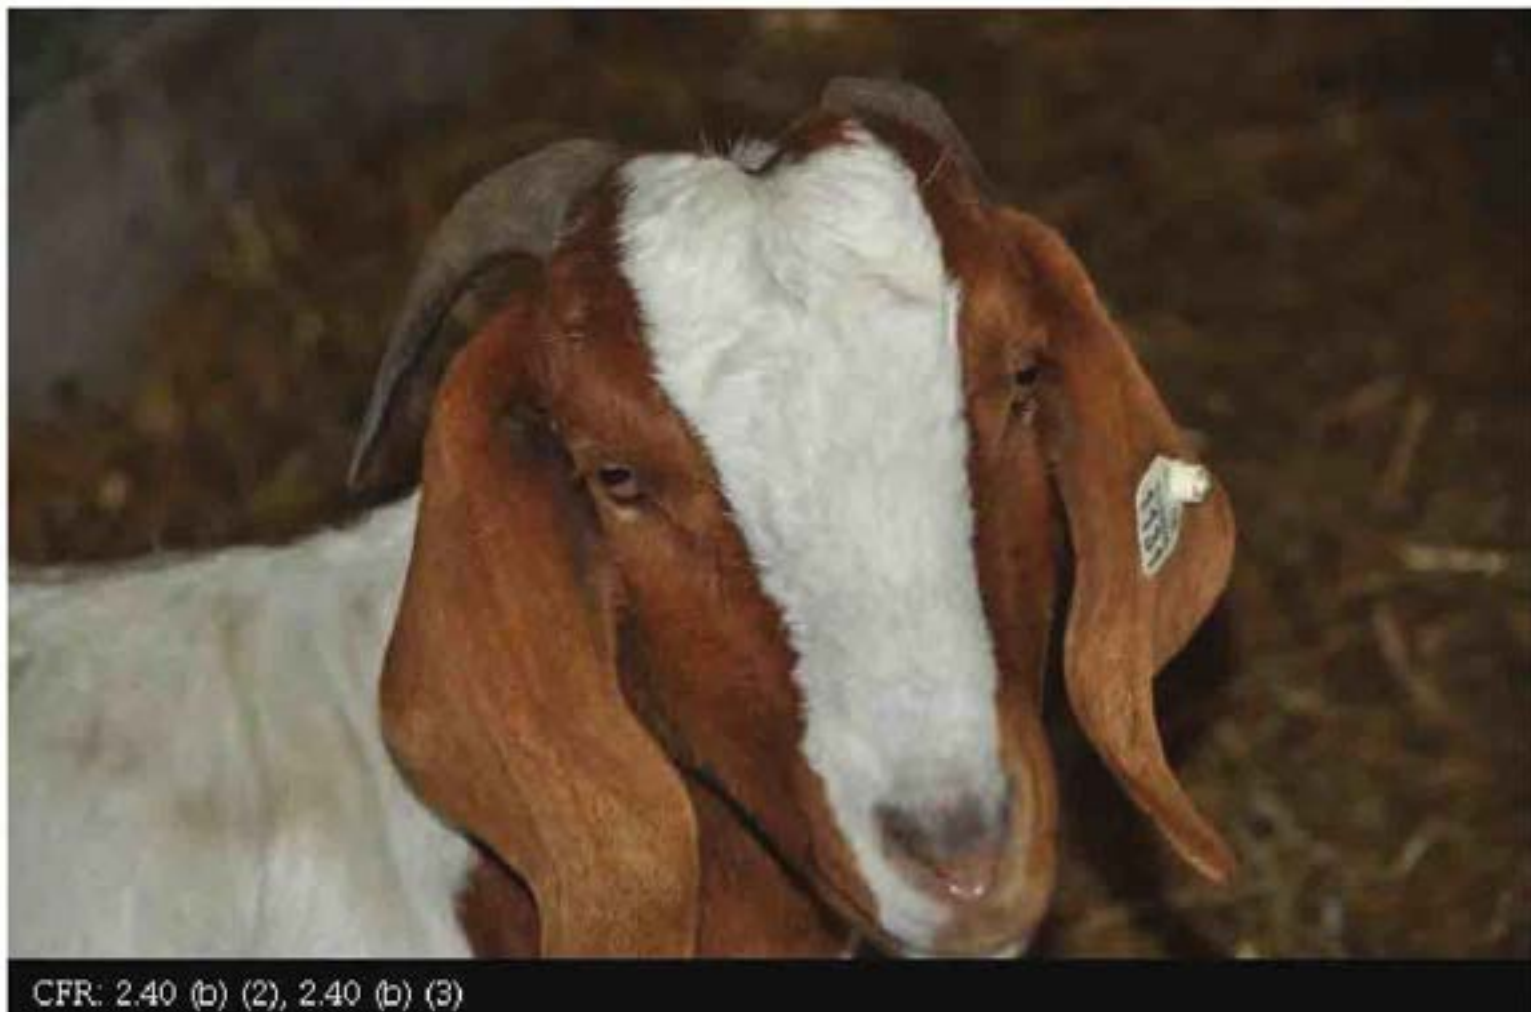
000117

CFR: 2.40 (b) (3), 2.40 (b) (2)

Photographer:	R. Coleman, ACI	Legal Name:	55-B-0069
Photo Taken:	Wed, Nov 12, '14 12-4 pm	HENRY HAMPTON	
Inspection:	321140657190604		
Description:	Red and white bohr goat #1120 with mass in R upper neck area.

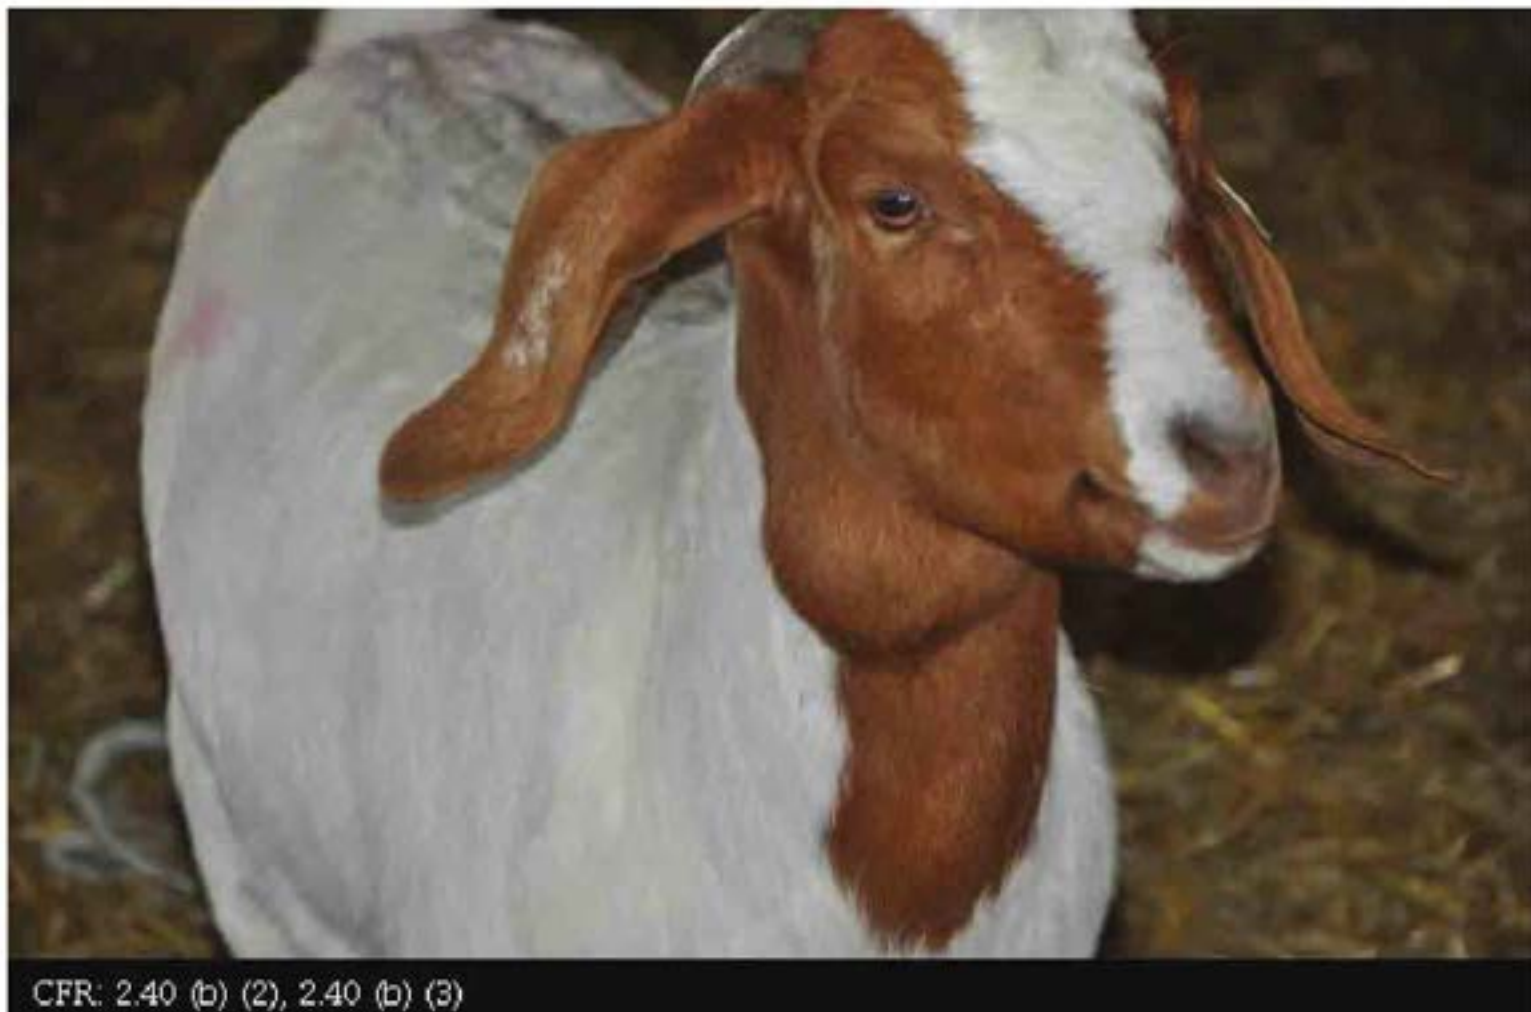
Photographer:	R. Coleman, ACI	Legal Name:	55-B-0069
Photo Taken:	Wed, Nov 12, '14 12-4 pm	HENRY HAMPTON	
Inspection:	321140657190604		
Description:	Red and white bohr goat #1120 with mass in R upper neck area.

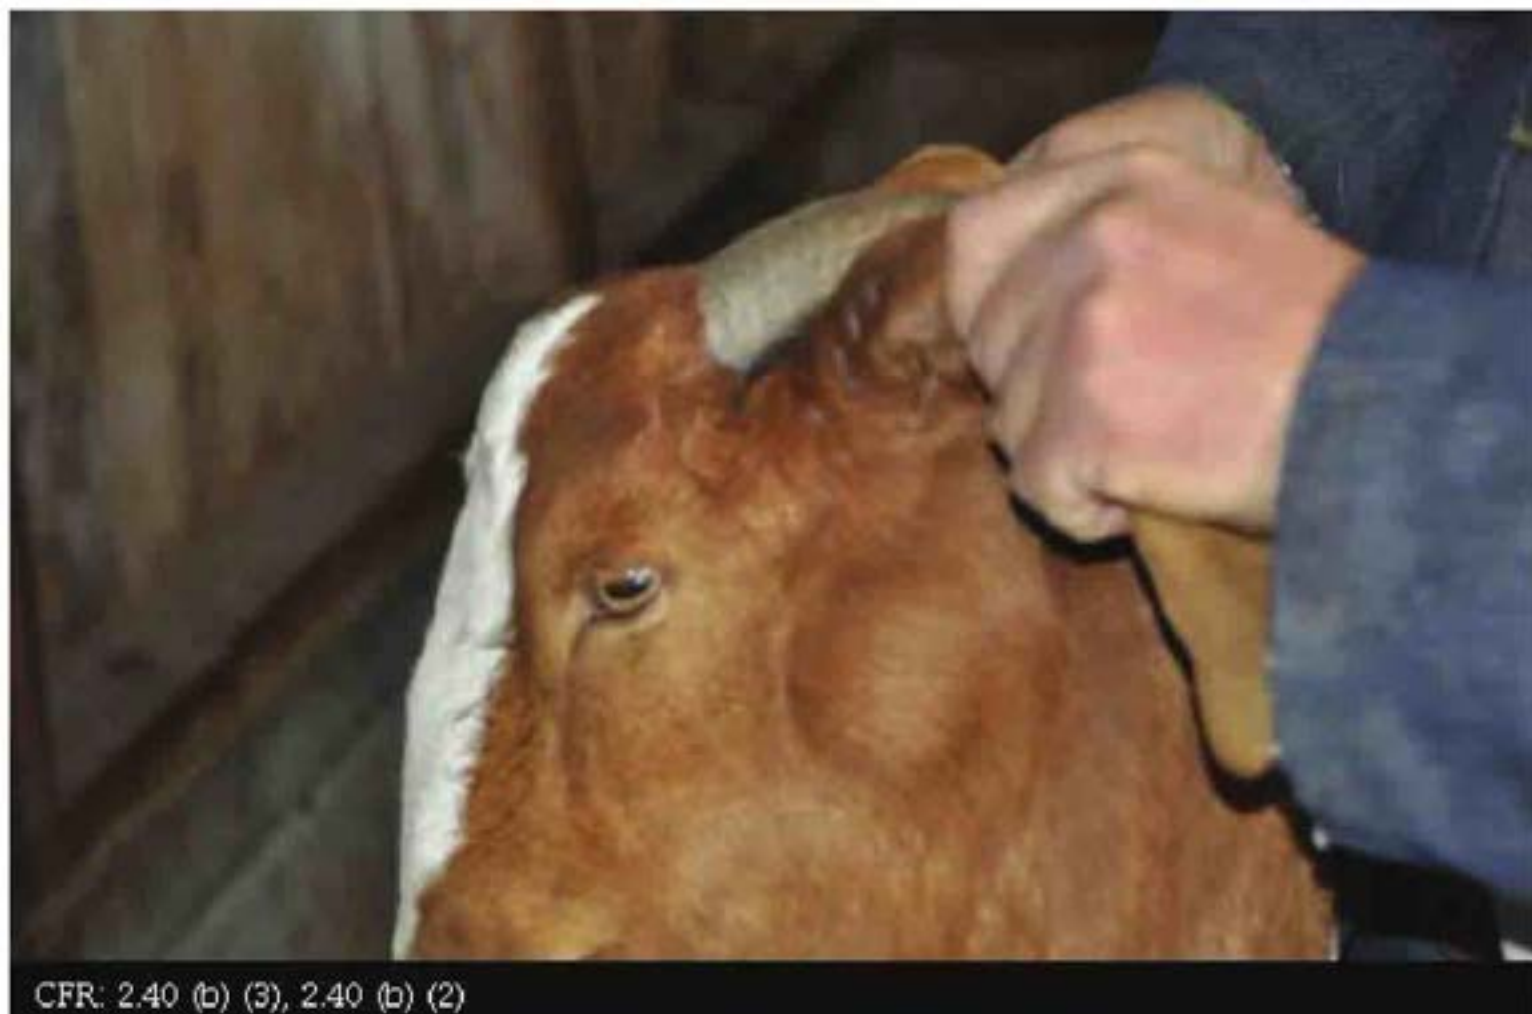
000119

CFR: 2.40 (b) (2), 2.40 (b) (3)

Photographer:	R. Coleman, ACI	Legal Name:	55-B-0069
Photo Taken:	Wed, Nov 12, '14 12-4 pm	HENRY HAMPTON	
Inspection:	321140657190604		
Description:	Red and white bohr goat #1120 with mass in R upper neck area.

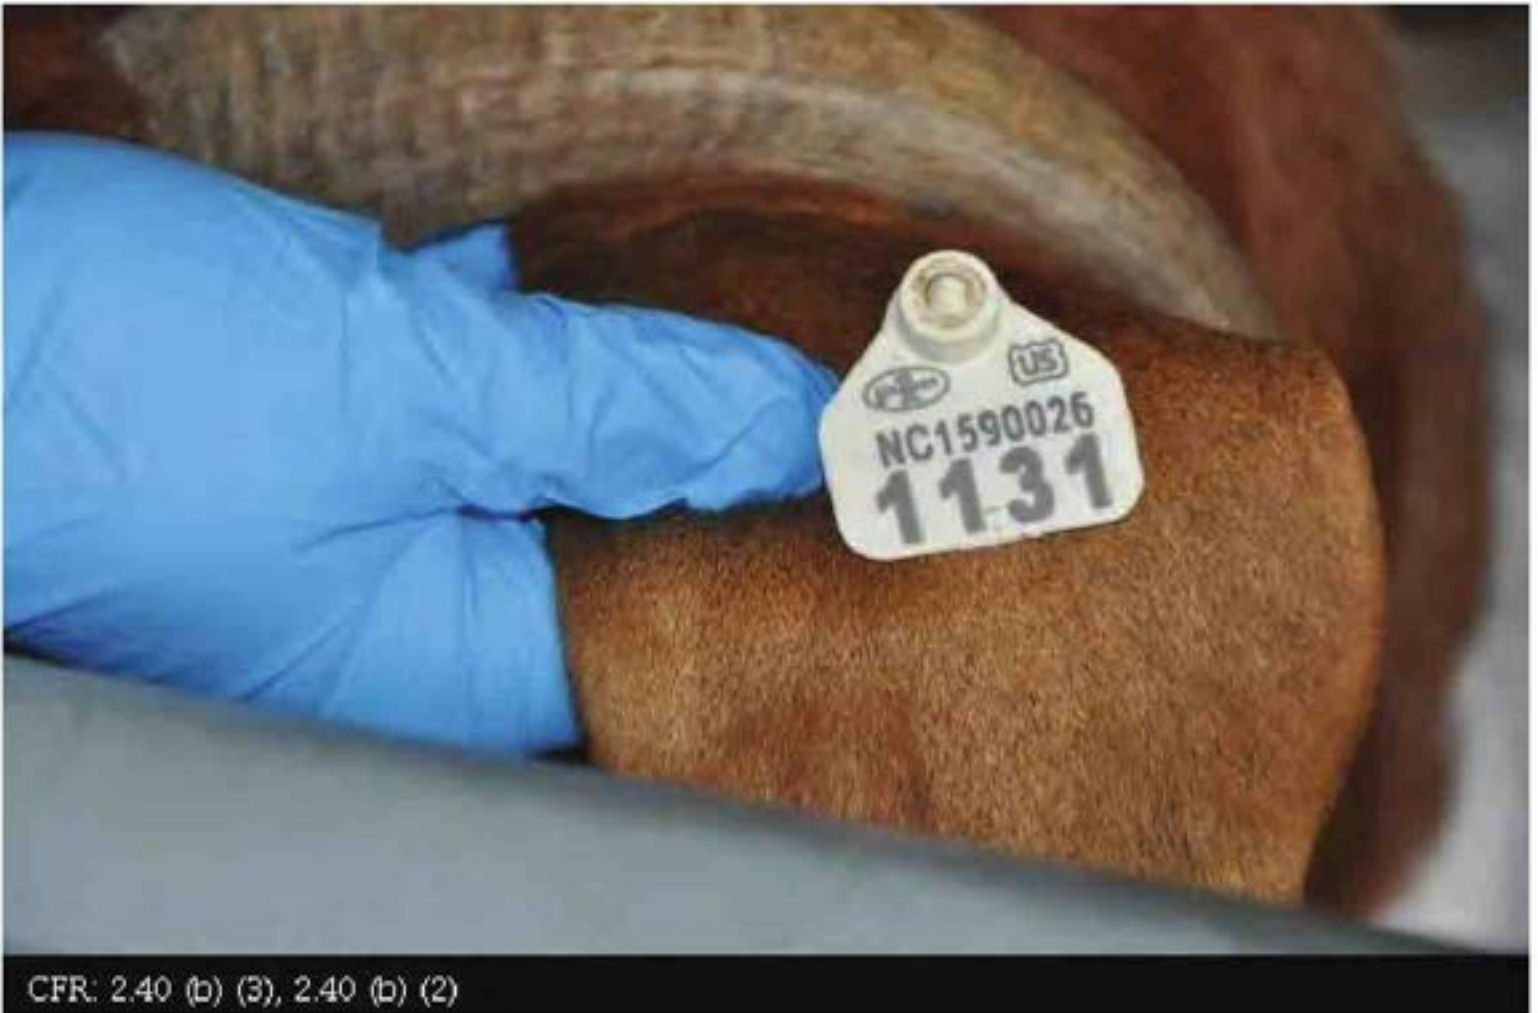
000120

CFR: 2.40 (b) (3), 2.40 (b) (2)

Photographer:	R. Coleman, ACI	Legal Name:	55-B-0069
Photo Taken:	Wed, Nov 12, '14 12-4 pm	HENRY HAMPTON	
Inspection:	321140657190604		
Description:	bohr goat #1131 with mass on L jaw below L ear.
