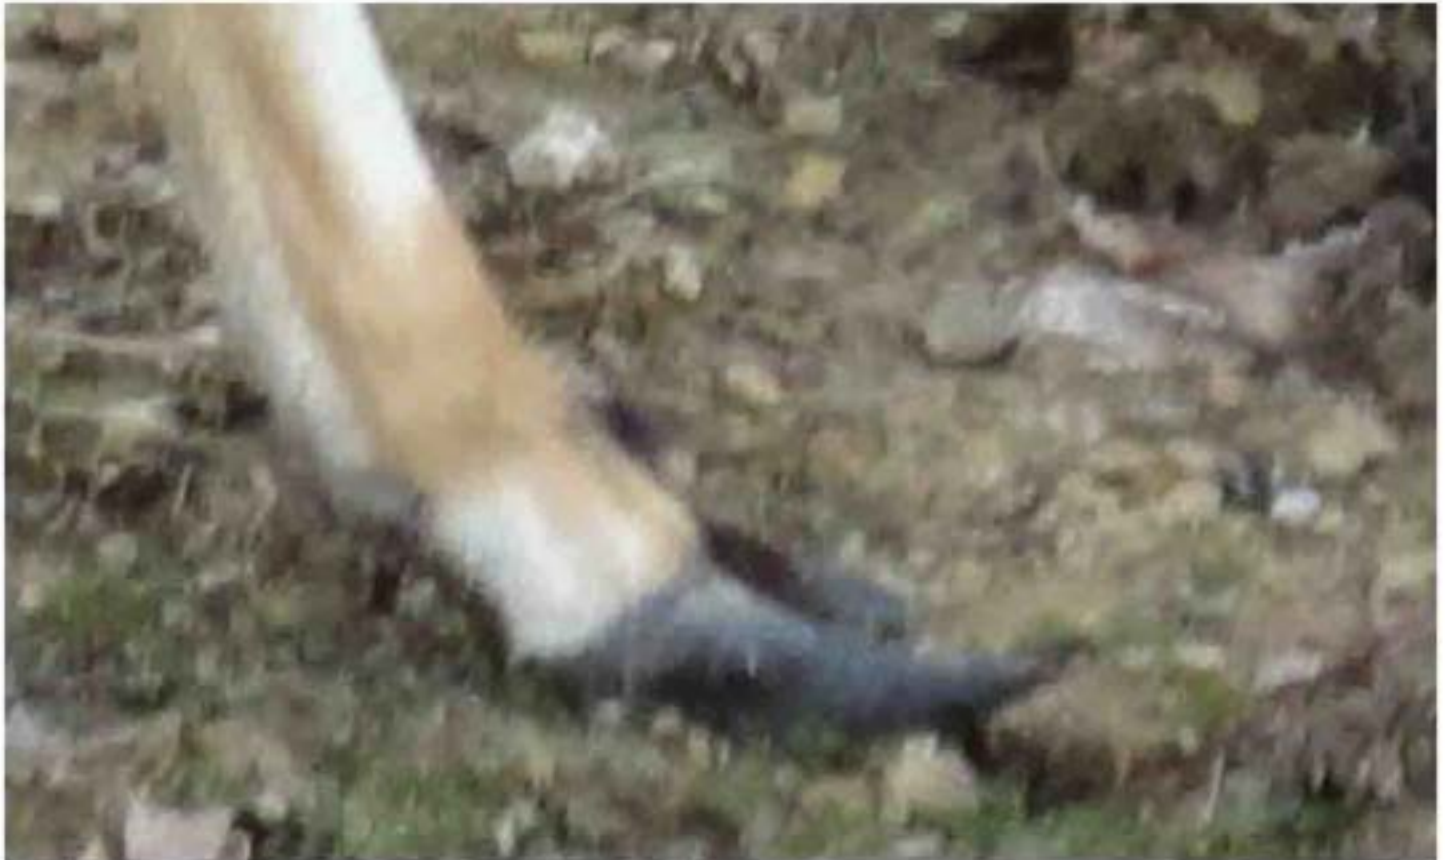
000122

CFR: 2.40 (b) (2), 2.40 (b) (3)

Photographer:	D. Miller, SACS	Legal Name:	55-B-0069
Photo Taken:	Wed, Nov 12, '14 12-4 pm	HENRY HAMPTON	
Inspection:	321140657190604		
Description:	Blackbuck antelope in drive thru with long feet.

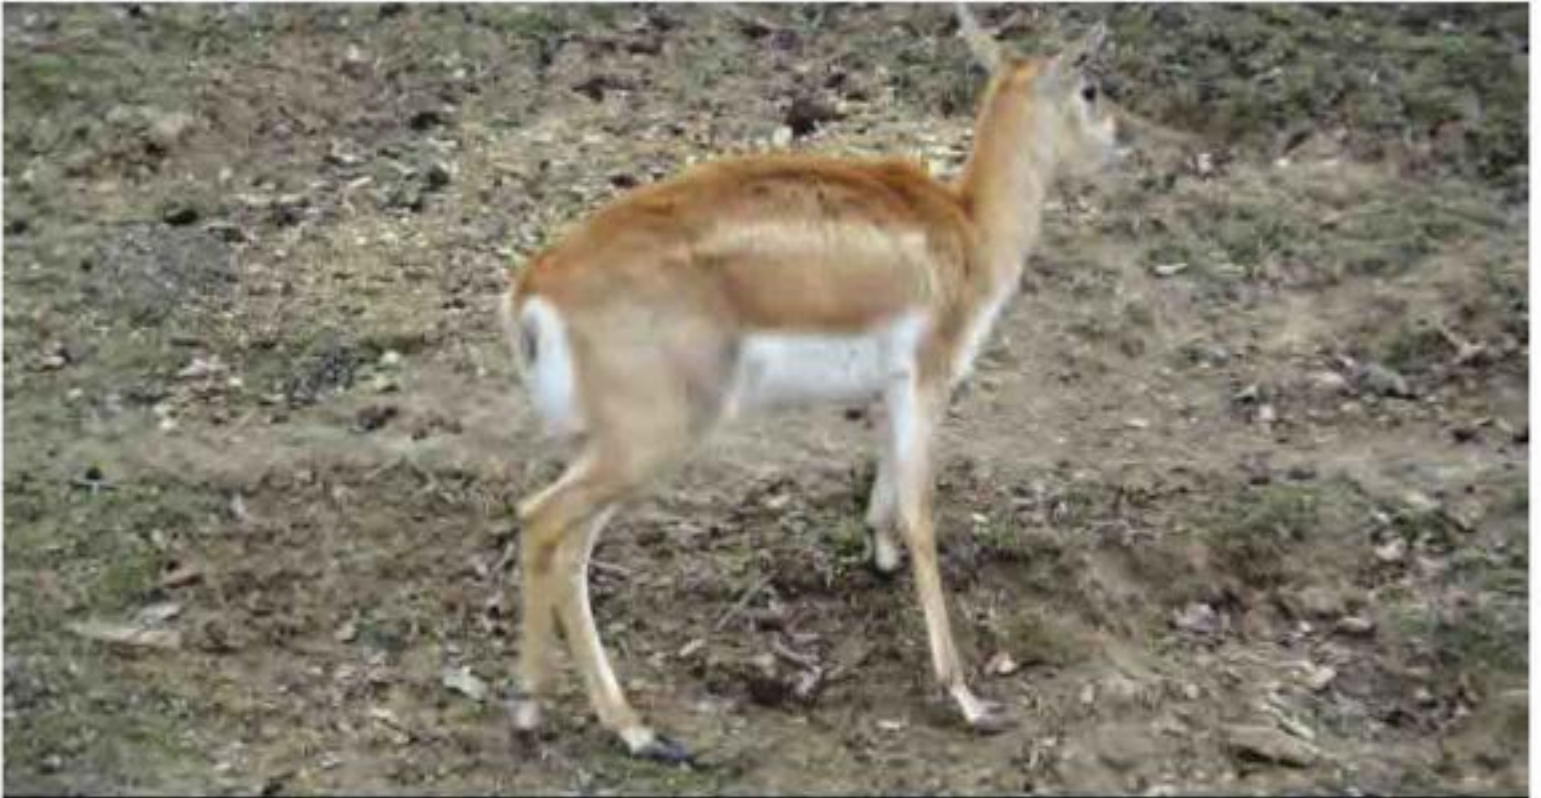
000123

CFR: 2.40 (b) (2), 2.40 (b) (3)

Photographer:	D. Miller, SACS	Legal Name:	55-B-0069
Photo Taken:	Wed, Nov 12, '14 12-4 pm	HENRY HAMPTON	
Inspection:	321140657190604		
Description:	***CROPPED PHOTO**showing close-up of left hind foot of blackbuck in drive thru area.

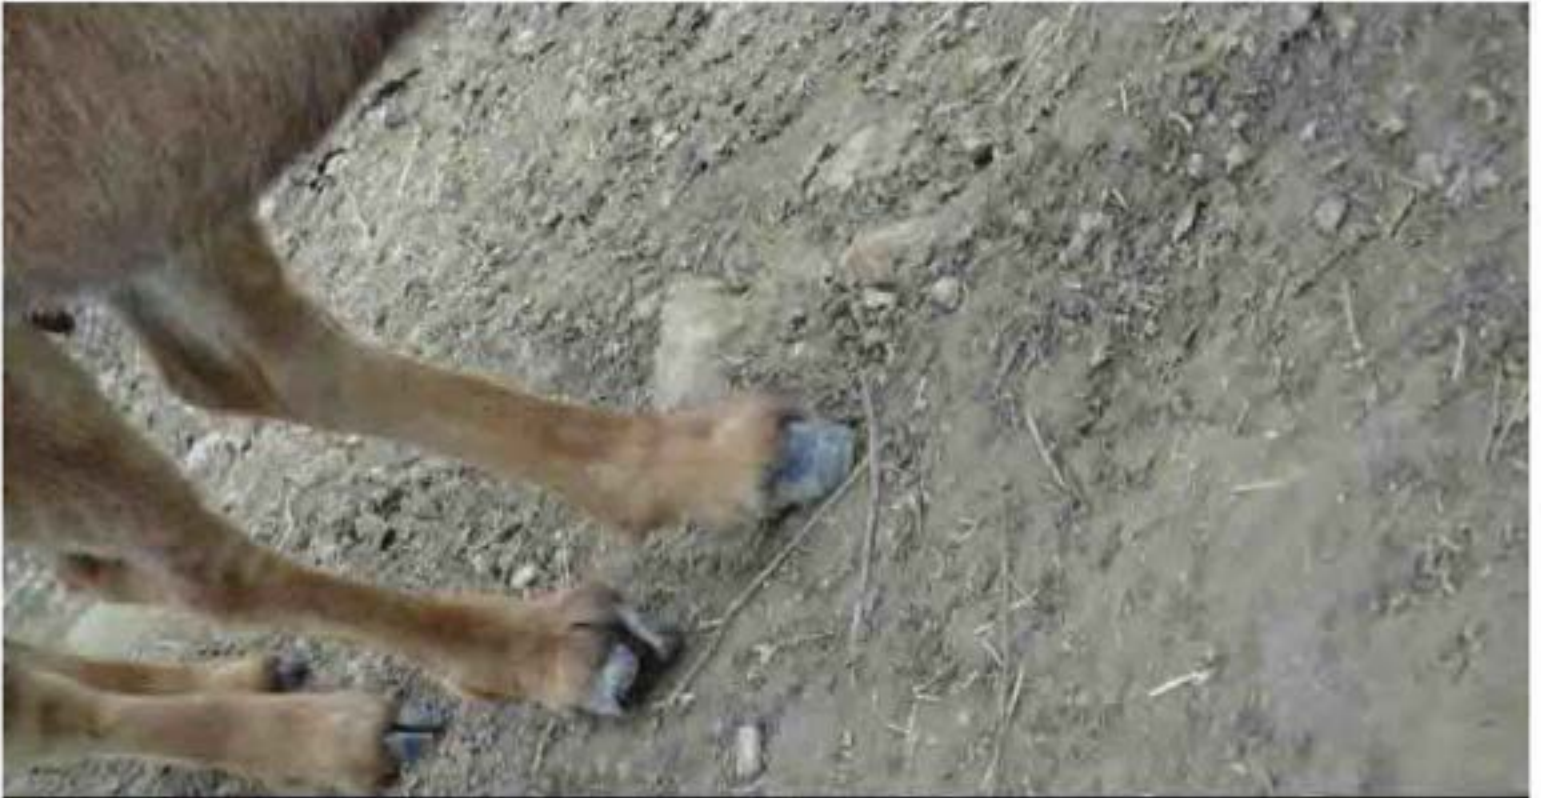
000124

CFR: 2.40 (b) (2), 2.40 (b) (3)

Photographer:	D. Miller, SACS	Legal Name:	55-B-0069
Photo Taken:	Wed, Nov 12, '14 12-4 pm	HENRY HAMPTON	
Inspection:	321140657190604		
Description:	**ORIGINAL PHOTO** blackbuck antelope with long feet.

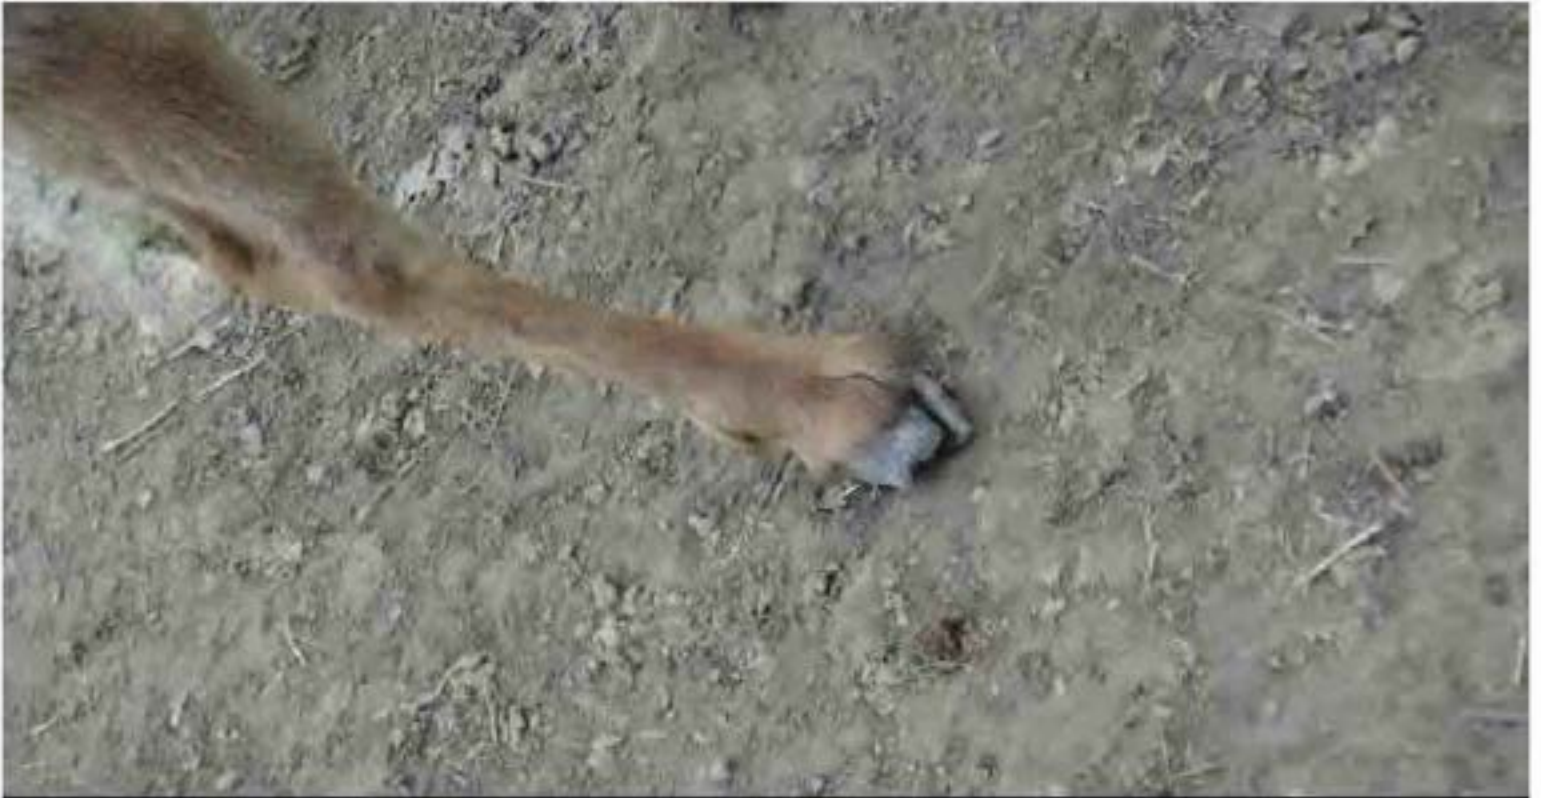
000125

CFR: 2.40 (b) (3), 2.40 (b) (2)

Photographer:	D. Miller, SACS	Legal Name:	55-B-0069
Photo Taken:	Wed, Nov 12, '14 12-4 pm	HENRY HAMPTON	
Inspection:	321140657190604		
Description:	Aoudad in drive thru area with long feet.

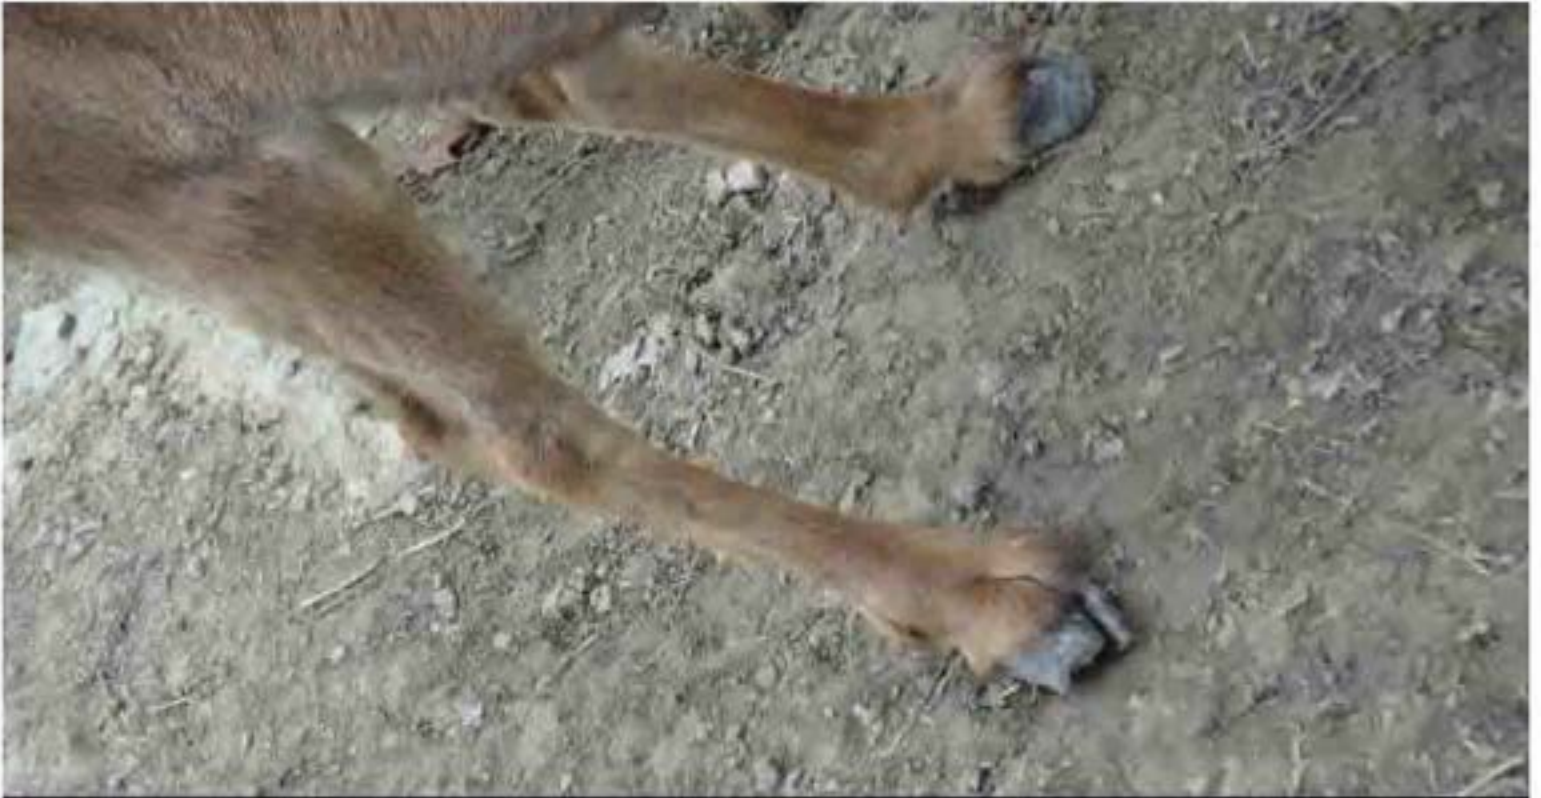
000127

CFR: 2.40 (b) (2), 2.40 (b) (3)

Photographer:	D. Miller, SACS	Legal Name:	55-B-0069
Photo Taken:	Wed, Nov 12, '14 12-4 pm	HENRY HAMPTON	
Inspection:	321140657190604		
Description:	Aoudad in drive thru area with long feet.

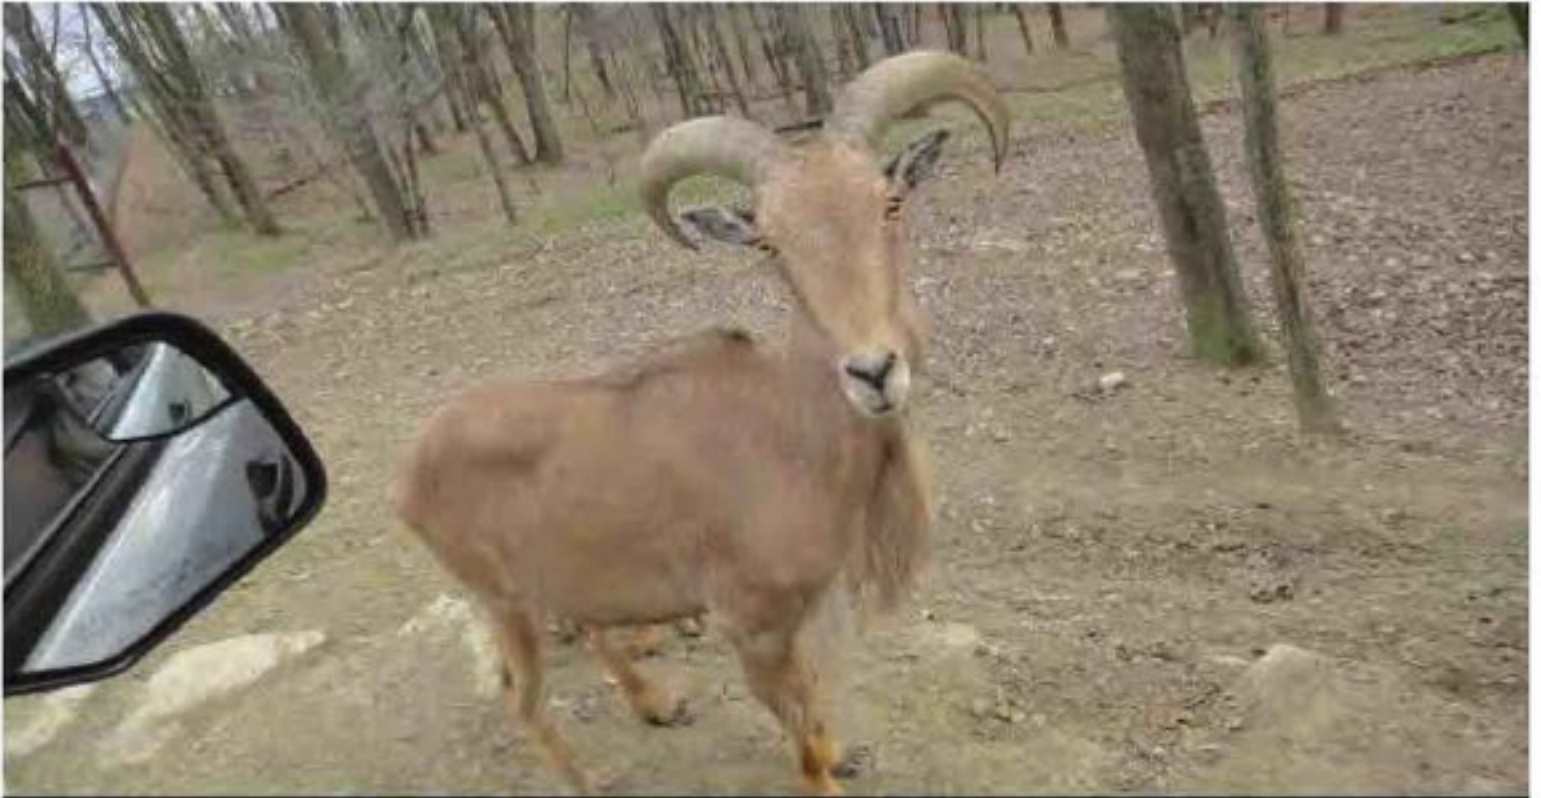
000128

CFR: 2.40 (b) (3), 2.40 (b) (2)

Photographer:	D. Miller, SACS	Legal Name:	55-B-0069
Photo Taken:	Wed, Nov 12, '14 12-4 pm	HENRY HAMPTON	
Inspection:	321140657190604		
Description:	Aoudad in drive thru area with long feet.

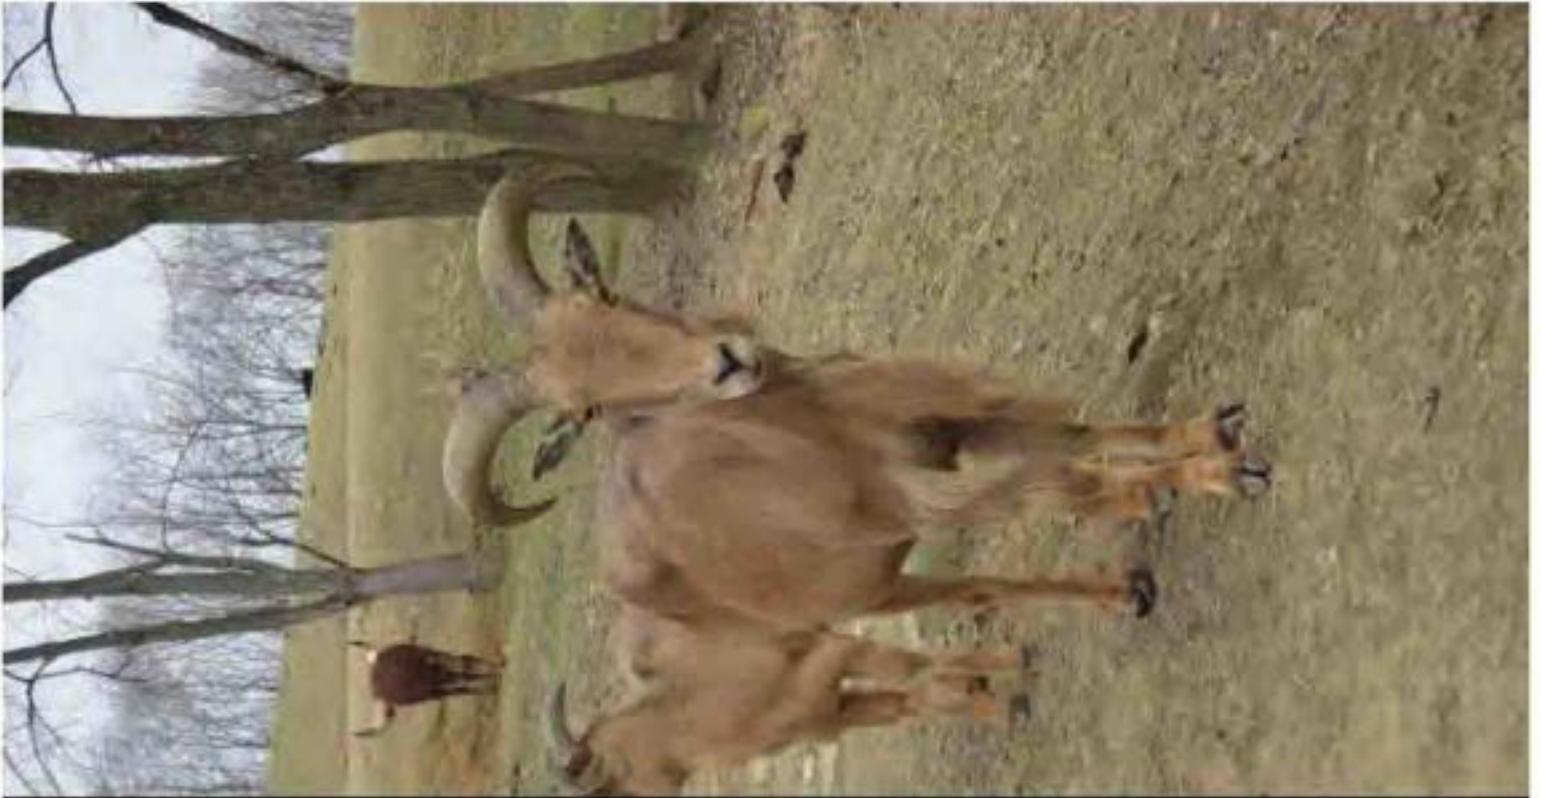
CFR: 2.40 (b) (2), 2.40 (b) (3)

Photographer:	D. Miller, SACS	Legal Name:	55-B-0069
Photo Taken:	Wed, Nov 12, '14 12-4 pm	HENRY HAMPTON	
Inspection:	321140657190604		
Description:	Aoudad in drive thru area with long feet.

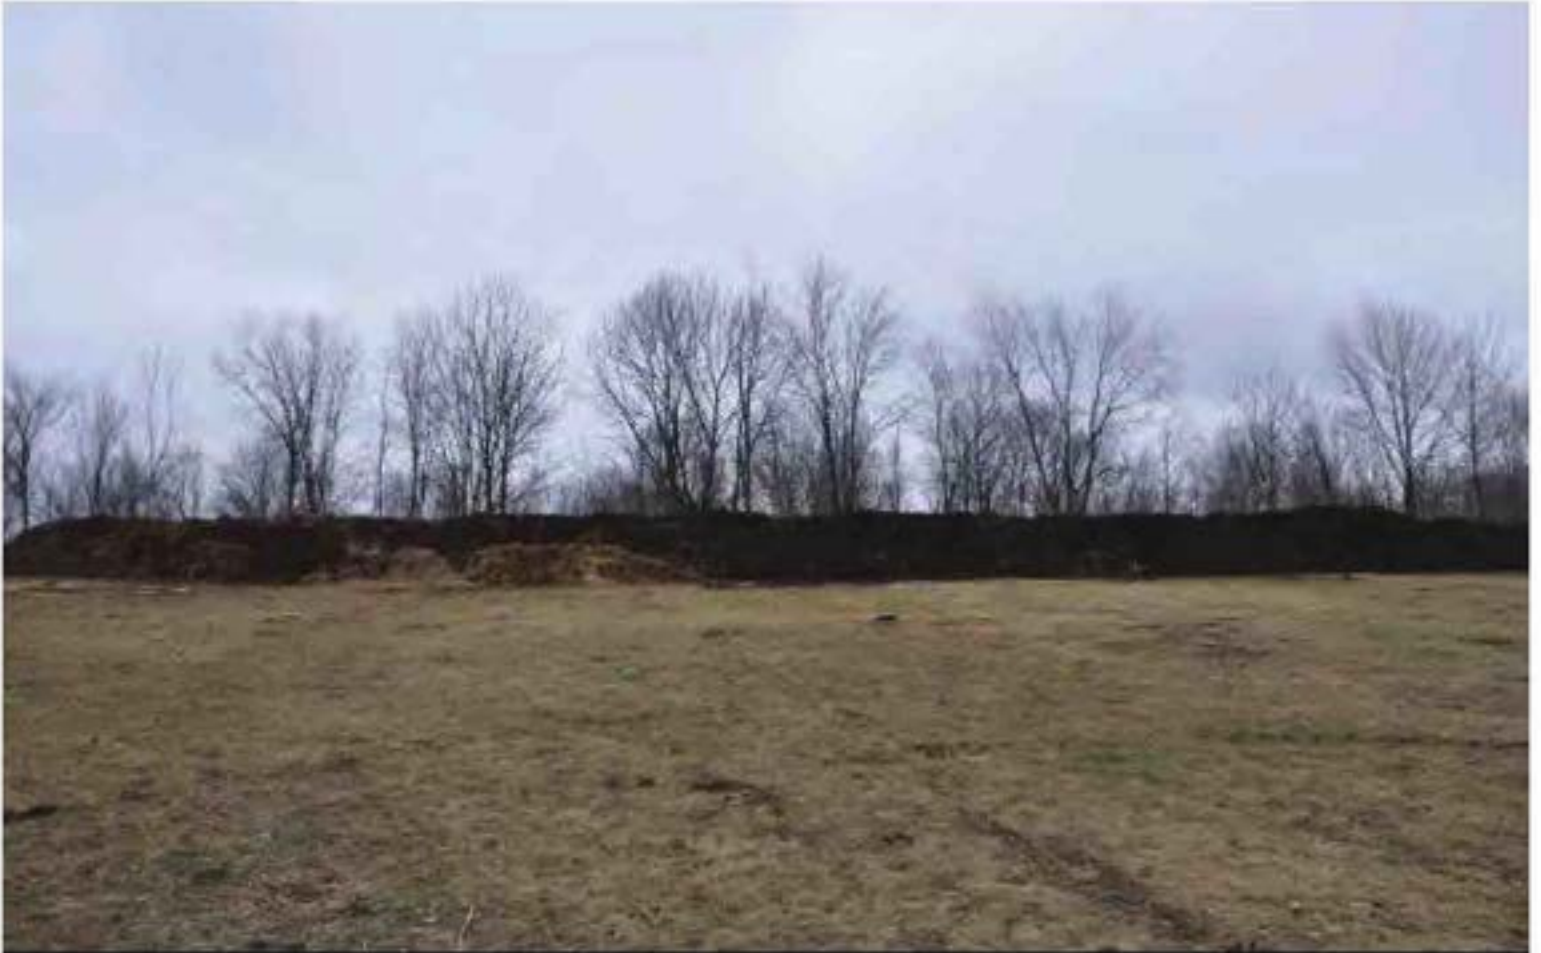
000137

CFR: 3.125 (d)

Photographer:	R. Coleman, ACI	Legal Name:	55-B-0069
Photo Taken:	Wed, Nov 12, '14 12-4 pm	HENRY HAMPTON	
Inspection:	321140657190604		
Description:	Waste pile in drive thru area.

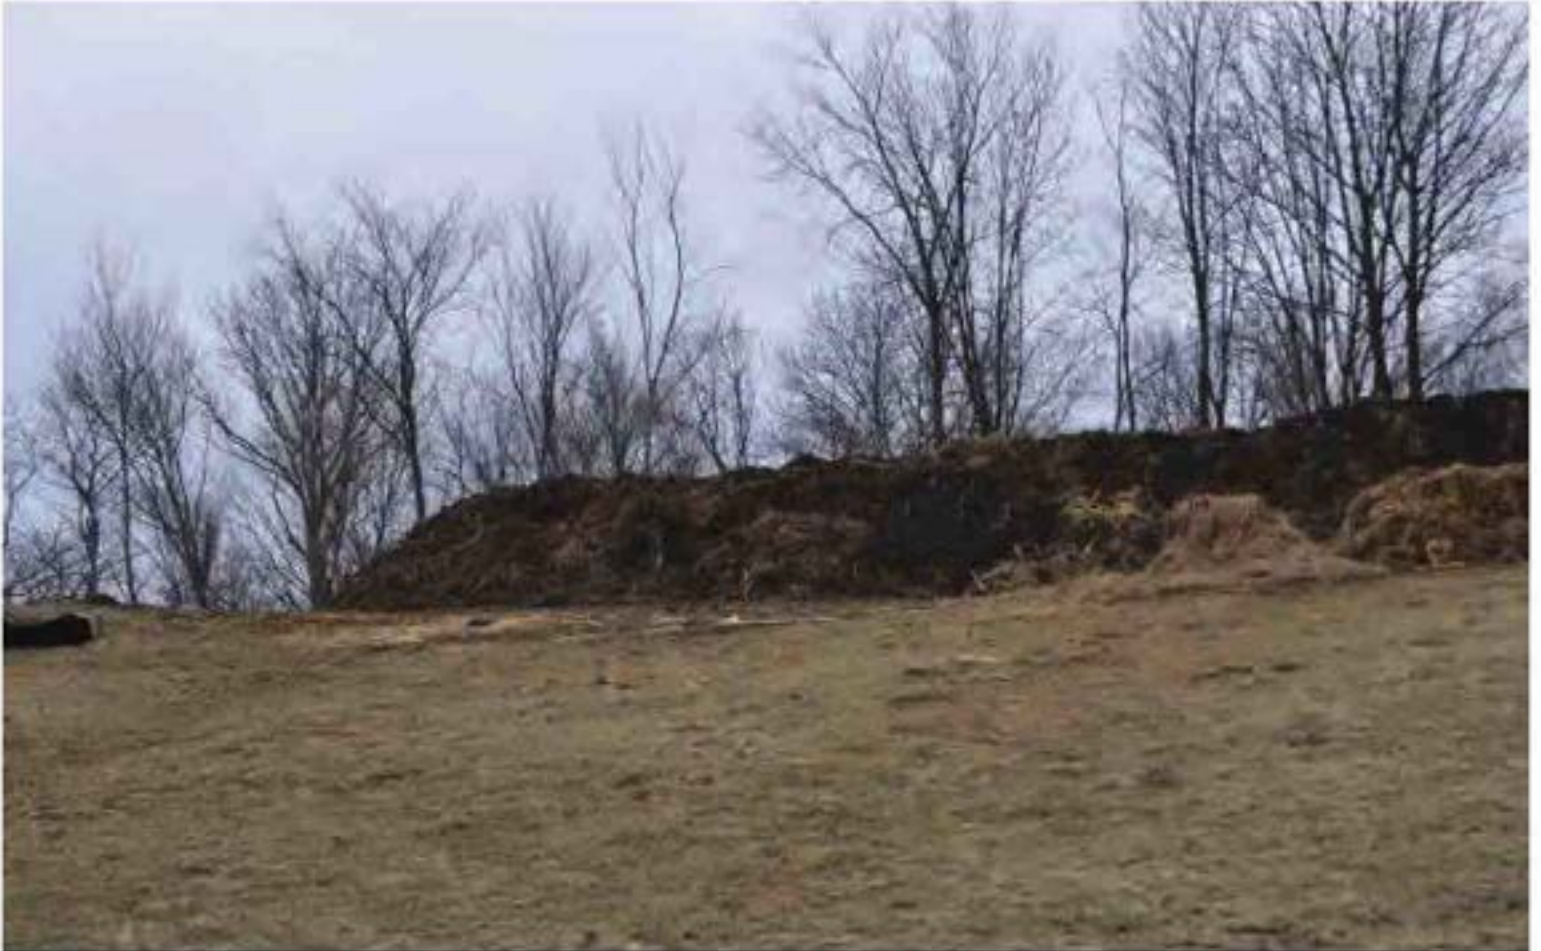
000138

CFR: 3.125 (d)

Photographer:	R. Coleman, ACI	Legal Name:	55-B-0069
Photo Taken:	Wed, Nov 12, '14 12-4 pm	HENRY HAMPTON	
Inspection:	321140657190604		
Description:	Waste pile in drive thru area.

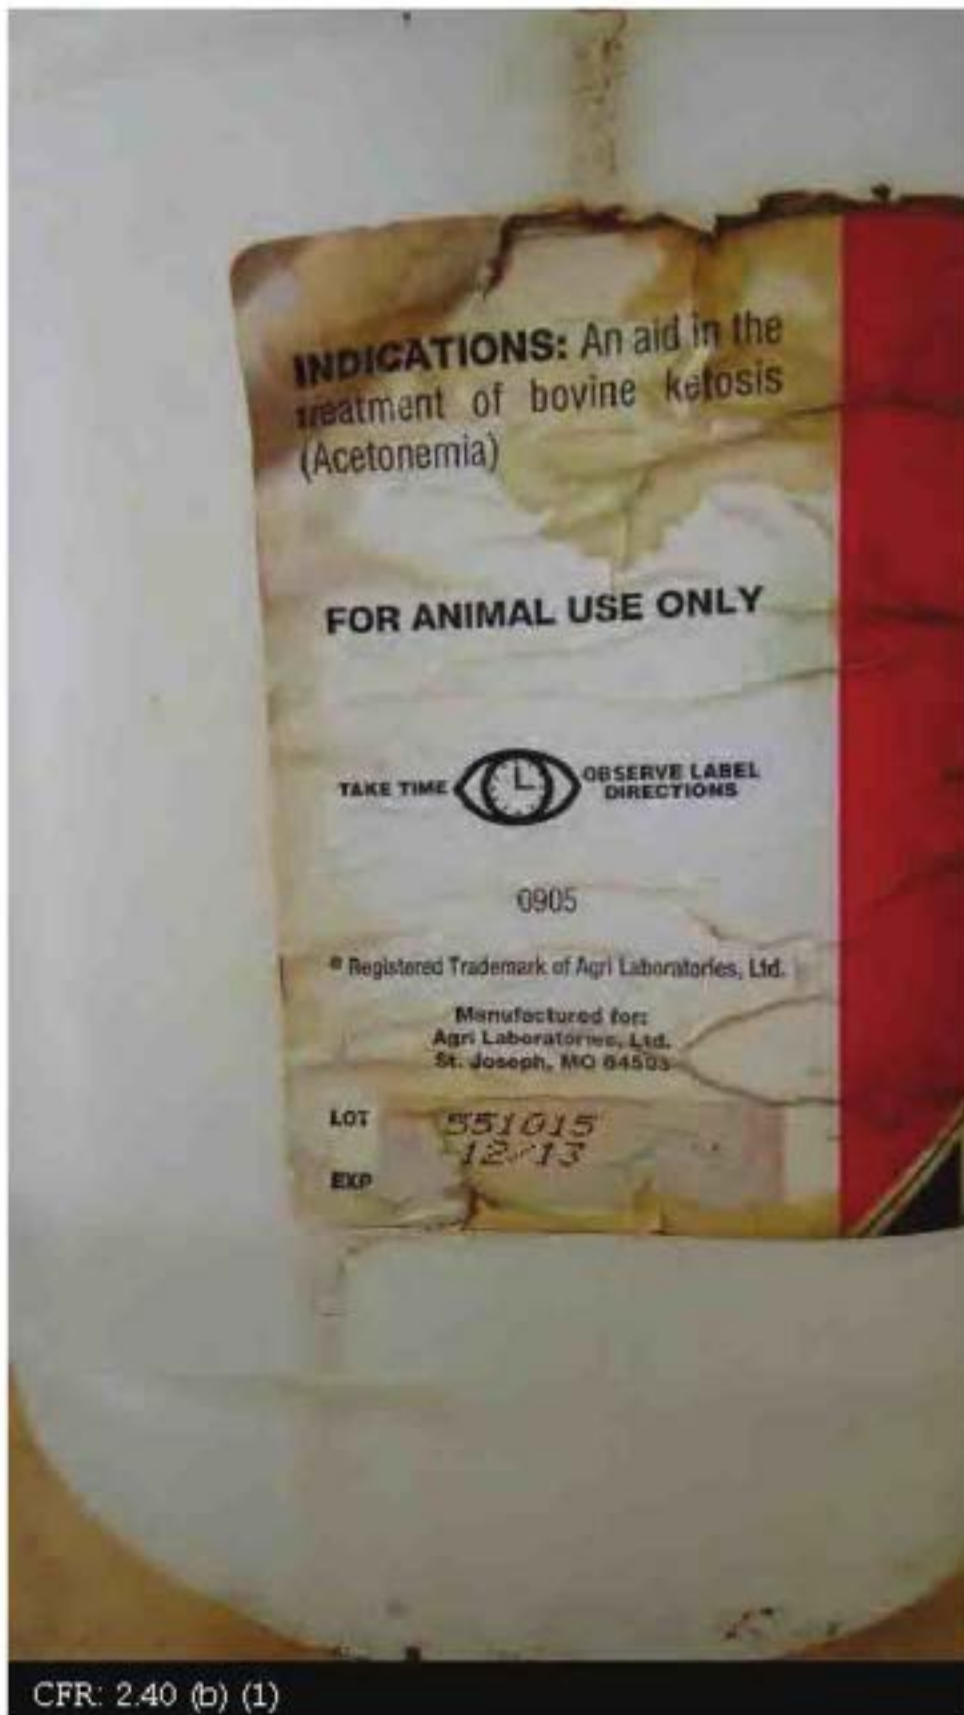
CFR: 2.40 (b) (1)

Description: Section 2.40(b)(1): Expired container of Propylene Glycol found in drug cart in milking parlor.

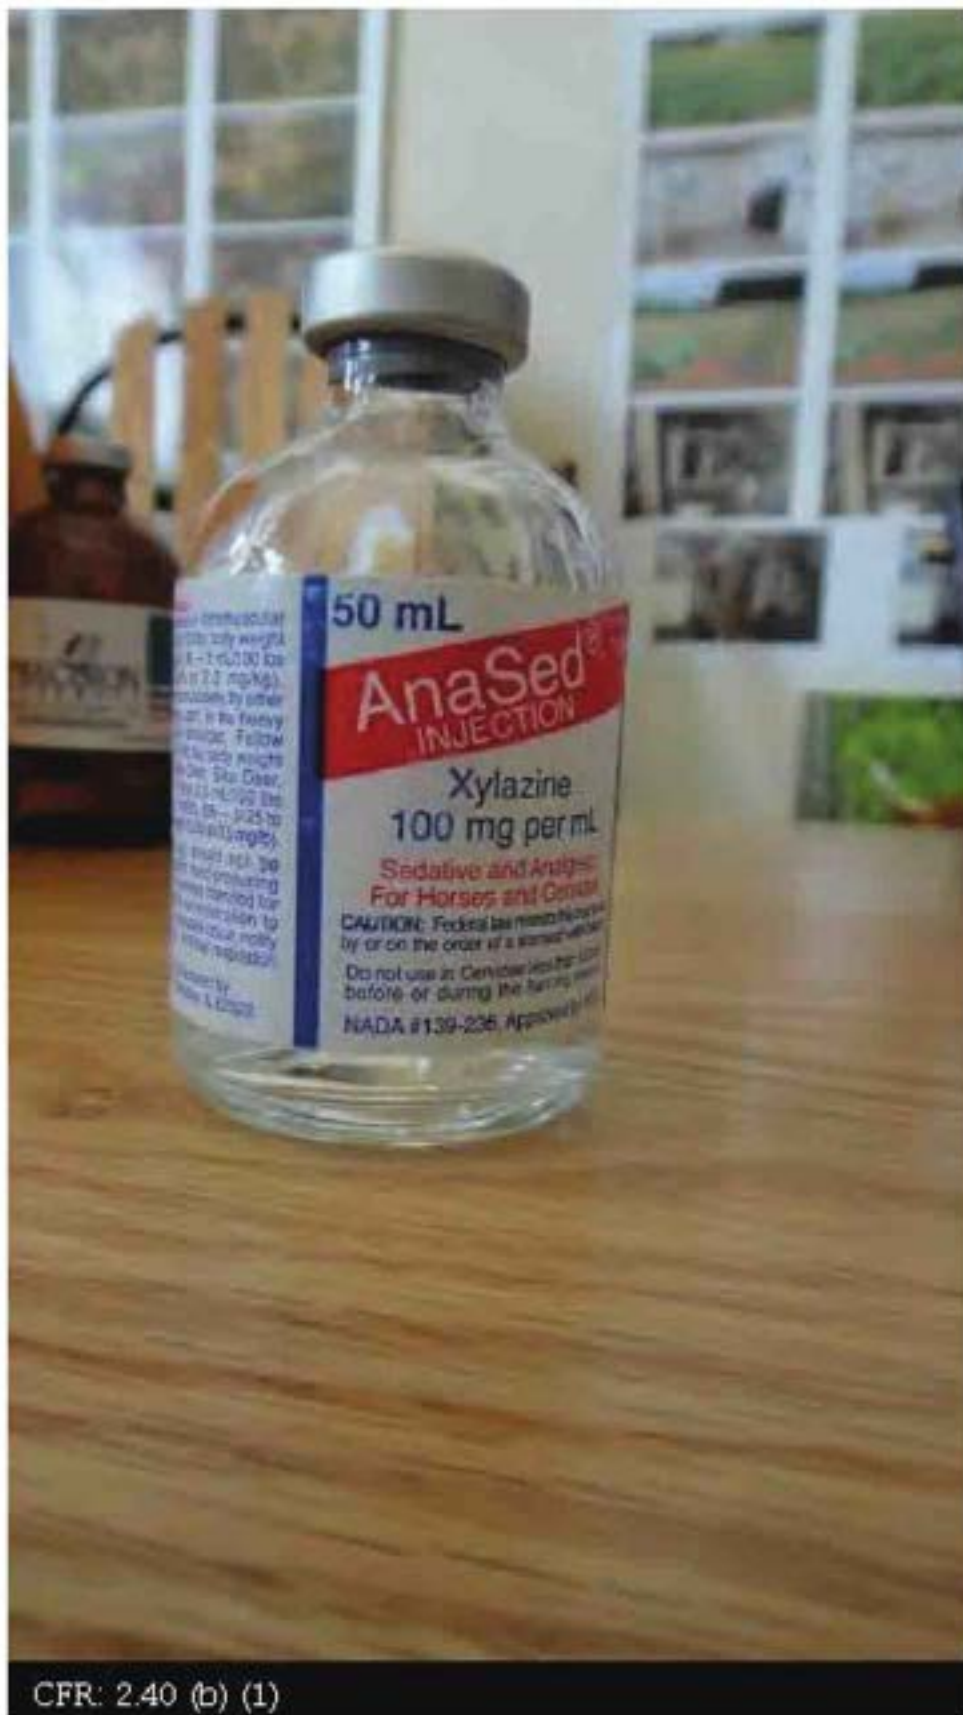
000163

CFR: 2.40 (b) (1)

Description: Section 2.40(b)(1): Expired bottle of Anased brand Xylazine.

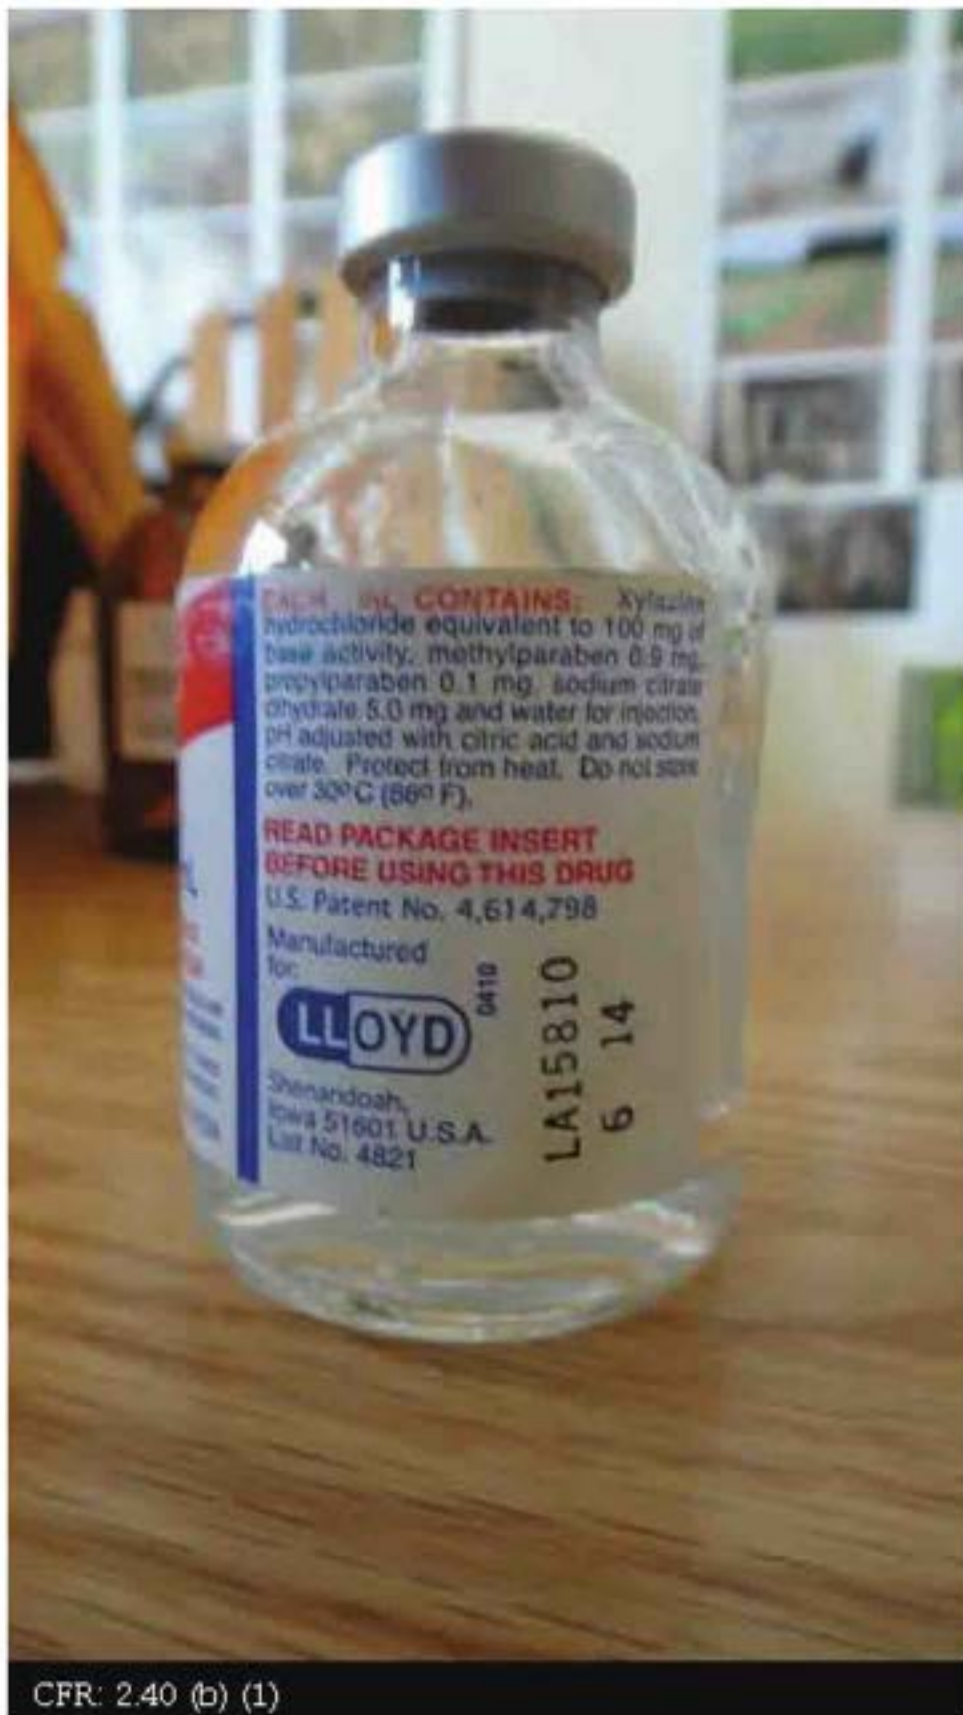
000164

CFR: 2.40 (b) (1)

Description: Section 2.40(b)(1): Expired bottle of Anased brand Xylazine.

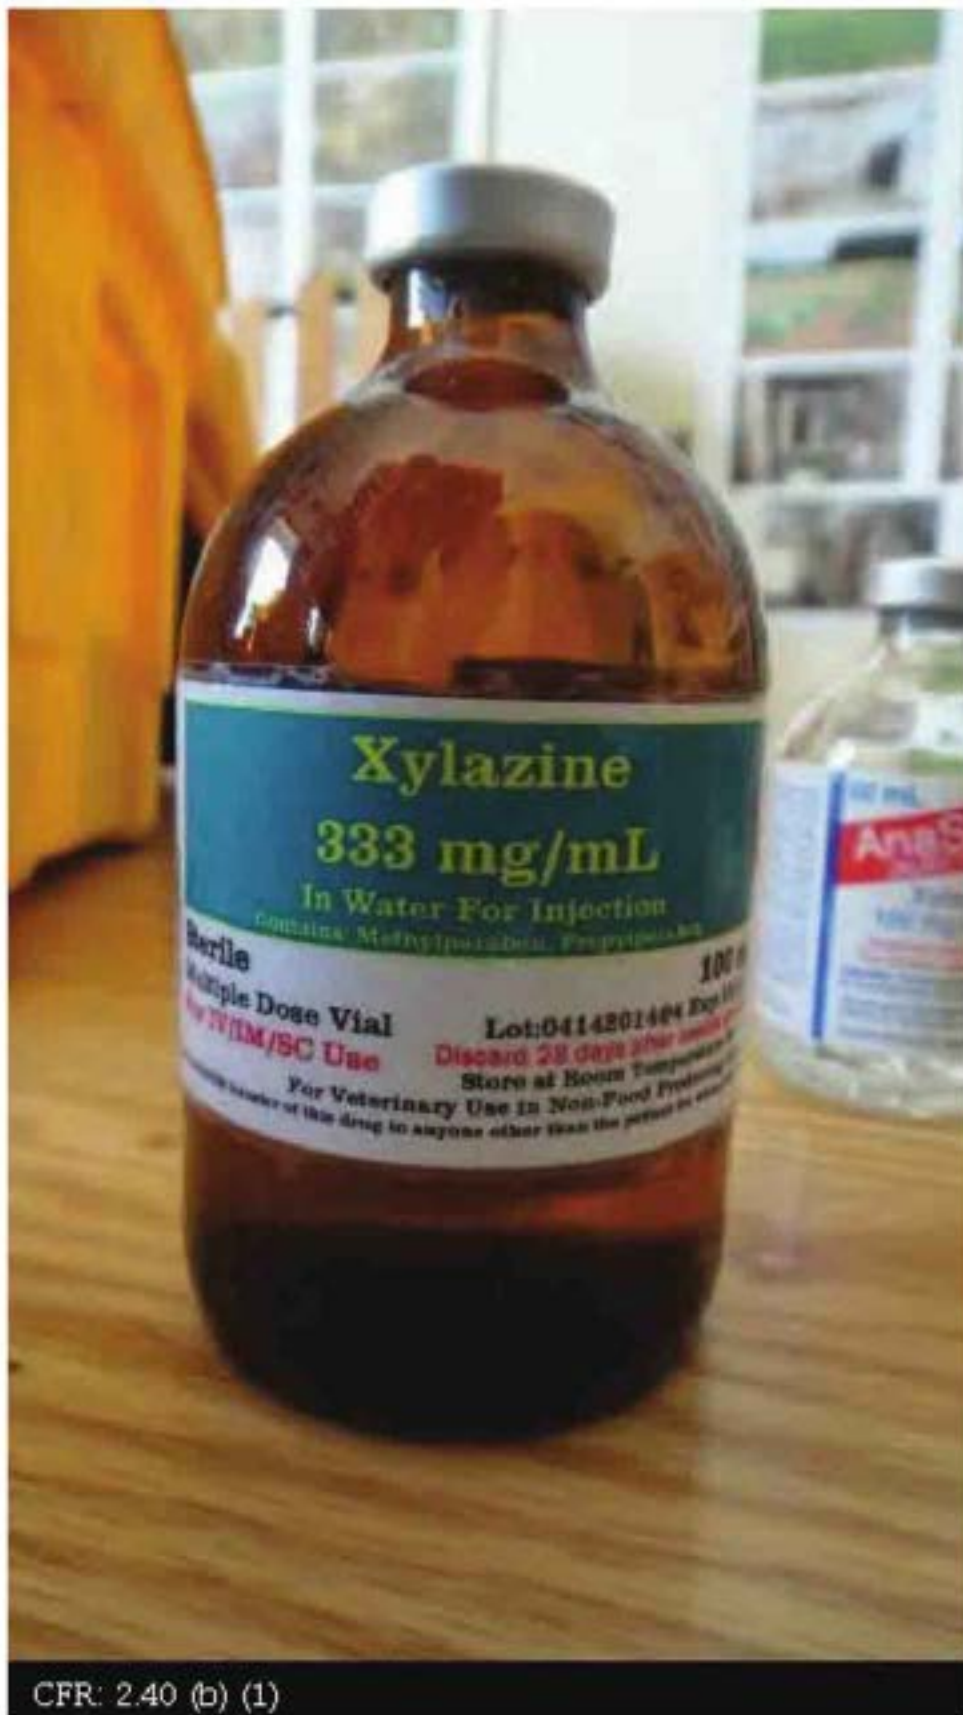
000165

CFR: 2.40 (b) (1)

Description: Section 2.40(b)(1): Expired bottle of Xylazine.

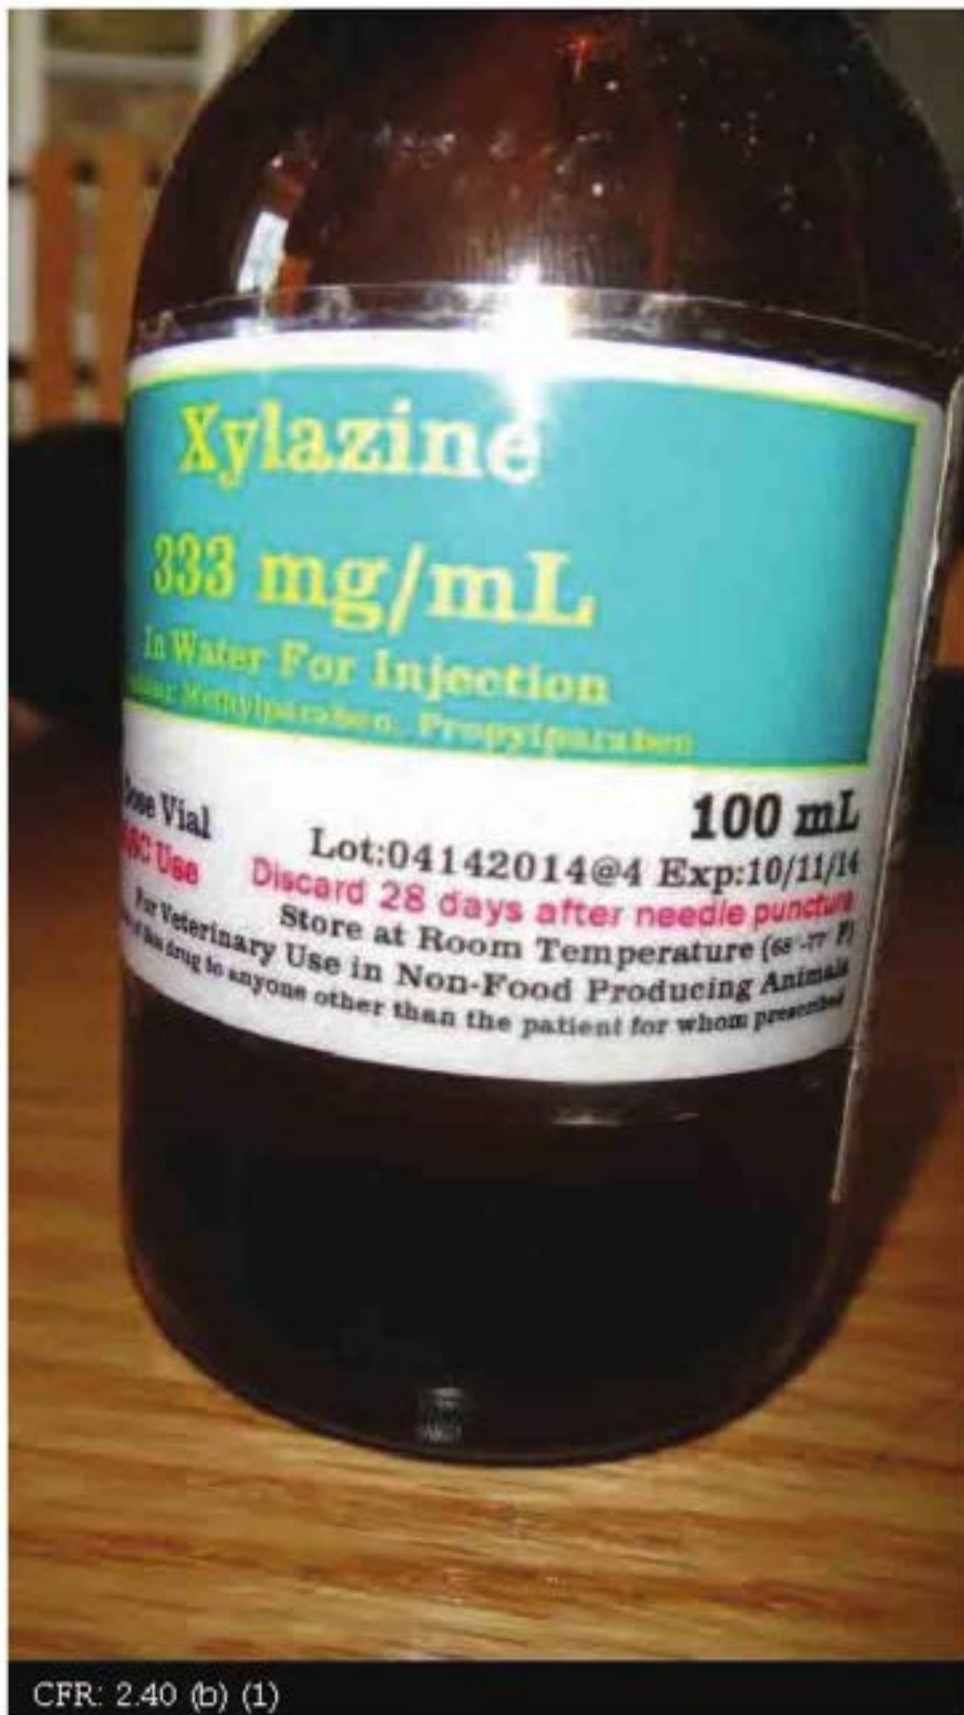
000166

CFR: 2.40 (b) (1)

Description: Section 2.40(b)(1): Expired bottle of Xylazine.

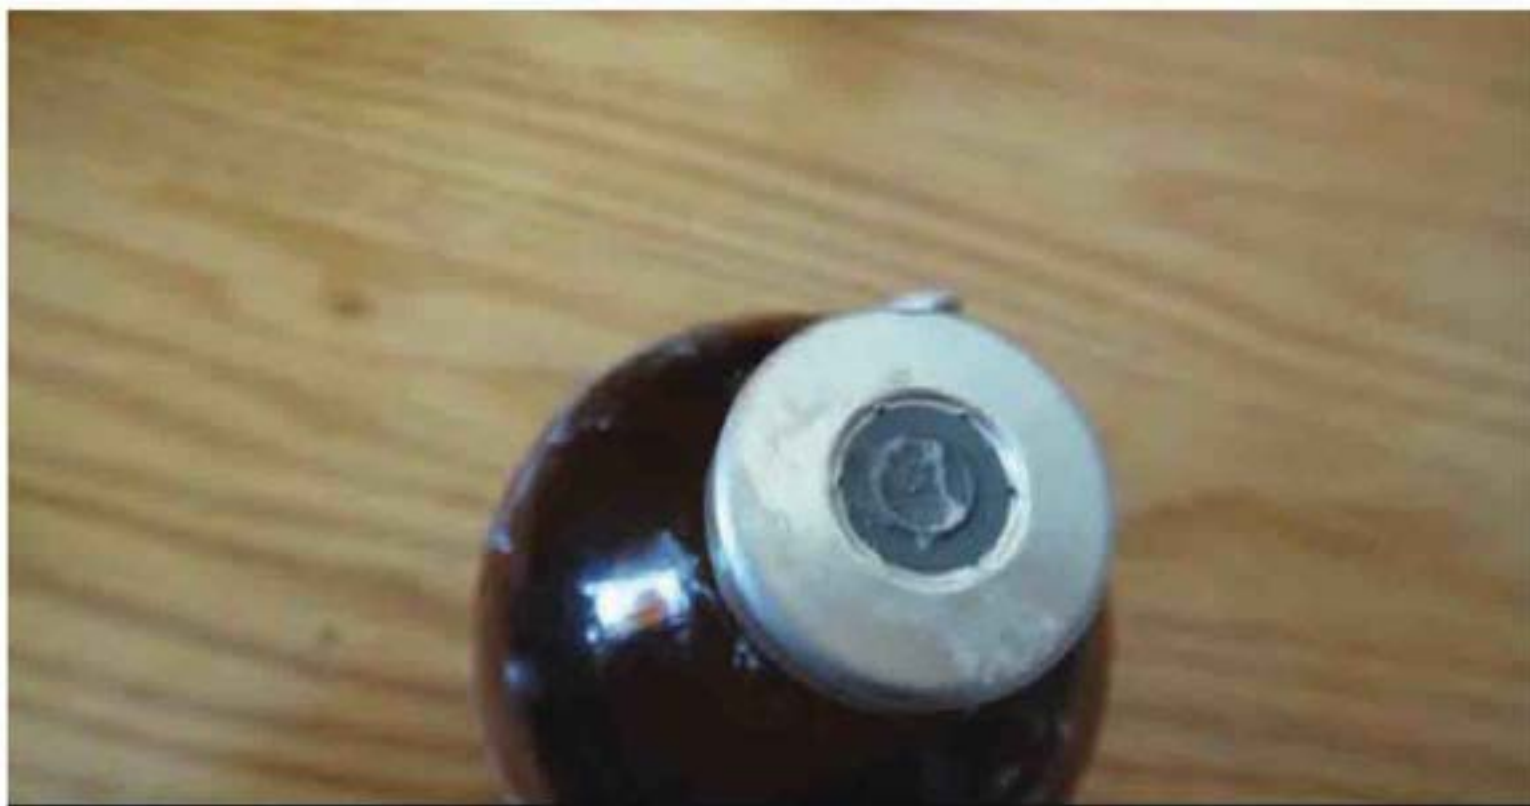
000167

CFR: 2.40 (b) (1)

Photographer:	Dana Miller, SACS	Legal Name:	55-B-0069
Photo Taken:	Mon, Mar 2, '15	HENRY HAMPTON	
Inspection:	64151500440984		
Description:	Section 2.40(b)(1): Expired bottle of Xylazine with signs of needle puncture in bottle marked to discard in 28 days.

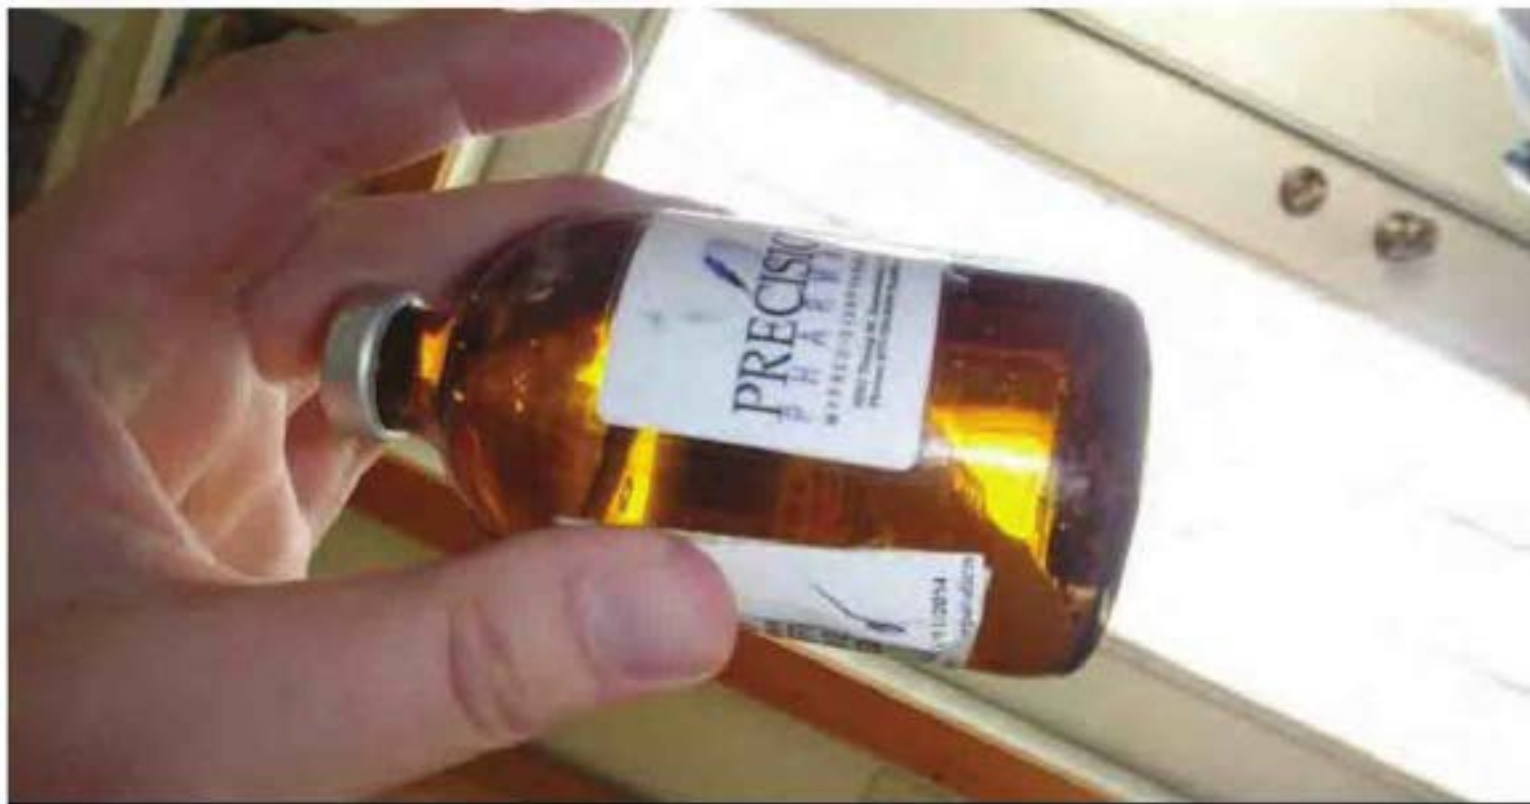
000168

CFR: 2.40 (b) (1)

Photographer:	Dana Miller, SACS	Legal Name:	55-B-0069
Photo Taken:	Mon, Mar 2, '15	HENRY HAMPTON	
Inspection:	64151500440984		
Description:	Section 2.40(b)(1): Expired bottle of Xylazine with crystal material floating in it.
