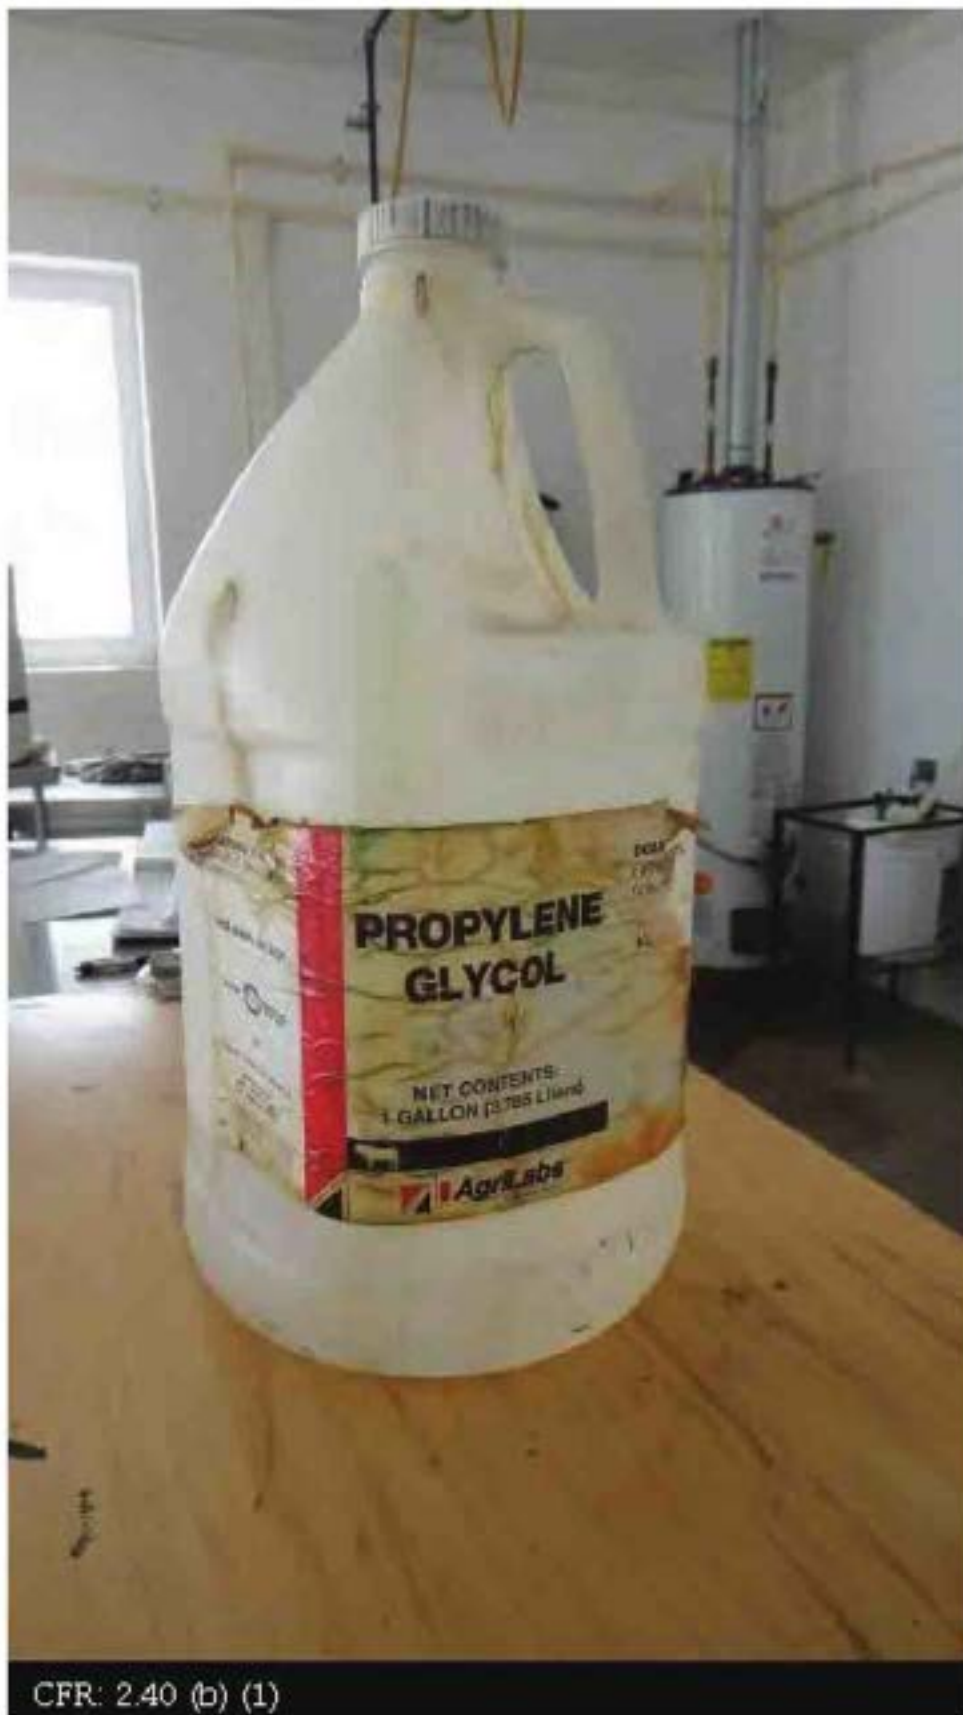
CFR: 2.40 (b) (1)

Description: Section 2.40(b)(1): Expired container of Propylene Glycol found in drug cart in milking parlor.

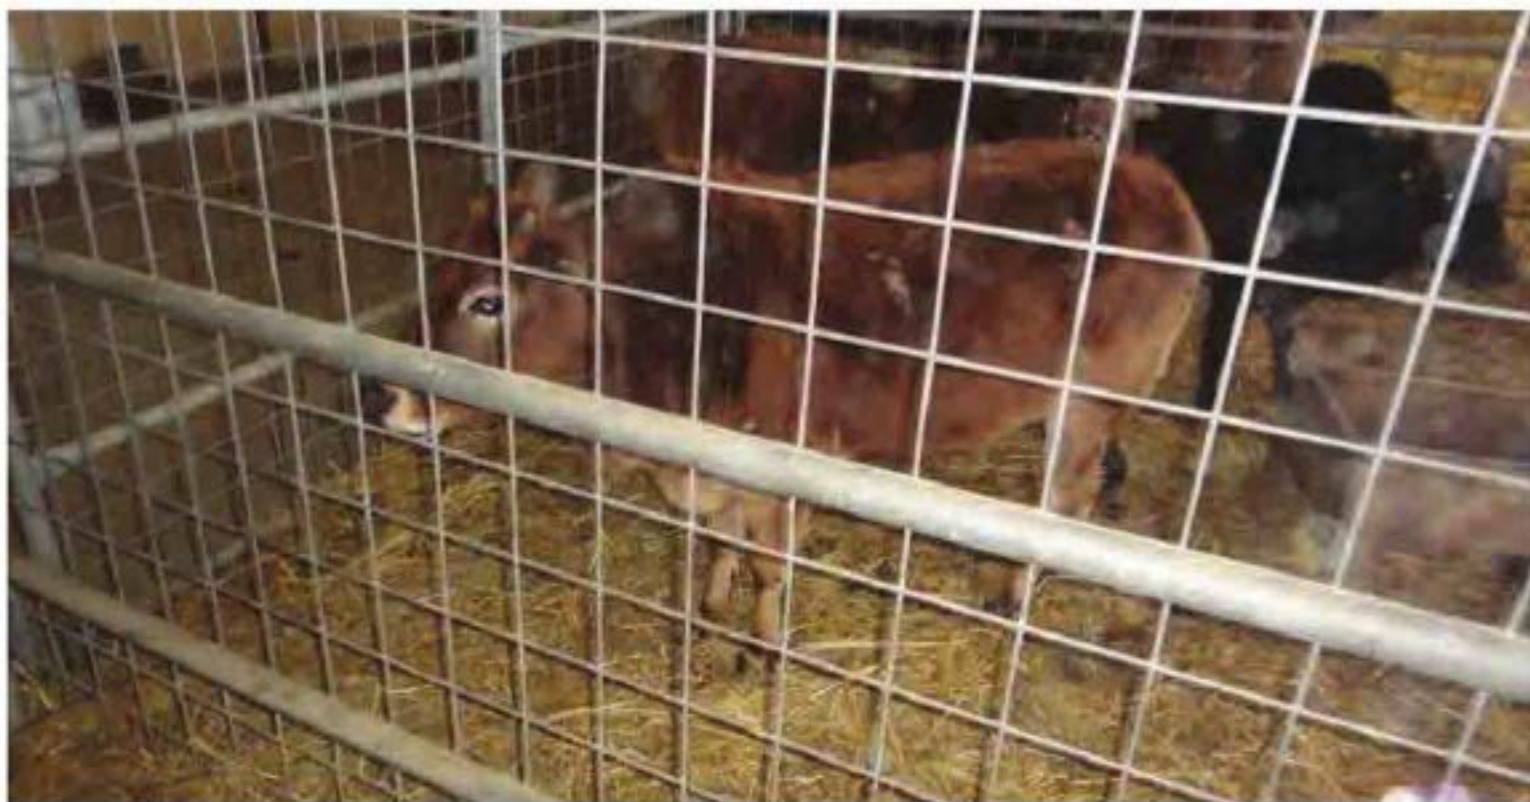
000171

CFR: 2.40 (b) (2)

Photographer:	Dana Miller, SACS	Legal Name:	55-B-0069
Photo Taken:	Mon, Mar 2, '15 125 pm	HENRY HAMPTON	
Inspection:	64151500440984		
Description:	Section 2.40(b)(2): Brown miniature zebu with areas of patchy hair loss.

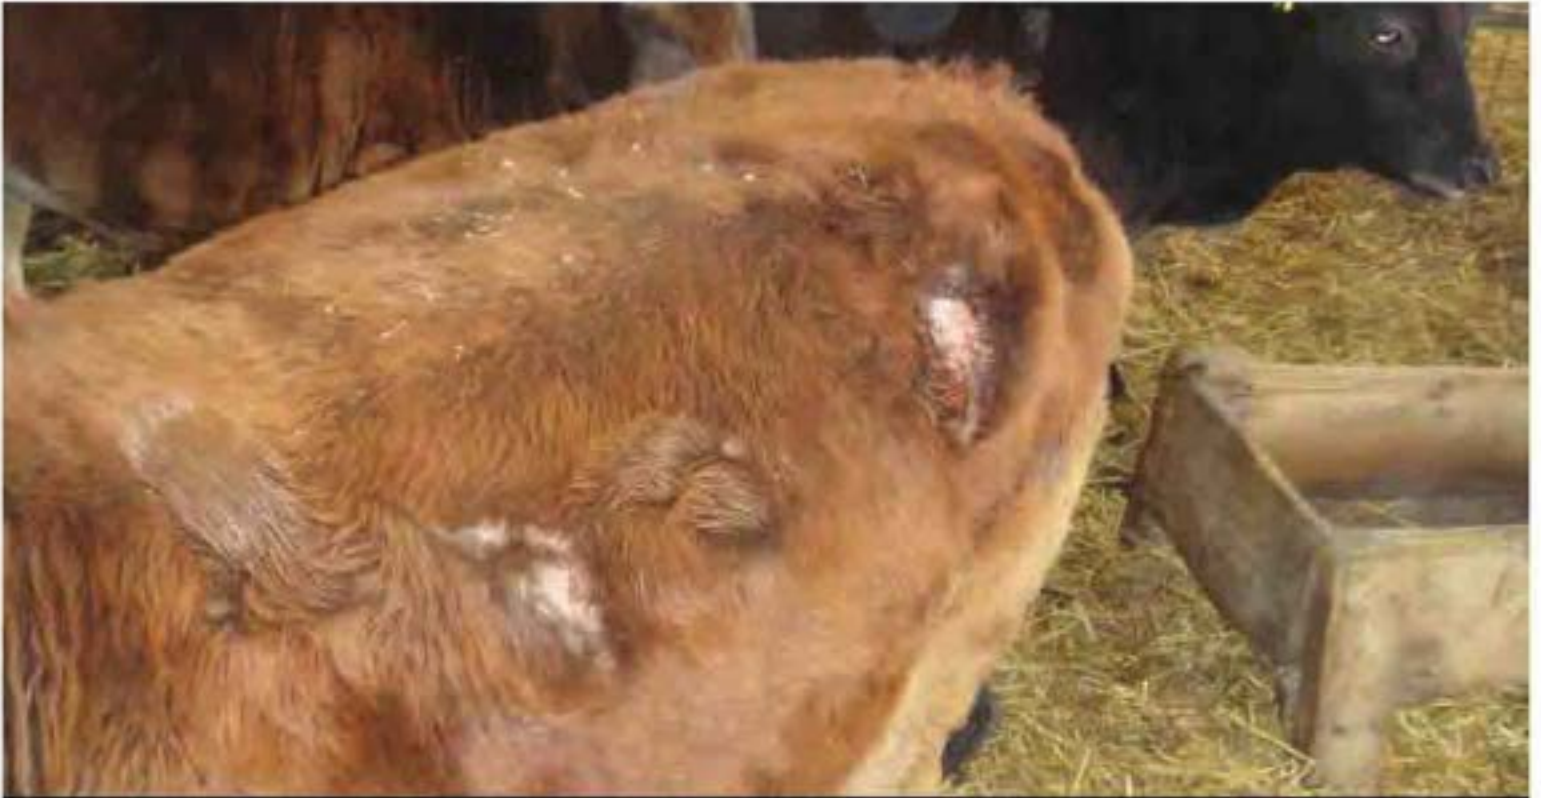
000172

CFR: 2.40 (b) (2)

Photographer:	Dana Miller, SACS	Legal Name:	55-B-0069
Photo Taken:	Mon, Mar 2, '15 125 pm	HENRY HAMPTON	
Inspection:	64151500440984		
Description:	Section 2.40(b)(2): Brown miniature zebu with areas of patchy hair loss.

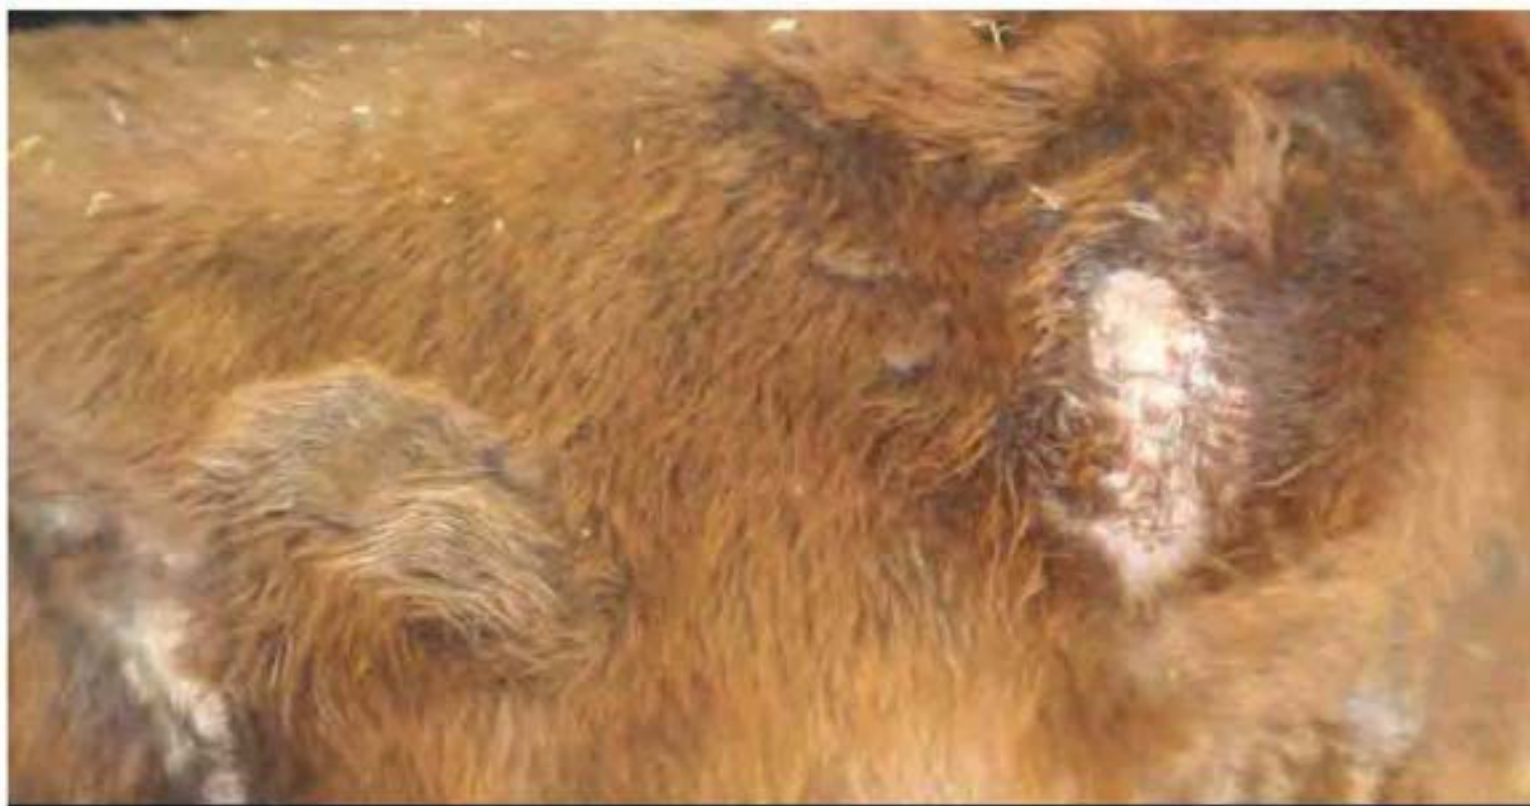
000173

CFR: 2.40 (b) (2)

Photographer:	Dana Miller, SACS	Legal Name:	55-B-0069
Photo Taken:	Mon, Mar 2, '15 125 pm	HENRY HAMPTON	
Inspection:	64151500440984		
Description:	Section 2.40(b)(2): Brown miniature zebu with areas of patchy hair loss.

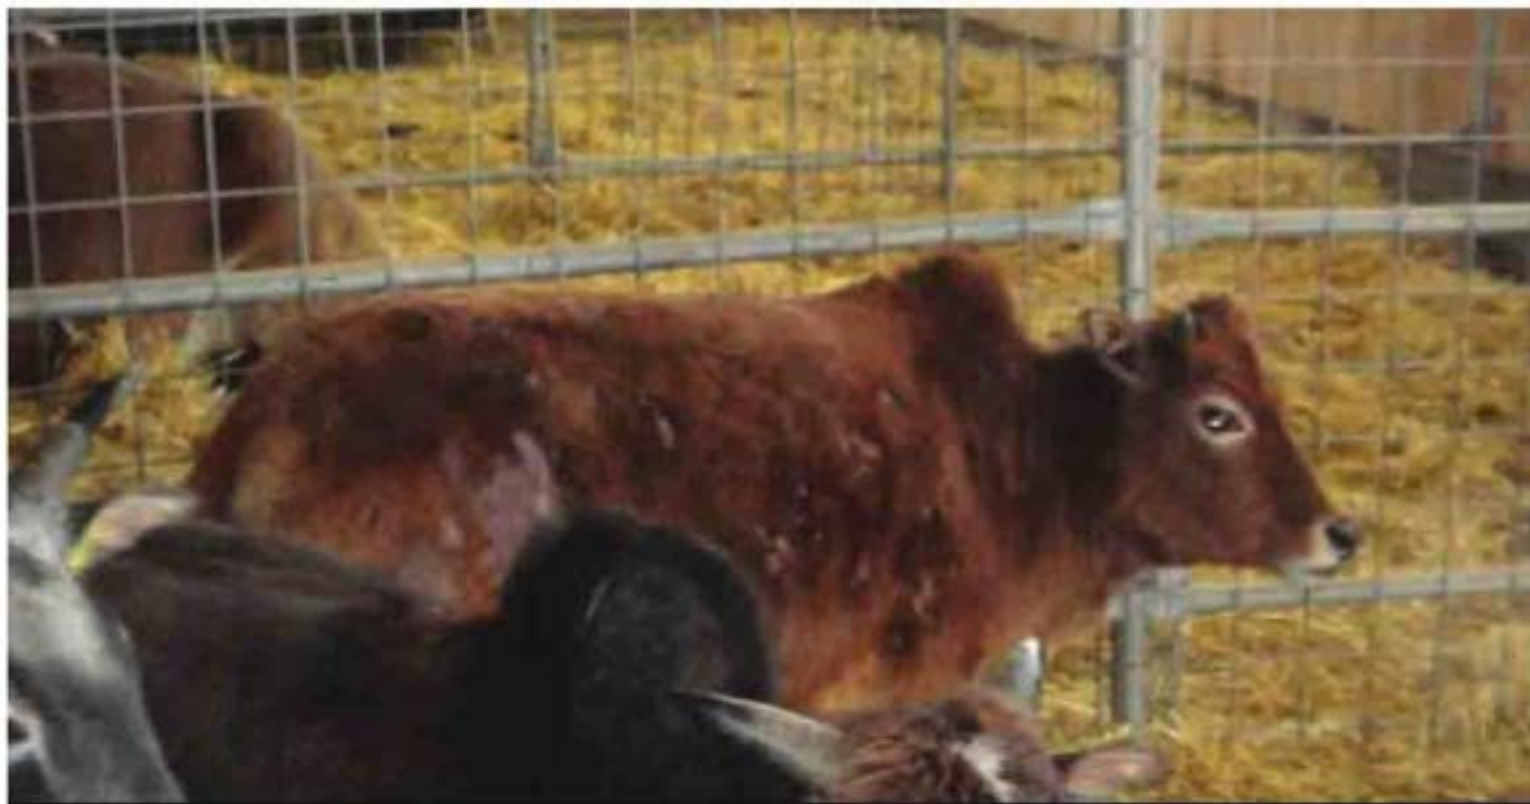
000174

CFR: 2.40 (b) (2)

Photographer:	Dana Miller, SACS	Legal Name:	55-B-0069
Photo Taken:	Mon, Mar 2, '15 125 pm	HENRY HAMPTON	
Inspection:	64151500440984		
Description:	Section 2.40(b)(2): Brown miniature zebu with areas of patchy hair loss.

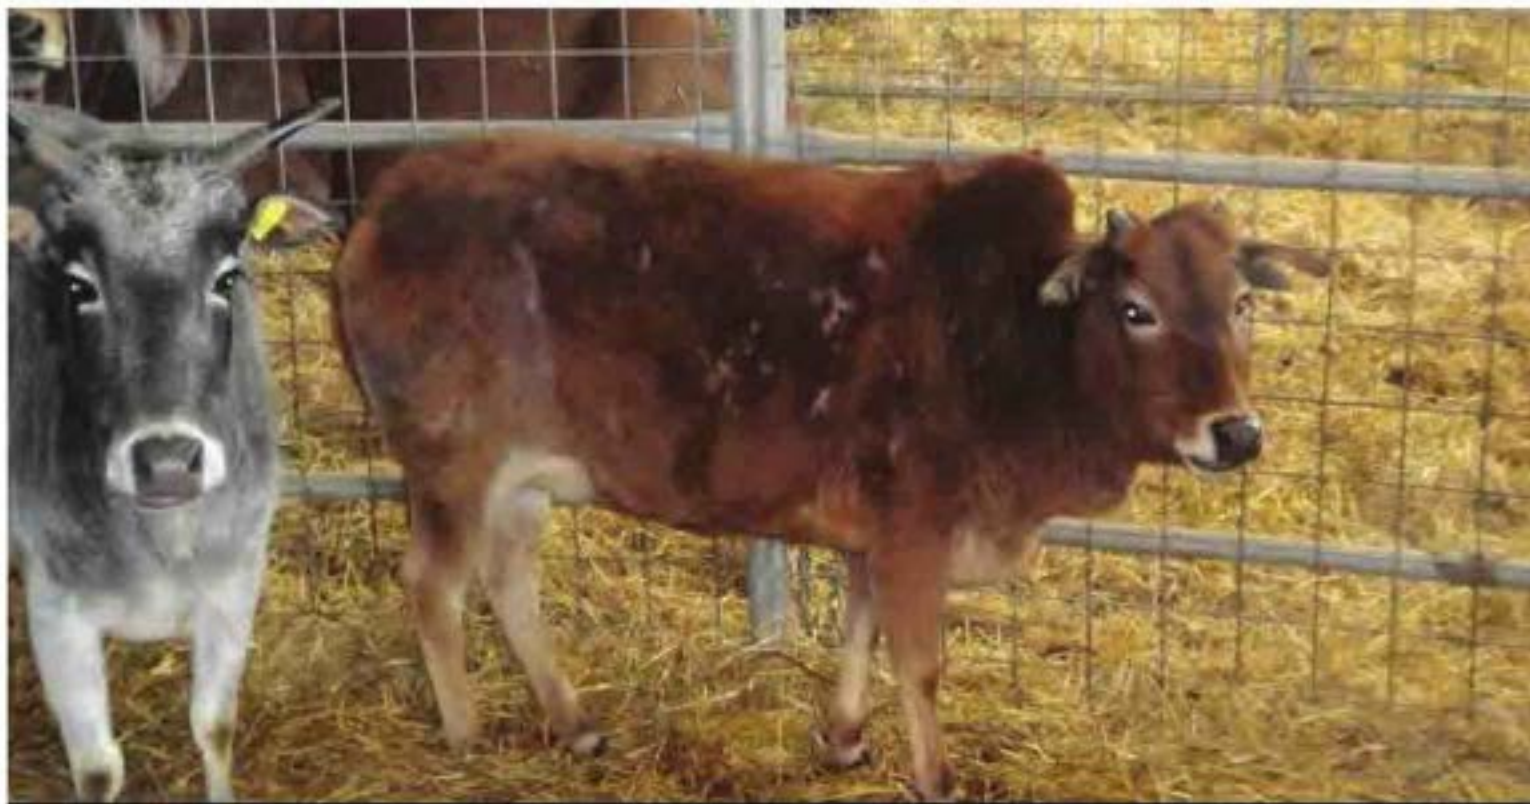
000175

CFR: 2.40 (b) (2)

Photographer:	Dana Miller, SACS	Legal Name:	55-B-0069
Photo Taken:	Mon, Mar 2, '15 125 pm	HENRY HAMPTON	
Inspection:	64151500440984		
Description:	Section 2.40(b)(2): Brown miniature zebu with areas of patchy hair loss.

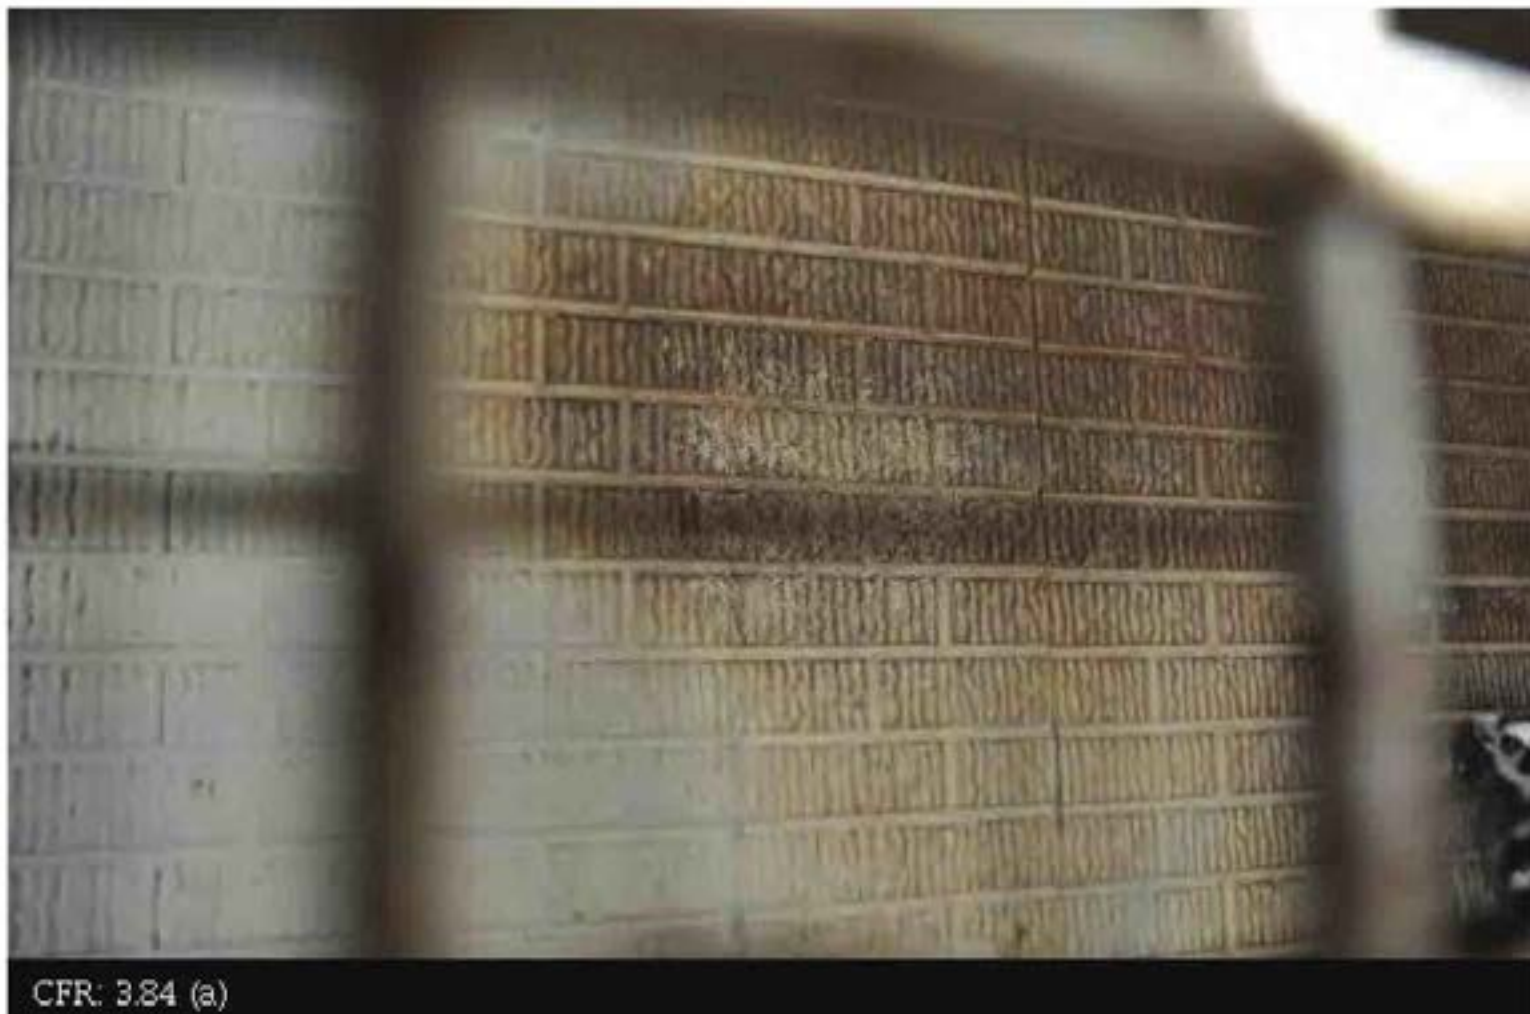
CFR: 3.84 (a)

Photographer:	Randy Coleman, ACI	Legal Name:	55-B-0069
Photo Taken:	Mon, Mar 2, '15	HENRY HAMPTON	
Inspection:	64151500440984		
Description:	Section 3.84(a): Dirty walls of lemur enclosure.

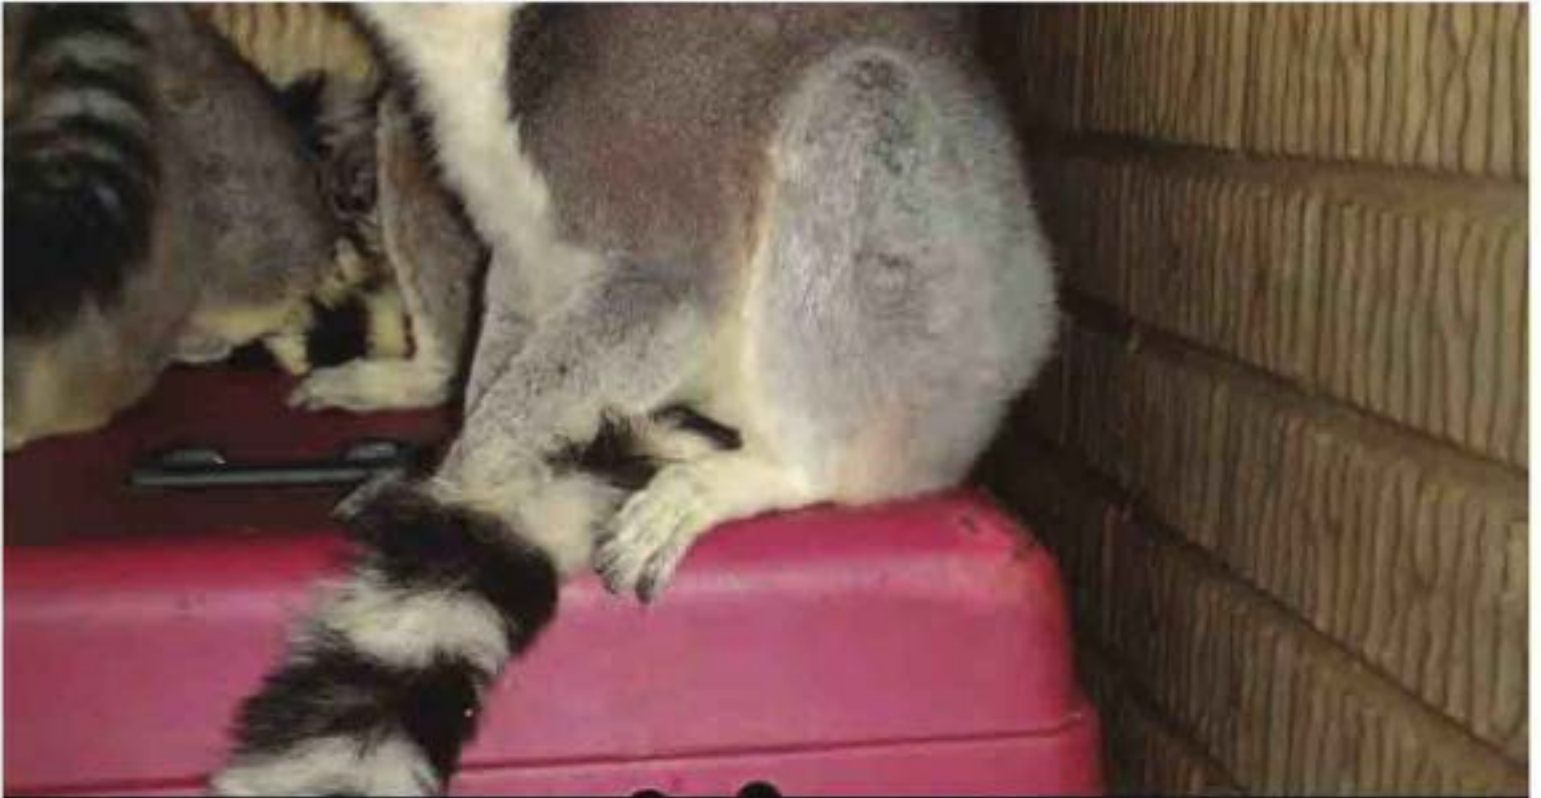
000180

CFR: 3.84 (a)

Photographer:	Dana Miller, SACS	Legal Name:	55-B-0069
Photo Taken:	Mon, Mar 2, '15 1130 am	HENRY HAMPTON	
Inspection:	64151500440984		
Description:	Section 3.84(a): Buildup an debris in lemur enclosure.

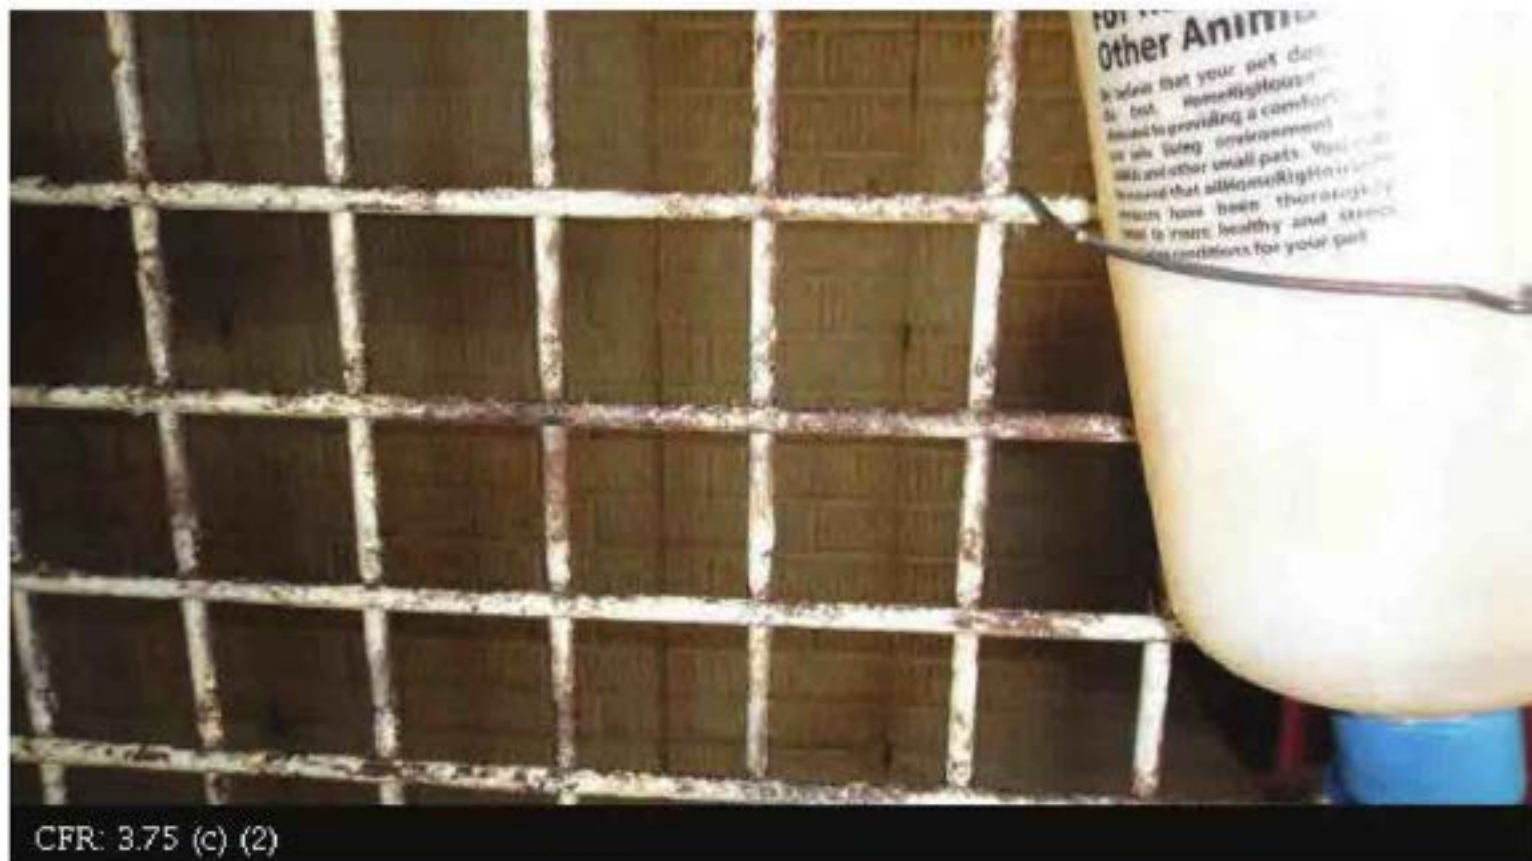
000181

CFR: 3.75 (c) (2)

Photographer:	Dana Miller, SACS	Legal Name:	55-B-0069
Photo Taken:	Mon, Mar 2, '15 1130 am	HENRY HAMPTON	
Inspection:	64151500440984		
Description:	Section 3.75(c)(2): Section 3.75(c)(2): Metal bars for the lemur enclosure with worn and chipped paint.

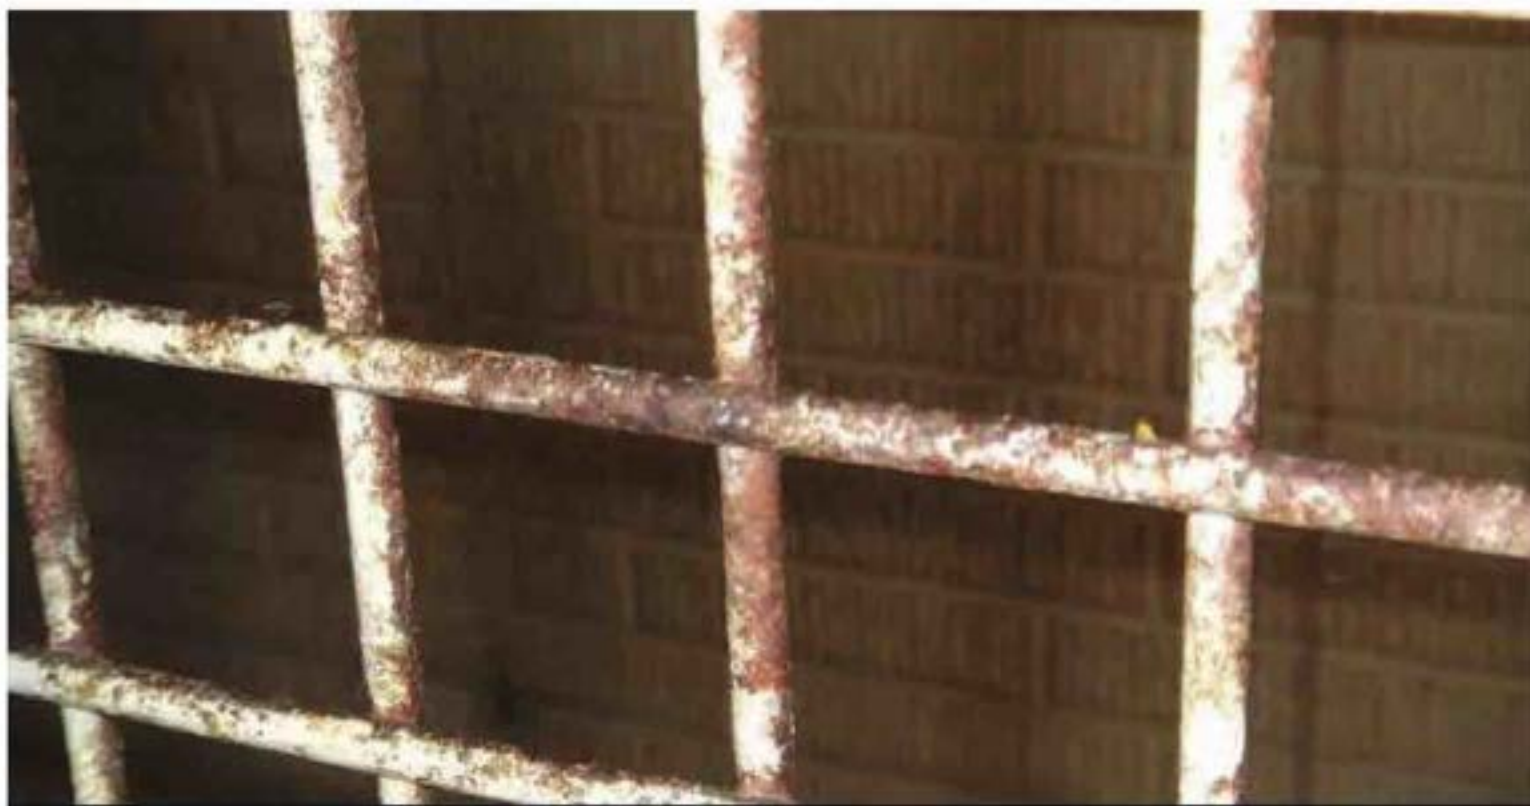
000182

CFR: 3.75 (c) (2)

Photographer:	Dana Miller, SACS	Legal Name:	55-B-0069
Photo Taken:	Mon, Mar 2, '15 1130 am	HENRY HAMPTON	
Inspection:	64151500440984		
Description:	Section 3.75(c)(2): Section 3.75(c)(2): Metal bars for the lemur enclosure with worn and chipped paint.

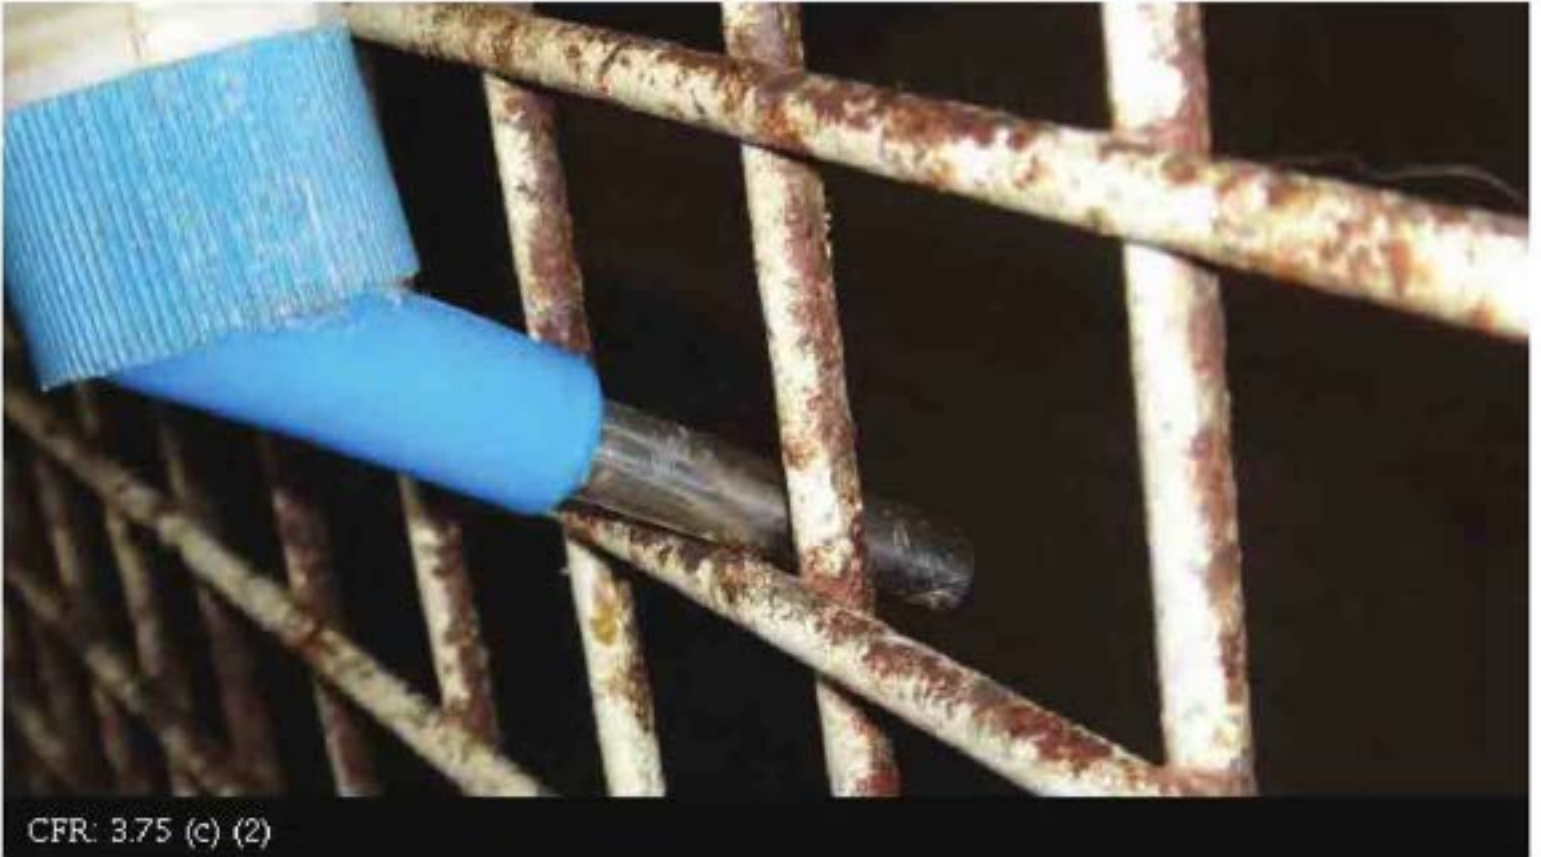
CFR: 3.75 (c) (2)

Photographer:	Dana Miller, SACS	Legal Name:	55-B-0069
Photo Taken:	Mon, Mar 2, '15 1130 am	HENRY HAMPTON	
Inspection:	64151500440984		
Description:	Section 3.75(c)(2): Section 3.75(c)(2): Metal bars for the lemur enclosure with worn and chipped paint.

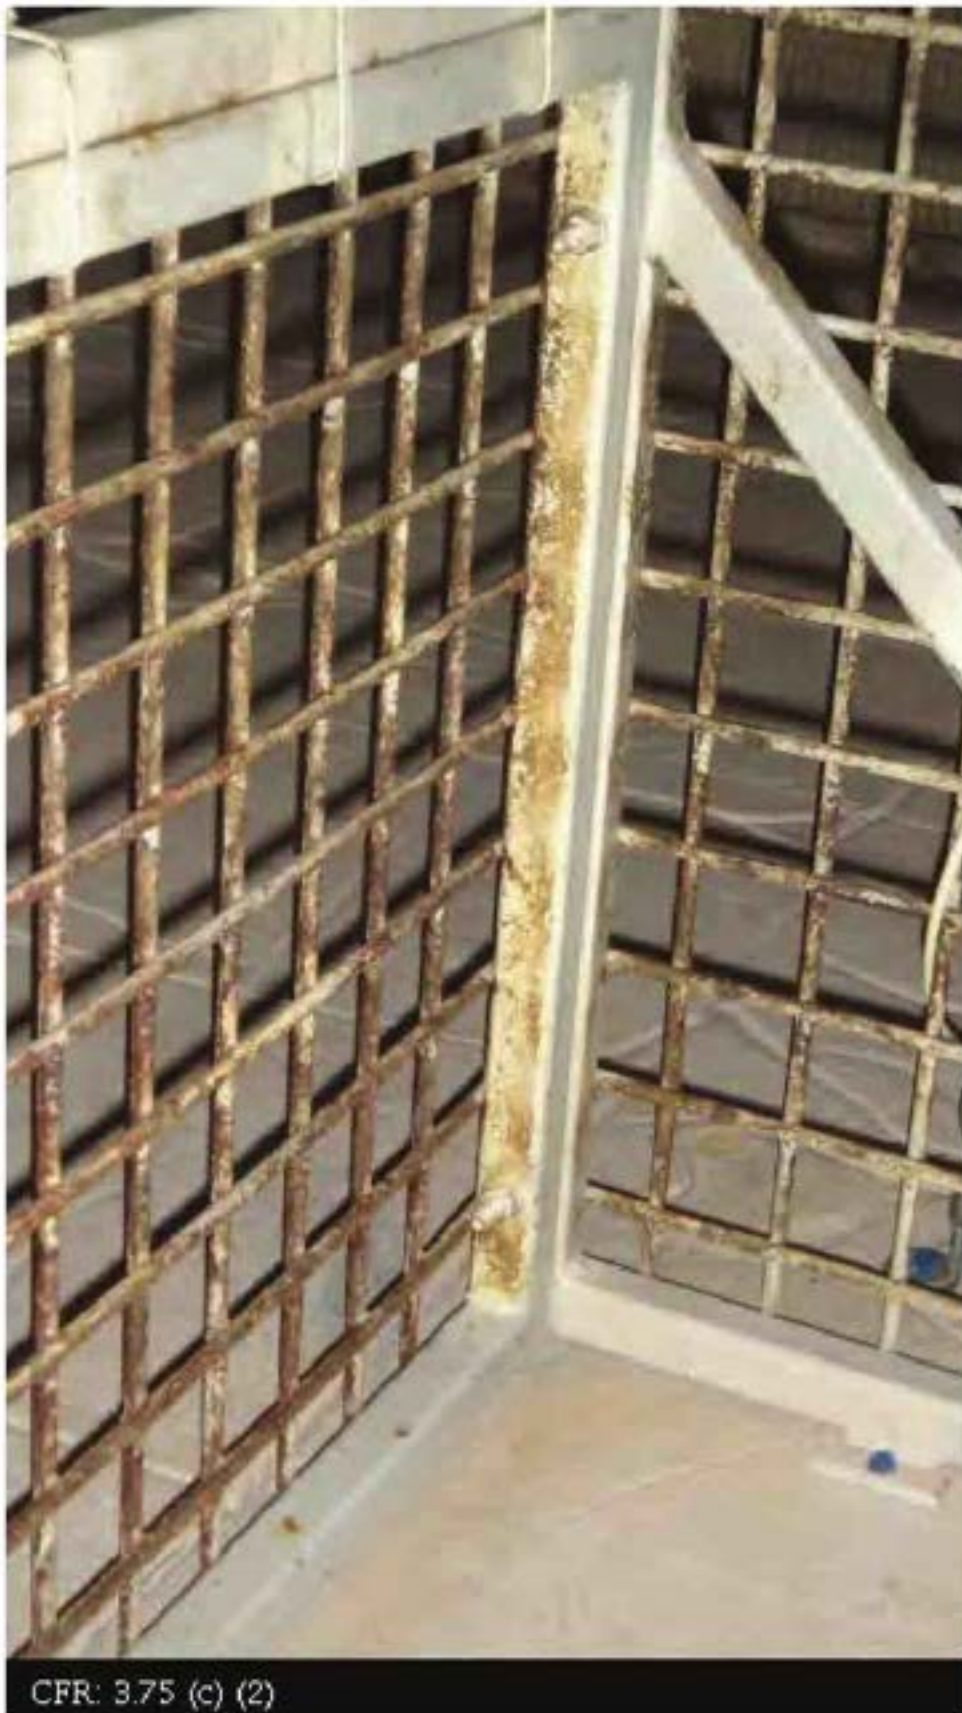
000184

CFR: 3.75 (c) (2)

Description: Section 3.75(c)(2): Metal bars for the lemur enclosure with worn and chipped paint.

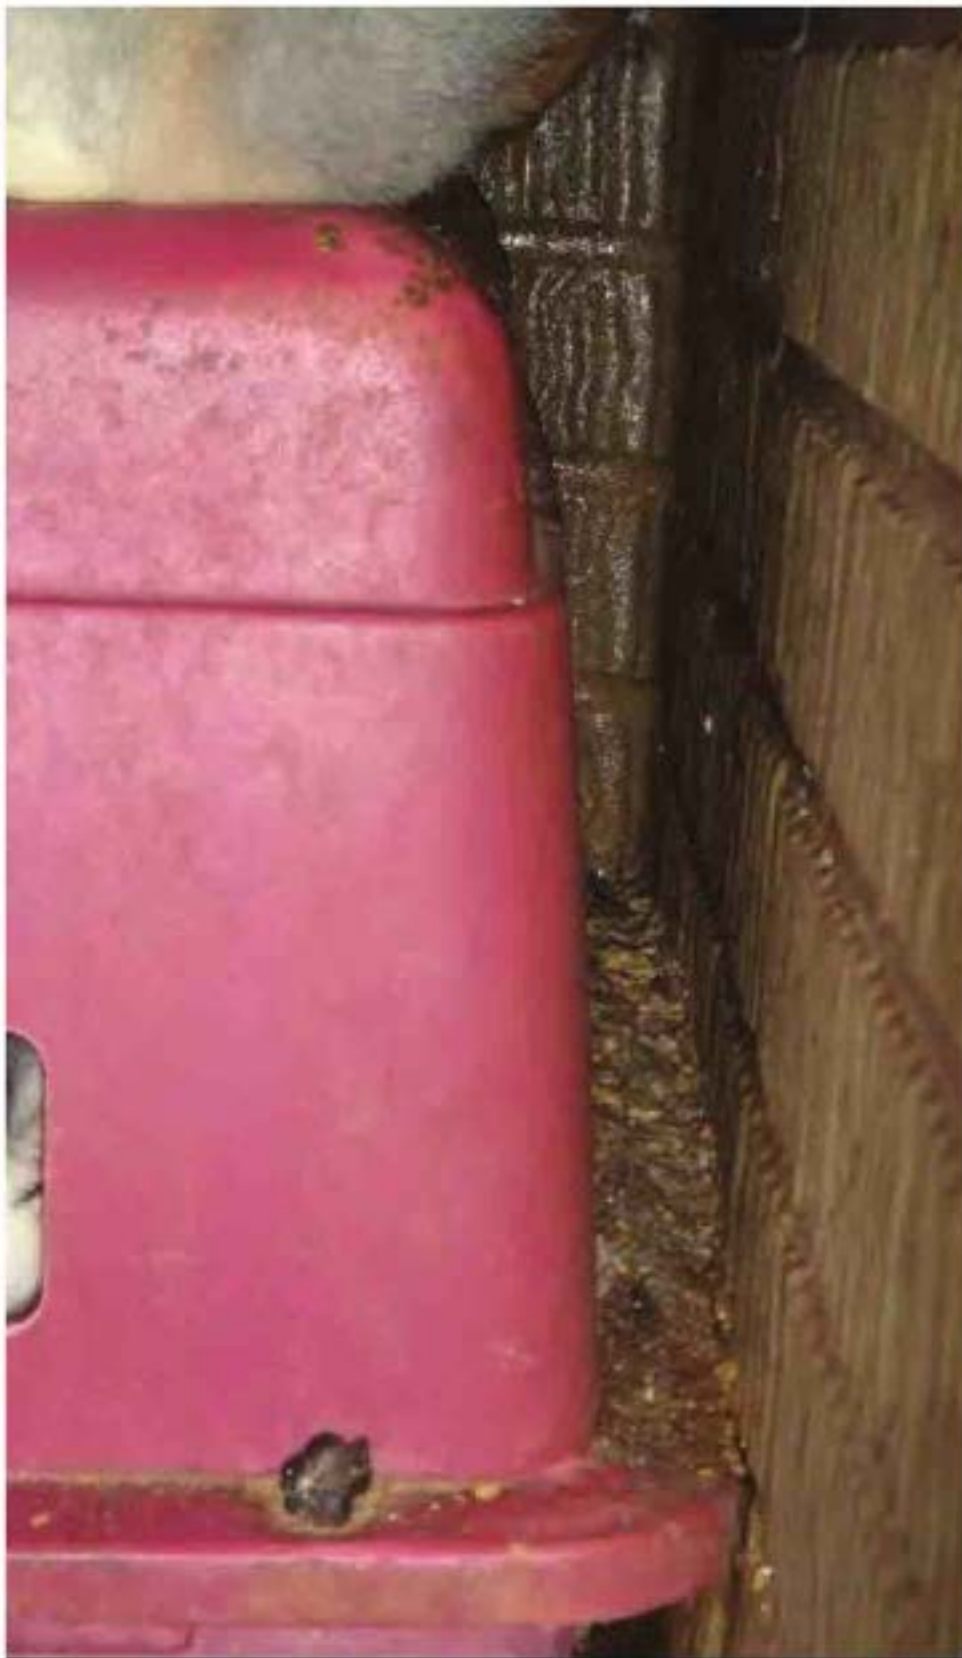
000185

CFR: 3.84 (a)

Description: Section 3.84(a): Build up and debris behind plastic kennel nest box of lemur enclosure.

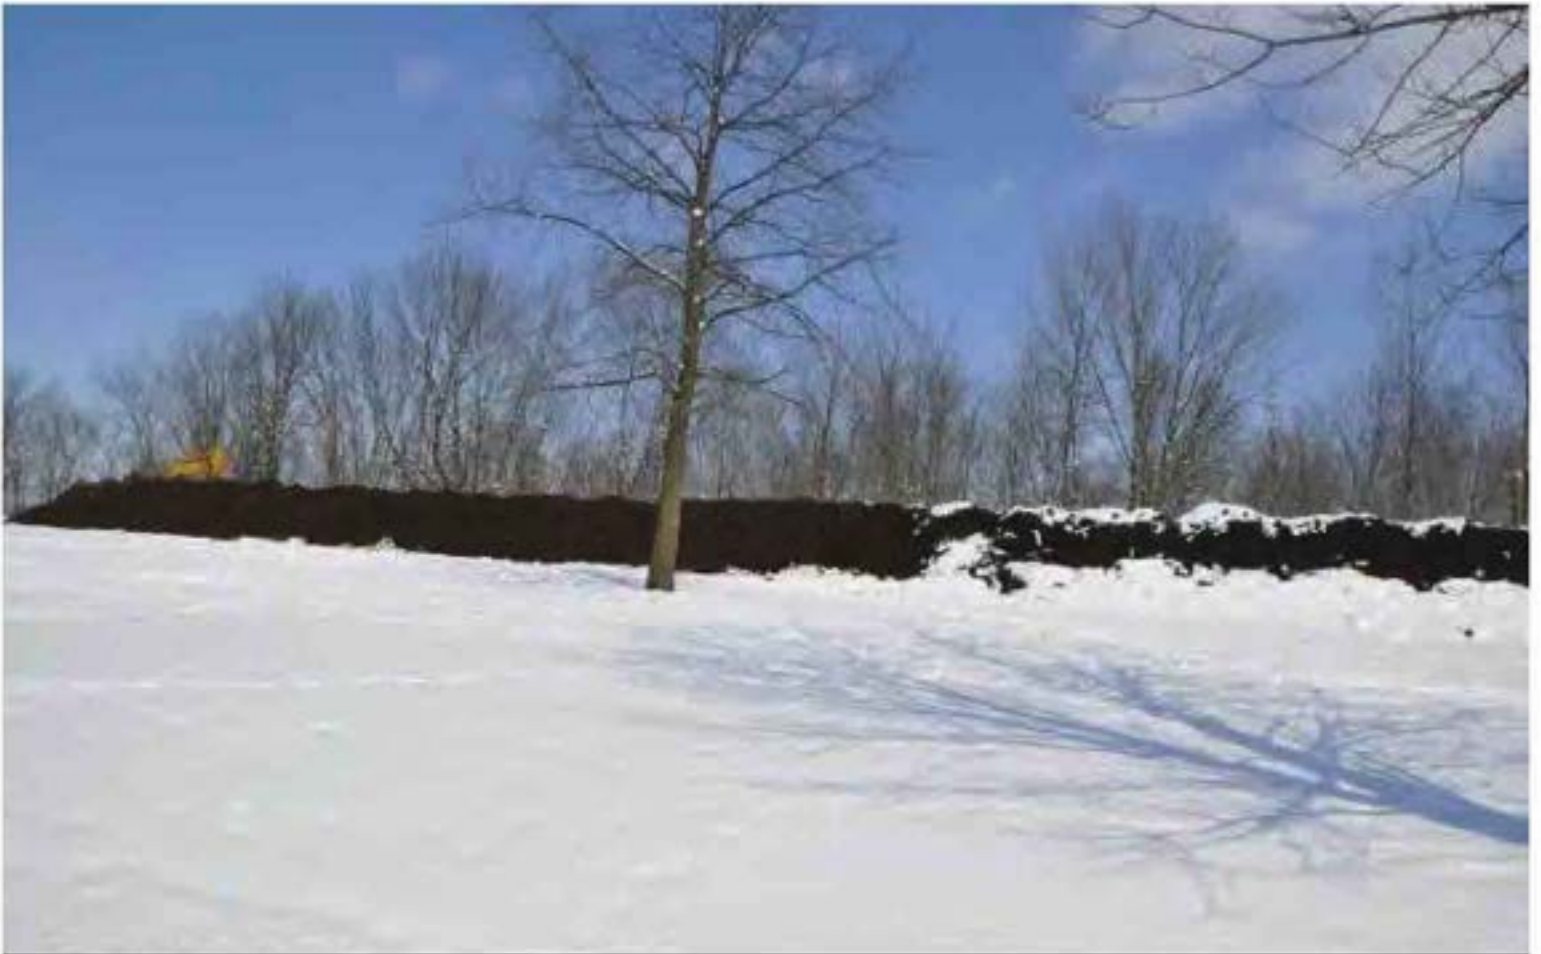
000186

CFR: 3.125 (d)

Photographer:	Randy Coleman, ACI	Legal Name:	55-B-0069
Photo Taken:	Mon, Mar 2, '15 1245 pm	HENRY HAMPTON	
Inspection:	64151500440984		
Description:	Section 3.125(d): Muck heap remains in the drive thru area.

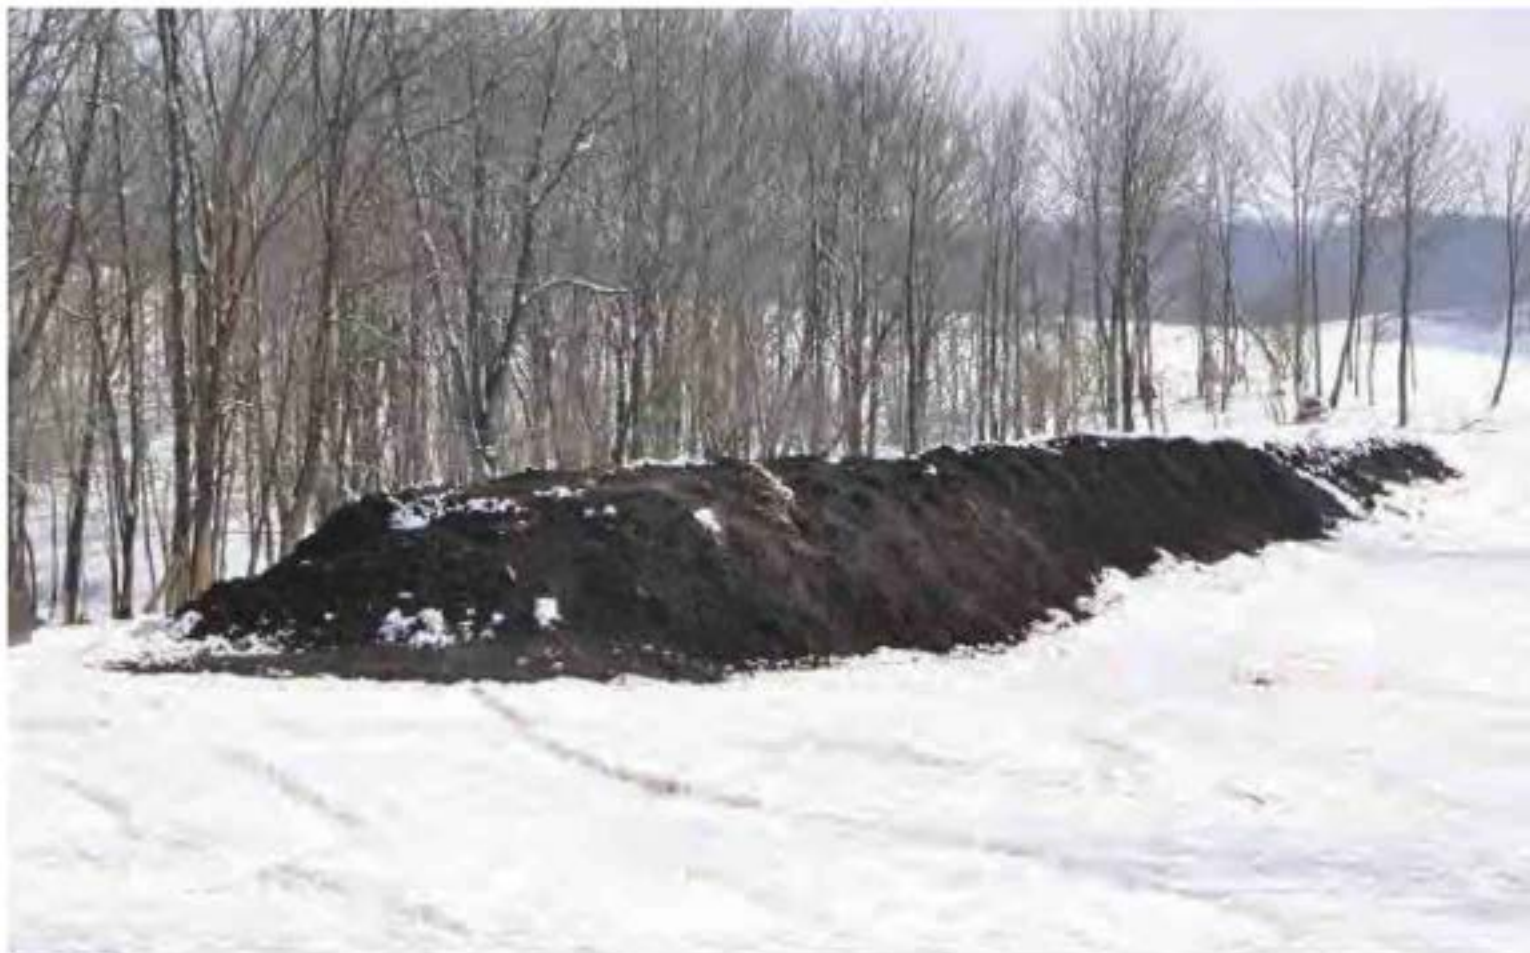
000187

CFR: 3.125 (d)

Photographer:	Randy Coleman, ACI	Legal Name:	55-B-0069
Photo Taken:	Mon, Mar 2, '15 1245 pm	HENRY HAMPTON	
Inspection:	64151500440984		
Description:	Section 3.125(d): Muck heap remains in the drive thru area.

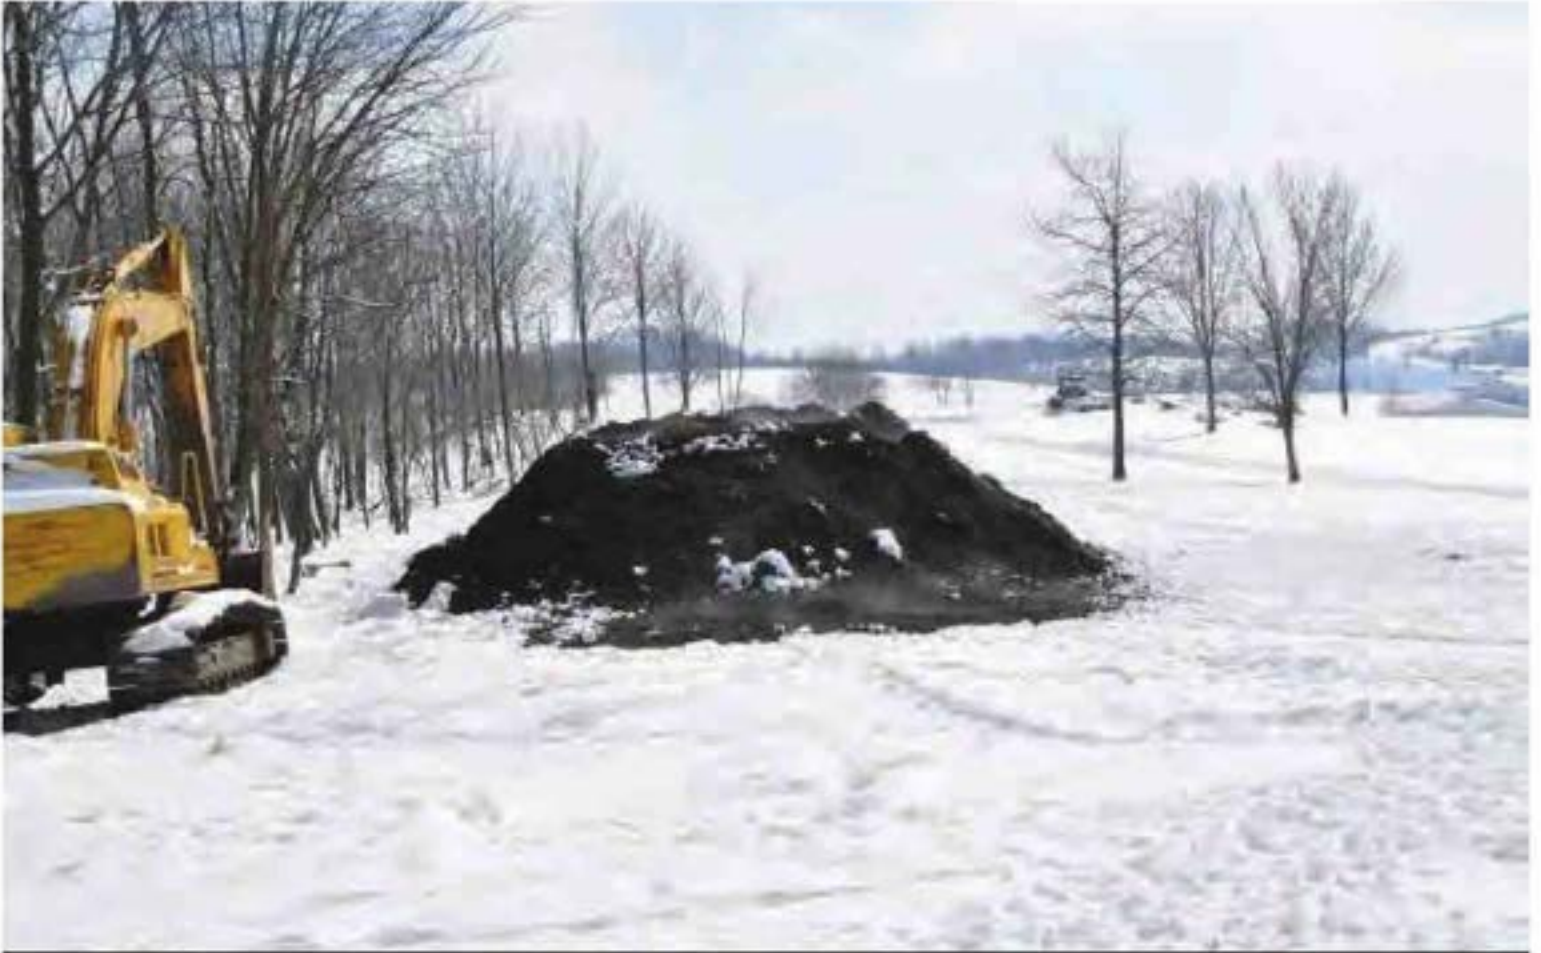
000188

CFR: 3.125 (d)

Photographer:	Randy Coleman, ACI	Legal Name:	55-B-0069
Photo Taken:	Mon, Mar 2, '15 1245 pm	HENRY HAMPTON	
Inspection:	64151500440984		
Description:	Section 3.125(d): Muck heap remains in the drive thru area.
