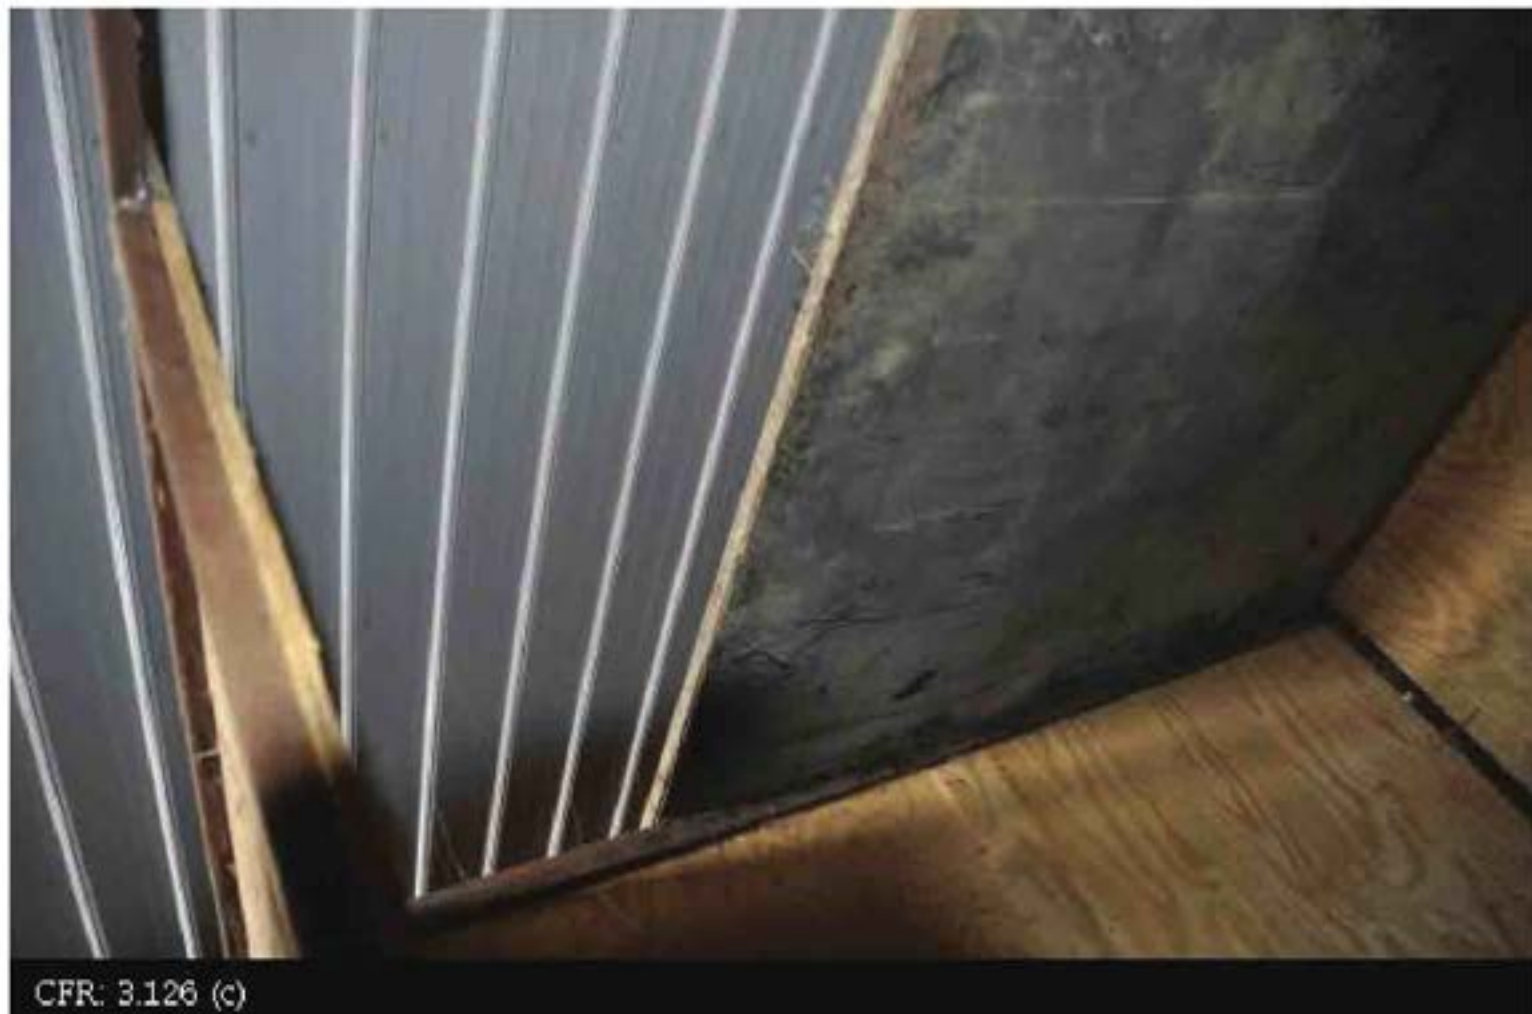
000189

Photographer:	Randy Coleman, ACI	Legal Name:	55-B-0069
Photo Taken:	Tue, Mar 3, '15 11:25 am	HENRY HAMPTON	
Inspection:	64151500440984		
Description:	Section 3.126(c): DIRECT: PHoto of top of enclosre showing sheeting moved away to allow light in. This was enclosure used to house Tahr goat in complete darkness.

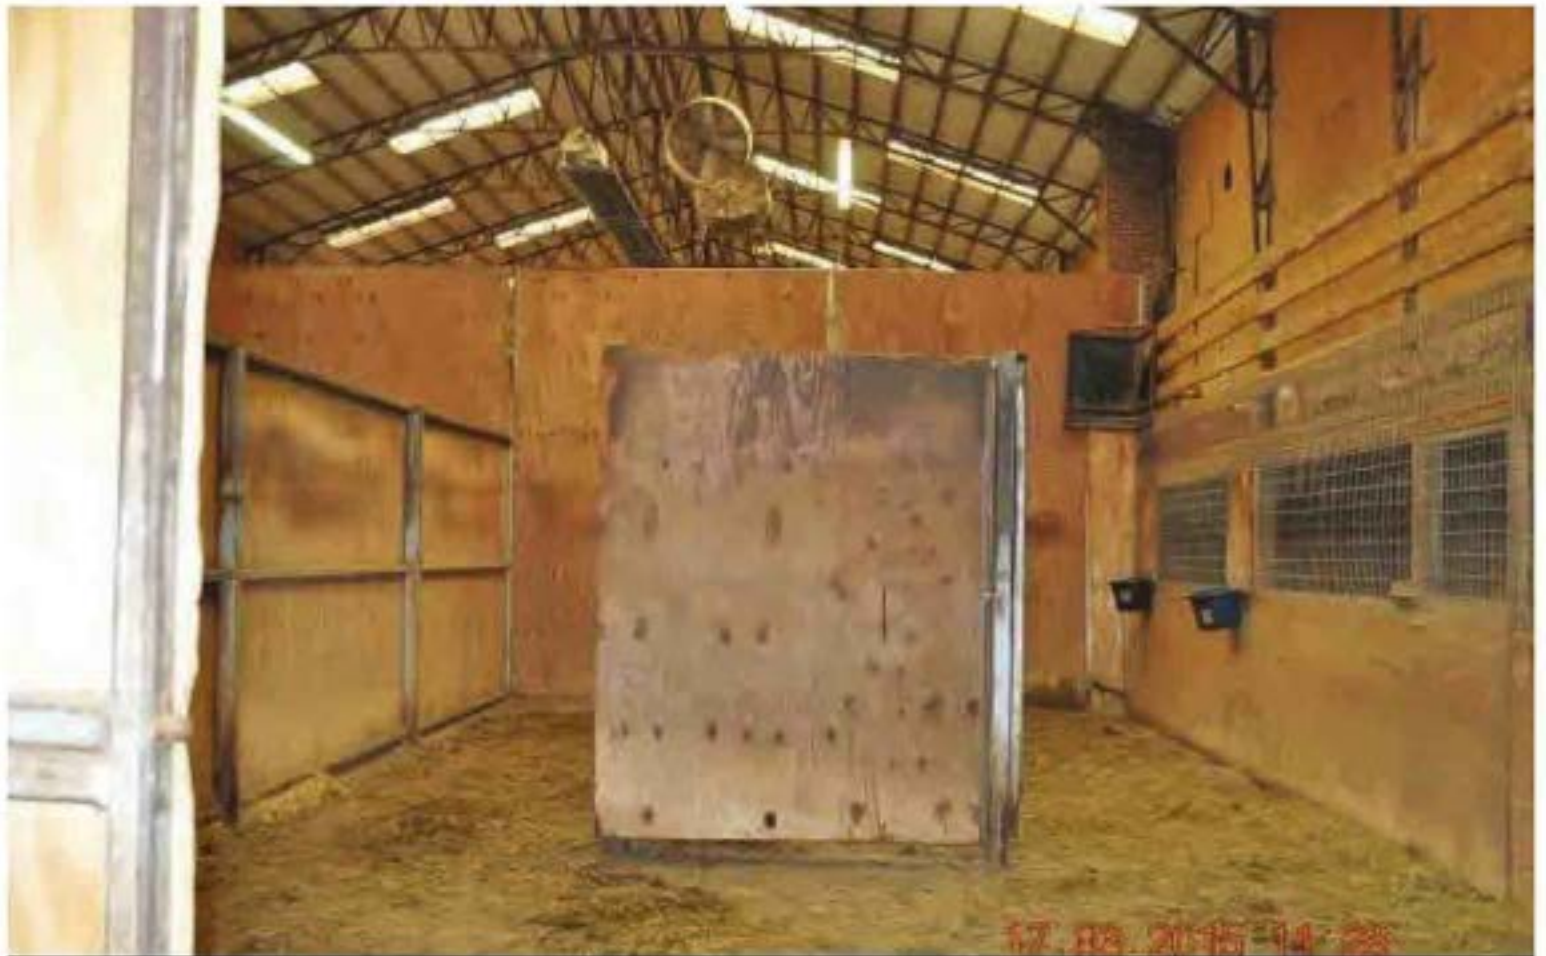
000200

CFR: 3.126 (b)

Photographer:	G. McFadden	Legal Name:	55-B-0069
Photo Taken:	Tue, Mar 17, '15	HENRY HAMPTON	
Inspection:	76151915490483		
Description:	Giraffe stall with prominent ammonia odor.

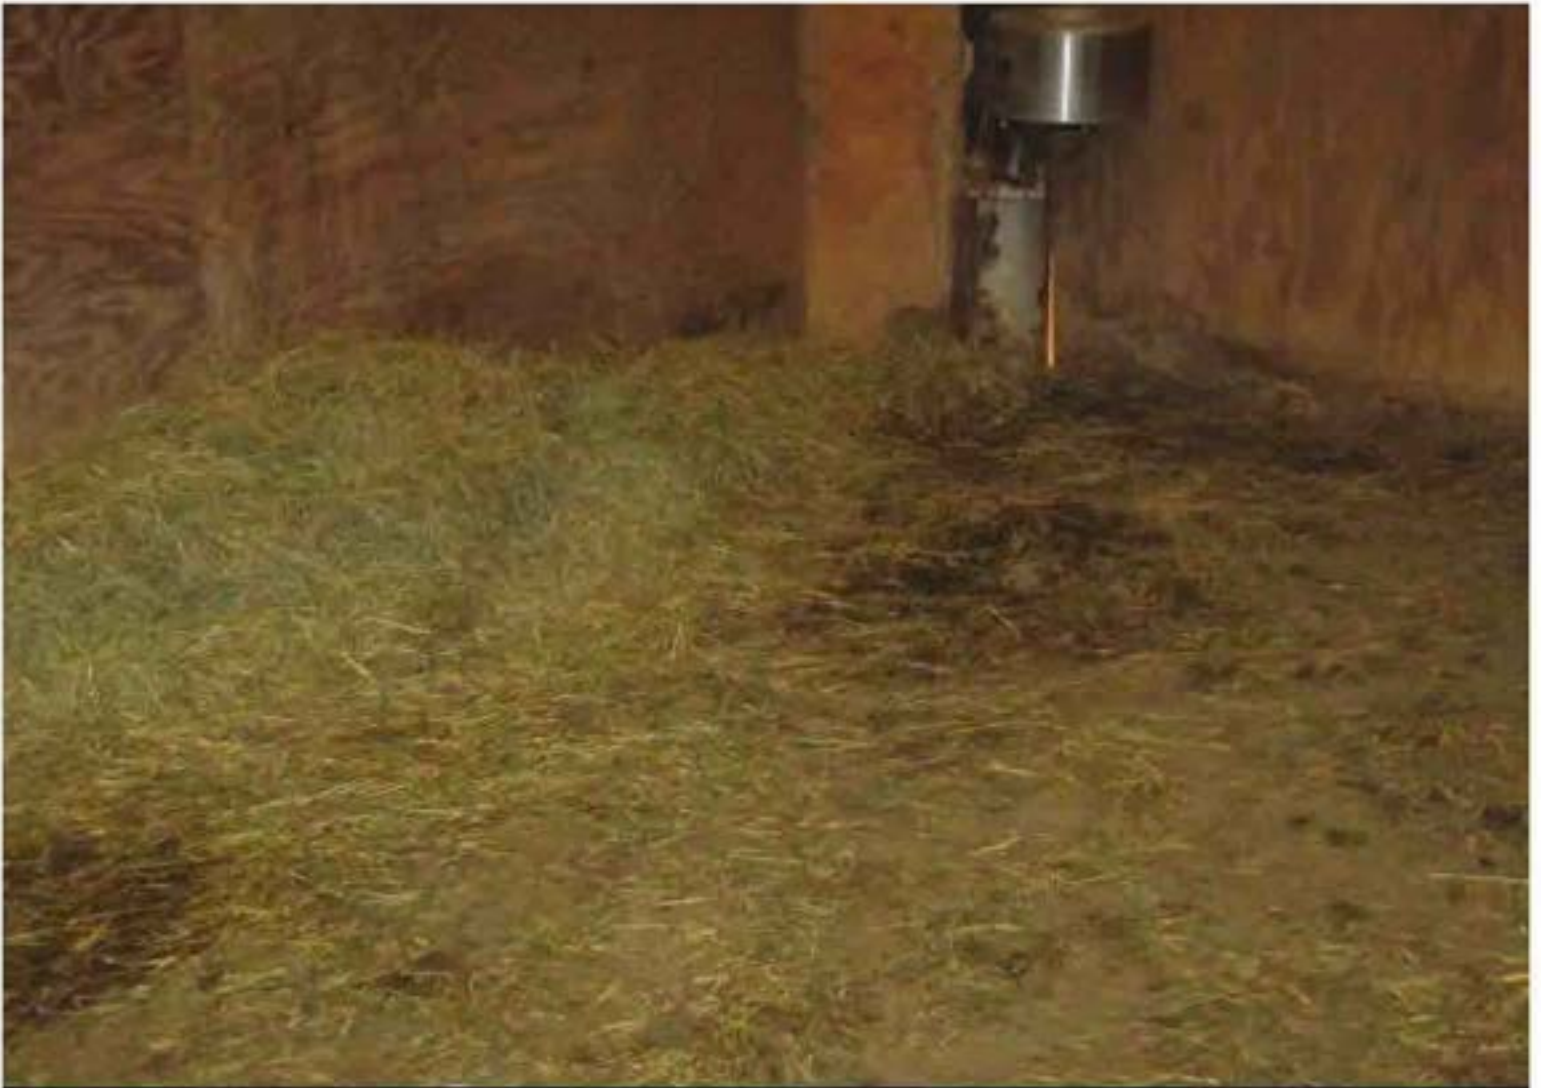
CFR: 3.126 (b)

Photographer:	S. Brunkhorst	Legal Name:	55-B-0069
Photo Taken:	Tue, Mar 17, '15	HENRY HAMPTON	
Inspection:	76151915490483		
Description:	Close up of part of floor of giraffe stall with prominent ammonia odor.

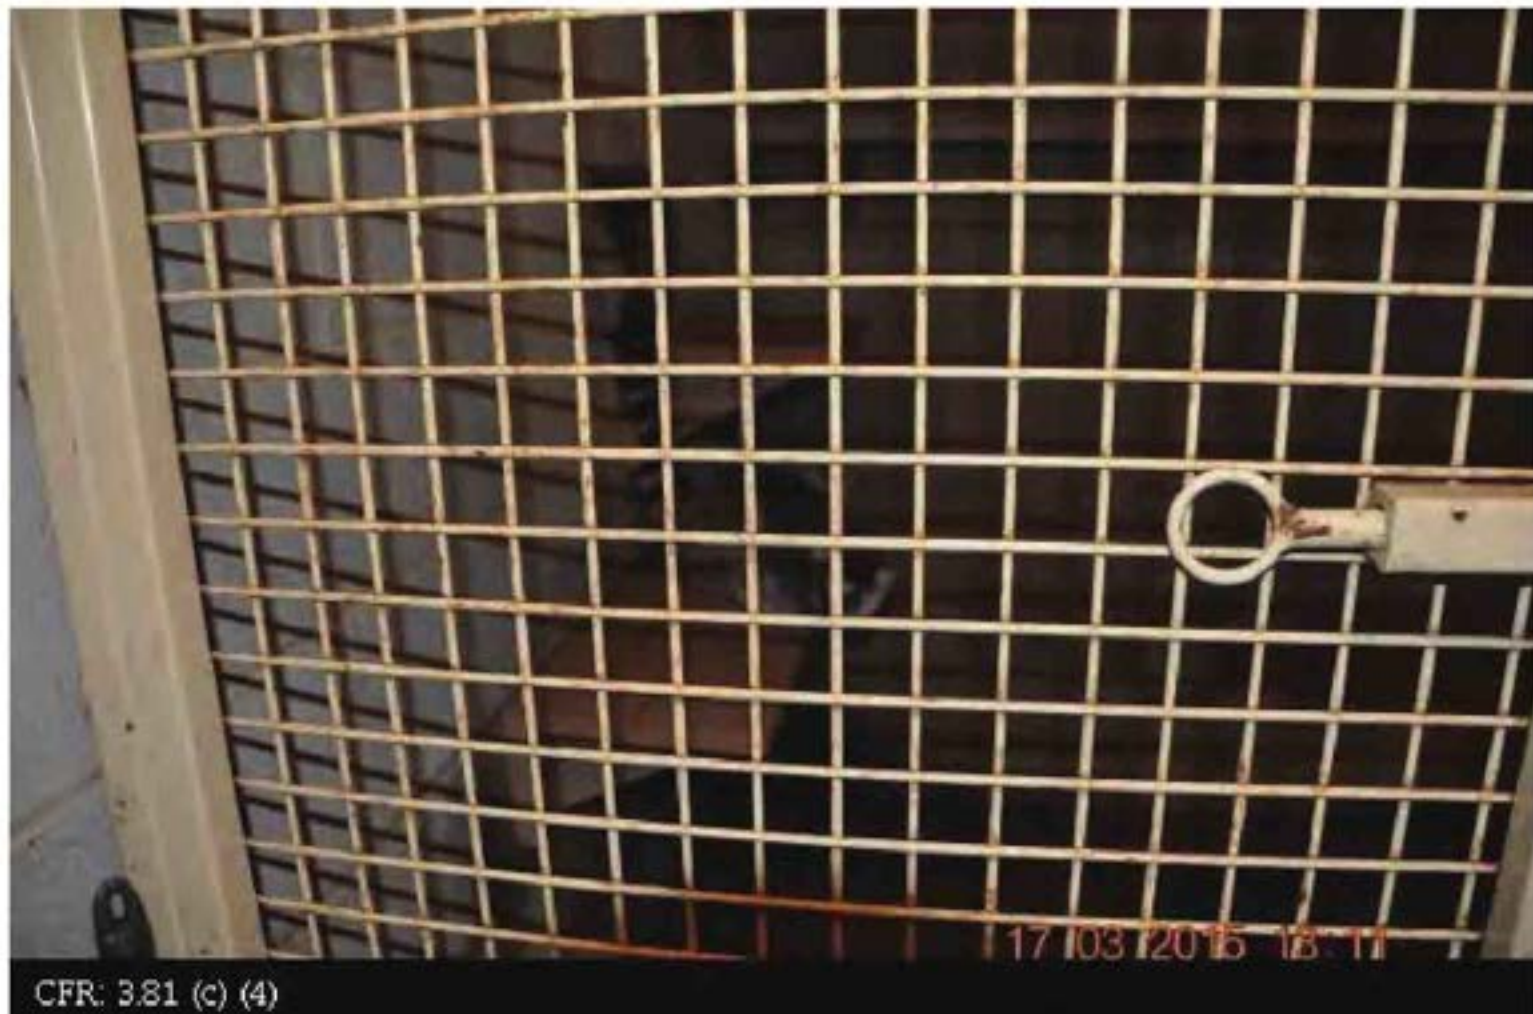
Photographer:	G. McFadden	Legal Name:	55-B-0069
Photo Taken:	Tue, Mar 17, '15	HENRY HAMPTON	
Inspection:	76151915490483		
Description:	Singly housed, isolated ringtail lemur with no enrichment.

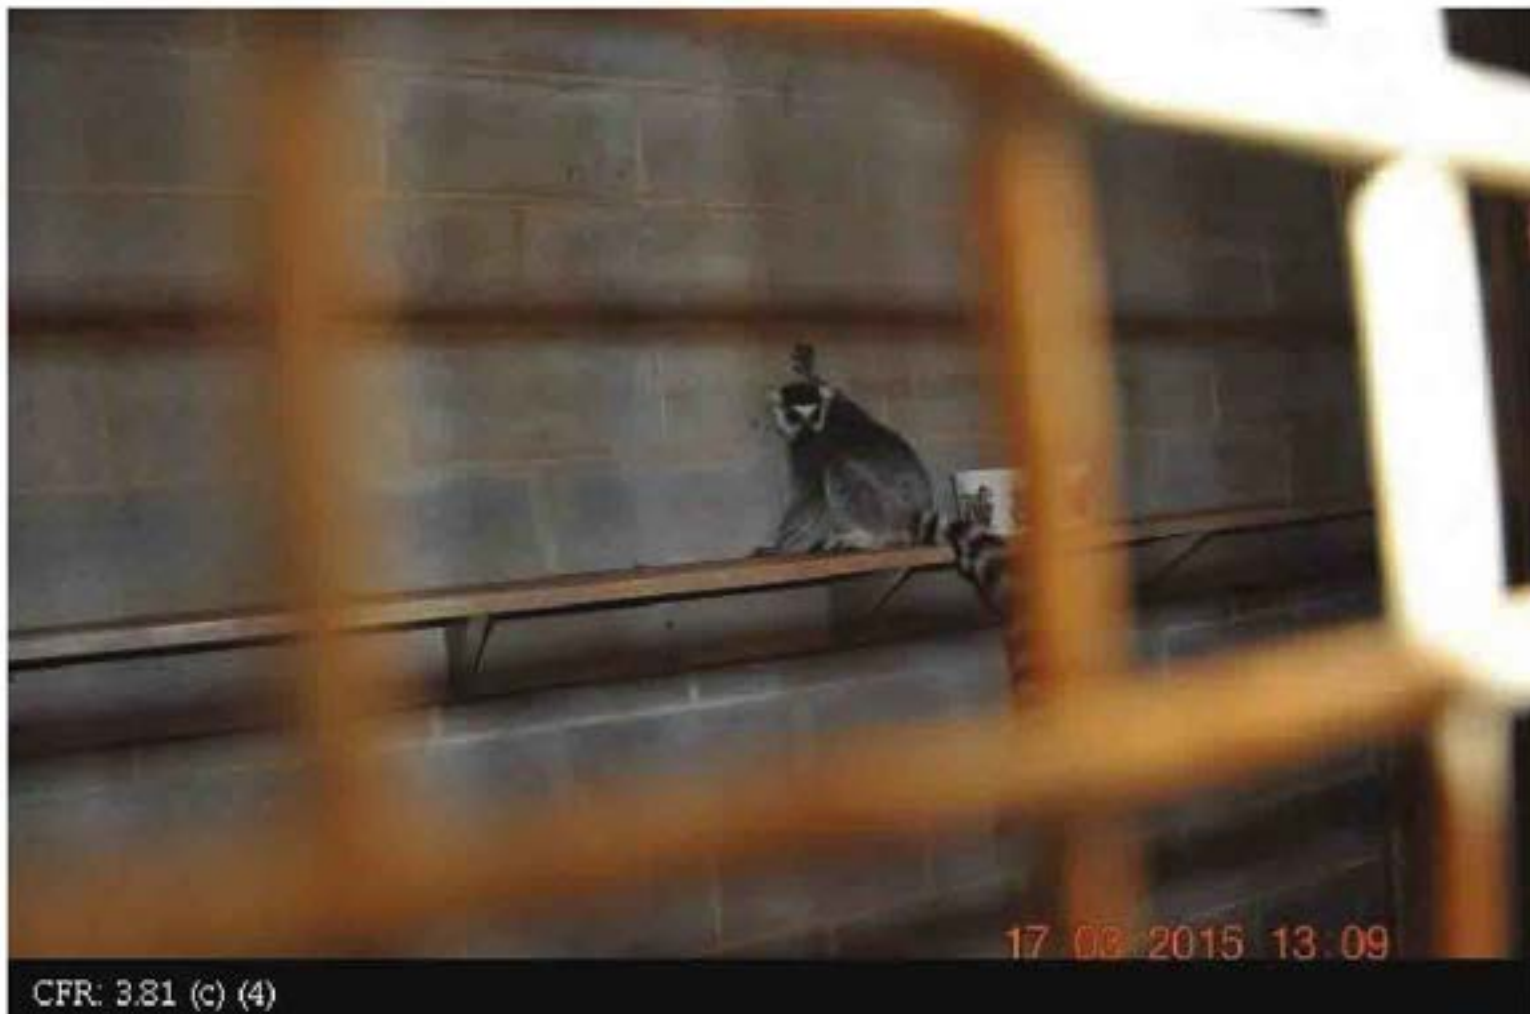
Photographer:	G. McFadden	Legal Name:	55-B-0069
Photo Taken:	Tue, Mar 17, '15	HENRY HAMPTON	
Inspection:	76151915490483		
Description:	Singly housed, isolated lemur with no enrichment.

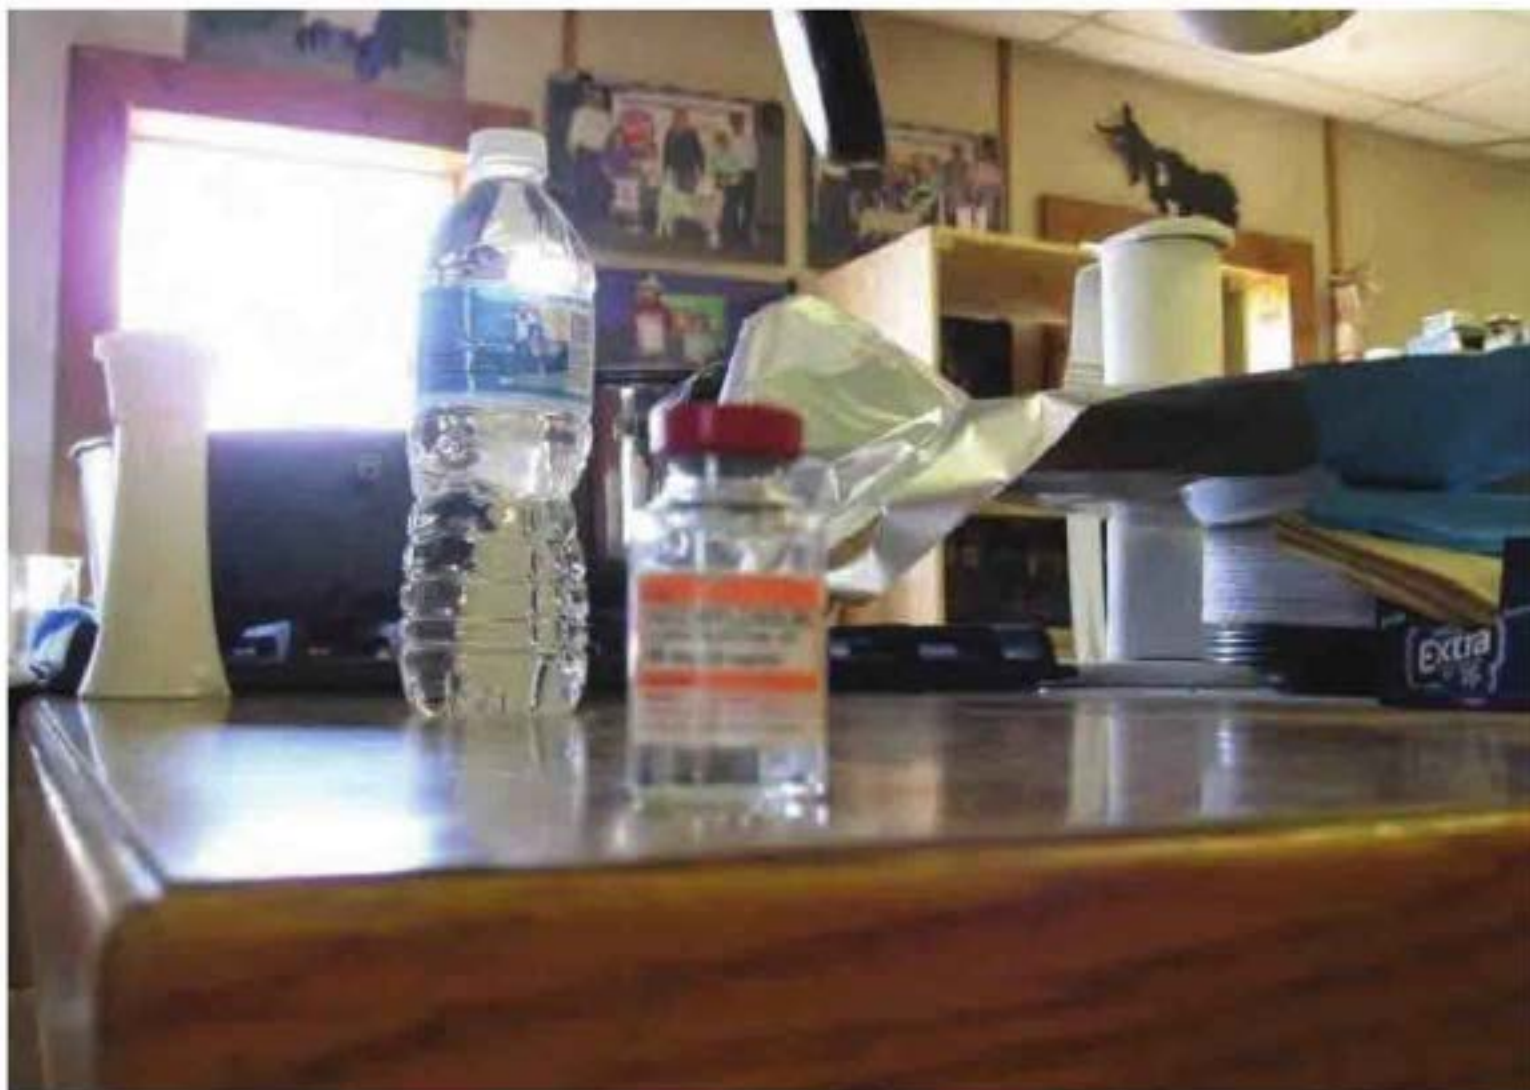
000213

CFR: 2.40 (b) (4)

Photographer:	G. McFadden	Legal Name:	55-B-0069
Photo Taken:	Wed, Mar 18, '15	HENRY HAMPTON	
Inspection:	76151915490483		
Description:	Bottle of succinylcholine on hand at facility; no xylazine on hand

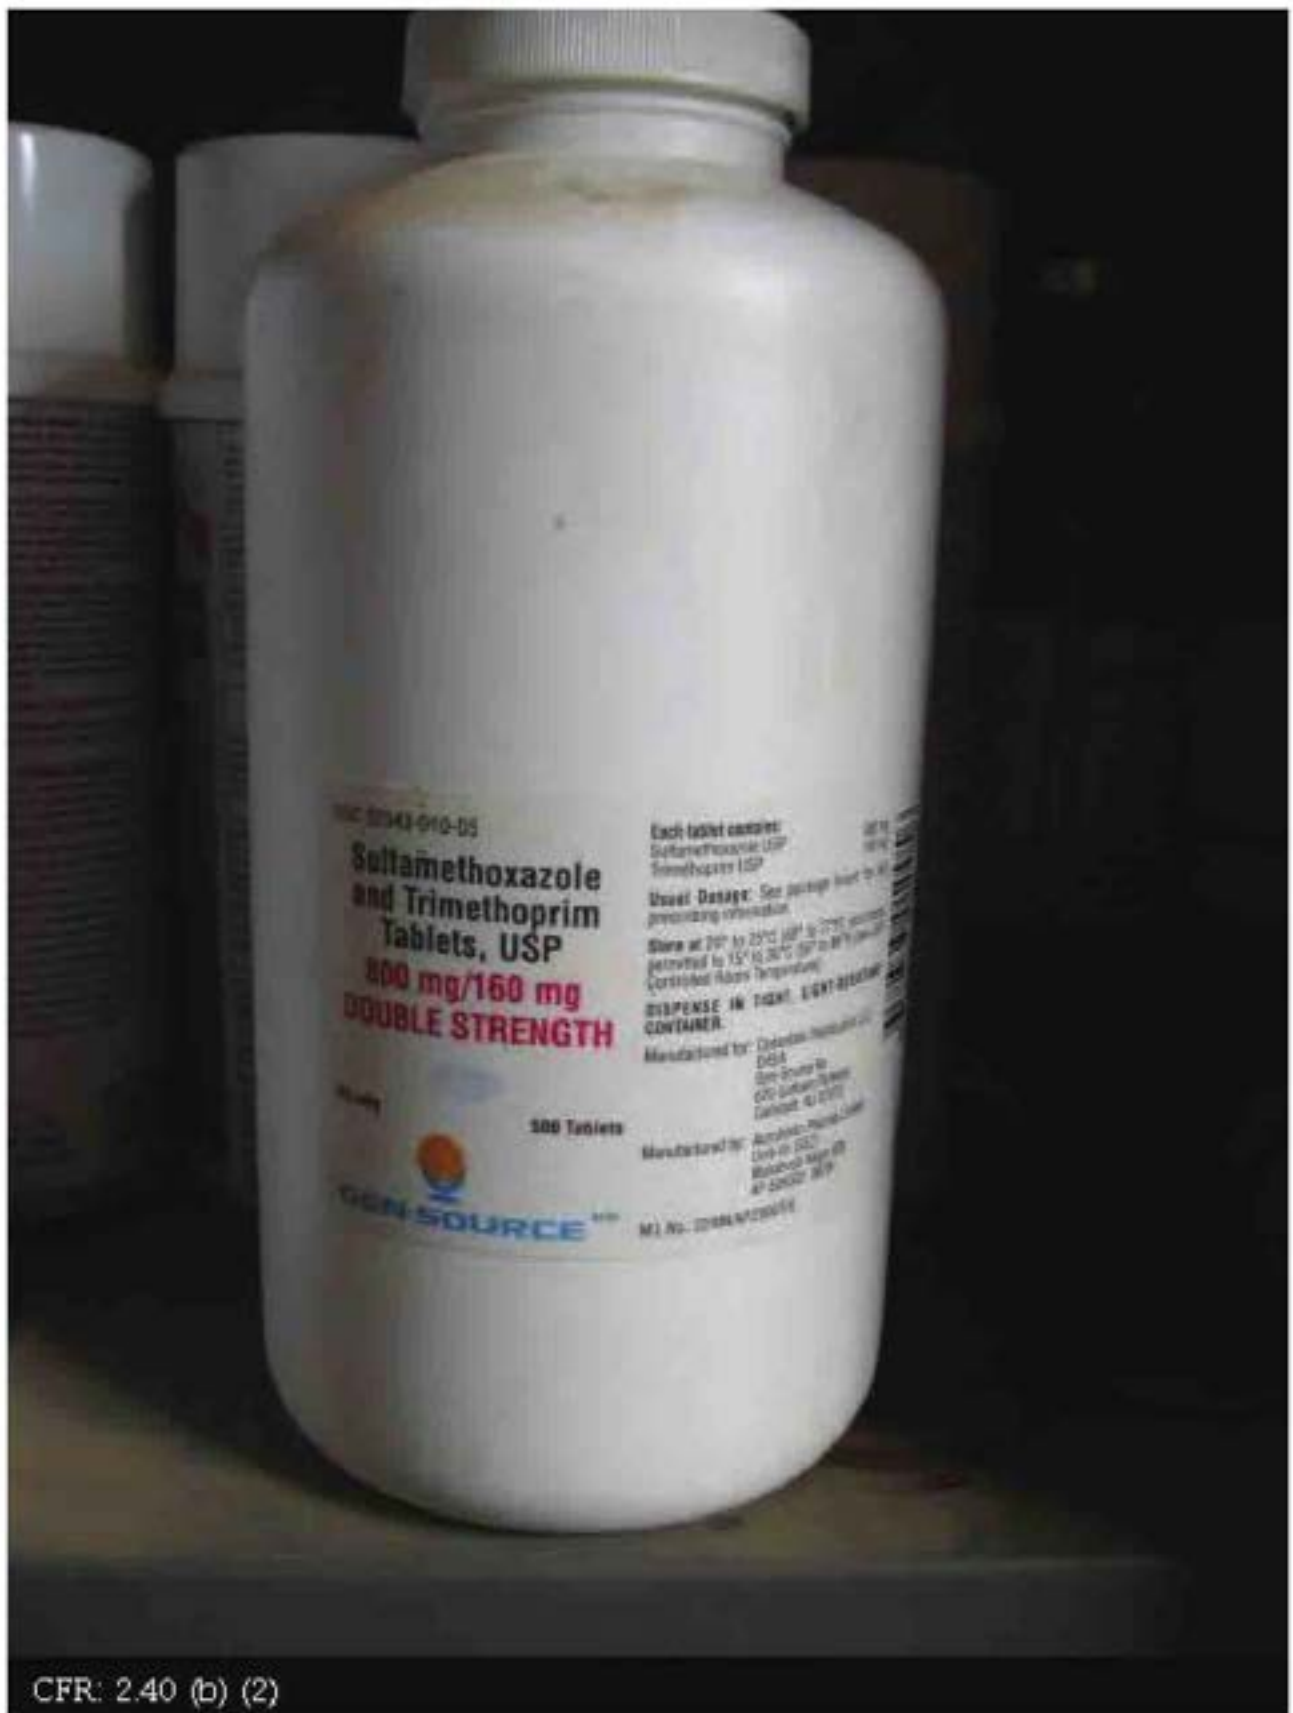
CFR: 2.40 (b) (2)

Photographer:	G. McFadden	Legal Name:	HENRY HAMPTON	55-B-0069
Photo Taken:	Wed, Mar 18, '15			
Inspection:	76151915490483			
Description:	Bottle of expired Sulfa-Trimethoprim tablets.

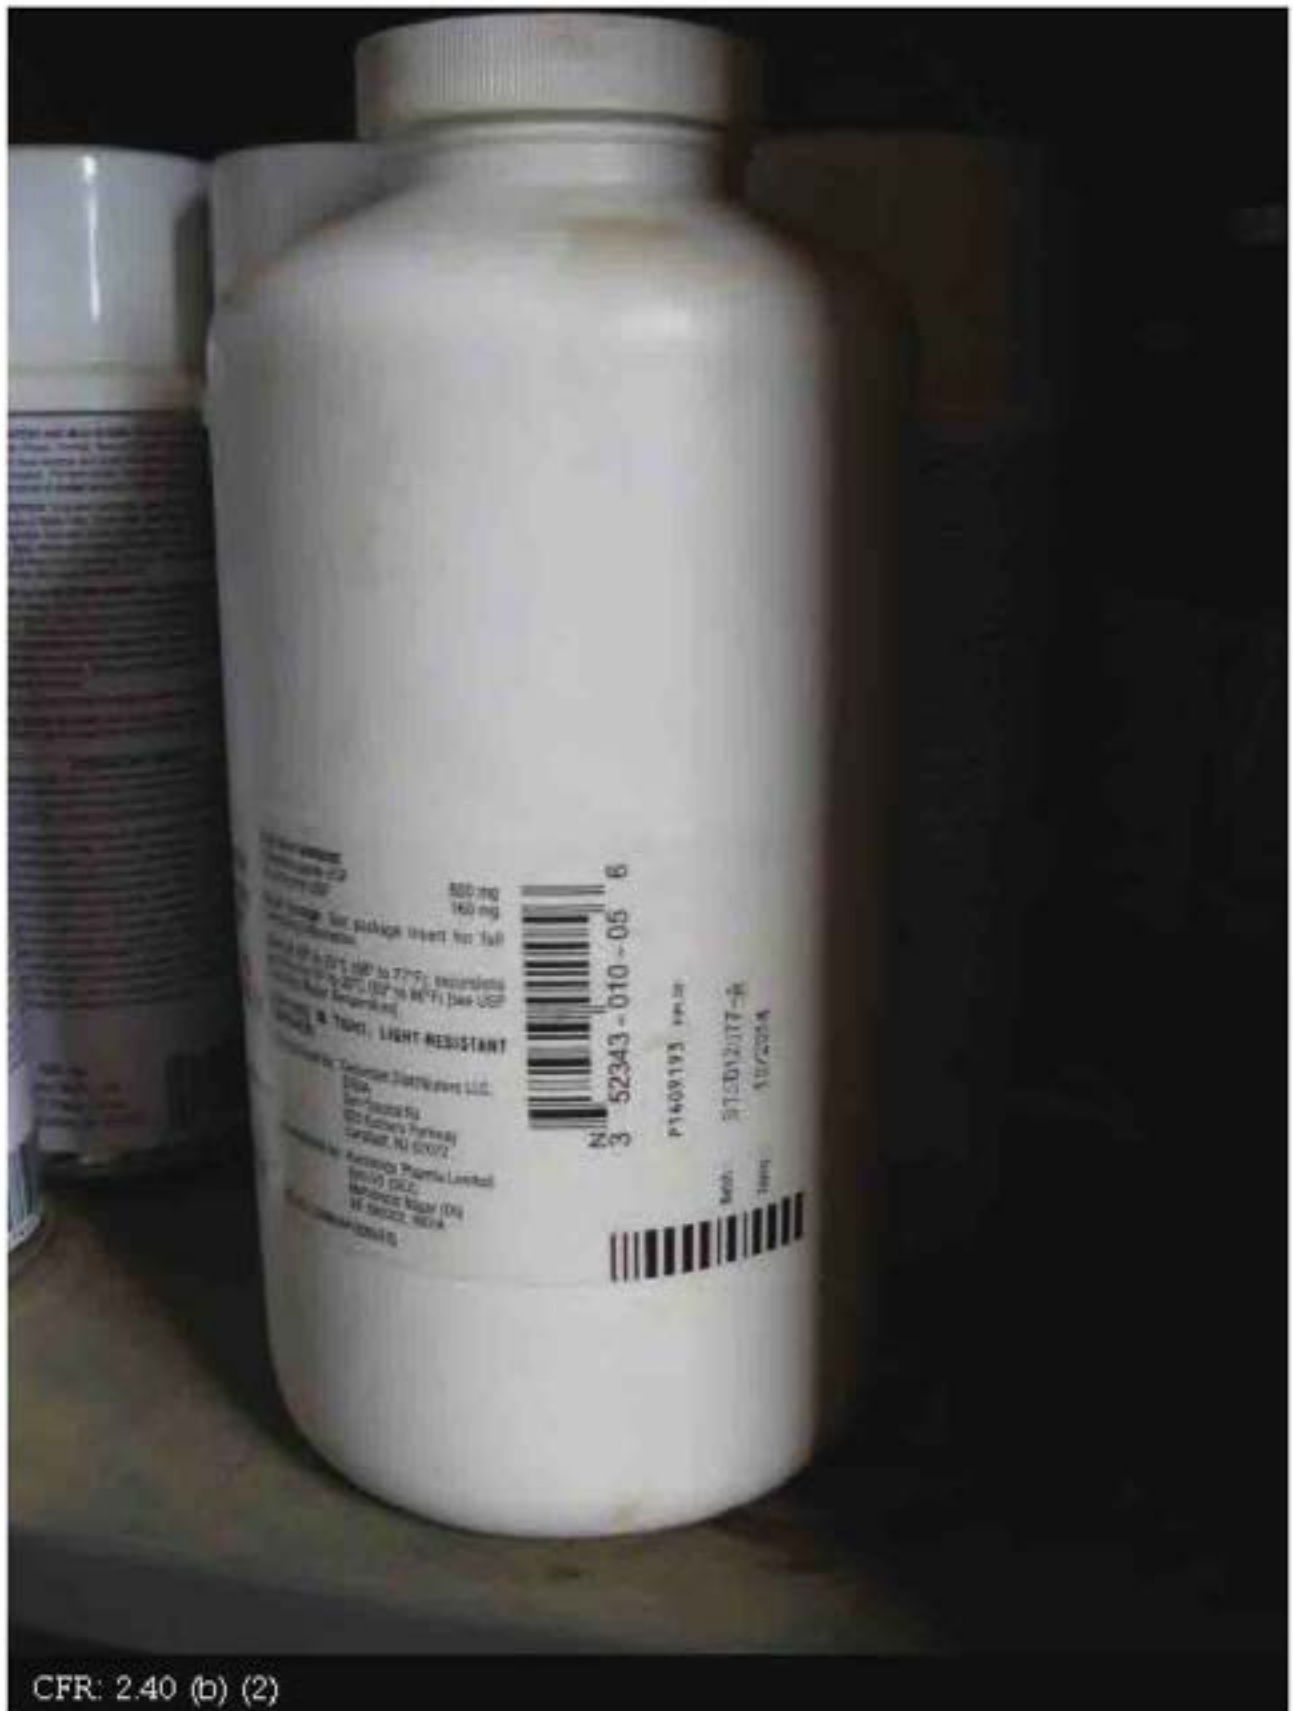
CFR: 2.40 (b) (2)

Photographer:	G. McFadden	Legal Name:	HENRY HAMPTON	55-B-0069
Photo Taken:	Wed, Mar 18, '15			
Inspection:	76151915490483			
Description:	Expiration date of expired Sulfa-Trimethoprim (10/2014).

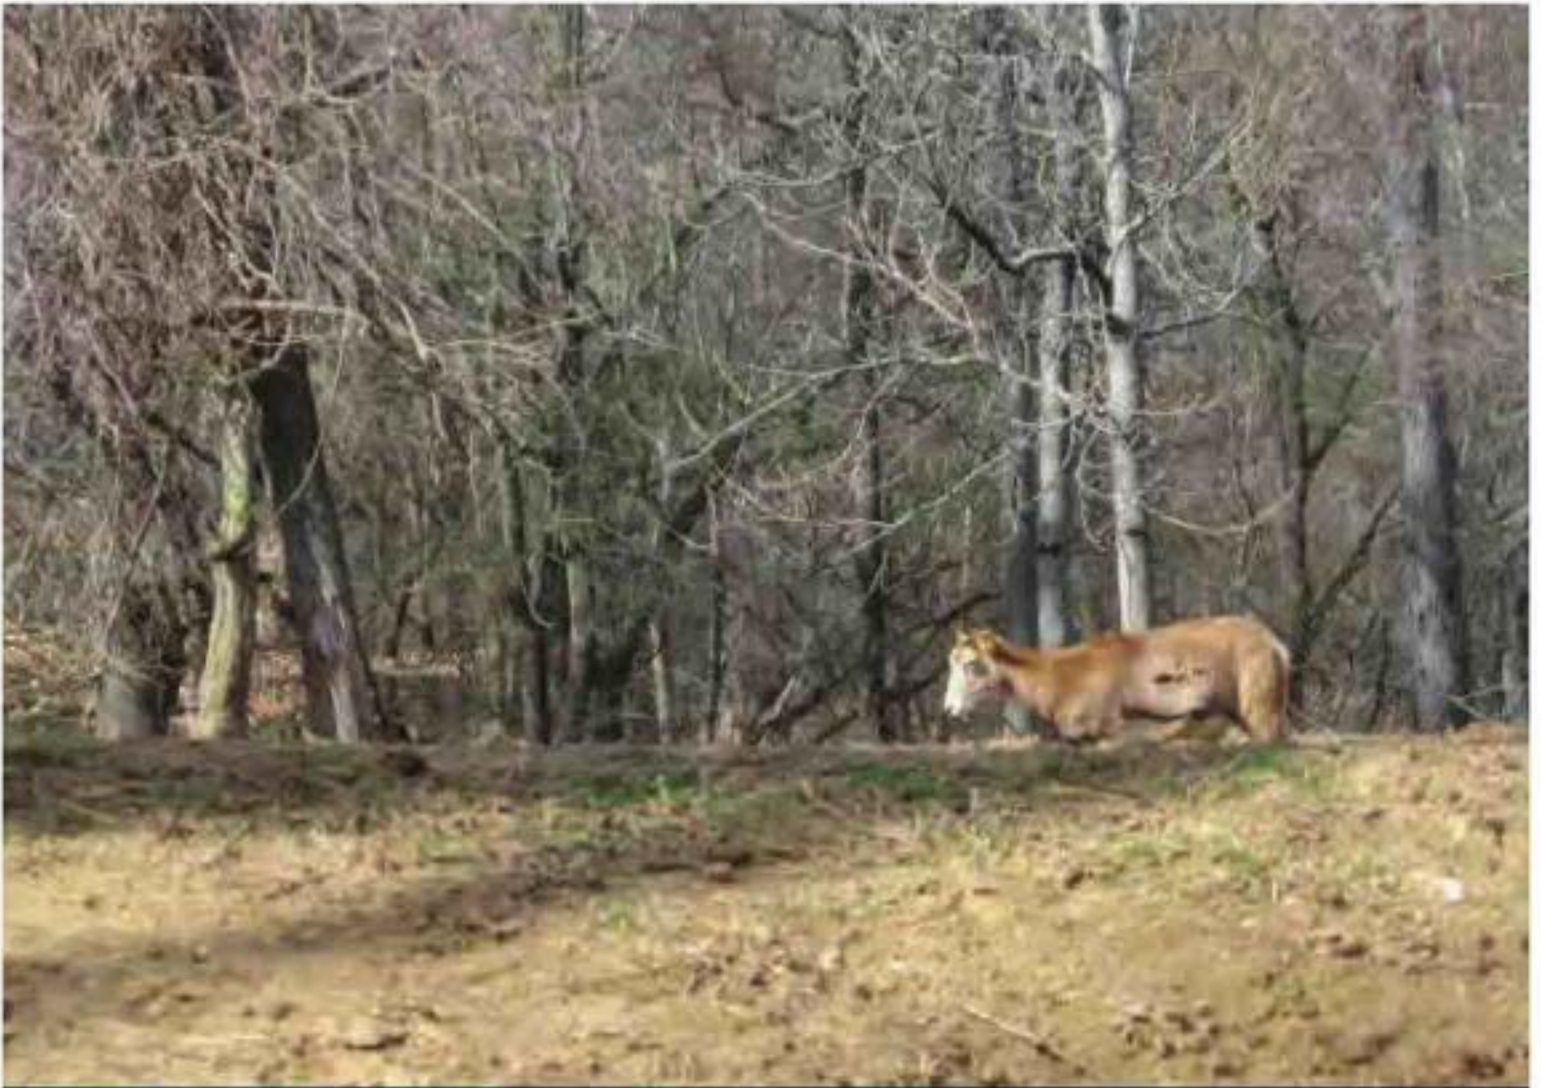
000216

CFR: 2.40 (b) (2)

Photographer:	S. Brunkhorst	Legal Name:	55-B-0069
Photo Taken:	Tue, Mar 17, '15	HENRY HAMPTON	
Inspection:	76151915490483		
Description:	Limping female mouflon with darkened haircoat on left side.

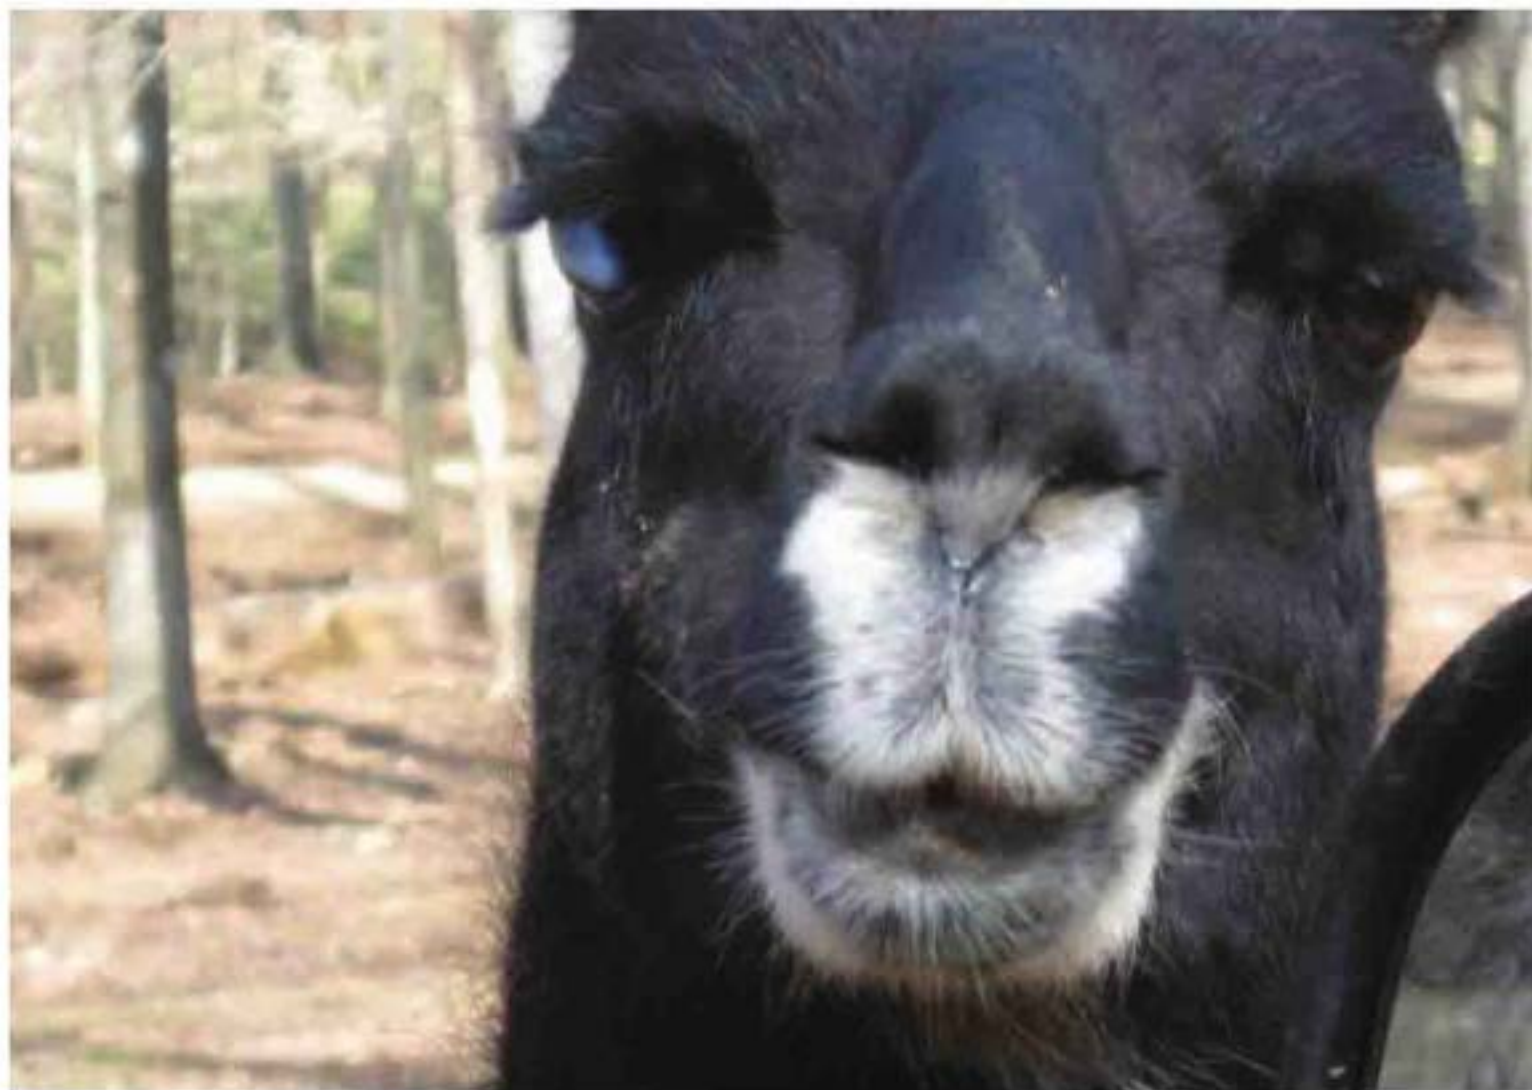
000217

CFR: 2.40 (b) (2)

Photographer:	S. Brunkhorst	Legal Name:	55-B-0069
Photo Taken:	Tue, Mar 17, '15	HENRY HAMPTON	
Inspection:	76151915490483		
Description:	Black and white llama with whitish light bluish colored right eye.

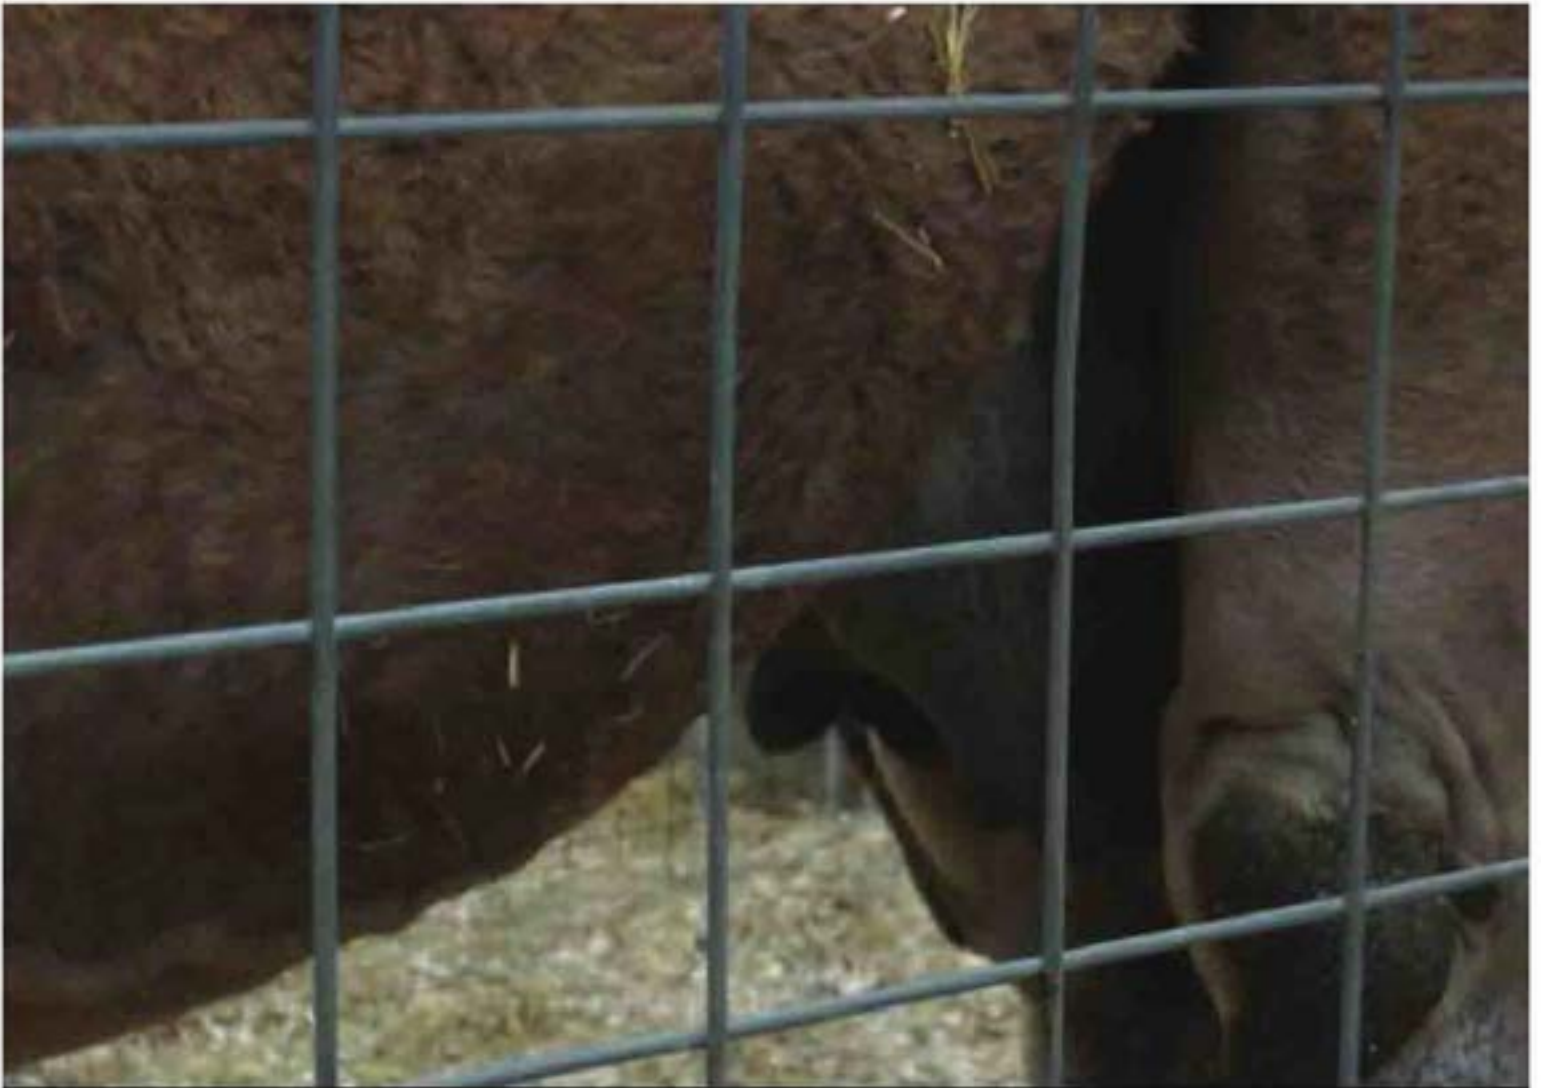
000219

Photographer:	S. Brunkhorst	Legal Name:	55-B-0069
Photo Taken:	Tue, Mar 17, '15	HENRY HAMPTON	
Inspection:	76151915490483		
Description:	Pregnant female camel with labored breathing-neck and head extended; swelling

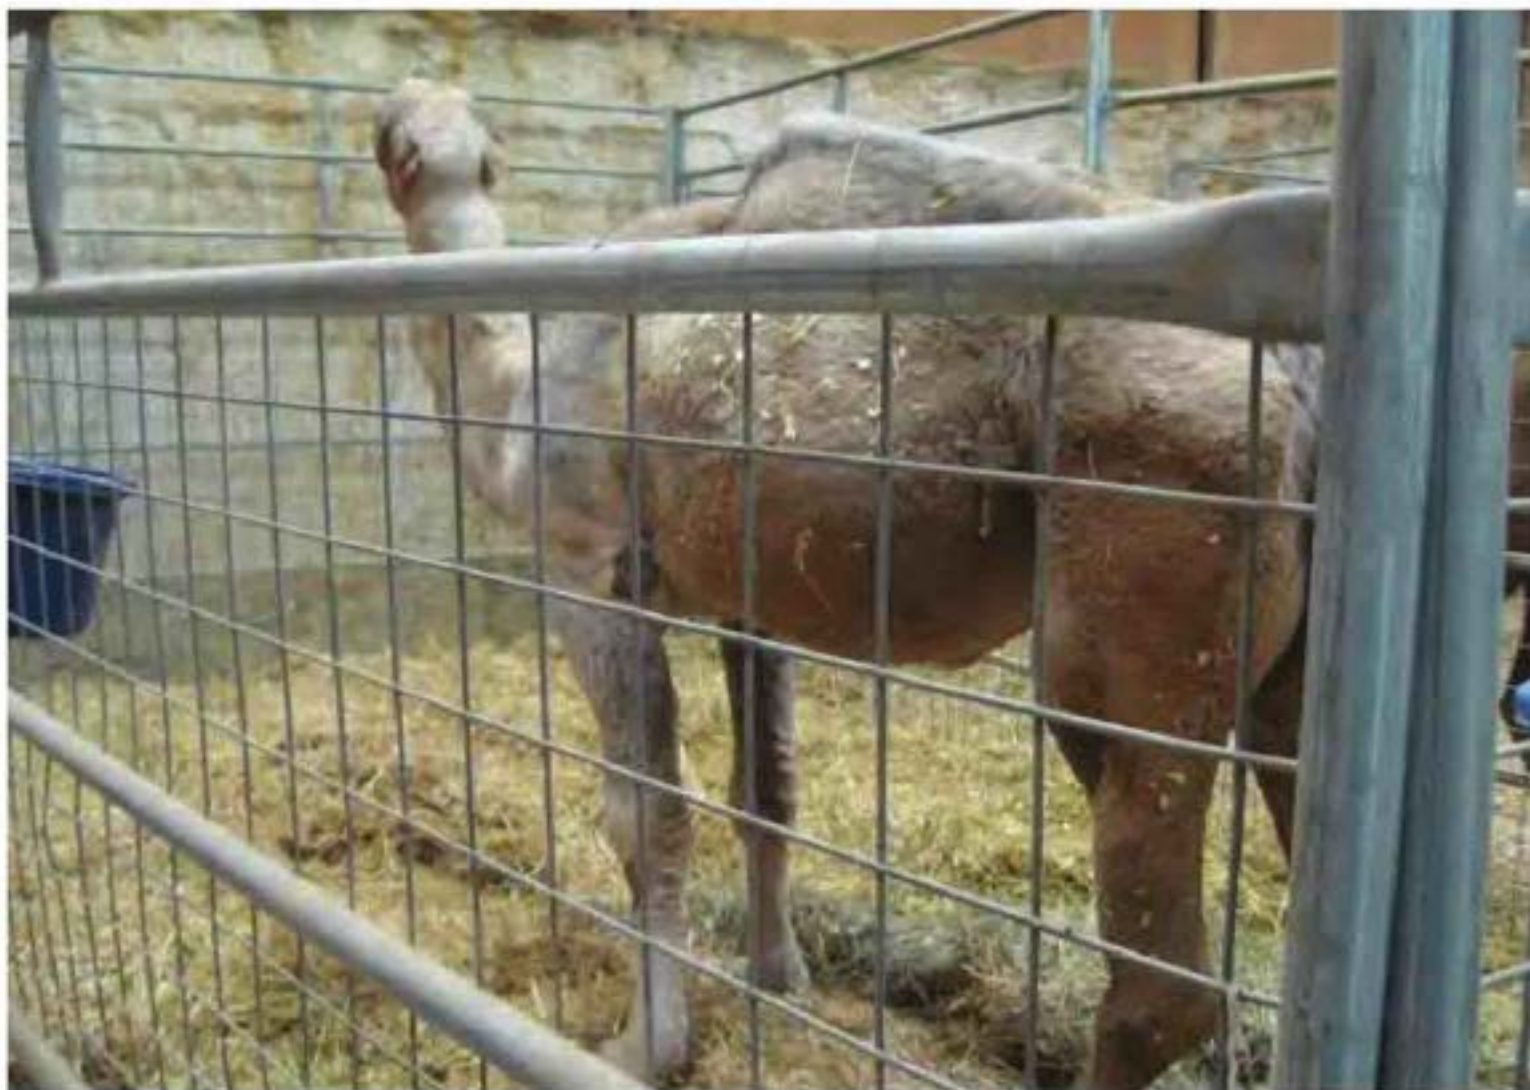
000220

Photographer:	S. Brunkhorst	Legal Name:	55-B-0069
Photo Taken:	Tue, Mar 17, '15	HENRY HAMPTON	
Inspection:	76151915490483		
Description:	Pregnant female camel with difficulty breathing-close up of head and upper neck

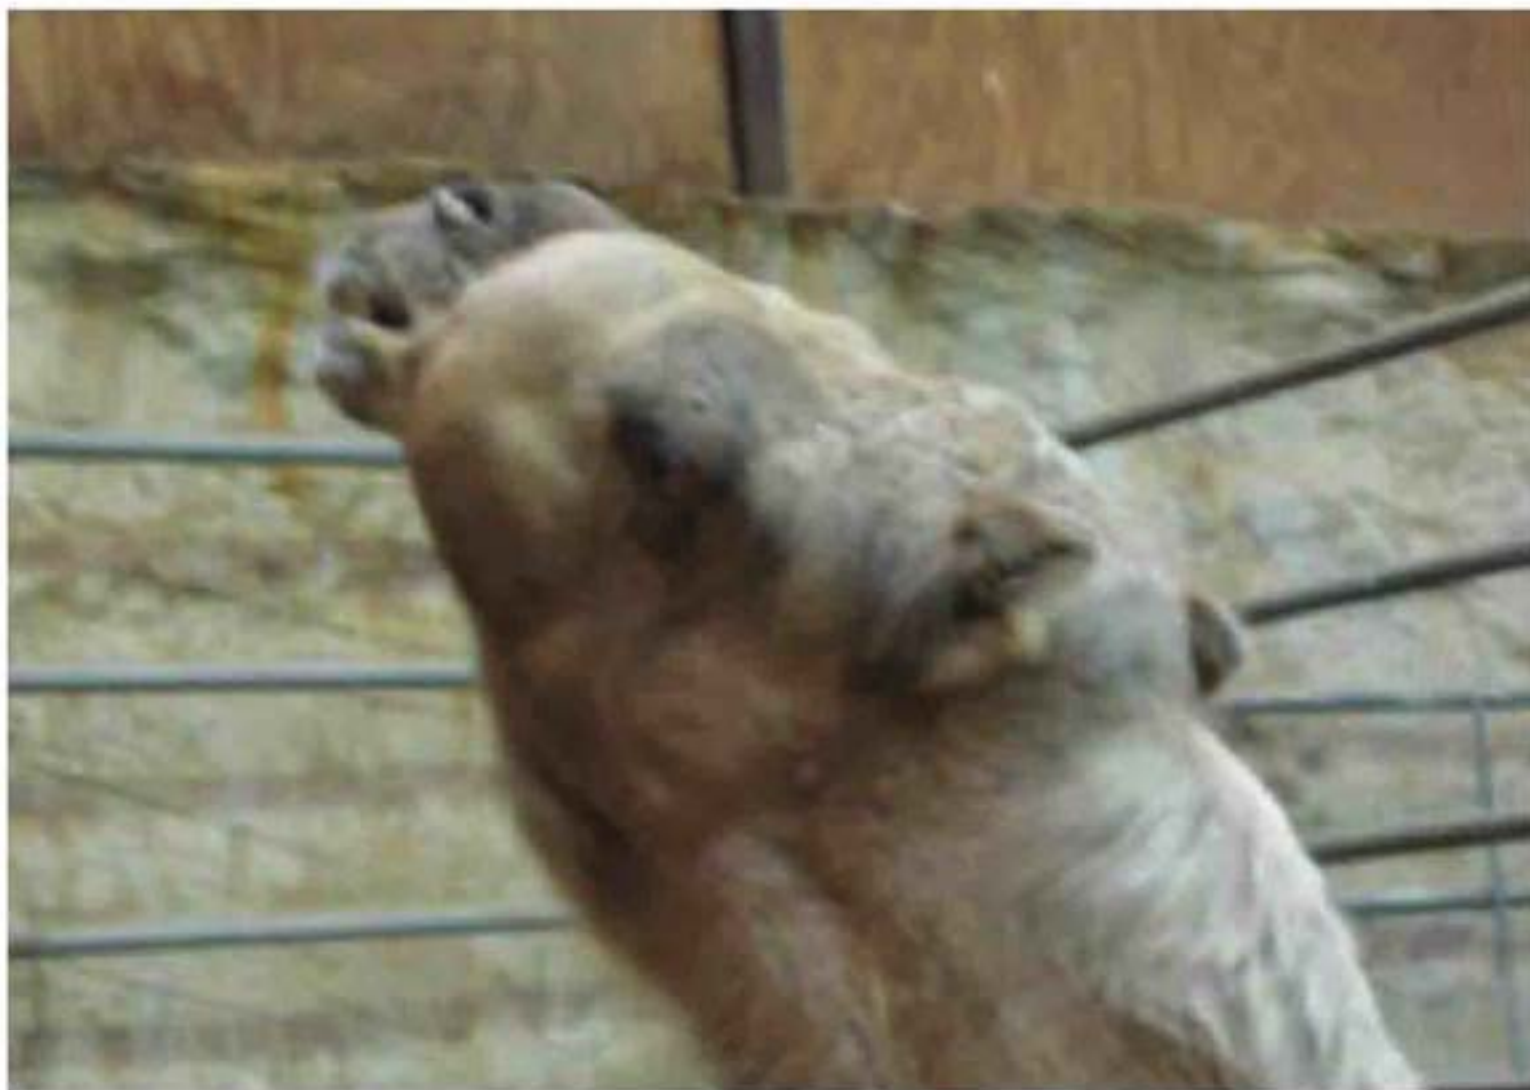
000221

Photographer:	S. Brunkhorst	Legal Name:	55-B-0069
Photo Taken:	Tue, Mar 17, '15	HENRY HAMPTON	
Inspection:	76151915490483		
Description:	Pregnant female camel with difficulty breathing-close up of swelling of face
