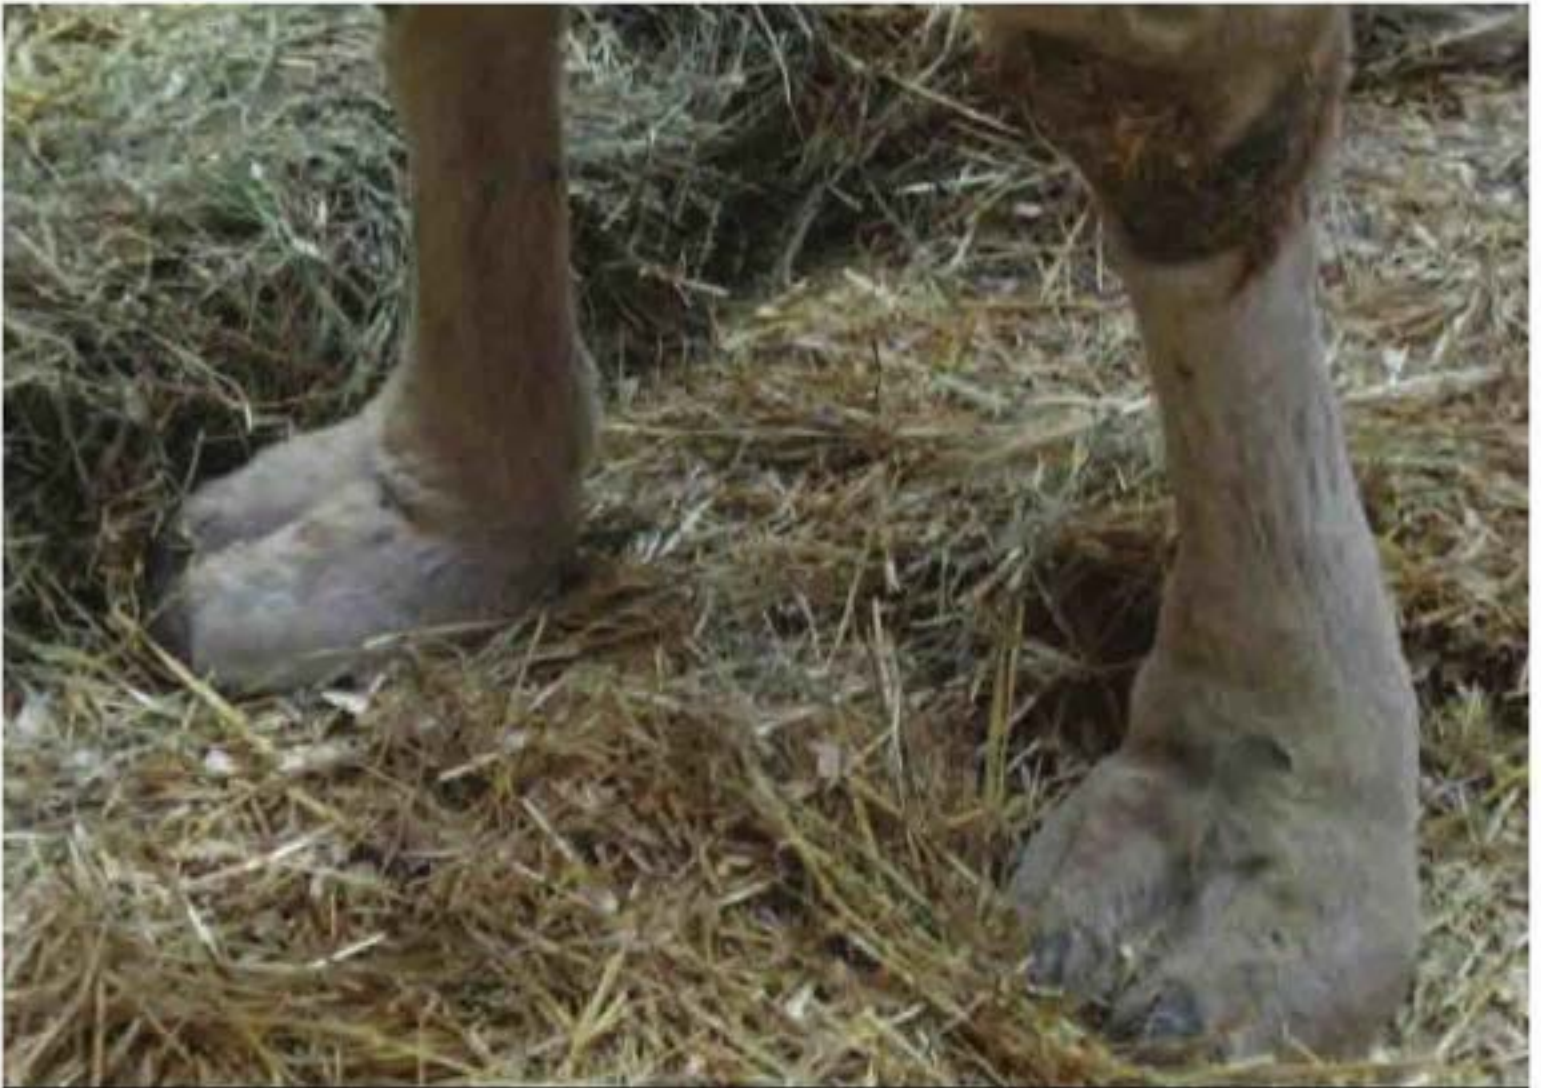
000223

Photographer:	G. McFadden	Legal Name:	55-B-0069
Photo Taken:	Tue, Mar 17, '15	HENRY HAMPTON	
Inspection:	76151915490483		
Description:	Pregnant female camel with difficulty breathing

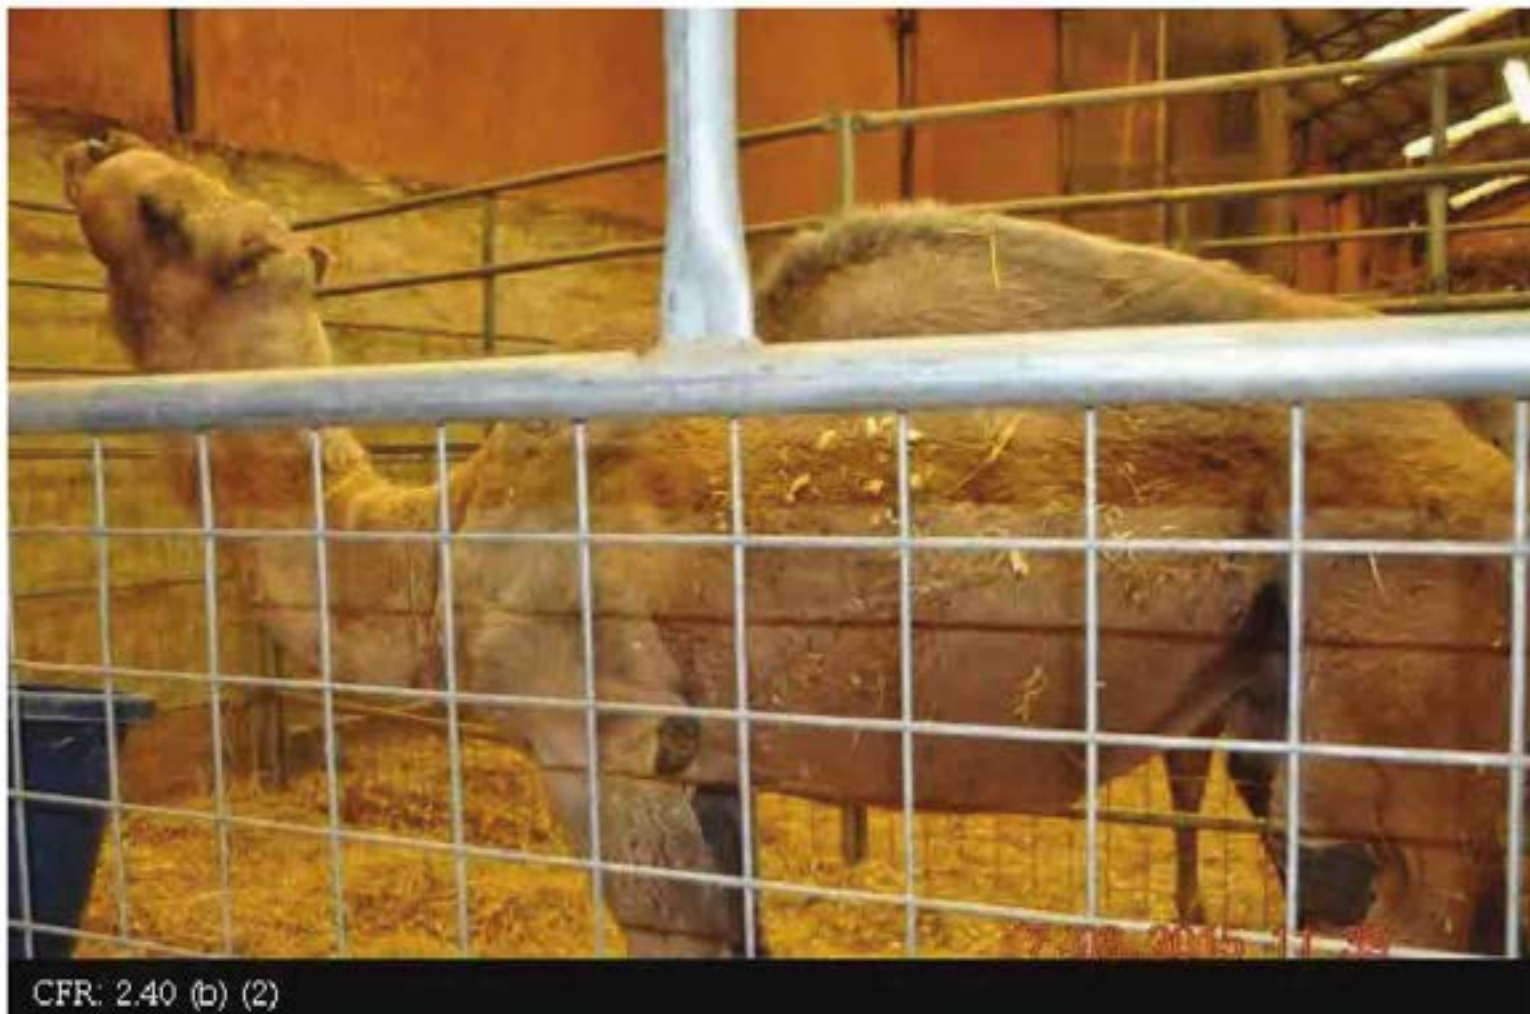
Photographer:	G. McFadden	Legal Name:	55-B-0069
Photo Taken:	Tue, Mar 17, '15	HENRY HAMPTON	
Inspection:	76151915490483		
Description:	Pregnant female camel with difficulty breathing-extended neck

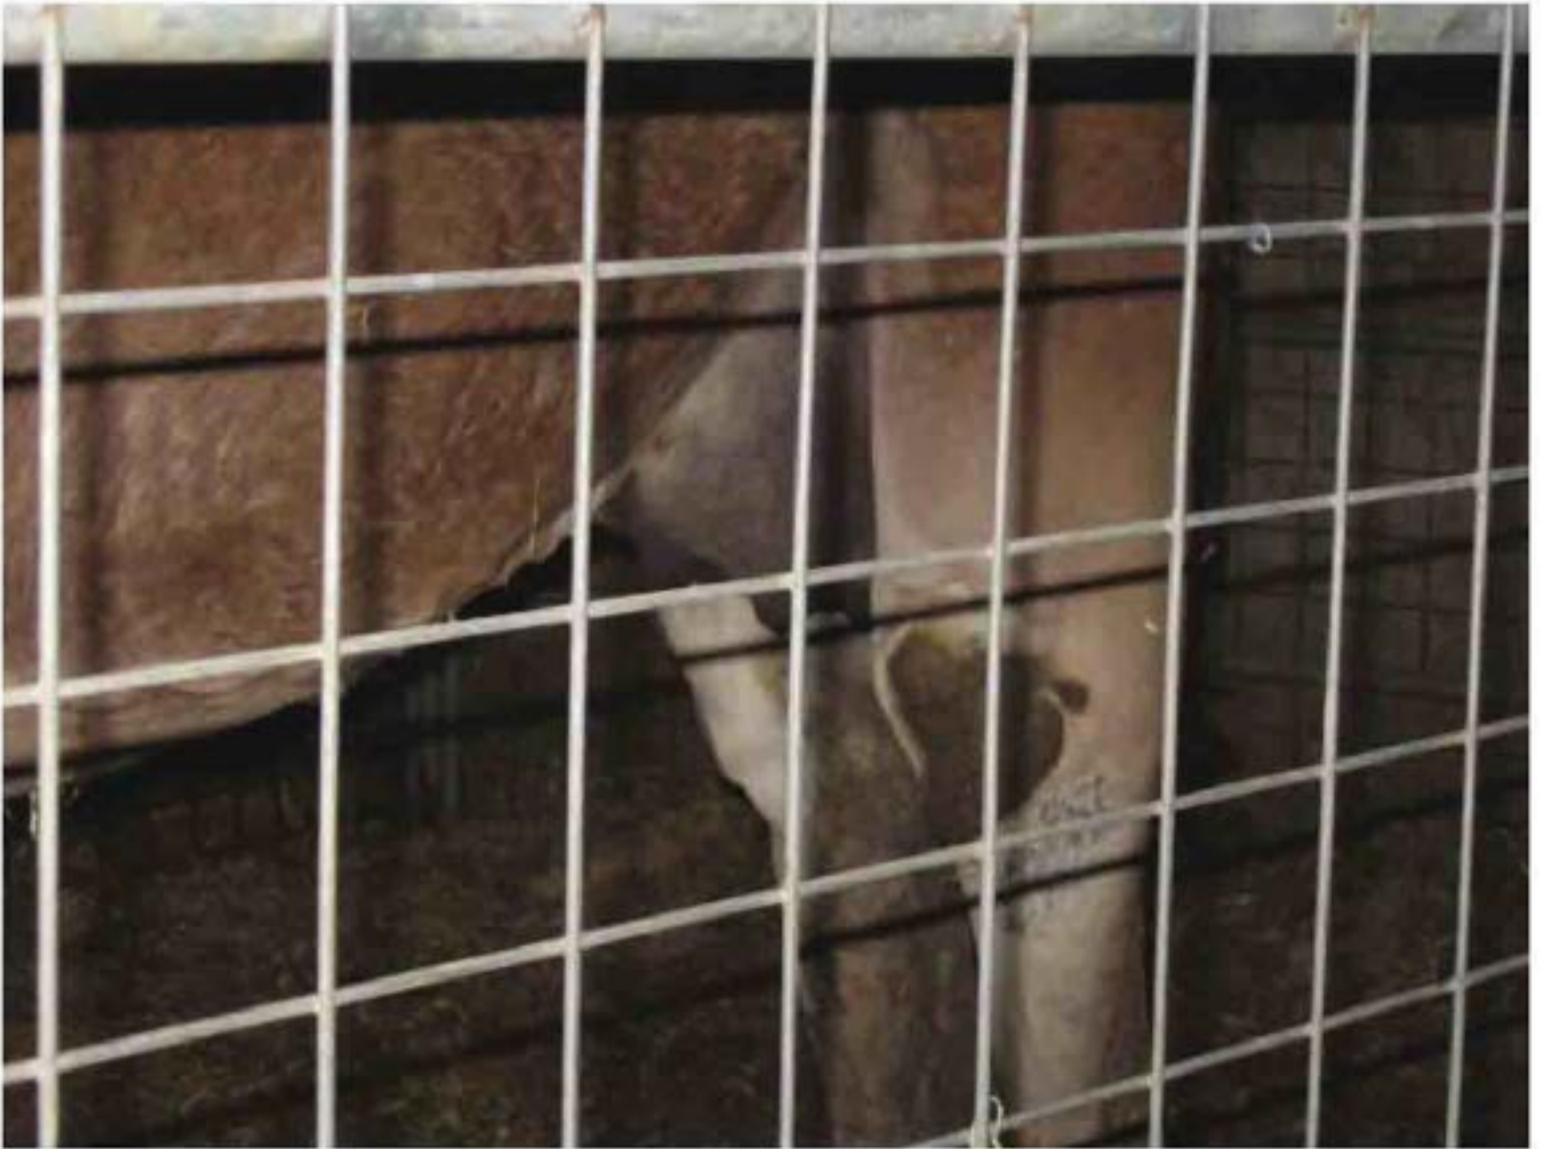
Photographer:	S. Brunkhorst	Legal Name:	55-B-0069
Photo Taken:	Thu, Mar 19, '15	HENRY HAMPTON	
Inspection:	78150959020185		
Description:	Udder of camel that recently gave birth

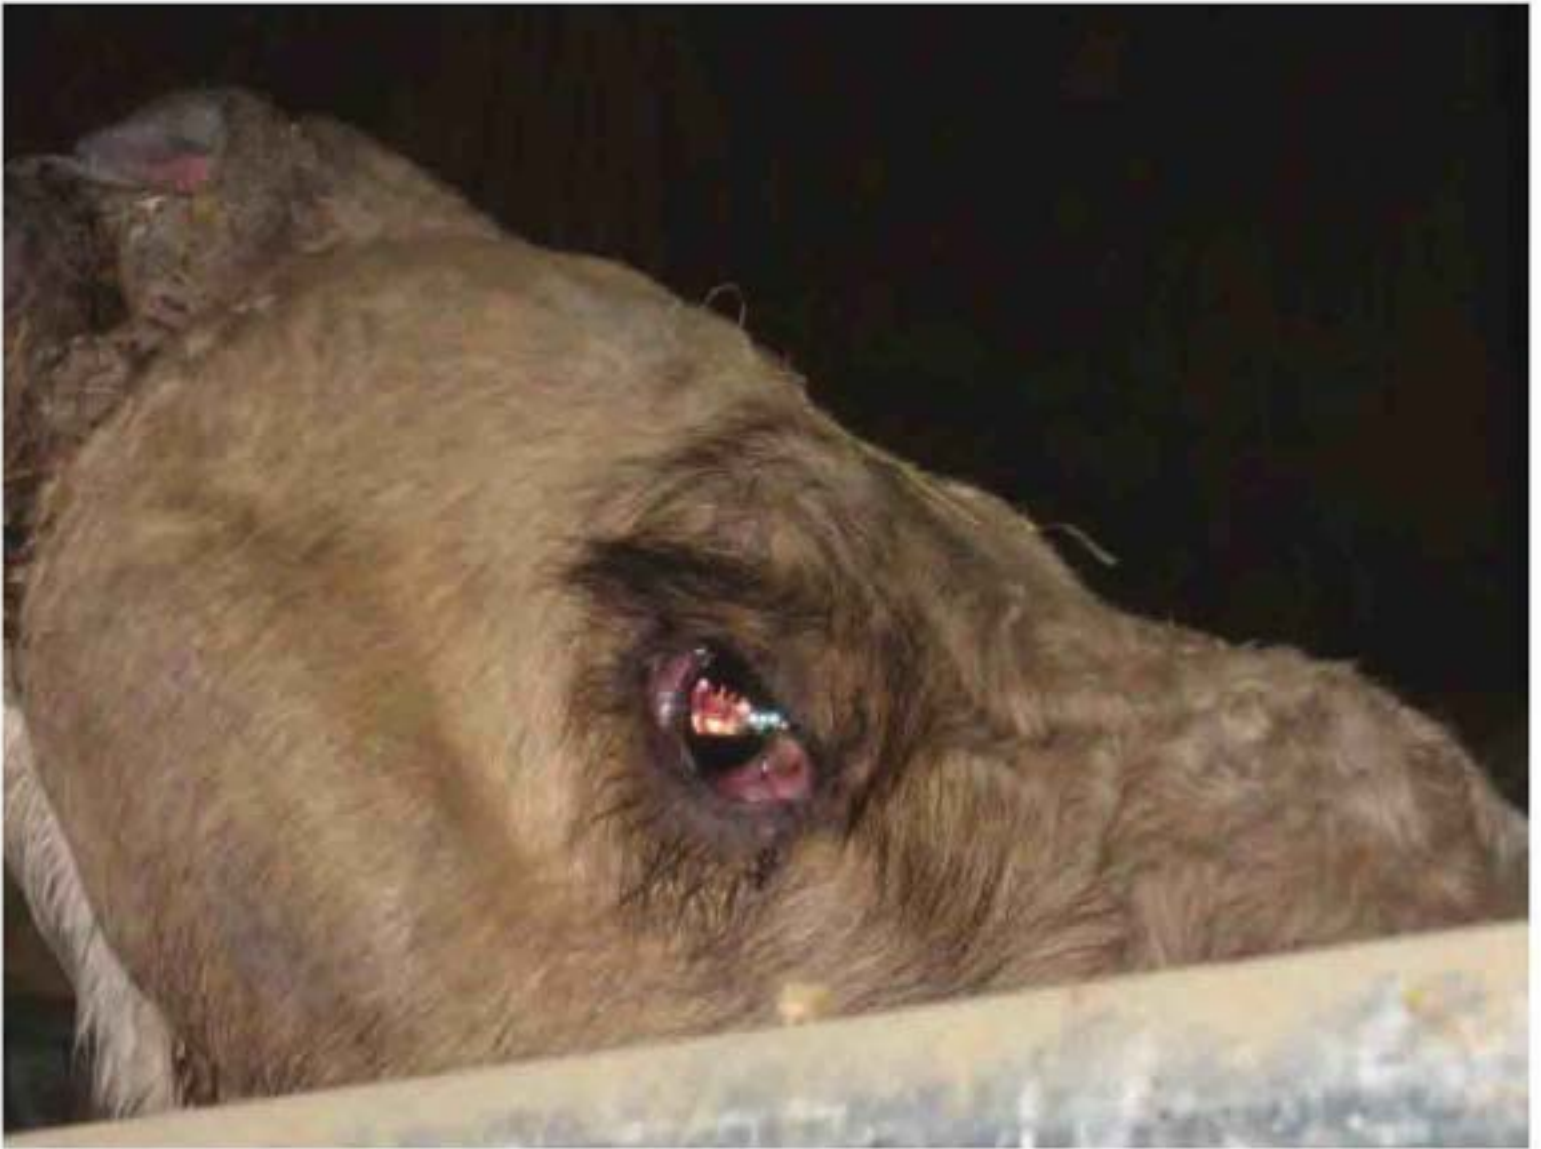
Photographer:	S. Brunkhorst	Legal Name:	55-B-0069
Photo Taken:	Thu, Mar 19, '15	HENRY HAMPTON	
Inspection:	78150959020185		
Description:	Pregnant camel-close up of eye

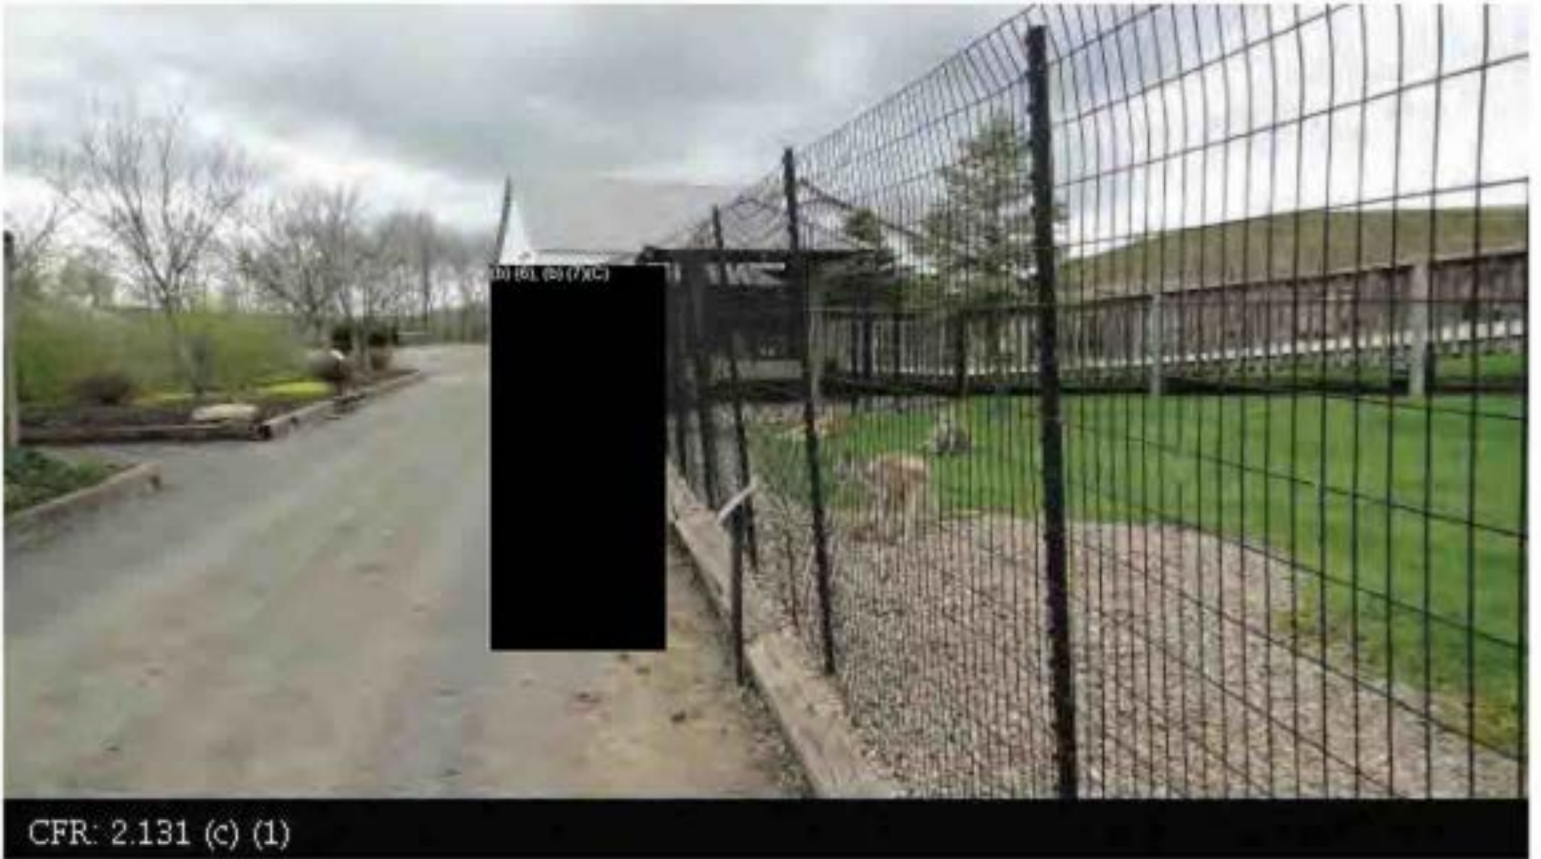
Photographer:	Dana Miller, SACS	Legal Name:	55-B-0069
Photo Taken:	Mon, Apr 20, '15 1243 pm	HENRY HAMPTON	
Inspection:	194151734120886		
Description:	Section 2.131(c)(1): Lack of public barriers for kangaroos.

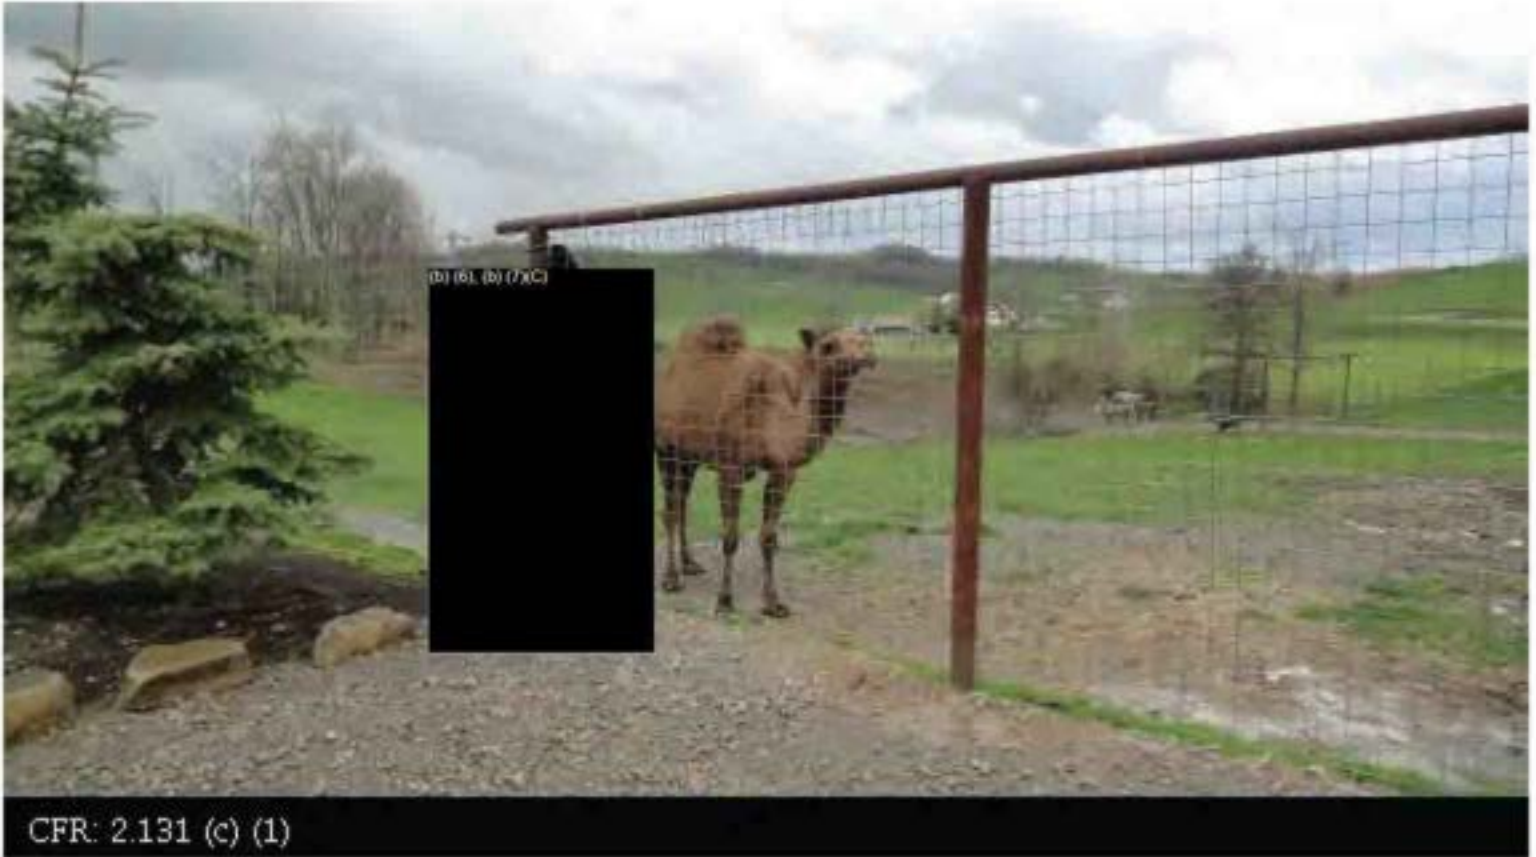
Photographer:	Dana Miller, SACS	Legal Name:	55-B-0069
Photo Taken:	Mon, Apr 20, '15 1120 am	HENRY HAMPTON	
Inspection:	194151734120886		
Description:	Section 2.131(c)(1): Lack of public barriers for camels.

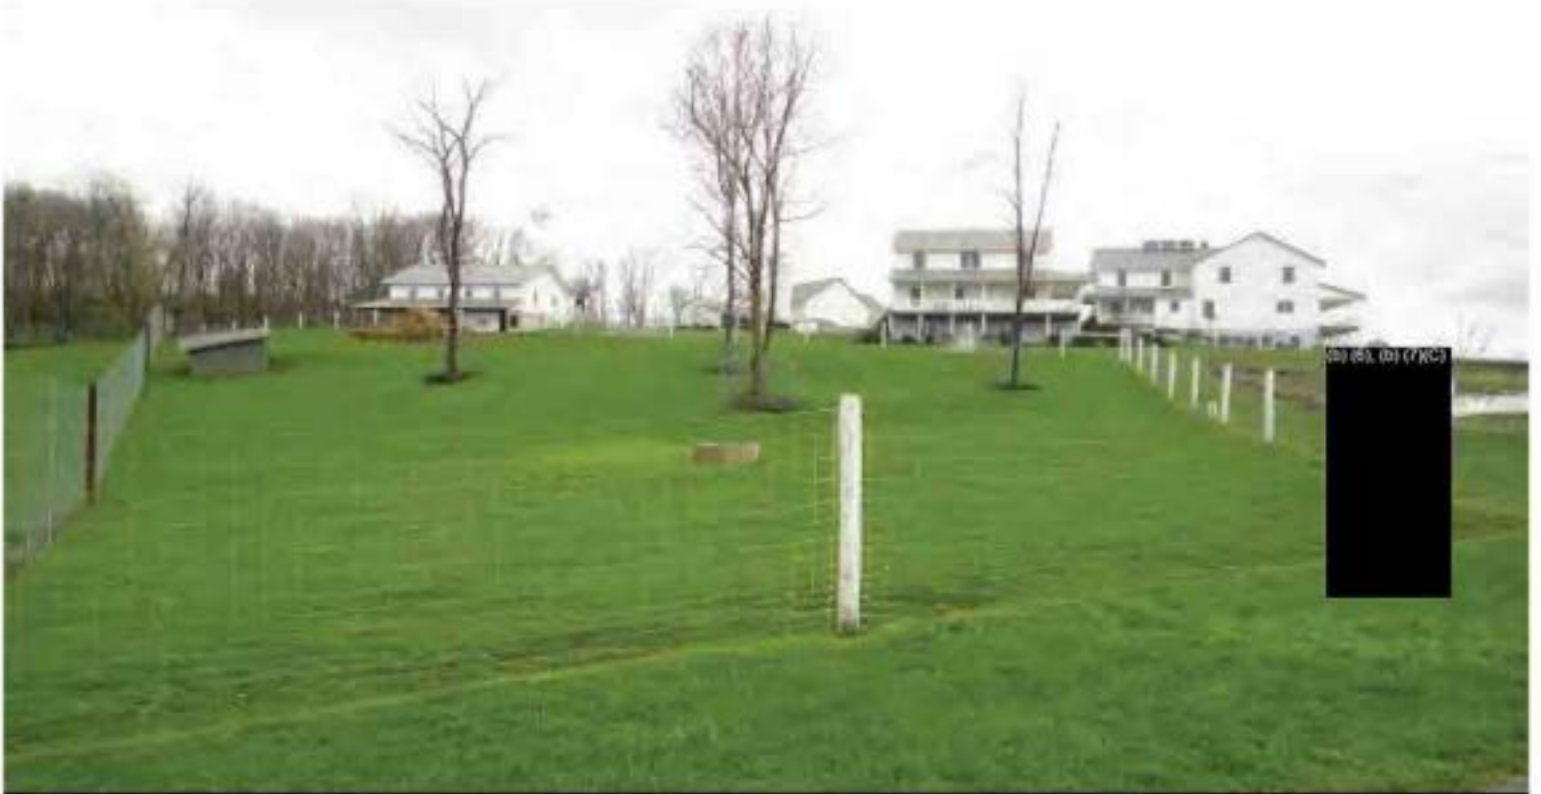
000233

Photographer:	Dana Miller, SACS	Legal Name:	55-B-0069
Photo Taken:	Mon, Apr 20, '15 11:22 am	HENRY HAMPTON	
Inspection:	194151734120886		
Description:	Section 2.131(c)(1): Lack of public barriers for goats.

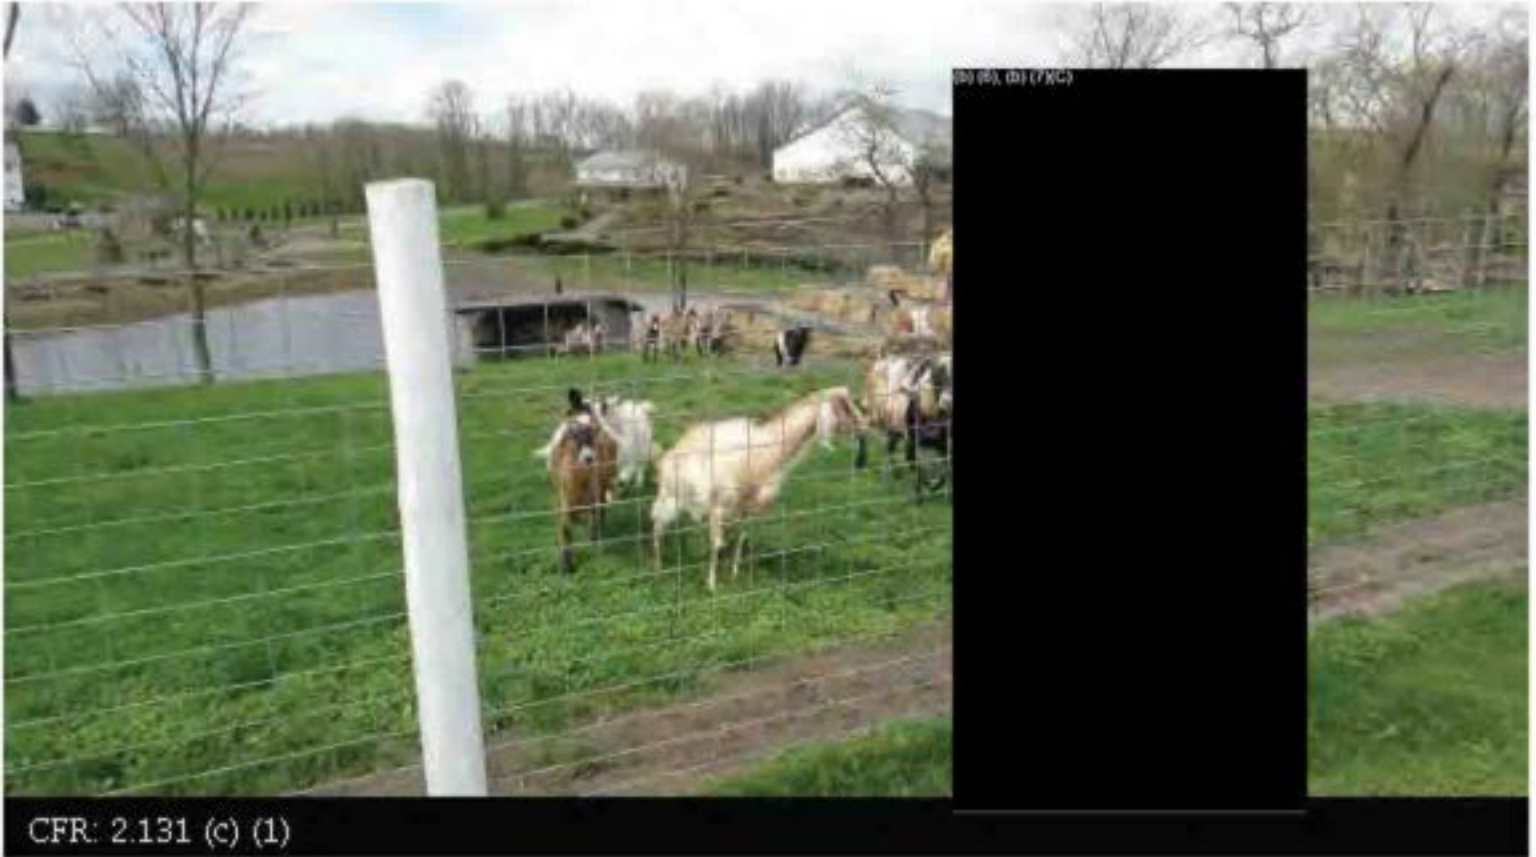
Photographer:	Dana Miller, SACS	Legal Name:	55-B-0069
Photo Taken:	Mon, Apr 20, '15 1125 am	HENRY HAMPTON	
Inspection:	194151734120886		
Description:	Section 2.131(c)(1): Lack of public barriers for goats.

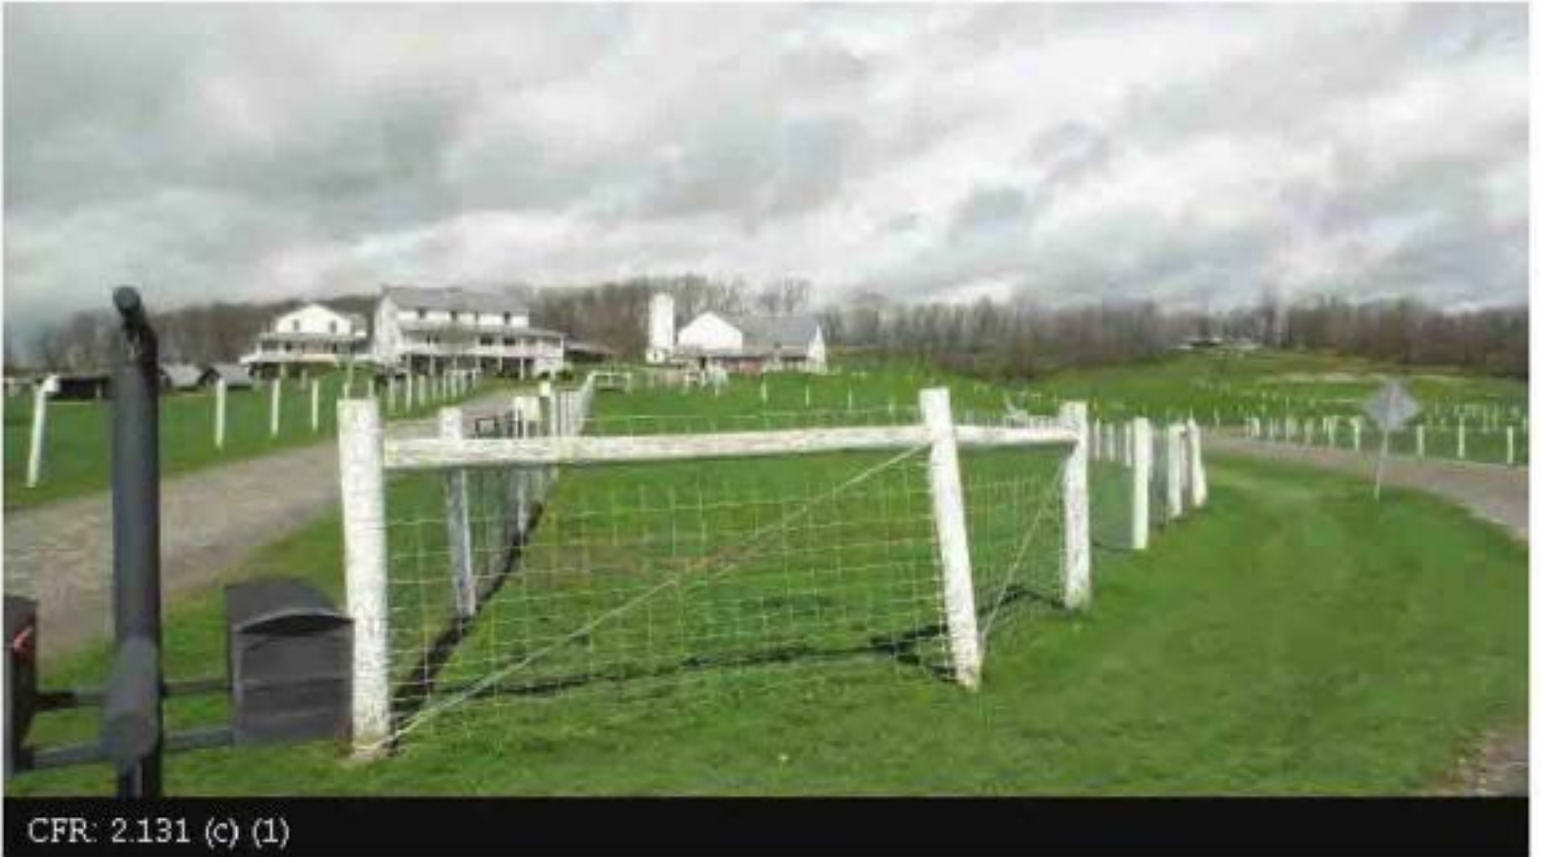
Photographer:	Dana Miller, SACS	Legal Name:	55-B-0069
Photo Taken:	Mon, Apr 20, '15 1134 am	HENRY HAMPTON	
Inspection:	194151734120886		
Description:	Section 2.131(c)(1): Lack of public barriers for jersey cows.

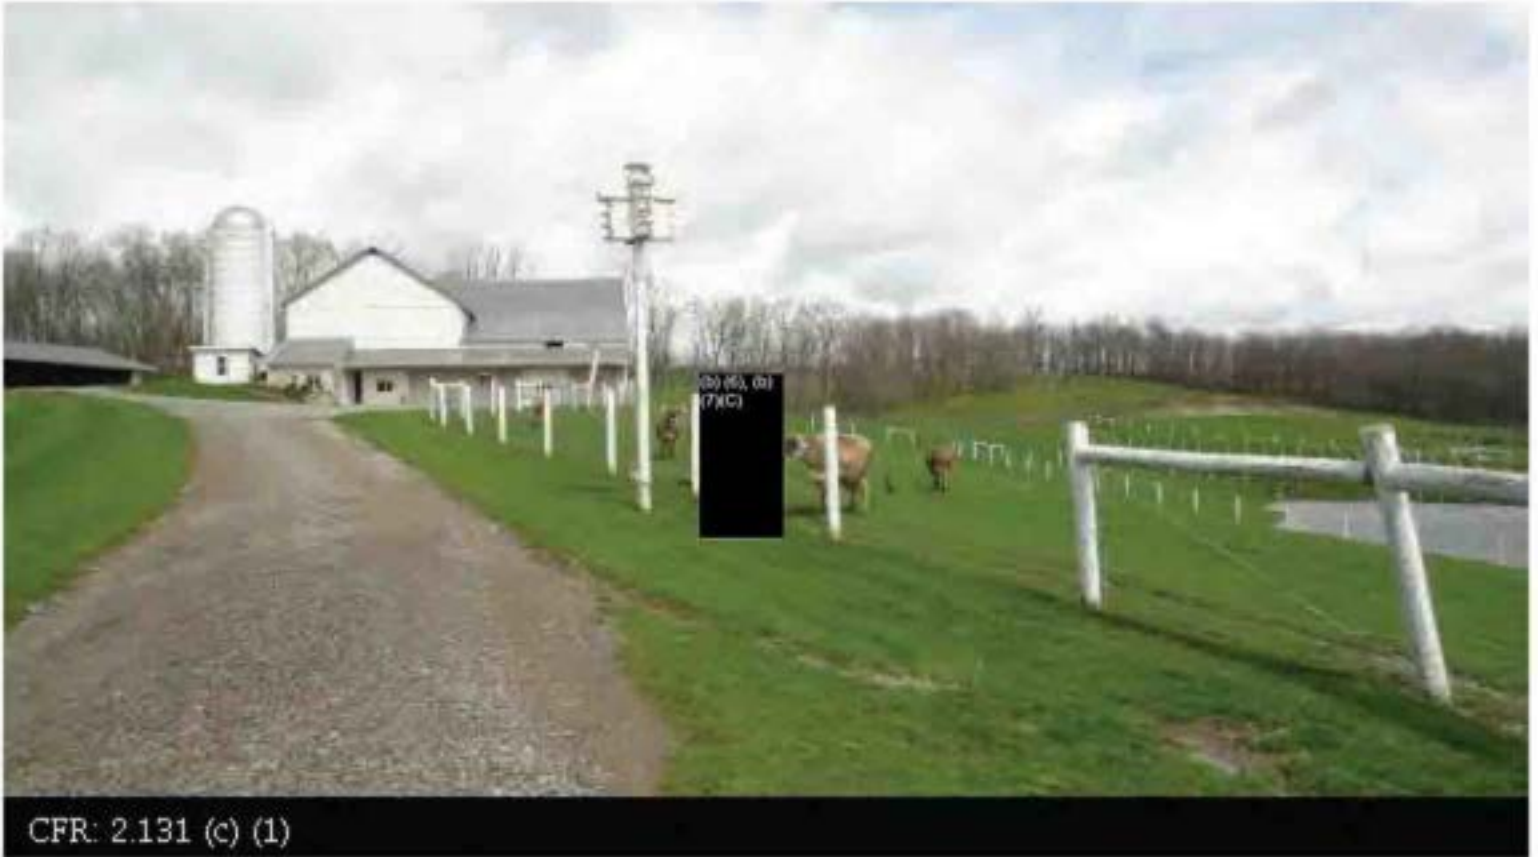
Photographer:	Dana Miller, SACS	Legal Name:	55-B-0069
Photo Taken:	Mon, Apr 20, '15 1136 am	HENRY HAMPTON	
Inspection:	194151734120886		
Description:	Section 2.131(c)(1): Lack of public barriers for jersey cows.

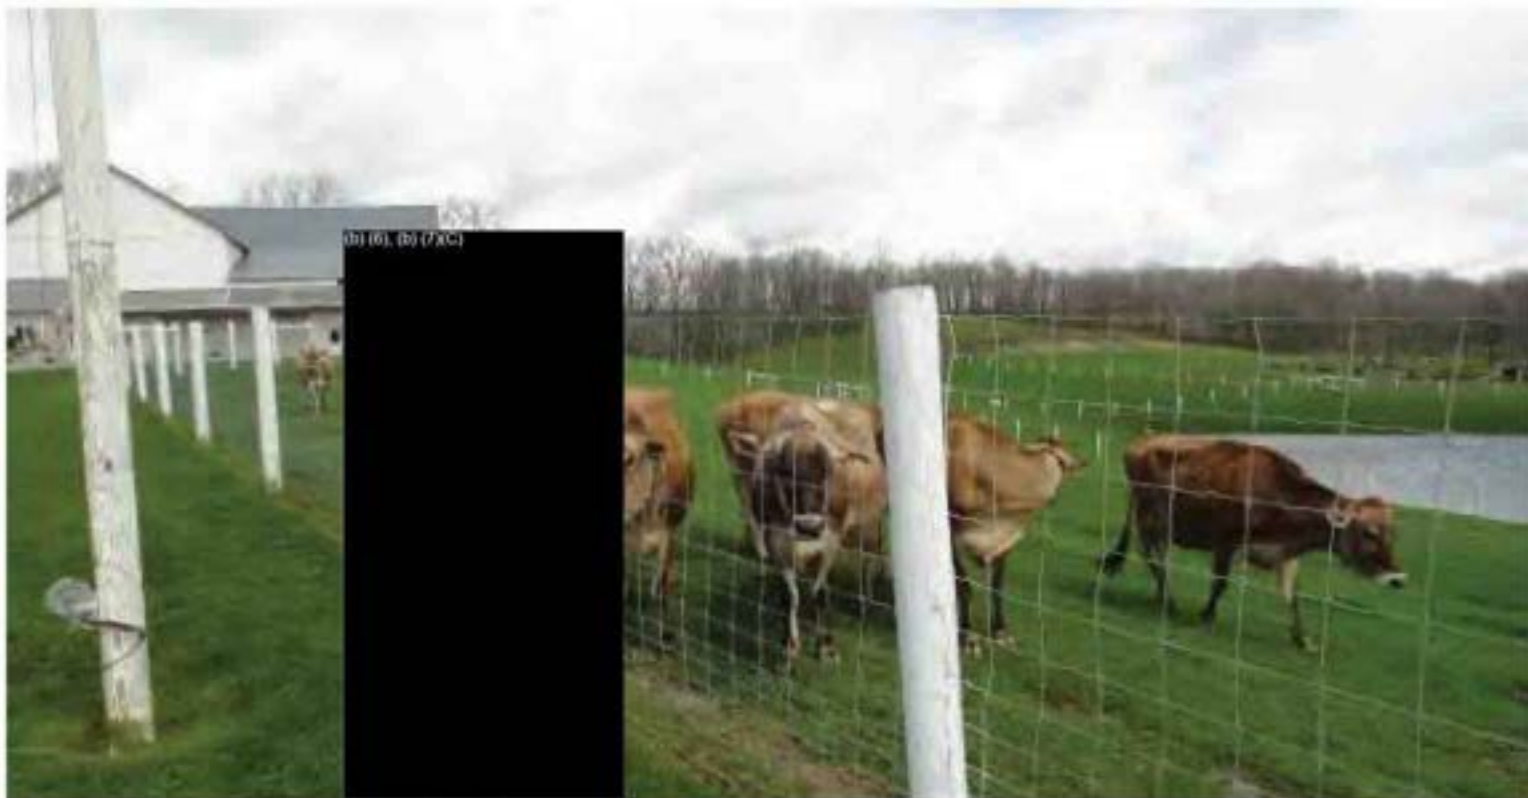
Photographer:	Dana Miller, SACS	Legal Name:	55-B-0069
Photo Taken:	Mon, Apr 20, '15 1136 am	HENRY HAMPTON	
Inspection:	194151734120886		
Description:	Section 2.131(c)(1): Lack of public barriers for jersey cows.

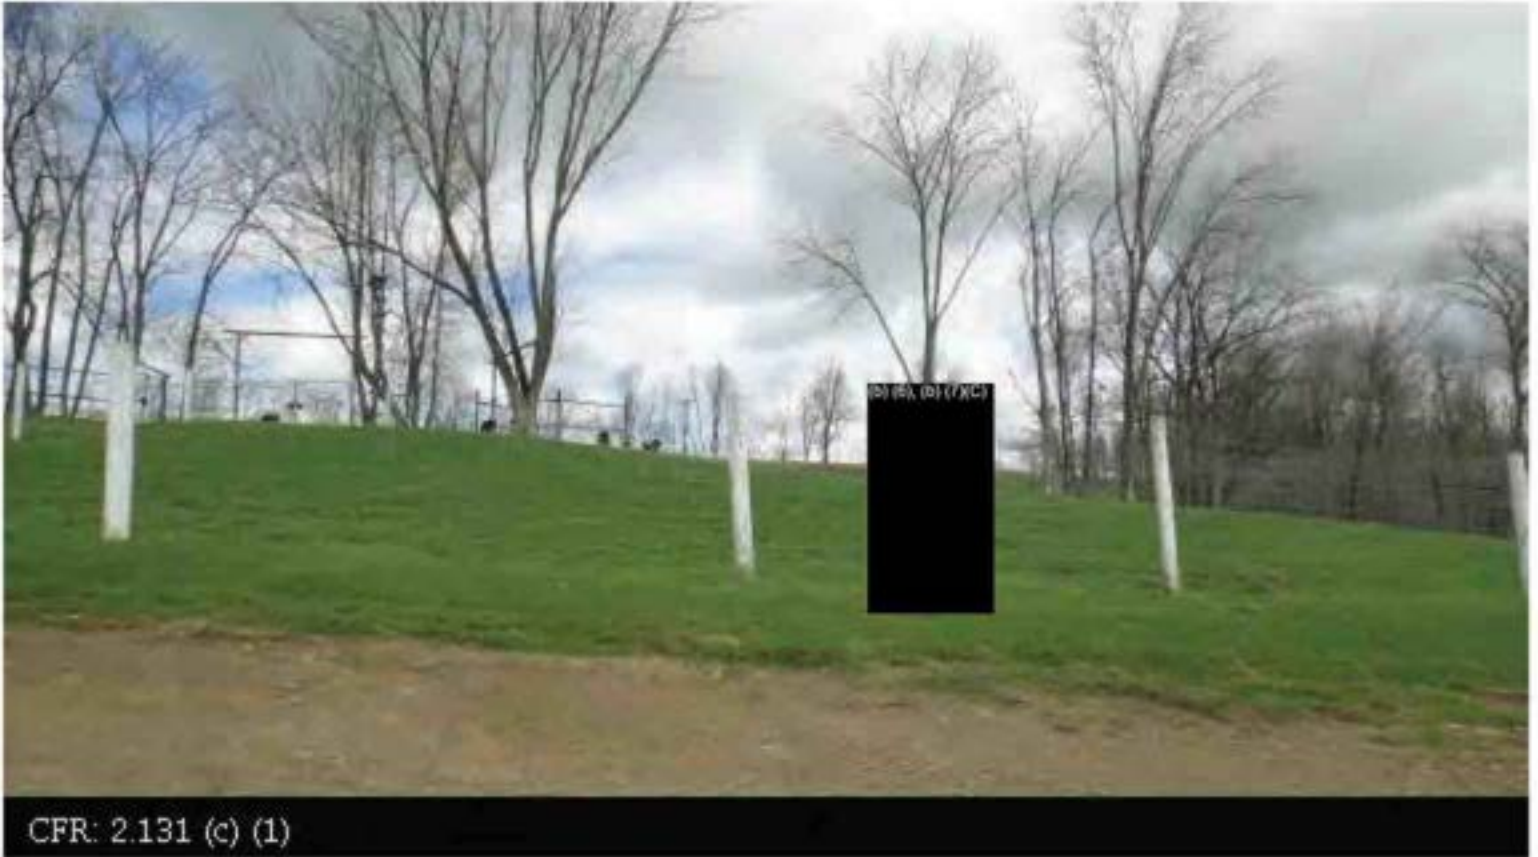
Photographer:	Dana Miller, SACS	Legal Name:	55-B-0069
Photo Taken:	Mon, Apr 20, '15 1149 am	HENRY HAMPTON	
Inspection:	194151734120886		
Description:	Section 2.131(c)(1): Lack of public barriers for 4-horn sheep

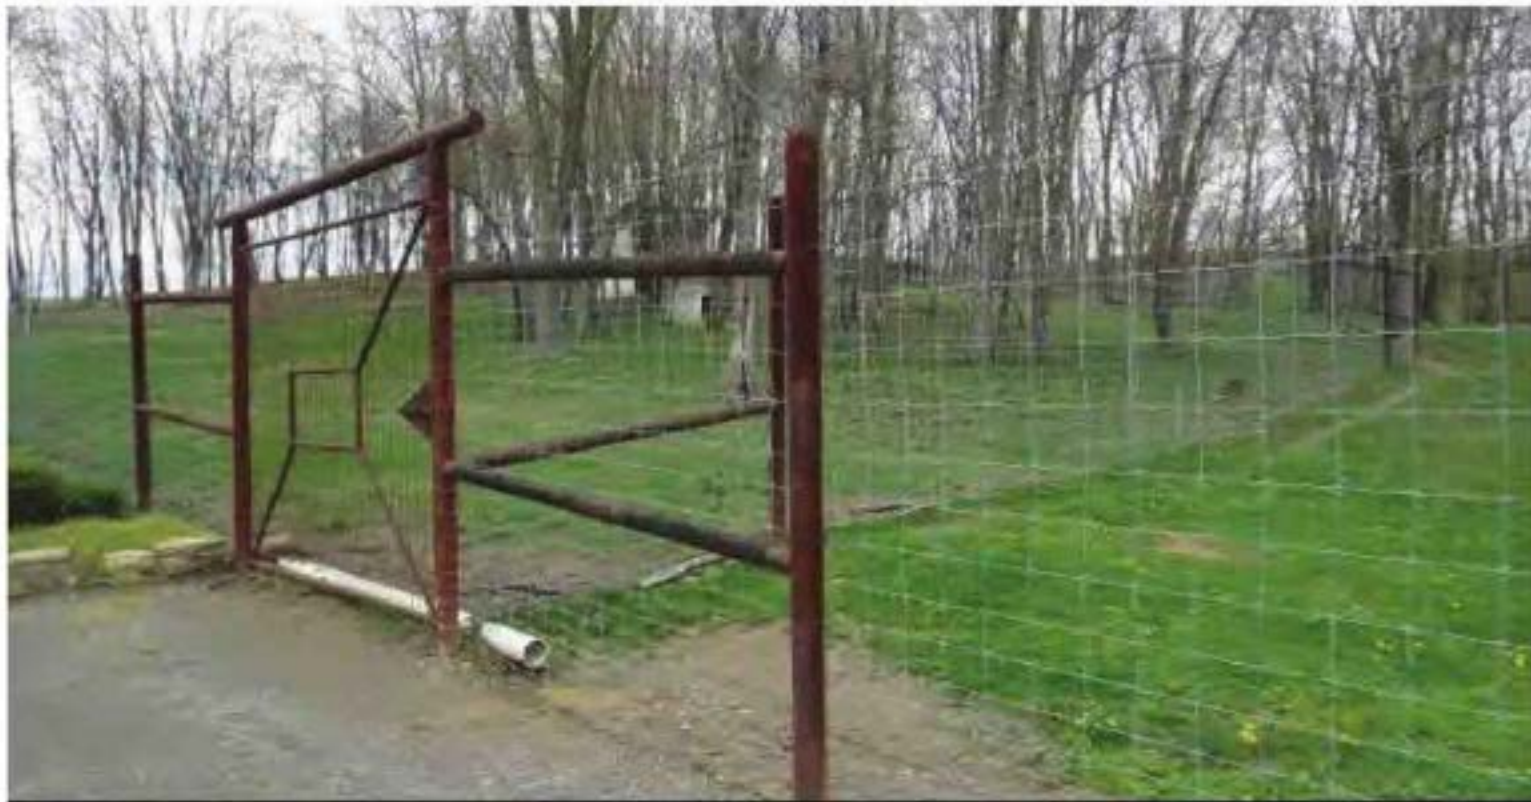
000241

Photographer:	Dana Miller, SACS	Legal Name:	55-B-0069
Photo Taken:	Mon, Apr 20, '15 1236 pm	HENRY HAMPTON	
Inspection:	194151734120886		
Description:	Section 2.131(c)(1): Lack of public barriers for muntjac deer.

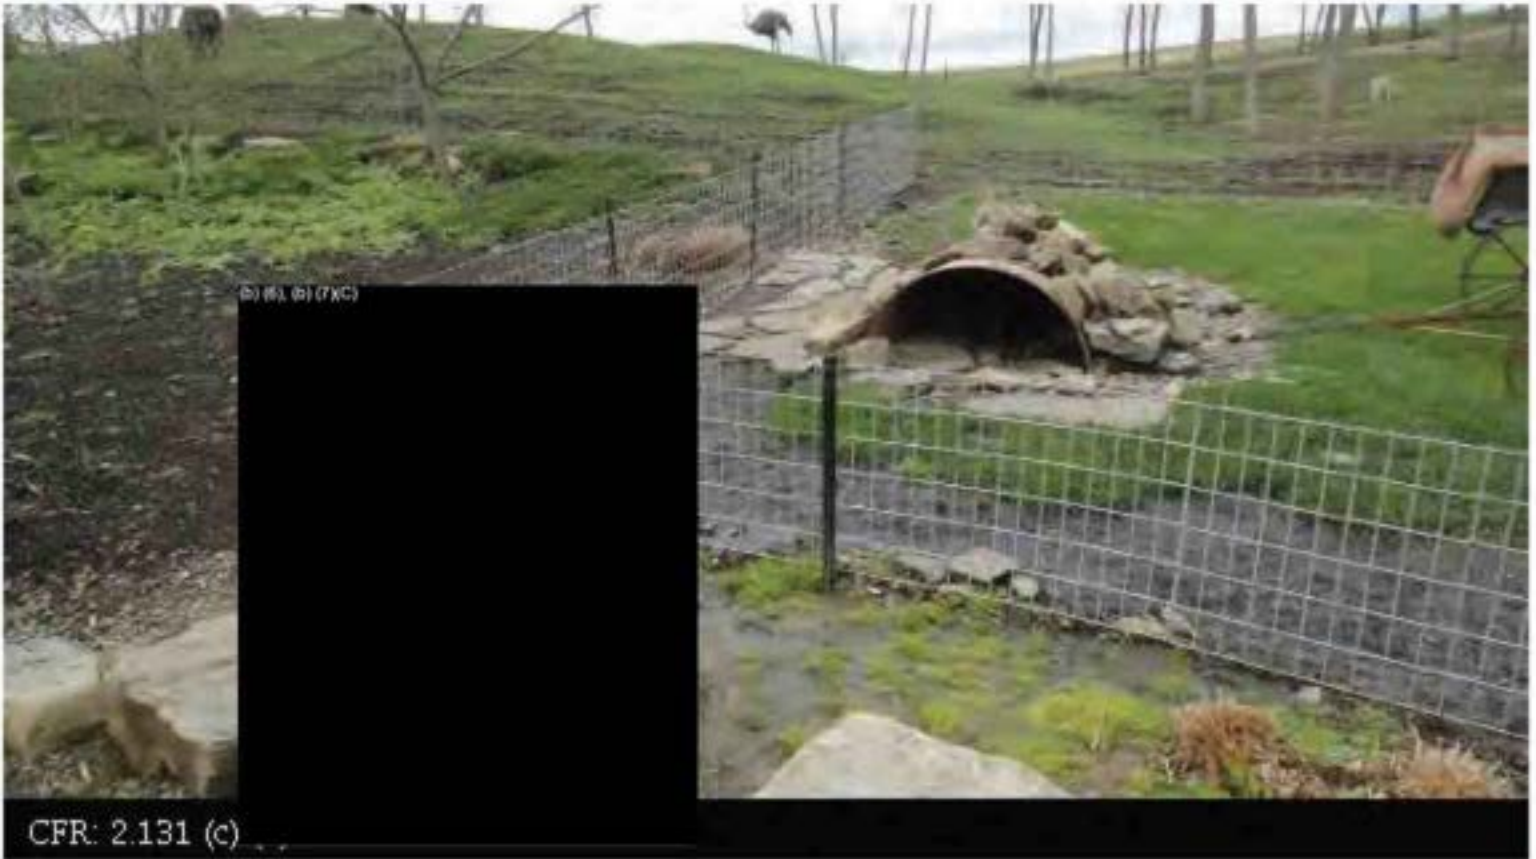
Photographer:	Dana Miller, SACS	Legal Name:	55-B-0069
Photo Taken:	Mon, Apr 20, '15 1240 pm	HENRY HAMPTON	
Inspection:	194151734120886		
Description:	Section 2.131(c)(1): Lack of public barriers for porcupines,

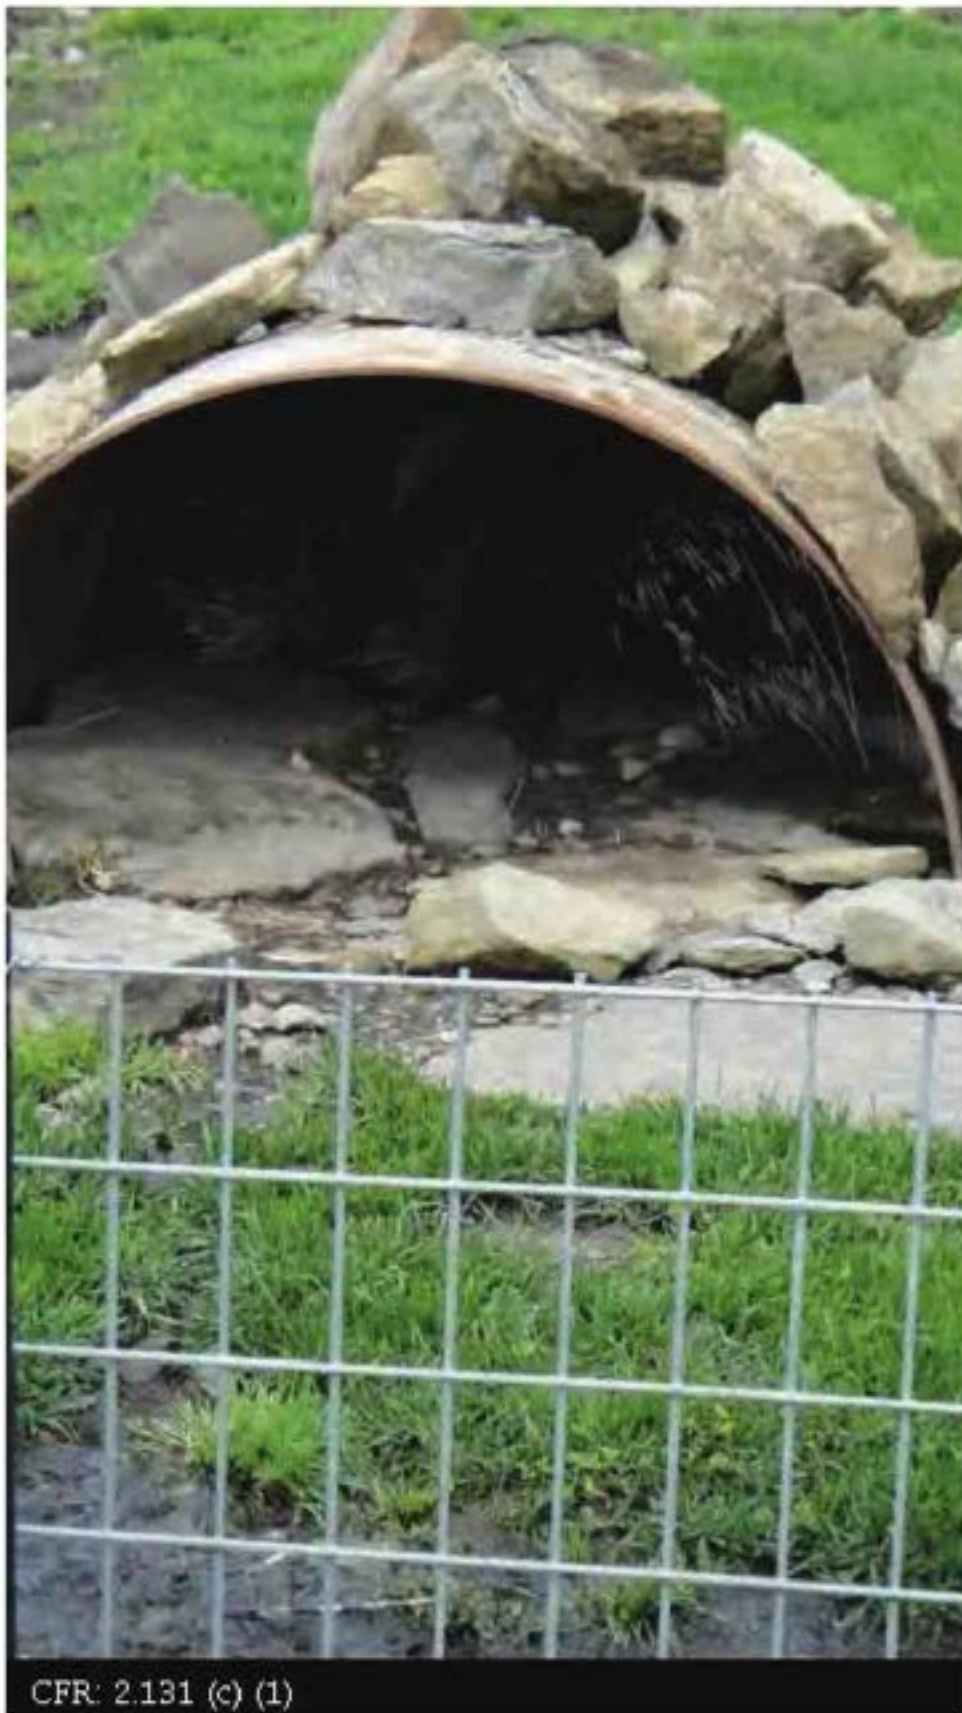
Photographer:	Dana Miller, SACS	Legal Name:	HENRY HAMPTON	55-B-0069
Photo Taken:	Mon, Apr 20, '15 1240 pm			
Inspection:	194151734120886			
Description:	Section 2.131(c)(1): Lack of public barriers for porcupines.
