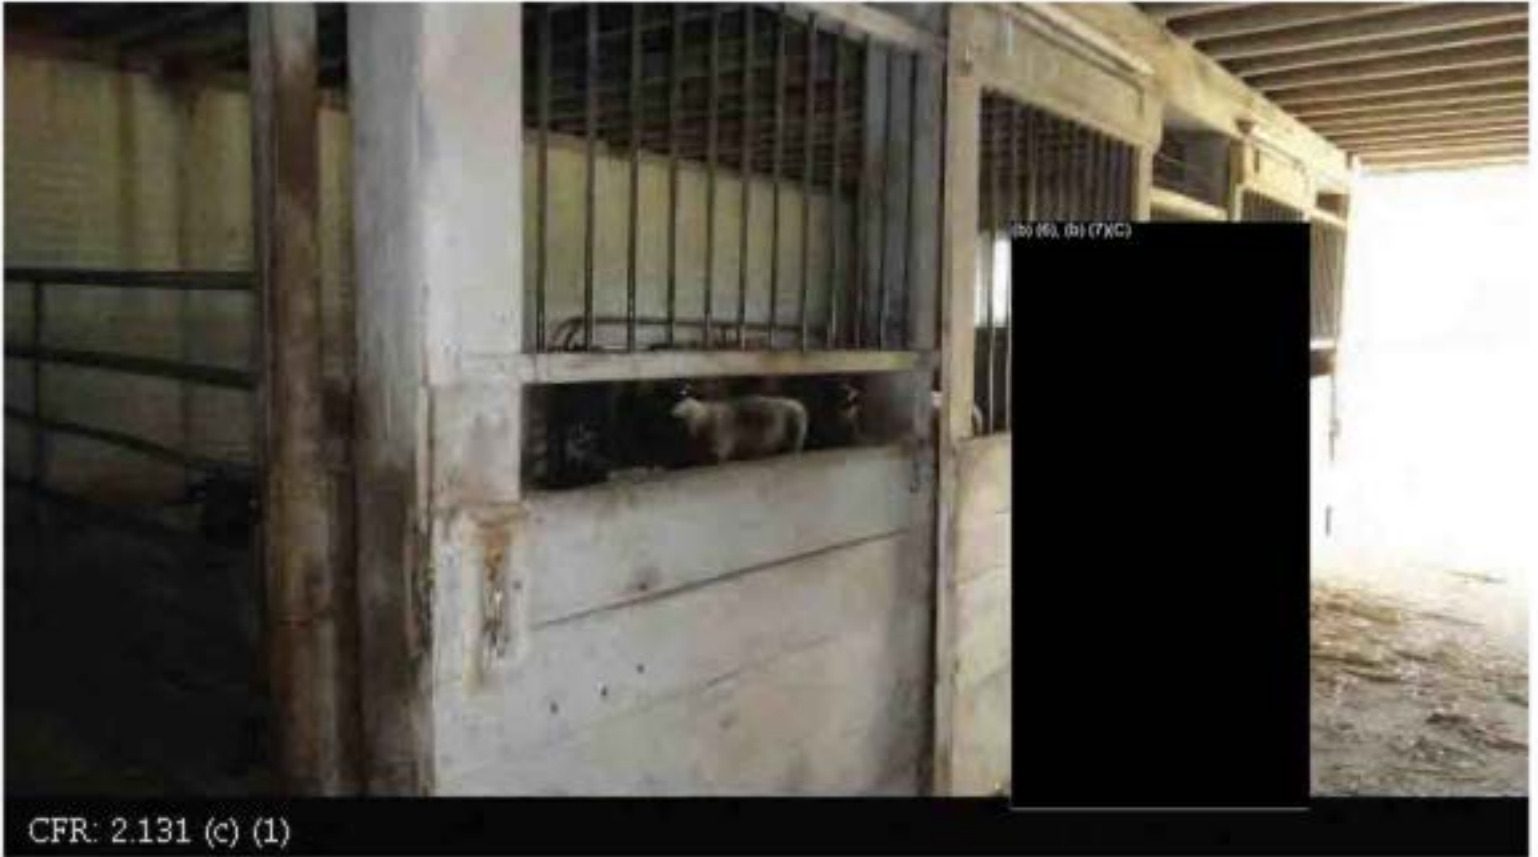
Photographer:	Dana Miller, SACS	Legal Name:	55-B-0069
Photo Taken:	Mon, Apr 20, '15 1145 am	HENRY HAMPTON	
Inspection:	194151734120886		
Description:	Section 2.131(c)(1): Lack of public barriers for sheep in dairy barn.

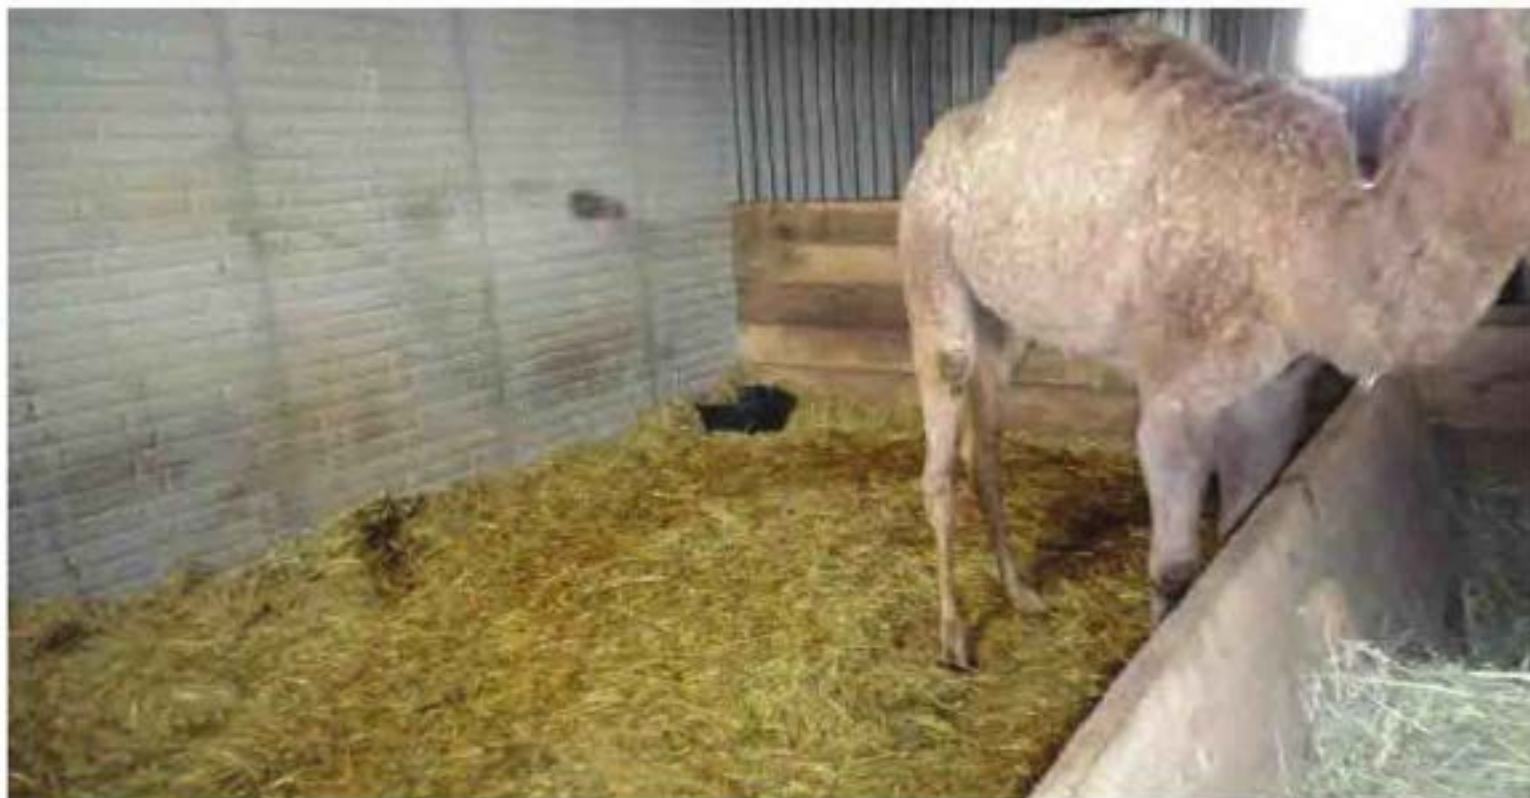
000246

Photographer:	Dana Miller, SACS	Legal Name:	55-B-0069
Photo Taken:	Mon, Apr 20, '15 1230 pm	HENRY HAMPTON	
Inspection:	194151734120886		
Description:	3.131(a): Stall for camel in Daughy barn excessively wet and dirty.

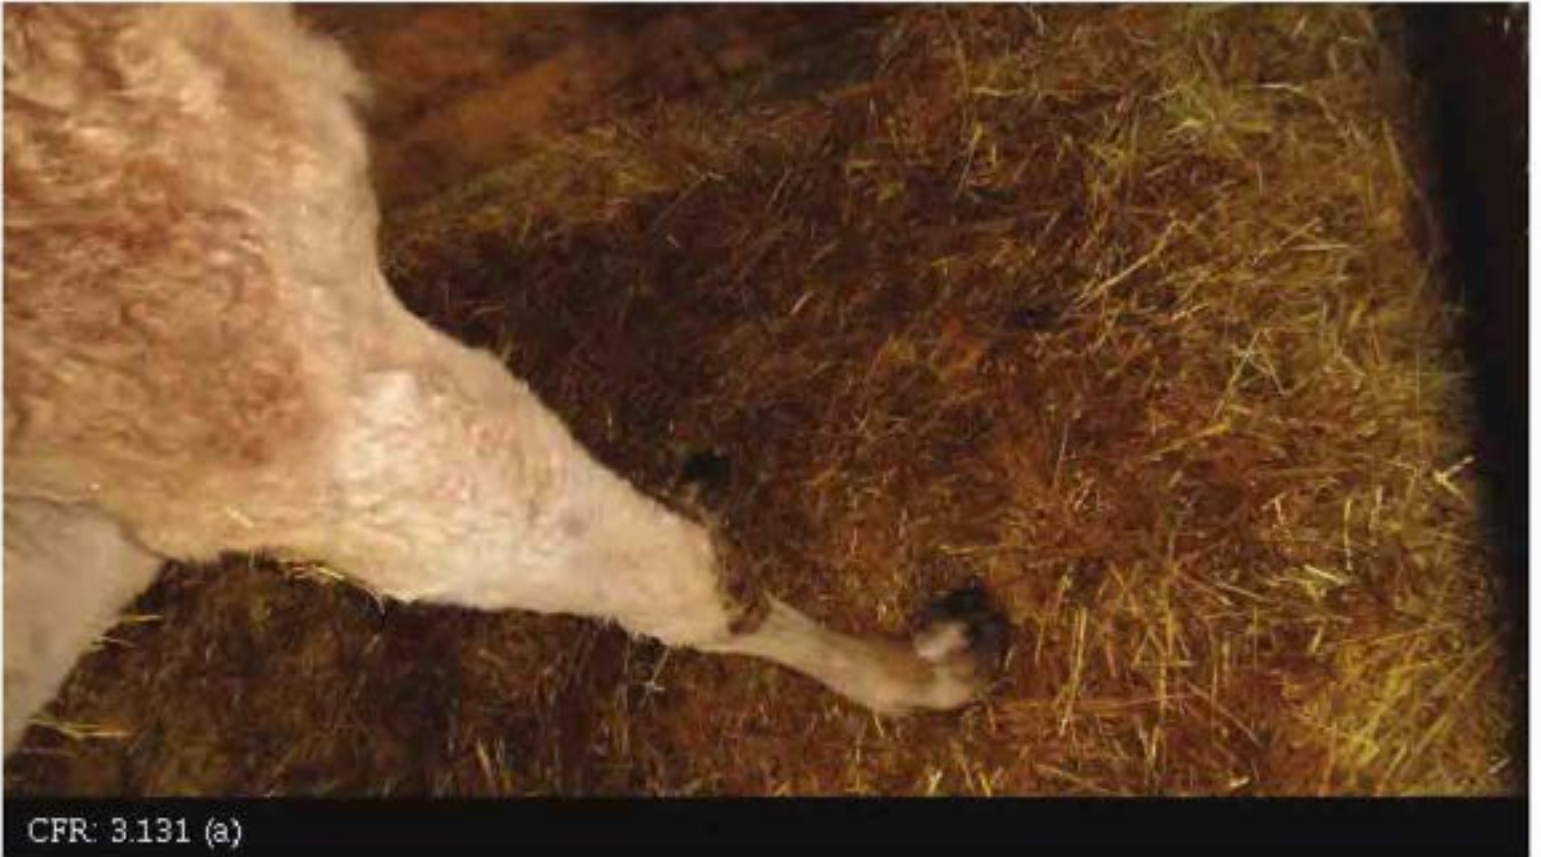
000247

Photographer:	Dana Miller, SACS	Legal Name:	55-B-0069
Photo Taken:	Mon, Apr 20, '15 1230 pm	HENRY HAMPTON	
Inspection:	194151734120886		
Description:	3.131(a): Stall for camel in Daughy barn excessively wet and dirty.

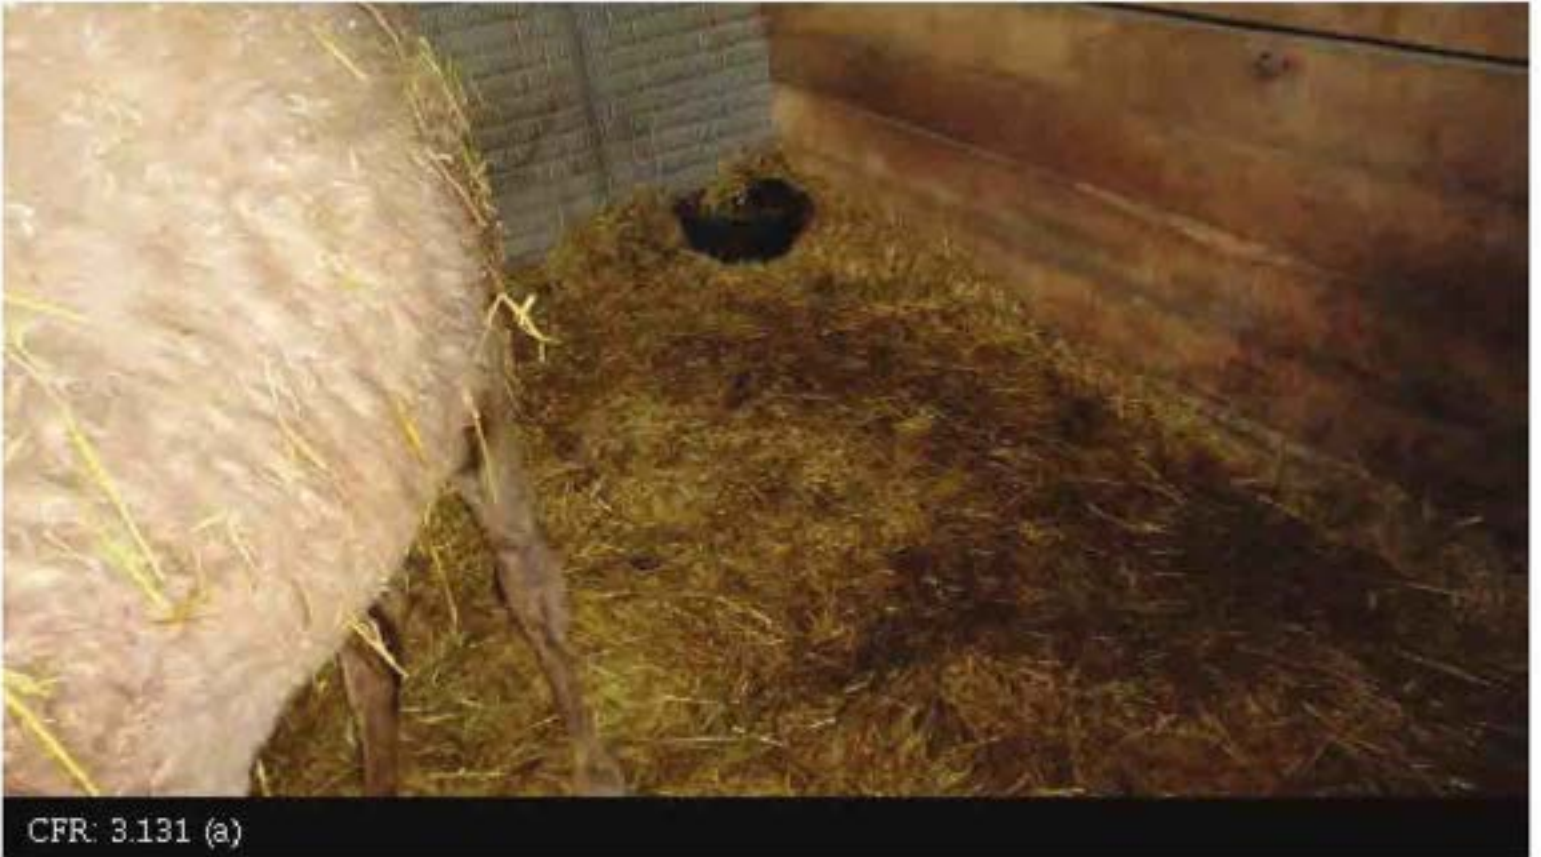
000248

Photographer:	Dana Miller, SACS	Legal Name:	55-B-0069
Photo Taken:	Mon, Apr 20, '15 1230 pm	HENRY HAMPTON	
Inspection:	194151734120886		
Description:	3.131(a): Stall for camel in Daughy barn excessively wet and dirty.

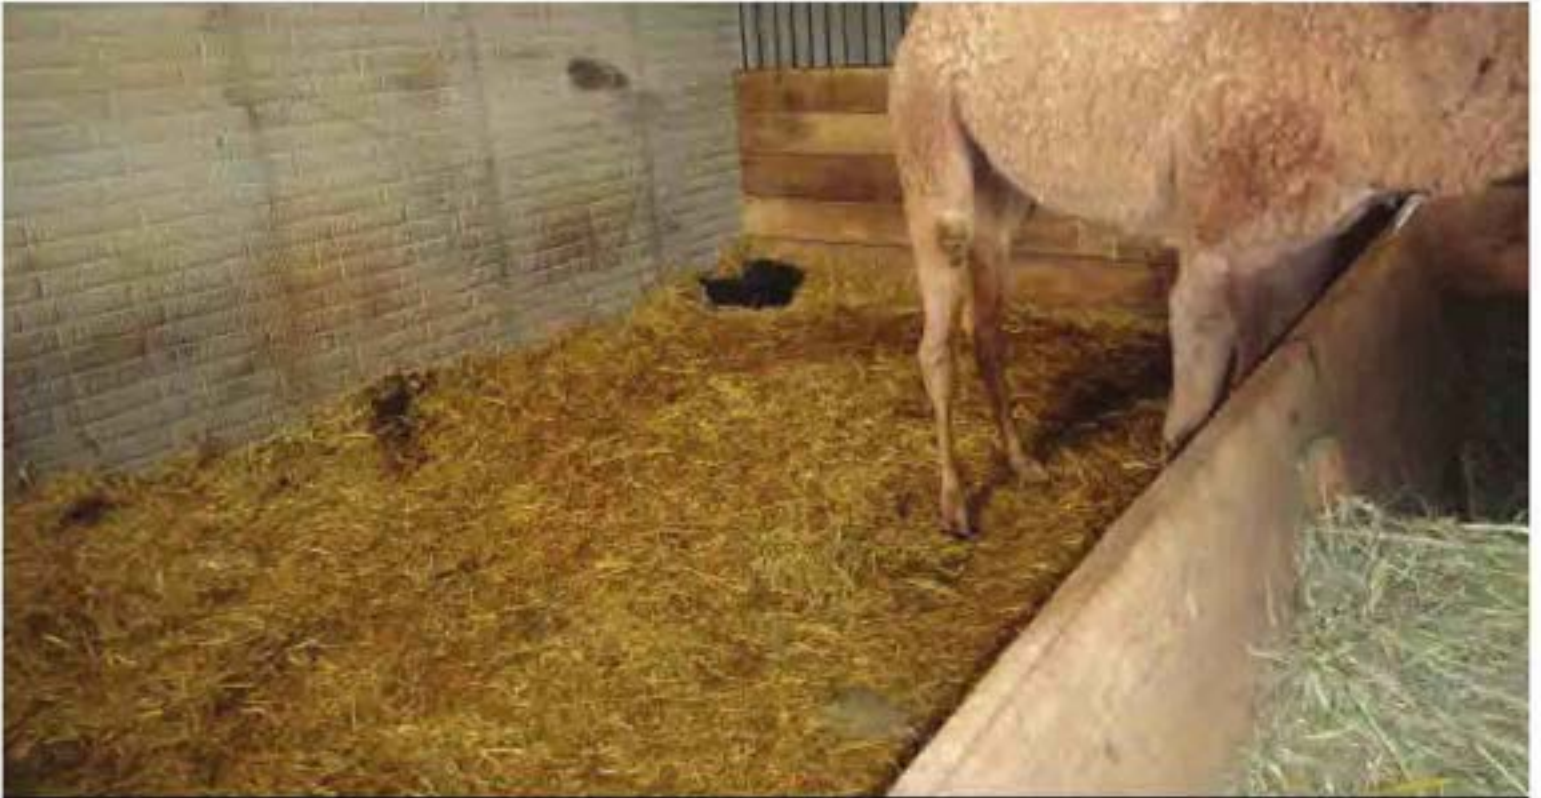
000249

Photographer:	Dana Miller, SACS	Legal Name:	55-B-0069
Photo Taken:	Mon, Apr 20, '15 1230 pm	HENRY HAMPTON	
Inspection:	194151734120886		
Description:	3.131(a): Stall for camel in Daughy barn excessively wet and dirty.

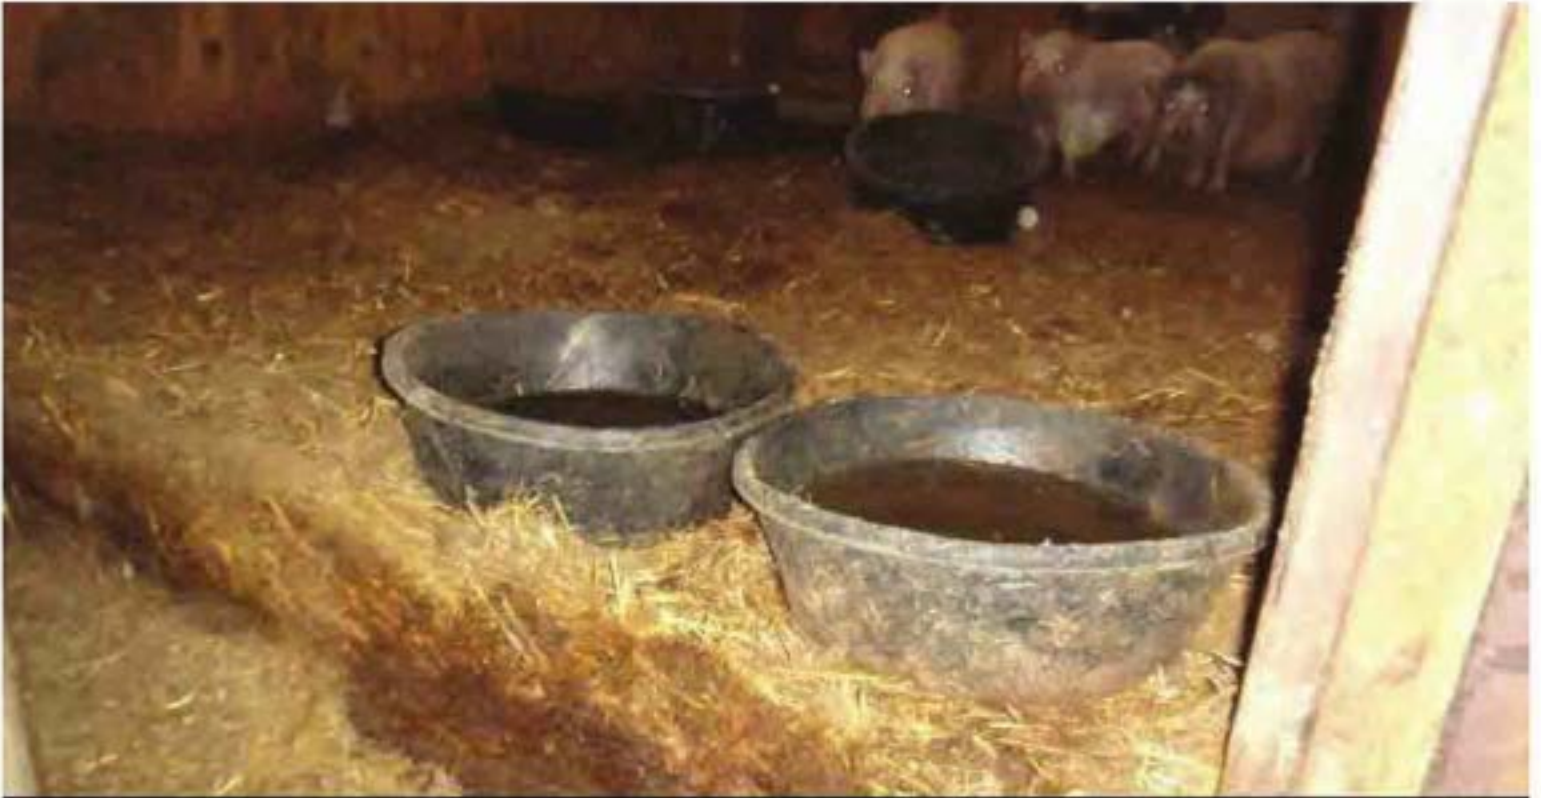
000250

Photographer:	Dana Miller, SACS	Legal Name:	55-B-0069
Photo Taken:	Mon, Apr 20, '15 2:13 pm	HENRY HAMPTON	
Inspection:	194151734120886		
Description:	3.131(a): Stall for pigs in giraffe barn excessively dirty.

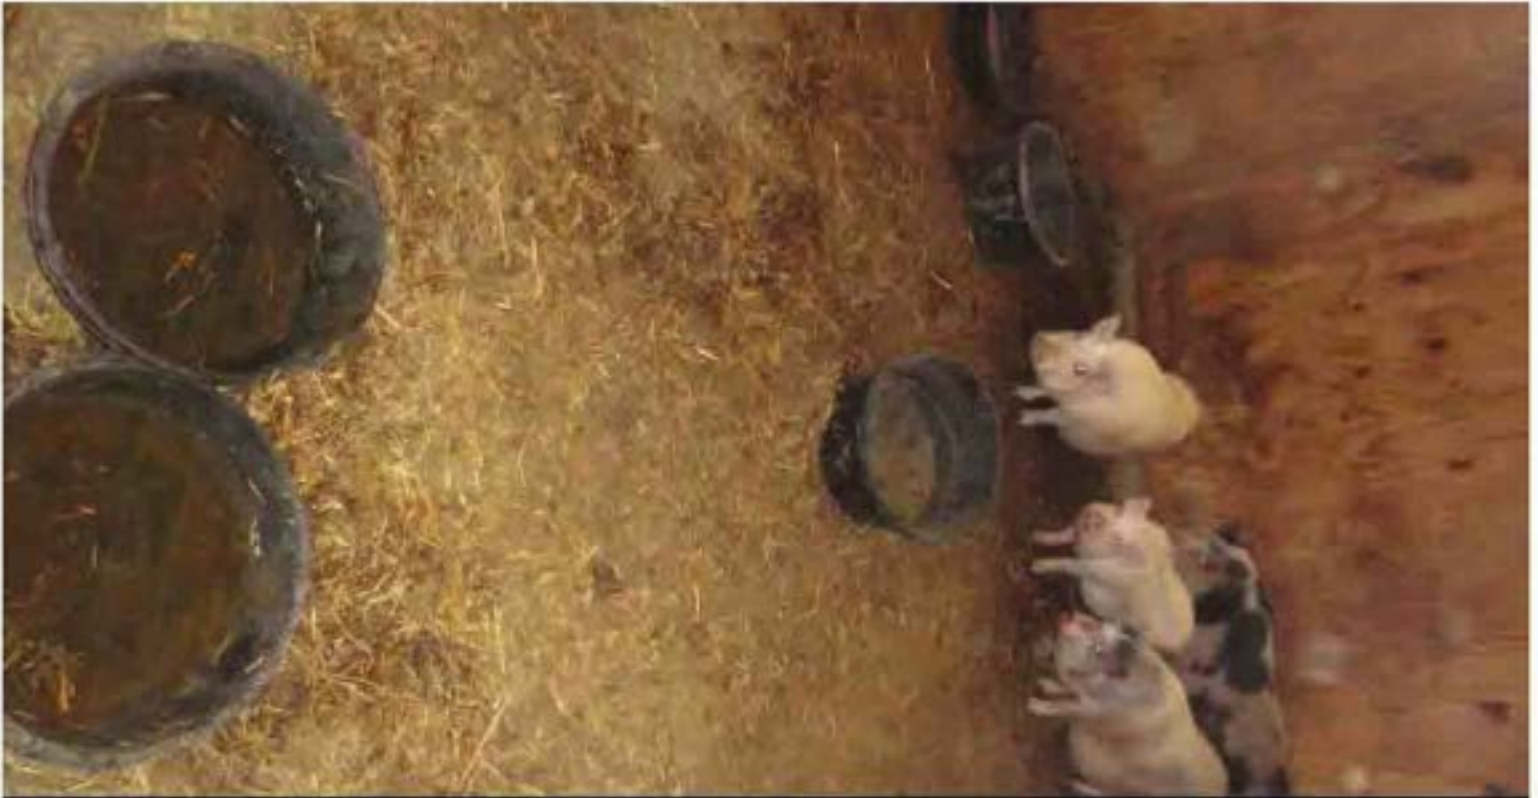
000251

Photographer:	Dana Miller, SACS	Legal Name:	55-B-0069
Photo Taken:	Mon, Apr 20, '15 2:13 pm	HENRY HAMPTON	
Inspection:	194151734120886		
Description:	3.131(a): Stall for pigs in giraffe barn excessively dirty.

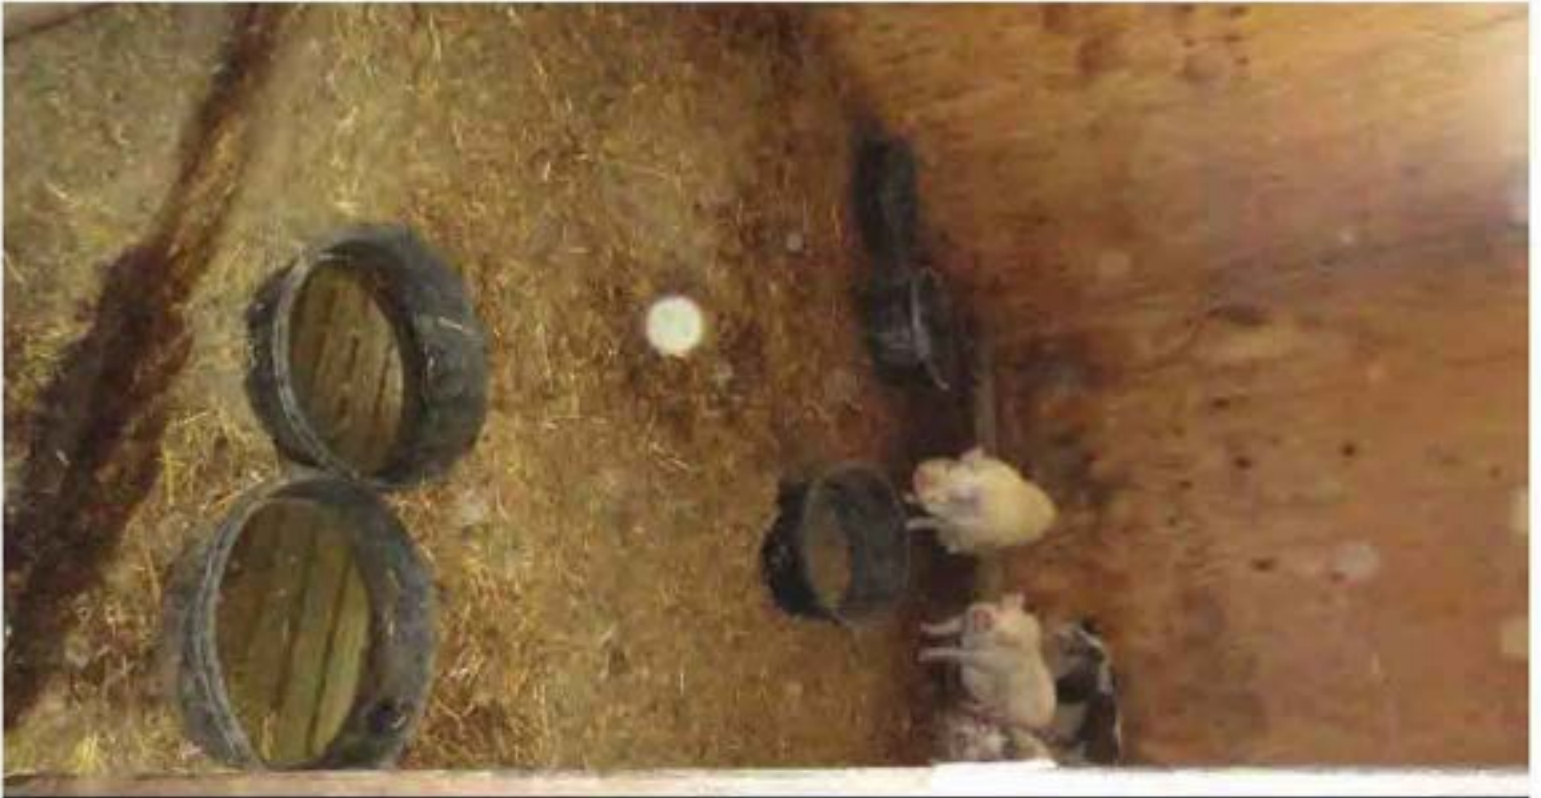
000252

Photographer:	Dana Miller, SACS	Legal Name:	55-B-0069
Photo Taken:	Mon, Apr 20, '15 2:13 pm	HENRY HAMPTON	
Inspection:	194151734120886		
Description:	3.131(a): Stall for pigs in giraffe barn excessively dirty.

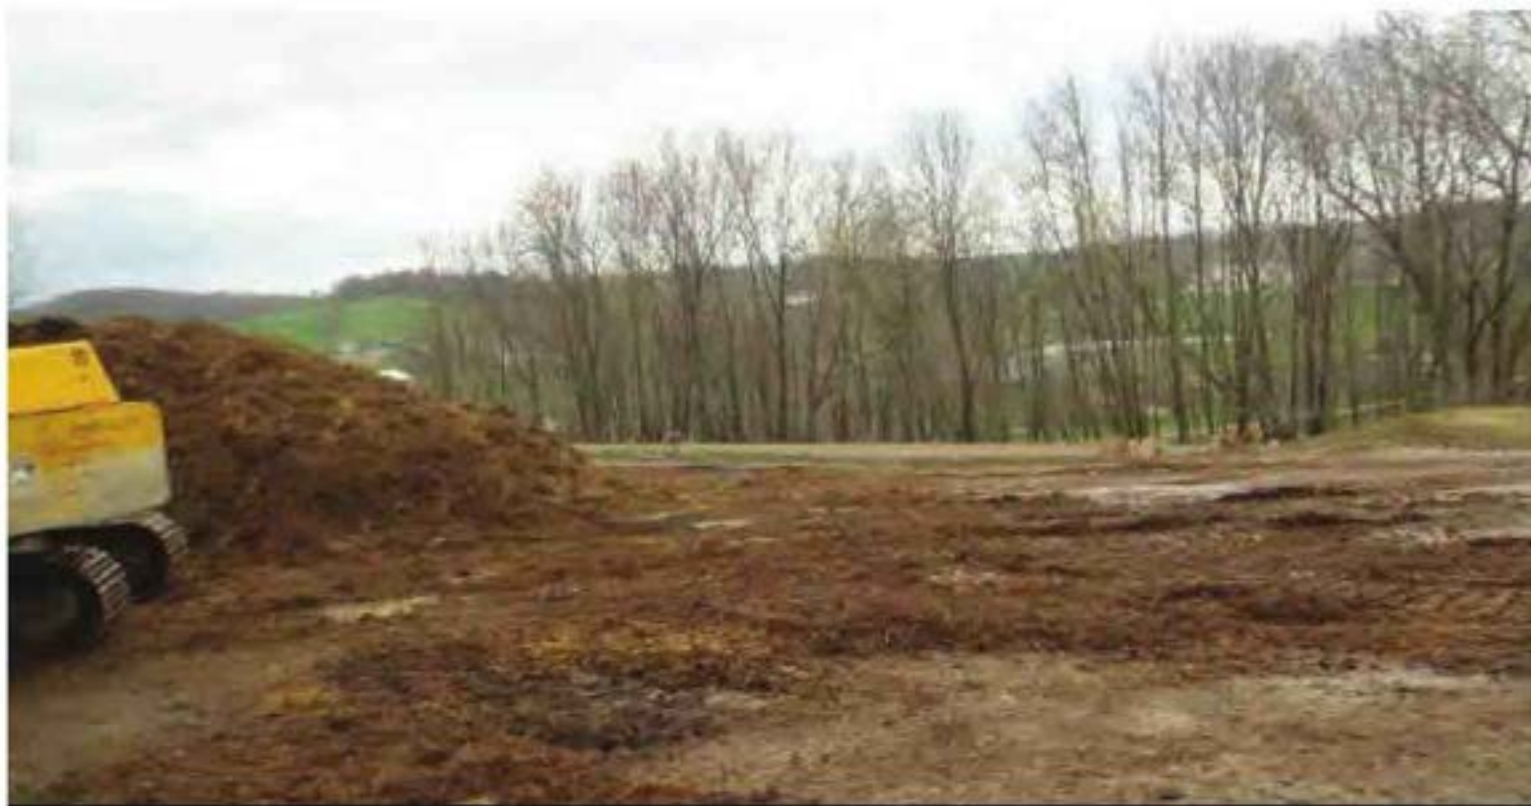
000253

Photographer:	Dana Miller, SACS	Legal Name:	55-B-0069
Photo Taken:	Mon, Apr 20, '15 140 pm	HENRY HAMPTON	
Inspection:	194151734120886		
Description:	Section 3.125(d): Waste pile in dirve thru area.

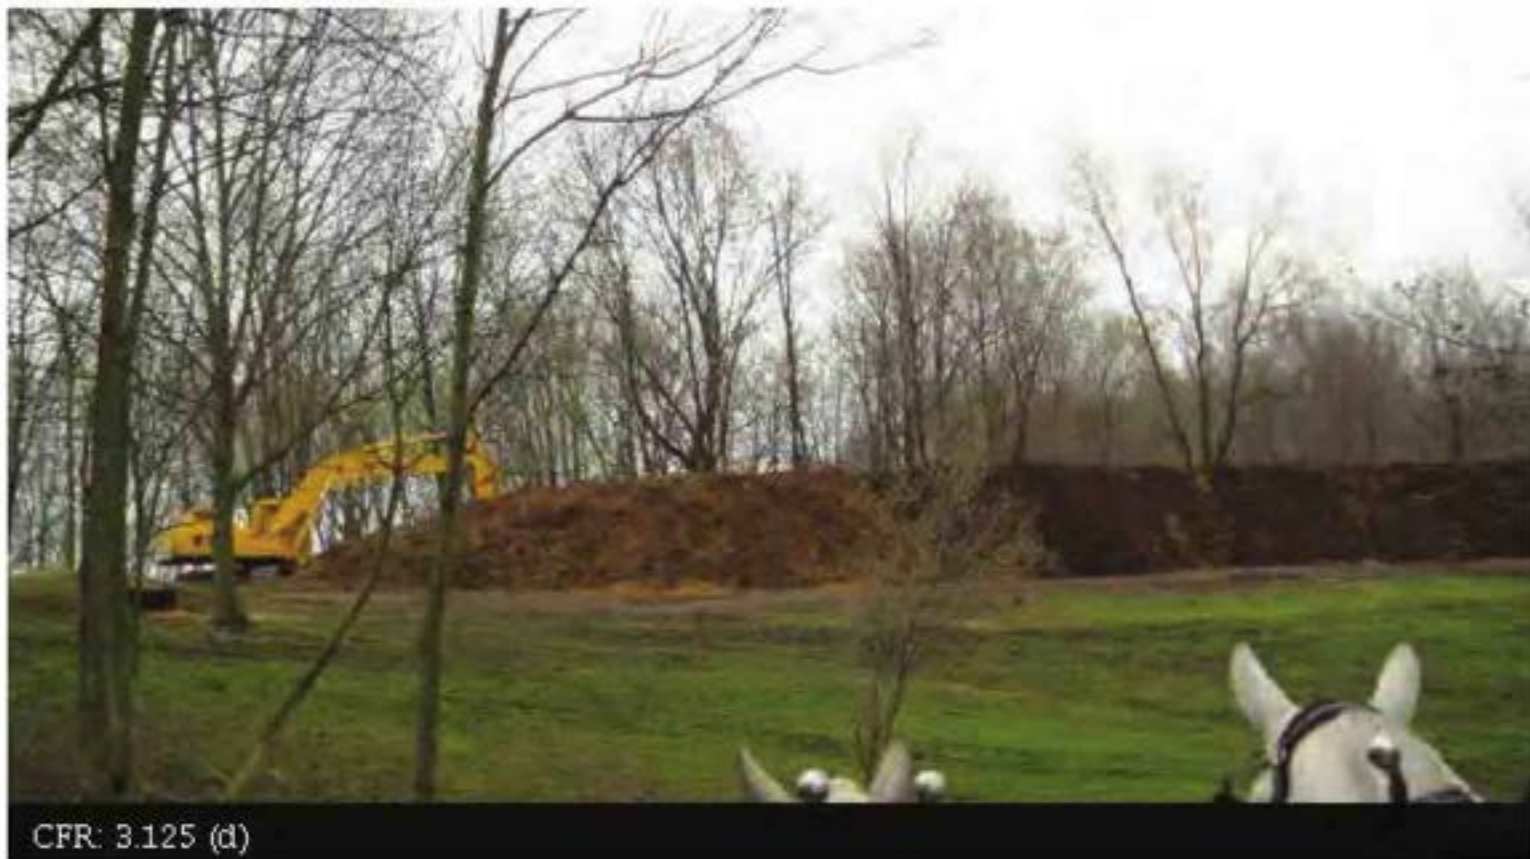
000254

Photographer:	Dana Miller, SACS	Legal Name:	55-B-0069
Photo Taken:	Mon, Apr 20, '15 140 pm	HENRY HAMPTON	
Inspection:	194151734120886		
Description:	Section 3.125(d): Waste pile in dirve thru area.

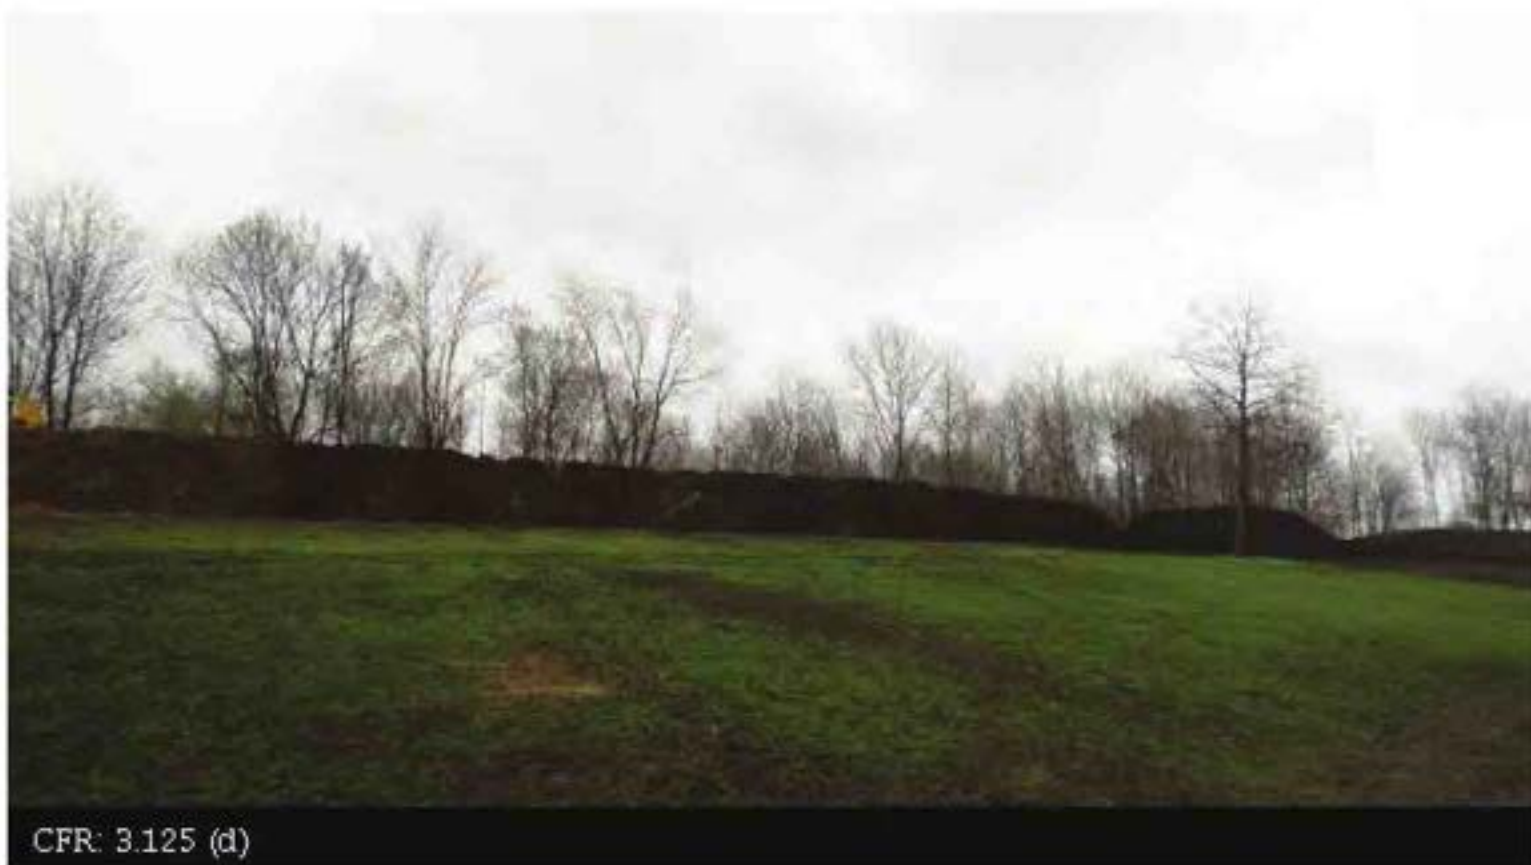
Photographer:	Dana Miller, SACS	Legal Name:	55-B-0069
Photo Taken:	Mon, Apr 20, '15 140 pm	HENRY HAMPTON	
Inspection:	194151734120886		
Description:	Section 3.125(d): Waste pile in dirve thru area.

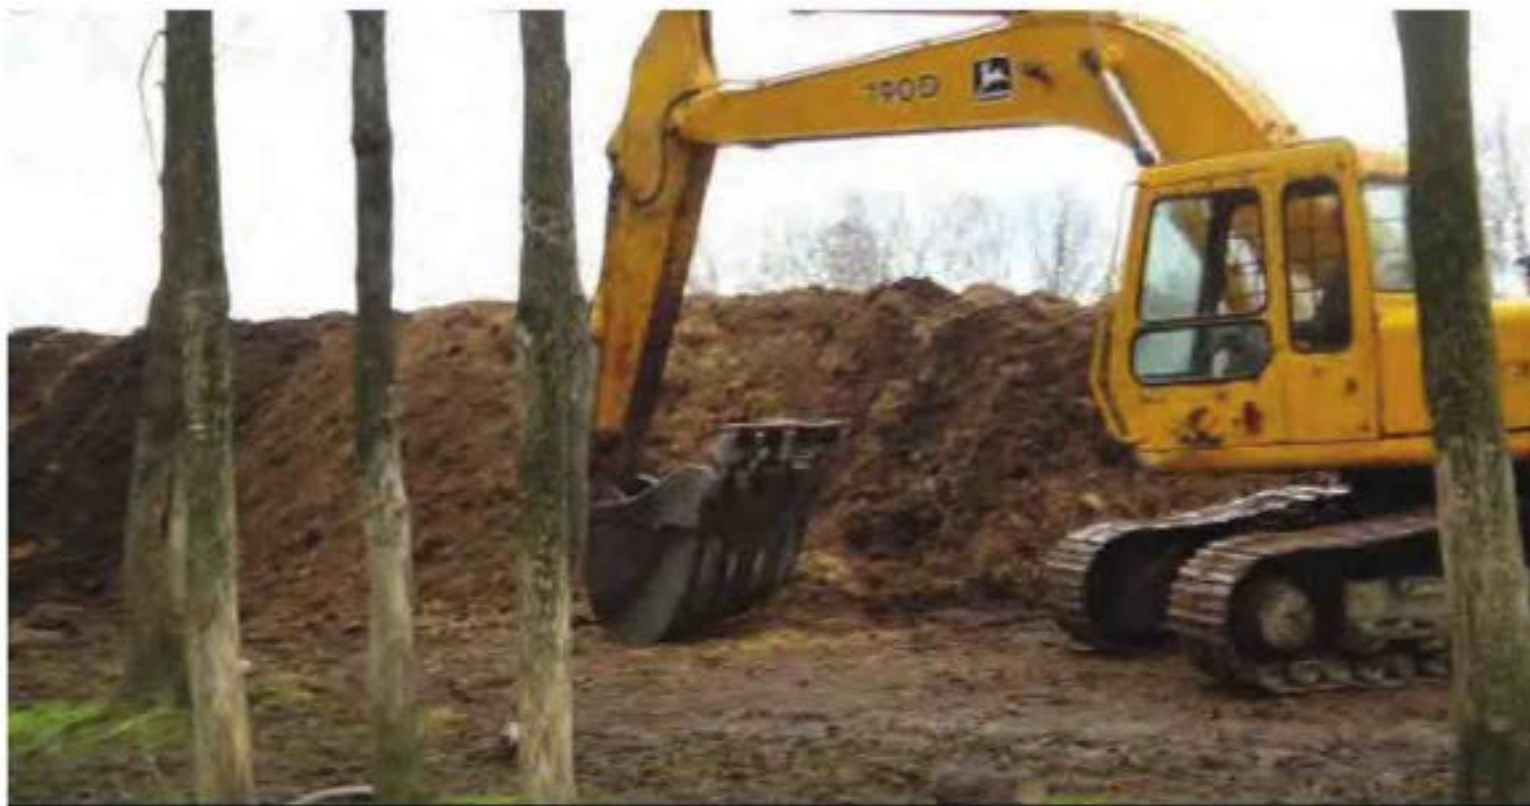
000256

Photographer:	Dana Miller, SACS	Legal Name:	55-B-0069
Photo Taken:	Mon, Apr 20, '15 140 pm	HENRY HAMPTON	
Inspection:	194151734120886		
Description:	Section 3.125(d): Waste pile in dirve thru area.

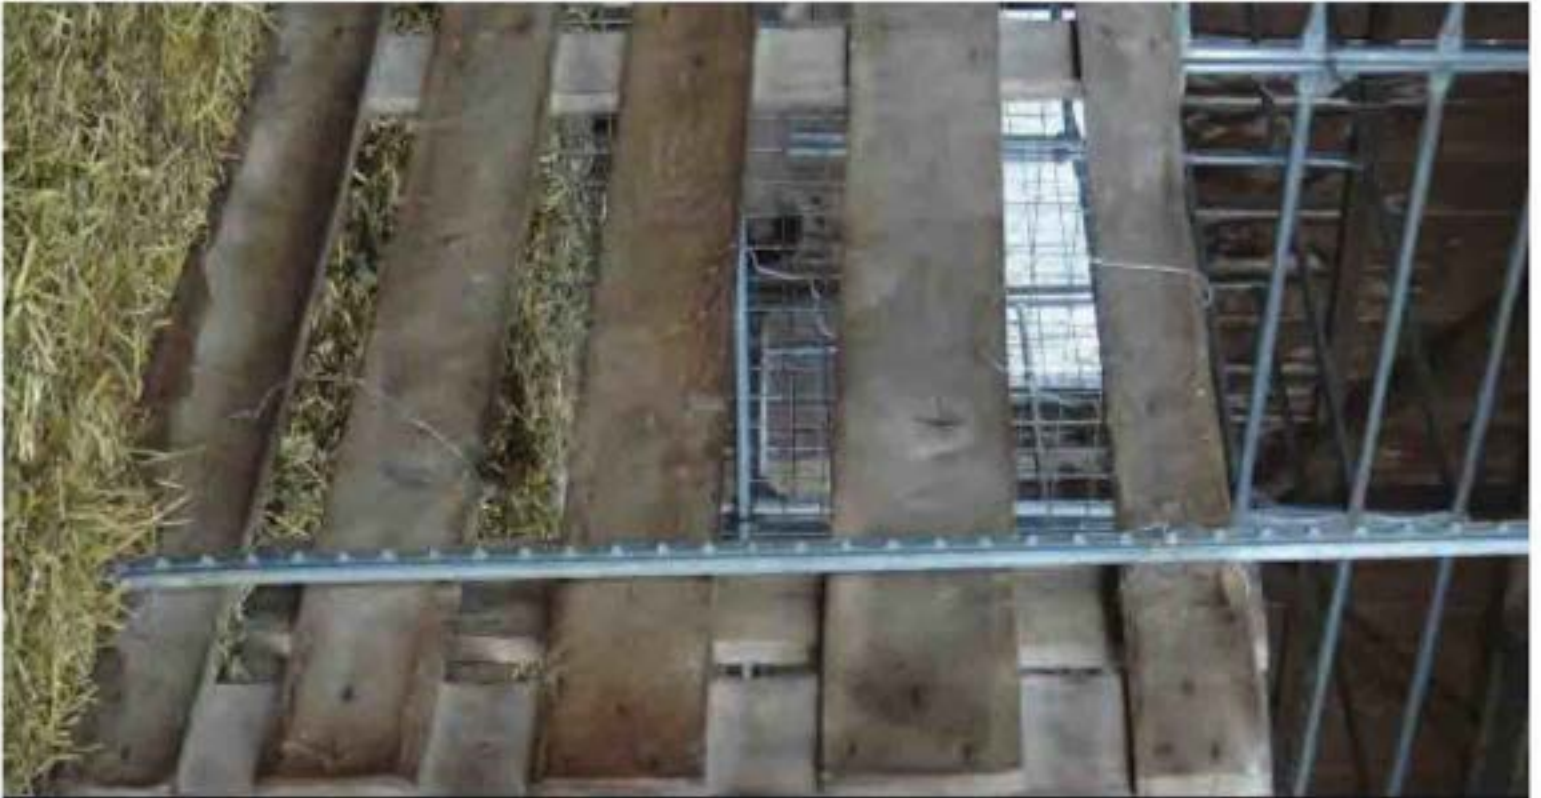
000257

Photographer:	Dana Miller, SACS	Legal Name:	55-B-0069
Photo Taken:	Mon, Apr 20, '15 1218 pm	HENRY HAMPTON	
Inspection:	194151734120886		
Description:	Section 3.125(a): Loose wires in enclosure with sheep.

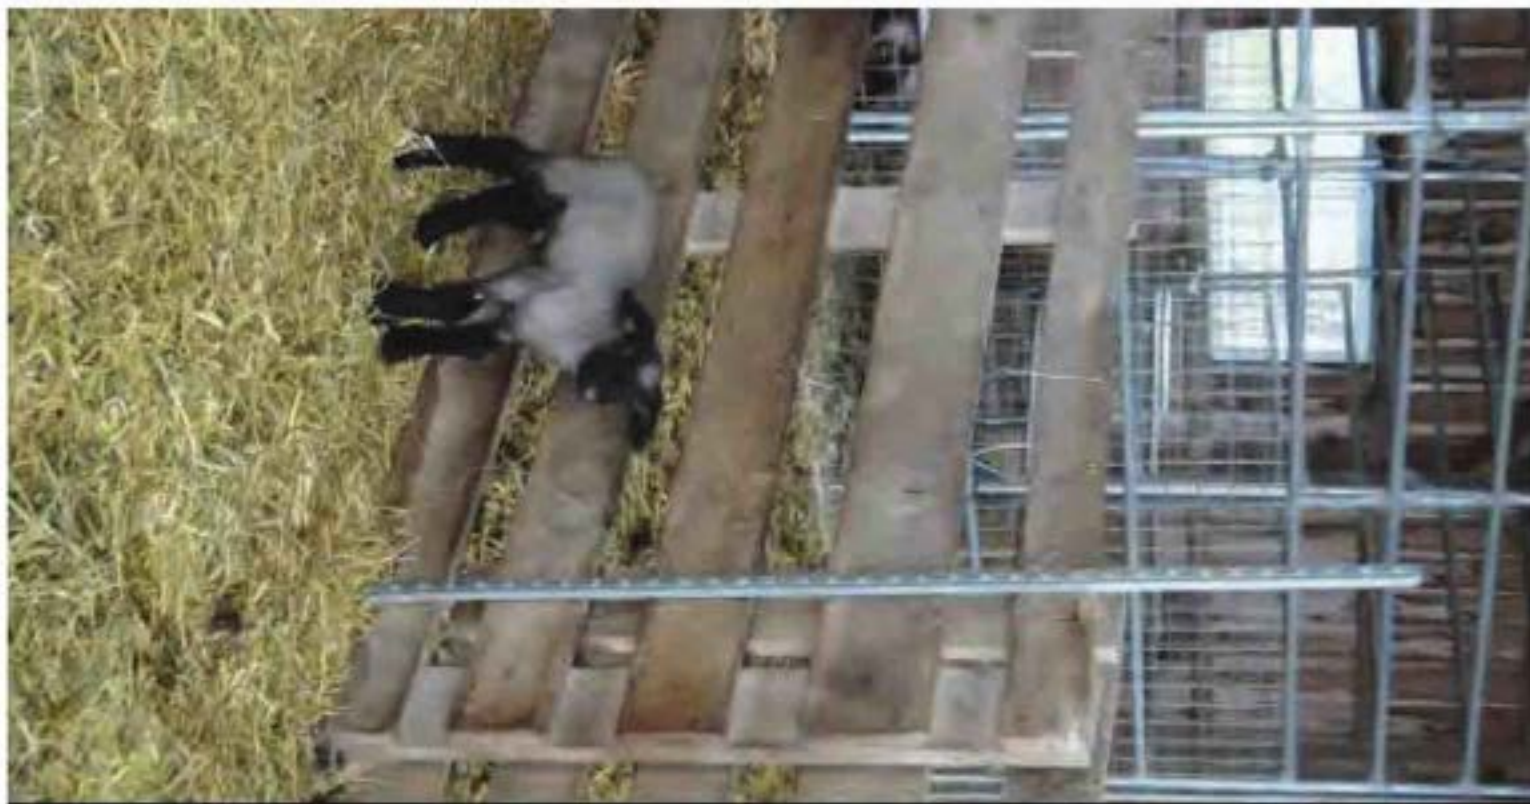
000258

Photographer:	Dana Miller, SACS	Legal Name:	55-B-0069
Photo Taken:	Mon, Apr 20, '15 1218 pm	HENRY HAMPTON	
Inspection:	194151734120886		
Description:	Section 3.125(a): Loose wires in enclosure with sheep.

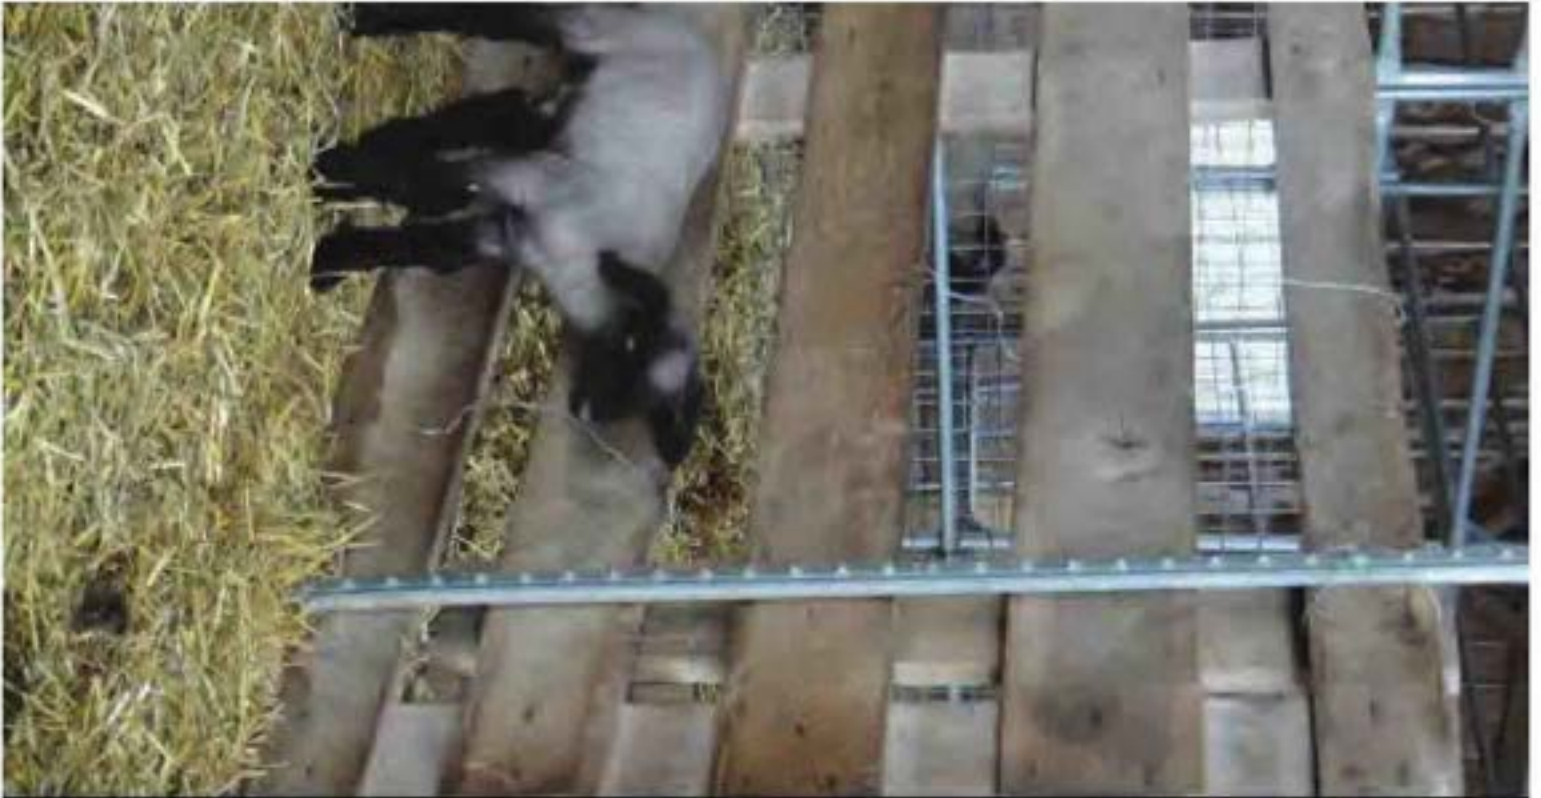
000259

Photographer:	Dana Miller, SACS	Legal Name:	55-B-0069
Photo Taken:	Mon, Apr 20, '15 1218 pm	HENRY HAMPTON	
Inspection:	194151734120886		
Description:	Section 3.125(a): Loose wires in enclosure with sheep.

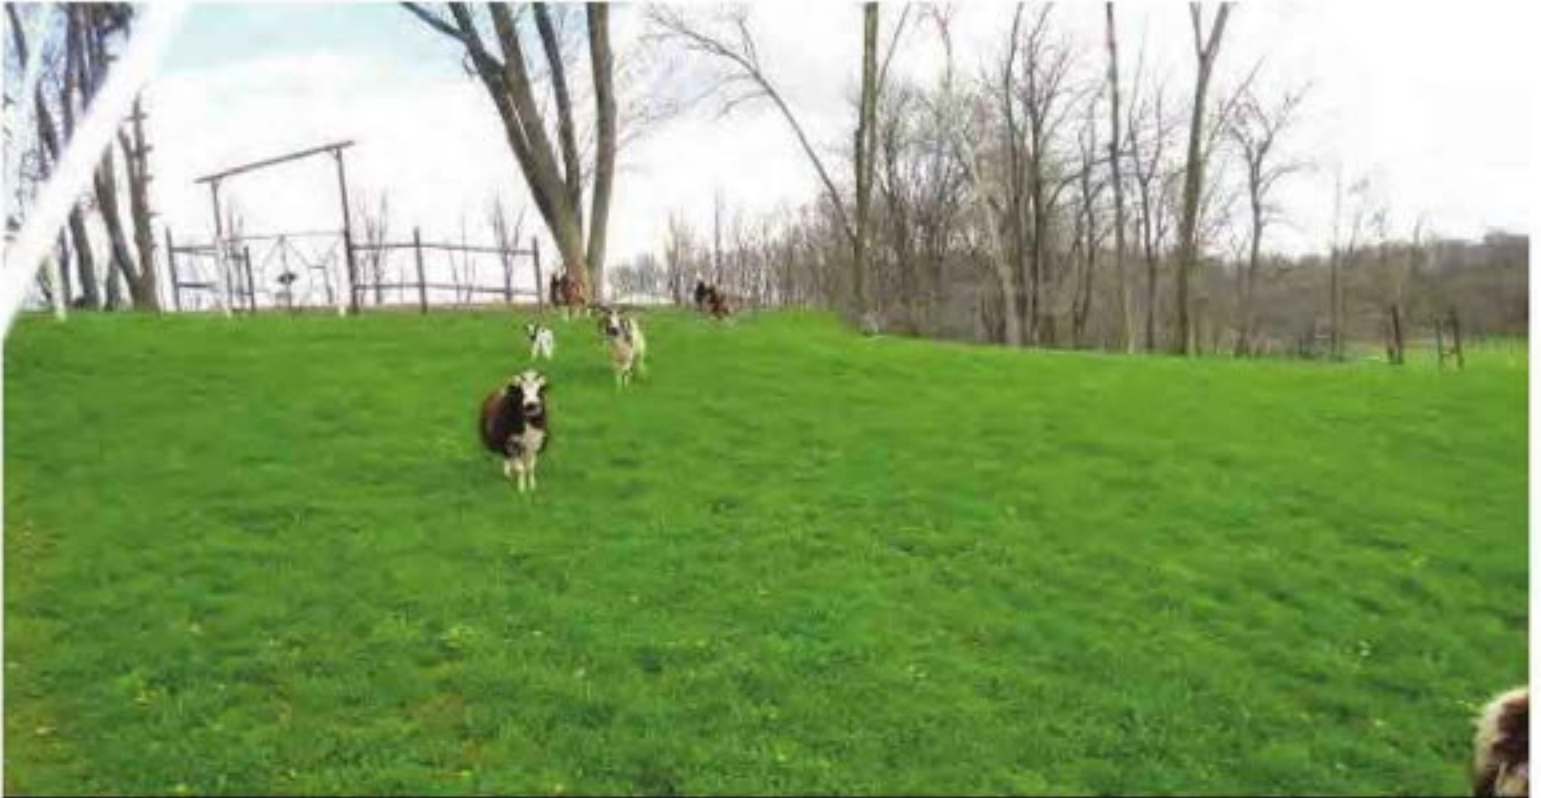
Photographer:	Dana Miller, SACS	Legal Name:	55-B-0069
Photo Taken:	Mon, Apr 20, '15 1150 am	HENRY HAMPTON	
Inspection:	194151734120886		
Description:	Section 3.125(a): Section of fence with space on bottom large enough for potential escape of lamb.

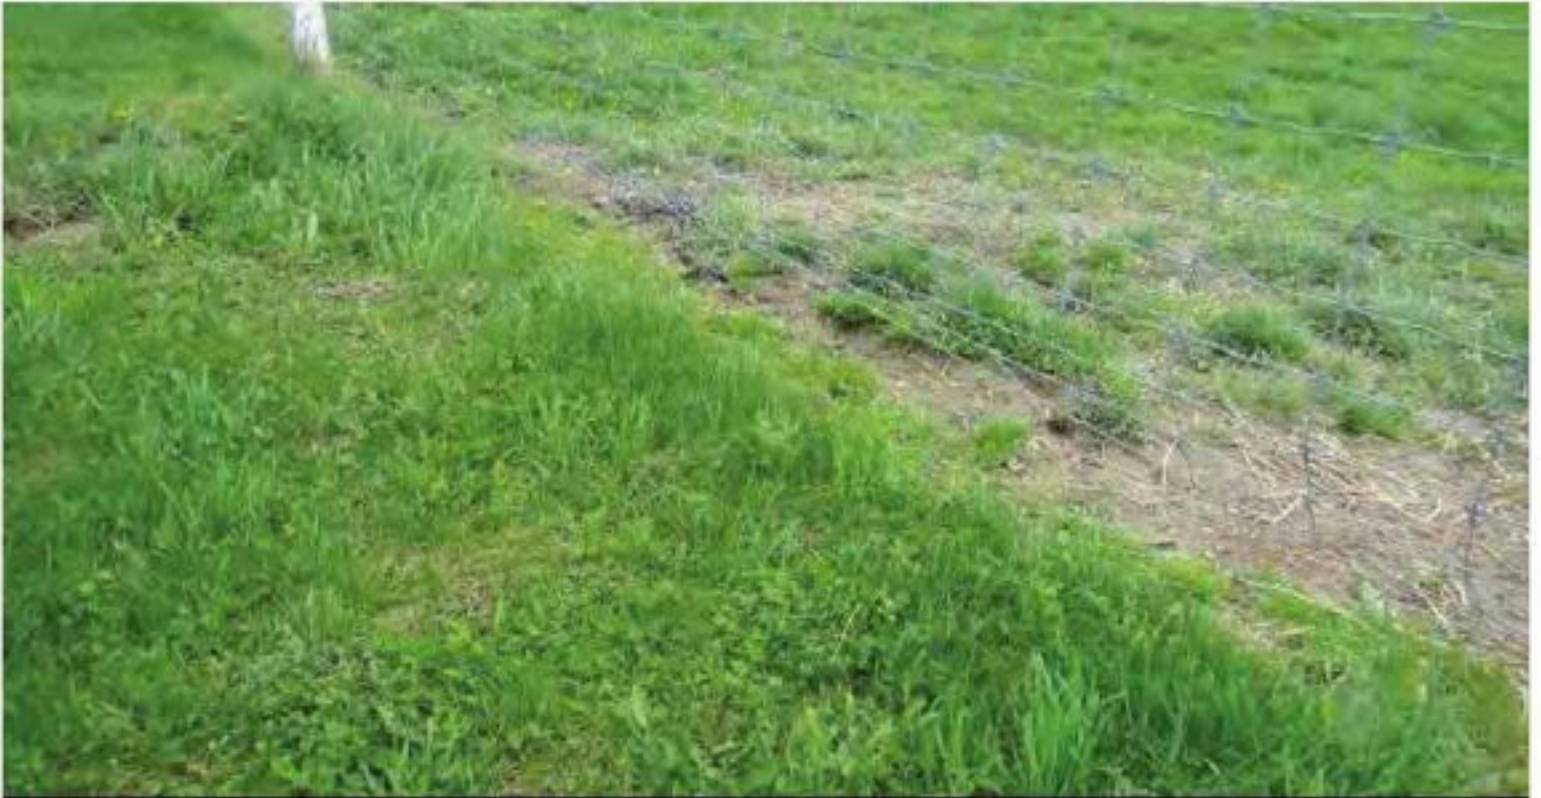
CFR: 3.125 (a)

Photographer:	Dana Miller, SACS	Legal Name:	55-B-0069
Photo Taken:	Mon, Apr 20, '15 1150 am	HENRY HAMPTON	
Inspection:	194151734120886		
Description:	Section 3.125(a): Section of fence with space on bottom large enough for potential escape of lamb.
