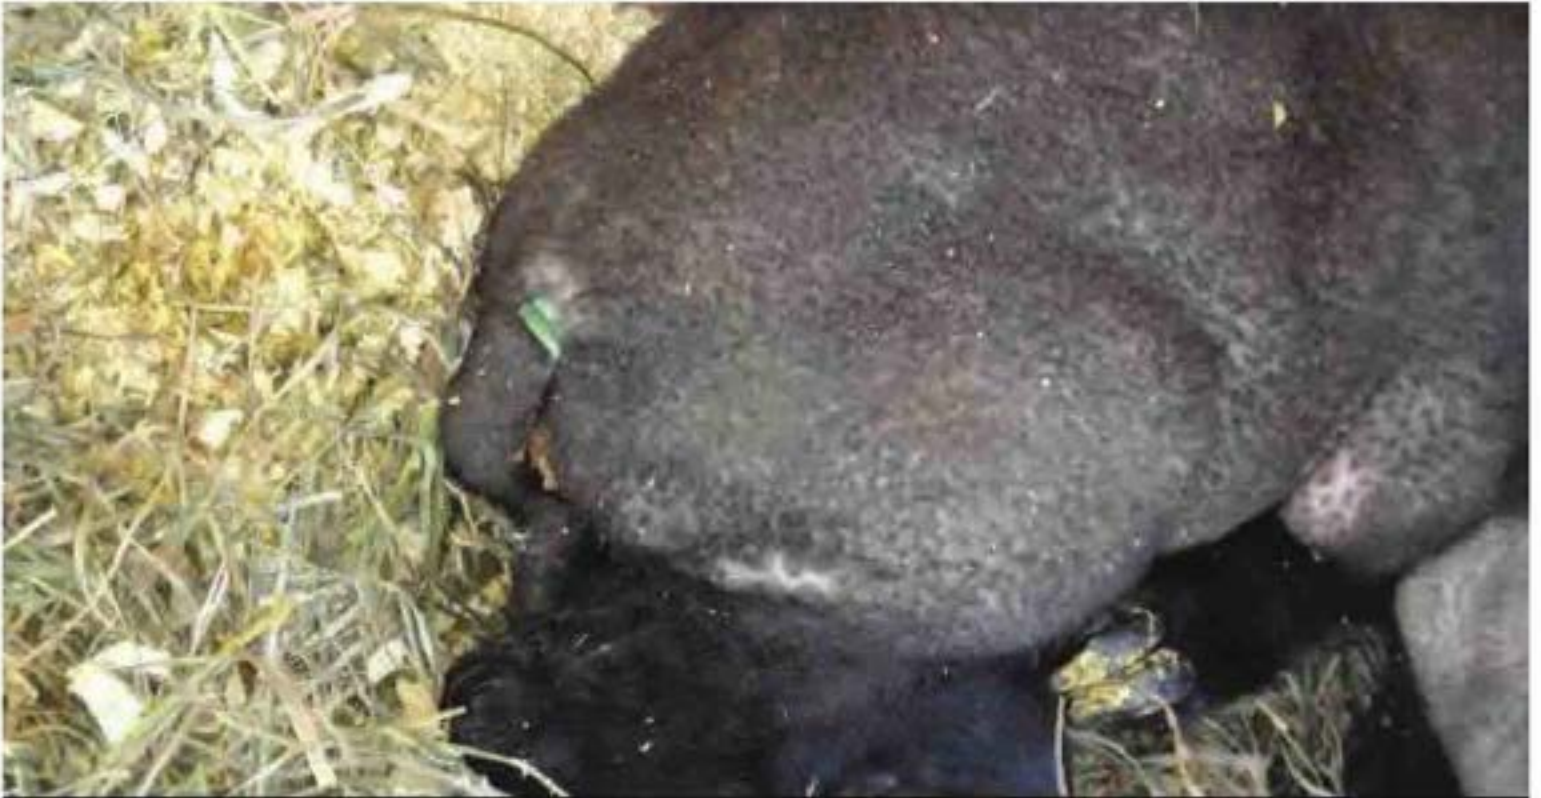
CFR: 2.40 (a) (1)

Photographer:	Dana Miller, SACS	Legal Name:	55-B-0069
Photo Taken:	Mon, Apr 20, '15 115 pm	HENRY HAMPTON	
Inspection:	194151734120886		
Description:	Section 2.40(a)(1): Lambs found with tail bands in place. No guidance for this procedure in PVC.

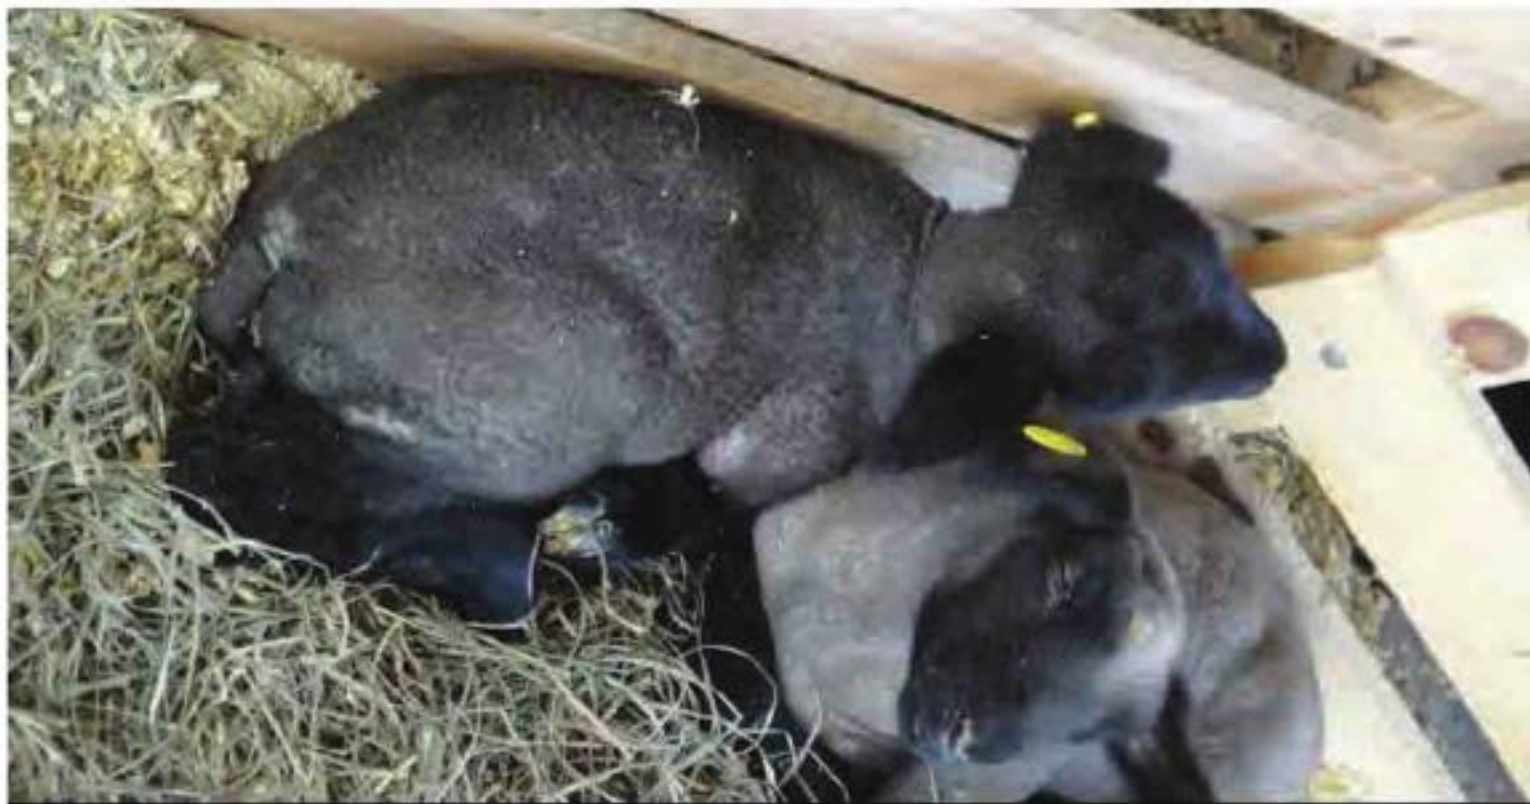
CFR: 2.40 (a) (1)

Photographer:	Dana Miller, SACS	Legal Name:	55-B-0069
Photo Taken:	Mon, Apr 20, '15 115 pm	HENRY HAMPTON	
Inspection:	194151734120886		
Description:	Section 2.40(a)(1): Lambs found with tail bands in place. No guidance for this procedure in PVC.

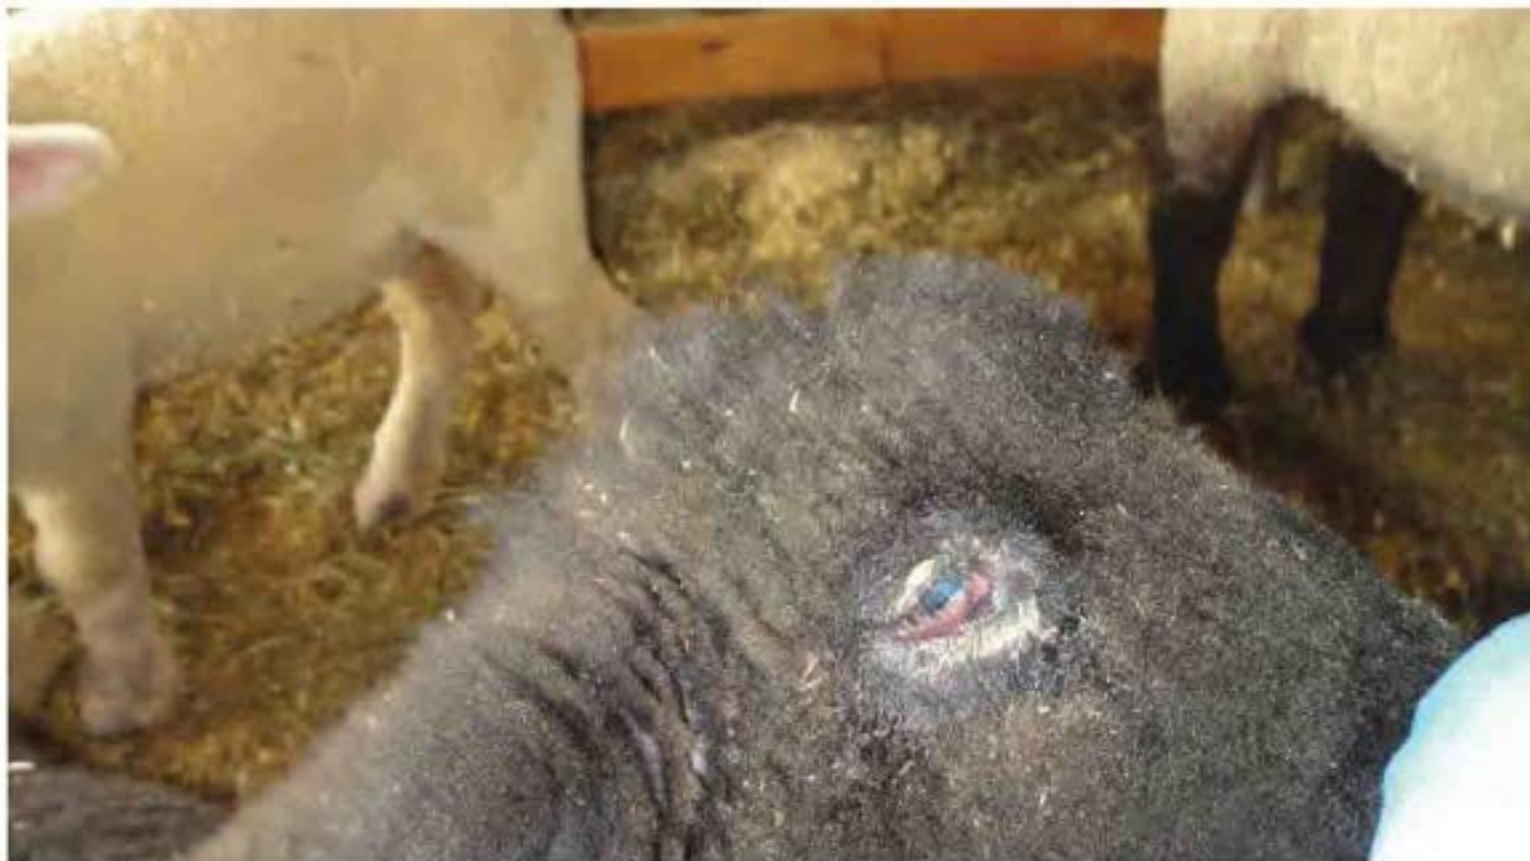
Photographer:	Dana Miller, SACS	Legal Name:	55-B-0069
Photo Taken:	Mon, Apr 20, '15 115 pm	HENRY HAMPTON	
Inspection:	194151734120886		
Description:	Section 2.40(b)(2) and Section 2.40 (b)(3): Lambs found in machine shop area with excessive crust around eyes and/or noses.

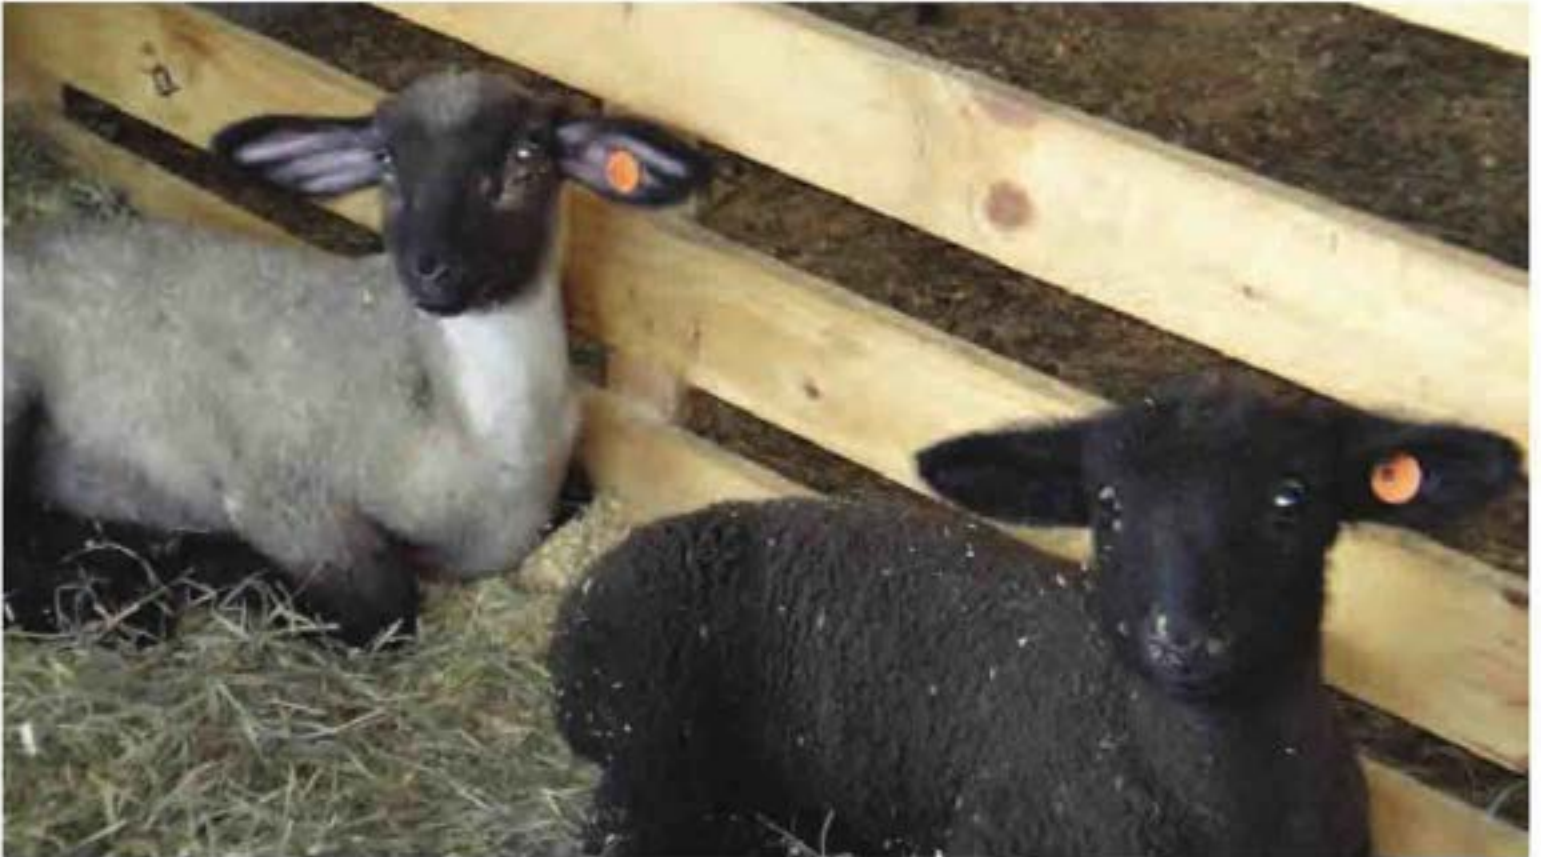
Photographer:	Dana Miller, SACS	Legal Name:	55-B-0069
Photo Taken:	Mon, Apr 20, '15 115 pm	HENRY HAMPTON	
Inspection:	194151734120886		
Description:	Section 2.40(b)(2) and Section 2.40 (b)(3): Lambs found in machine shop area with excessive crust around eyes and/or noses.

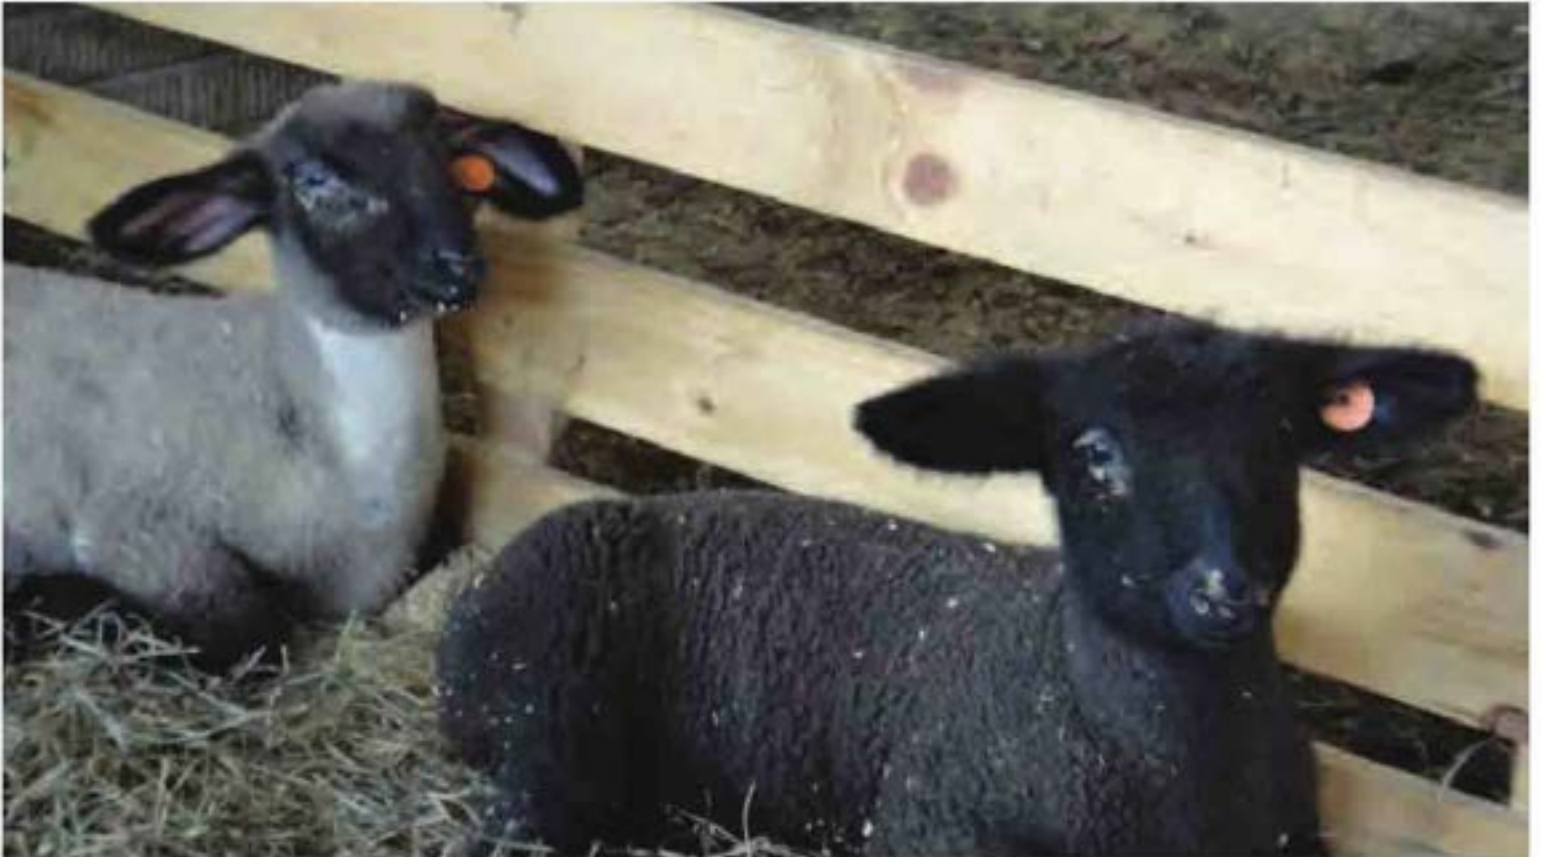
Photographer:	Dana Miller, SACS	Legal Name:	55-B-0069
Photo Taken:	Mon, Apr 20, '15 115 pm	HENRY HAMPTON	
Inspection:	194151734120886		
Description:	Section 2.40(b)(2) and Section 2.40 (b)(3): Lambs found in machine shop area with excessive crust around eyes and/or noses.

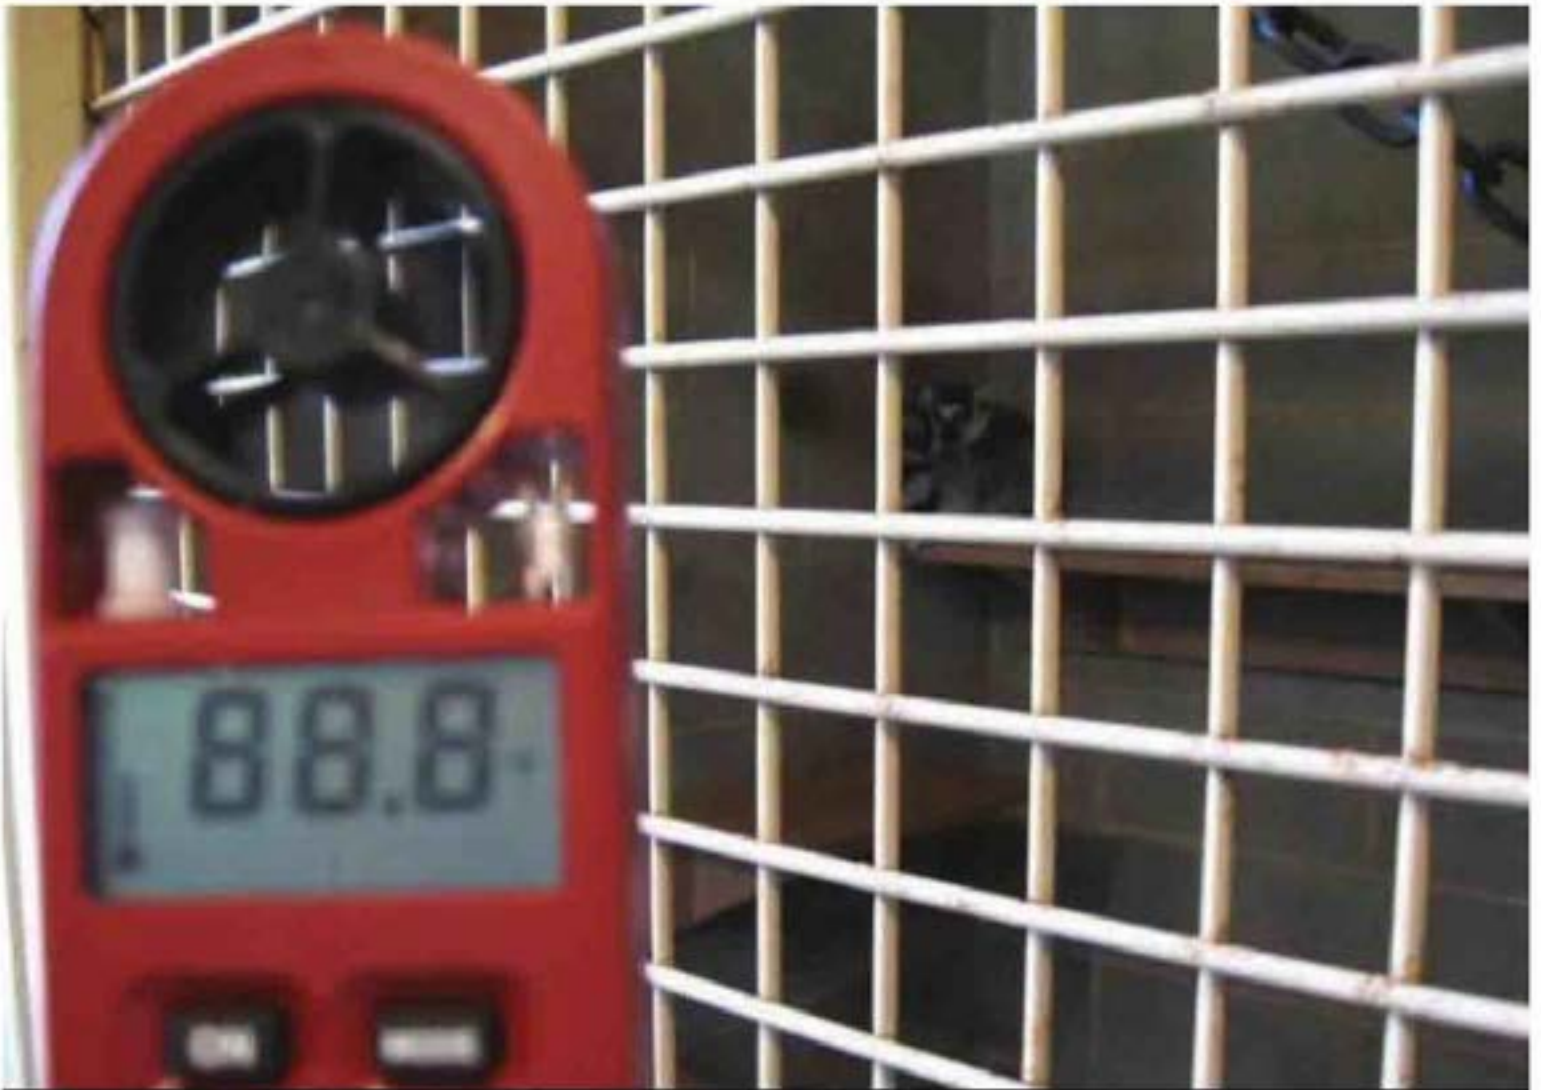
CFR: 3.76 (a)

Photographer:	S. Brunkhorst	Legal Name:	55-B-0069
Photo Taken:	Tue, Jun 16, '15 10:41	HENRY HAMPTON	
Inspection:	167151730070898		
Description:	Temperature in indoor lemur enclosure at 10:45 am

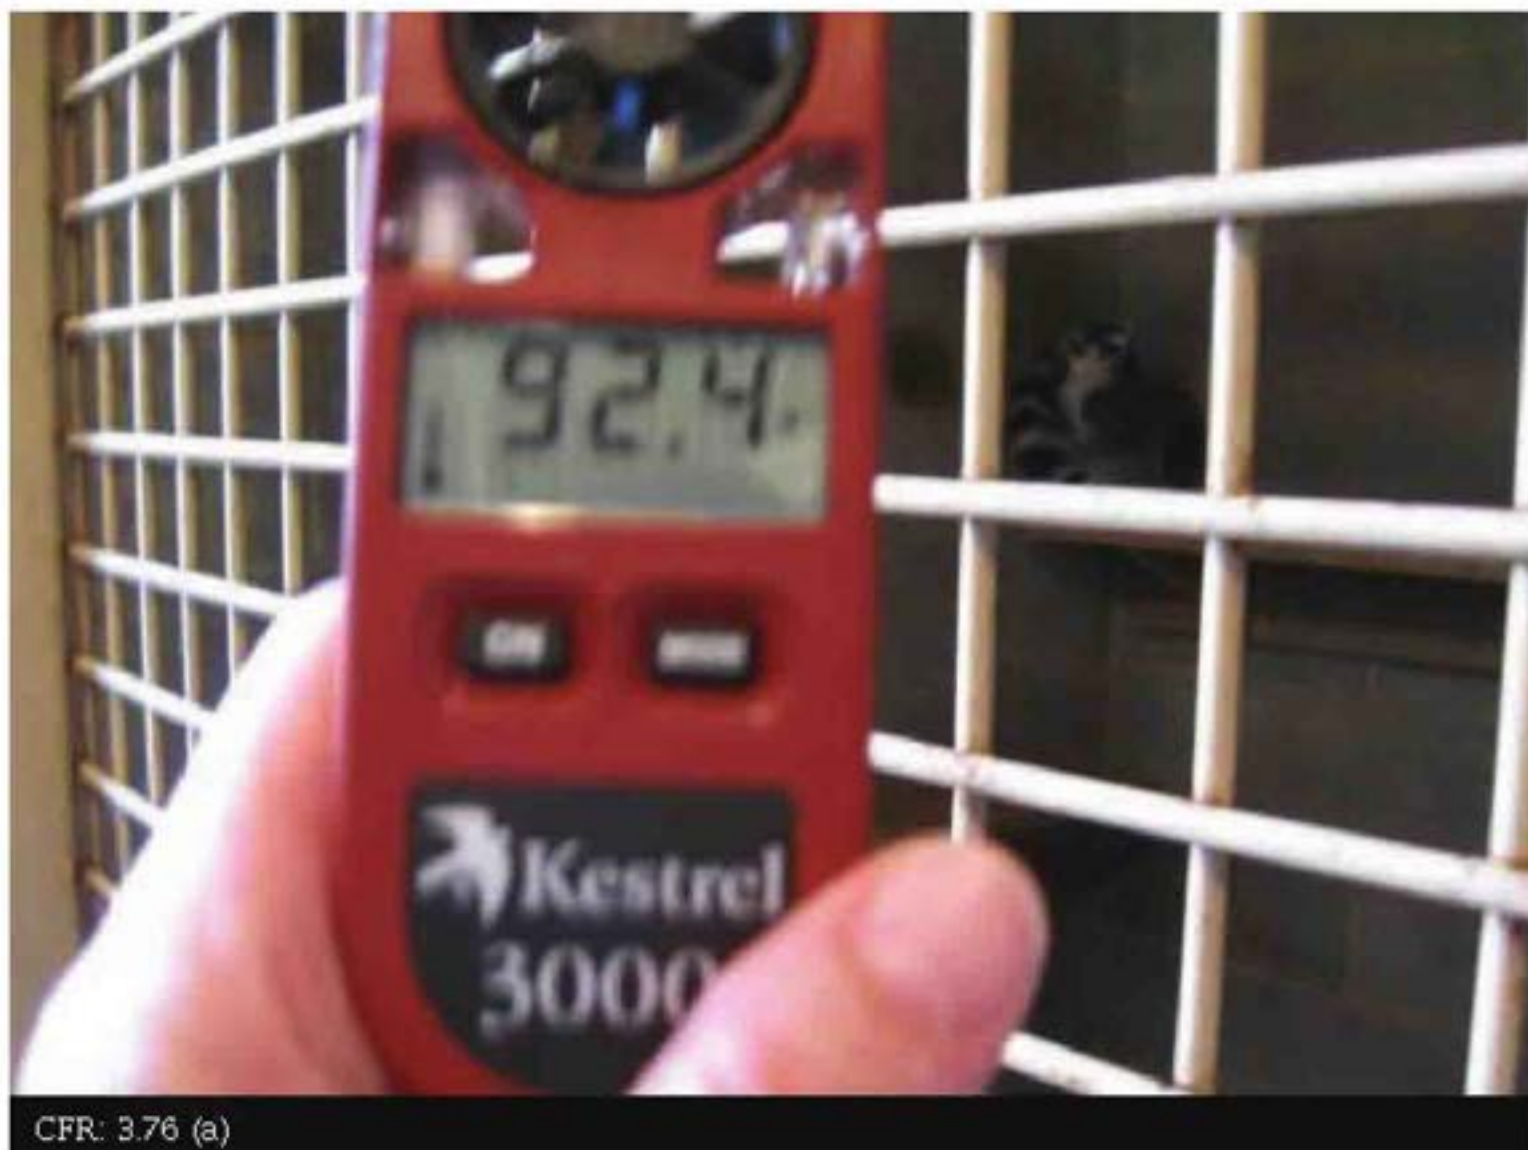
CFR: 3.76 (a)

Photographer:	S. Brunkhorst	Legal Name:	55-B-0069
Photo Taken:	Tue, Jun 16, '15 12:45	HENRY HAMPTON	
Inspection:	167151730070898		
Description:	Temperature in indoor lemur enclosure at 12:45pm

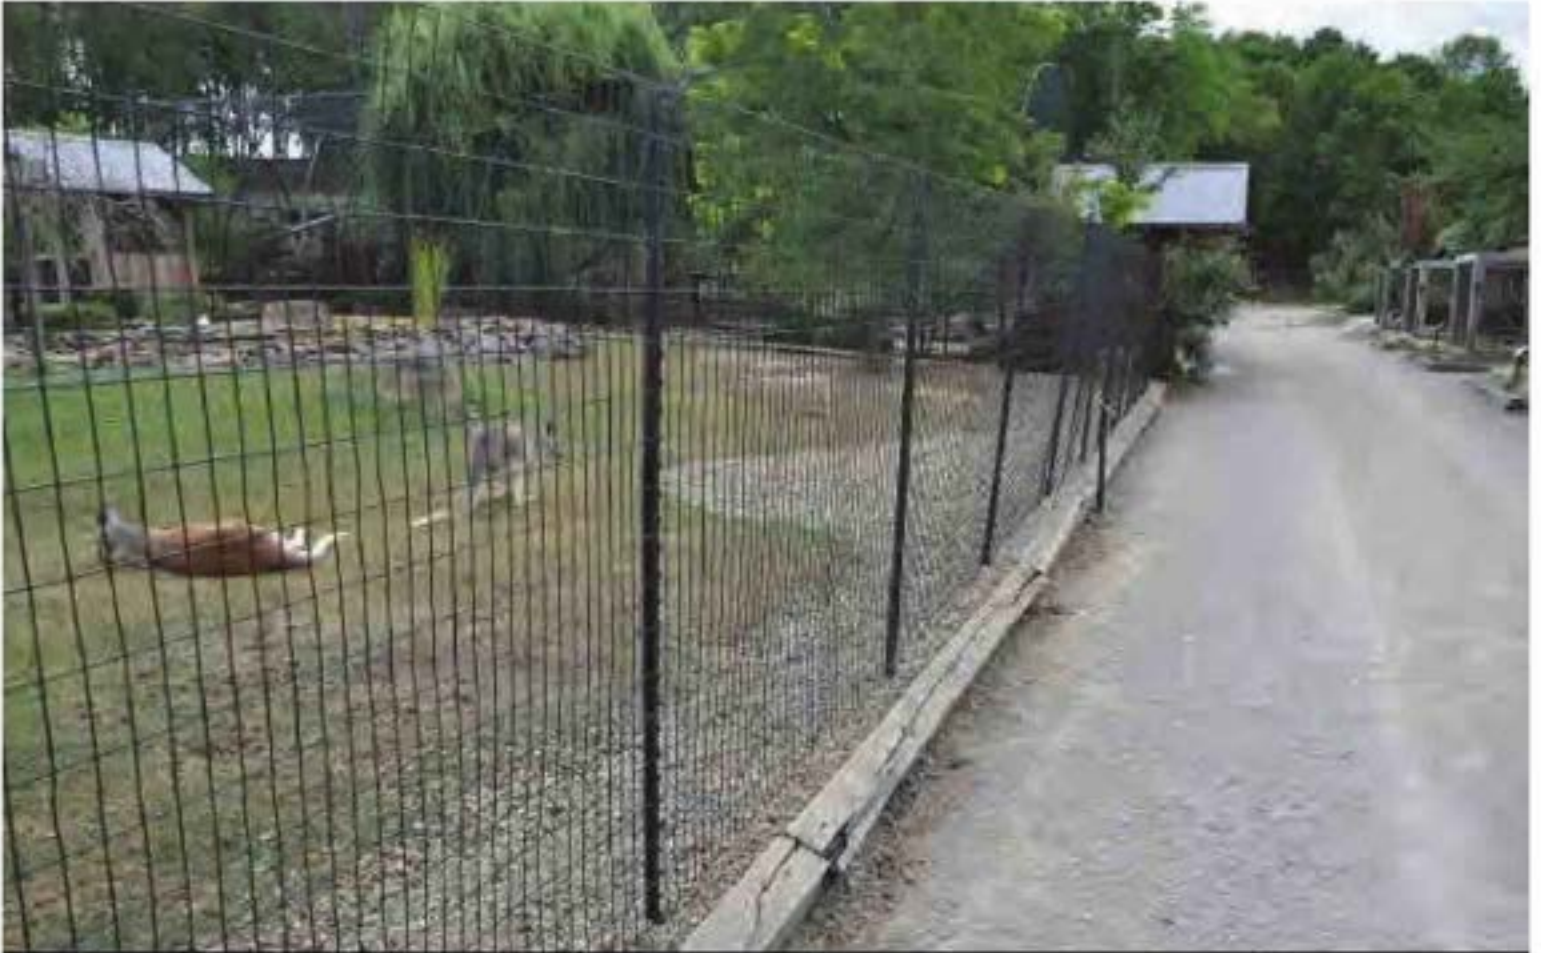
CFR: 2.131 (c) (1)

Photographer:	Randy Coleman	Legal Name:	55-B-0069
Photo Taken:	Tue, Aug 25, '15 12-130 pm	HENRY HAMPTON	
Inspection:	240150633510674		
Description:	Section 2.131 (c)(1): Public walk thru area of facility with no barriers or attendants.

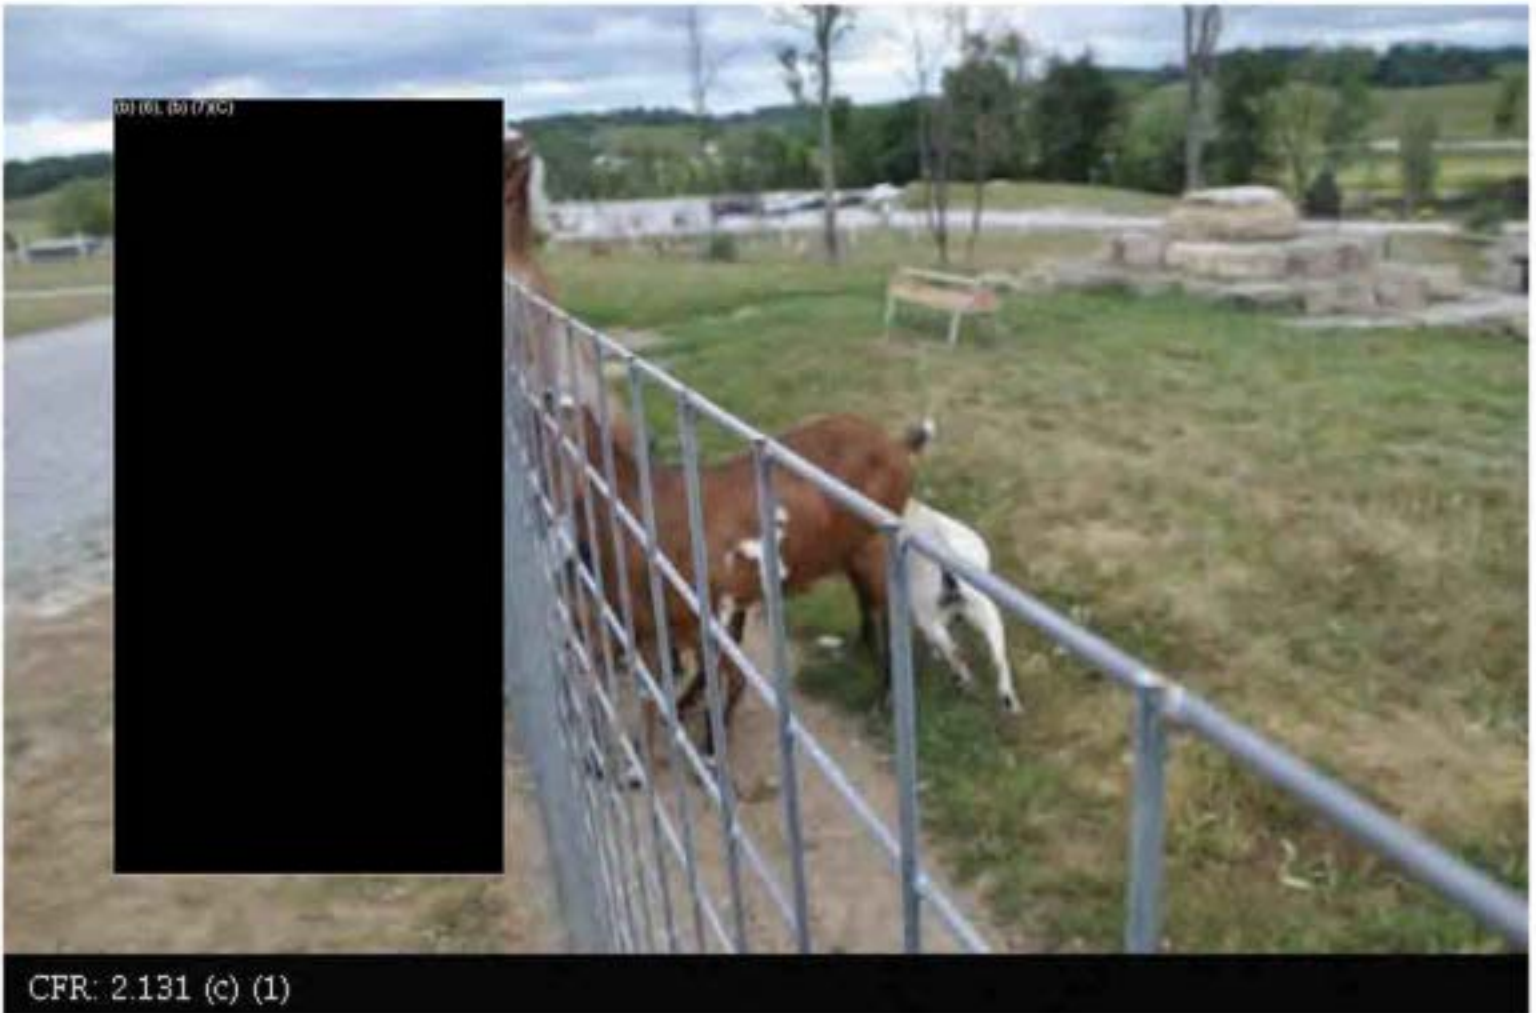
Photographer:	Randy Coleman	Legal Name:	55-B-0069
Photo Taken:	Tue, Aug 25, '15 12-130 pm	HENRY HAMPTON	
Inspection:	240150633510674		
Description:	Section 2.131 (c)(1): Public walk thru area of facility with no barriers or attendants.

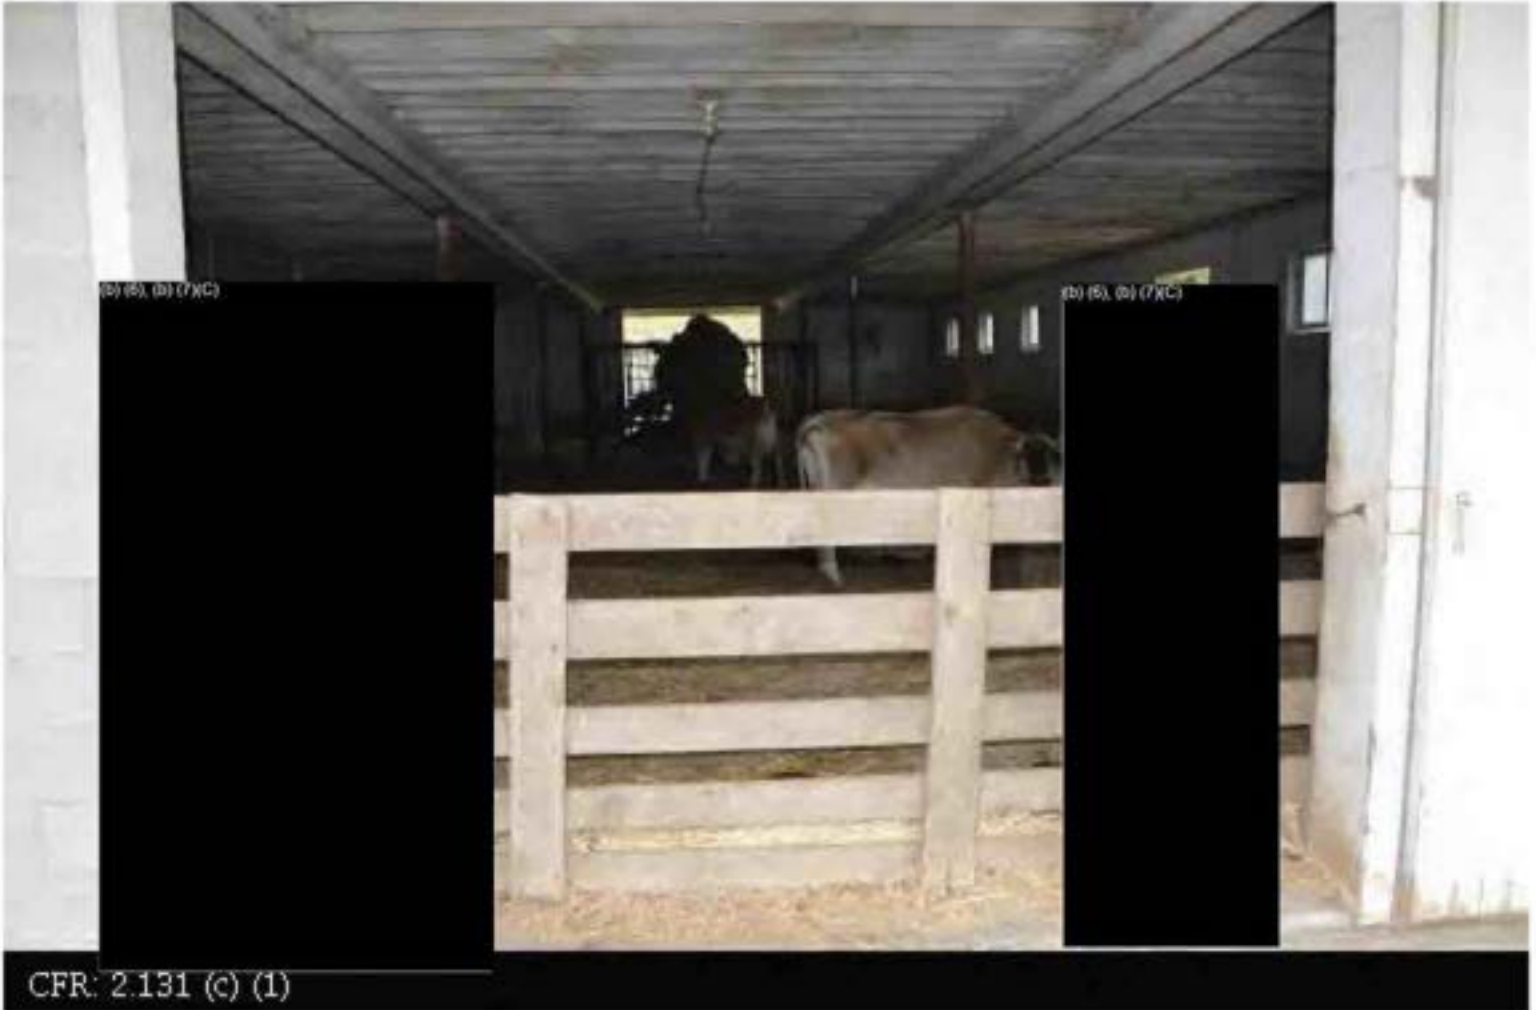
Photographer:	Randy Coleman	Legal Name:	55-B-0069
Photo Taken:	Tue, Aug 25, '15 12-130 pm	HENRY HAMPTON	
Inspection:	240150633510674		
Description:	Section 2.131 (c)(1): Public walk thru area of facility with no barriers or attendants.

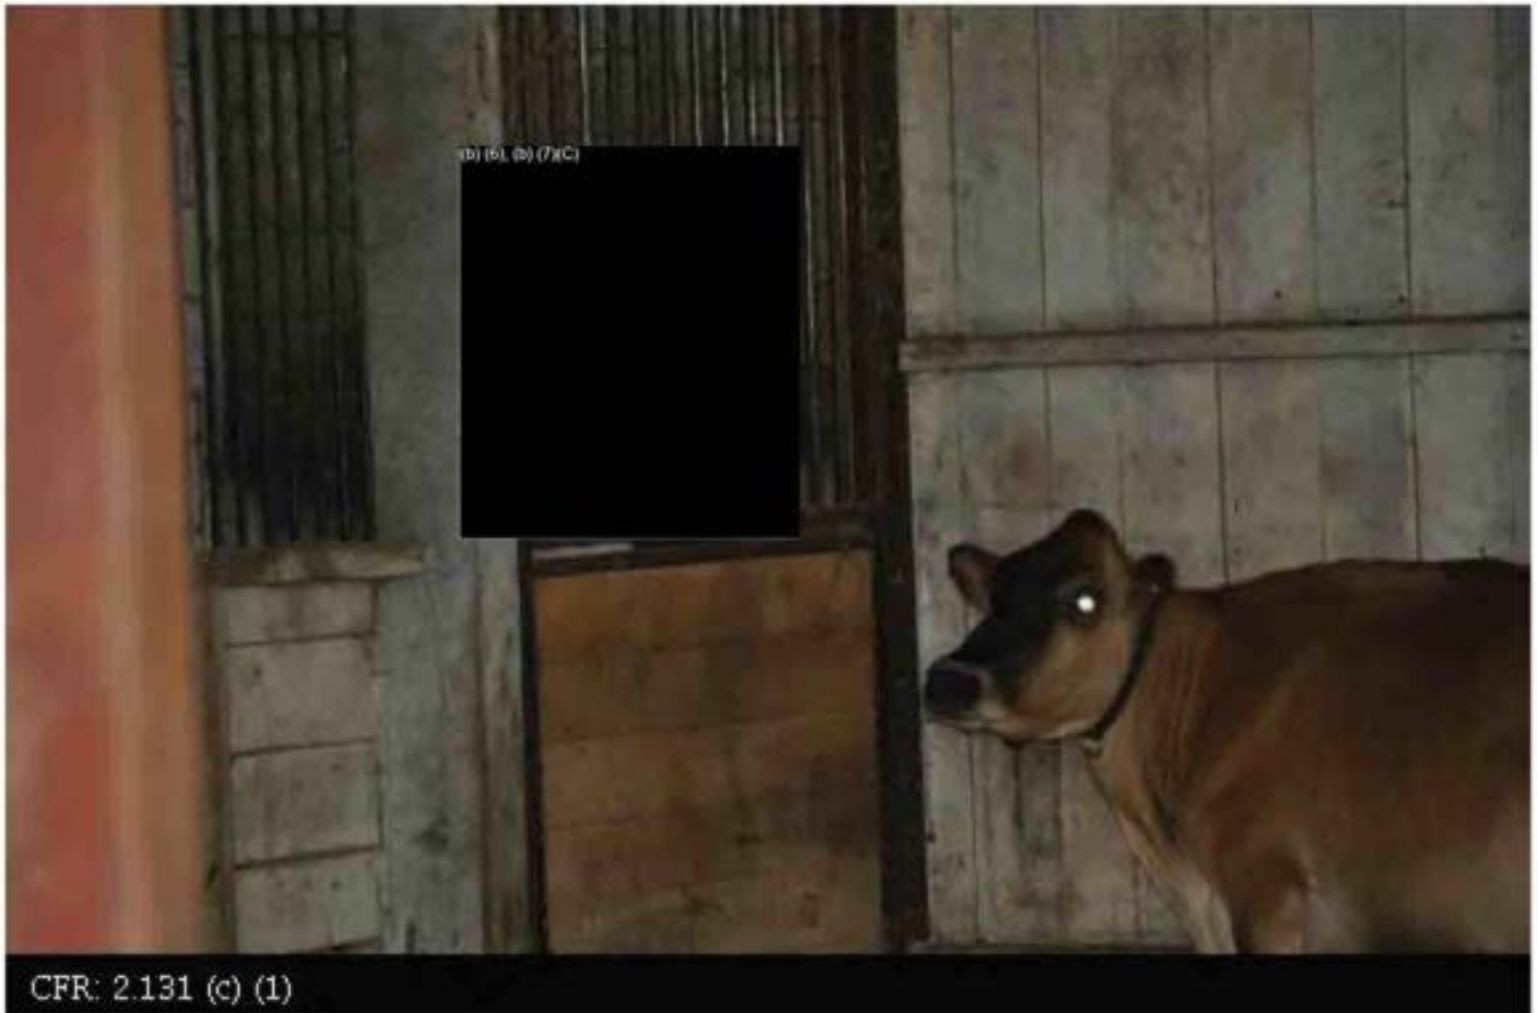
Photographer:	Randy Coleman	Legal Name:	55-B-0069
Photo Taken:	Tue, Aug 25, '15 12-130 pm	HENRY HAMPTON	
Inspection:	240150633510674		
Description:	Section 2.131 (c)(1): Public walk thru area of facility with no barriers or attendants.

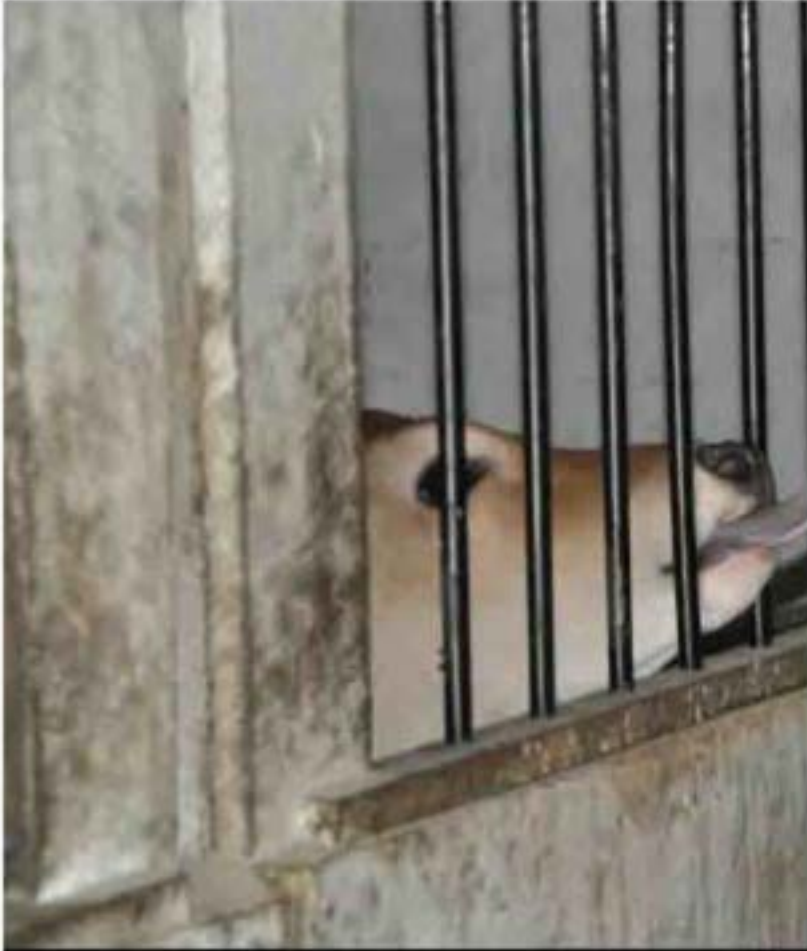
CFR: 2.131 (c) (1)

Photographer:	Randy Coleman	Legal Name:	55-B-0069
Photo Taken:	Tue, Aug 25, '15 12-130 pm	HENRY HAMPTON	
Inspection:	240150633510674		
Description:	Section 2.131 (c)(1): Public walk thru area of facility with no barriers or attendants.

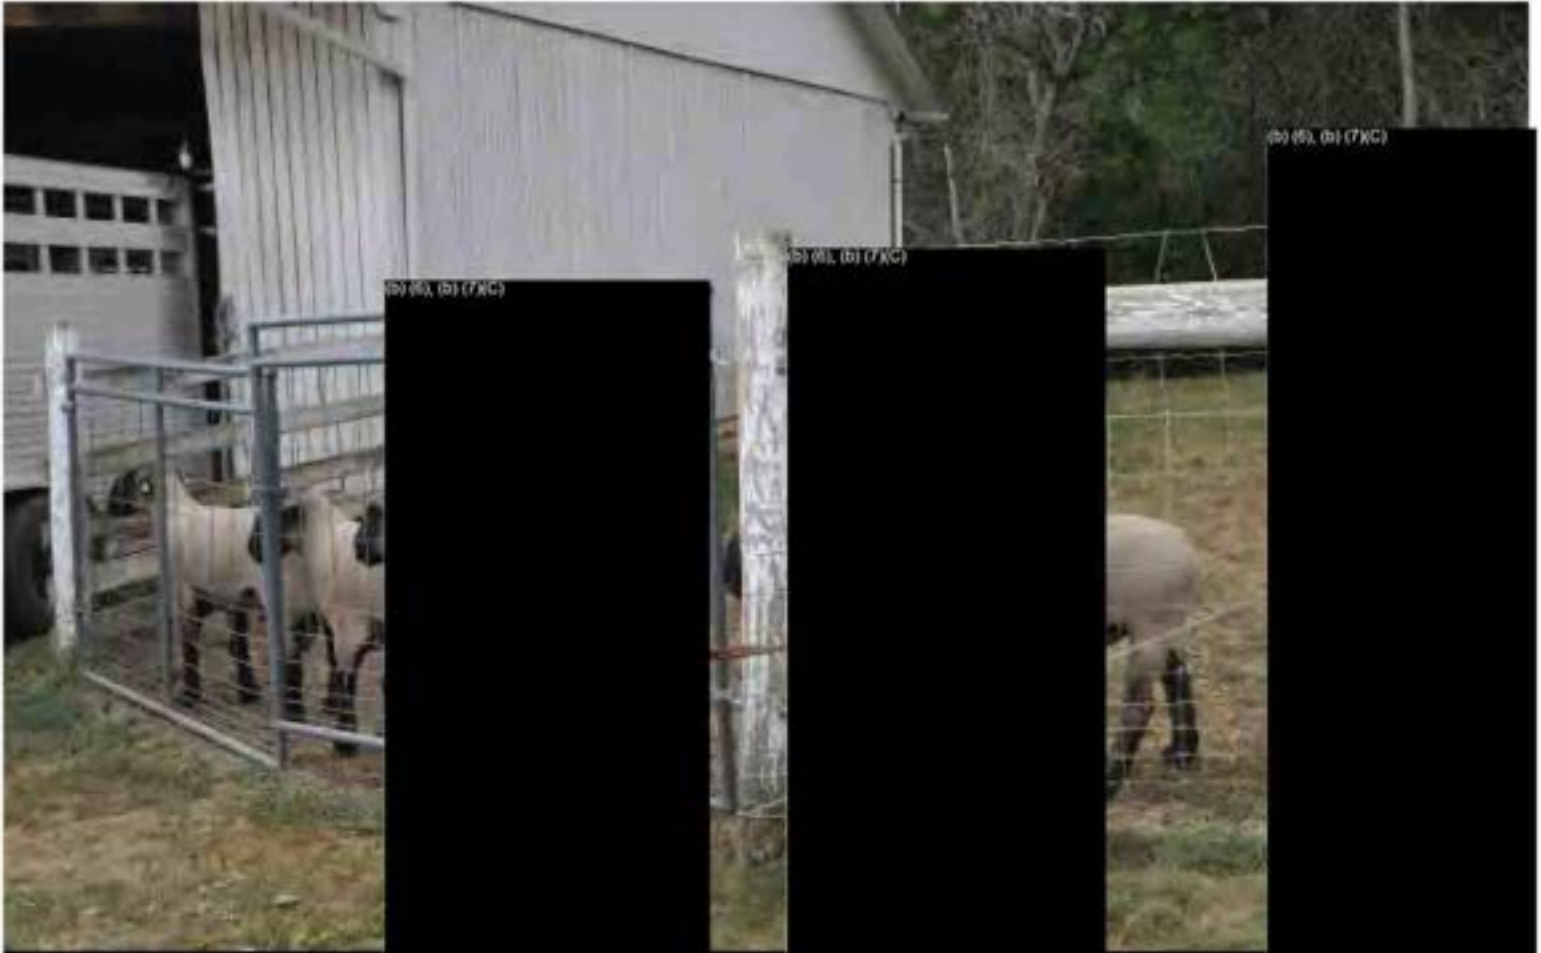
CFR: 2.131 (c) (1)

Photographer:	Randy Coleman	Legal Name:	55-B-0069
Photo Taken:	Tue, Aug 25, '15 12-130 pm	HENRY HAMPTON	
Inspection:	240150633510674		
Description:	Section 2.131 (c)(1): Public walk thru area of facility with no barriers or attendants.

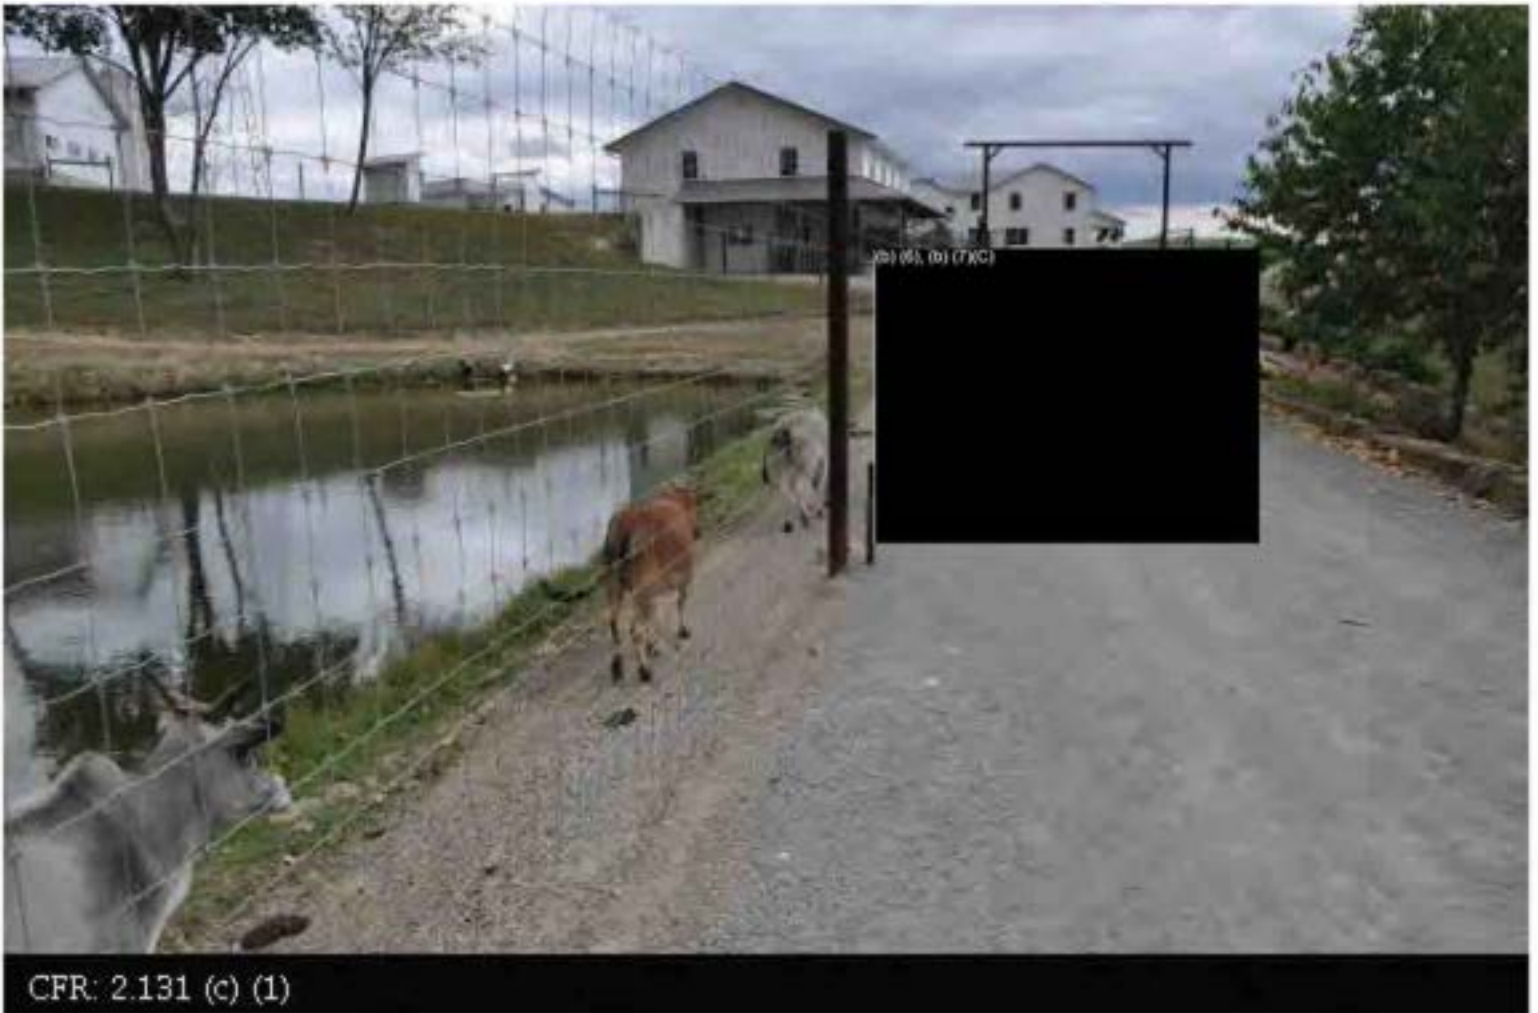
Photographer:	Randy Coleman	Legal Name:	55-B-0069
Photo Taken:	Tue, Aug 25, '15 12-130 pm	HENRY HAMPTON	
Inspection:	240150633510674		
Description:	Section 2.131 (c)(1): Public walk thru area of facility with no barriers or attendants.

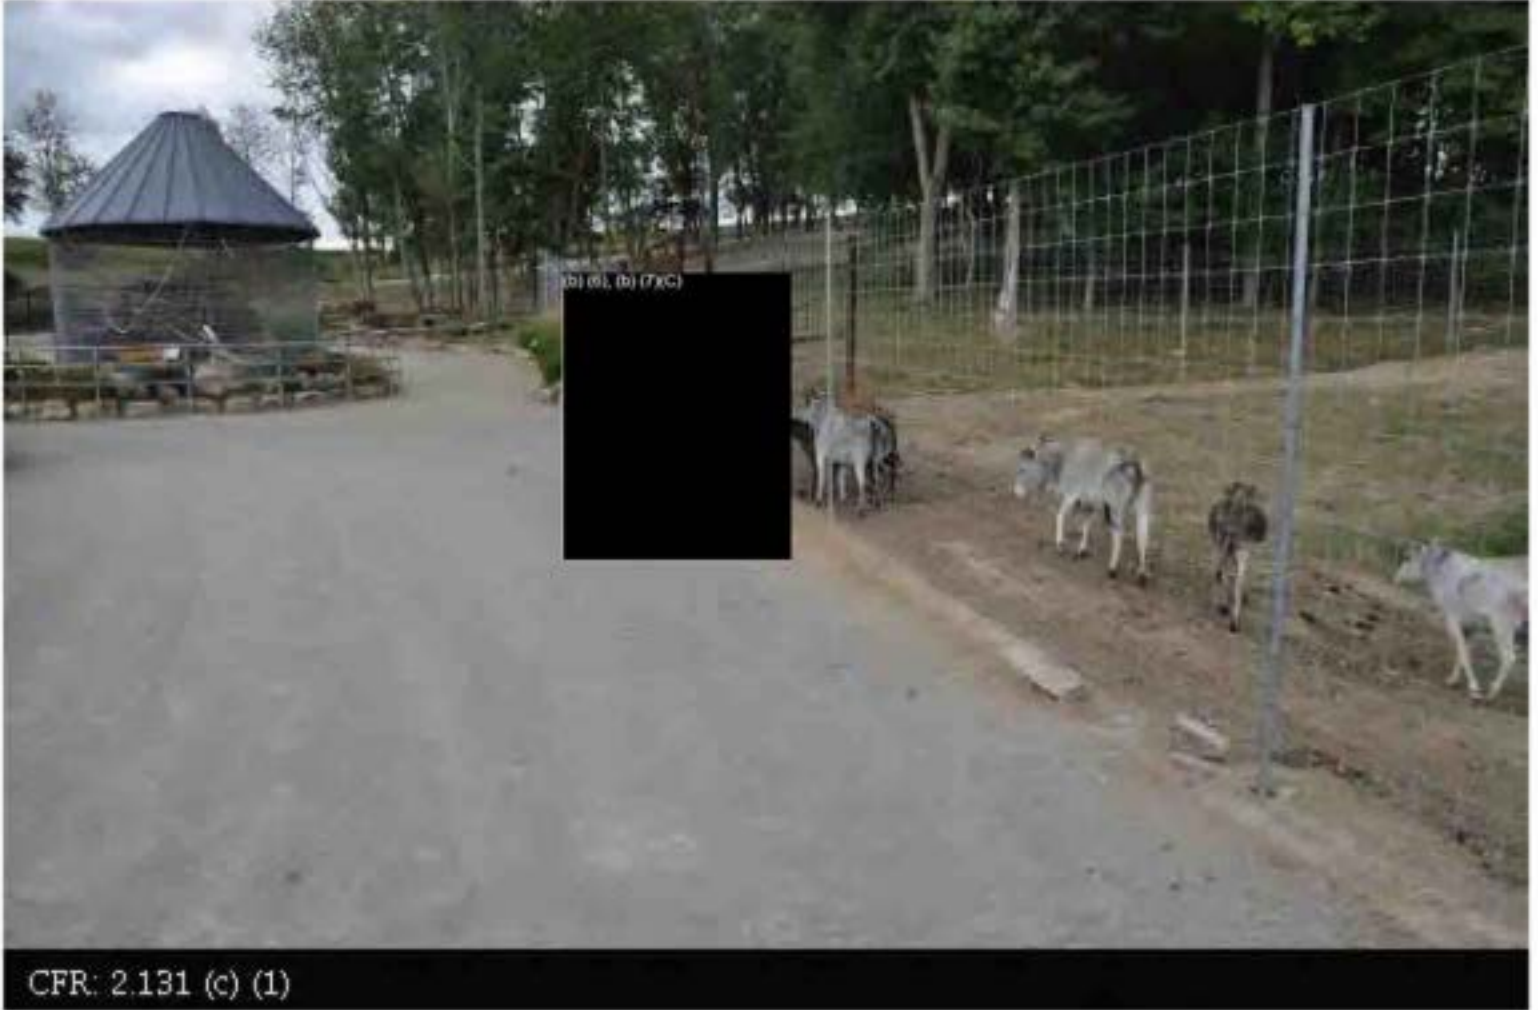
Photographer:	Randy Coleman	Legal Name:	55-B-0069
Photo Taken:	Tue, Aug 25, '15 12-130 pm	HENRY HAMPTON	
Inspection:	240150633510674		
Description:	Section 2.131 (c)(1): Public walk thru area of facility with no barriers or attendants.
