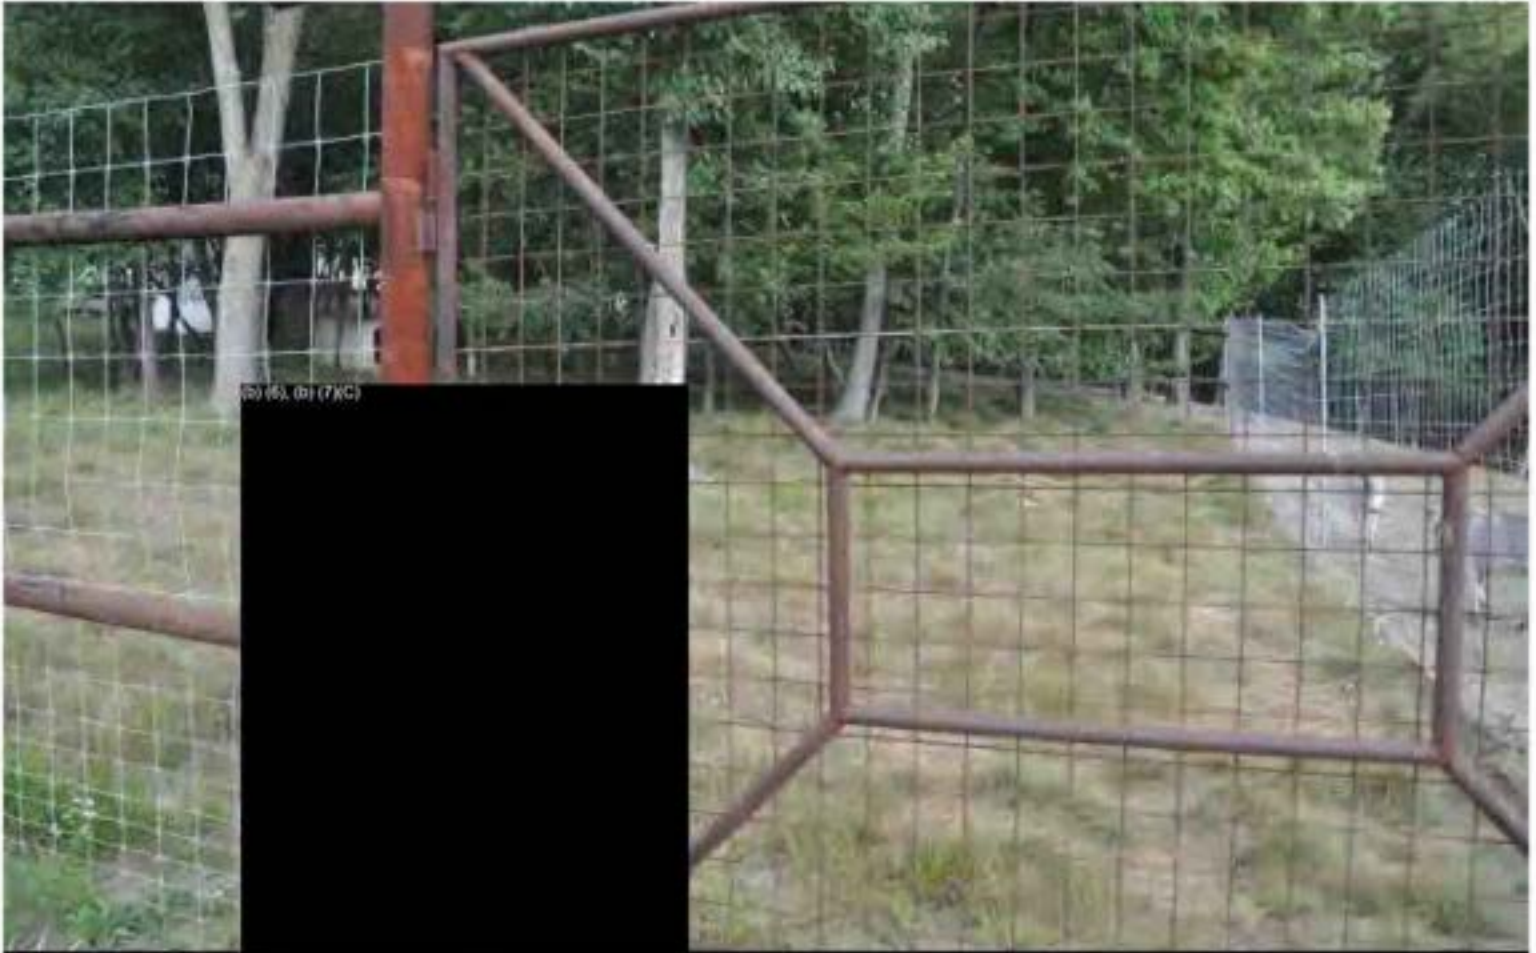
CFR: 2.131 (c) (1)

Photographer:	Randy Coleman	Legal Name:	55-B-0069
Photo Taken:	Tue, Aug 25, '15 12-130 pm	HENRY HAMPTON	
Inspection:	240150633510674		
Description:	Section 2.131 (c)(1): Public walk thru area of facility with no barriers or attendants.

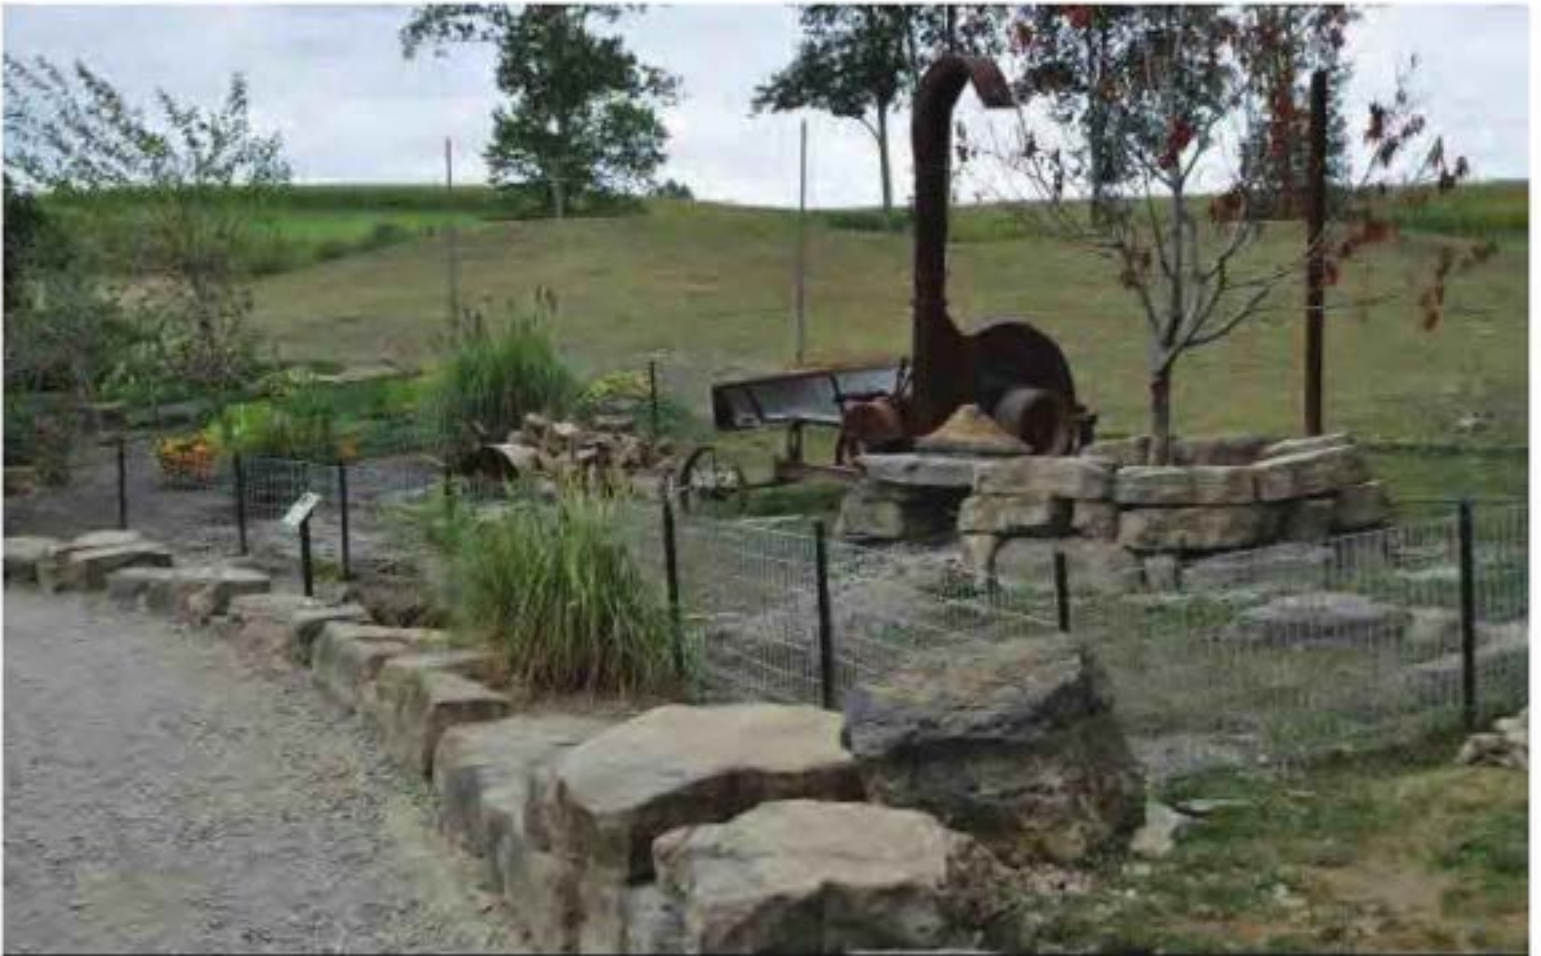
CFR: 2.131 (c) (1)

Photographer:	Randy Coleman	Legal Name:	55-B-0069
Photo Taken:	Tue, Aug 25, '15 12-130 pm	HENRY HAMPTON	
Inspection:	240150633510674		
Description:	Section 2.131 (c)(1): Public walk thru area of facility with no barriers or attendants.

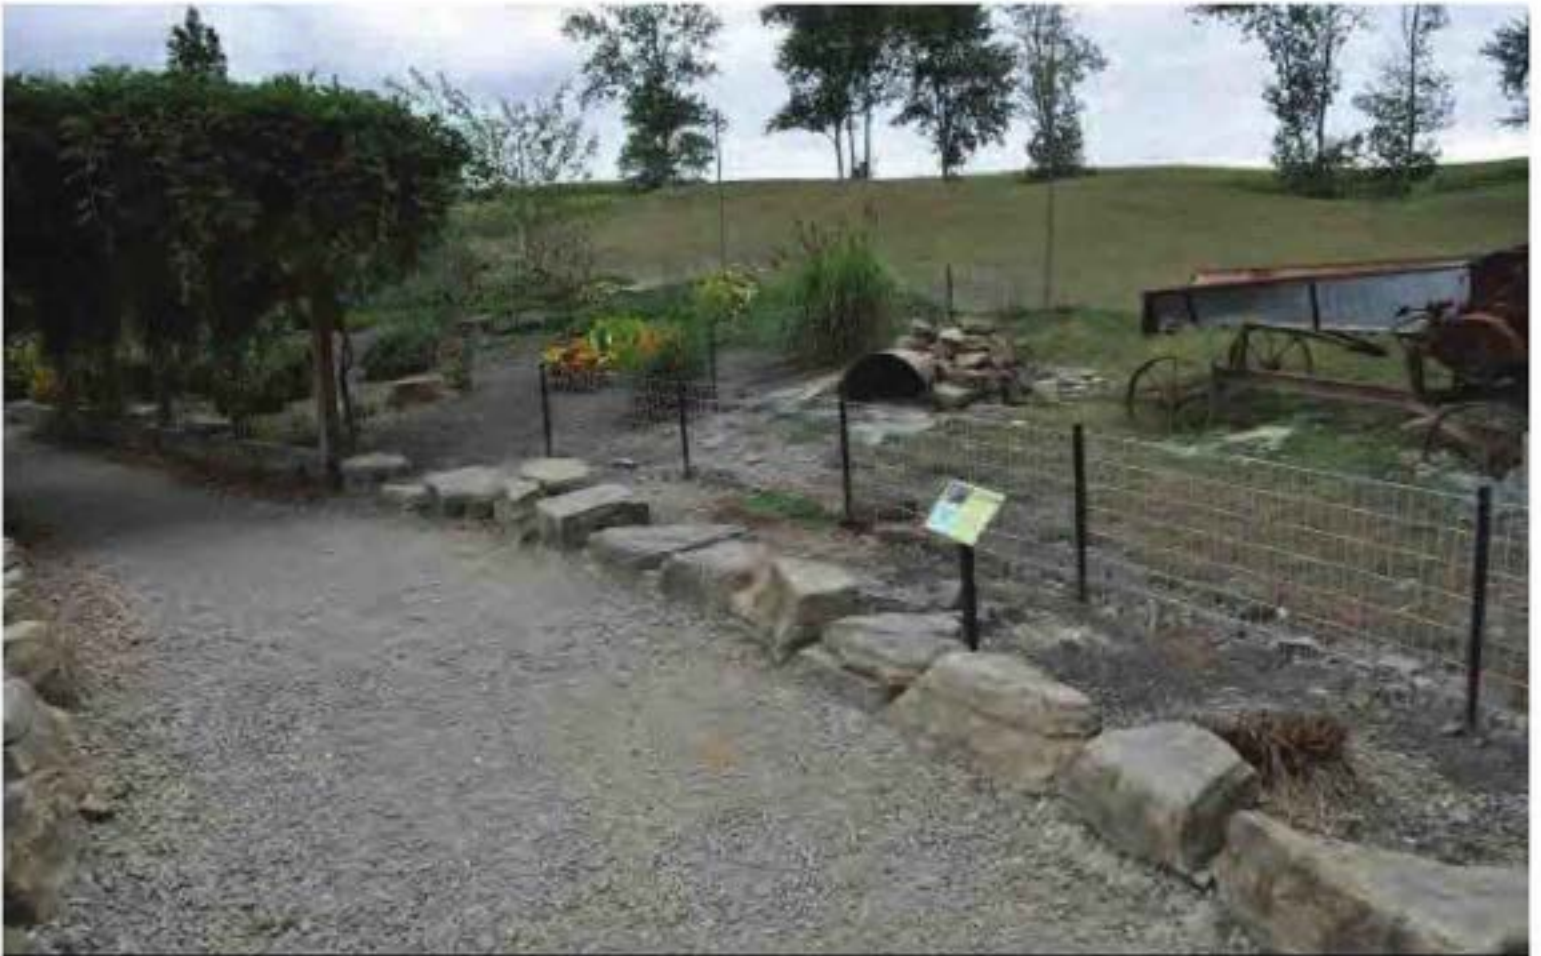
CFR: 2.131 (c) (1)

Photographer:	Randy Coleman	Legal Name:	55-B-0069
Photo Taken:	Tue, Aug 25, '15 12-130 pm	HENRY HAMPTON	
Inspection:	240150633510674		
Description:	Section 2.131 (c)(1): Public walk thru area of facility with no barriers or attendants.

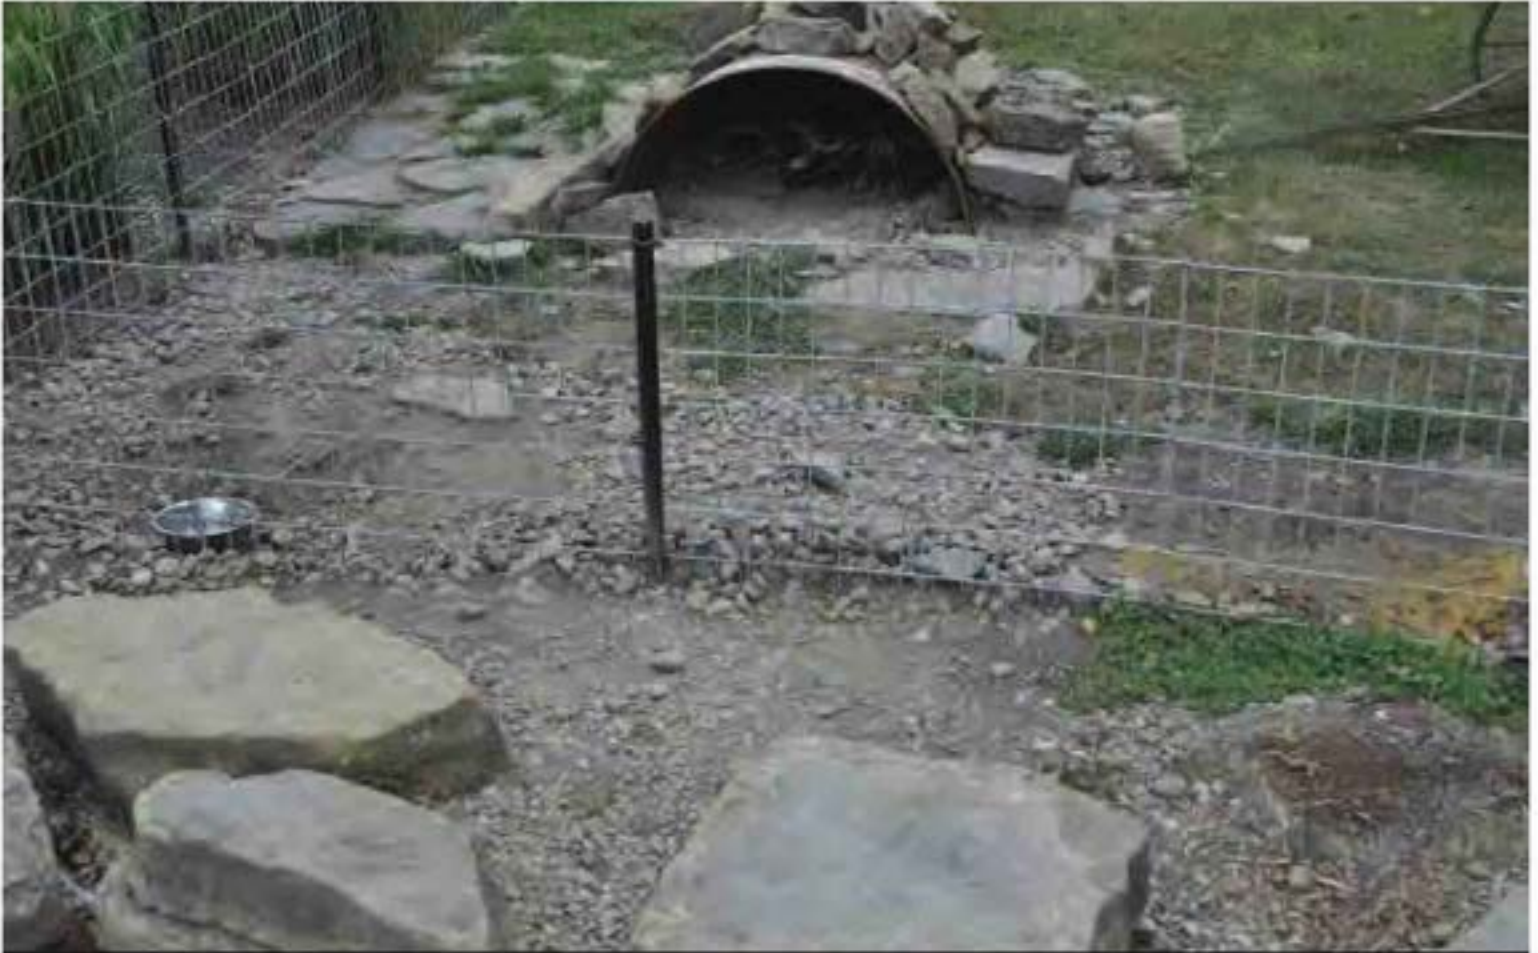
CFR: 2.131 (c) (1)

Photographer:	Randy Coleman	Legal Name:	55-B-0069
Photo Taken:	Tue, Aug 25, '15 12-130 pm	HENRY HAMPTON	
Inspection:	240150633510674		
Description:	Section 2.131 (c)(1): Public walk thru area of facility with no barriers or attendants.

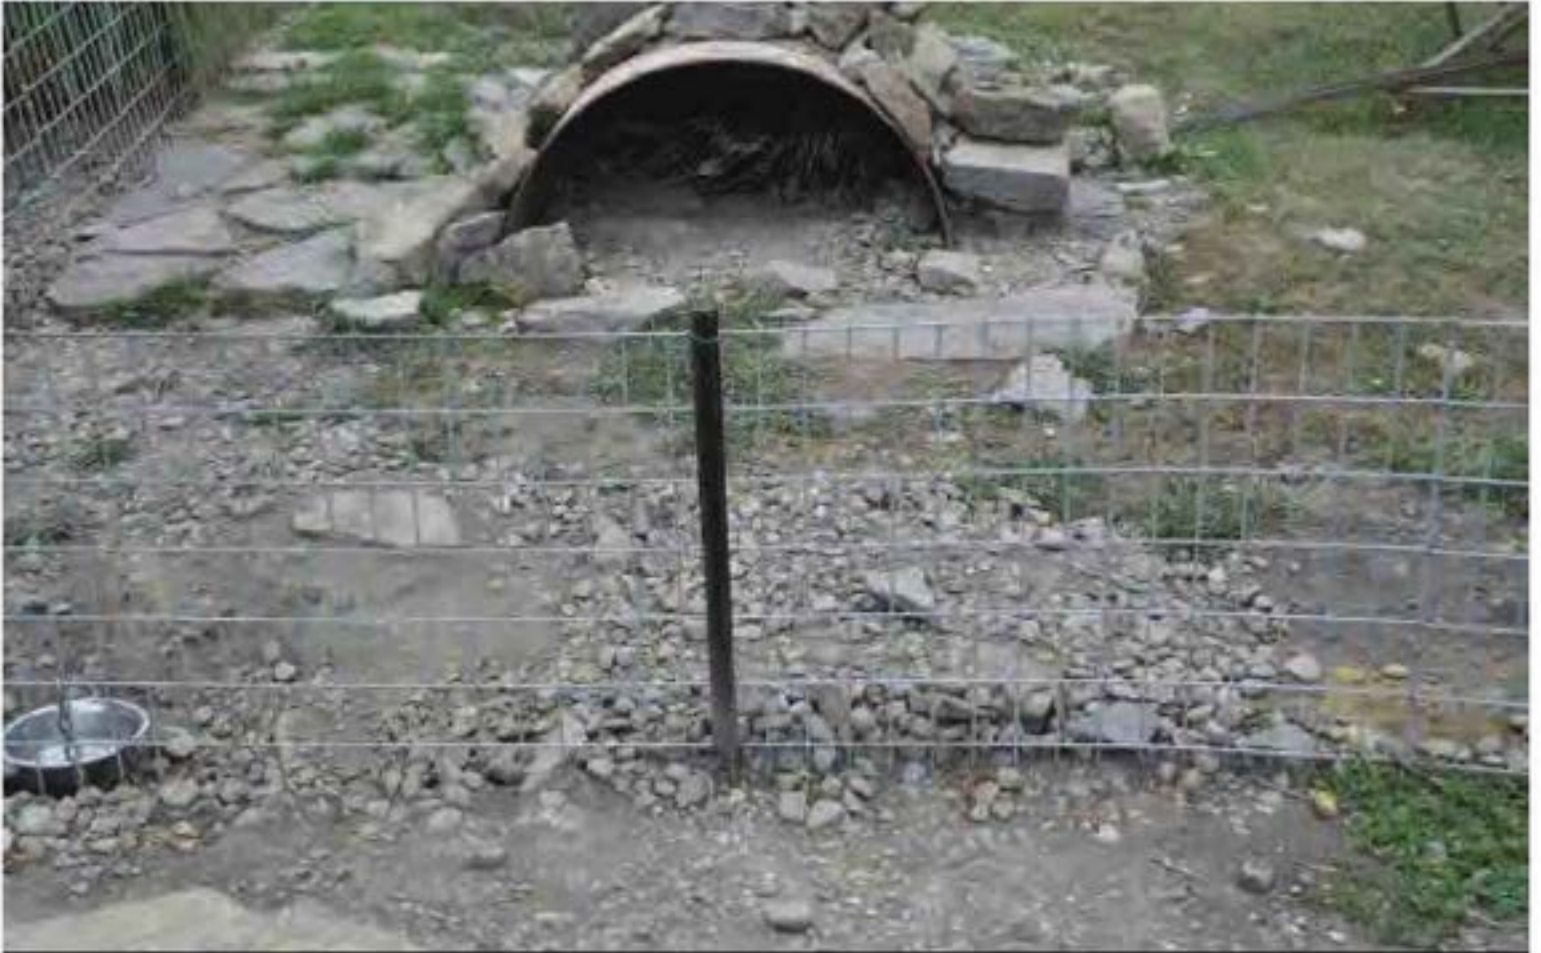
CFR: 2.131 (c) (1)

Photographer:	Randy Coleman	Legal Name:	55-B-0069
Photo Taken:	Tue, Aug 25, '15 12-130 pm	HENRY HAMPTON	
Inspection:	240150633510674		
Description:	Section 2.131 (c)(1): Public walk thru area of facility with no barriers or attendants.

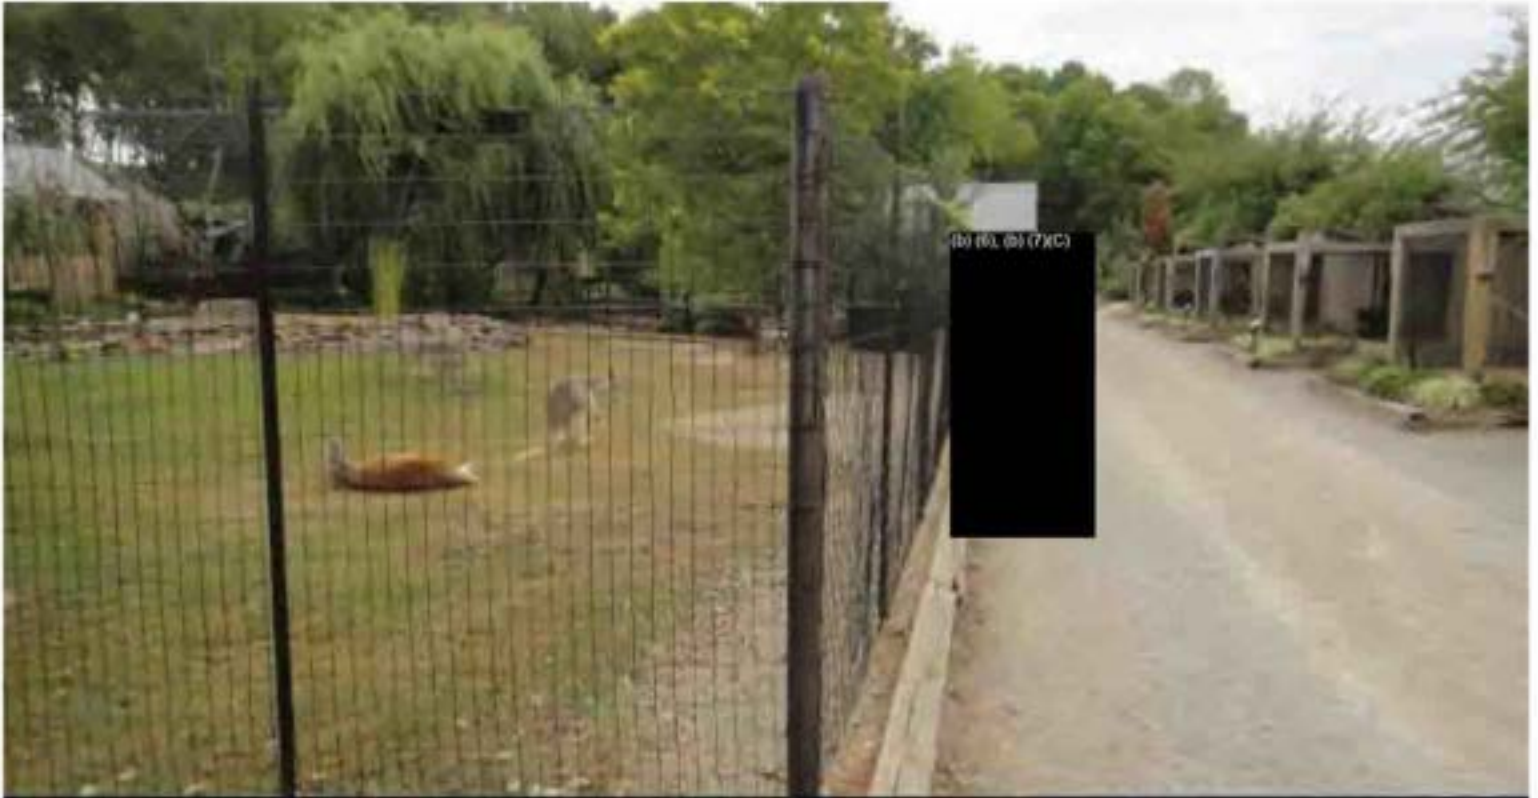
CFR: 2.131 (c) (1)

Photographer:	Dana Miller	Legal Name:	55-B-0069
Photo Taken:	Tue, Aug 25, '15 12-130 pm	HENRY HAMPTON	
Inspection:	240150633510674		
Description:	Section 2.131 (c)(1): Public walk thru area of facility with no barriers or attendants.

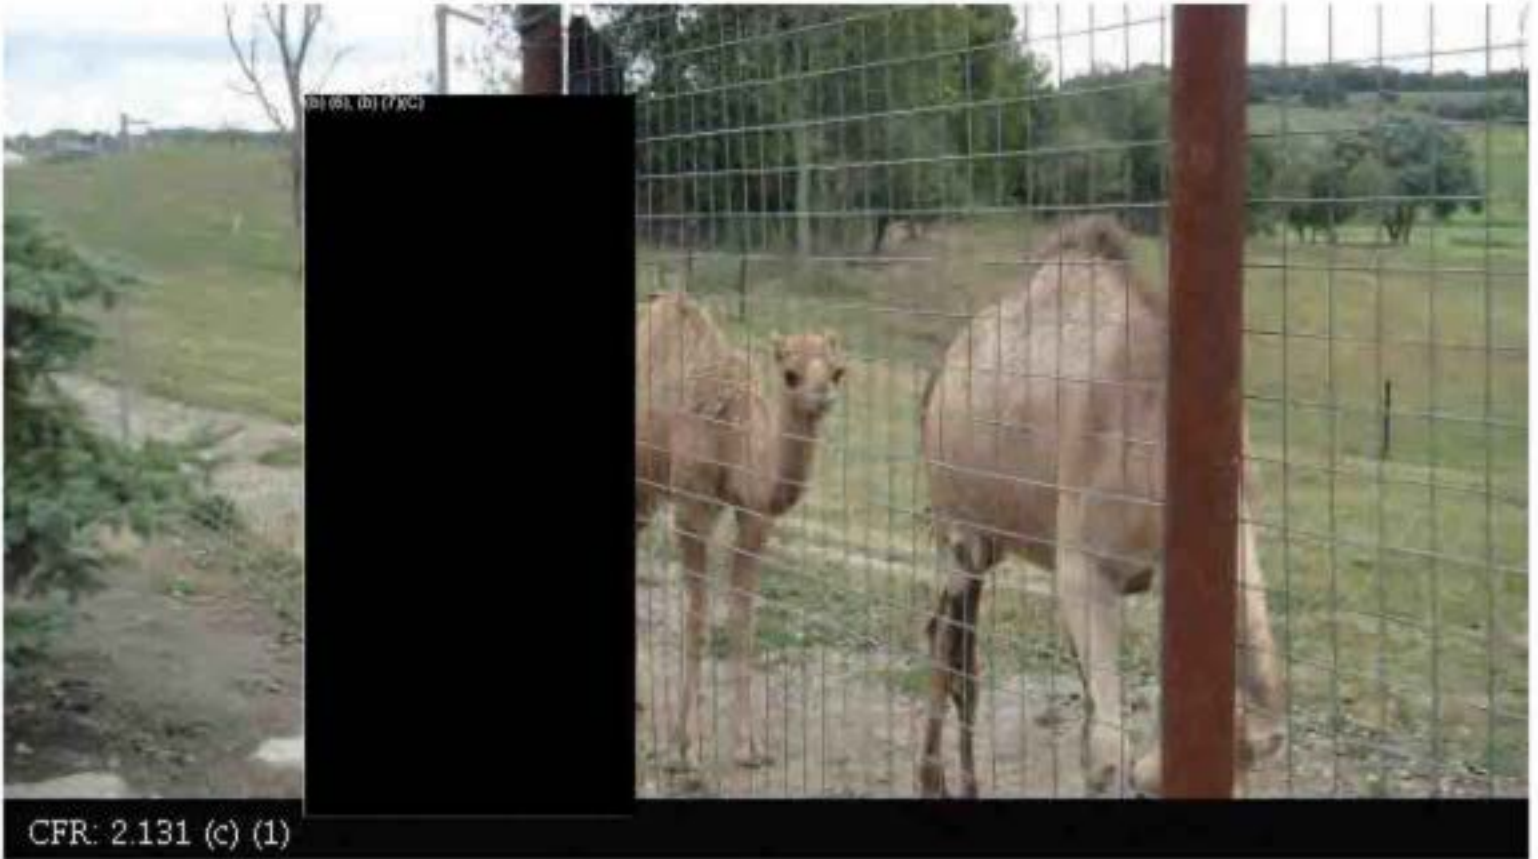
Photographer:	Dana Miller	Legal Name:	55-B-0069
Photo Taken:	Tue, Aug 25, '15 12-130 pm	HENRY HAMPTON	
Inspection:	240150633510674		
Description:	Section 2.131 (c)(1): Public walk thru area of facility with no barriers or attendants.

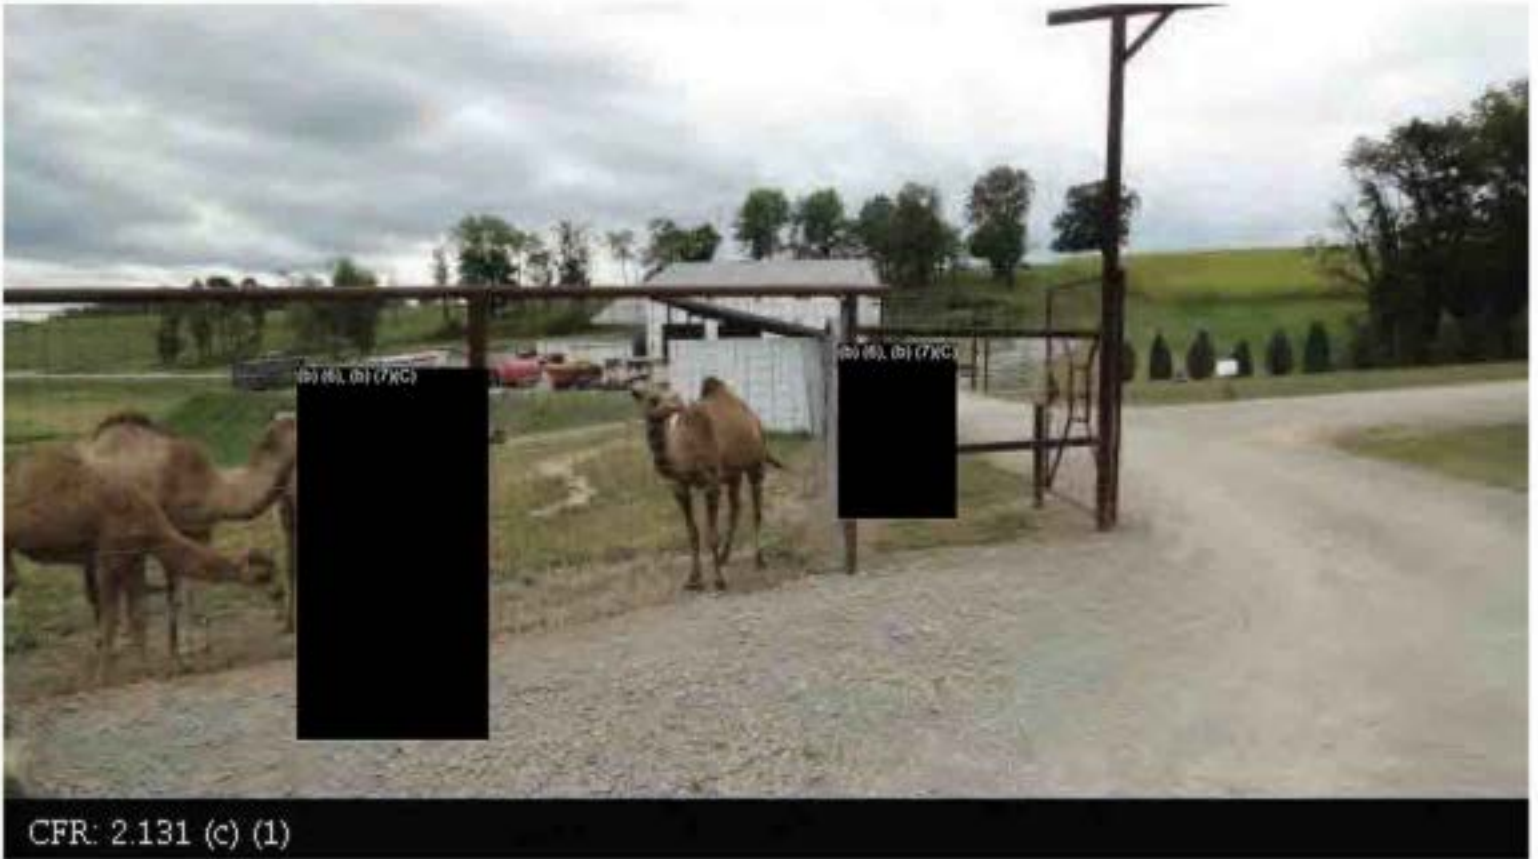
CFR: 2.131 (c) (1)

Photographer:	Dana Miller	Legal Name:	55-B-0069
Photo Taken:	Tue, Aug 25, '15 12-130 pm	HENRY HAMPTON	
Inspection:	240150633510674		
Description:	Section 2.131 (c)(1): Public walk thru area of facility with no barriers or attendants.

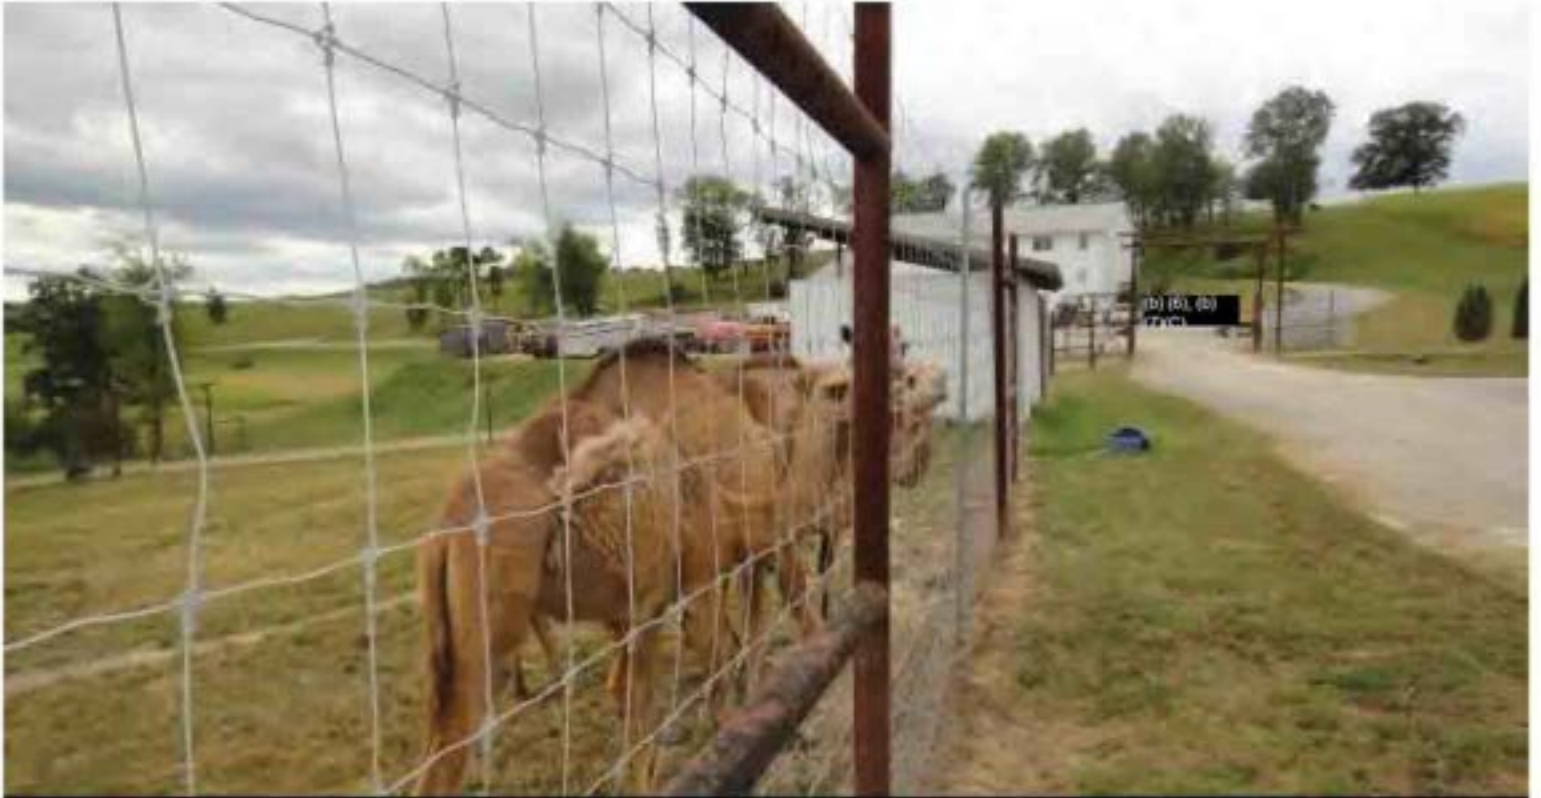
CFR: 2.131 (c) (1)

Photographer:	Dana Miller	Legal Name:	55-B-0069
Photo Taken:	Tue, Aug 25, '15 12-130 pm	HENRY HAMPTON	
Inspection:	240150633510674		
Description:	Section 2.131 (c)(1): Public walk thru area of facility with no barriers or attendants.

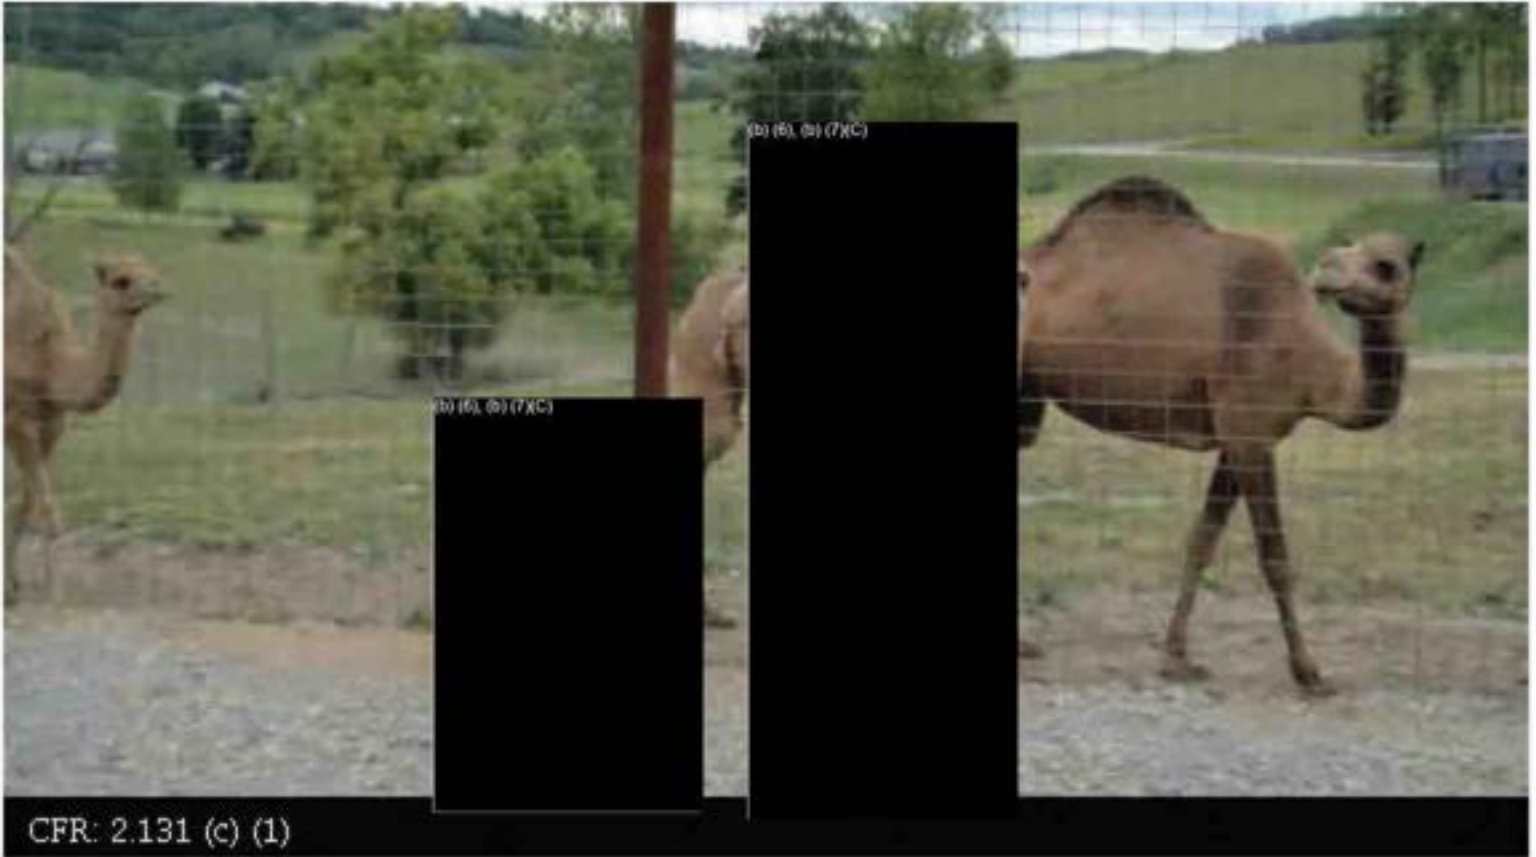
Photographer:	Dana Miller	Legal Name:	55-B-0069
Photo Taken:	Tue, Aug 25, '15 12-130 pm	HENRY HAMPTON	
Inspection:	240150633510674		
Description:	Section 2.131 (c)(1): Public walk thru area of facility with no barriers or attendants.

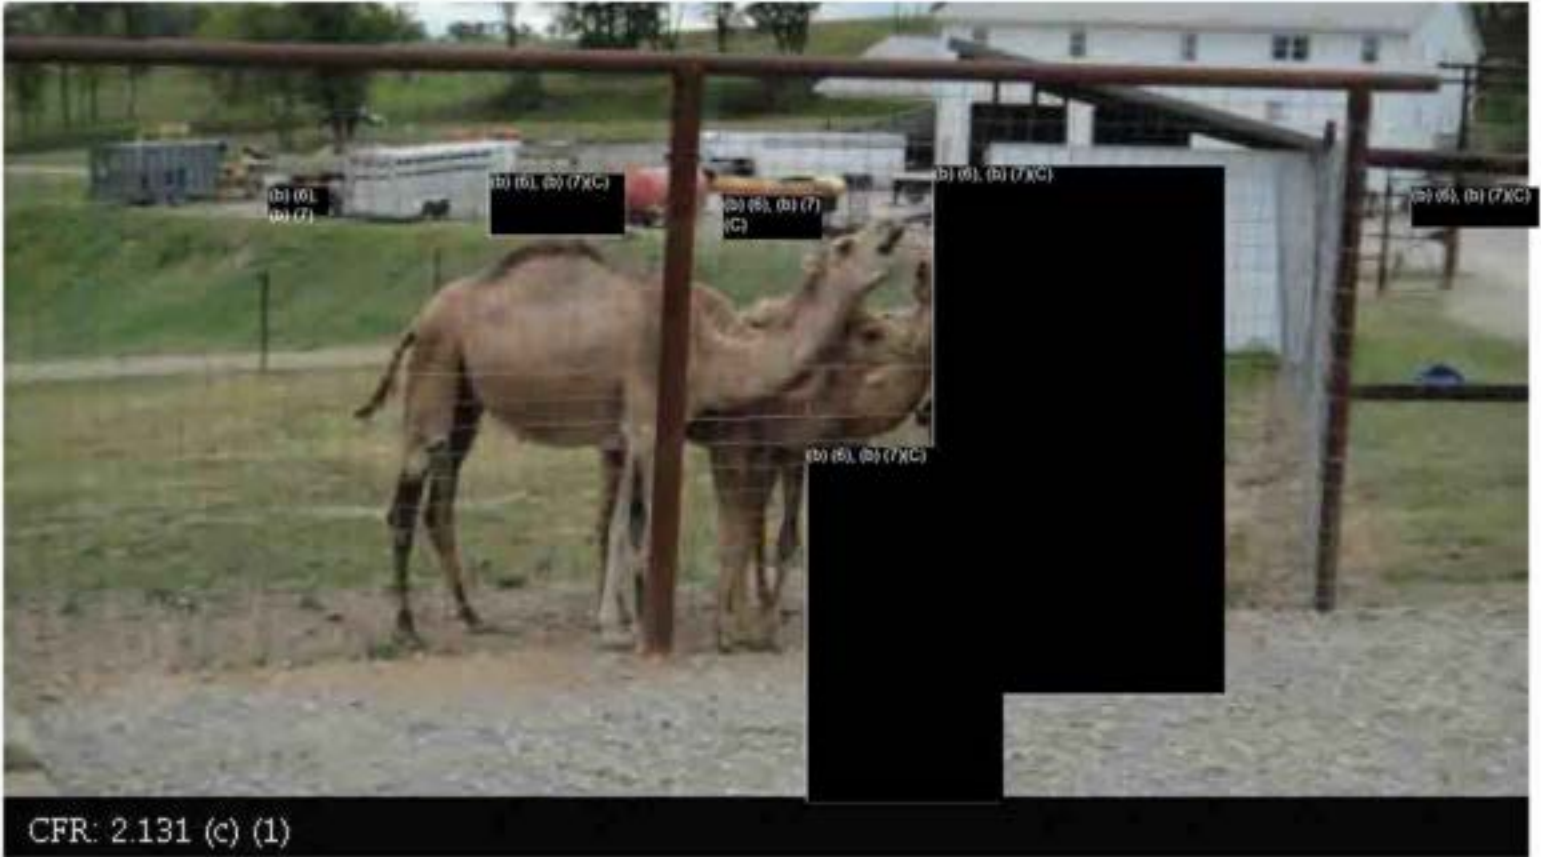
Photographer:	Dana Miller	Legal Name:	55-B-0069
Photo Taken:	Tue, Aug 25, '15 12-130 pm	HENRY HAMPTON	
Inspection:	240150633510674		
Description:	Section 2.131 (c)(1): Public walk thru area of facility with no barriers or attendants.

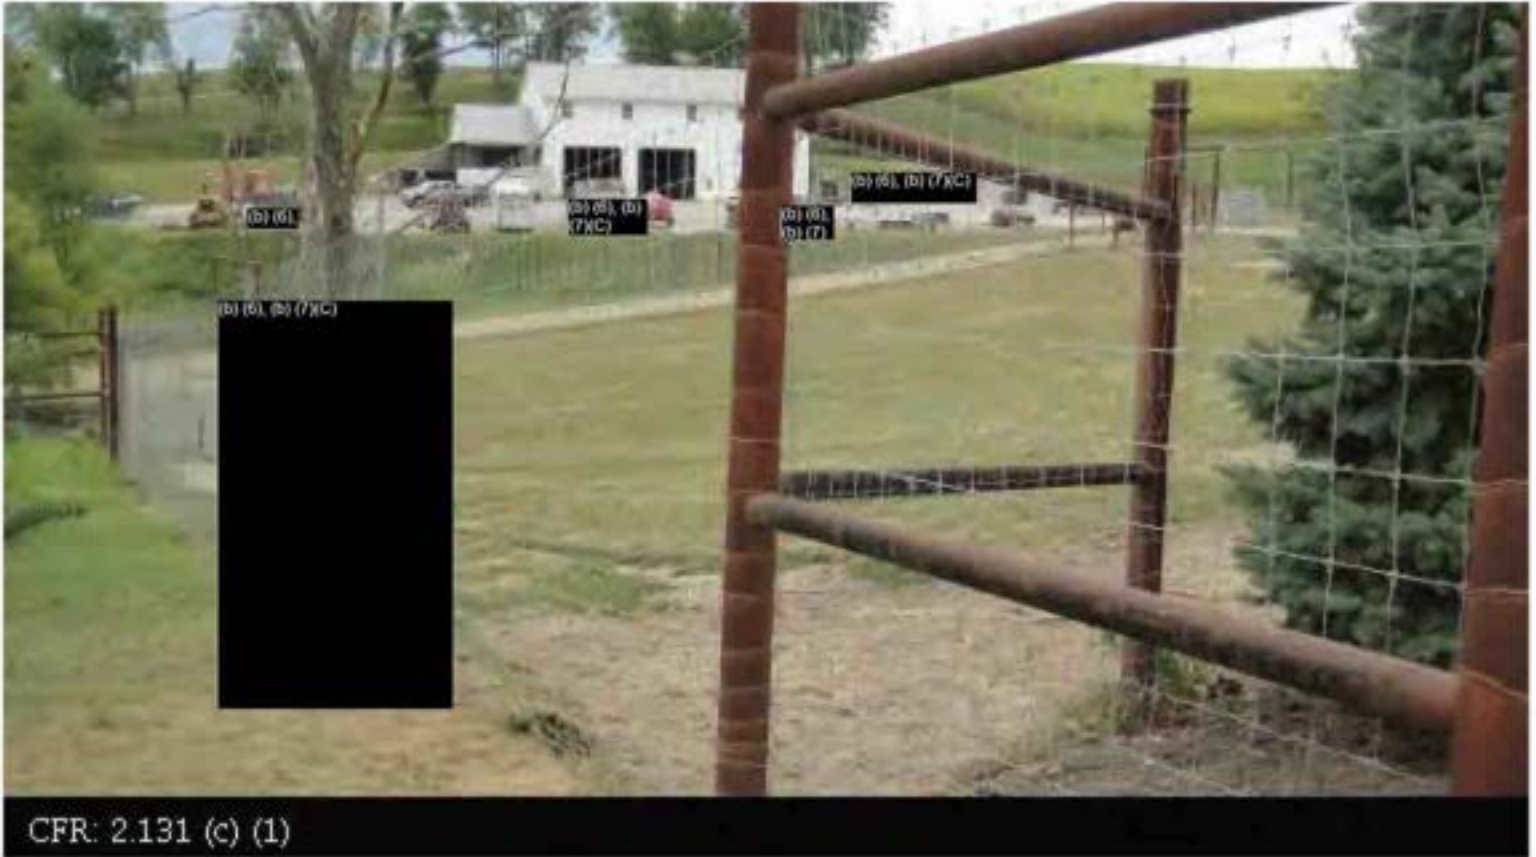
Photographer:	Dana Miller	Legal Name:	55-B-0069
Photo Taken:	Tue, Aug 25, '15 12-130 pm	HENRY HAMPTON	
Inspection:	240150633510674		
Description:	Section 2.131 (c)(1): Public walk thru area of facility with no barriers or attendants.

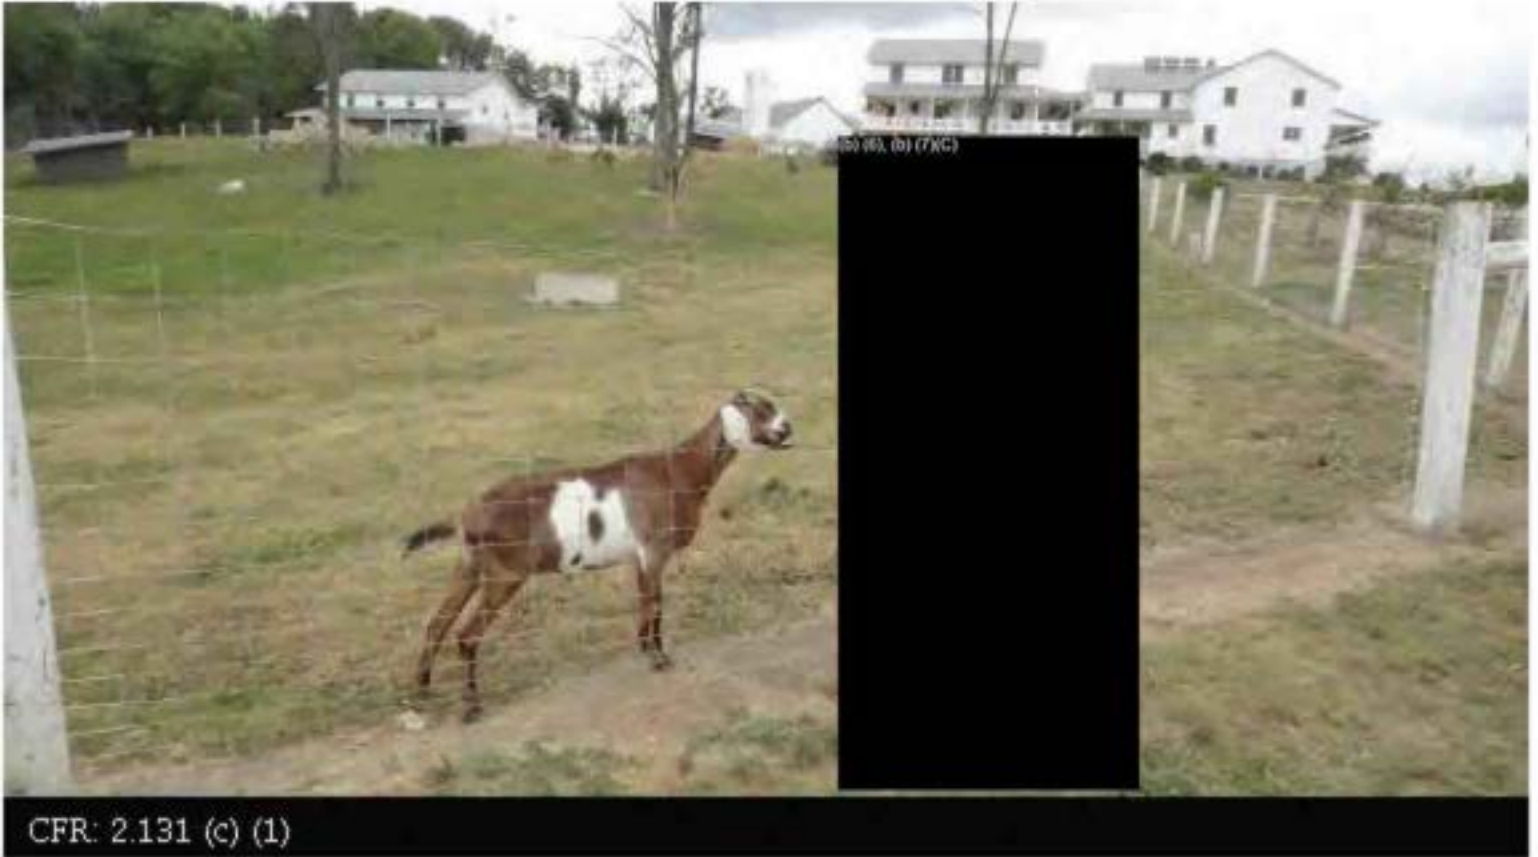
Photographer:	Dana Miller	Legal Name:	55-B-0069
Photo Taken:	Tue, Aug 25, '15 12-130 pm	HENRY HAMPTON	
Inspection:	240150633510674		
Description:	Section 2.131 (c)(1): Public walk thru area of facility with no barriers or attendants.

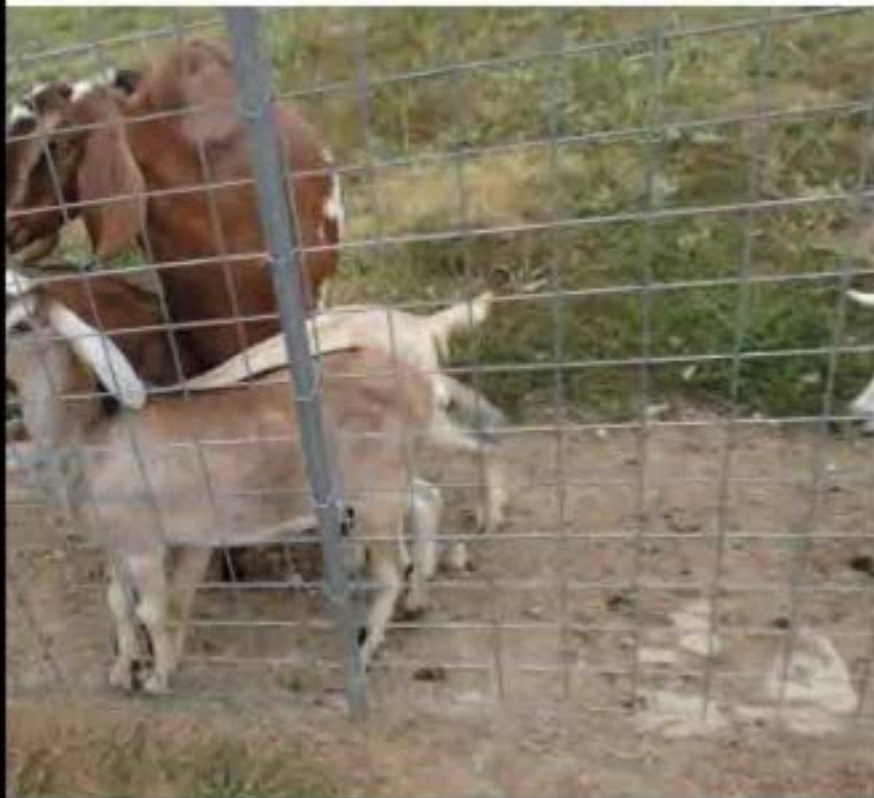
CFR: 2.131 (c) (1)

Photographer:	Dana Miller	Legal Name:	55-B-0069
Photo Taken:	Tue, Aug 25, '15 12-130 pm	HENRY HAMPTON	
Inspection:	240150633510674		
Description:	Section 2.131 (c)(1): Public walk thru area of facility with no barriers or attendants.

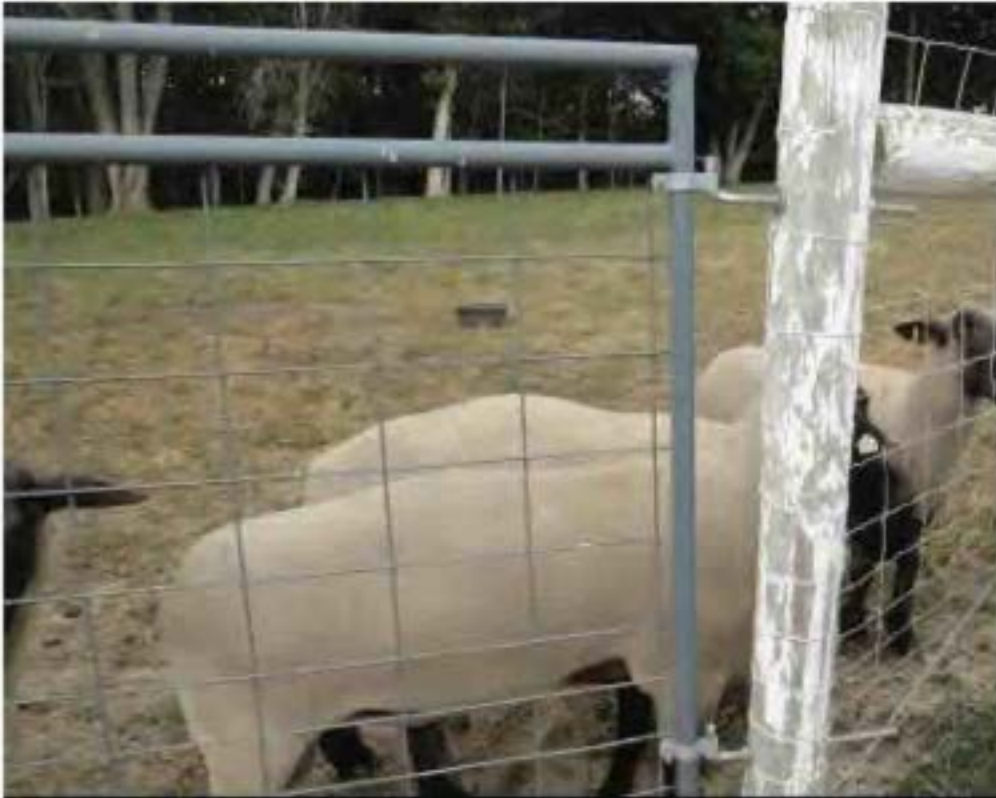
CFR: 2.131 (c) (1)

Photographer:	Dana Miller	Legal Name:	55-B-0069
Photo Taken:	Tue, Aug 25, '15 12-130 pm	HENRY HAMPTON	
Inspection:	240150633510674		
Description:	Section 2.131 (c)(1): Public walk thru area of facility with no barriers or attendants.

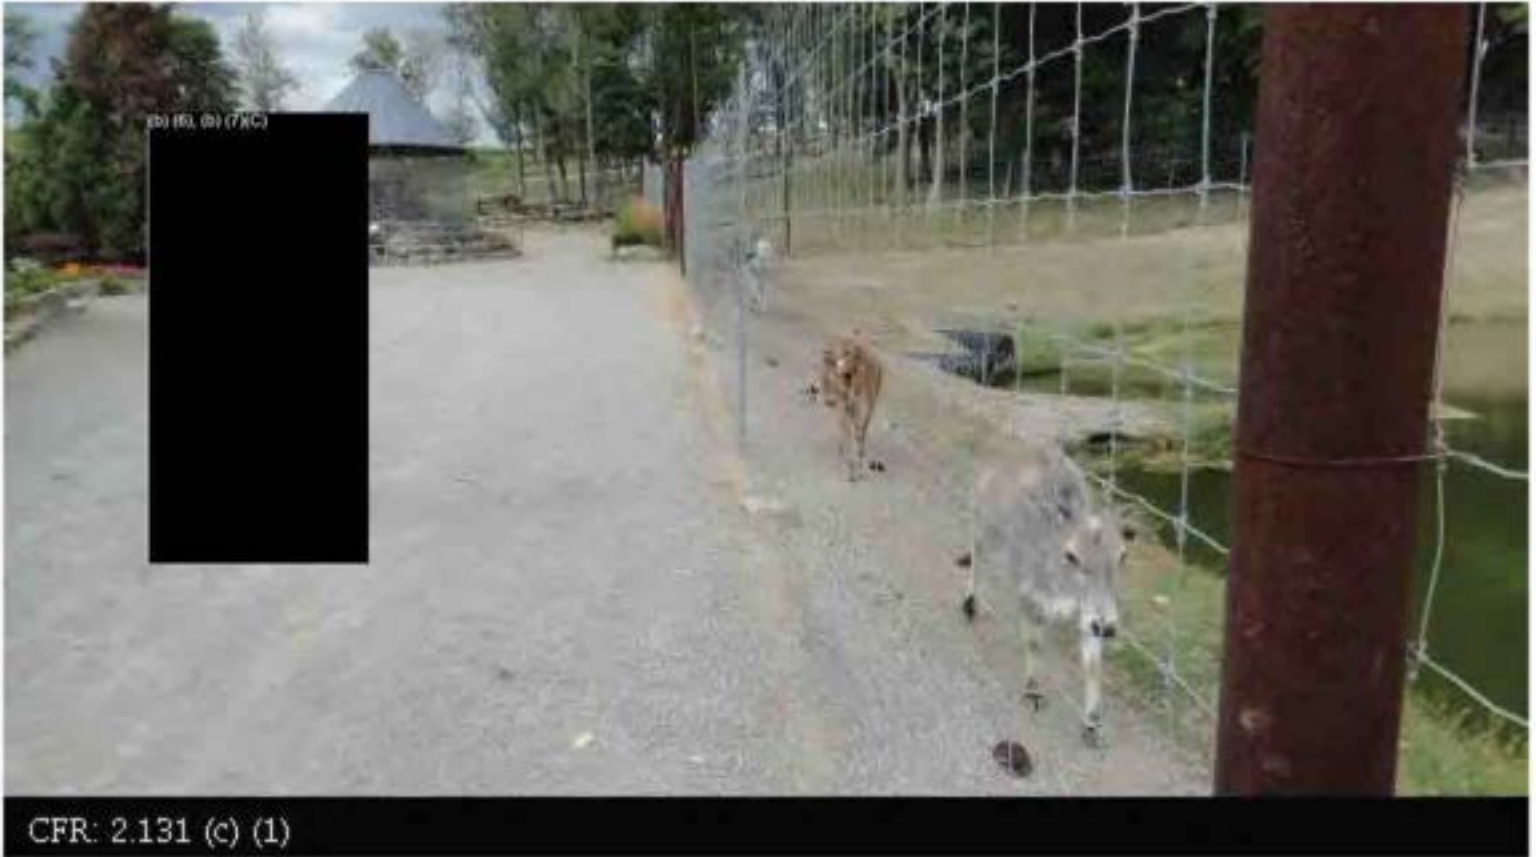
Photographer:	Dana Miller	Legal Name:	55-B-0069
Photo Taken:	Tue, Aug 25, '15 12-130 pm	HENRY HAMPTON	
Inspection:	240150633510674		
Description:	Section 2.131 (c)(1): Public walk thru area of facility with no barriers or attendants.

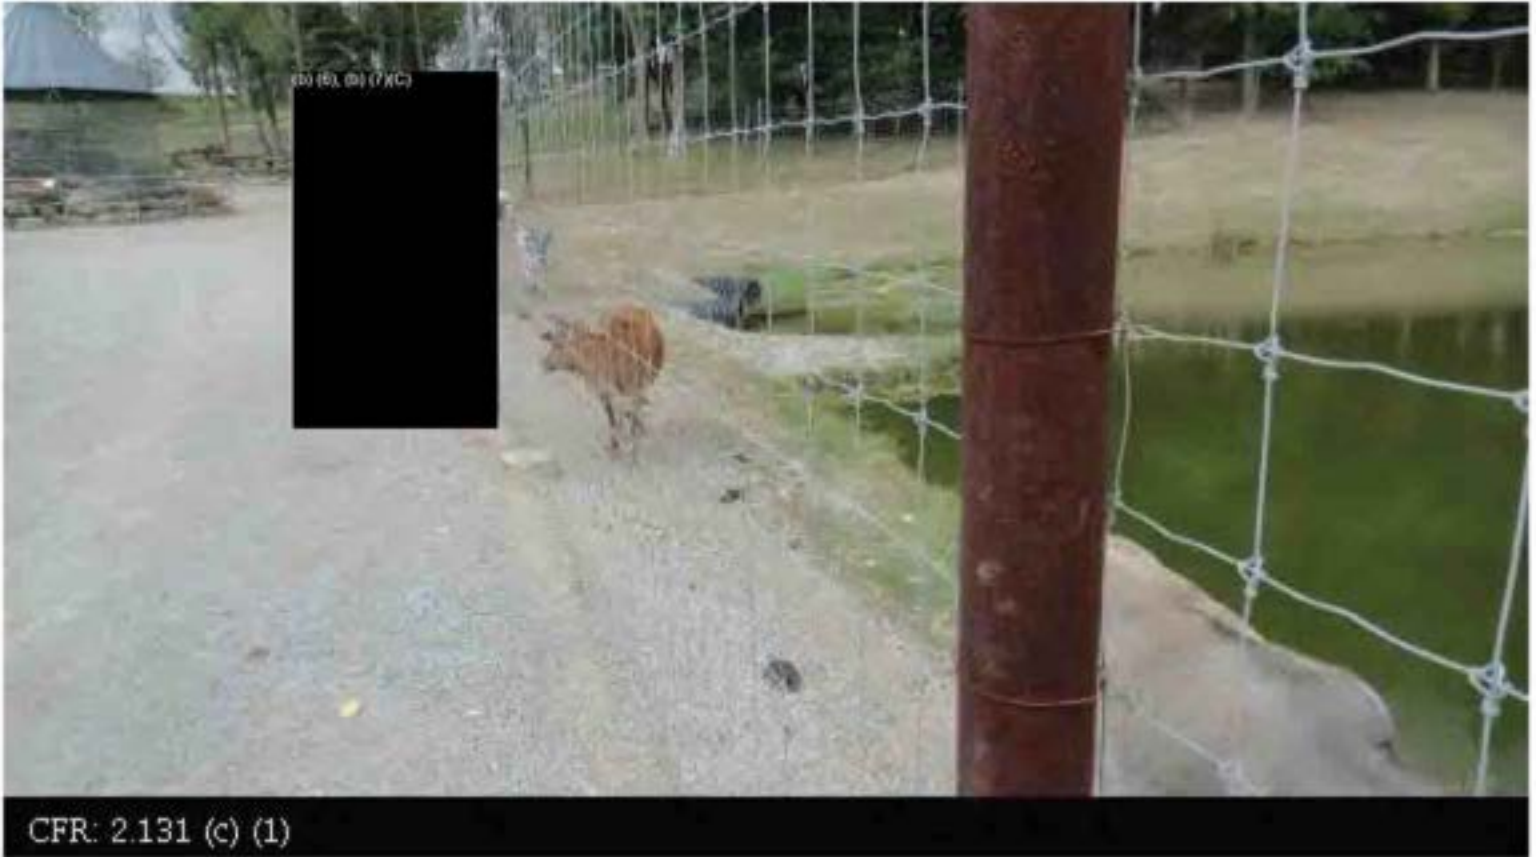
Photographer:	Dana Miller	Legal Name:	55-B-0069
Photo Taken:	Tue, Aug 25, '15 12-130 pm	HENRY HAMPTON	
Inspection:	240150633510674		
Description:	Section 2.131 (c)(1): Public walk thru area of facility with no barriers or attendants.
