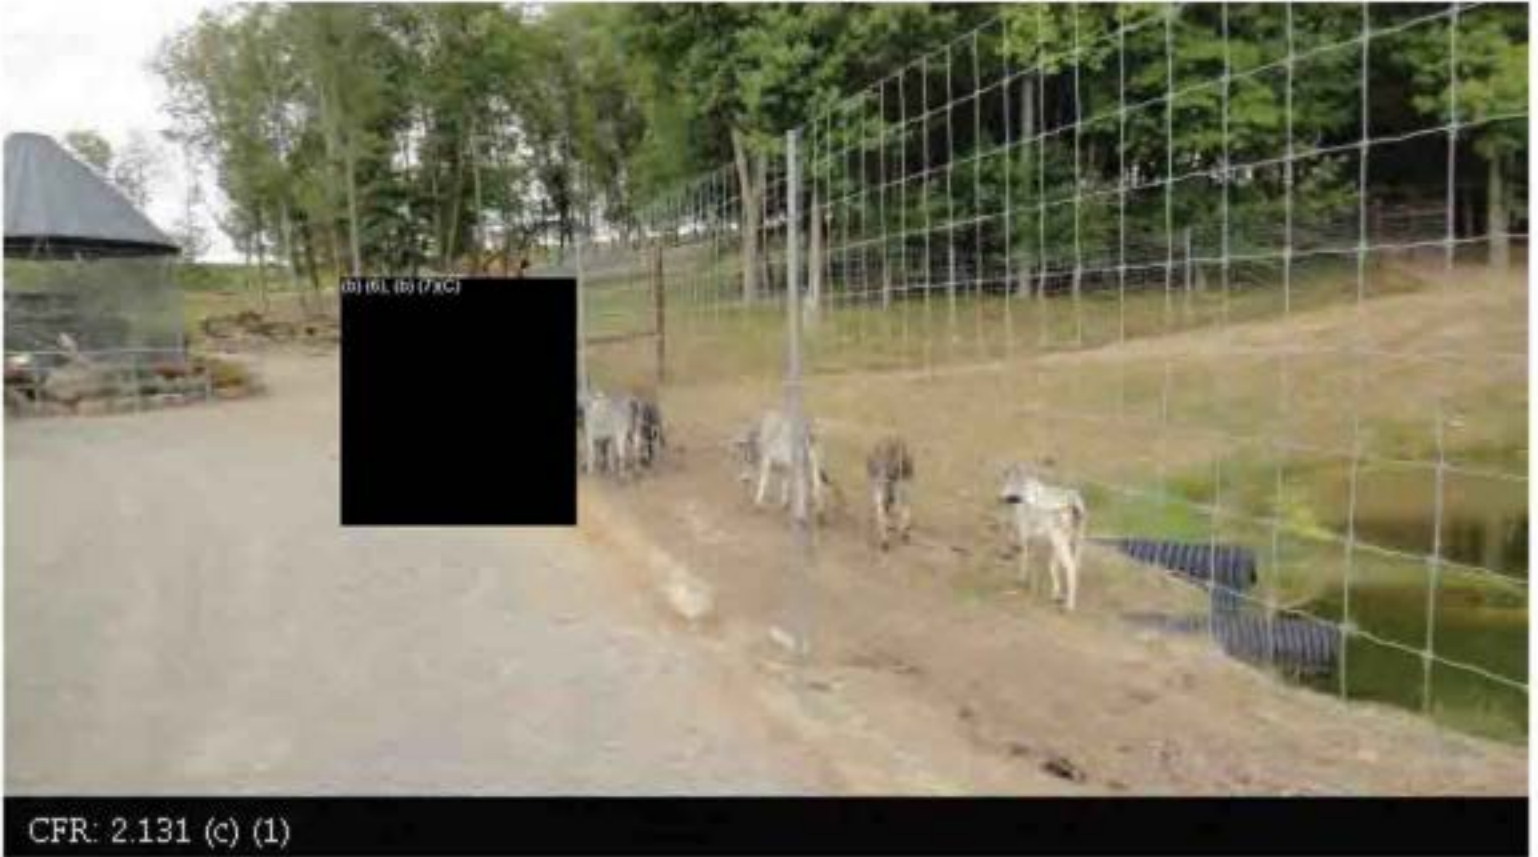
CFR: 2.131 (c) (1)

Photographer:	Dana Miller	Legal Name:	55-B-0069
Photo Taken:	Tue, Aug 25, '15 12-130 pm	HENRY HAMPTON	
Inspection:	240150633510674		
Description:	Section 2.131 (c)(1): Public walk thru area of facility with no barriers or attendants.

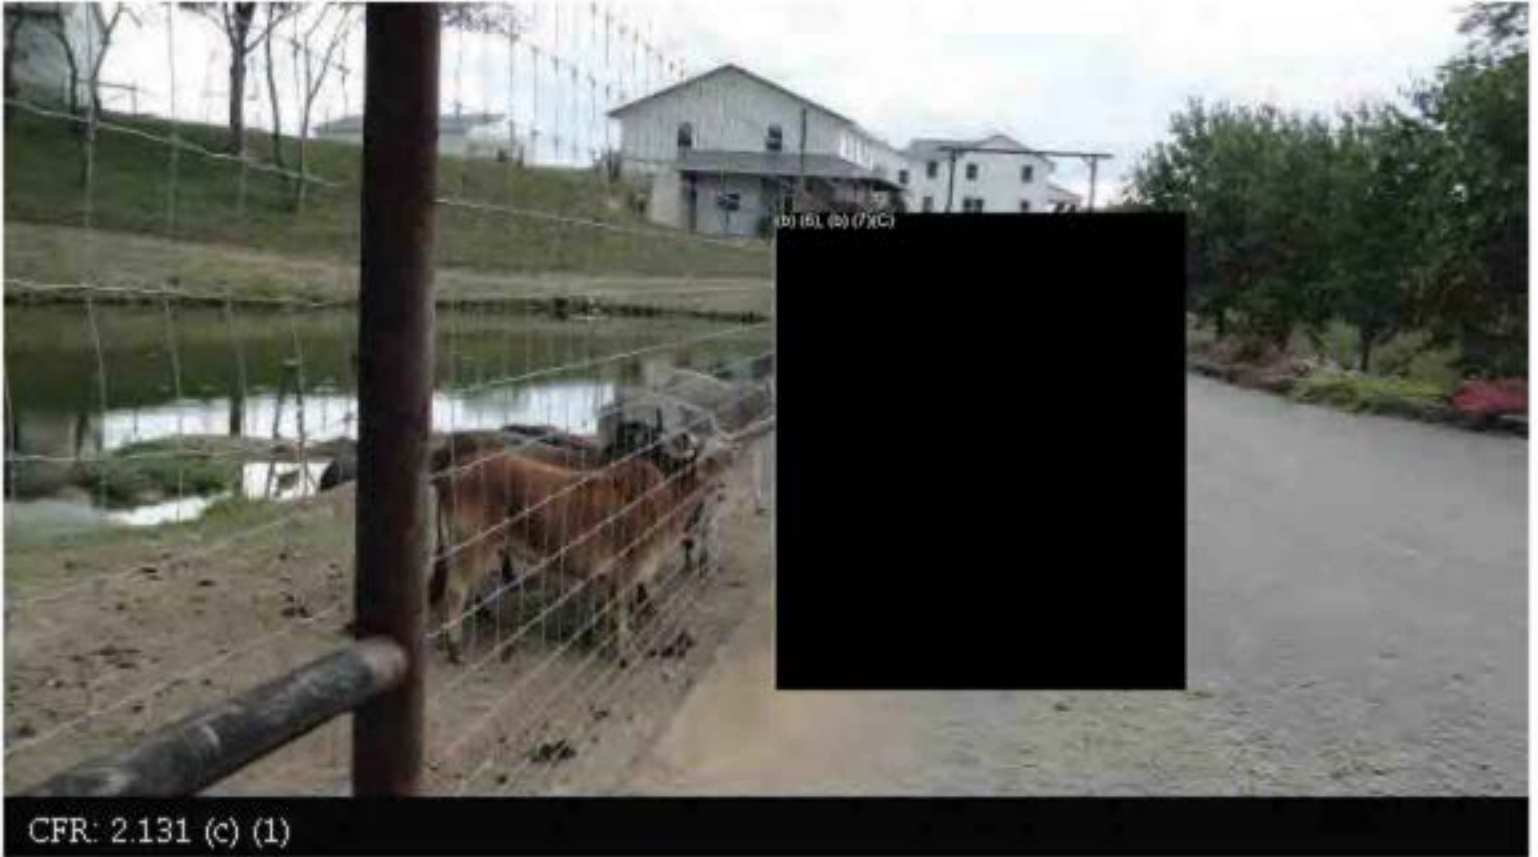
Photographer:	Dana Miller	Legal Name:	55-B-0069
Photo Taken:	Tue, Aug 25, '15 12-130 pm	HENRY HAMPTON	
Inspection:	240150633510674		
Description:	Section 2.131 (c)(1): Public walk thru area of facility with no barriers or attendants.

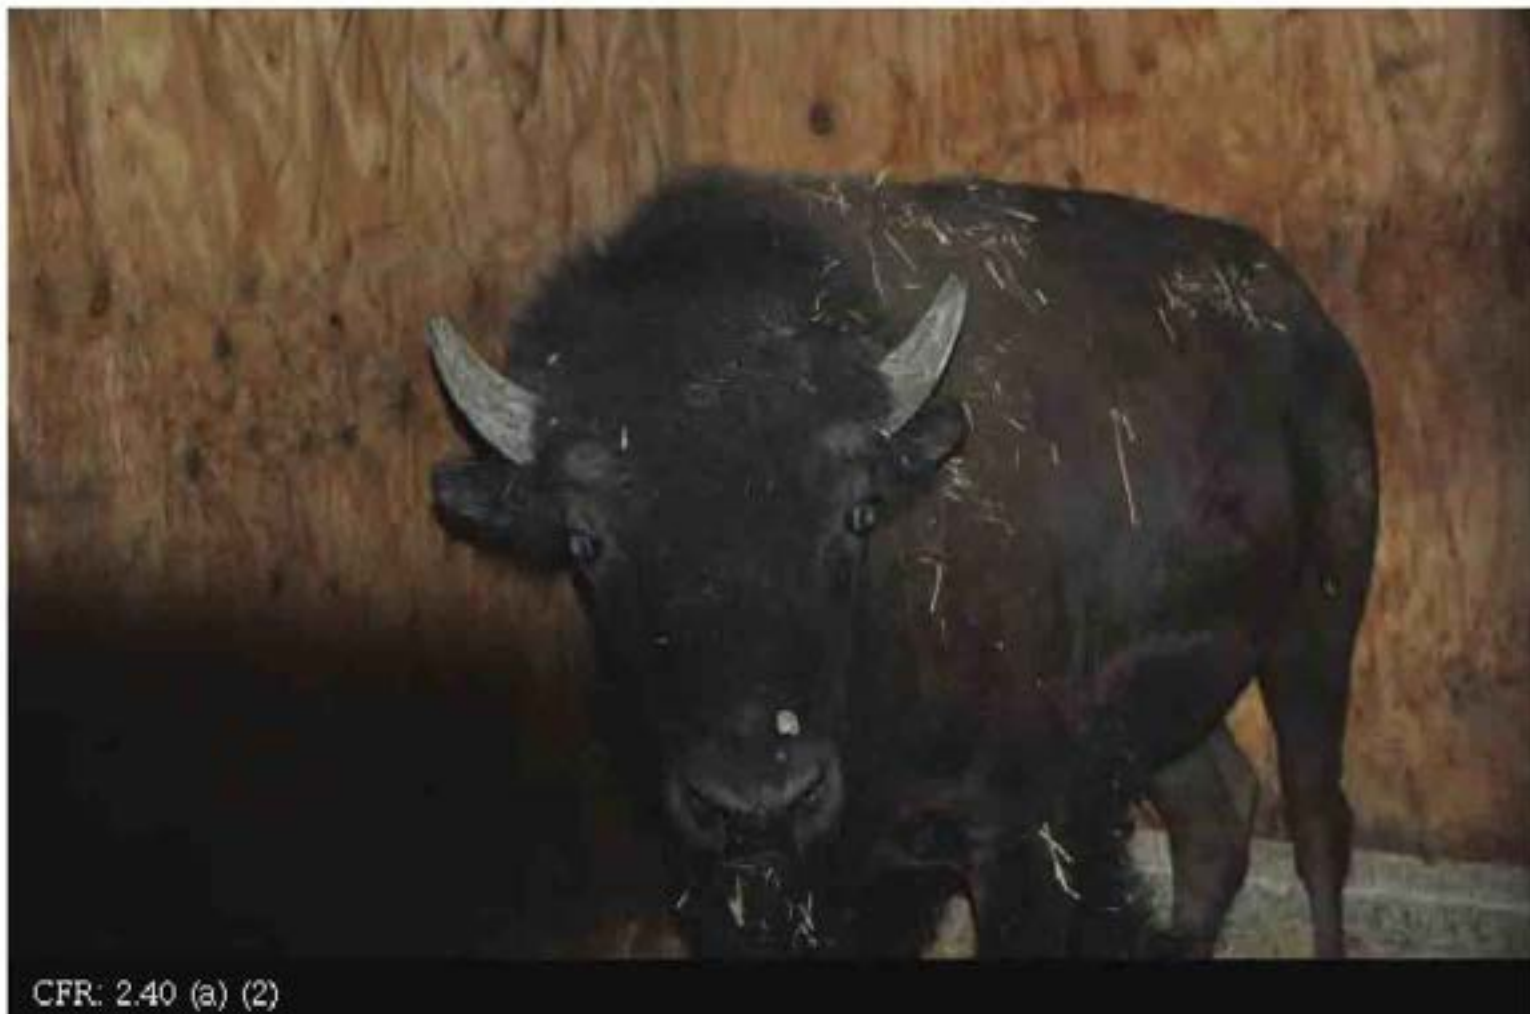
CFR: 2.40 (a) (2)

Photographer:	Randy Coleman	Legal Name:	55-B-0069
Photo Taken:	Tue, Aug 25, '15 234 pm	HENRY HAMPTON	
Inspection:	240150633510674		
Description:	Section 2.40(a)(2): Buffalo with cornea opacity in both eyes.

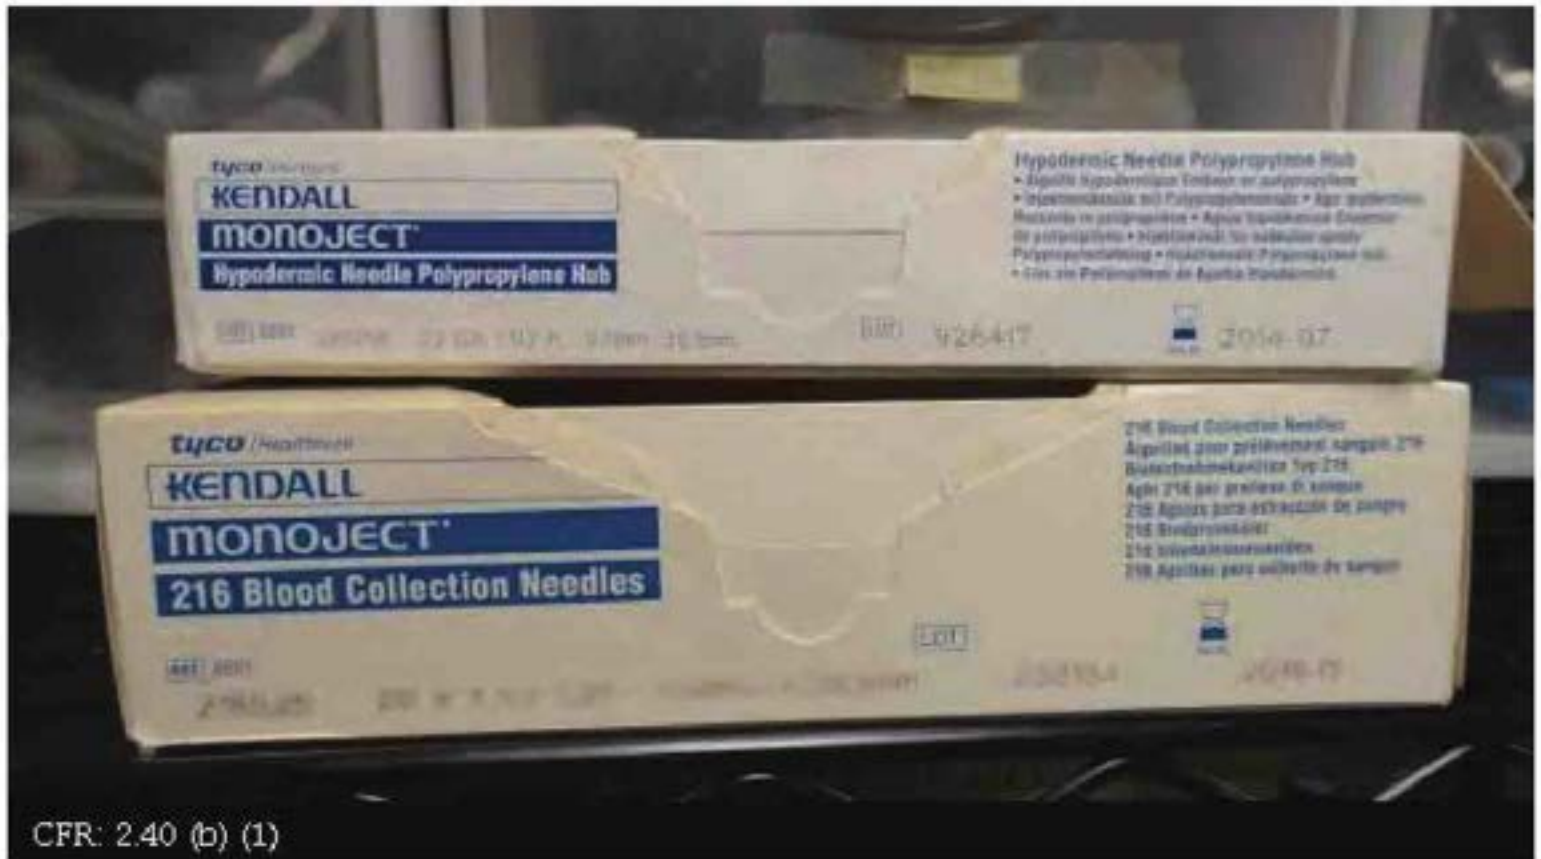
CFR: 2.40 (b) (1)

Photographer:	Dana Miller	Legal Name:	55-B-0069
Photo Taken:	Tue, Aug 25, '15 359 pm	HENRY HAMPTON	
Inspection:	240150633510674		
Description:	Section 2.40(b)(1): Expired medical materials found at facility.

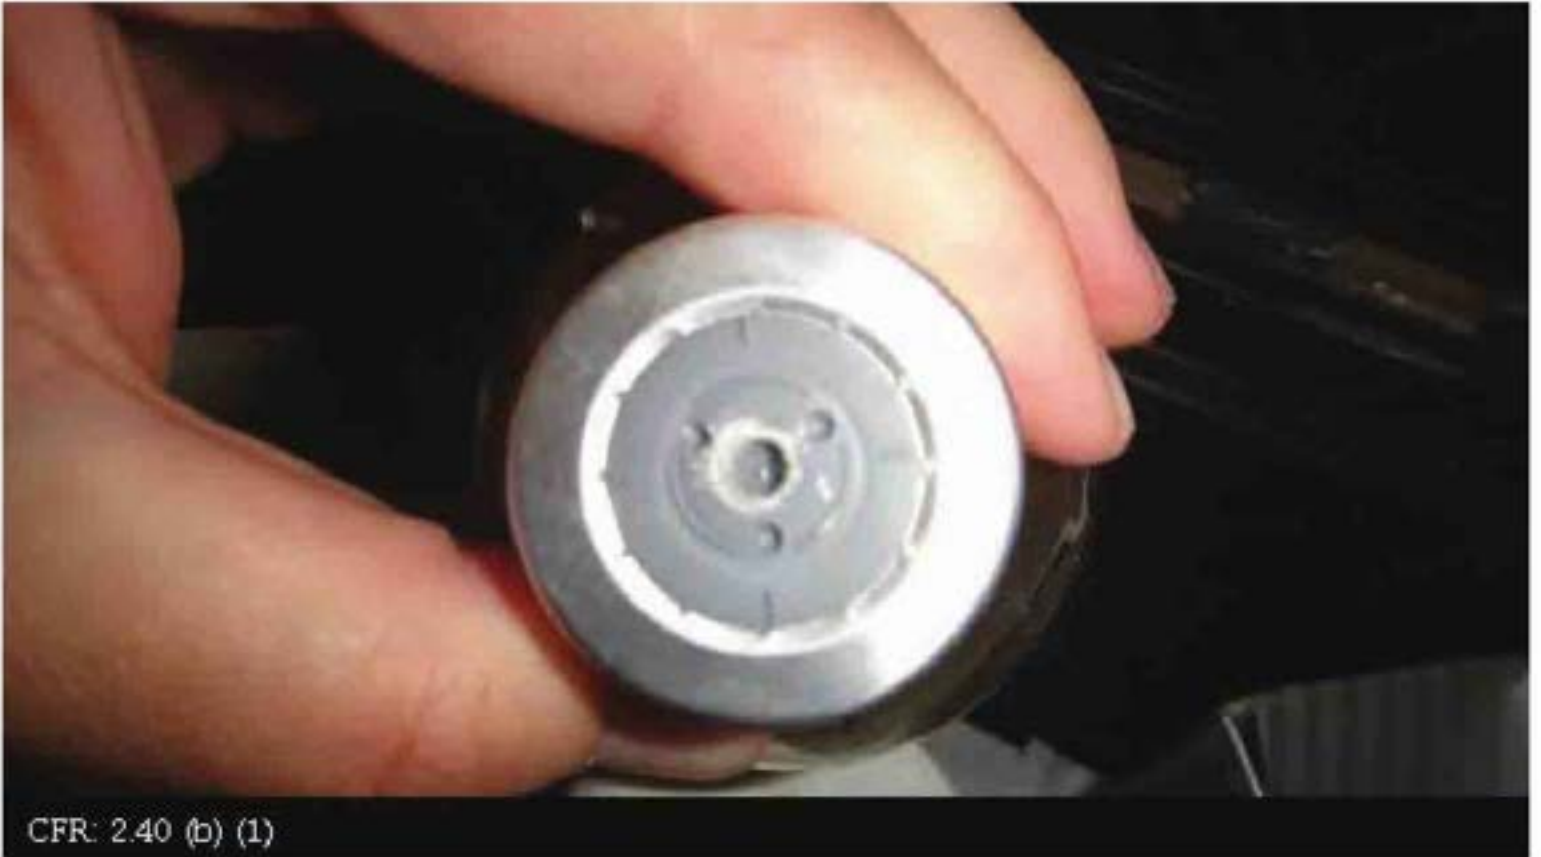
Photographer:	Dana Miller	Legal Name:	55-B-0069
Photo Taken:	Tue, Aug 25, '15 1255 pm	HENRY HAMPTON	
Inspection:	240150633510674		
Description:	Section 2.40(b)(1): Expired drug found at facility.

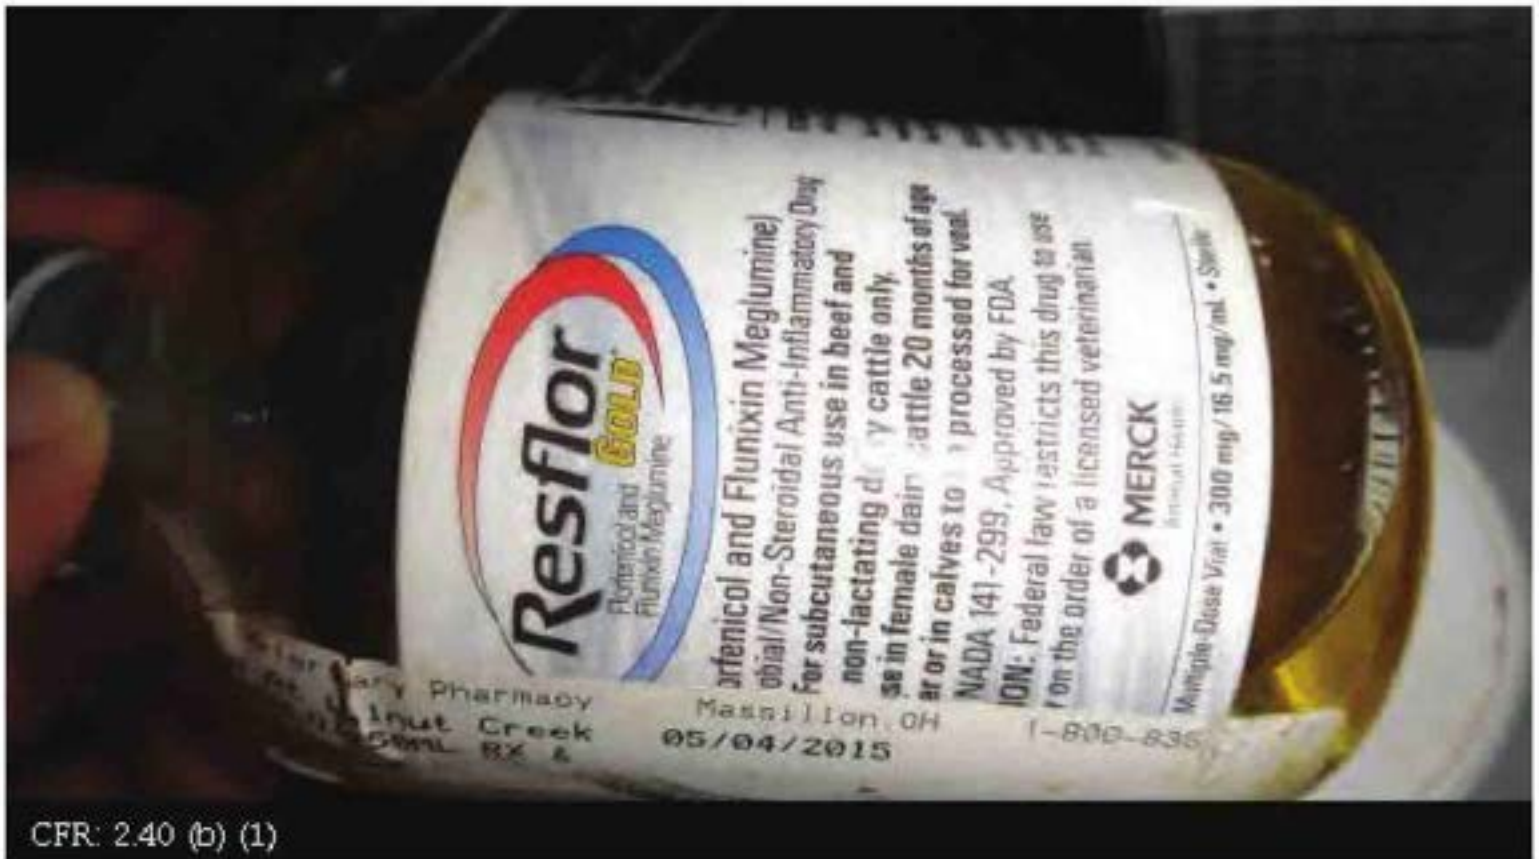
CFR: 2.40 (b) (1)

Photographer:	Dana Miller	Legal Name:	55-B-0069
Photo Taken:	Tue, Aug 25, '15 1255 pm	HENRY HAMPTON	
Inspection:	240150633510674		
Description:	Section 2.40(b)(1): Expired drug found at facility.

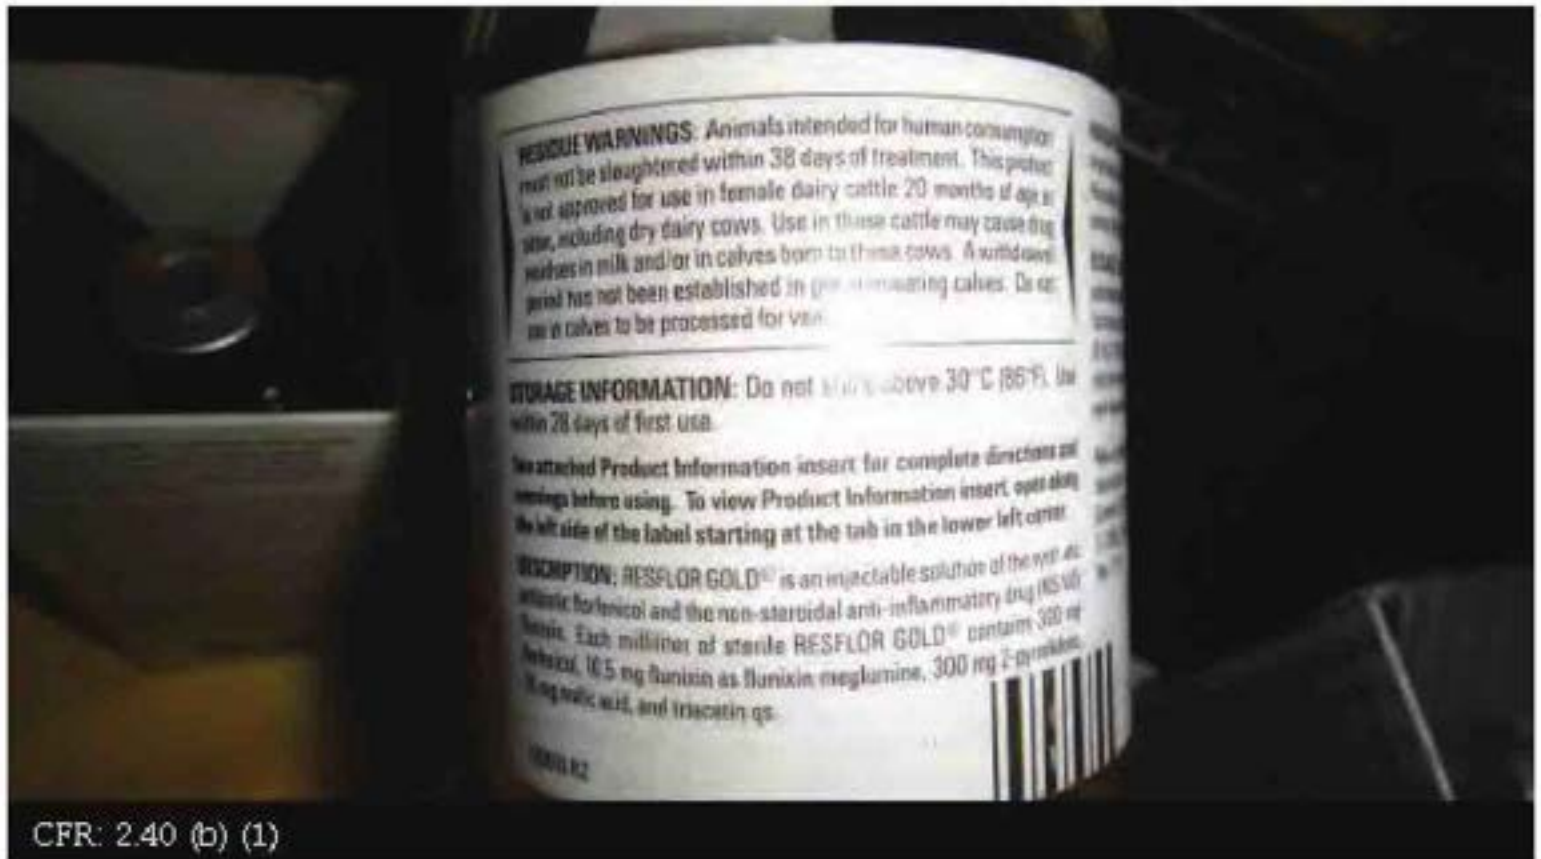
CFR: 2.40 (b) (1)

Photographer:	Dana Miller	Legal Name:	55-B-0069
Photo Taken:	Tue, Aug 25, '15 1255 pm	HENRY HAMPTON	
Inspection:	240150633510674		
Description:	Section 2.40(b)(1): Expired drug found at facility.

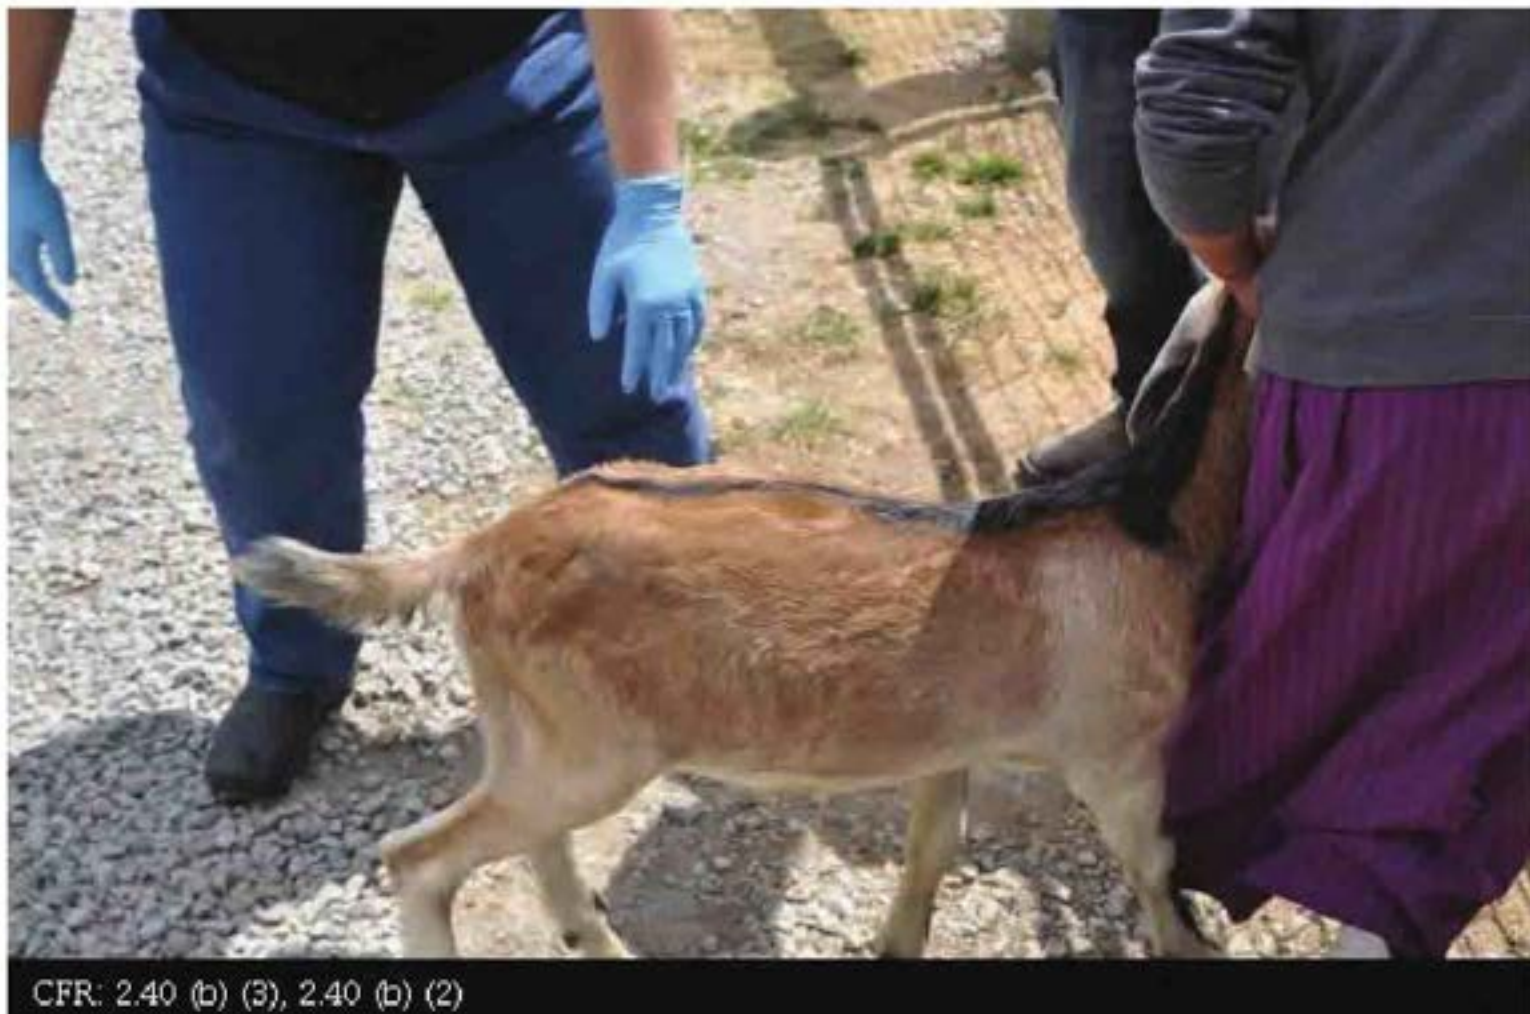
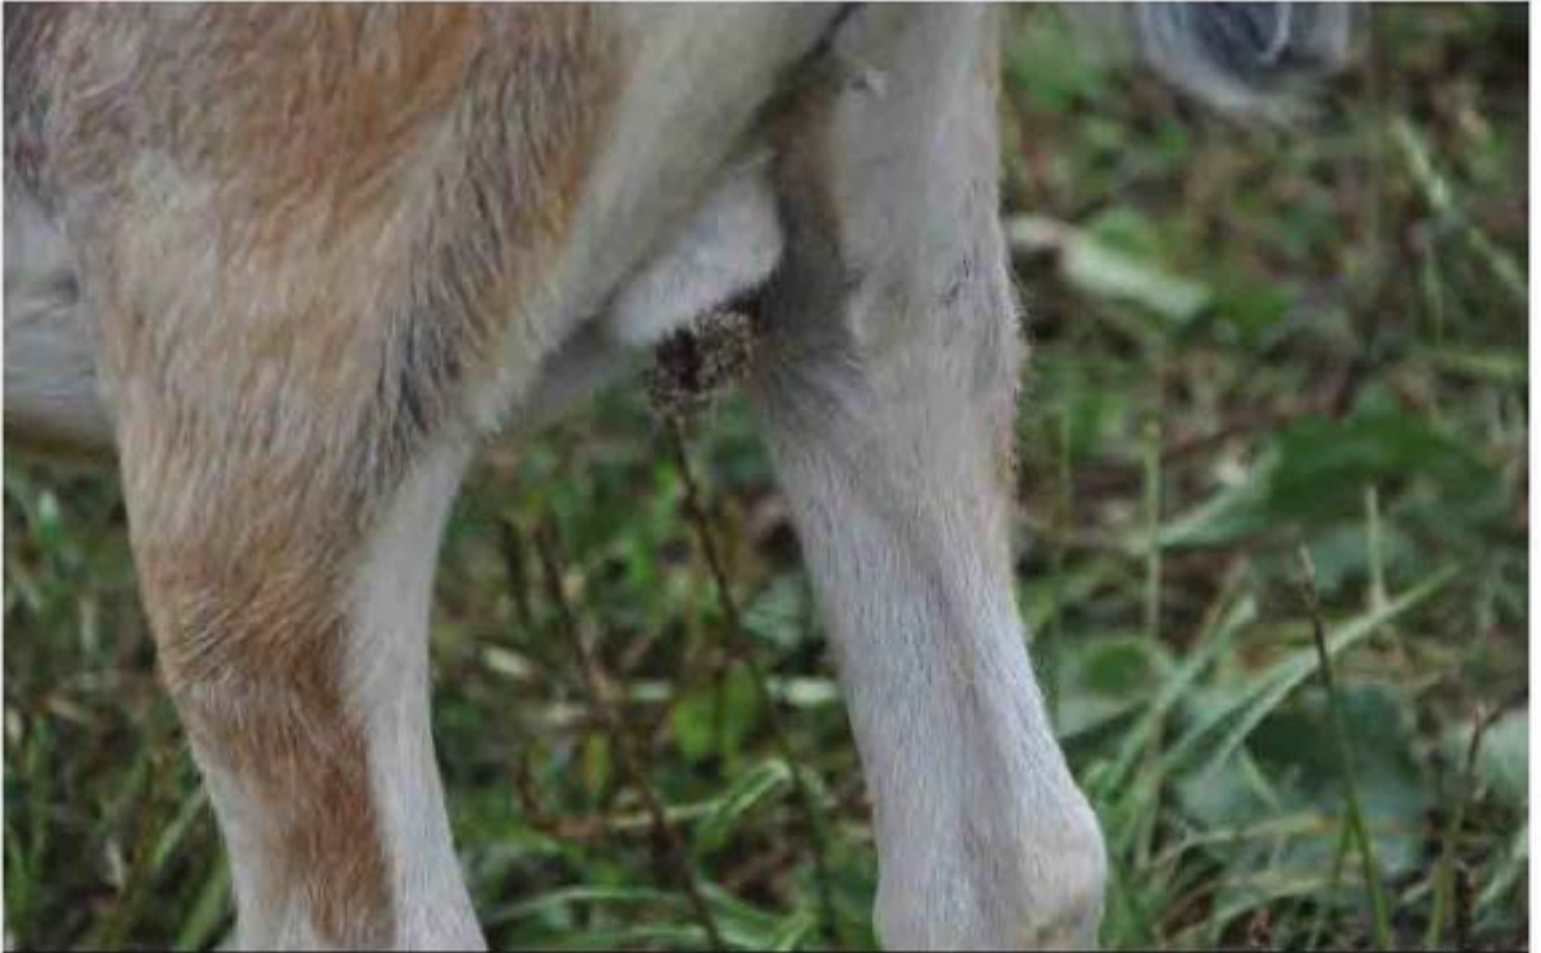
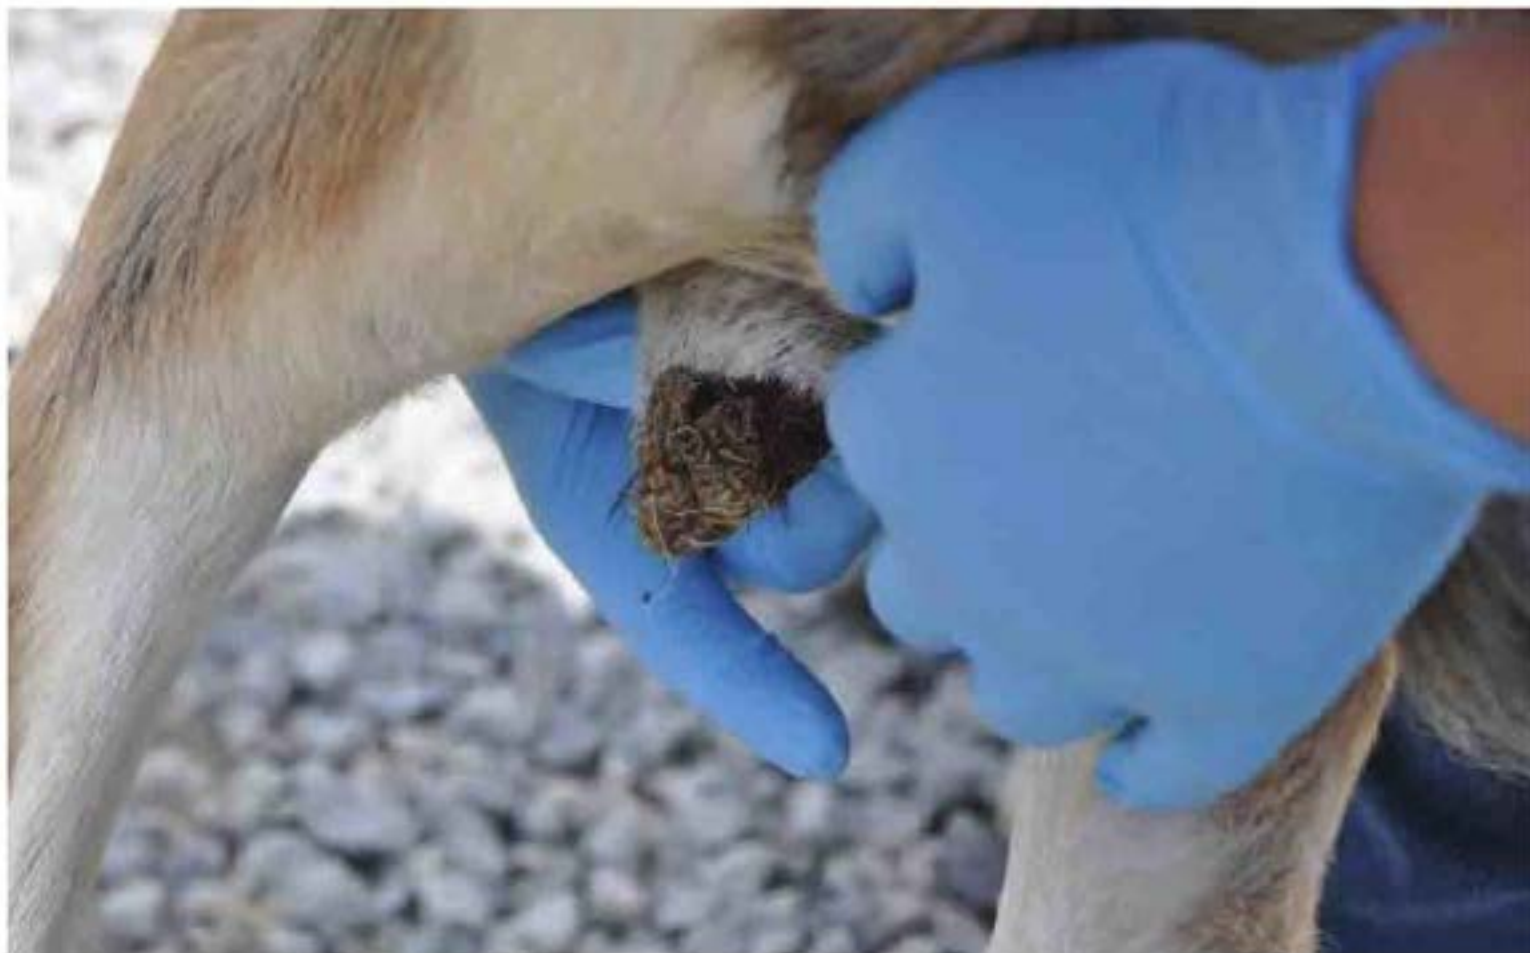
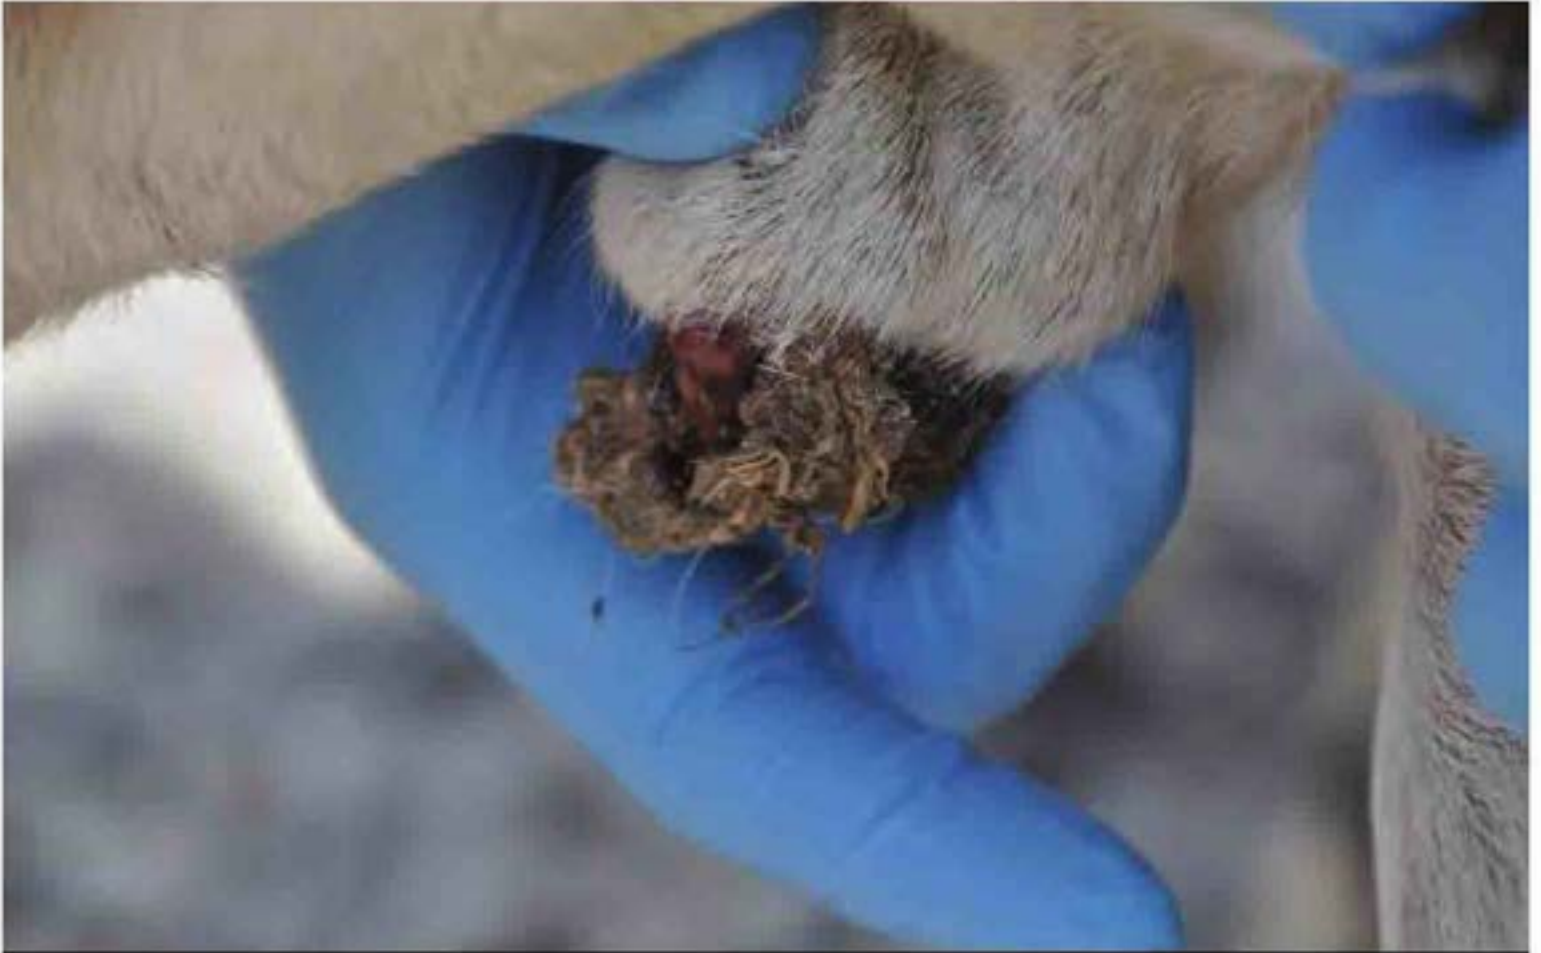
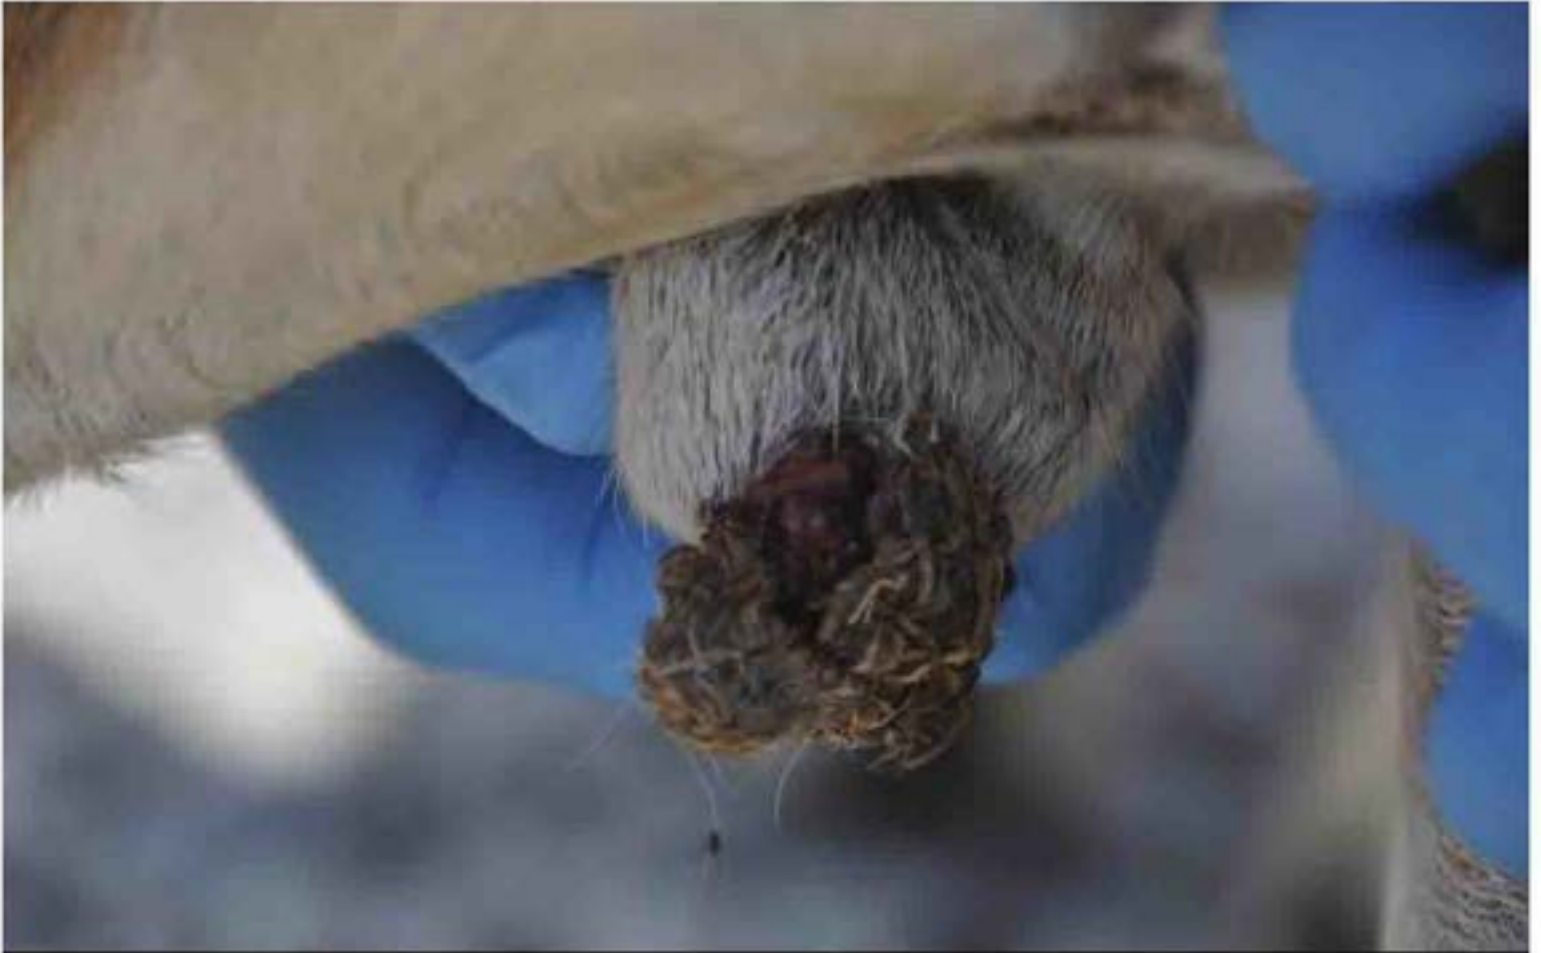
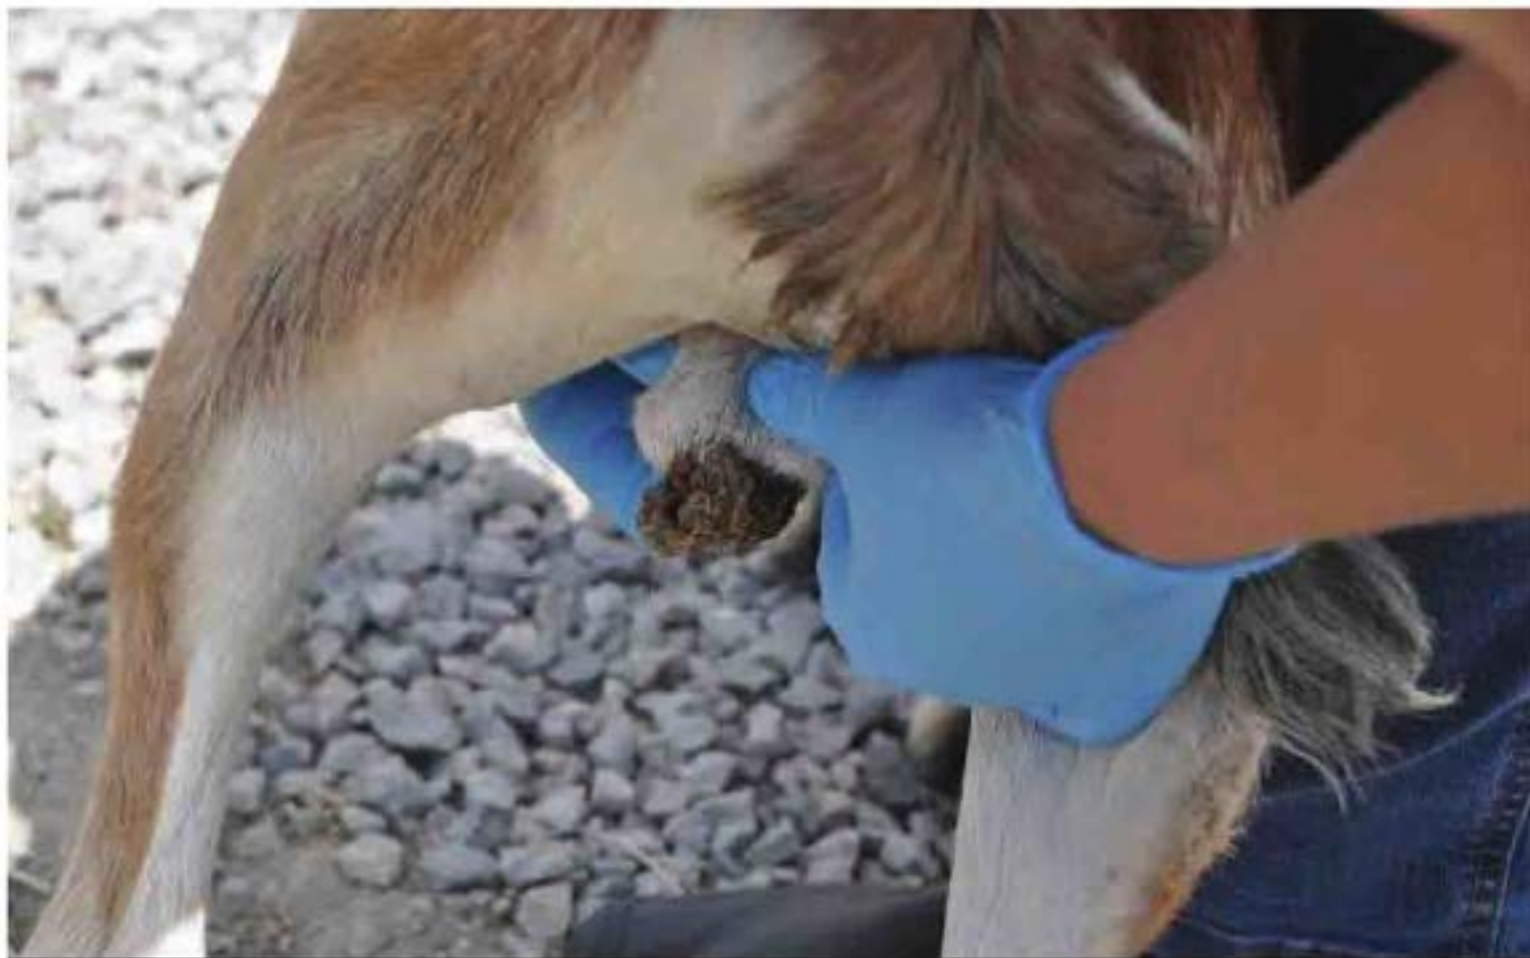
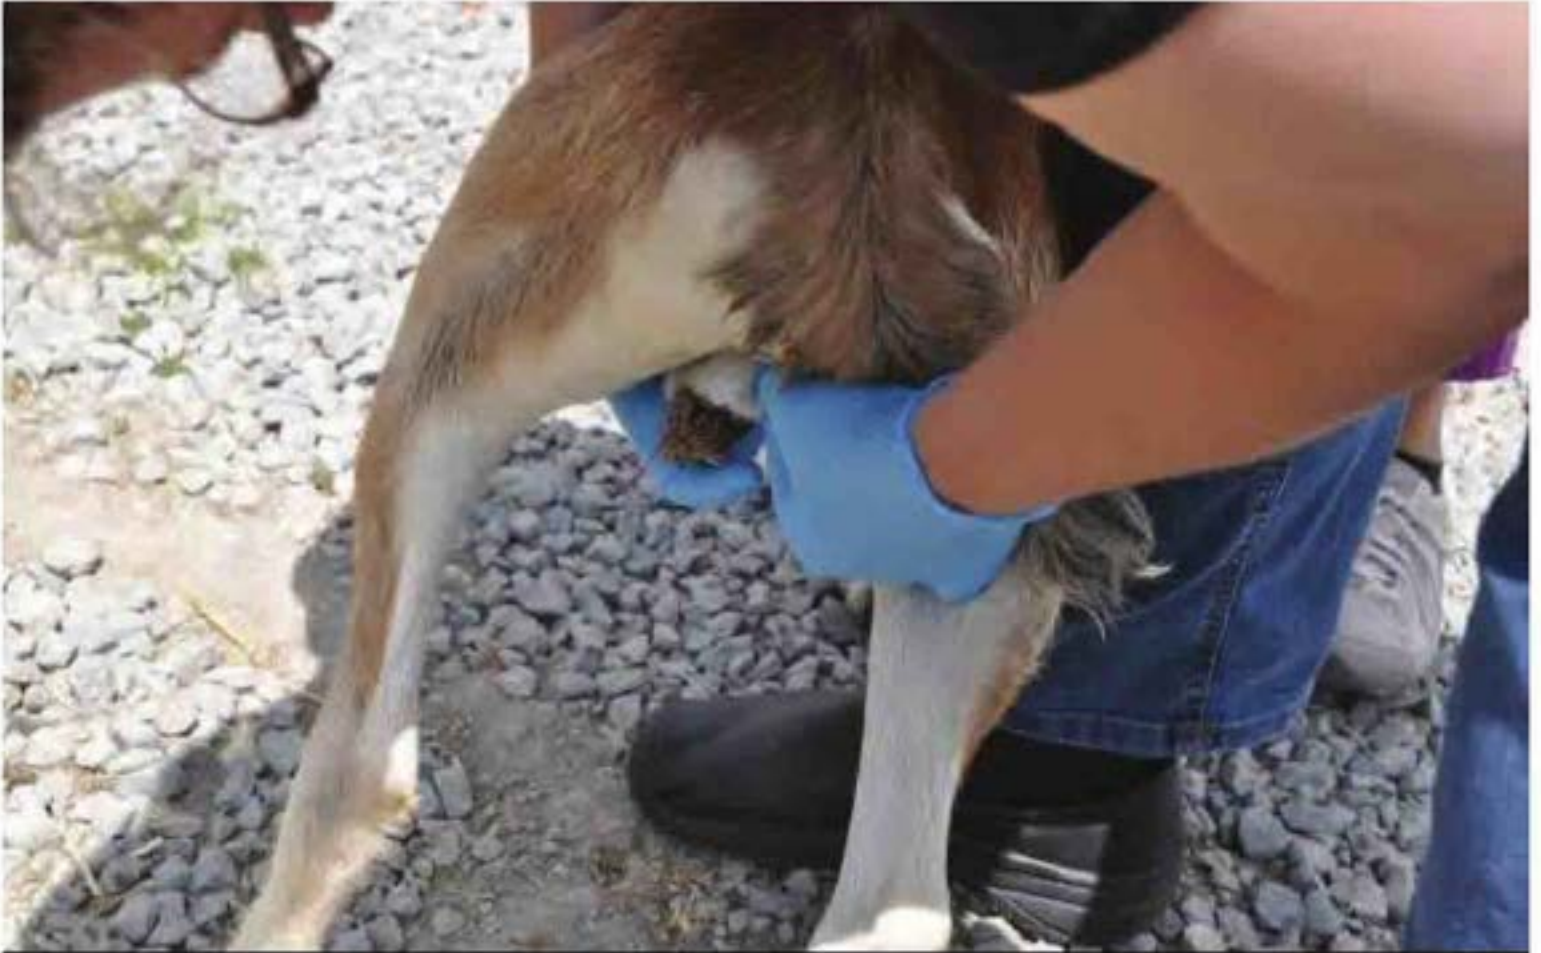
Photographer:	Randy Coleman	Legal Name:	55-B-0069
Photo Taken:	Tue, Aug 25, '15 115 pm	HENRY HAMPTON	
Inspection:	240150633510674		
Description:	Section 2.40(b)(2): Male brown and black Nubian type goat with scrotum injury,

Photographer:	Randy Coleman	Legal Name:	55-B-0069
Photo Taken:	Tue, Aug 25, '15 115 pm	HENRY HAMPTON	
Inspection:	240150633510674		
Description:	Section 2.40(b)(2): Male brown and black Nubian type goat with scrotum injury.
