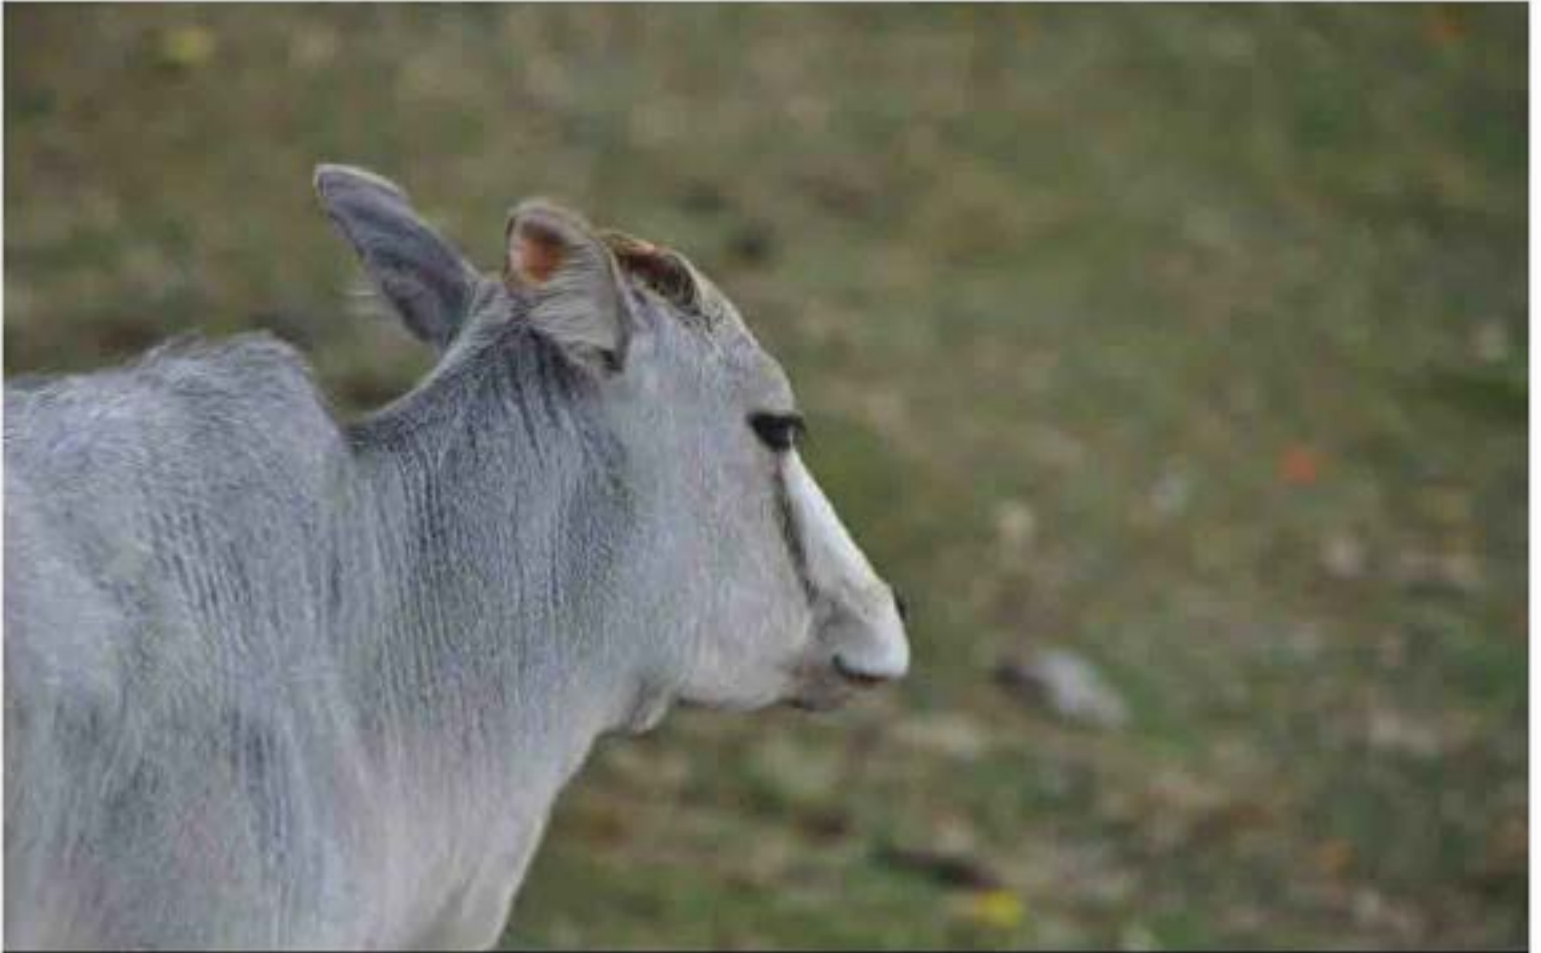
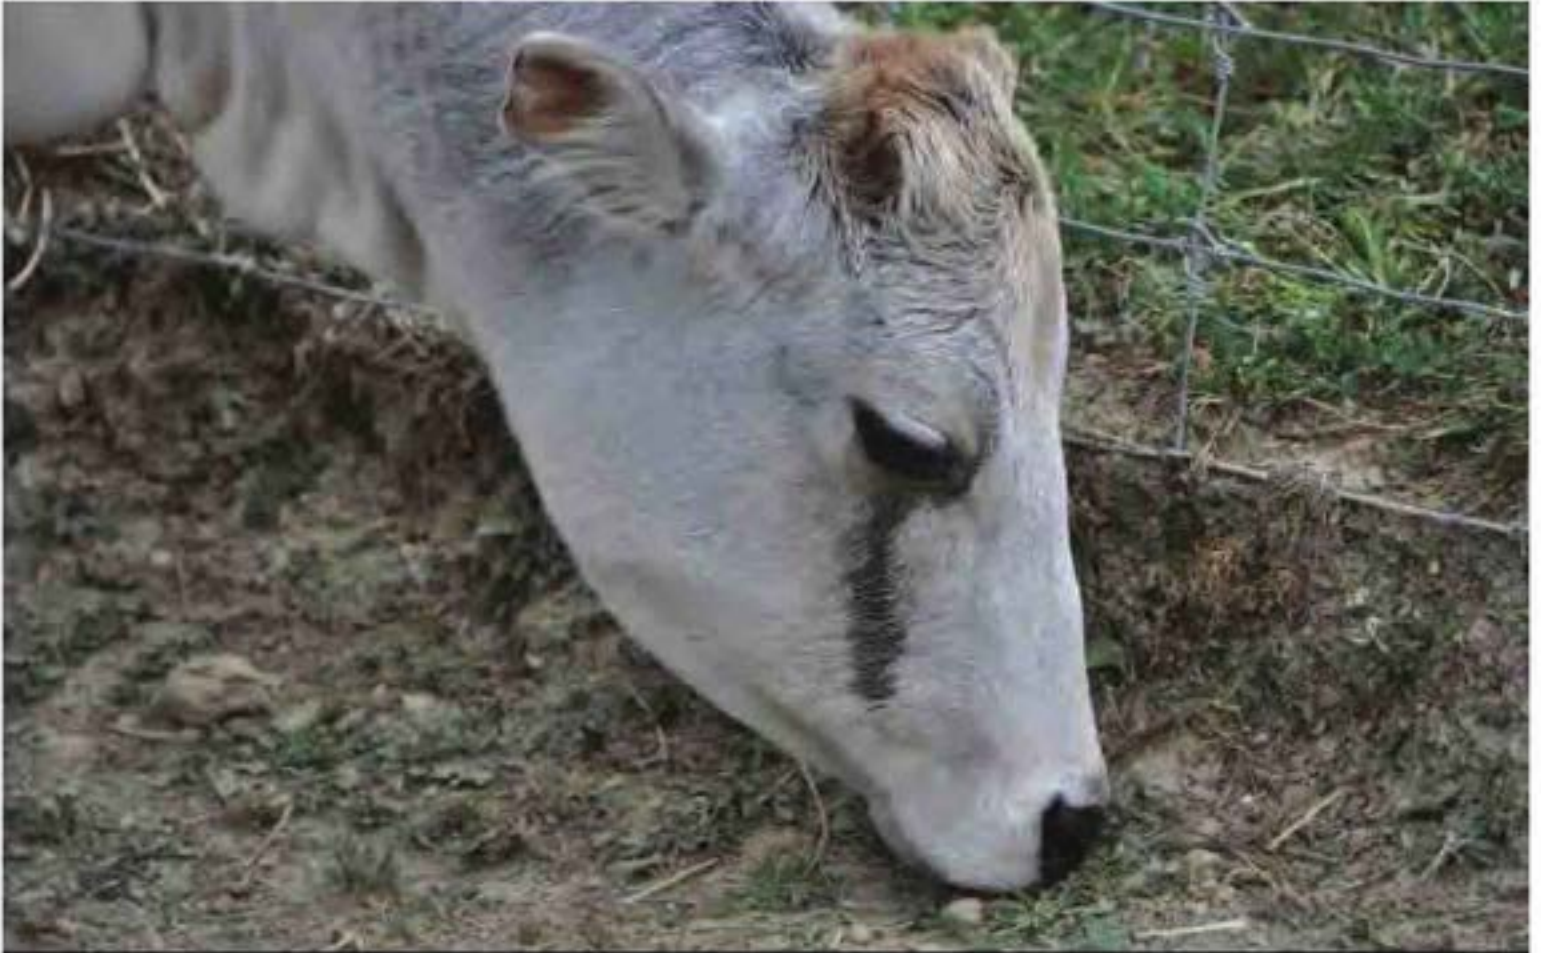
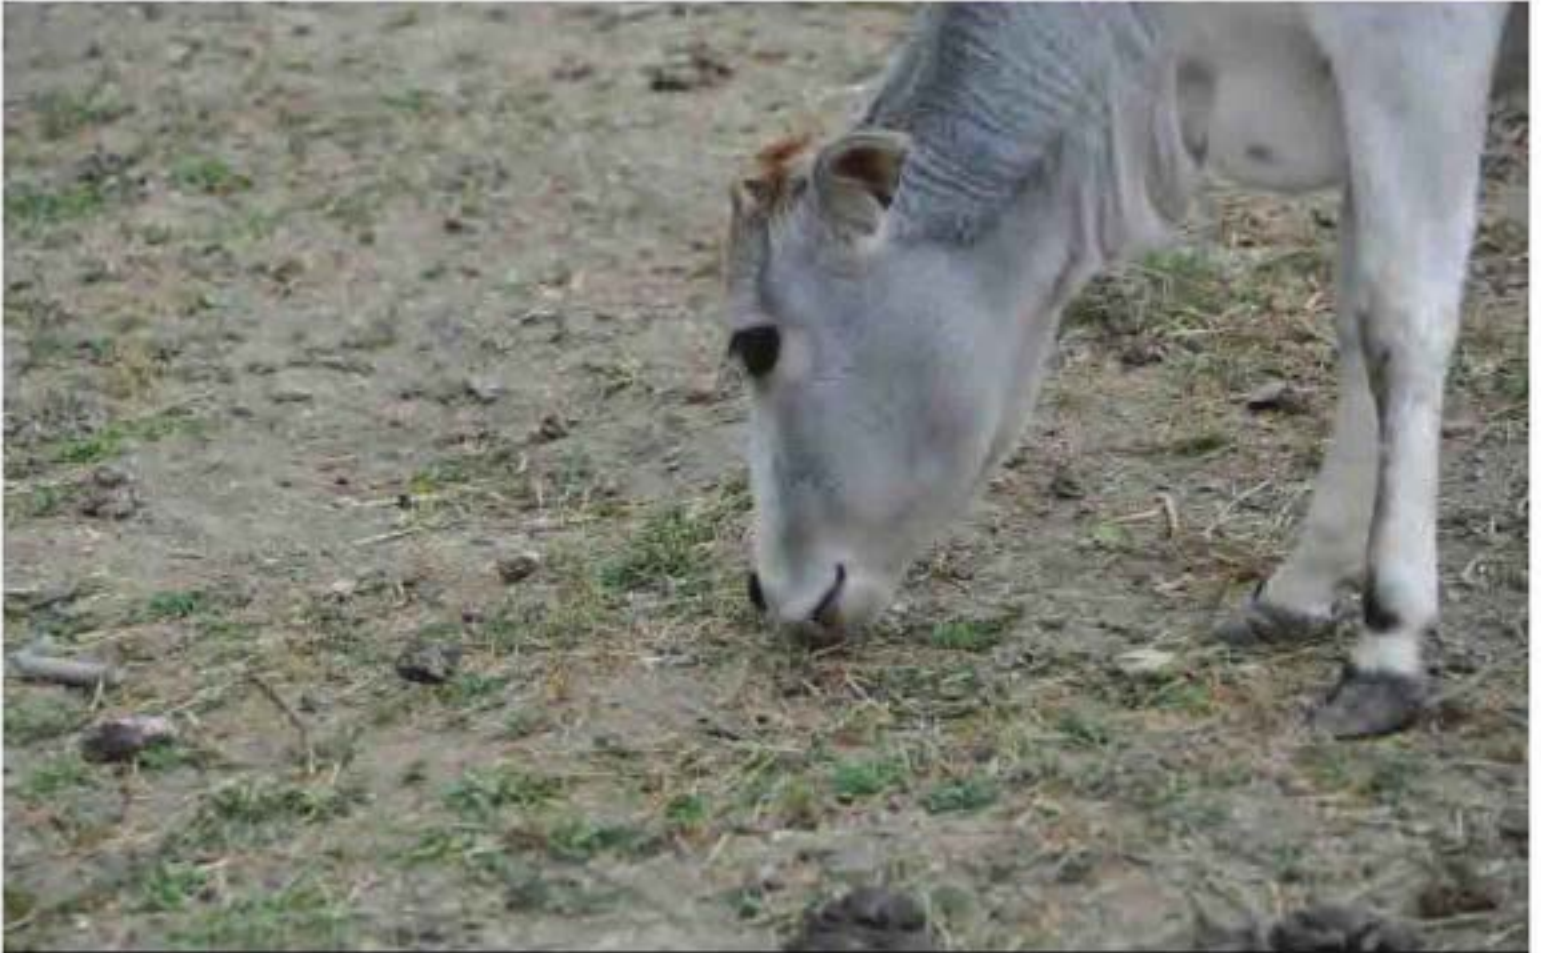
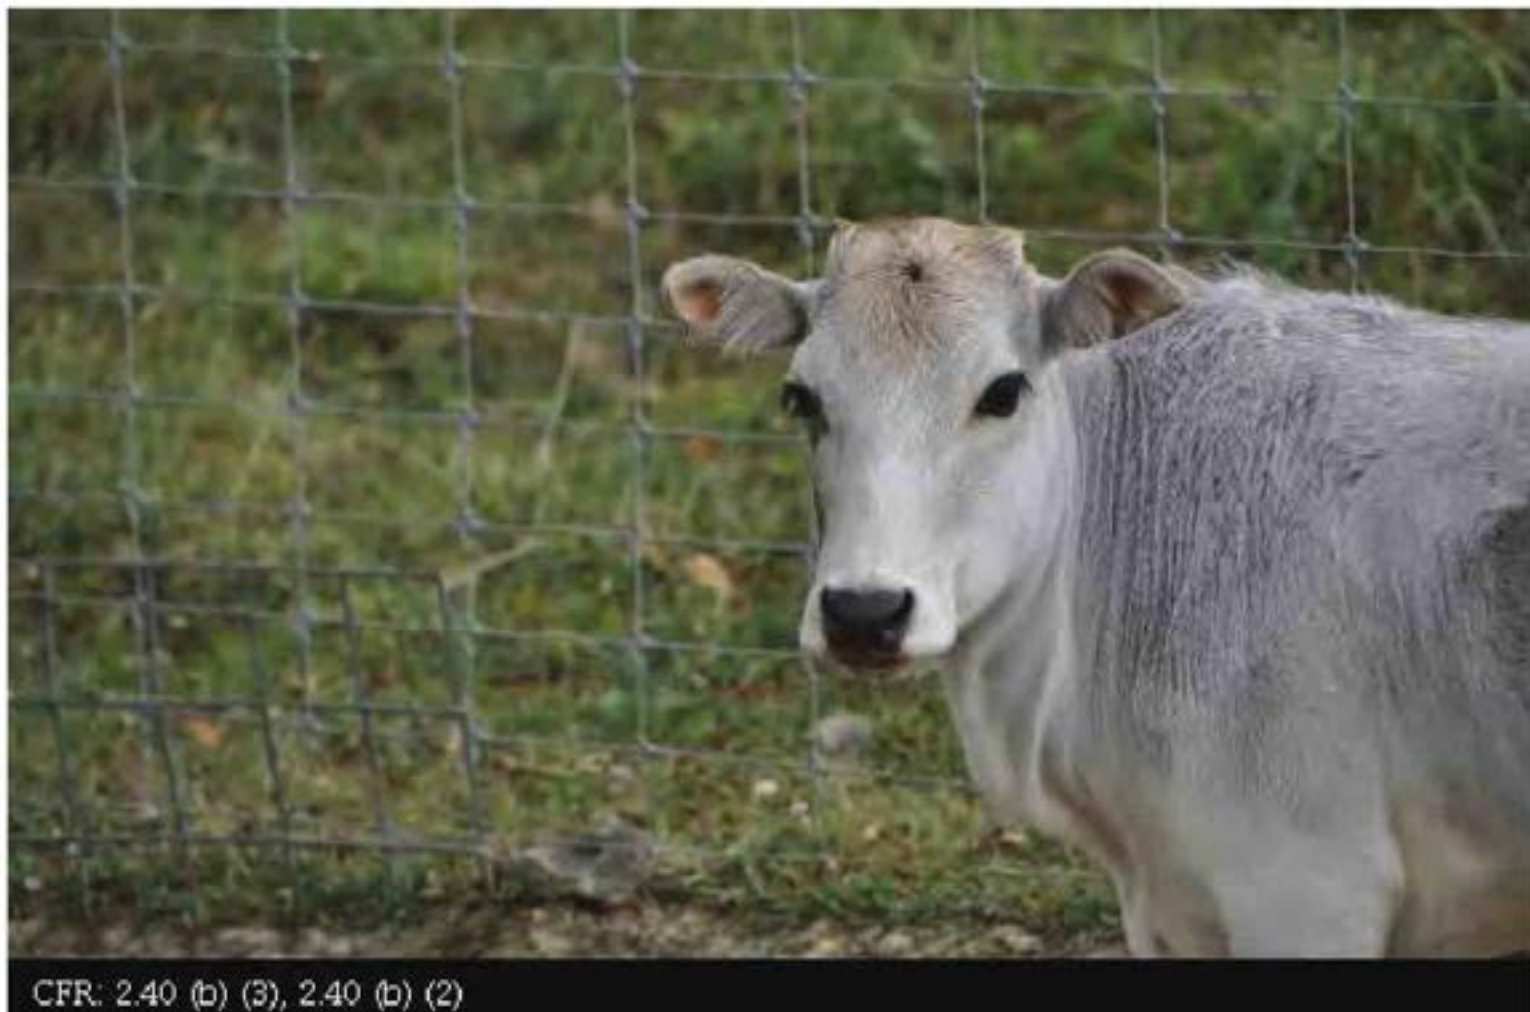
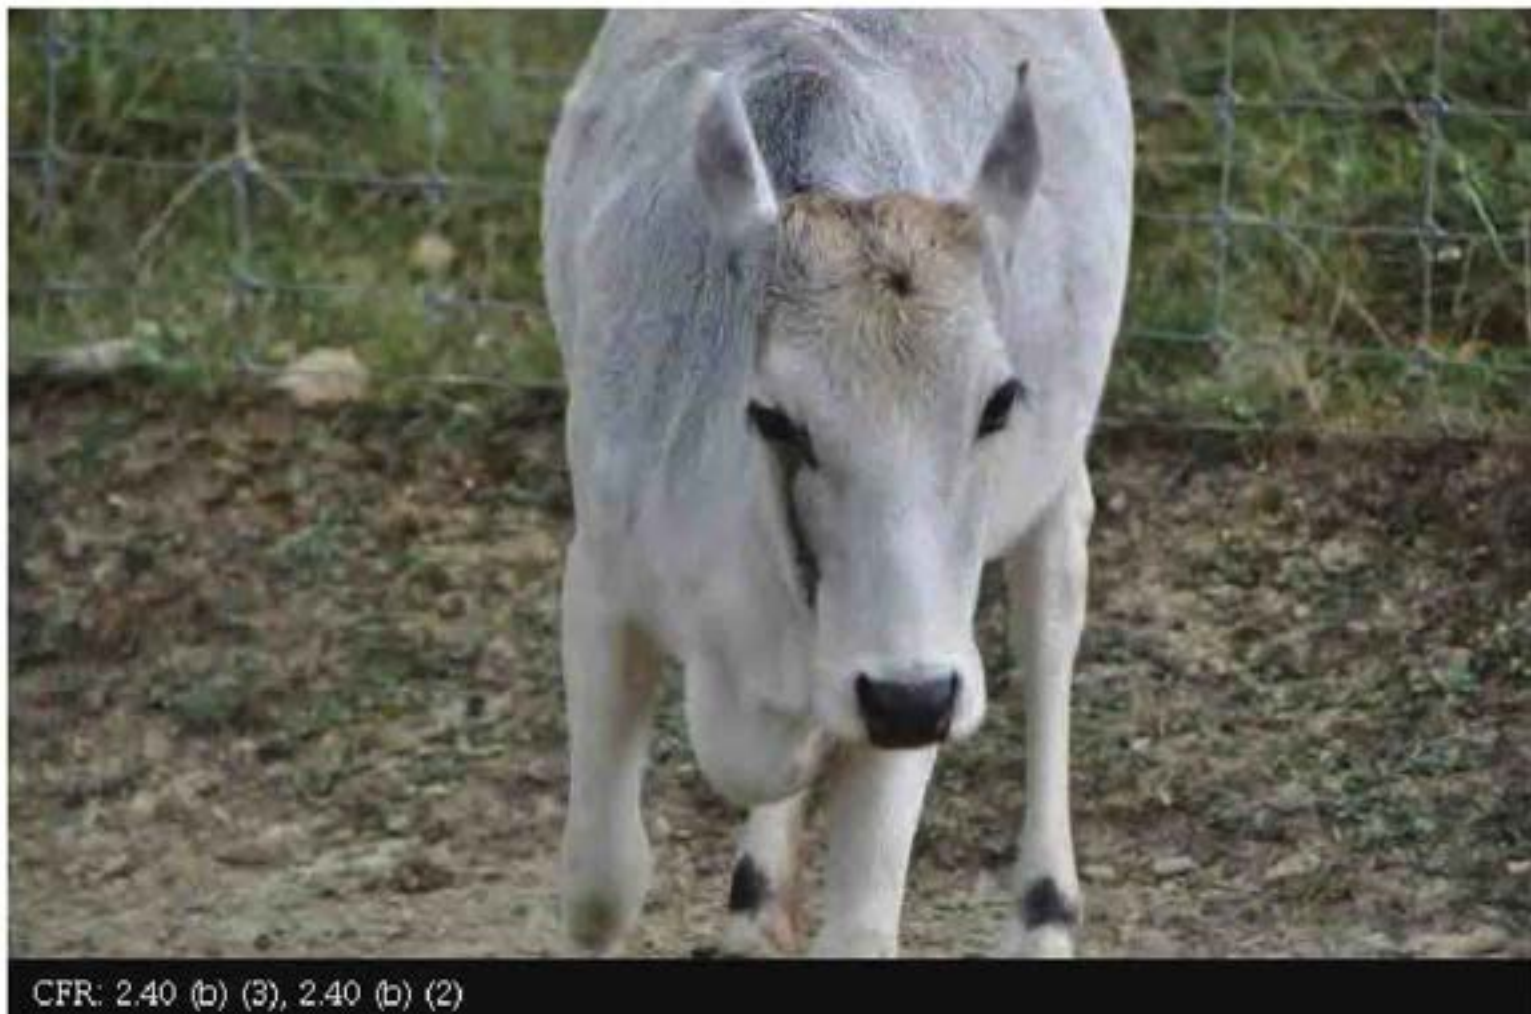
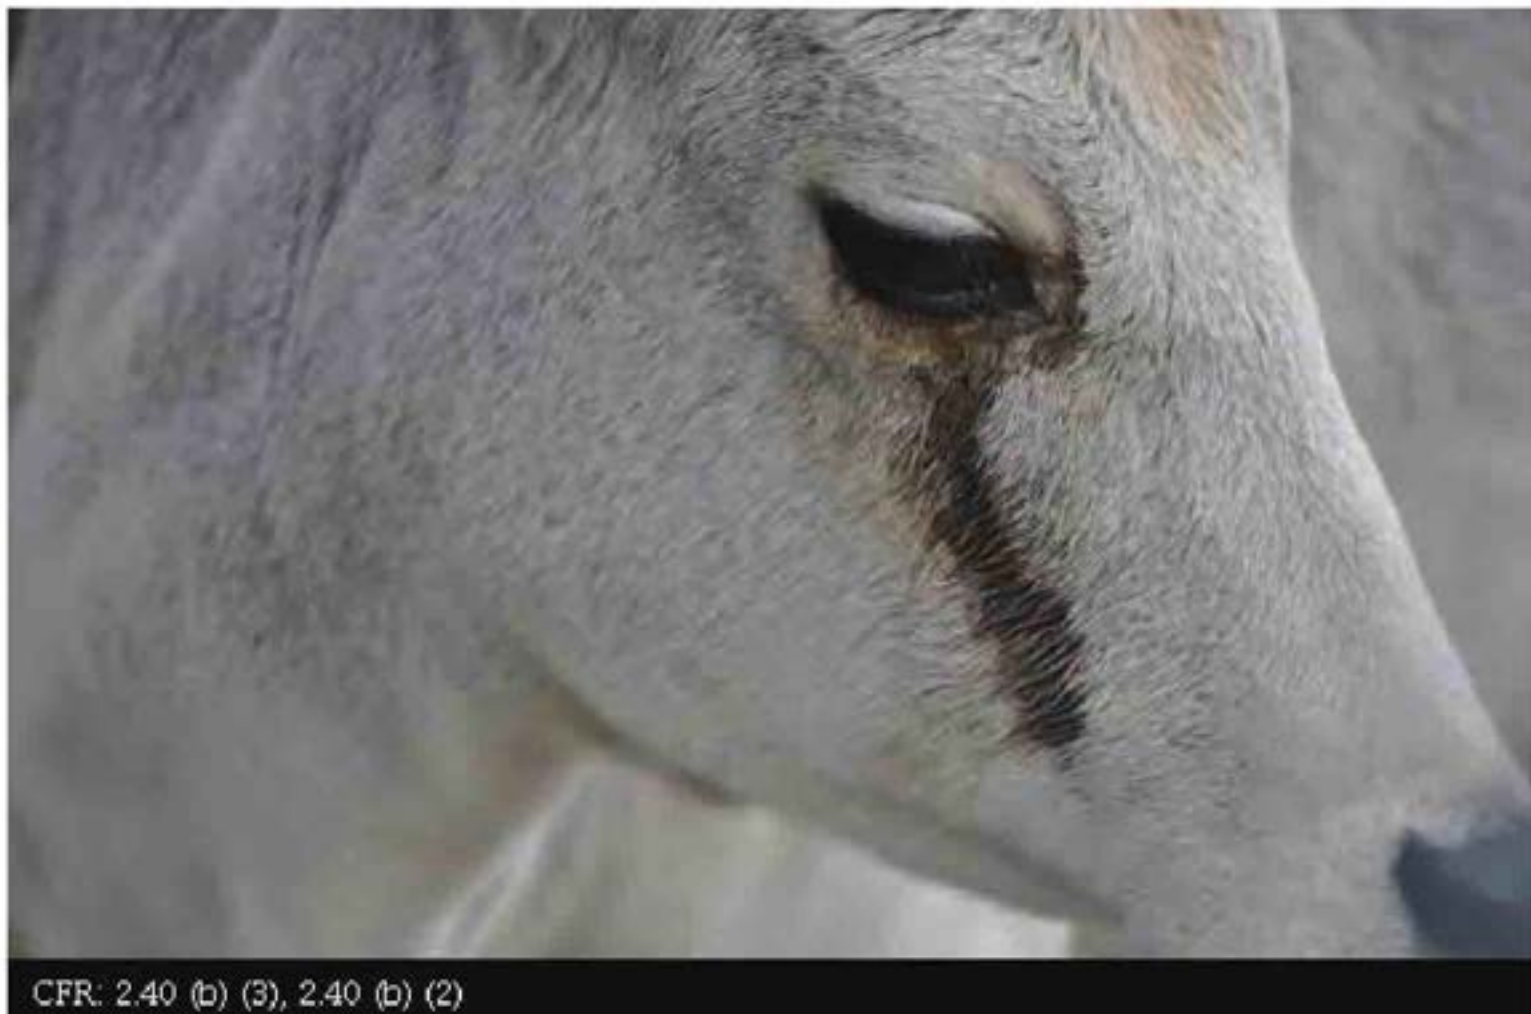
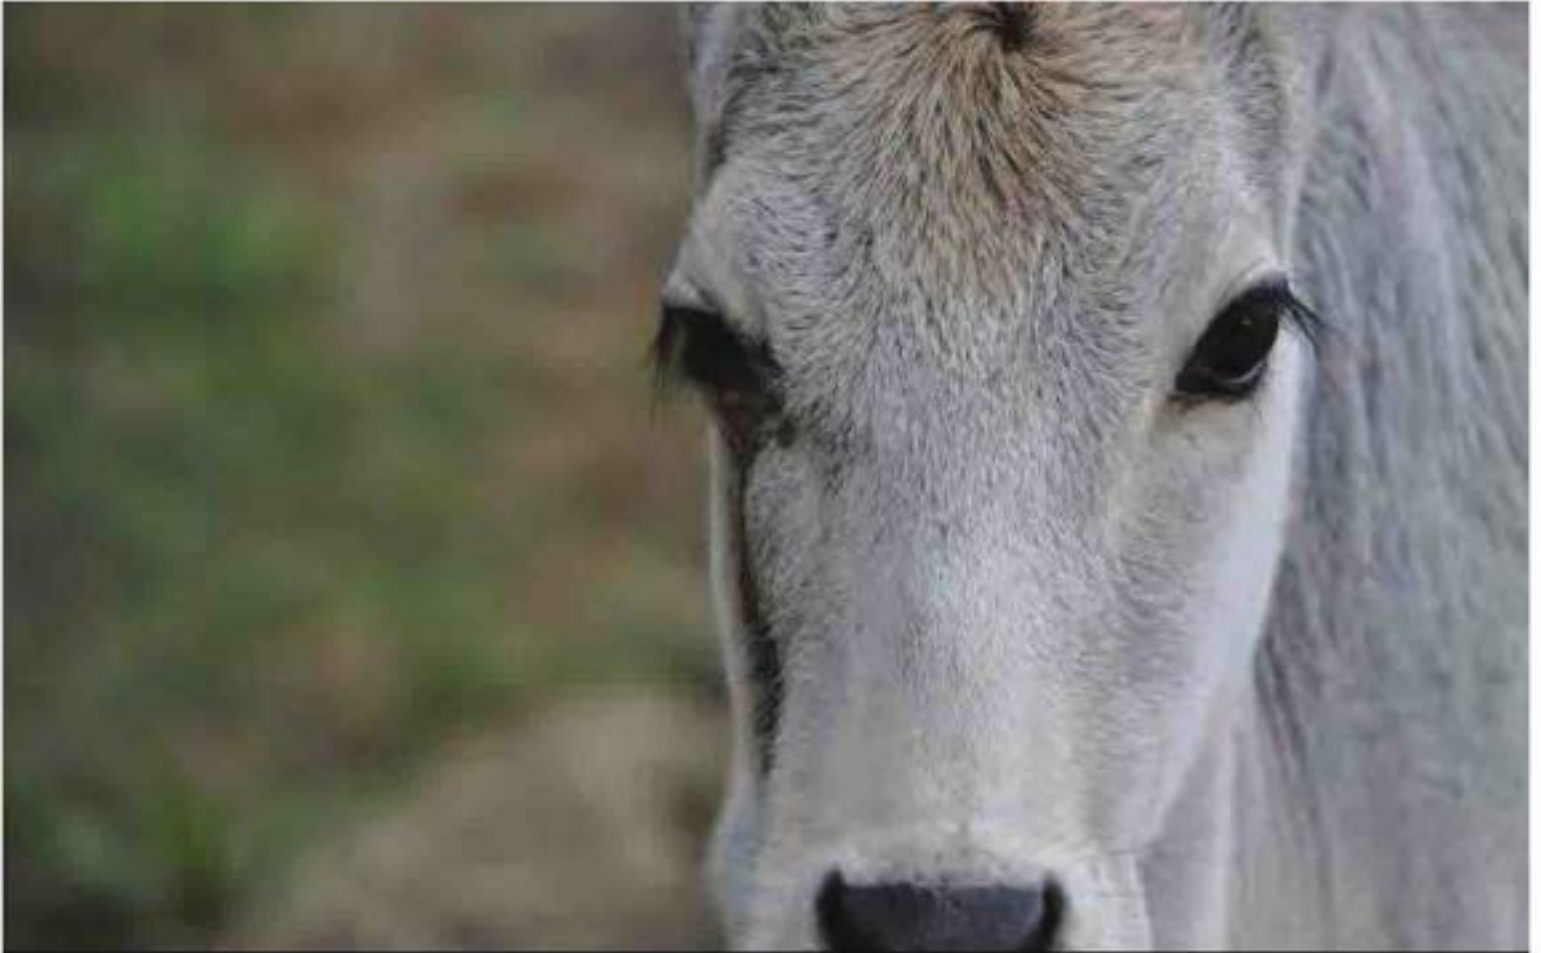
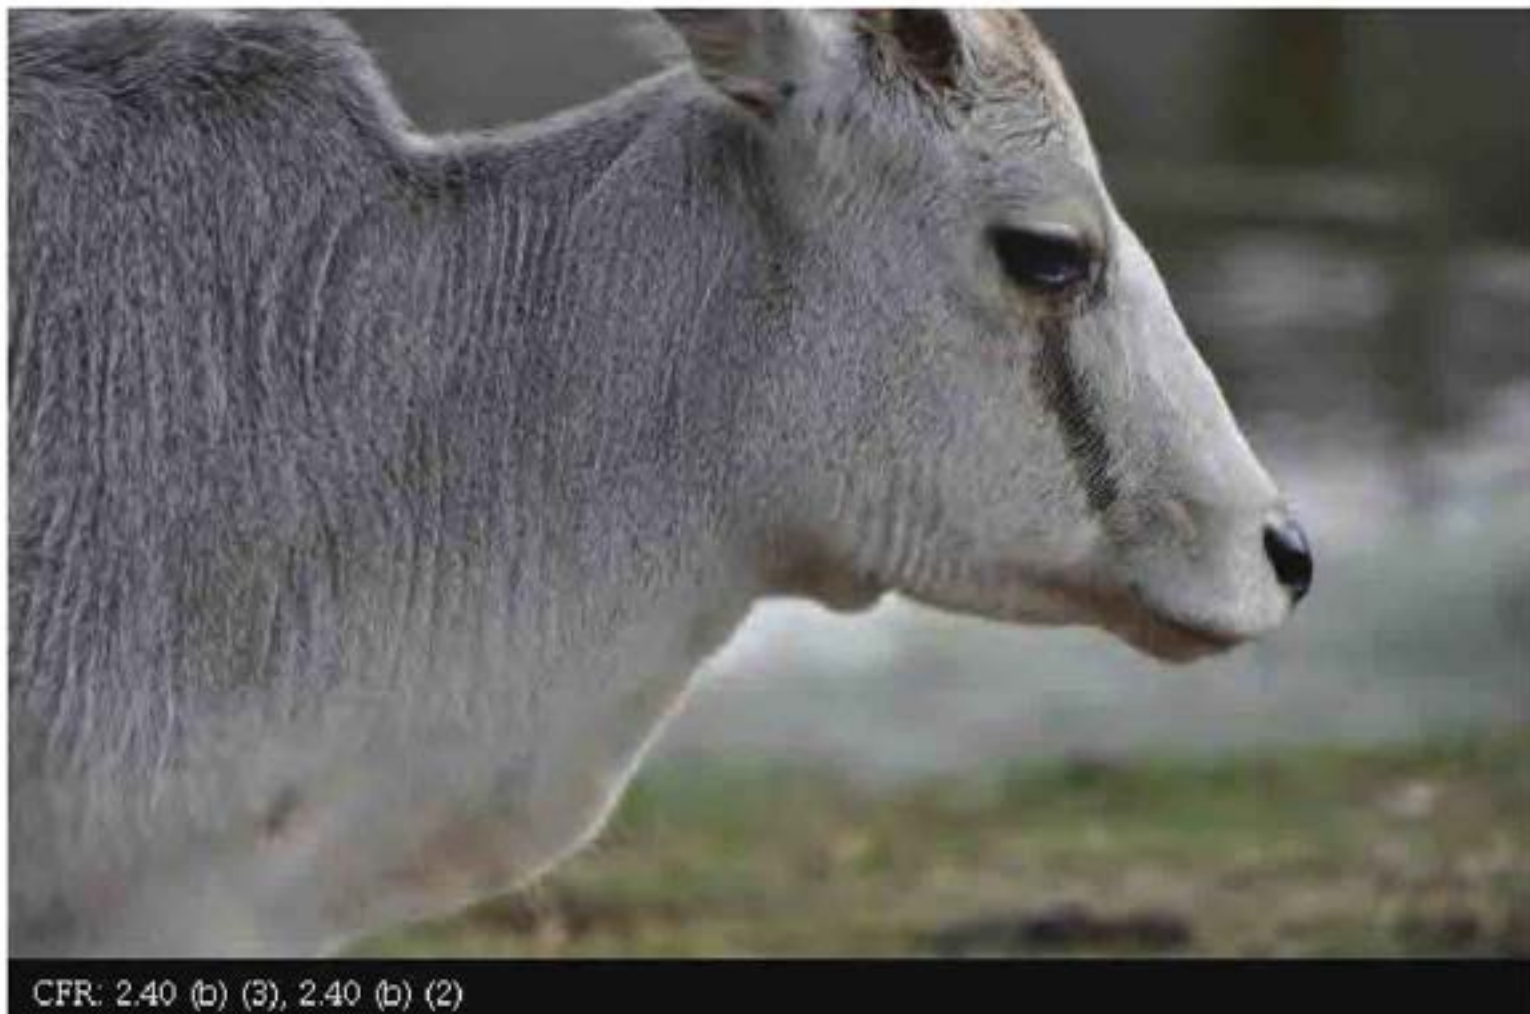
Photographer:	Randy Coleman	Legal Name:	55-B-0069
Photo Taken:	Tue, Aug 25, '15 130 pm	HENRY HAMPTON	
Inspection:	240150633510674		
Description:	Section 2.40(b)(2): Female mini-zebu with eye drainage.

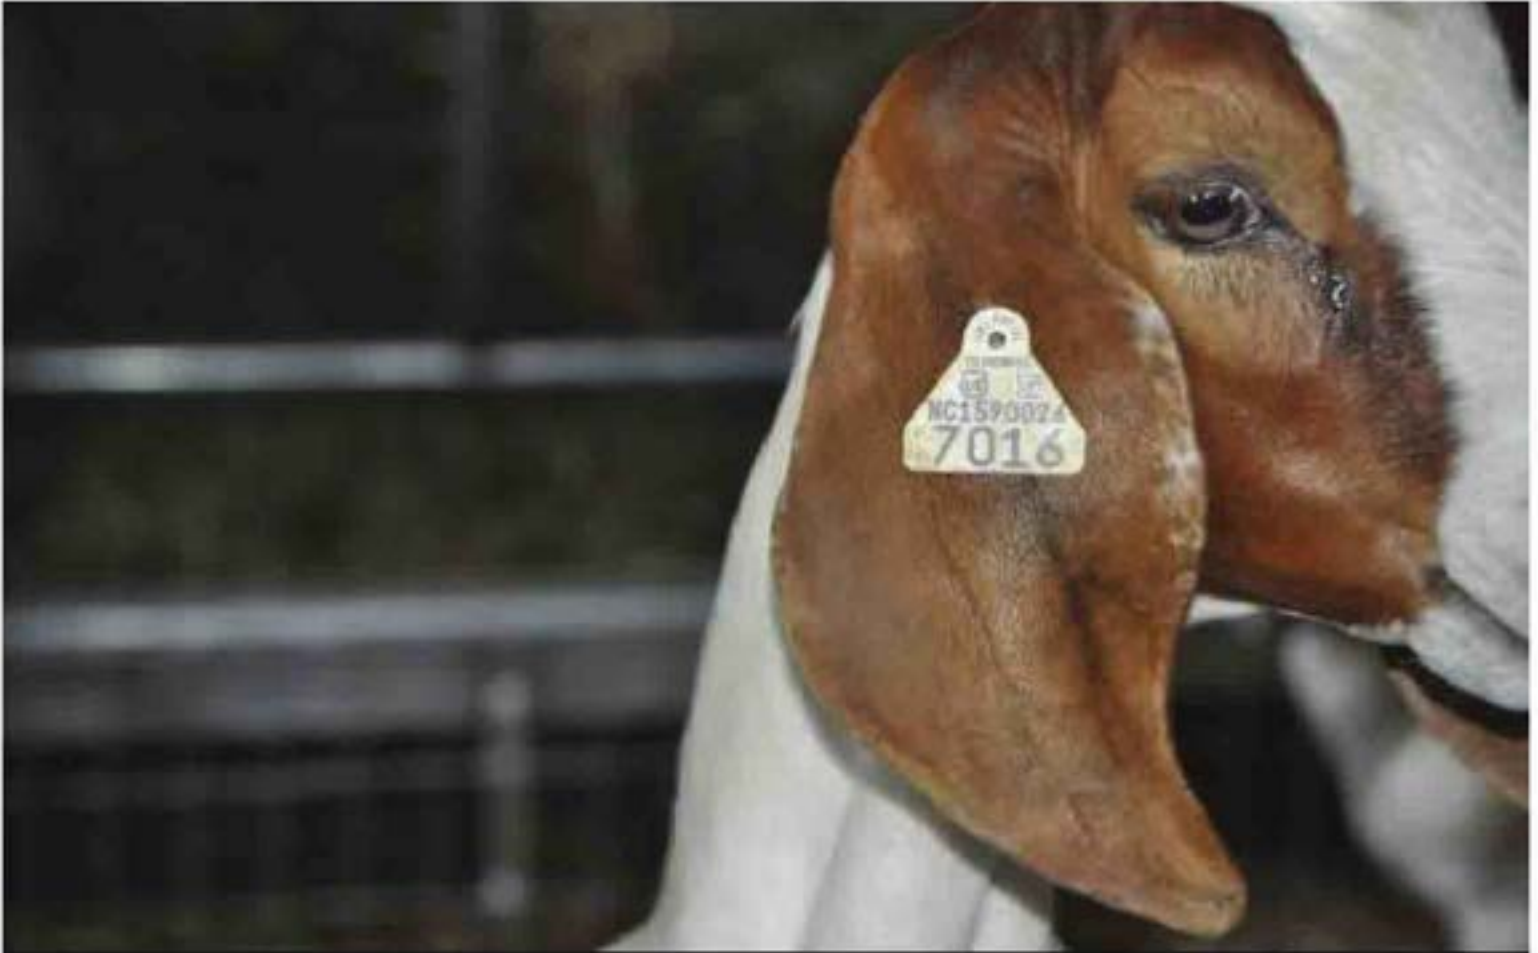
Photographer:	Randy Coleman	Legal Name:	55-B-0069
Photo Taken:	Tue, Aug 25, '15 103 pm	HENRY HAMPTON	
Inspection:	240150633510674		
Description:	Section 2.40(b)(2): Brown and white Boer-type goat with loose stool.

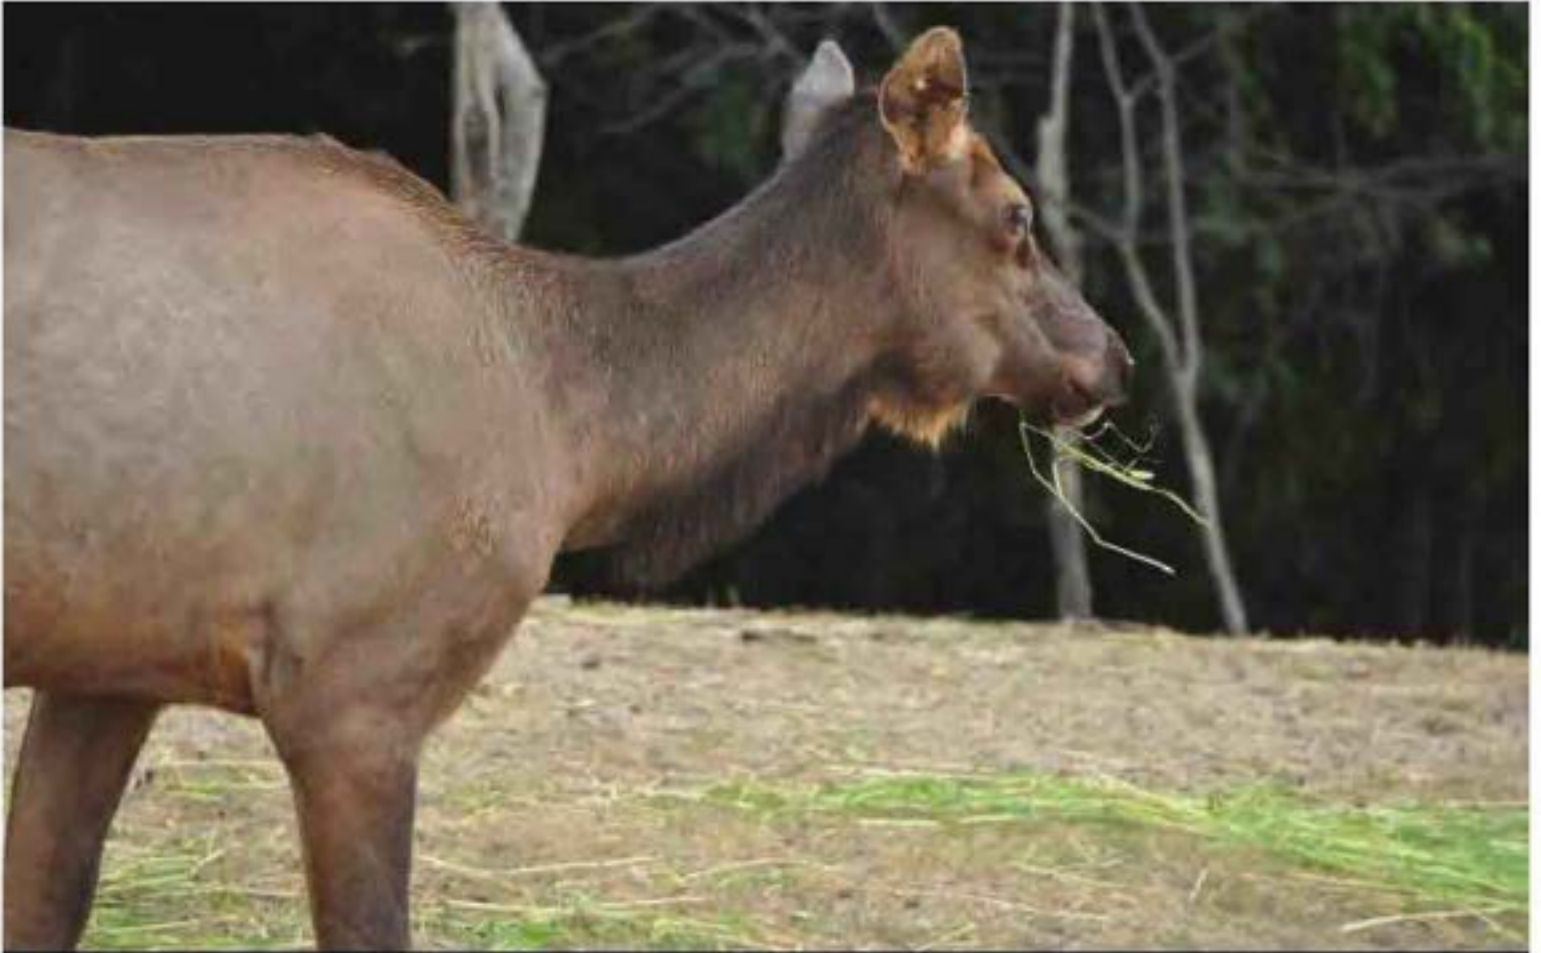
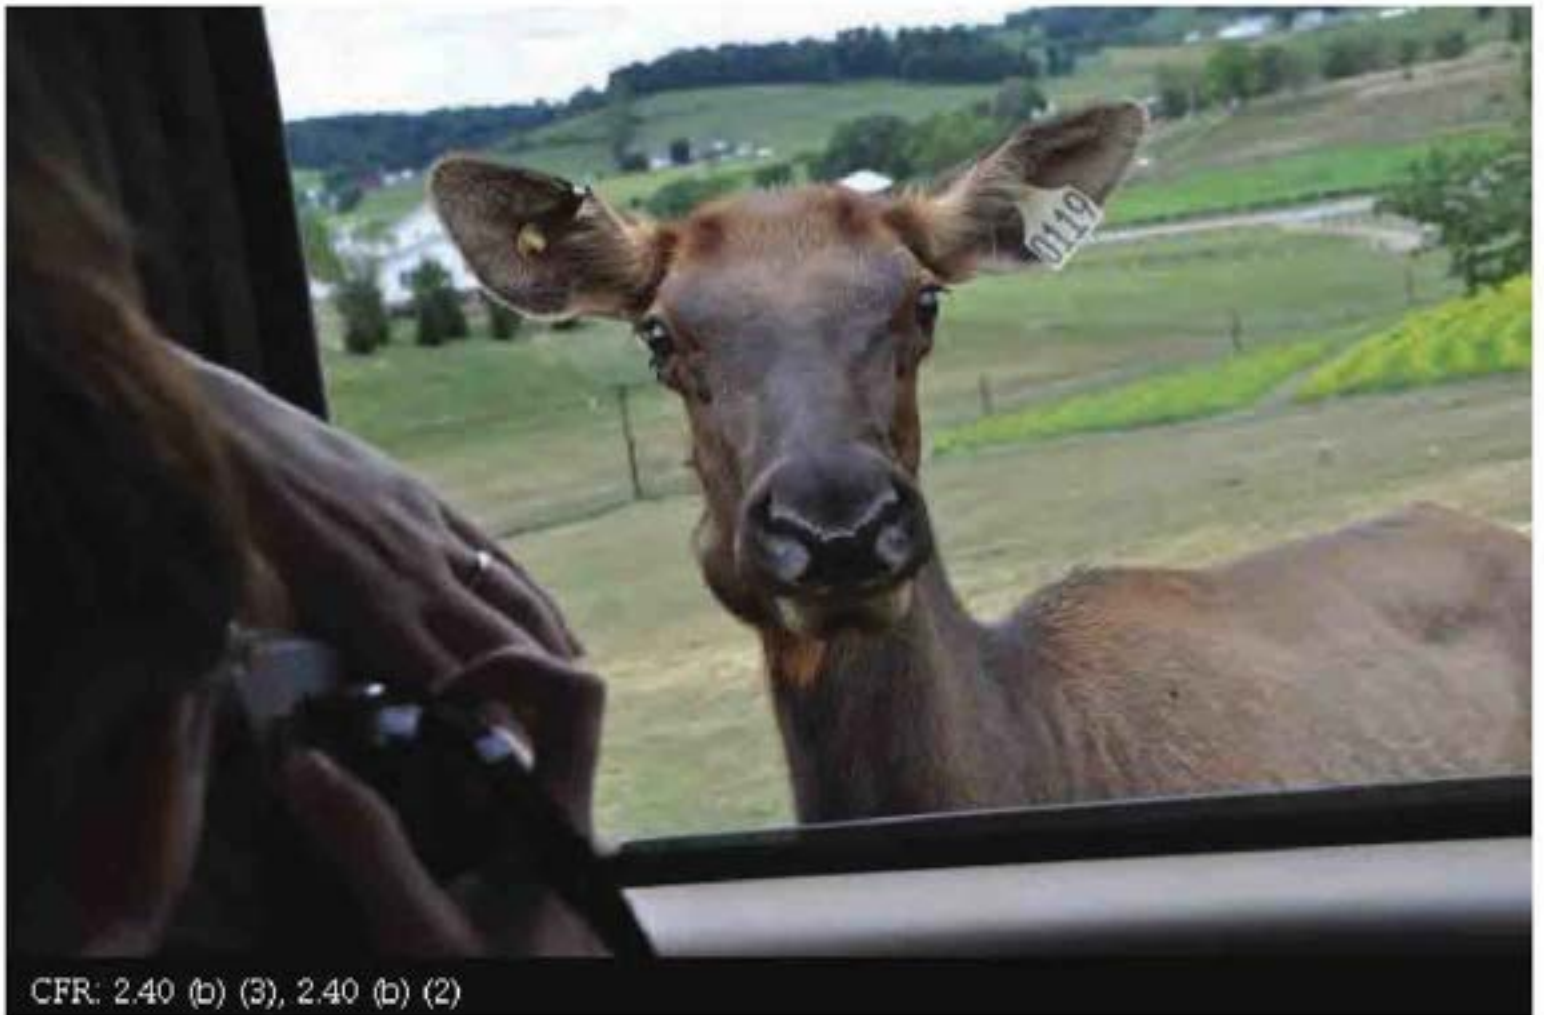
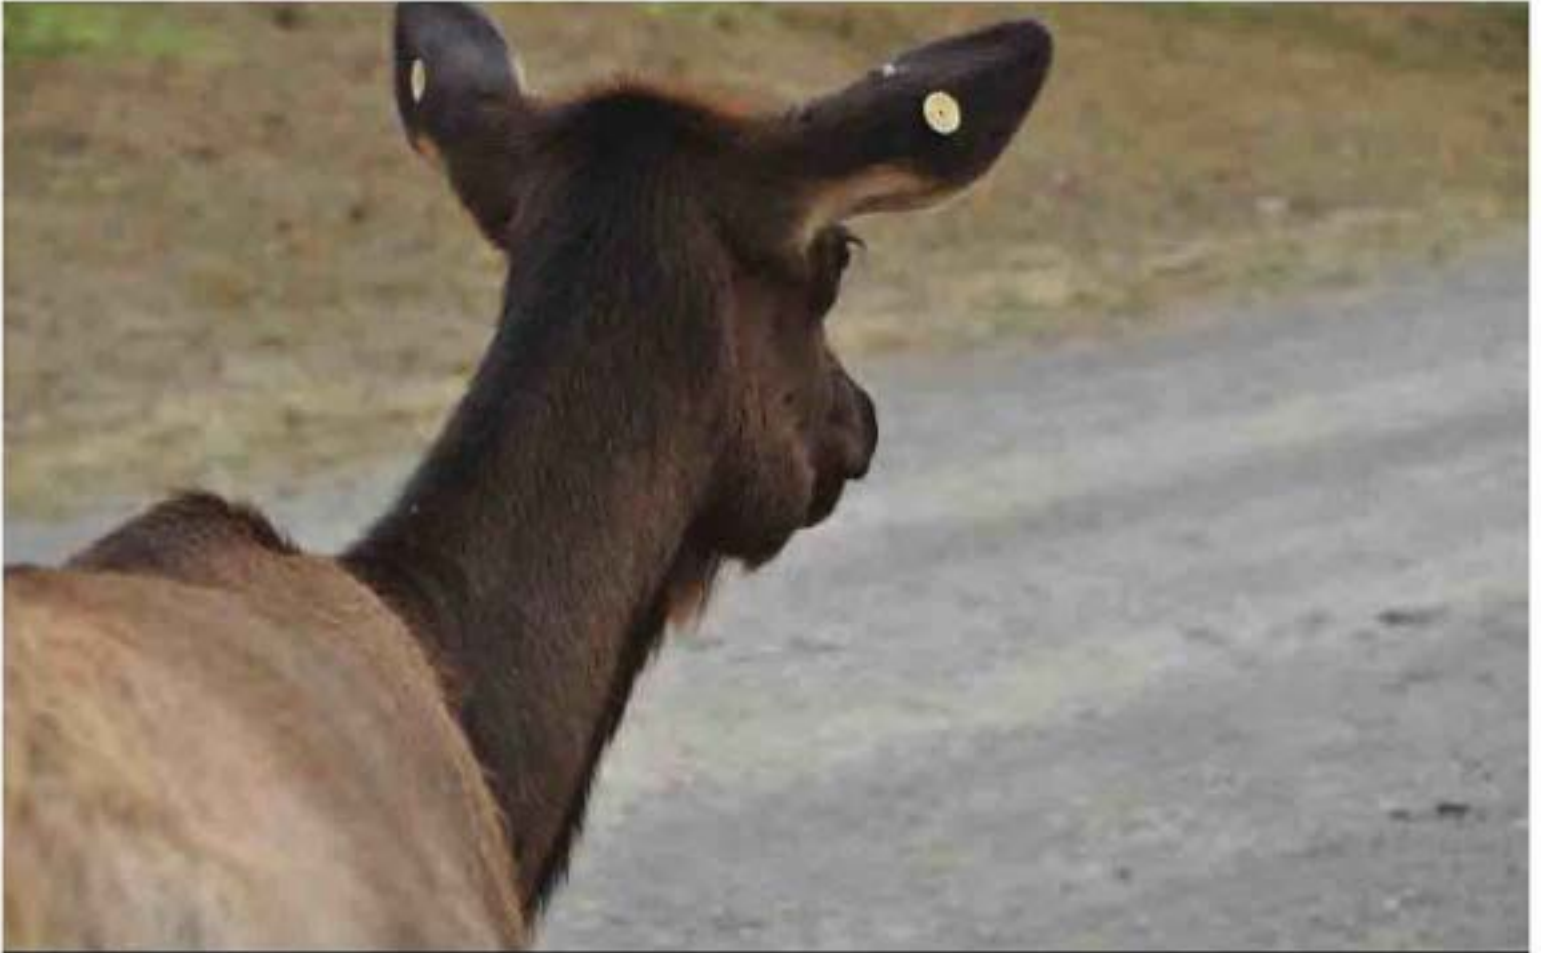
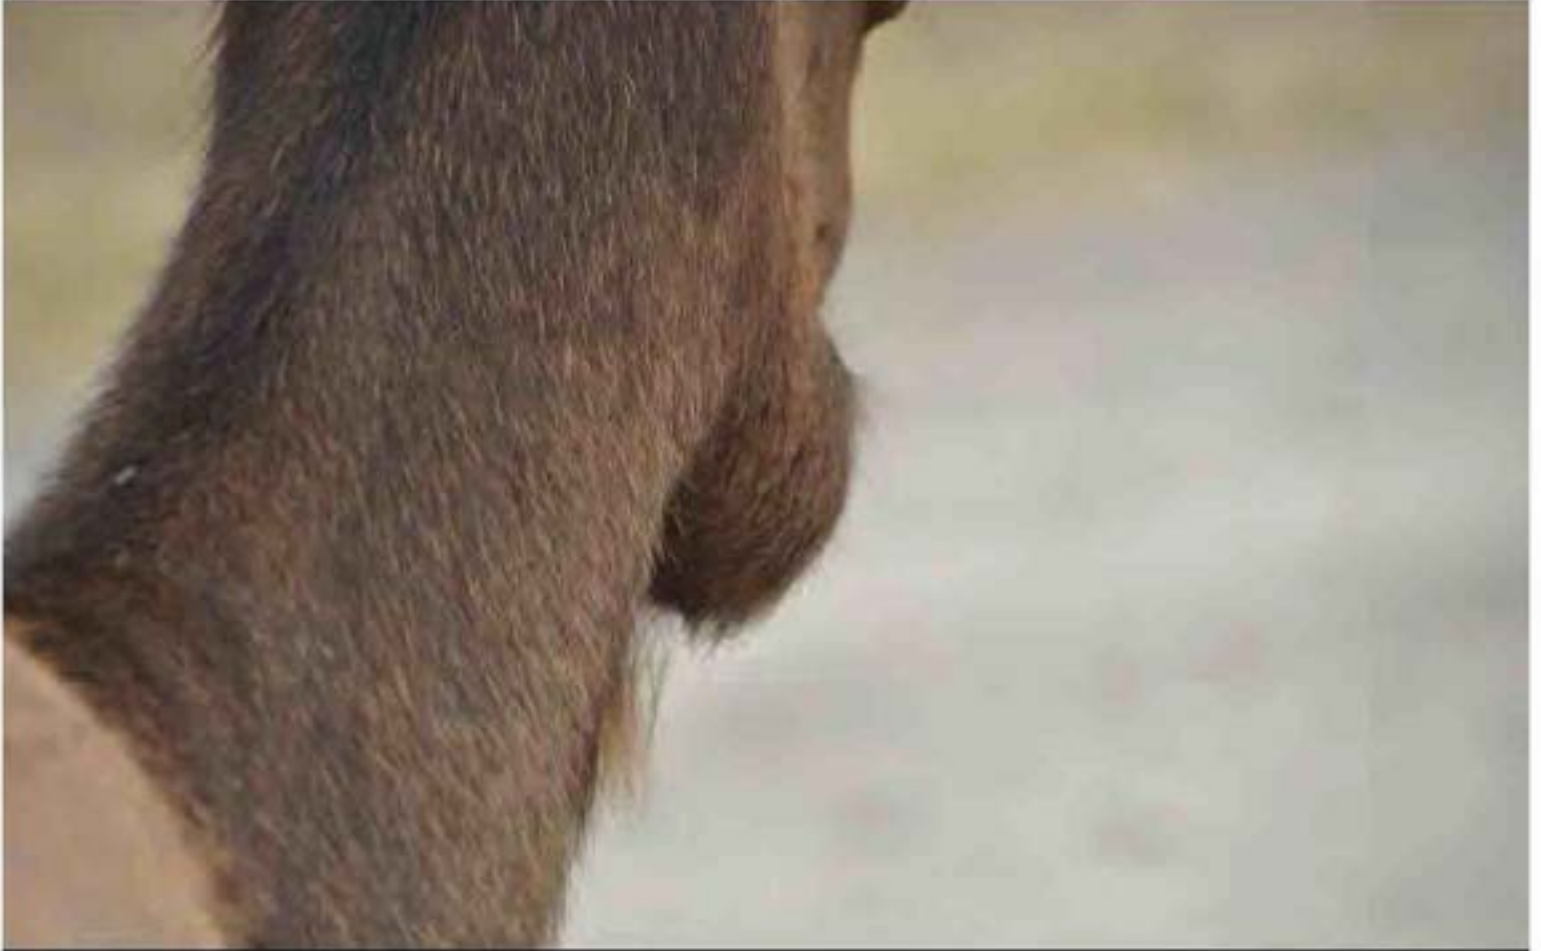
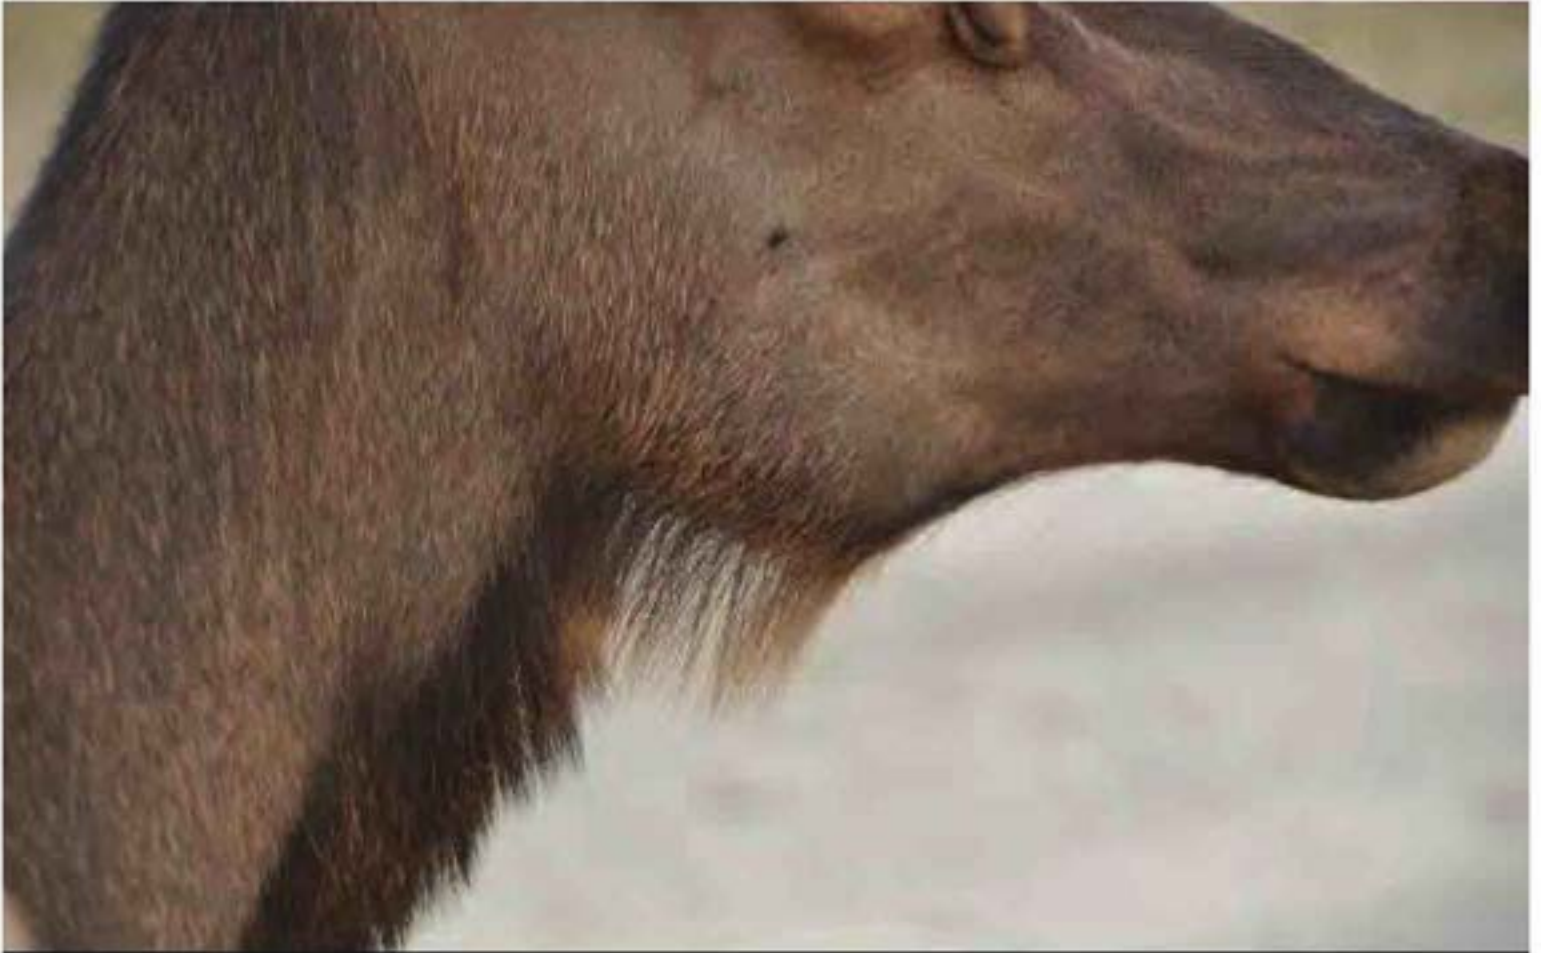
Photographer:	Randy Coleman	Legal Name:	55-B-0069
Photo Taken:	Tue, Aug 25, '15 307 pm	HENRY HAMPTON	
Inspection:	240150633510674		
Description:	Section 2.40(b)(2): Female Elk #0119 with mass on jaw.

Photographer:	Randy Coleman	Legal Name:	55-B-0069
Photo Taken:	Tue, Aug 25, '15 3:07 pm	HENRY HAMPTON	
Inspection:	240150633510674		
Description:	Section 2.40(b)(2): Female Elk #0119 with mass on jaw.
