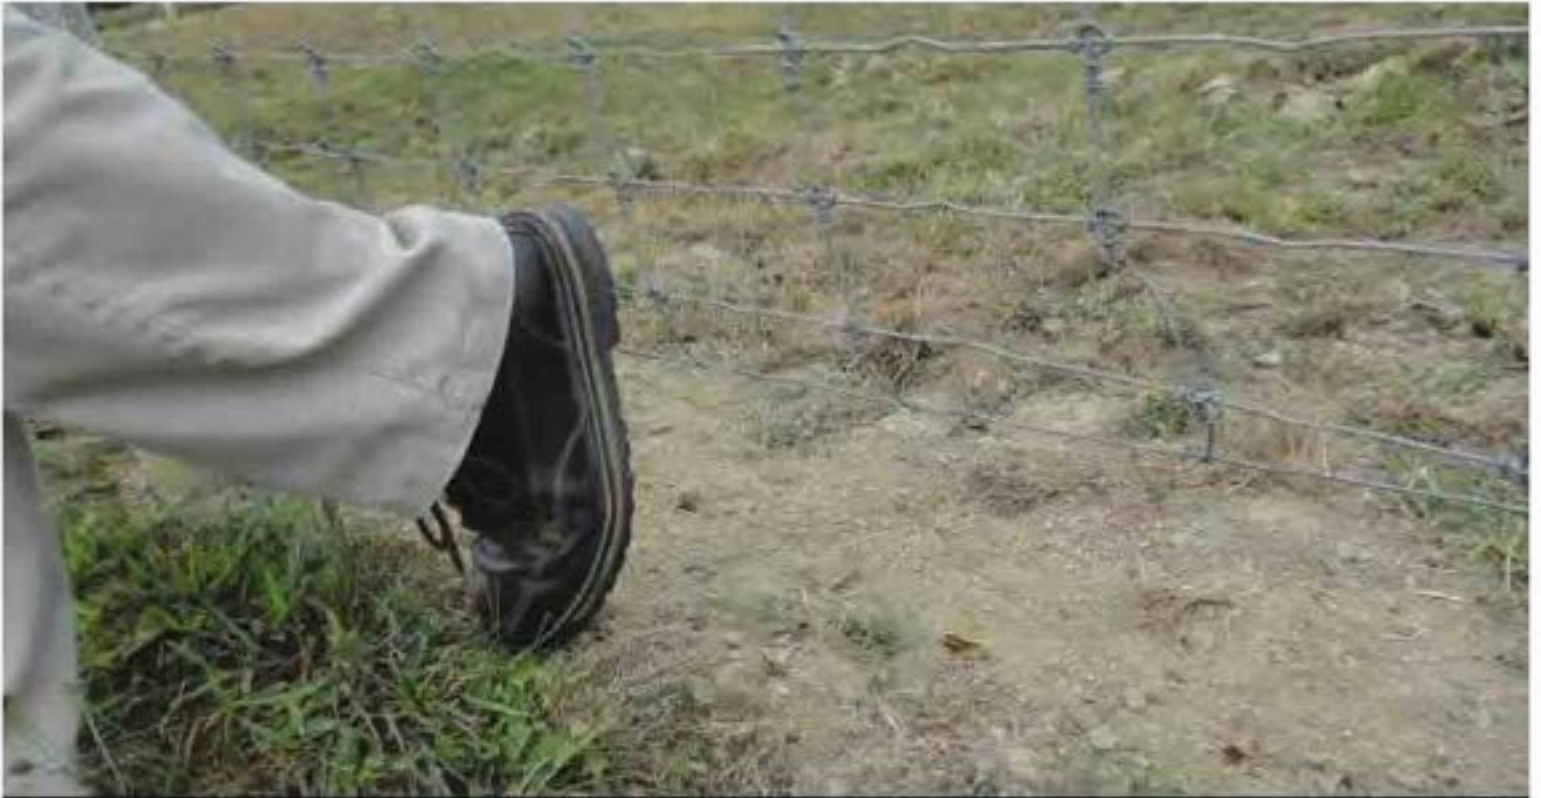
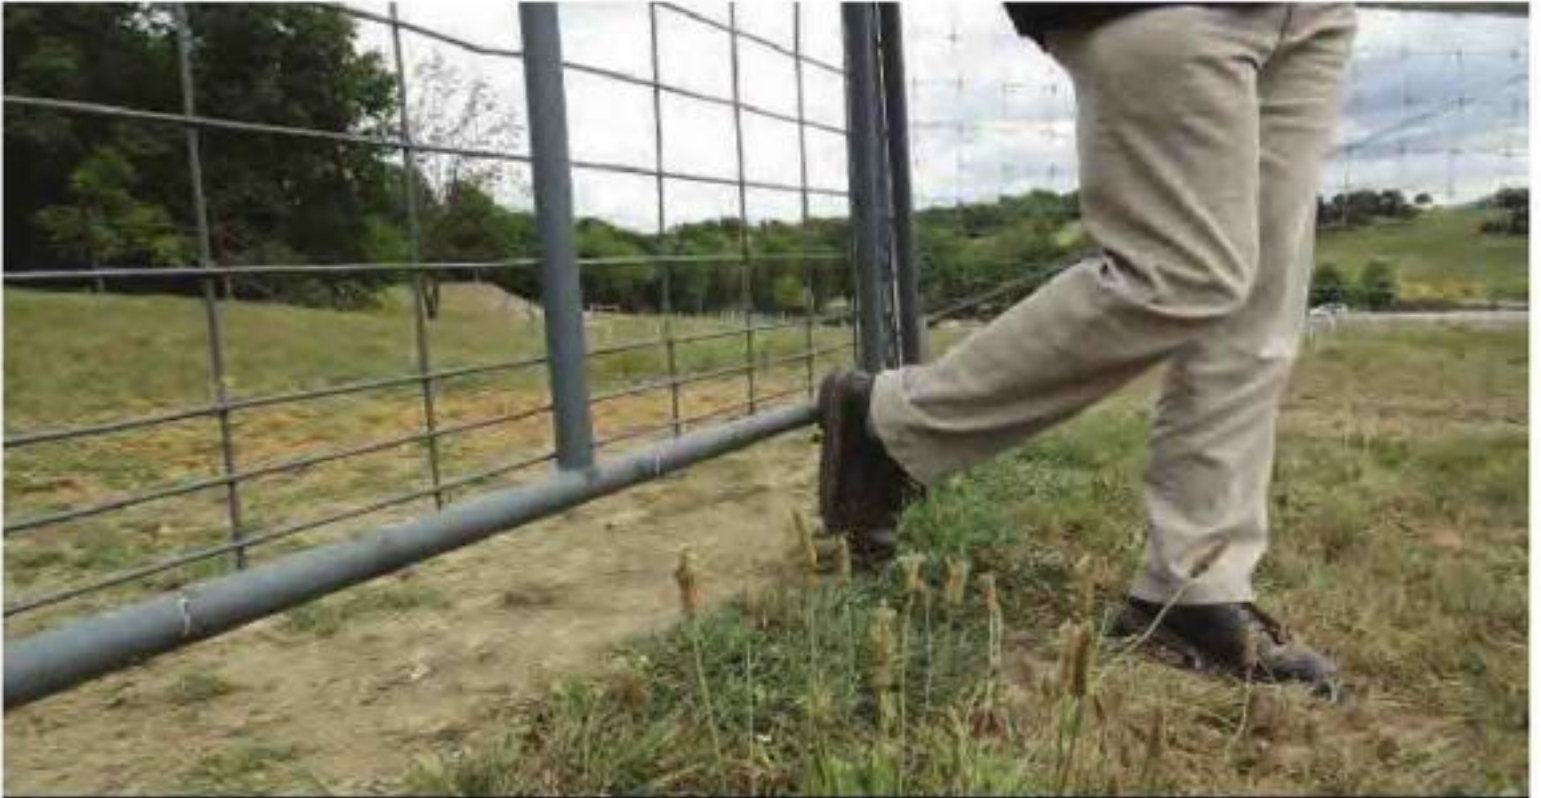
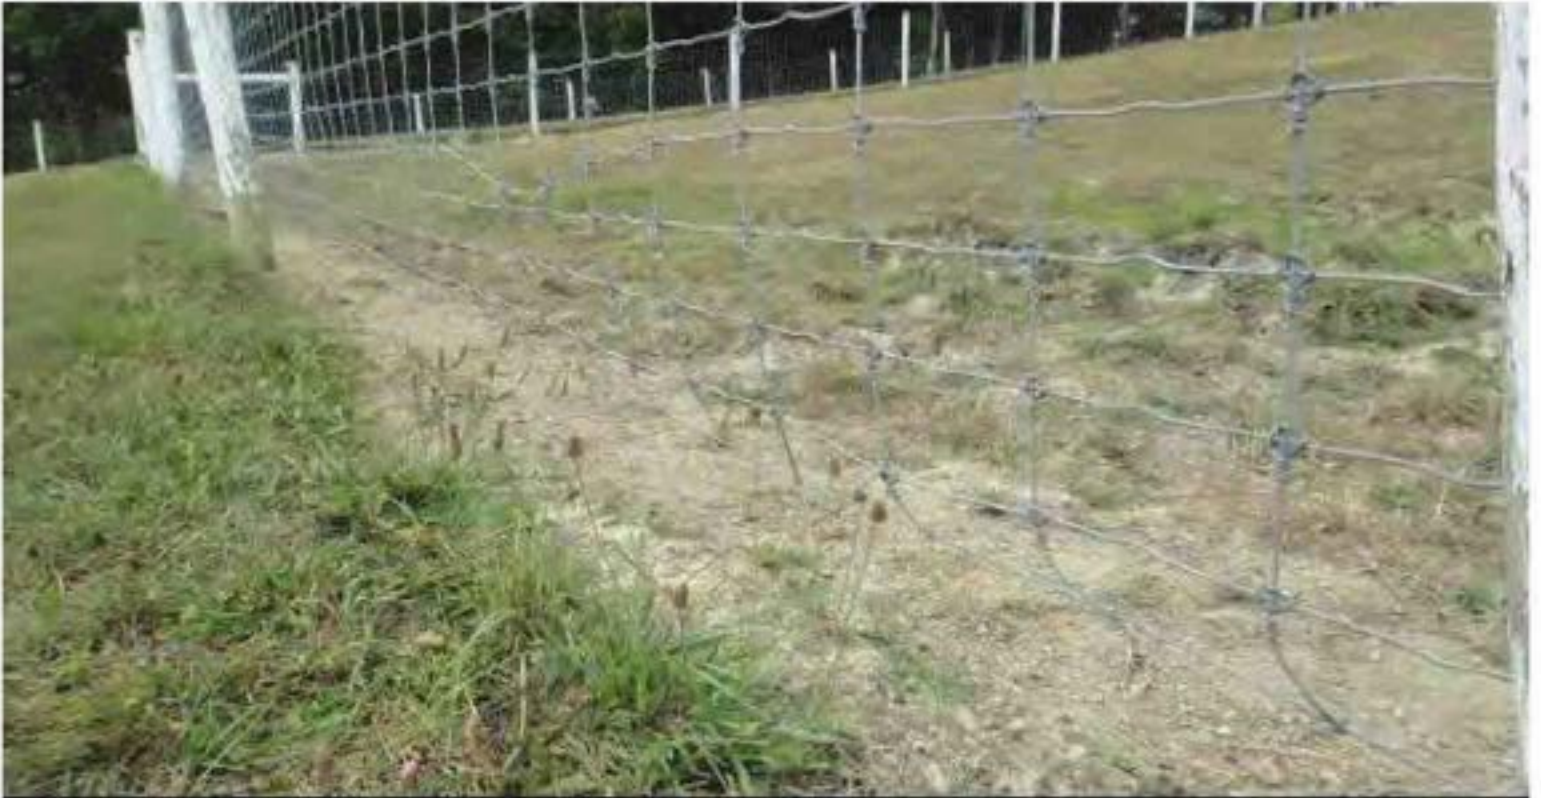
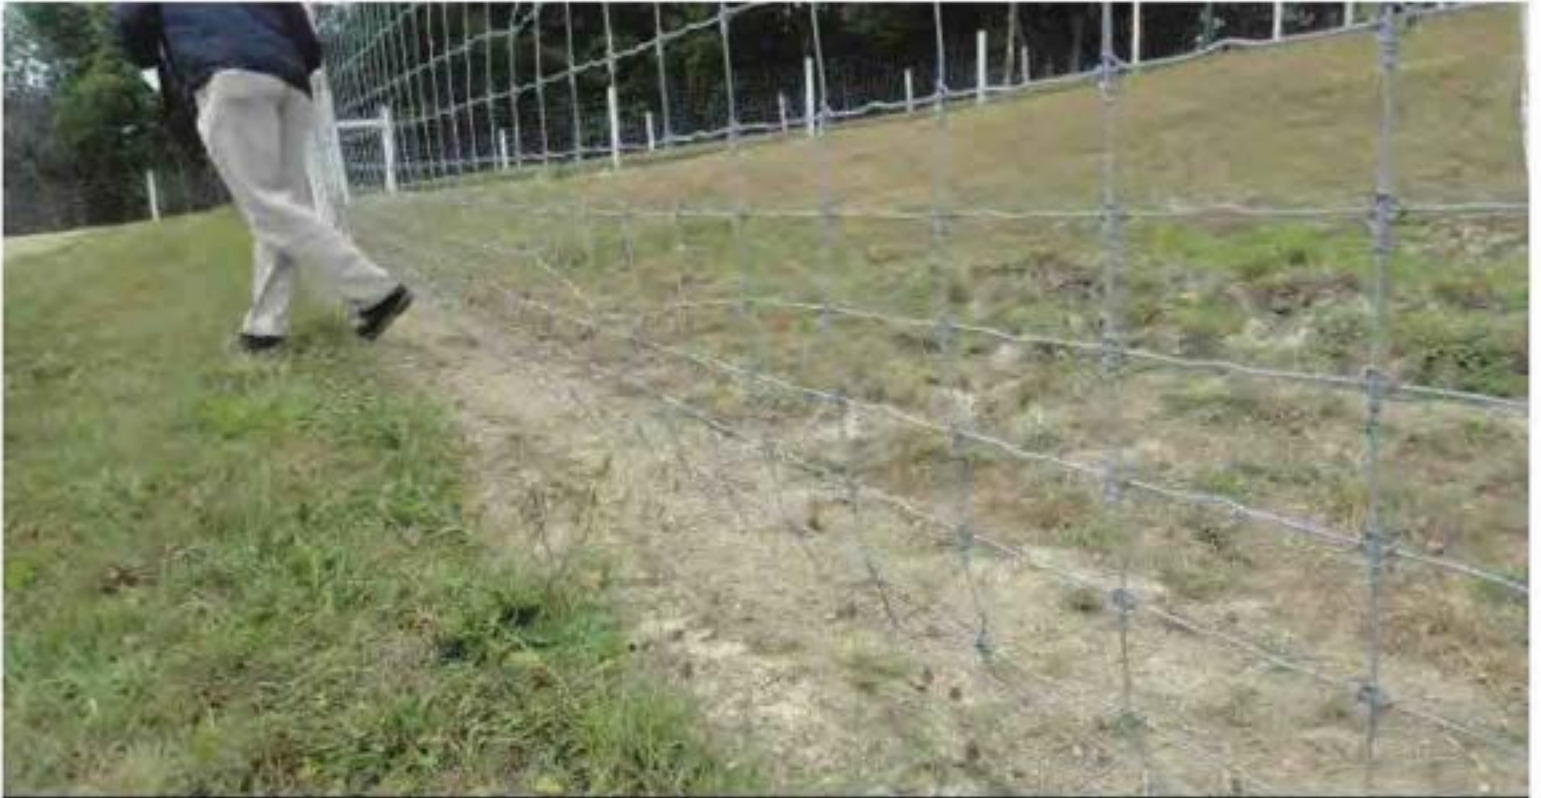
Photographer:	Dana Miller	Legal Name:	55-B-0069
Photo Taken:	Tue, Aug 25, '15 1230 pm	HENRY HAMPTON	
Inspection:	240150633510674		
Description:	Section 3.125(a): Space below gate panel and fencing for 4-horn sheep.

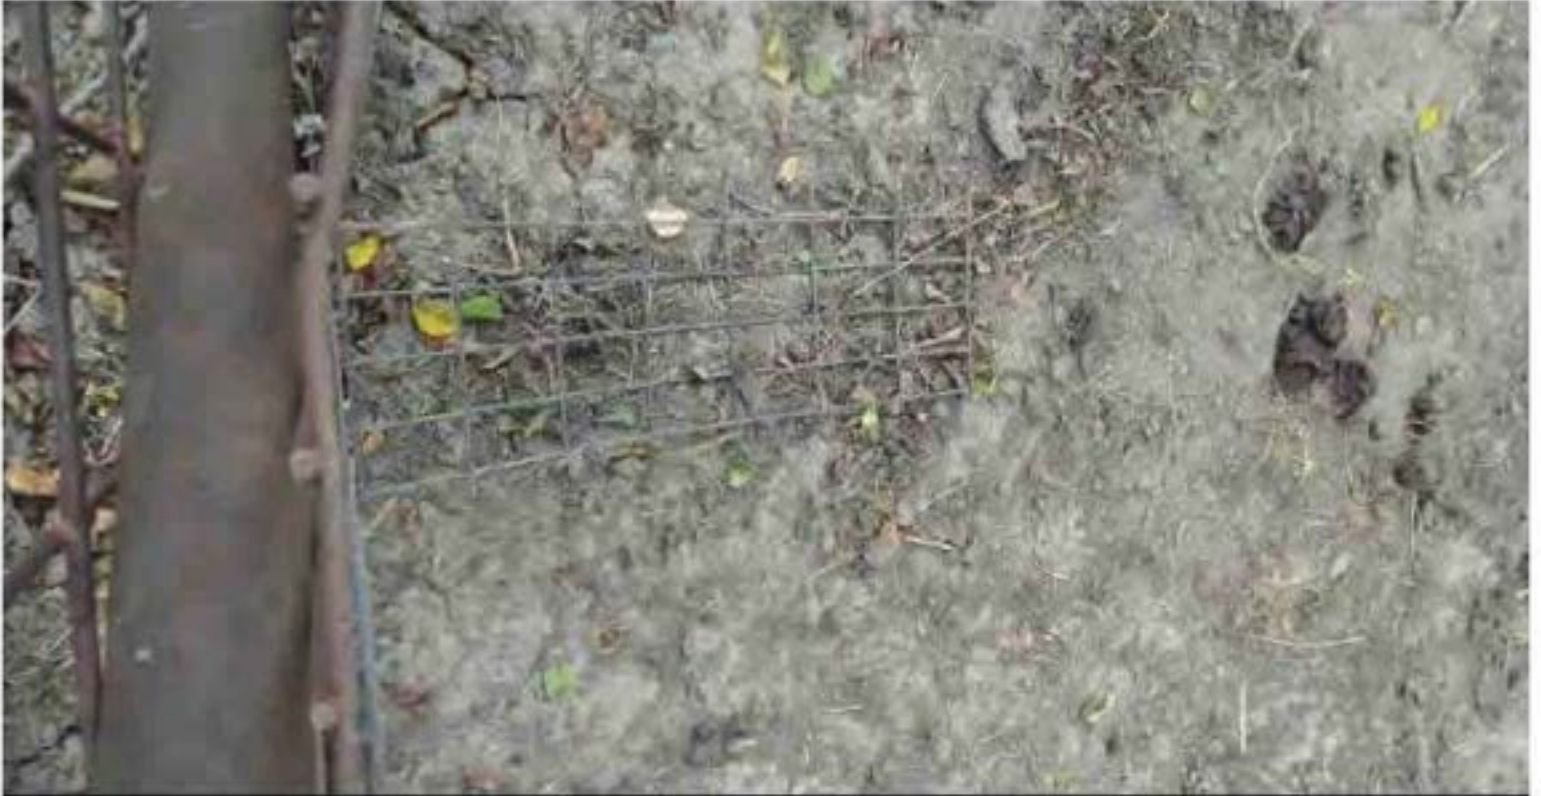
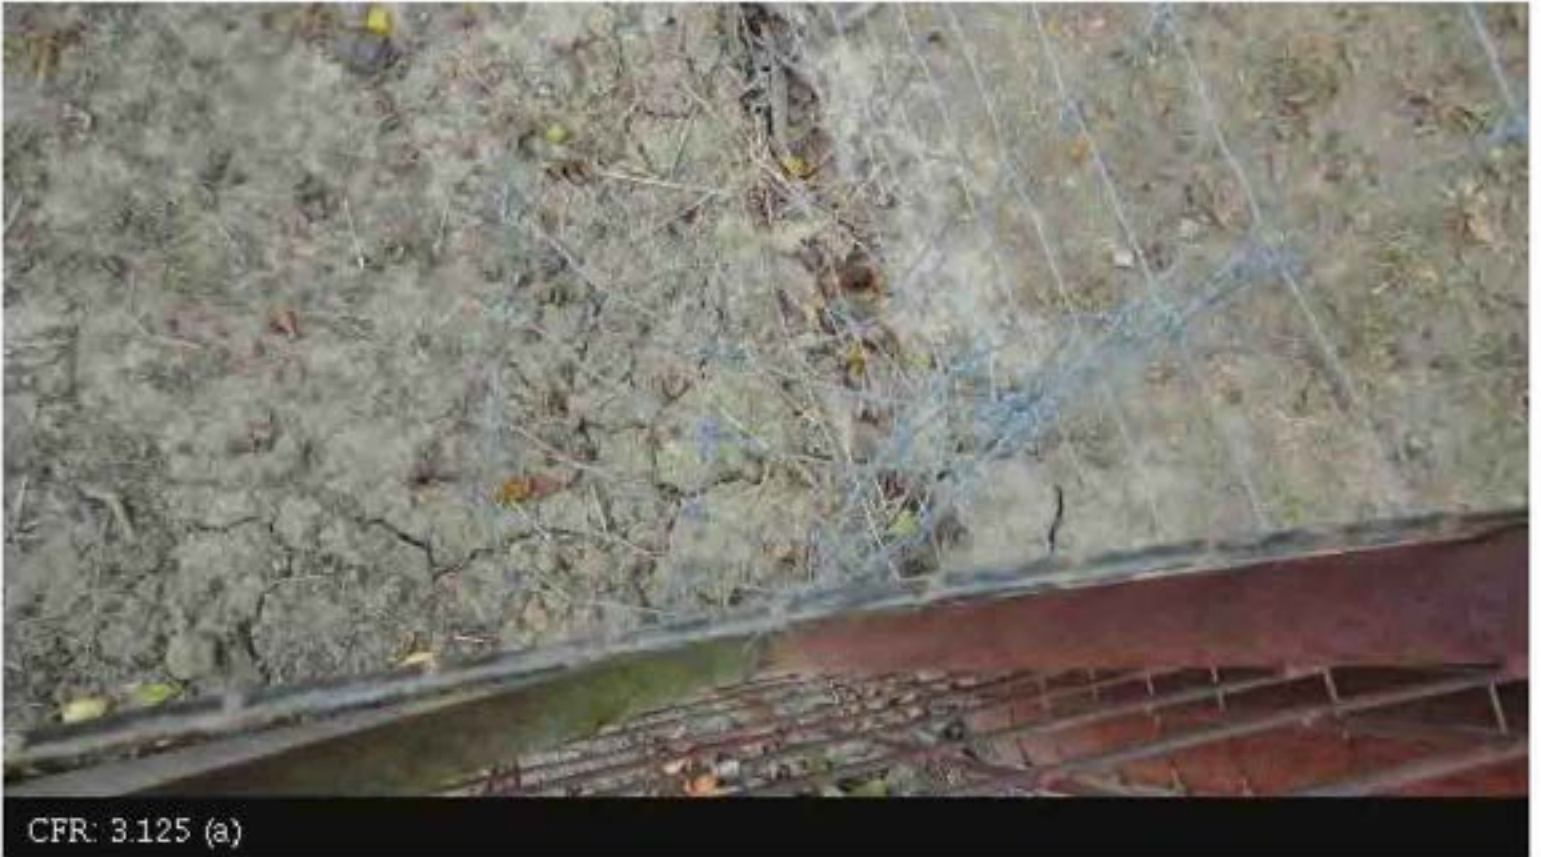
Photographer:	Dana Miller	Legal Name:	55-B-0069
Photo Taken:	Tue, Aug 25, '15 1235 pm	HENRY HAMPTON	
Inspection:	240150633510674		
Description:	Section 3.125(a):Loose wires and section of loose fence panel in zebu enclosure.

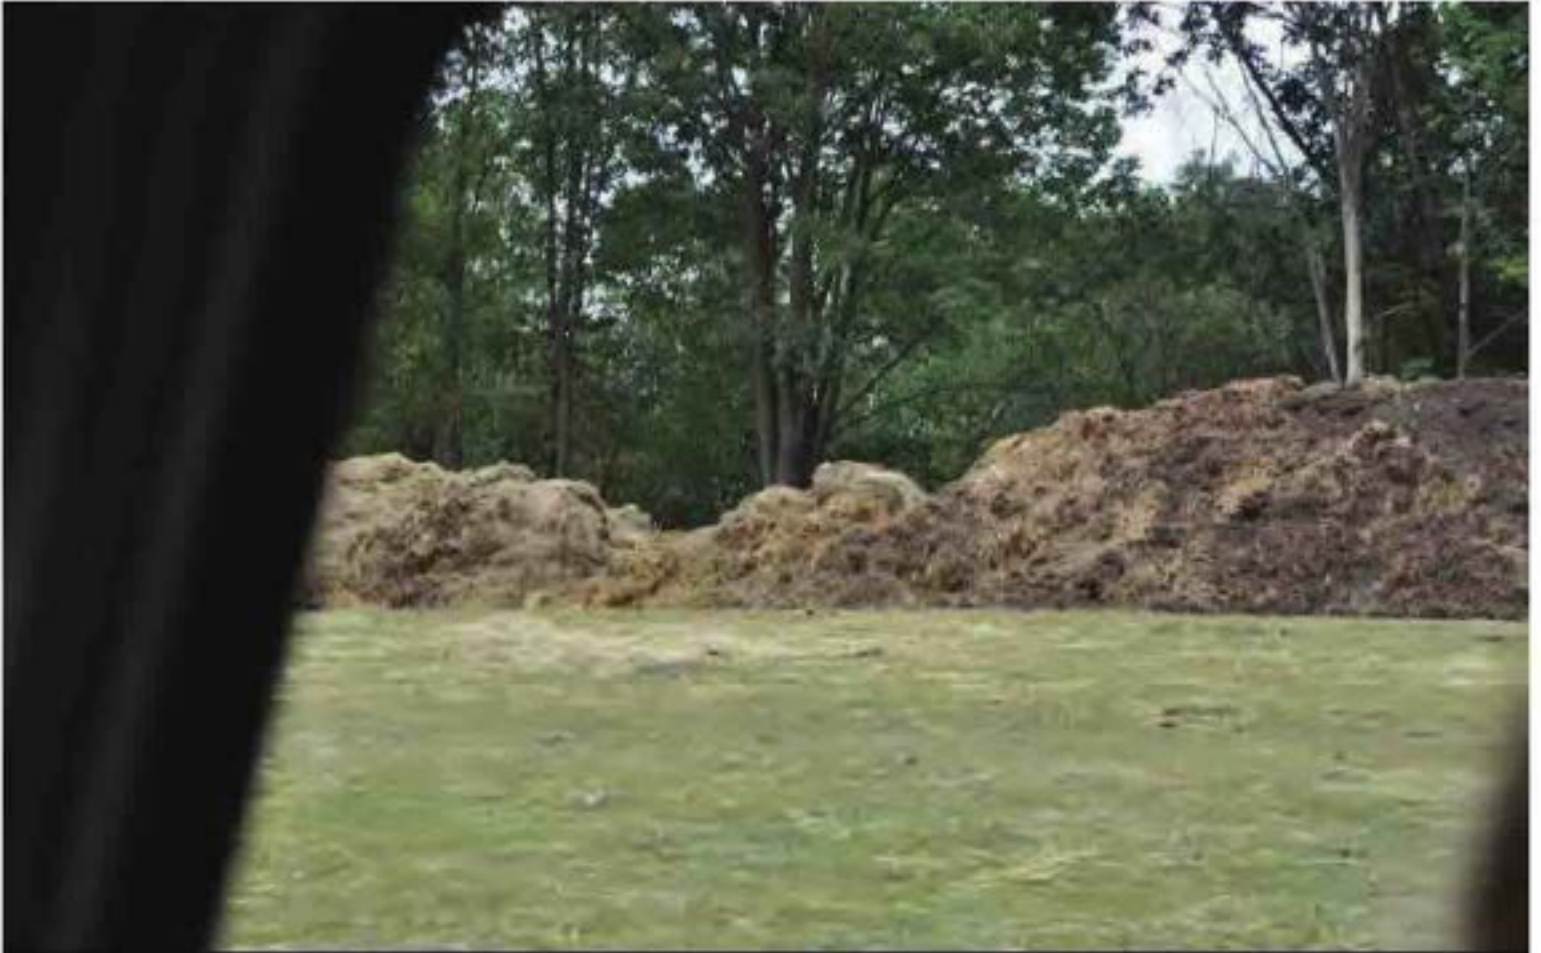
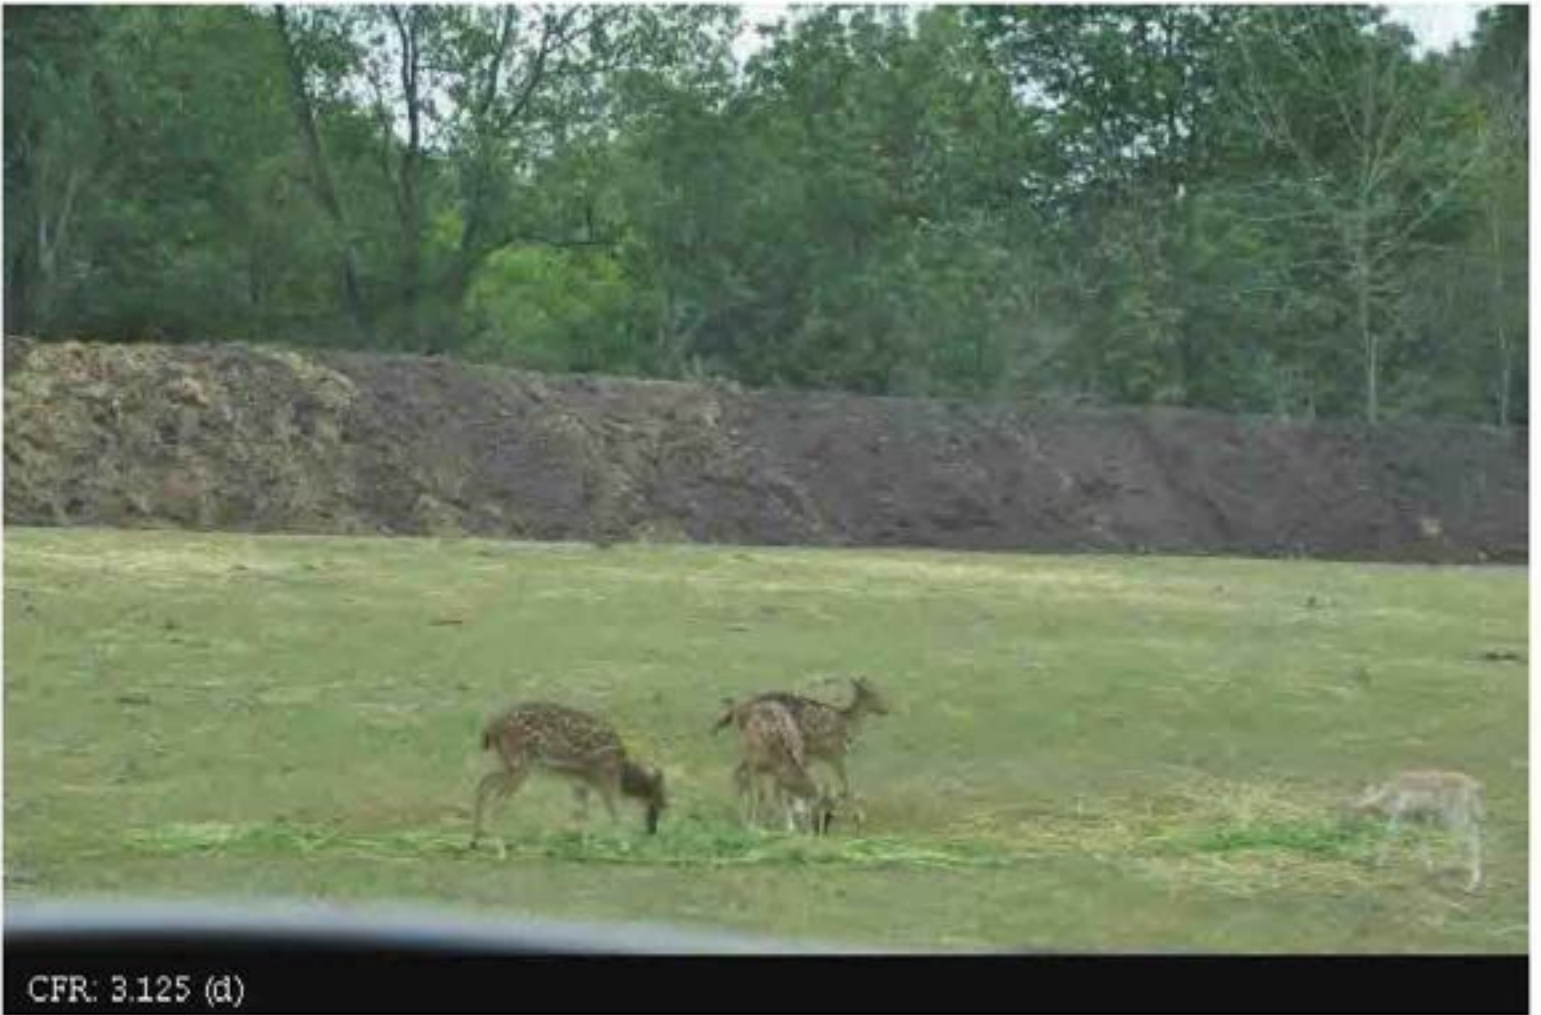
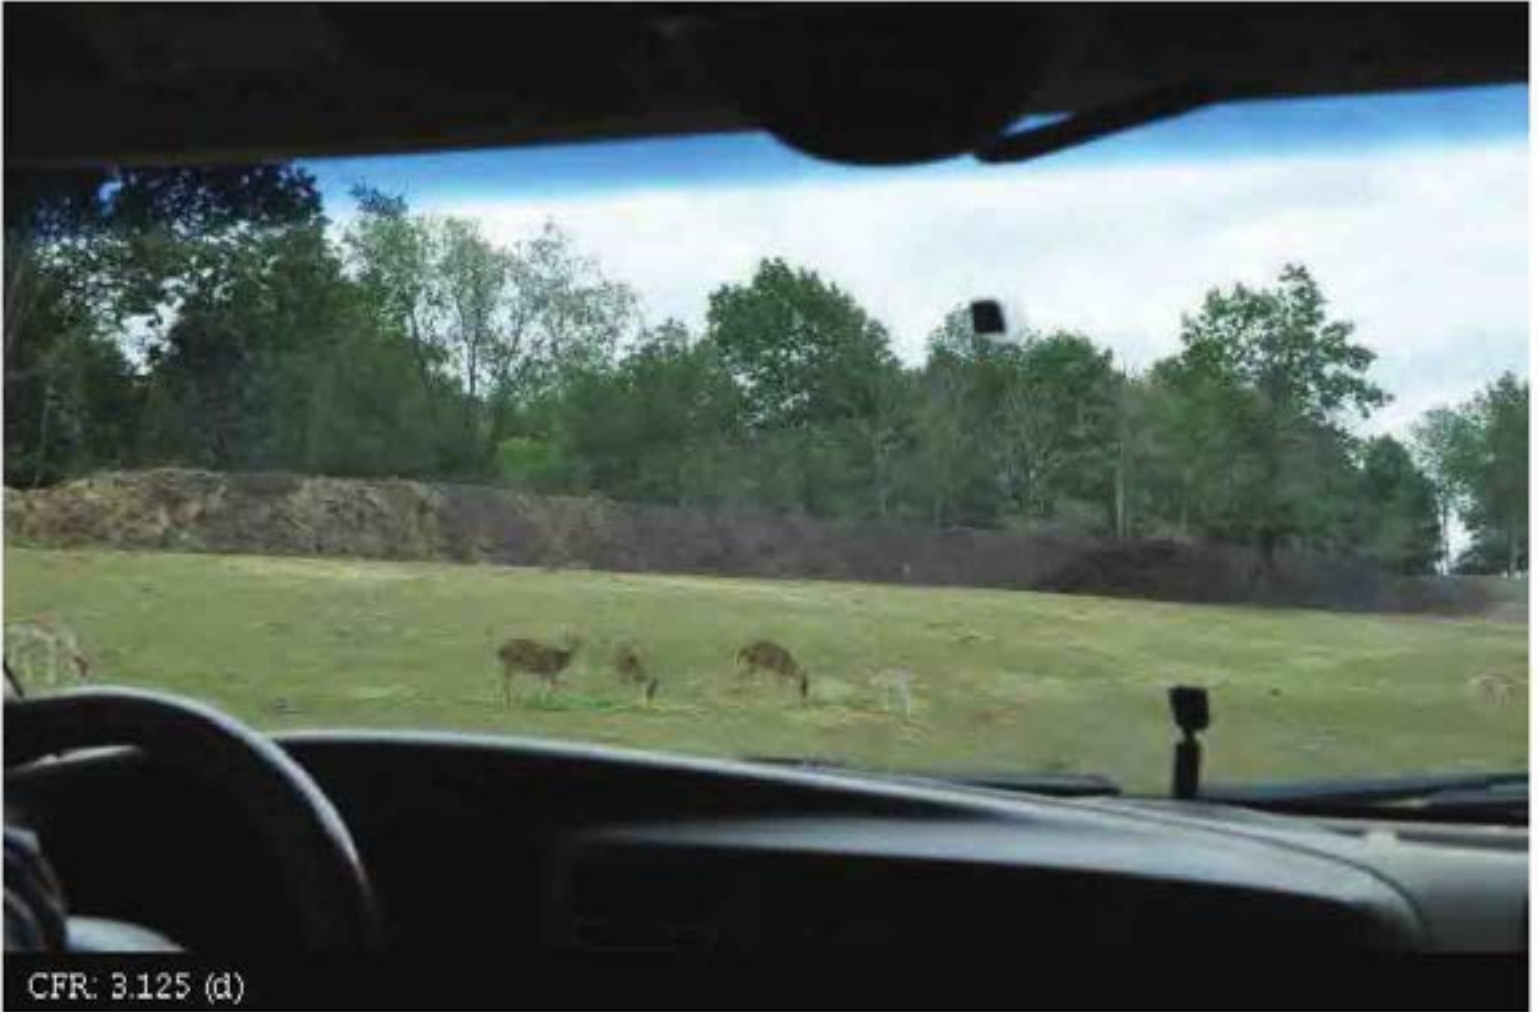
Photographer:	Randy Coleman	Legal Name:	55-B-0069
Photo Taken:	Tue, Aug 25, '15 258 pm	HENRY HAMPTON	
Inspection:	240150633510674		
Description:	Section 3.125(d): Large heap of animal waste and spent bedding remains in drive thru area.

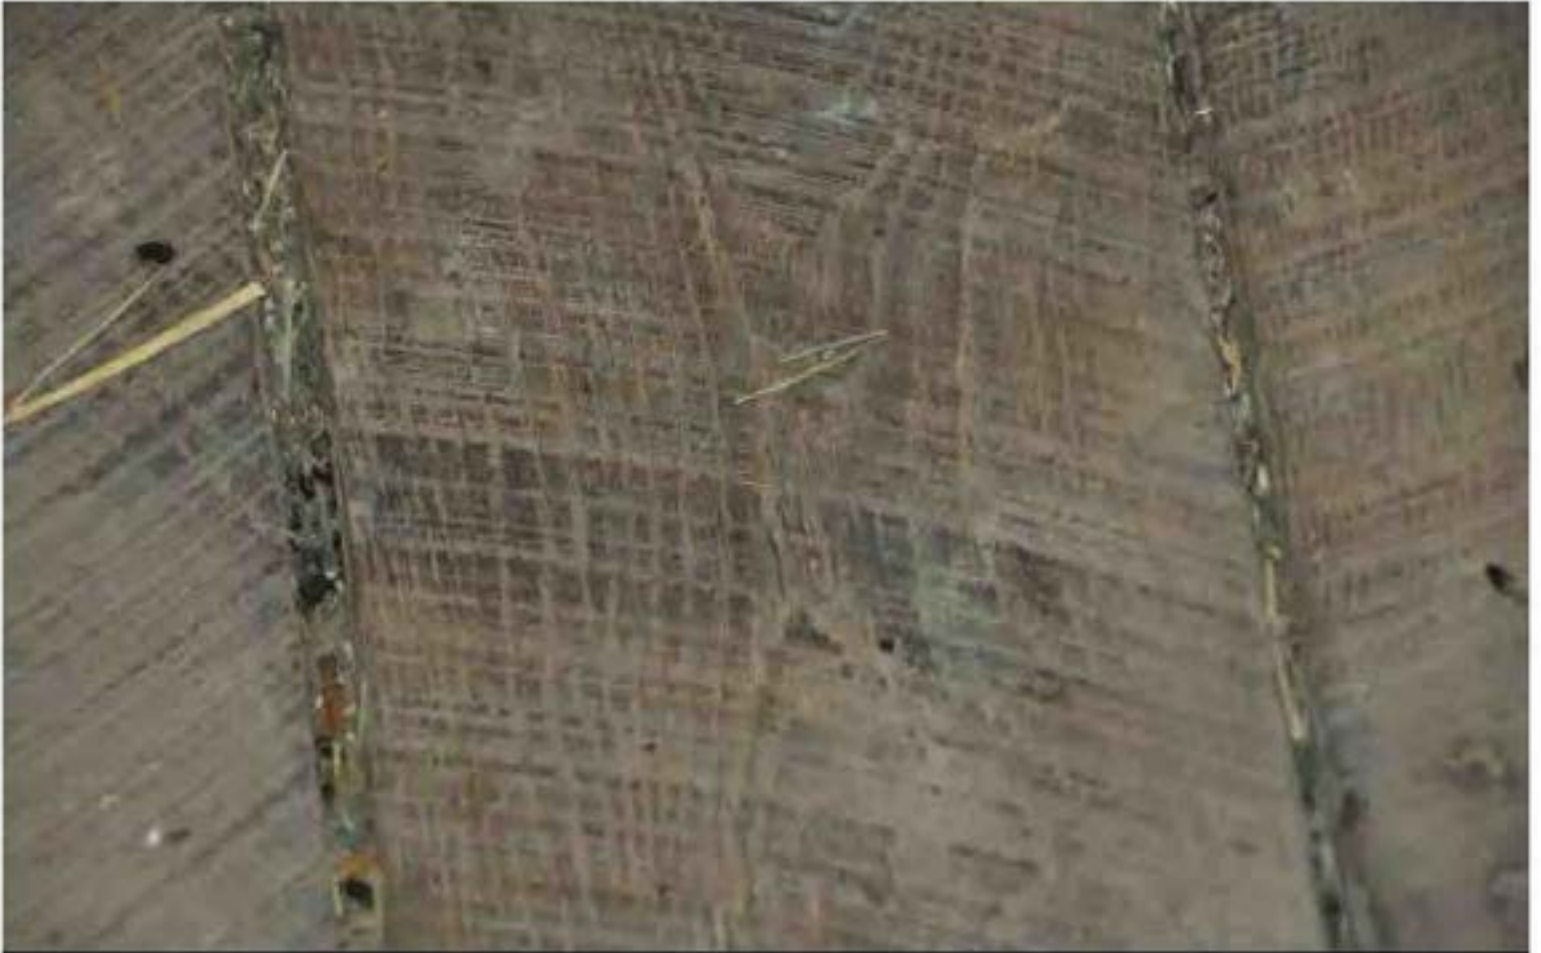
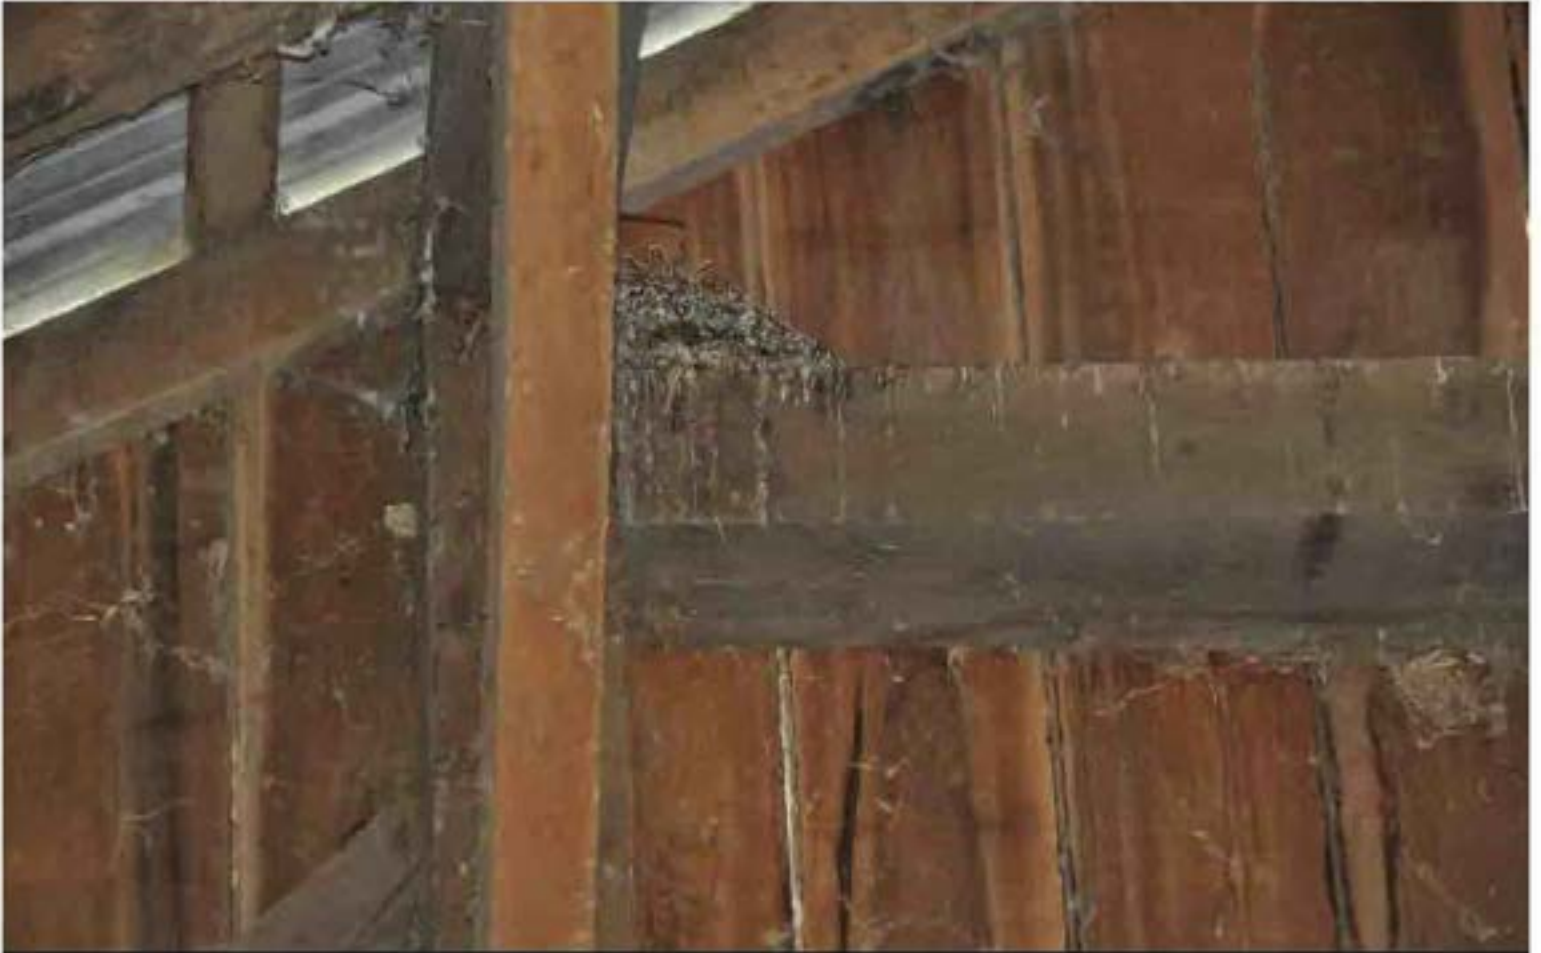
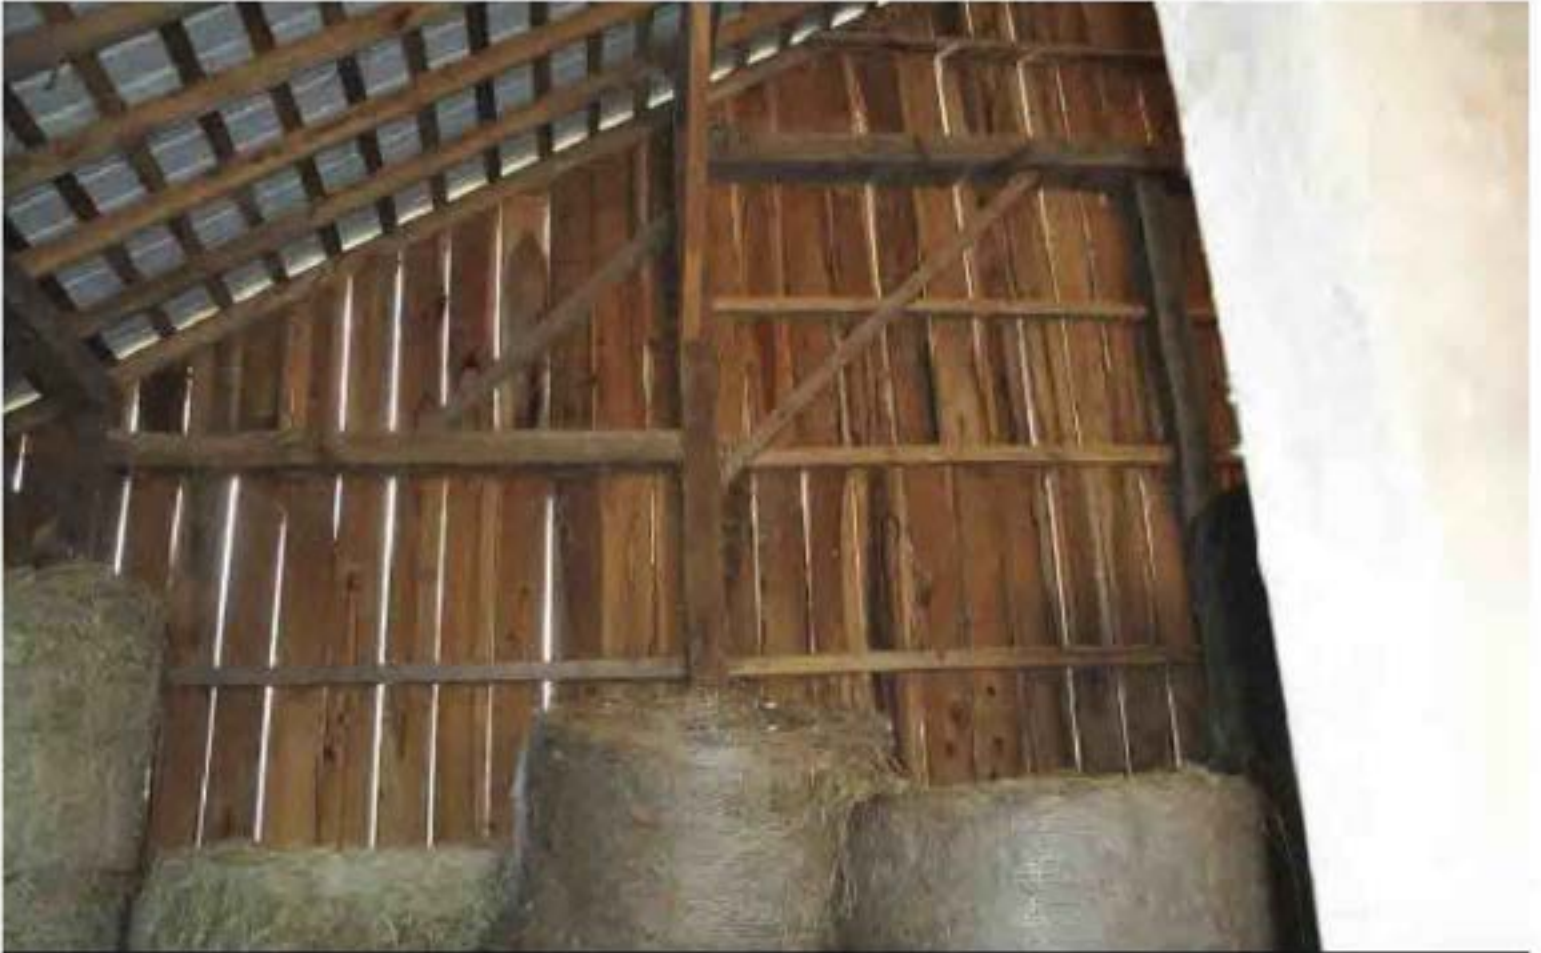
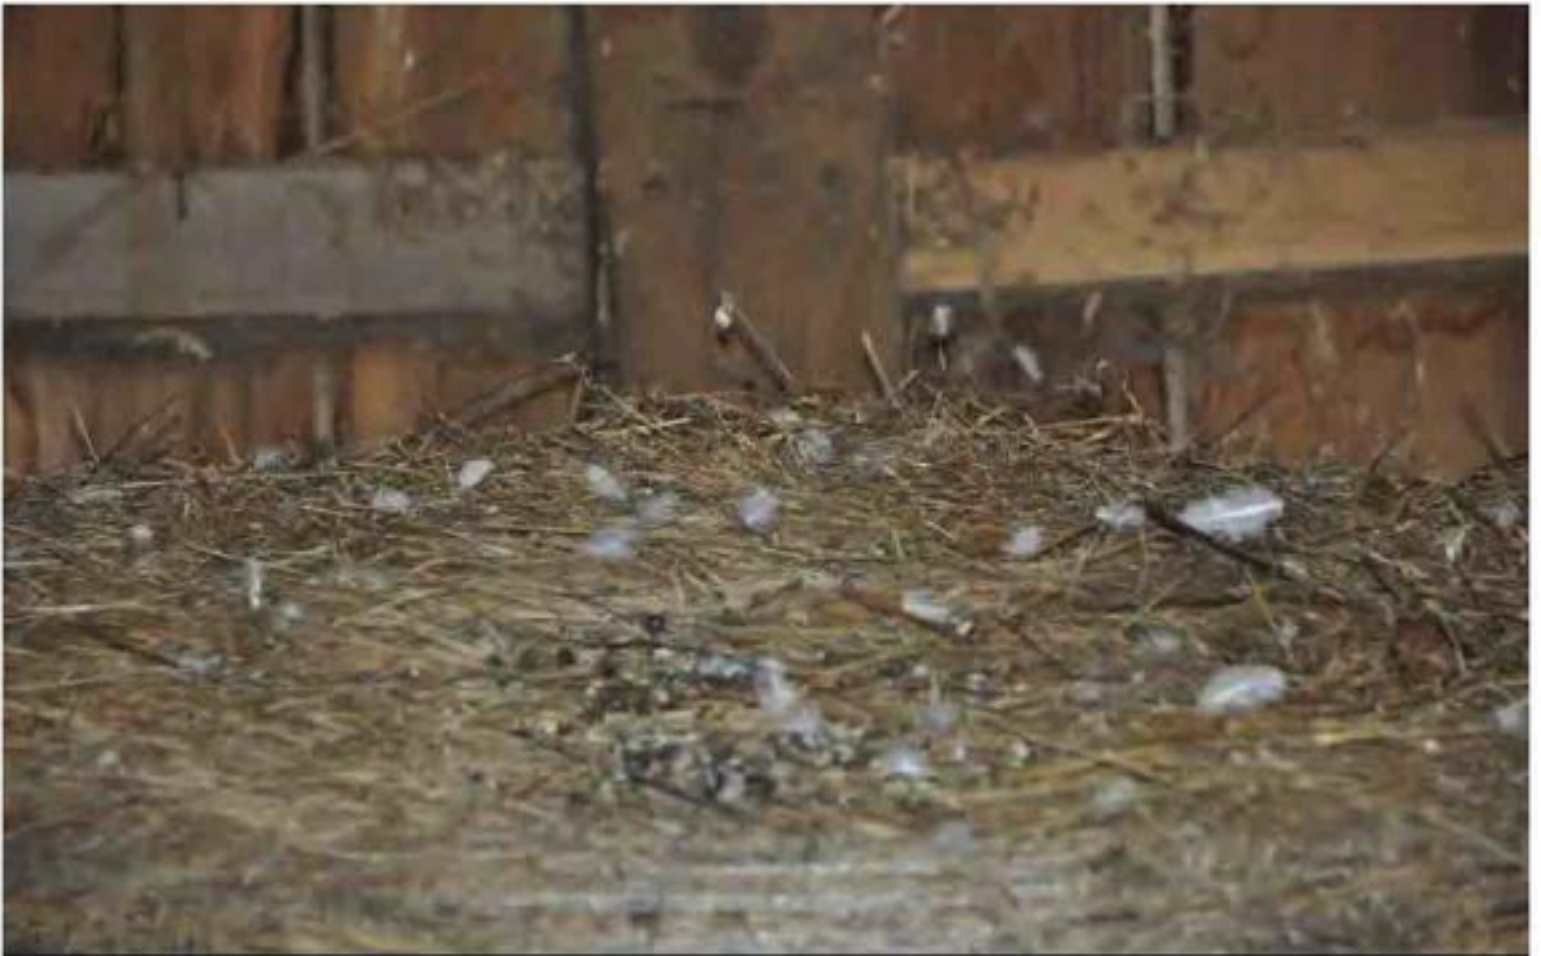
Photographer:	Randy Coleman	Legal Name:	55-B-0069
Photo Taken:	Tue, Aug 25, '15 1256 pm	HENRY HAMPTON	
Inspection:	240150633510674		
Description:	Section 3.131(d): Evidence of bird pests in hay storage area of dairy barn.
