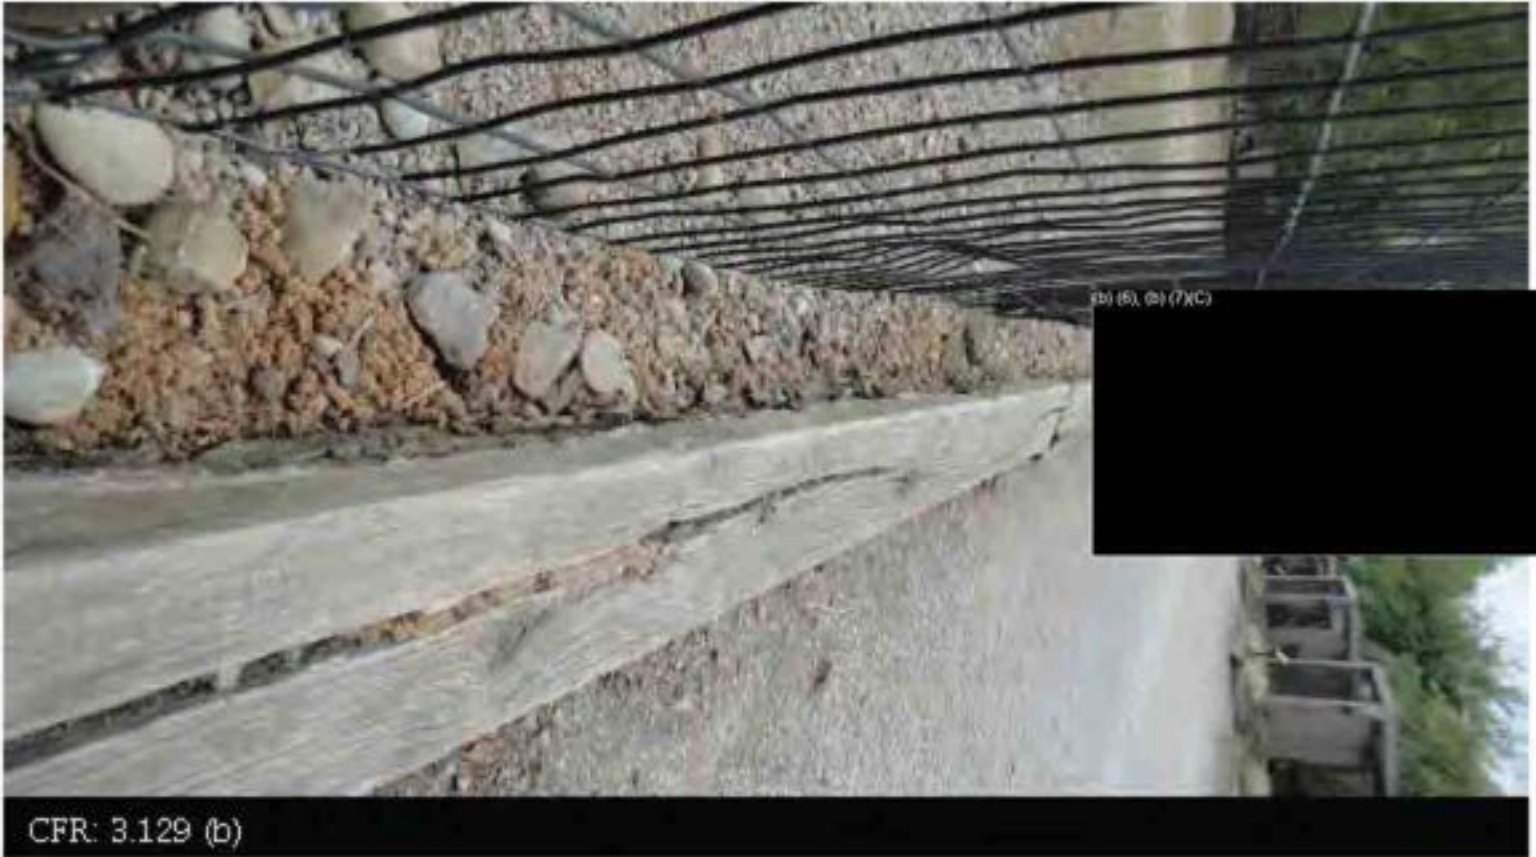
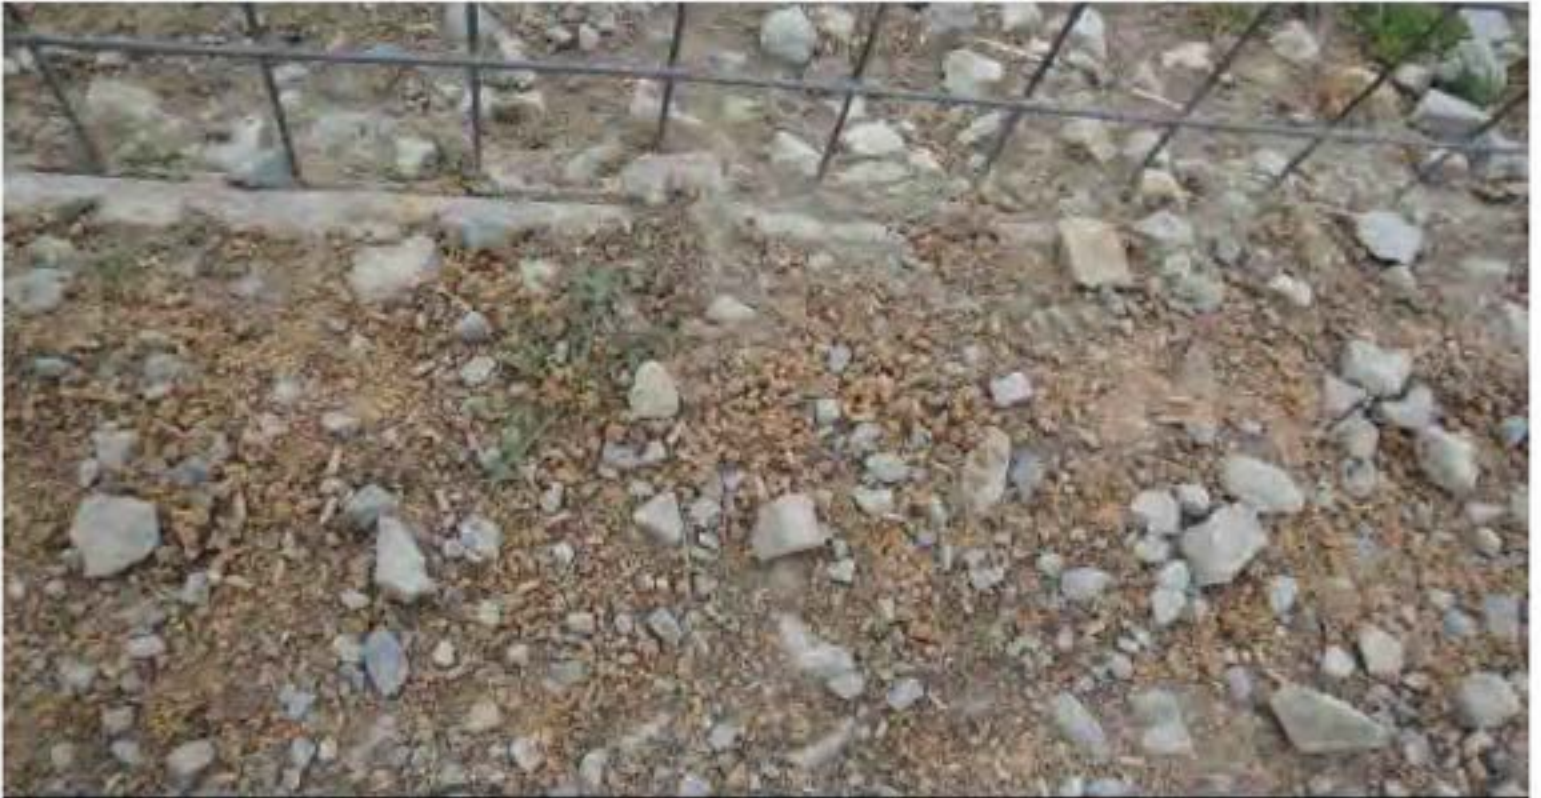
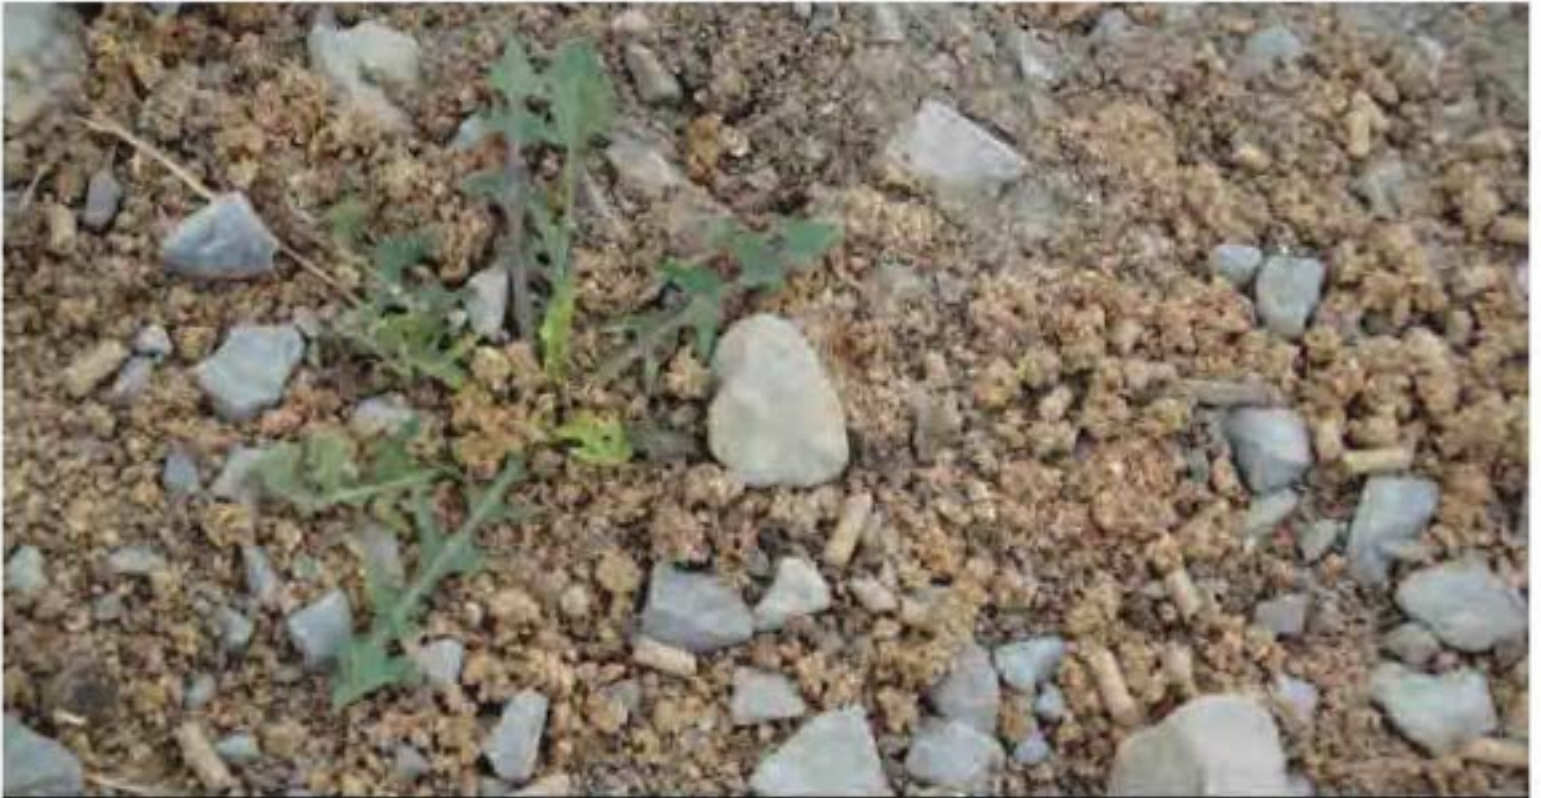
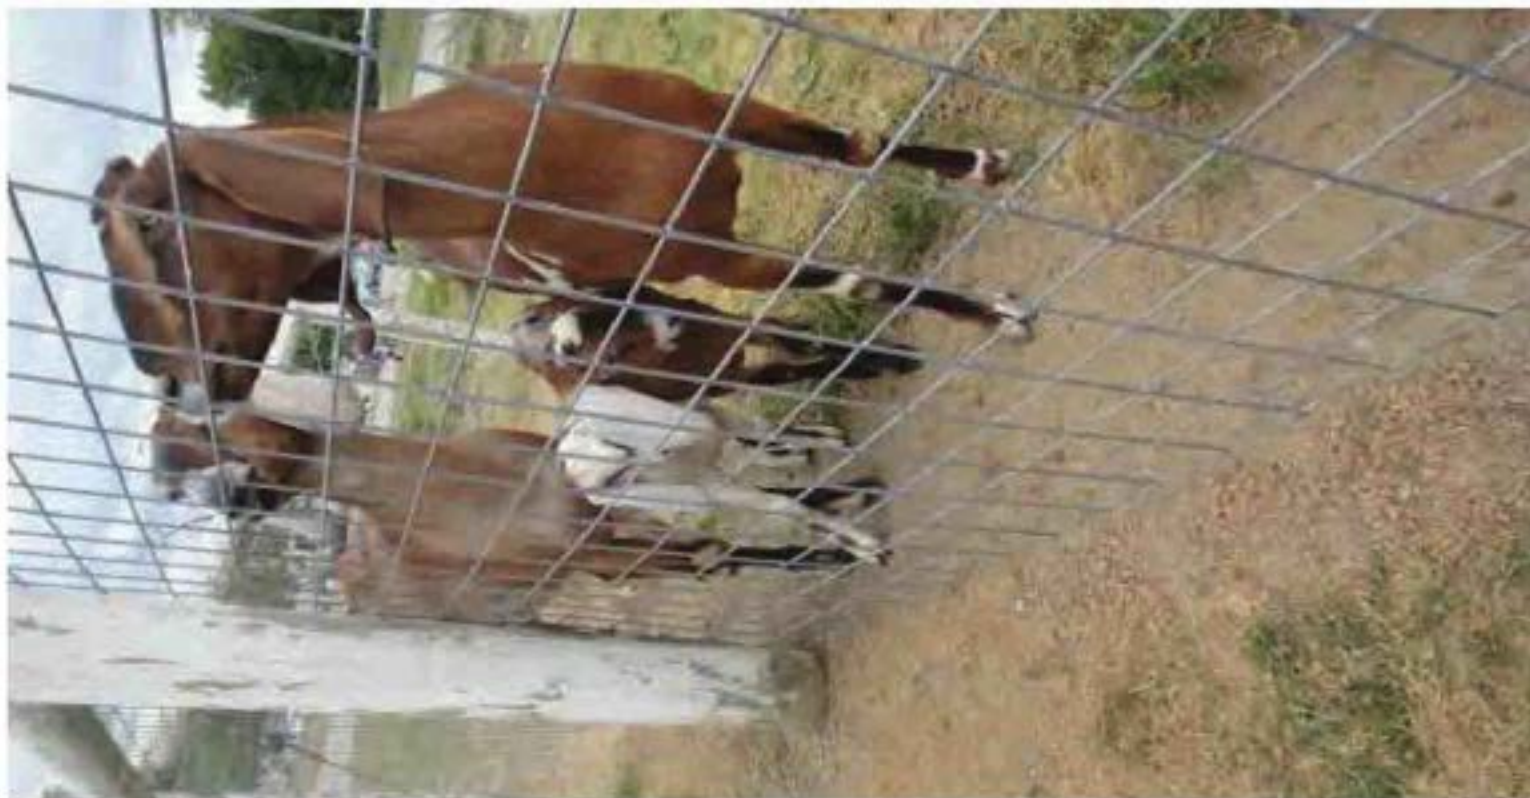
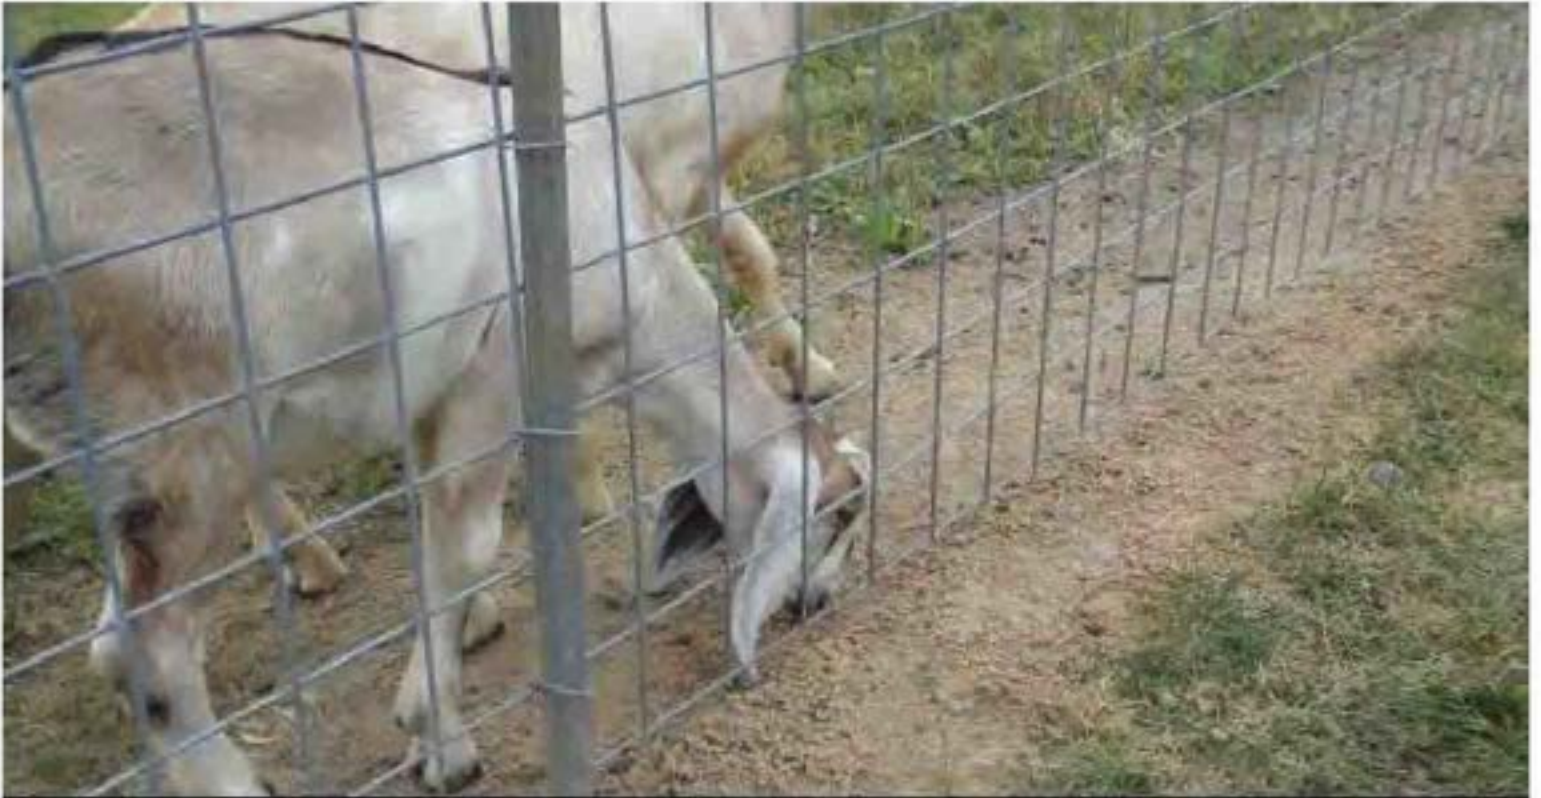
Photographer: Dana Miller Legal Name: HENRY HAMPTON 55-B-0069
Photo Taken: Tue, Aug 25, '15 145 pm
Inspection: 240150633510674
Description: Section 3.129(b): Spilled filled along fence line of many enclosures, Food deteriorating.

Photographer:	Dana Miller	Legal Name:	55-B-0069
Photo Taken:	Tue, Aug 25, '15 145 pm	HENRY HAMPTON	
Inspection:	240150633510674		
Description:	Section 3.129(b): Spilled filled along fence line of many enclosures, Food deteriorating.

Photographer:	Dana Miller	Legal Name:	55-B-0069
Photo Taken:	Tue, Aug 25, '15 145 pm	HENRY HAMPTON	
Inspection:	240150633510674		
Description:	Section 3.129(b): Spilled feed along fence line of many enclosures, Food deteriorating.

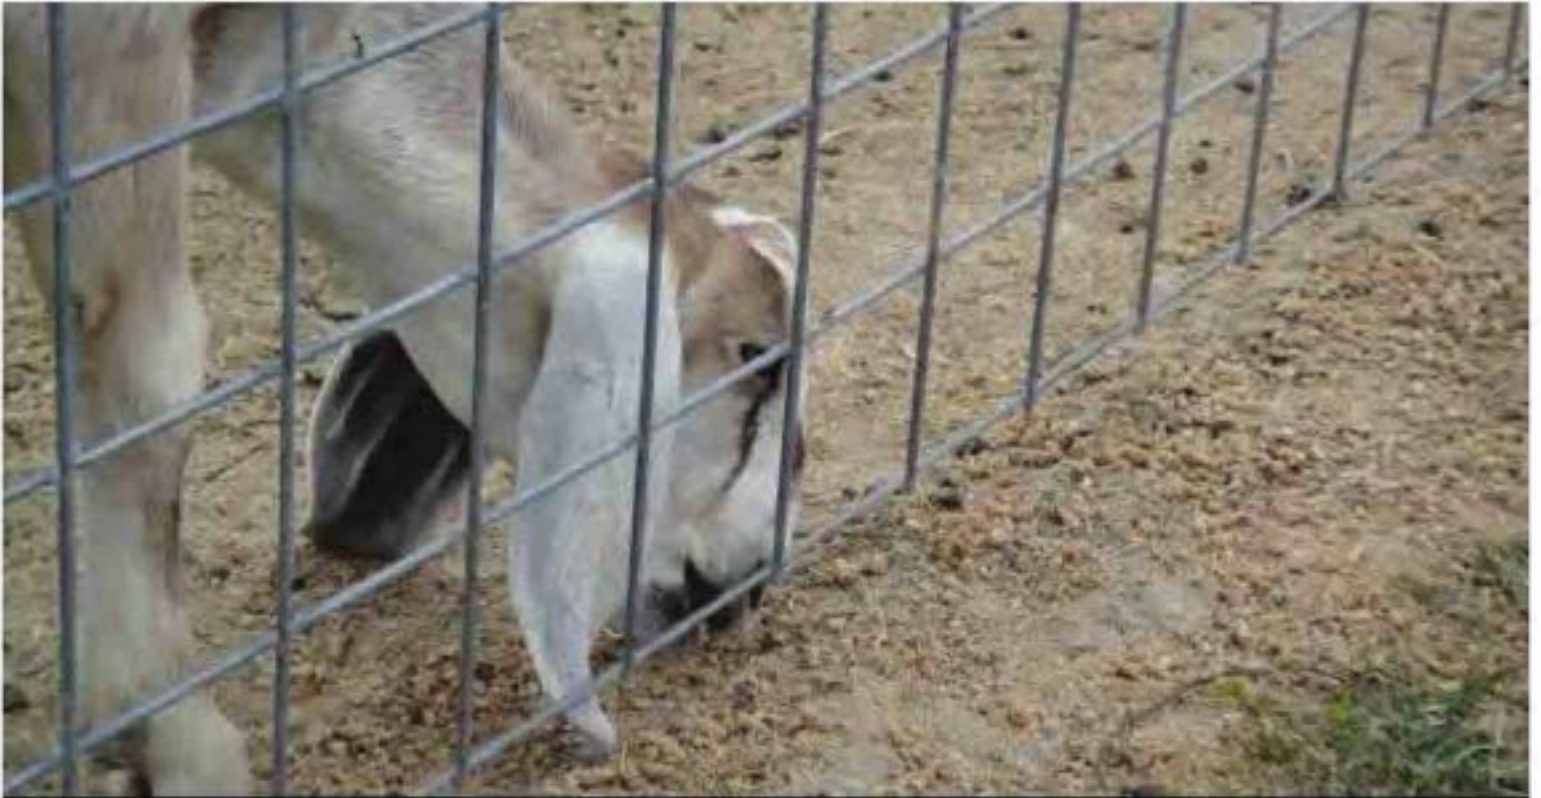
000363

CFR: 3.129 (b)

Photographer:	Dana Miller	Legal Name:	55-B-0069
Photo Taken:	Tue, Aug 25, '15 145 pm	HENRY HAMPTON	
Inspection:	240150633510674		
Description:	Section 3.129(b): Spilled filled along fence line of many enclosures, Food deteriorating.

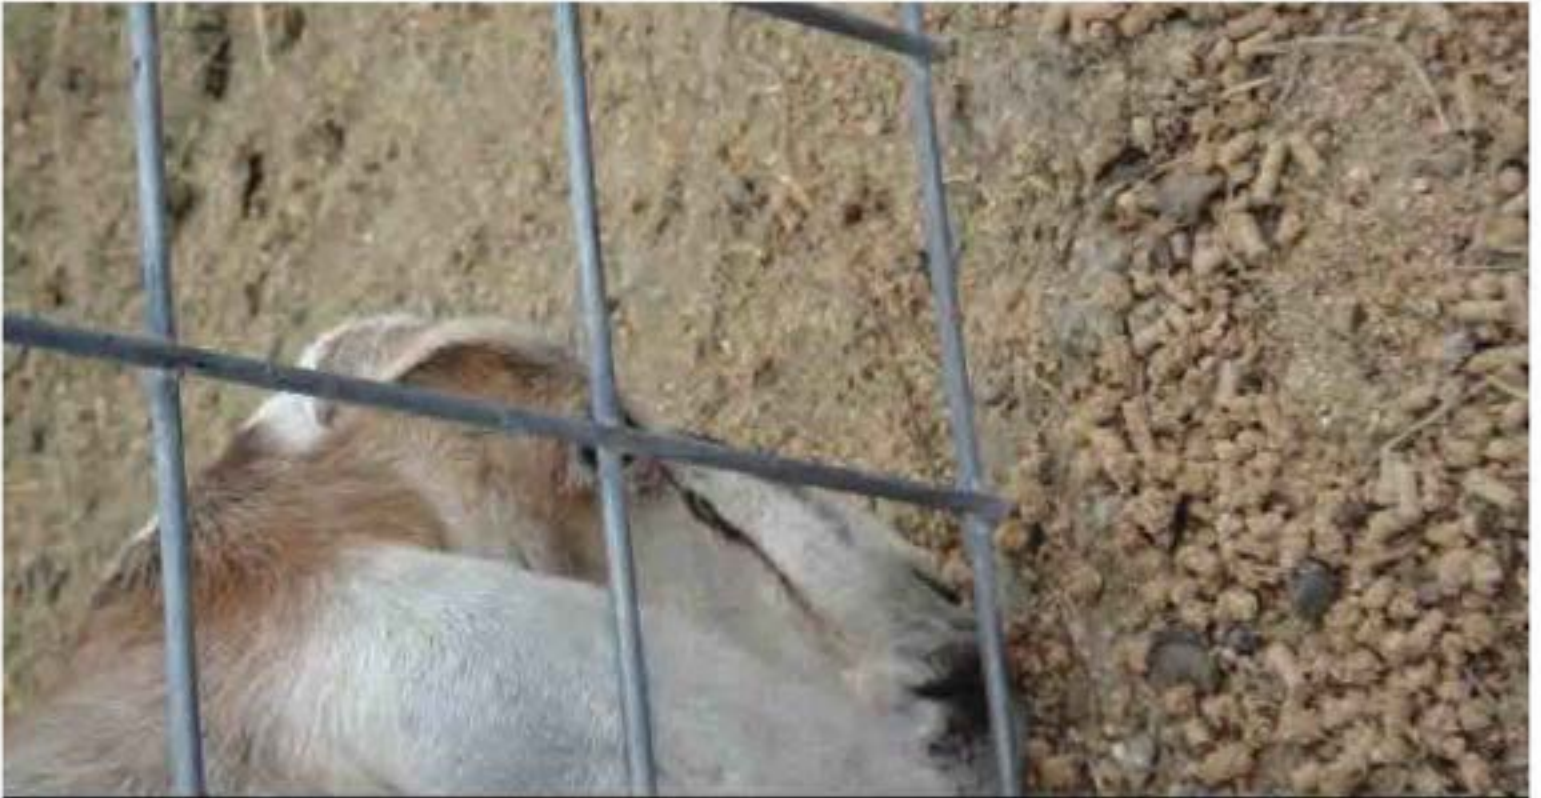
000364

CFR: 3.129 (b)

Photographer:	Dana Miller	Legal Name:	55-B-0069
Photo Taken:	Tue, Aug 25, '15 145 pm	HENRY HAMPTON	
Inspection:	240150633510674		
Description:	Section 3.129(b): Spilled filled along fence line of many enclosures, Food deteriorating.

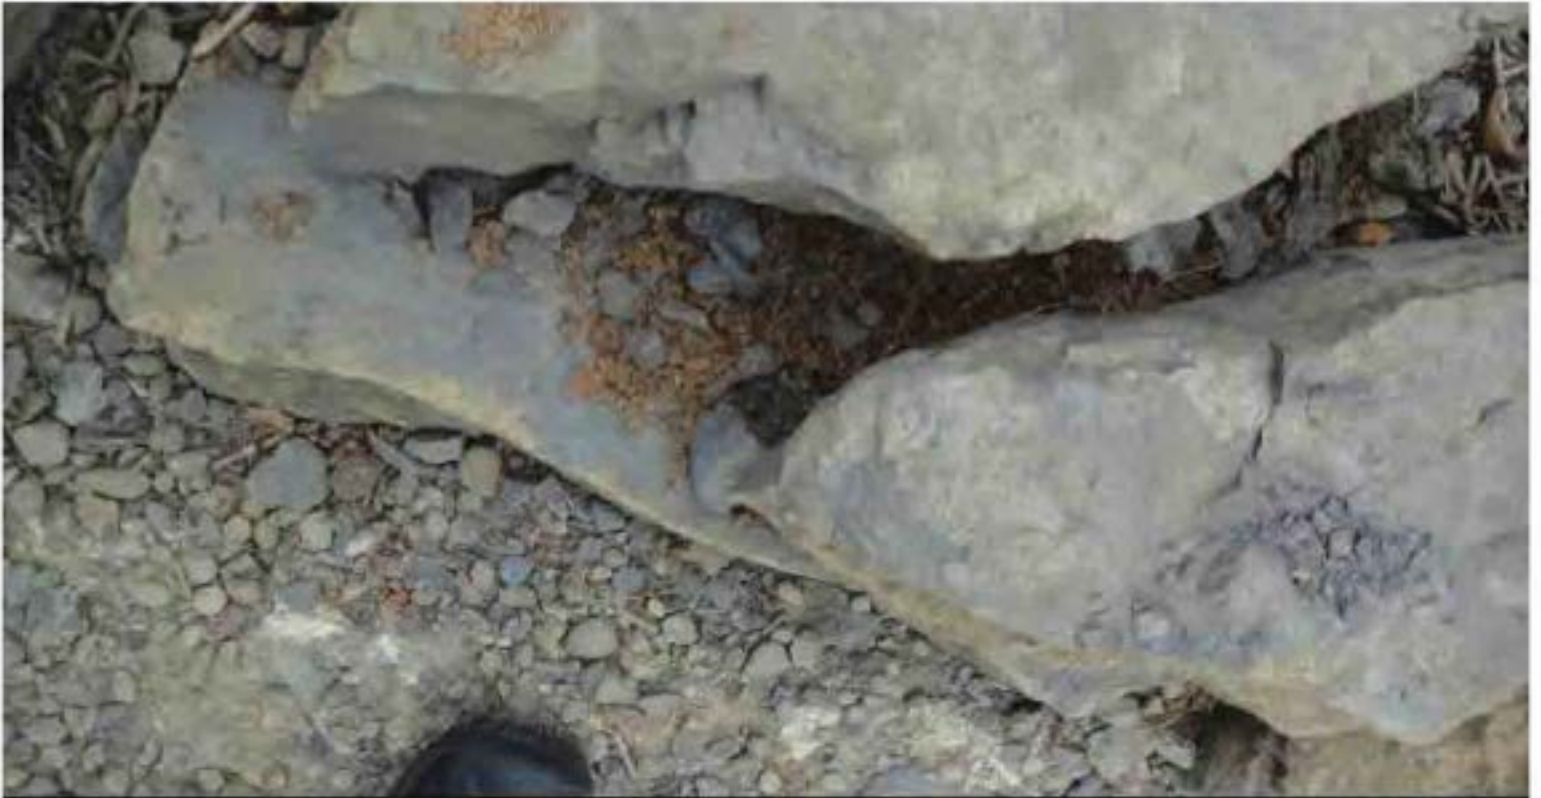
000365

CFR: 3.129 (b)

Photographer:	Dana Miller	Legal Name:	55-B-0069
Photo Taken:	Tue, Aug 25, '15 145 pm	HENRY HAMPTON	
Inspection:	240150633510674		
Description:	Section 3.129(b): Spilled filled along fence line of many enclosures, Food deteriorating.

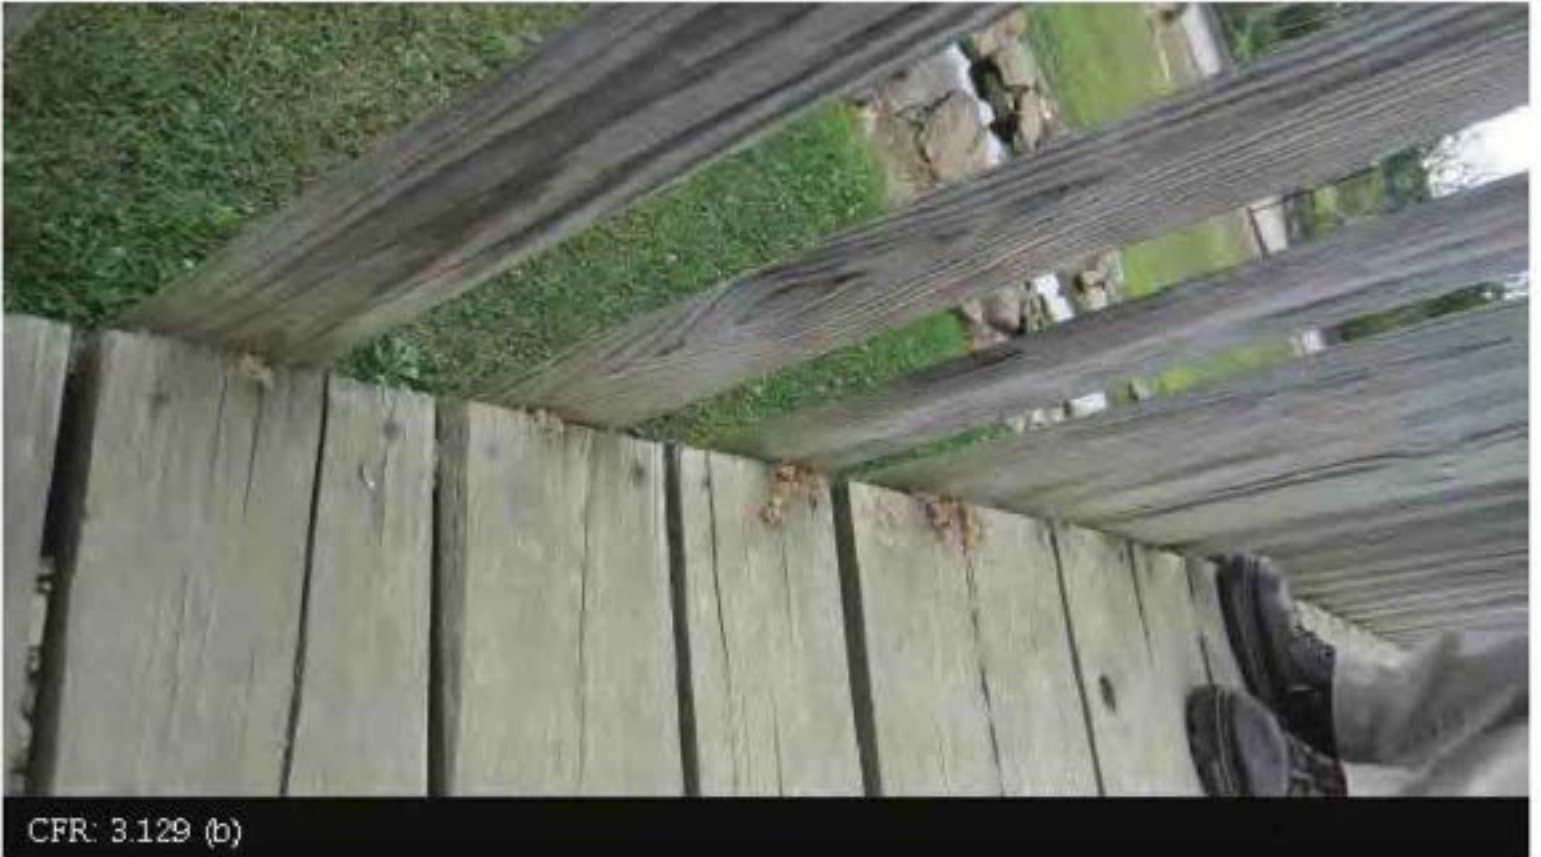
000366

CFR: 3.129 (b)

Photographer:	Dana Miller	Legal Name:	55-B-0069
Photo Taken:	Tue, Aug 25, '15 145 pm	HENRY HAMPTON	
Inspection:	240150633510674		
Description:	Section 3.129(b): Spilled filled along fence line of many enclosures, Food deteriorating.

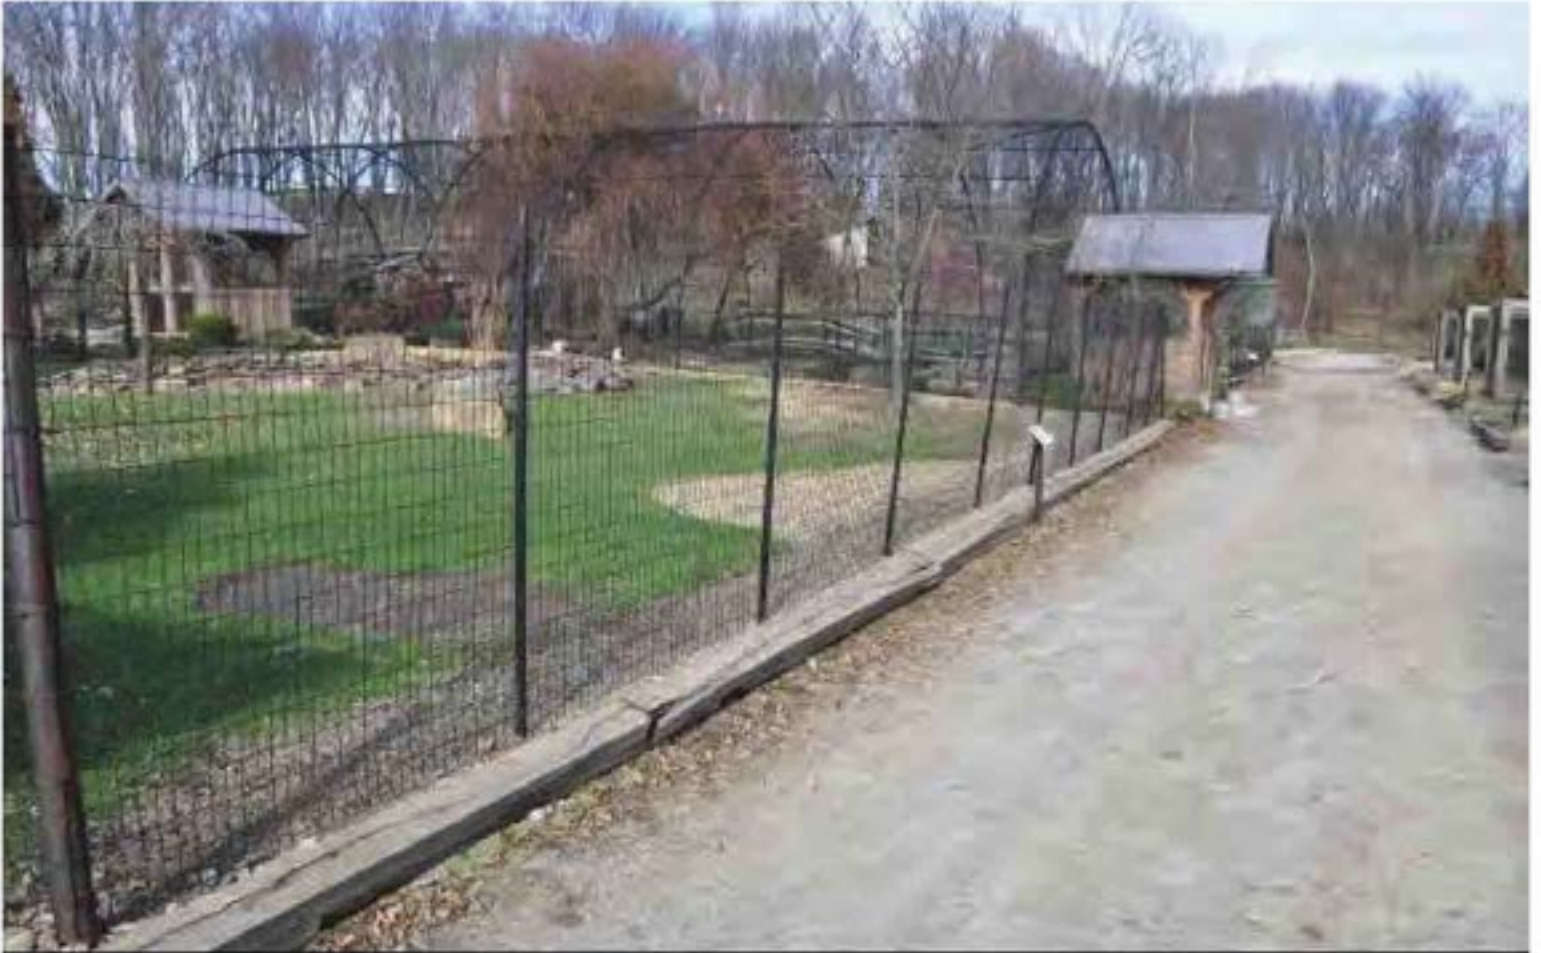
000367

CFR: 2.131 (c) (1)

Photographer:	Randy Coleman	Legal Name:	55-B-0069
Photo Taken:	Mon, Nov 9, '15	HENRY HAMPTON	
Inspection:	314151637070903		
Description:	Section 2.131(c)(1): Lack of barriers allows public to walk up to animal enclosures.

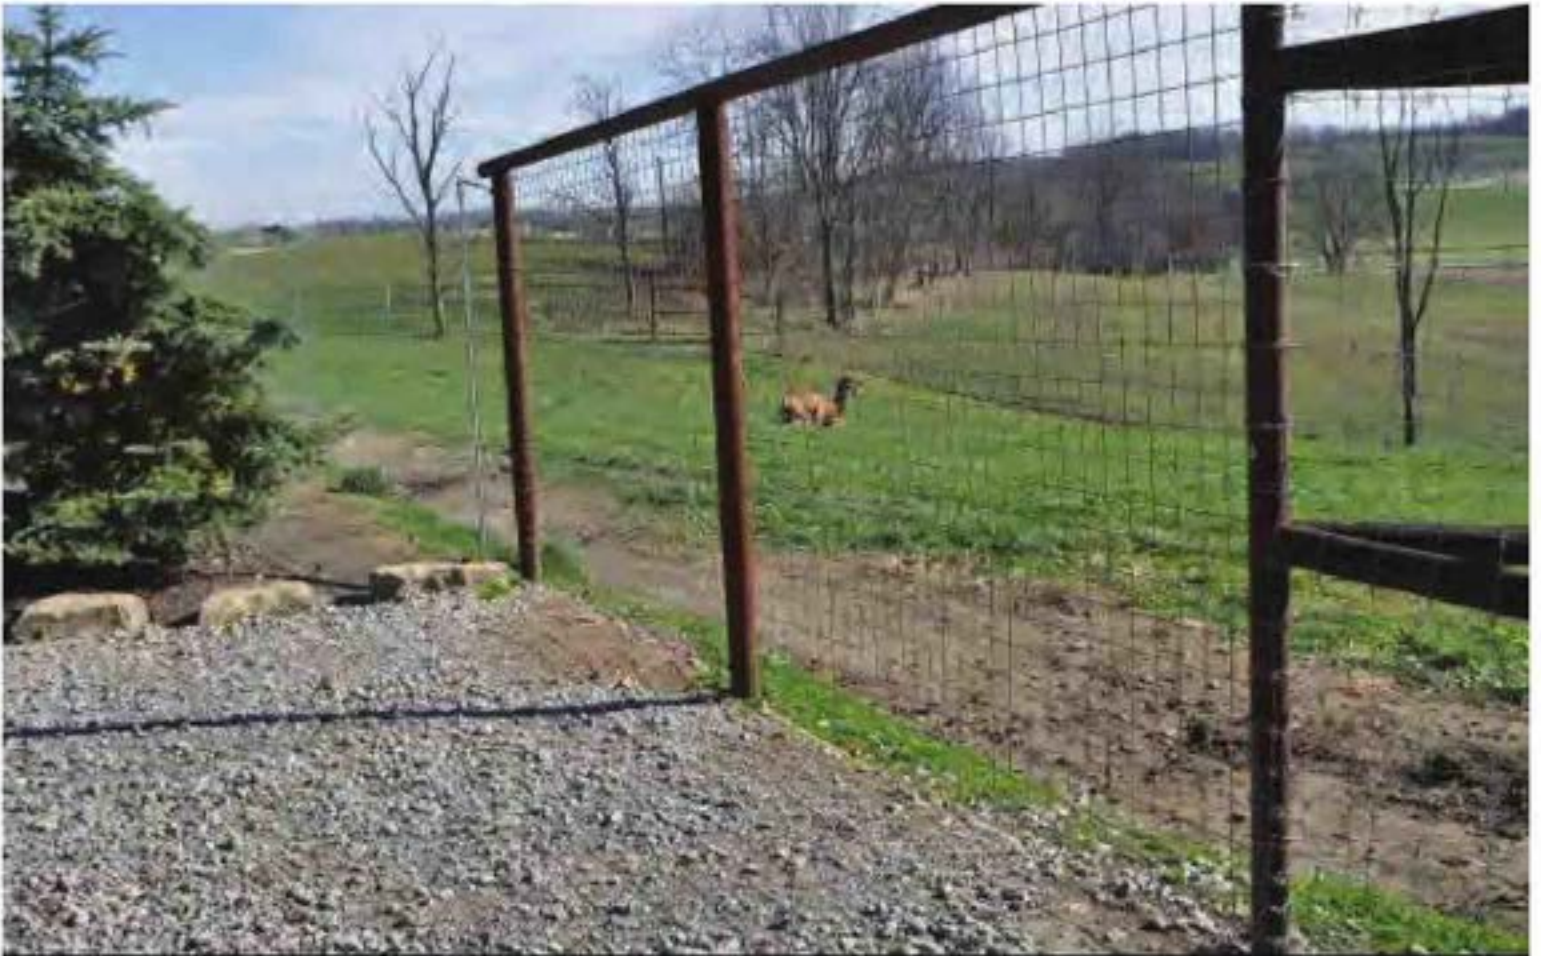
000401

CFR: 2.131 (c) (1)

Photographer:	Randy Coleman	Legal Name:	55-B-0069
Photo Taken:	Mon, Nov 9, '15	HENRY HAMPTON	
Inspection:	314151637070903		
Description:	Section 2.131(c)(1): Lack of barriers allows public to walk up to animal enclosures.

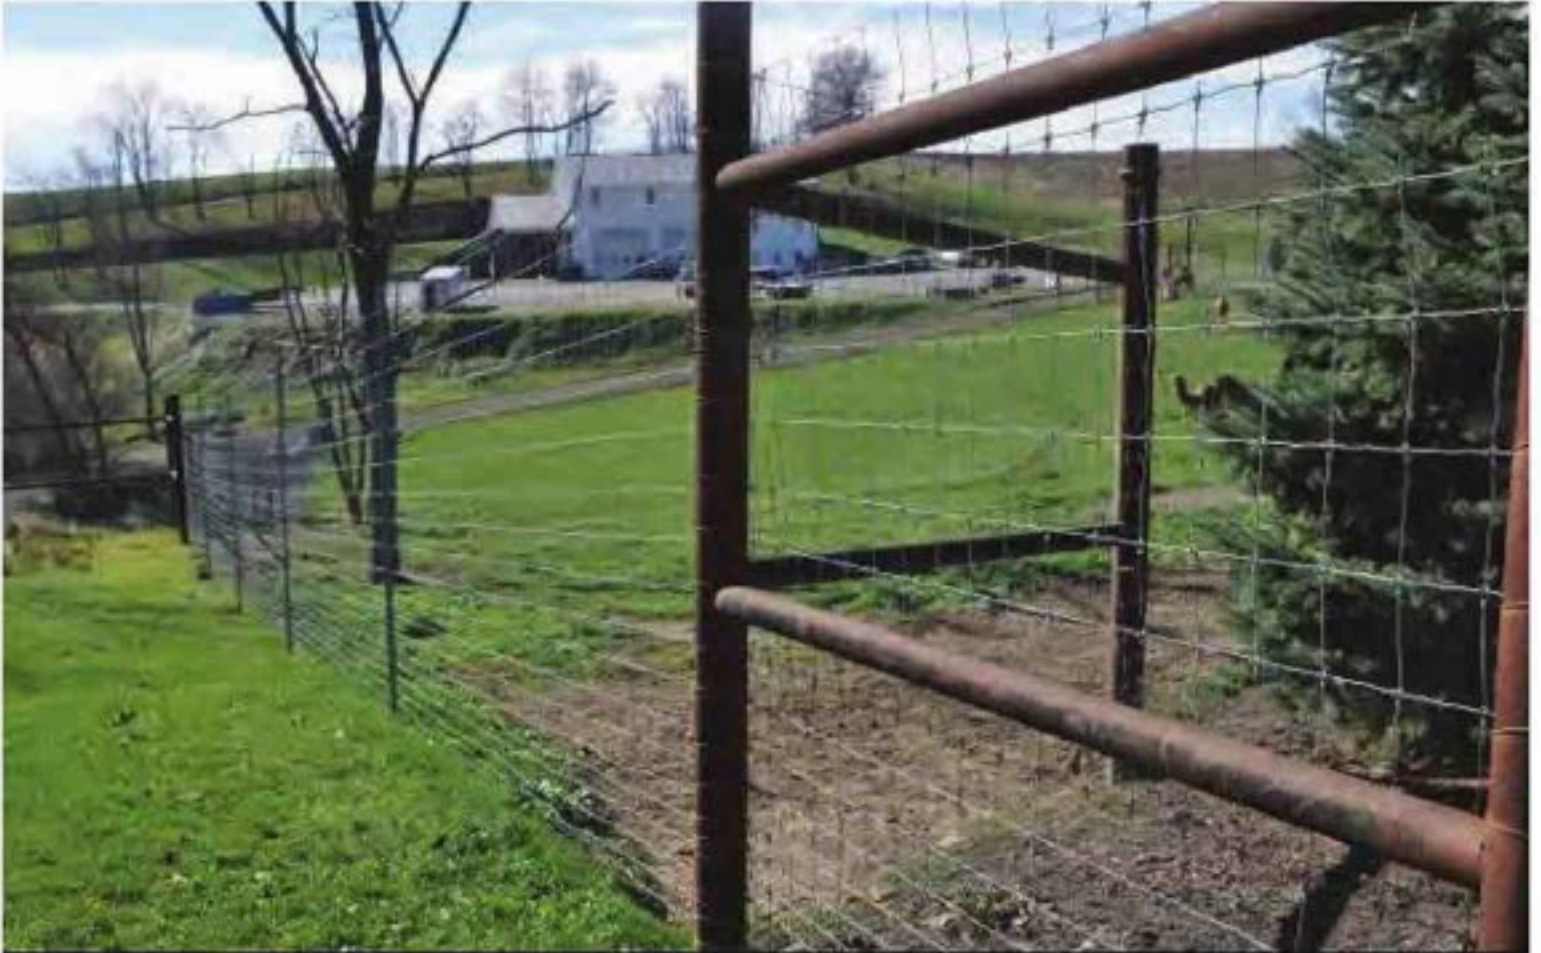
000402

CFR: 2.131 (c) (1)

Photographer:	Randy Coleman	Legal Name:	55-B-0069
Photo Taken:	Mon, Nov 9, '15	HENRY HAMPTON	
Inspection:	314151637070903		
Description:	Section 2.131(c)(1): Lack of barriers allows public to walk up to animal enclosures.

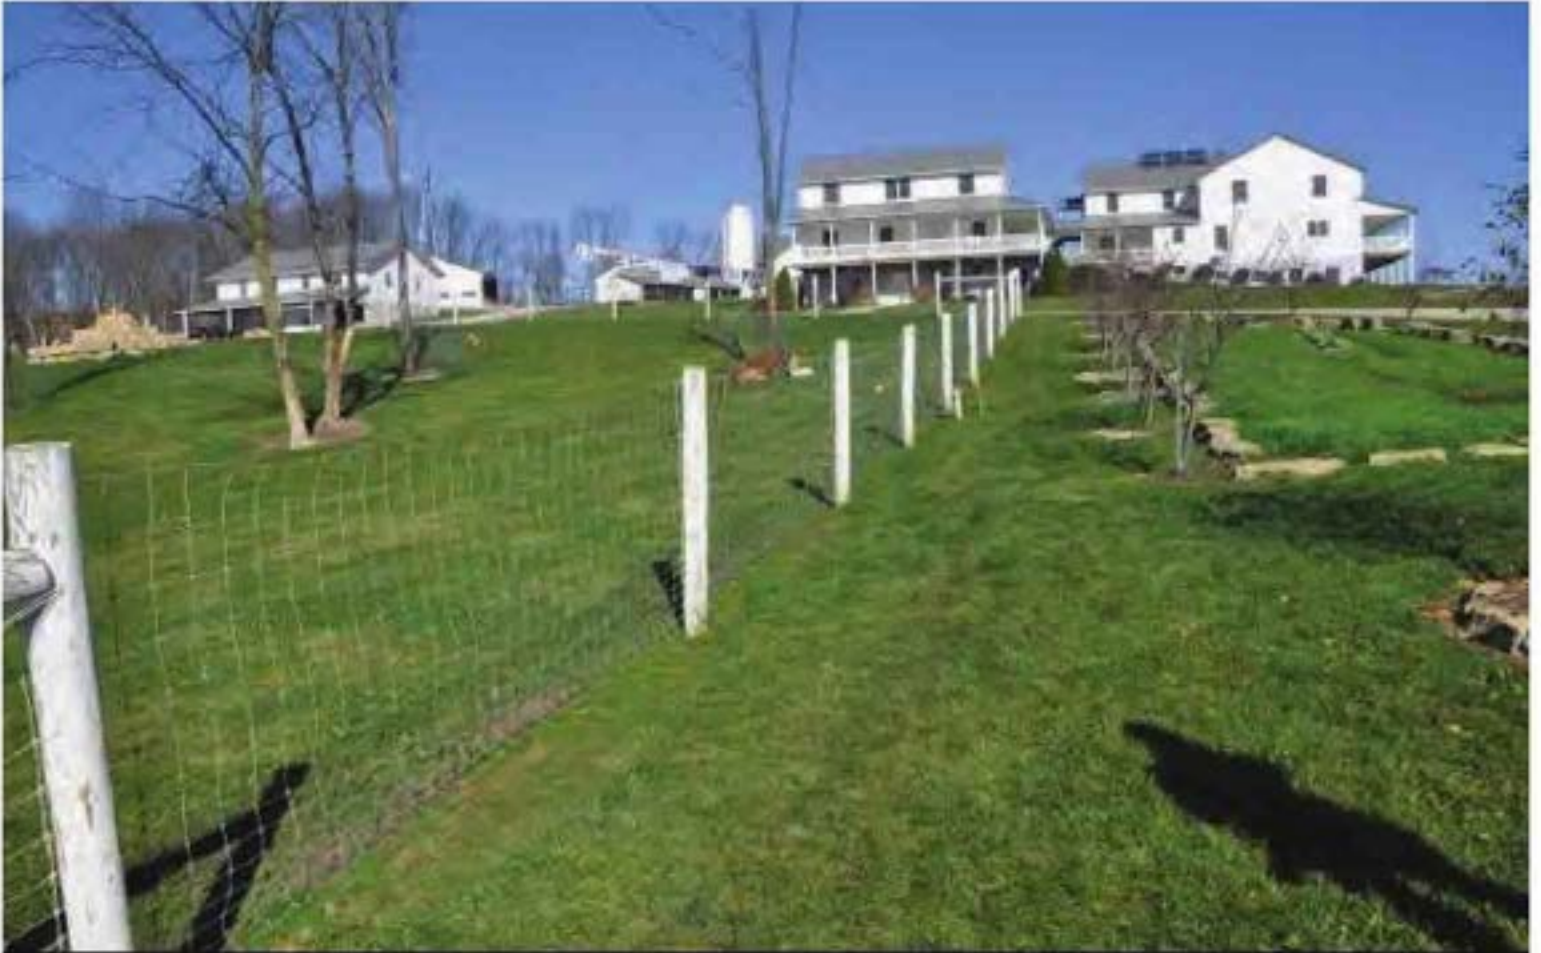
000403

CFR: 2.131 (c) (1)

Photographer:	Randy Coleman	Legal Name:	55-B-0069
Photo Taken:	Mon, Nov 9, '15	HENRY HAMPTON	
Inspection:	314151637070903		
Description:	Section 2.131(c)(1): Lack of barriers allows public to walk up to animal enclosures.

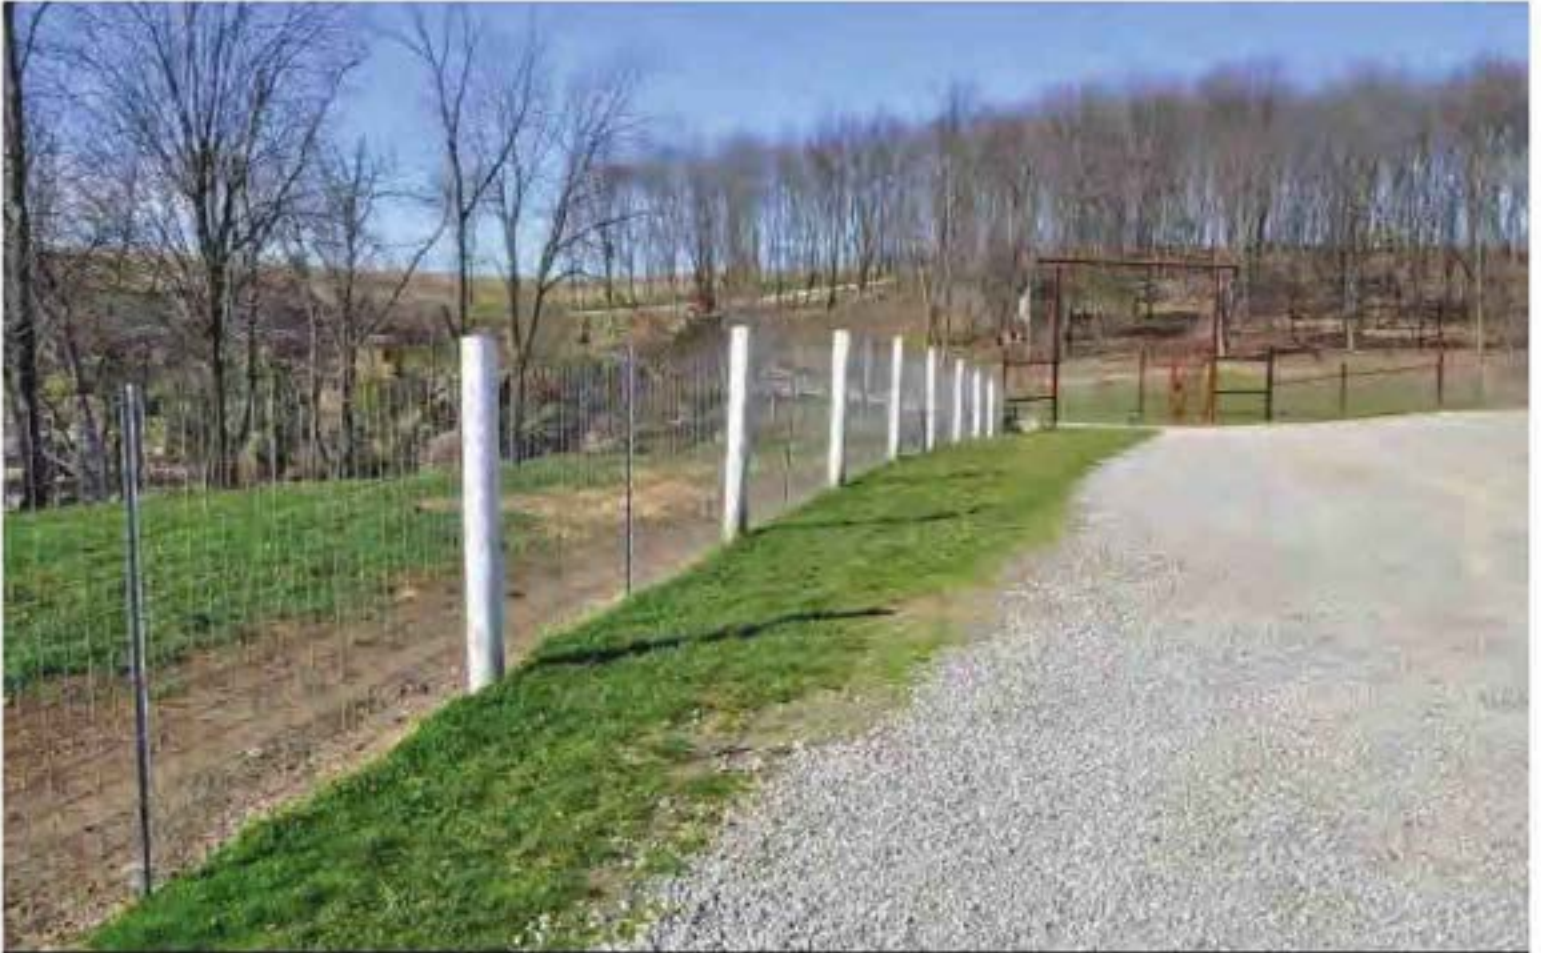
000404

CFR: 2.131 (c) (1)

Photographer:	Randy Coleman	Legal Name:	55-B-0069
Photo Taken:	Mon, Nov 9, '15	HENRY HAMPTON	
Inspection:	314151637070903		
Description:	Section 2.131(c)(1): Lack of barriers allows public to walk up to animal enclosures.

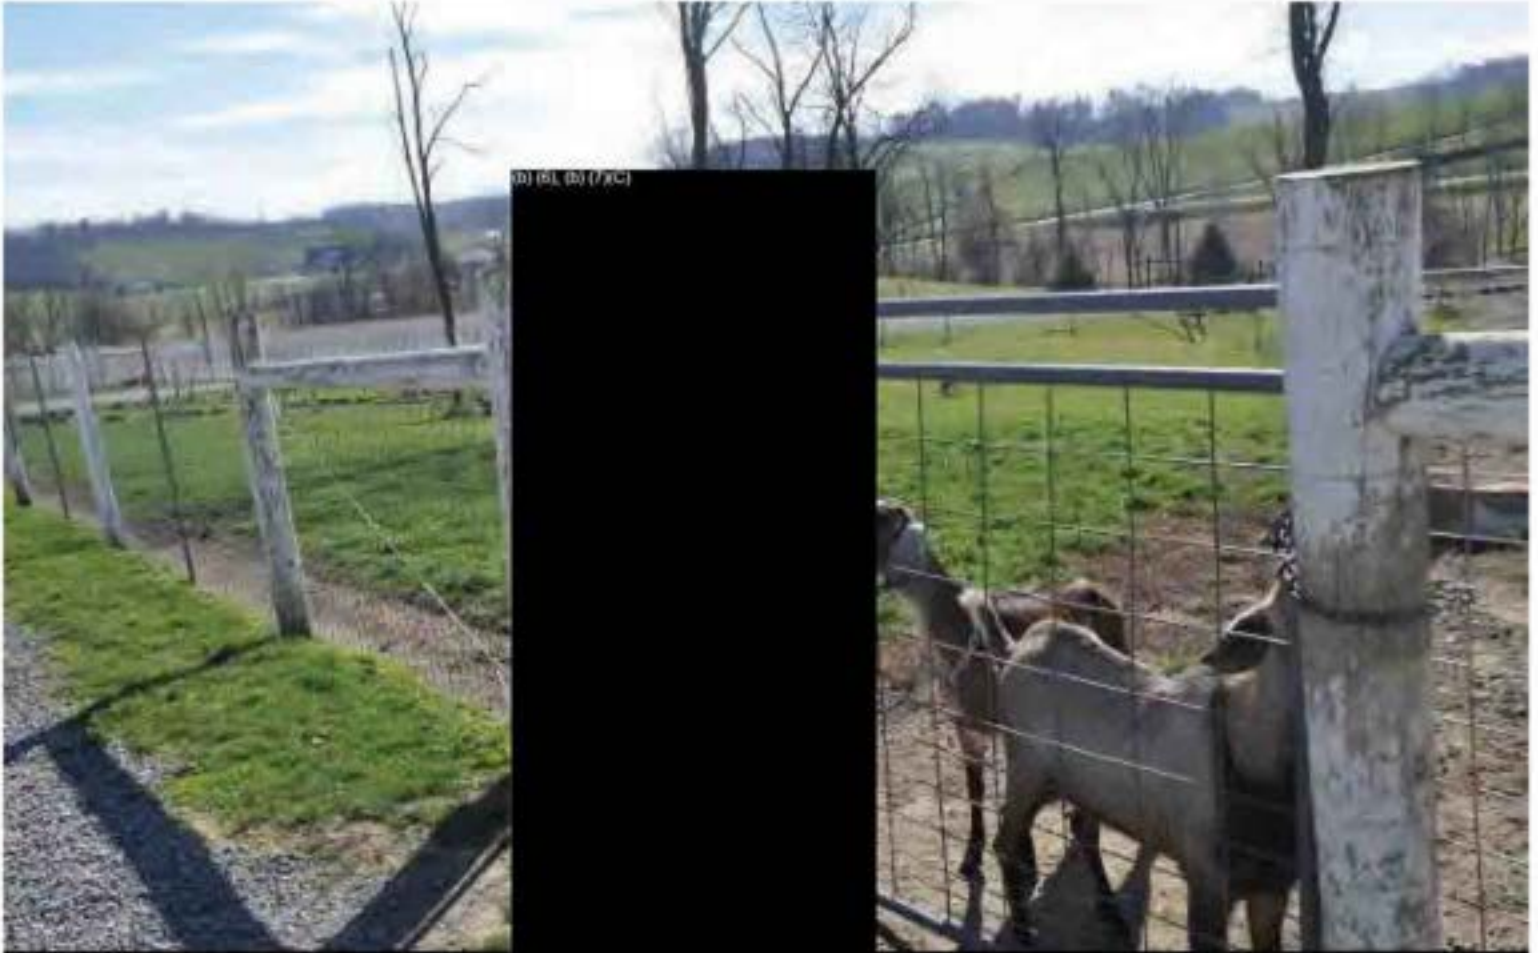
000405

CFR: 2.131 (c) (1)

Photographer:	Randy Coleman	Legal Name:	55-B-0069
Photo Taken:	Mon, Nov 9, '15	HENRY HAMPTON	
Inspection:	314151637070903		
Description:	Section 2.131(c)(1): Lack of barriers allows public to walk up to animal enclosures.

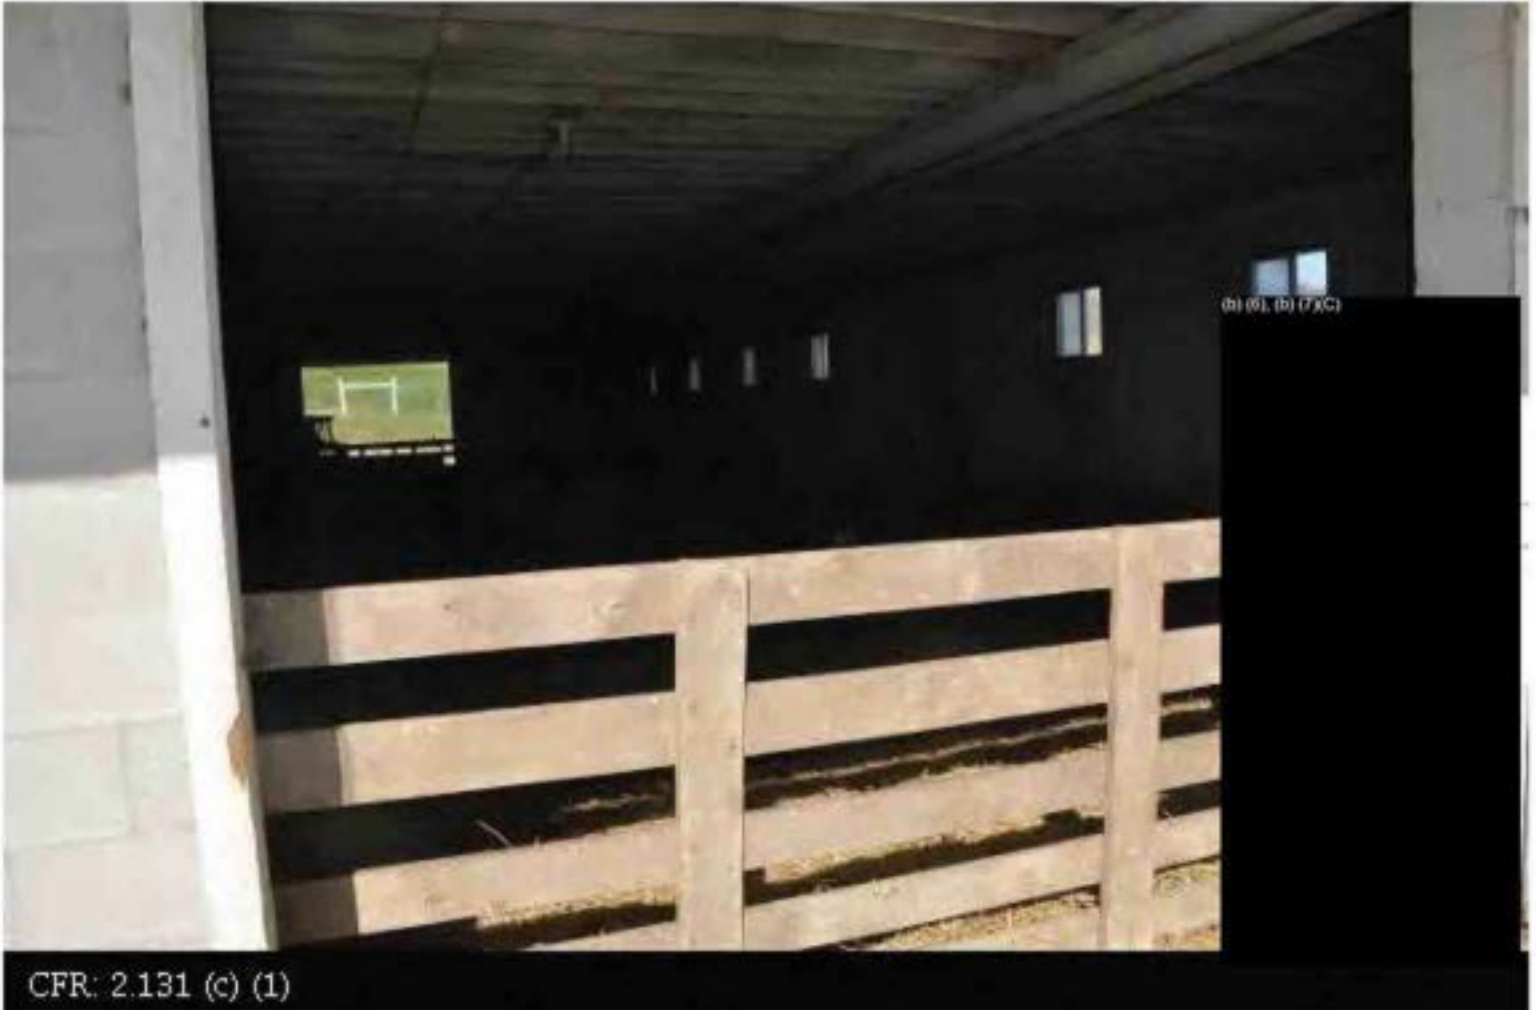
CFR: 2.131 (c) (1)

Photographer:	Randy Coleman	Legal Name:	55-B-0069
Photo Taken:	Mon, Nov 9, '15	HENRY HAMPTON	
Inspection:	314151637070903		
Description:	Section 2.131(c)(1): Lack of barriers allows public to walk up to animal enclosures.
