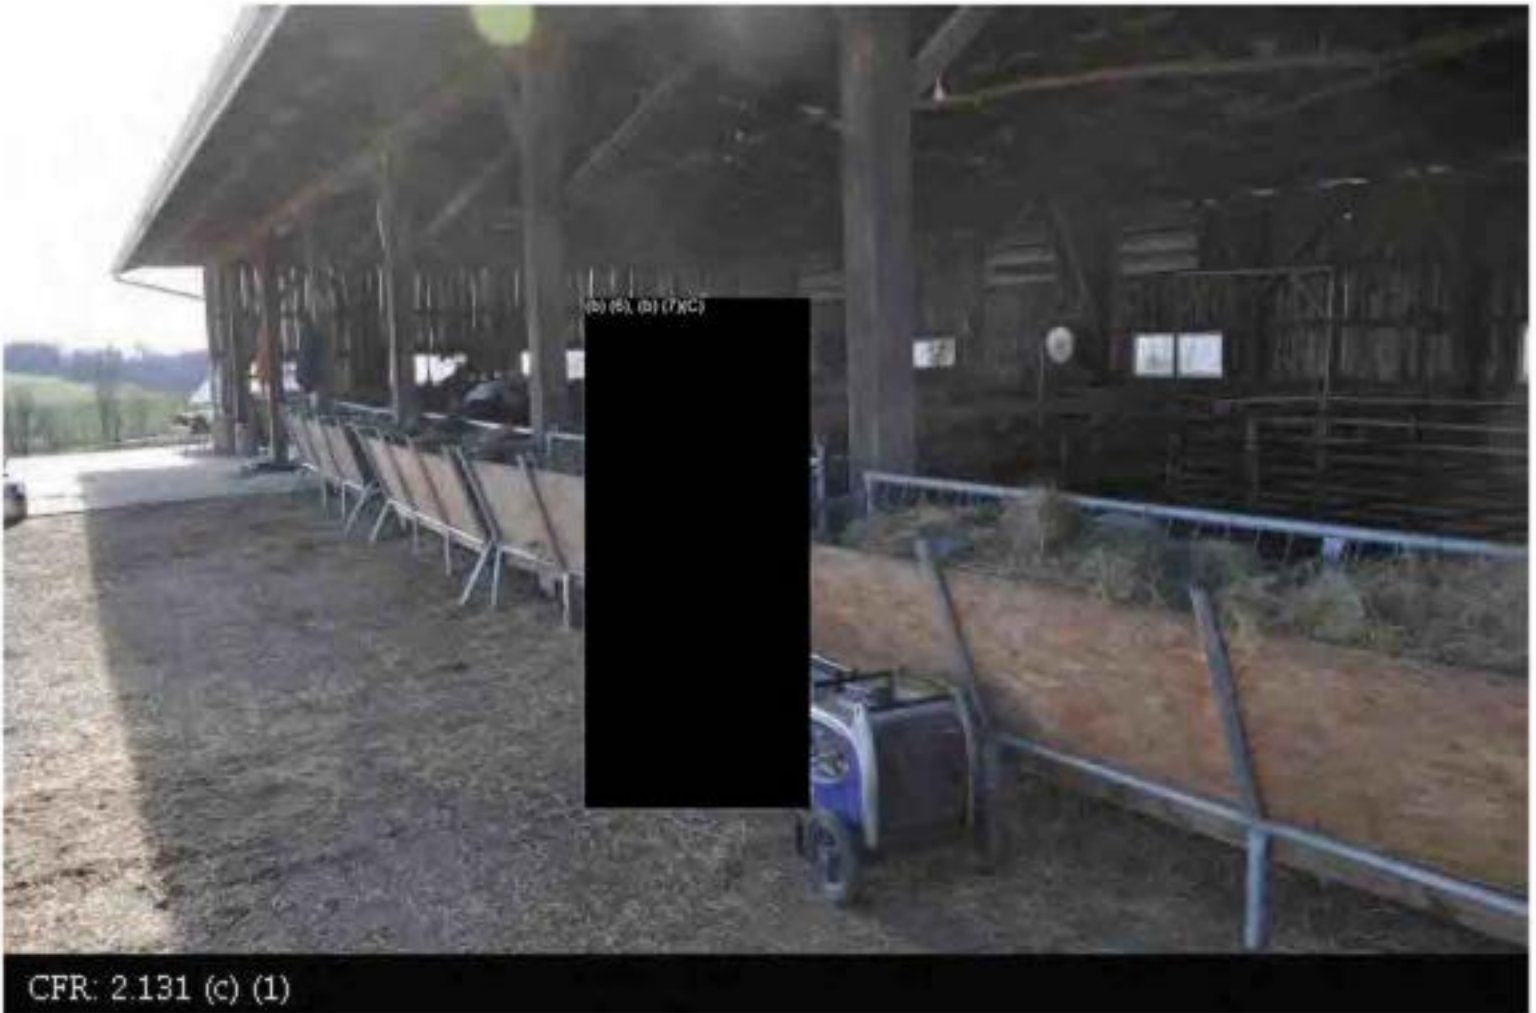
Photographer:	Randy Coleman	Legal Name:	55-B-0069
Photo Taken:	Mon, Nov 9, '15	HENRY HAMPTON	
Inspection:	314151637070903		
Description:	Section 2.131(c)(1): Lack of barriers allows public to walk up to animal enclosures.

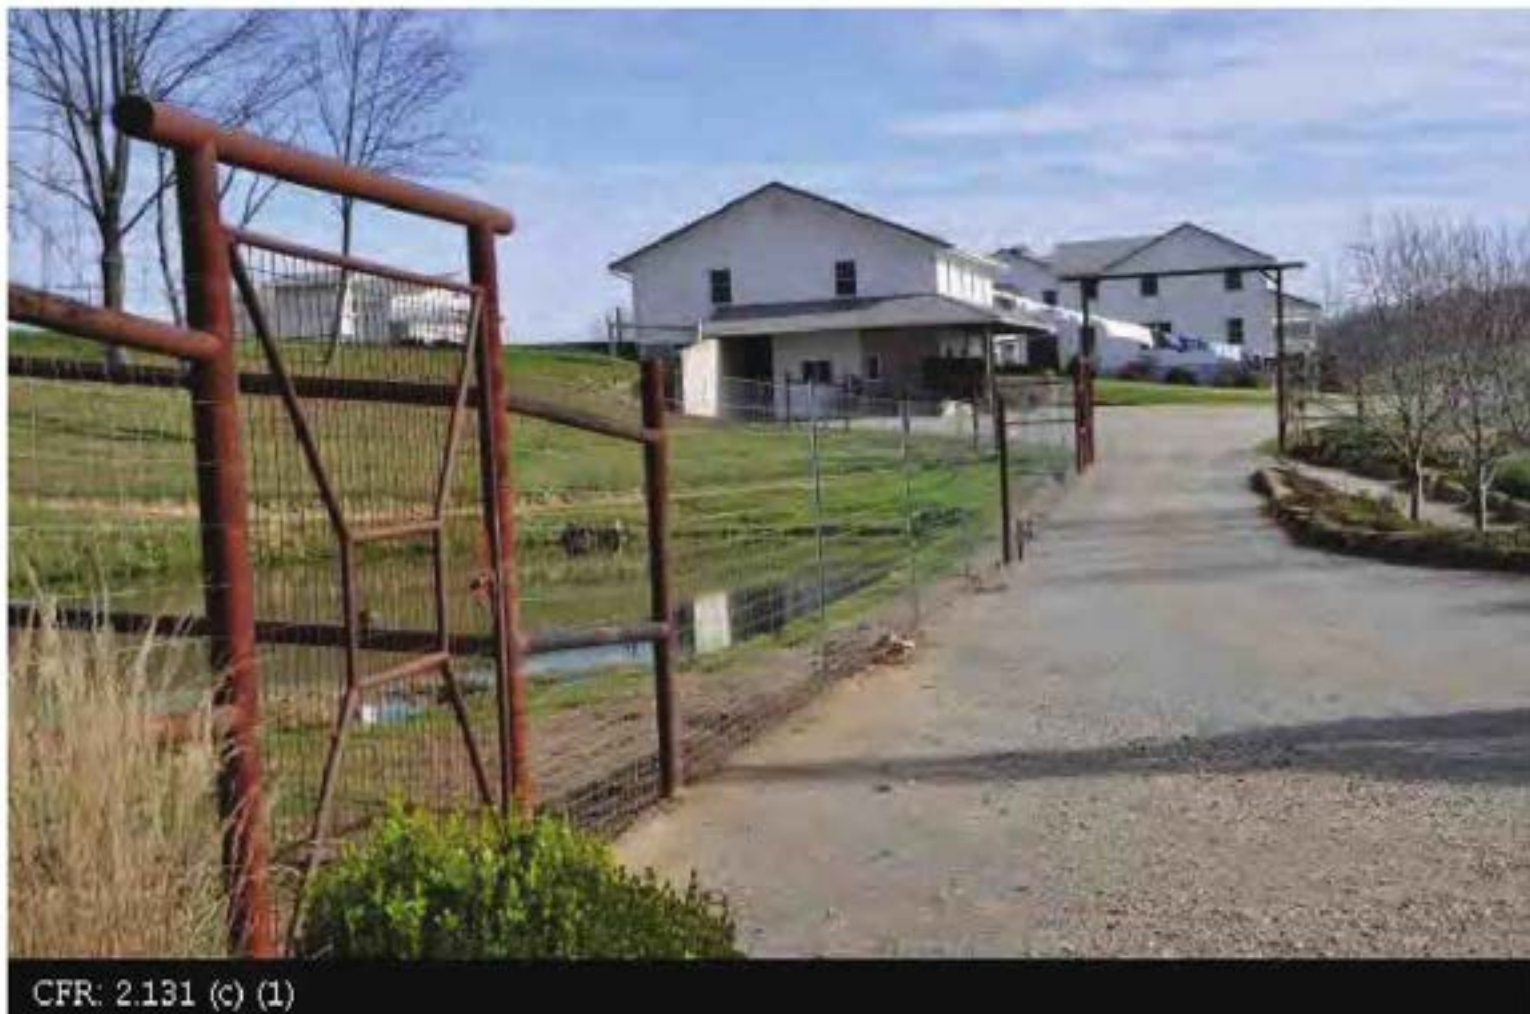
CFR: 2.131 (c) (1)

Photographer:	Randy Coleman	Legal Name:	55-B-0069
Photo Taken:	Mon, Nov 9, '15	HENRY HAMPTON	
Inspection:	314151637070903		
Description:	Section 2.131(c)(1): Lack of barriers allows public to walk up to animal enclosures.

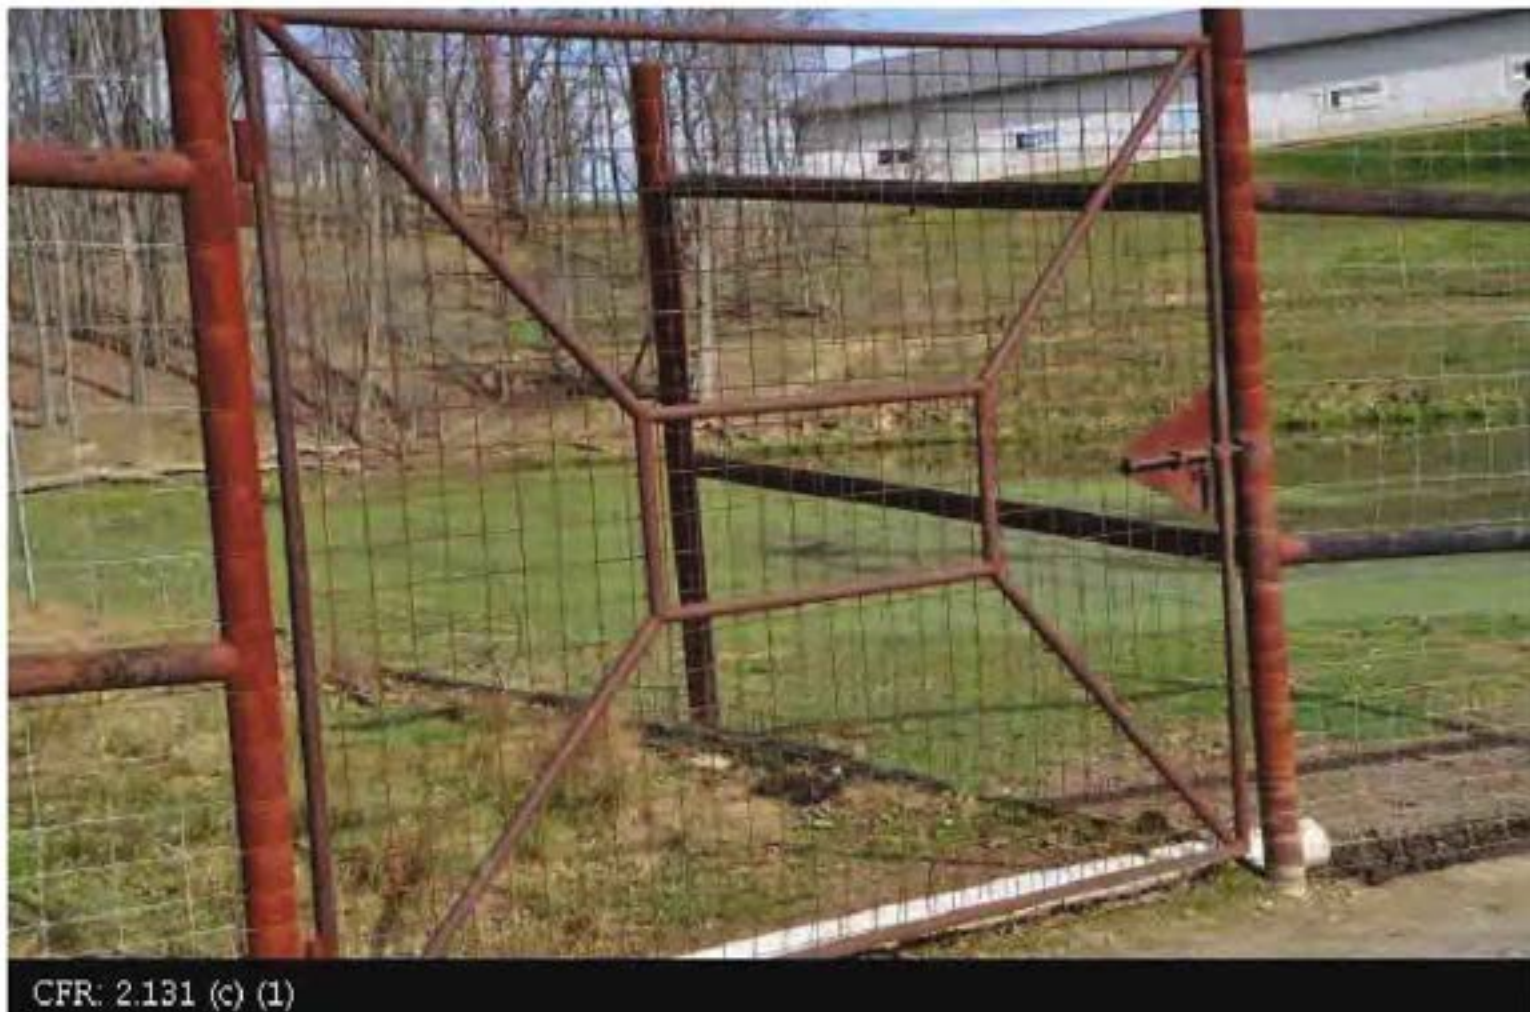
000409

CFR: 2.131 (c) (1)

Photographer:	Randy Coleman	Legal Name:	55-B-0069
Photo Taken:	Mon, Nov 9, '15	HENRY HAMPTON	
Inspection:	314151637070903		
Description:	Section 2.131(c)(1): Lack of barriers allows public to walk up to animal enclosures.

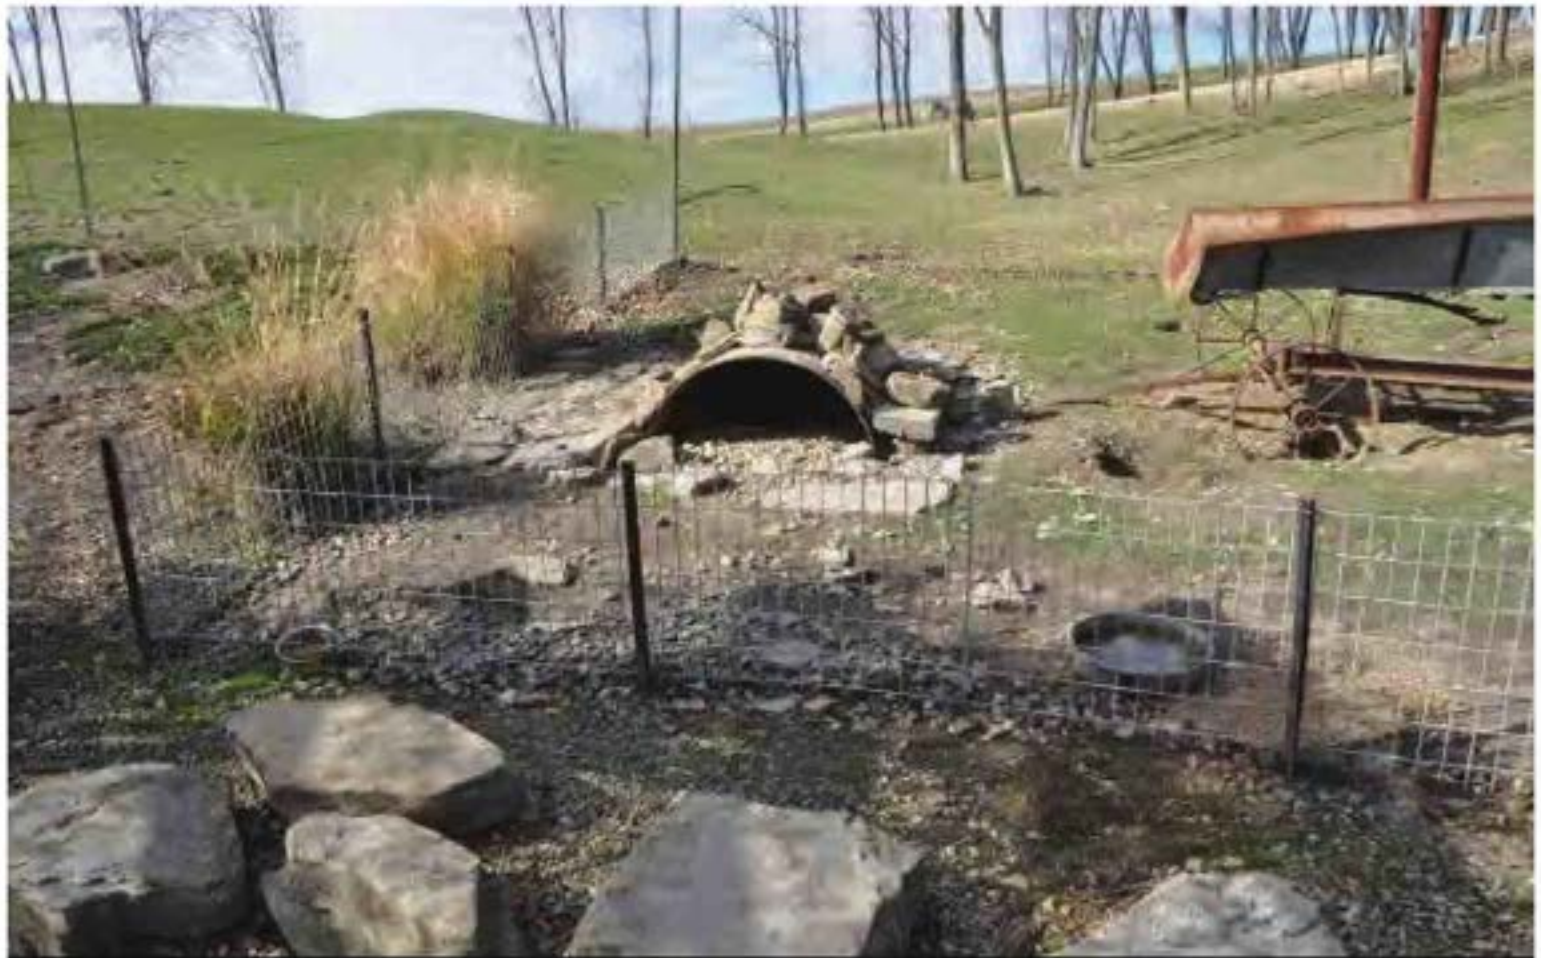
000410

CFR: 2.131 (c) (1)

Photographer:	Randy Coleman	Legal Name:	55-B-0069
Photo Taken:	Mon, Nov 9, '15	HENRY HAMPTON	
Inspection:	314151637070903		
Description:	Section 2.131(c)(1): Lack of barriers allows public to walk up to animal enclosures.

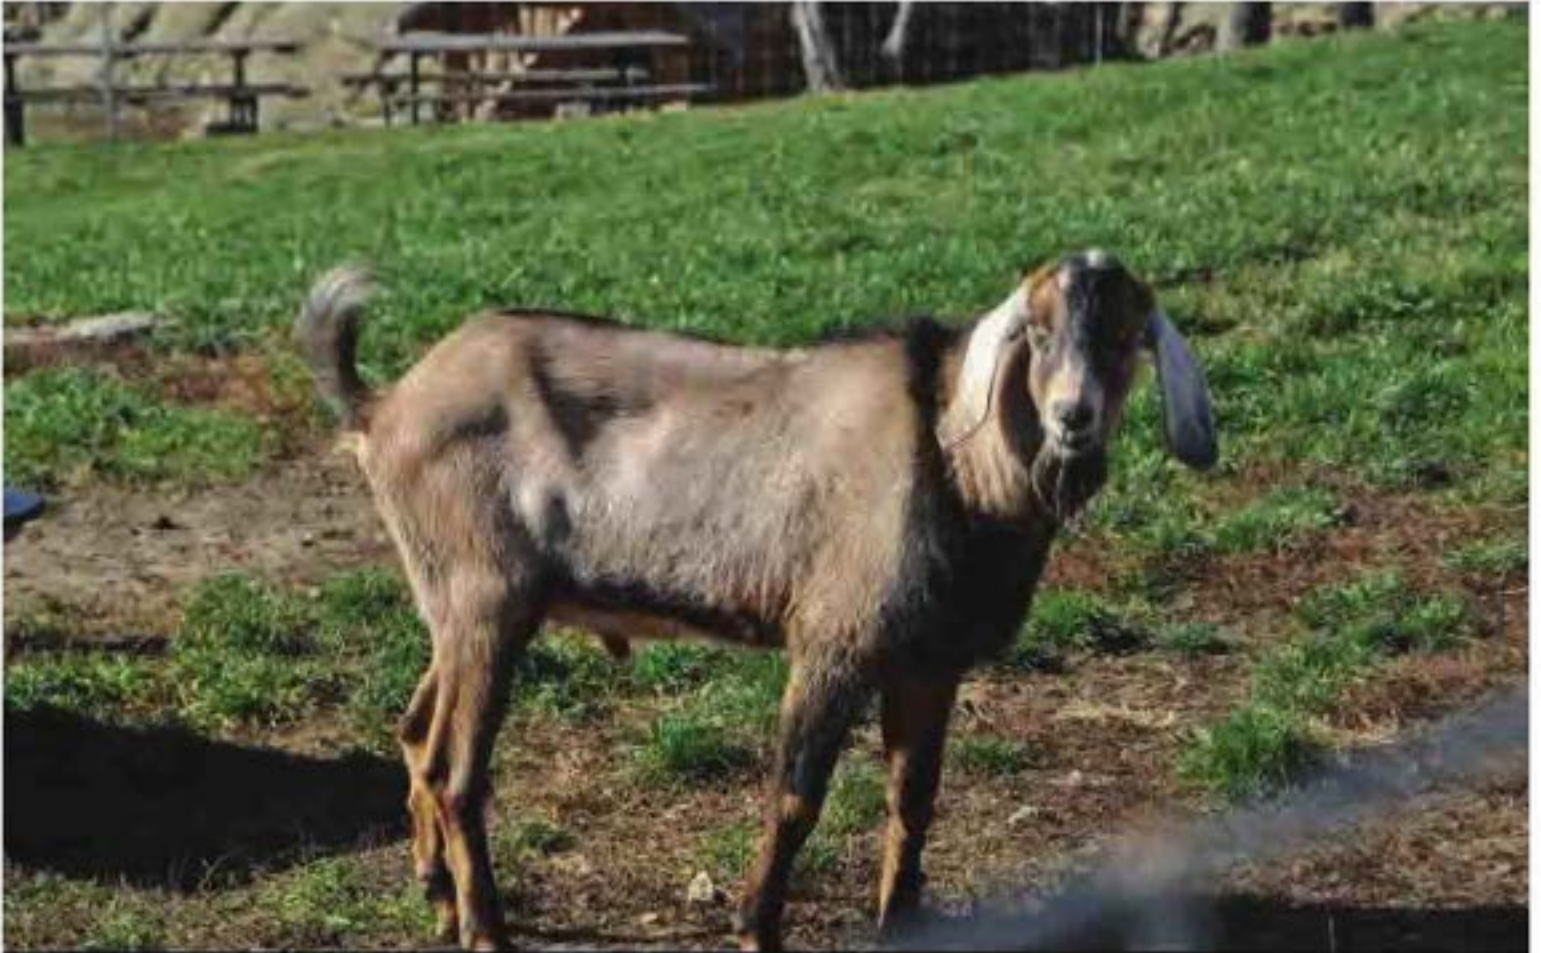
000411

CFR: 2.40 (b) (3), 2.40 (b) (2)

Photographer:	Randy Coleman	Legal Name:	55-B-0069
Photo Taken:	Mon, Nov 9, '15 1126 am	HENRY HAMPTON	
Inspection:	314151637070903		
Description:	Section 2.40(b)(2) and 2.40 (b)(3): Male goat found with mass on right flank area.

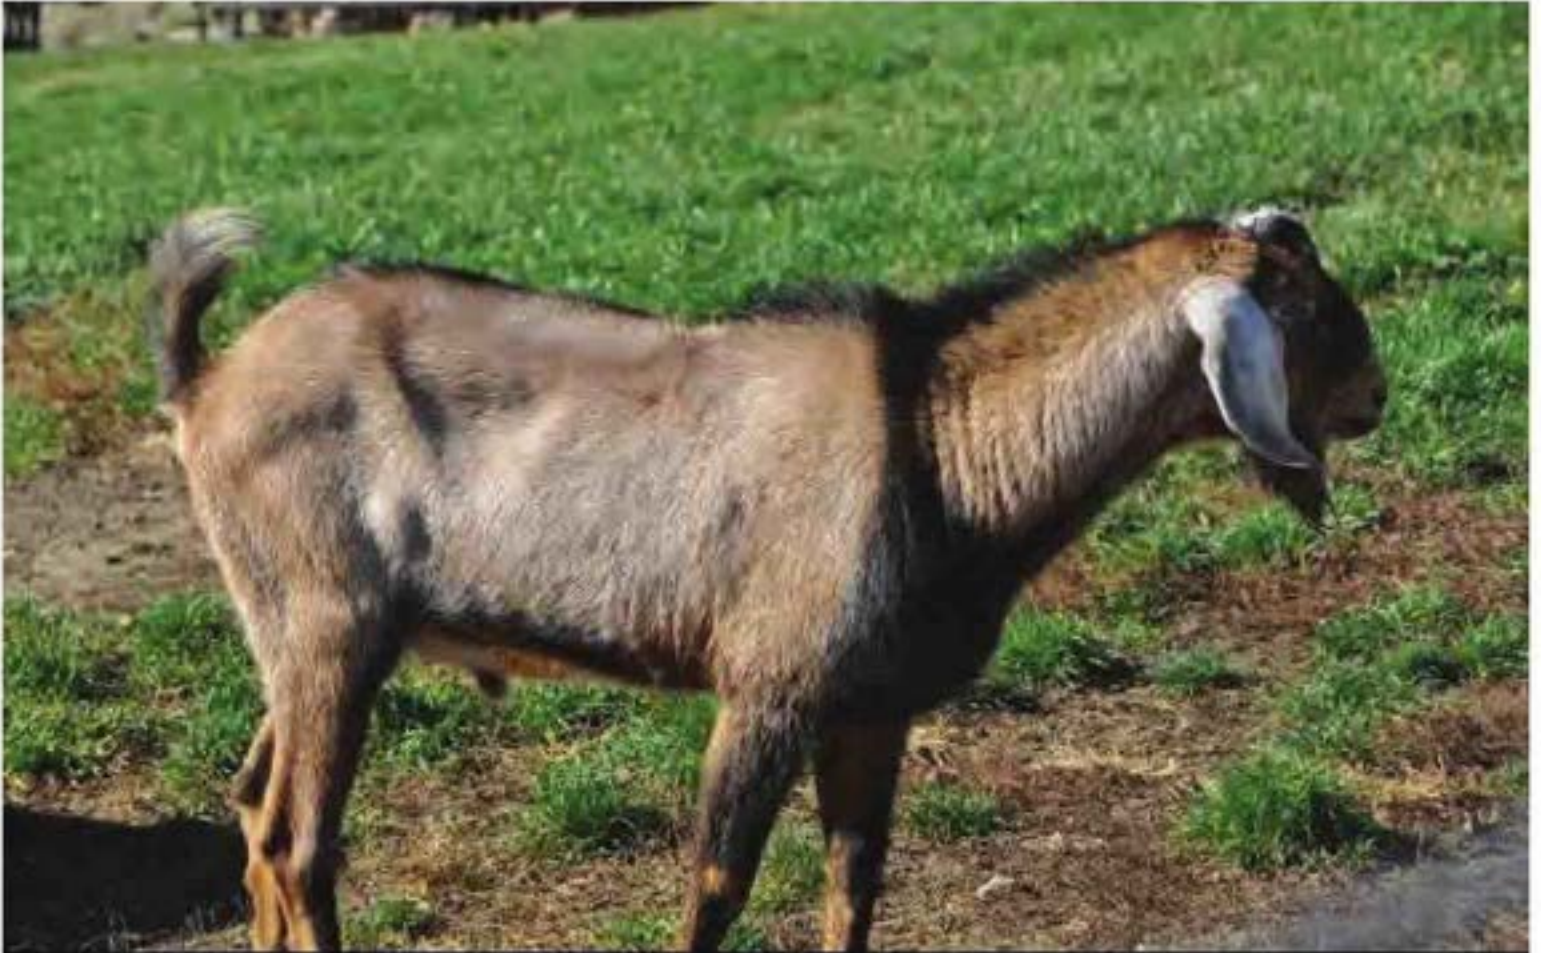
000412

CFR: 2.40 (b) (2), 2.40 (b) (3)

Photographer:	Randy Coleman	Legal Name:	55-B-0069
Photo Taken:	Mon, Nov 9, '15 11:26 am	HENRY HAMPTON	
Inspection:	314151637070903		
Description:	Section 2.40(b)(2) and 2.40 (b)(3): Male goat found with mass on right flank area.

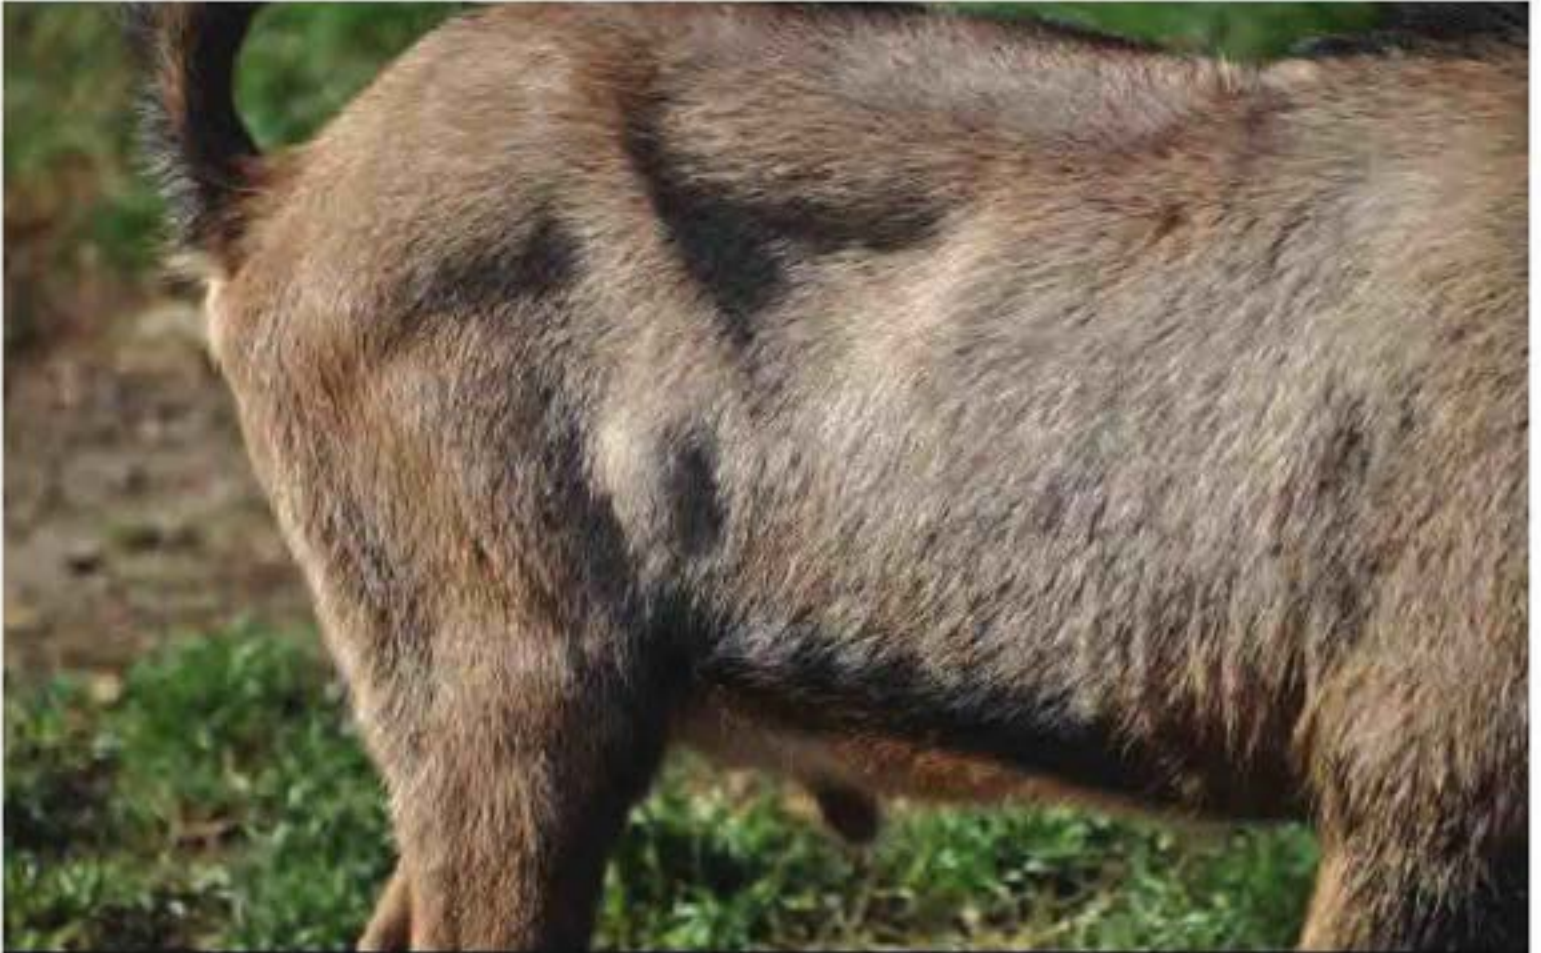
000413

CFR: 2.40 (b) (2)

Photographer:	Randy Coleman	Legal Name:	55-B-0069
Photo Taken:	Mon, Nov 9, '15 1126 am	HENRY HAMPTON	
Inspection:	314151637070903		
Description:	Section 2.40(b)(2) and 2.40 (b)(3): Male goat found with mass on right flank area.

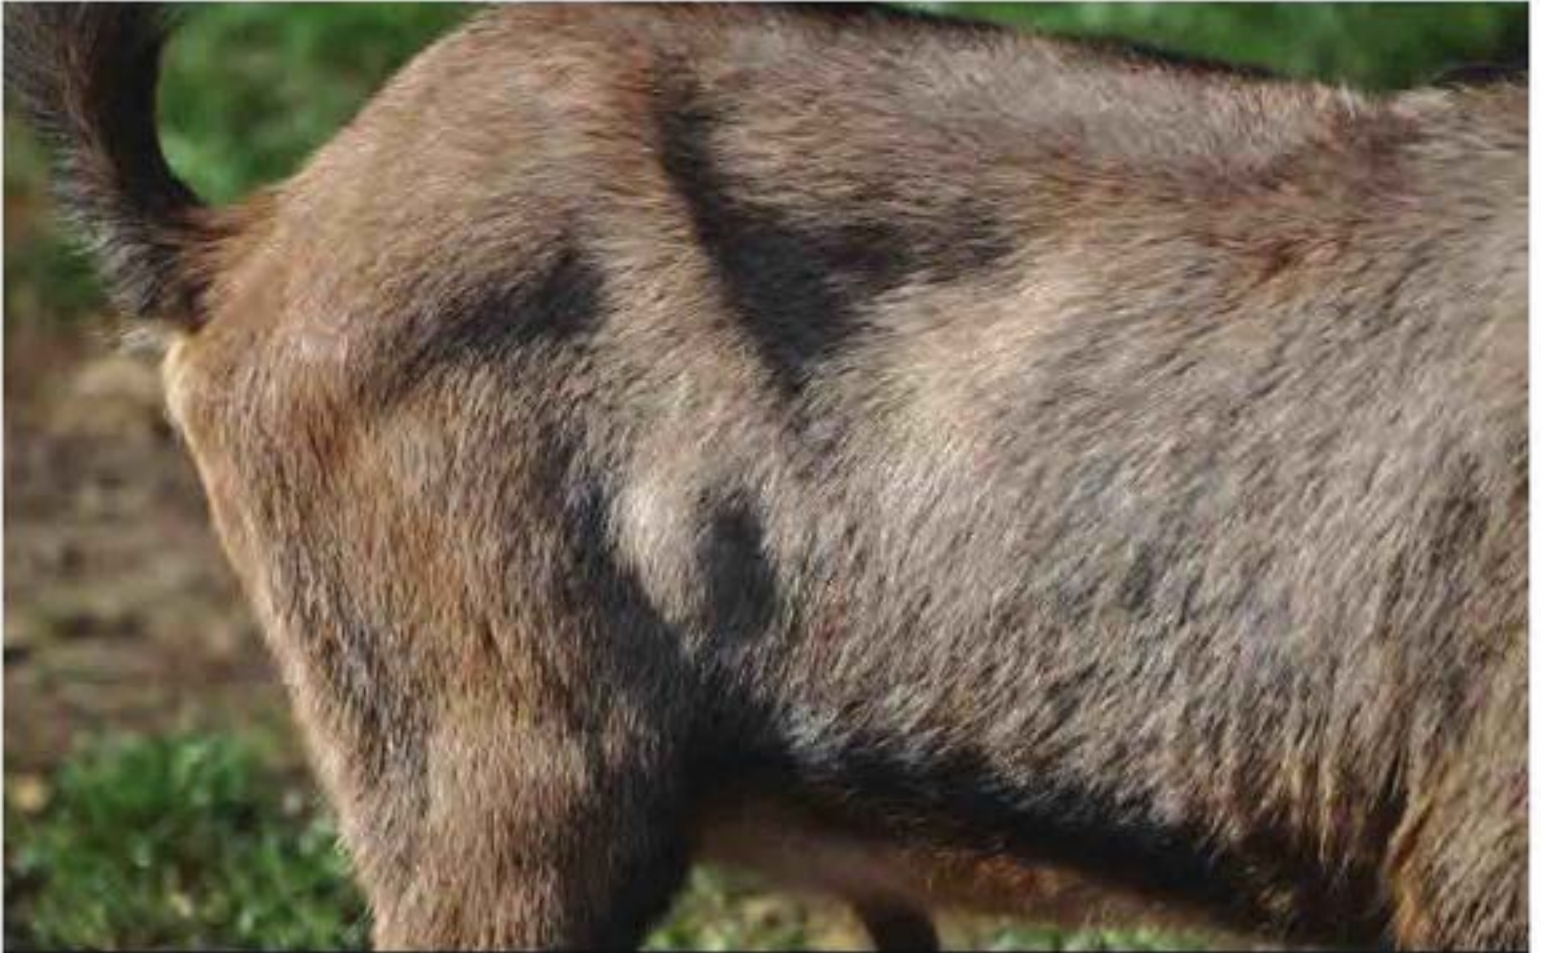
000414

CFR: 2.40 (b) (2), 2.40 (b) (3)

Photographer:	Randy Coleman	Legal Name:	55-B-0069
Photo Taken:	Mon, Nov 9, '15 1126 am	HENRY HAMPTON	
Inspection:	314151637070903		
Description:	Section 2.40(b)(2) and 2.40 (b)(3): Male goat found with mass on right flank area.

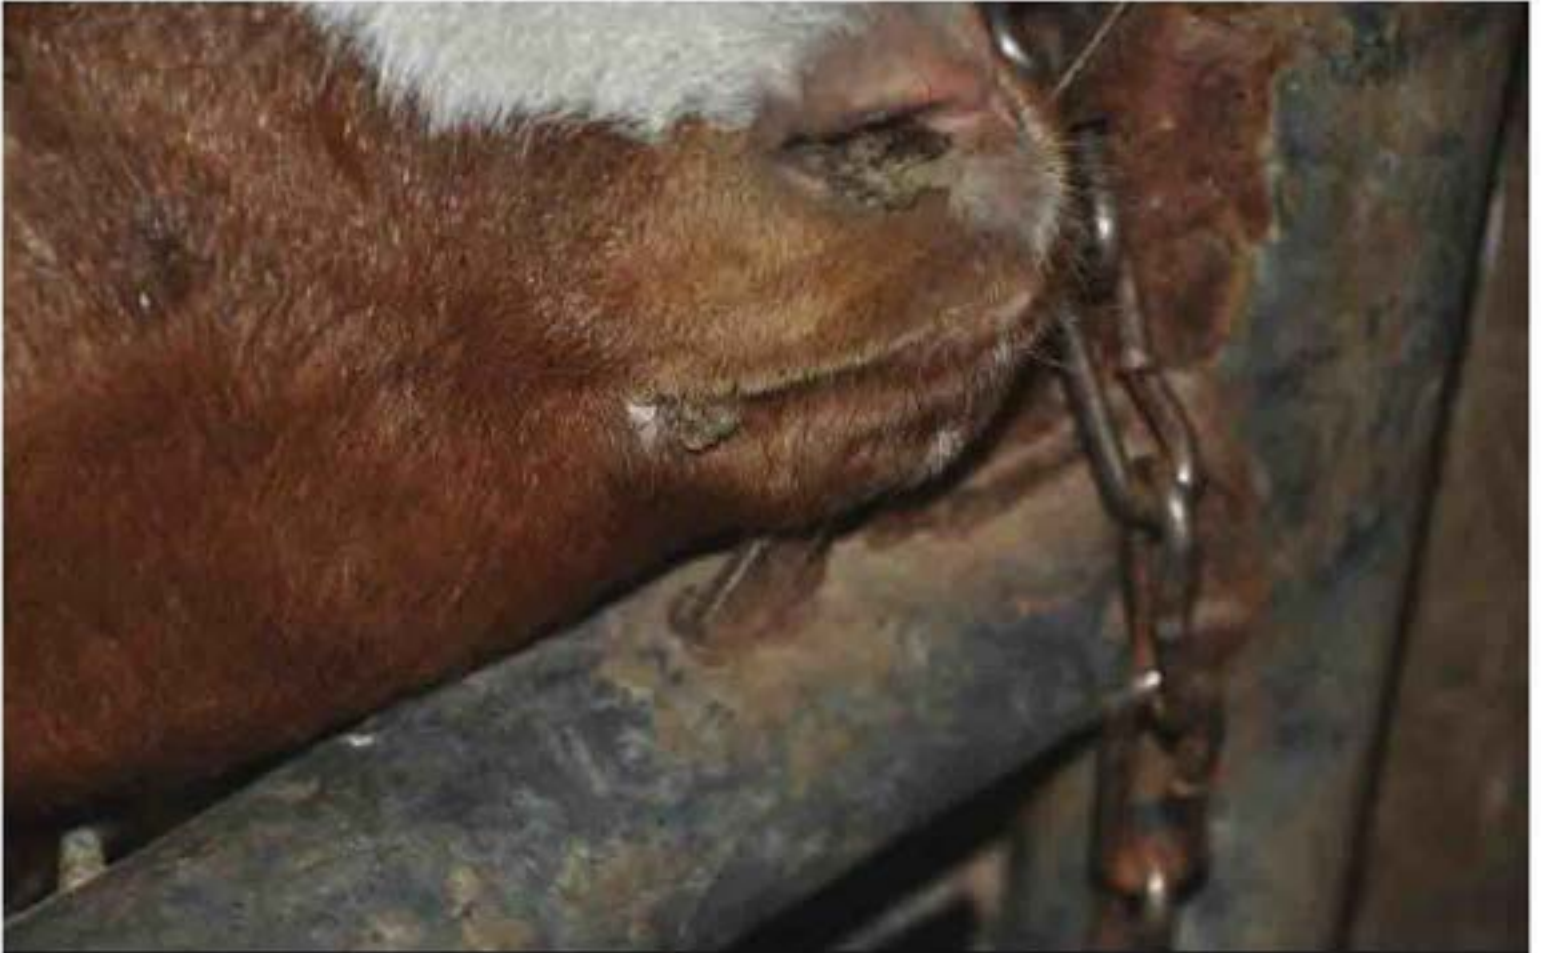
000415

CFR: 2.40 (b) (2), 2.40 (b) (3)

Photographer:	Randy Coleman	Legal Name:	55-B-0069
Photo Taken:	Mon, Nov 9, '15 1146 am	HENRY HAMPTON	
Inspection:	314151637070903		
Description:	Section 2.40(b)(2) and 2.40(b)(3): Female goat #7000 found with mass on right side of mouth.

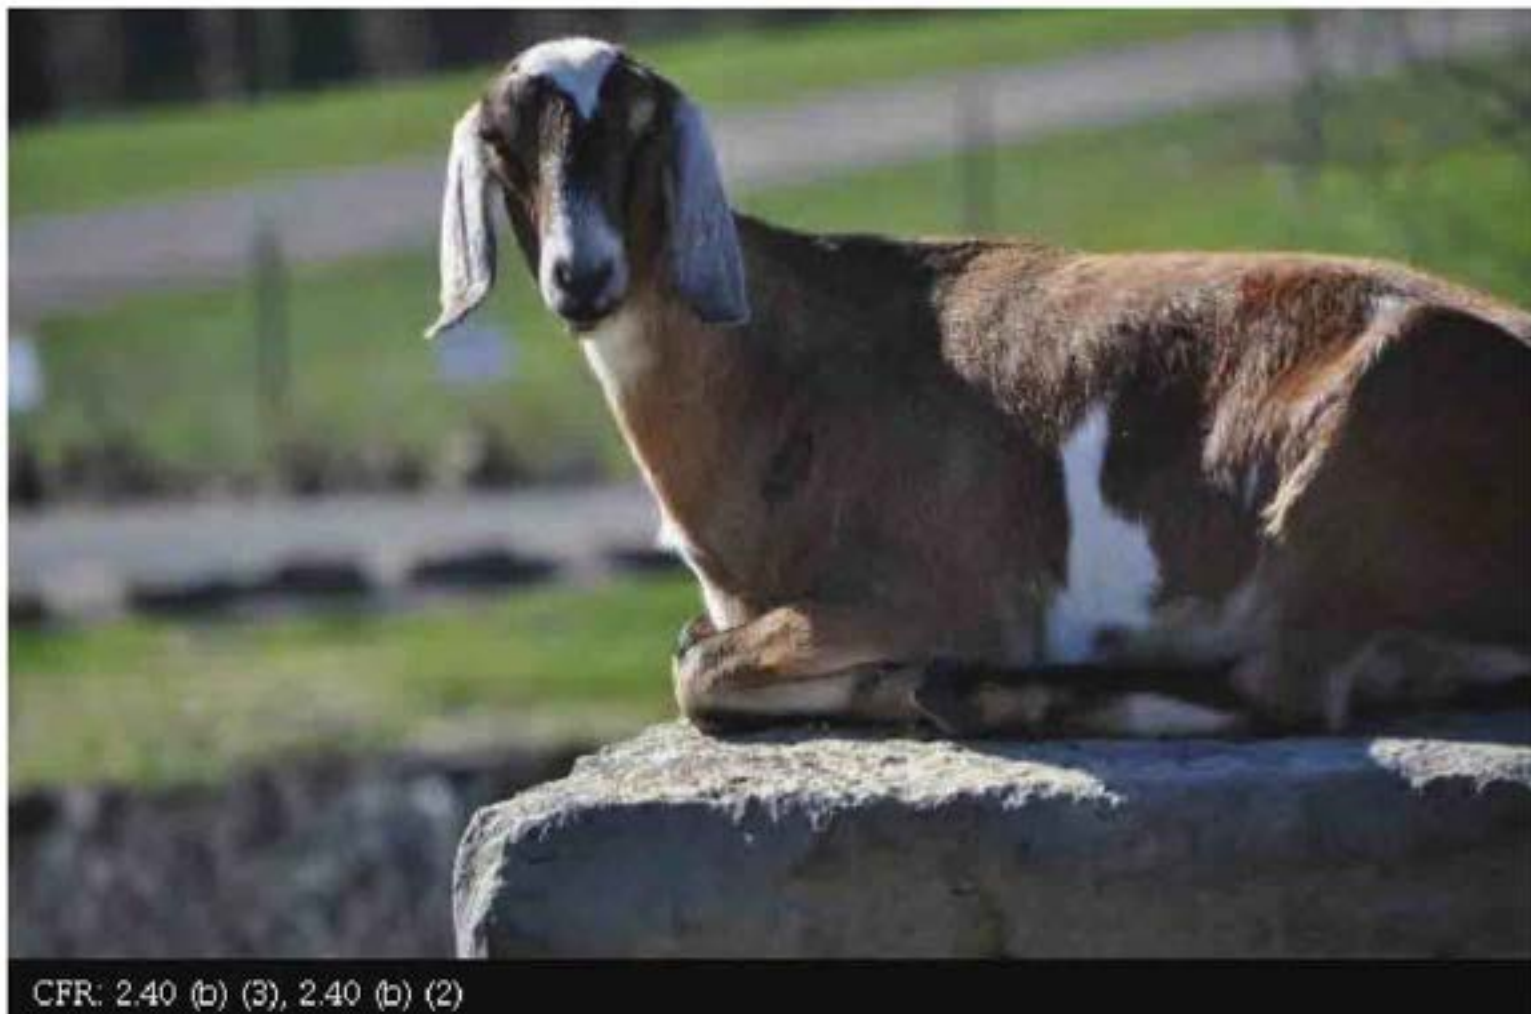
000417

CFR: 2.40 (b) (3), 2.40 (b) (2)

Photographer:	Randy Coleman	Legal Name:	55-B-0069
Photo Taken:	Mon, Nov 9, '15 1130 am	HENRY HAMPTON	
Inspection:	314151637070903		
Description:	Section 2.40(b)(2) and 2.40(b)(3): Female goat found with discolored area on left side of neck.

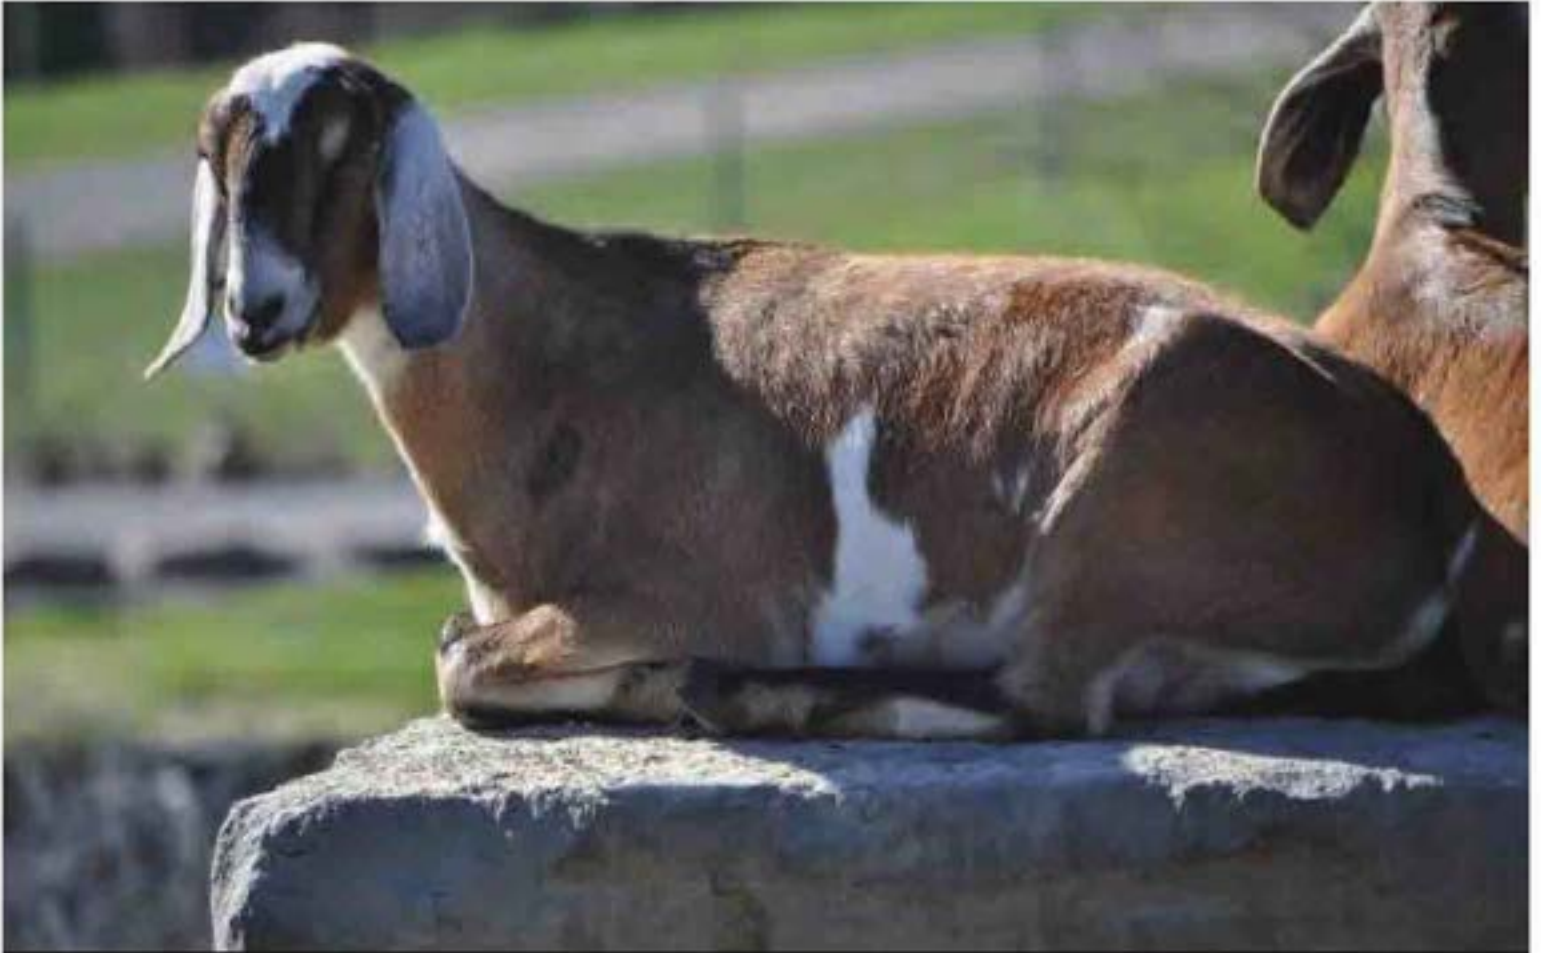
000418

CFR: 2.40 (b) (2), 2.40 (b) (3)

Photographer:	Randy Coleman	Legal Name:	55-B-0069
Photo Taken:	Mon, Nov 9, '15 1130 am	HENRY HAMPTON	
Inspection:	314151637070903		
Description:	Section 2.40(b)(2) and 2.40(b)(3): Female goat found with discolored area on left side of neck.

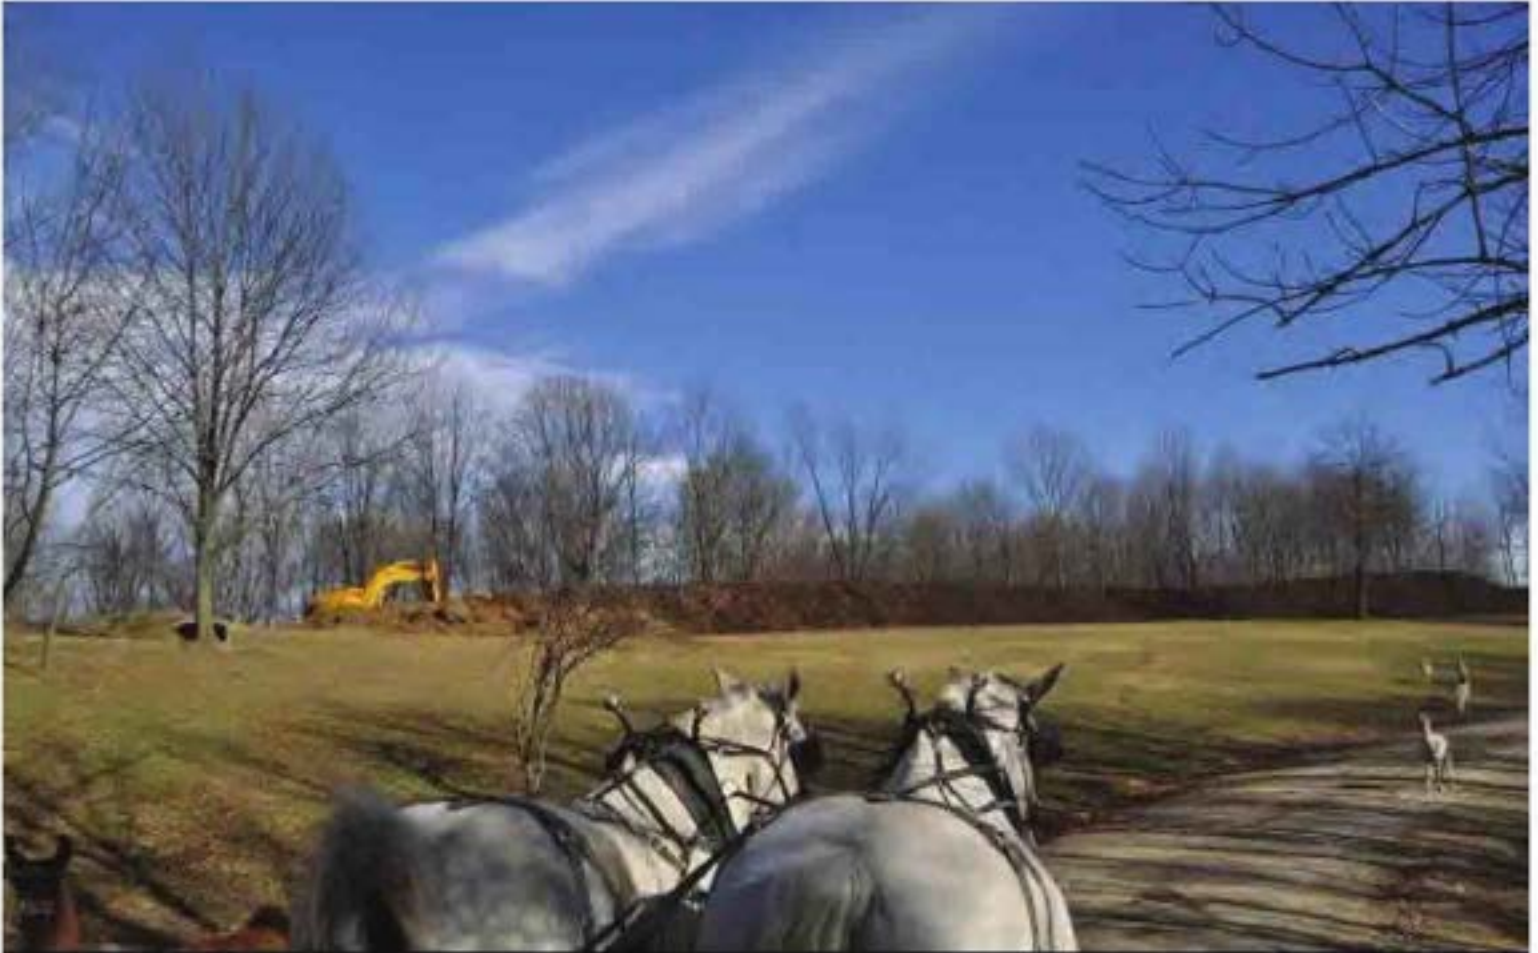
CFR: 3.125 (d)

Photographer:	Randy Coleman	Legal Name:	55-B-0069
Photo Taken:	Mon, Nov 9, '15 128 pm	HENRY HAMPTON	
Inspection:	314151637070903		
Description:	Section 3.125(d): Large mound of animal waste and bedding remains in drive thru area.

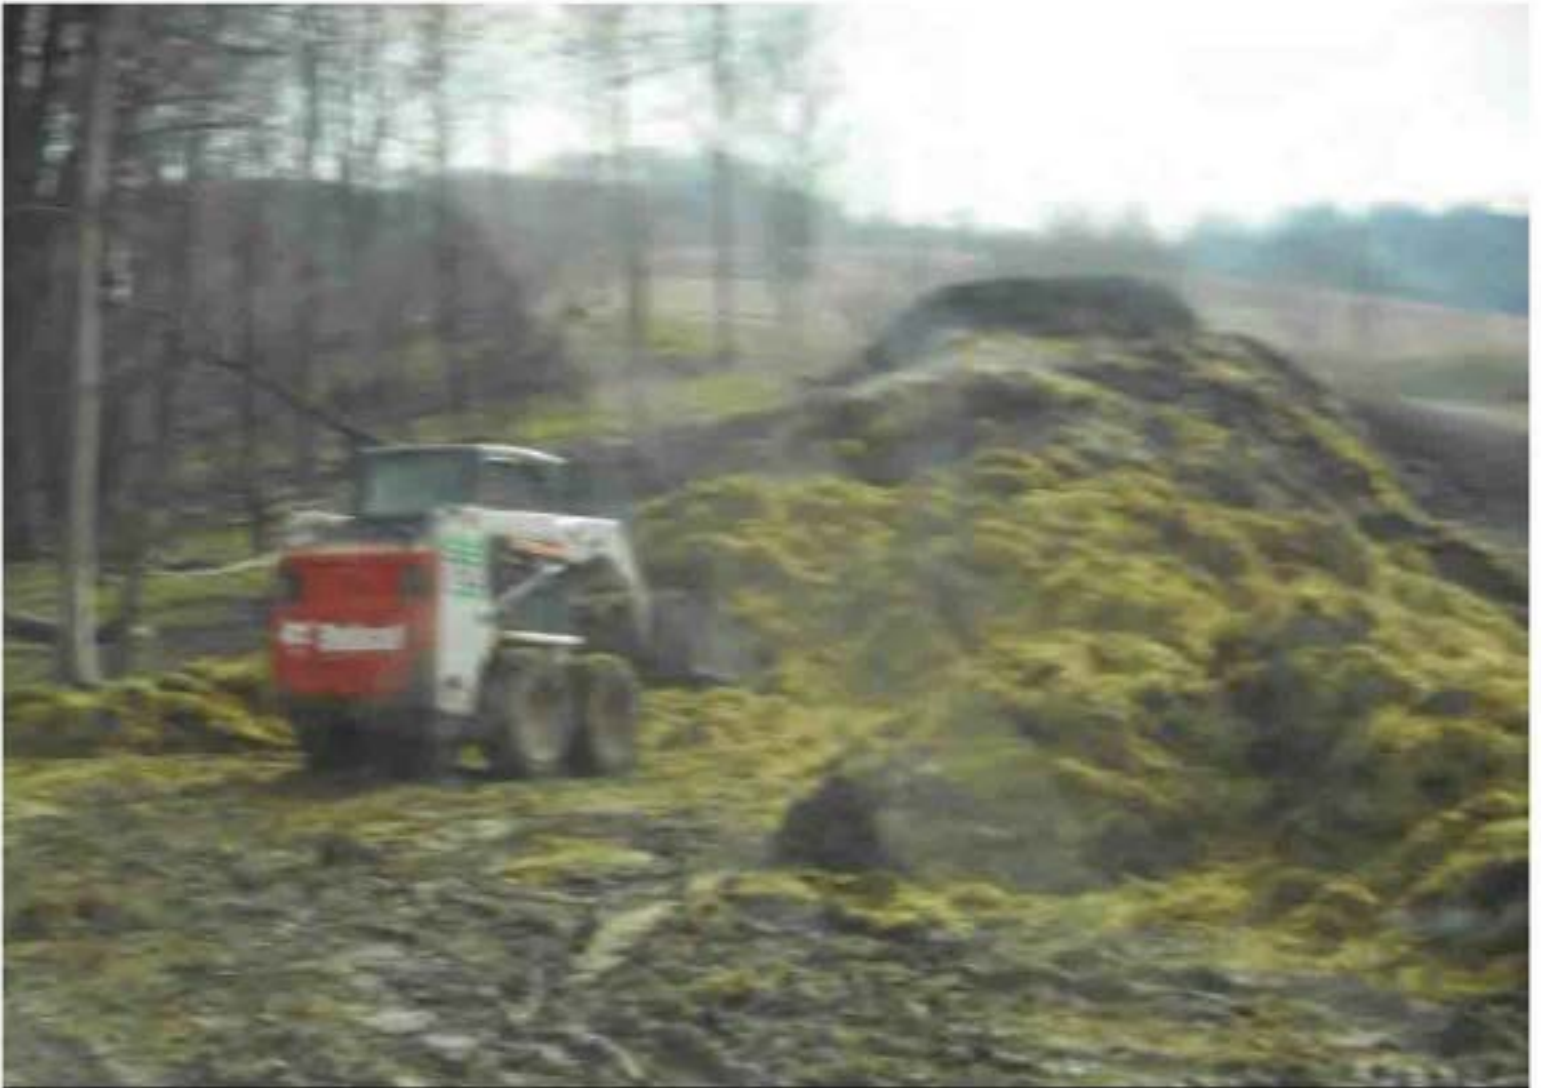
000423

CFR: 3.125 (d)

Photographer:	Randy Coleman	Legal Name:	55-B-0069
Photo Taken:	Tue, Feb 2, '16 121 pm	HENRY HAMPTON	
Inspection:	34160639230389		
Description:	Section 3.125(d): Large pile of waste and spent bedding remains in the drive thru section of the facility.

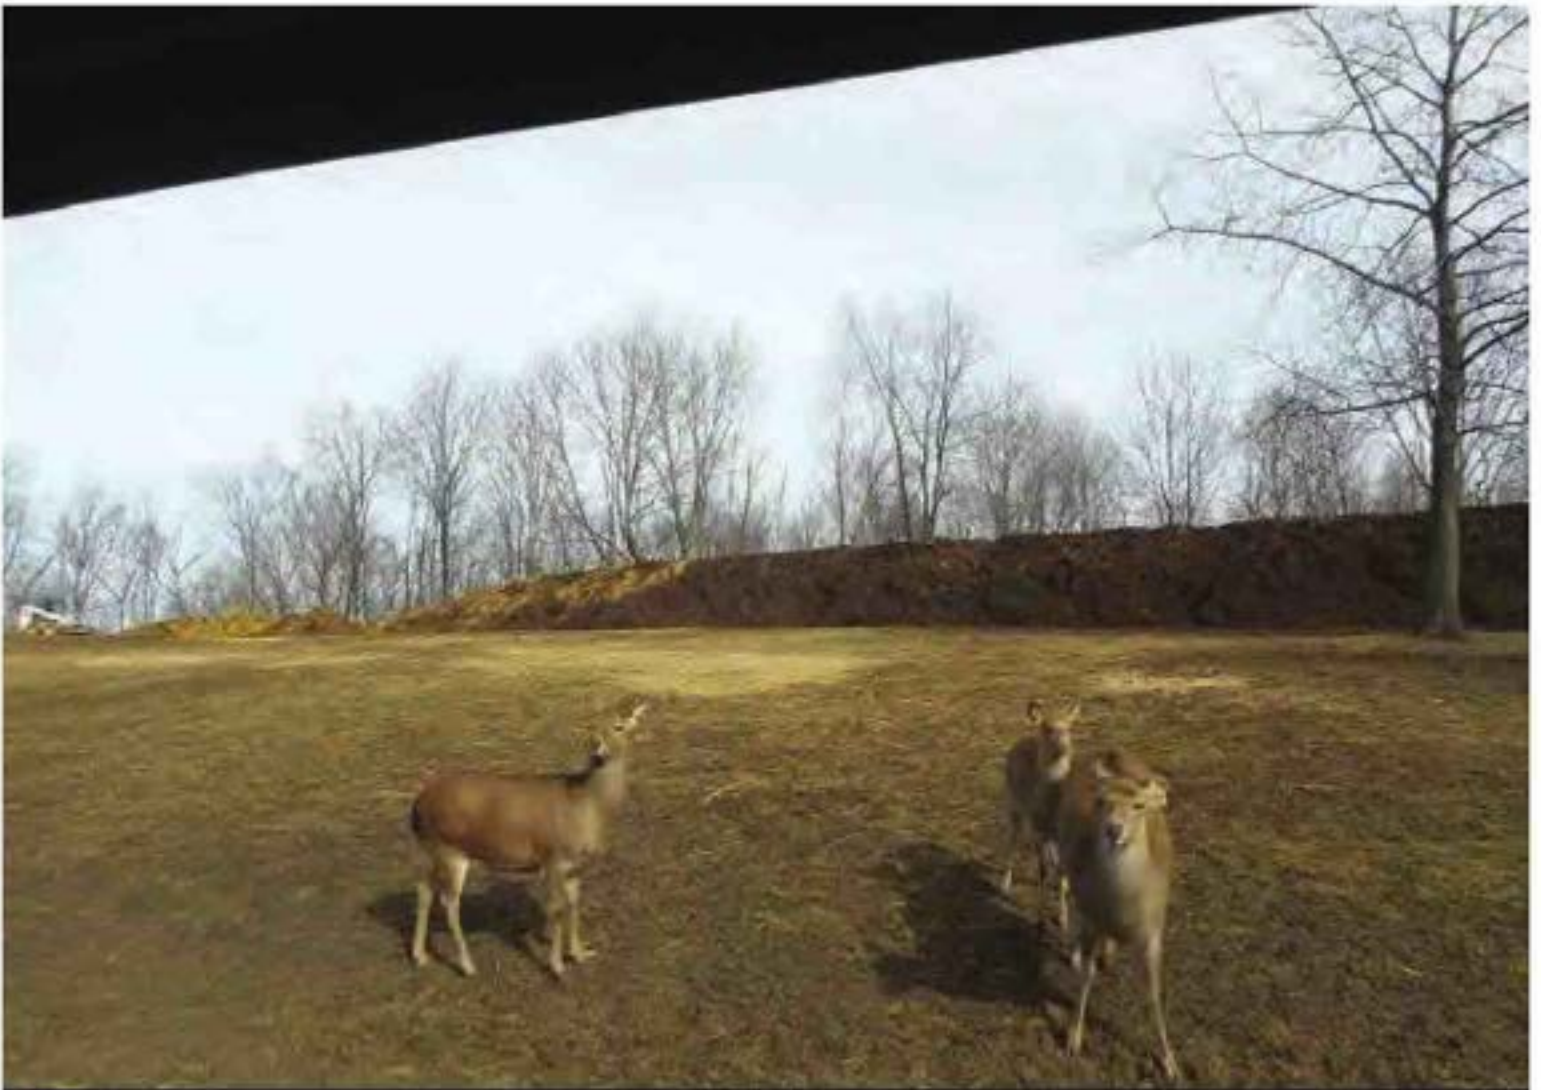
000424

CFR: 3.125 (d)

Photographer:	Randy Coleman	Legal Name:	55-B-0069
Photo Taken:	Tue, Feb 2, '16 119 pm	HENRY HAMPTON	
Inspection:	34160639230389		
Description:	Section 3.125(d): Large pile of waste and spent bedding remains in the drive thru section of the facility.
