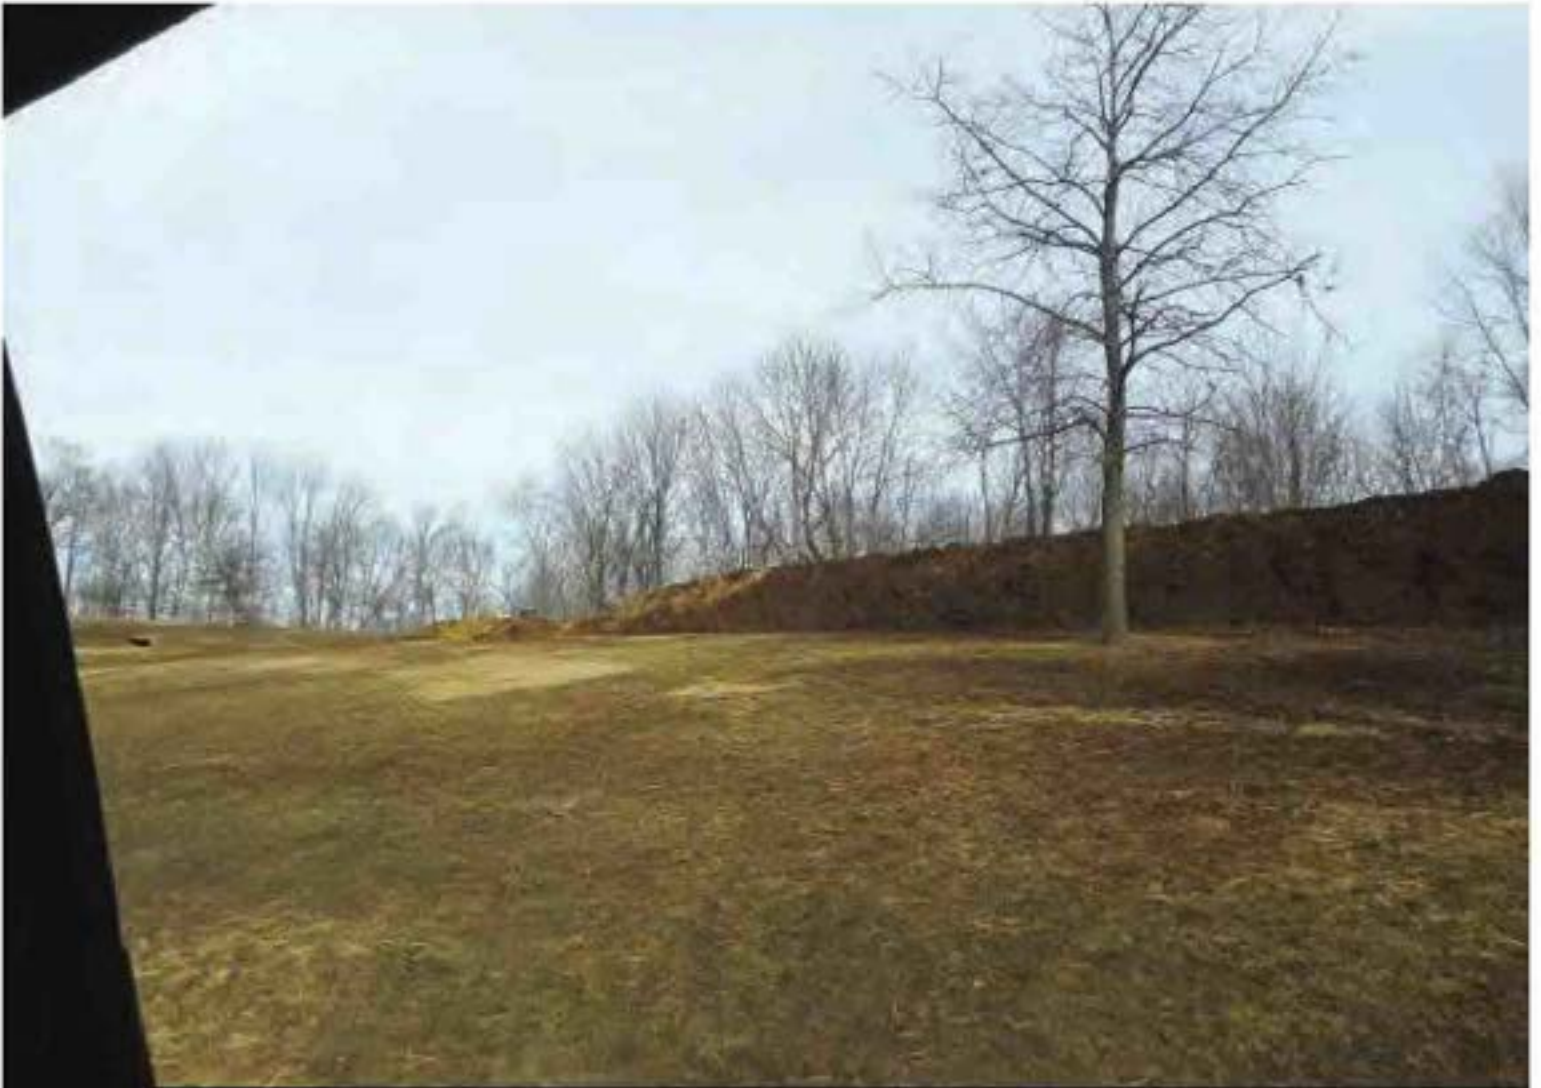
000425

CFR: 3.125 (d)

Photographer:	Randy Coleman	Legal Name:	55-B-0069
Photo Taken:	Tue, Feb 2, '16 119 pm	HENRY HAMPTON	
Inspection:	34160639230389		
Description:	Section 3.125(d): Large pile of waste and spent bedding remains in the drive thru section of the facility.

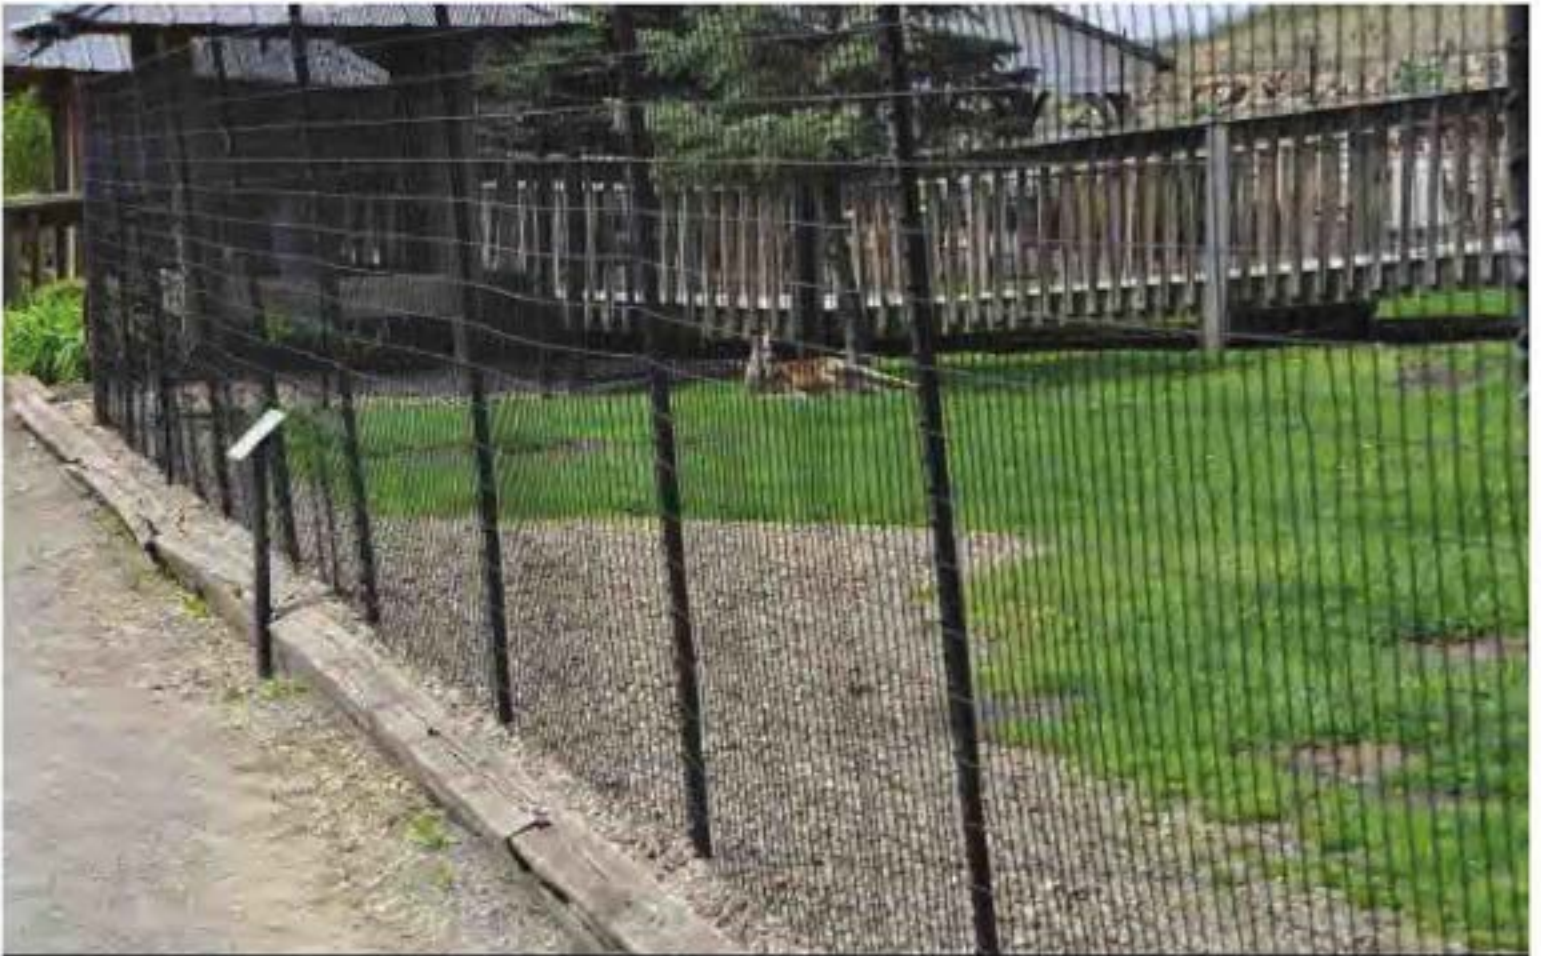
000426

CFR: 2.131 (c) (1)

Photographer:	Randy Coleman	Legal Name:	55-B-0069
Photo Taken:	Mon, Apr 25, '16 1144 am	HENRY HAMPTON	
Inspection:	119160939110230		
Description:	Section 2.131(c)(1): Public continues to be able to walk up to animal enclosures with no barriers or attendants.

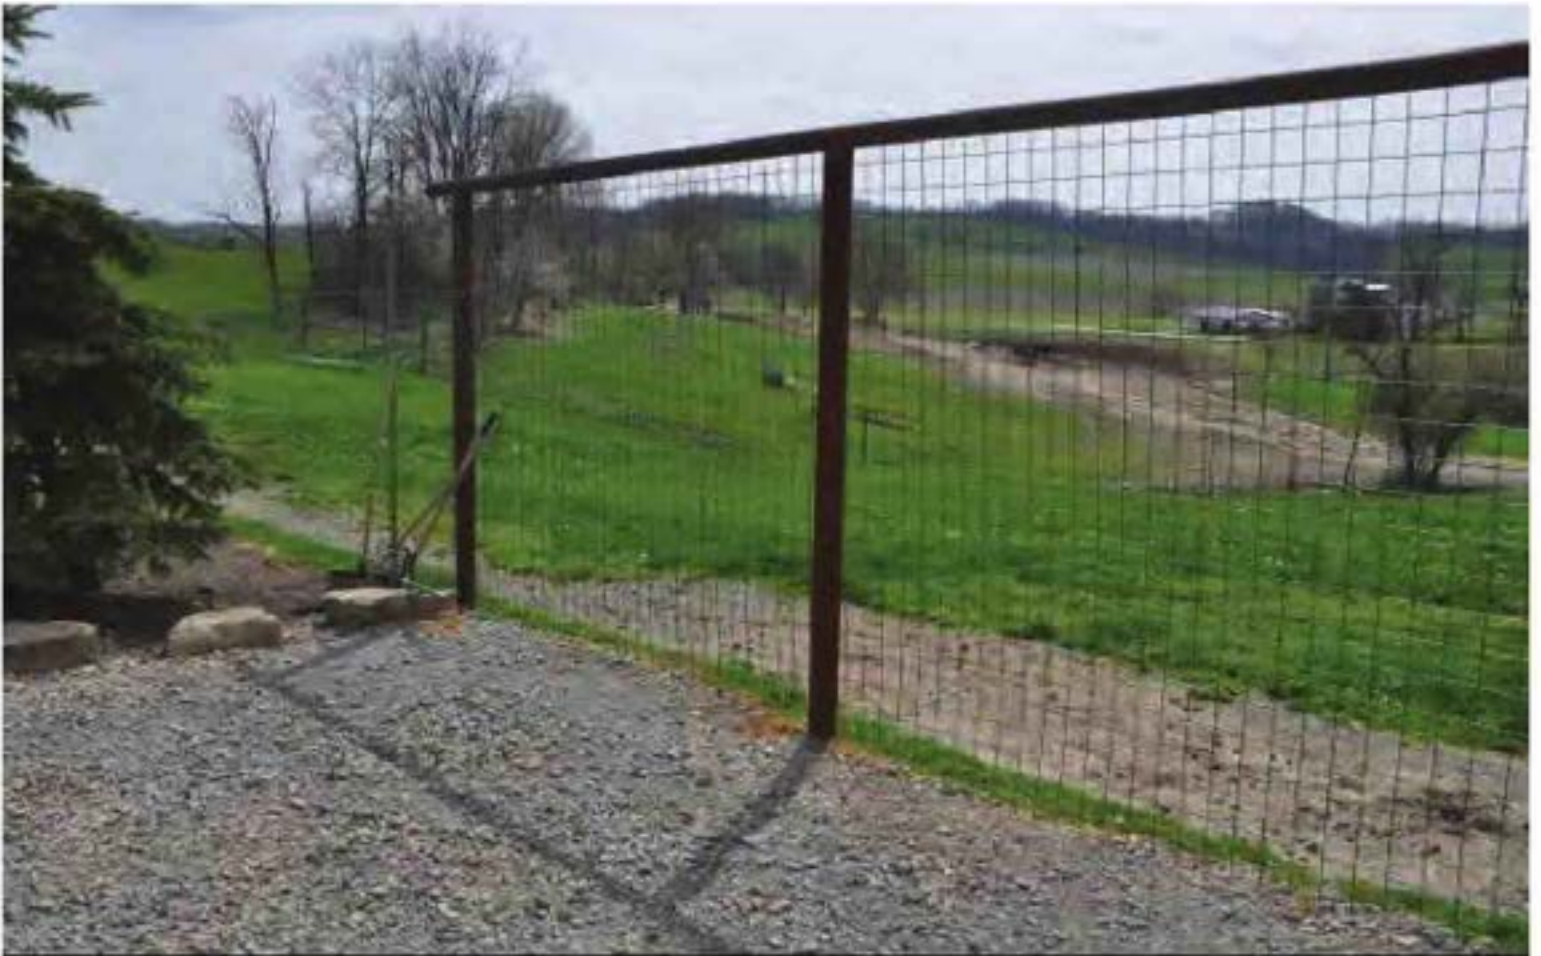
000427

CFR: 2.131 (c) (1)

Photographer:	Randy Coleman	Legal Name:	55-B-0069
Photo Taken:	Mon, Apr 25, '16 1100 am	HENRY HAMPTON	
Inspection:	119160939110230		
Description:	Section 2.131(c)(1): Public continues to be able to walk up to animal enclosures with no barriers or attendants.

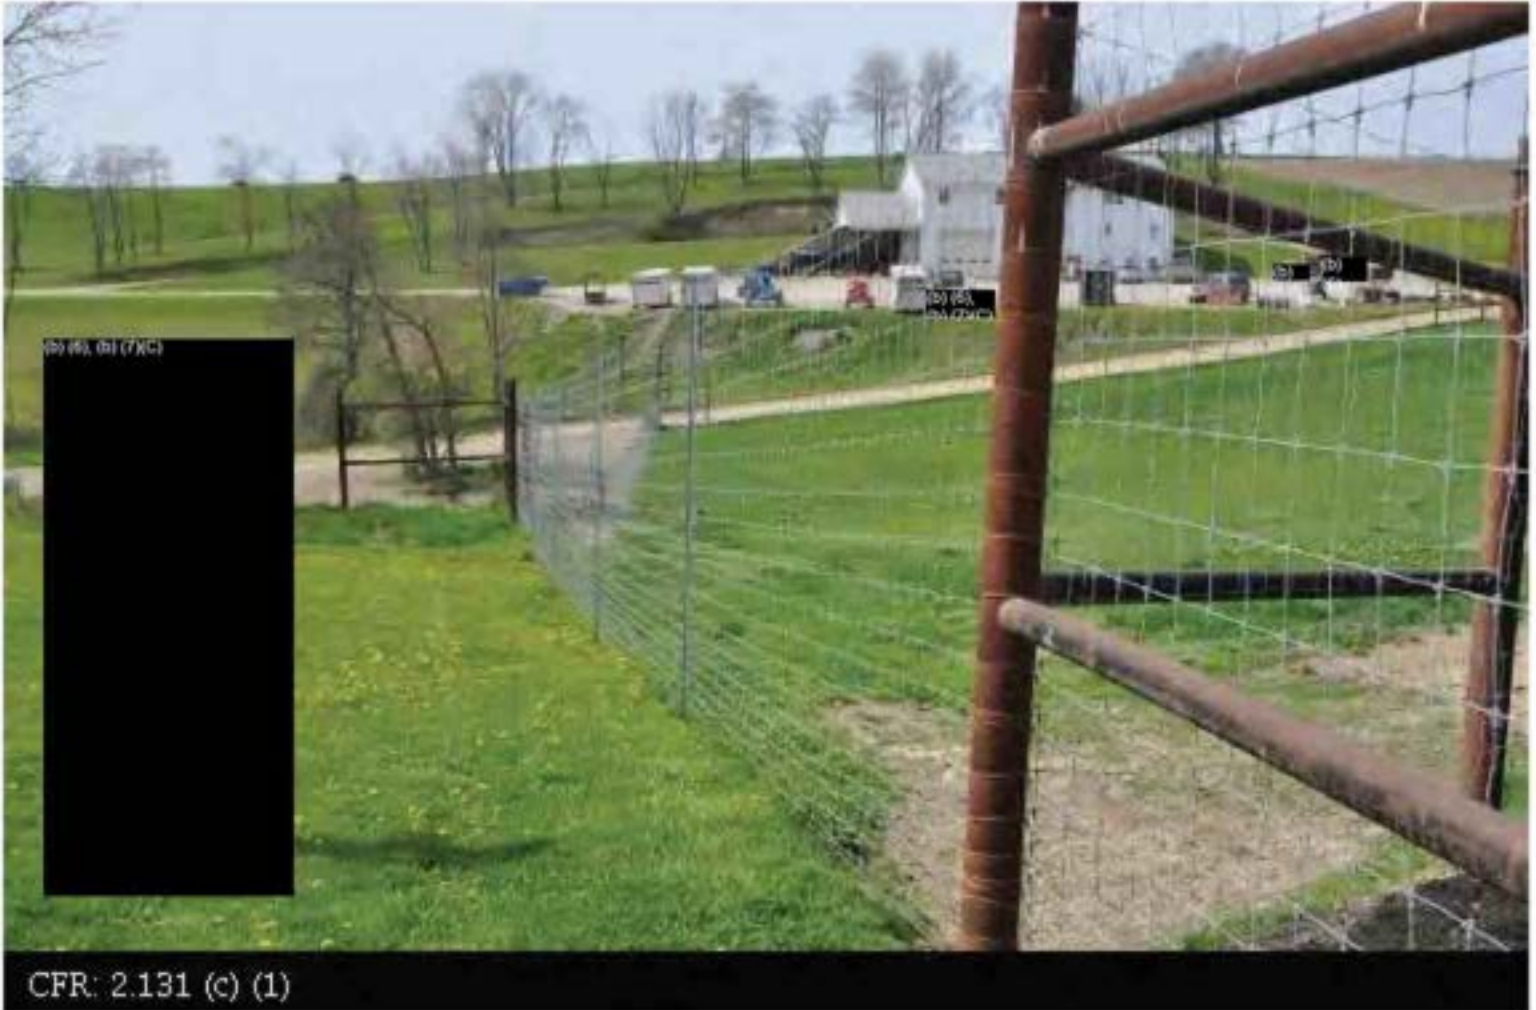
000428

Photographer:	Randy Coleman	Legal Name:	55-B-0069
Photo Taken:	Mon, Apr 25, '16 1105 am	HENRY HAMPTON	
Inspection:	119160939110230		
Description:	Section 2.131(c)(1): Public continues to be able to walk up to animal enclosures with no barriers or attendants.

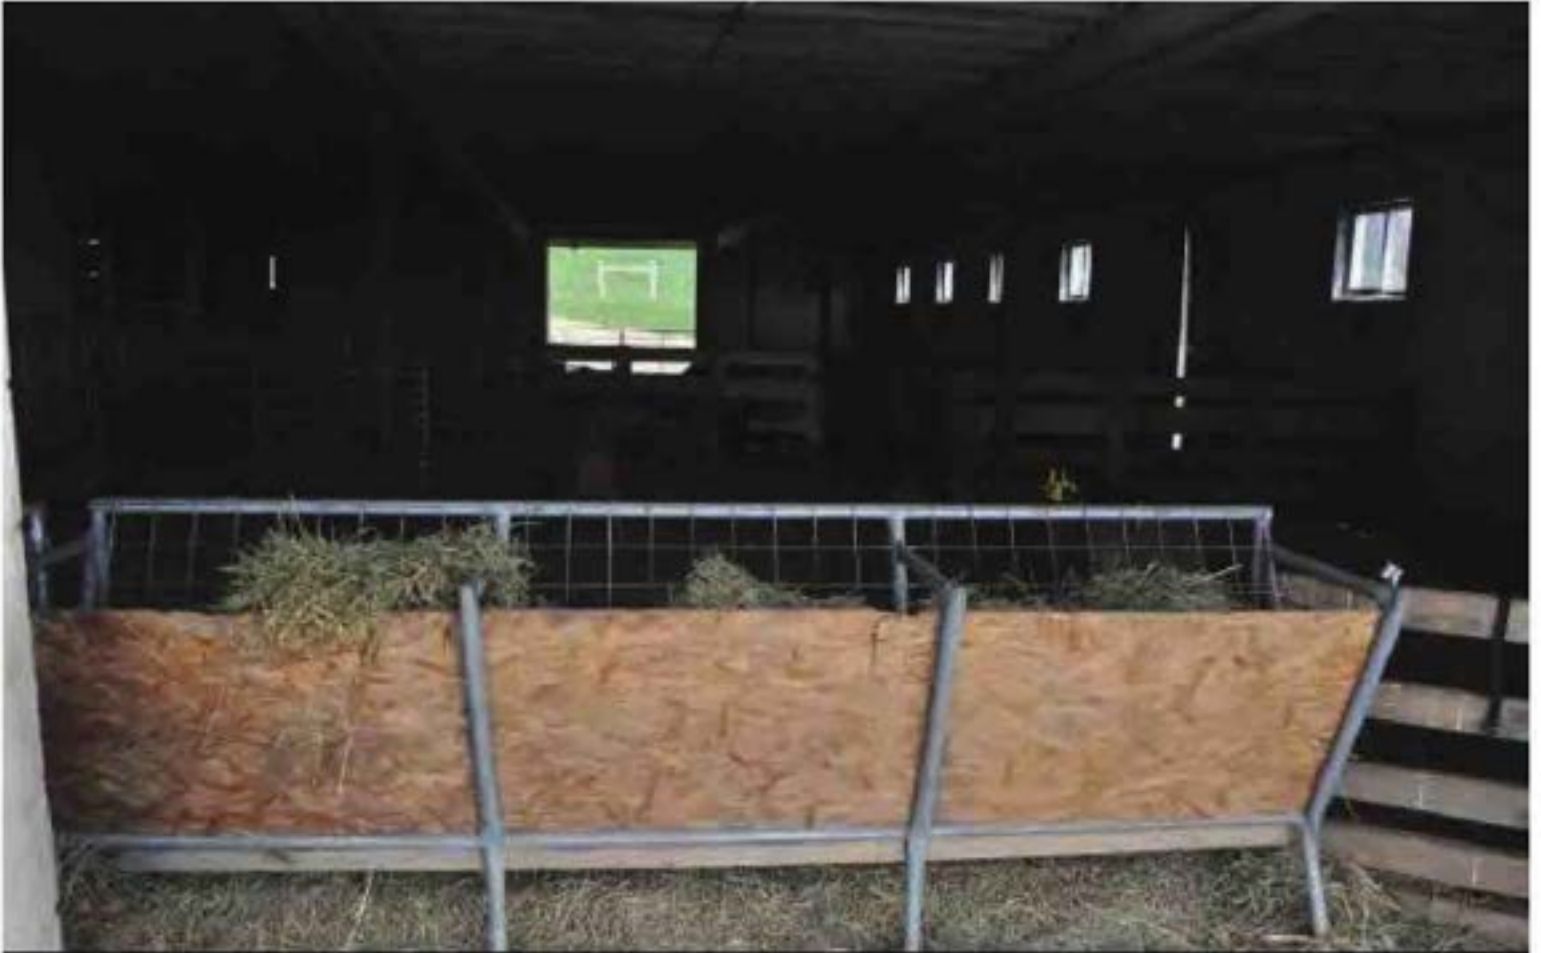
CFR: 2.131 (c) (1)

Photographer:	Randy Coleman	Legal Name:	55-B-0069
Photo Taken:	Mon, Apr 25, '16 11:15 am	HENRY HAMPTON	
Inspection:	119160939110230		
Description:	Section 2.131(c)(1): Public continues to be able to walk up to animal enclosures with no barriers or attendants.

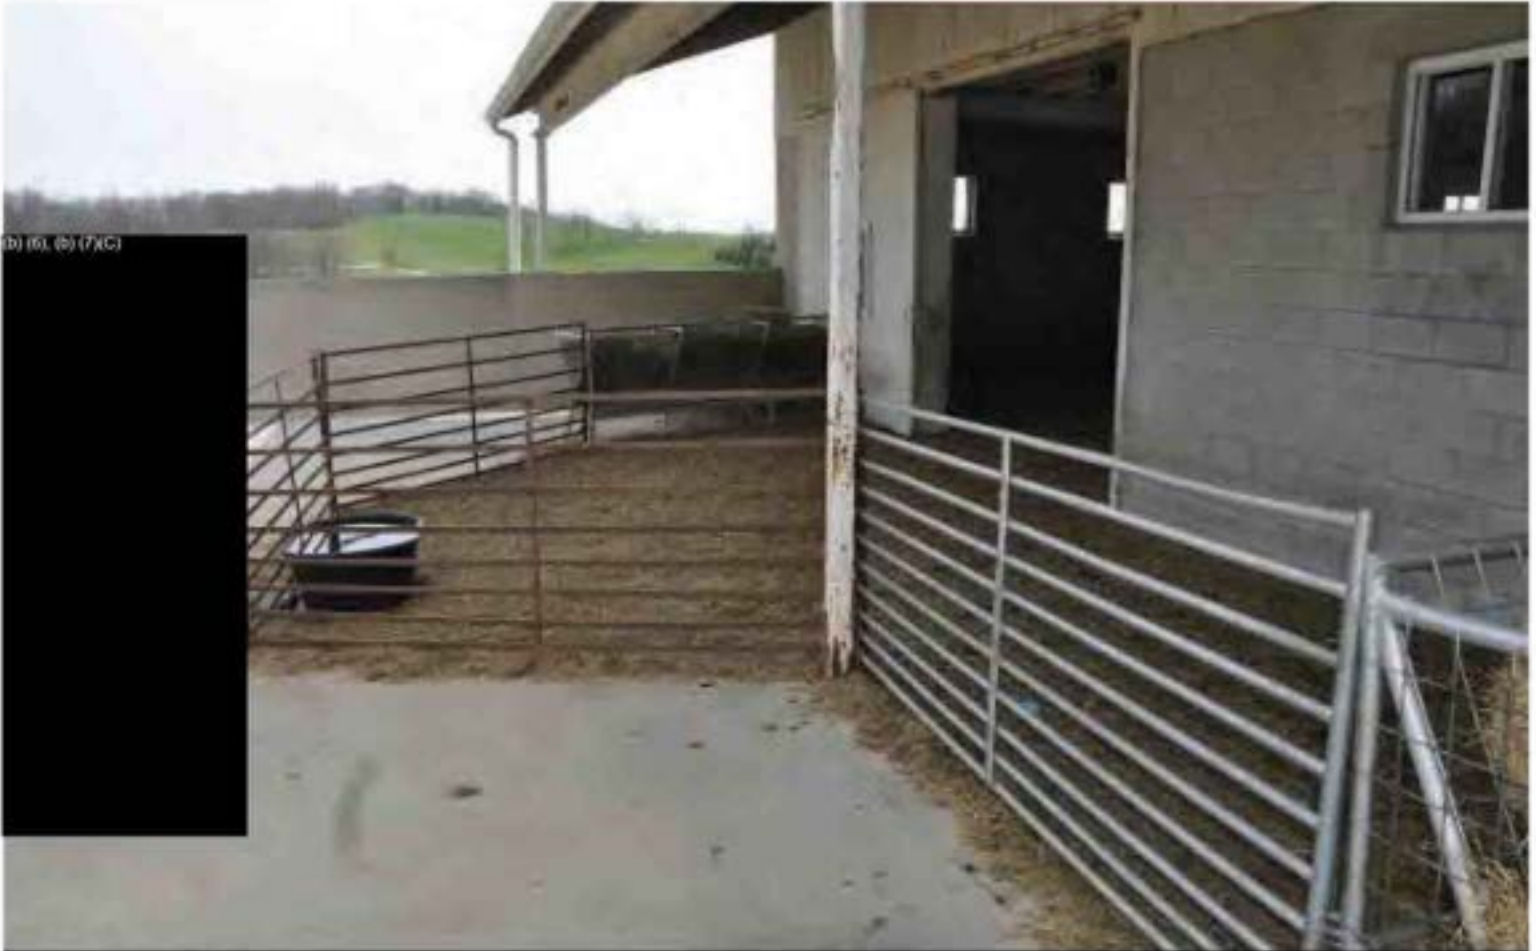
000430

CFR: 2.131 (c) (1)

Photographer:	Randy Coleman	Legal Name:	55-B-0069
Photo Taken:	Mon, Apr 25, '16 11:15 am	HENRY HAMPTON	
Inspection:	119160939110230		
Description:	Section 2.131(c)(1): Public continues to be able to walk up to animal enclosures with no barriers or attendants.

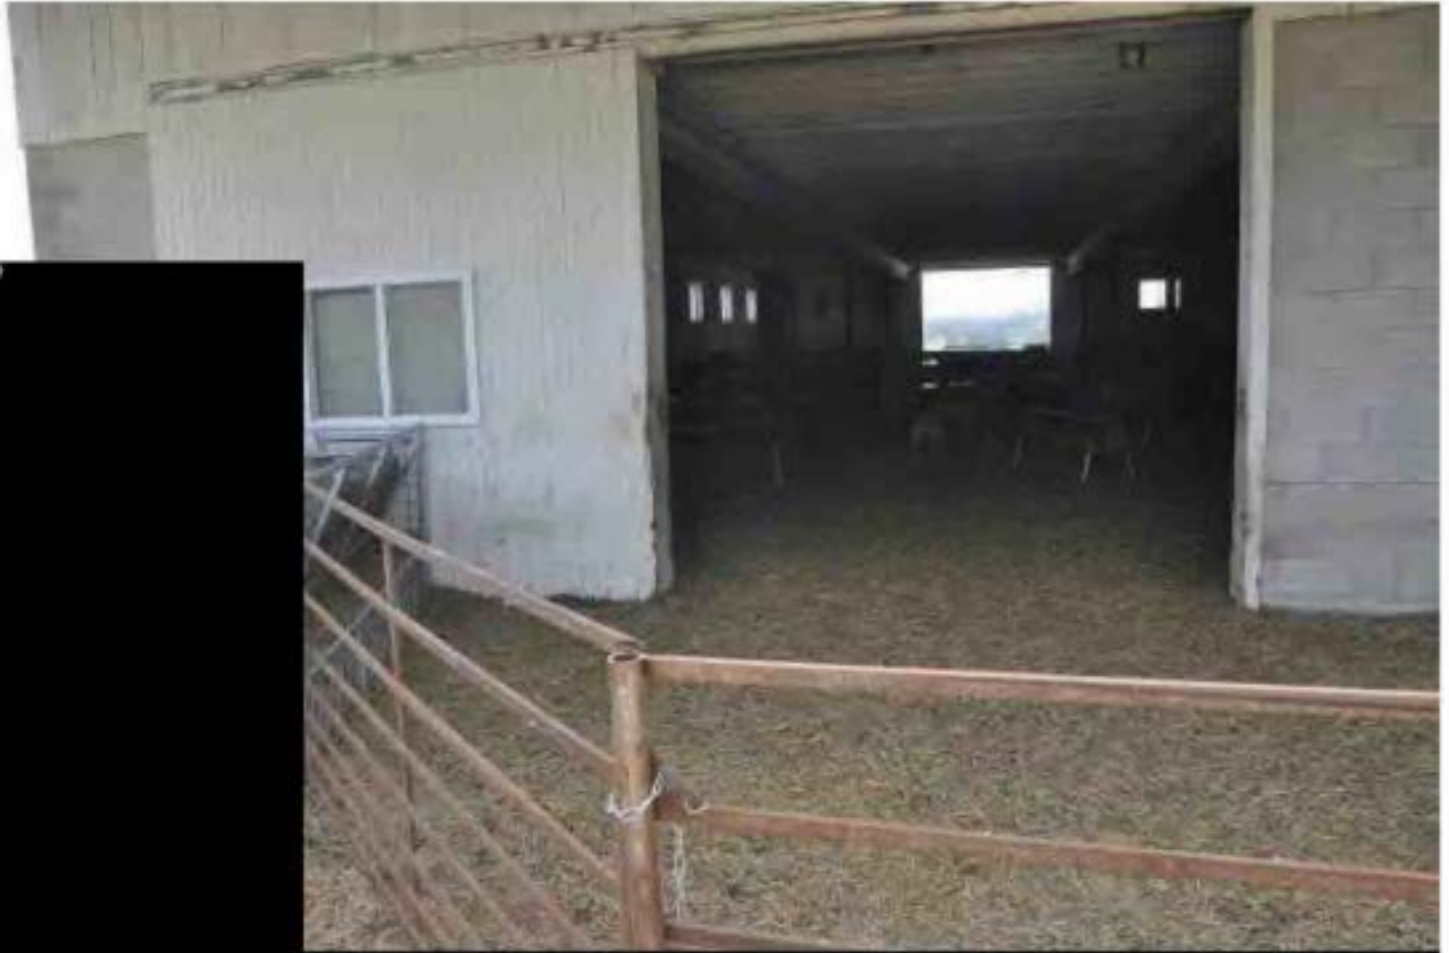
CPR: 2.131 (c) (1)

Photographer:	Randy Coleman	Legal Name:	55-B-0069
Photo Taken:	Mon, Apr 25, '16 11:15 am	HENRY HAMPTON	
Inspection:	119160939110230		
Description:	Section 2.131(c)(1): Public continues to be able to walk up to animal enclosures with no barriers or attendants.

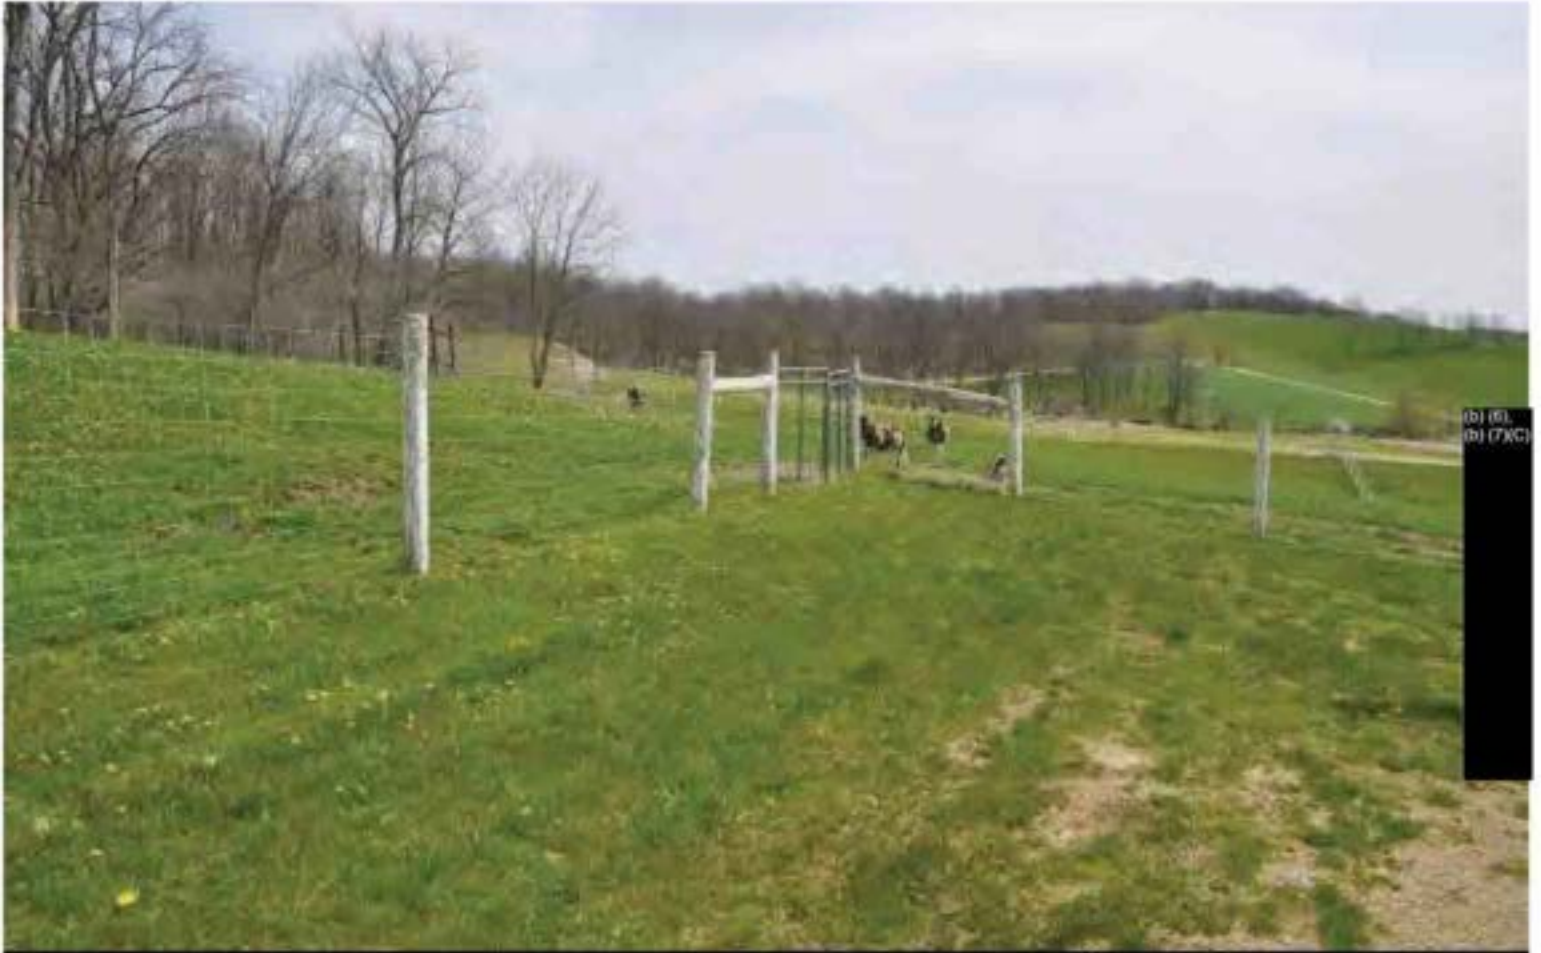
000432

CFR: 2.131 (c) (1)

Photographer:	Randy Coleman	Legal Name:	55-B-0069
Photo Taken:	Mon, Apr 25, '16 11:12 am	HENRY HAMPTON	
Inspection:	119160939110230		
Description:	Section 2.131(c)(1): Public continues to be able to walk up to animal enclosures with no barriers or attendants.

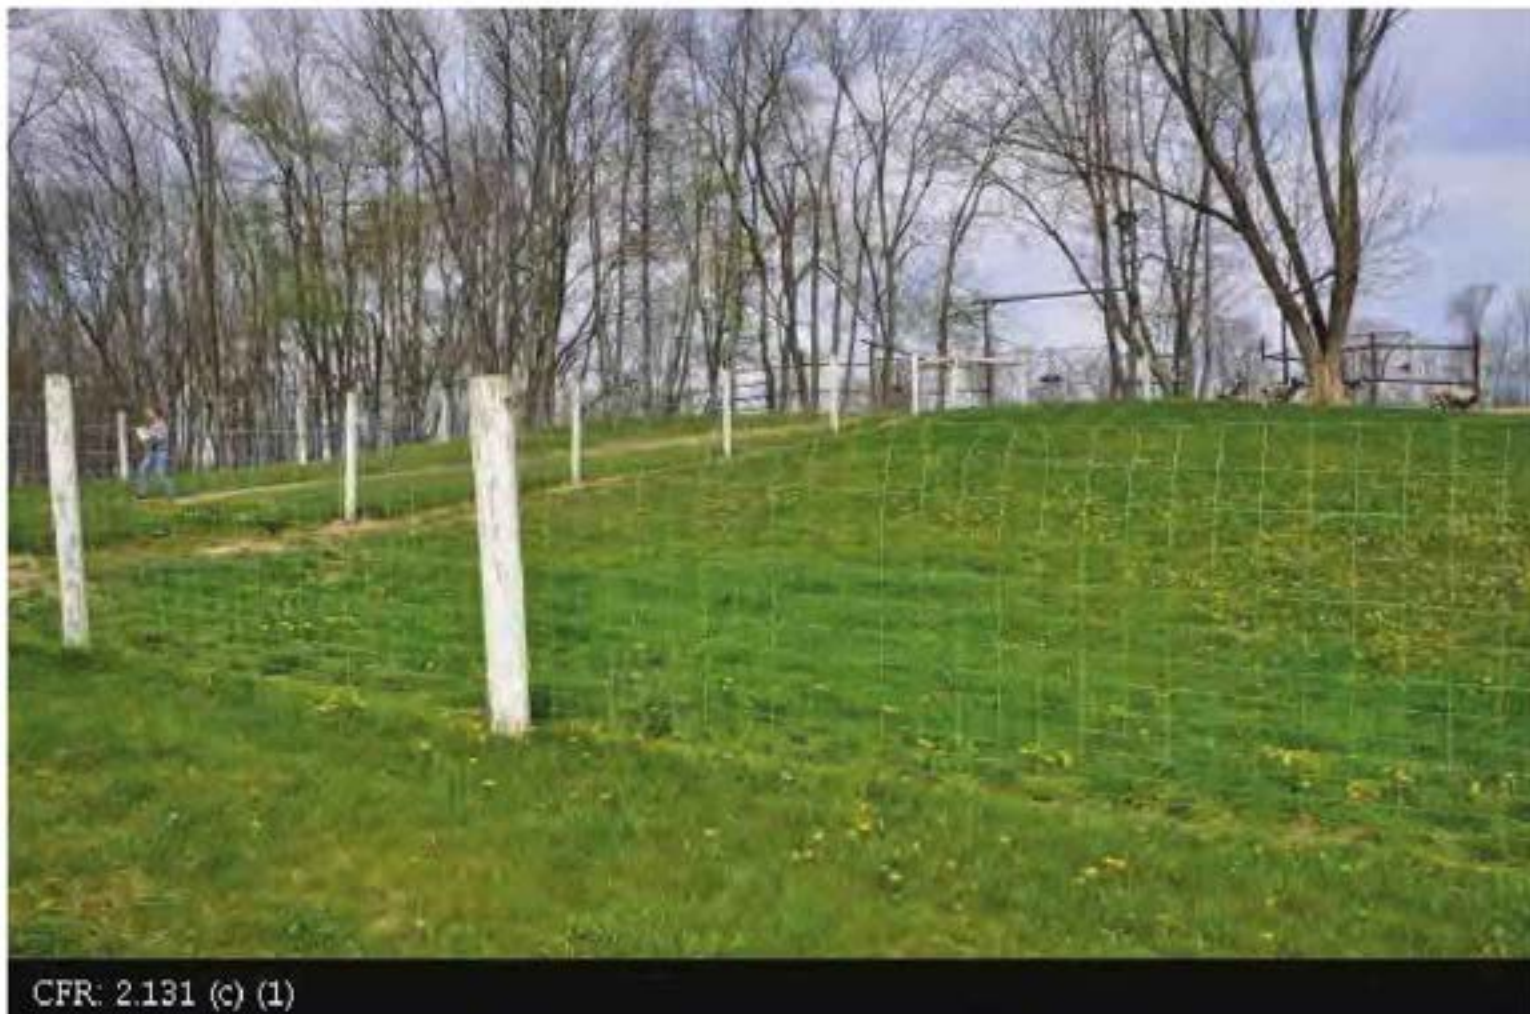
000433

CFR: 2.131 (c) (1)

Photographer:	Randy Coleman	Legal Name:	55-B-0069
Photo Taken:	Mon, Apr 25, '16 11:12 am	HENRY HAMPTON	
Inspection:	119160939110230		
Description:	Section 2.131(c)(1): Public continues to be able to walk up to animal enclosures with no barriers or attendants.

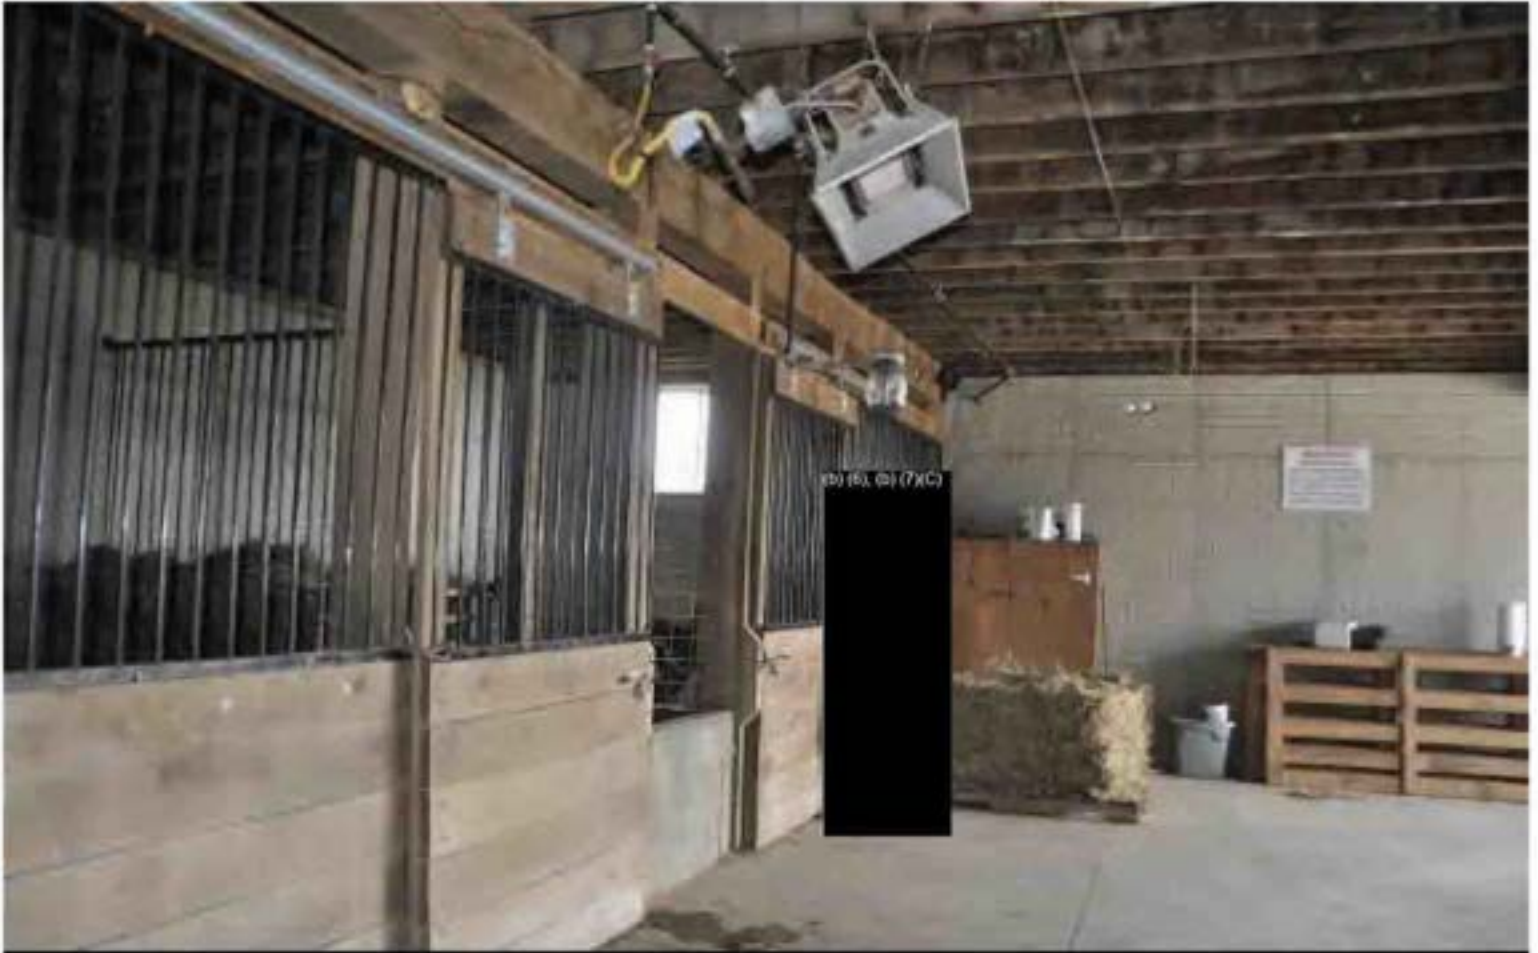
000434

CFR: 2.131 (c) (1)

Photographer:	Randy Coleman	Legal Name:	55-B-0069
Photo Taken:	Mon, Apr 25, '16 1133 am	HENRY HAMPTON	
Inspection:	119160939110230		
Description:	Section 2.131(c)(1): Public continues to be able to walk up to animal enclosures with no barriers or attendants.

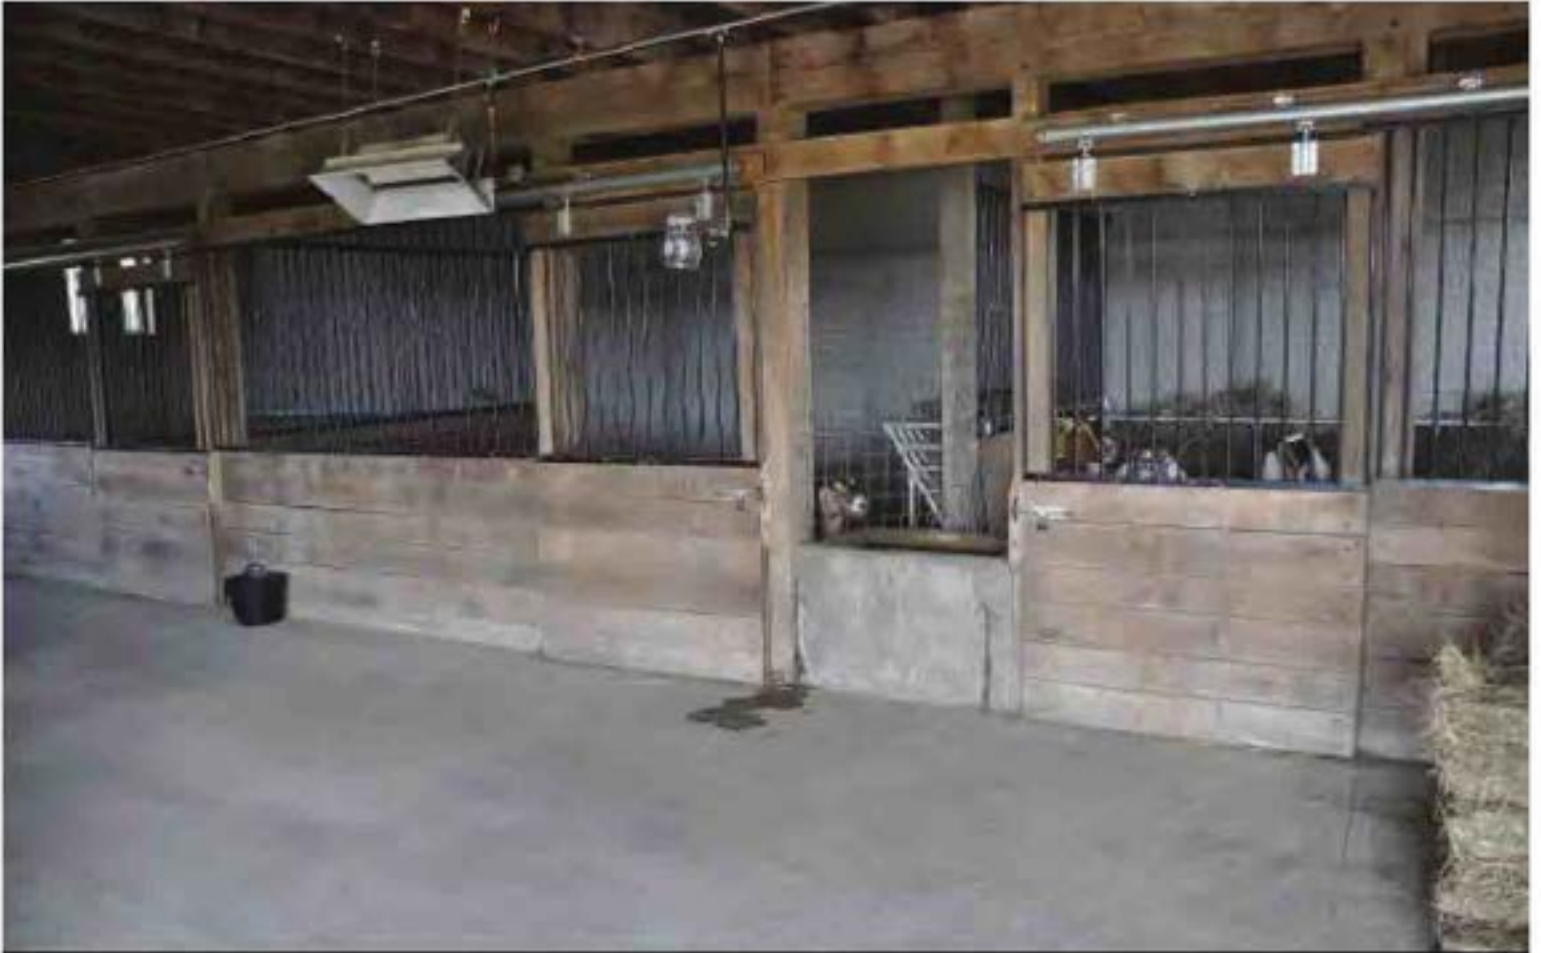
000435

CFR: 2.131 (c) (1)

Photographer:	Randy Coleman	Legal Name:	55-B-0069
Photo Taken:	Mon, Apr 25, '16 1133 am	HENRY HAMPTON	
Inspection:	119160939110230		
Description:	Section 2.131(c)(1): Public continues to be able to walk up to animal enclosures with no barriers or attendants.

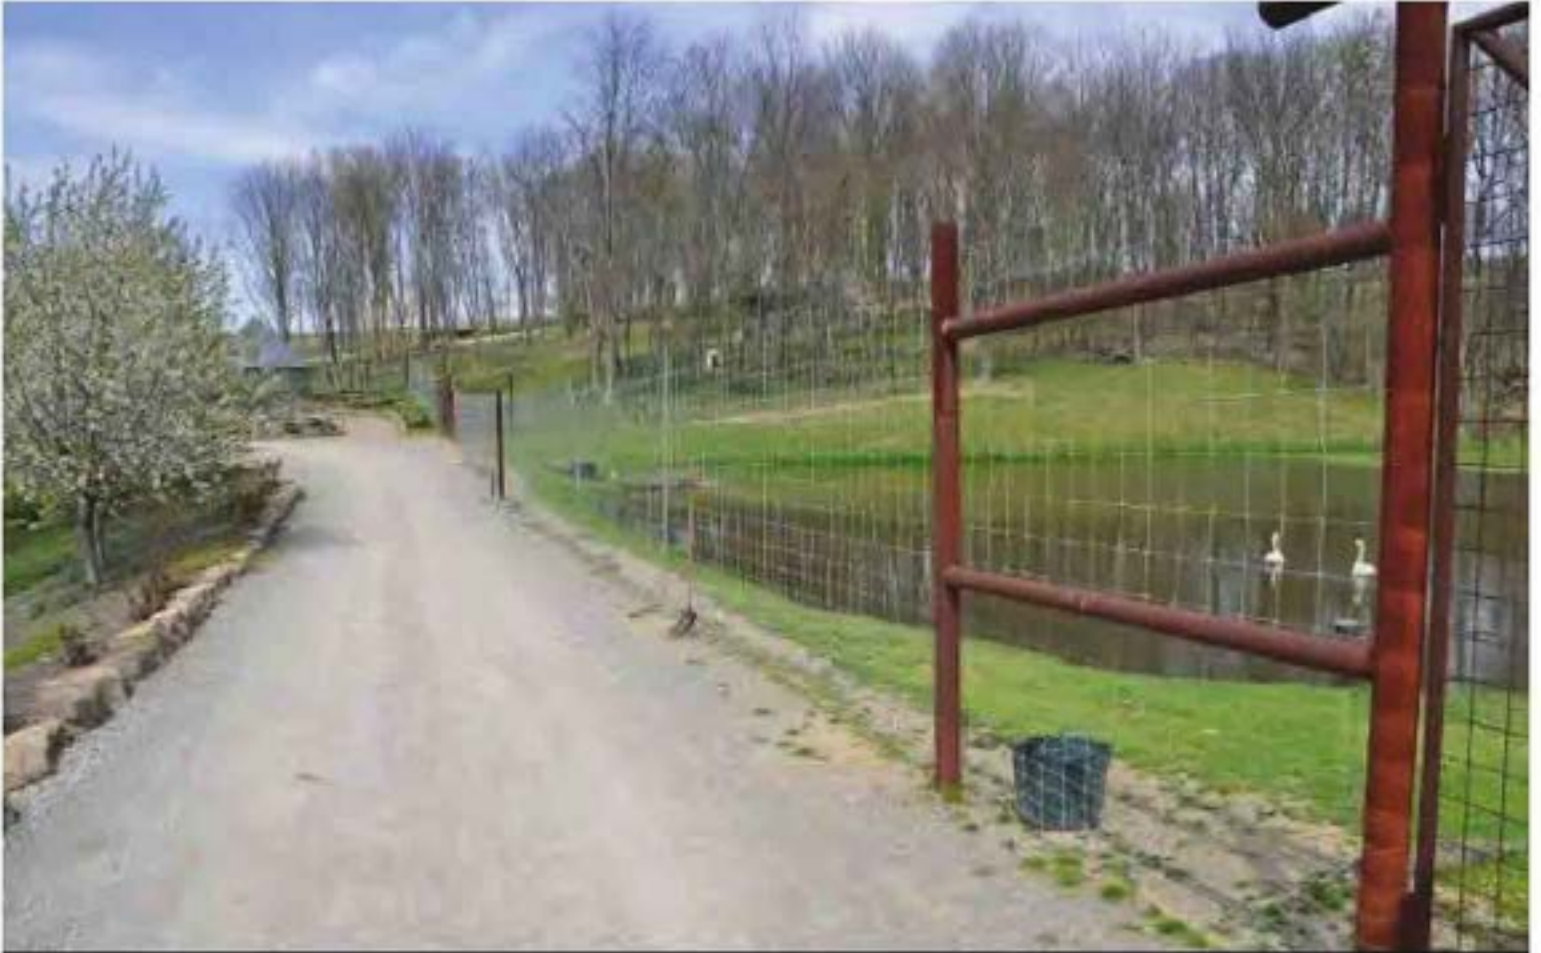
000436

CFR: 2.131 (c) (1)

Photographer:	Randy Coleman	Legal Name:	55-B-0069
Photo Taken:	Mon, Apr 25, '16 1135 am	HENRY HAMPTON	
Inspection:	119160939110230		
Description:	Section 2.131(c)(1): Public continues to be able to walk up to animal enclosures with no barriers or attendants.

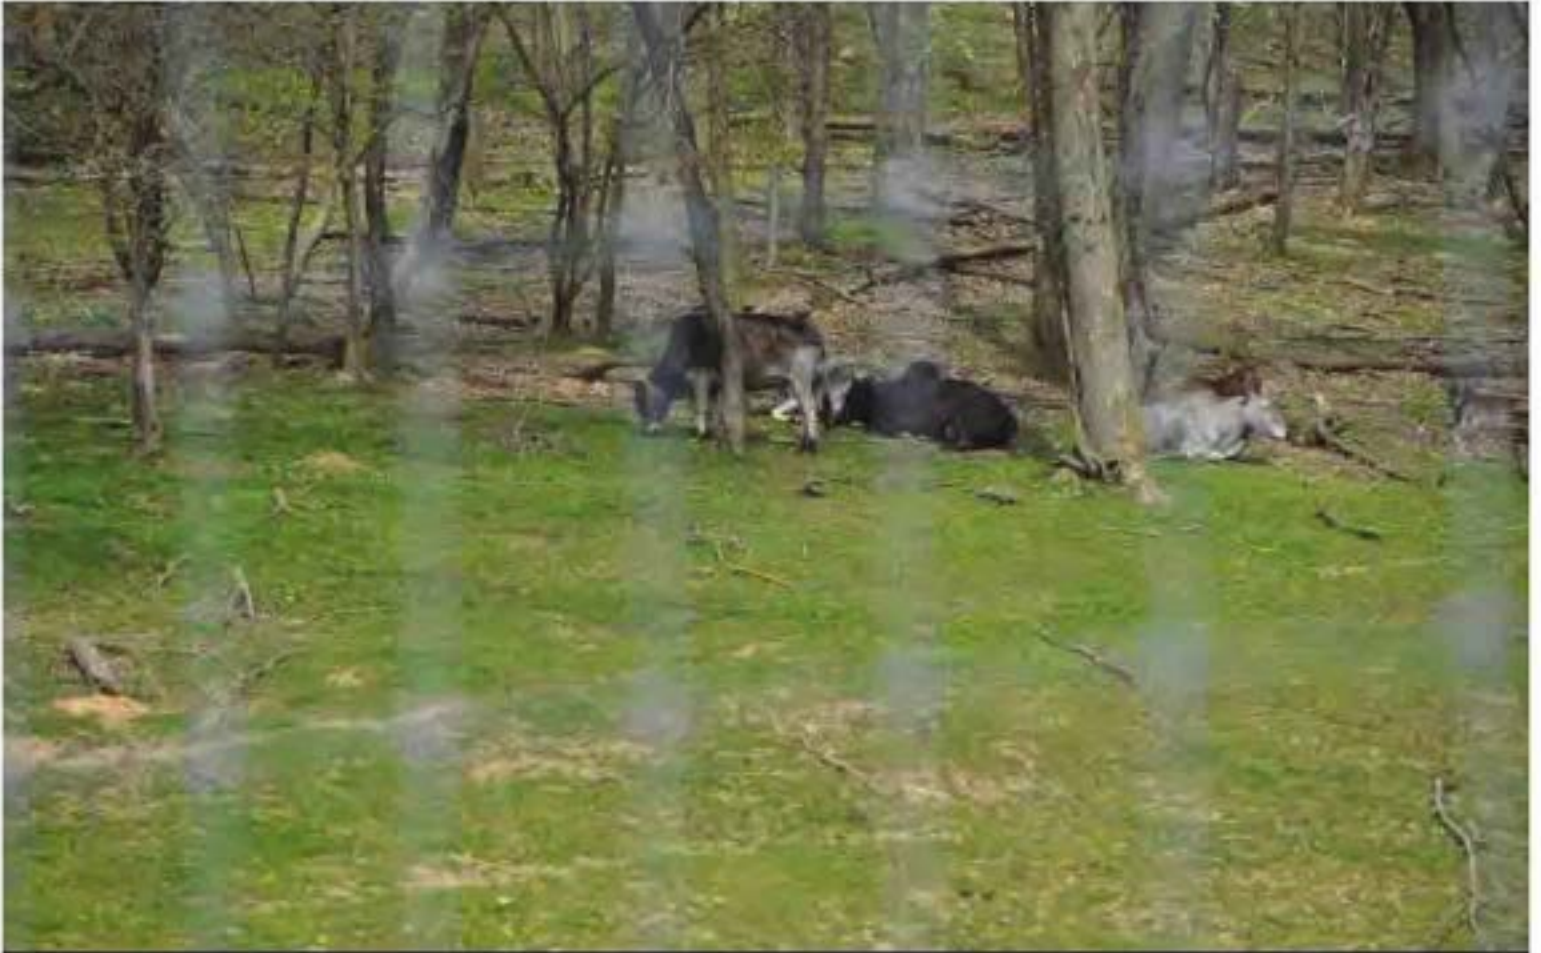
000437

CFR: 2.131 (c) (1)

Photographer:	Randy Coleman	Legal Name:	55-B-0069
Photo Taken:	Mon, Apr 25, '16 1135 am	HENRY HAMPTON	
Inspection:	119160939110230		
Description:	Section 2.131(c)(1): Public continues to be able to walk up to animal enclosures with no barriers or attendants.

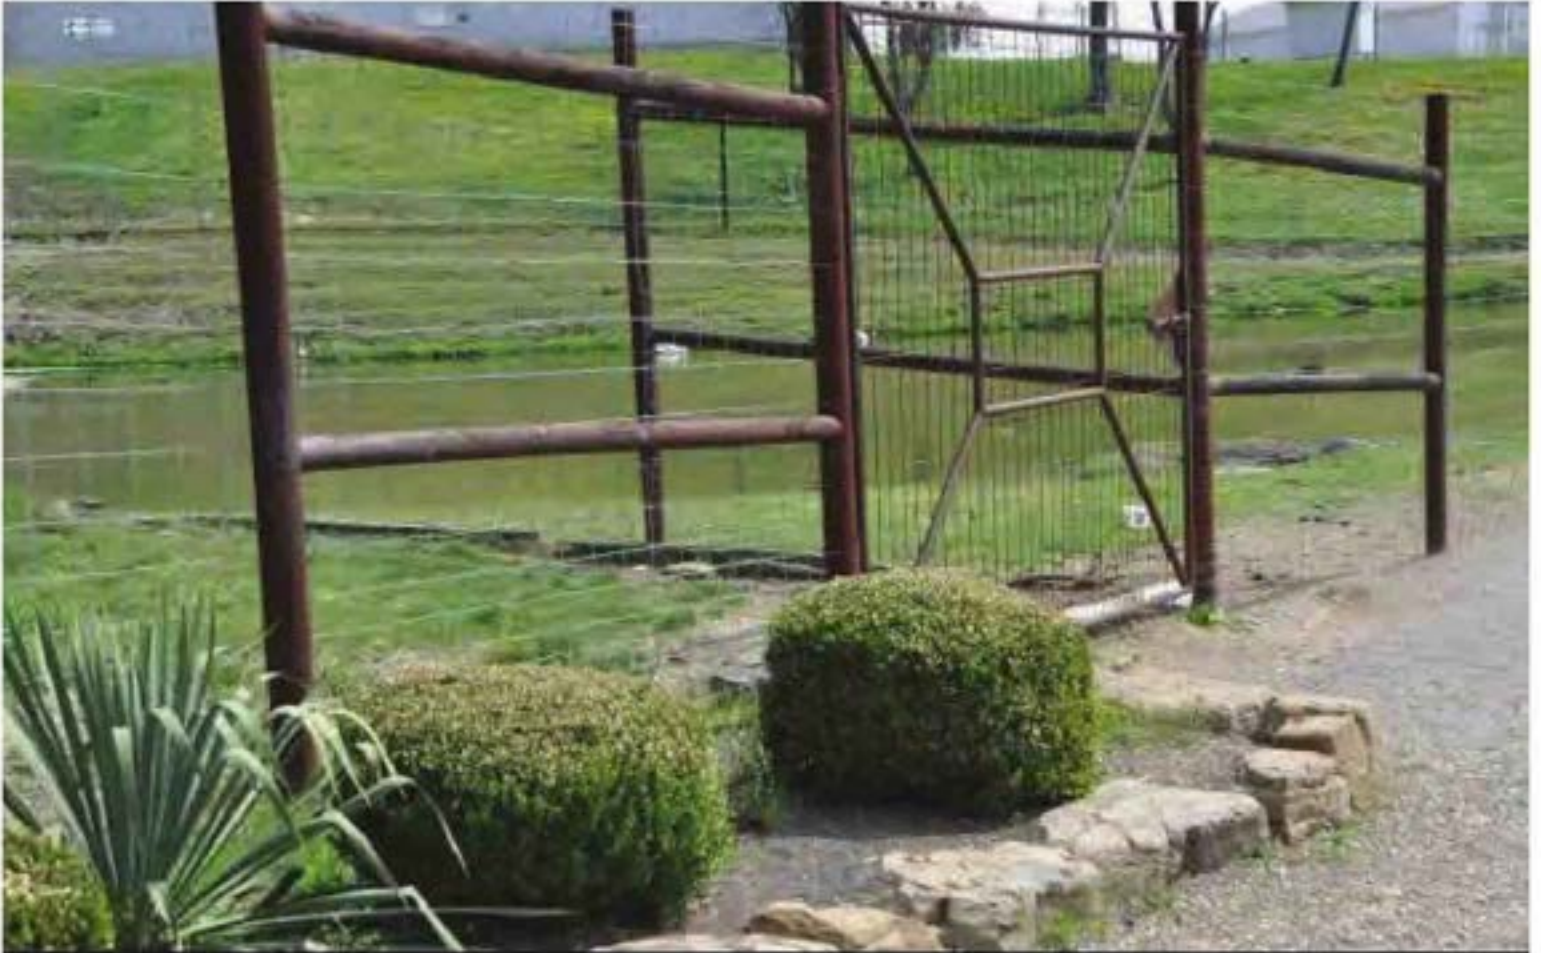
000438

CFR: 2.131 (c) (1)

Photographer:	Randy Coleman	Legal Name:	55-B-0069
Photo Taken:	Mon, Apr 25, '16 1100 am	HENRY HAMPTON	
Inspection:	119160939110230		
Description:	Section 2.131(c)(1): Public continues to be able to walk up to animal enclosures with no barriers or attendants.
