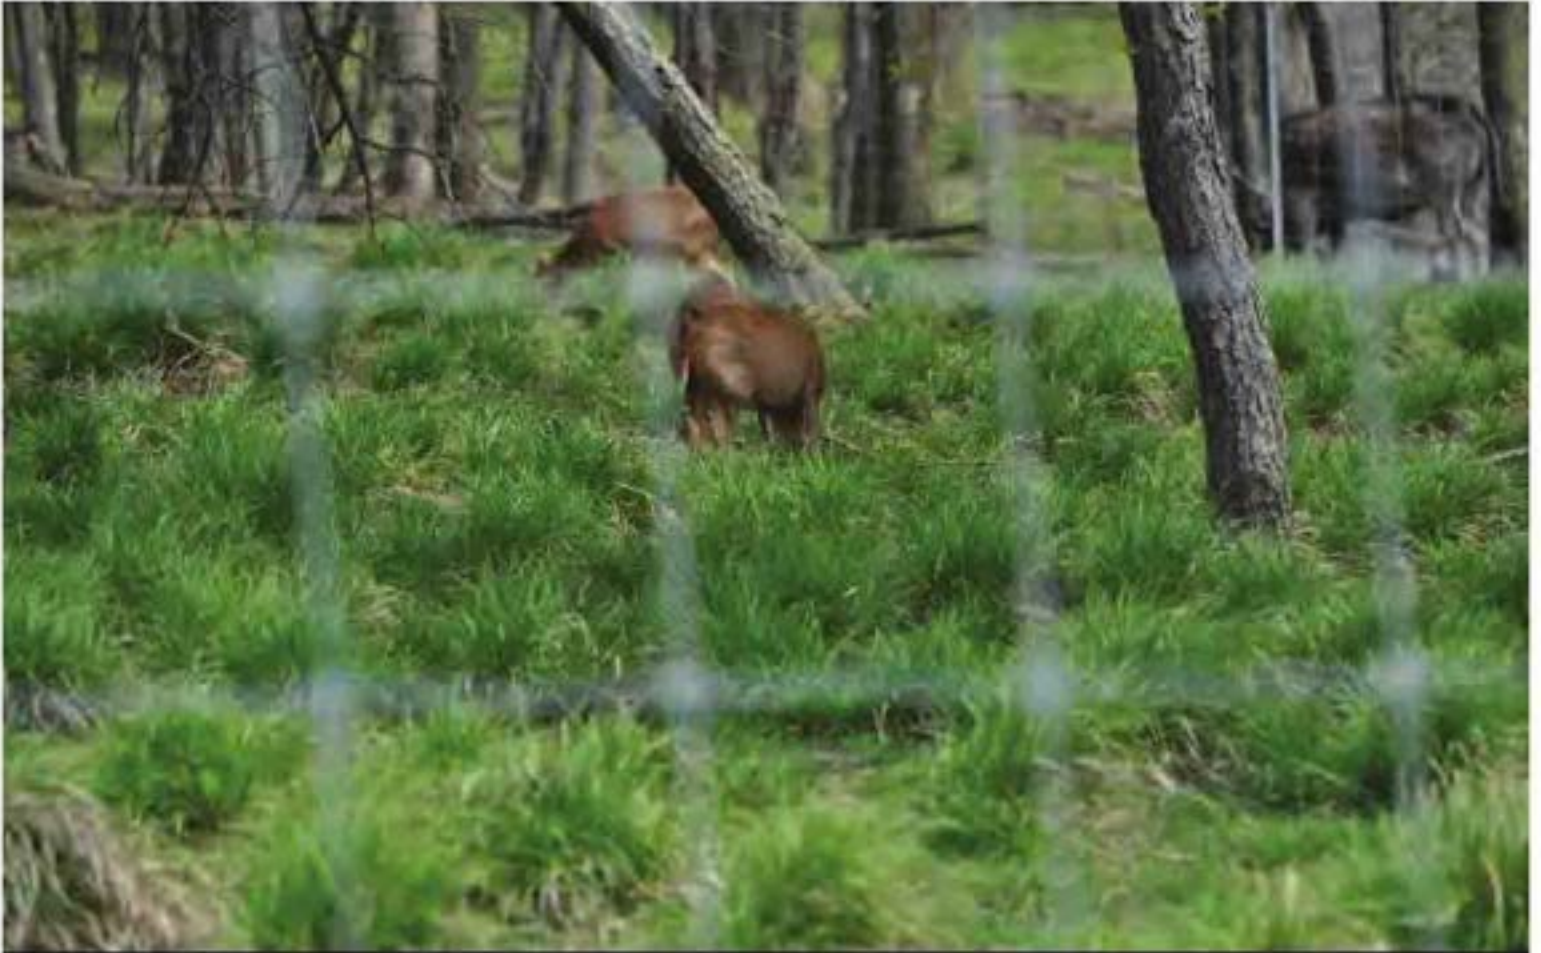
000439

CFR: 2.131 (c) (1)

Photographer:	Randy Coleman	Legal Name:	55-B-0069
Photo Taken:	Mon, Apr 25, '16 1140 am	HENRY HAMPTON	
Inspection:	119160939110230		
Description:	Section 2.131(c)(1): Public continues to be able to walk up to animal enclosures with no barriers or attendants.

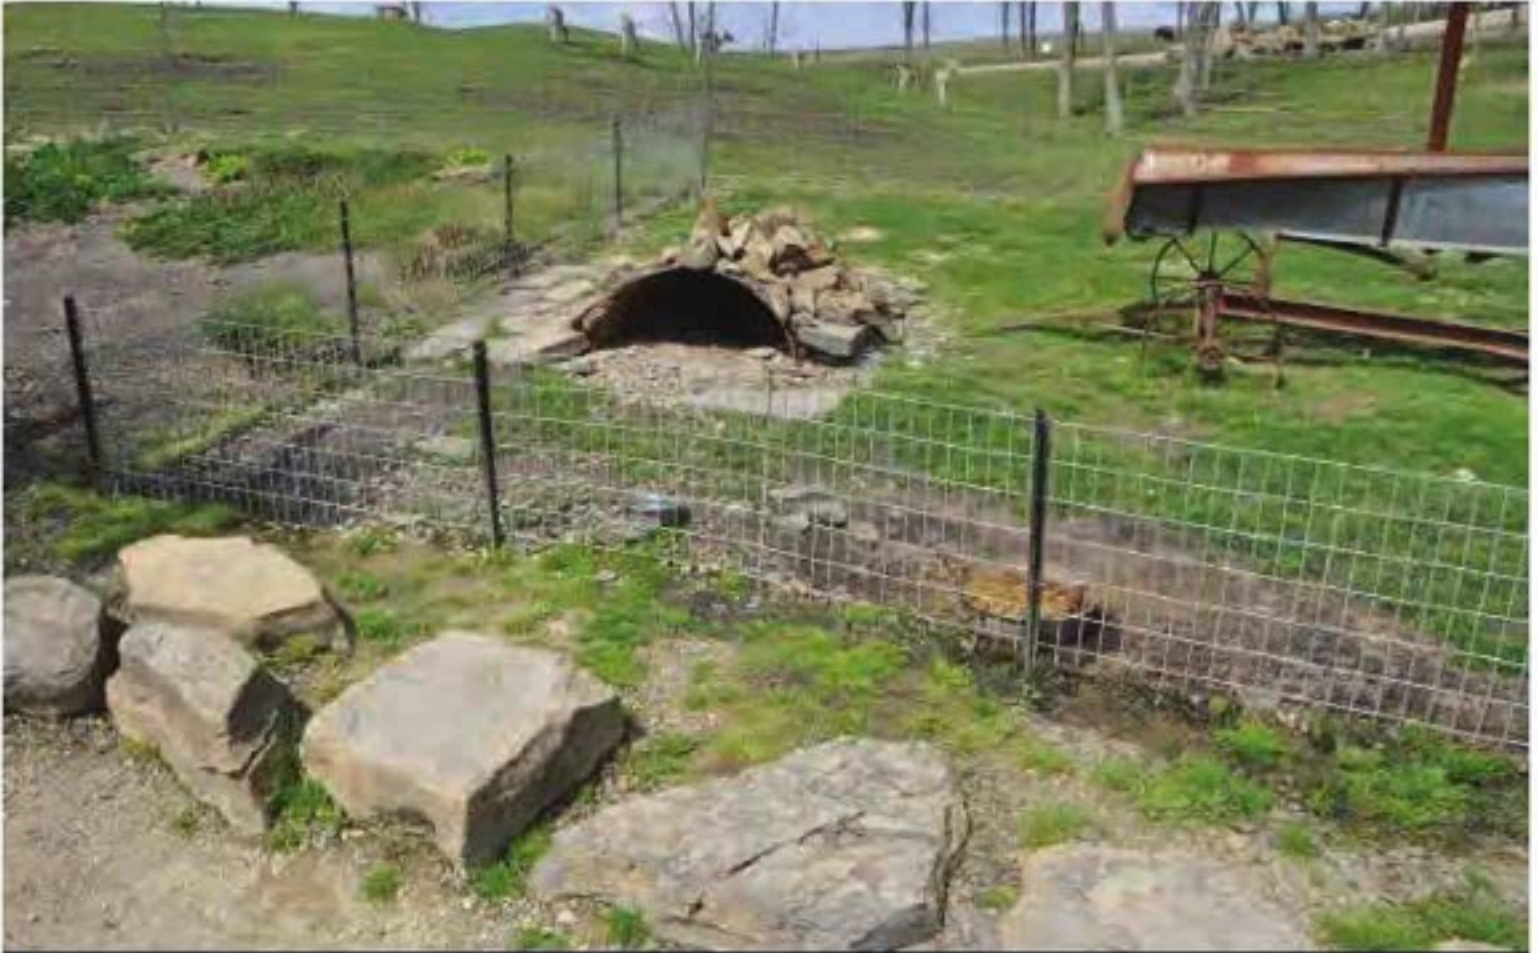
CFR: 2.131 (c) (1)

Photographer:	Randy Coleman	Legal Name:	55-B-0069
Photo Taken:	Mon, Apr 25, '16 1140 am	HENRY HAMPTON	
Inspection:	119160939110230		
Description:	Section 2.131(c)(1): Public continues to be able to walk up to animal enclosures with no barriers or attendants.

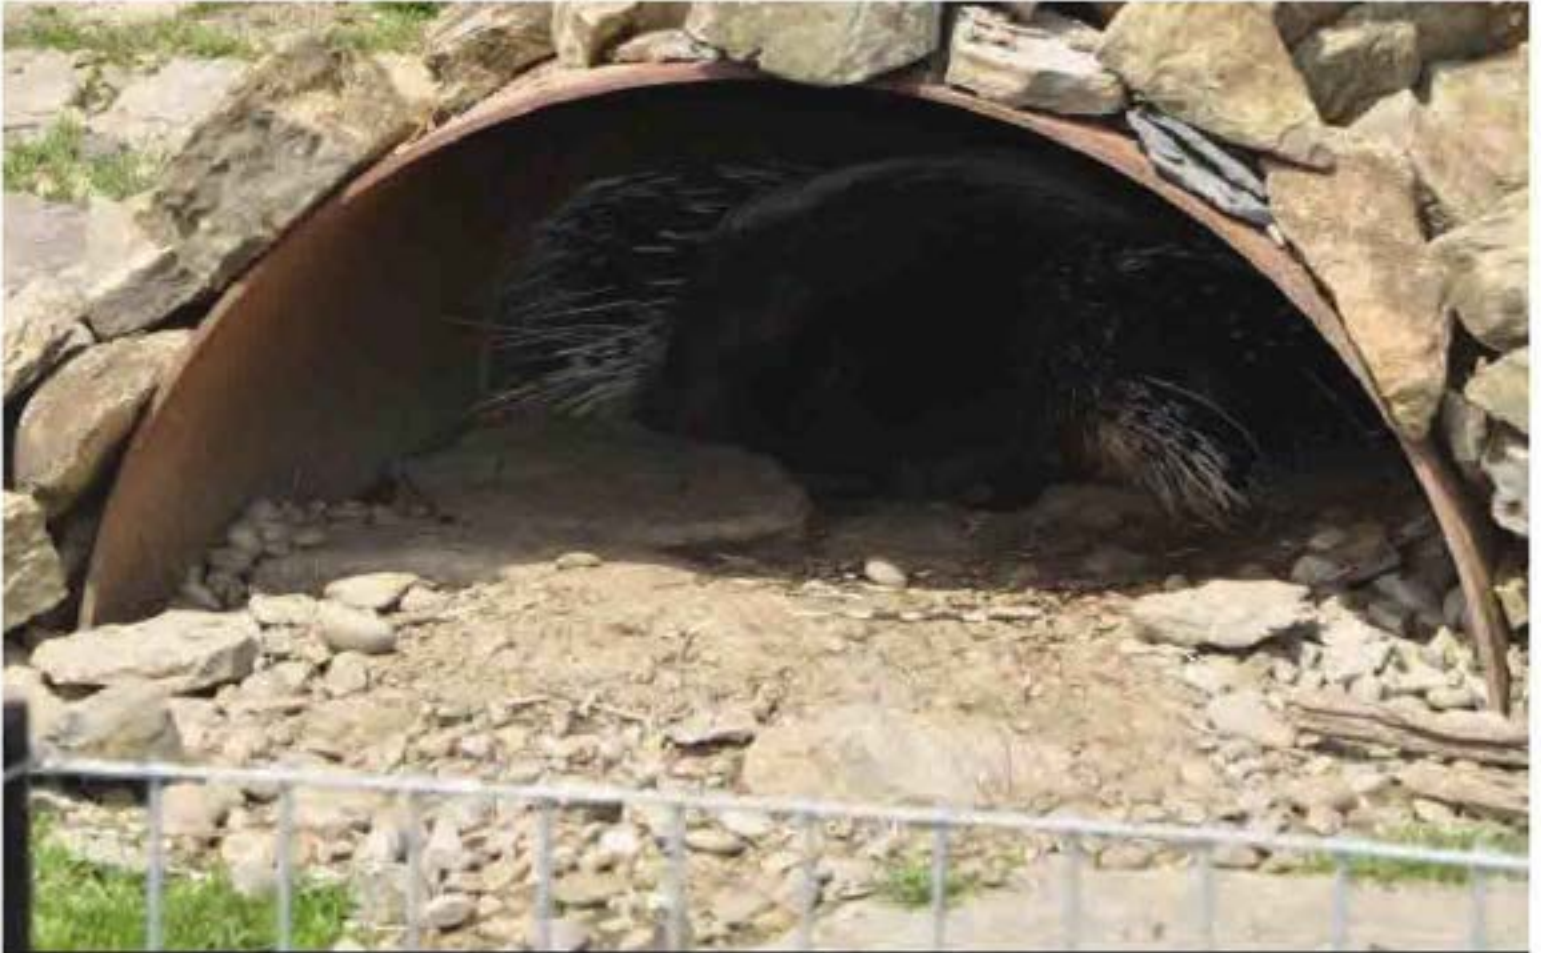
CFR: 2.131 (c) (1)

Photographer:	Randy Coleman	Legal Name:	55-B-0069
Photo Taken:	Mon, Apr 25, '16 1140 am	HENRY HAMPTON	
Inspection:	119160939110230		
Description:	Section 2.131(c)(1): Public continues to be able to walk up to animal enclosures with no barriers or attendants.

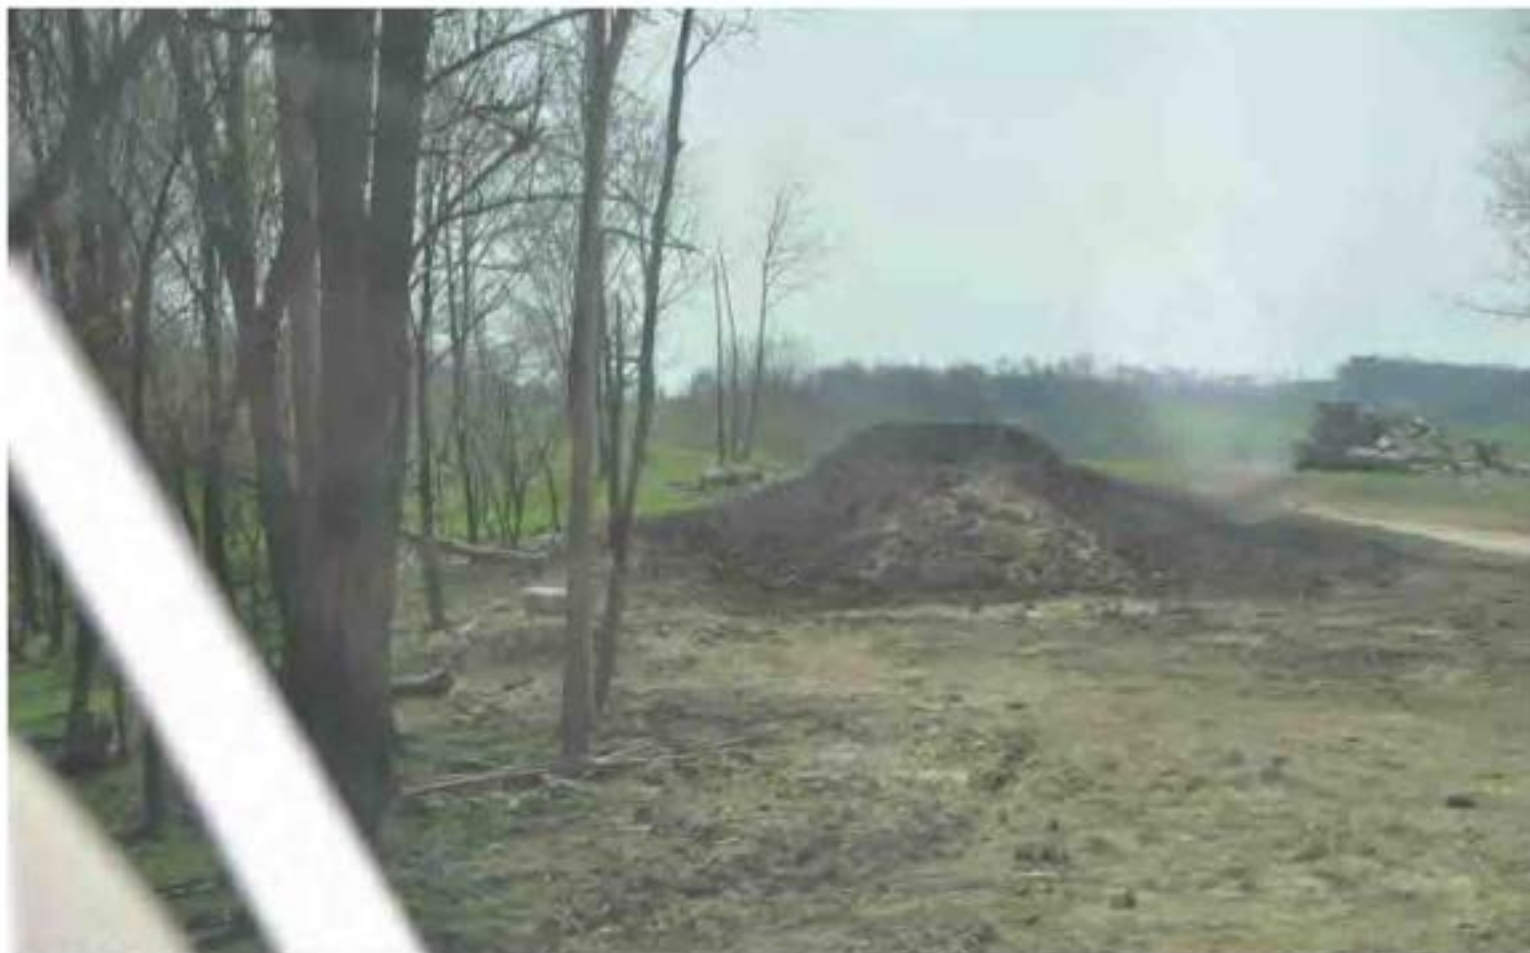
CFR: 3.125 (d)

Photographer:	Randy Coleman	Legal Name:	55-B-0069
Photo Taken:	Mon, Apr 25, '16 pm	HENRY HAMPTON	
Inspection:	119160939110230		
Description:	Section 3.125(d): Muck heap reduced in size but remains in drive thru area.

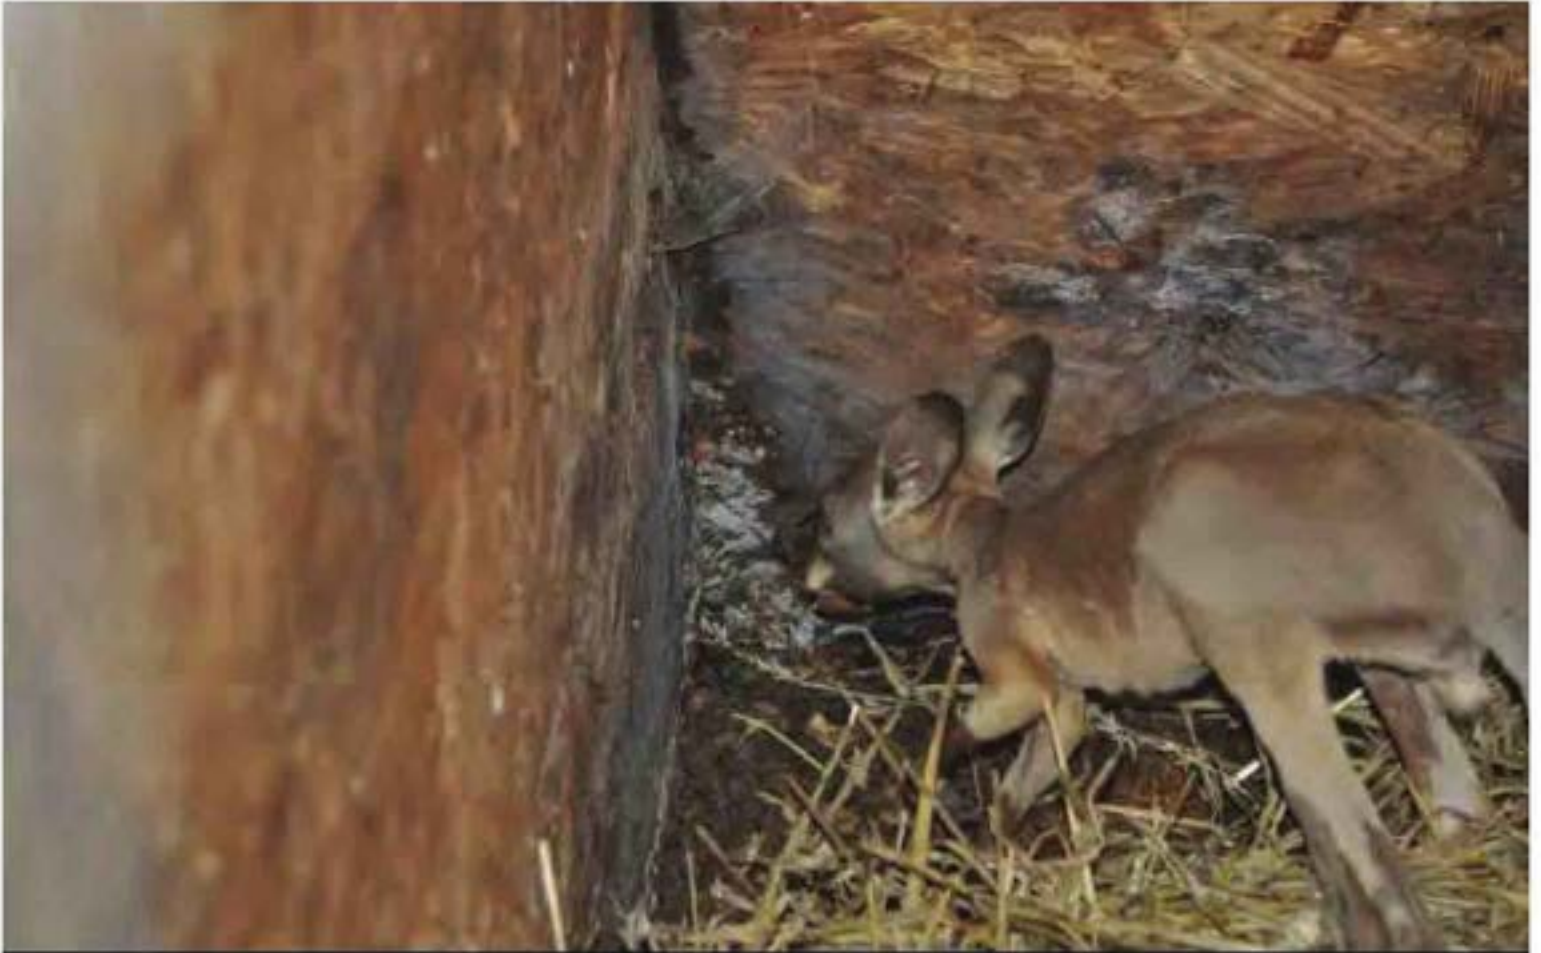
CFR: 3.125 (a)

Photographer:	Randy Coleman	Legal Name:	55-B-0069
Photo Taken:	Mon, Apr 25, '16 1145 am	HENRY HAMPTON	
Inspection:	119160939110230		
Description:	Section 3.125(a): Wet/moldy walls for indoor area for kangaroos.

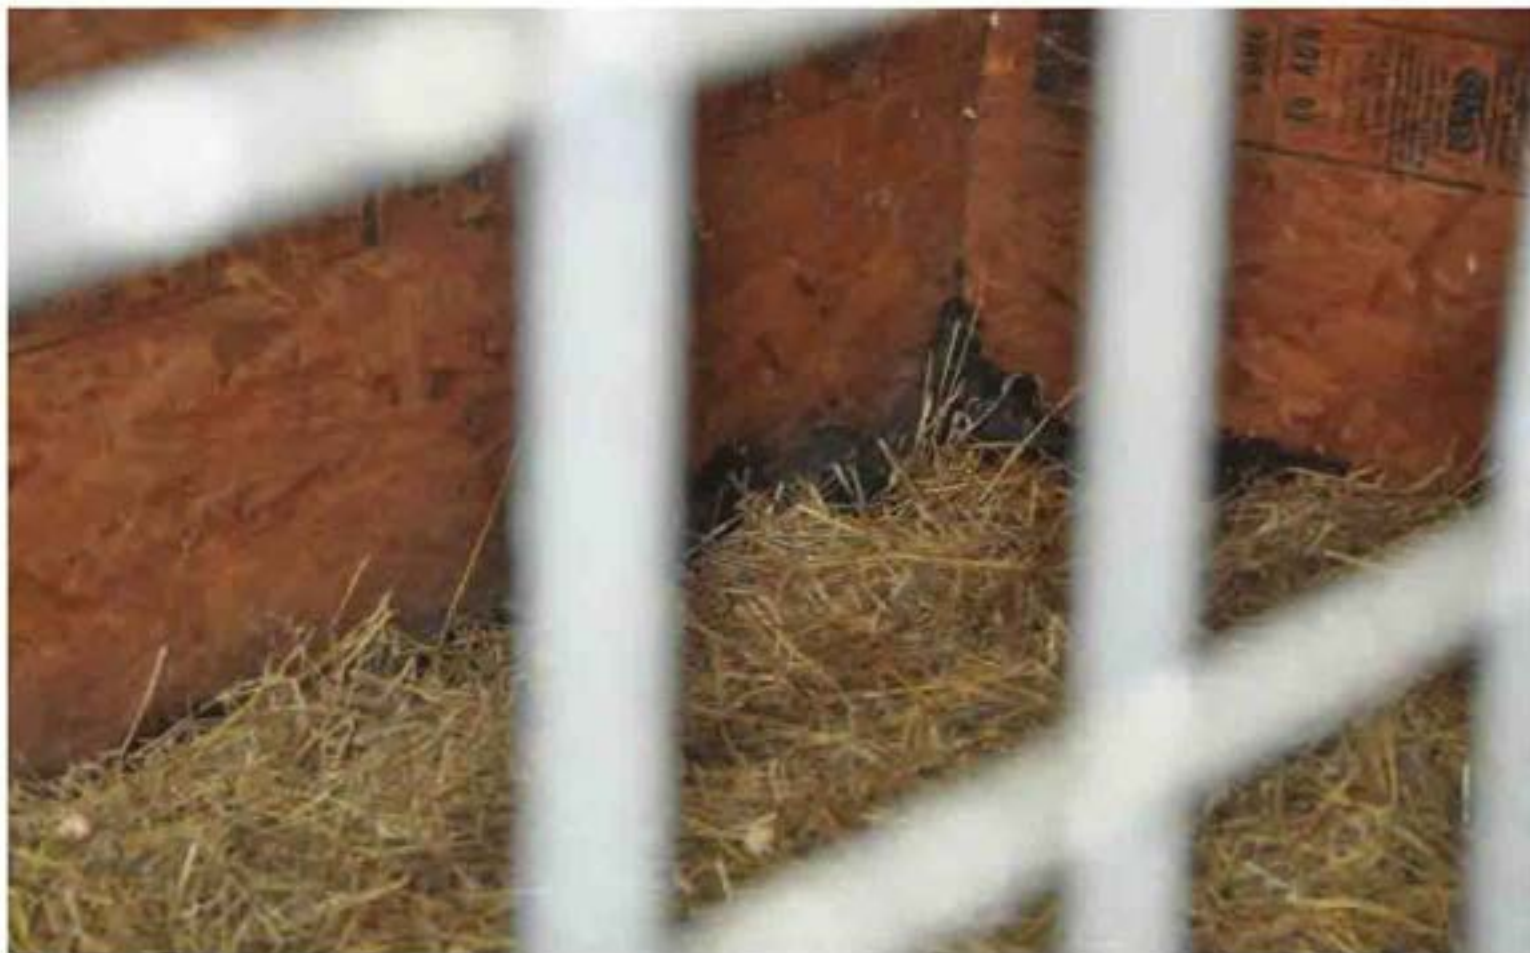
CFR: 3.125 (a)

Photographer:	Randy Coleman	Legal Name:	55-B-0069
Photo Taken:	Mon, Apr 25, '16 1145 am	HENRY HAMPTON	
Inspection:	119160939110230		
Description:	Section 3.125(a): Wet/moldy walls for indoor area for kangaroos.

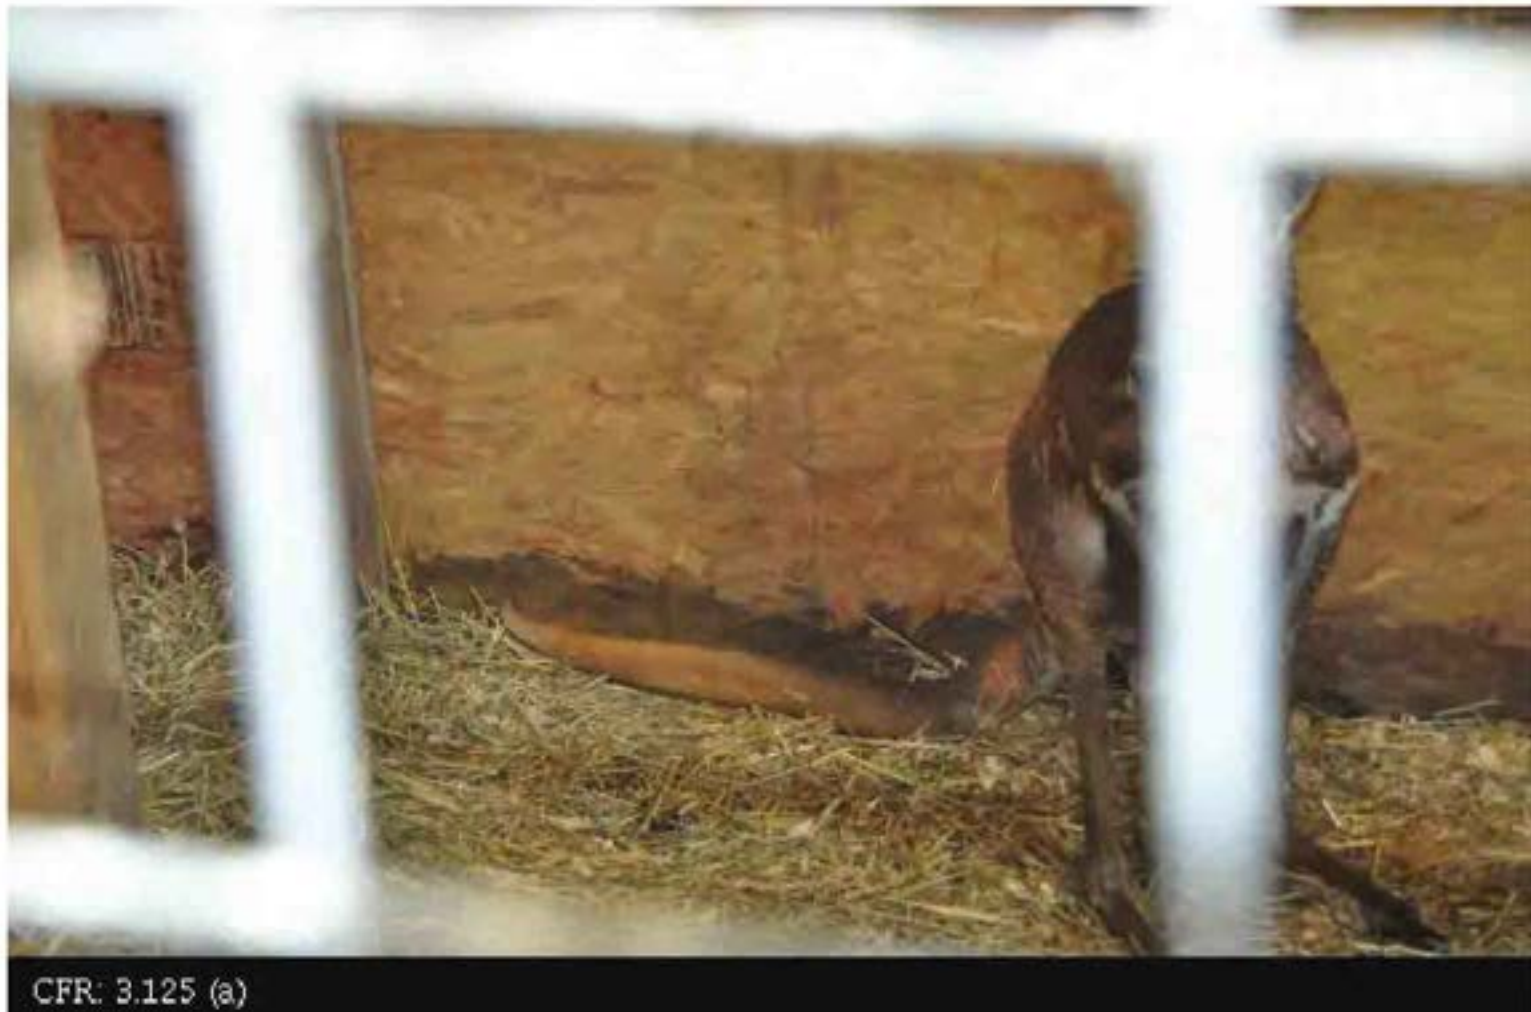
CFR: 3.125 (a)

Photographer:	Randy Coleman	Legal Name:	55-B-0069
Photo Taken:	Mon, Apr 25, '16 1145 am	HENRY HAMPTON	
Inspection:	119160939110230		
Description:	Section 3.125(a): Wet/moldy walls for indoor area for kangaroos.

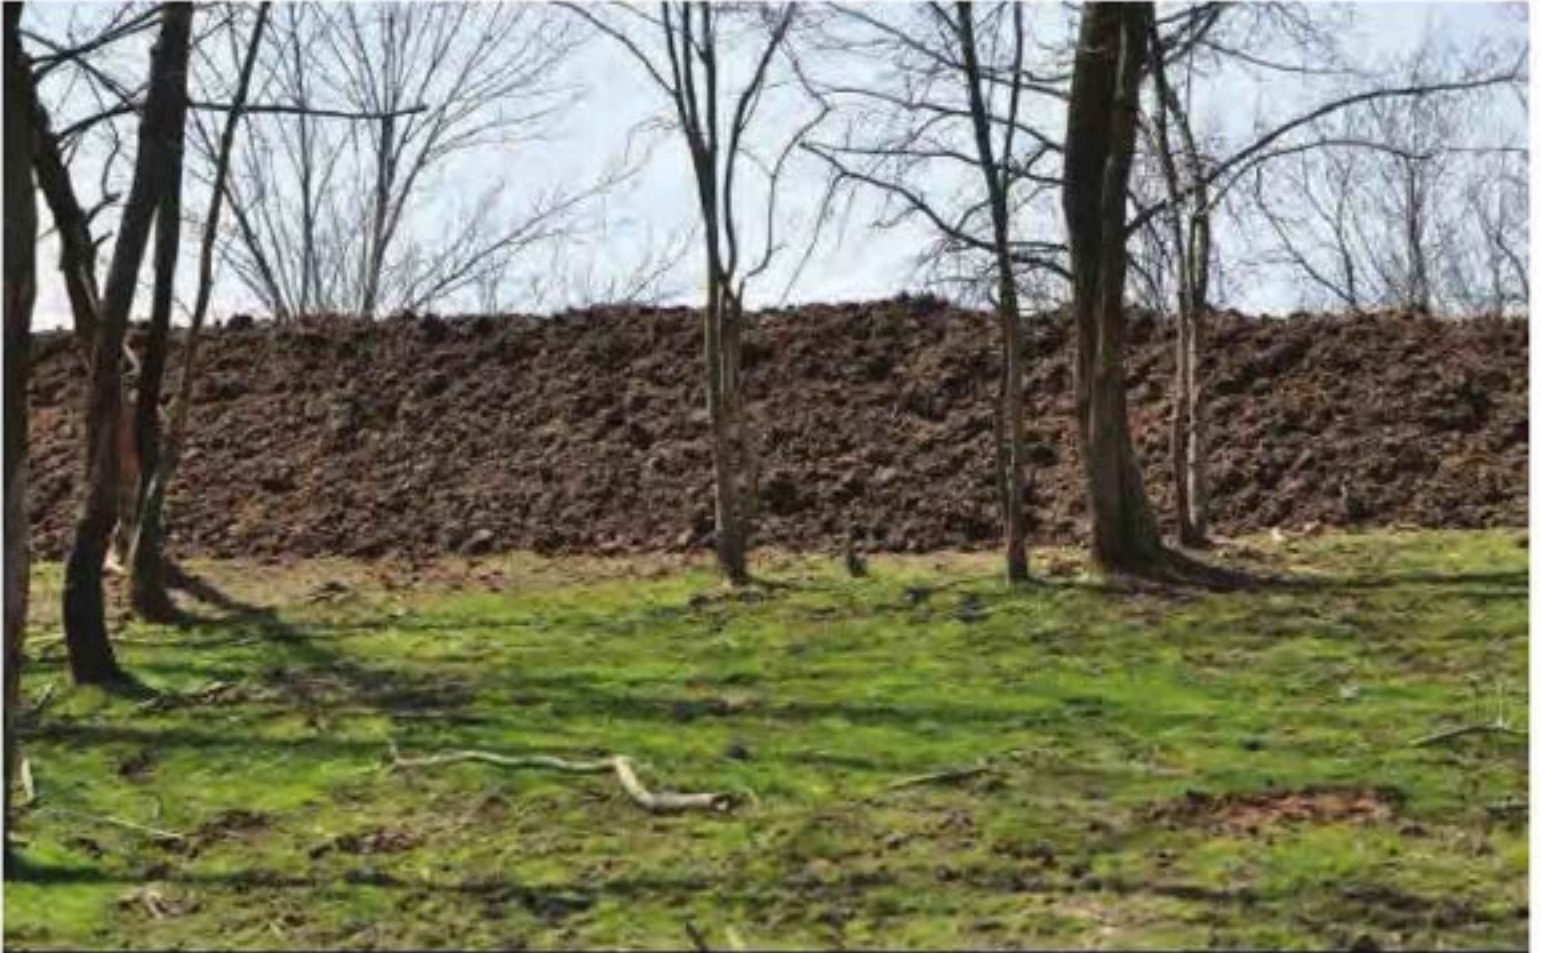
CFR: 3.125 (d)

Photographer:	Randy Coleman	Legal Name:	55-B-0069
Photo Taken:	Mon, Apr 25, '16 1225 pm	HENRY HAMPTON	
Inspection:	119160939110230		
Description:	Section 3.125(d): Muck heap reduced in size but remains in drive thru area.

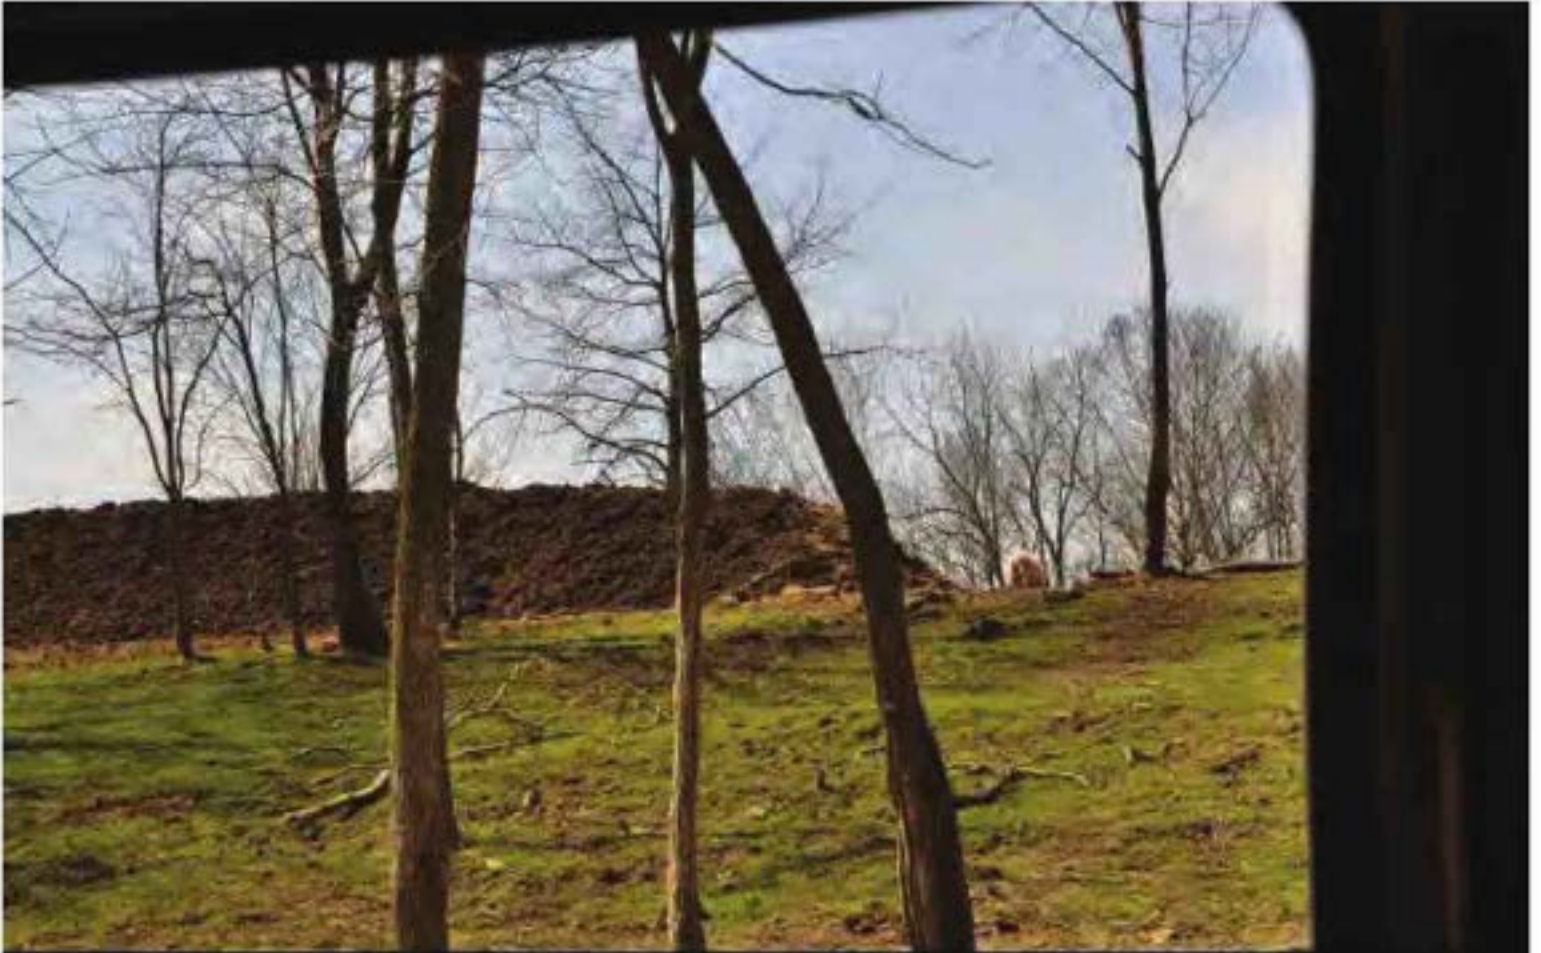
CFR: 3.125 (d)

Photographer:	Randy Coleman	Legal Name:	55-B-0069
Photo Taken:	Mon, Apr 25, '16 1225 pm	HENRY HAMPTON	
Inspection:	119160939110230		
Description:	Section 3.125(d): Muck heap reduced in size but remains in drive thru area.

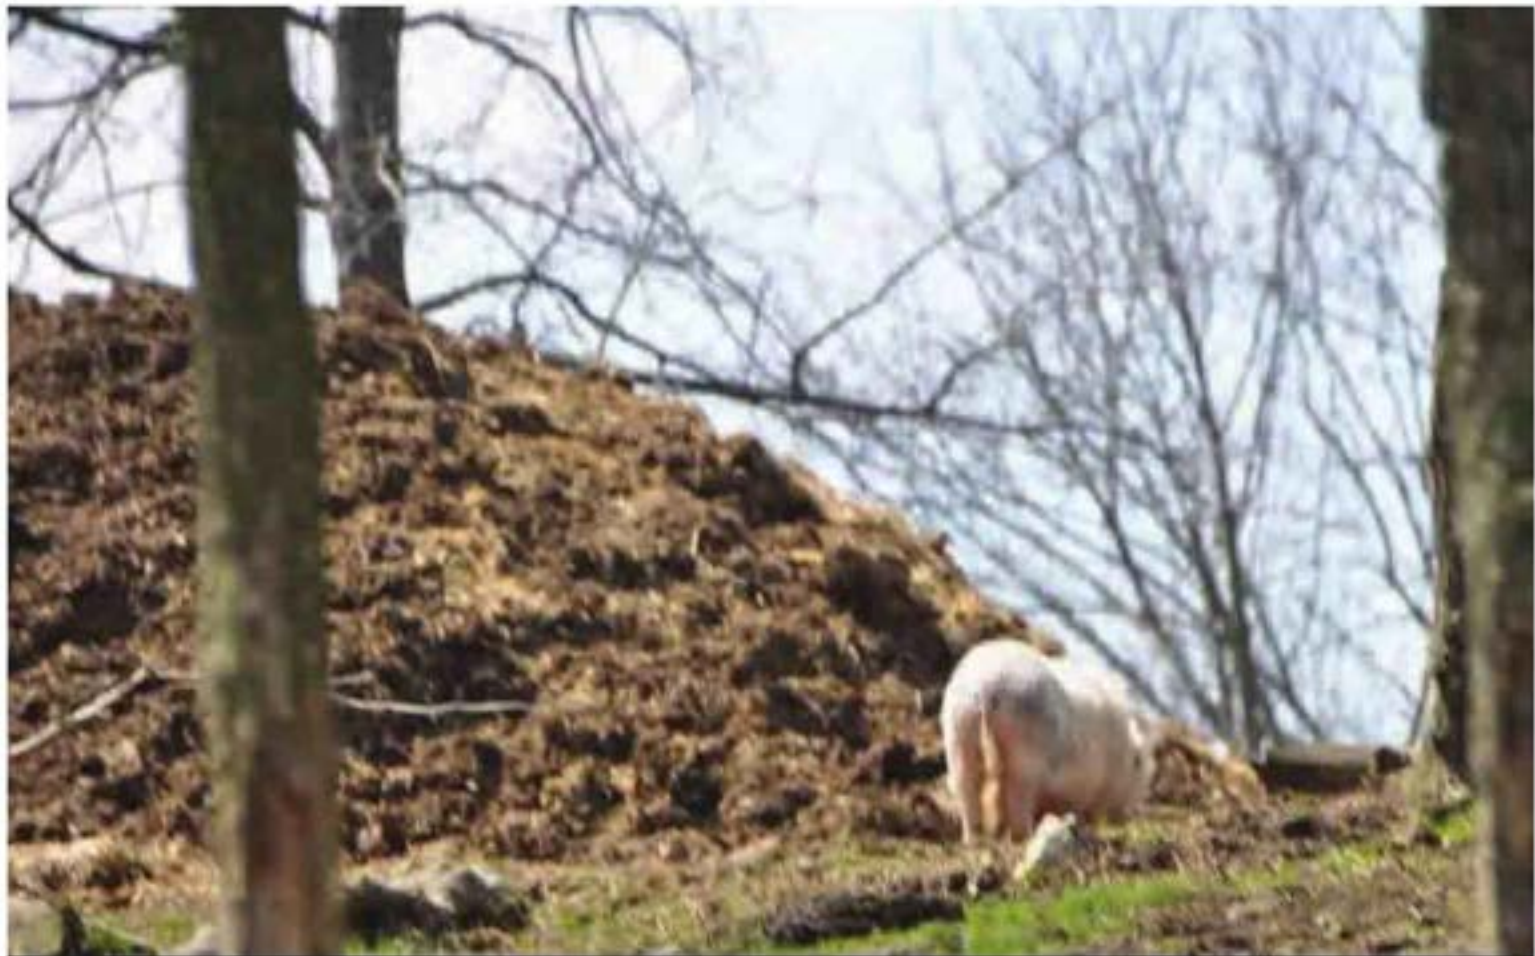
CFR: 3.125 (d)

Photographer:	Randy Coleman	Legal Name:	55-B-0069
Photo Taken:	Mon, Apr 25, '16 1225 pm	HENRY HAMPTON	
Inspection:	119160939110230		
Description:	Section 3.125(d): Muck heap reduced in size but remains in drive thru area.

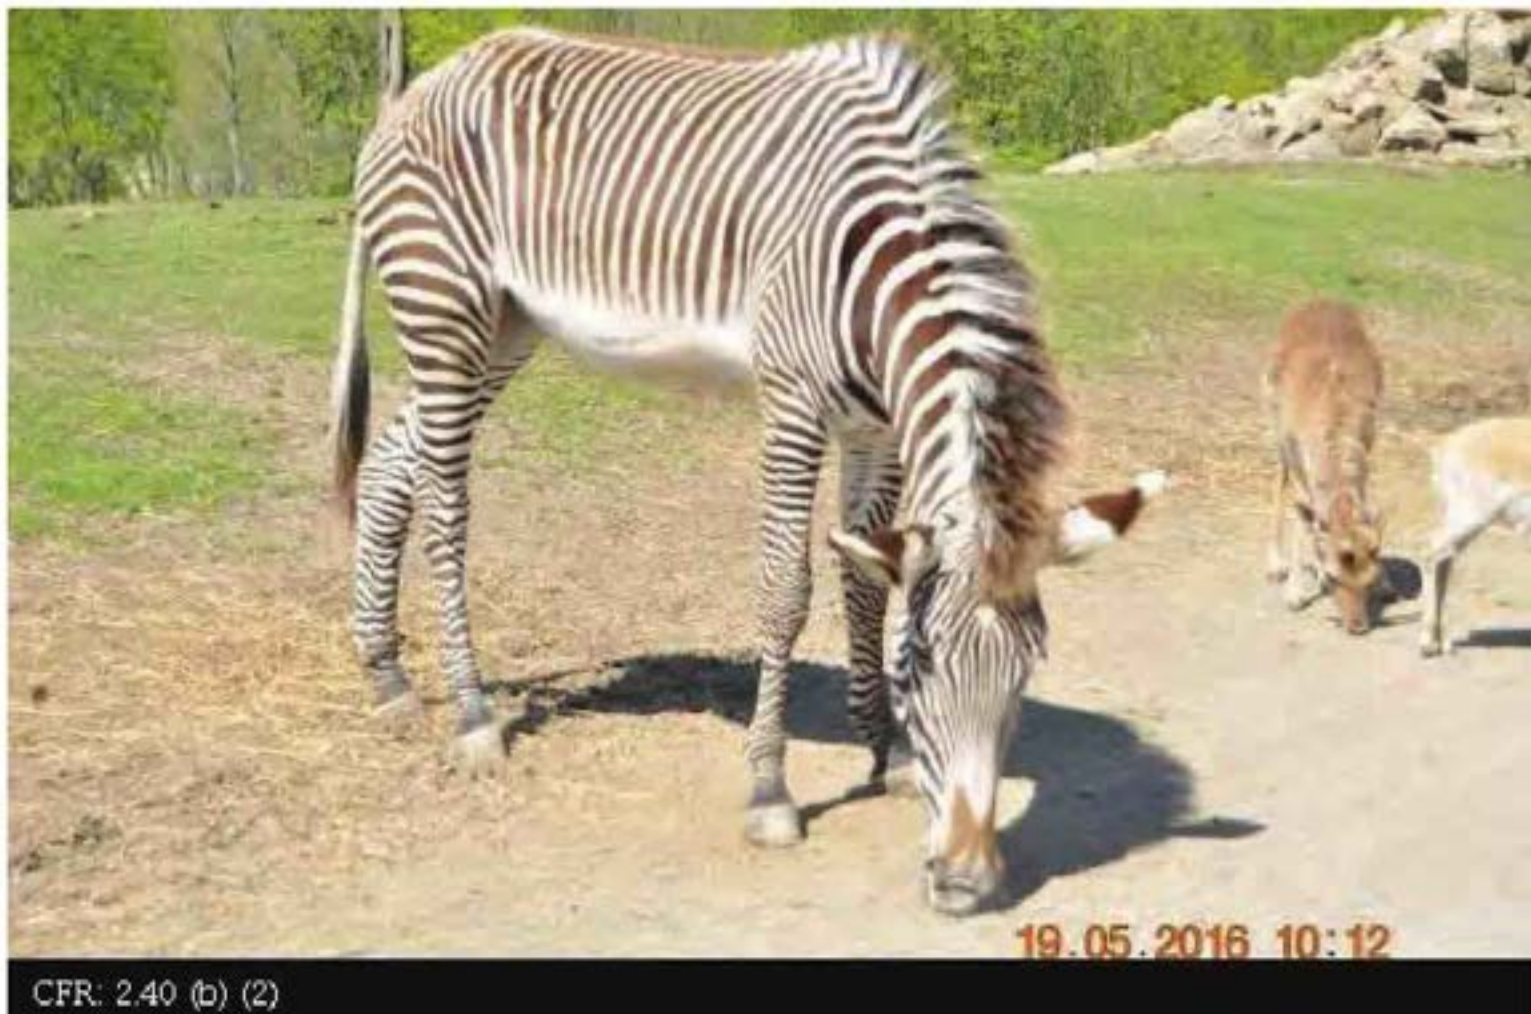
CFR: 2.40 (b) (2)

Photographer:	K. Campitelli	Legal Name:	55-B-0069
Photo Taken:	Thu, May 19, '16 10:30	HENRY HAMPTON	
Inspection:	141161055040796		
Description:	Zebra in drive-thru with hoof crack

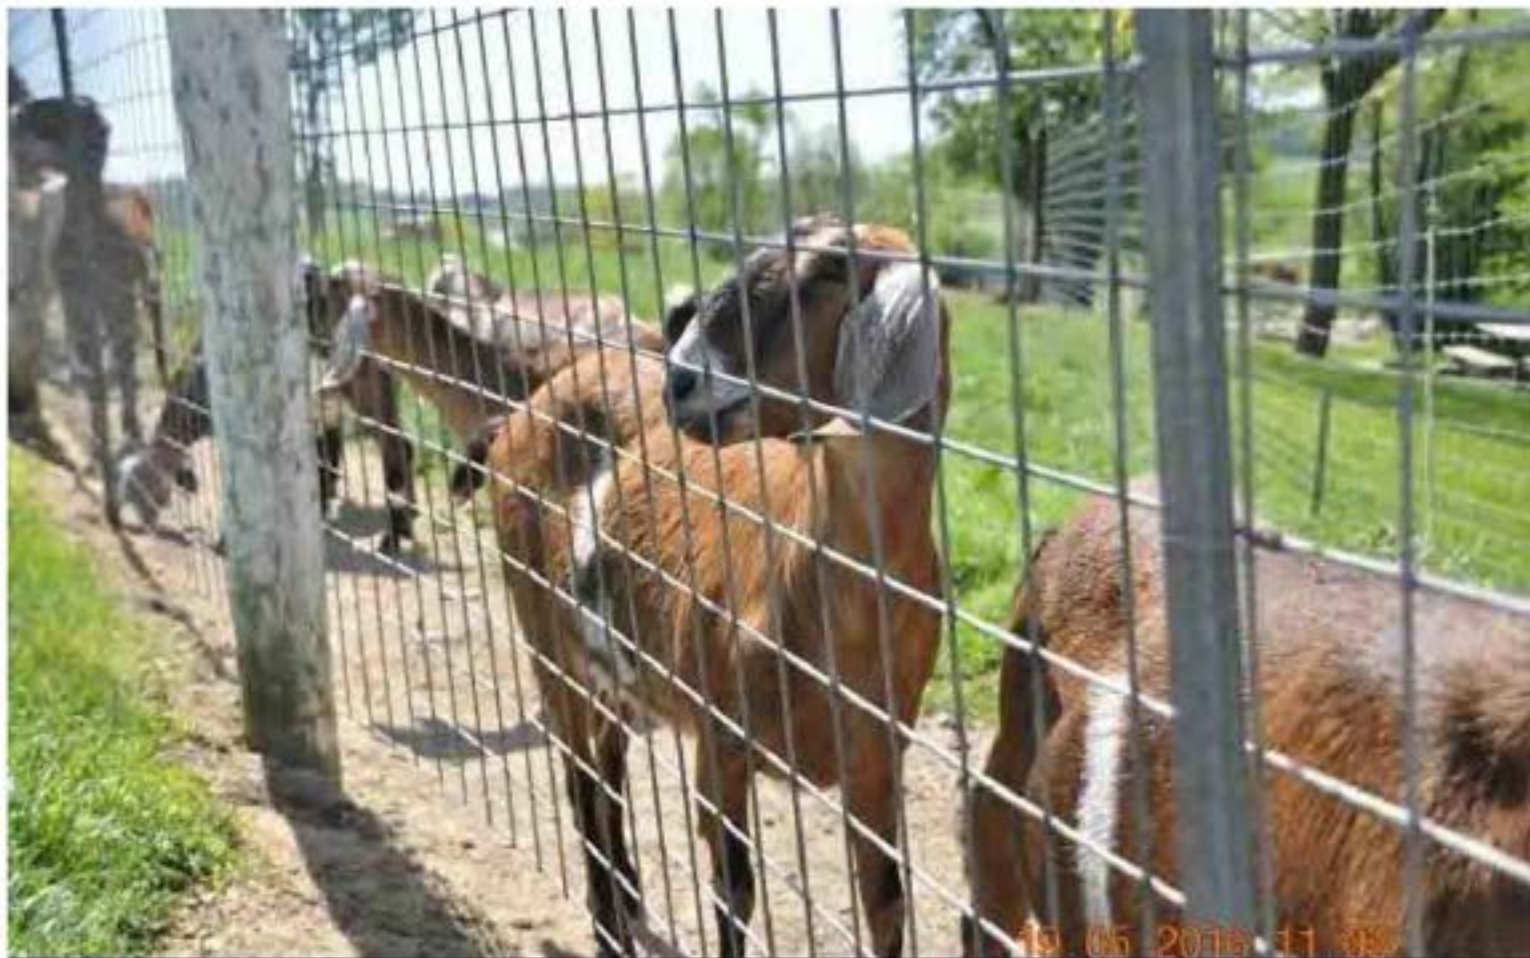
CFR: 2.40 (b) (2)

Photographer:	K. Campitelli	Legal Name:	55-B-0069
Photo Taken:	Thu, May 19, '16 10:30	HENRY HAMPTON	
Inspection:	141161055040796		
Description:	Alternate view of goat with lump on right shoulder

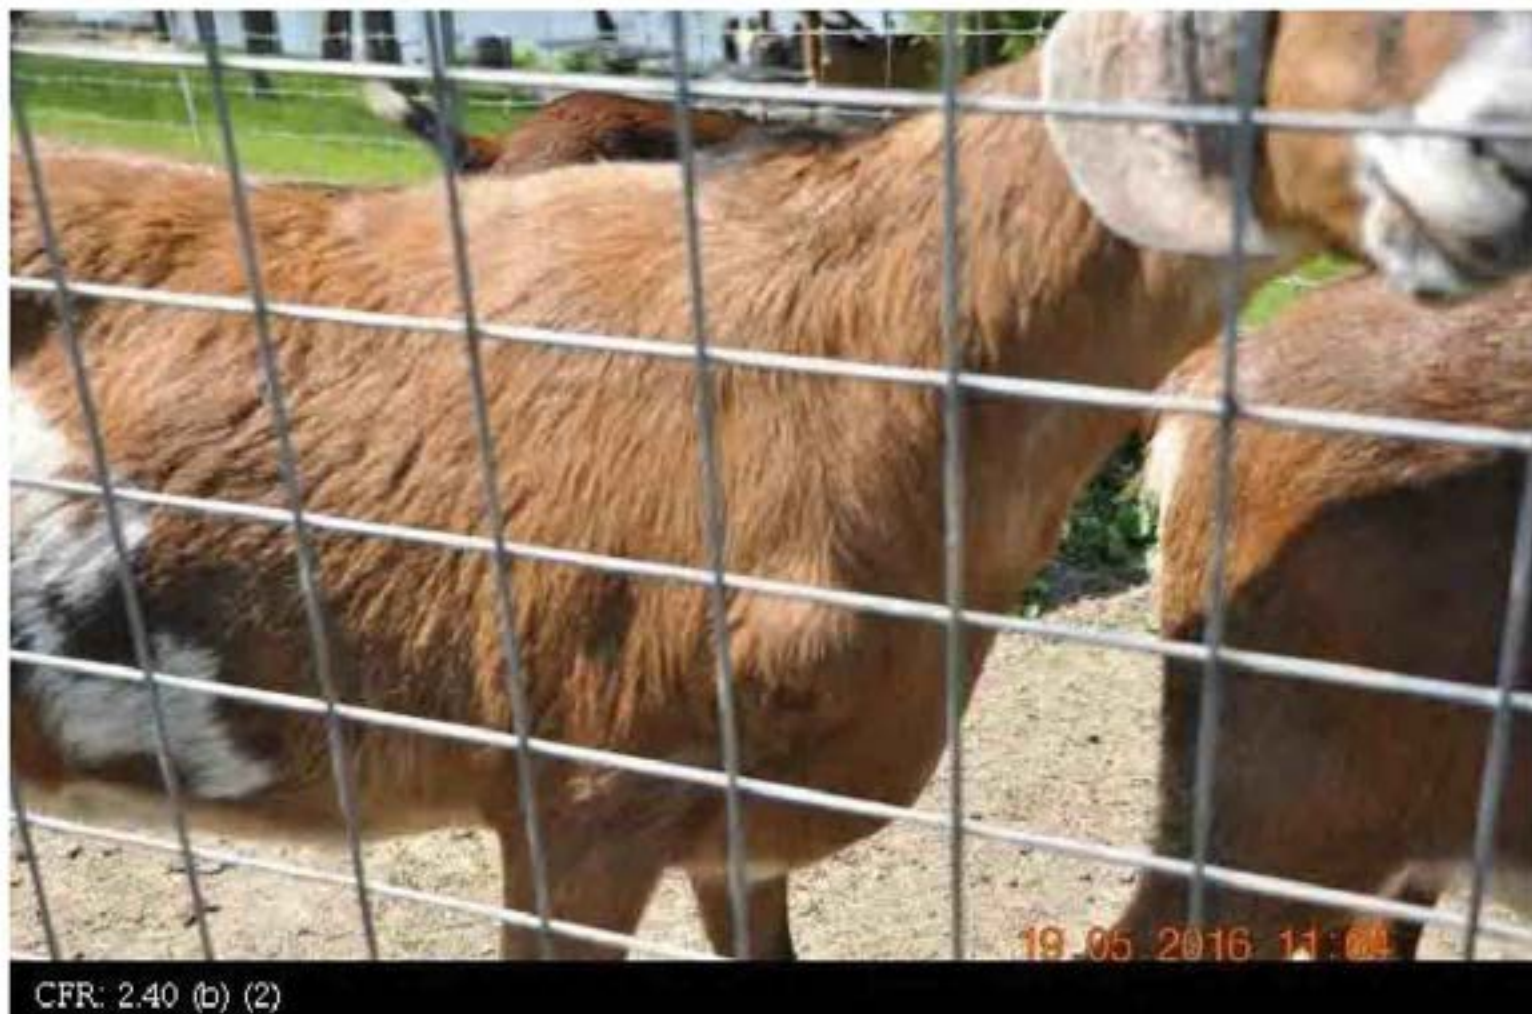
Photographer:	K. Campitelli	Legal Name:	55-B-0069
Photo Taken:	Thu, May 19, '16 10:30	HENRY HAMPTON	
Inspection:	141161055040796		
Description:	Close-up of lump on goat's right shoulder

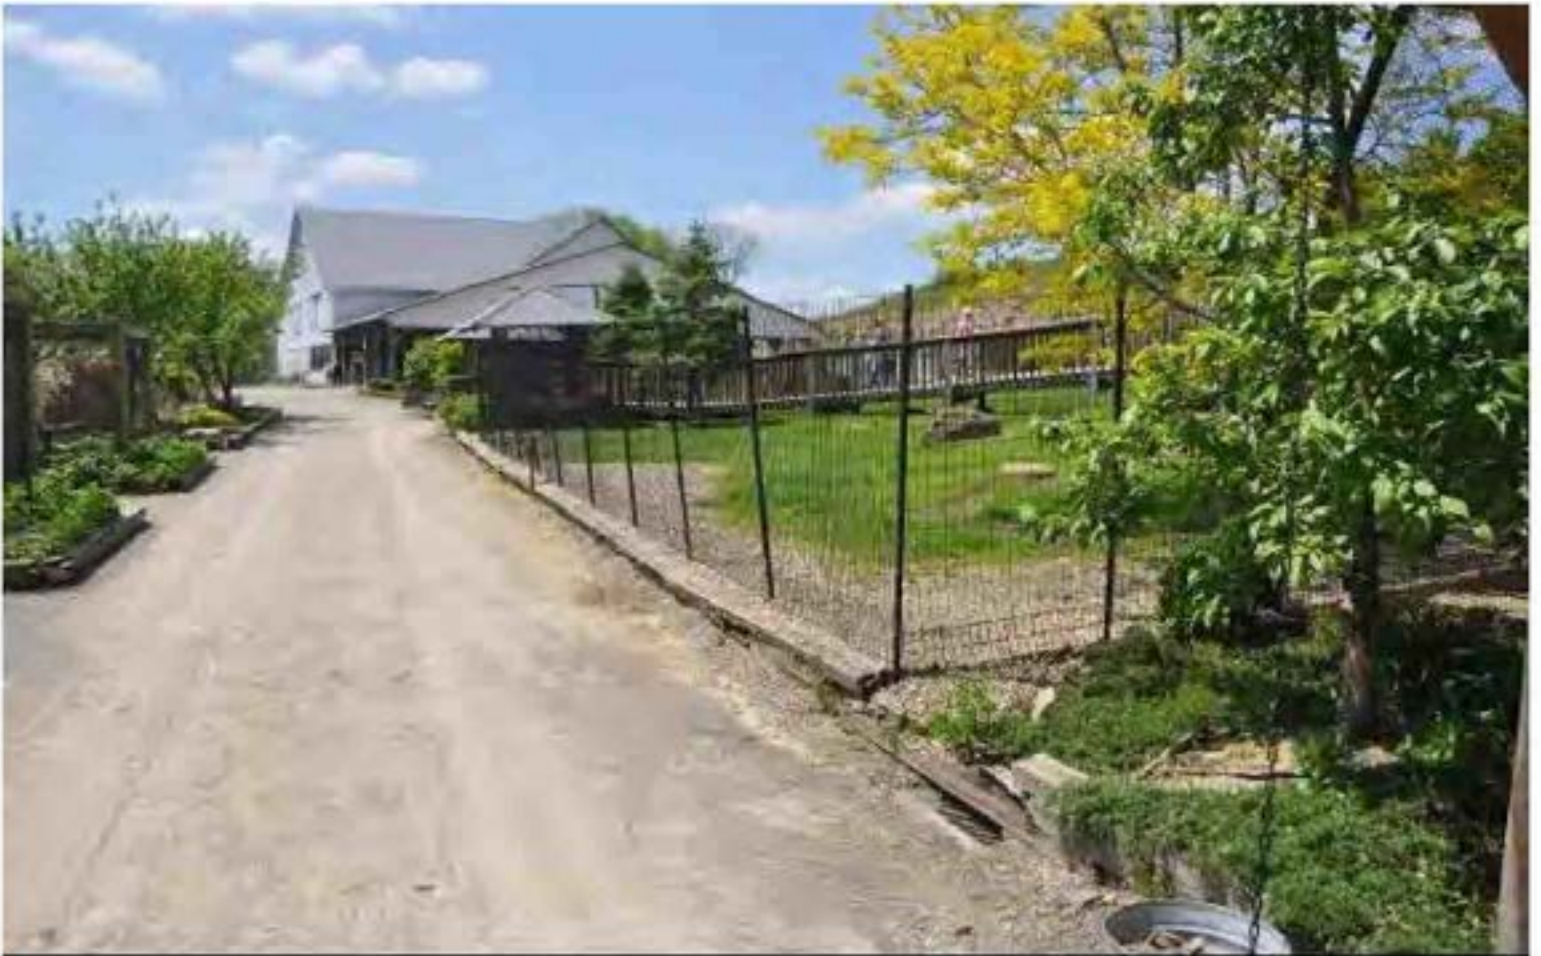
CFR: 2.131 (c) (1)

Photographer:	Randy Coleman	Legal Name:	55-B-0069
Photo Taken:	Thu, May 19, '16 1030	HENRY HAMPTON	
Inspection:	141161055040796		
Description:	Section 2.131: Areas of public contact with animals without barriers or attendants.

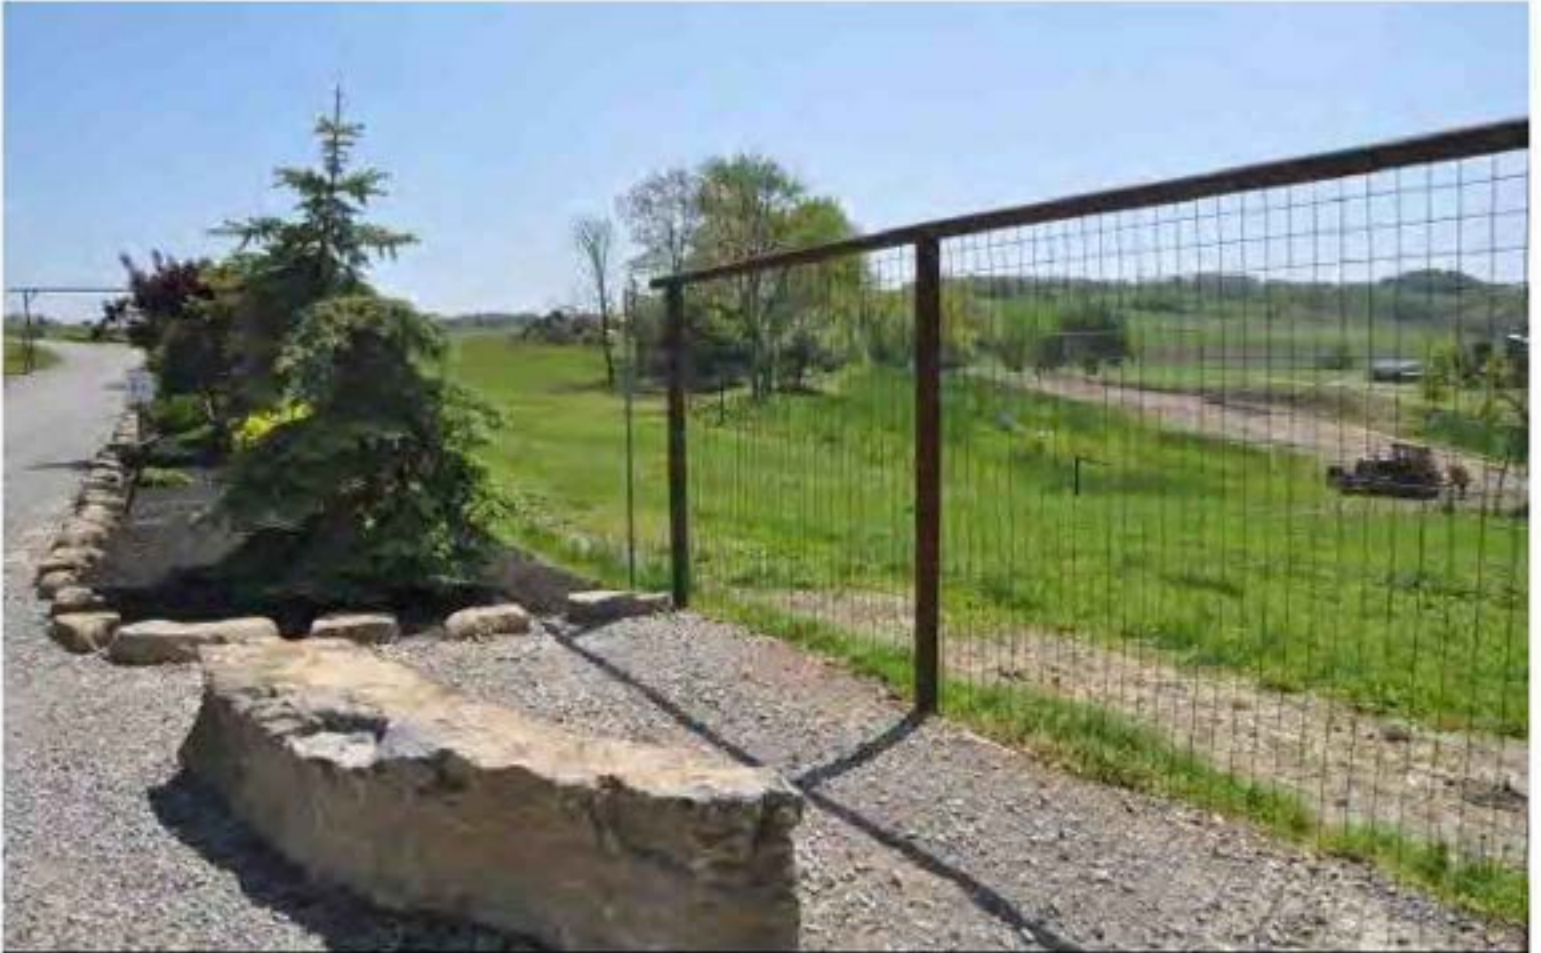
CFR: 2.131 (c) (1)

Photographer:	Randy Coleman	Legal Name:	55-B-0069
Photo Taken:	Thu, May 19, '16 1030	HENRY HAMPTON	
Inspection:	141161055040796		
Description:	Section 2.131: Areas of public contact with animals without barriers or attendants.
