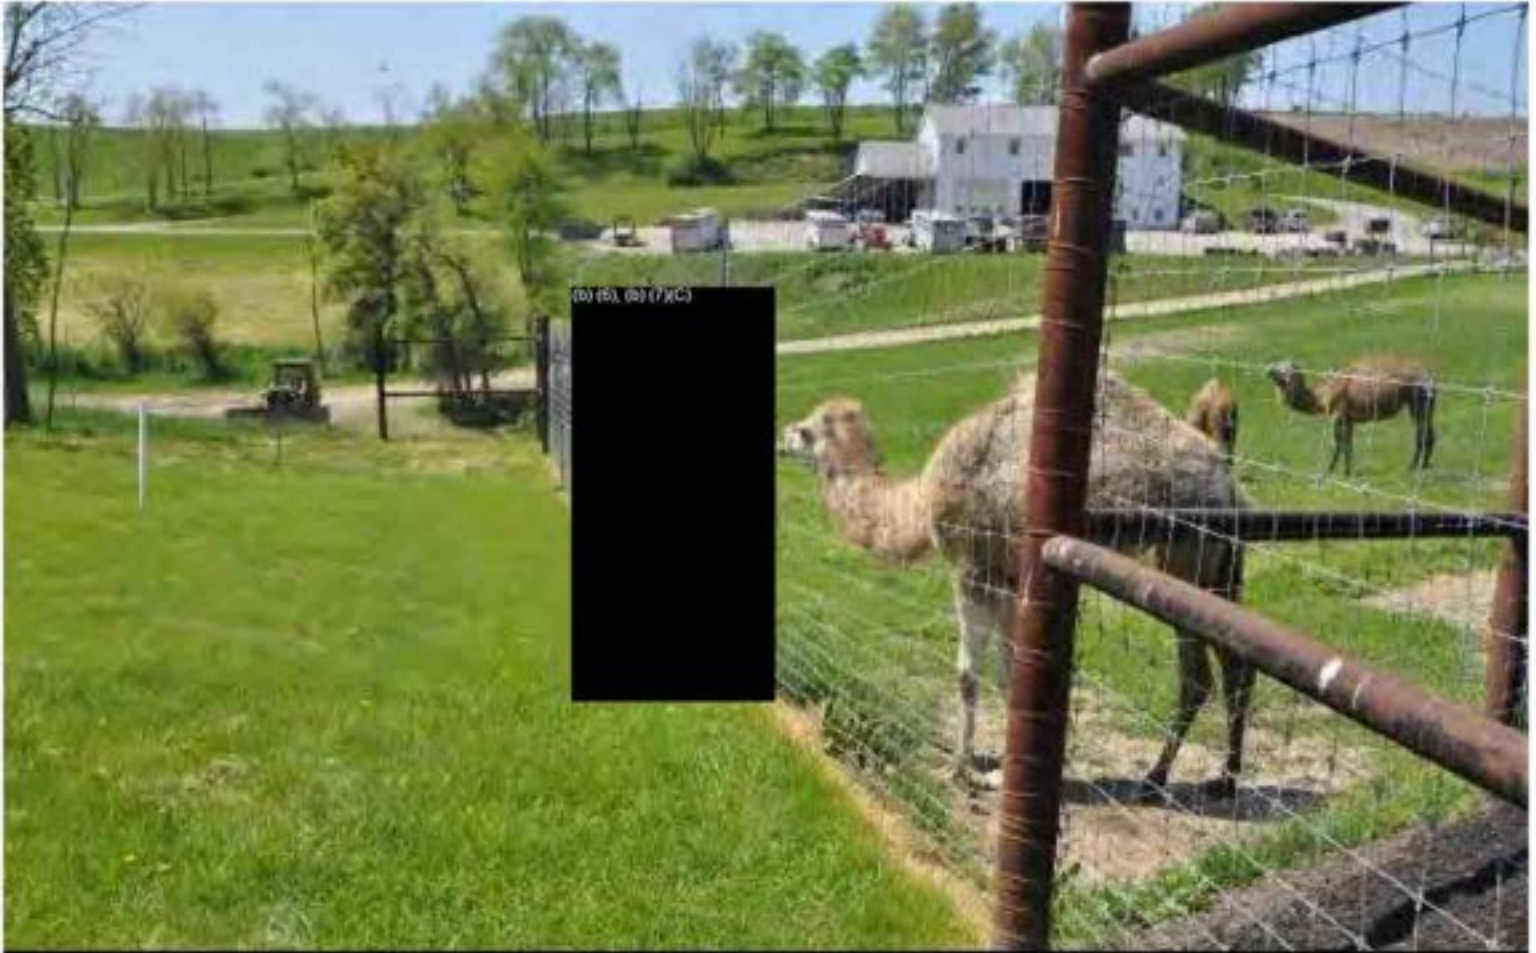
CFR: 2.131 (c) (1)

Photographer:	Randy Coleman	Legal Name:	55-B-0069
Photo Taken:	Thu, May 19, '16 1030	HENRY HAMPTON	
Inspection:	141161055040796		
Description:	Section 2.131: Areas of public contact with animals without barriers or attendants.

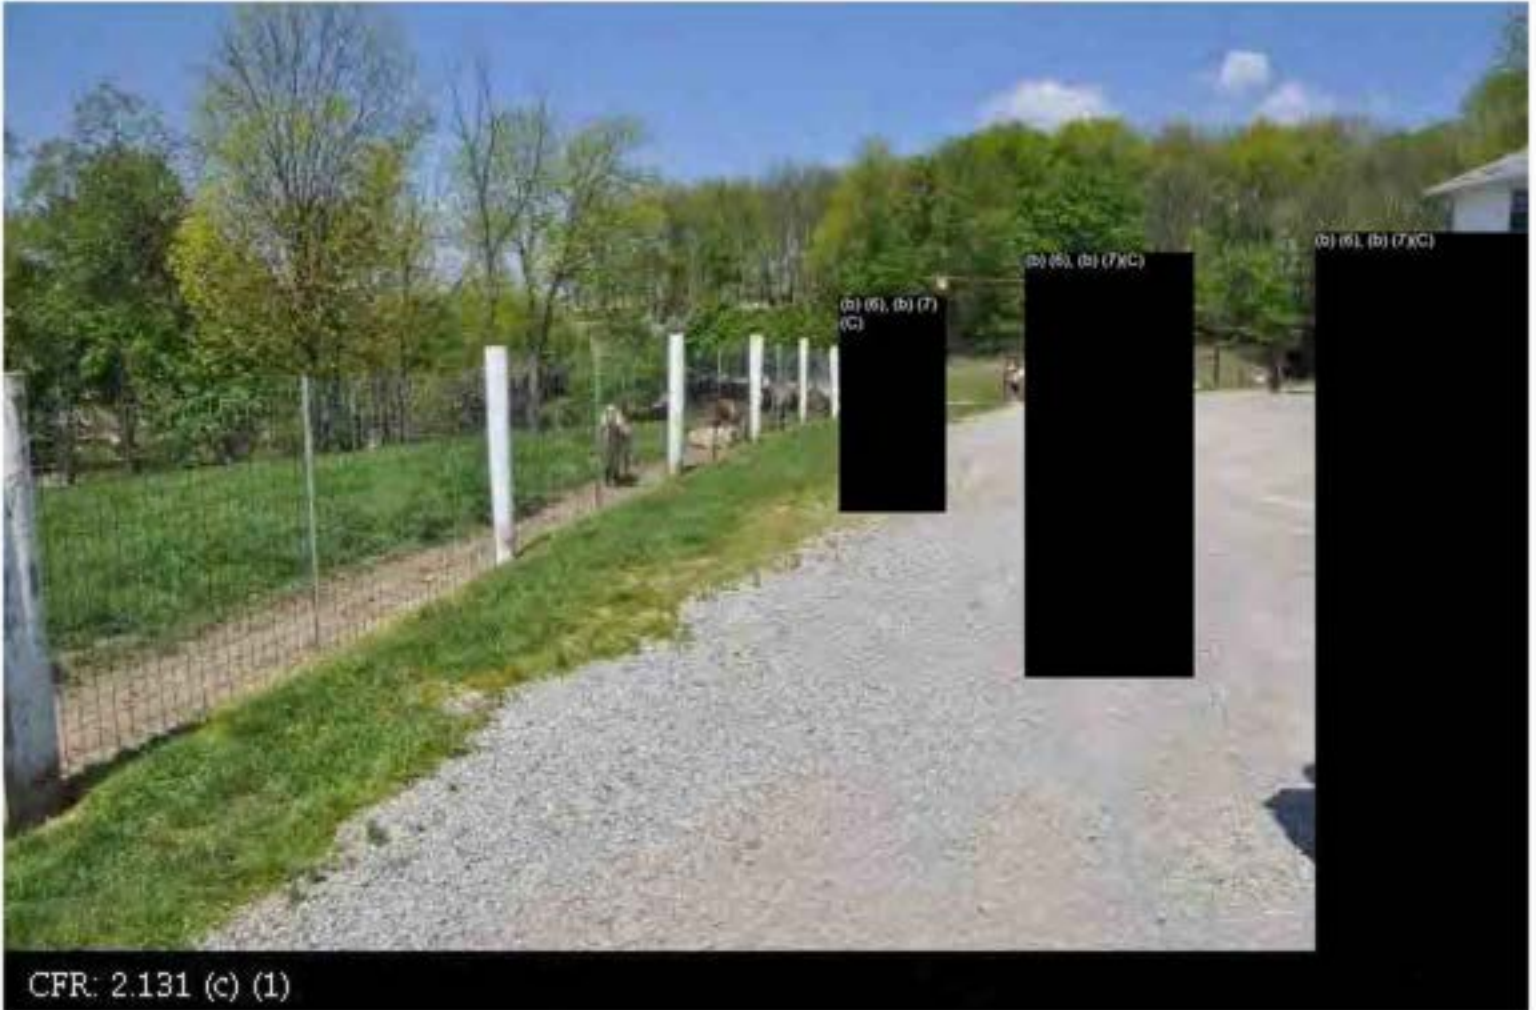
Photographer:	Randy Coleman	Legal Name:	55-B-0069
Photo Taken:	Thu, May 19, '16 1030	HENRY HAMPTON	
Inspection:	141161055040796		
Description:	Section 2.131: Areas of public contact with animals without barriers or attendants.

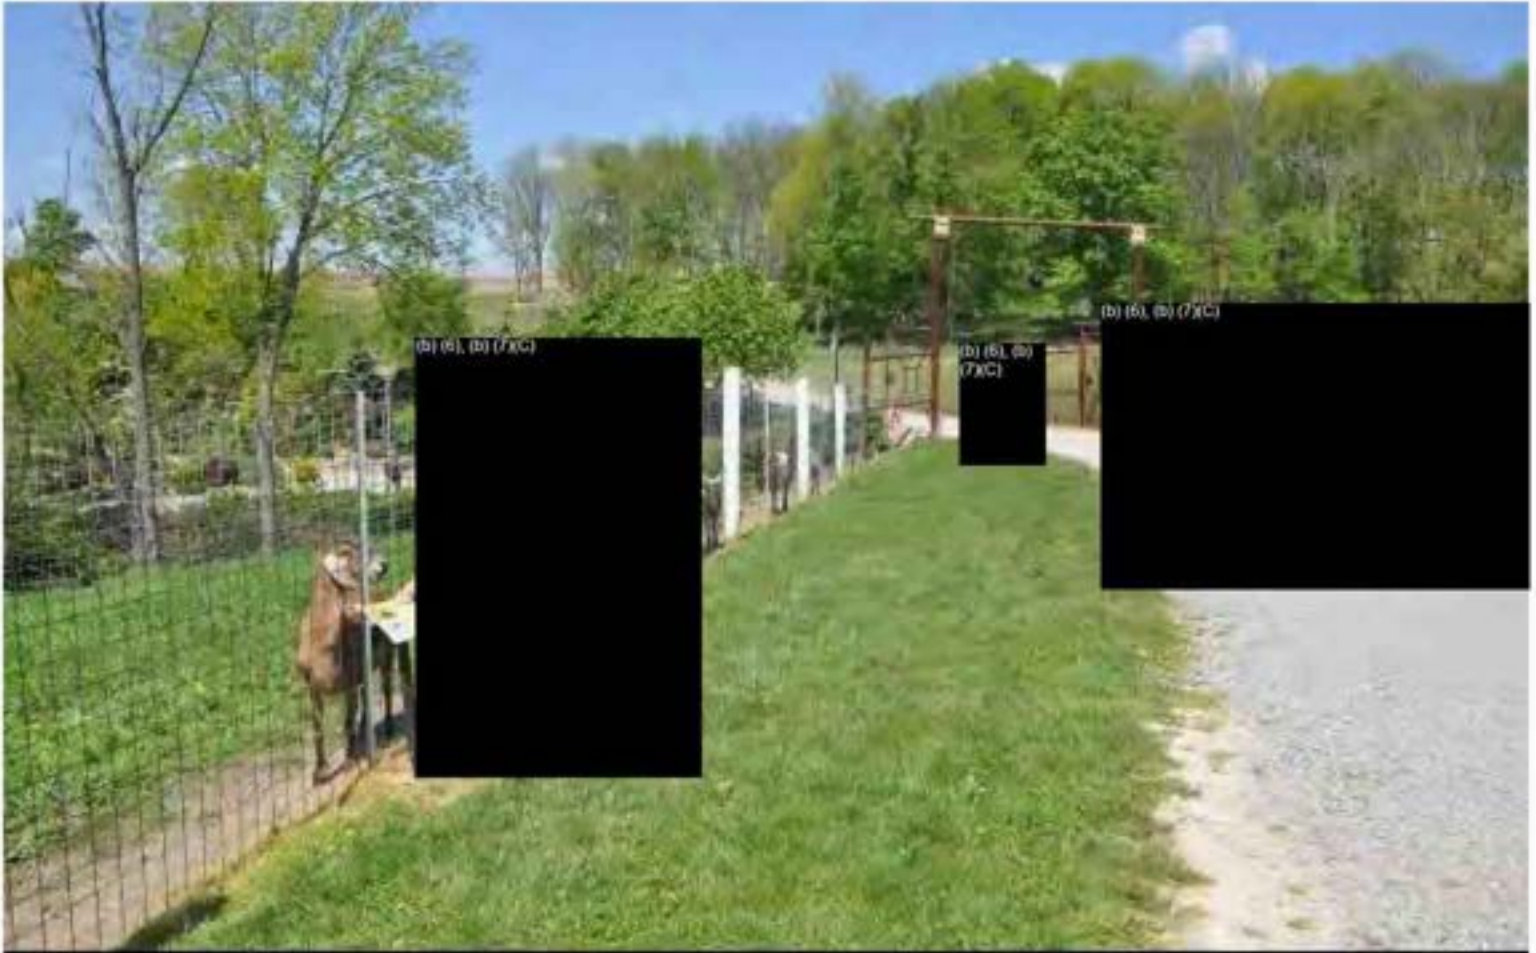
CFR: 2.131 (c) (1)

Photographer:	Randy Coleman	Legal Name:	55-B-0069
Photo Taken:	Thu, May 19, '16 1030	HENRY HAMPTON	
Inspection:	141161055040796		
Description:	Section 2.131: Areas of public contact with animals without barriers or attendants.

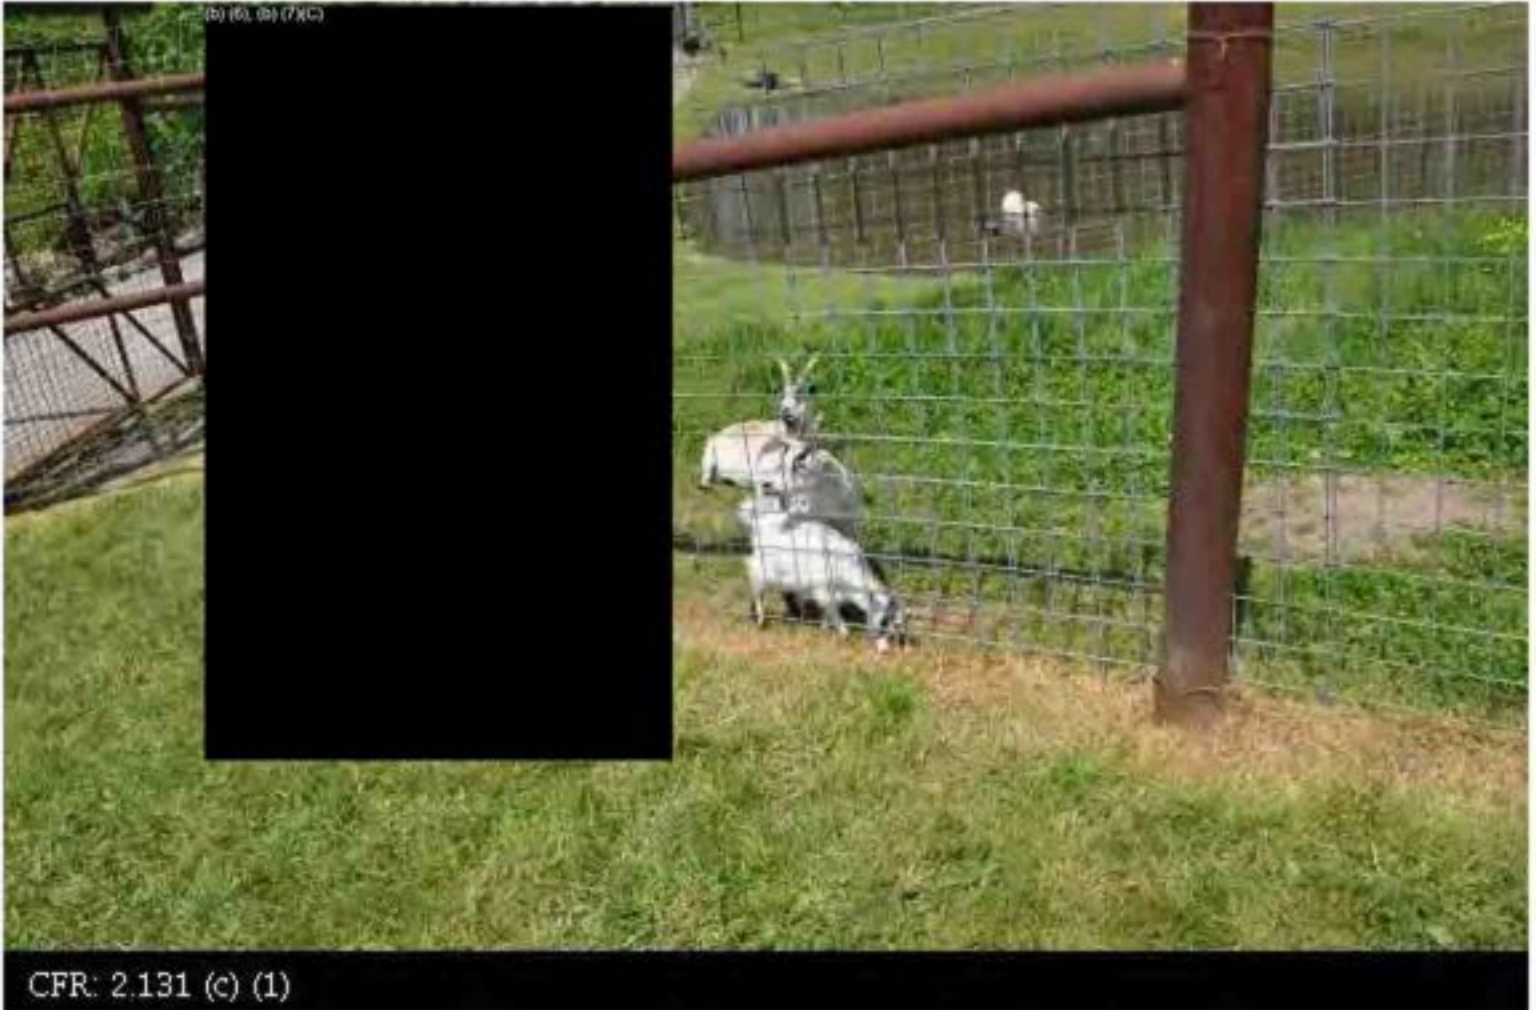
Photographer:	Randy Coleman	Legal Name:	55-B-0069
Photo Taken:	Thu, May 19, '16 1030	HENRY HAMPTON	
Inspection:	141161055040796		
Description:	Section 2.131: Areas of public contact with animals without barriers or attendants.

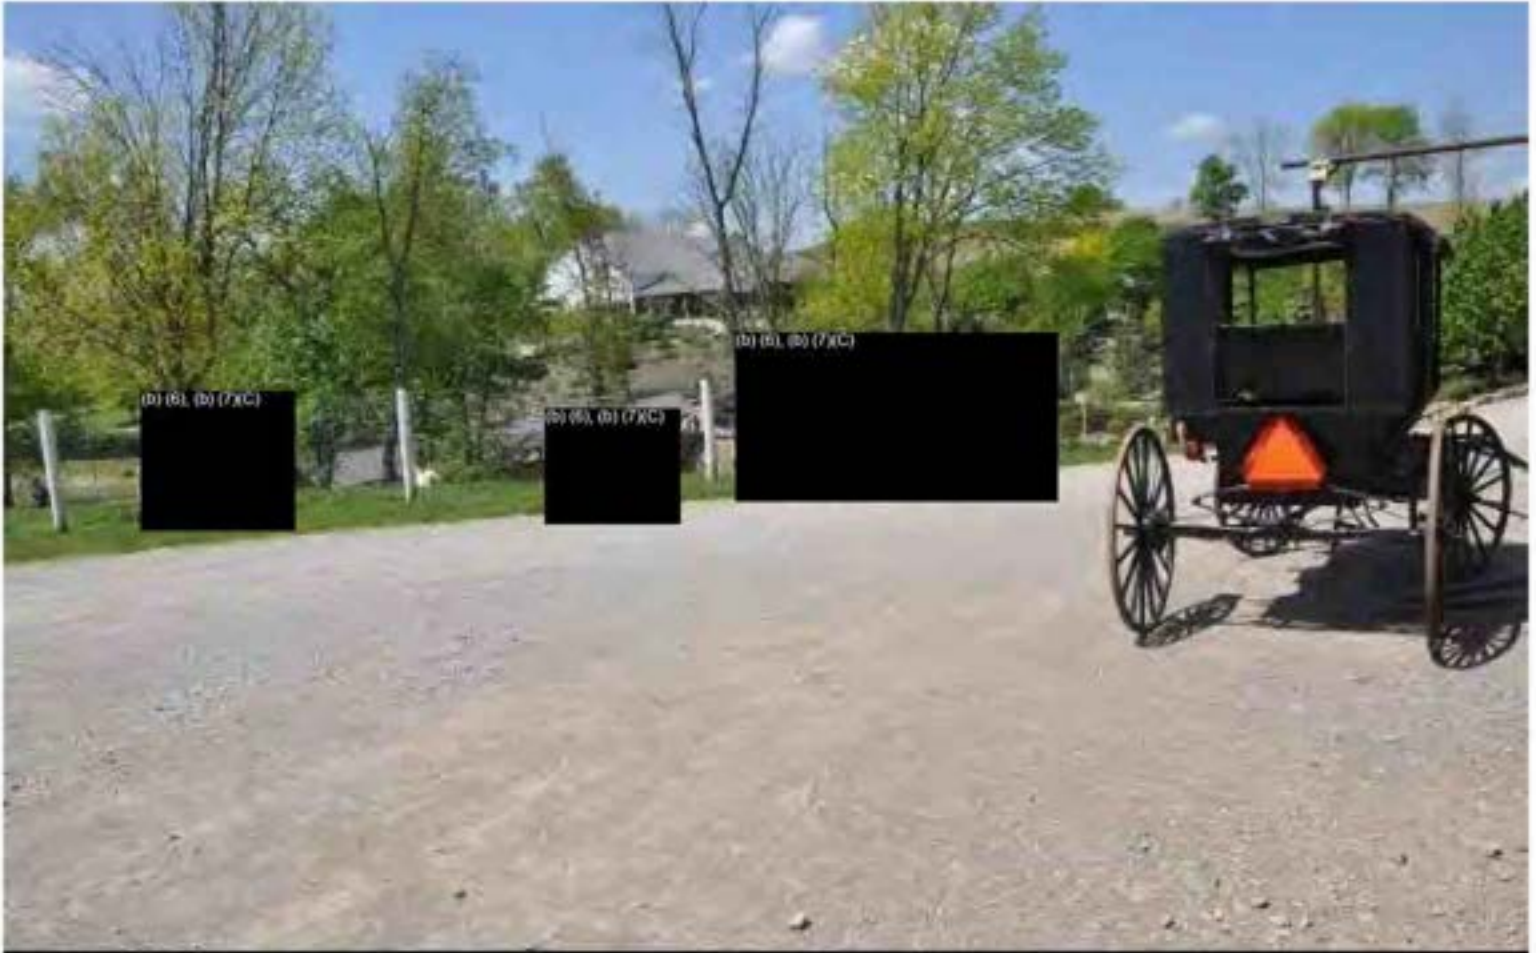
CFR: 2.131 (c) (1)

Photographer:	Randy Coleman	Legal Name:	55-B-0069
Photo Taken:	Thu, May 19, '16 1030	HENRY HAMPTON	
Inspection:	141161055040796		
Description:	Section 2.131: Areas of public contact with animals without barriers or attendants.

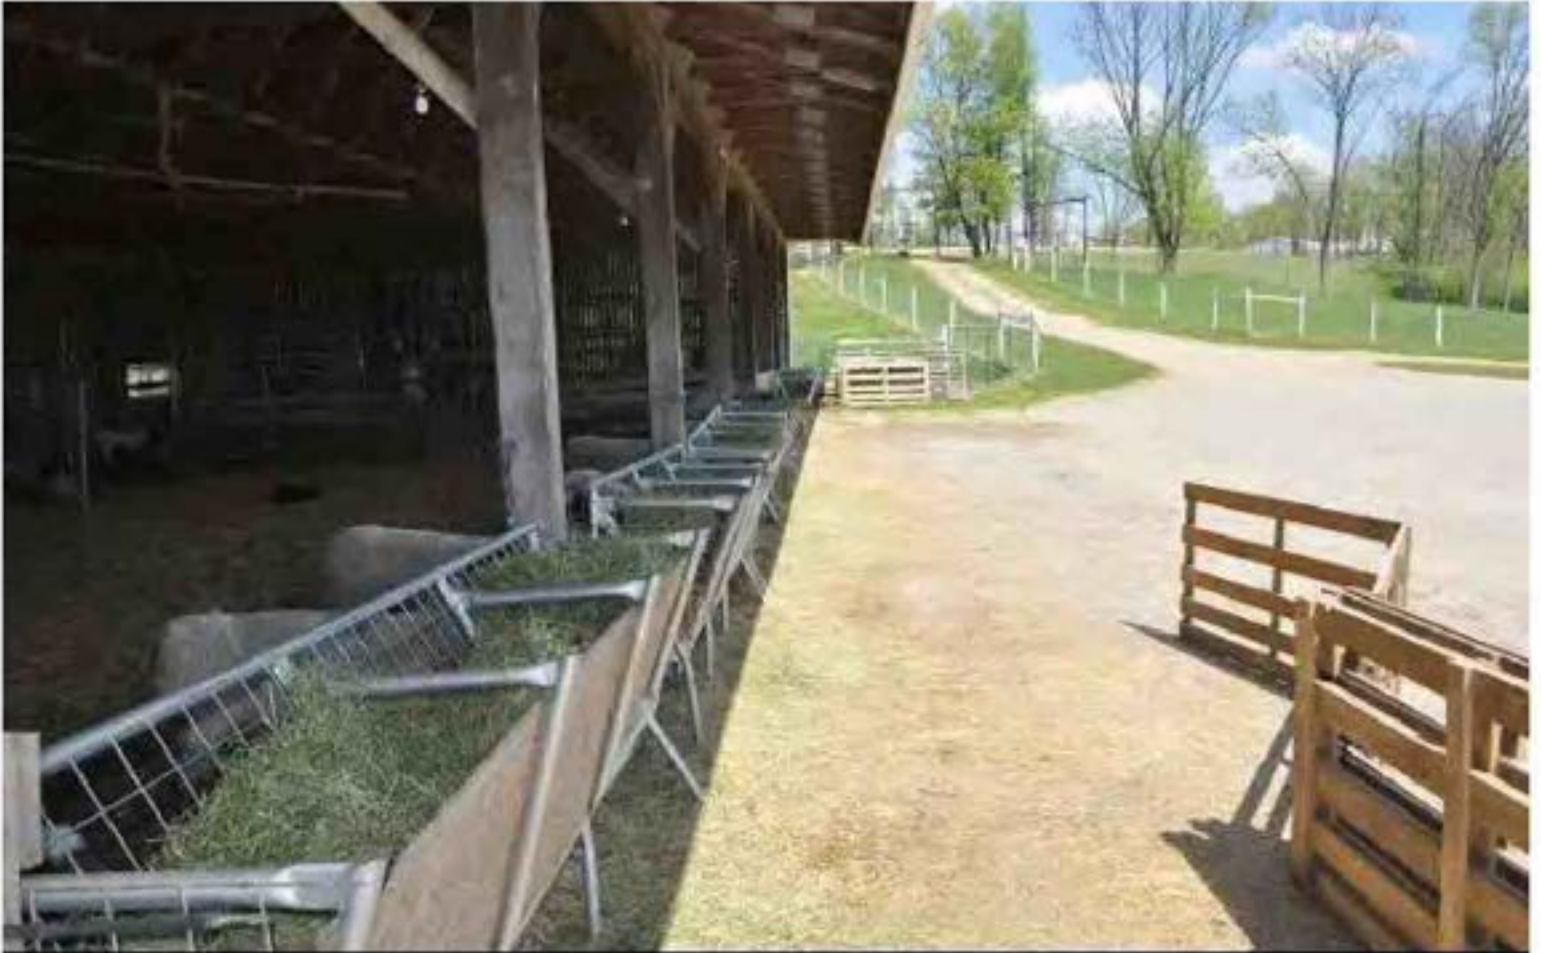
CFR: 2.131 (c) (1)

Photographer:	Randy Coleman	Legal Name:	55-B-0069
Photo Taken:	Thu, May 19, '16 1030	HENRY HAMPTON	
Inspection:	141161055040796		
Description:	Section 2.131: Areas of public contact with animals without barriers or attendants.

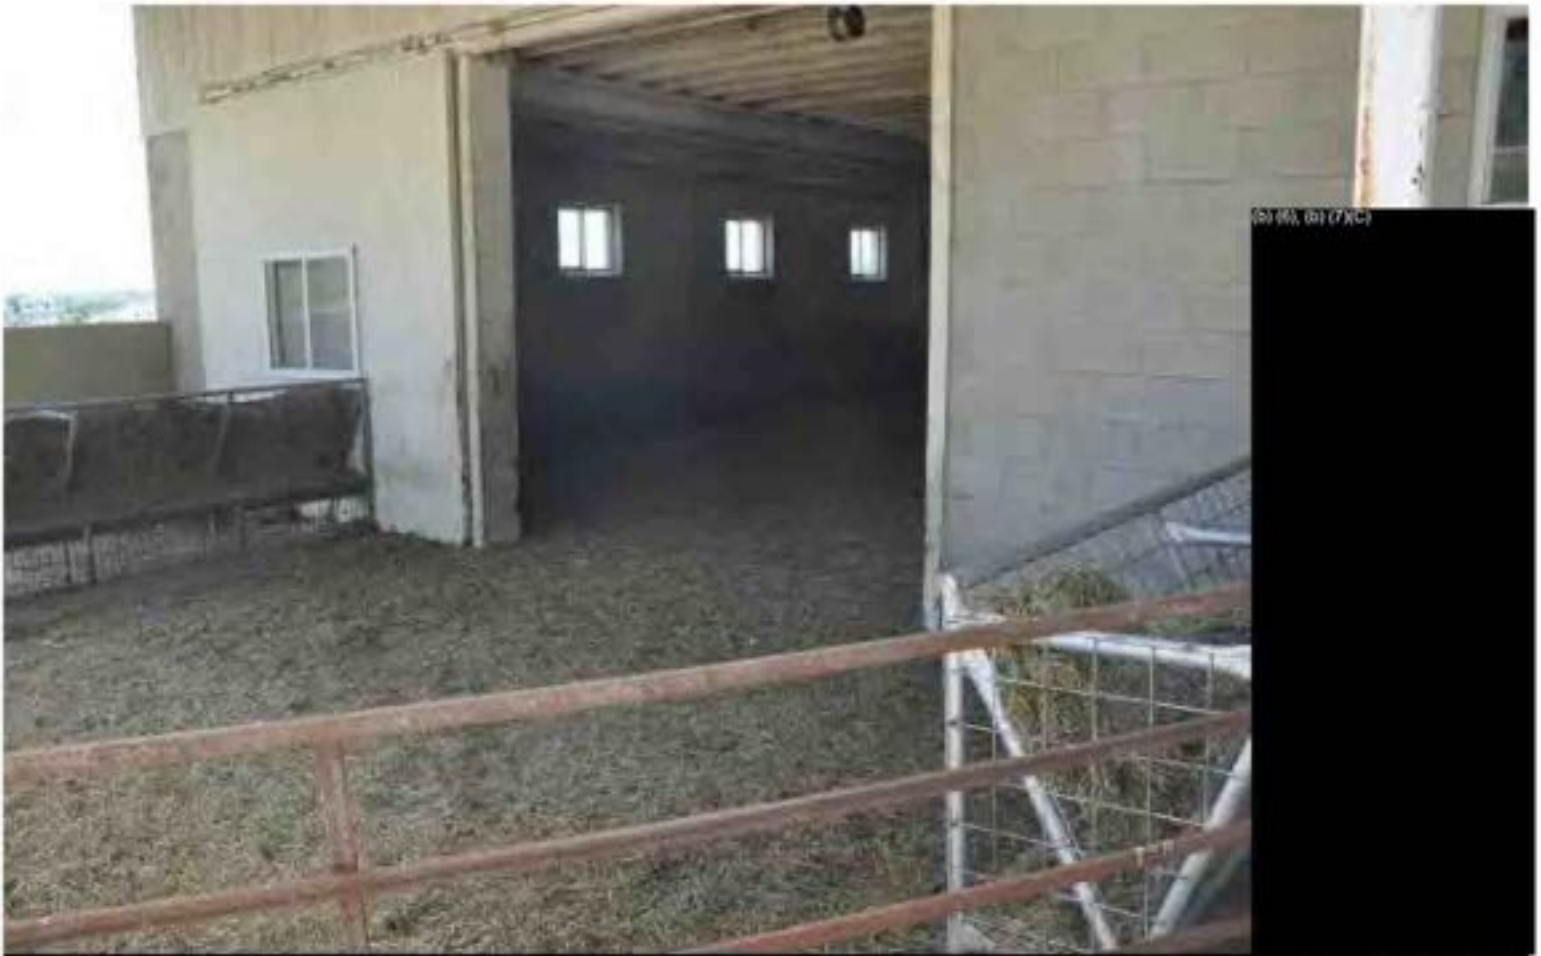
CFR: 2.131 (c) (1)

Photographer:	Randy Coleman	Legal Name:	55-B-0069
Photo Taken:	Thu, May 19, '16 1030	HENRY HAMPTON	
Inspection:	141161055040796		
Description:	Section 2.131: Areas of public contact with animals without barriers or attendants.

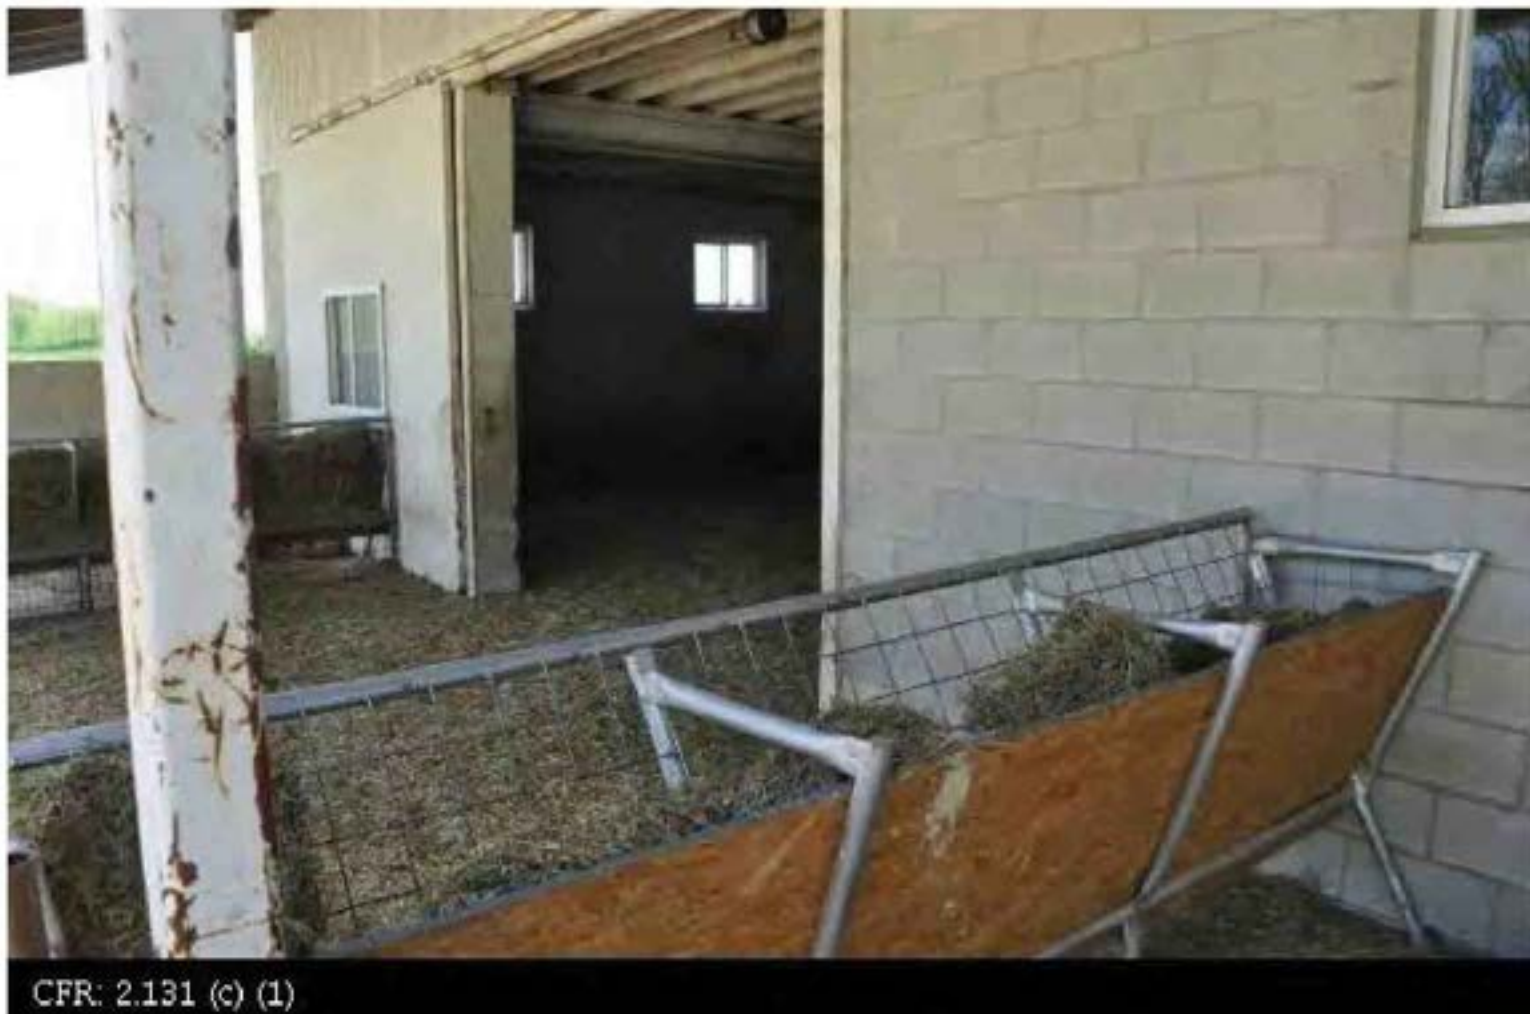
Photographer:	Randy Coleman	Legal Name:	55-B-0069
Photo Taken:	Thu, May 19, '16 1030	HENRY HAMPTON	
Inspection:	141161055040796		
Description:	Section 2.131: Areas of public contact with animals without barriers or attendants.

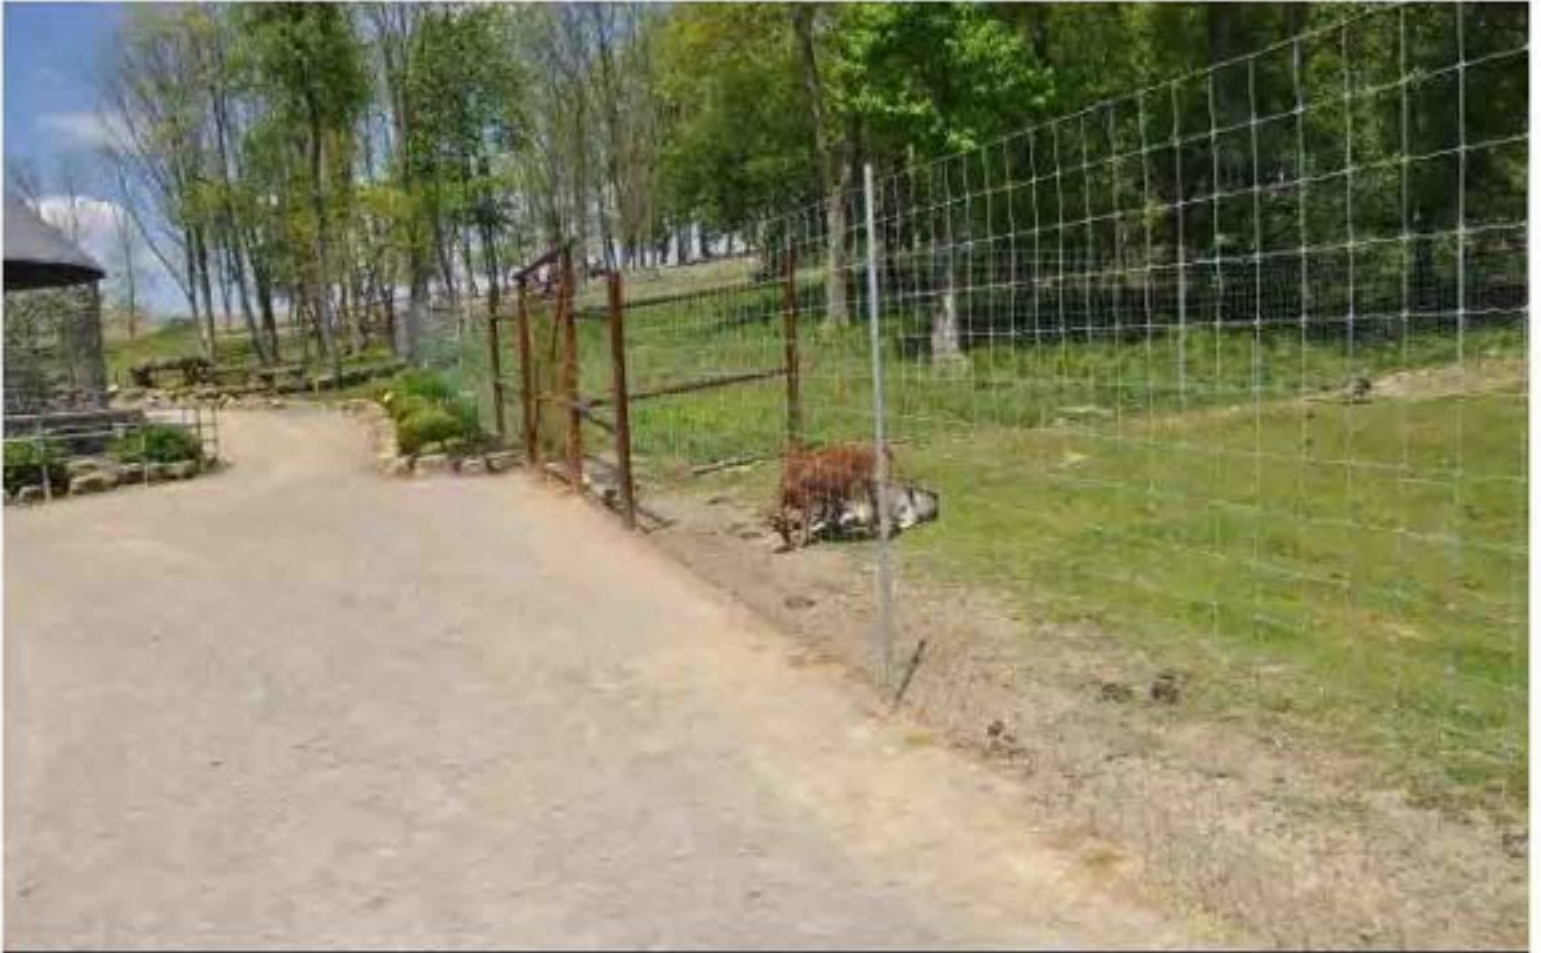
CFR: 2.131 (c) (1)

Photographer:	Randy Coleman	Legal Name:	55-B-0069
Photo Taken:	Thu, May 19, '16 1030	HENRY HAMPTON	
Inspection:	141161055040796		
Description:	Section 2.131: Areas of public contact with animals without barriers or attendants.

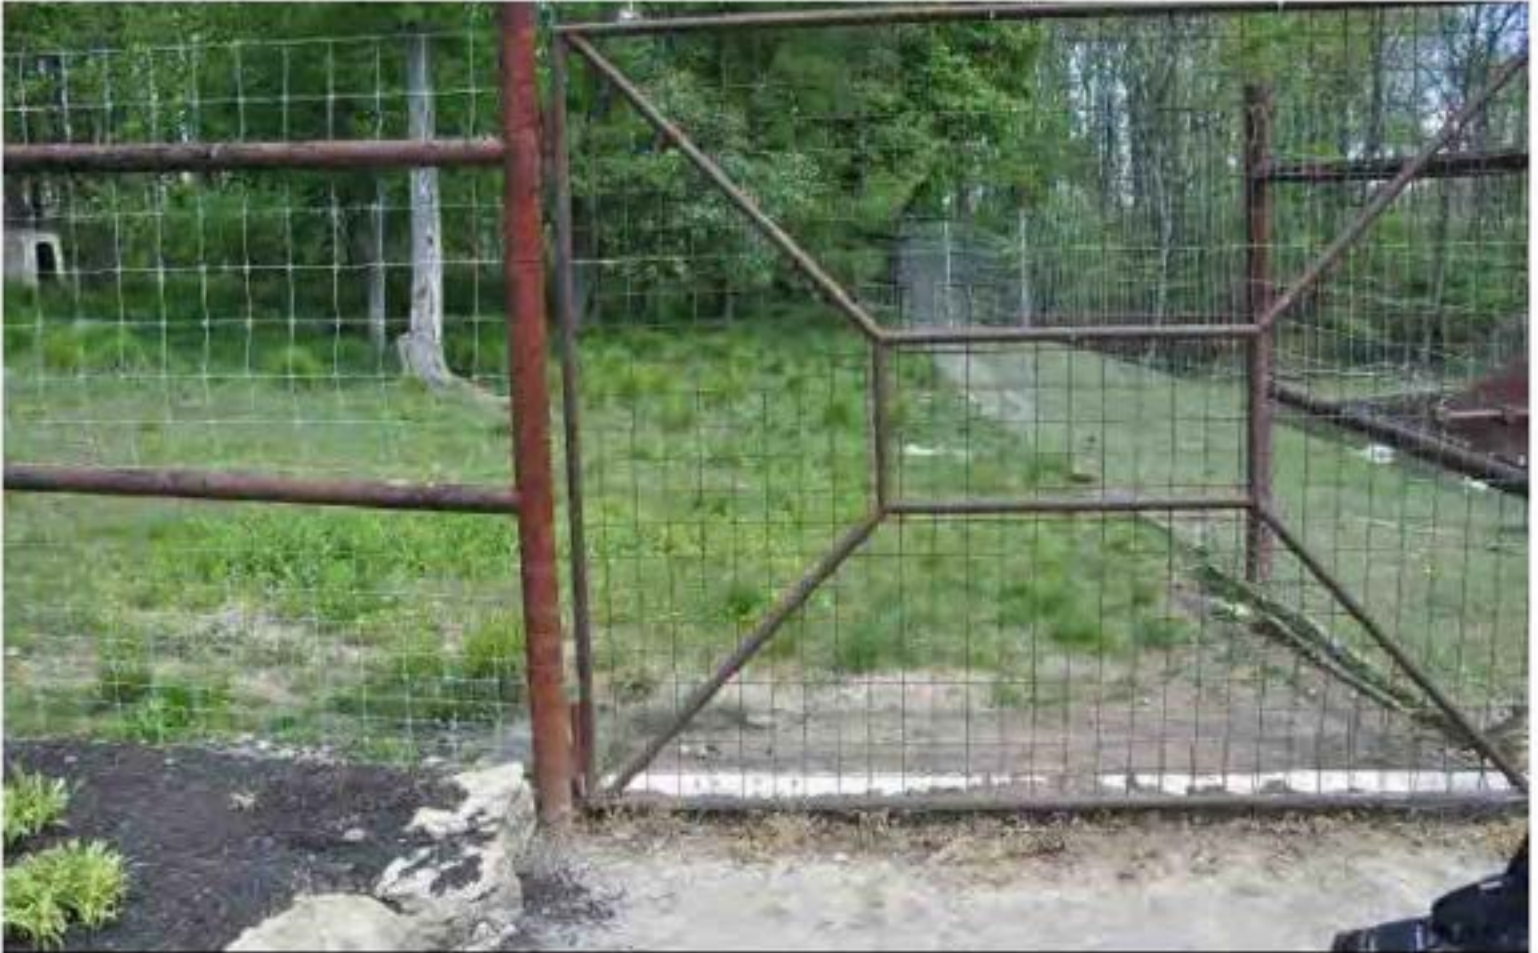
CFR: 2.131 (c) (1)

Photographer:	Randy Coleman	Legal Name:	55-B-0069
Photo Taken:	Thu, May 19, '16 1030	HENRY HAMPTON	
Inspection:	141161055040796		
Description:	Section 2.131: Areas of public contact with animals without barriers or attendants.

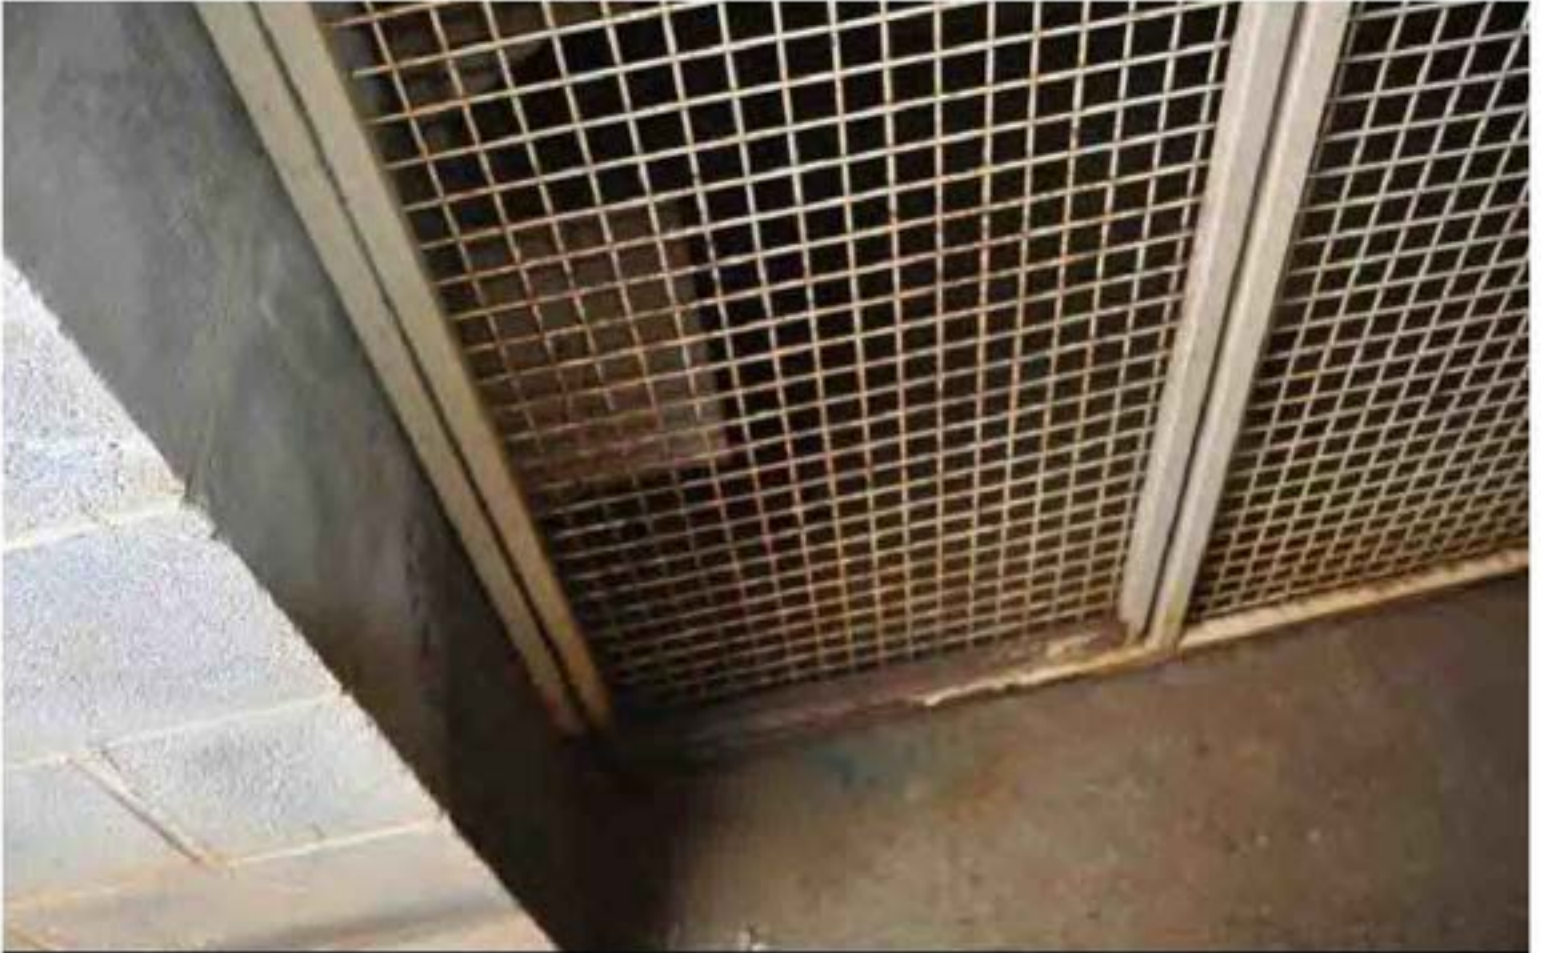
CFR: 3.75 (c) (1) (i)

Photographer:	Randy Coleman	Legal Name:	55-B-0069
Photo Taken:	Wed, May 25, '16	HENRY HAMPTON	
Inspection:	147160841480226		
Description:	Section 3.75(c)(1): Rusty bars of indoor lemur enclosure on lower lemur island.

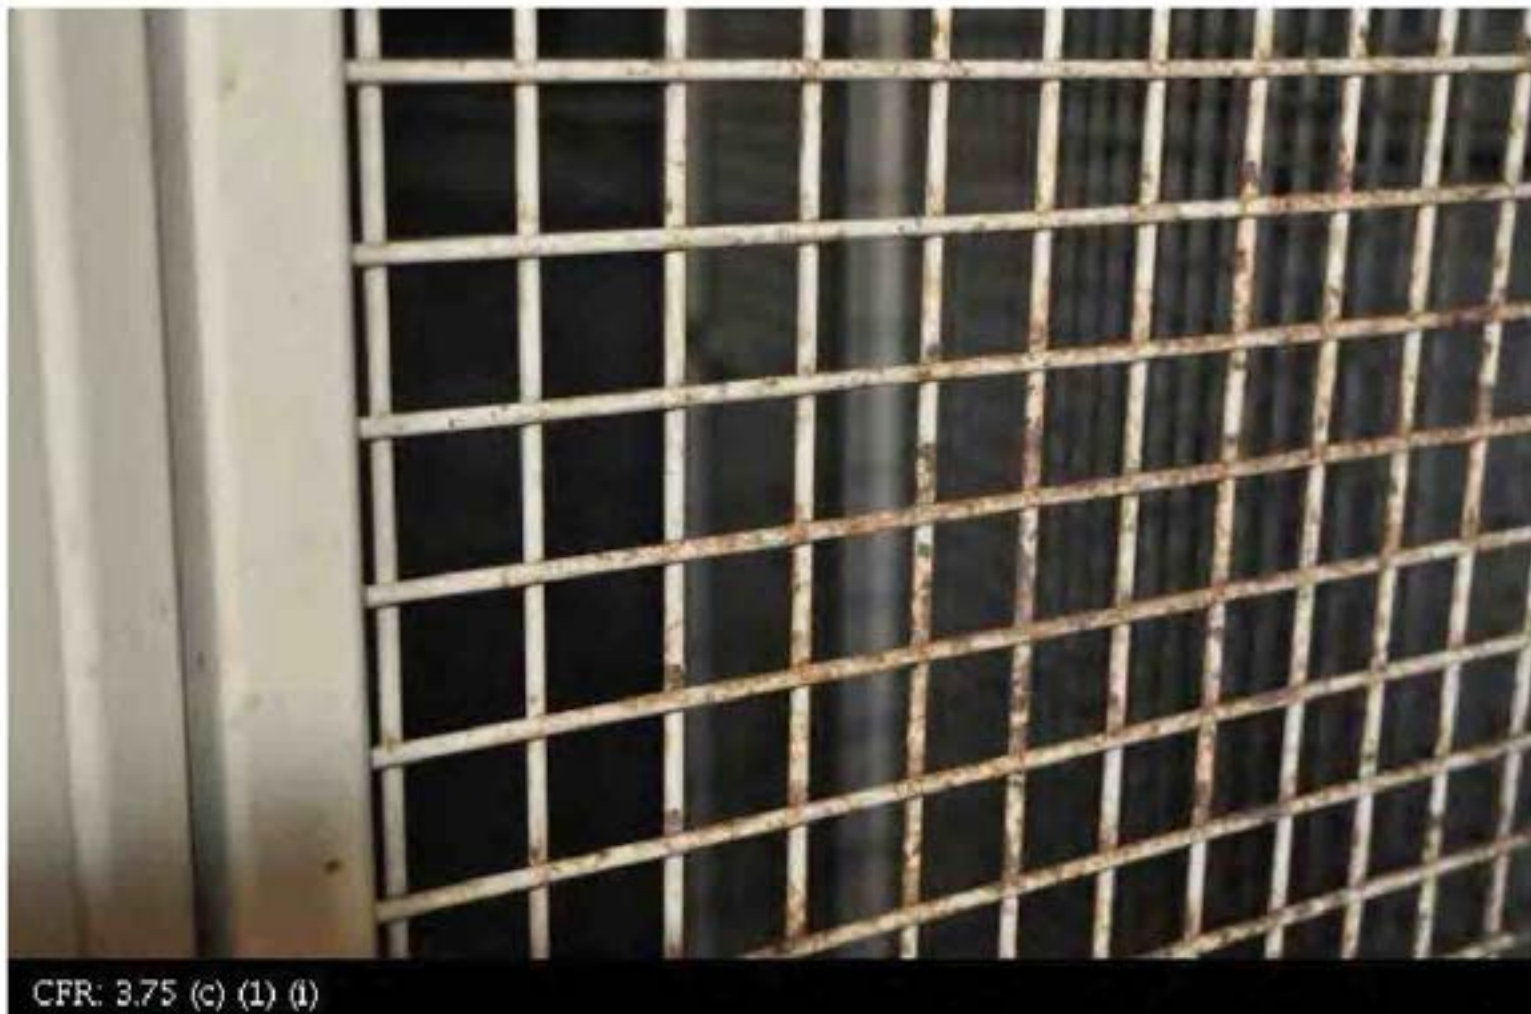
CFR: 3.75 (c) (1) (i)

Photographer:	Randy Coleman	Legal Name:	55-B-0069
Photo Taken:	Wed, May 25, '16	HENRY HAMPTON	
Inspection:	147160841480226		
Description:	Section 3.75(c)(1): Rusty bars of indoor lemur enclosure on lower lemur island.

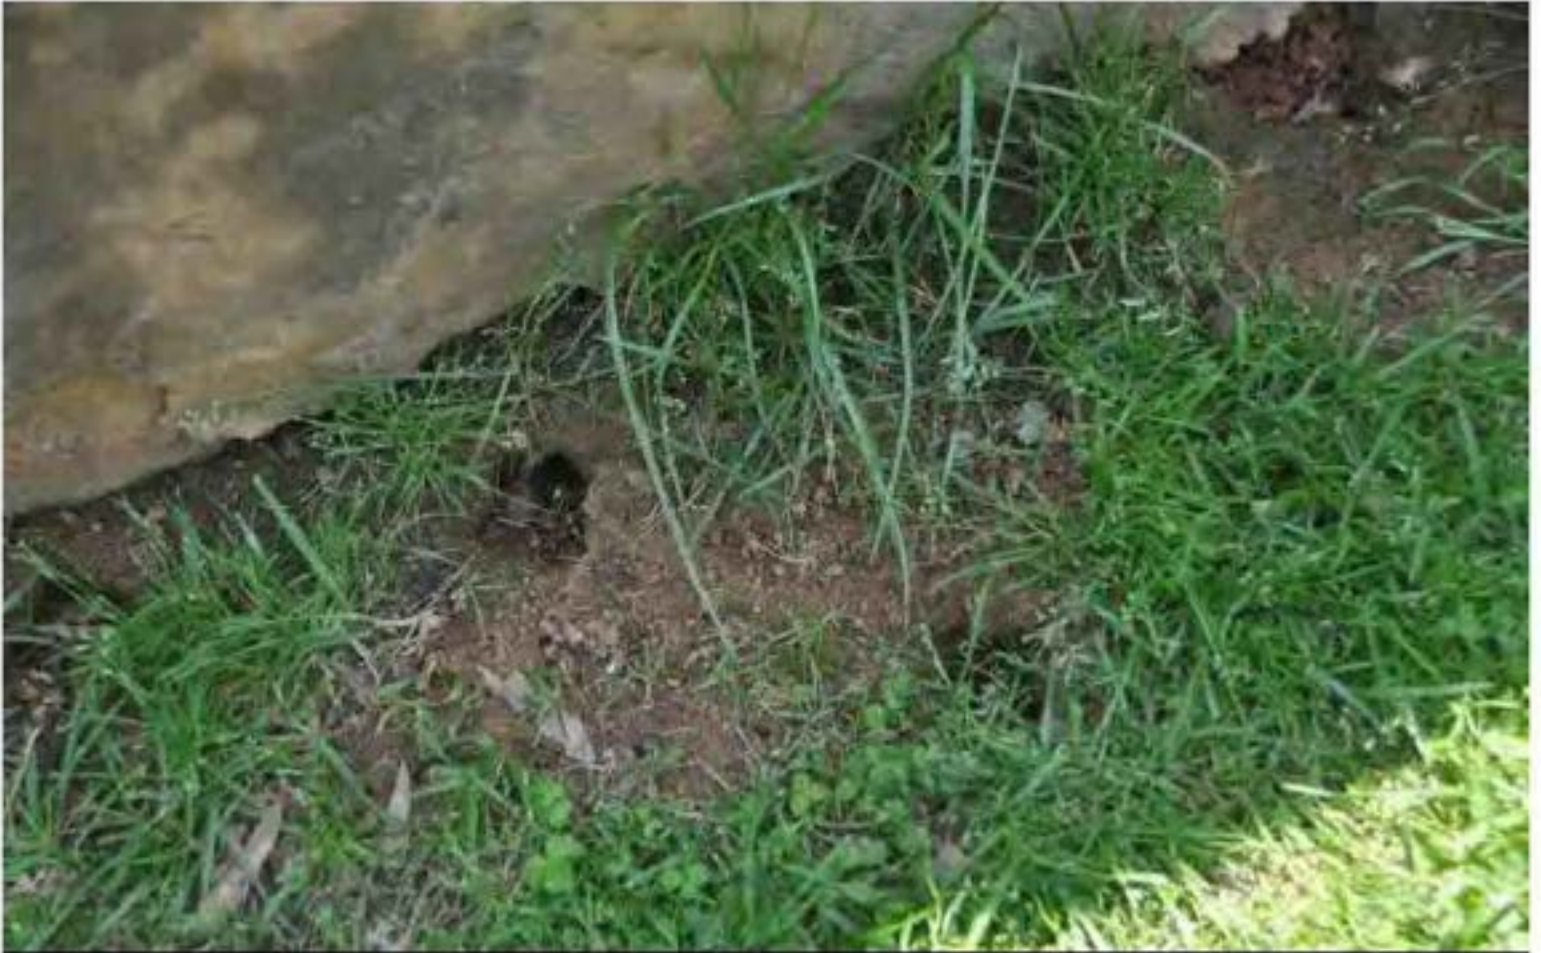
CFR: 3.84 (d)

Photographer:	Randy Coleman	Legal Name:	55-B-0069
Photo Taken:	Wed, May 25, '16	HENRY HAMPTON	
Inspection:	147160841480226		
Description:	Section 3.84(d): Rodent holes found on outside of exhibits on both lemur islands.

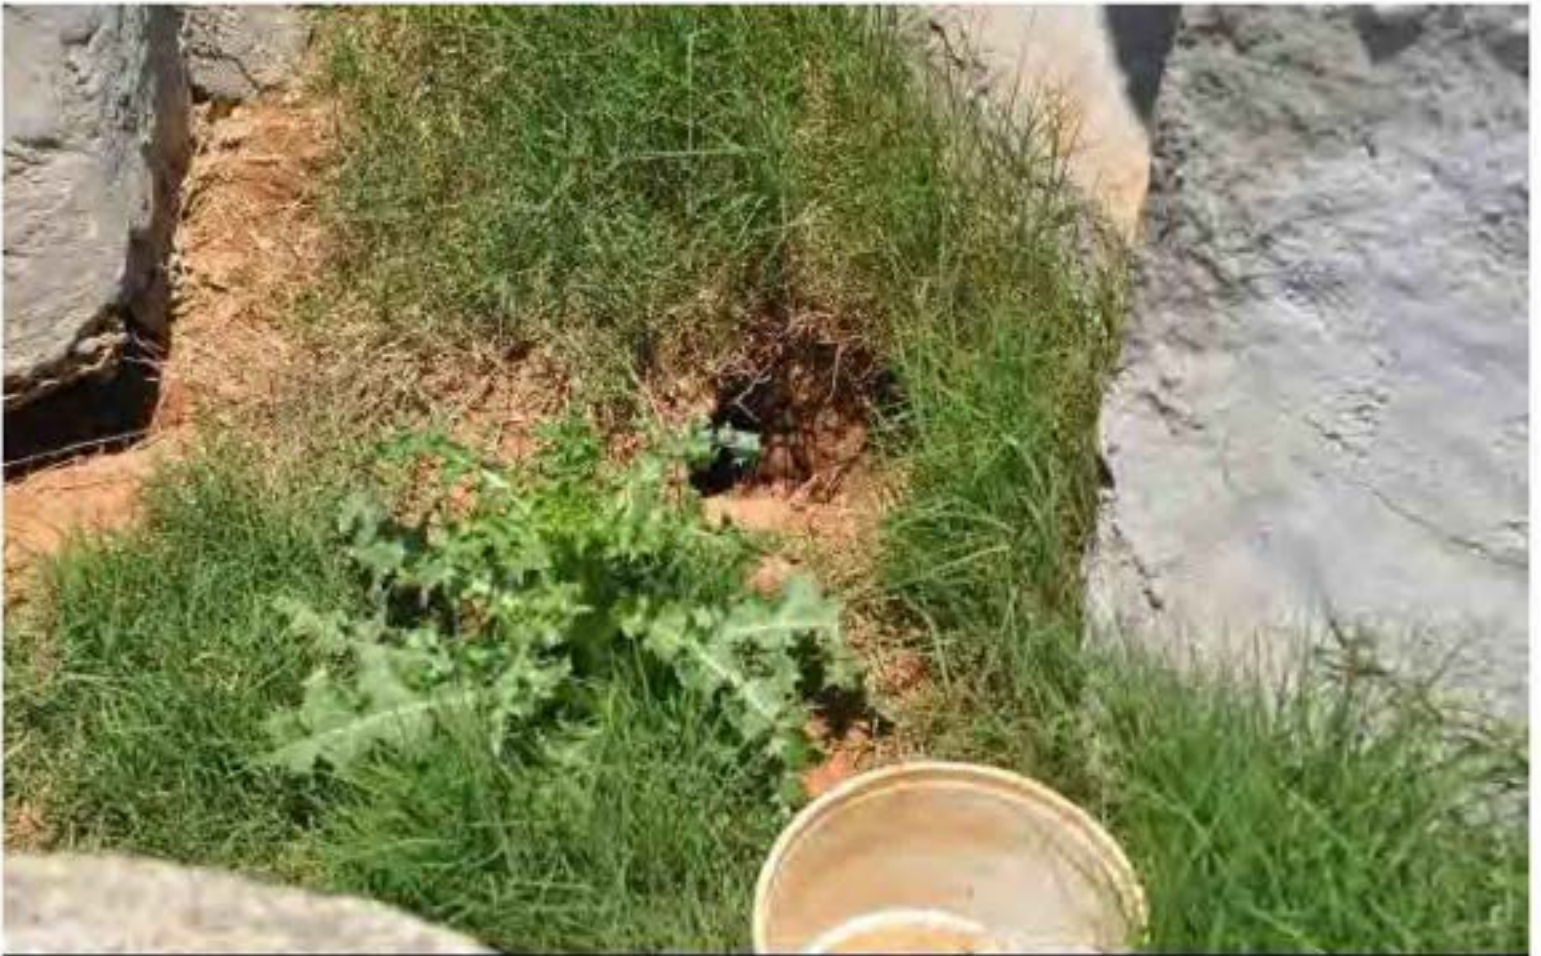
CFR: 3.84 (d)

Photographer:	Randy Coleman	Legal Name:	55-B-0069
Photo Taken:	Wed, May 25, '16	HENRY HAMPTON	
Inspection:	147160841480226		
Description:	Section 3.84(d): Rodent holes found on outside of exhibits on both lemur islands.

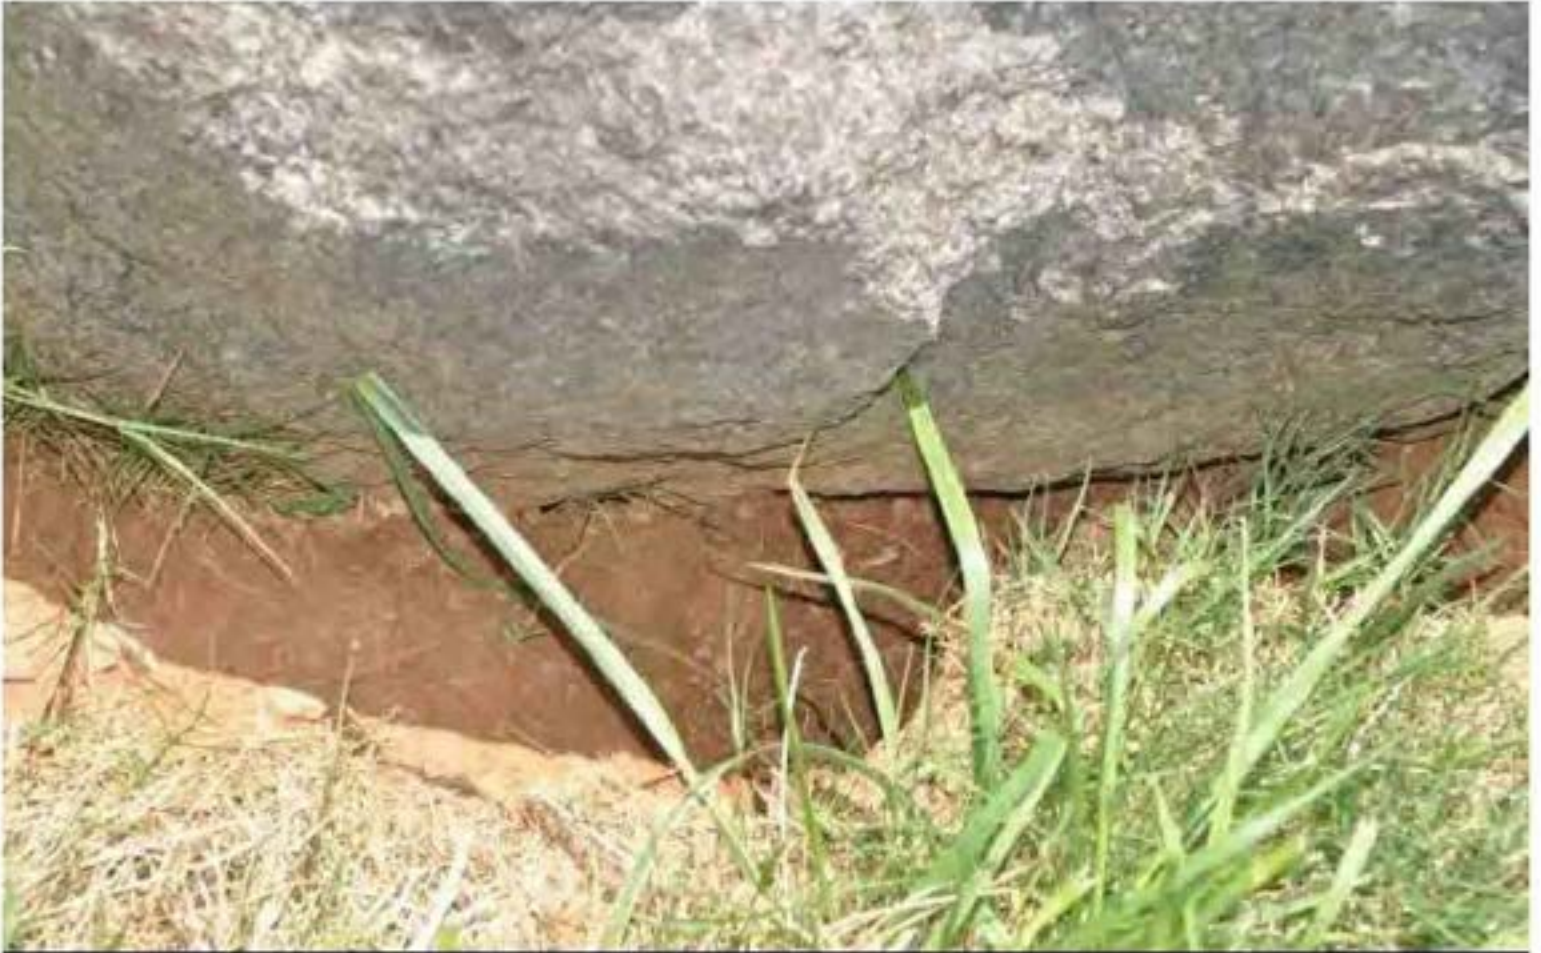
CFR: 3.84 (d)

Photographer:	Randy Coleman	Legal Name:	55-B-0069
Photo Taken:	Wed, May 25, '16	HENRY HAMPTON	
Inspection:	147160841480226		
Description:	Section 3.84(d): Rodent holes found on outside of exhibits on both lemur islands.
