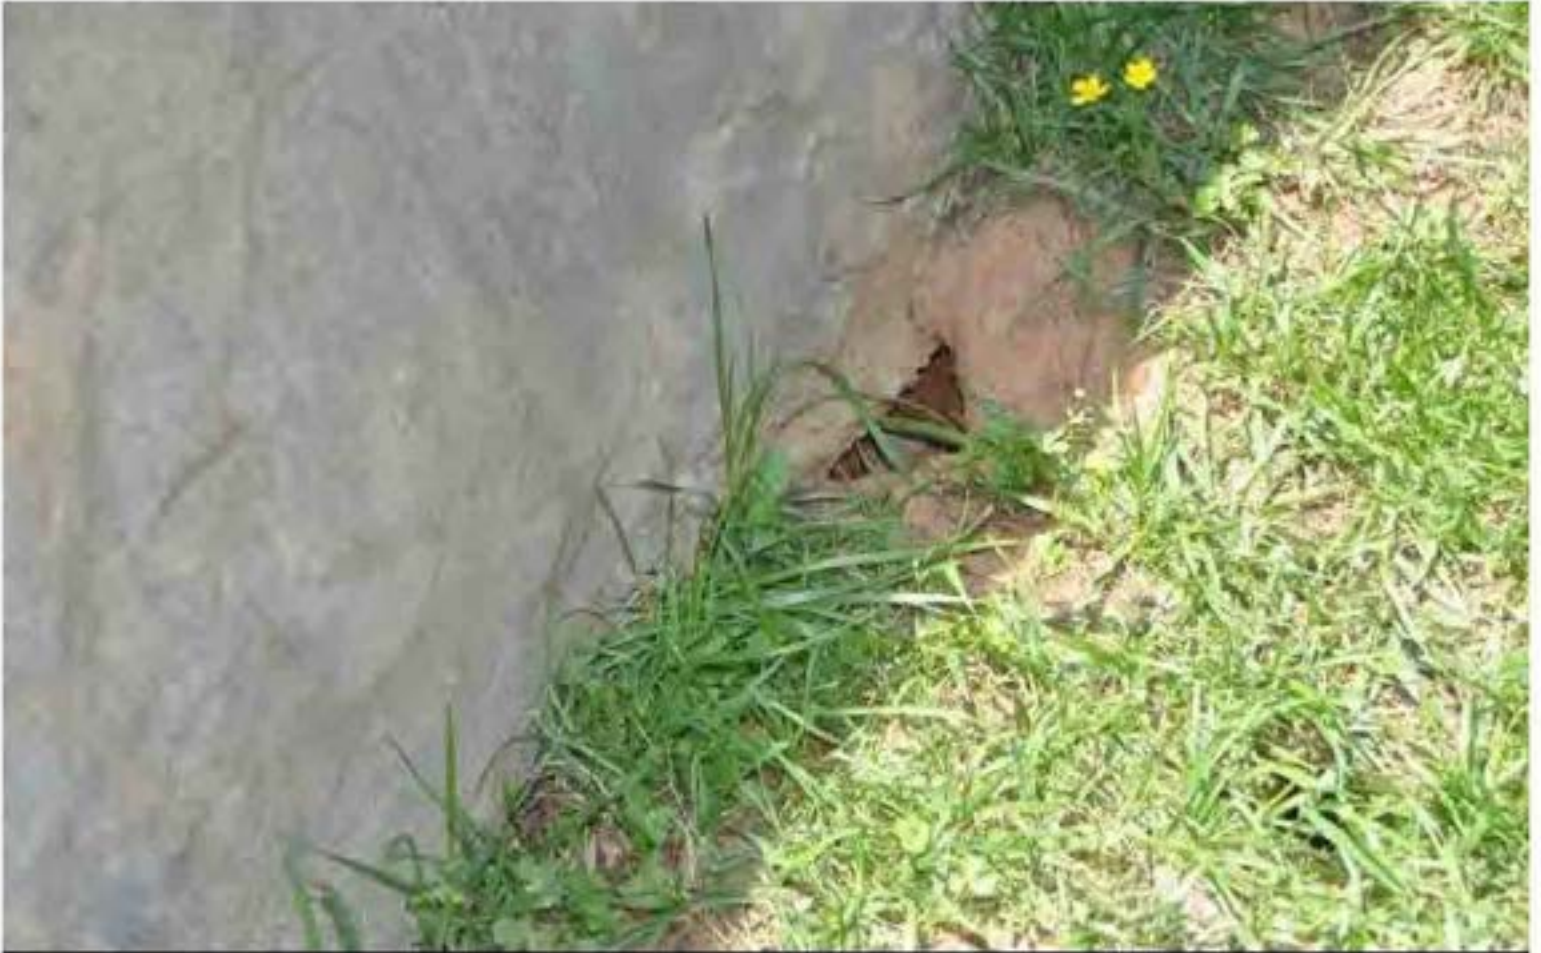
CFR: 3.84 (d)

Photographer:	Randy Coleman	Legal Name:	55-B-0069
Photo Taken:	Wed, May 25, '16	HENRY HAMPTON	
Inspection:	147160841480226		
Description:	Section 3.84(d): Rodent holes found on outside of exhibits on both lemur islands.

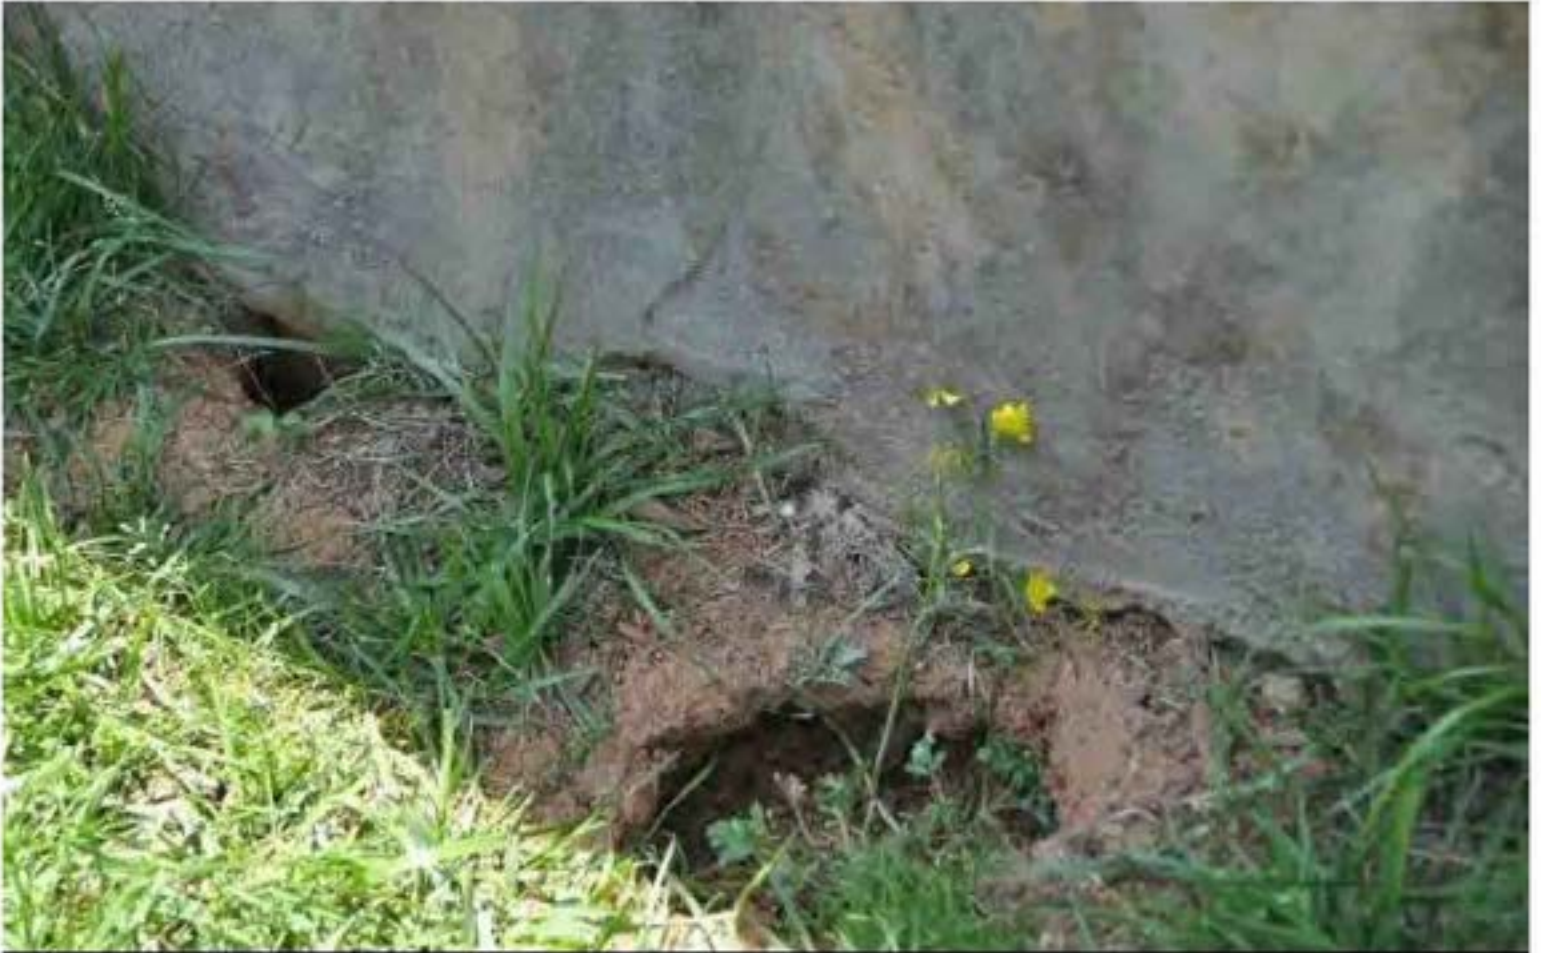
CFR: 3.84 (d)

Photographer:	Randy Coleman	Legal Name:	55-B-0069
Photo Taken:	Wed, May 25, '16	HENRY HAMPTON	
Inspection:	147160841480226		
Description:	Section 3.84(d): Rodent holes found on outside of exhibits on both lemur islands.

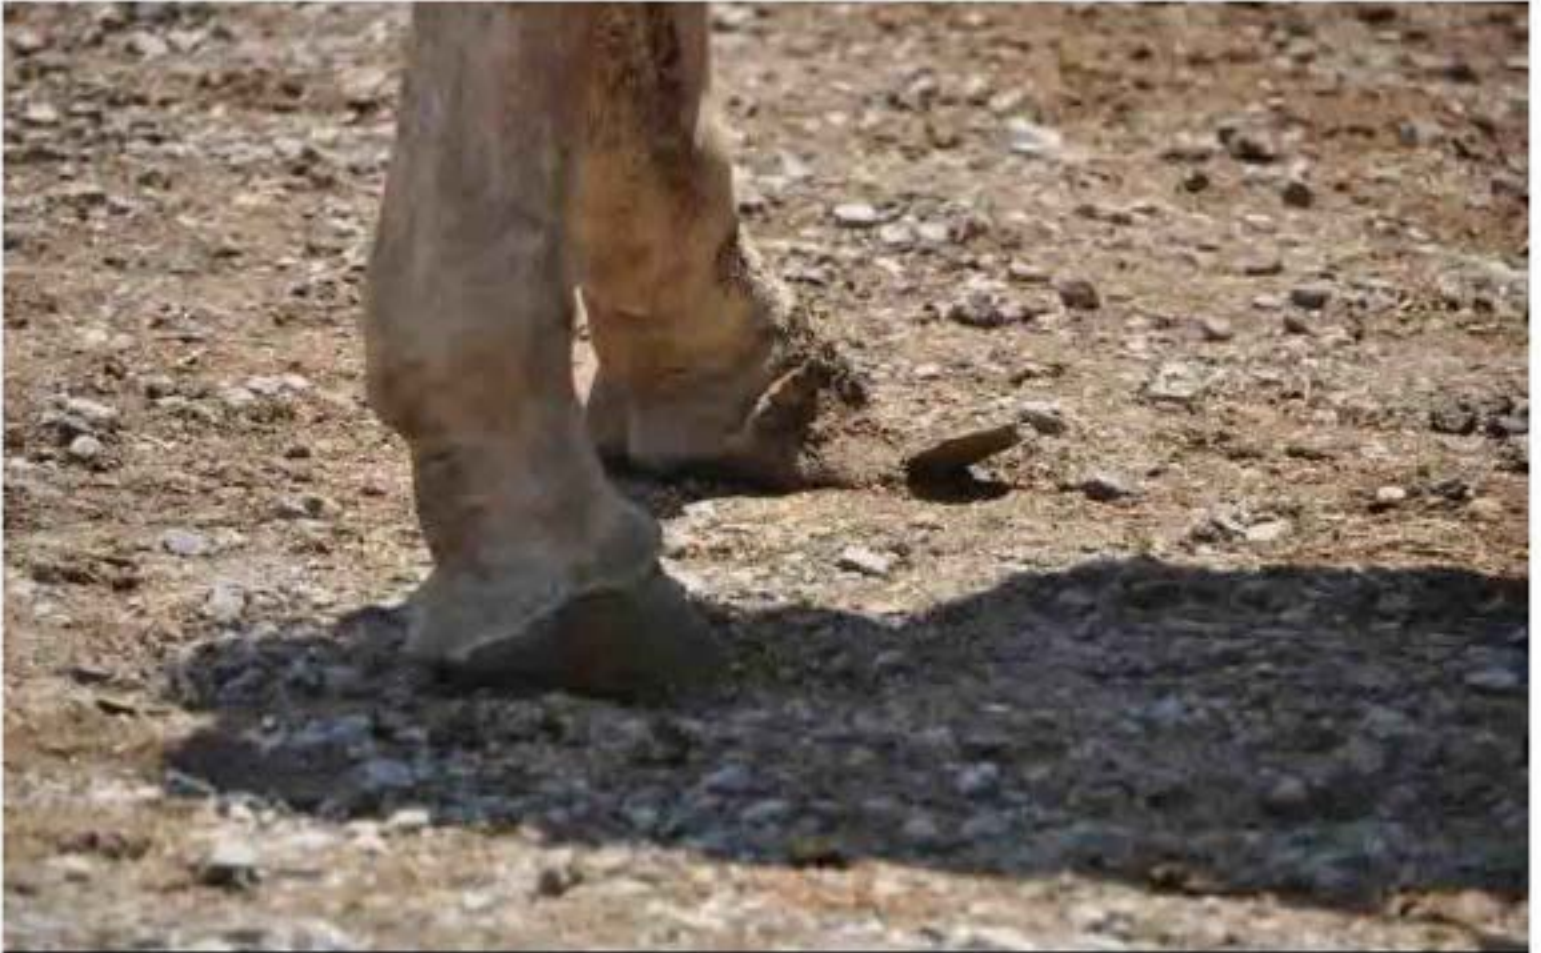
CFR: 2.40 (b) (2)

Photographer:	Randy Coleman	Legal Name:	55-B-0069
Photo Taken:	Wed, May 25, '16	HENRY HAMPTON	
Inspection:	147160841480226		
Description:	Section 2.40(b)(2): Overgrown feet on adult giraffe named Mary.

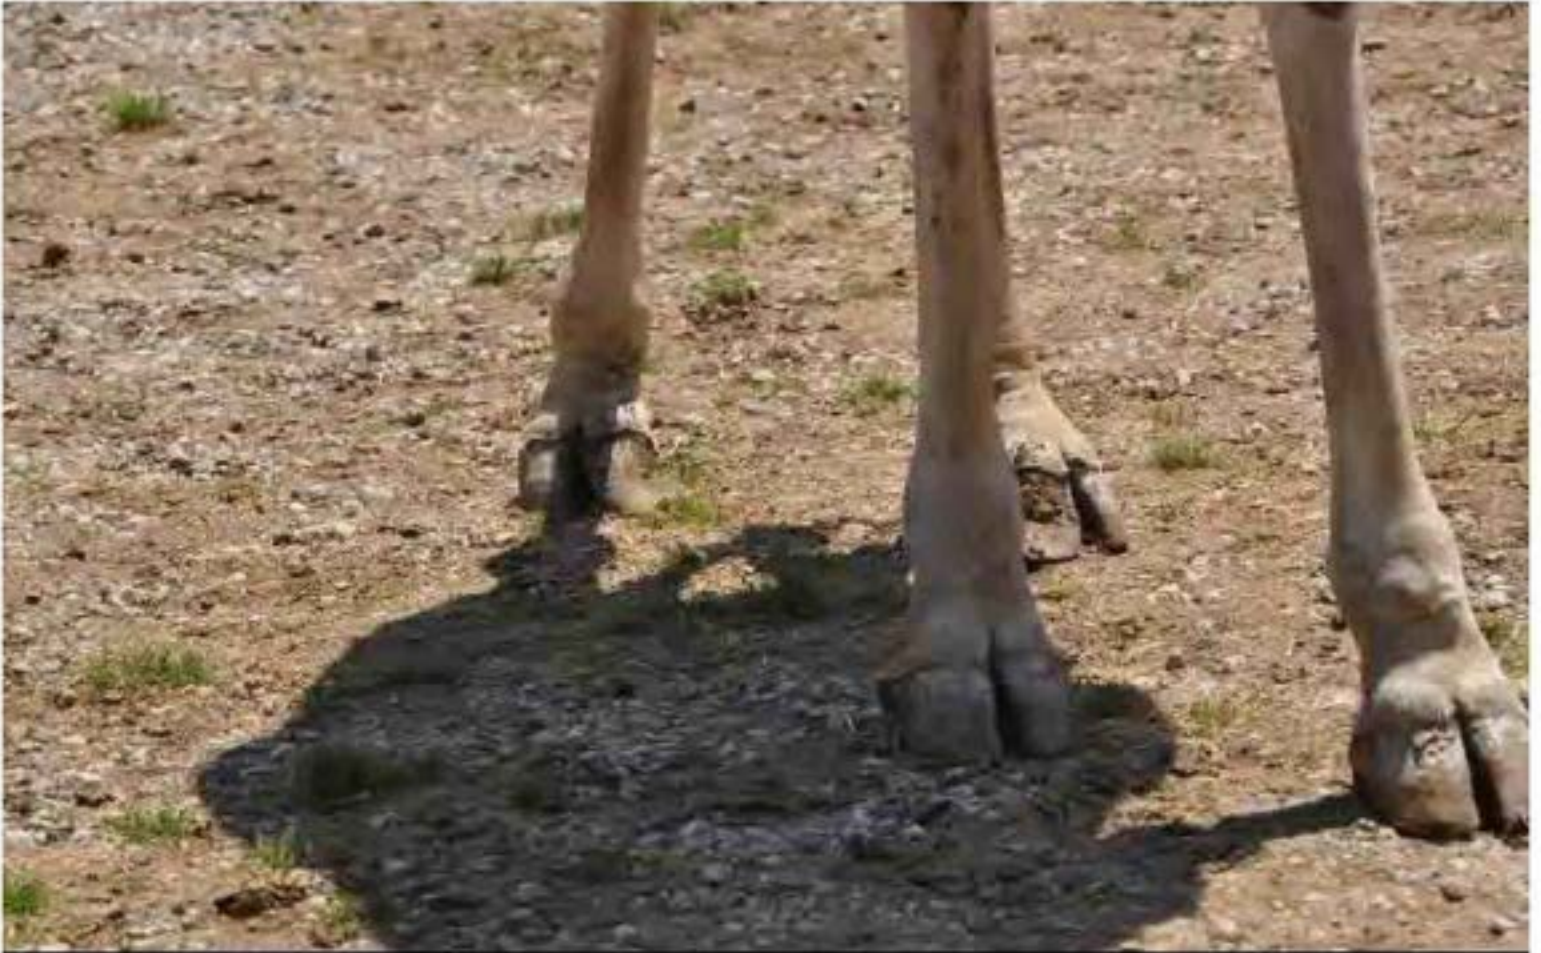
CFR: 2.40 (b) (2)

Photographer:	Randy Coleman	Legal Name:	55-B-0069
Photo Taken:	Wed, May 25, '16	HENRY HAMPTON	
Inspection:	147160841480226		
Description:	Section 2.40(b)(2): Overgrown feet on adult giraffe named Mary.

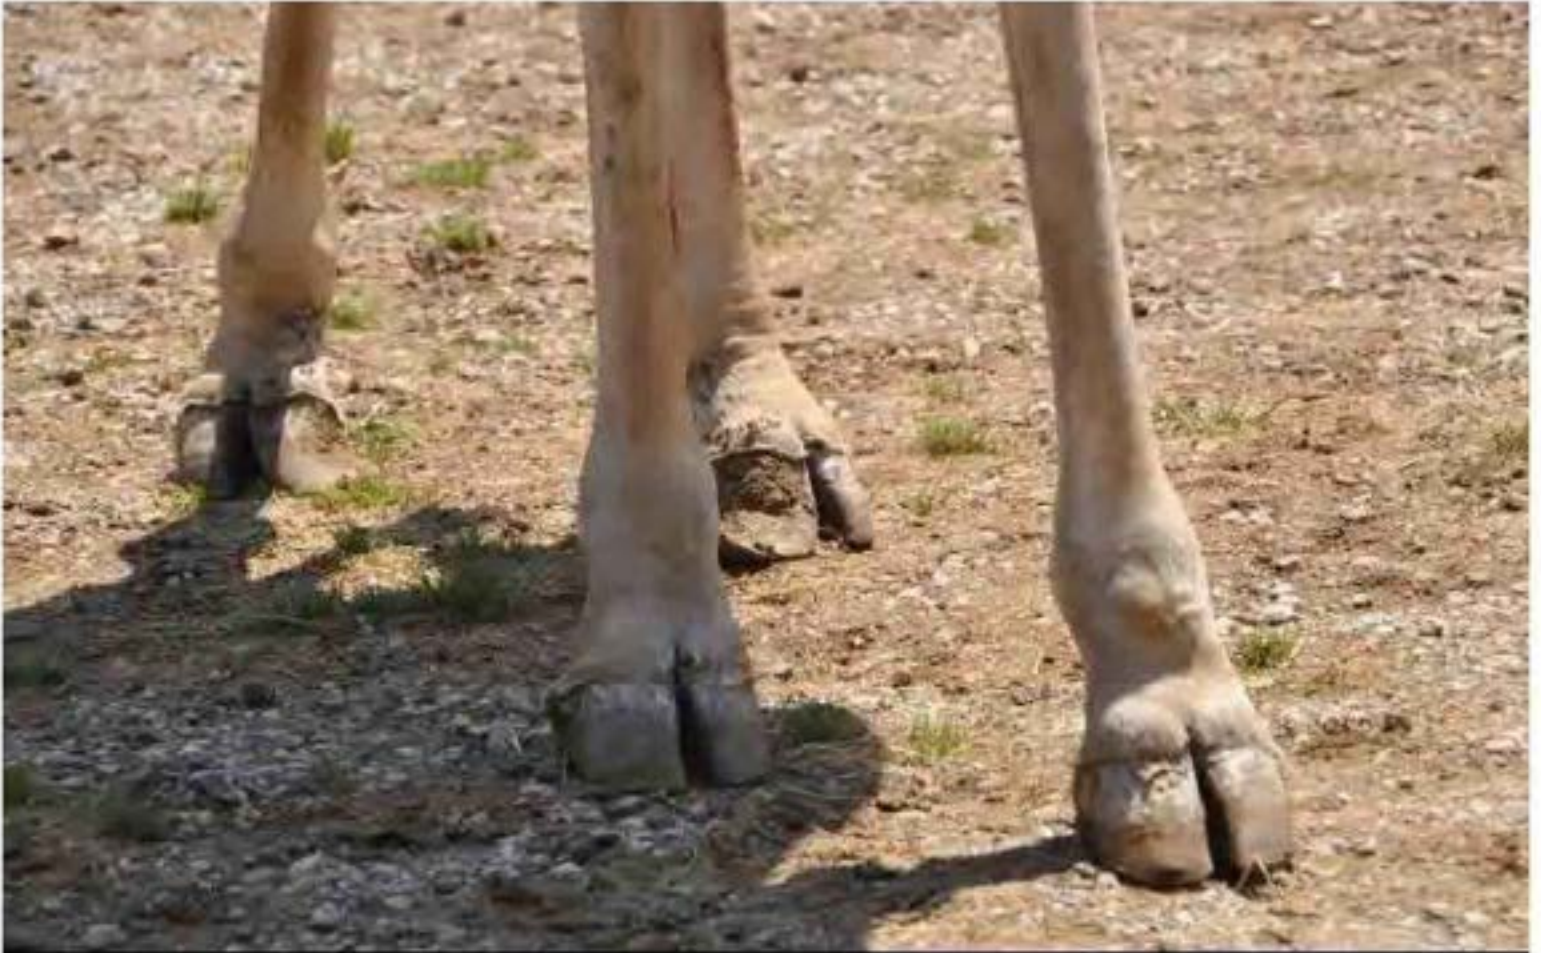
CFR: 2.40 (b) (2)

Photographer:	Randy Coleman	Legal Name:	55-B-0069
Photo Taken:	Wed, May 25, '16	HENRY HAMPTON	
Inspection:	147160841480226		
Description:	Section 2.40(b)(2): Overgrown feet on adult giraffe named Mary.

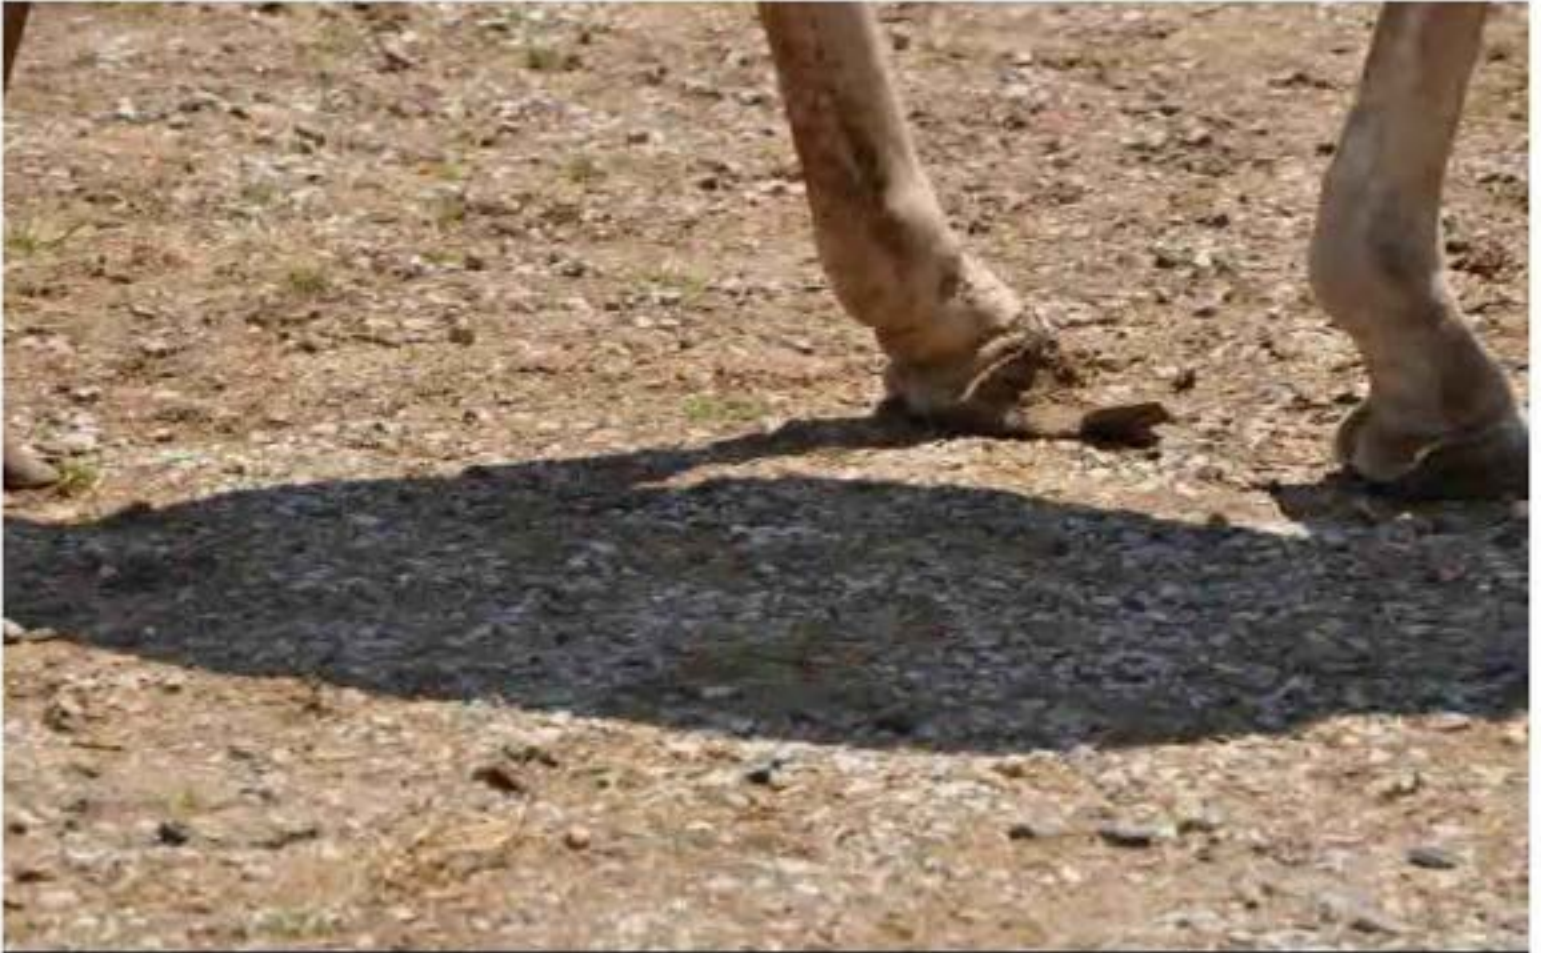
CFR: 2.40 (b) (2)

Photographer:	Randy Coleman	Legal Name:	55-B-0069
Photo Taken:	Wed, May 25, '16	HENRY HAMPTON	
Inspection:	147160841480226		
Description:	Section 2.40(b)(2): Overgrown feet on adult giraffe named Mary.

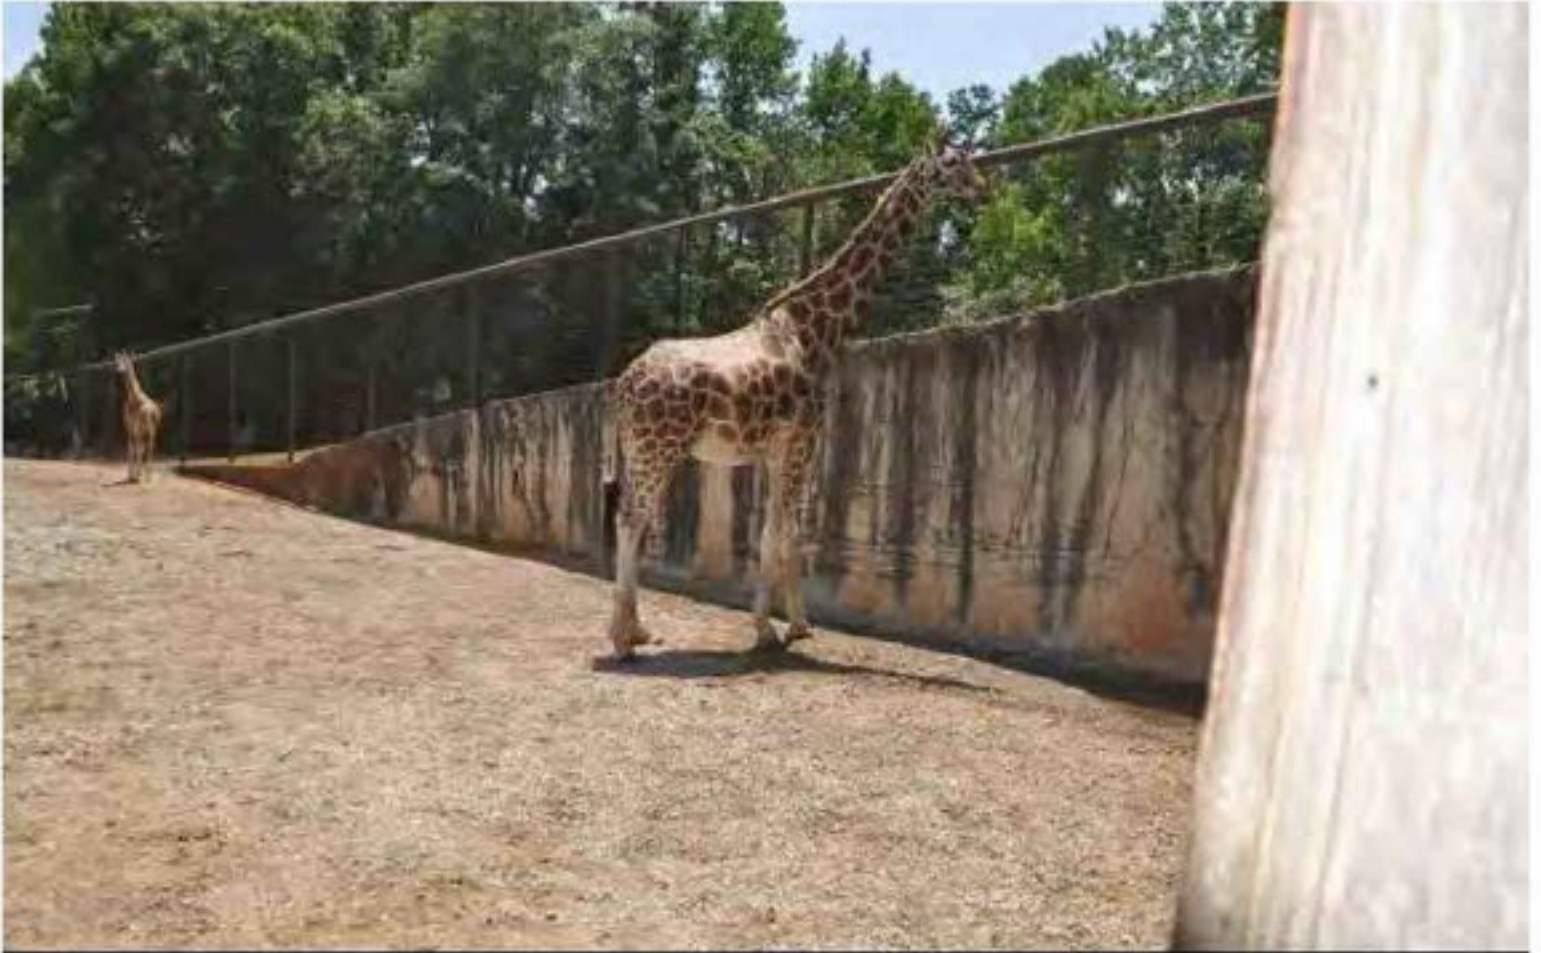
CFR: 2.40 (b) (2)

Photographer:	Randy Coleman	Legal Name:	55-B-0069
Photo Taken:	Wed, May 25, '16	HENRY HAMPTON	
Inspection:	147160841480226		
Description:	Section 2.40(b)(2): Overgrown feet on adult giraffe named Mary.

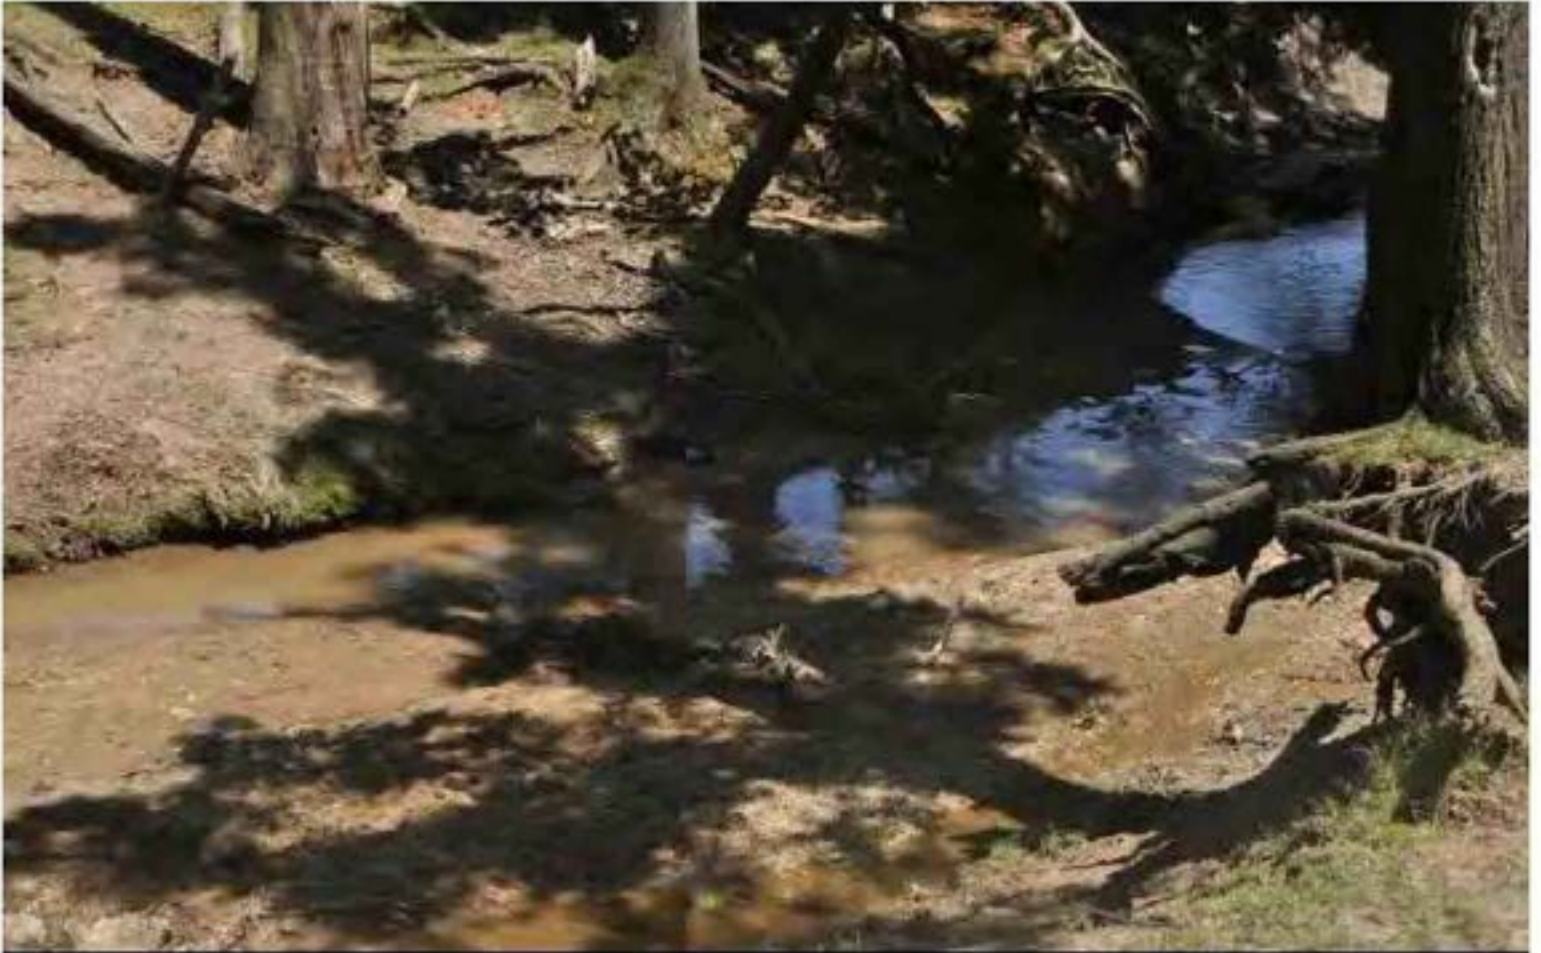
CFR: 3.125 (a)

Photographer:	Randy Coleman	Legal Name:	55-B-0069
Photo Taken:	Wed, May 25, '16	HENRY HAMPTON	
Inspection:	147160841480226		
Description:	Section 3.130: Creek which is water source for animals in the drive thru area.

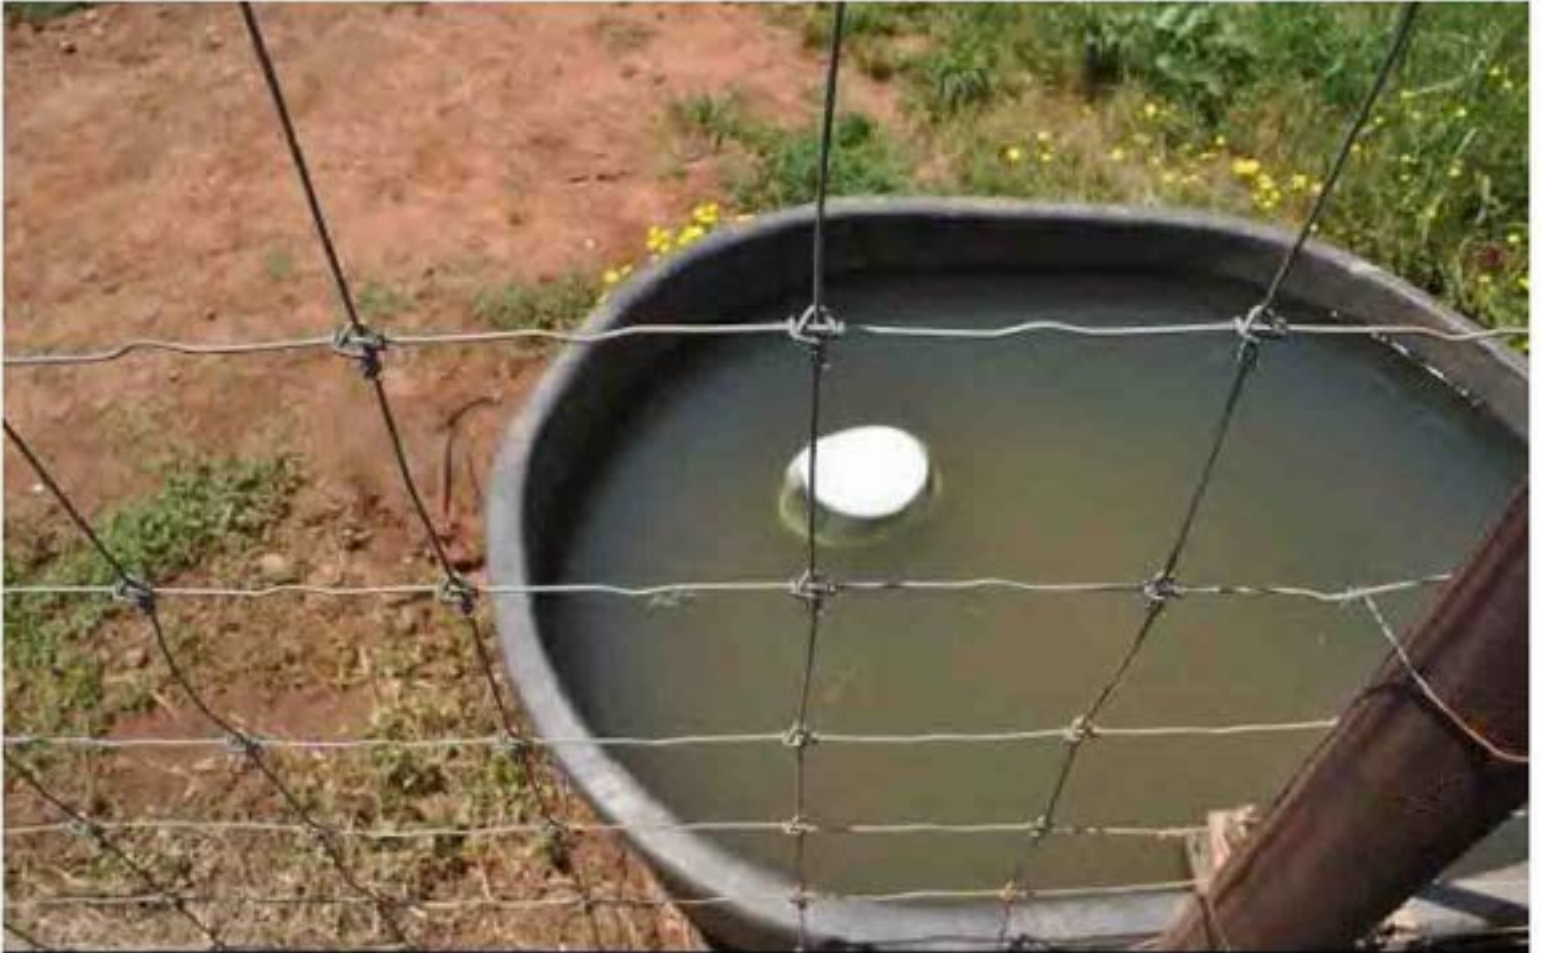
CFR: 3.125 (a)

Photographer:	Randy Coleman	Legal Name:	55-B-0069
Photo Taken:	Wed, May 25, '16	HENRY HAMPTON	
Inspection:	147160841480226		
Description:	Section 3.130: Cloudy water in trough for camels in front pasture.

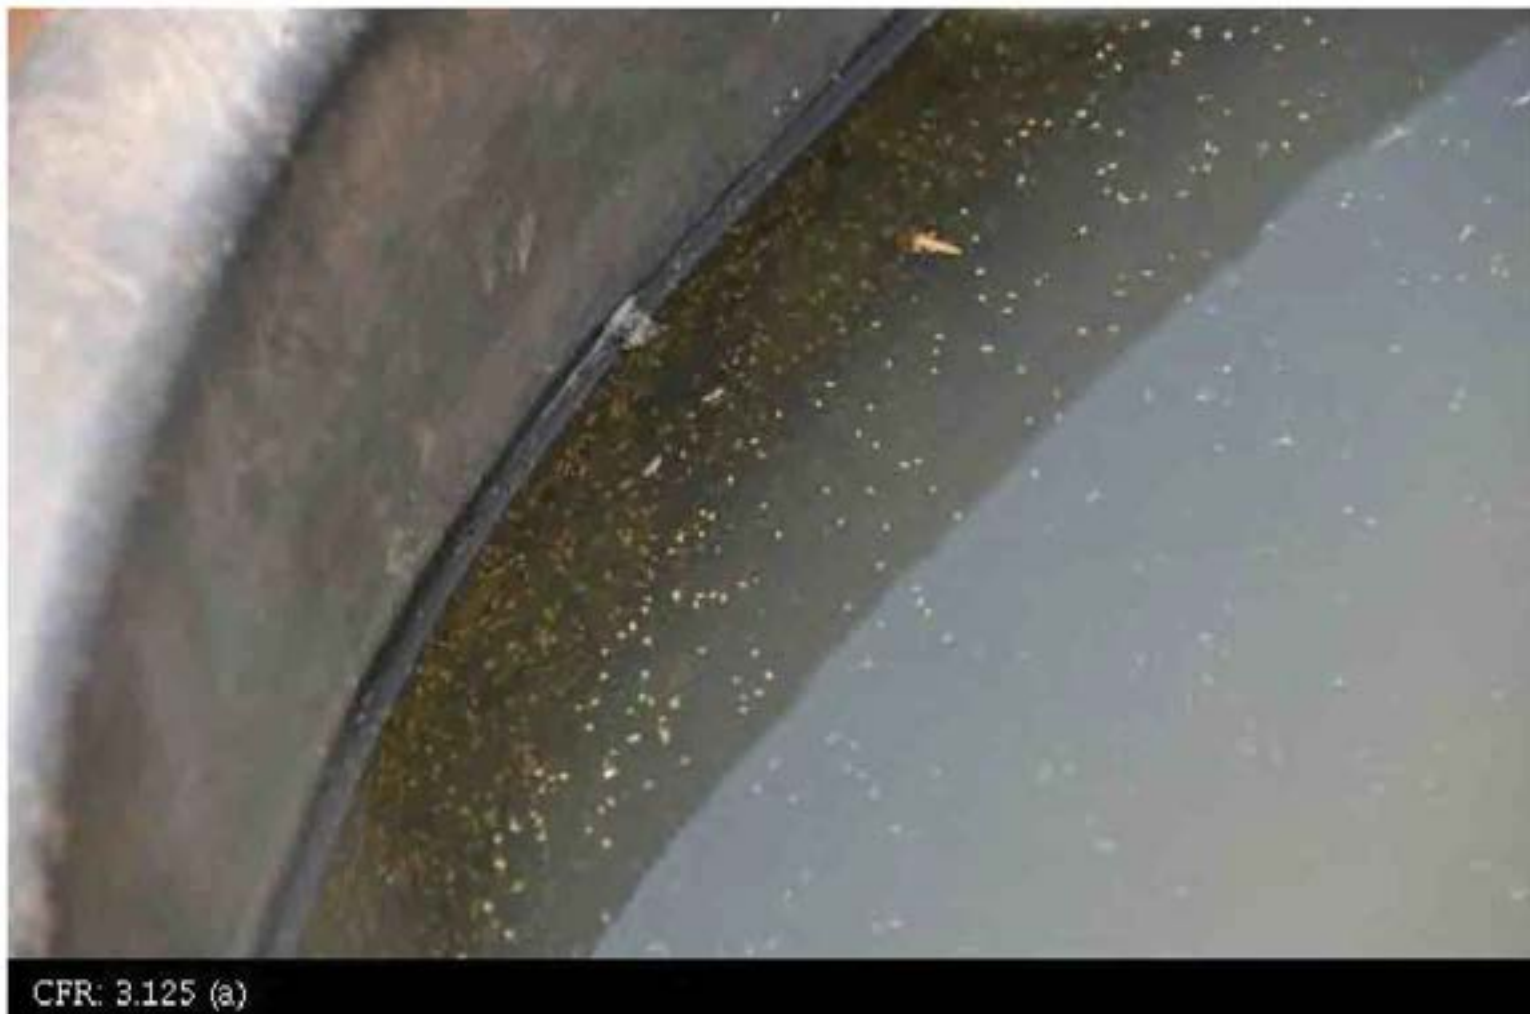
CFR: 3.125 (a)

Photographer:	Randy Coleman	Legal Name:	55-B-0069
Photo Taken:	Wed, May 25, '16	HENRY HAMPTON	
Inspection:	147160841480226		
Description:	Section 3.130: Cloudy water in trough for camels in front pasture, also showing insect larvae.

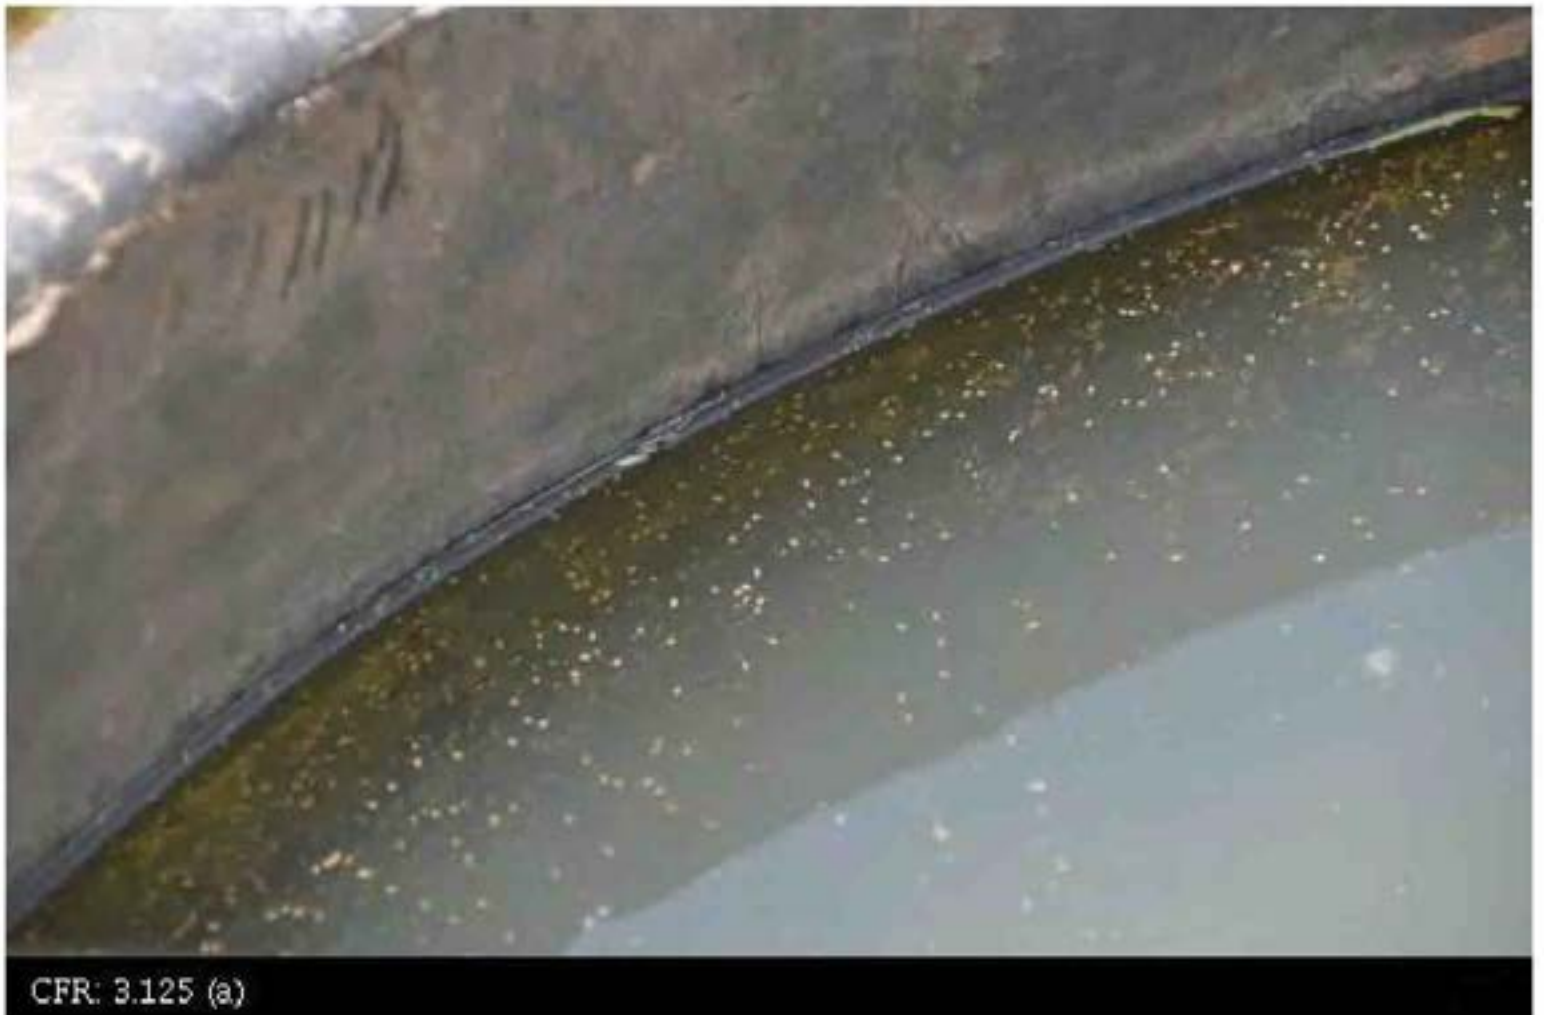
CFR: 3.125 (a)

Photographer:	Randy Coleman	Legal Name:	55-B-0069
Photo Taken:	Wed, May 25, '16	HENRY HAMPTON	
Inspection:	147160841480226		
Description:	Section 3.130: Cloudy water in trough for camels in front pasture, also showing insect larvae.

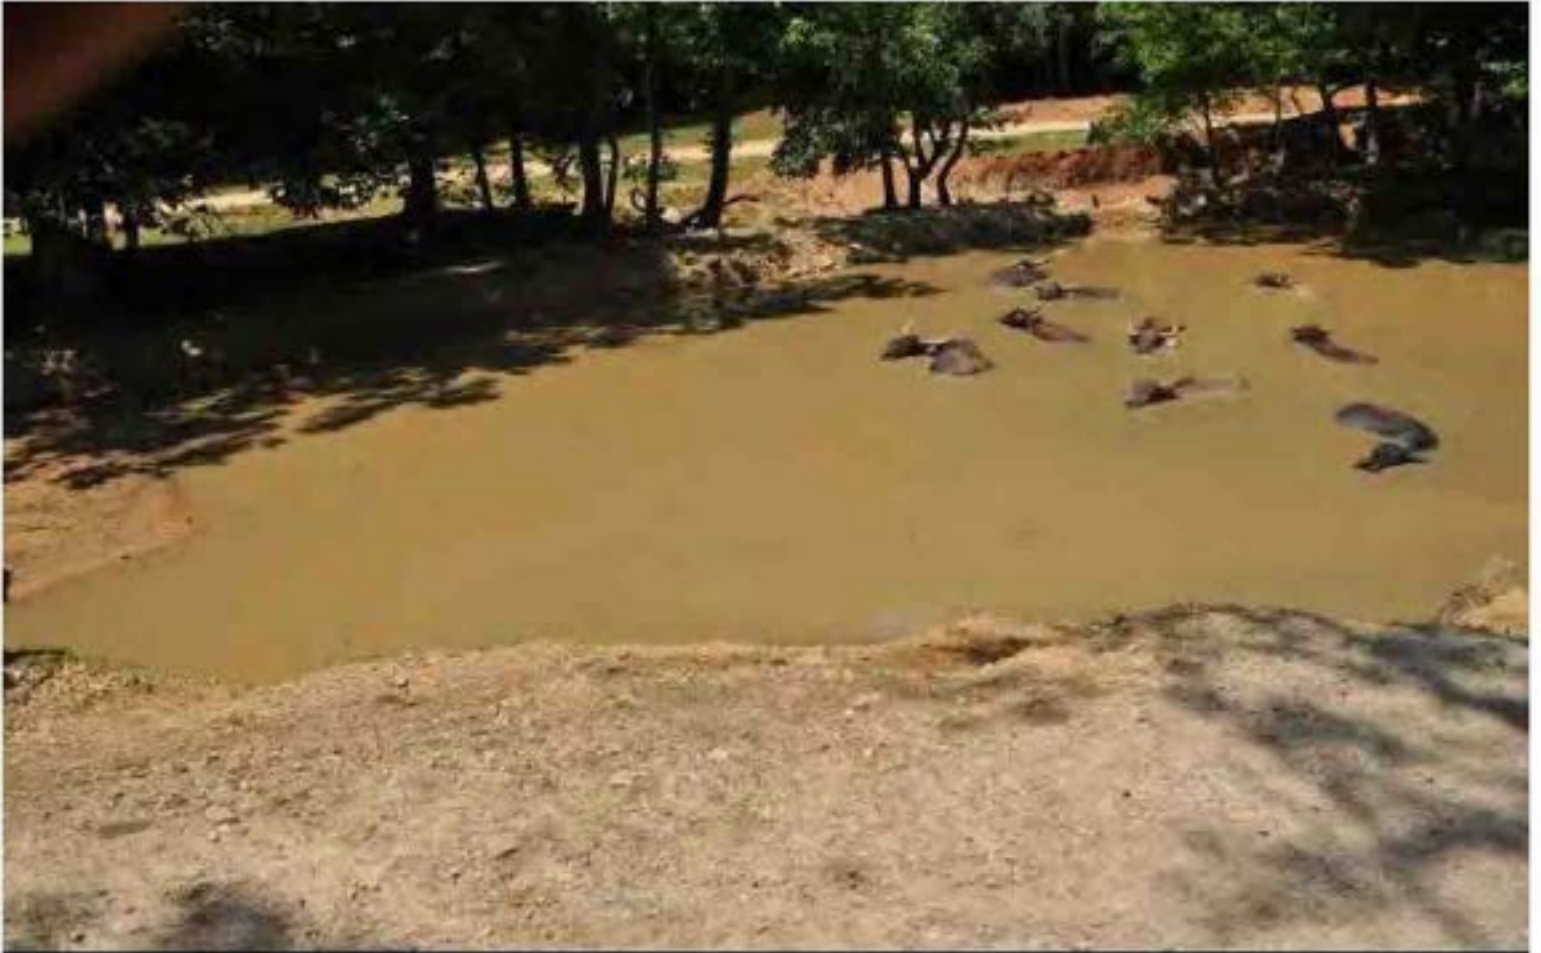
CFR: 3.125 (a)

Photographer:	Randy Coleman	Legal Name:	55-B-0069
Photo Taken:	Wed, May 25, '16	HENRY HAMPTON	
Inspection:	147160841480226		
Description:	Section 3.130: Creek that is water source for animals in drive-thru area of the facility, photo shows water buffalo bathing in water.

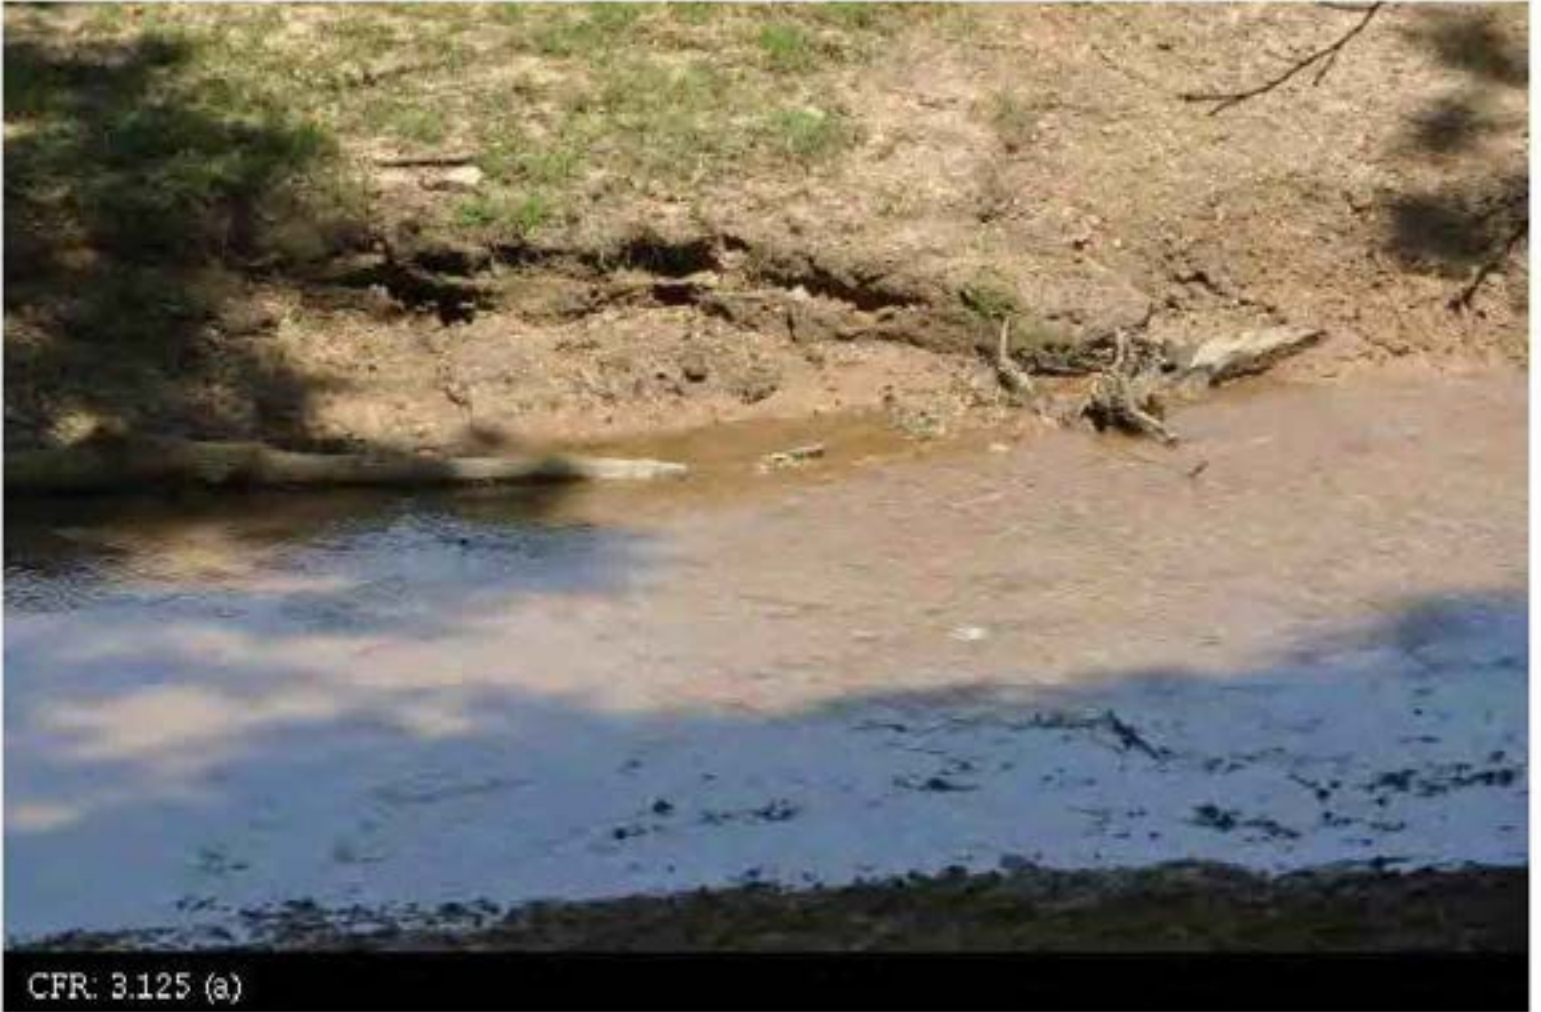
CFR: 3.125 (a)

Photographer:	Randy Coleman	Legal Name:	55-B-0069
Photo Taken:	Wed, May 25, '16	HENRY HAMPTON	
Inspection:	147160841480226		
Description:	Section 3.130: Creek that is water source for animals in drive-thru area of the facility.

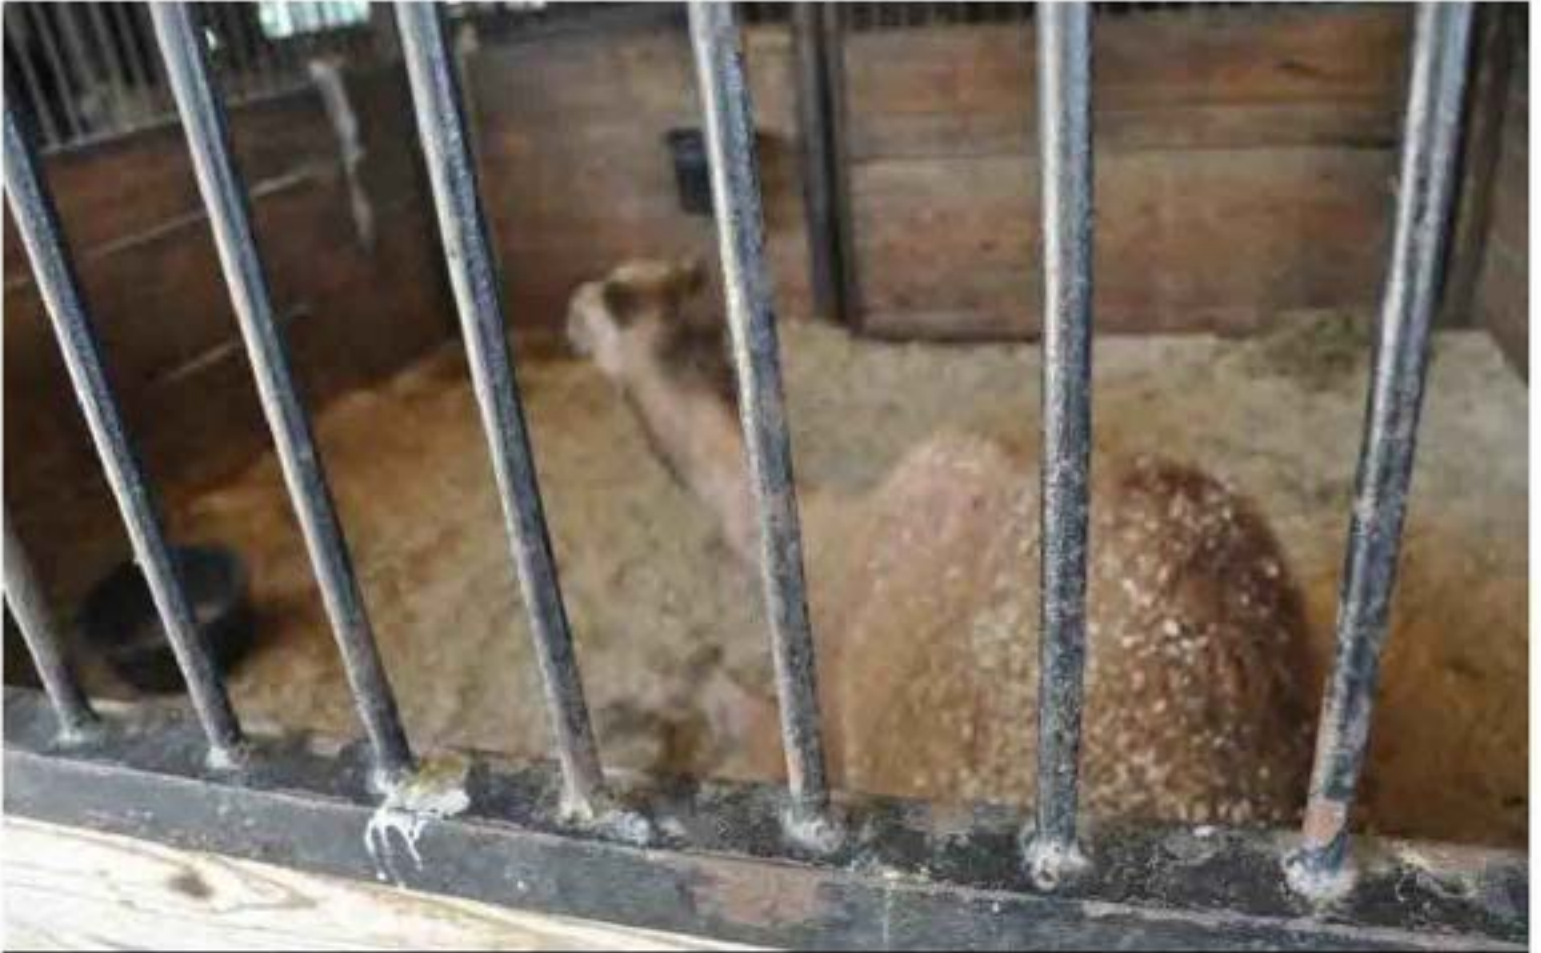
CFR: 2.131 (c) (1)

Photographer:	Randy Coleman	Legal Name:	55-B-0069
Photo Taken:	Wed, May 25, '16	HENRY HAMPTON	
Inspection:	147160841480226		
Description:	Section 2.131: Lack of barriers or attendants for animals in walk thru area of the park. Photo shows camel in wagon loading area.

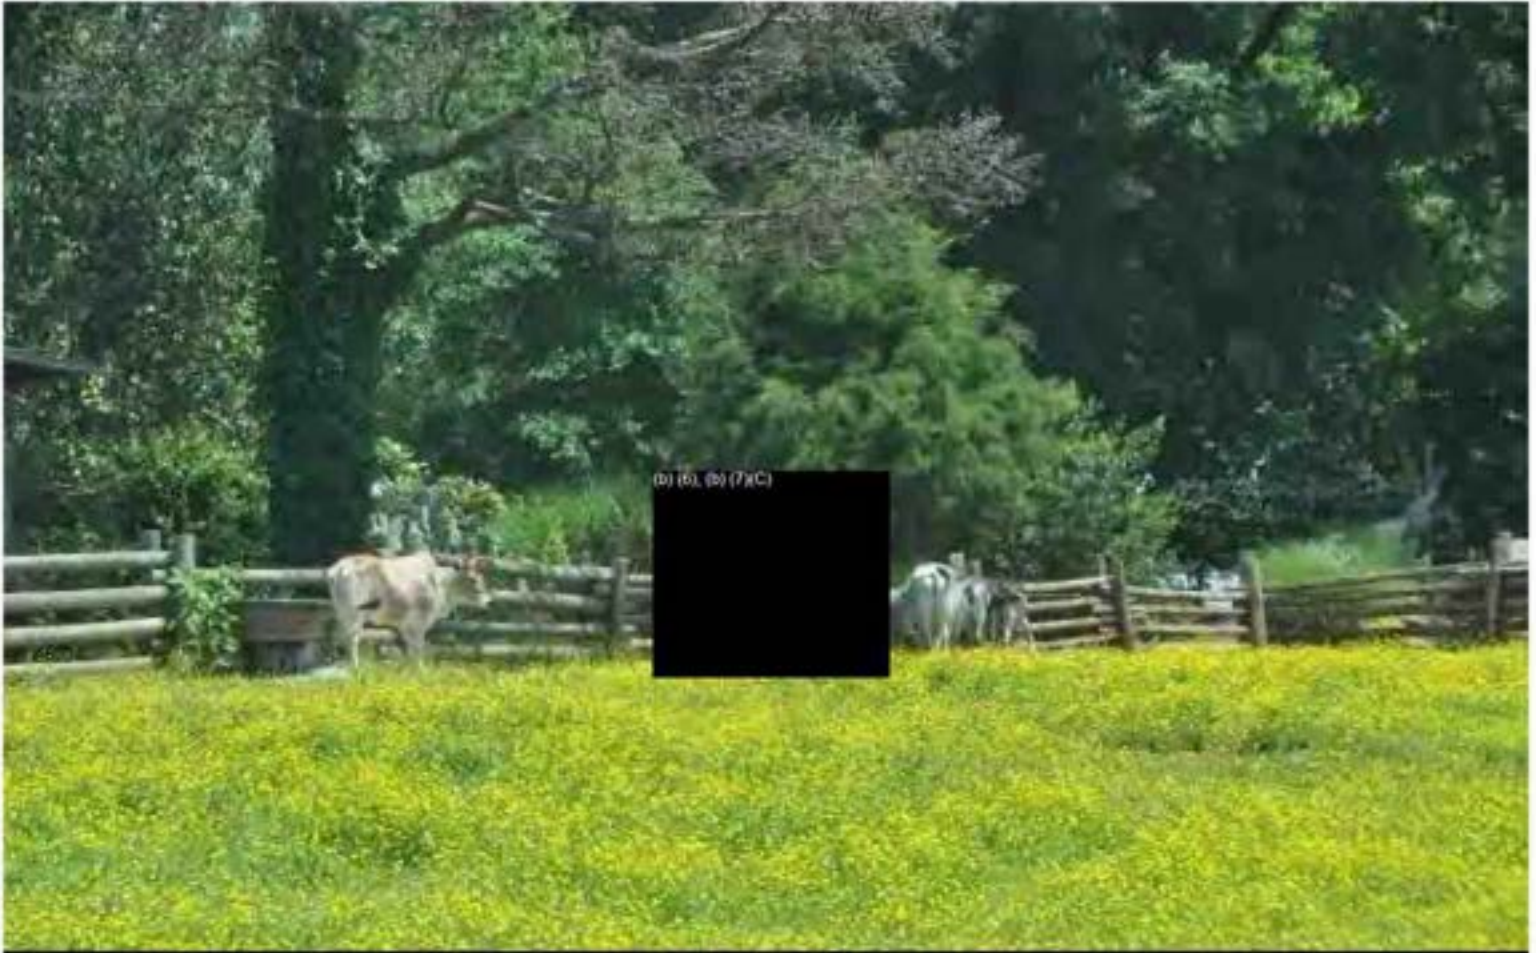
CFR: 2.131 (c) (1)

Photographer:	Randy Coleman	Legal Name:	55-B-0069
Photo Taken:	Wed, May 25, '16	HENRY HAMPTON	
Inspection:	147160841480226		
Description:	Section 2.131: Lack of barriers or attendants for animals in walk thru area of the park.
