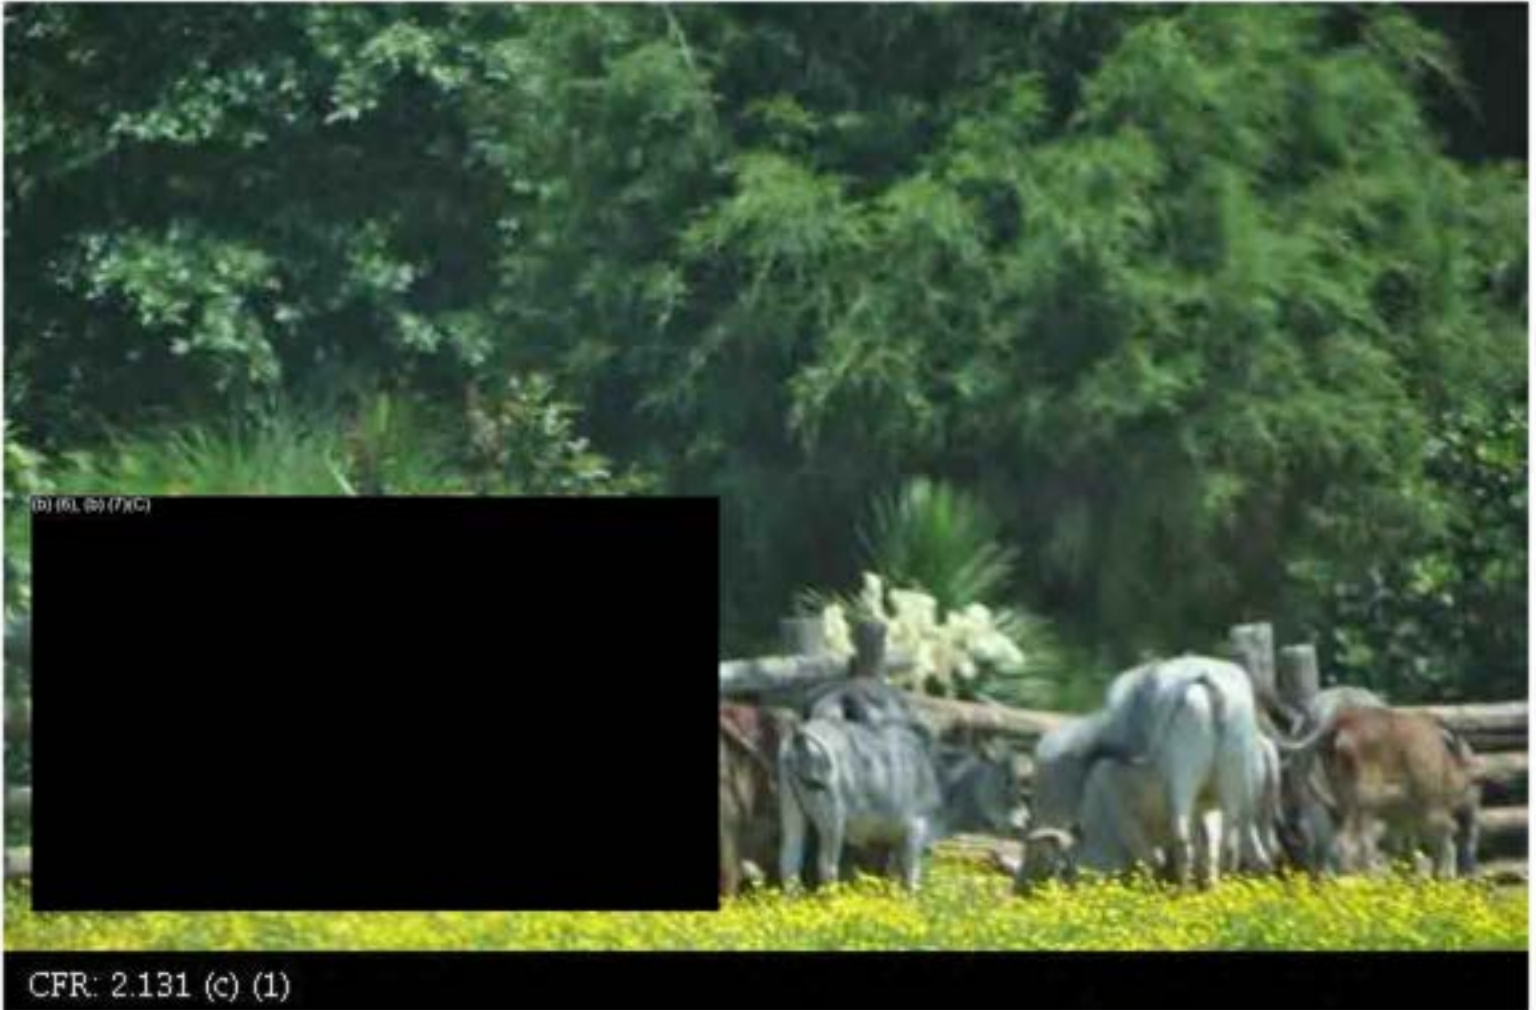
CFR: 2.131 (c) (1)

Photographer:	Randy Coleman	Legal Name:	55-B-0069
Photo Taken:	Wed, May 25, '16	HENRY HAMPTON	
Inspection:	147160841480226		
Description:	Section 2.131: Lack of barriers or attendants for animals in walk thru area of the park.

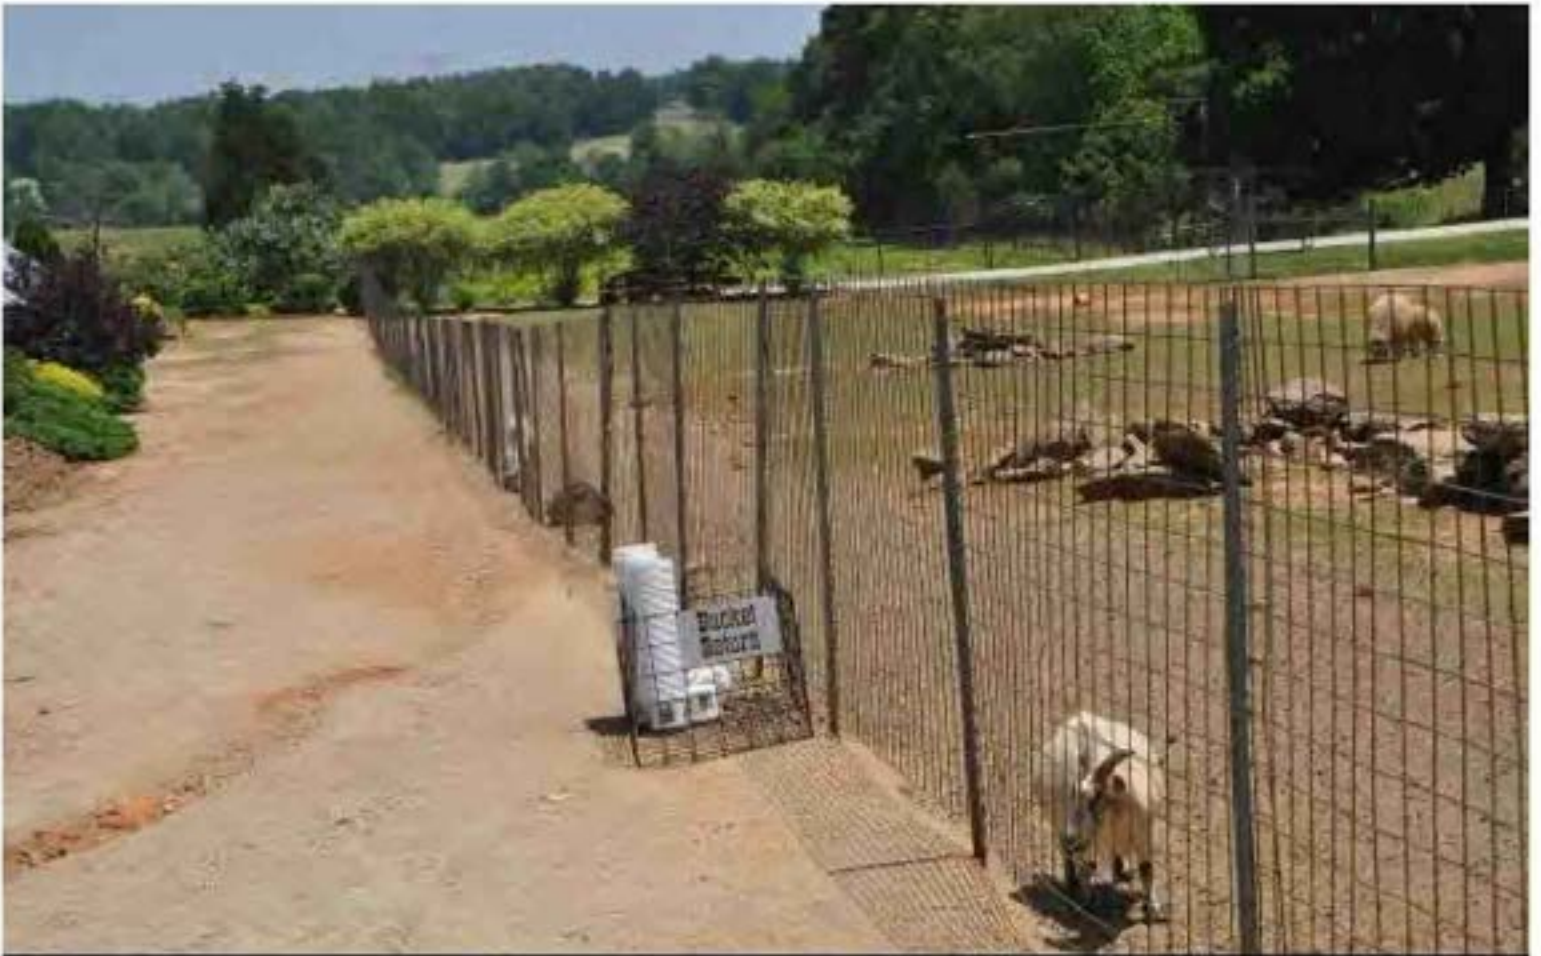
CFR: 2.131 (c) (1)

Photographer:	Randy Coleman	Legal Name:	55-B-0069
Photo Taken:	Wed, May 25, '16	HENRY HAMPTON	
Inspection:	147160841480226		
Description:	Section 2.131: Lack of barriers or attendants for animals in walk thru area of the park.

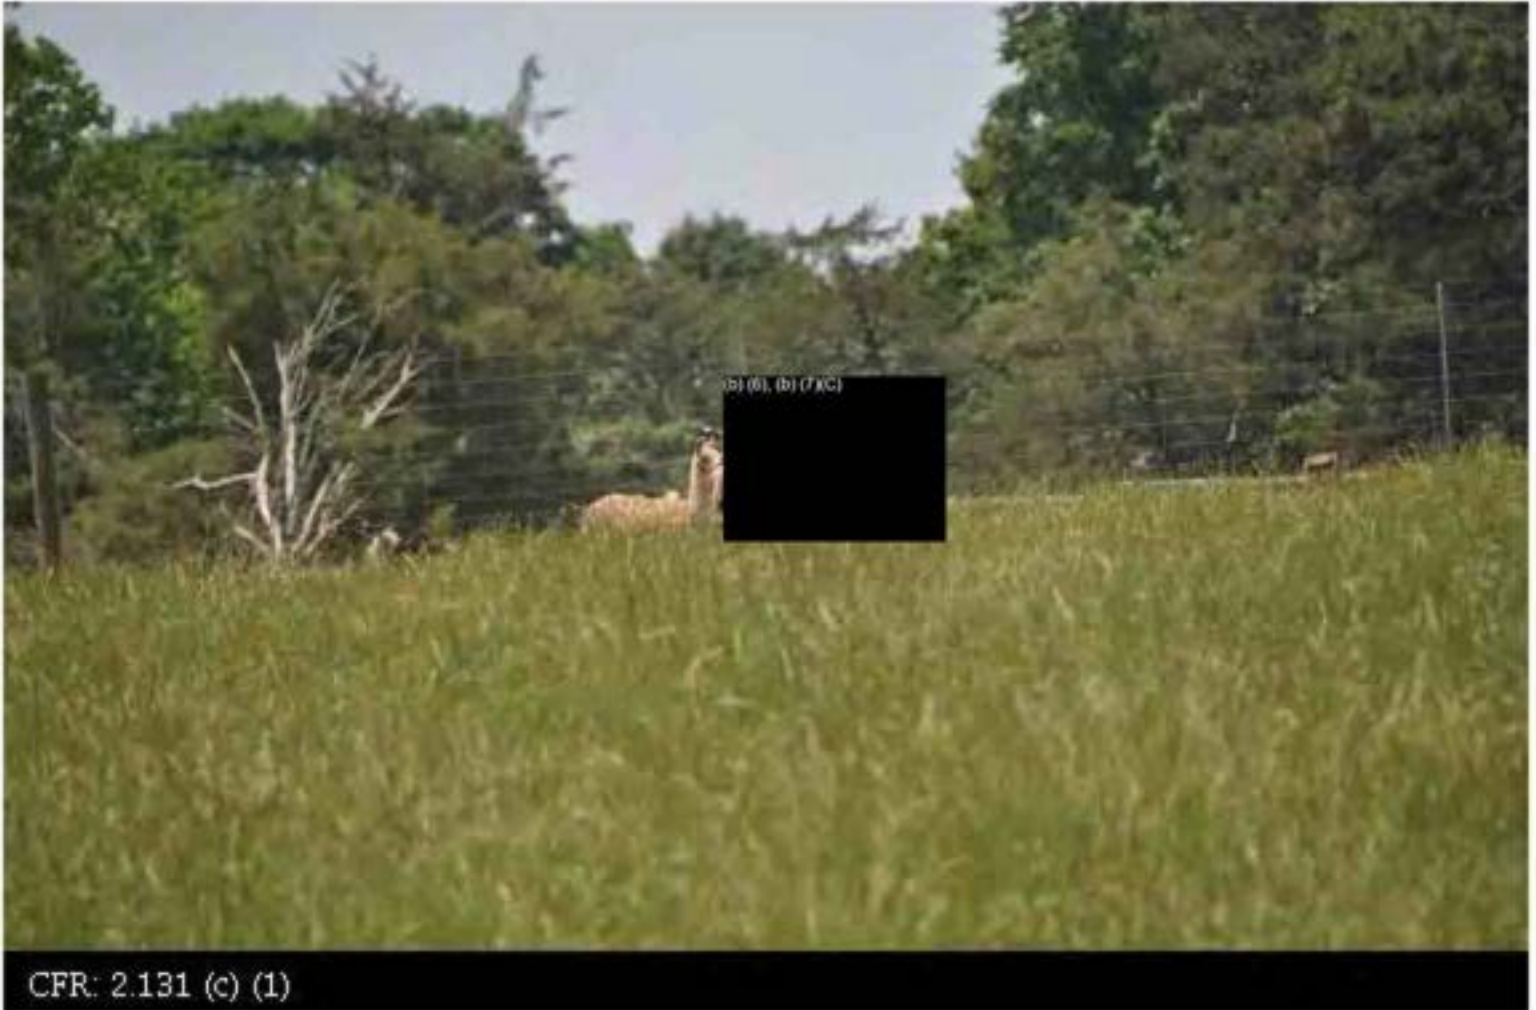
Photographer:	Randy Coleman	Legal Name:	55-B-0069
Photo Taken:	Wed, May 25, '16	HENRY HAMPTON	
Inspection:	147160841480226		
Description:	Section 2.131: Lack of barriers or attendants for animals in walk thru area of the park.

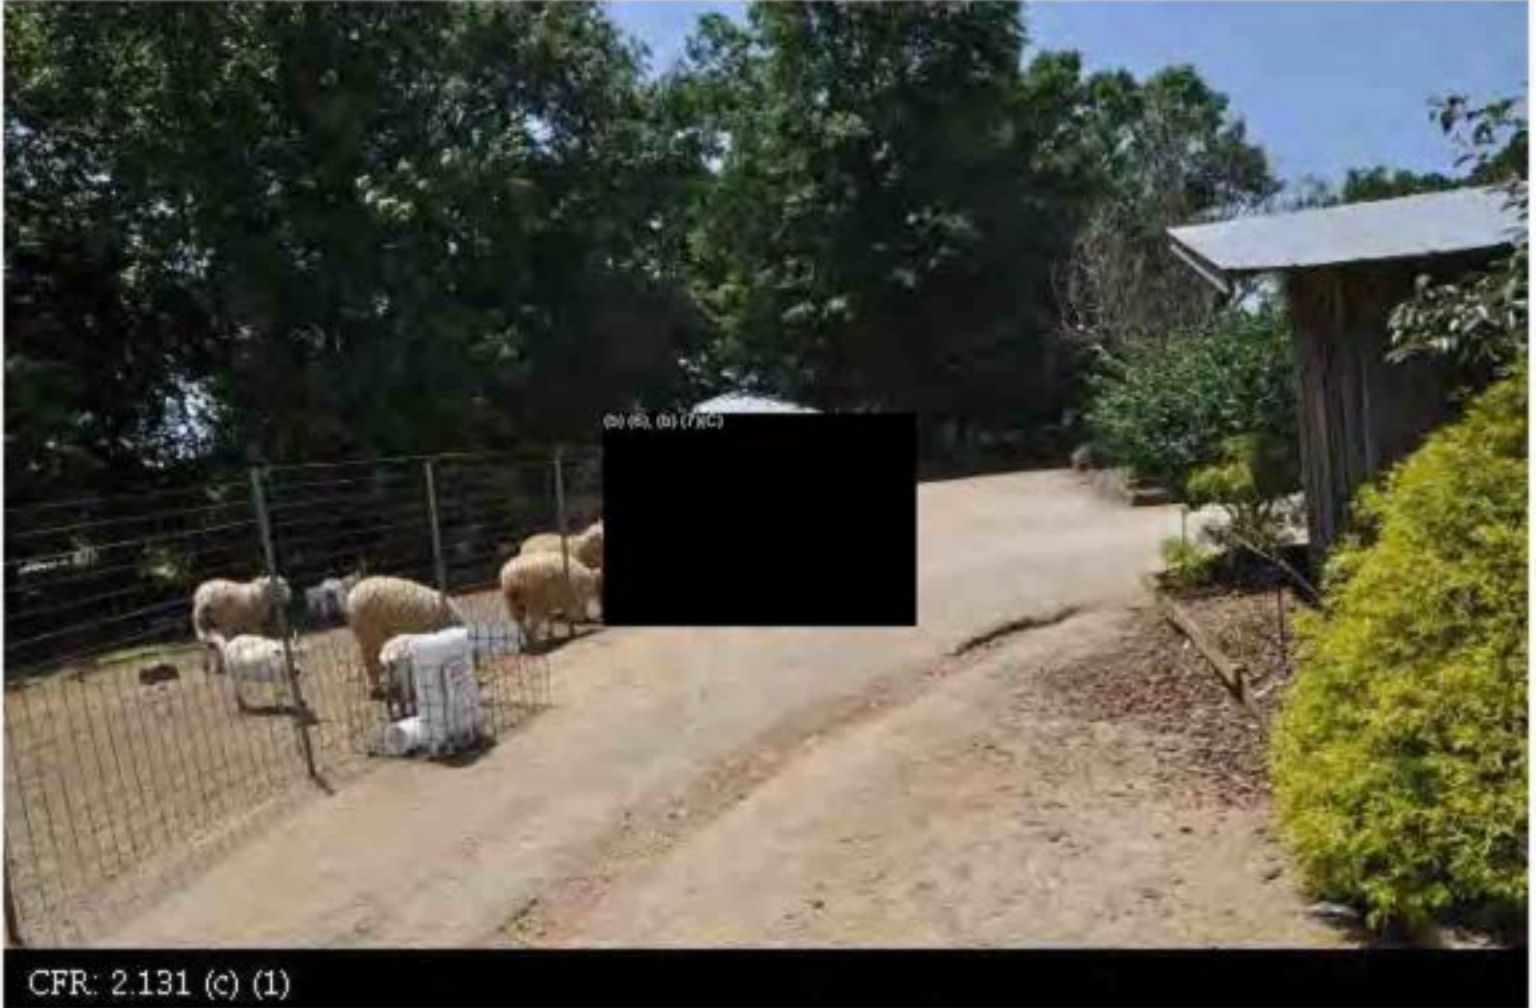
Photographer:	Randy Coleman	Legal Name:	55-B-0069
Photo Taken:	Wed, May 25, '16	HENRY HAMPTON	
Inspection:	147160841480226		
Description:	Section 2.131: Lack of barriers or attendants for animals in walk thru area of the park.

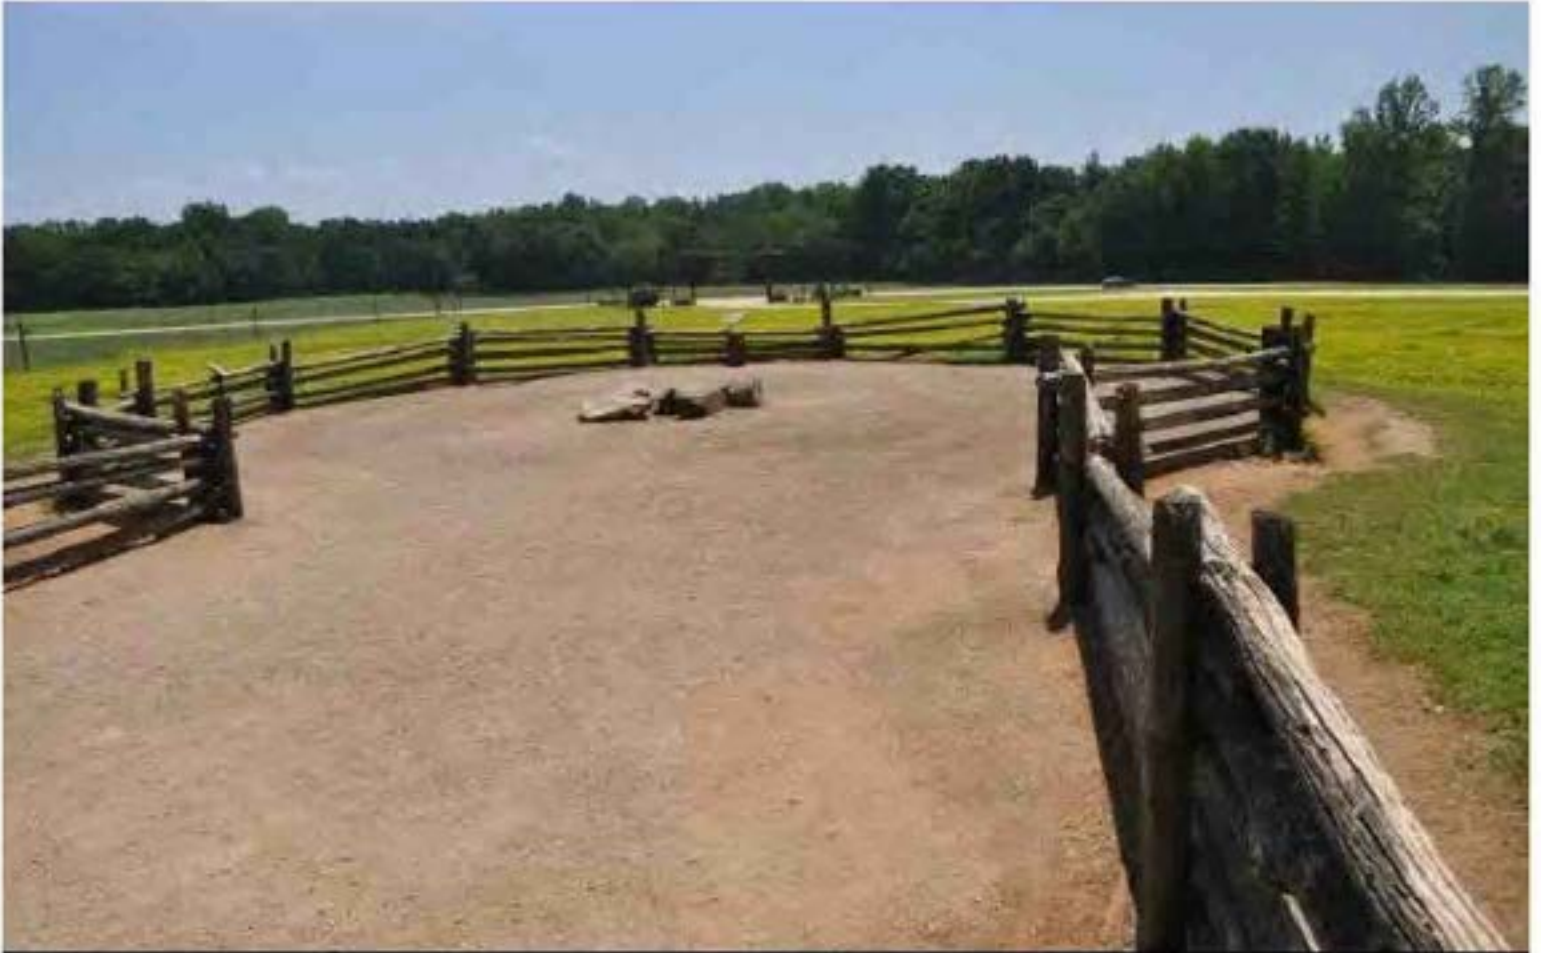
CFR: 2.131 (c) (1)

Photographer:	Randy Coleman	Legal Name:	55-B-0069
Photo Taken:	Wed, May 25, '16	HENRY HAMPTON	
Inspection:	147160841480226		
Description:	Section 2.131: Lack of barriers or attendants for animals in walk thru area of the park.

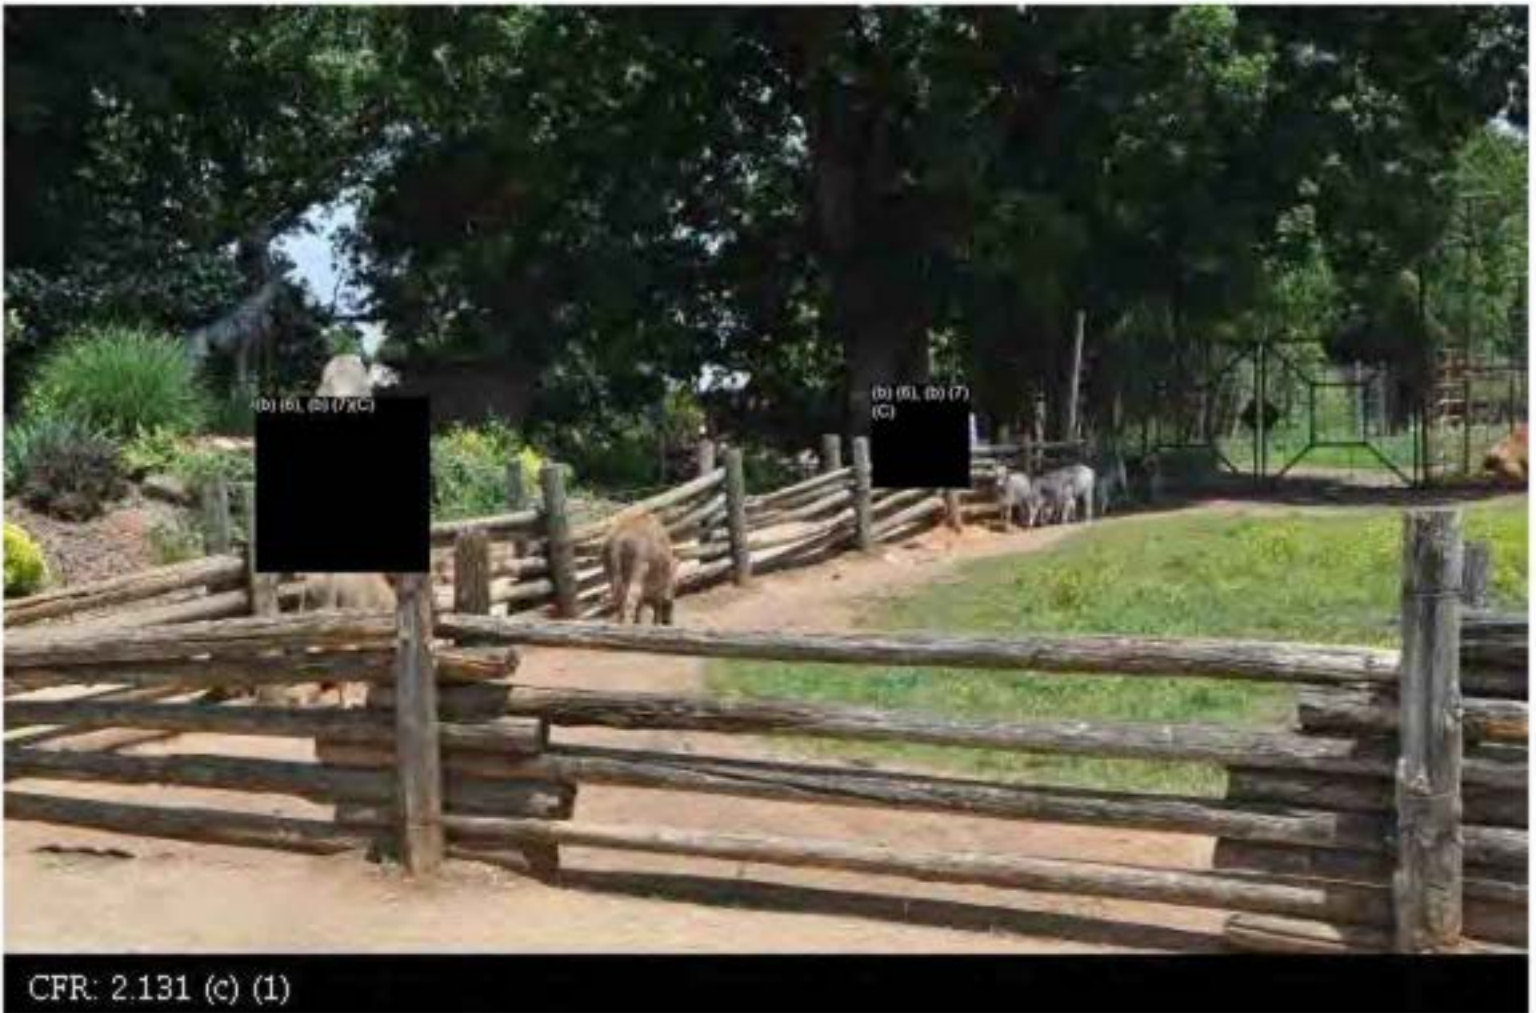
Photographer:	Randy Coleman	Legal Name:	55-B-0069
Photo Taken:	Wed, May 25, '16	HENRY HAMPTON	
Inspection:	147160841480226		
Description:	Section 2.131: Lack of barriers or attendants for animals in walk thru area of the park.

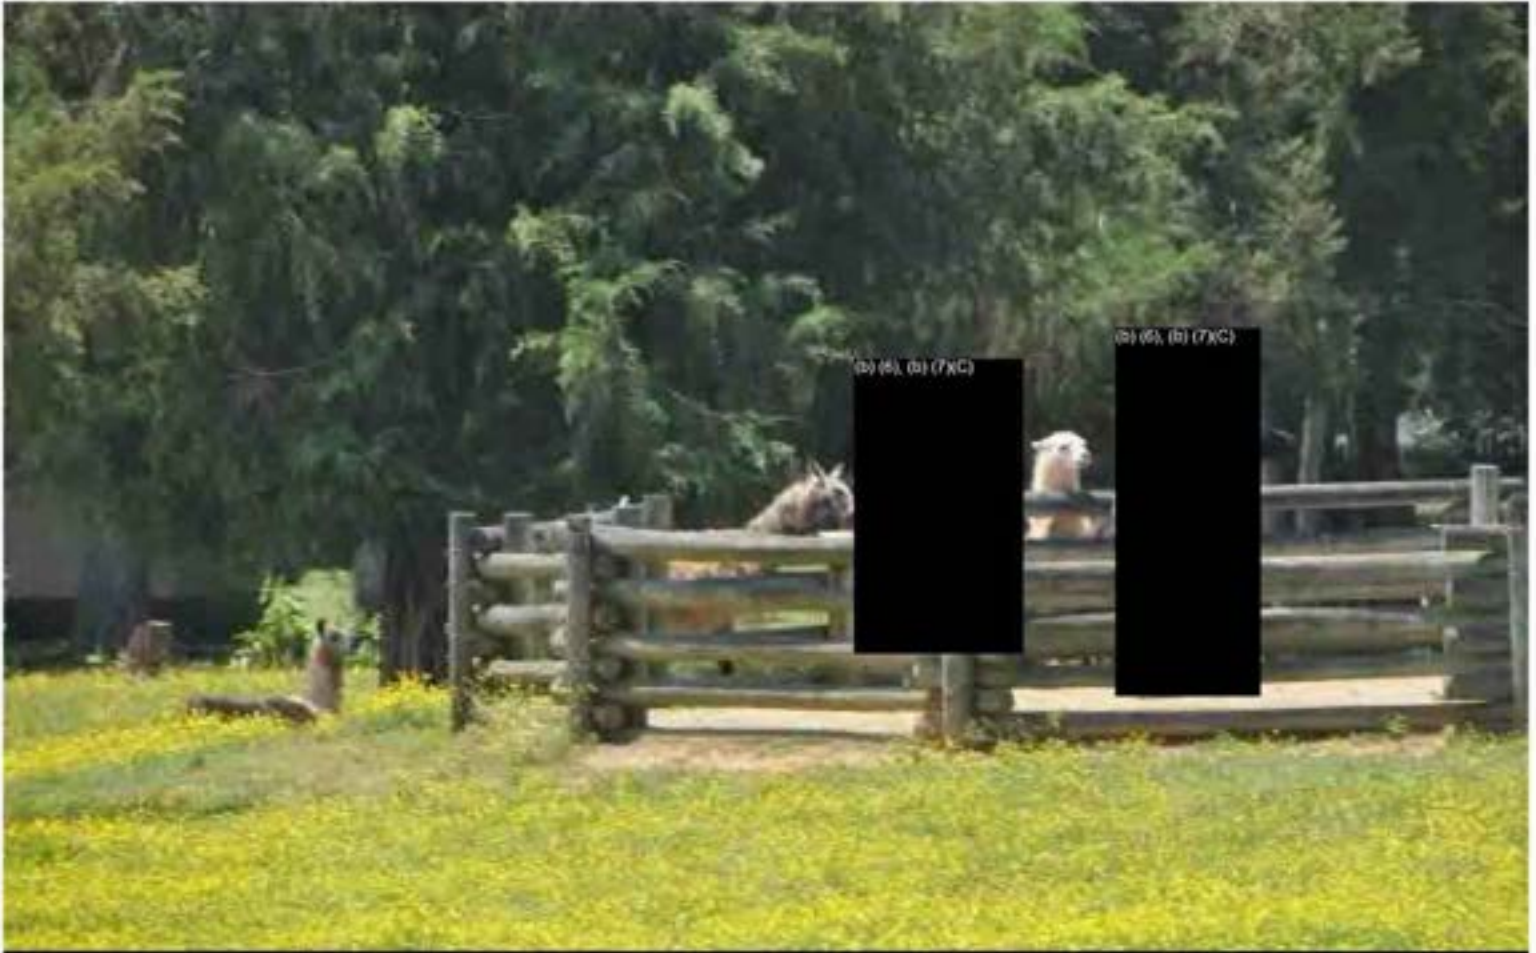
CFR: 2.131 (c) (1)

Photographer:	Randy Coleman	Legal Name:	55-B-0069
Photo Taken:	Wed, May 25, '16	HENRY HAMPTON	
Inspection:	147160841480226		
Description:	Section 2.131: Lack of barriers or attendants for animals in walk thru area of the park.

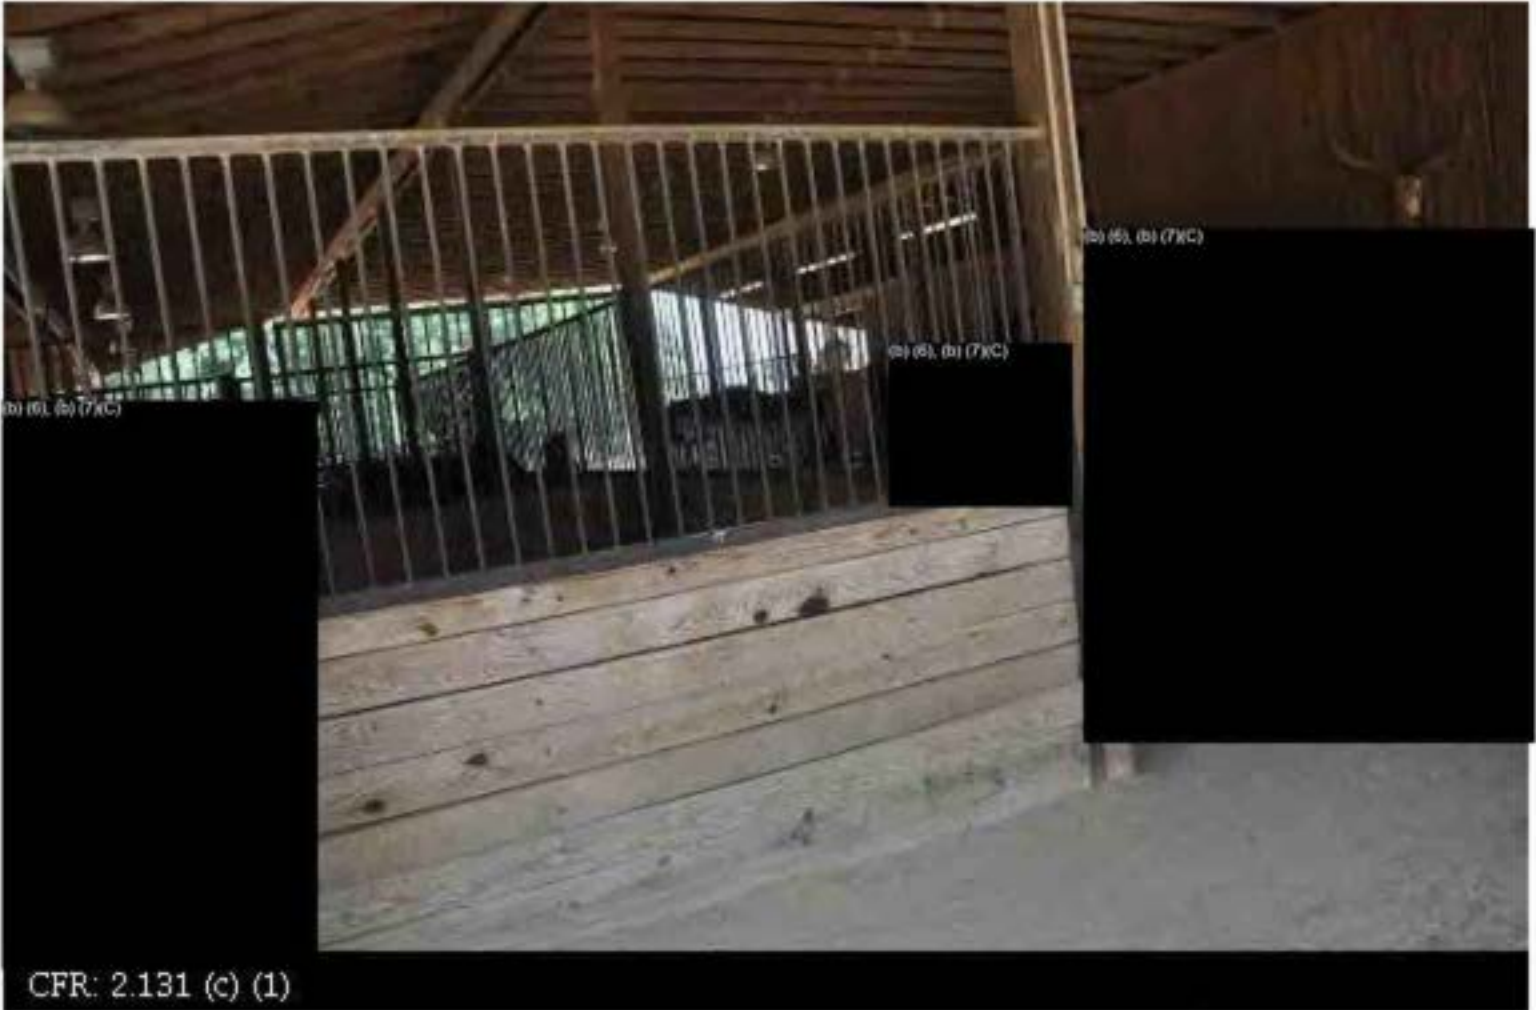
Photographer:	Randy Coleman	Legal Name:	55-B-0069
Photo Taken:	Wed, May 25, '16	HENRY HAMPTON	
Inspection:	147160841480226		
Description:	Section 2.131: Lack of barriers or attendants for animals in walk thru area of the park. Photo shows horse stall housing camel in wagon loading area.

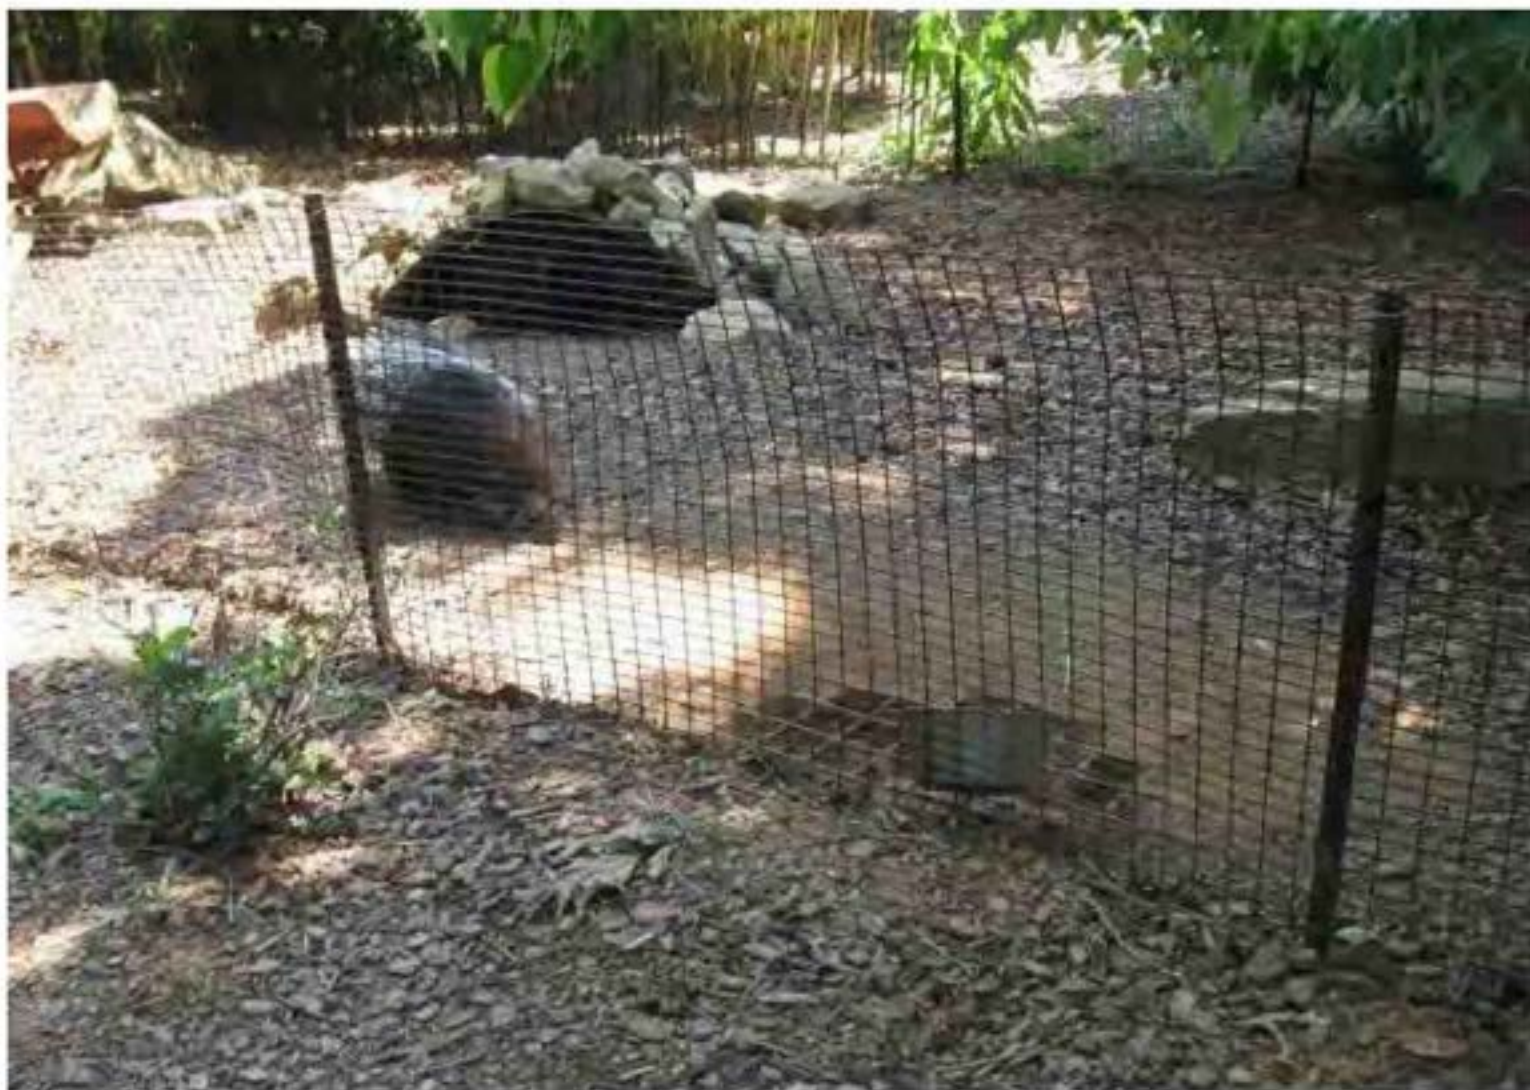
CFR: 3.125 (a)

Photographer:	S.Brunkhorst	Legal Name:	55-B-0069
Photo Taken:	Wed, May 25, '16	HENRY HAMPTON	
Inspection:	147160841480226		
Description:	Overview of African Crested porcupine enclosure

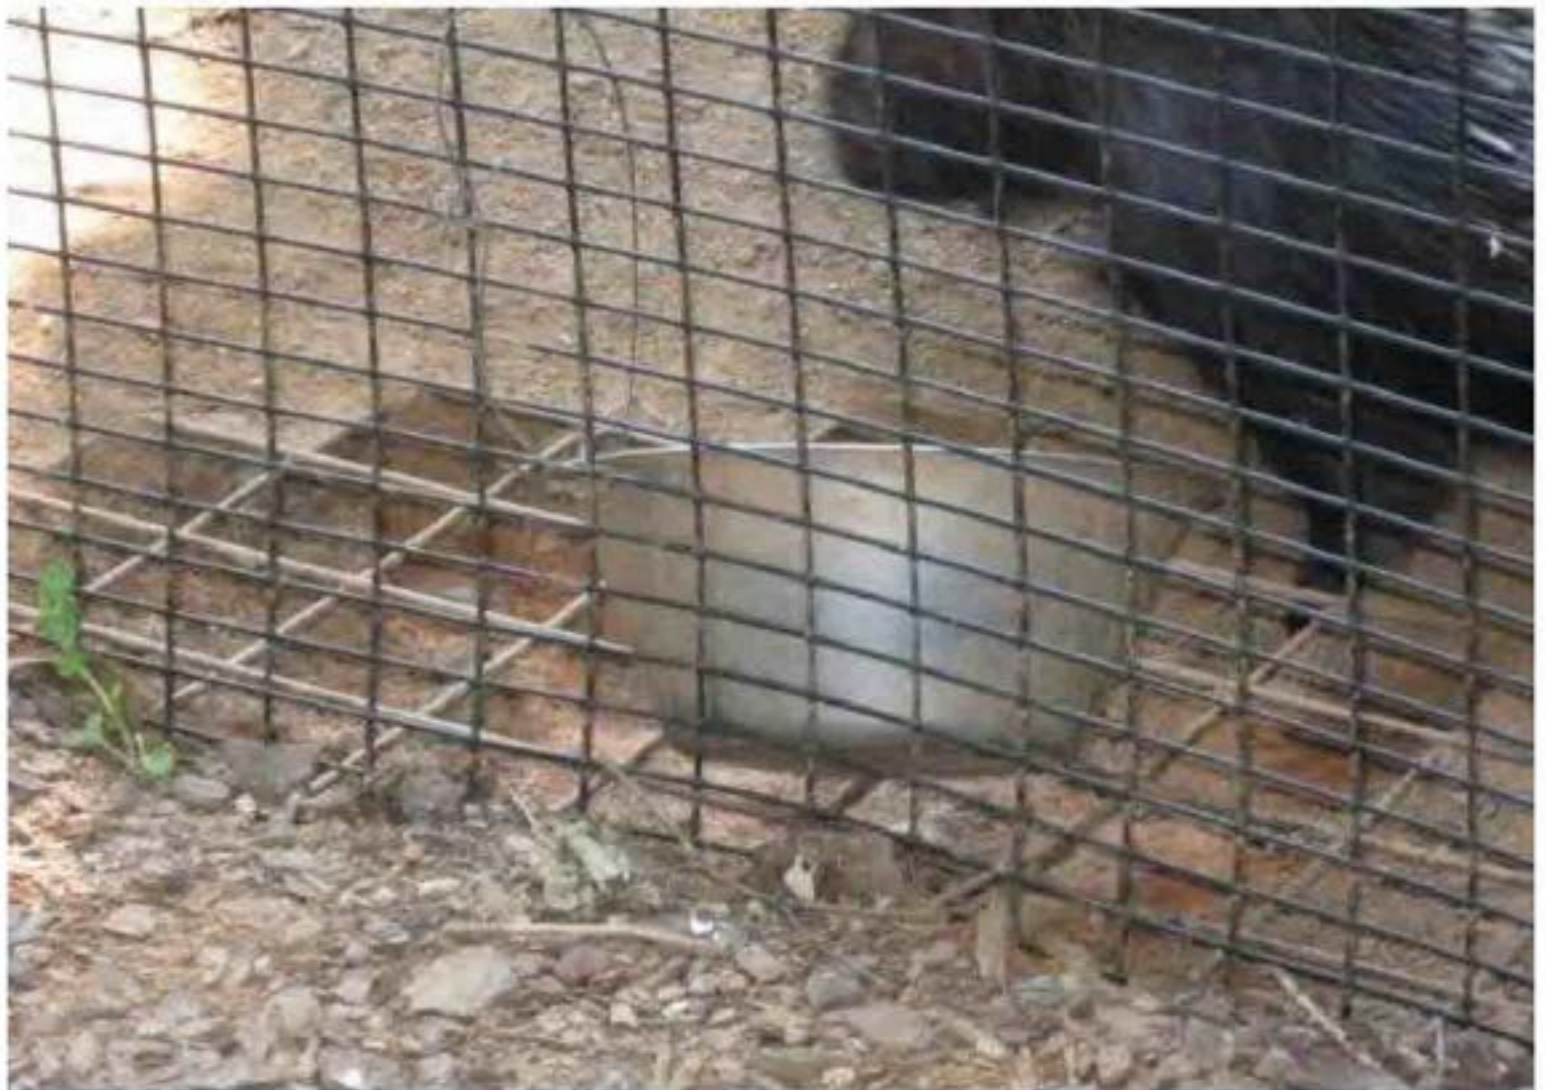
CFR: 3.125 (a)

Photographer:	S.Brunkhorst	Legal Name:	55-B-0069
Photo Taken:	Wed, May 25, '16	HENRY HAMPTON	
Inspection:	147160841480226		
Description:	Section 3.125a: Closeup of African Crested porcupine feed receptacle with dirt dug out underneath- animal's front foot slipping into one of the openings

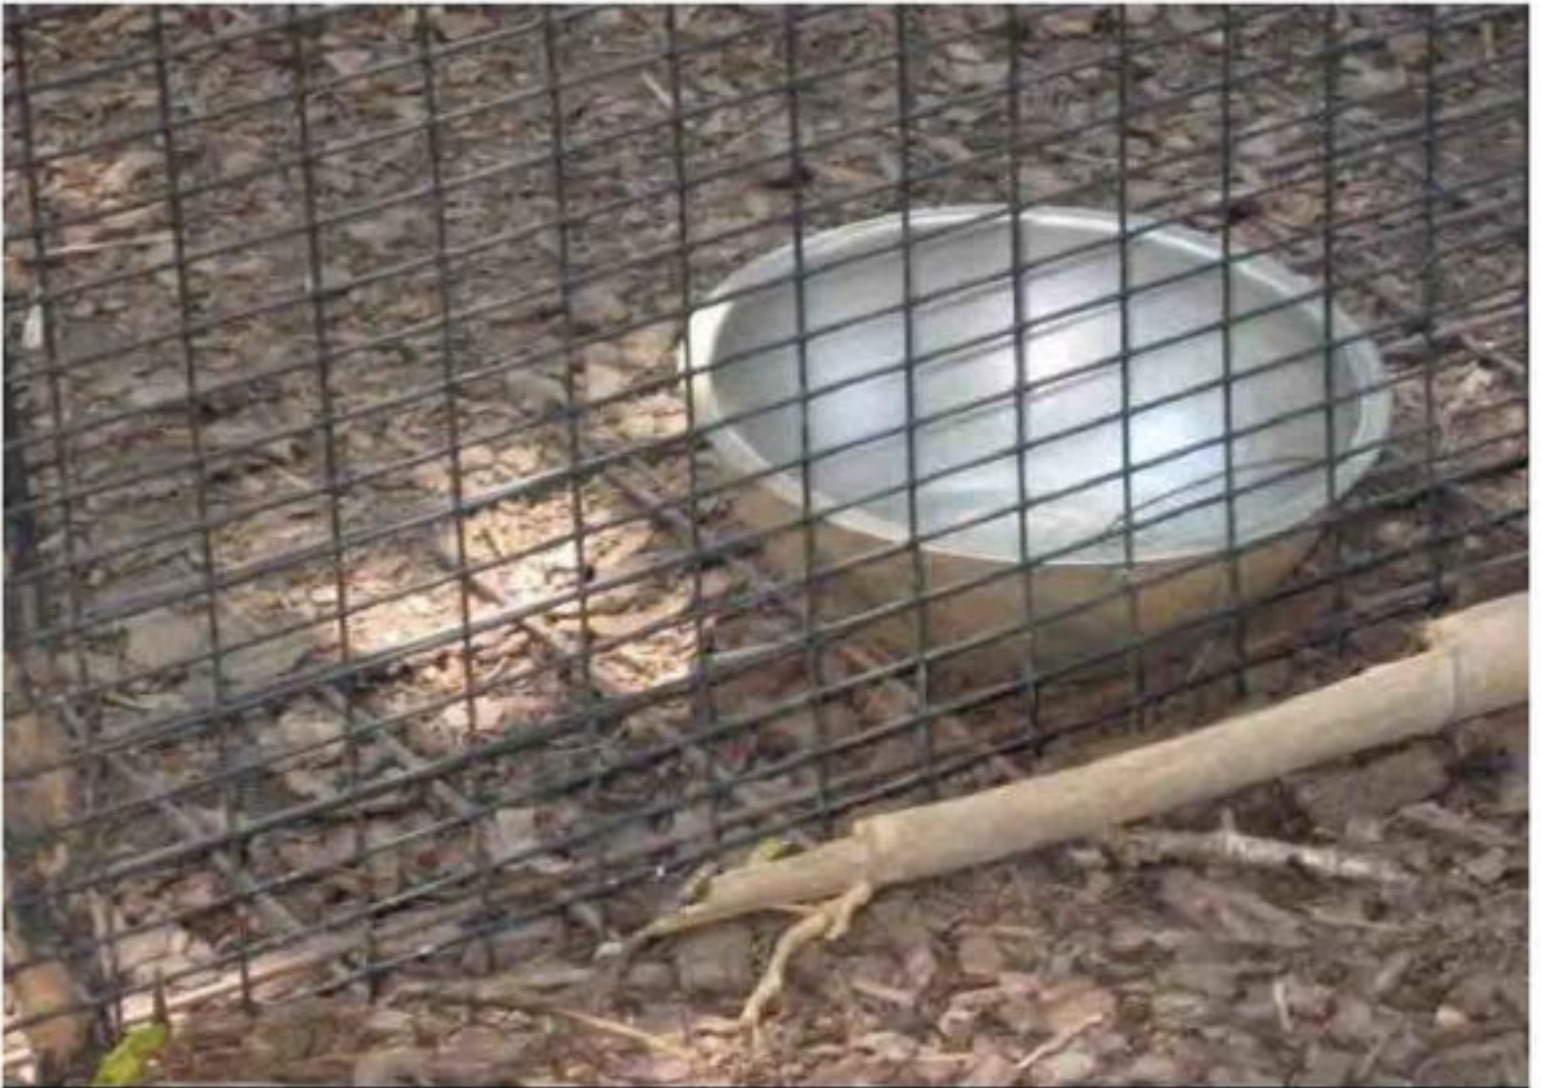
CFR: 3.125 (a)

Photographer:	S.Brunkhorst	Legal Name:	55-B-0069
Photo Taken:	Wed, May 25, '16	HENRY HAMPTON	
Inspection:	147160841480226		
Description:	Section 3.125a: African Crested porcupine water receptacle with dirt dug out underneath

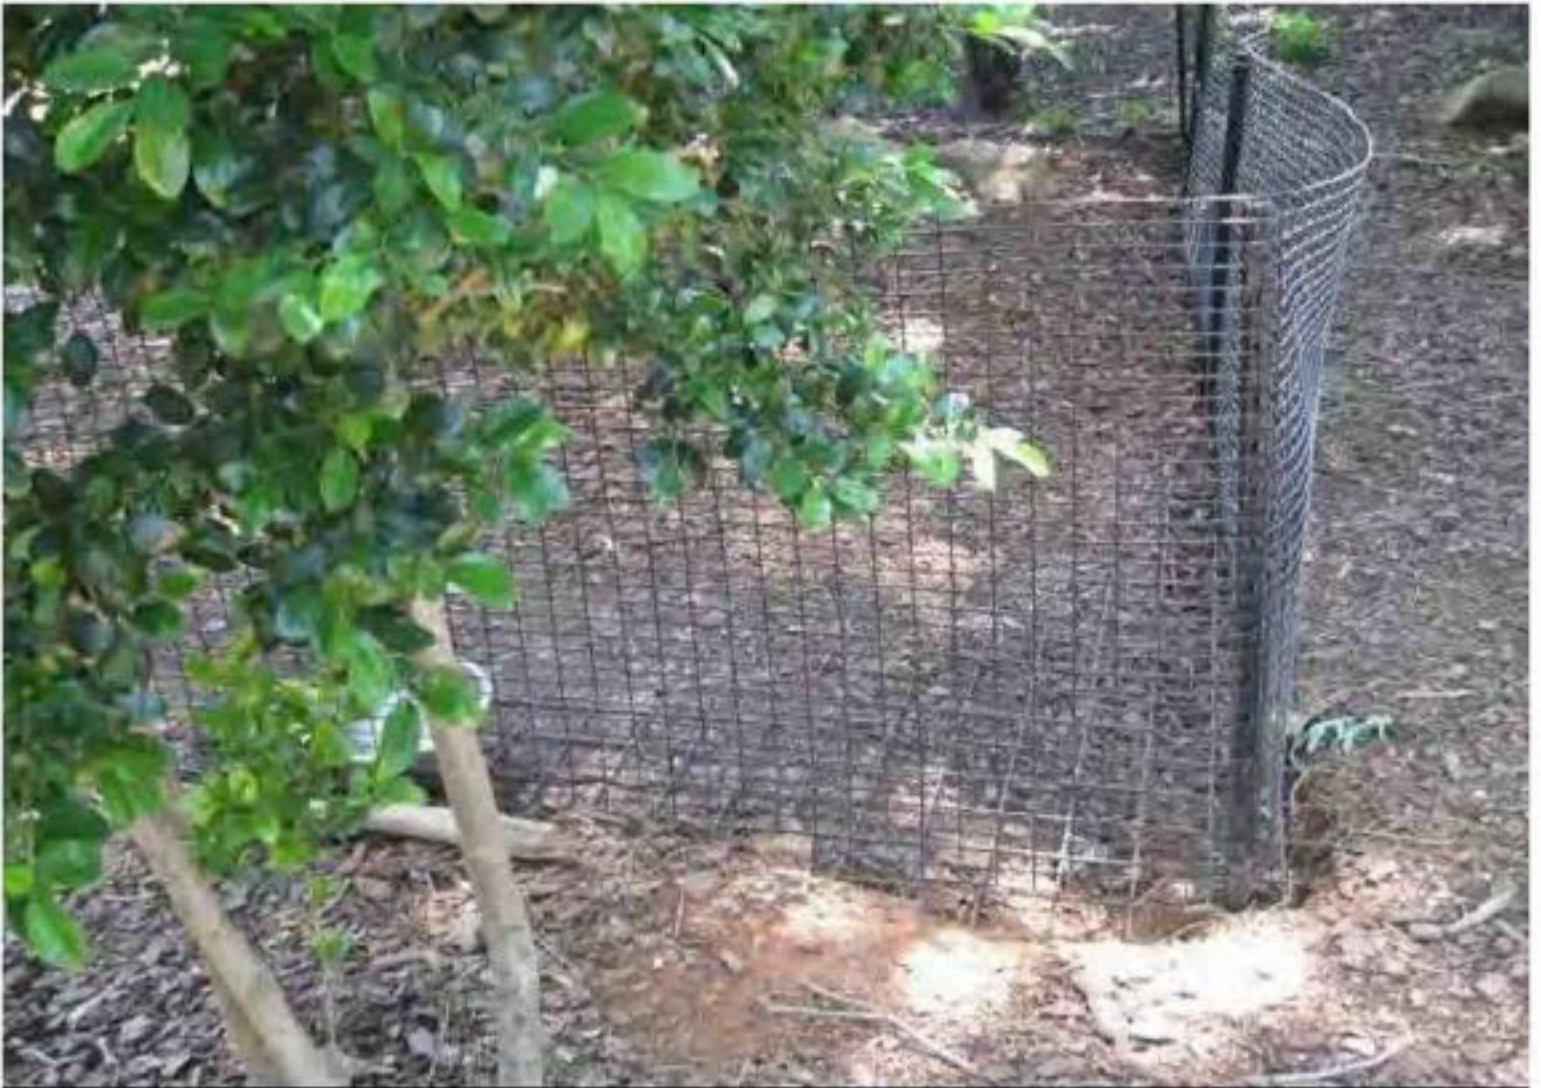
CFR: 3.125 (a)

Photographer:	S.Brunkhorst	Legal Name:	55-B-0069
Photo Taken:	Wed, May 25, '16	HENRY HAMPTON	
Inspection:	147160841480226		
Description:	Section 3.125a: African Crested porcupine-corner of enclosure with dirt dug out underneath wire

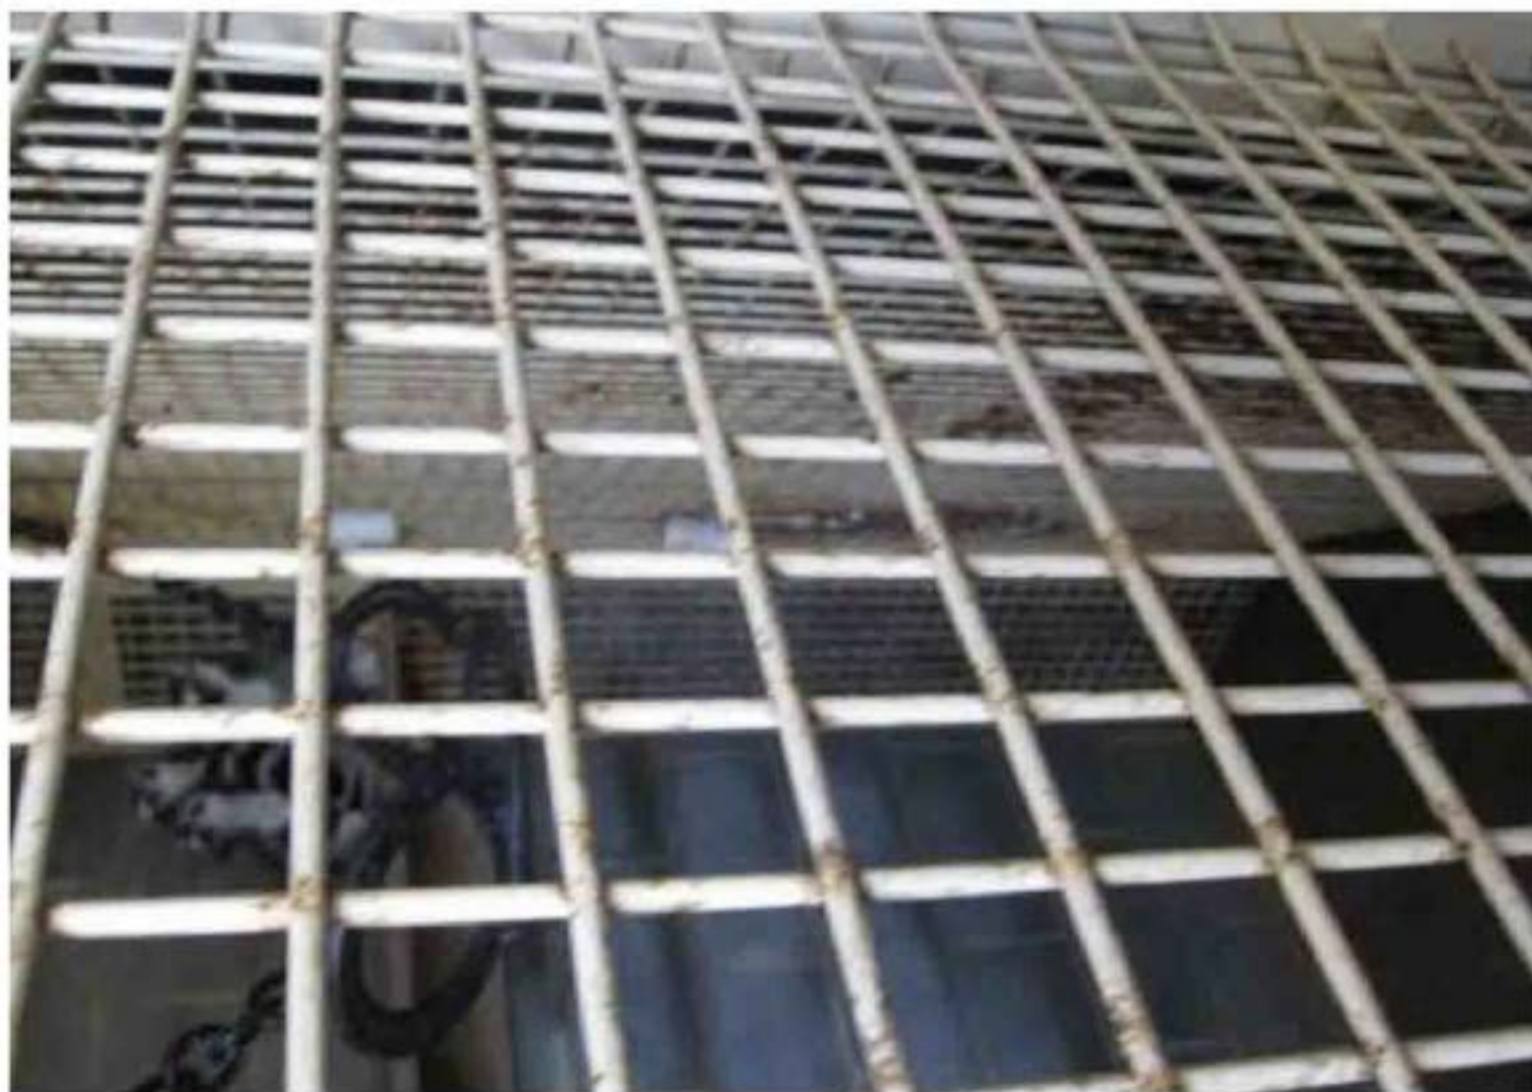
CFR: 3.75 (c) (1) (i)

Photographer:	S.Brunkhorst	Legal Name:	55-B-0069
Photo Taken:	Wed, May 25, '16	HENRY HAMPTON	
Inspection:	147160841480226		
Description:	Section 3.75(c)(1): Lemurs in indoor enclosure (upper corner) of enclosure with rusty bars

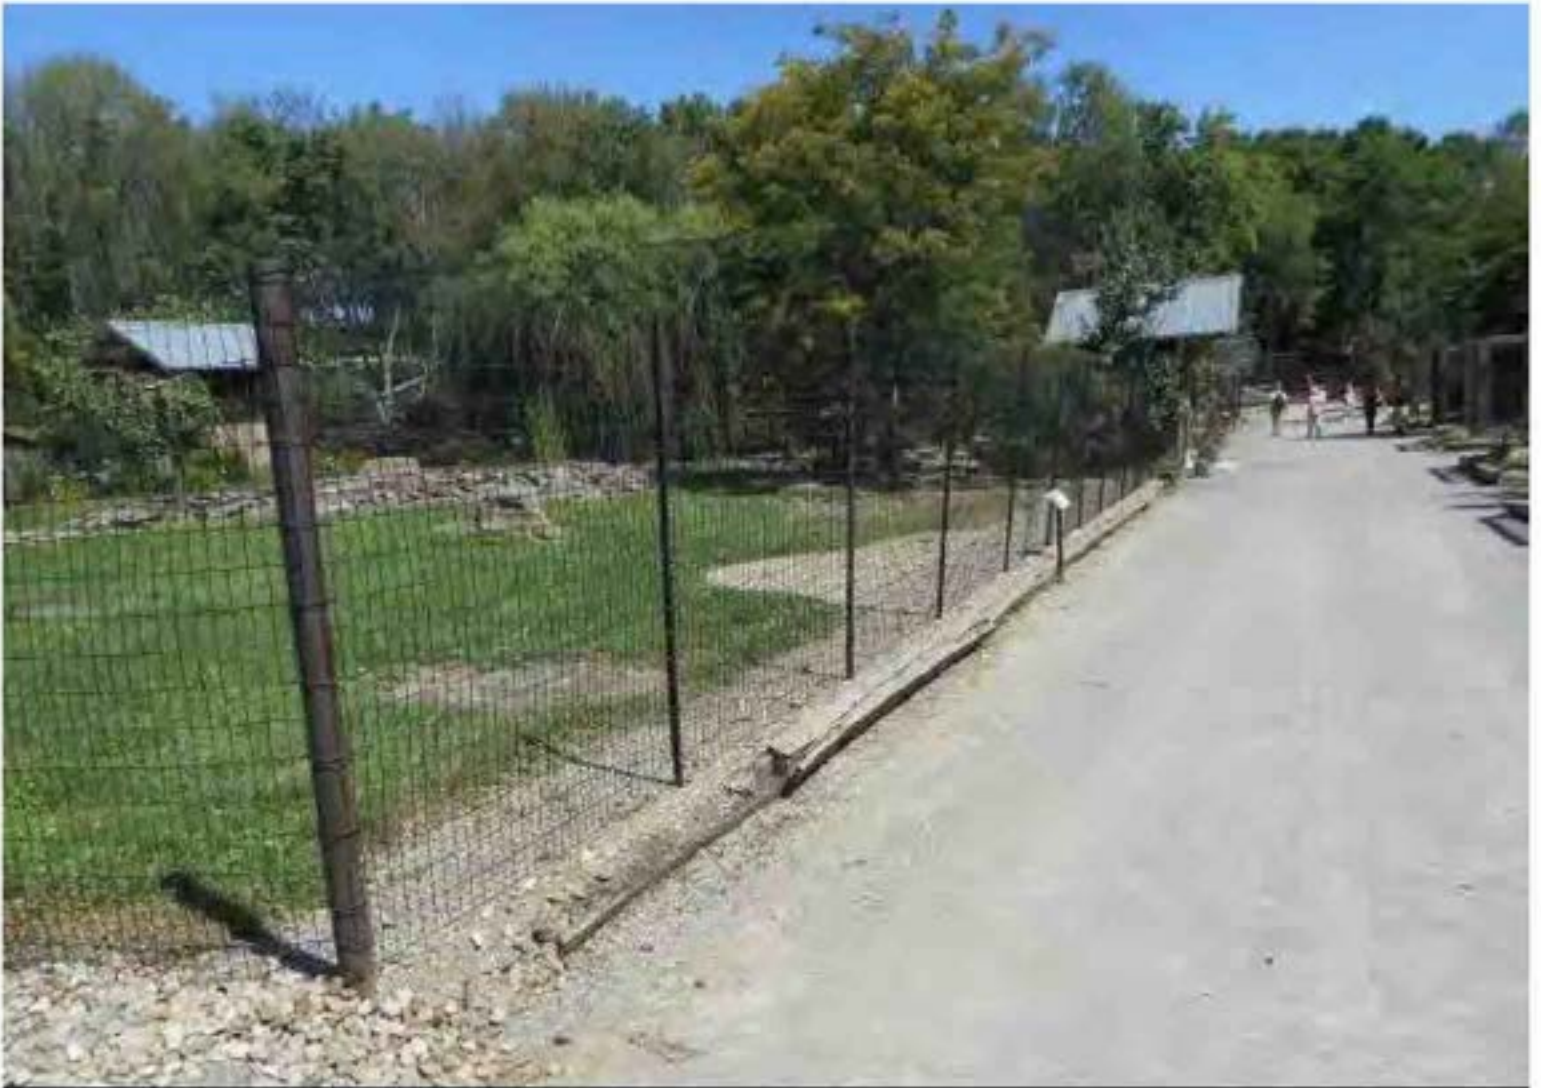
CFR: 2.131 (c) (1)

Photographer:	Randy Coleman	Legal Name:	55-B-0069
Photo Taken:	Wed, Aug 3, '16 1100 am	HENRY HAMPTON	
Inspection:	217160732290590		
Description:	2.131(c)(1): Lack of barriers or attendants throughout facility.
