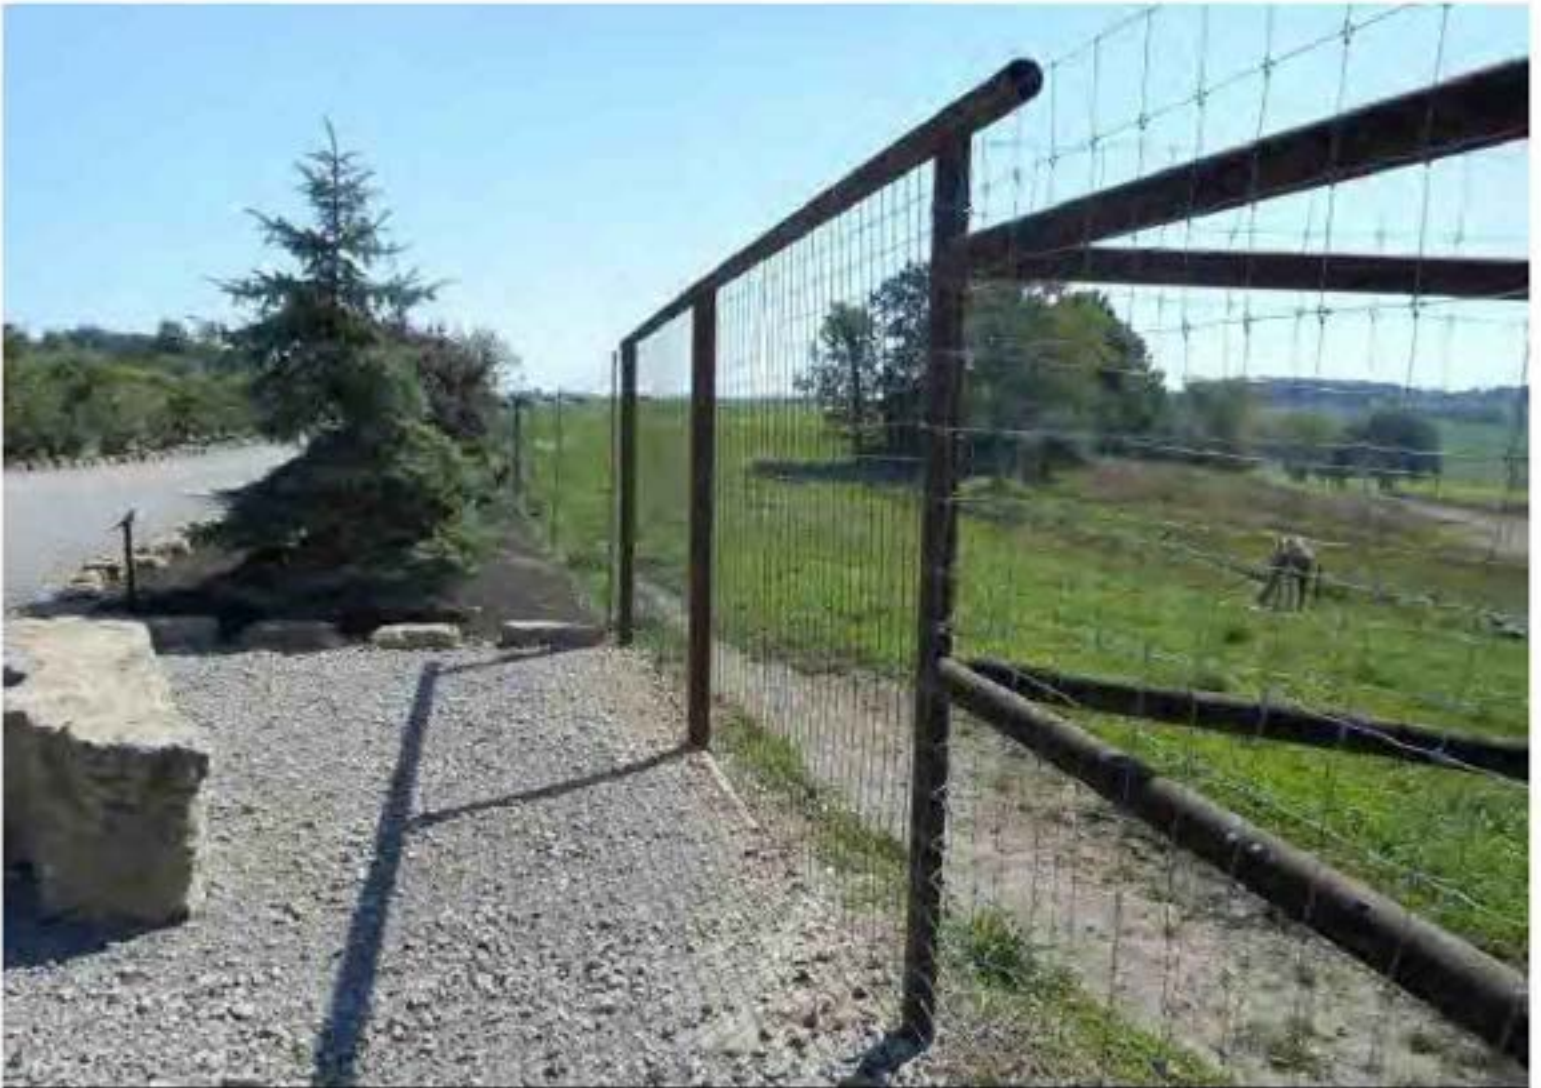
CFR: 2.131 (c) (1)

Photographer:	Randy Coleman	Legal Name:	55-B-0069
Photo Taken:	Wed, Aug 3, '16 1100 am	HENRY HAMPTON	
Inspection:	217160732290590		
Description:	2.131(c)(1): Lack of barriers or attendants throughout facility.

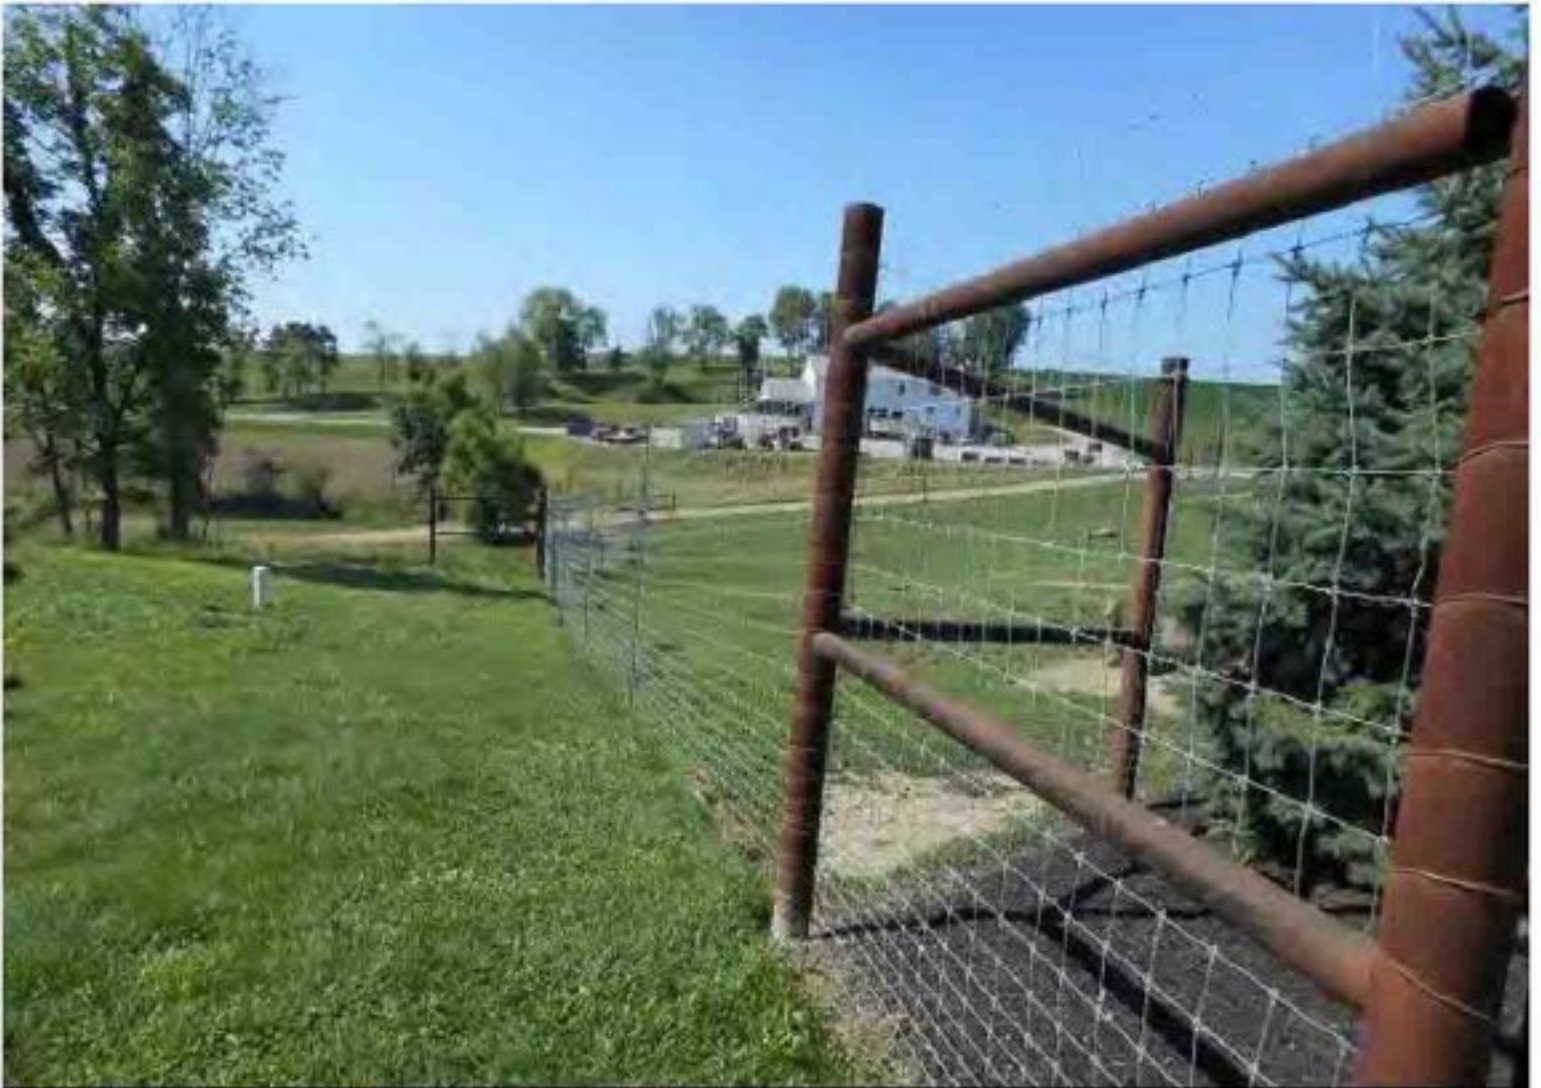
CFR: 2.131 (c) (1)

Photographer:	Randy Coleman	Legal Name:	55-B-0069
Photo Taken:	Wed, Aug 3, '16 1100 am	HENRY HAMPTON	
Inspection:	217160732290590		
Description:	2.131(c)(1): Lack of barriers or attendants throughout facility.

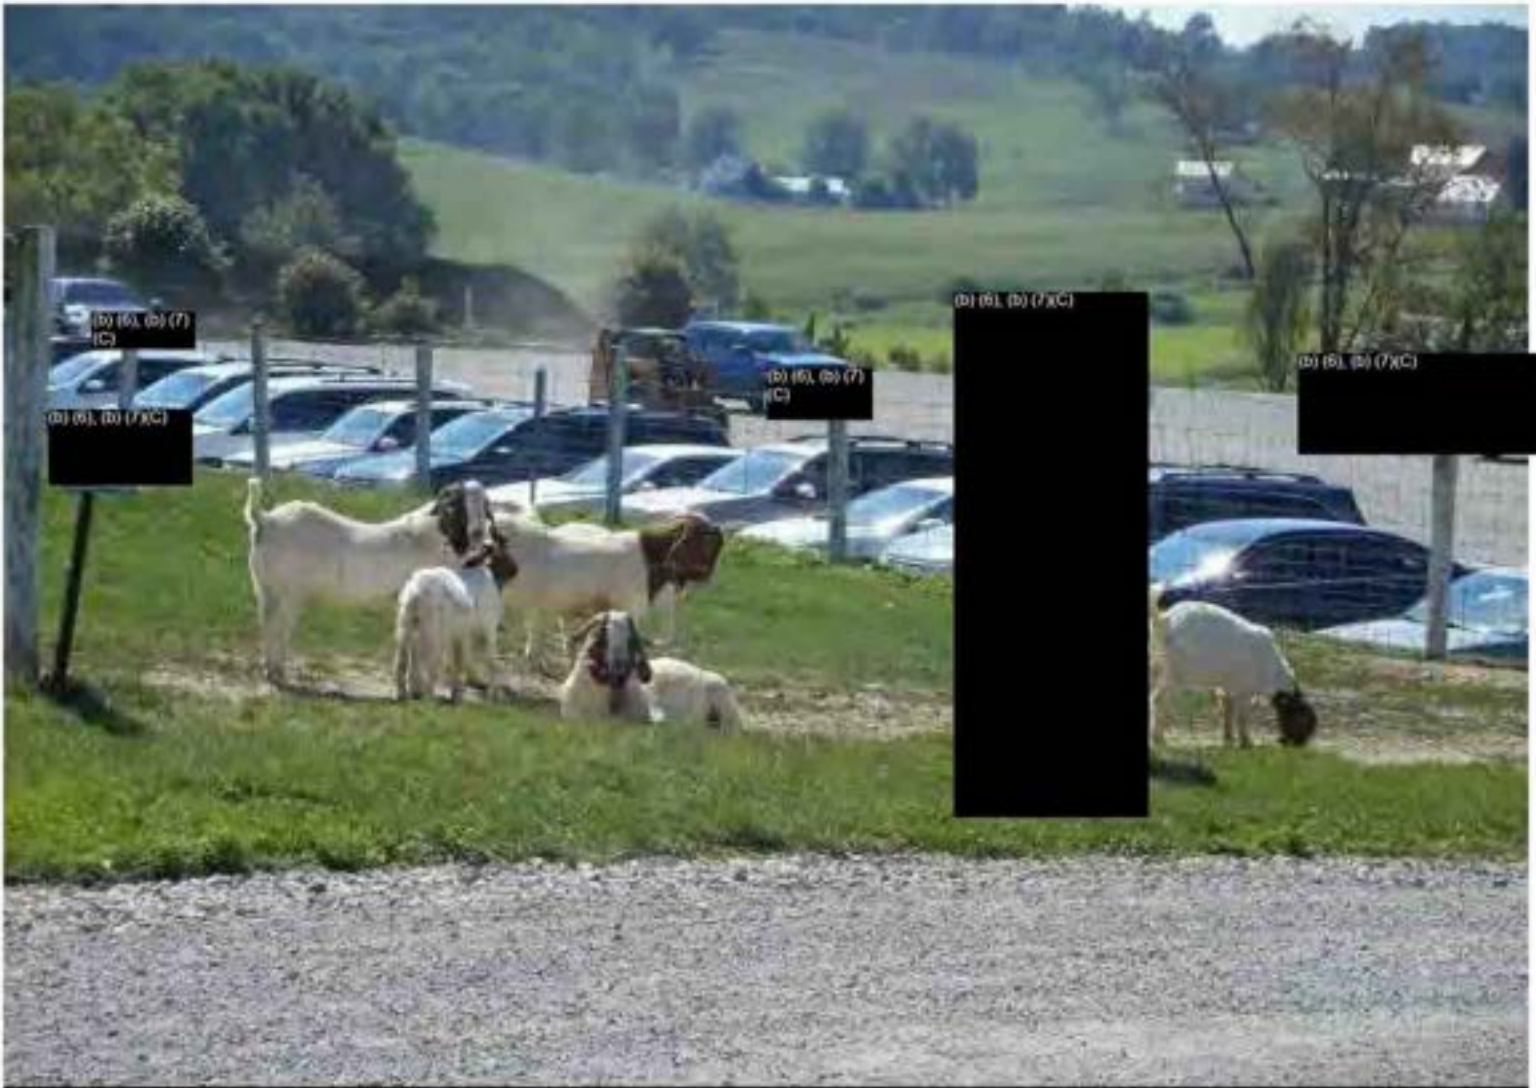
CFR: 2.131 (c) (1)

Photographer:	Randy Coleman	Legal Name:	55-B-0069
Photo Taken:	Wed, Aug 3, '16 1100 am	HENRY HAMPTON	
Inspection:	217160732290590		
Description:	2.131(c)(1): Lack of barriers or attendants throughout facility.

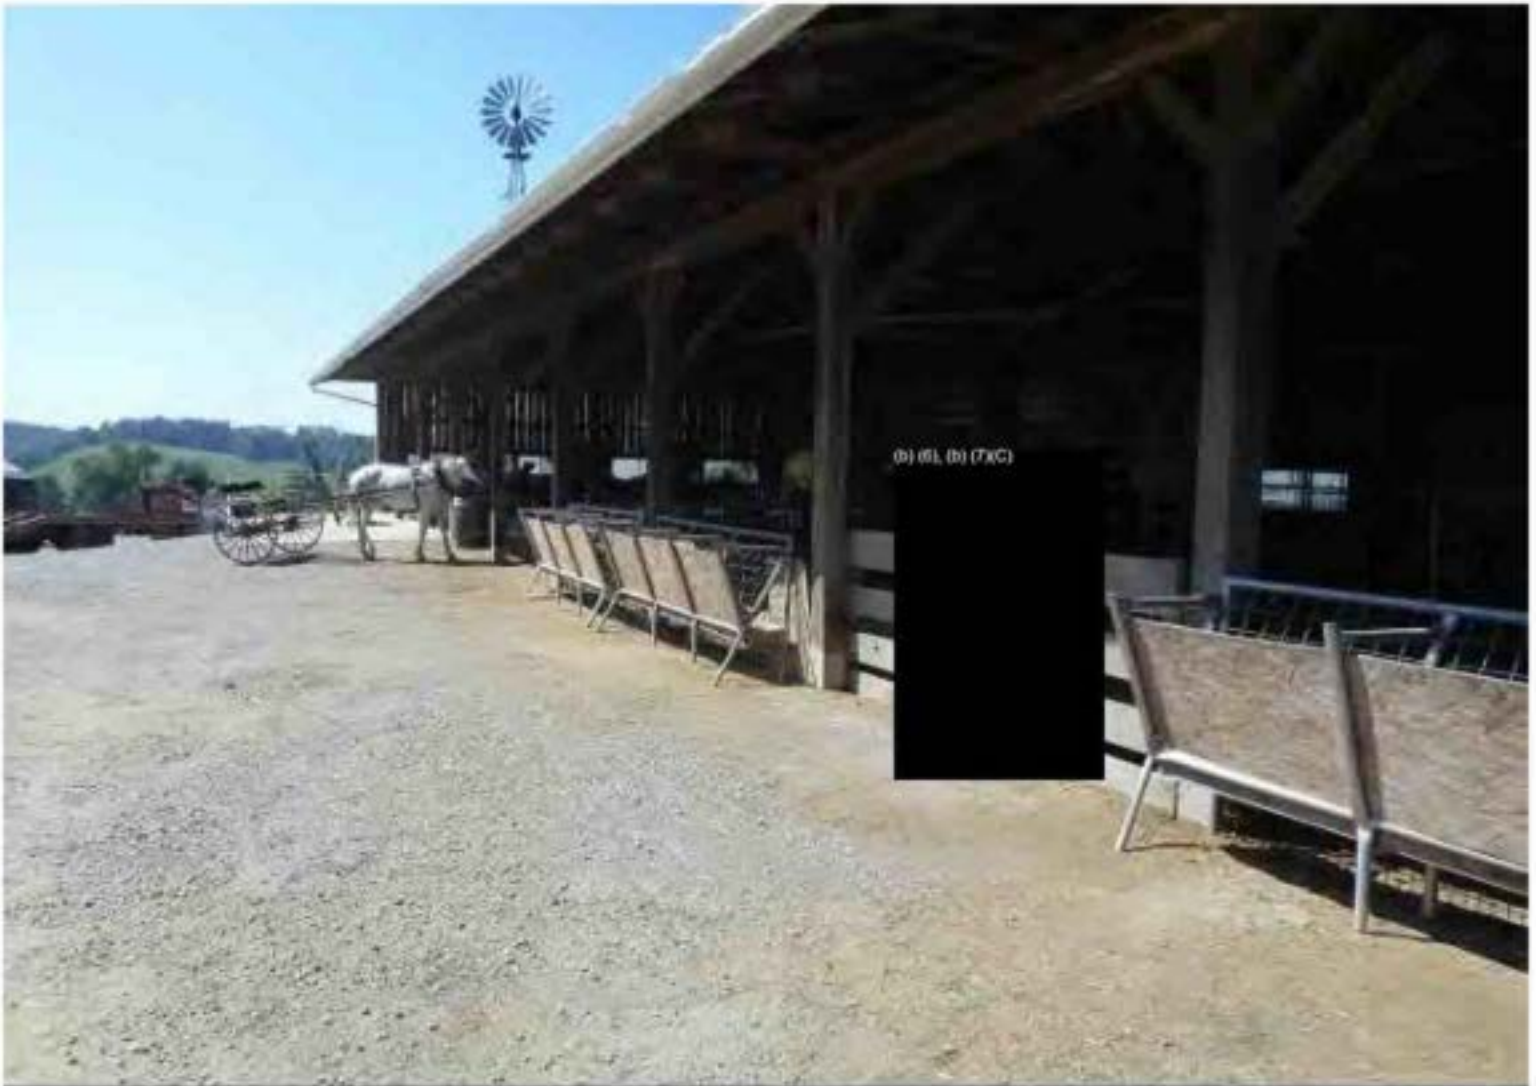
CFR: 2.131 (c) (1)

Photographer:	Randy Coleman	Legal Name:	55-B-0069
Photo Taken:	Wed, Aug 3, '16 1100 am	HENRY HAMPTON	
Inspection:	217160732290590		
Description:	2.131(c)(1): Lack of barriers or attendants throughout facility.

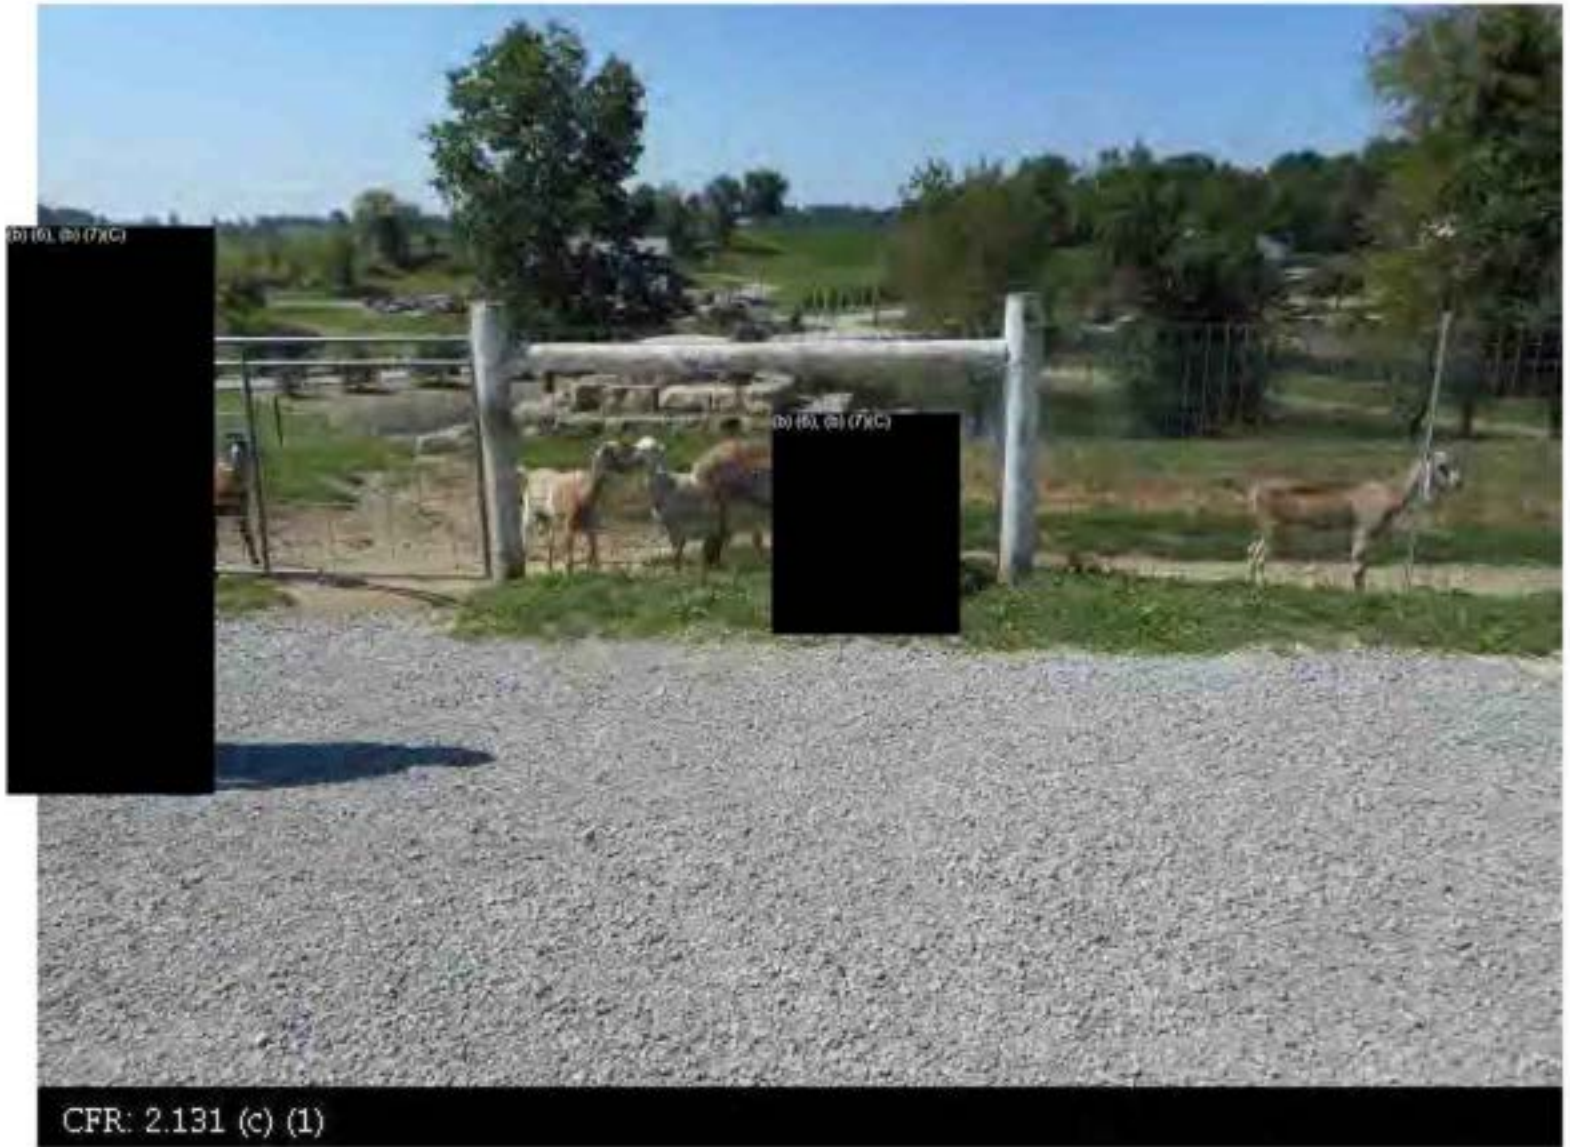
Photographer:	Randy Coleman	Legal Name:	55-B-0069
Photo Taken:	Wed, Aug 3, '16 1100 am	HENRY HAMPTON	
Inspection:	217160732290590		
Description:	2.131(c)(1): Lack of barriers or attendants throughout facility.

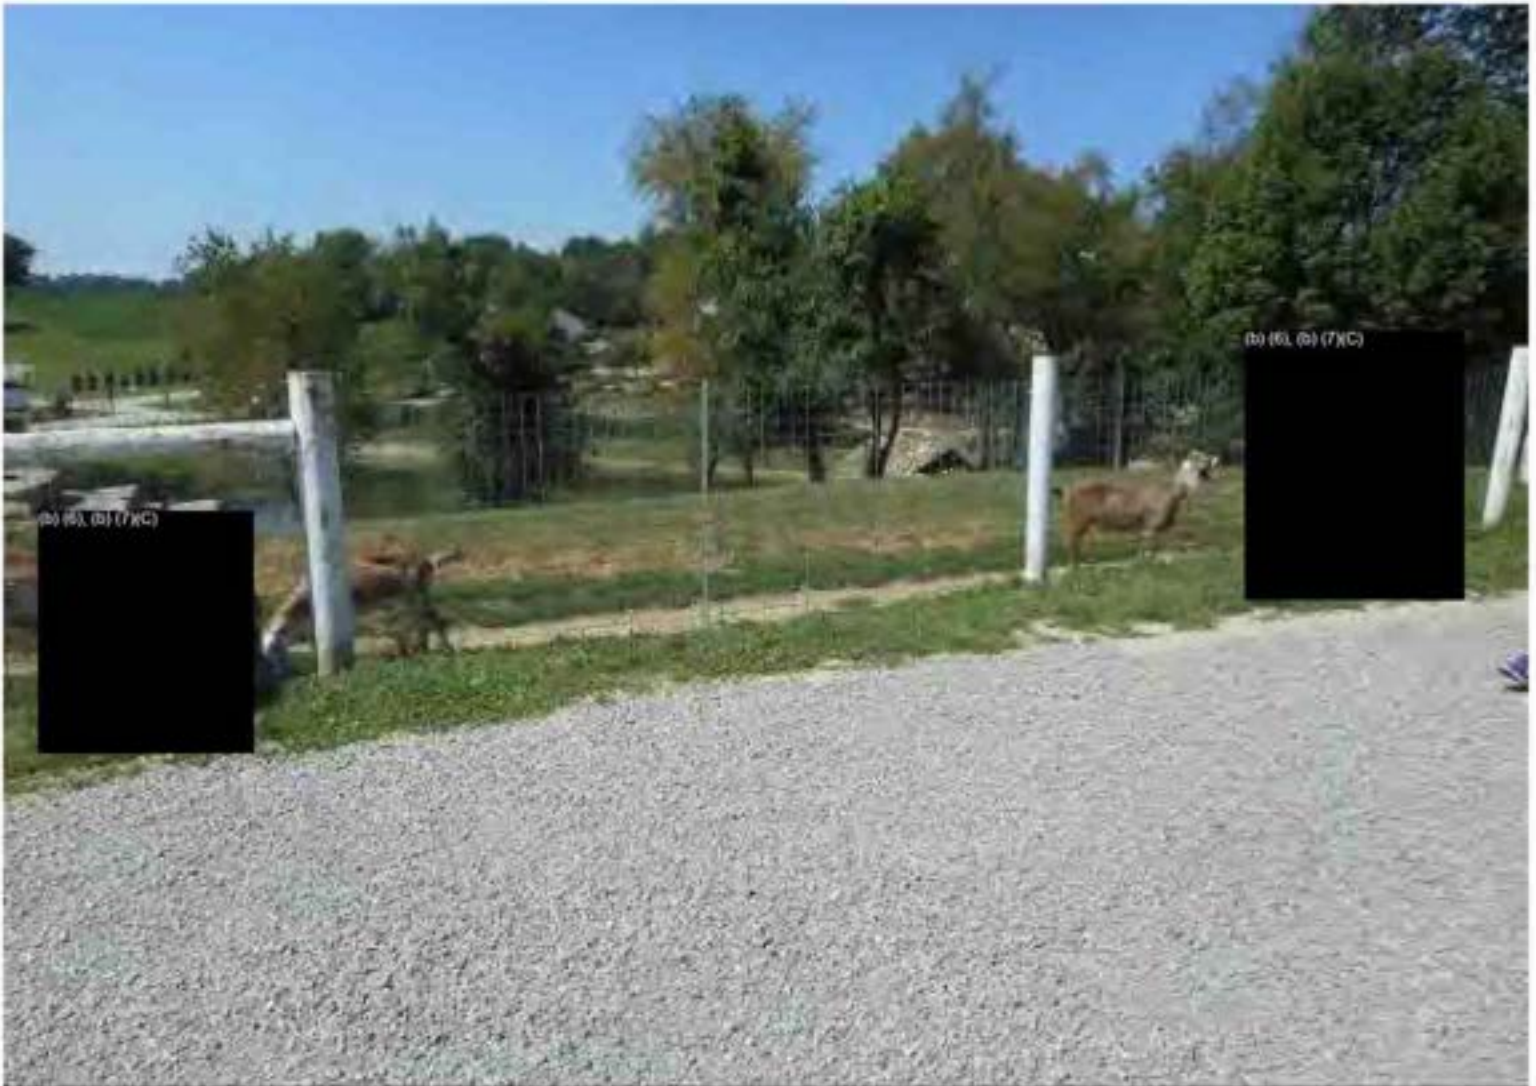
CFR: 2.131 (c) (1)

Photographer:	Randy Coleman	Legal Name:	55-B-0069
Photo Taken:	Wed, Aug 3, '16 1100 am	HENRY HAMPTON	
Inspection:	217160732290590		
Description:	2.131(c)(1): Lack of barriers or attendants throughout facility.

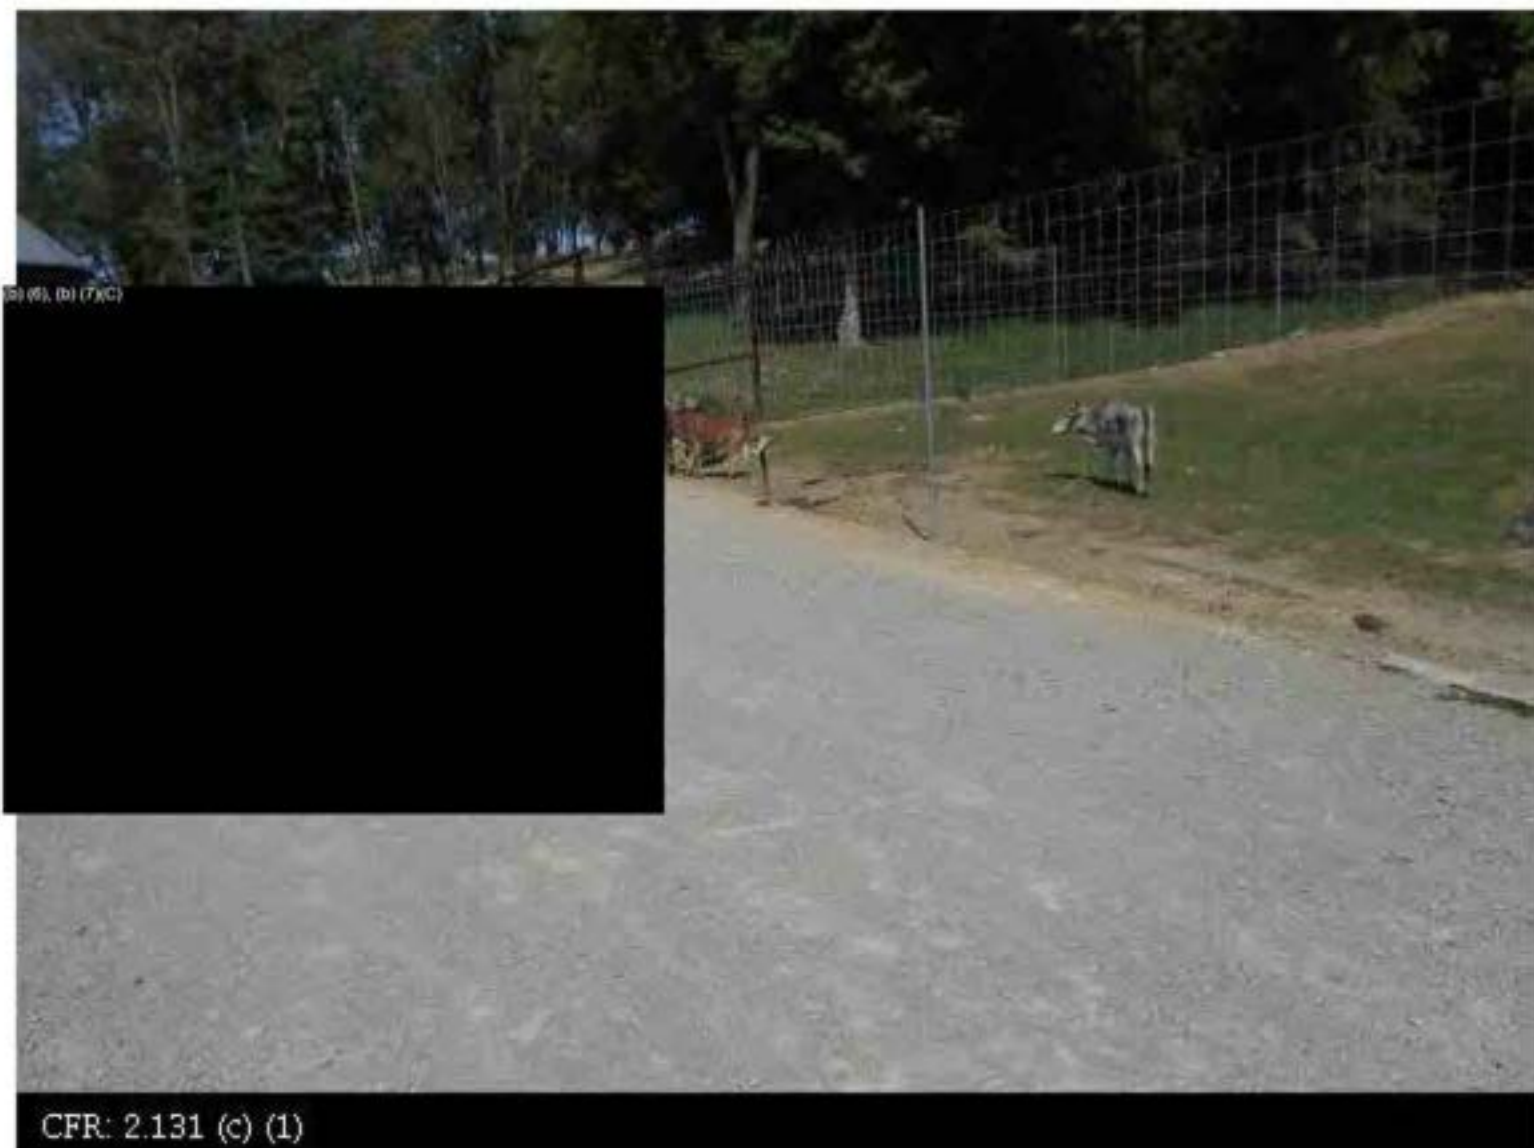
Photographer:	Randy Coleman	Legal Name:	55-B-0069
Photo Taken:	Wed, Aug 3, '16 1100 am	HENRY HAMPTON	
Inspection:	217160732290590		
Description:	2.131(c)(1): Lack of barriers or attendants throughout facility.

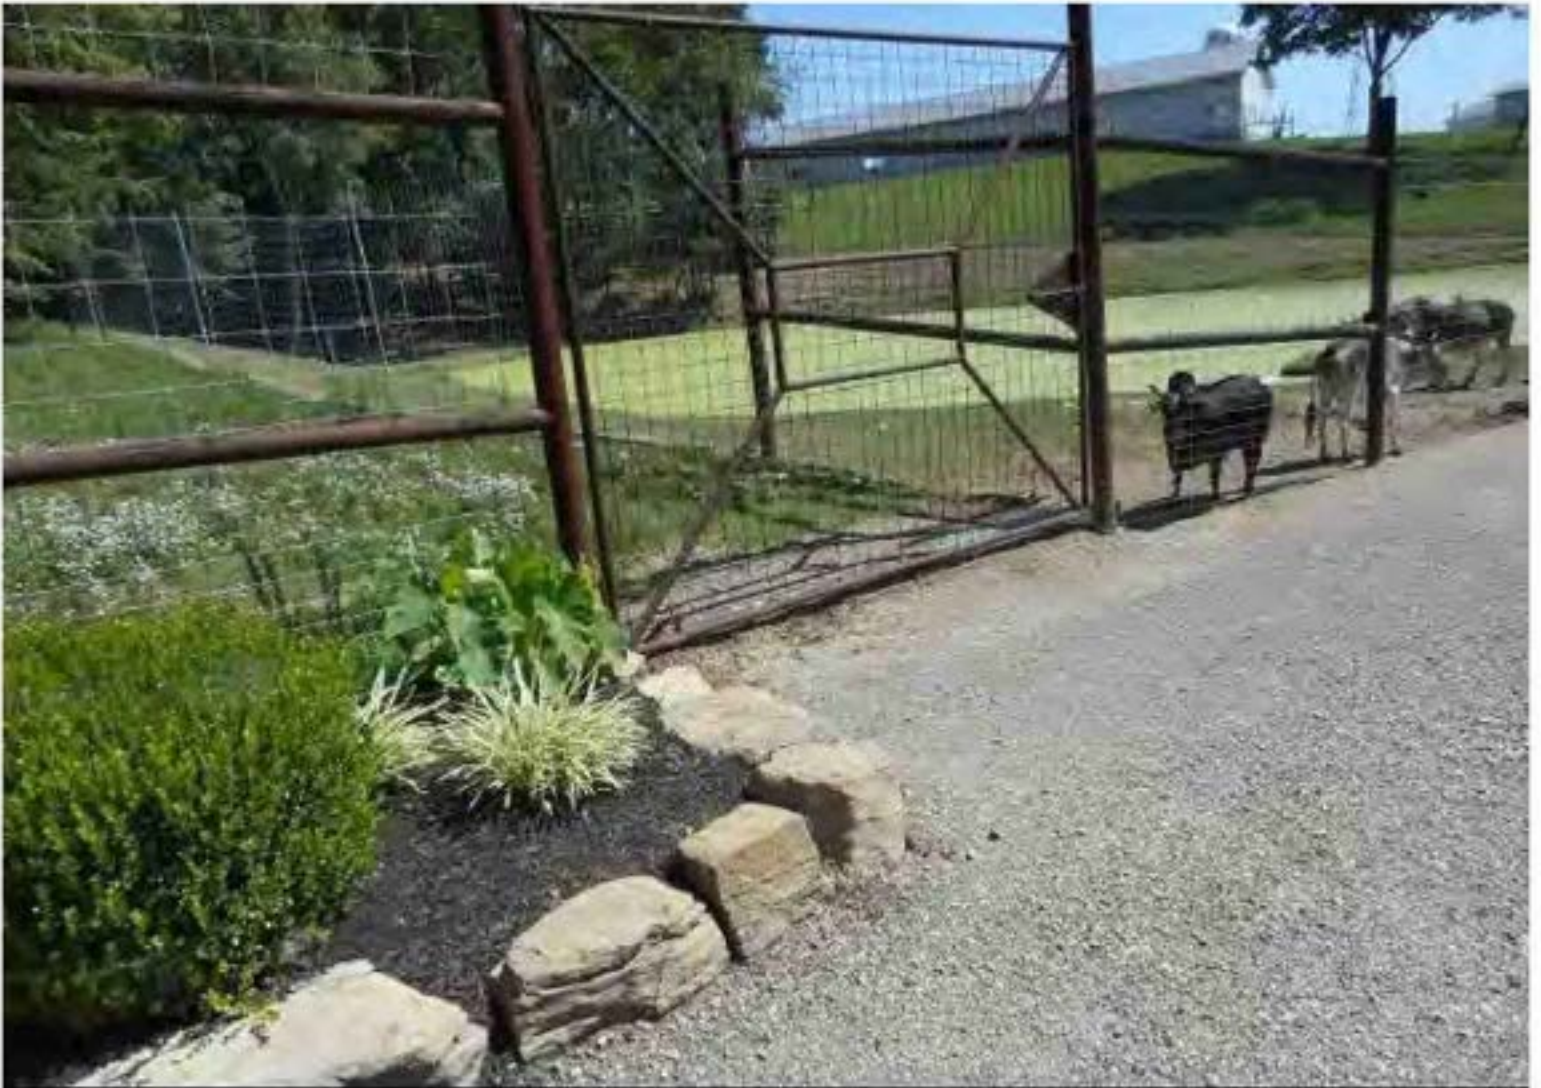
CFR: 2.131 (c) (1)

Photographer:	Randy Coleman	Legal Name:	55-B-0069
Photo Taken:	Wed, Aug 3, '16 1100 am	HENRY HAMPTON	
Inspection:	217160732290590		
Description:	2.131(c)(1): Lack of barriers or attendants throughout facility.

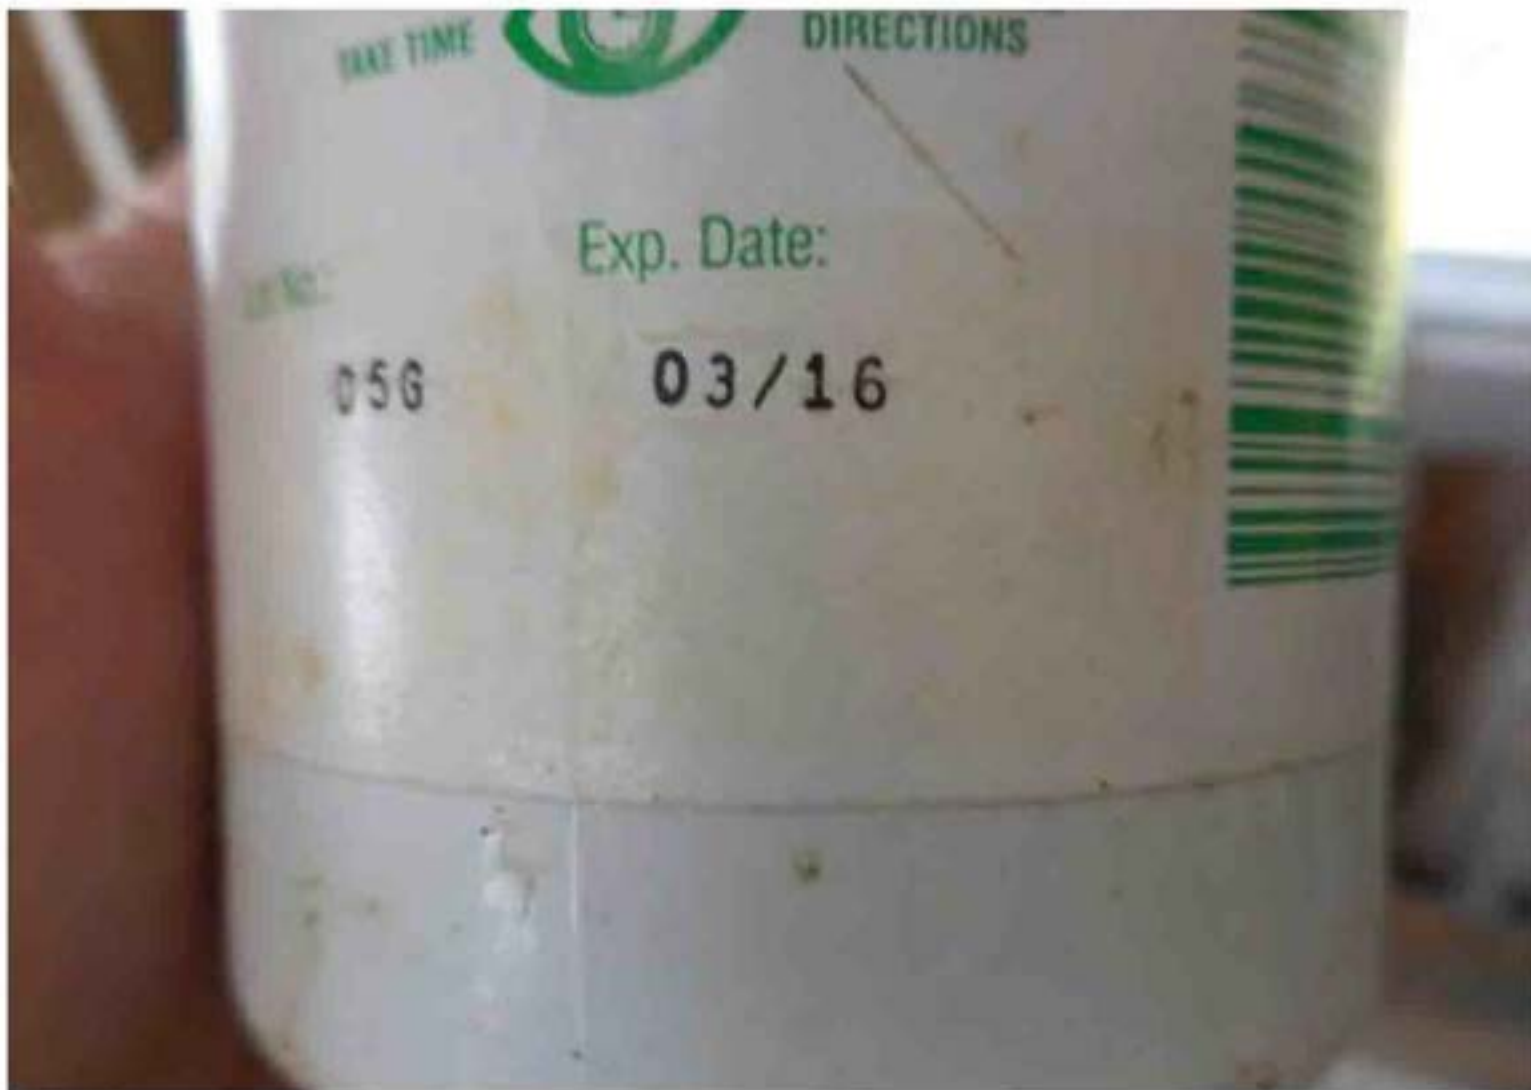
CFR: 2.40 (b) (1)

Photographer:	Randy Coleman	Legal Name:	55-B-0069
Photo Taken:	Wed, Aug 3, '16 1100 am	HENRY HAMPTON	
Inspection:	217160732290590		
Description:	2.40(b)(2): expired drugs found at facility.

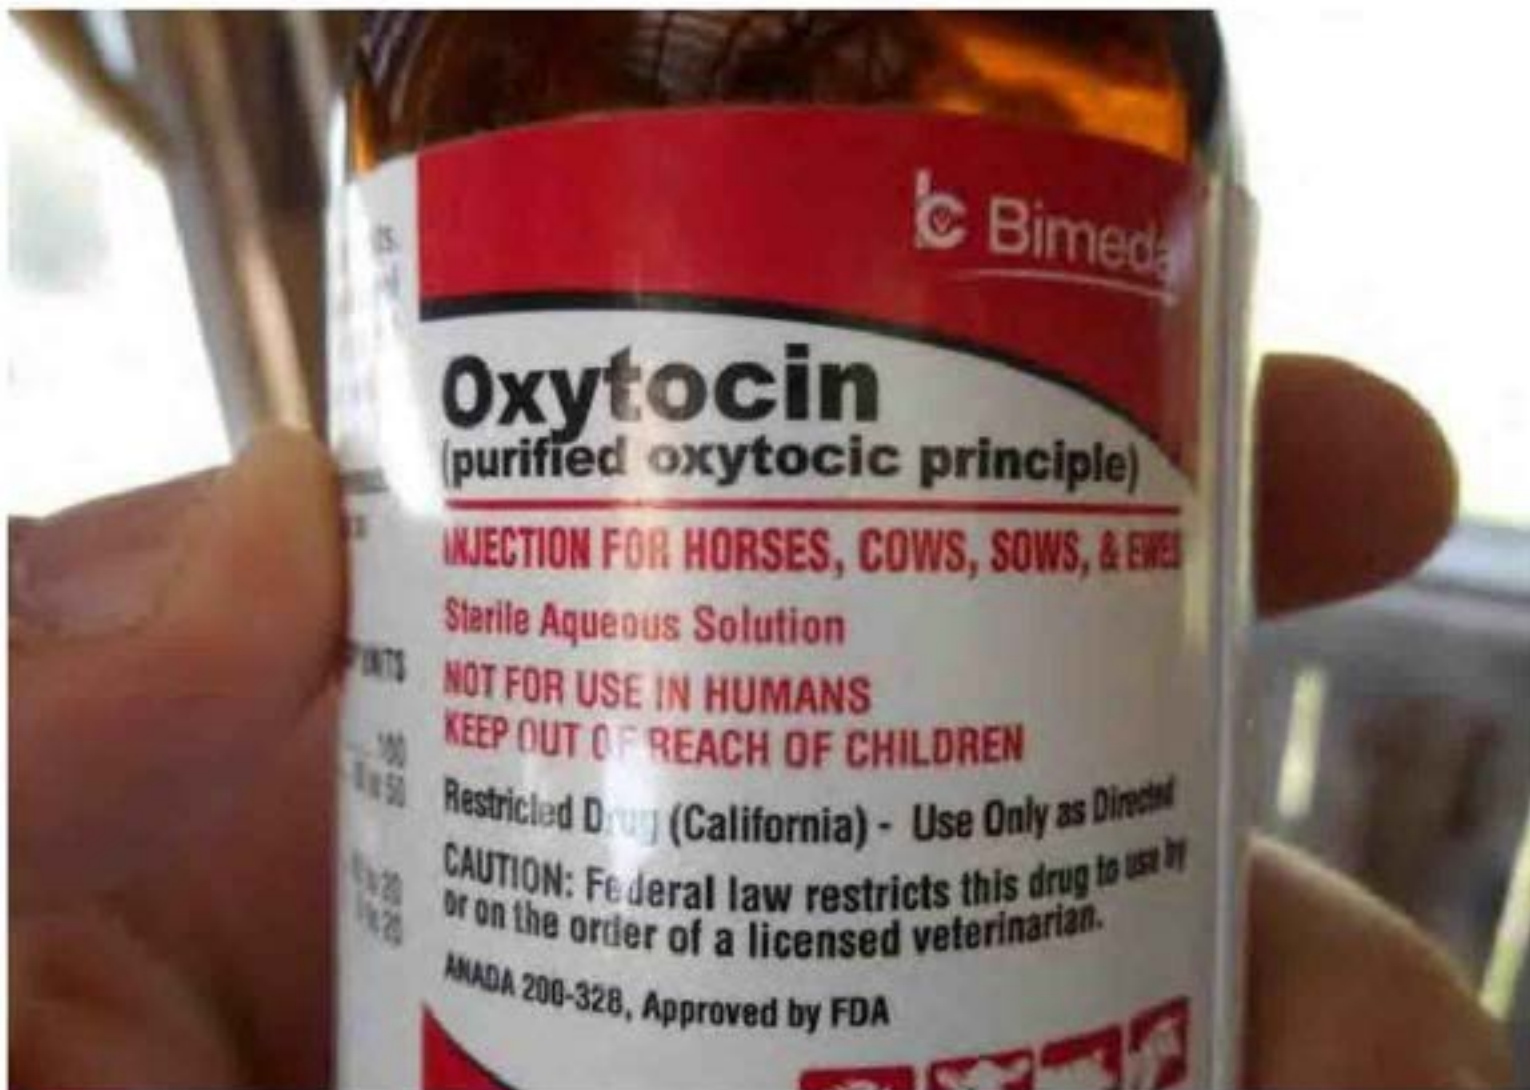
CFR: 2.40 (b) (1)

Photographer:	Randy Coleman	Legal Name:	55-B-0069
Photo Taken:	Wed, Aug 3, '16 1100 am	HENRY HAMPTON	
Inspection:	217160732290590		
Description:	2.40(b)(2): expired drugs found at facility.

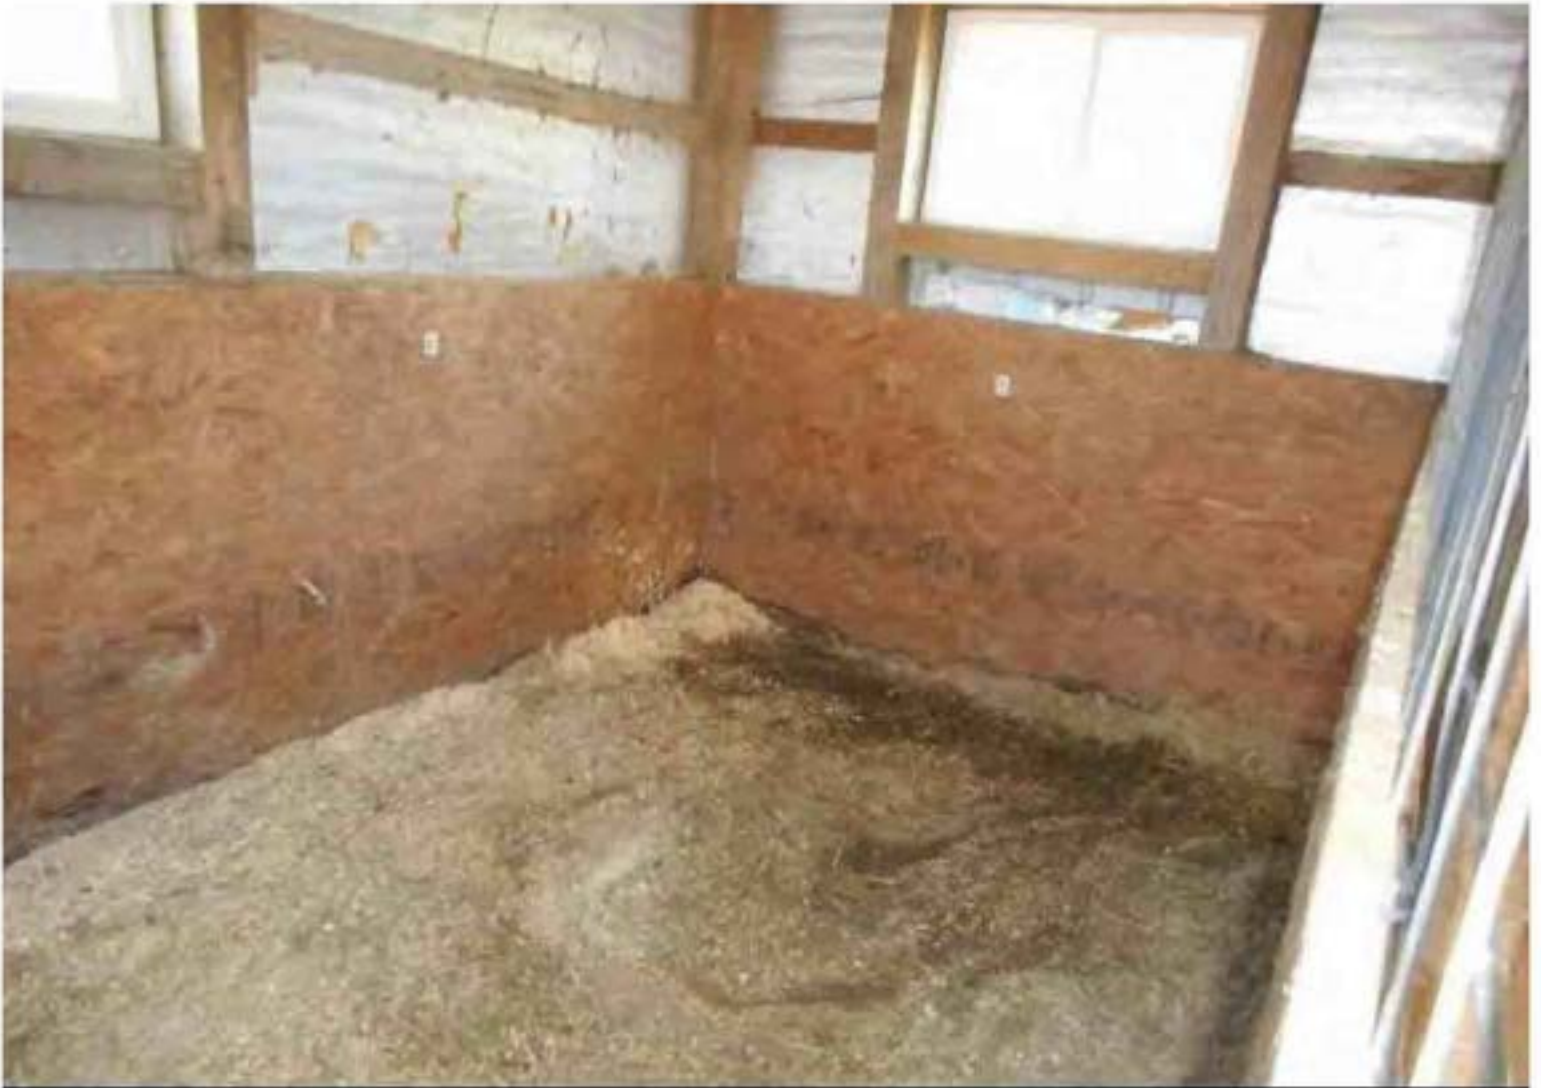
CFR: 3.131 (c)

Photographer:	Randy Coleman	Legal Name:	55-B-0069
Photo Taken:	Wed, Aug 3, '16 1100 am	HENRY HAMPTON	
Inspection:	217160732290590		
Description:	3.131(c): Kangaroo indoor area in need of cleaning.

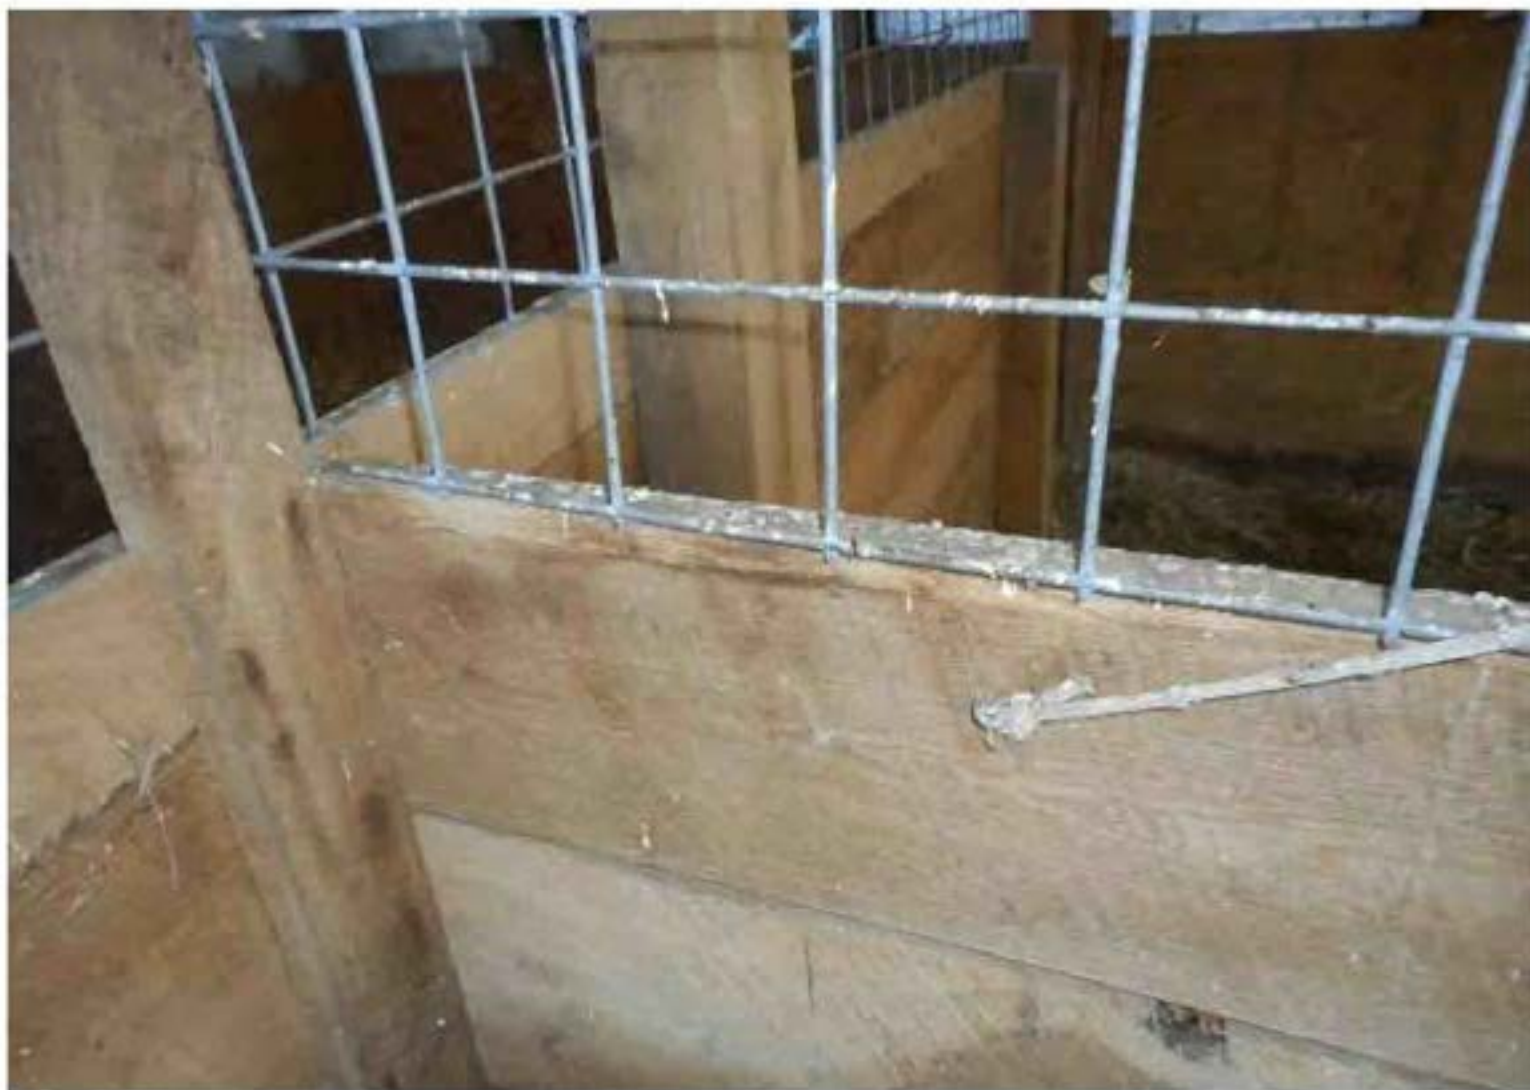
CFR: 3.131 (c)

Photographer:	Randy Coleman	Legal Name:	55-B-0069
Photo Taken:	Wed, Aug 3, '16 1100 am	HENRY HAMPTON	
Inspection:	217160732290590		
Description:	3.131(c): Kangaroo indoor area in need of cleaning.

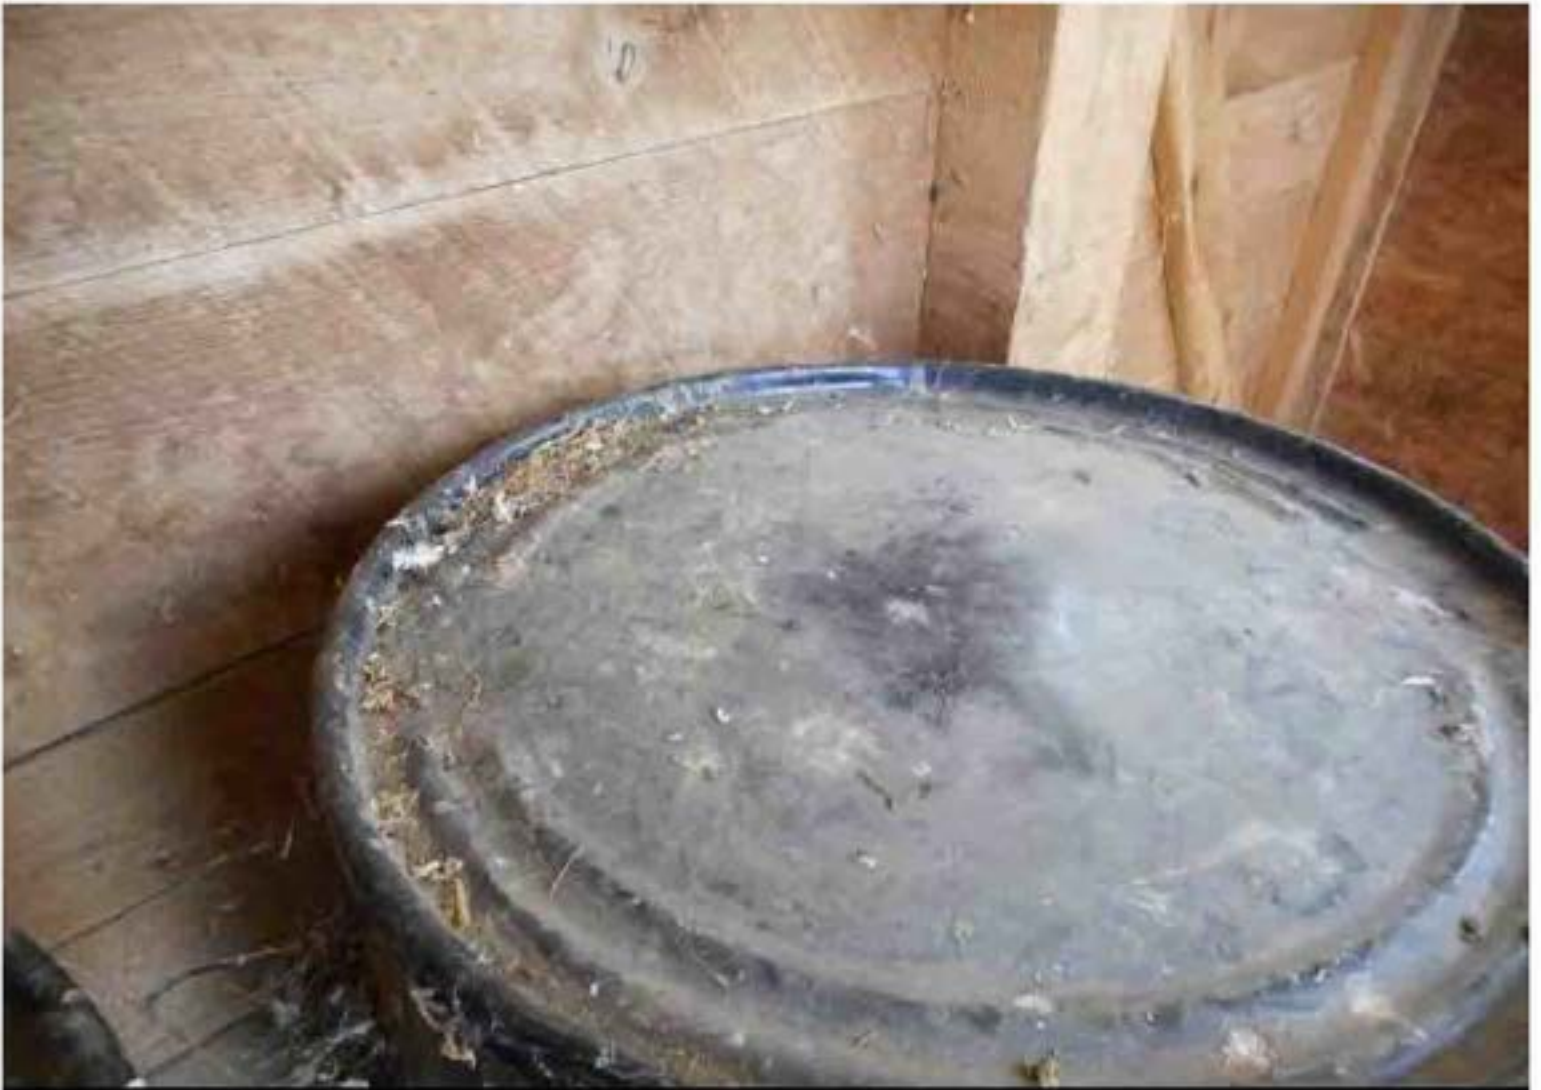
CFR: 3.131 (c)

Photographer:	Randy Coleman	Legal Name:	55-B-0069
Photo Taken:	Wed, Aug 3, '16 1100 am	HENRY HAMPTON	
Inspection:	217160732290590		
Description:	3.131(c): Kangaroo indoor area in need of cleaning.
