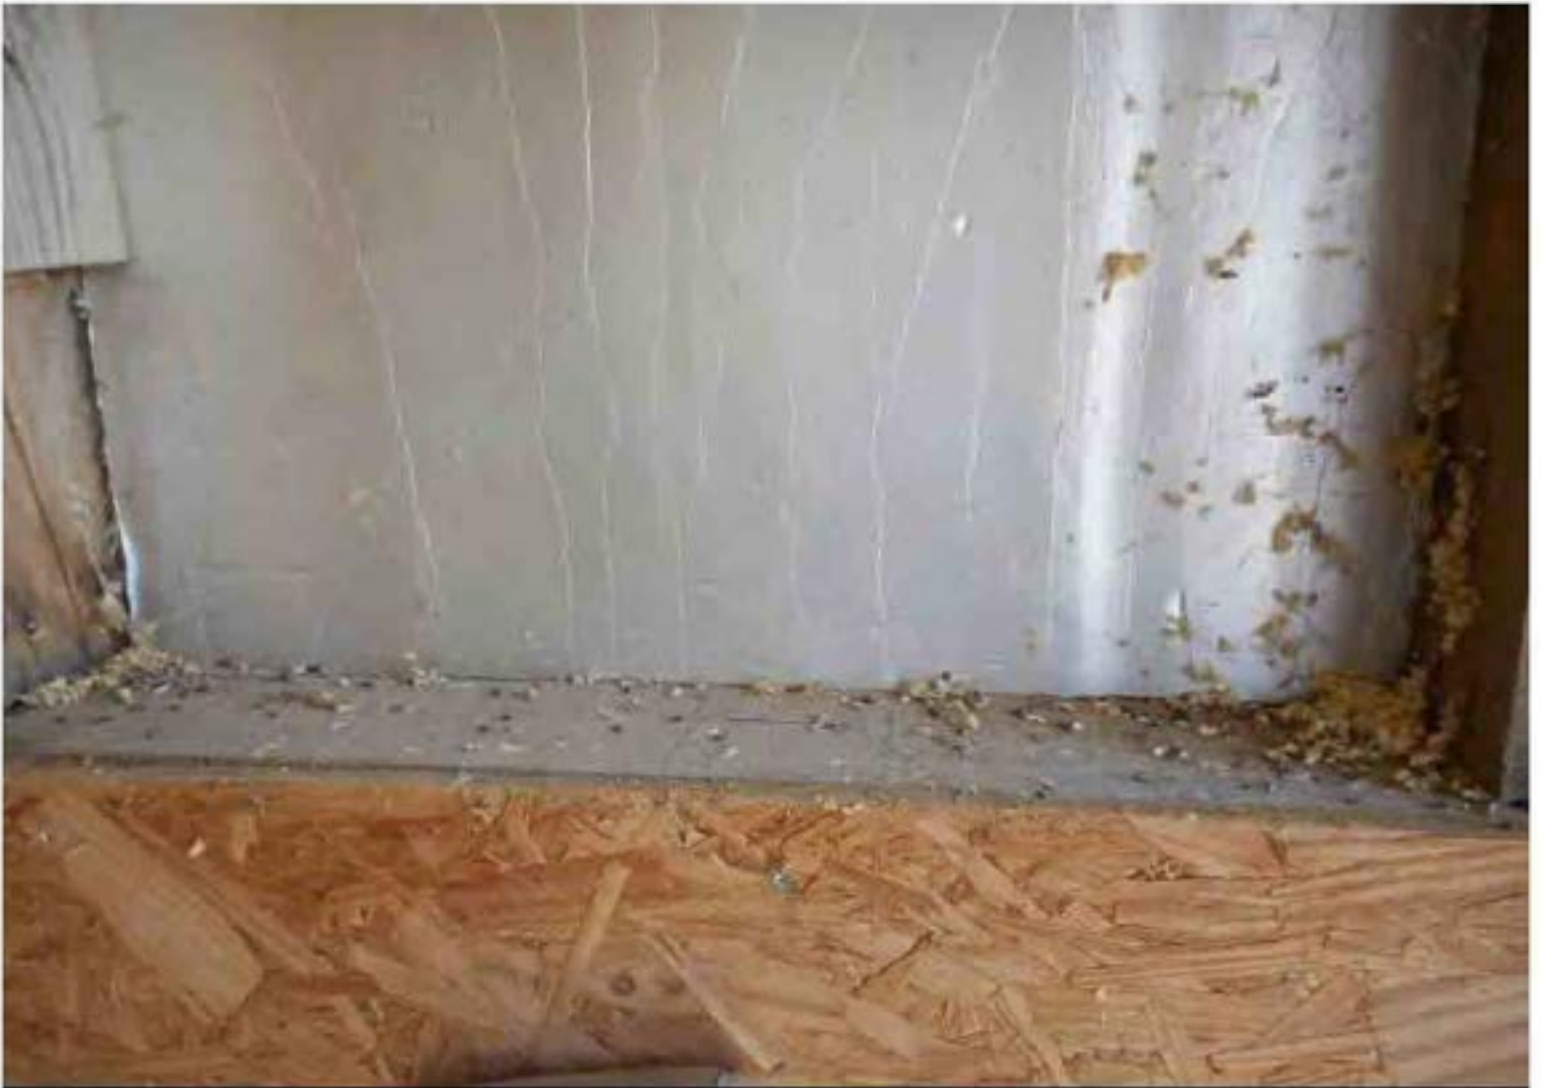
CFR: 3.131 (c)

Photographer:	Randy Coleman	Legal Name:	55-B-0069
Photo Taken:	Wed, Aug 3, '16 1100 am	HENRY HAMPTON	
Inspection:	217160732290590		
Description:	3.131(c): Kangaroo indoor area in need of cleaning.

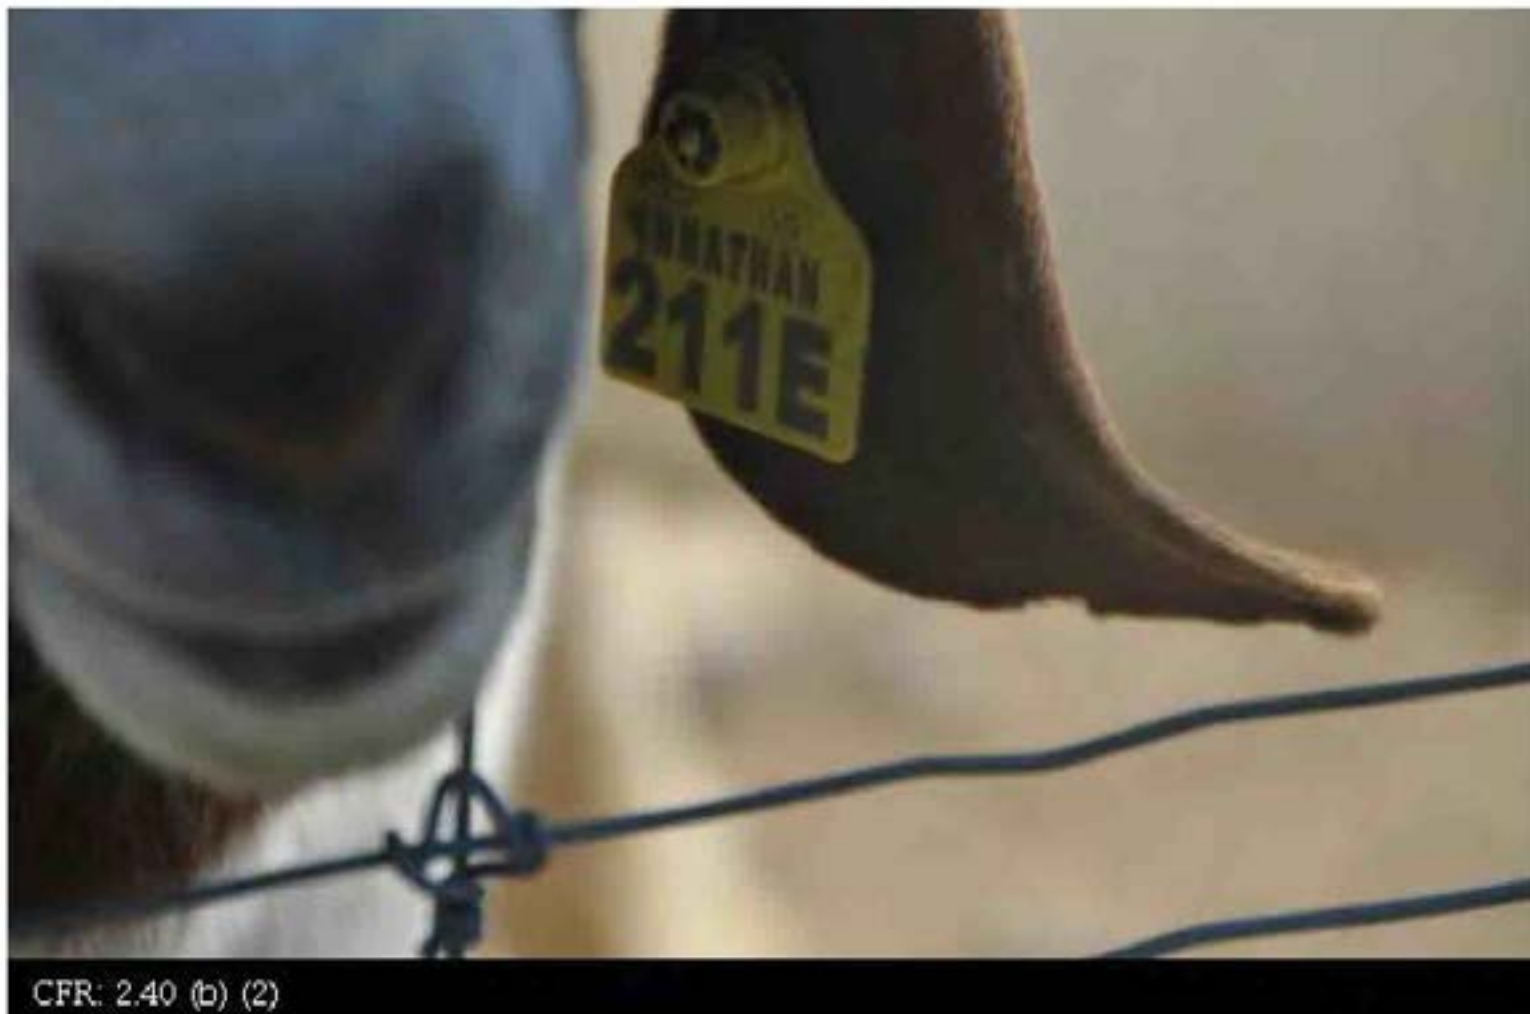
CFR: 2.40 (b) (2)

Photographer:	Kathy Campitelli	Legal Name:	55-B-0069
Photo Taken:	Wed, Aug 3, '16 1100 am	HENRY HAMPTON	
Inspection:	217160732290590		
Description:	2.40(b)(2): Goat 211E found with long feet

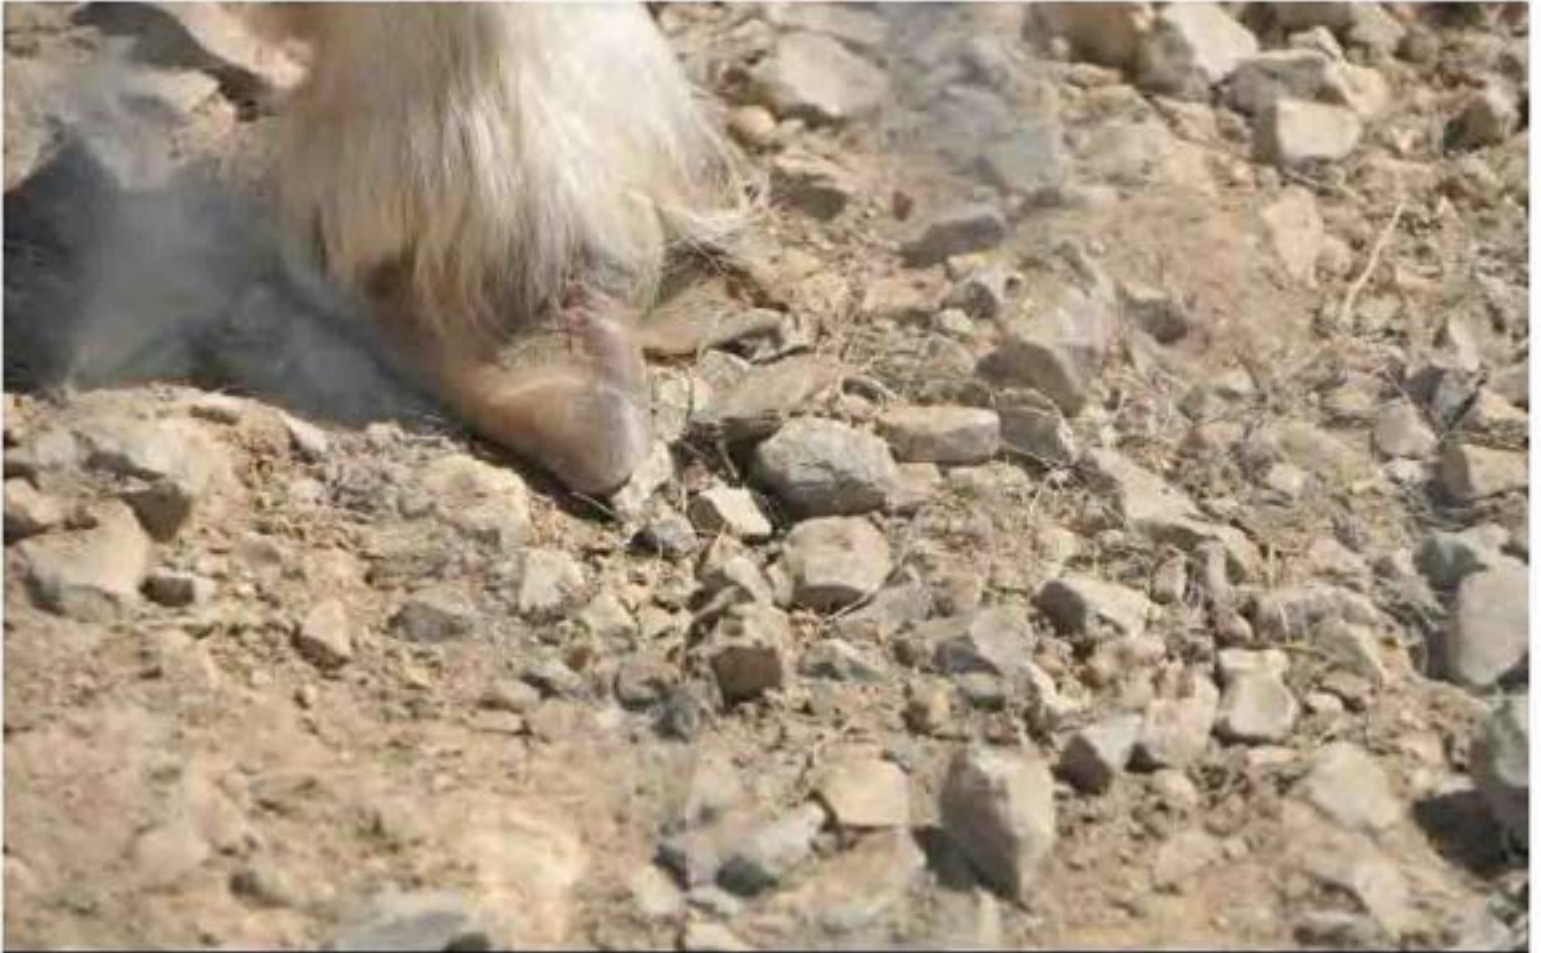
CFR: 2.40 (b) (2)

Photographer:	Kathy Campitelli	Legal Name:	55-B-0069
Photo Taken:	Wed, Aug 3, '16 1100 am	HENRY HAMPTON	
Inspection:	217160732290590		
Description:	2.40(b)(2): Goat 211E found with long feet

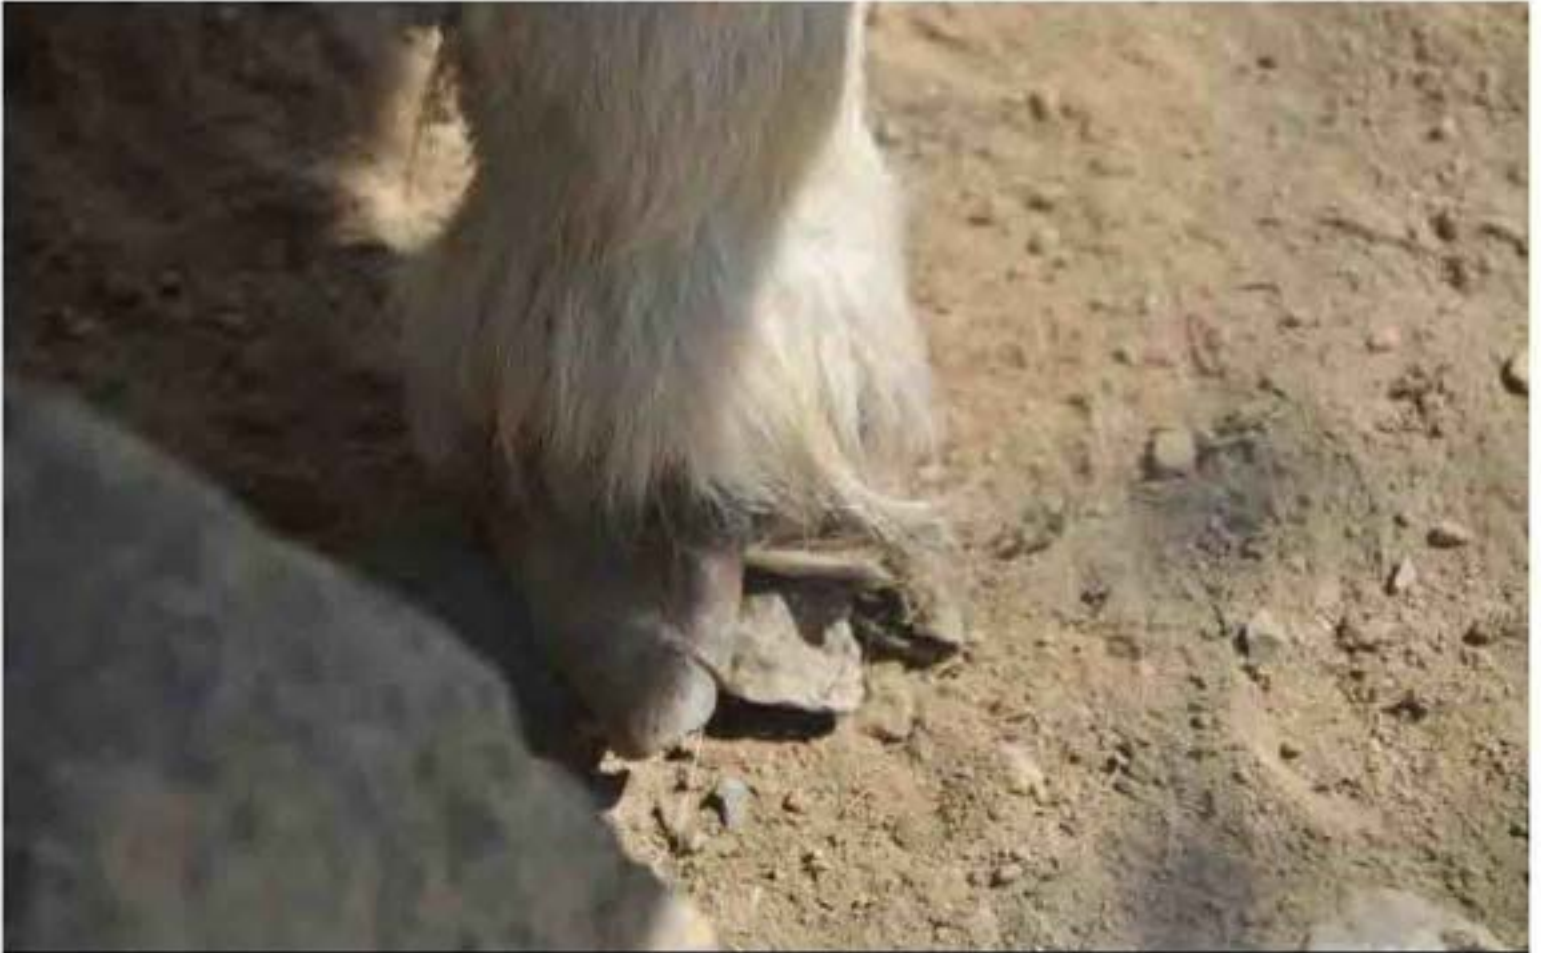
CFR: 2.40 (b) (2)

Photographer:	Kathy Campitelli	Legal Name:	55-B-0069
Photo Taken:	Wed, Aug 3, '16 1100 am	HENRY HAMPTON	
Inspection:	217160732290590		
Description:	2.40(b)(2): Goat 211E found with long feet

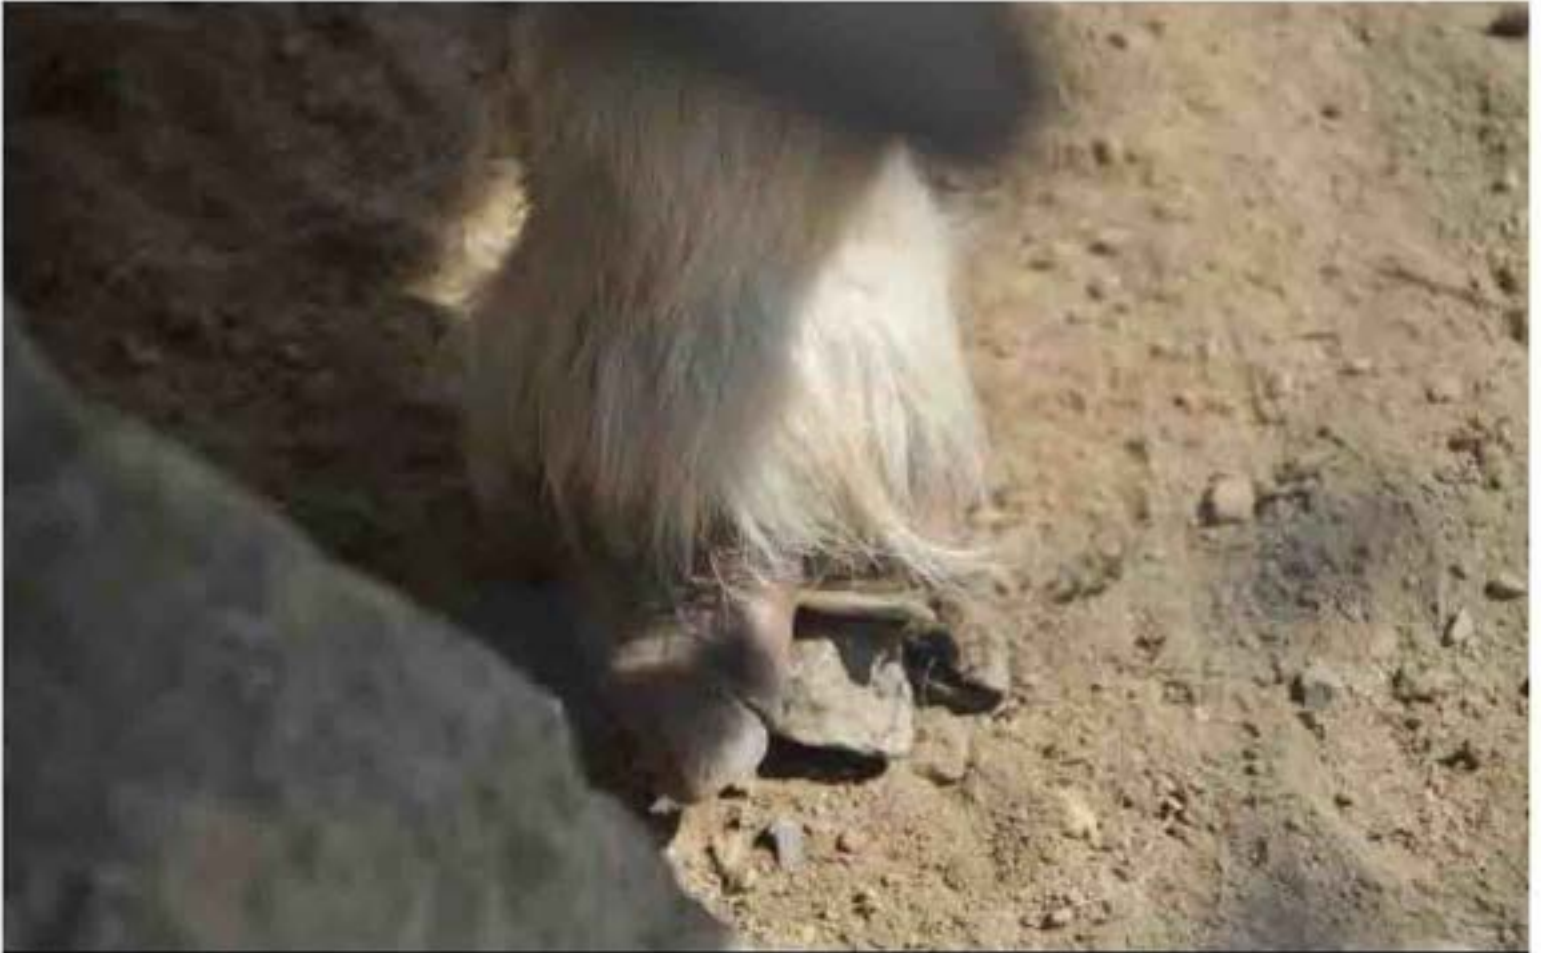
CFR: 2.40 (b) (2)

Photographer:	Kathy Campitelli	Legal Name:	55-B-0069
Photo Taken:	Wed, Aug 3, '16 1100 am	HENRY HAMPTON	
Inspection:	217160732290590		
Description:	2.40(b)(2): Goat 211E found with long feet

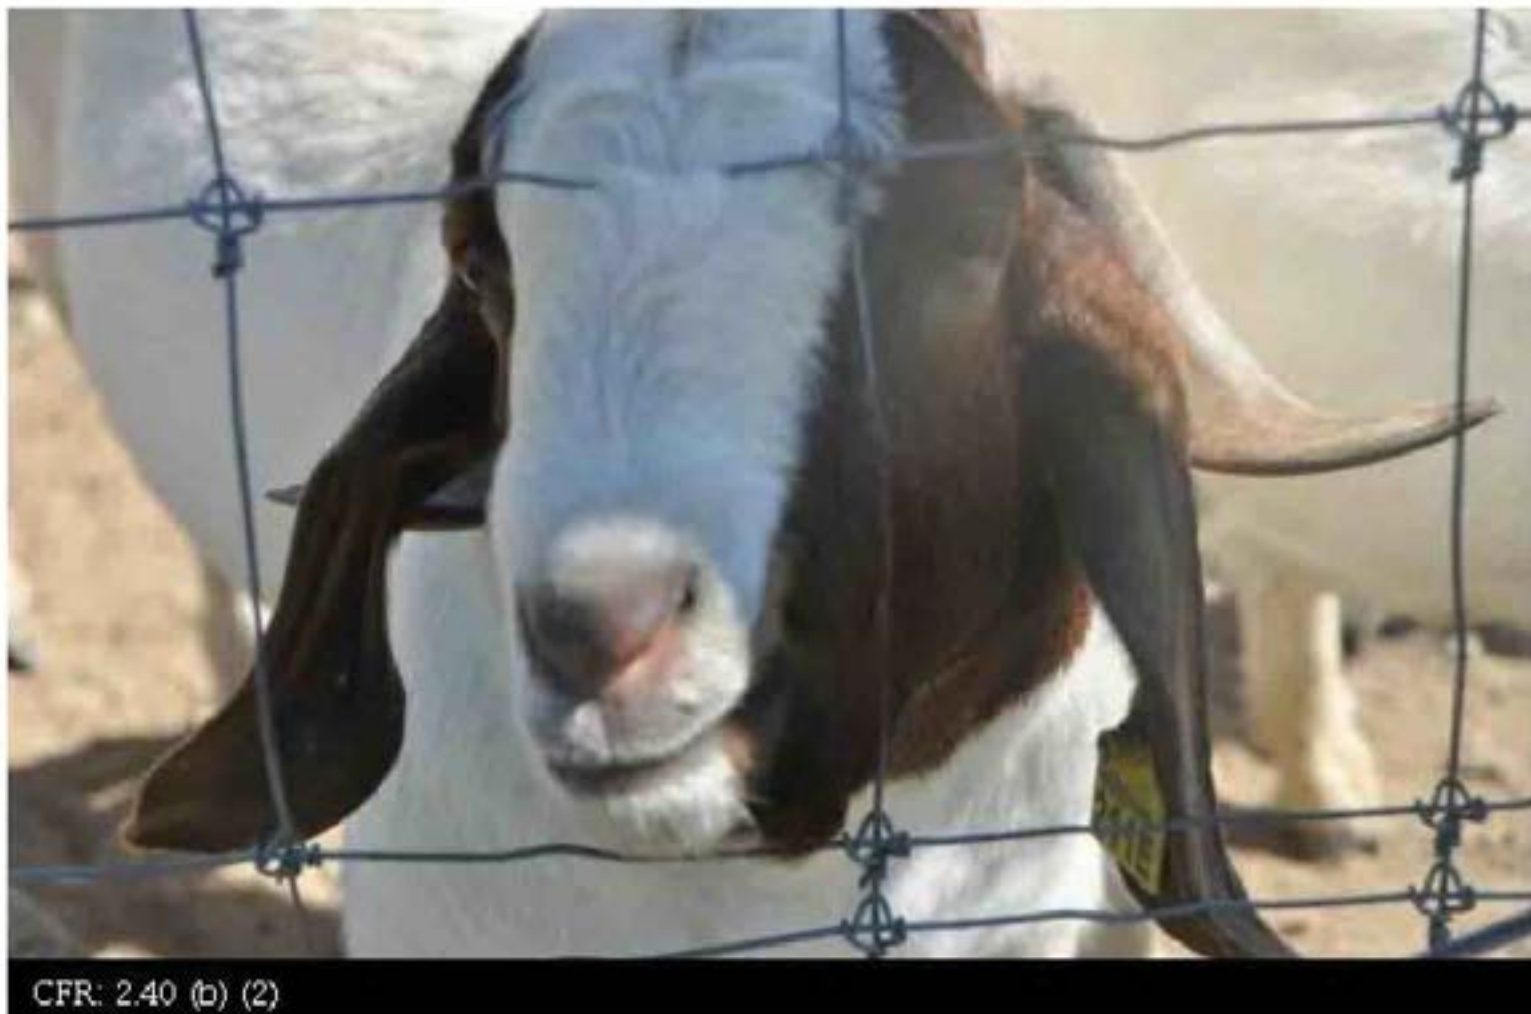
CFR: 2.40 (b) (2)

Photographer:	Kathy Campitelli	Legal Name:	55-B-0069
Photo Taken:	Wed, Aug 3, '16 1100 am	HENRY HAMPTON	
Inspection:	217160732290590		
Description:	2.40(b)(2): Goat 211E found with long feet

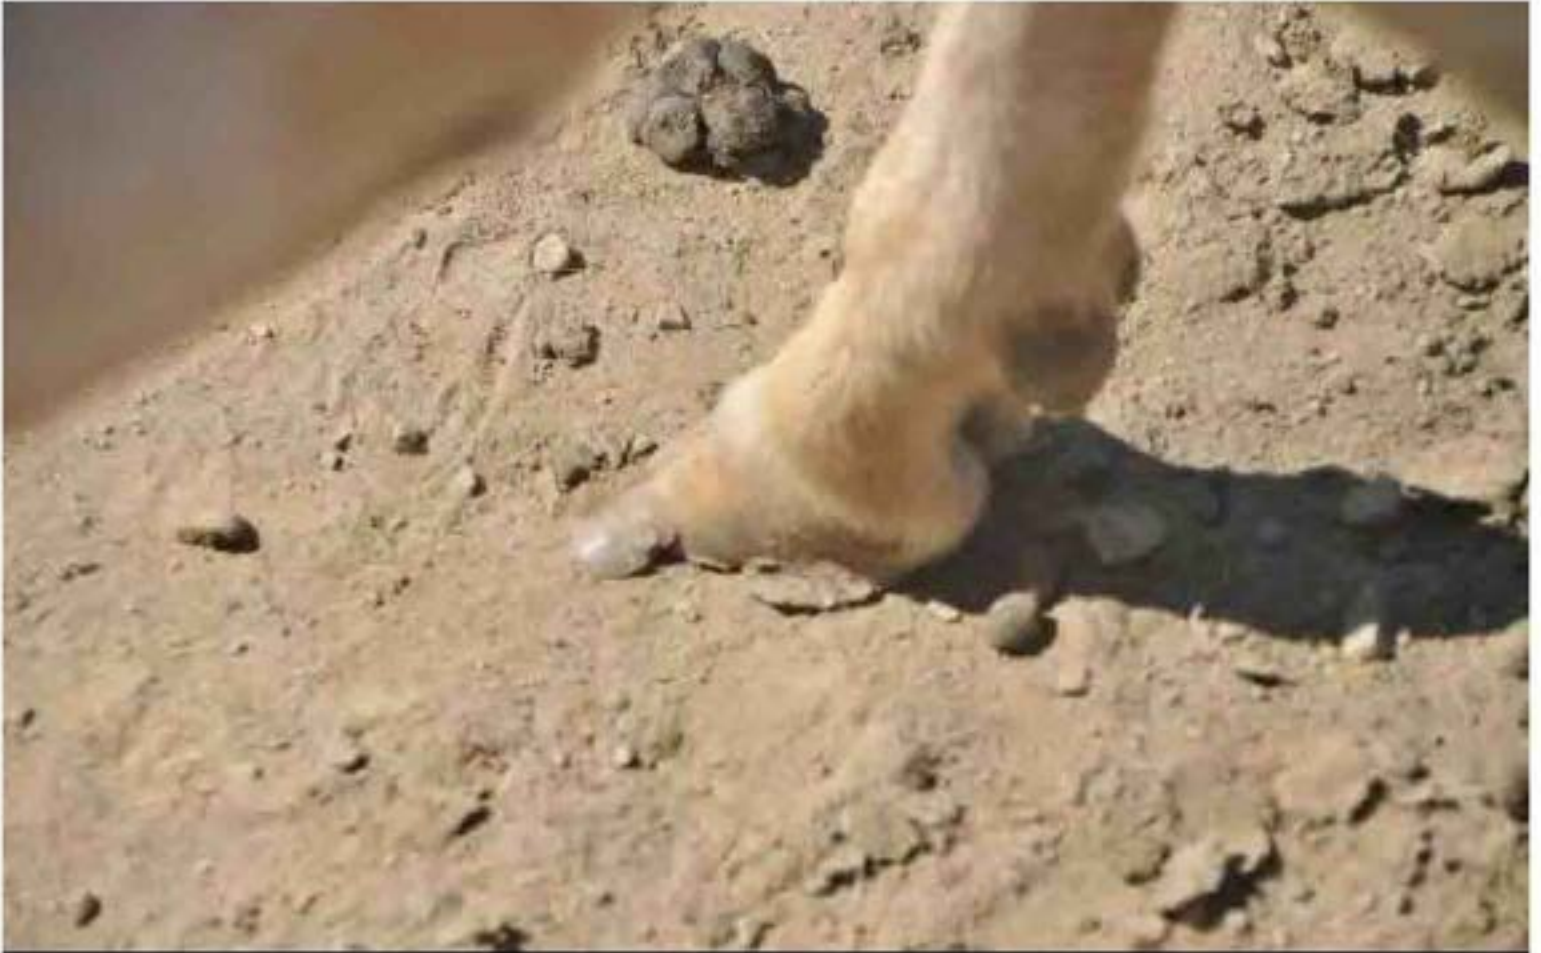
CFR: 2.40 (b) (2)

Photographer:	Kathy Campitelli	Legal Name:	55-B-0069
Photo Taken:	Wed, Aug 3, '16 1100 am	HENRY HAMPTON	
Inspection:	217160732290590		
Description:	2.40(b)(2): white Nubian with no ID found with long feet.

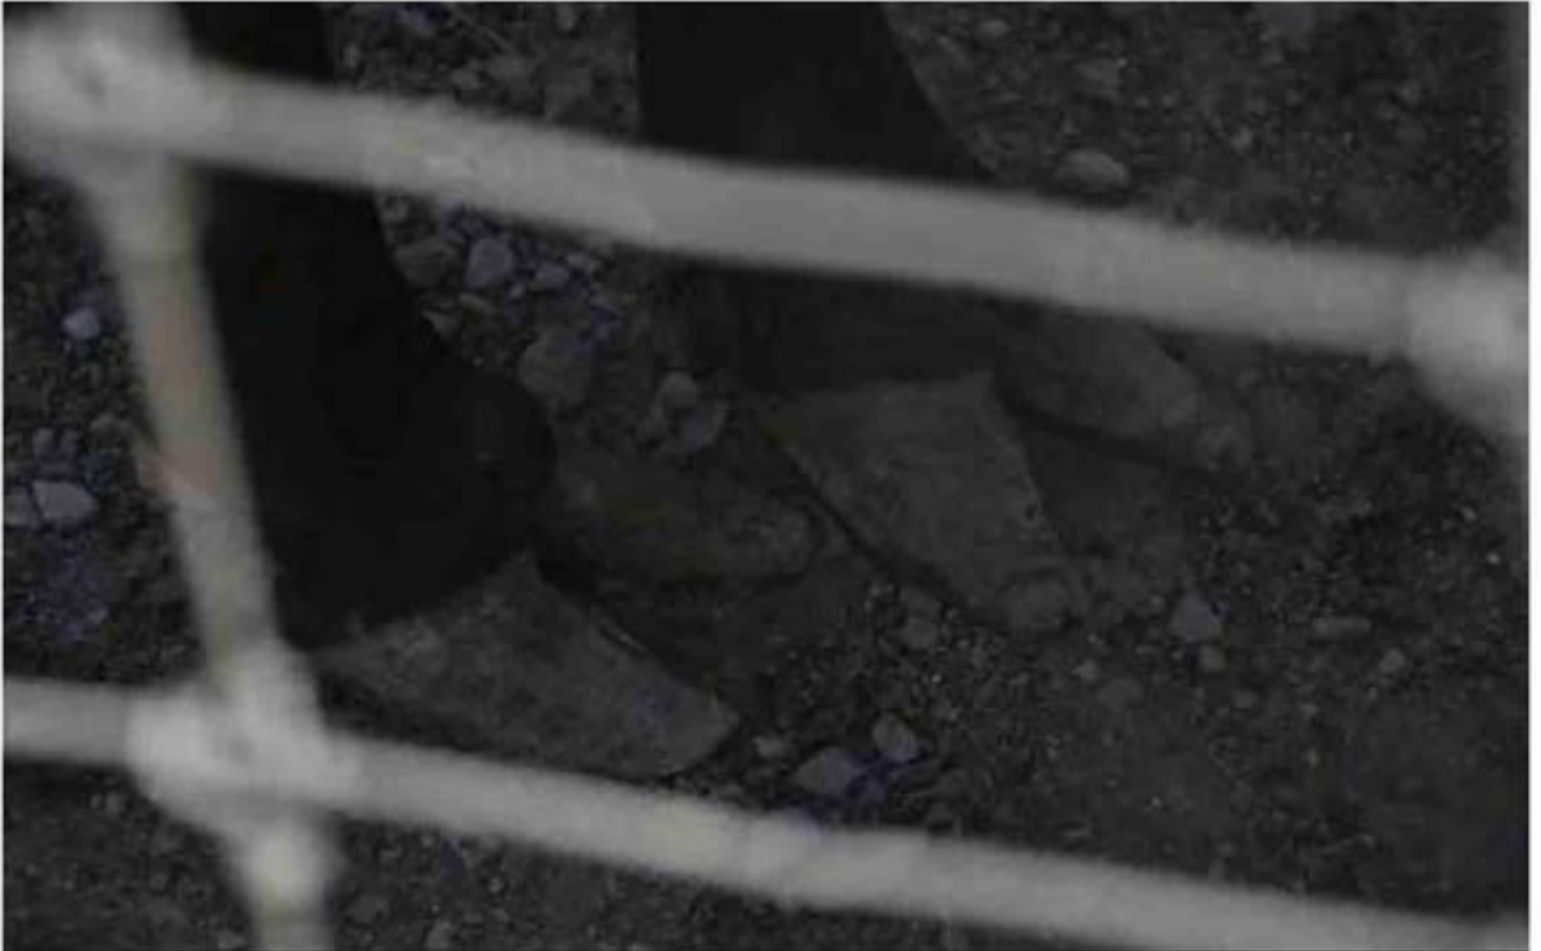
CFR: 2.40 (b) (2)

Photographer:	Kathy Campitelli	Legal Name:	55-B-0069
Photo Taken:	Wed, Aug 3, '16 1100 am	HENRY HAMPTON	
Inspection:	217160732290590		
Description:	2.40(b)(2): Pygmy zebu found with long feet.

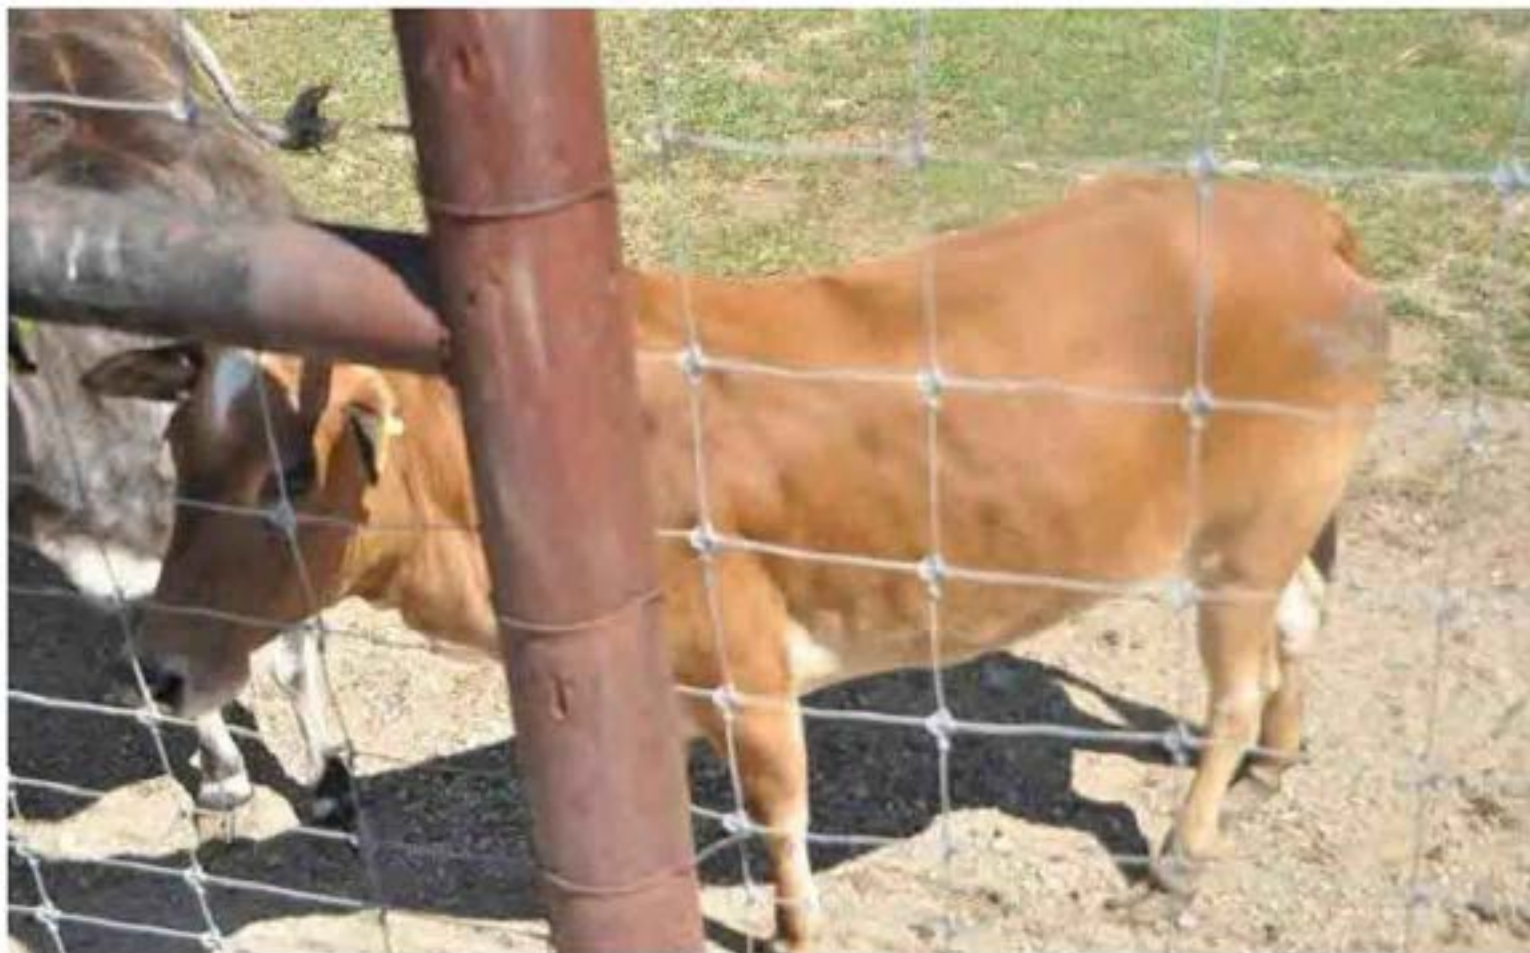
CFR: 2.40 (b) (2)

Photographer:	Kathy Campitelli	Legal Name:	55-B-0069
Photo Taken:	Wed, Aug 3, '16 1100 am	HENRY HAMPTON	
Inspection:	217160732290590		
Description:	2.40(b)(2): Pygmy zebu found with long feet.

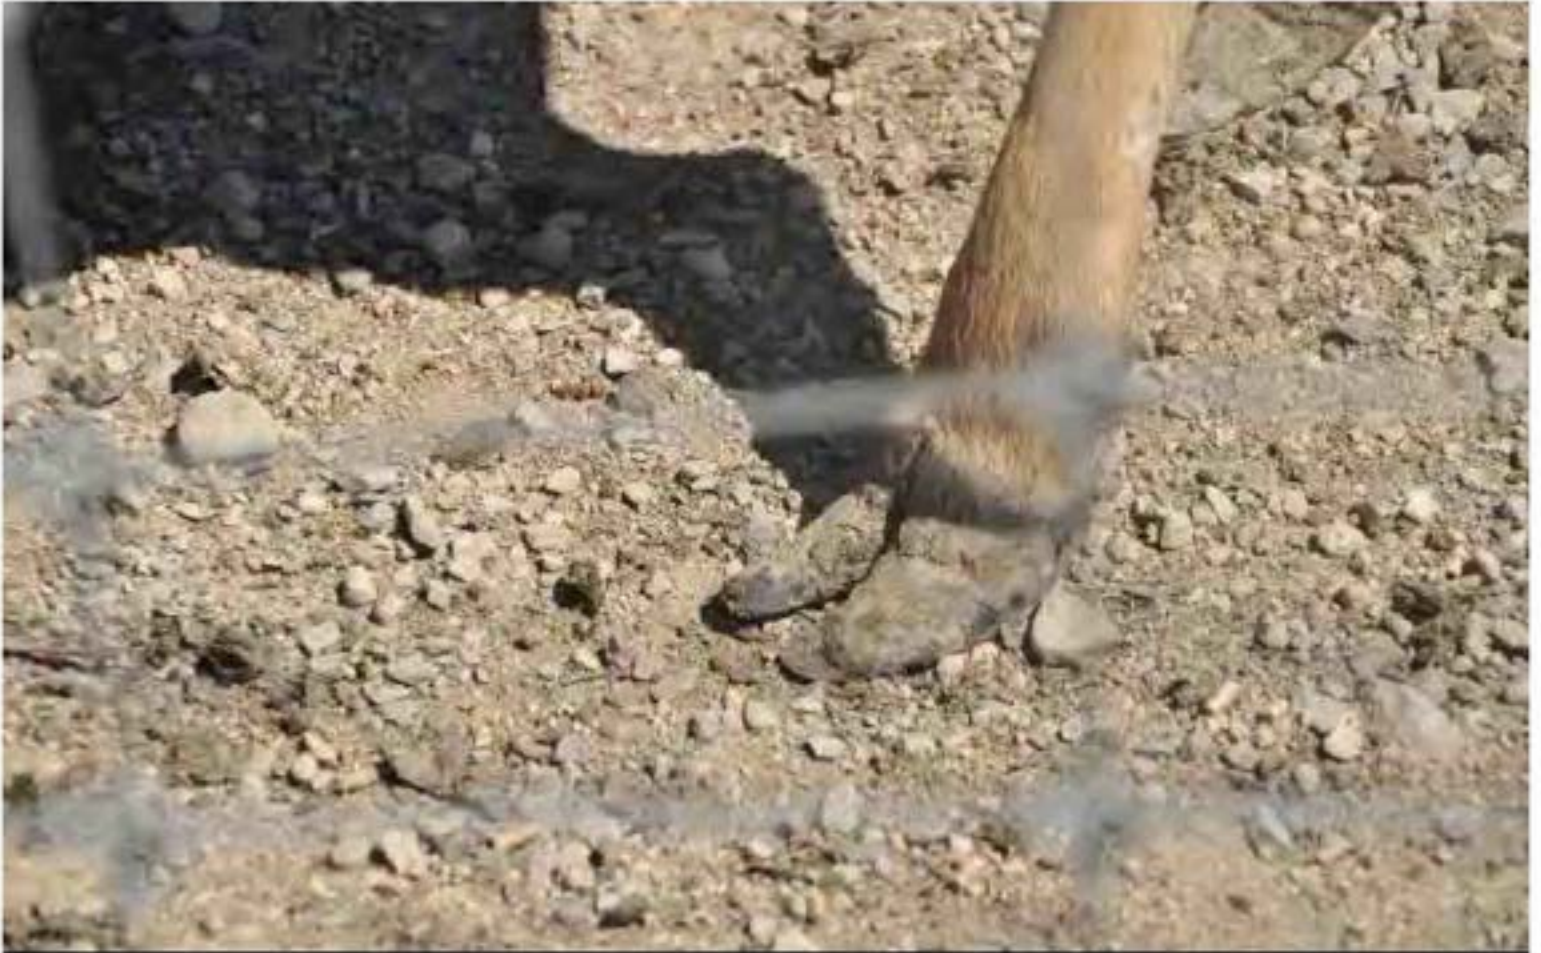
CFR: 2.40 (b) (2)

Photographer:	Kathy Campitelli	Legal Name:	55-B-0069
Photo Taken:	Wed, Aug 3, '16 1100 am	HENRY HAMPTON	
Inspection:	217160732290590		
Description:	2.40(b)(2): Pygmy zebu found with long feet.

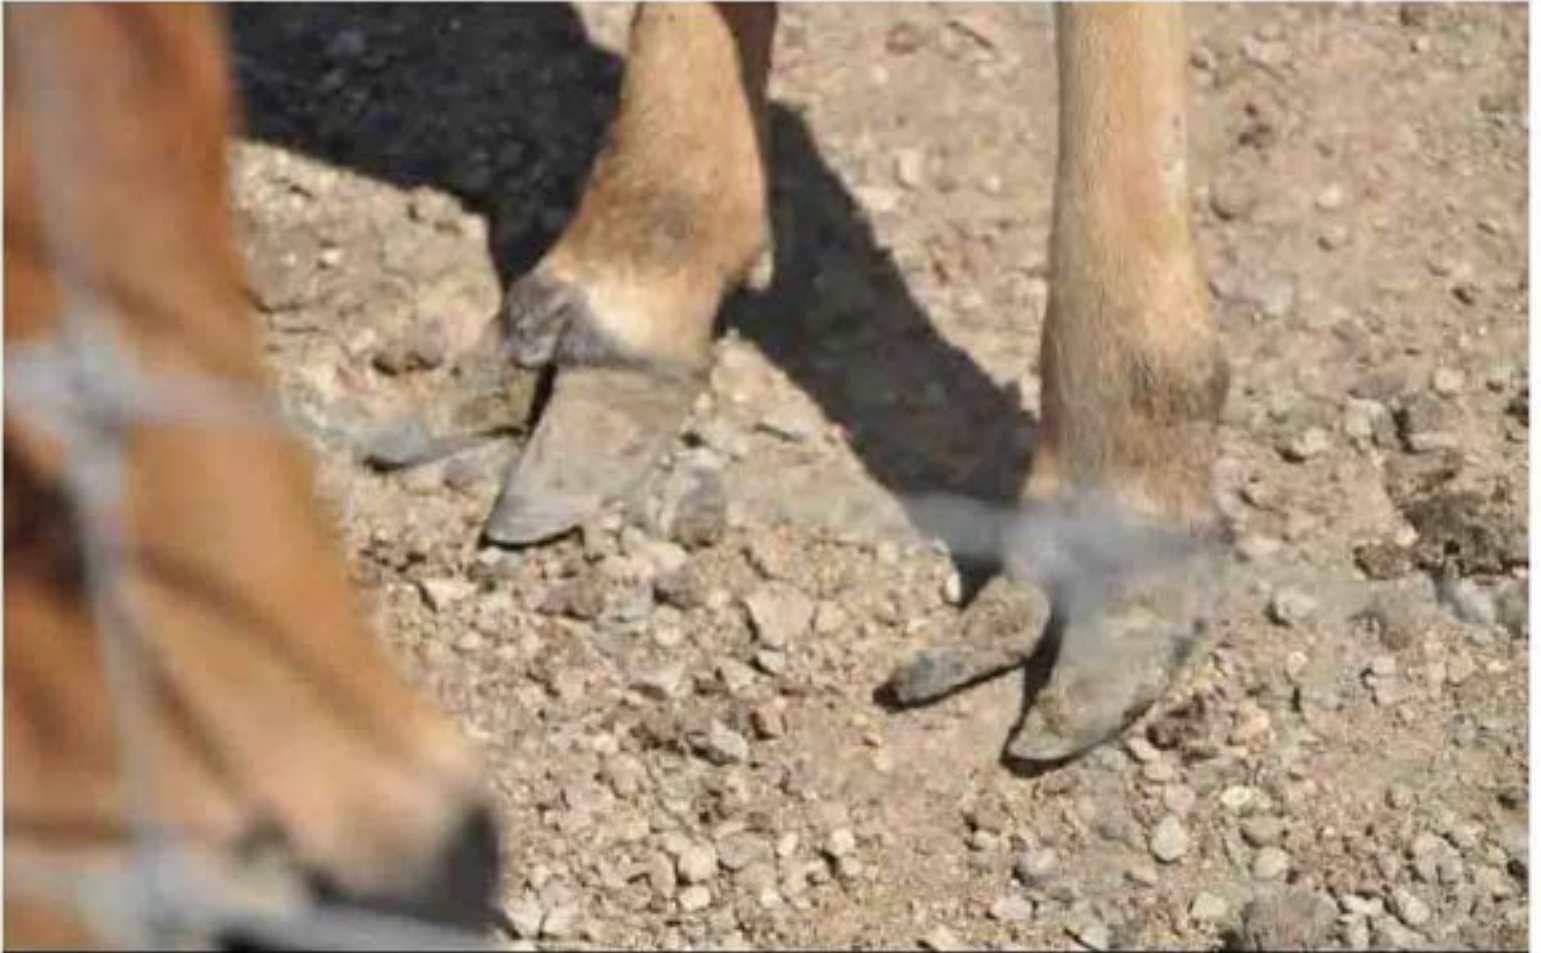
CFR: 2.40 (b) (2)

Photographer:	Kathy Campitelli	Legal Name:	55-B-0069
Photo Taken:	Wed, Aug 3, '16 1100 am	HENRY HAMPTON	
Inspection:	217160732290590		
Description:	2.40(b)(2): Pygmy zebu found with long feet.

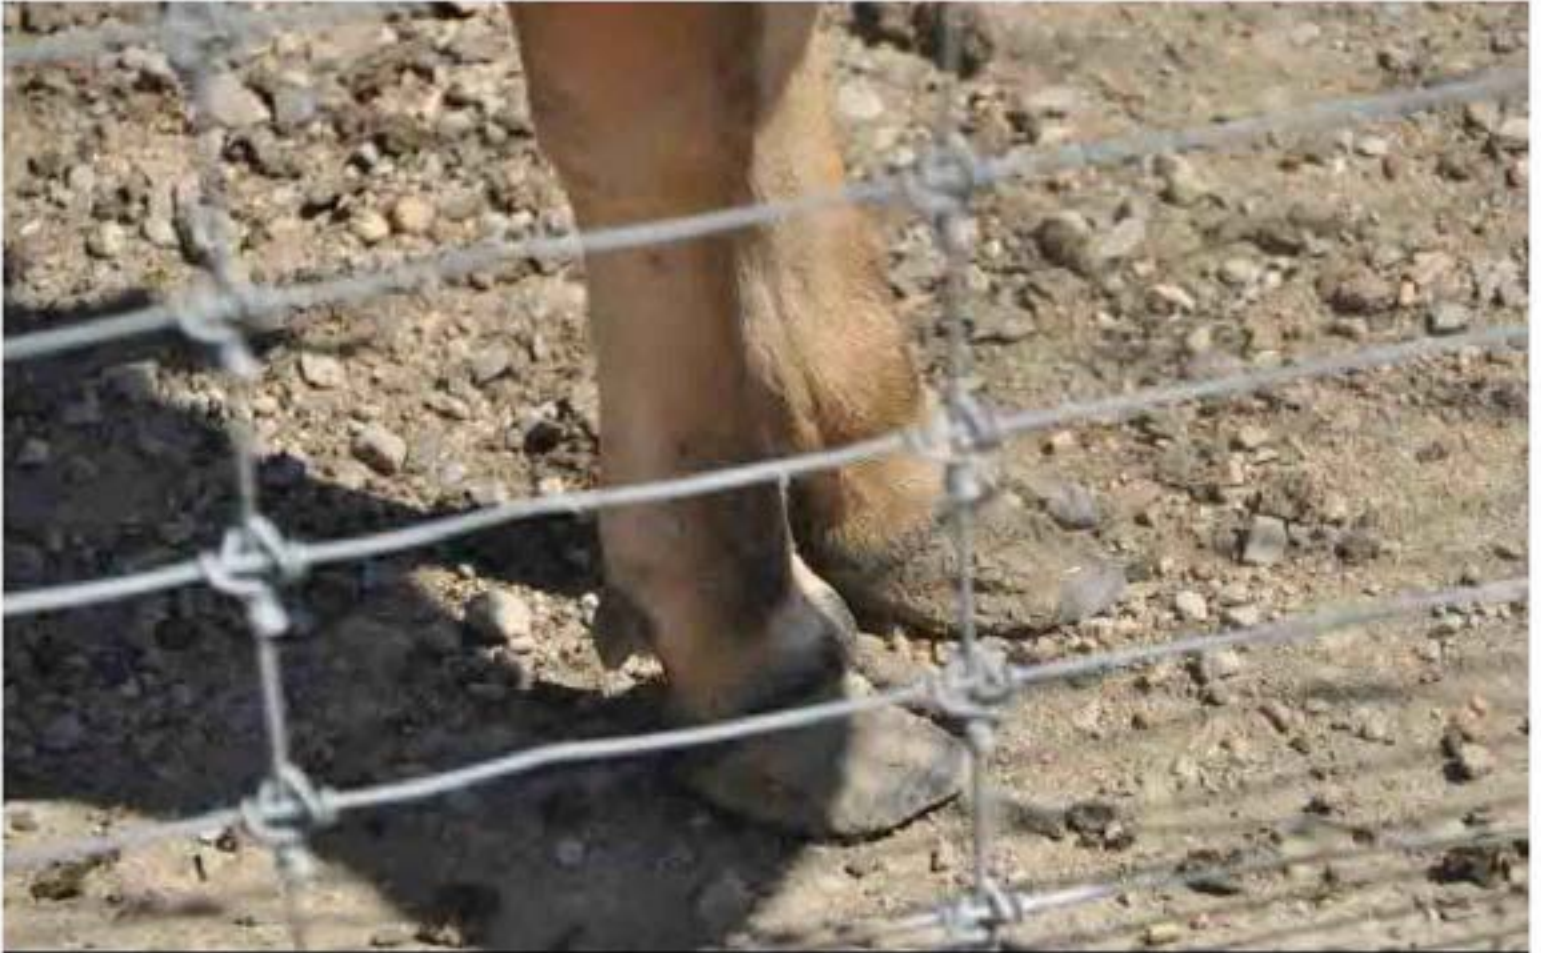
CFR: 2.40 (b) (2)

Photographer:	Kathy Campitelli	Legal Name:	55-B-0069
Photo Taken:	Wed, Aug 3, '16 1100 am	HENRY HAMPTON	
Inspection:	217160732290590		
Description:	2.40(b)(2): Pygmy zebu found with long feet.

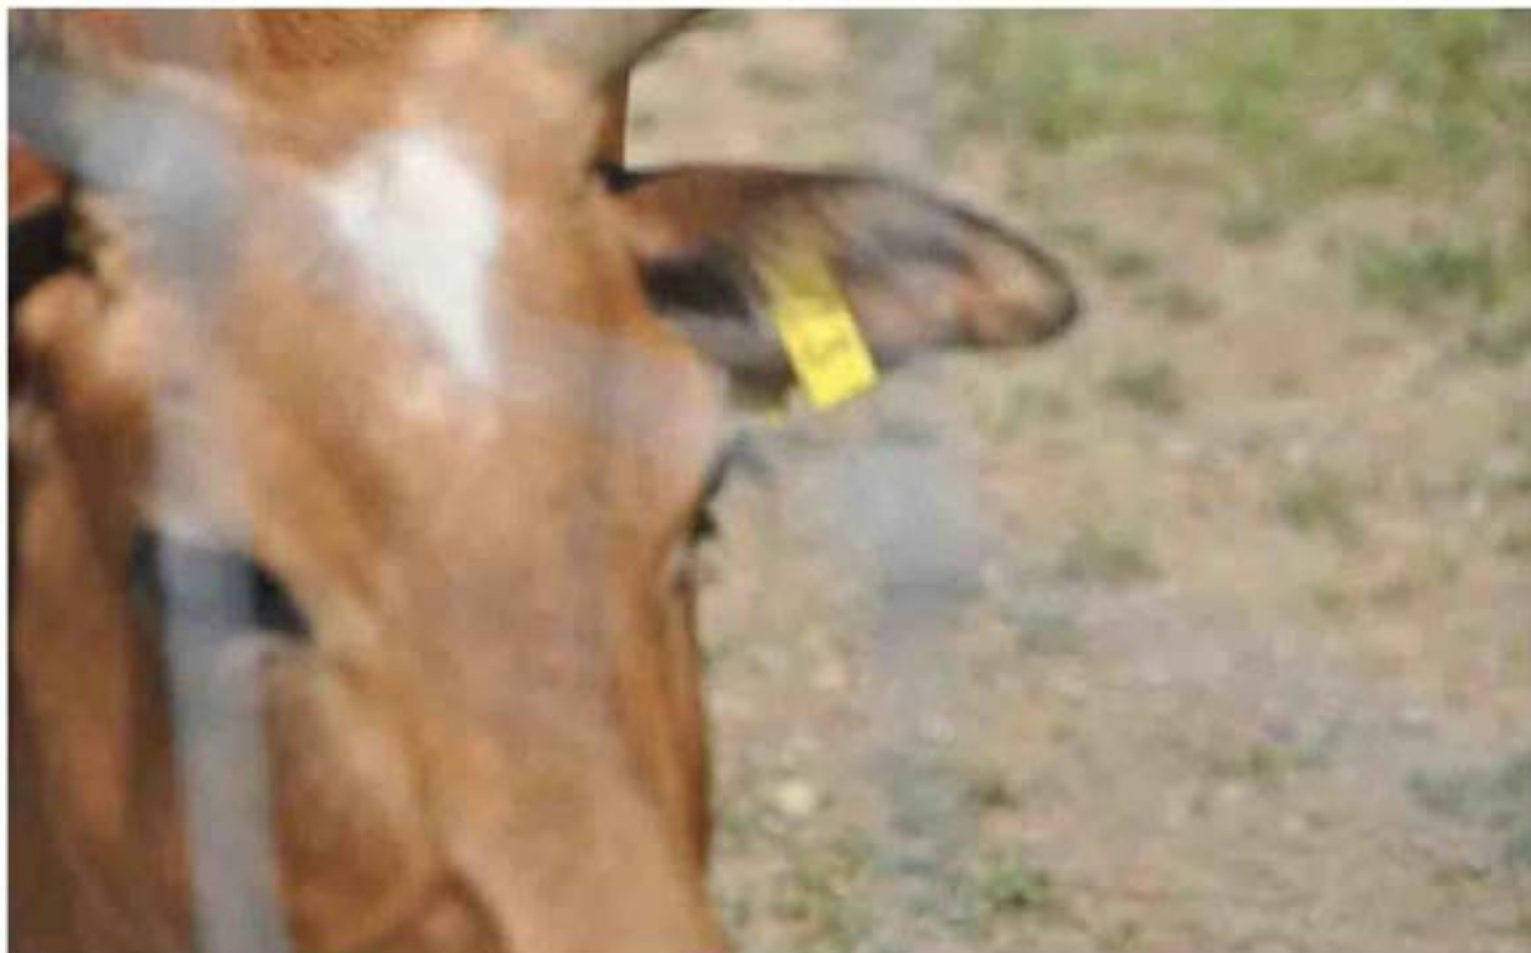
CFR: 2.40 (b) (2)

Photographer:	Kathy Campitelli	Legal Name:	55-B-0069
Photo Taken:	Wed, Aug 3, '16 1100 am	HENRY HAMPTON	
Inspection:	217160732290590		
Description:	2.40(b)(2): Pygmy zebu found with long feet.

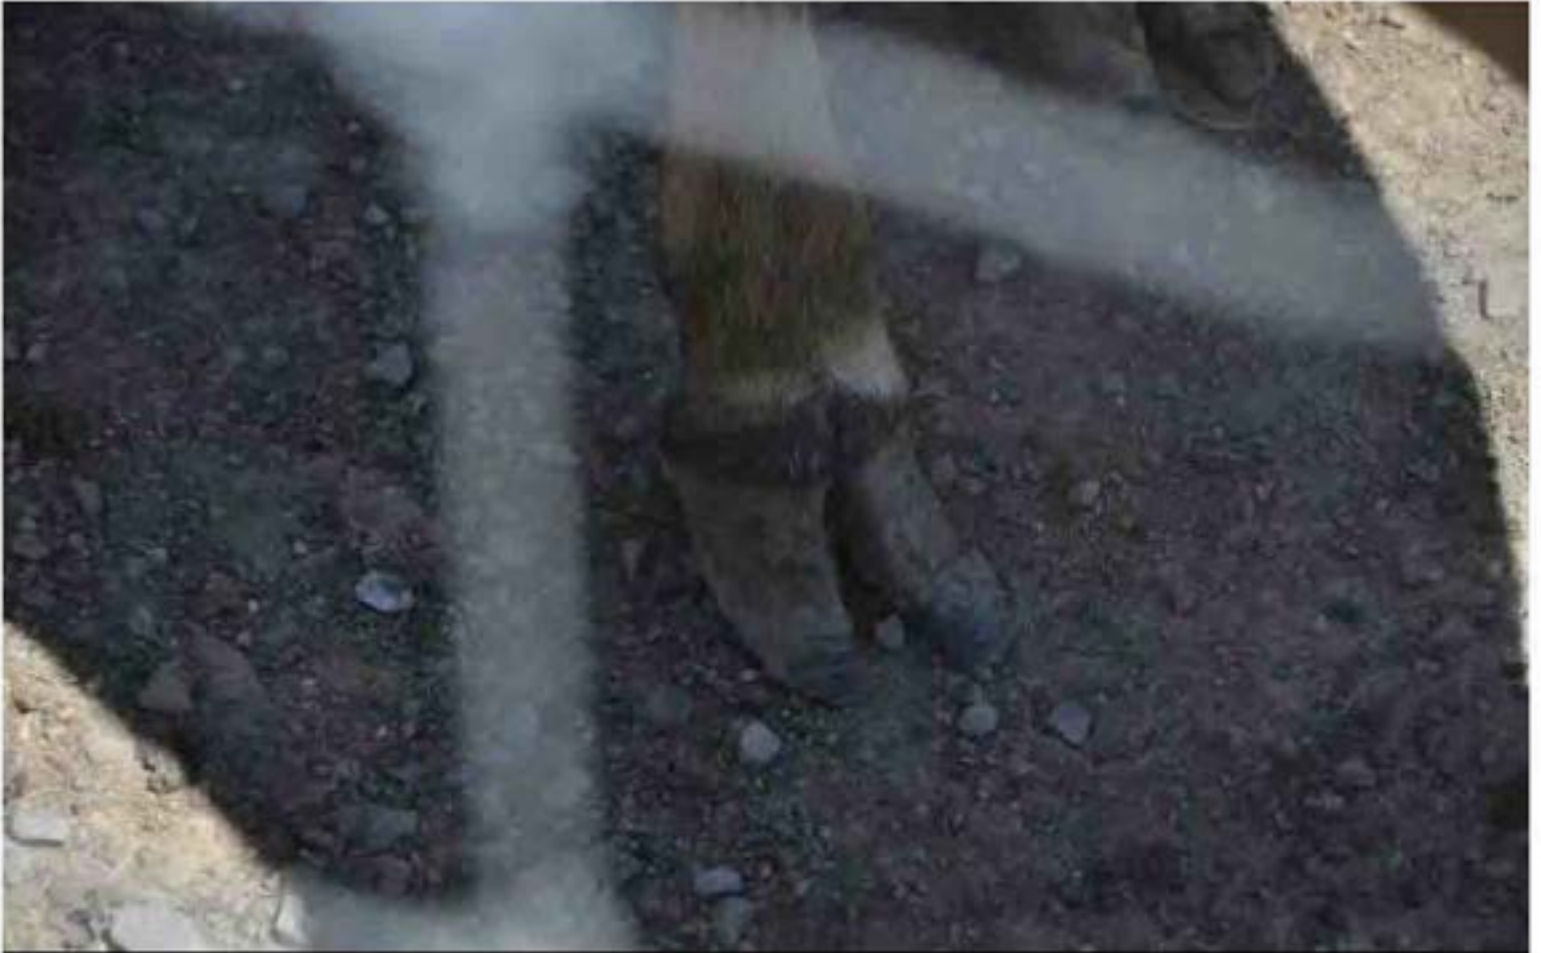
CFR: 2.40 (b) (2)

Photographer:	Kathy Campitelli	Legal Name:	55-B-0069
Photo Taken:	Wed, Aug 3, '16 1100 am	HENRY HAMPTON	
Inspection:	217160732290590		
Description:	2.40(b)(2): Pygmy zebu found with long feet.

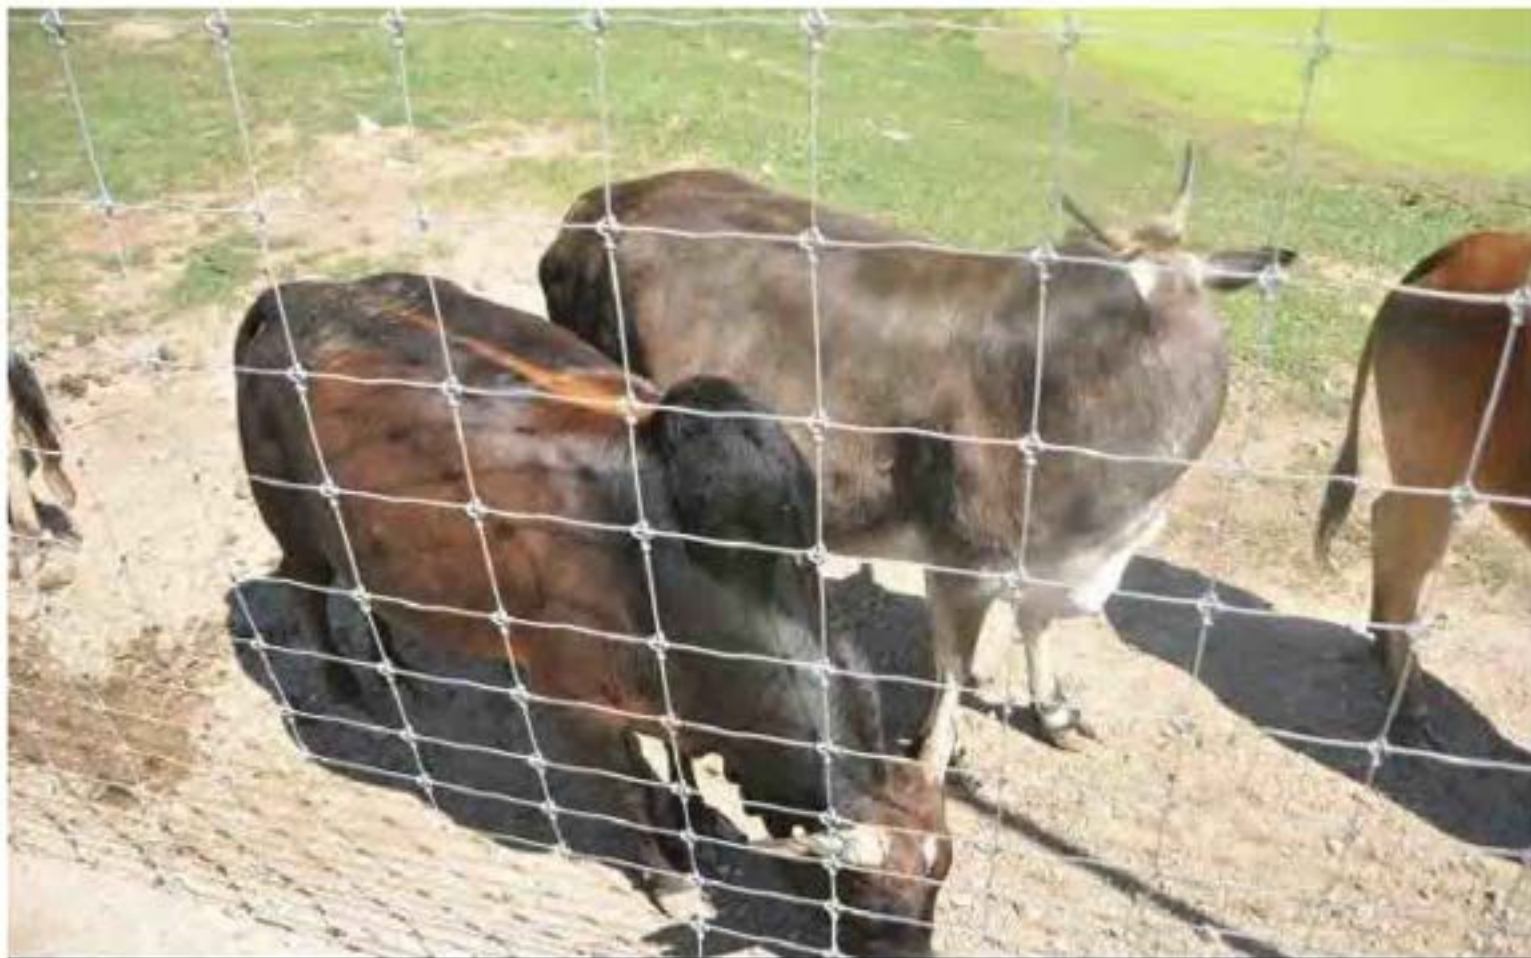
CFR: 2.40 (b) (2)

Photographer:	Kathy Campitelli	Legal Name:	55-B-0069
Photo Taken:	Wed, Aug 3, '16 1100 am	HENRY HAMPTON	
Inspection:	217160732290590		
Description:	2.40(b)(2): Pygmy zebu found with long feet.
