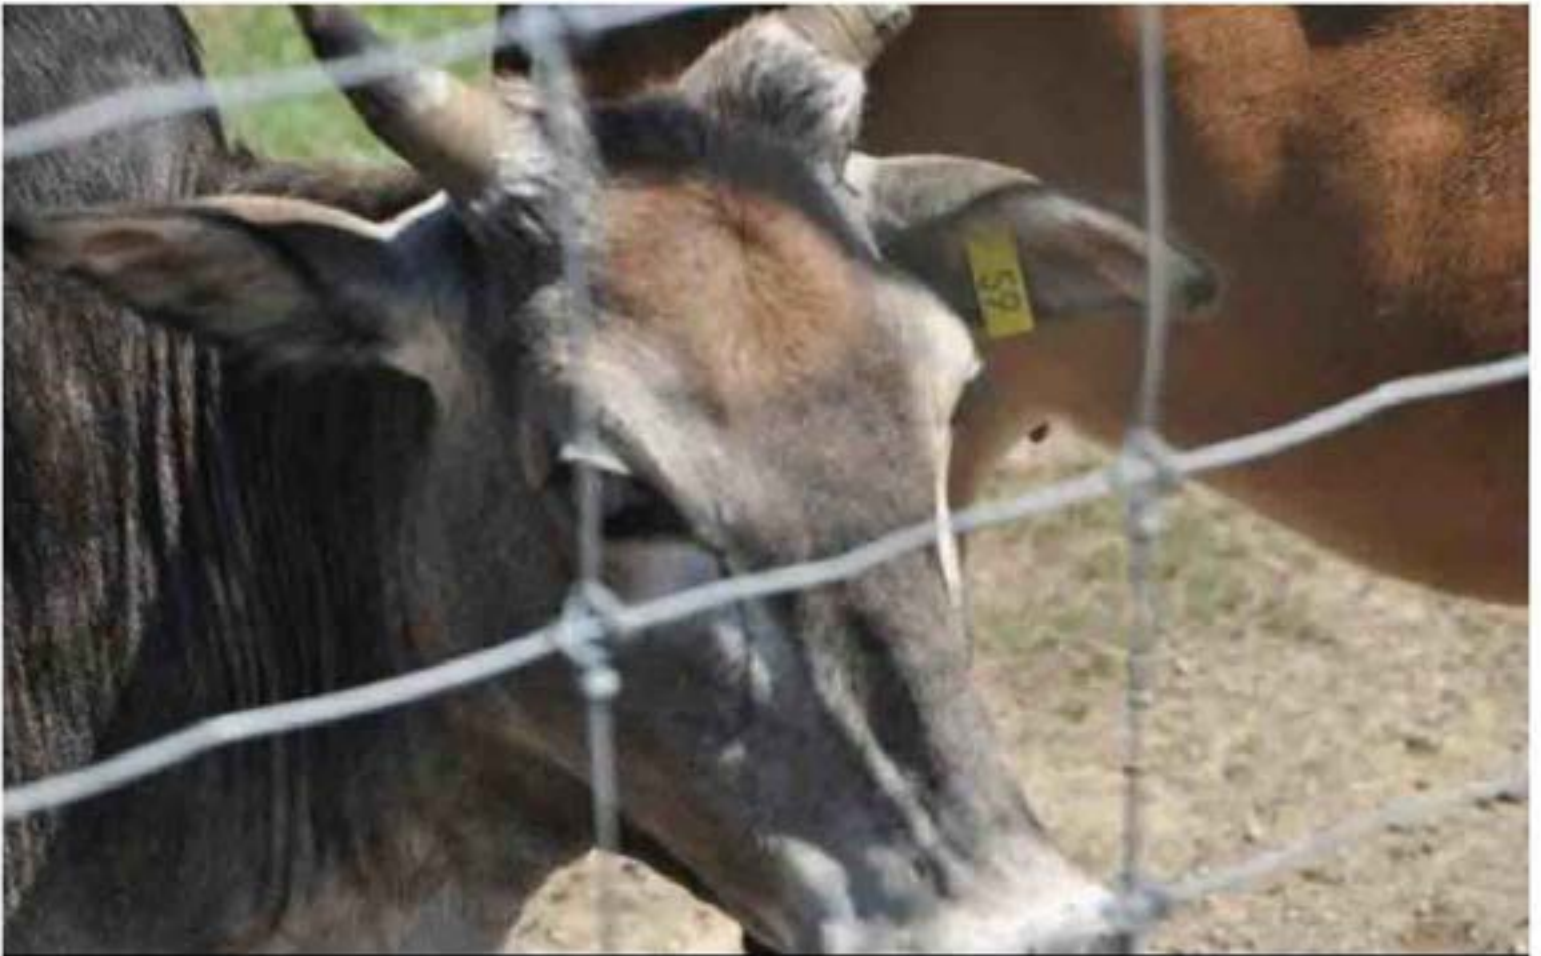
CFR: 2.40 (b) (2)

Photographer:	Kathy Campitelli	Legal Name:	55-B-0069
Photo Taken:	Wed, Aug 3, '16 1100 am	HENRY HAMPTON	
Inspection:	217160732290590		
Description:	2.40(b)(2): Pygmy zebu found with long feet.

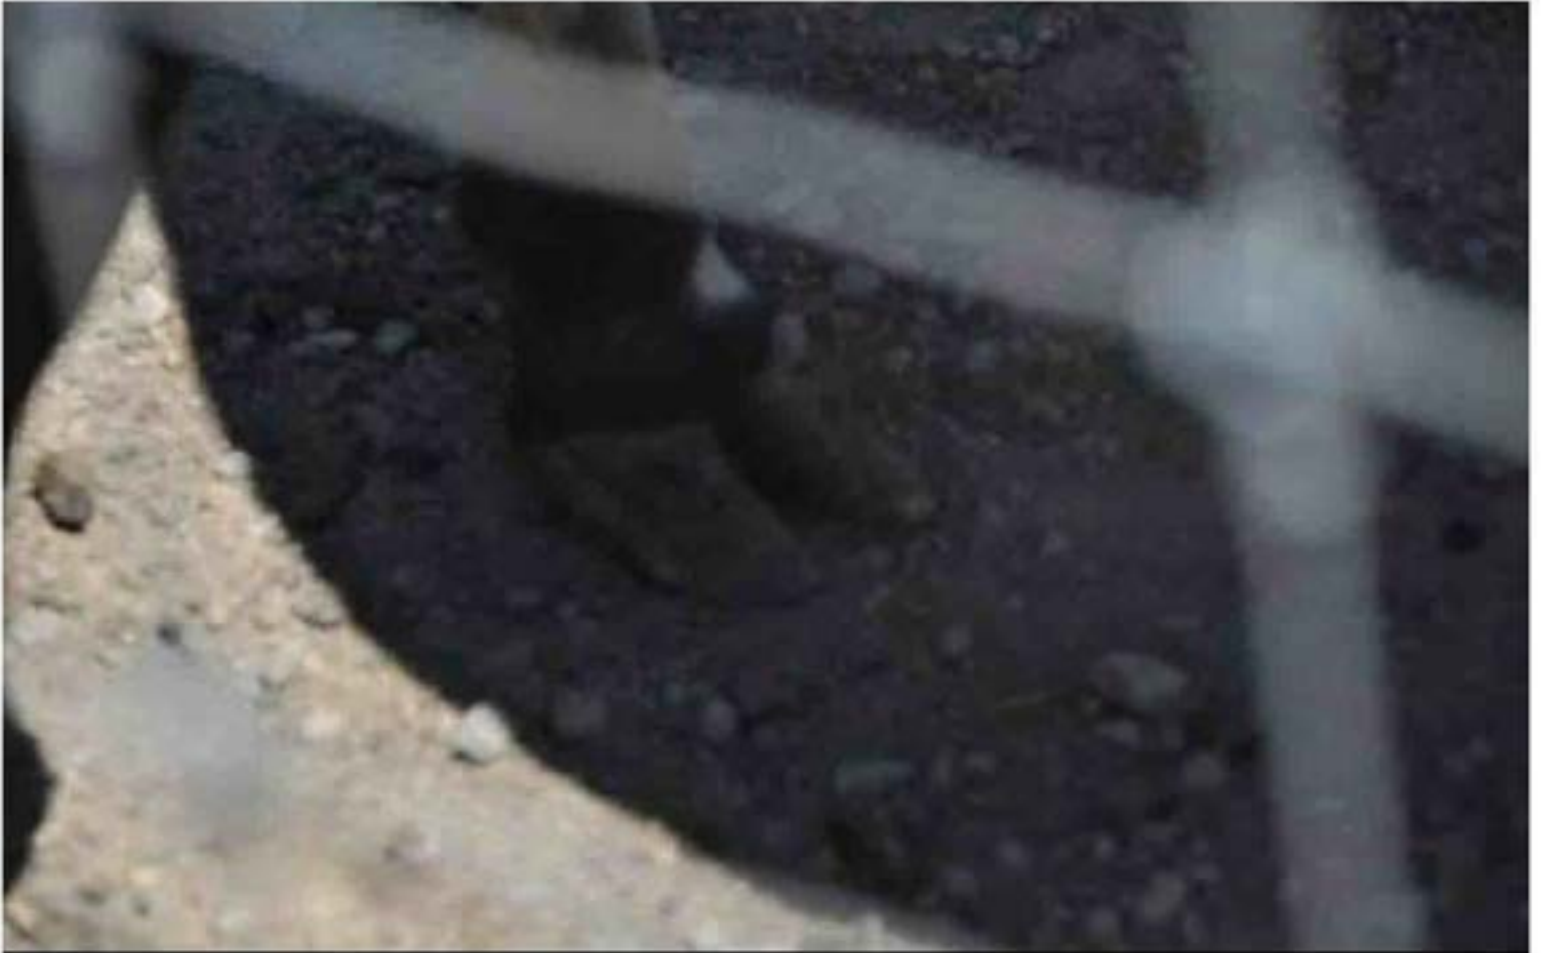
CFR: 2.40 (b) (2)

Photographer:	Kathy Campitelli	Legal Name:	55-B-0069
Photo Taken:	Wed, Aug 3, '16 1100 am	HENRY HAMPTON	
Inspection:	217160732290590		
Description:	2.40(b)(2): Pygmy zebu found with long feet.

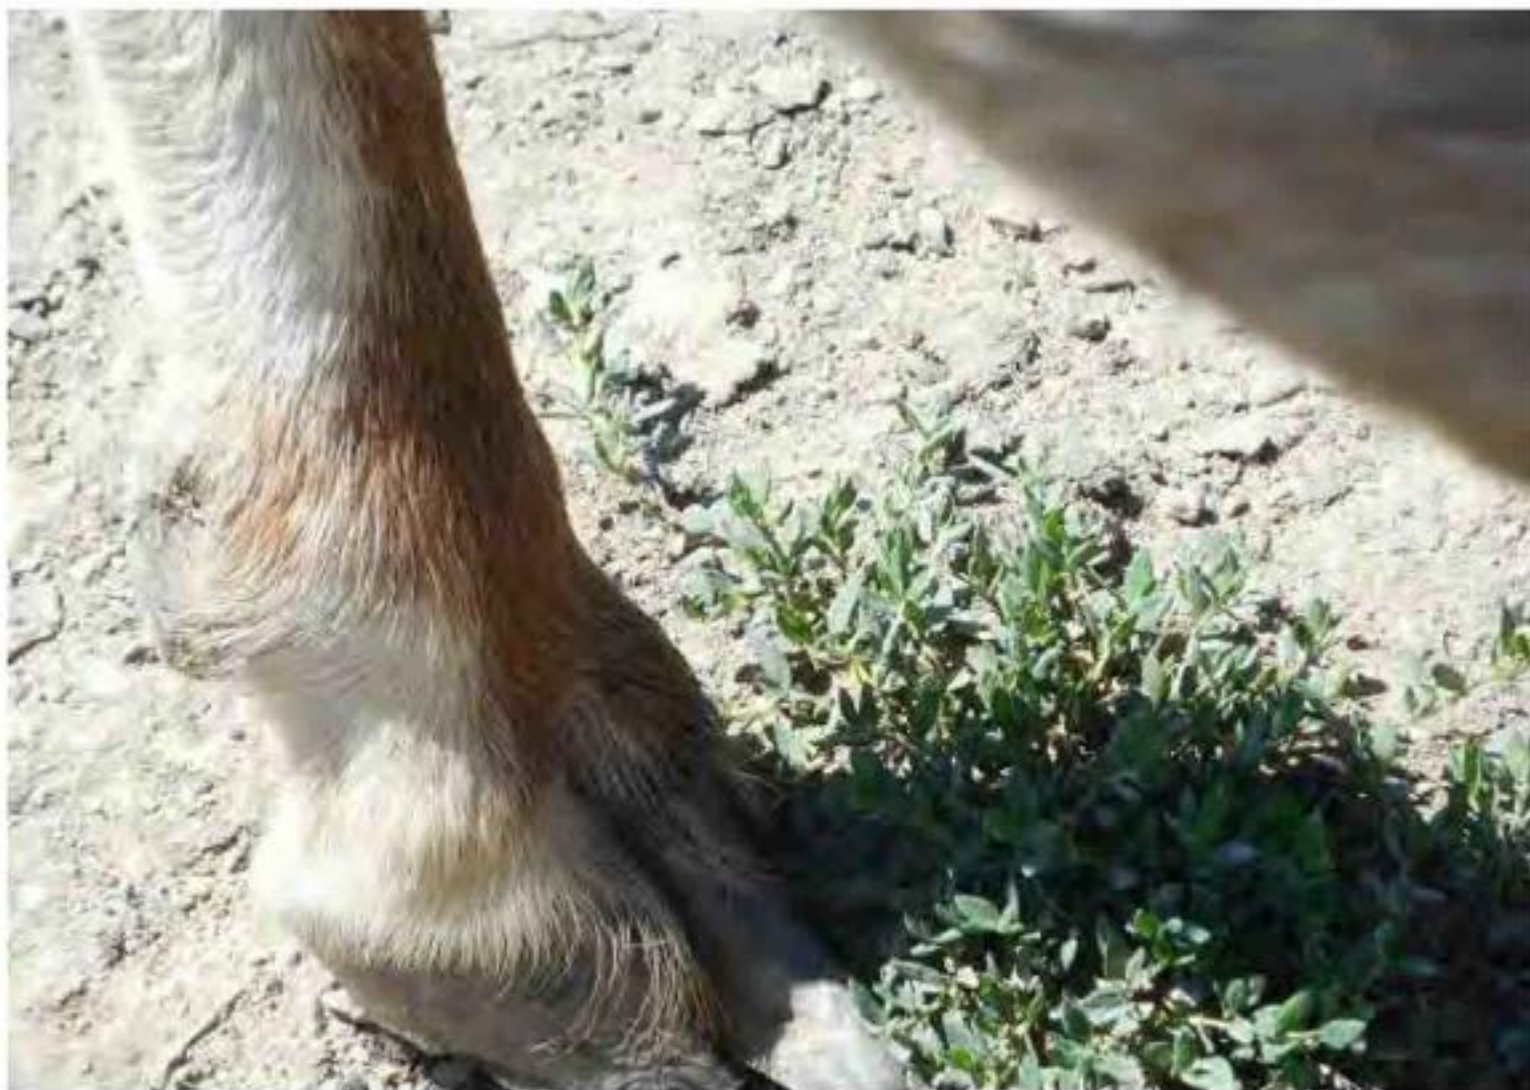
CFR: 2.40 (b) (2)

Photographer:	Randy Coleman	Legal Name:	55-B-0069
Photo Taken:	Wed, Aug 3, '16 1100 am	HENRY HAMPTON	
Inspection:	217160732290590		
Description:	2.40(b)(2): Female Nubian #1323 found with long feet.

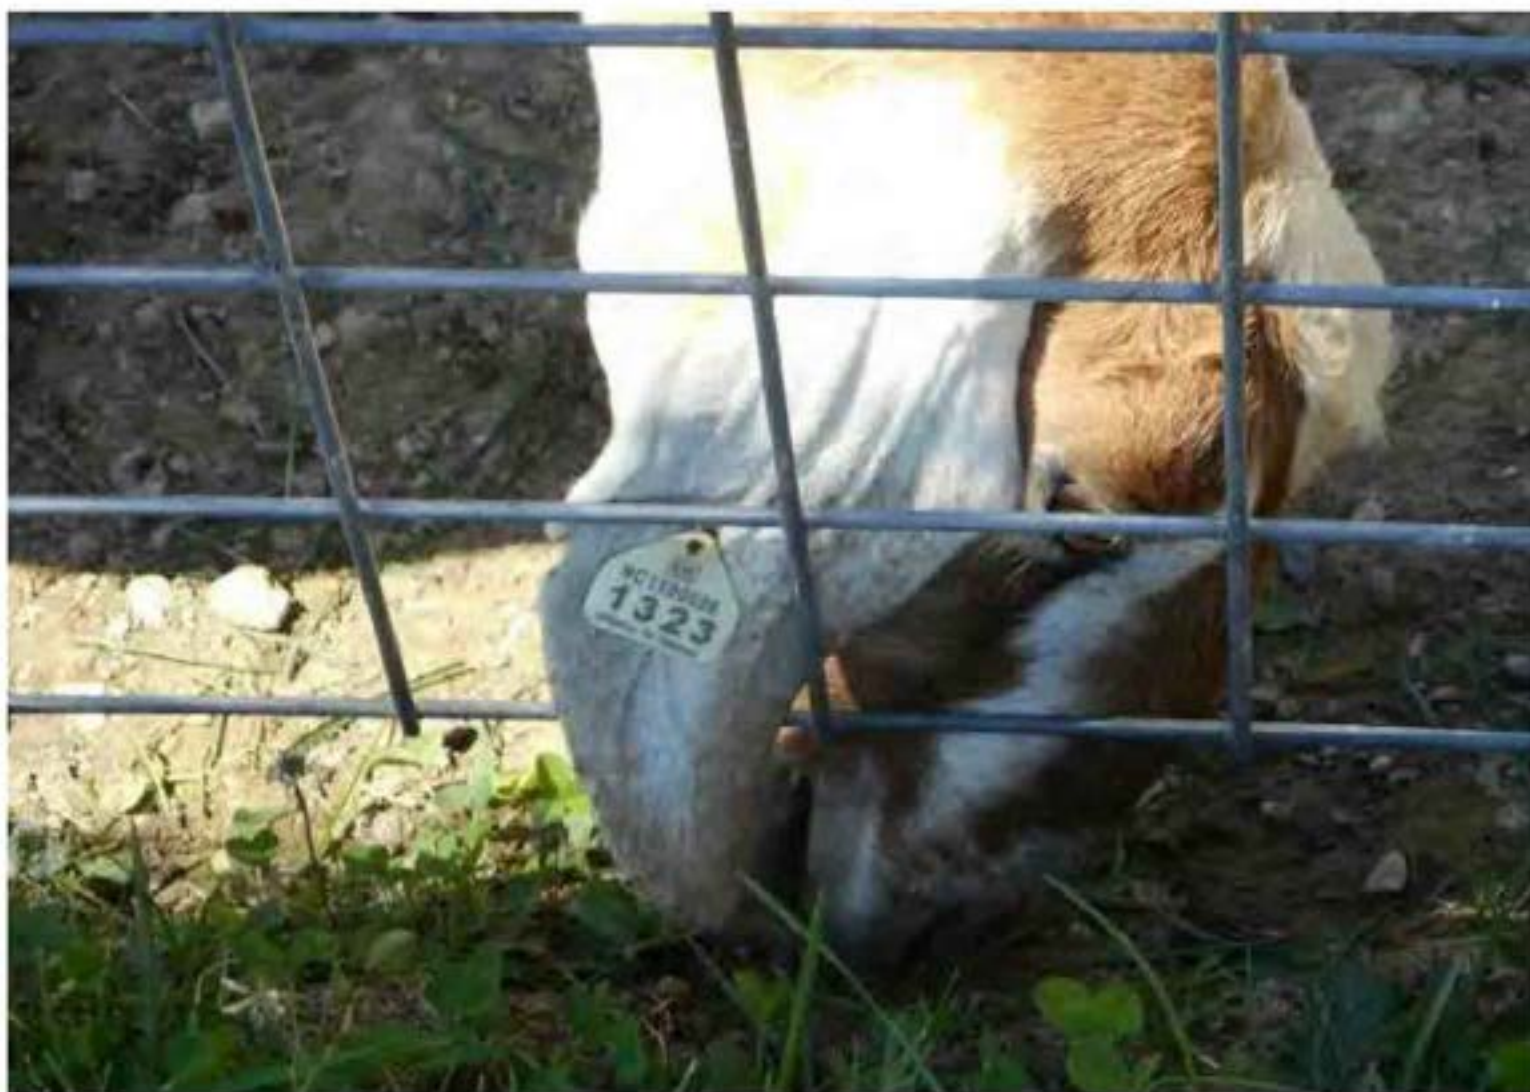
CFR: 2.40 (b) (2)

Photographer:	Randy Coleman	Legal Name:	55-B-0069
Photo Taken:	Wed, Aug 3, '16 1100 am	HENRY HAMPTON	
Inspection:	217160732290590		
Description:	2.40(b)(2): Female Nubian #1323 found with long feet.

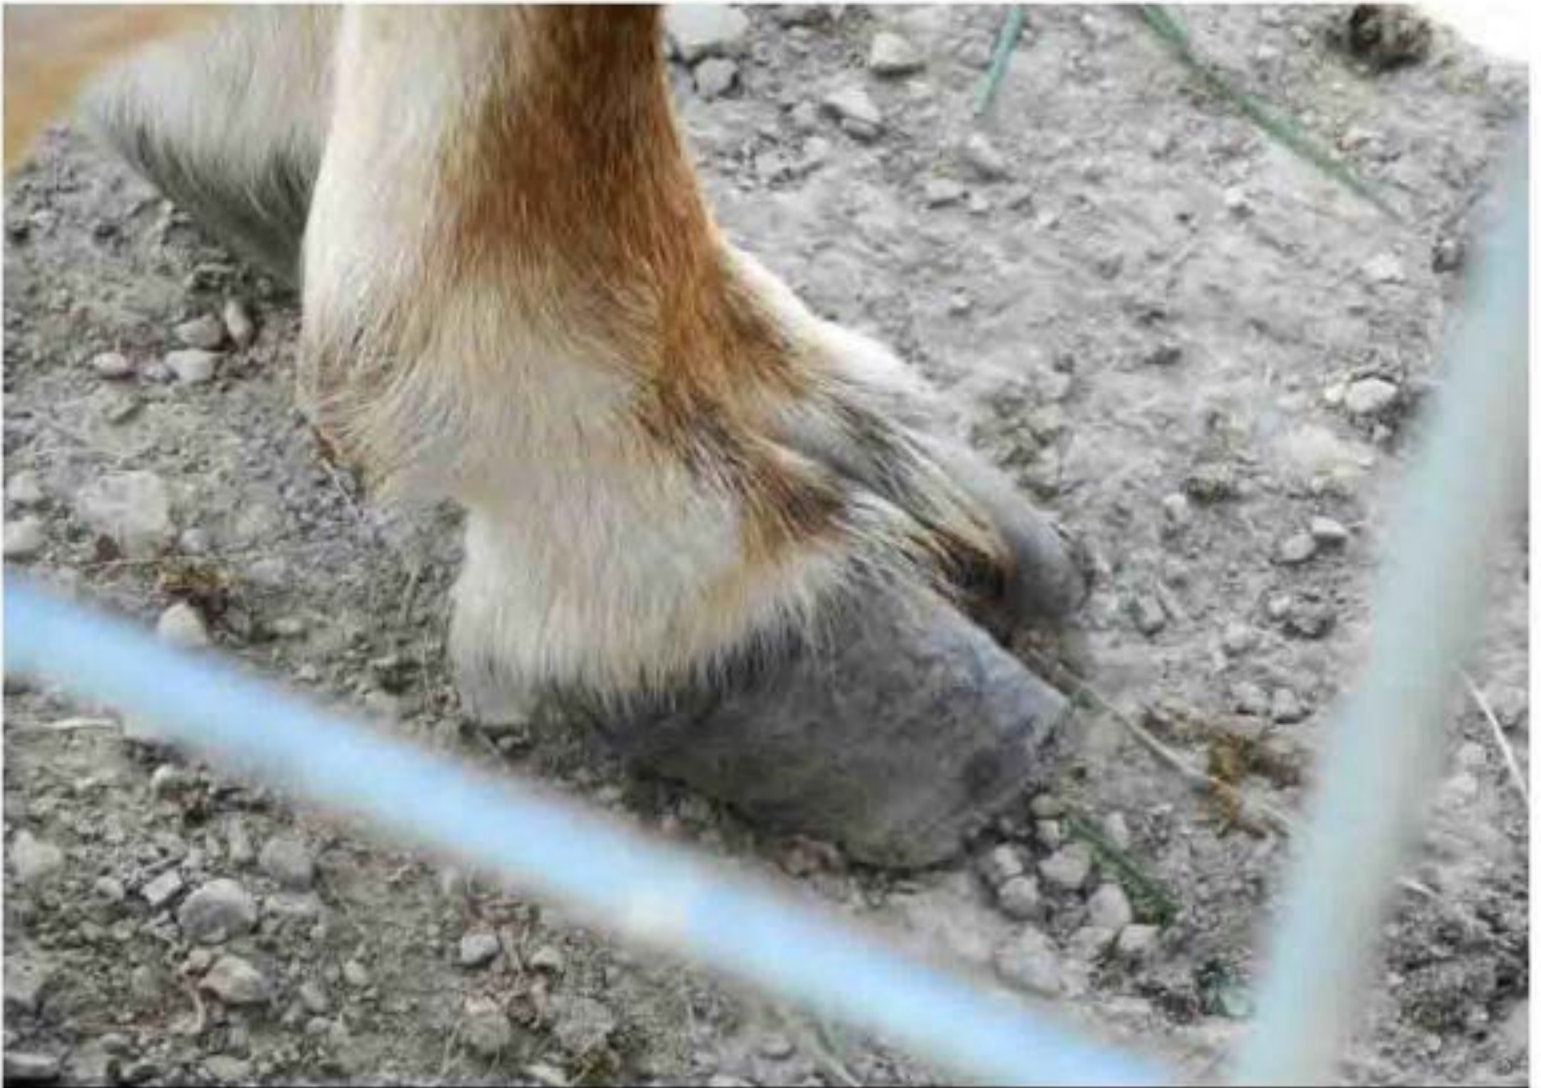
CFR: 2.40 (b) (2)

Photographer:	Randy Coleman	Legal Name:	55-B-0069
Photo Taken:	Wed, Aug 3, '16 1100 am	HENRY HAMPTON	
Inspection:	217160732290590		
Description:	2.40(b)(2): Female Nubian #1323 found with long feet.

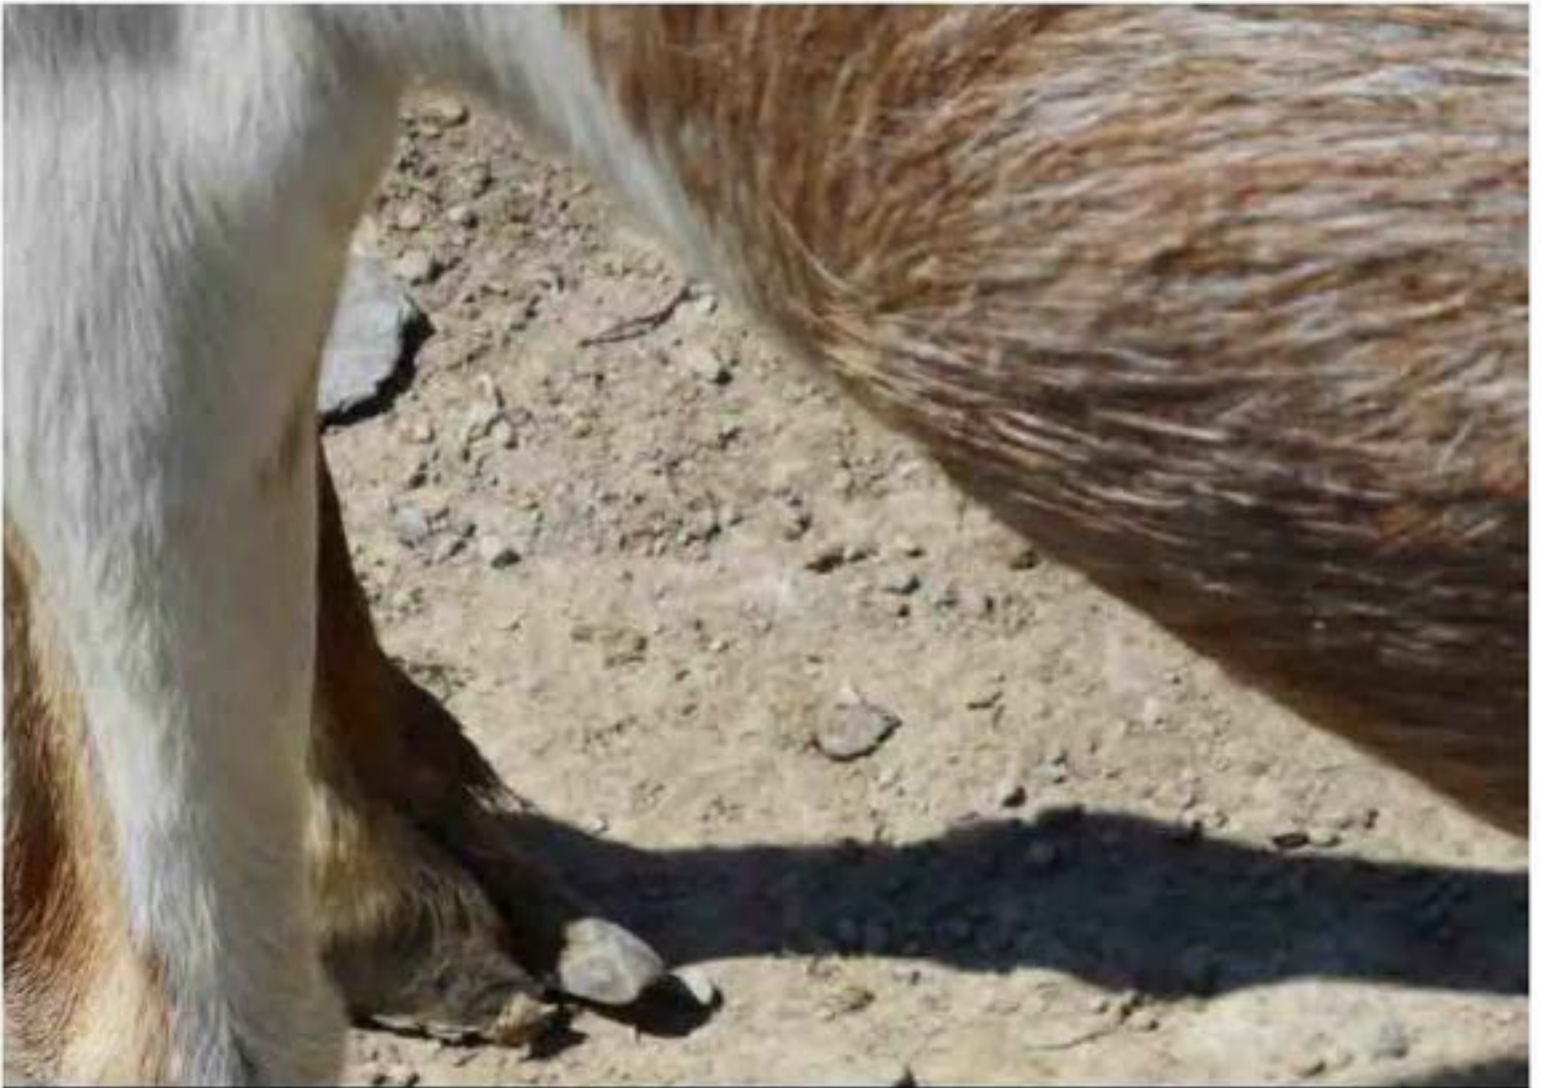
CFR: 2.40 (b) (2)

Photographer:	Randy Coleman	Legal Name:	55-B-0069
Photo Taken:	Wed, Aug 3, '16 1100 am	HENRY HAMPTON	
Inspection:	217160732290590		
Description:	2.40(b)(2): Female Nubian #1323 found with long feet.

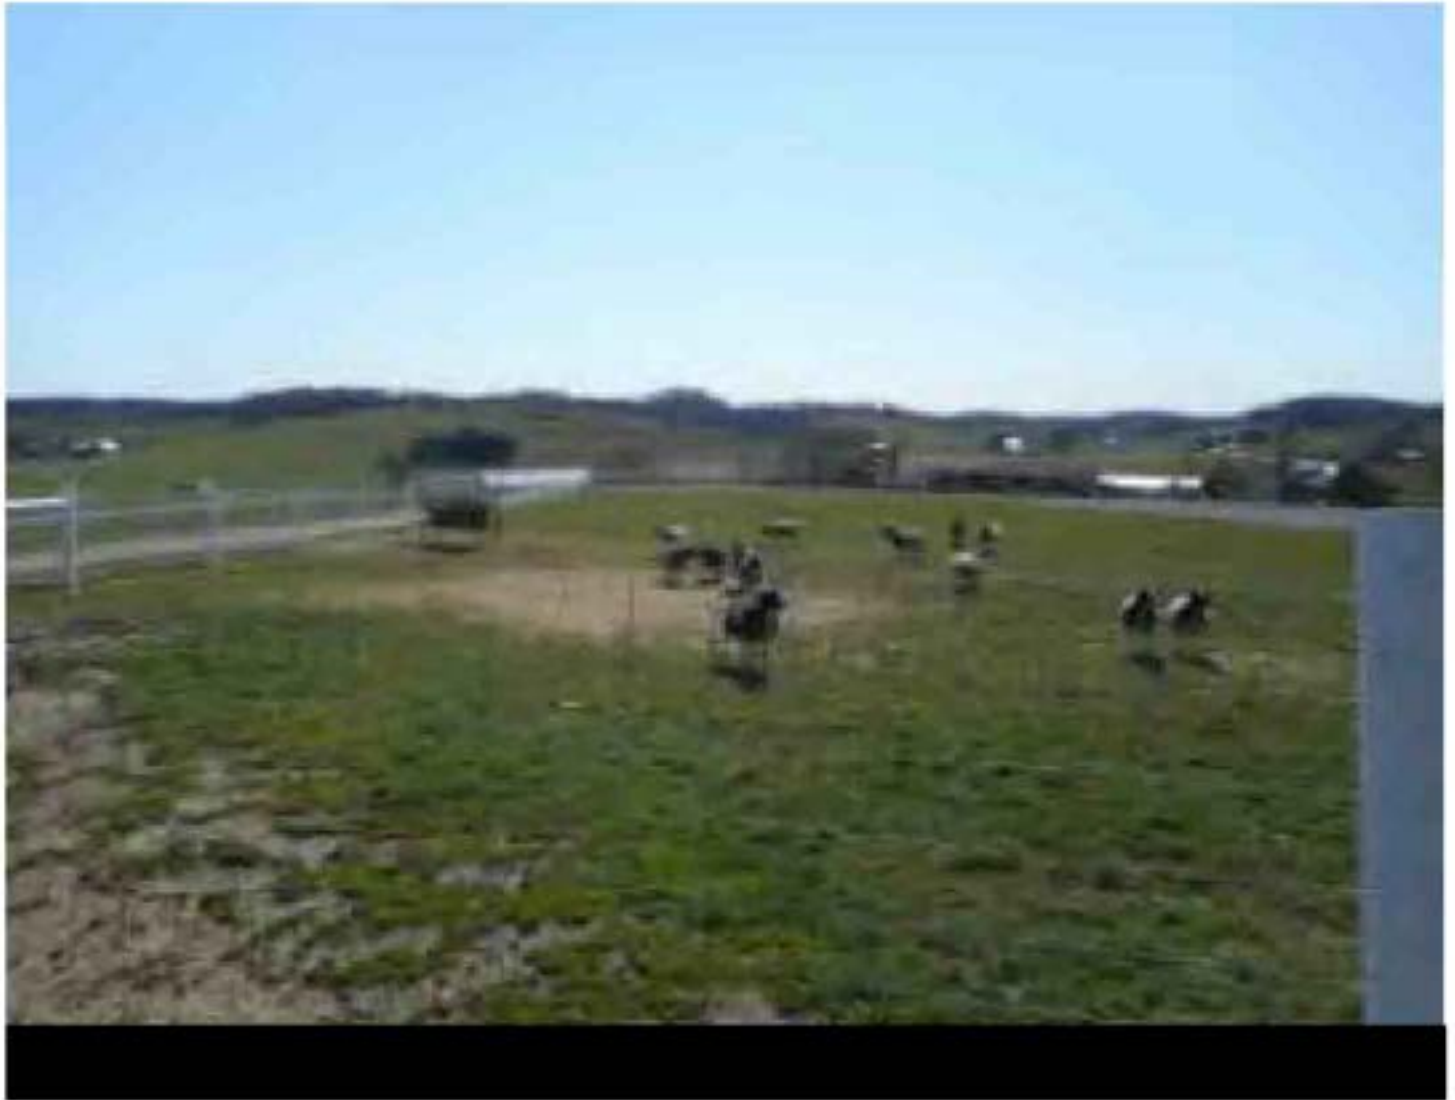
Description:
Section 2.131(c)(1): Walk-through areas of the facility without barriers or attendants.

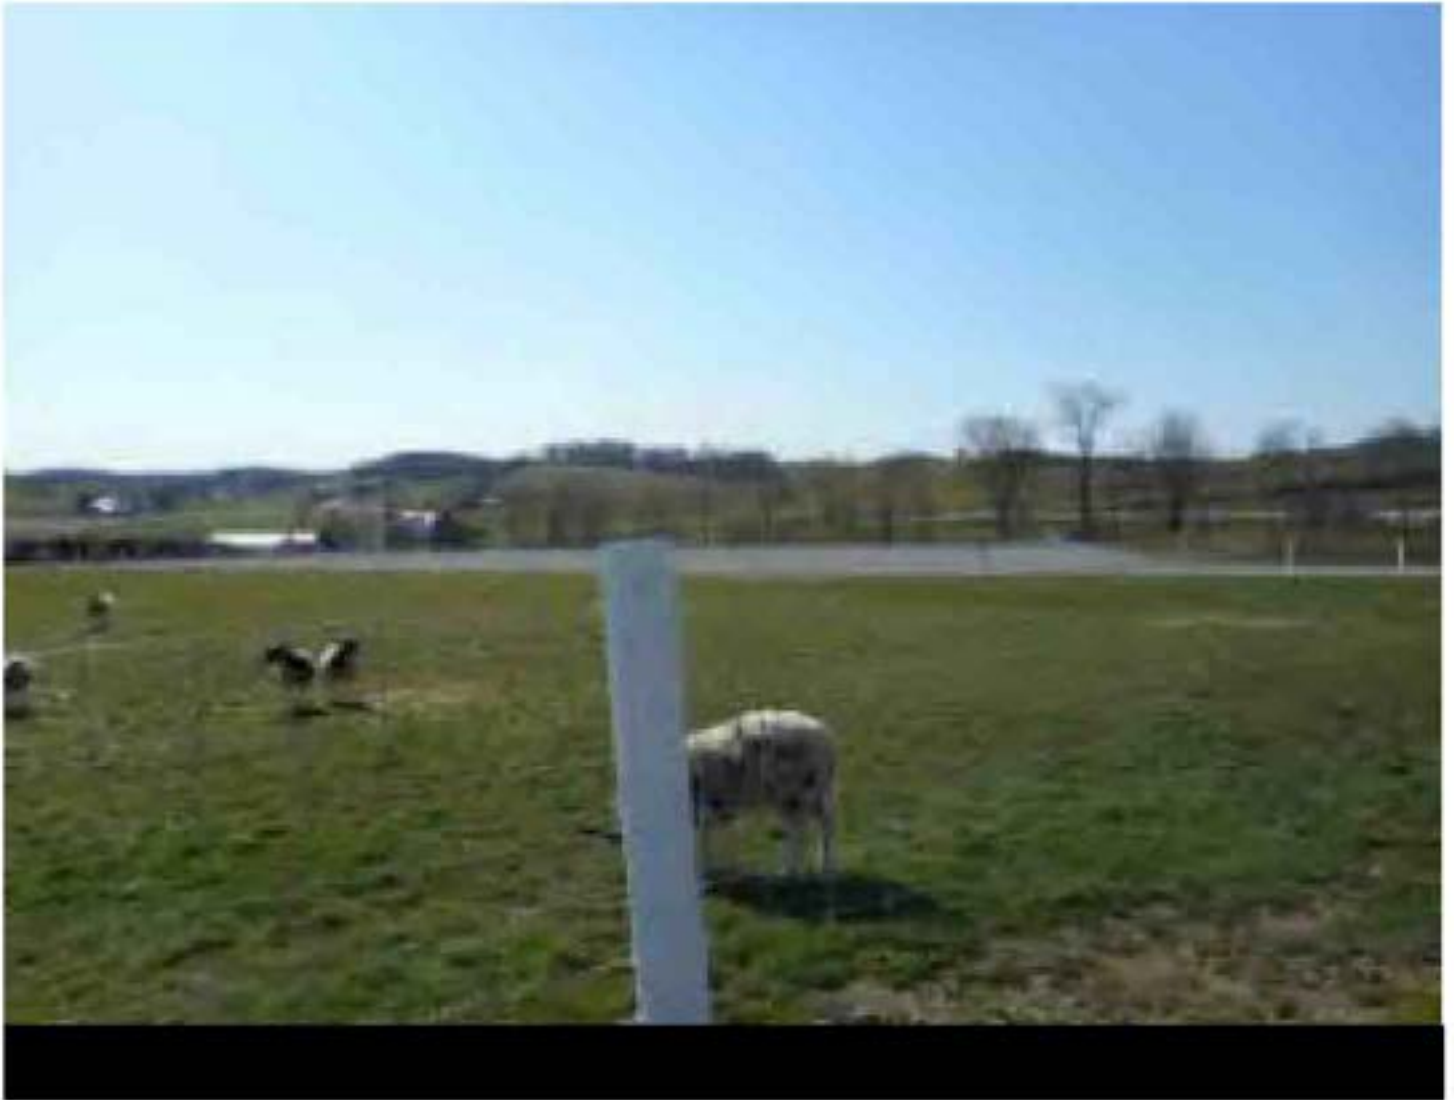
Description:
Section 2.131(c)(1): Walk-through areas of the facility without barriers or attendants.

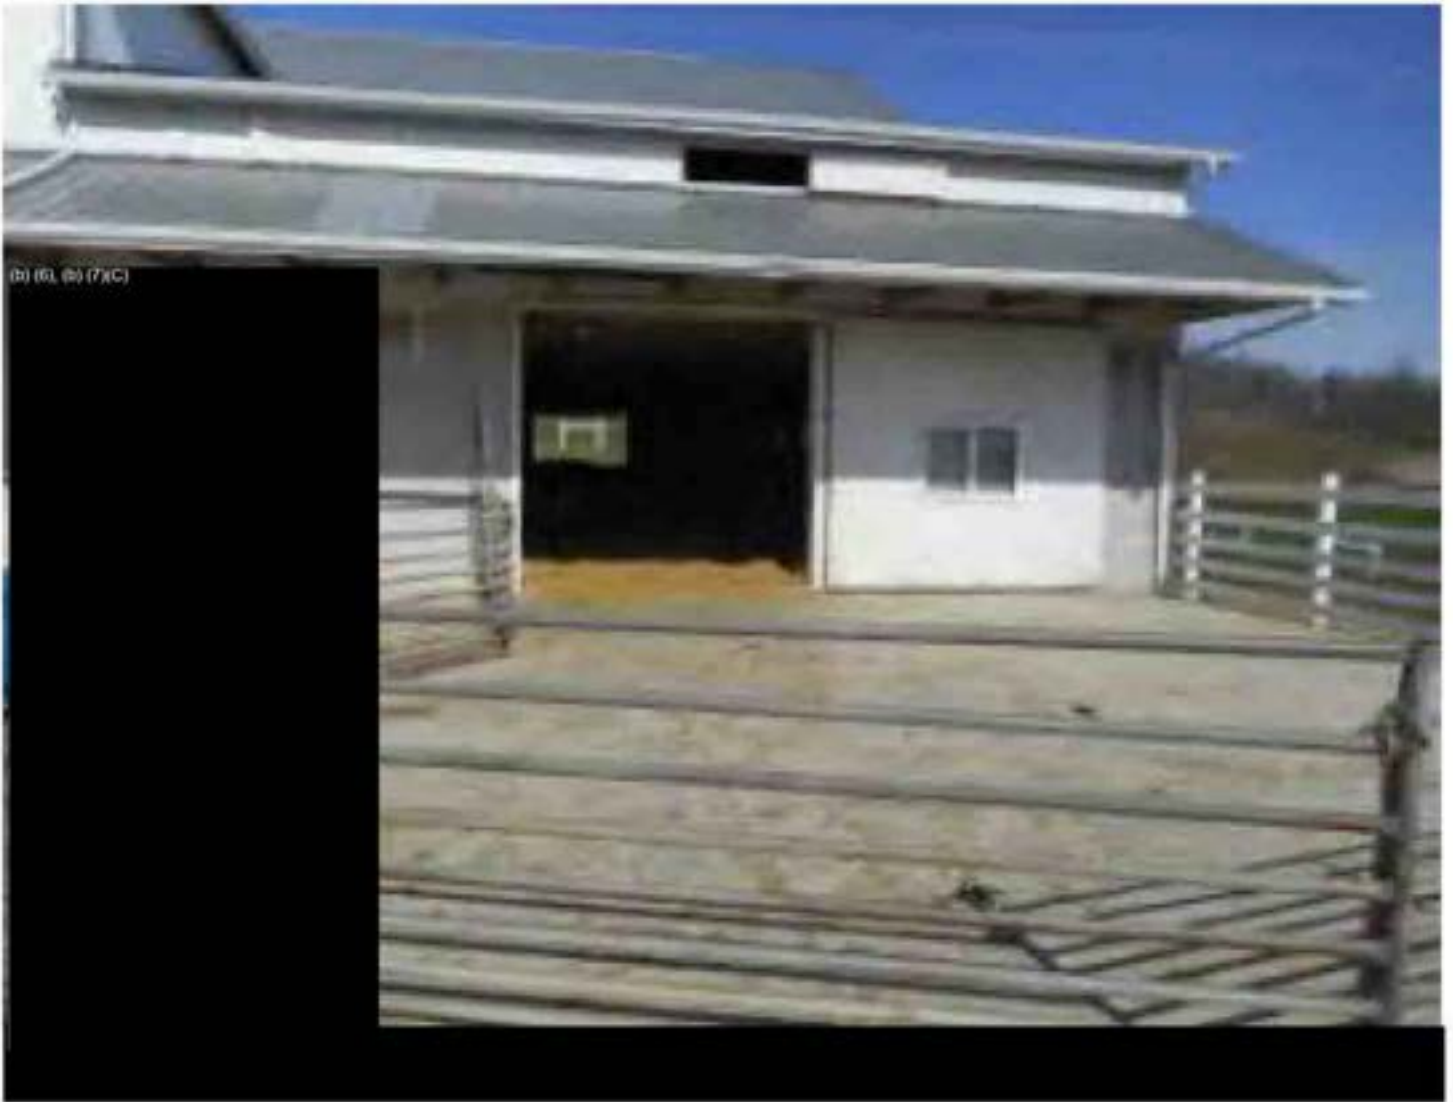
Description:
Section 2.131(c)(1): Walk-through areas of the facility without barriers or attendants.

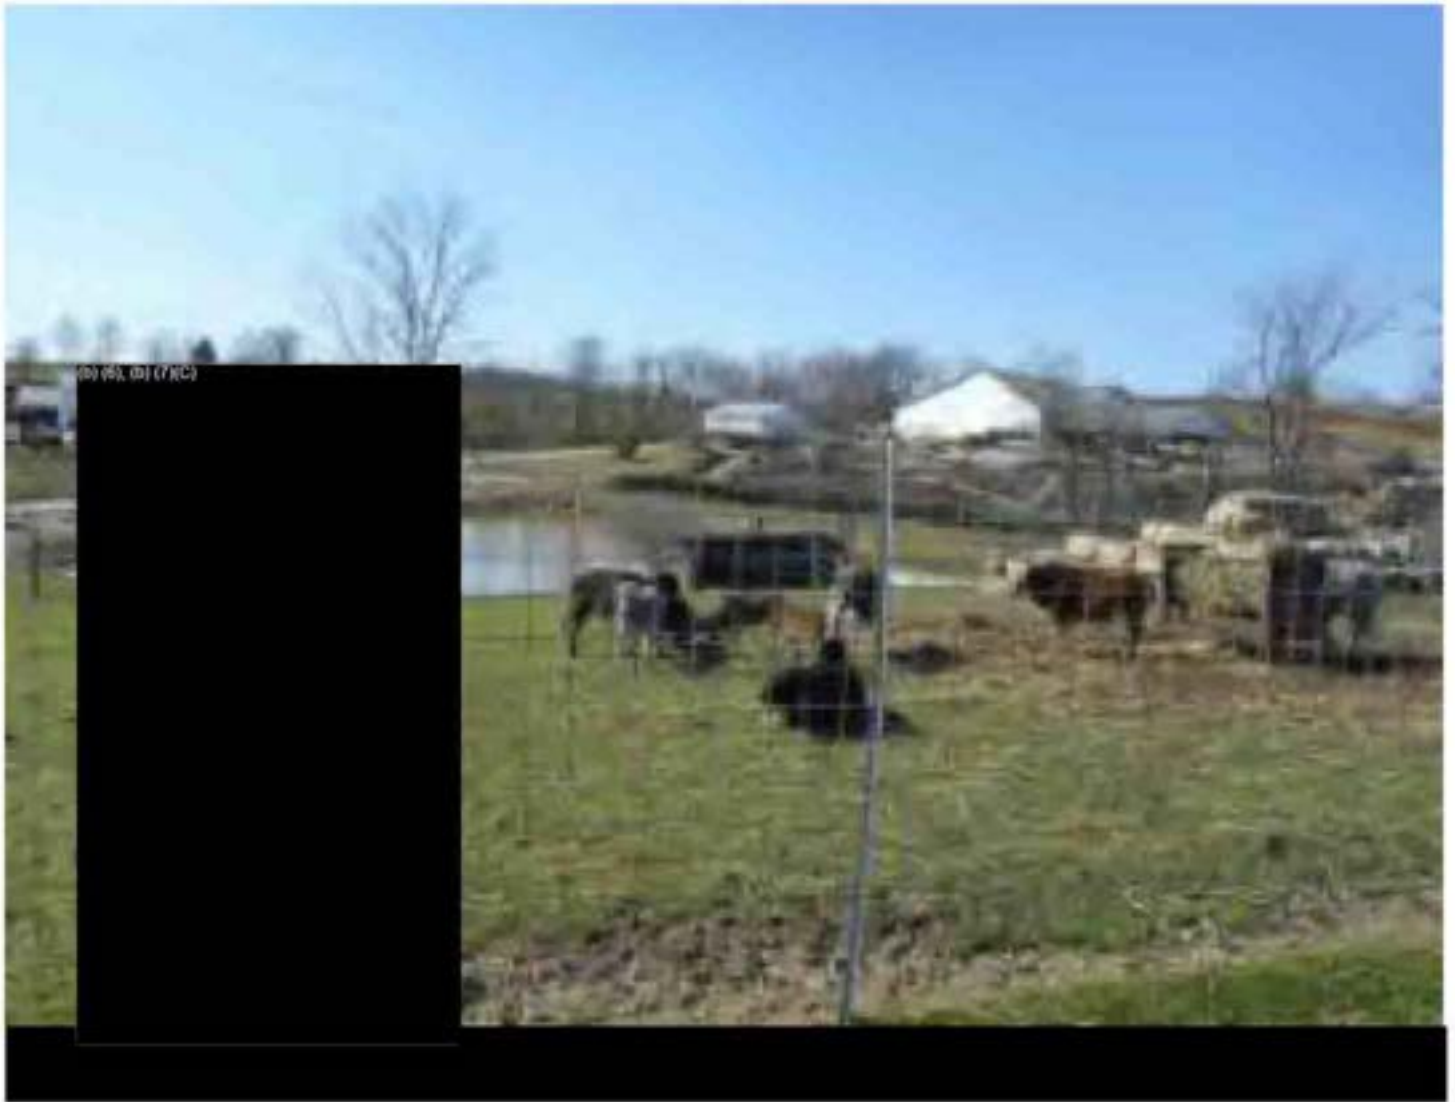
Description:
Section 2.131(c)(1): Walk-through areas of the facility without barriers or attendants.

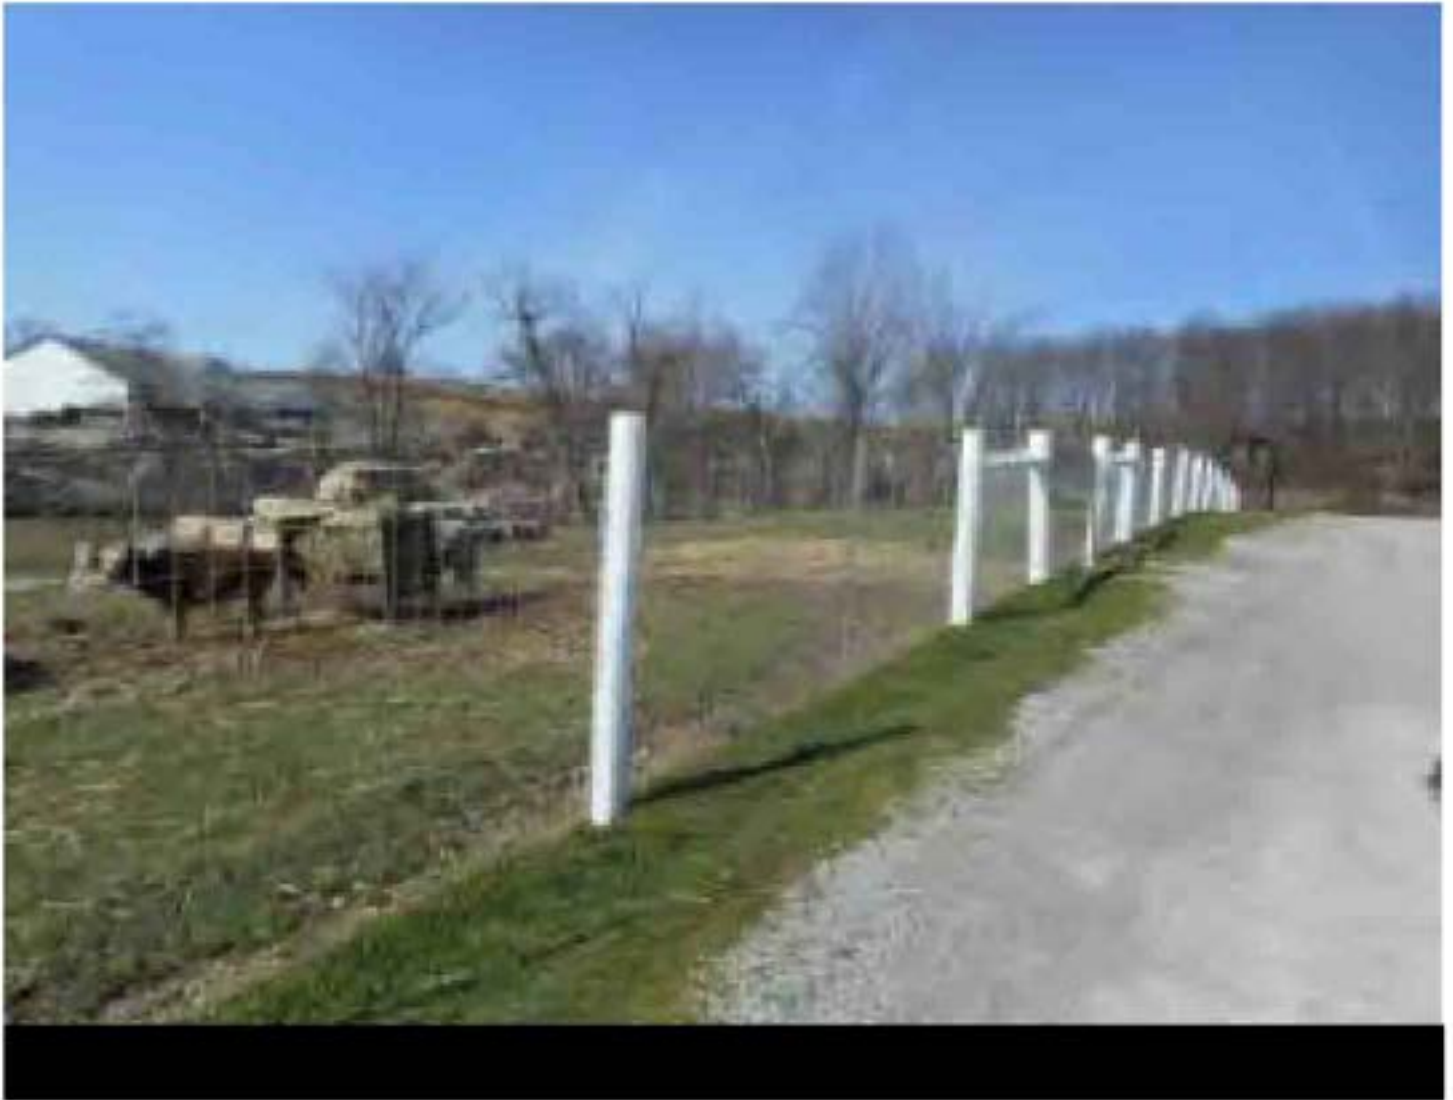
Description:
Section 2.131(c)(1): Walk-through areas of the facility without barriers or attendants.

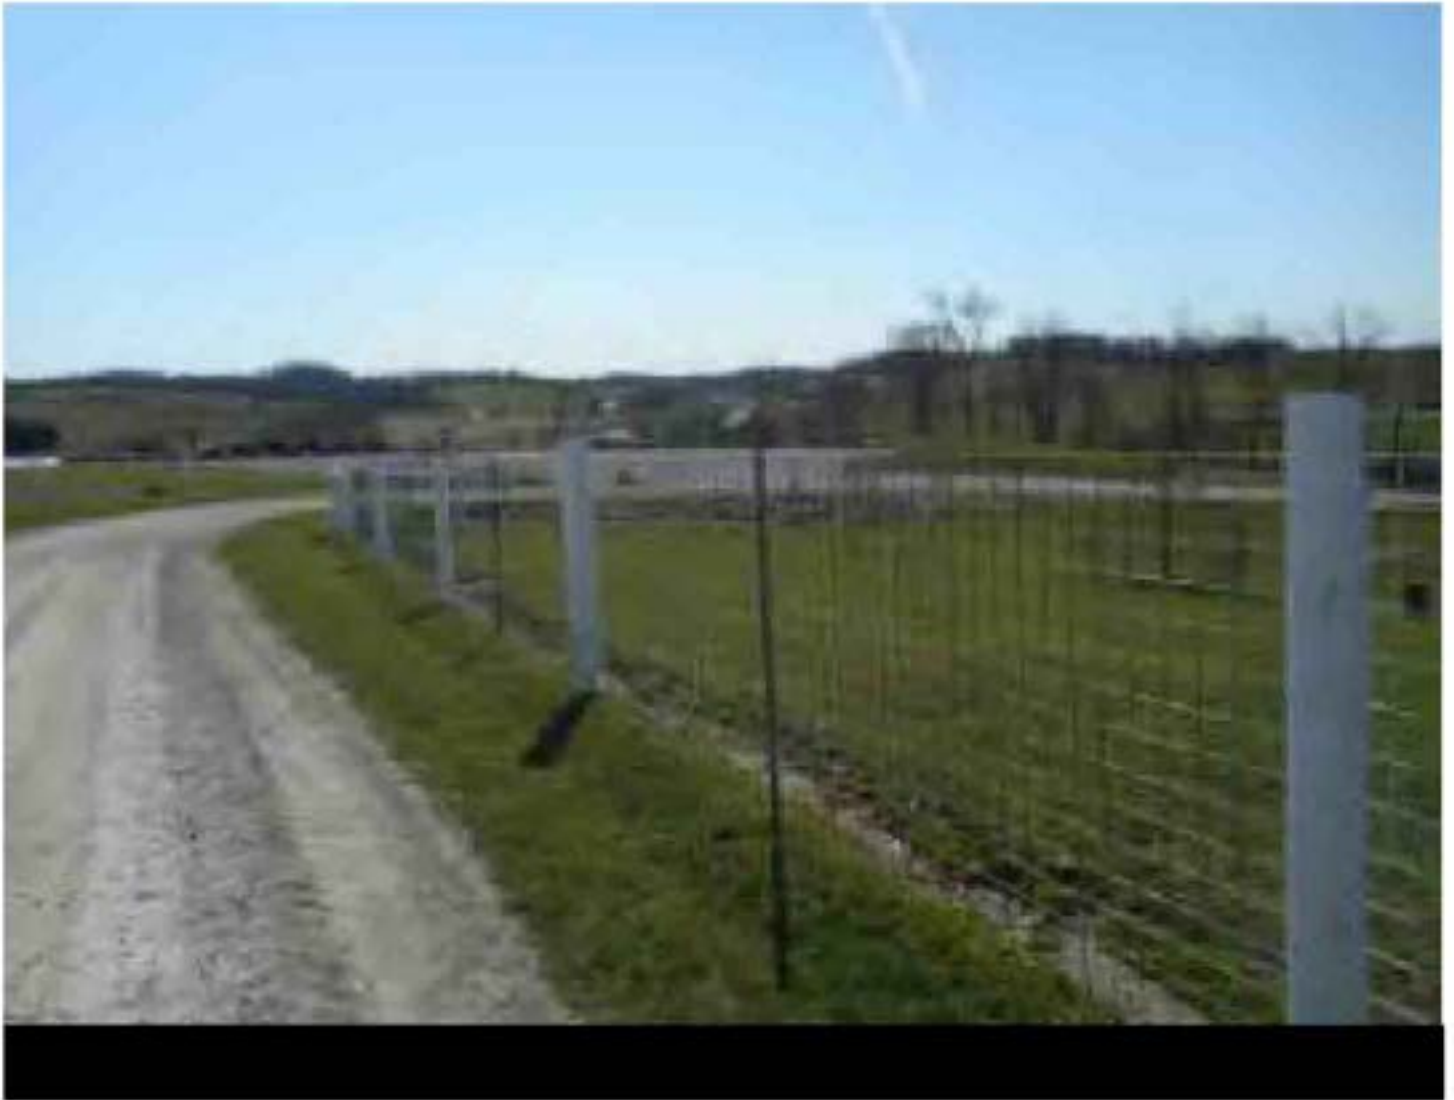
Description:
Section 2.131(c)(1): Walk-through areas of the facility without barriers or attendants.

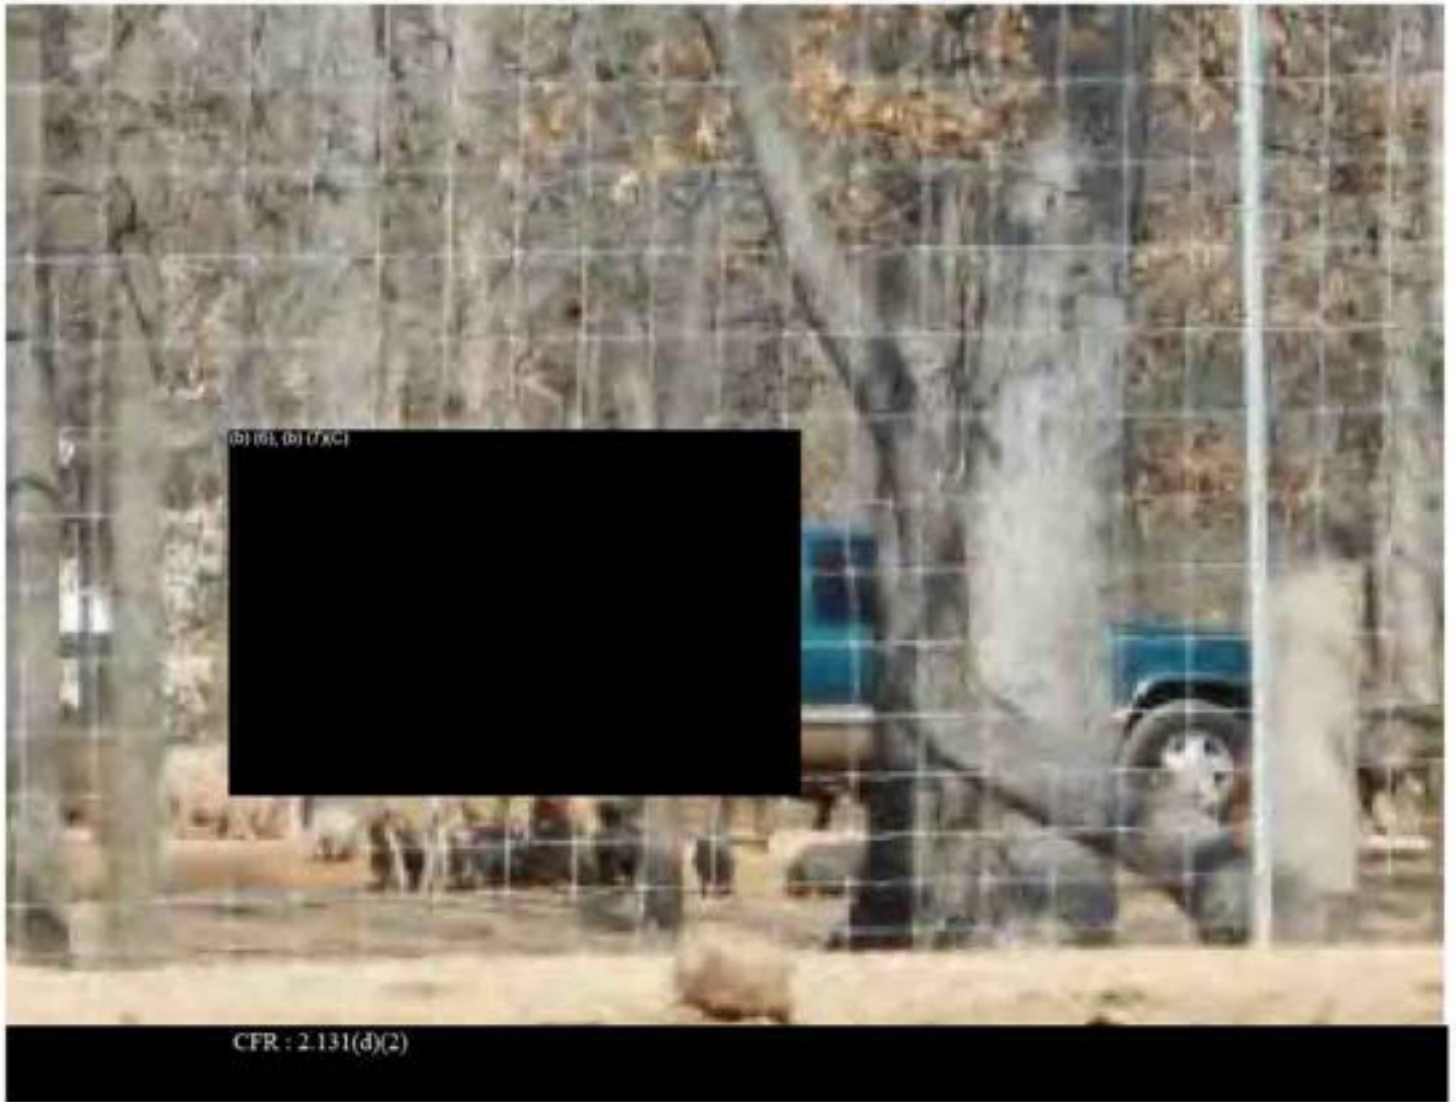
Description:
Section 2.131(d)(2): Photo of members of the public feeding animals in the drive-thru area of the facility from the bed of a pick-up truck.

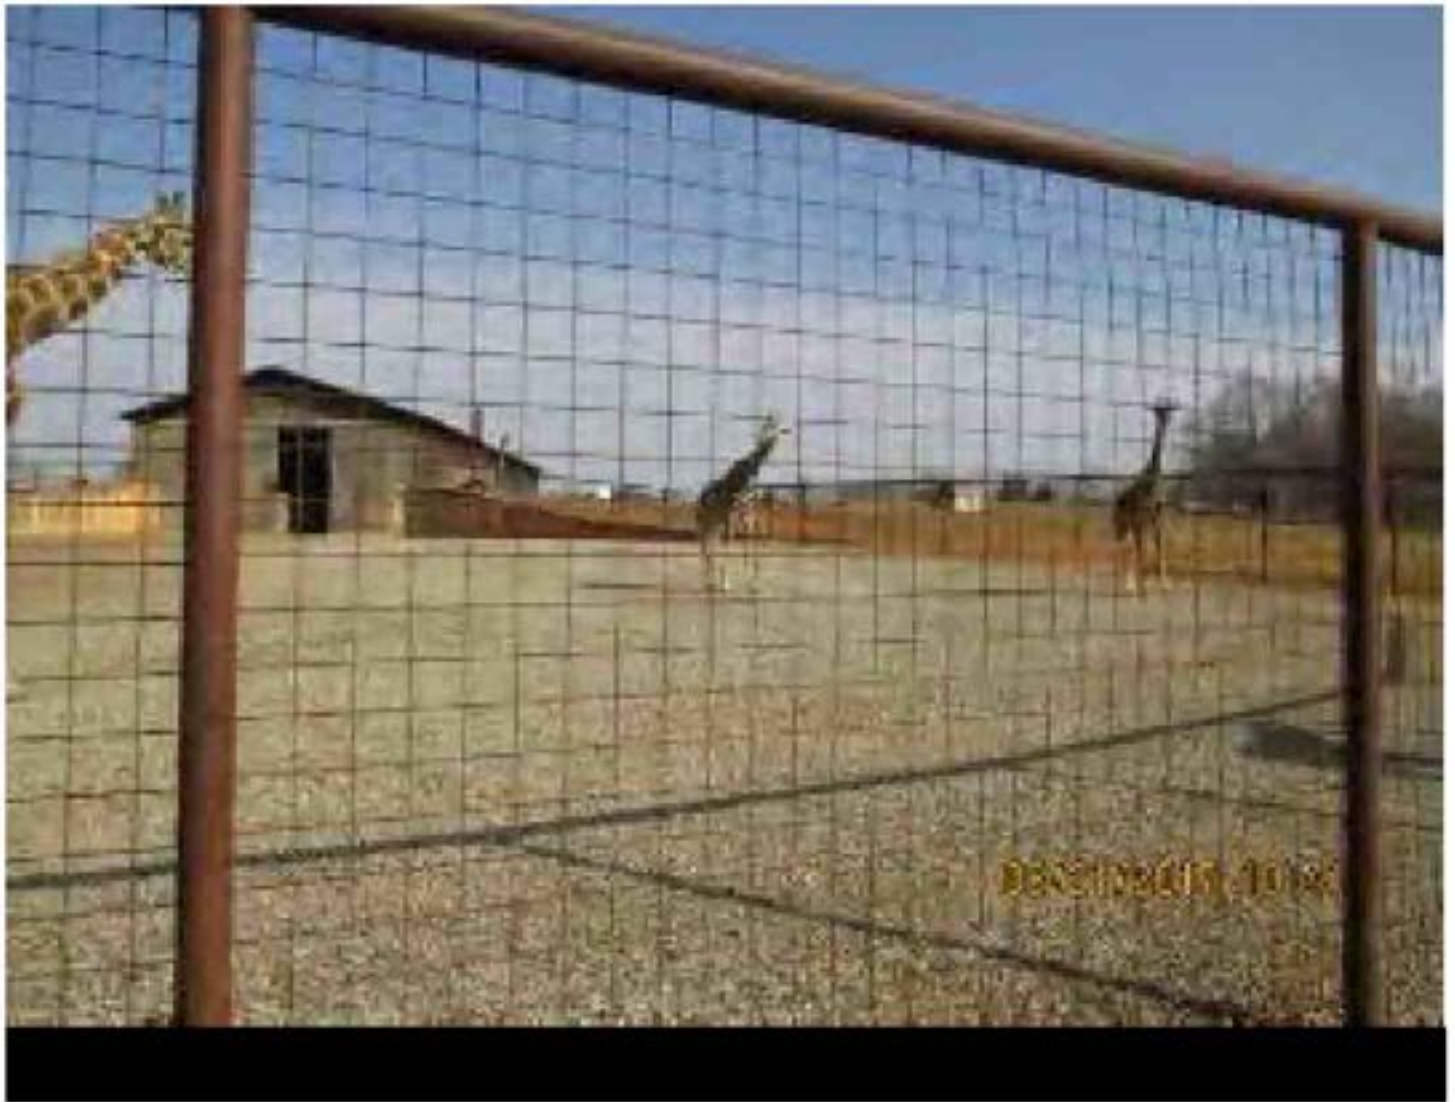
Photographer: M. MCBRIDE
Date and Time: 21-MAR-17
Inspection No: 2016082568176386
Description:
Giraffe Mary - corrected hoof issue.
