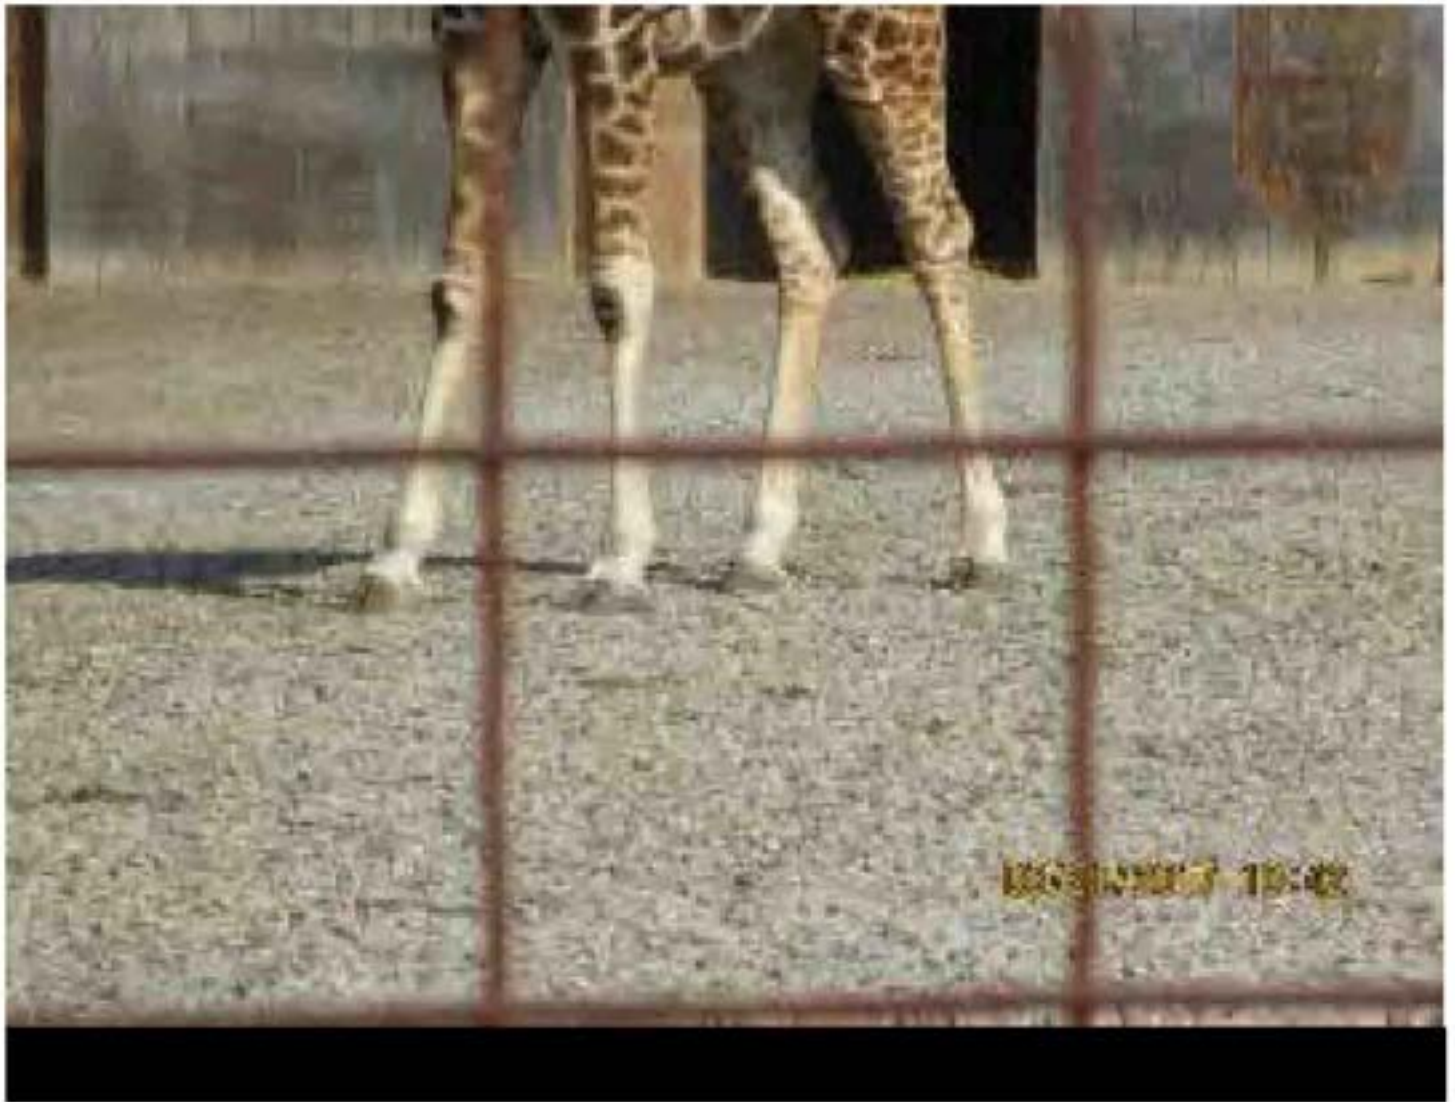
Photographer: M. MCBRIDE
Date and Time: 21-MAR-17
Inspection No: 2016082568176386
Description:
Giraffe Mary - hoof issue corrected

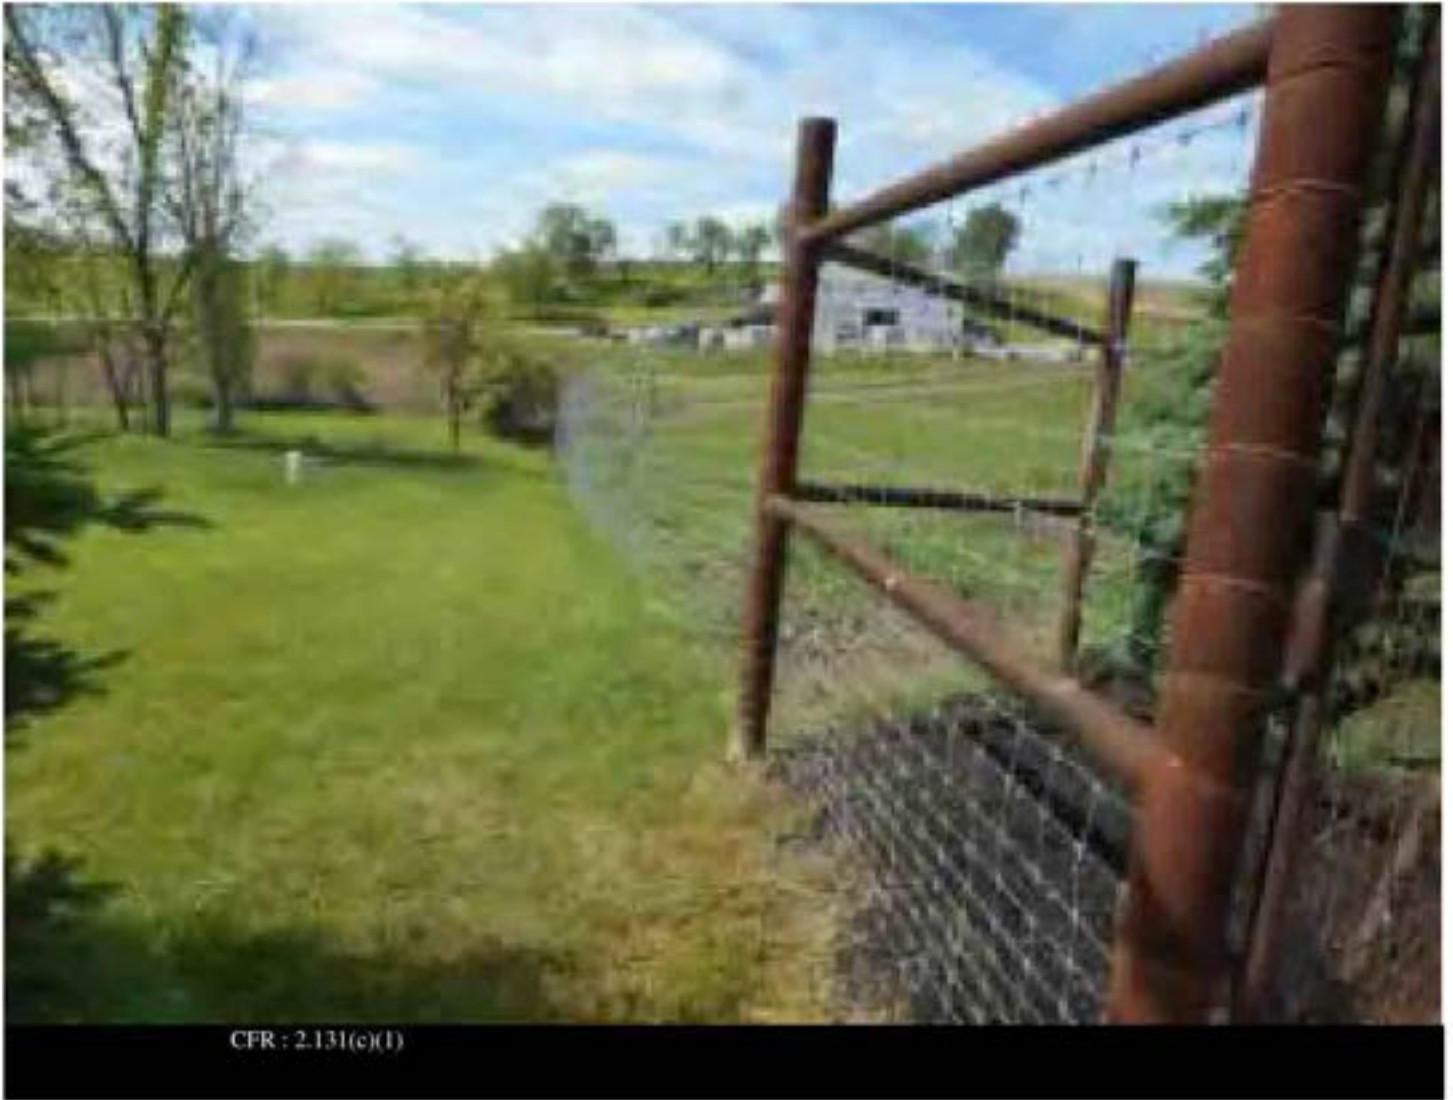
CFR : 2.131(c)(1)

Description:
Section 2.131 (c)(1): Lack of barriers or attendants throughout facility.

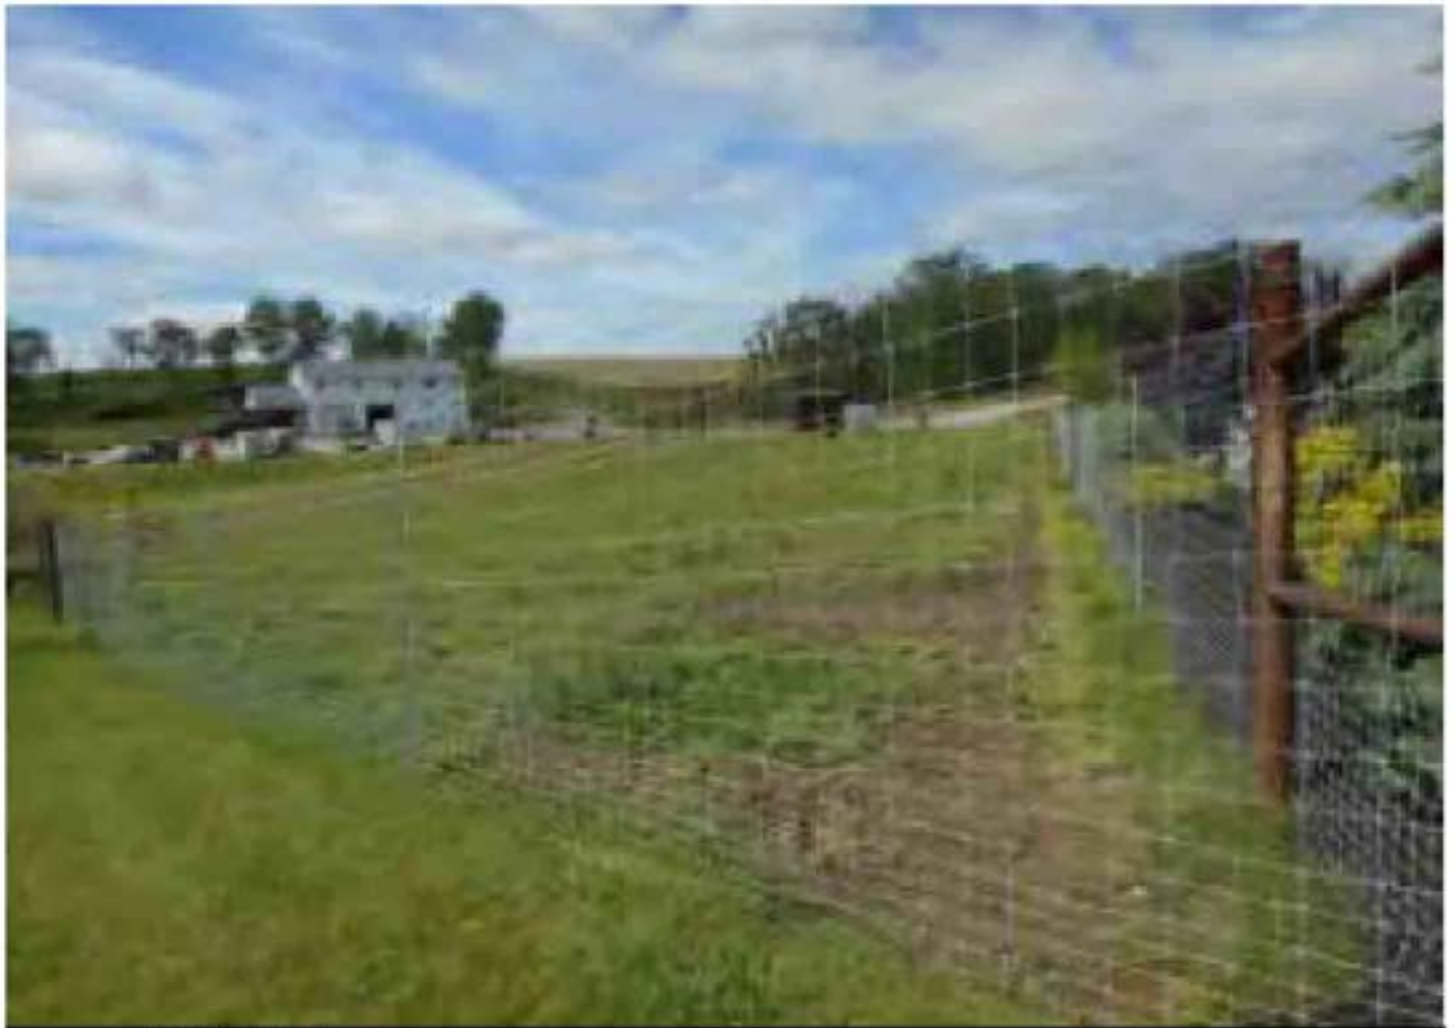
CFR : 2.131(c)(1)

Description:
Section 2.131 (c)(1): Lack of barriers or attendants throughout facility.

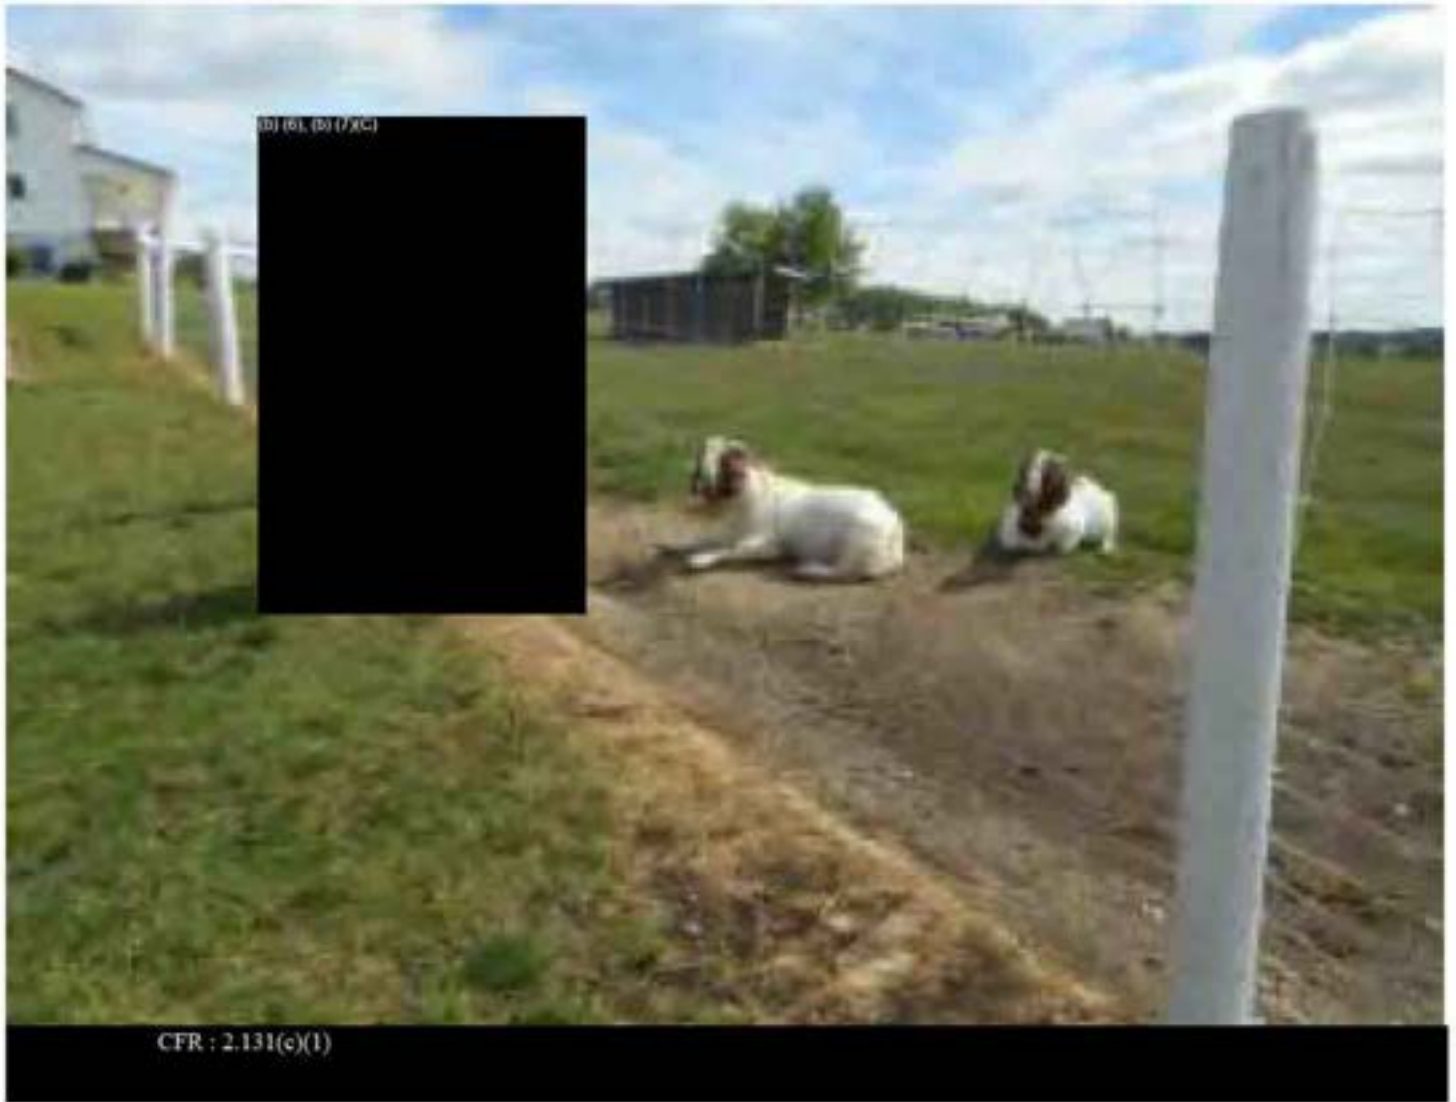
Description:
Section 2.131 (c)(1): Lack of barriers or attendants throughout facility.

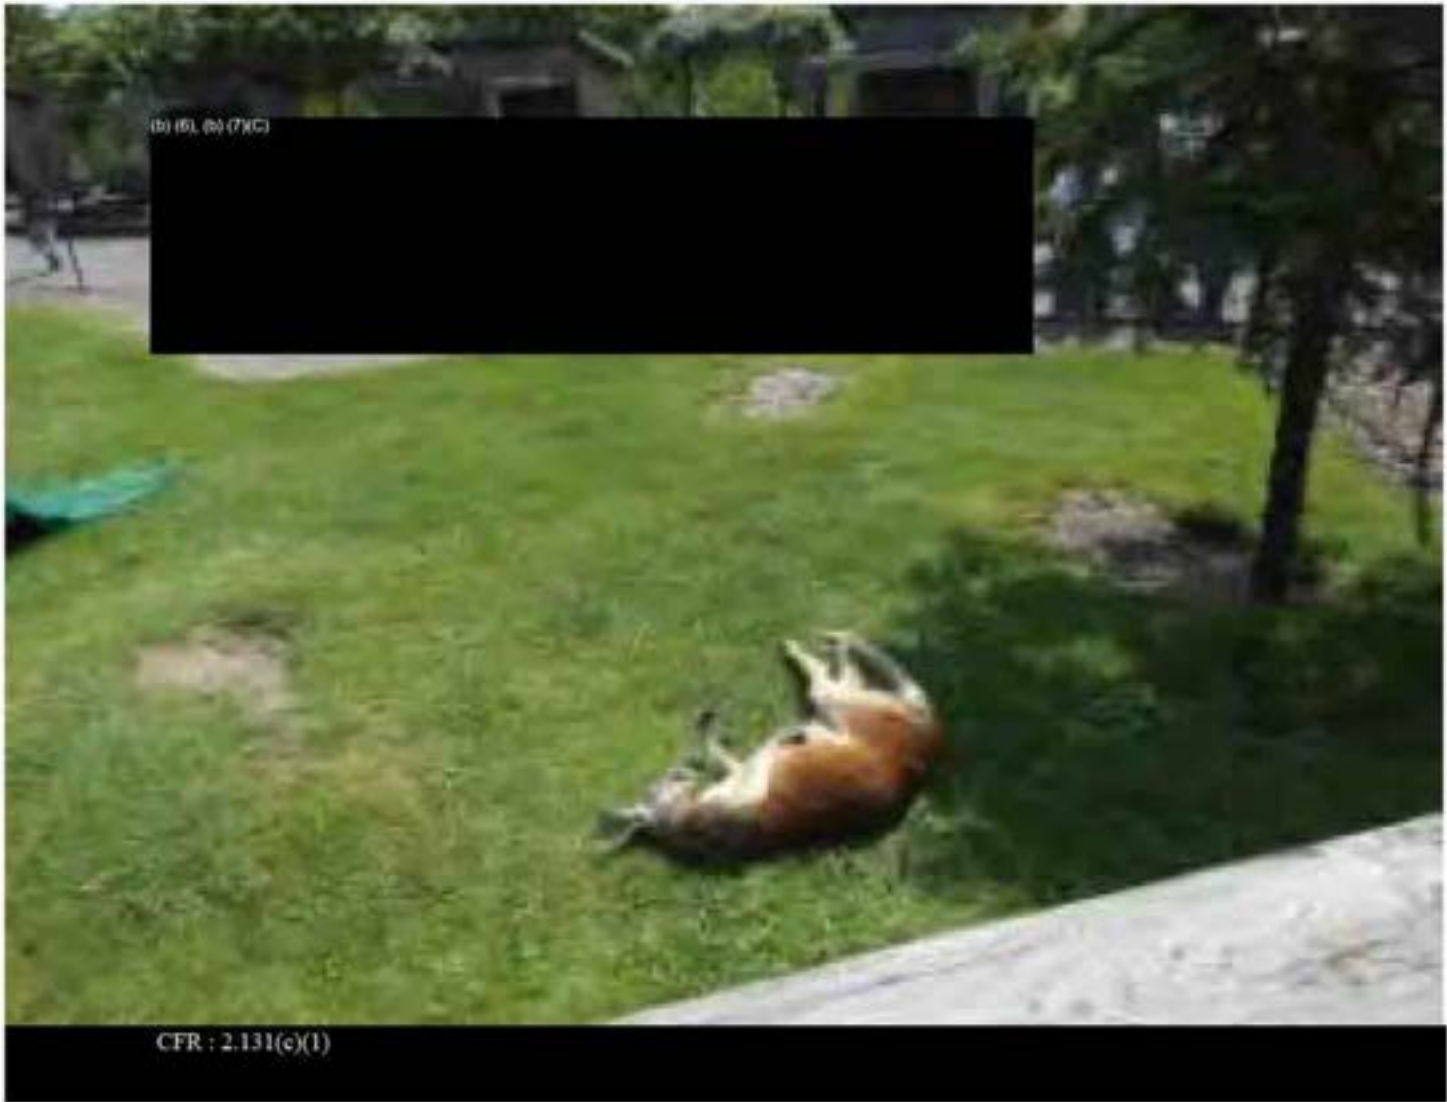
Description:
Section 2.131 (c)(1): Lack of barriers or attendants throughout facility.

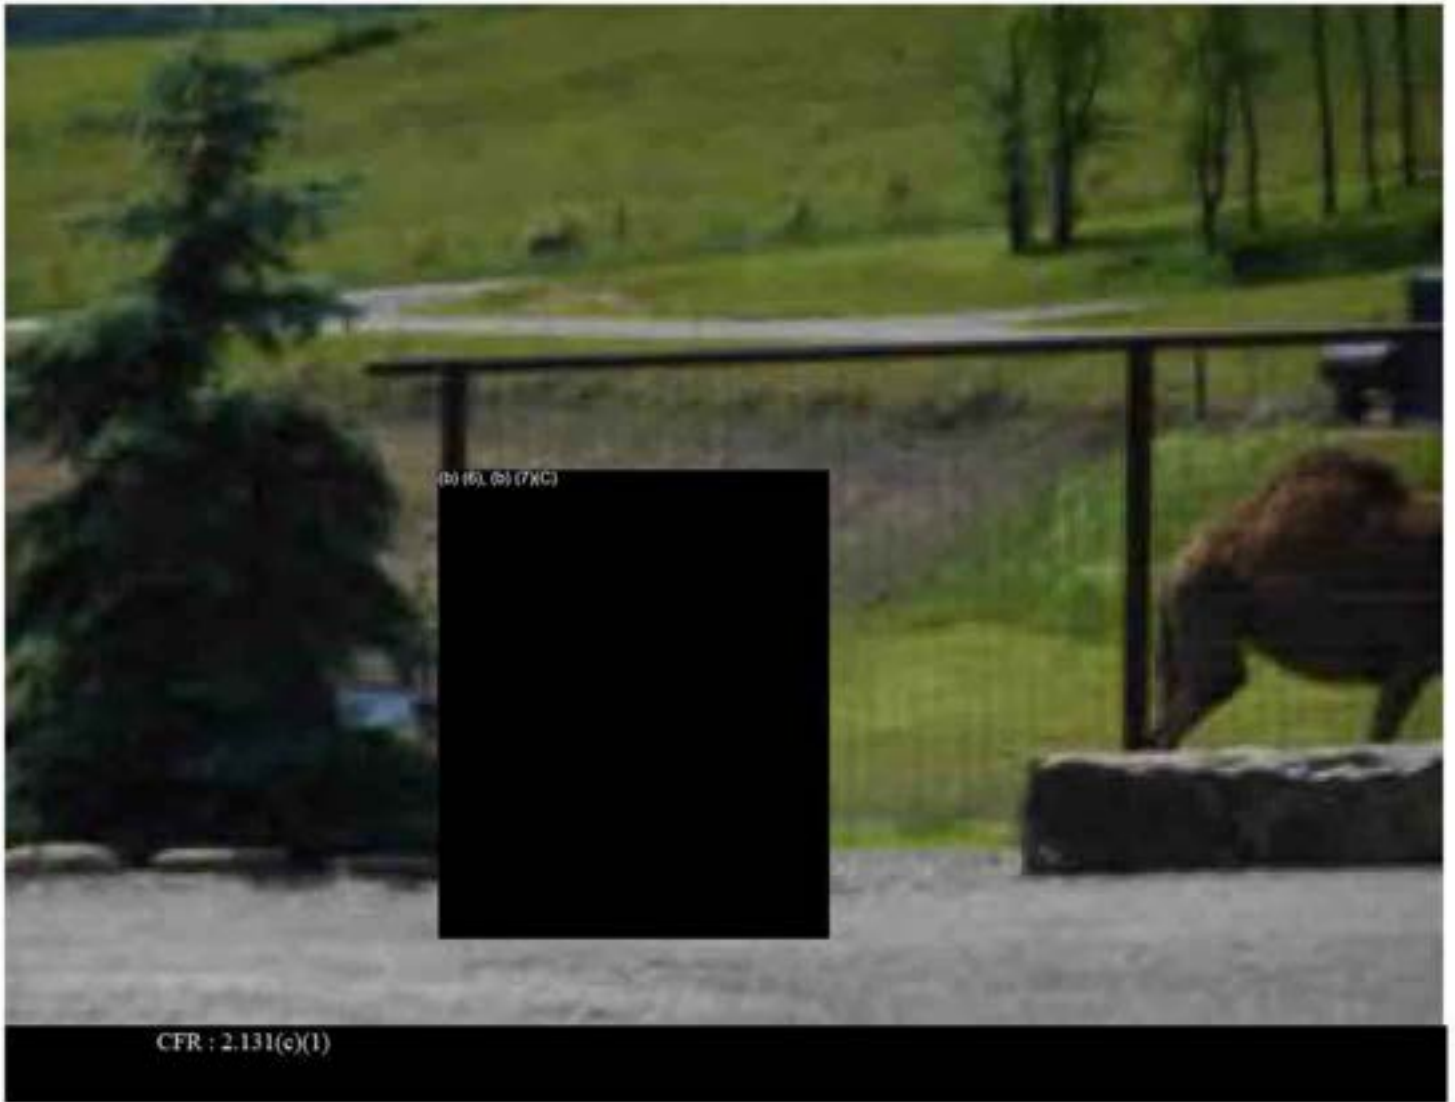
Description:
Section 2.131 (c)(1): Lack of barriers or attendants throughout facility.

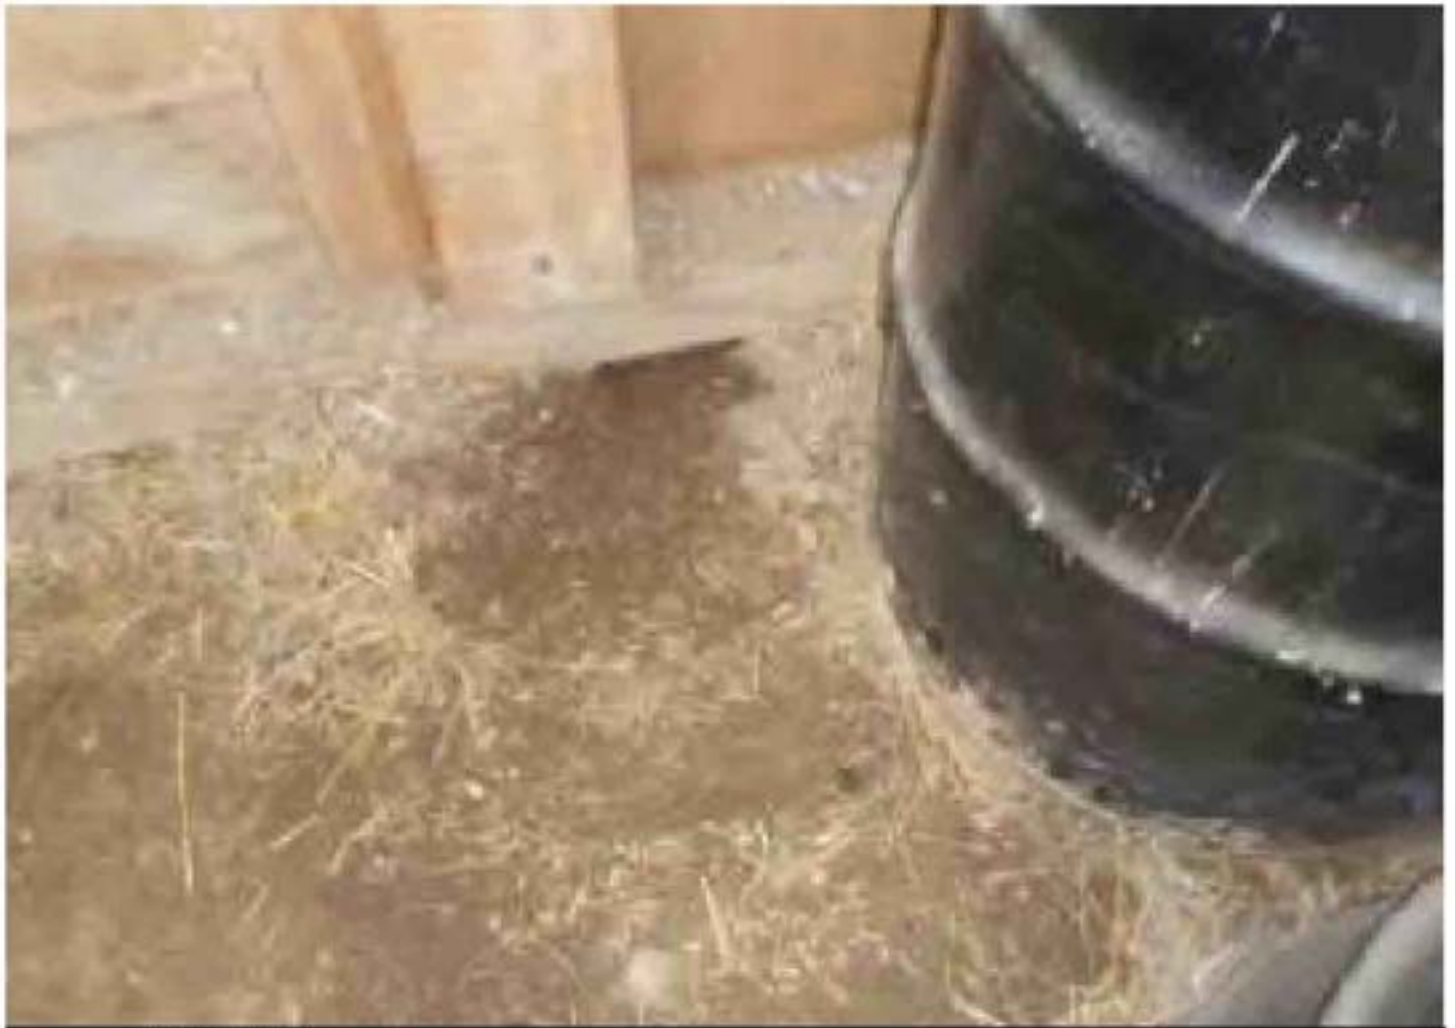
CFR : 3.131(d)

Section 3.131(d): Rodent holes found in kangaroo shelter.

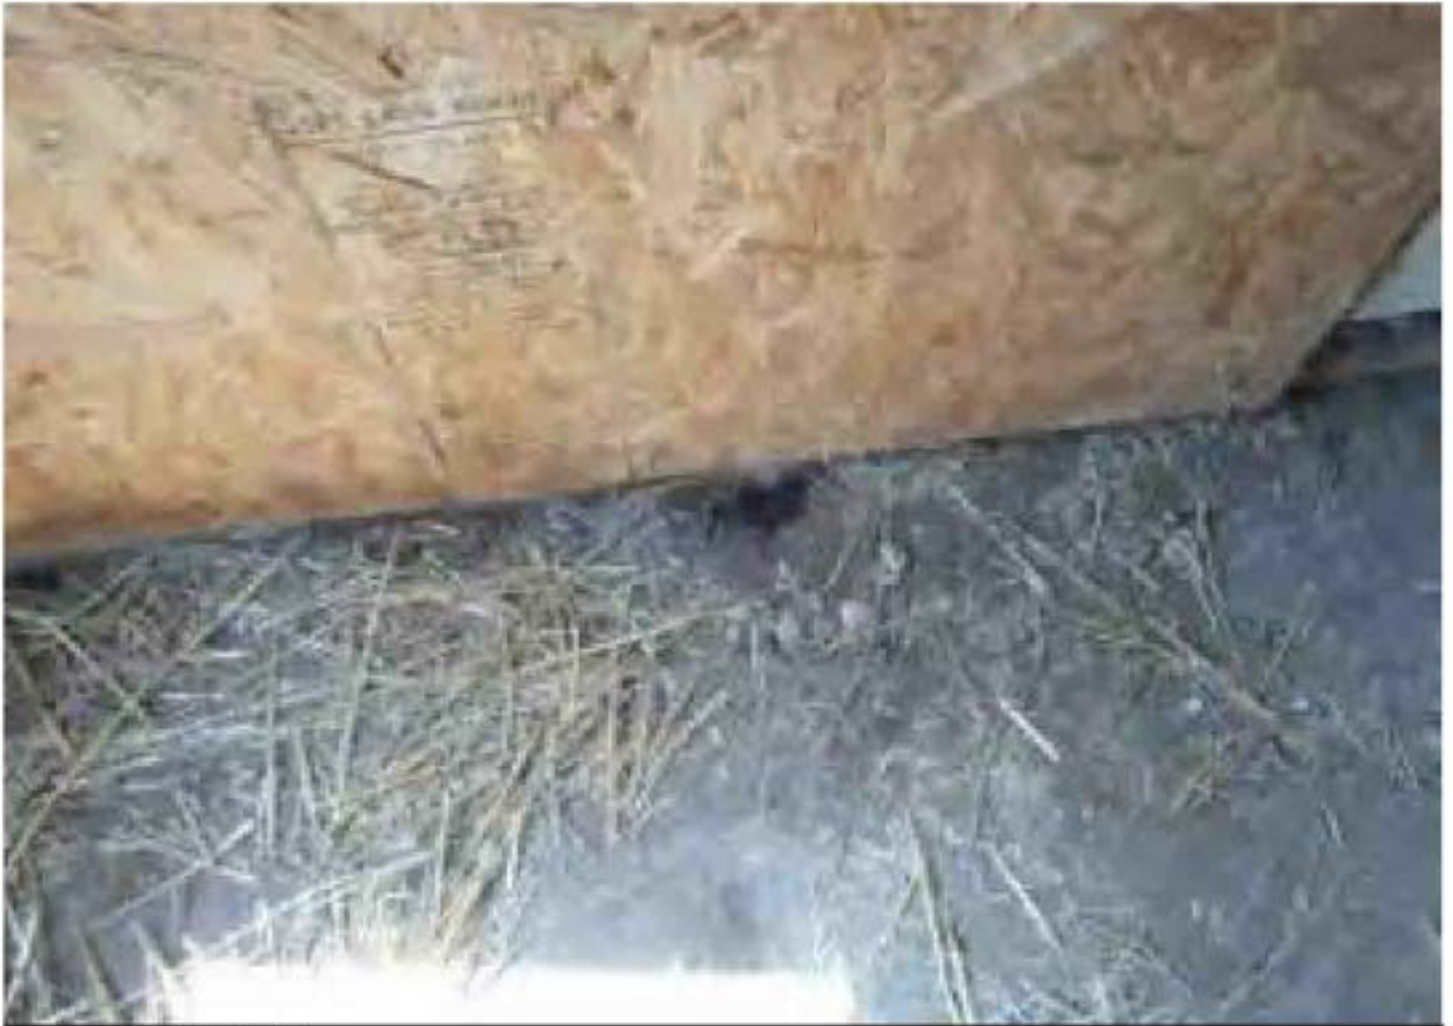
CFR : 3.131(d)

Section 3.131(d): Rodent holes found in kangaroo shelter.

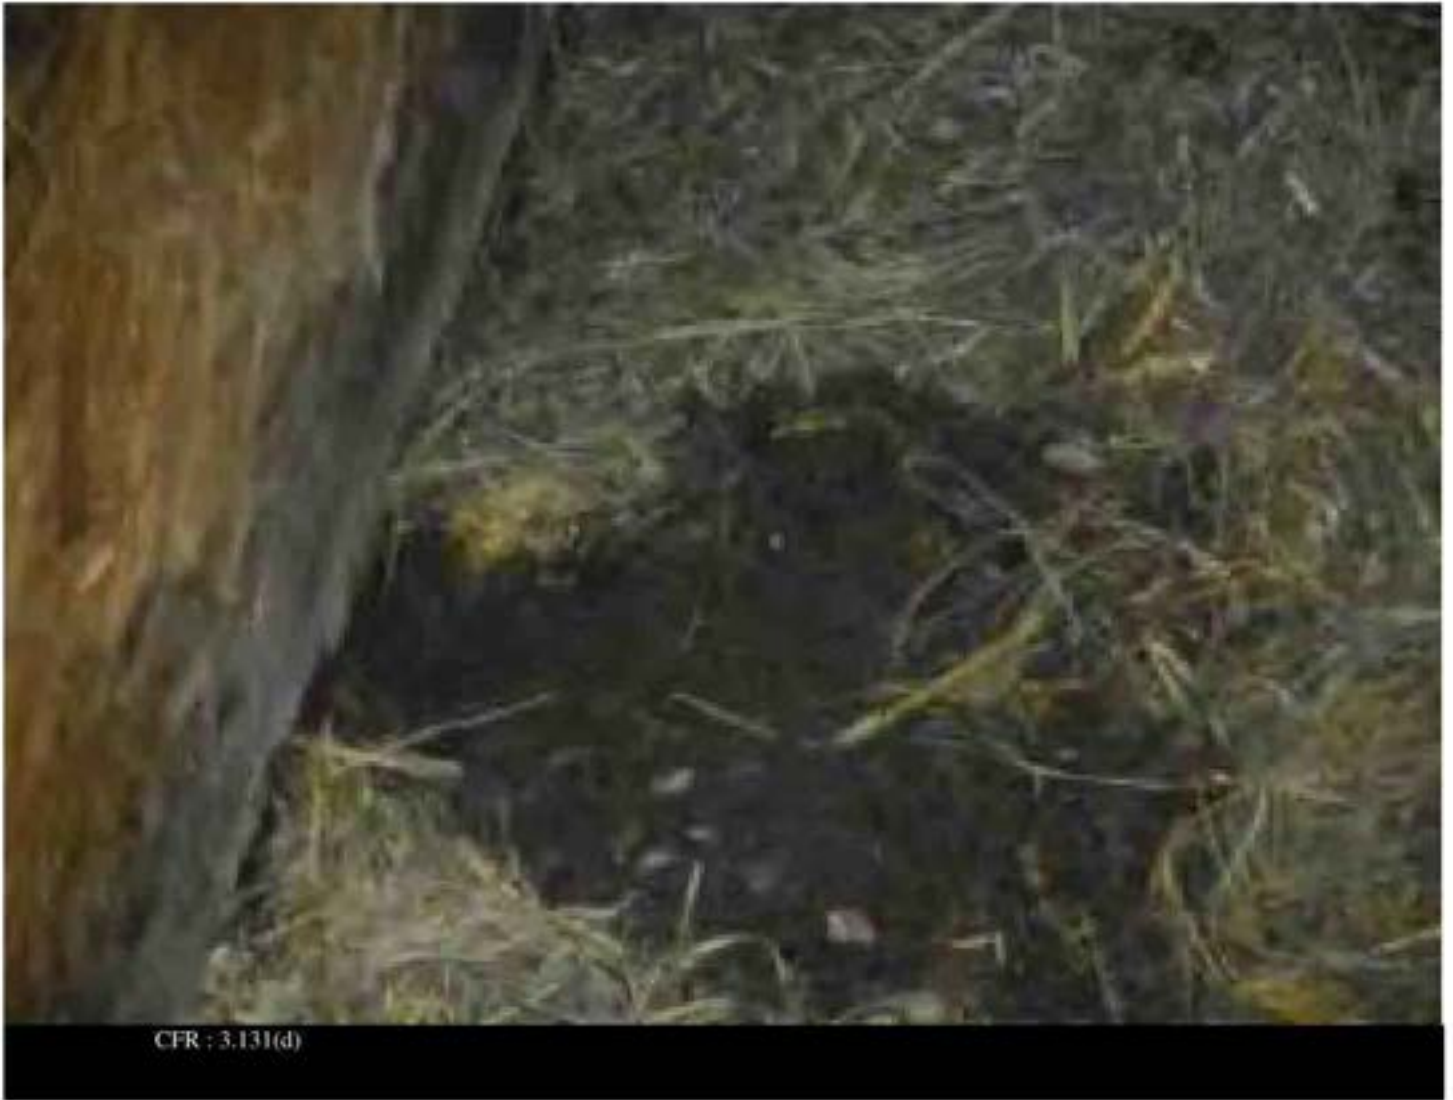
CFR : 3.131(d)

Section 3.131(d): Rodent holes found in kangaroo shelter.

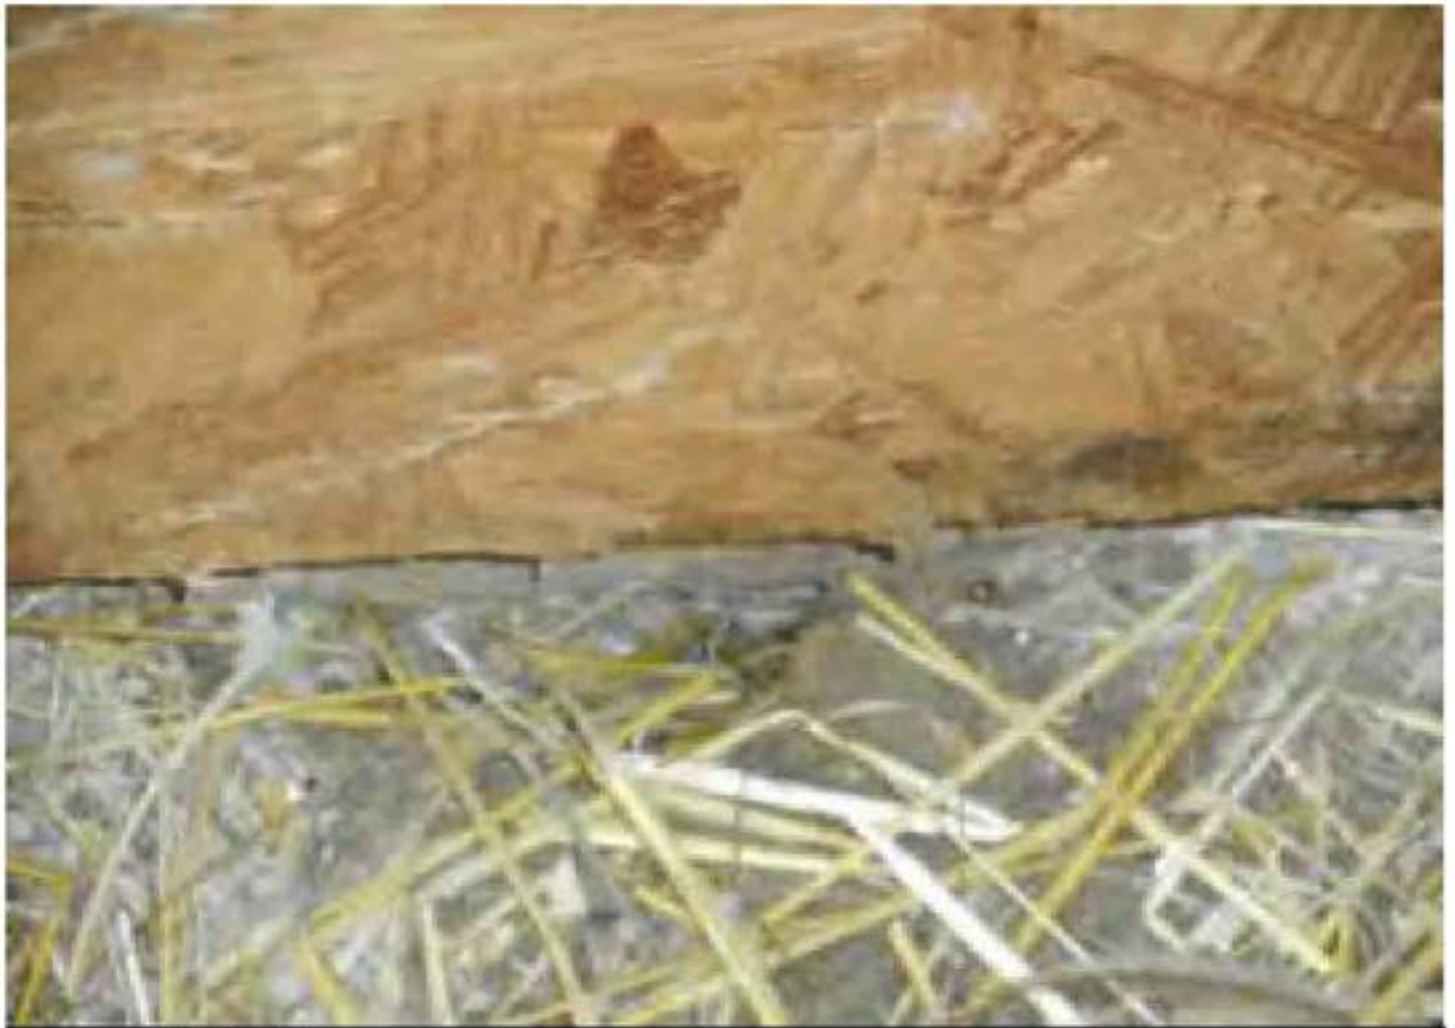
CFR : 3.131(d)

Section 3.131(d): Rodent holes found in kangaroo shelter.

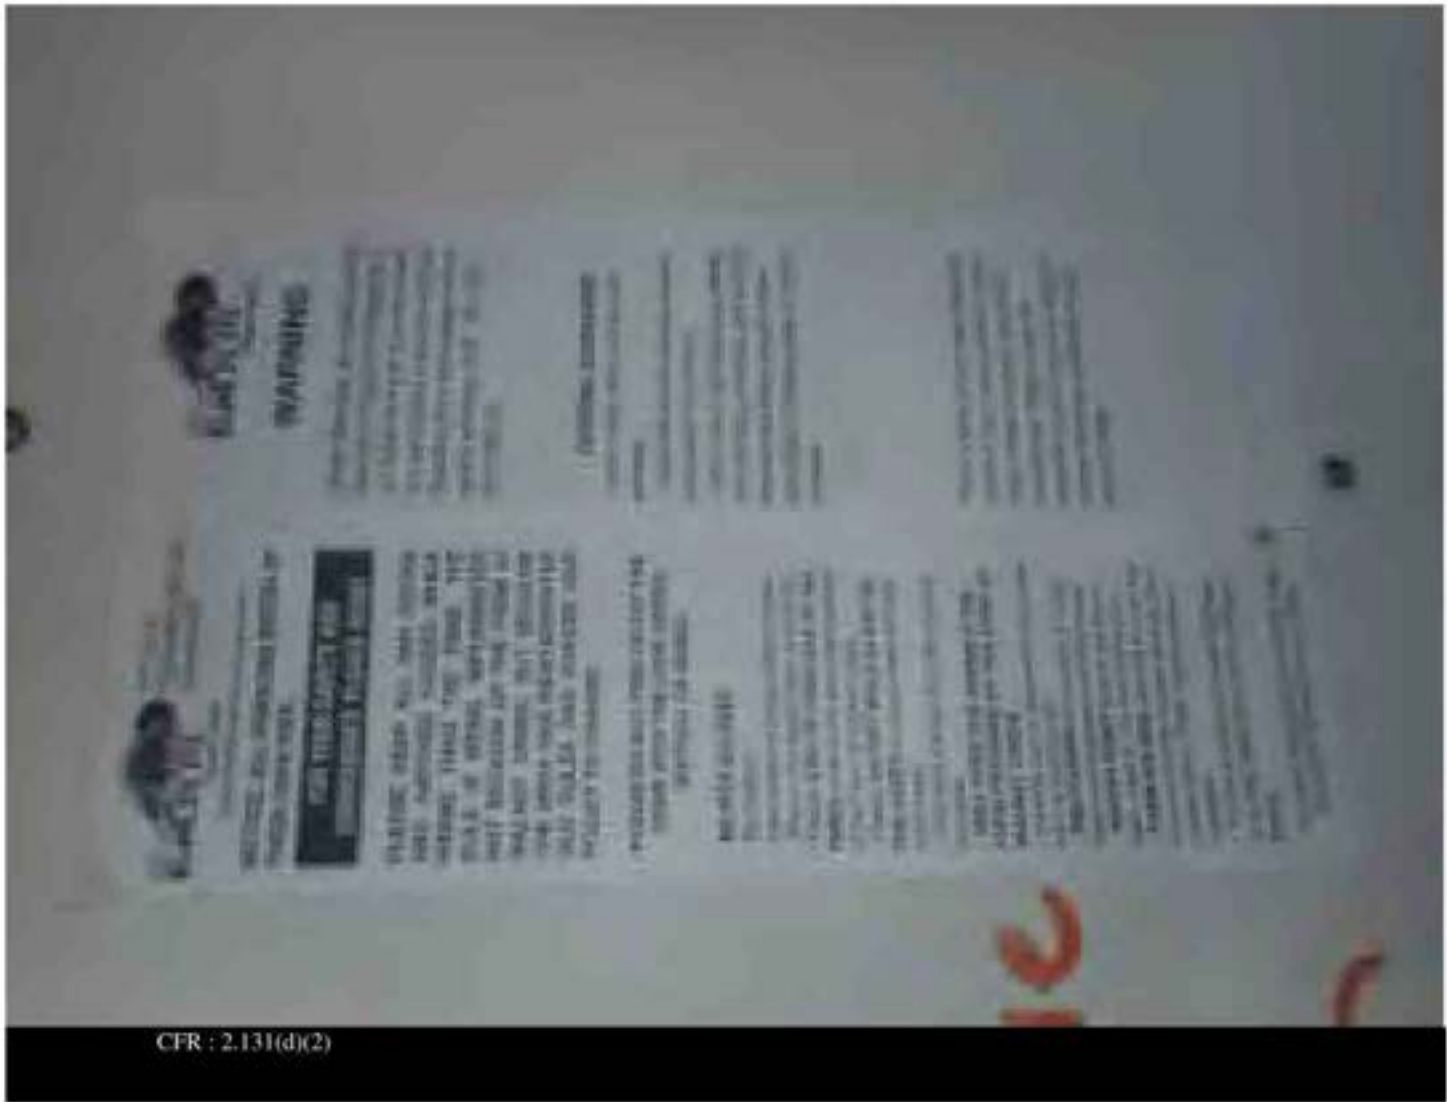
CFR : 2.131(d)(2)

Description: Section 2.131(d)(2): Driver guidance posted in horse barn and photos of vehicles with windows down and/or feeding animals. **HENRY HAMPTON**

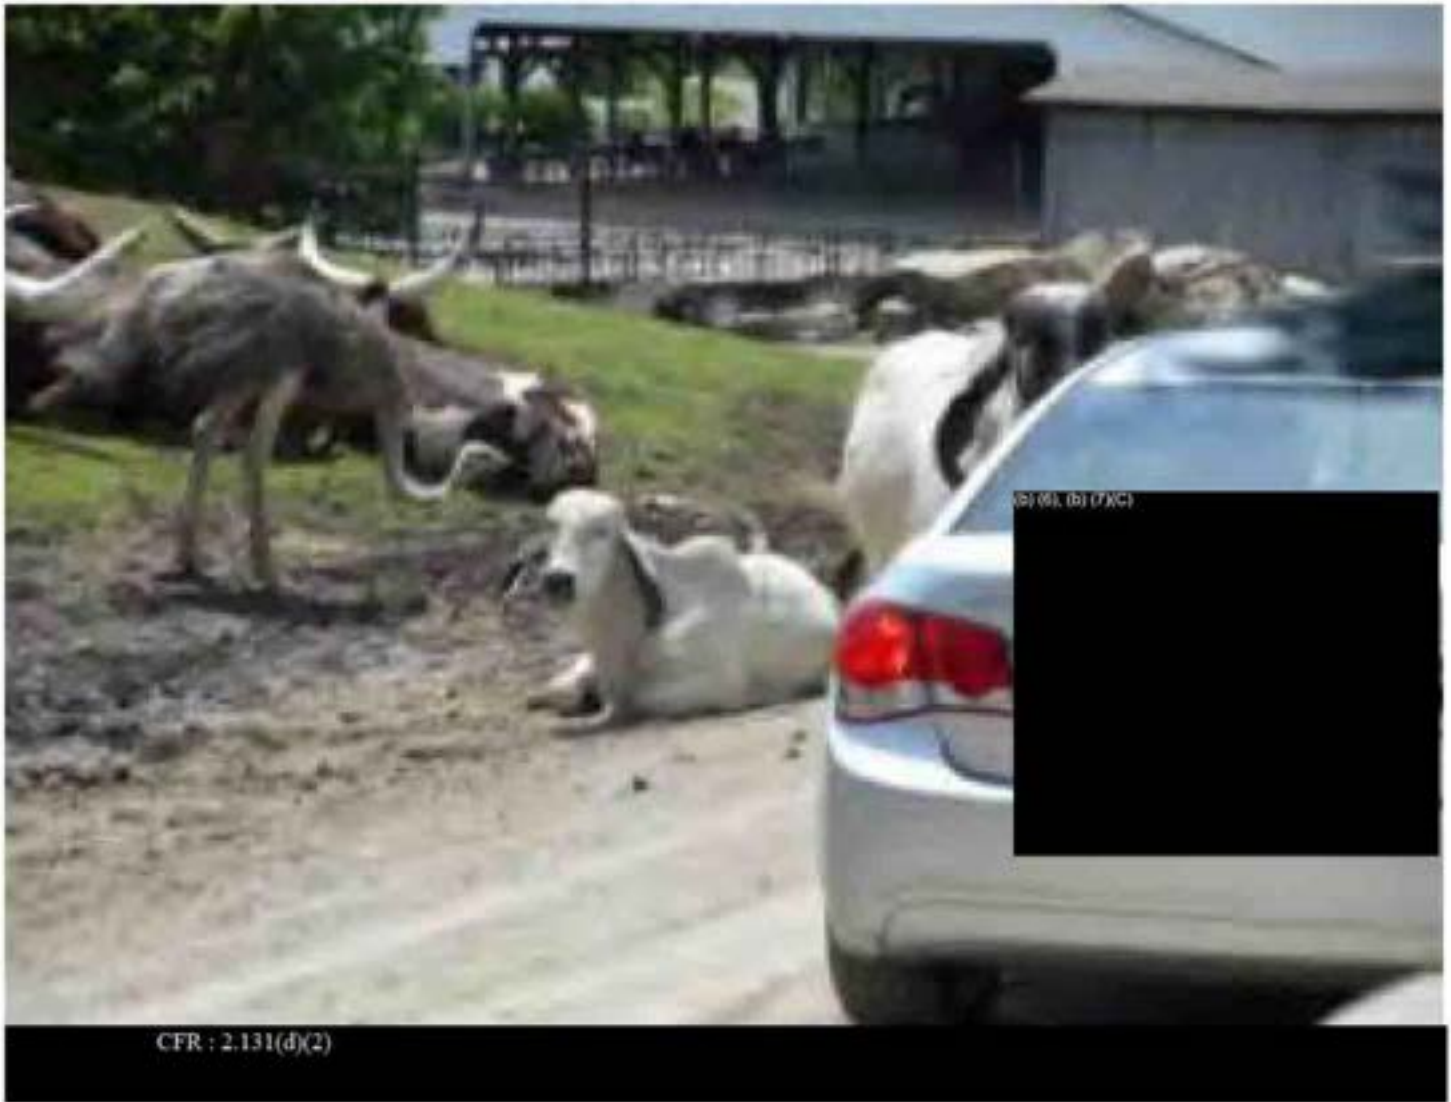
Description:
Section 2.131(d)(2): Driver guidance posted in horse barn and photos of vehicles with windows down and/or feeding animals.

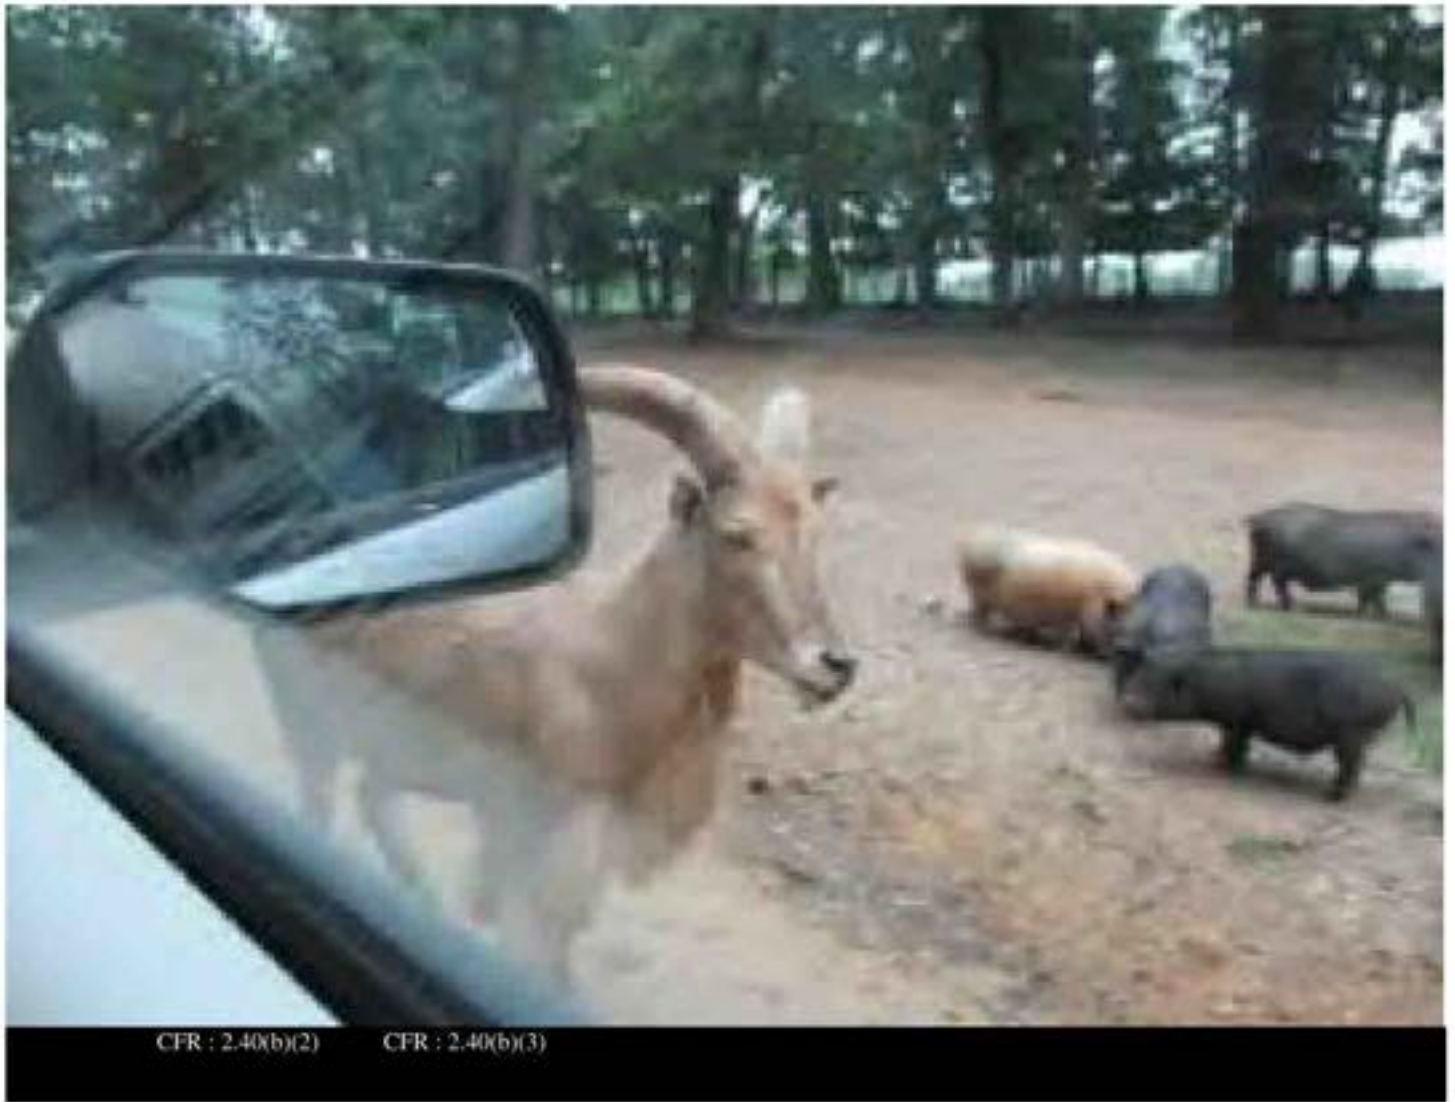
Photographer: S. BRUNKHORST
Date and Time: 23-MAY-17
Inspection No: 2016082568296926
Description:
Close up of limping aoudad #504 for ID

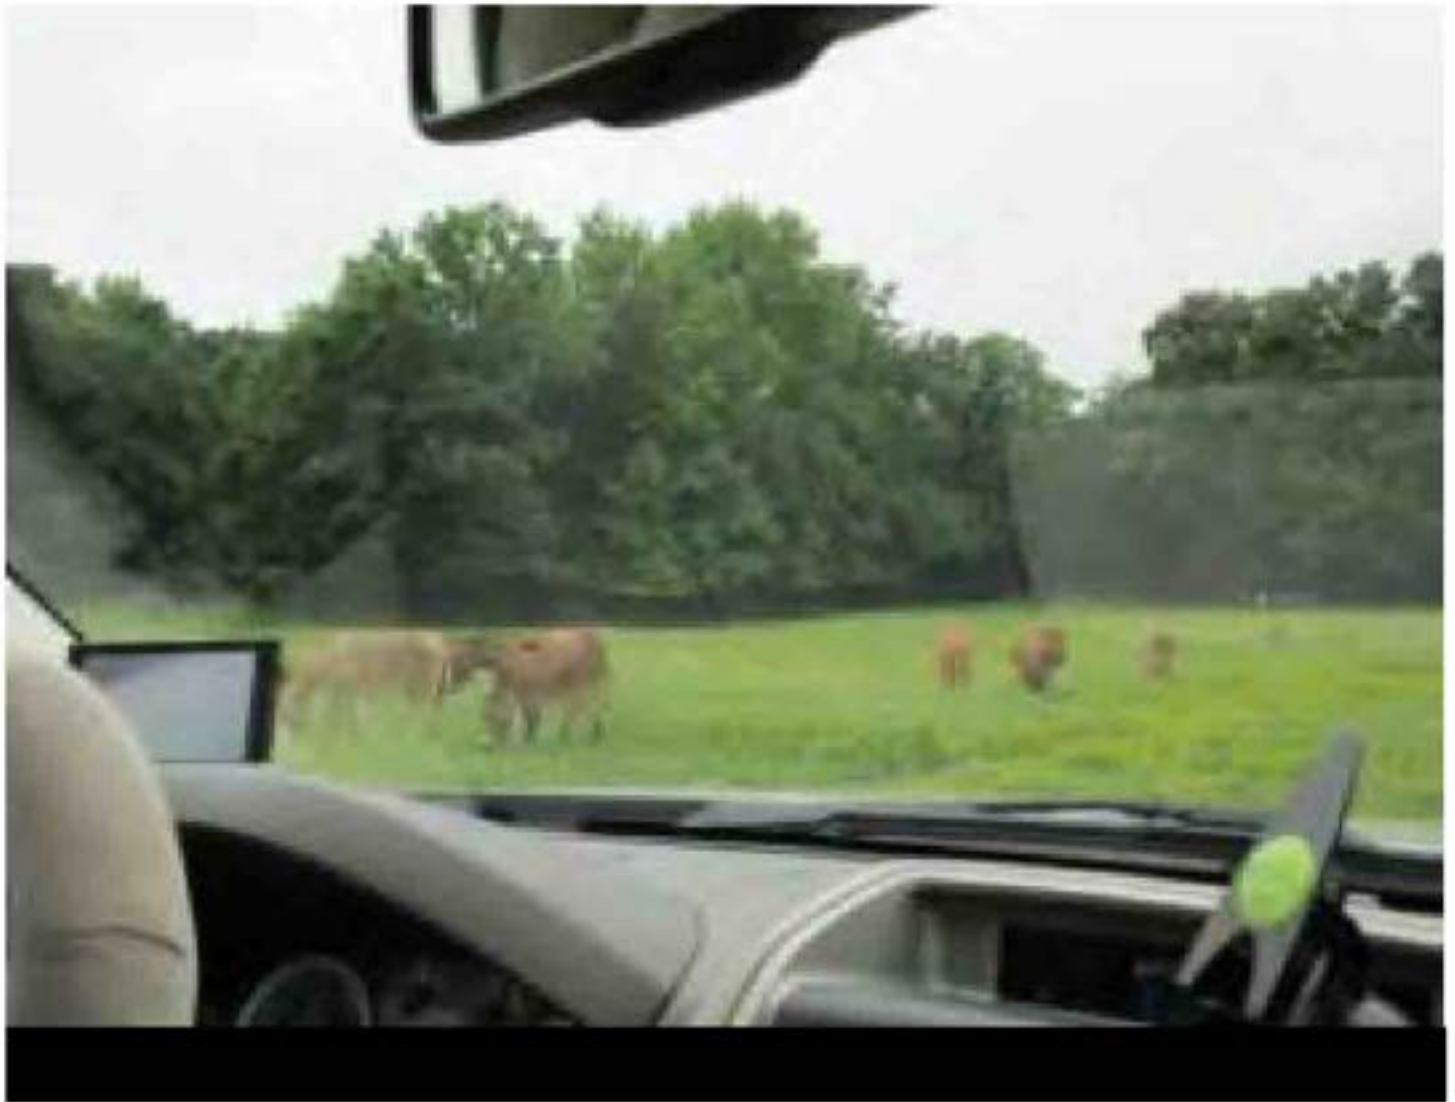
Photo for complaint re donkeys-no bloody or injured ears noted today
