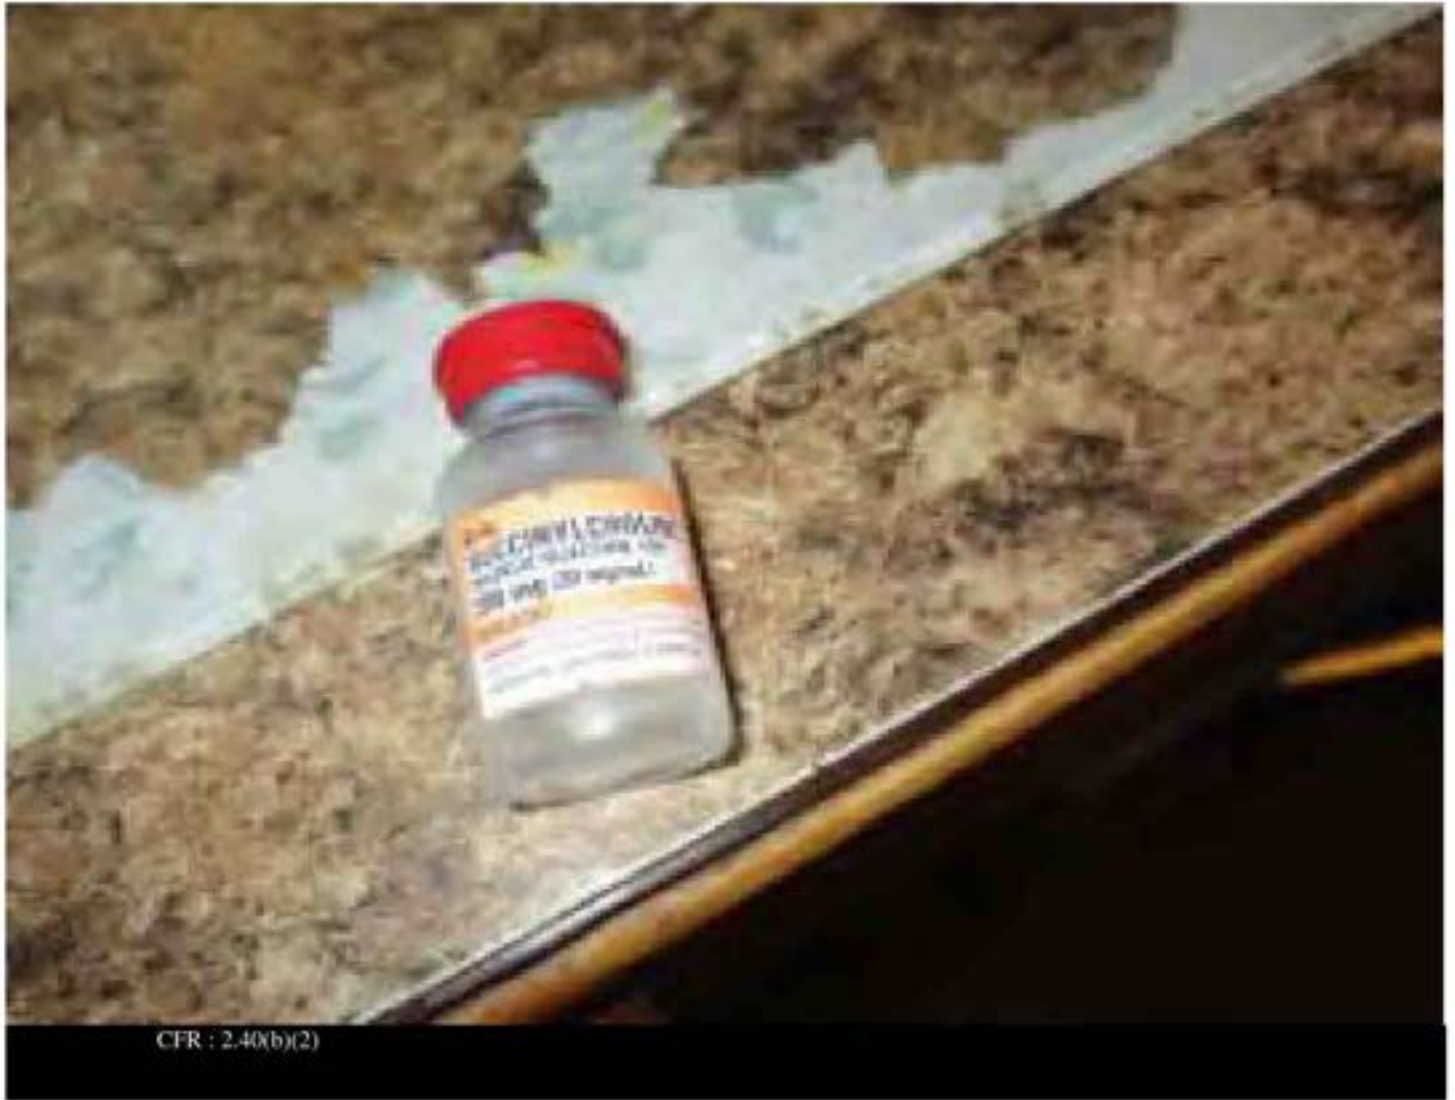
CFR : 2.40(b)(2)

One of several bottles of succinylcholine found in refrigerator ready for use

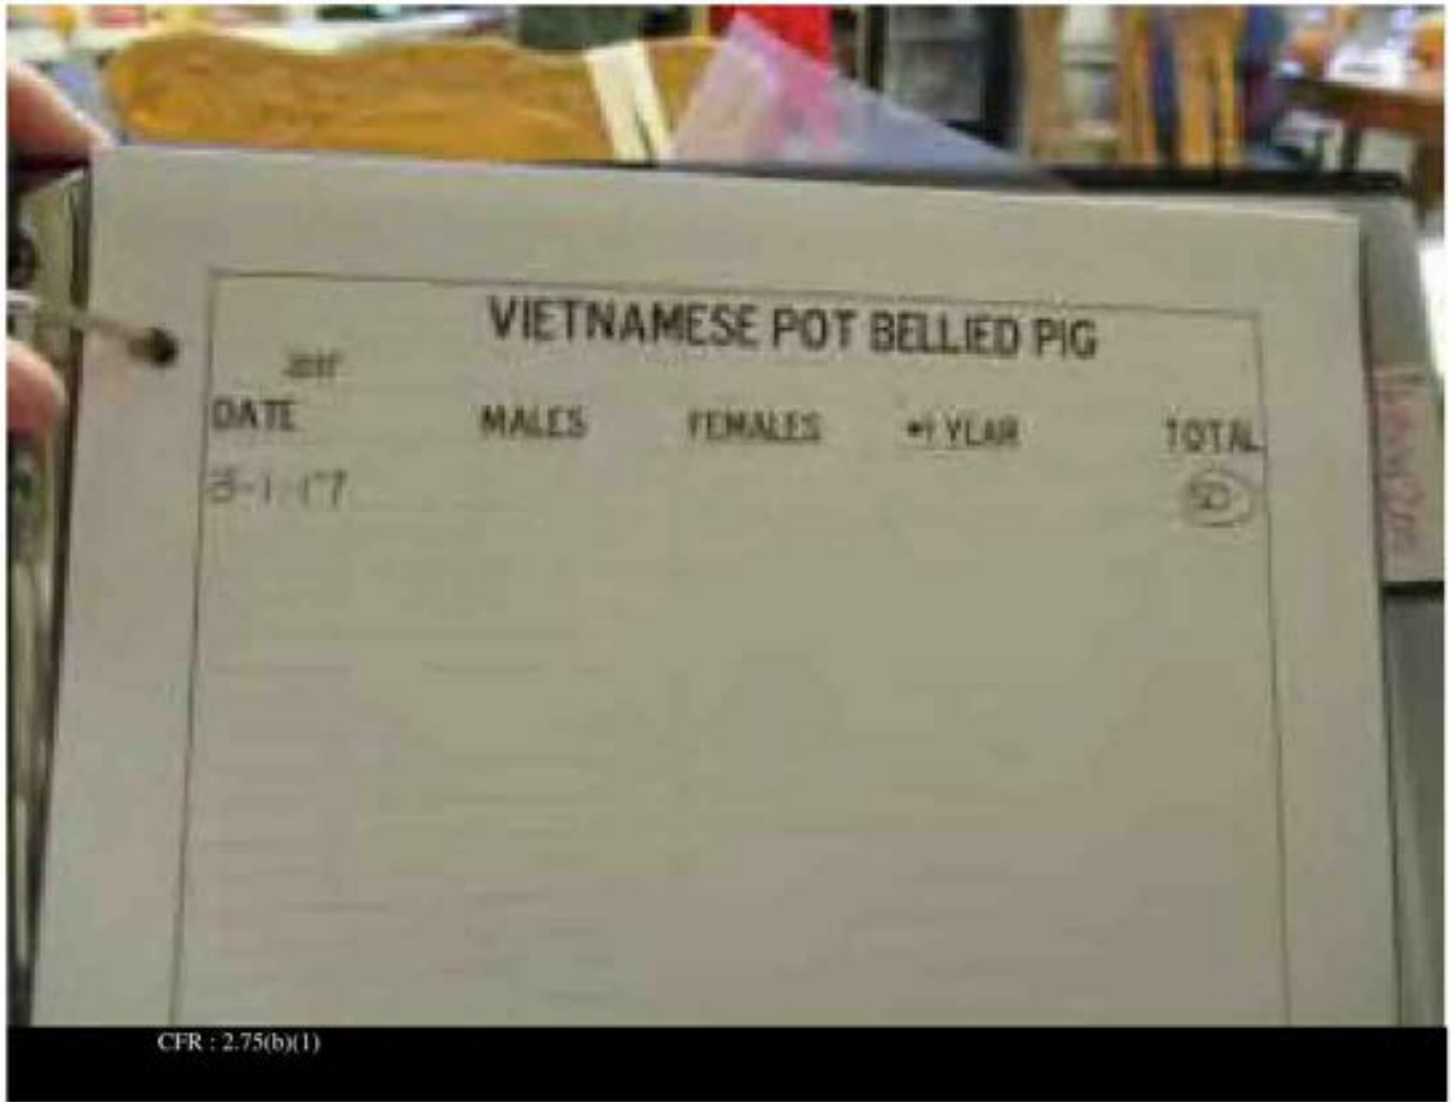
CFR : 2.75(b)(1)

Pigs record on hand shows a total of 50 pigs as of 3/1/17. More than 50 pigs were noted during the inspection (at least 59) with several piglets born more recently than 3/1/17 based on size and nursing females

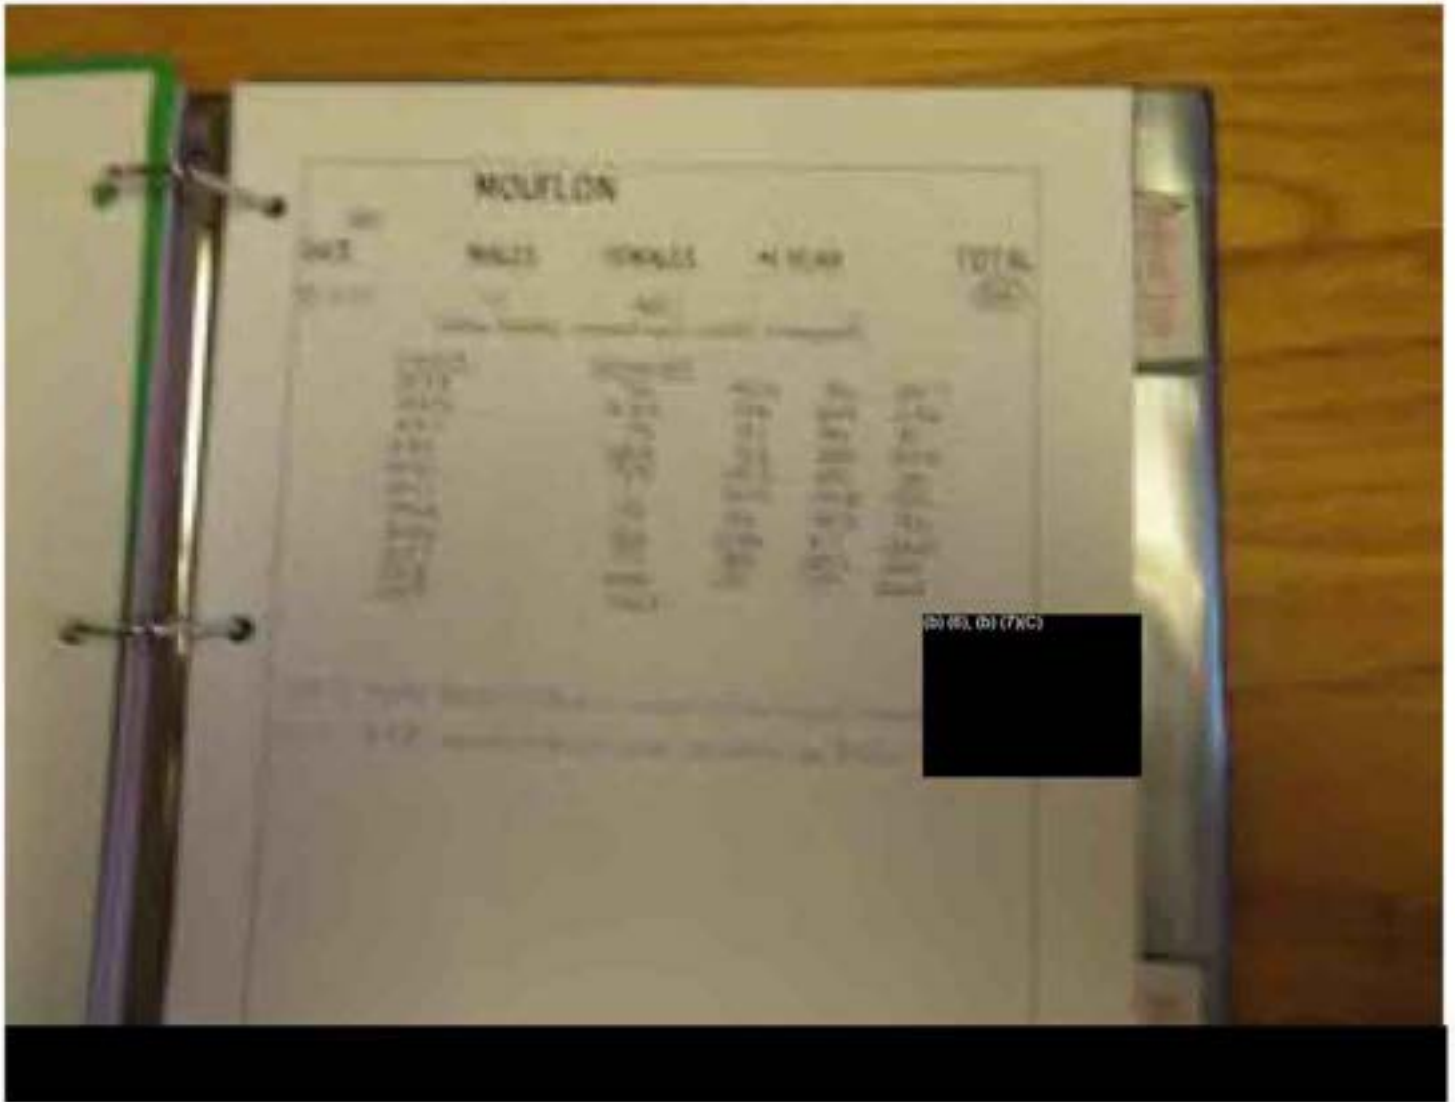
Photographer: BRUNKHORST
Date and Time: 23-AUG-17
Inspection No: 2016082568761330
Description:
documented use of BAM - 2

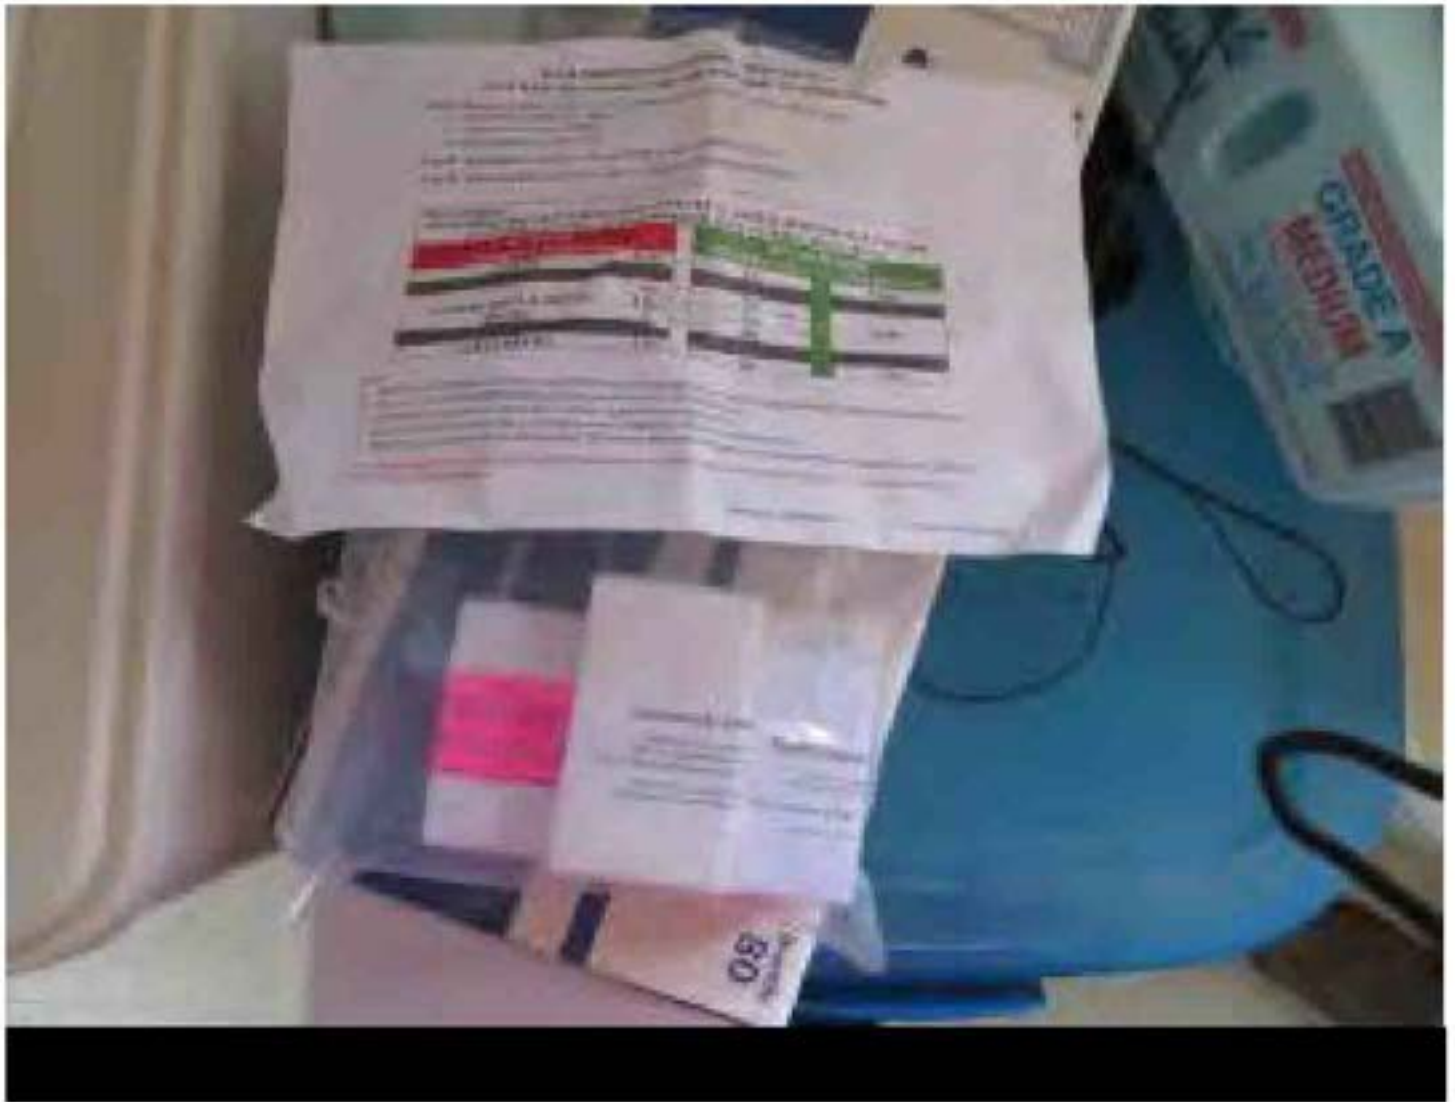
Photographer: BRUNKHORST
Date and Time: 23-AUG-17
Inspection No: 2016082568761330
Description:
BAM on premises

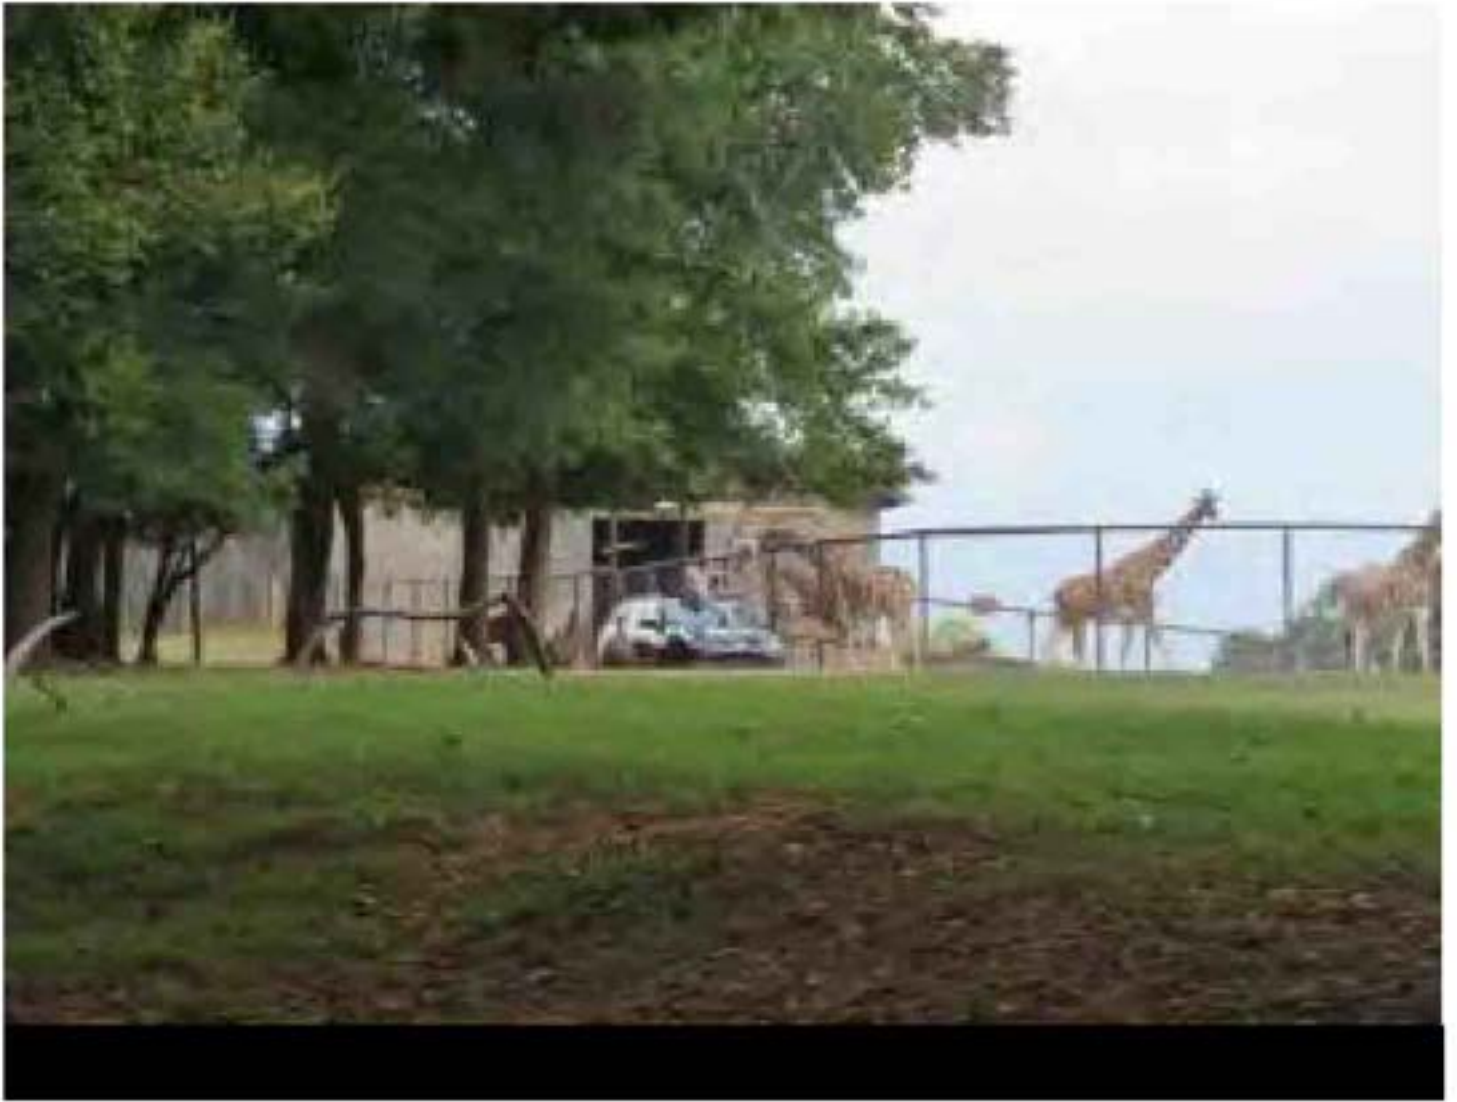
Photographer: BRUNKHORST
Date and Time: 23-AUG-17
Inspection No: 2016082568761330
Description:
feeding giraffes out of sunroof

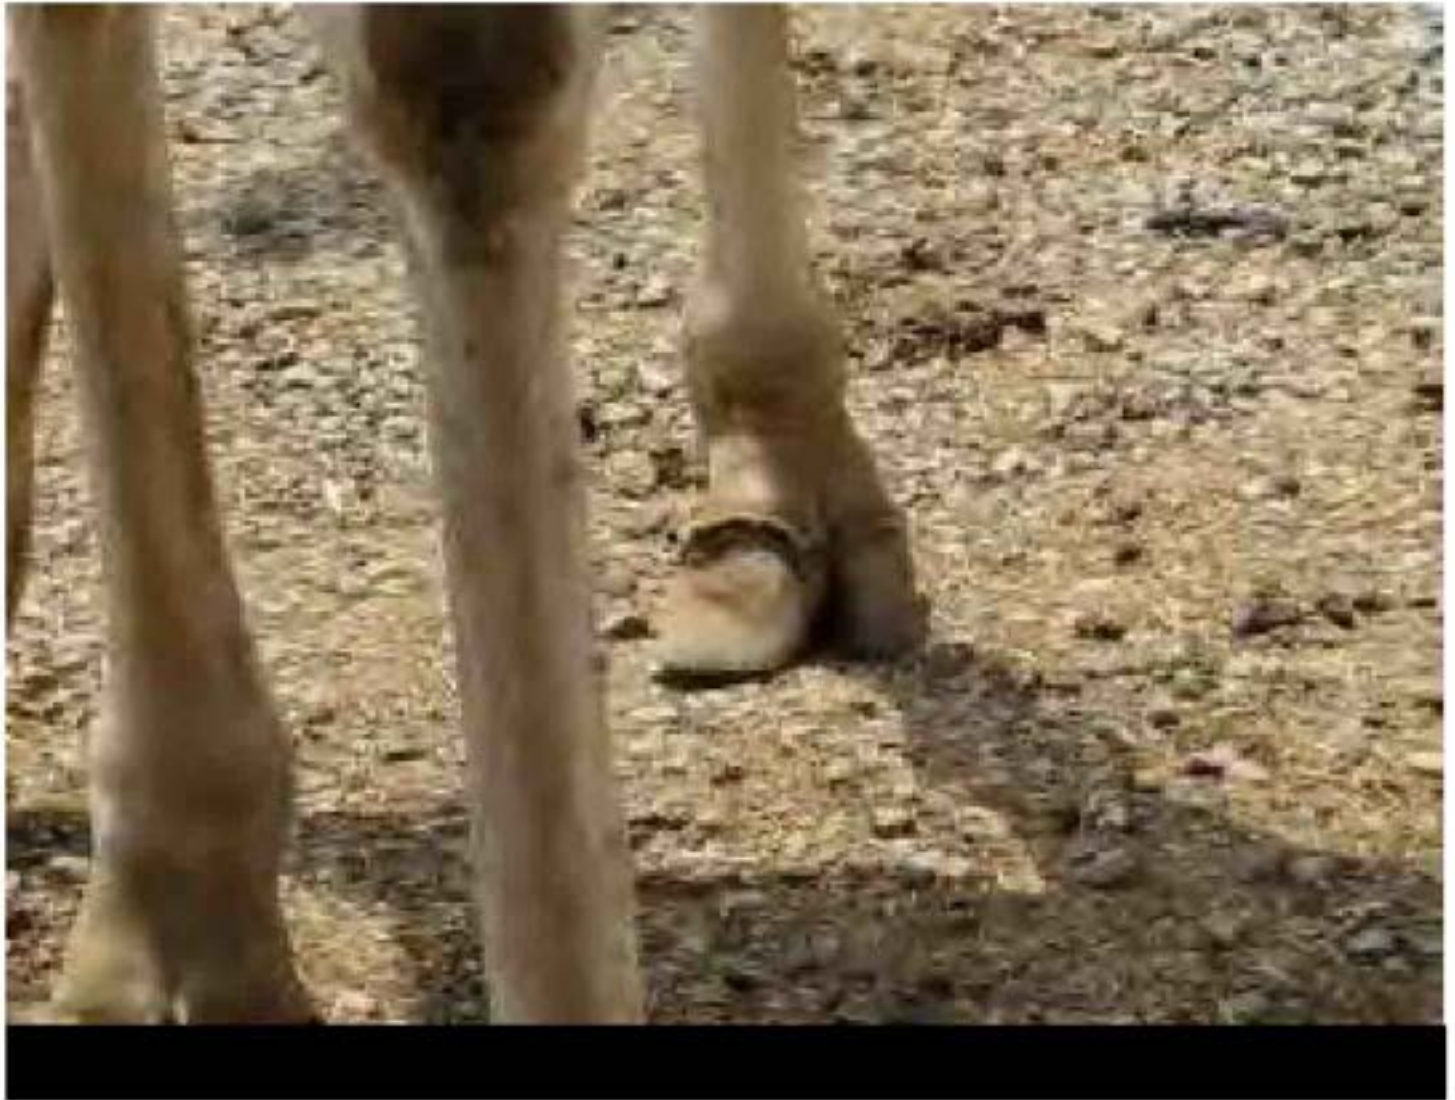
Photographer: BRUNKHORST
Date and Time: 23-AUG-17
Inspection No: 2016082568761330
Description:
giraffe overgrown splay inner claw
